1. Report No. FHWA/TX-06/0-4664-3		2. Government Accession No.		3. Recipient's Catalog No.	
4. Title and Subtitle INVESTIGATION FOR TRAFFIC MONITORING EQUIPMENT EVALUATION FACILITY				5. Report Date October 2005 Published: January 2007

INVESTIGATION FOR TRAFFIC MONITORING EQUIPMENT EVALUATION FACILITY

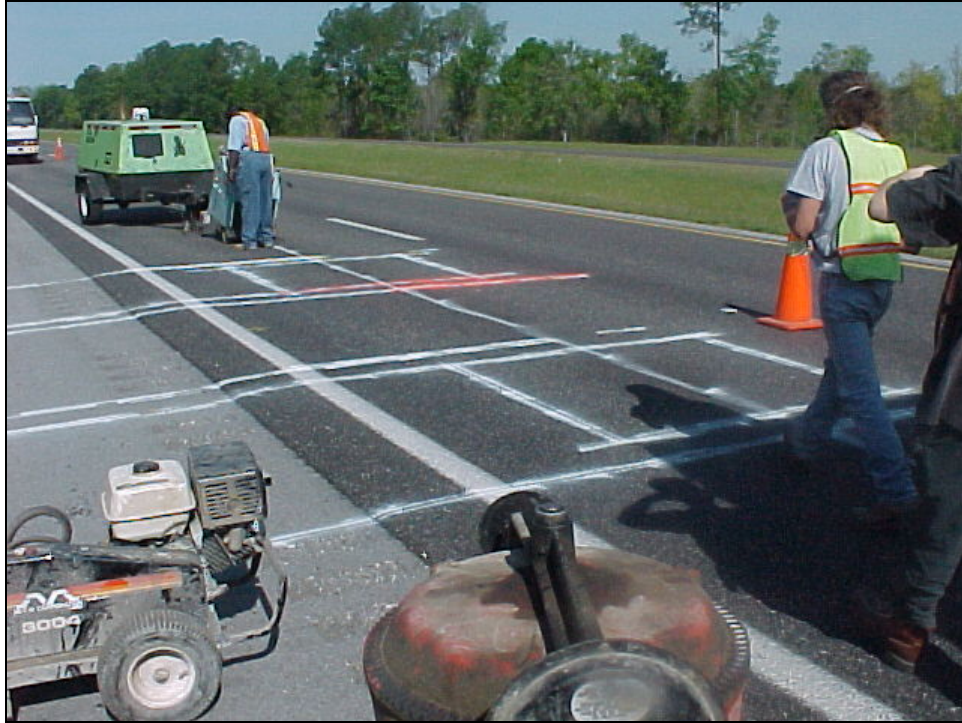
Figure 2. Kistler Sensor Layout before Installation.

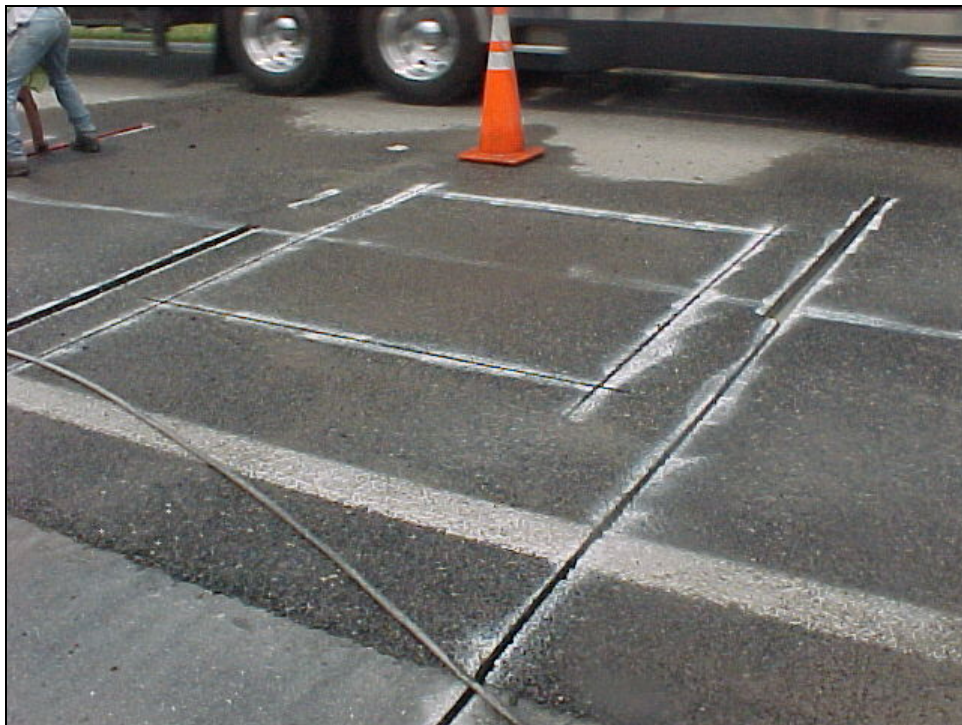
Figure 3. Kistler Sensor Saw Cuts during Installation.

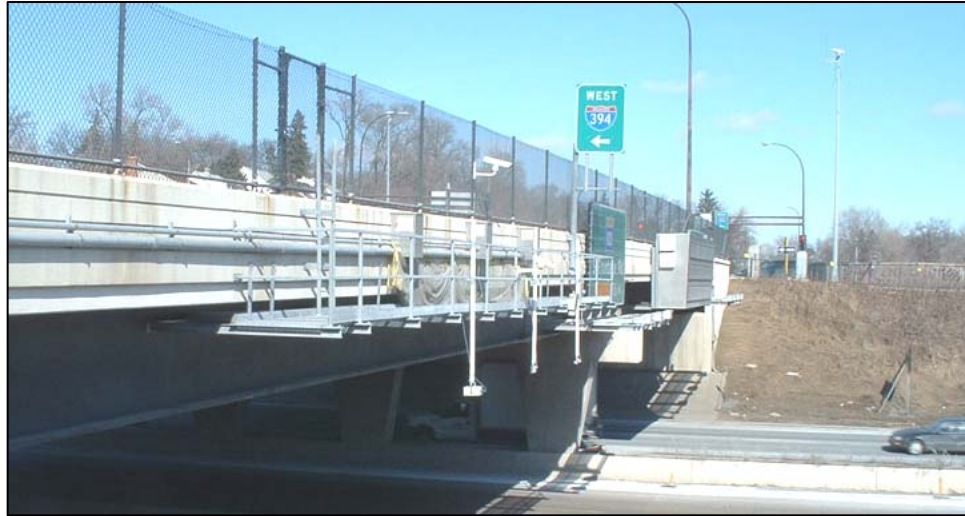
Figure 6. Catwalk for Mounting Detectors Overhead.

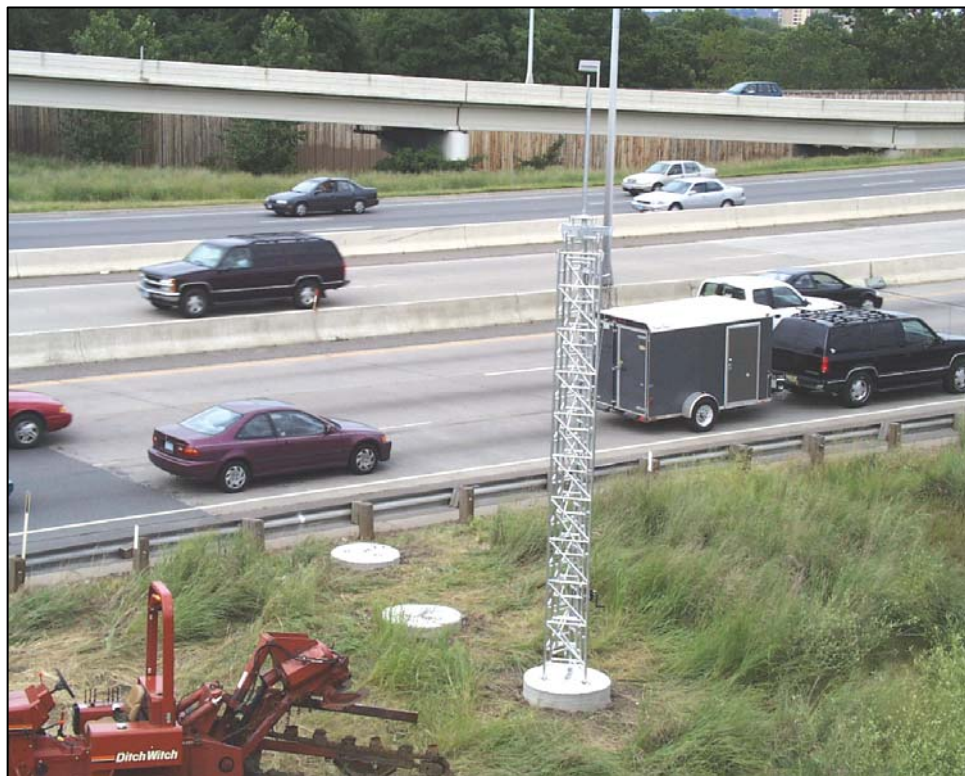
Figure 7. Aluminum Tower for Sidefire Mounting.

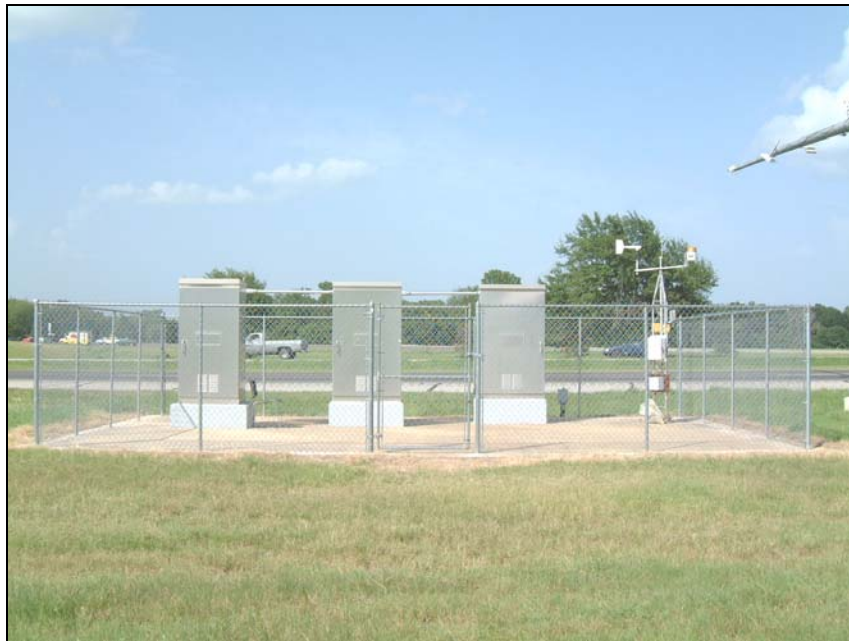
Figure 14. View of Equipment Cabinets and Weather Station.

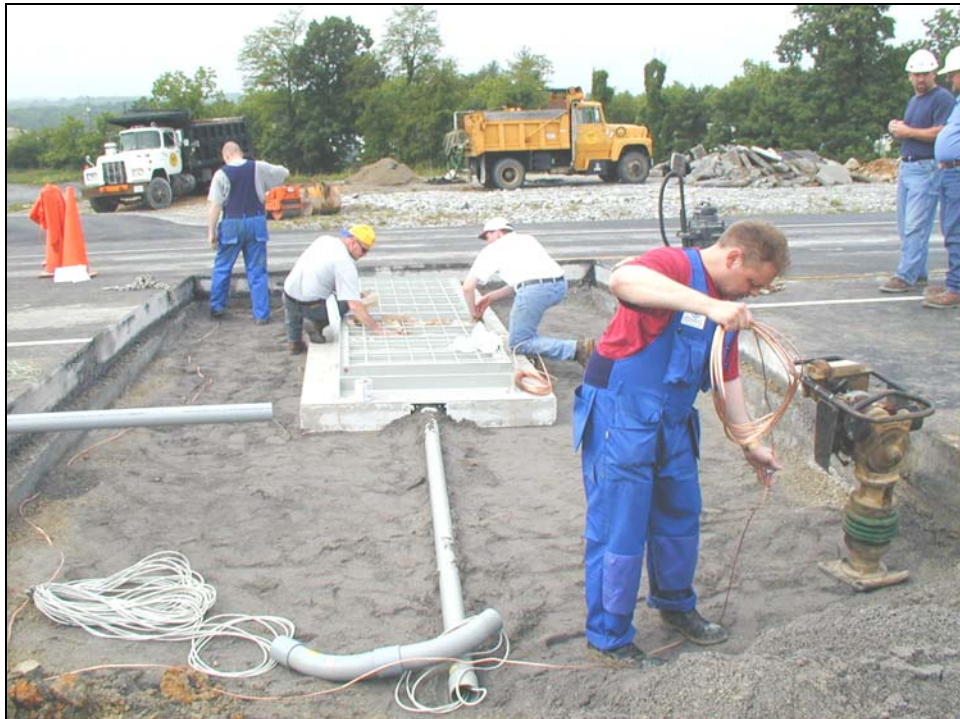
Figure 15. Installation of Omni WIM System at Virginia Tech’s Smart Road.

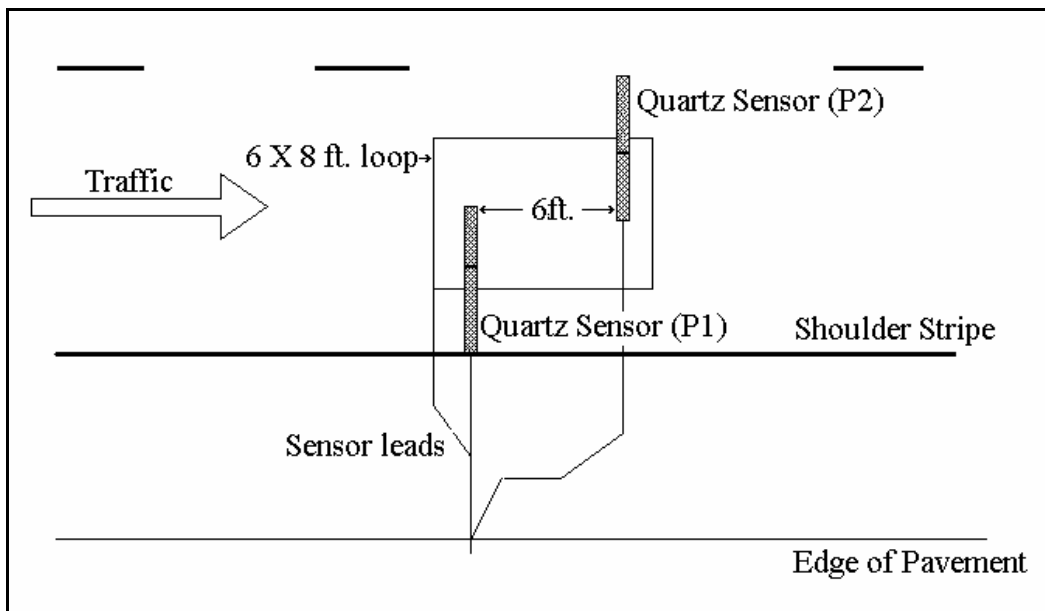
Figure 28. WIM Sensor Array (Typical).

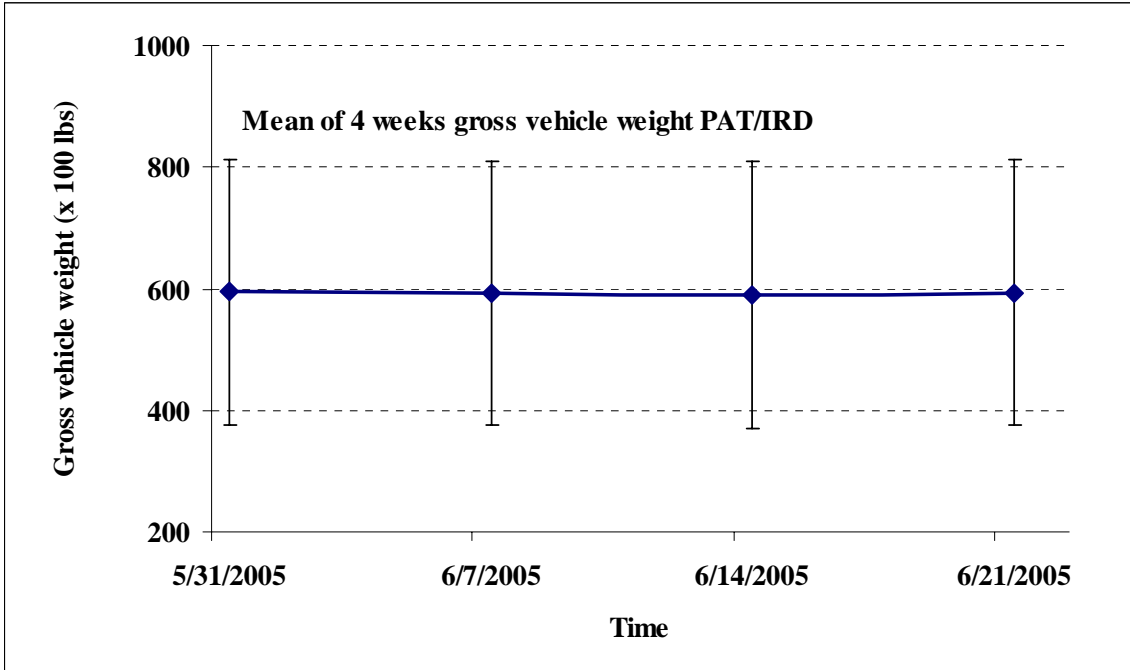
Figure 30. Weekly Averages \pm One Standard Deviation of Gross Weight for S.H. 6 Site.

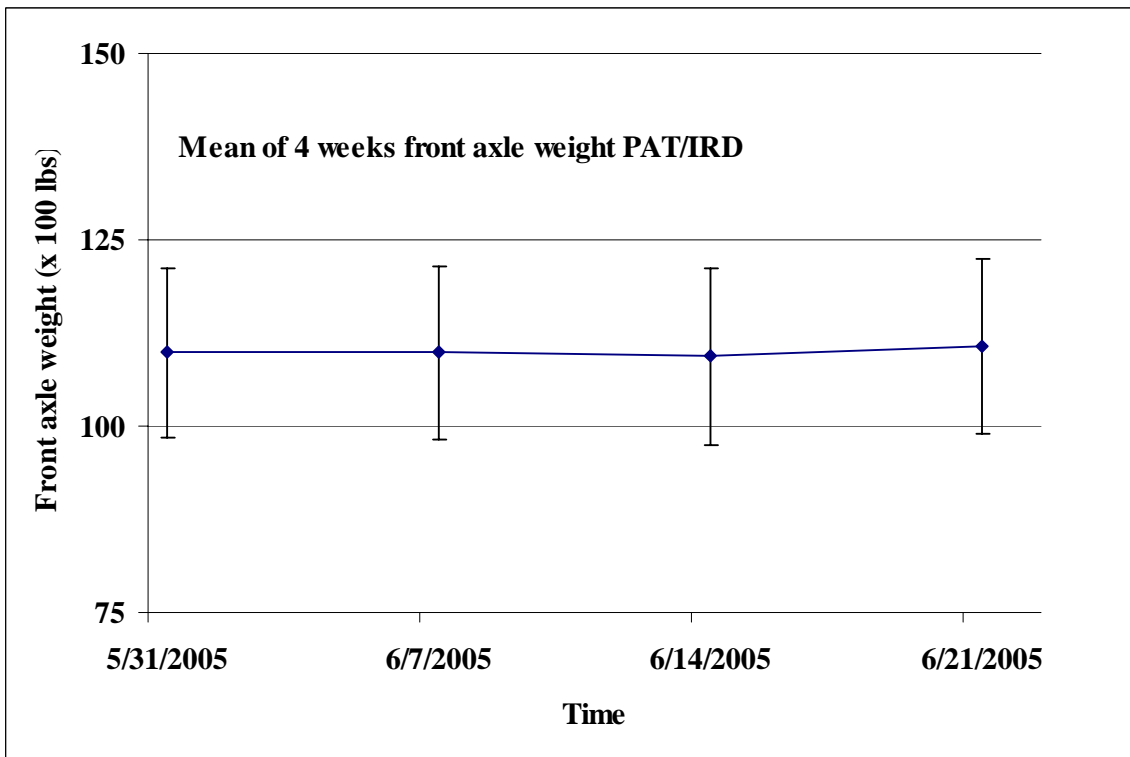
Figure 31. Weekly Averages \pm One Standard Deviation of Front Axle Weight for S.H. 6 Site.

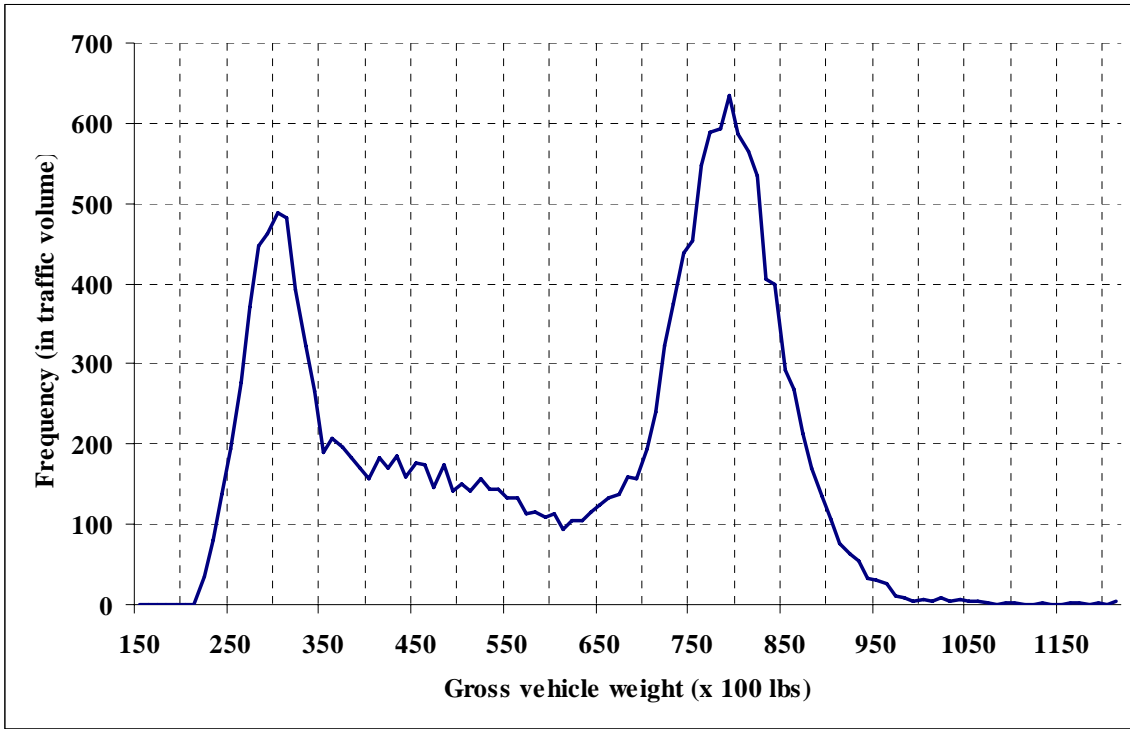
Figure 32. S.H. 6 PAT/IRD Gross Vehicle Weights (5/25/05-6/26/05).

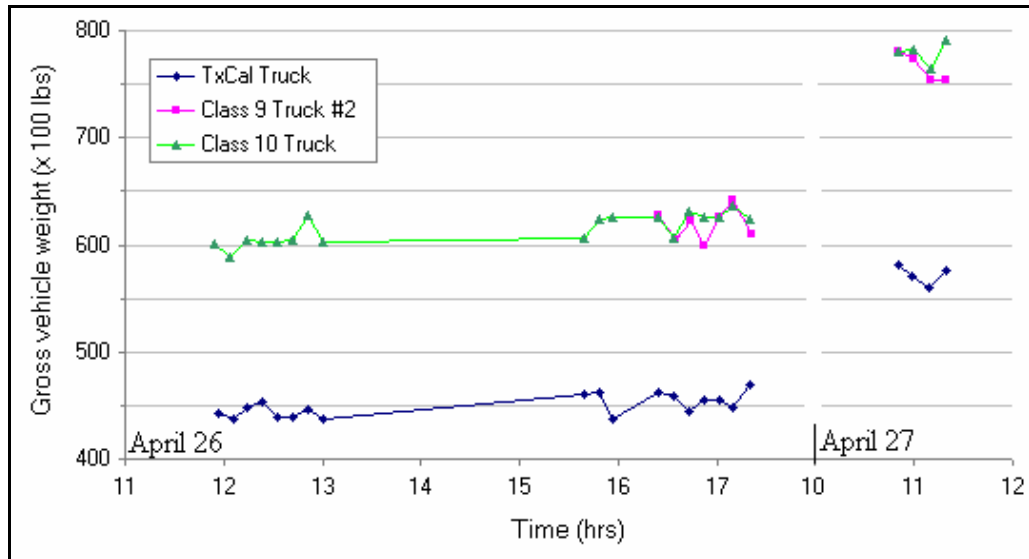
Data sets polled from the Falfurrias site cover a period of 51 days, beginning March 23 and ending May 12, 2005, with a total truck traffic volume of approximately 51,000. As shown in [Figure 35](#), gross weights from Class 9 trucks produced by Kistler sensors during this period had a bimodal distribution with two comparable peaks at the ranges 30,000 to 35,000 lb and 75,000 to 80,000 lb. As with the Los Tomates site (presented below), a single peak characterizes the distribution of front axle weights, yet shifted to the range 10,000 to 11,000 lb.

Figure 34. Falfurrias Calibration Truck Runs before and after Calibration.

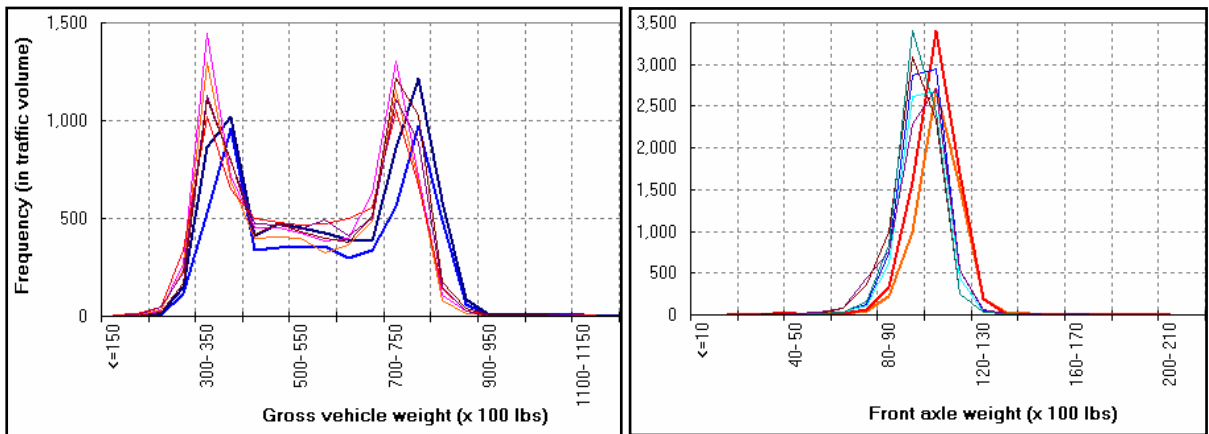
Figure 36 shows the weekly distributions of the measured weights. Although they have a similar shape as the overall distribution curve, the weekly distribution curves are not aligned as well as monthly distributions from the Los Tomates site (presented below). These curves exhibit more variation than Los Tomates data because only two weeks of these data were available after the calibration on April 27. Prior to this, researchers were making calibration adjustments by modem based on the statistical evaluation of truck traffic collected from the site. Figure 37 shows plots of weekly average weights ± 1 standard deviation. However, the accuracy and stability of the measured weights over time could not be evaluated given the relatively small size of the data sample polled after calibration.

Figure 36. Weekly Distributions of Gross Weight (Left) and Front Axle Weight (Right) for the Falfurrias Site.

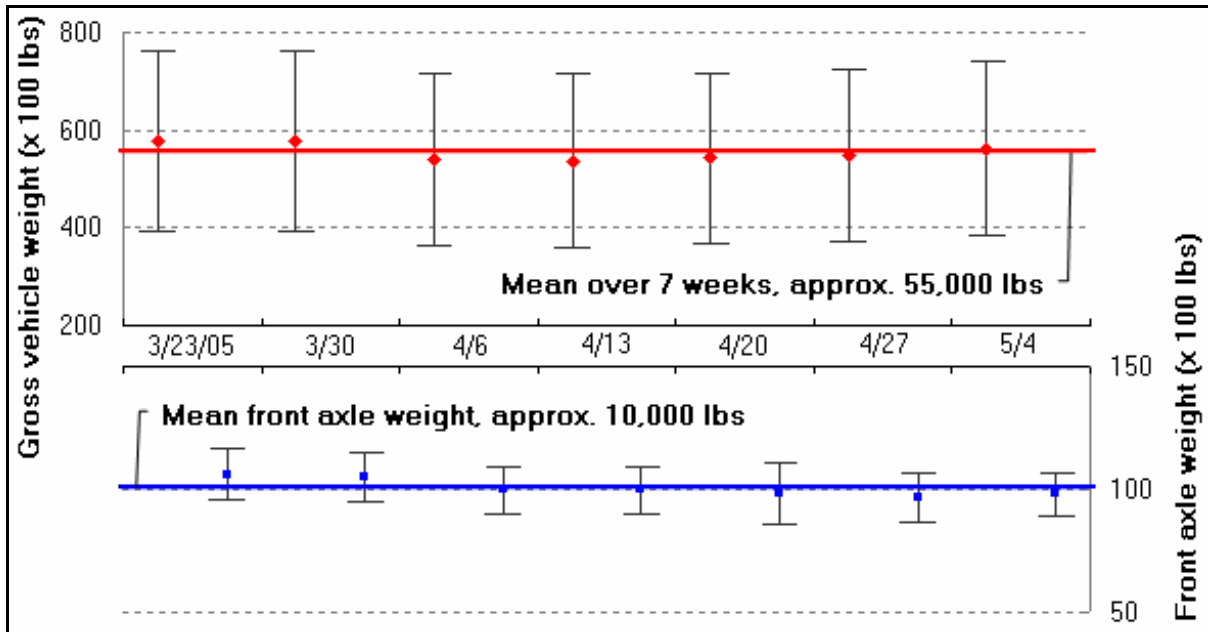
Figure 37. Weekly Averages \pm 1 Standard Deviation of Gross Weight (Top) and Front Axle Weight (Bottom) for the Falfurrias Site.

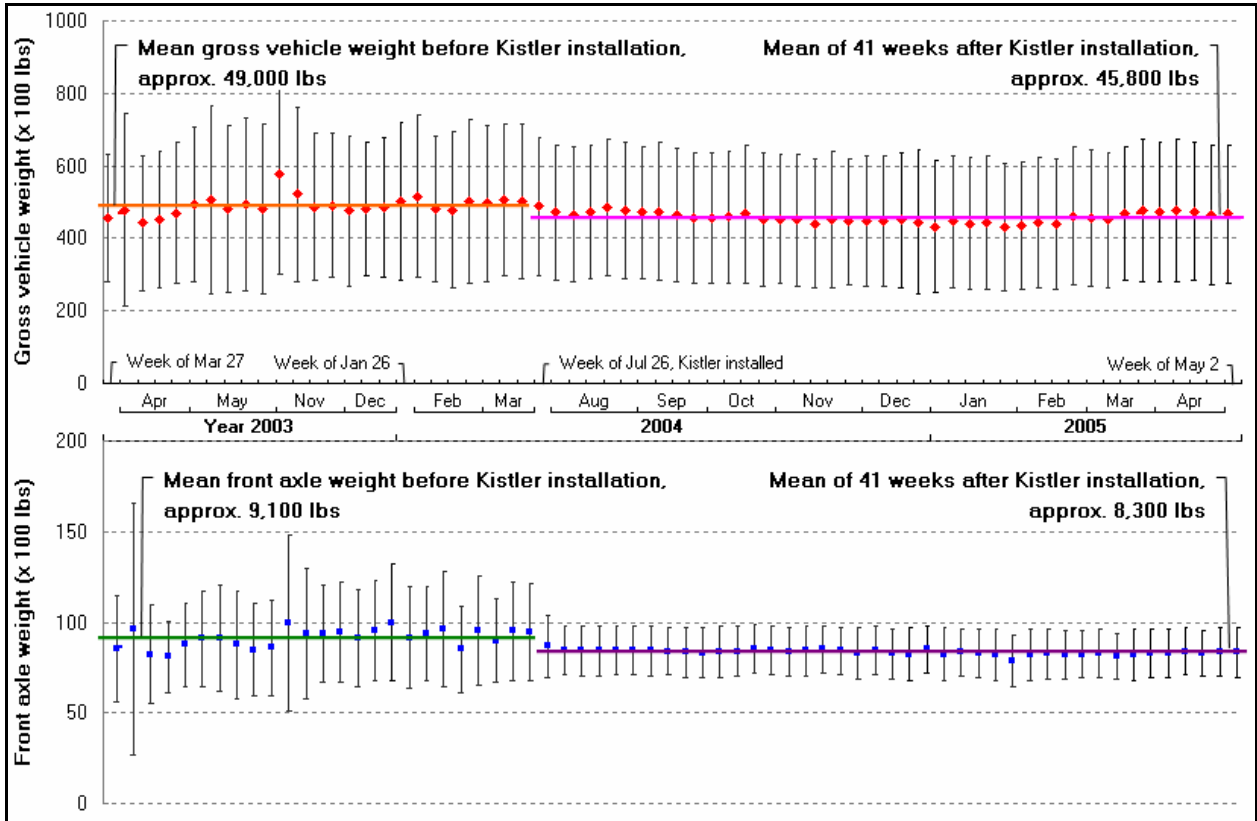
Figure 39. Weekly Averages \pm 1 Standard Deviation of Gross Weight (Top) and Front Axle Weight (Bottom) for the Los Tomates Site.

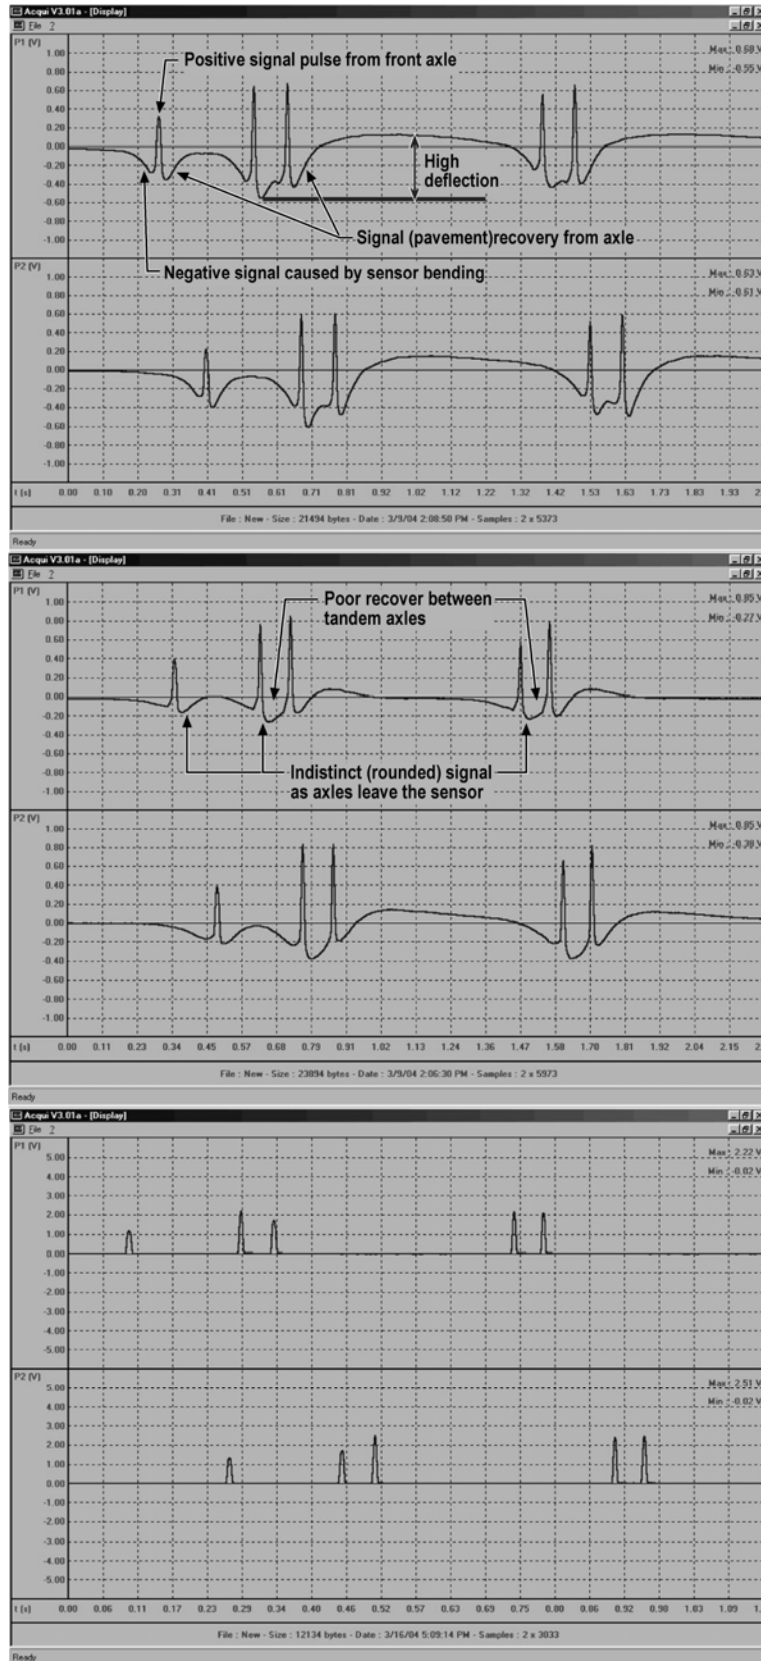
Researchers collected sensor signals from the Quartz sensors at all sites and evaluated the quality of the signals. There are several characteristics of piezo sensor signals that make them more or less desirable for WIM applications. These characteristics include the signal to noise ratio, signal shape, and the magnitude of the negative portion of the signal. In the case of piezo ceramic sensors, the stiffness and elastic behavior of a pavement structure directly affect the performance of a WIM system. When installed properly, these sensors become a part of the pavement structure, and as the pavement deflects under load, so will the piezo sensor. Also, as the pavement rebounds or recovers from a load, so will the sensor. If the pavement deflects too much or cannot recover quickly enough from an axle load, the quality of the piezo signal (and thus the accuracy of the WIM system) will decline. [Figure 40](#) illustrates the significance of pavement structure on the quality of a piezo ceramic sensor signal. The top pair of signals in this figure illustrates a sensor with low signal noise but a large negative signal component resulting from pavement deflection under load. The third and fourth signals from the top show another pair of ceramic sensor signals in a different asphalt

pavement that does not rebound quickly from load, which causes the rounded signal and poor signal recovery between consecutive axles in a tandem group. Each of these features contributes to produce less desirable sensor signals for weigh-in-motion applications and would lower the weighing accuracy of the WIM system. The last pair in [Figure 40](#) shows signals from the Quartz piezo sensors at Los Tomates taken as the TxDOT calibration truck crossed the sensors. This signal signature is typical of Quartz sensor output installed in PCC and asphalt pavement structures. The absence of a negative signal is due to the design and installation of the sensor, which isolates the sensing element of the sensor from the effects of pavement deflection and produces a signal that is ideal for weigh-in-motion applications.

Figure 40. Examples of Piezo Ceramic and Piezo Quartz Sensor Signals.

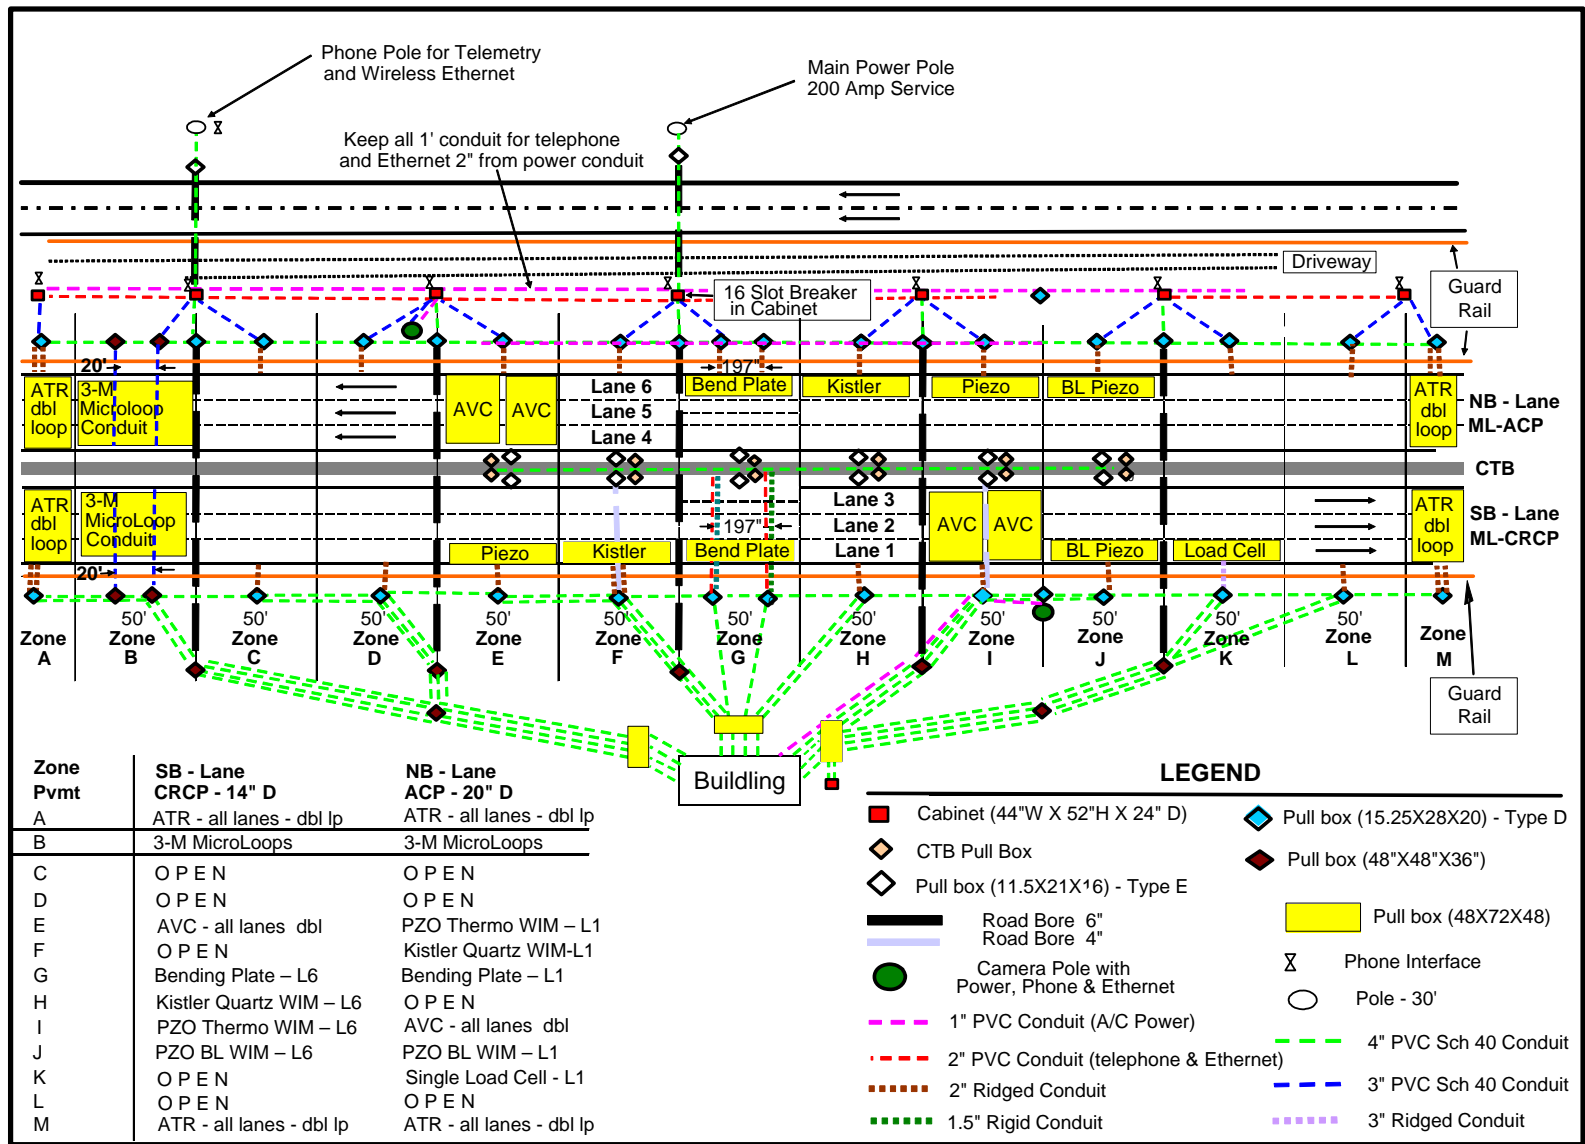
Figure 41. General Site Layout.
