1. Report No. FHWA/TX-06/0-4687-1		2. Government Accession No.		3. Recipient's Catalog No.	
4. Title and Subtitle RUBBLIZATION FOR REHABILITATION OF CONCRETE PAVEMENT IN TEXAS: PRELIMINARY GUIDELINES AND CASE STUDIES				5. Report Date November 2005 Resubmitted: February 2006

**RUBBLIZATION FOR REHABILITATION OF CONCRETE PAVEMENT
IN TEXAS: PRELIMINARY GUIDELINES AND CASE STUDIES**

Report 0-4687-1
Project 0-4687
Project Title: Rubblization and Crack and Seat
as Major Rehabilitation for Concrete Pavements

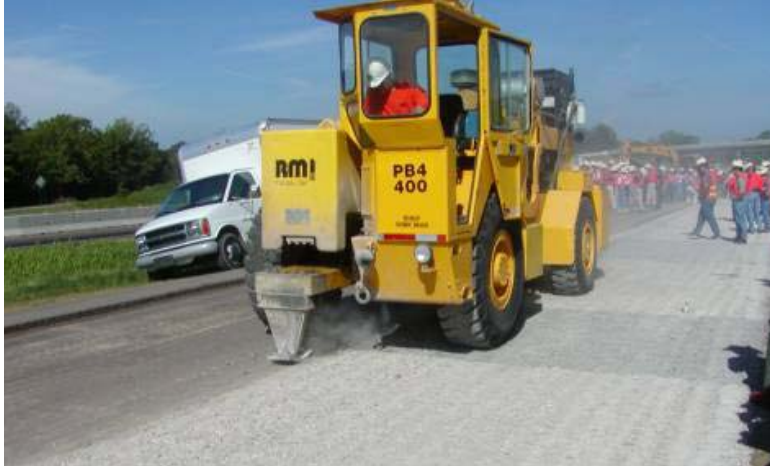
Figure 1.2. RMI Resonant Breaker (1).

Two primary pieces of equipment are available for rubblization. The resonant breaker method used by Resonant Machines, Inc. (RMI) employs a high-frequency, low-amplitude tamper to fracture the pavement. [Figure 1.2](#) shows this machine. More details of the equipment are available at the company’s website ([1](#)). The other common rubblizing equipment is the multi-head breaker (MHB) used by Antigo Construction, shown in [Figure 1.3](#). This equipment uses 12 drop hammers that impact the pavement to accomplish rubblization. More details of this equipment are available at Antigo’s website ([2](#)).

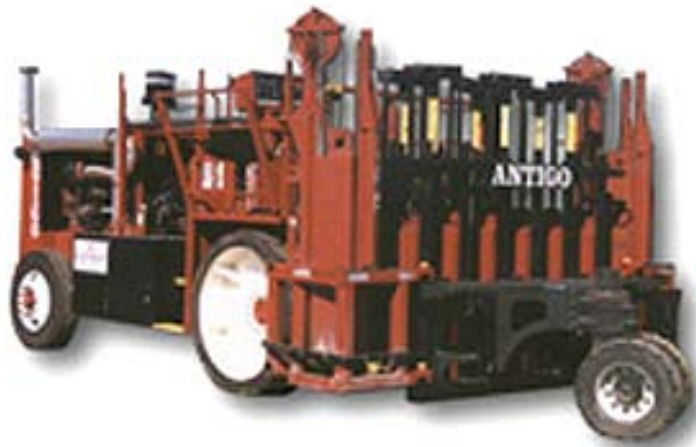
Figure 1.3. Multi-Head Breaker (2).

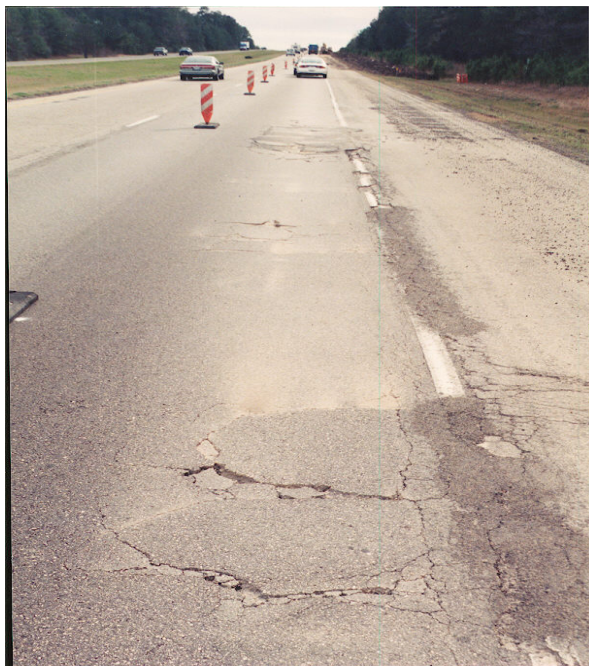
Figure 1.6. Three-Year-Old Crack and Seat Experimental Section on US 59.

Crack and seat has been widely used in West Texas but there has been little or no evaluation of the success or failure of this treatment. Most of the treatments have been reported to be working well; however, problems have been encountered when using this treatment on pavements with untreated subgrades. Crack and seat was the worst performing treatment on the US 59 experimental sections that were constructed just north of Corrigan in the Lufkin District. The condition of the section on US 59 is shown in [Figure 1.6](#).

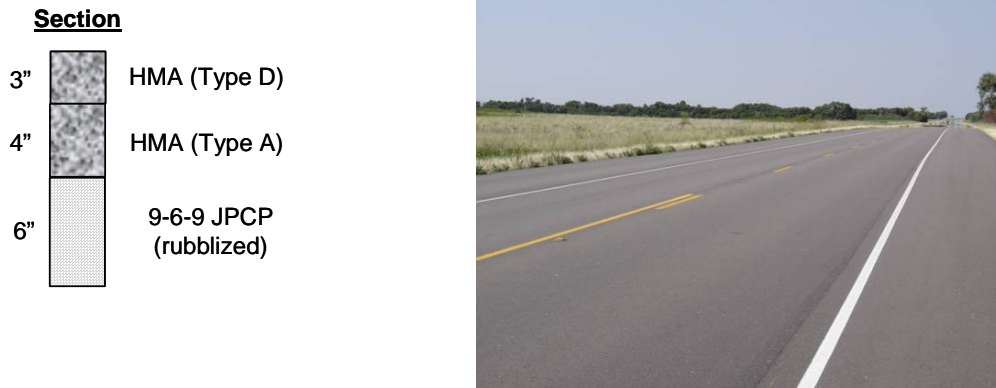
Figure 1.7. US 83 Rubblized Section Constructed in 2003.

The Childress District rubblized a section of US 83 in 2003. The Texas Transportation Institute (TTI) has evaluated a continuous section 0.9 miles long from FM 3256 northward. This section is still performing excellently. [Figure 1.7](#) shows the pavement section. FWD data collected after rubblization, illustrated in [Figure 1.8](#), show the variability in stiffness of the rubblized pavement is much less than the variability of crack and seat or break and seat projects illustrated previously in [Figure 1.4](#).

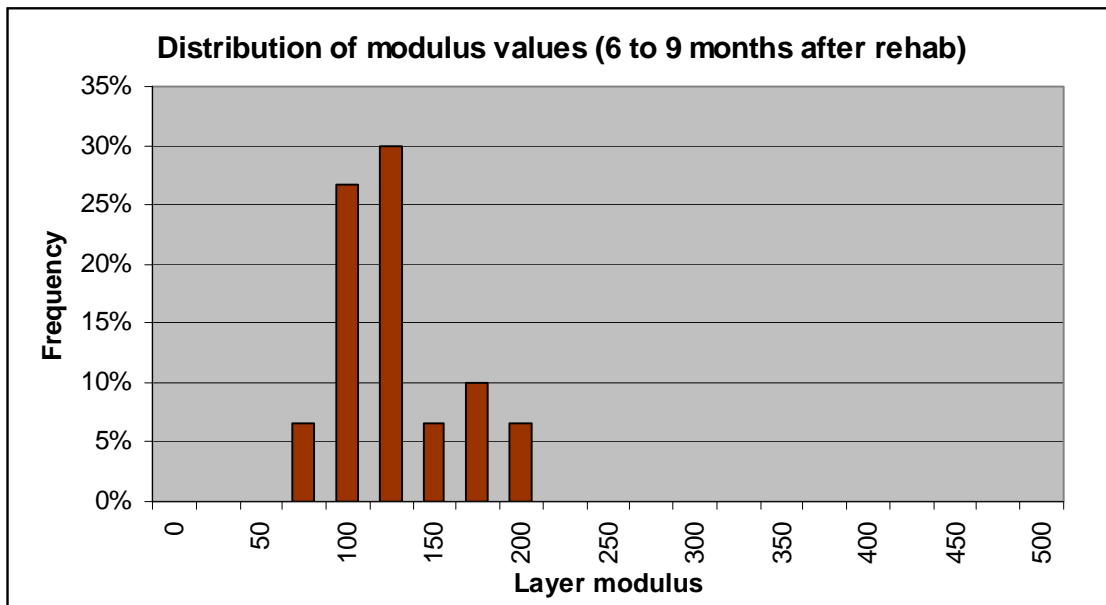
Figure 1.8. Distribution of Rubblized Layer Modulus on US 83.

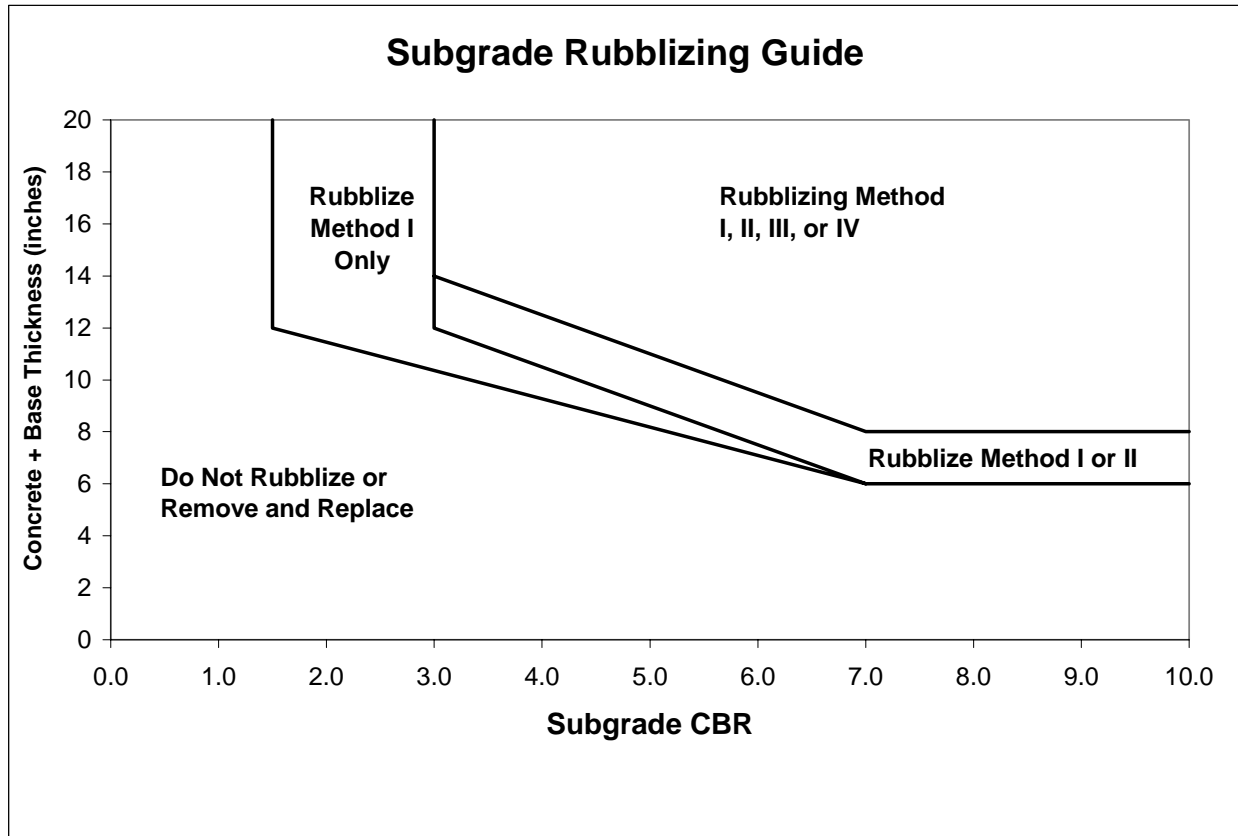
Figure 1.9. IDOT Subgrade Rubblizing Guide (5).

In reviewing the project, the first consideration is whether the rubblized pavement will protect the subgrade. An initial evaluation is made based on soils map data and personnel experience with the soils in the proposed project limits. If this analysis indicates the pavement can be rubblized, IDOT performs an extensive field analysis including, among other things, a review of the pavement structure, cone penetrometer testing, soil sampling, and a drainage survey. Their complete testing plan can be found in Heckel's report (5). After conducting testing, IDOT plots the CBR of the top 12 inches of subgrade soil (divided into two 6-inch layers) on their Subgrade Rubblizing Guide, shown in Figure 1.9, to aid in deciding whether the structure can be rubblized without subgrade failure. The four methods identified for rubblization by IDOT are (6):

After determining the suitability for rubblization of the field test locations by using the rubblization selection chart, IDOT's guidelines state, "If it is found that several short or a few substantial segments of the project require omissions, or removal and replacement of the pavement; then other rehabilitation options should be considered" (5).

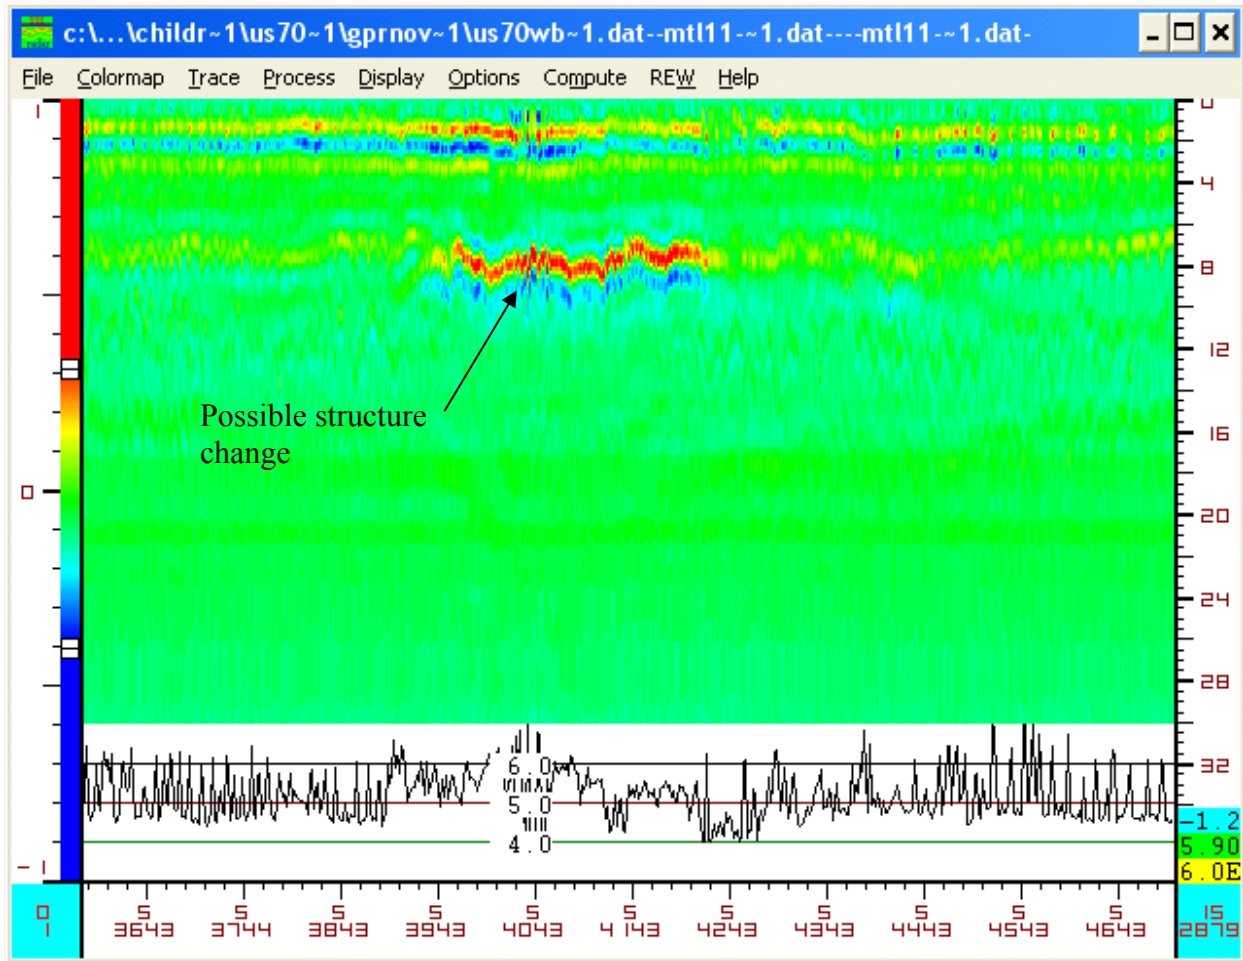
Figure 3.3. Possible Structure Change between Wilbarger County Line and FM 267.

The GPR survey on this section was conducted after FWD testing, and the intervals of the FWD tests did not fall within the limits of any of these sections. Therefore, no other additional information is currently available to verify the structure at these locations. Consideration should be given to coring within these locations to verify the pavement structure.

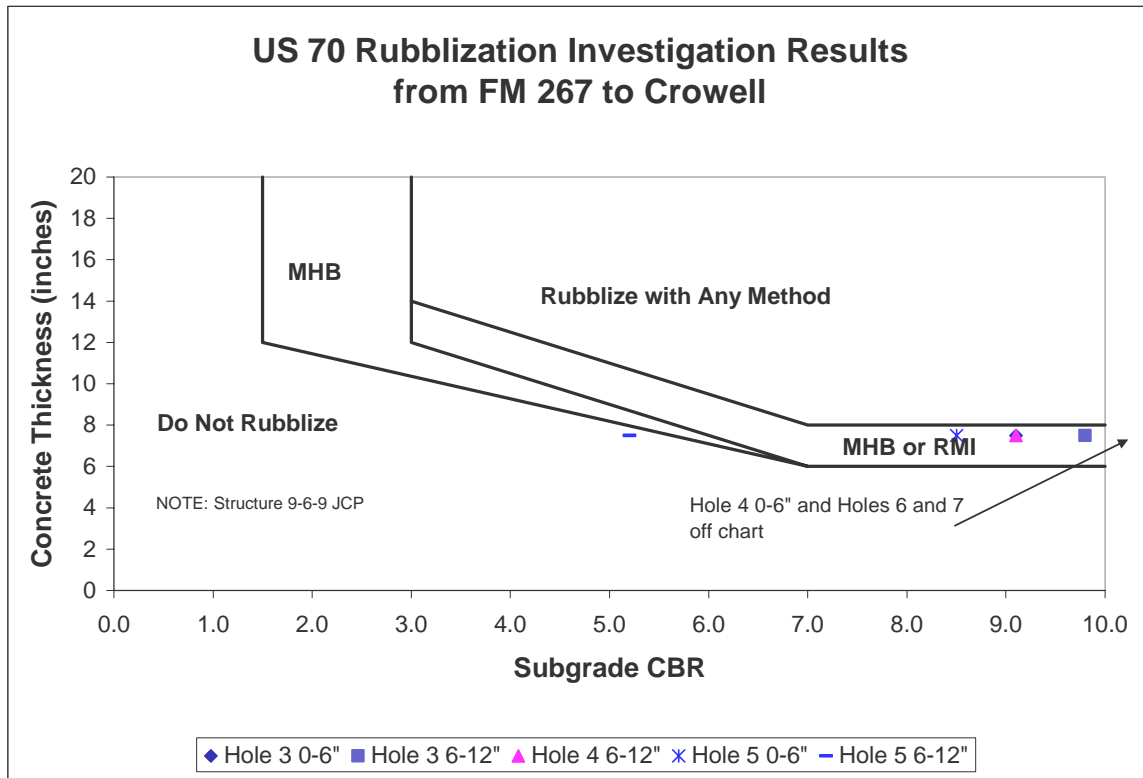
Figure 3.4. DCP Results for US 70 from FM 267 to Crowell.

For rubblization, two critical issues are drainage and support beneath the slab. The GPR data already indicated that trapped moisture was not a problem. From FM 267 to Crowell, all the DCP results (Holes 3 through 7) indicated subgrade support is suitable for rubblization. Figure 3.4 shows these data on IDOT's rubblization selection chart.

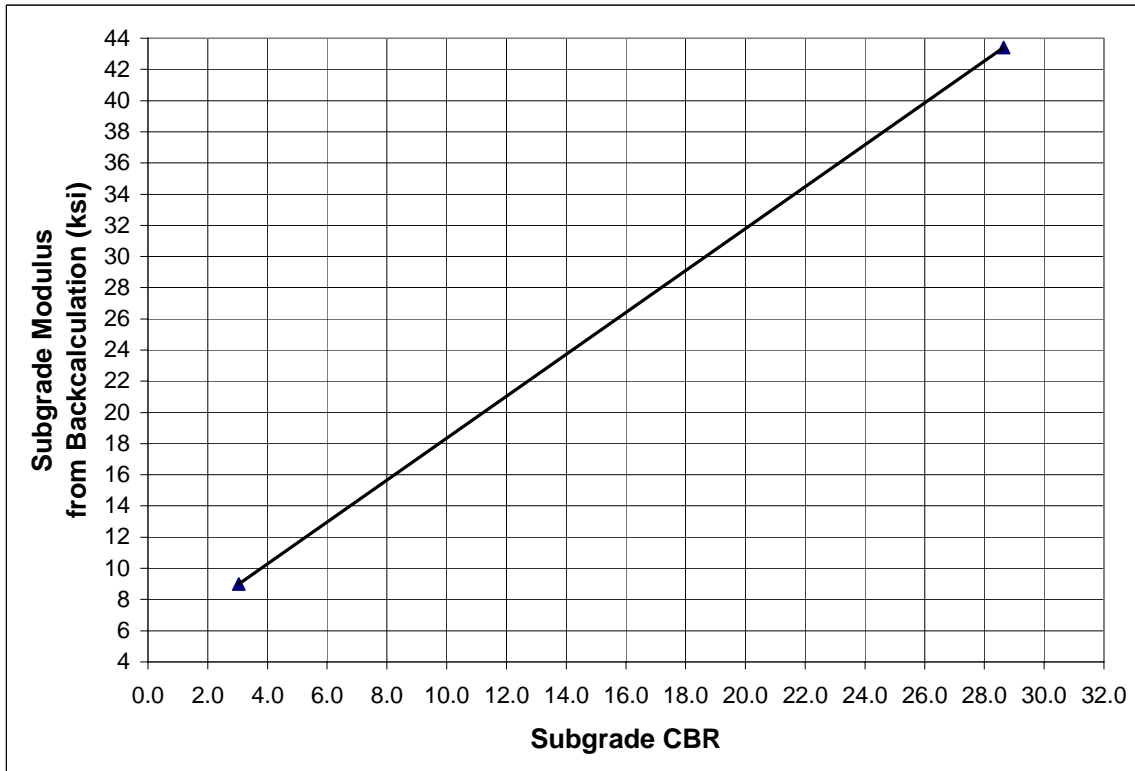
Figure 3.6. Subgrade Modulus of Top 12 Inches versus CBR of Top 12 Inches from Wilbarger County Line to FM 267.

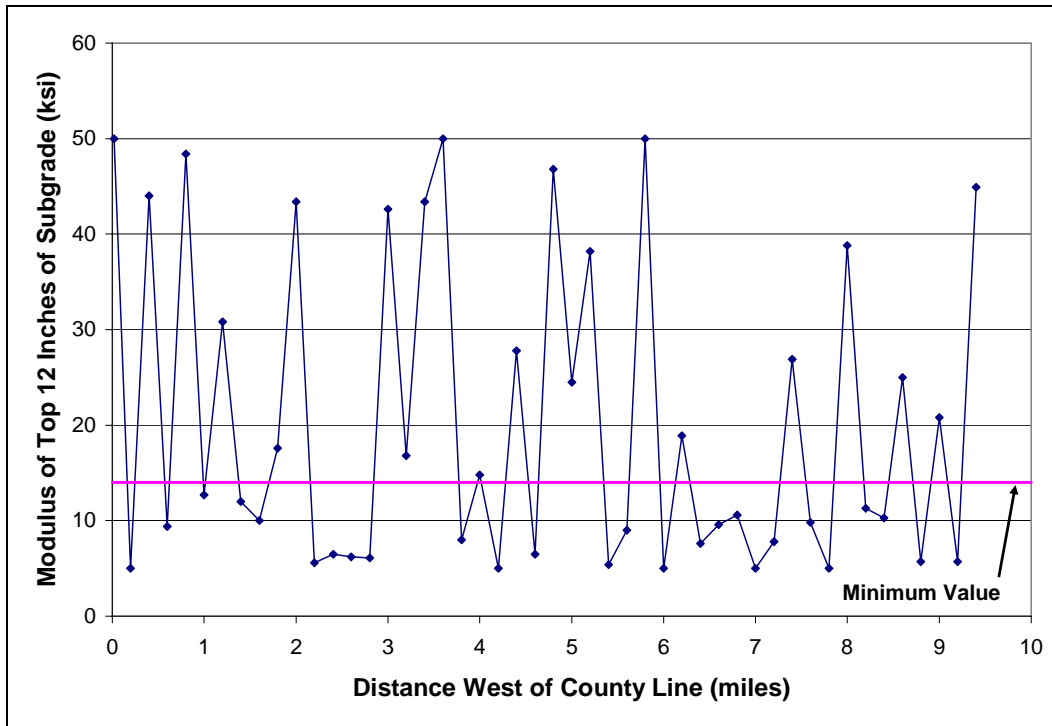
Figure 3.7. Subgrade Modulus of Top 12 Inches from Wilbarger County Line to FM 267.

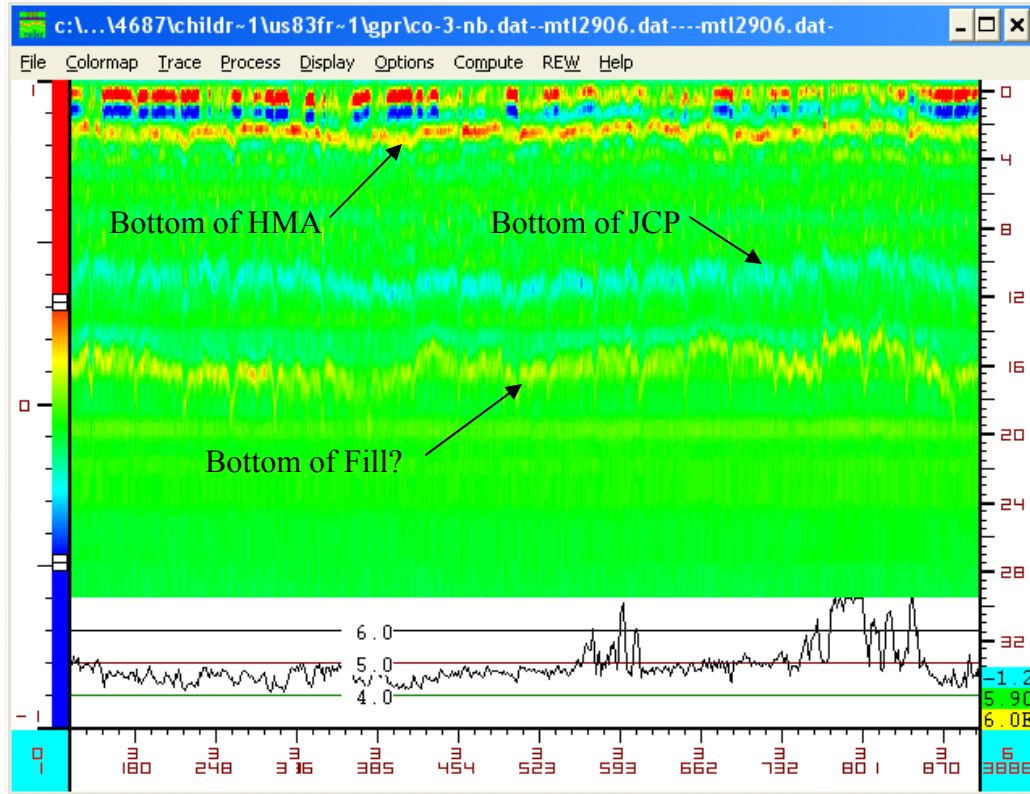
Figure 4.1. Representative GPR Data on US 83 in Cottle County.

Since a wet subgrade hinders the rubblization process, TTI reviewed the GPR data for signs of excessively wet subgrade, indicated by high subgrade dielectric values. The GPR data did not indicate any locations of excessively wet subgrade soil. Typical subgrade dielectric values ranged from 4.4 to 5.6.

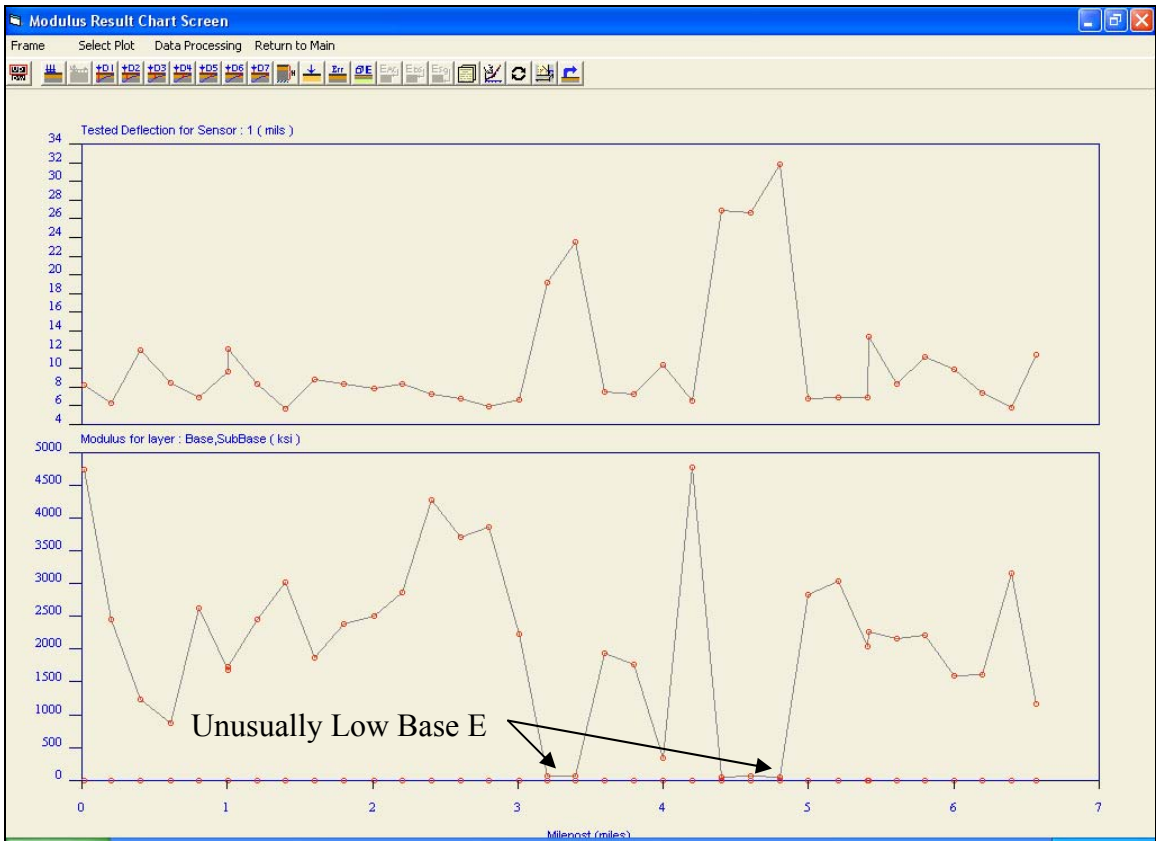
Figure 4.3. Base Modulus with Distance for US 83 Northbound.

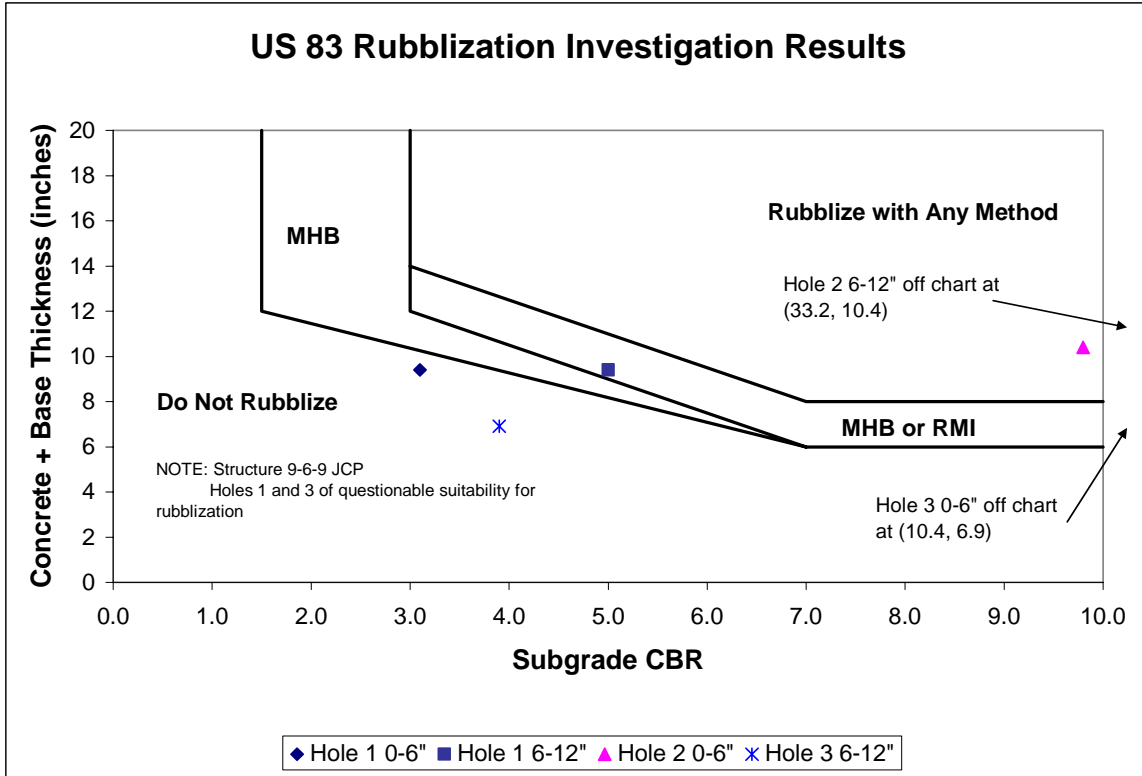
Figure 4.4. DCP Results from US 83 on IDOT Rubblization Selection Chart.

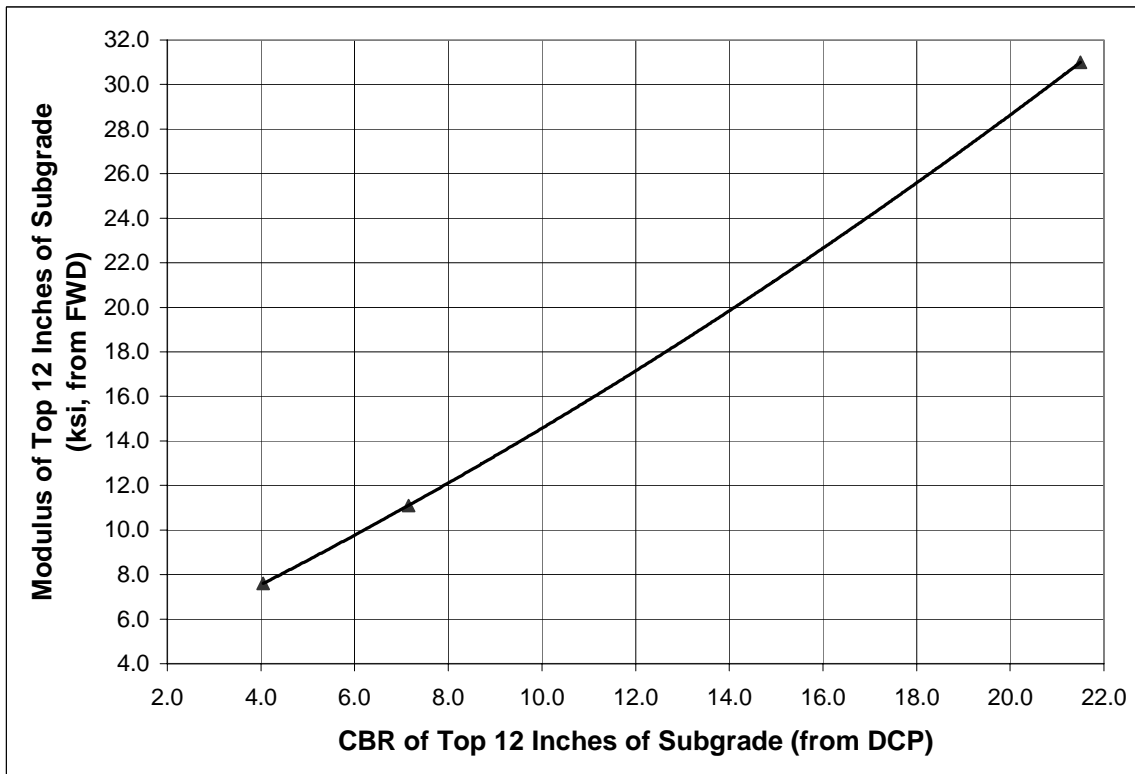
Figure 4.5. Relationship between Subgrade Modulus and CBR on US 83.

In light of these findings, TTI's investigation in conjunction with existing recommendations indicates a fair level of risk exists if the Childress District initiates rubblization on the US 83 project. Using a relationship between the subgrade CBR and backcalculated moduli values of the top 12 inches of subgrade, approximately 57 percent of the project may have subgrade too weak to support rubblization. However, the district may have prior experience on other similar projects that should also weigh into its decision on rehabilitation method. If the District does successfully rubblize this project, information gained from the US 83 project would be valuable input to modify existing rubblization guidelines to be more appropriate for Texas projects.
