1. Report No. FHWA/TX-05/0-4701-1		2. Government Accession No.		3. Recipient's Catalog No.	
4. Title and Subtitle EVALUATION OF TRAFFIC CONTROL DEVICES: FIRST YEAR ACTIVITIES				5. Report Date October 2004

9. Performing Organization Name and Address Texas Transportation Institute The Texas A&M University System College Station, Texas 77843-3135				10. Work Unit No. (TRAIS)

**EVALUATION OF TRAFFIC CONTROL DEVICES:  
FIRST YEAR ACTIVITIES**

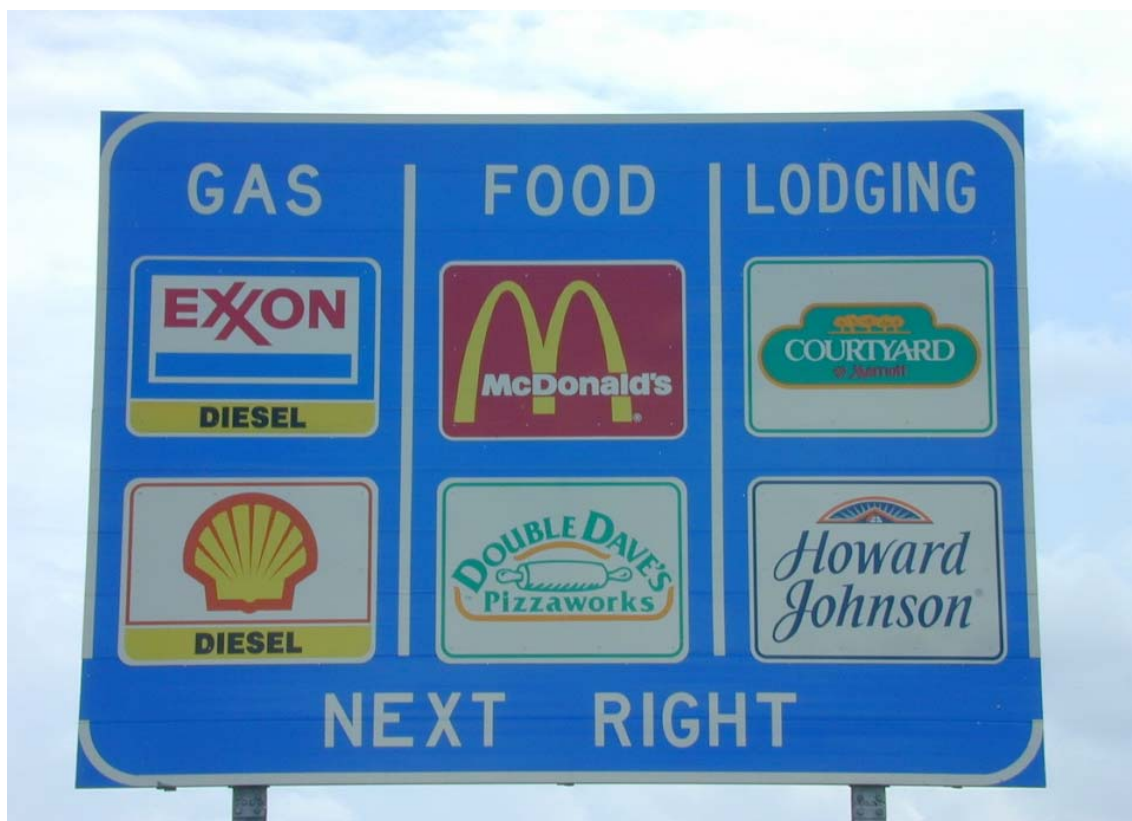
Specific service signs are large guide signs with a blue background that provide information to motorists about services available near a particular interchange exit. Graphic images or word messages (business logos) are used to represent a particular business on the sign. For this reason, specific service signs are commonly referred to as logo signs. The *Texas Manual on Uniform Traffic Control Devices* (TxMUTCD) defines specific service signs as “guide signs that provide road users with business identification and directional information for eligible services” (1). These signs may be used on any class of highway but are primarily used on interstates and freeways in advance of interchanges. Logo signs in Texas are used to inform the driver of specific services provided at an exit that the driver may need such as food, gas, lodging, and camping. In addition to the four categories described in the TxMUTCD, the national MUTCD also allows logos for some special attractions (2). Figure 2-1 shows an example of a logo sign with gas, food, and lodging logos.

Figure 2-1. Specific Service Sign—Three Service Categories and Six Logo Panels.

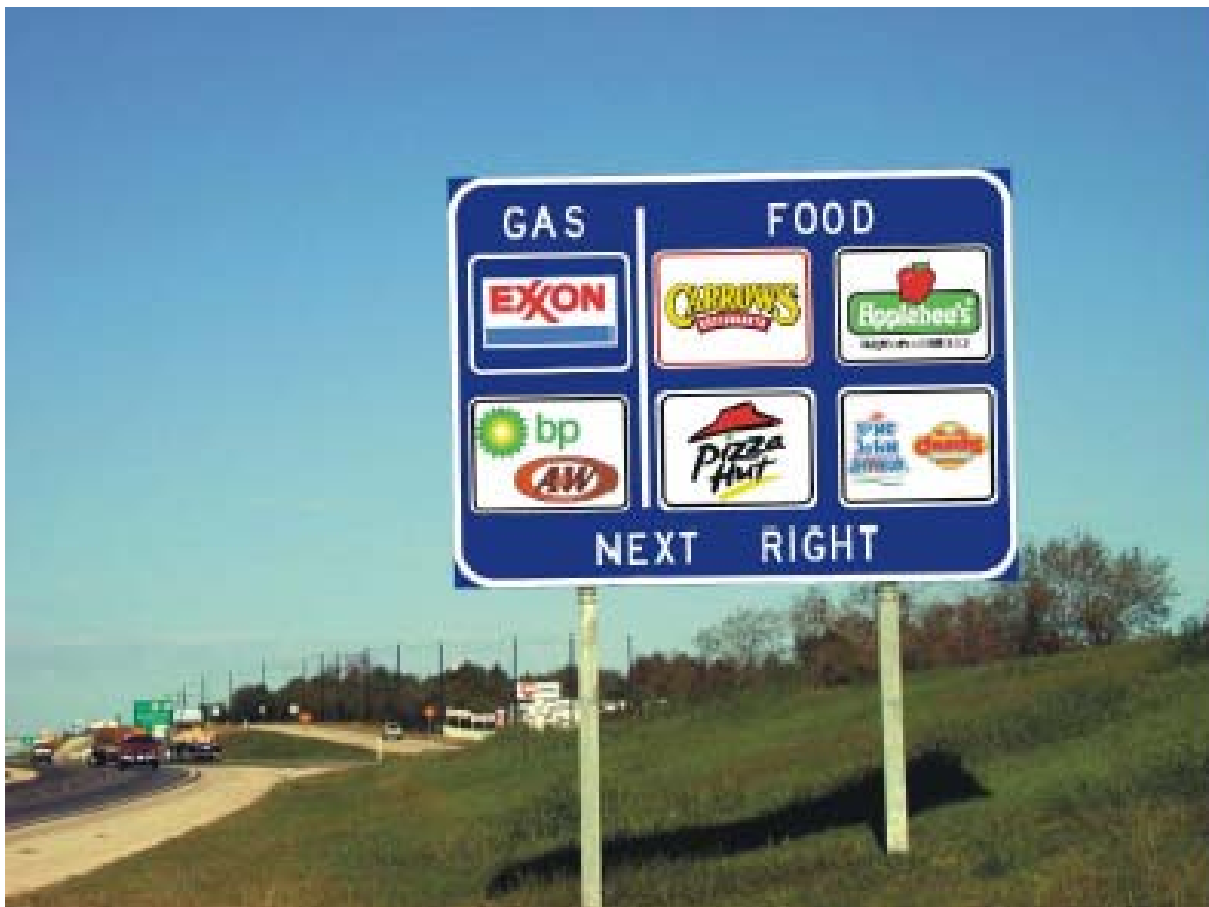
Figure 2-3. Example of the 2/4 Specific Service Sign “Picture Slide.”

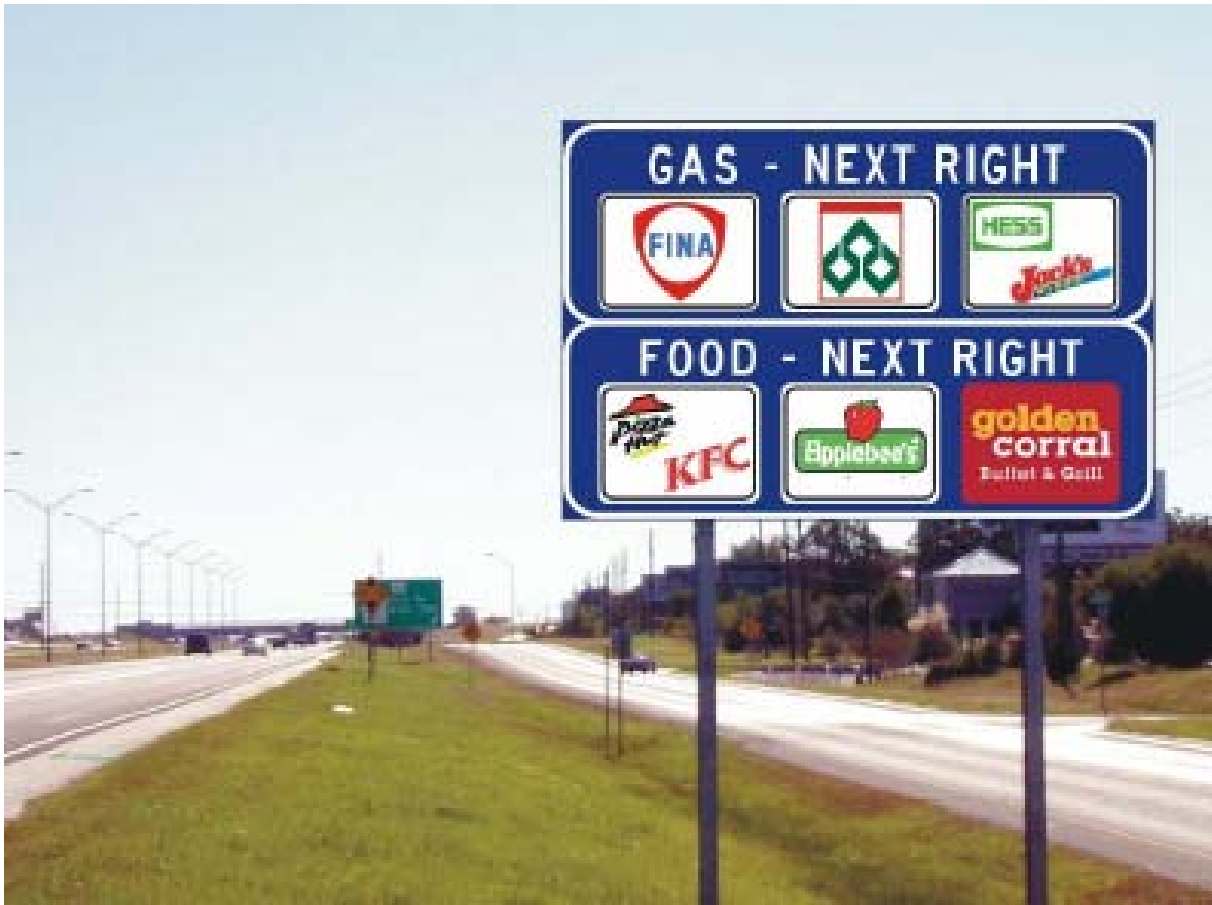
Figure 2-4. Example of the 3/3 Specific Service Sign “Picture Slide.”

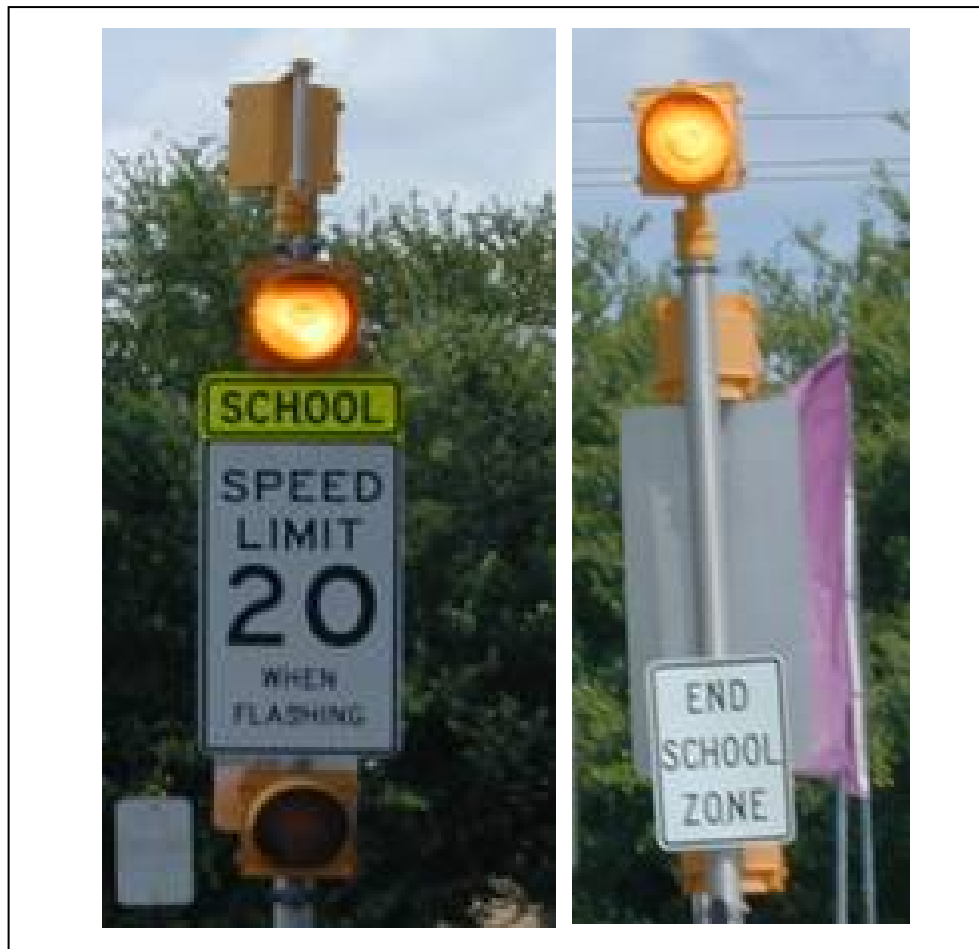
School Speed Limit sign assembly. The front and back of such an installation is pictured in [Figure 3-1](#). Each beacon was aimed in a rear-facing manner towards traffic already in the school zone. The flashing rate was identical to the front-facing beacons—approximately 1 flash per second. The rear-facing beacons were mounted on the left side of the street (as opposed to the right side) to utilize the power source from the existing front-facing beacons. Because power is already provided to the assembly, the only additional cost is that associated with the installation of the rear-facing beacon and the End School Zone sign. Because the rear-facing beacon and associated sign are located on the left side of the roadway, there should be an End School Zone or Speed Limit sign on the right side of the roadway although this sign installation will not have the rear-facing beacon.

**Figure 3-1. Rear-Facing Beacon Installation.**

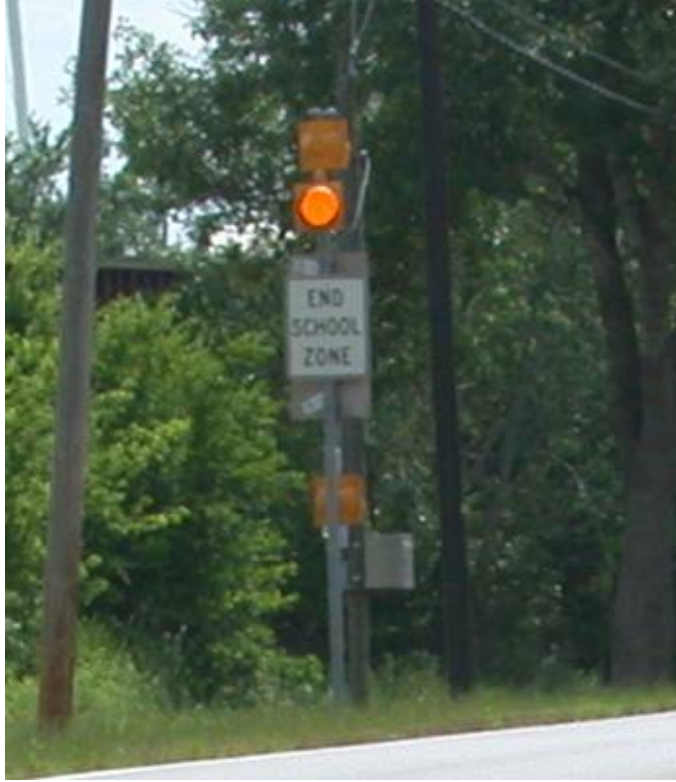
**Figure 3-2. Site 1—Thorndale Schools, Closeup of RFB.**

Site 1 is located on US 79 in Thorndale, Texas. The school zone is 2675 ft long, and a signalized intersection is located within the boundaries of the school zone. Traveling west, the signalized intersection is located about 1825 ft from the end of the school zone. An RFB and End School Zone sign were installed on the rear side of the east-facing school zone beacon and school zone speed limit sign. [Figure 3-2](#) shows a closeup of the RFB and End School Zone sign on US 79. The cross section at this location consists of five lanes with two lanes in each direction and a two-way left-turn lane (TWLTL). The speed limit on the road is 45 mph when the school zone is not active. [Figure 3-3](#) is a picture taken from the westbound lanes to illustrate what the driver sees when exiting the school zone. The school zone is active Monday through Friday (when school is in session) from 7:15 to 8:45 am and from 2:30 to 4:15 pm. The school zone speed limit is 30 mph. The school zone is active for an unusually long period of time in both the morning and the afternoon because there are four different schools within the zone—an elementary school, a middle school, a high school, and a small private school.

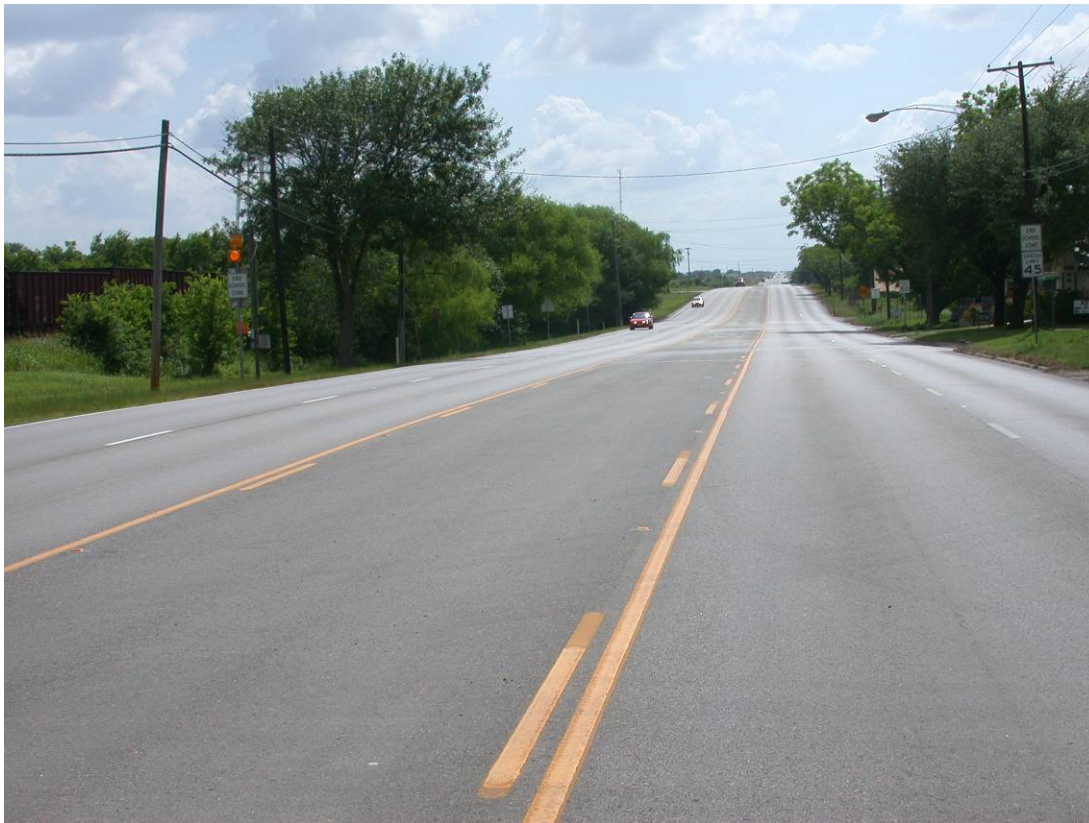
**Figure 3-3. Site 1—Thorndale Schools, Long School Zone with a Signalized Intersection.**

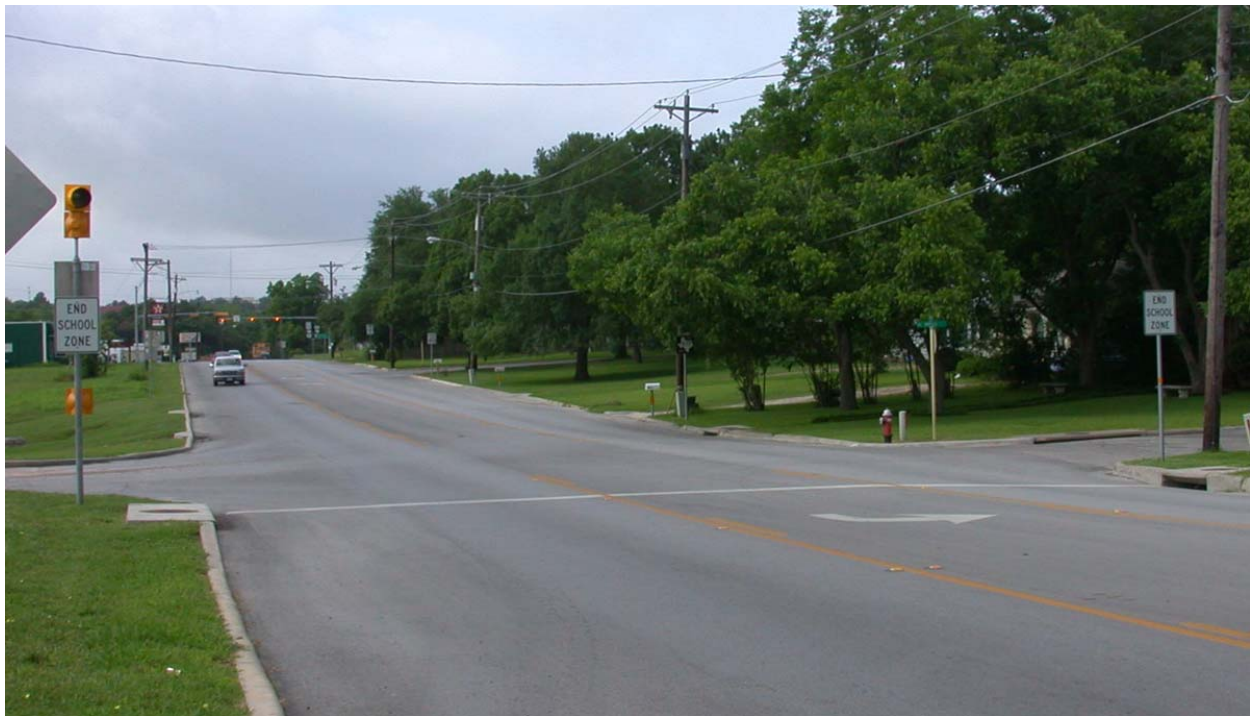
Site 2 is another school zone with a signalized intersection within its boundaries. Site 2 is located in Brenham, Texas, on Business 36 (North Park Street) and runs adjacent to the Brenham High School campus. Site 2 is about 1800 ft long. The intersection is located about 1000 ft from the end of the school zone traveling southbound. The cross section at this location consists of three lanes—one lane in each direction and one TWLTL. The school zone is active between 7:45 and 8:45 am and between 3:30 and 4:30 pm. [Figure 3-4](#) shows the RFB at Site 2.

**Figure 3-4. Site 2—Brenham High School, School Zone with a Signalized Intersection.**

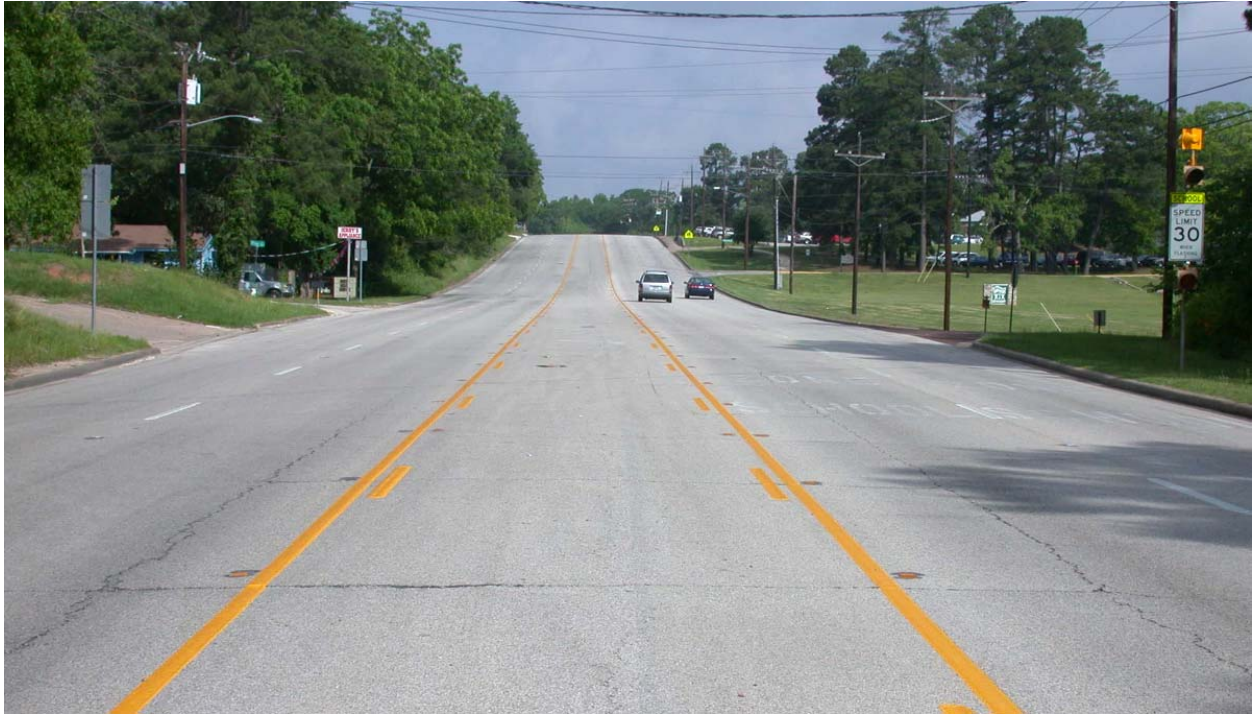
Site 3 is located in Huntsville, Texas, on US 190. This site was selected because it is a long school zone with no stop- or signal-controlled intersections. The school zone is about 1750 ft long and is located on a five-lane road (two lanes in each direction with a TWLTL). The speed limit within the school zone is 30 mph when the school zone is active and 45 mph when the school zone is not active. However, the speed limit increases to 50 mph as the driver exits the school zone traveling in the eastbound direction because the driver is leaving a small town area and entering a more rural area. An elementary school and an intermediate school are located within the school zone. The school zone is active from 7:25 to 8:10 am and from 3:15 to 4:00 pm. [Figure 3-5](#) shows a photograph of the westbound direction school zone sign. The eastbound traffic saw the RFB on this sign.

**Figure 3-5. Site 3—Scott Johnson Elementary and Huntsville Intermediate, Long School Zone.**

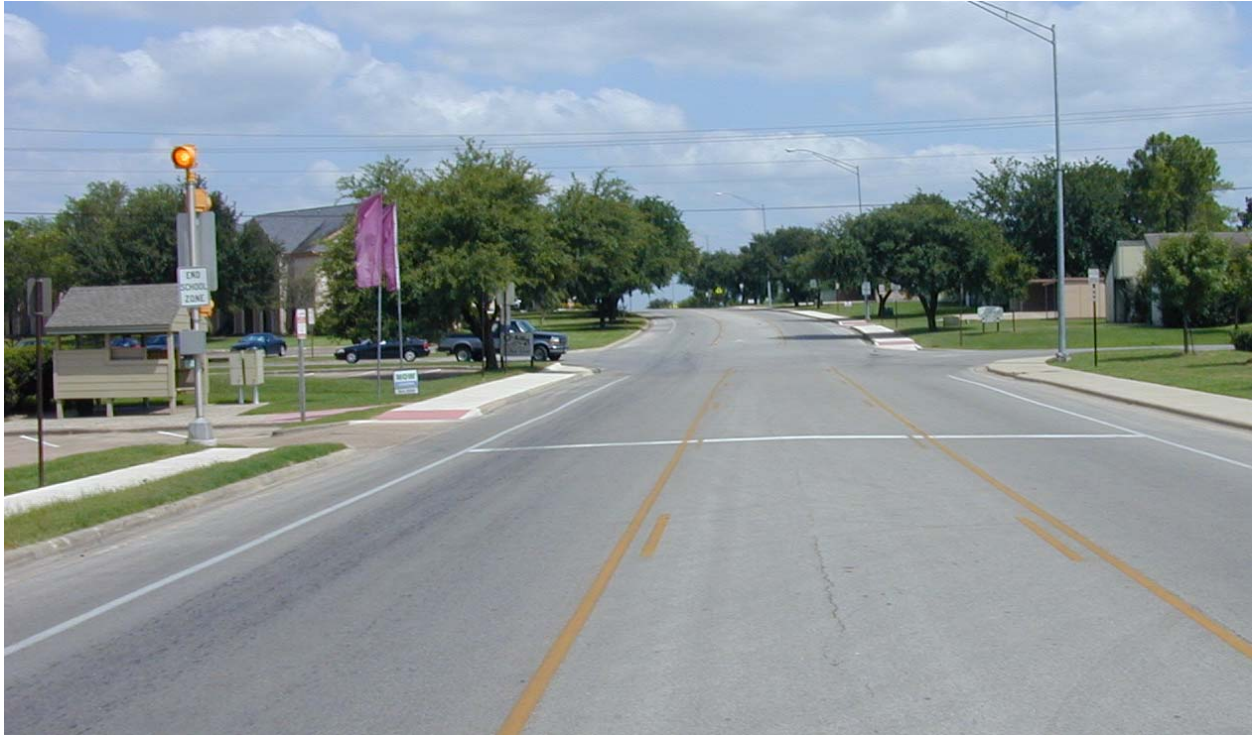
Site 4 is located in College Station on Anderson Street. The speed limit on this road when the school zone is not active is 35 mph and 20 mph when the school zone is active. The cross section at this site consists of three lanes for motor vehicle traffic—one lane in each direction and a TWLTL and a bike lane on either side of the roadway that runs through the length of the school zone but tapers off shortly after the end of the school zone. The school zone is active at this site Monday through Friday (when school is in session) from 7:45 to 8:45 am and from 3:15 to 4:00 pm. This site is about 1000 ft long and was considered an average length for a school zone. [Figure 3-6](#) is a picture of the RFB at Site 4. Anderson Street T-intersects with George Bush 200 ft beyond the far north end of the school zone. Researchers collected speed data for the southbound traffic at this site. Researchers assumed that since speed limits were low at this site, drivers would have plenty of distance to reach the speed limit before they were tracked through the end of the school zone.

**Figure 3-6. Site 4—A&M Consolidated Middle School and Oakwood Intermediate School, Average Length School Zone.**

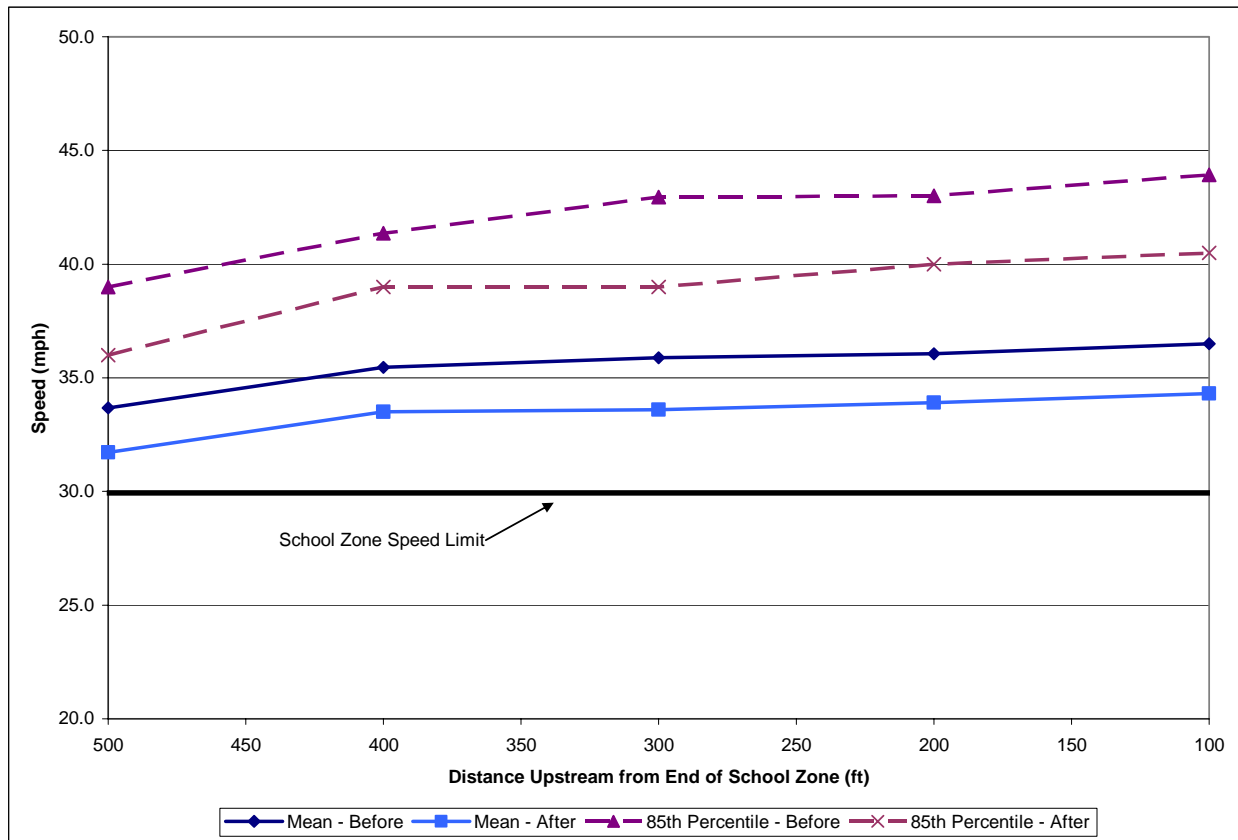
**Figure 3-7. Site 1—Mean and 85th Percentile School Zone Speeds before and after Rear-Facing Beacon Installation.**

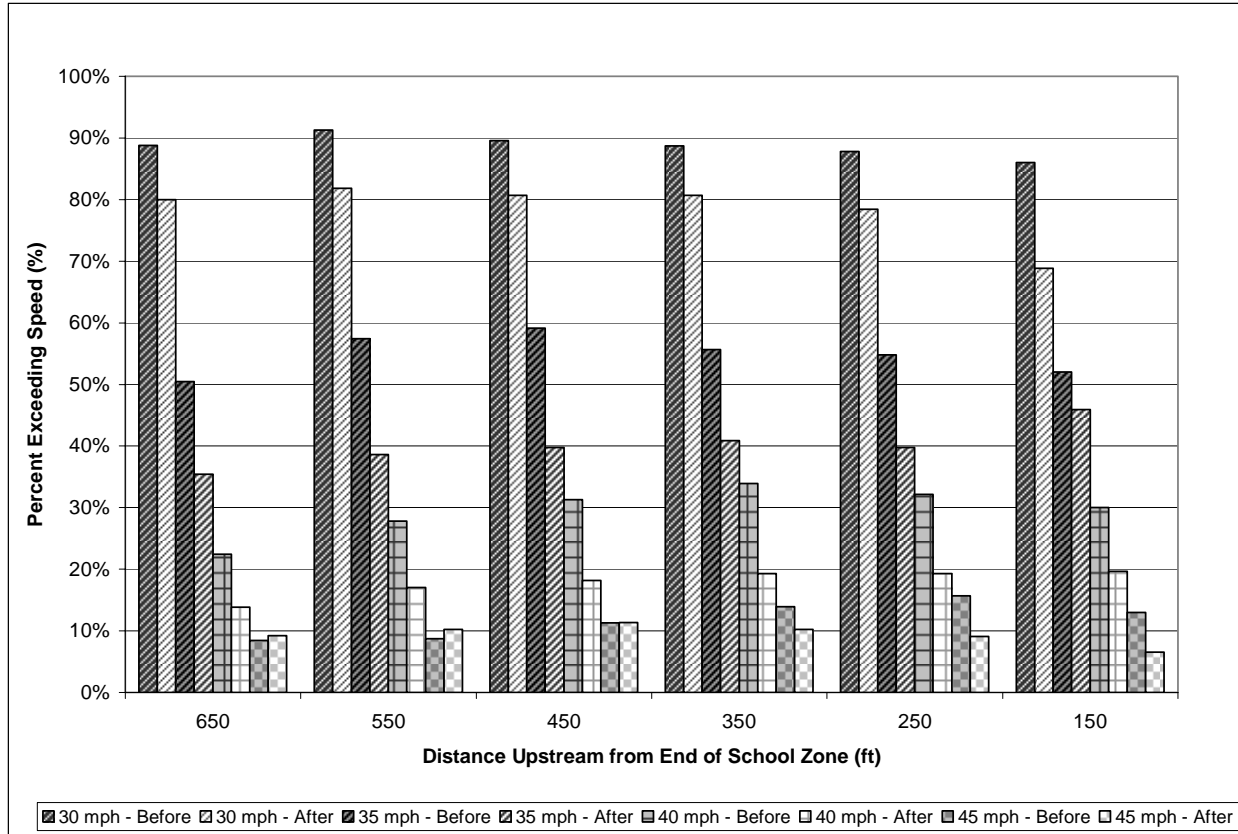
**Figure 3-12. Site 3—Percent of Vehicles Exceeding Various Speed Thresholds before and after Rear-Facing Beacon Installation.**

Significant differences were found between the percent of vehicles exceeding the speed limit, 5 mph over the speed limit, and 10 mph over the speed limit for the active school zone data. The difference between the percent of vehicles exceeding the speed limit in the after study was significantly lower than the percent of vehicles exceeding the speed limit in the before study at 550 and 150 ft in advance of the rear-facing beacon. At 5 mph over the speed limit (35 mph) a significant difference was seen at 550, 450, 350, and 250 ft in advance of the rear-facing beacon, and at 10 mph over the speed limit the percent of vehicles exceeding 40 mph was significantly lower at 450, 350, and 250 ft in advance of the rear-facing beacon. [Table 3-8](#) shows the results for the percent of vehicles exceeding various threshold speeds, and [Figure 3-12](#) is a graphical illustration of the results.

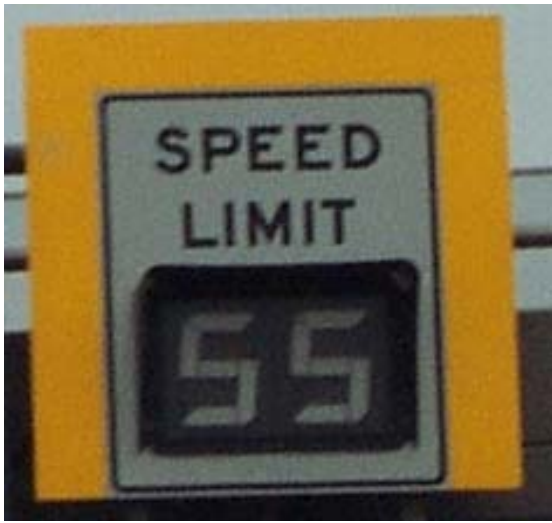
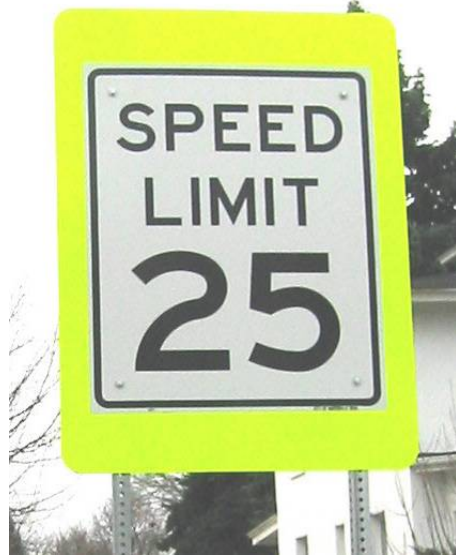
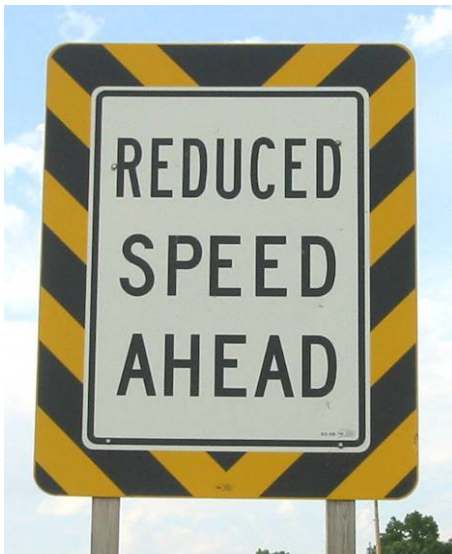
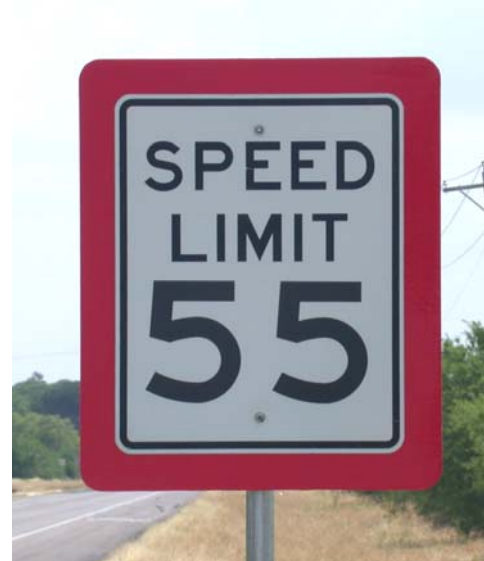
a. Fluorescent Yellow Border on Three Sides

b. Fluorescent Yellow Green Border

c. Yellow and Black Border

d. Red Border used in Prior TTI Project

**Figure 4-1. Examples of Speed Limit Conspicuity Treatments.**

The researchers believe that applying a conspicuity treatment to the Speed Limit sign would improve driver awareness of the sign and therefore improve driver compliance with the speed limit. Such treatments have been utilized in the past, as indicated in [Figure 4-1](#).

[Figure 4-1d](#) illustrates the use of a 3 inch red border around the standard Speed Limit sign. This particular treatment was evaluated as part of a prior Texas Transportation Institute (TTI) research project evaluating the impacts of higher performance sign sheeting materials (2). However, the prior TTI study evaluated the treatment at only one location. For the current project, researchers expanded the evaluation to several additional sites.

As part of the prior TTI study, the researchers considered the use of several border colors prior to selecting red for field experimentation. Four colors were initially considered as indicated below. Advantages and disadvantages of each color are also listed.

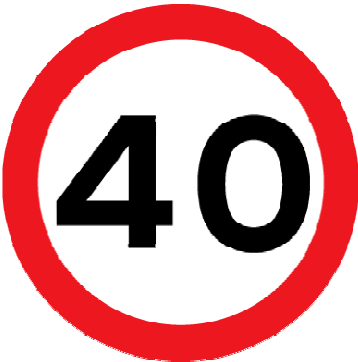
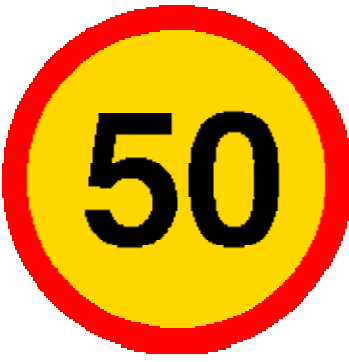
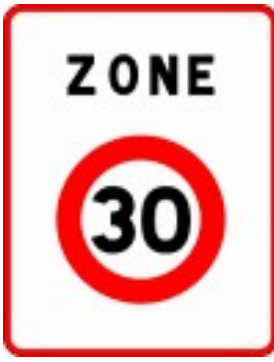
<p>(a) International Speed Limit</p>	<p>(b) International Speed Limit with Alternative Coloring (Used in Sweden)</p>	<p>(c) Speed Limit Sign Used in France</p>

**Figure 4-2. International Speed Limit Sign (Speed Limit in km/h).**

Red borders are used around the speed limit in signs in many different countries. Figure 4-2a and 4-2b are illustrations of international speed limit signs established at the Convention on the Unification of Road Signs held in Vienna in 1931 (3). In France, both the international speed limit sign and the sign shown in Figure 4-2c are used to indicate the speed limit to motorists (4).

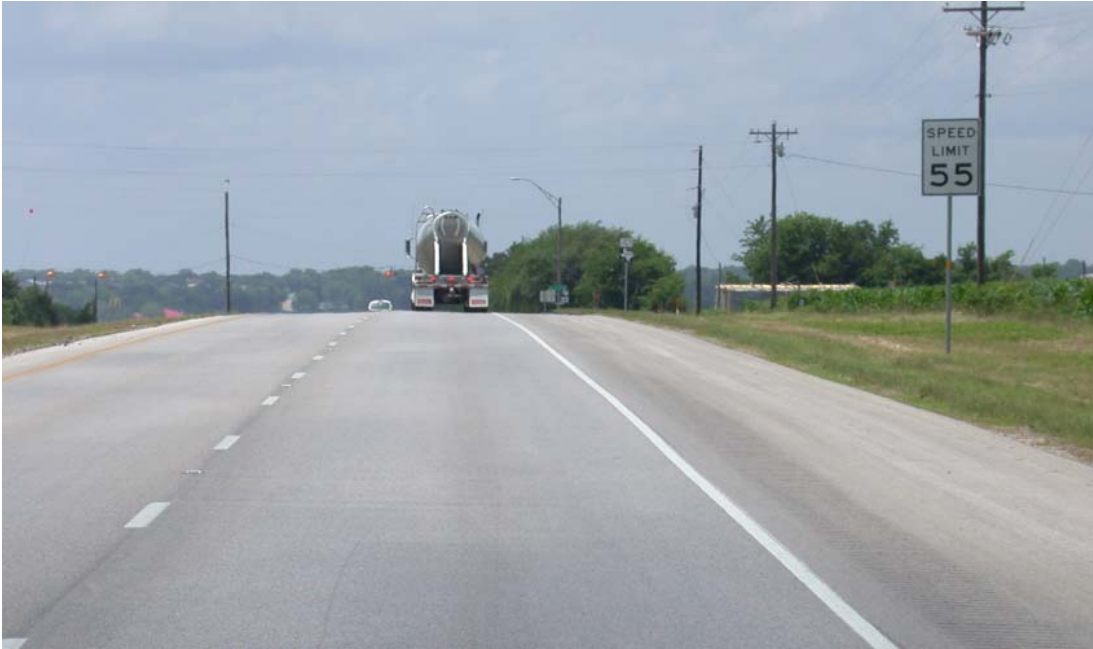
**Figure 4-3. Site 1—Caldwell before 3 Inch Red Border Treatment.**

The cross section on SH 21 at Site 1 consists of two lanes in each direction separated by a wide median with wide shoulders on the right side of the road in either direction. The speed on the road is 70 mph upstream of the 55 mph Speed Limit sign. The area is rural approaching the town, and the Caldwell City Limits sign is approximately one half a mile downstream. A flashing beacon is located at the bottom of the hill, downstream of the 55 mph transition Speed Limit sign but was considered far enough away from the reduced speed as to not influence the speed of the motorists within the test site. [Figure 4-3](#) shows the site before the 3 inch red border treatment; [Figure 4-4](#) shows the site after treatment. The data at this site were collected using portable automated classifiers connected to pneumatic tubes.

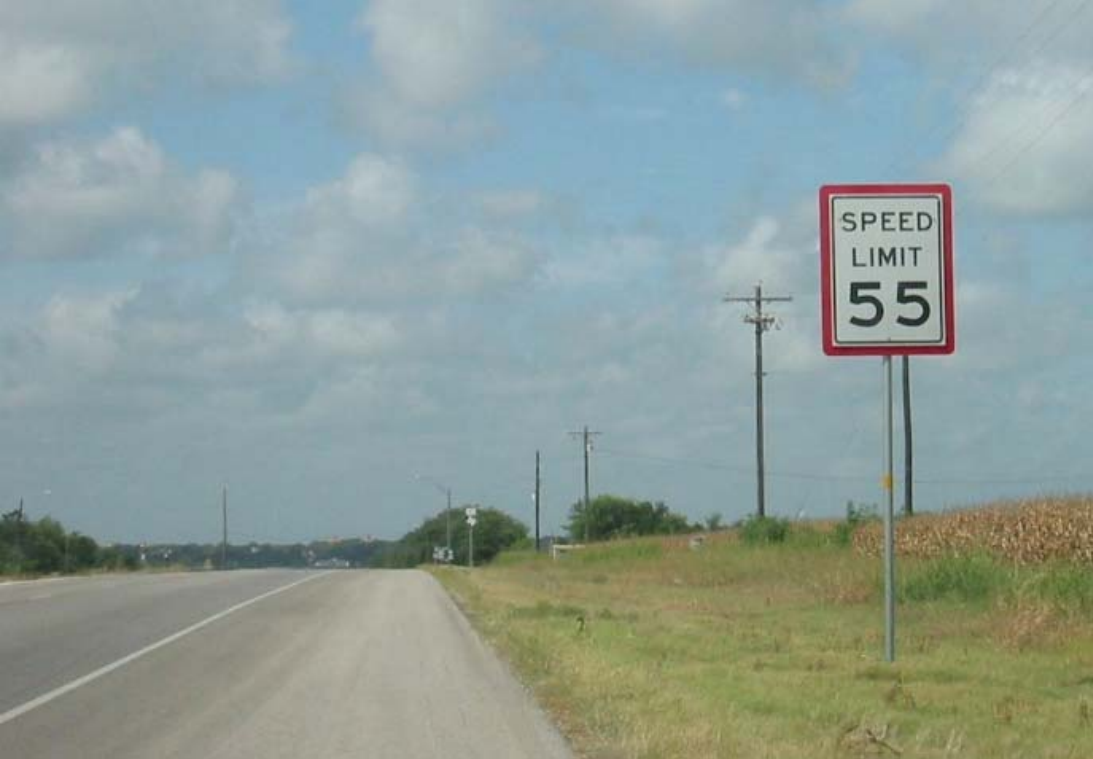
**Figure 4-4. Site 1—Caldwell after 3 Inch Red Border Treatment.**

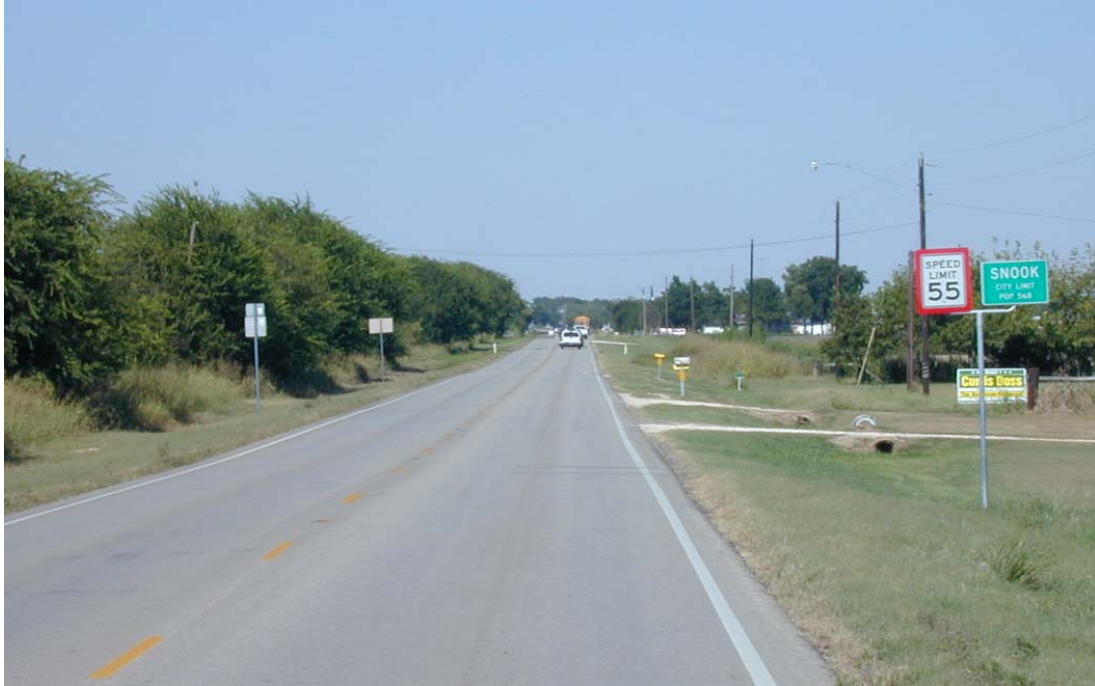
**Figure 4-5. Site 2—Snook after 3 Inch Red Border Treatment.**

The cross section on FM 60 approaching Snook consists of two lanes, one lane in each direction and almost no shoulder. The speed limit drops from 70 mph to 55 mph at the Snook city limits. At Site 2, the area is rural with mostly open fields and sparse residences. About one mile downstream of the 55 mph sign, there are a few small businesses, but nothing is visible from the locations where speed data were collected. [Figure 4-5](#) is a picture of the 55 mph sign in Snook after the 3 inch red border was installed. The data at this site were collected using portable automated classifiers connected to piezoelectric sensors.

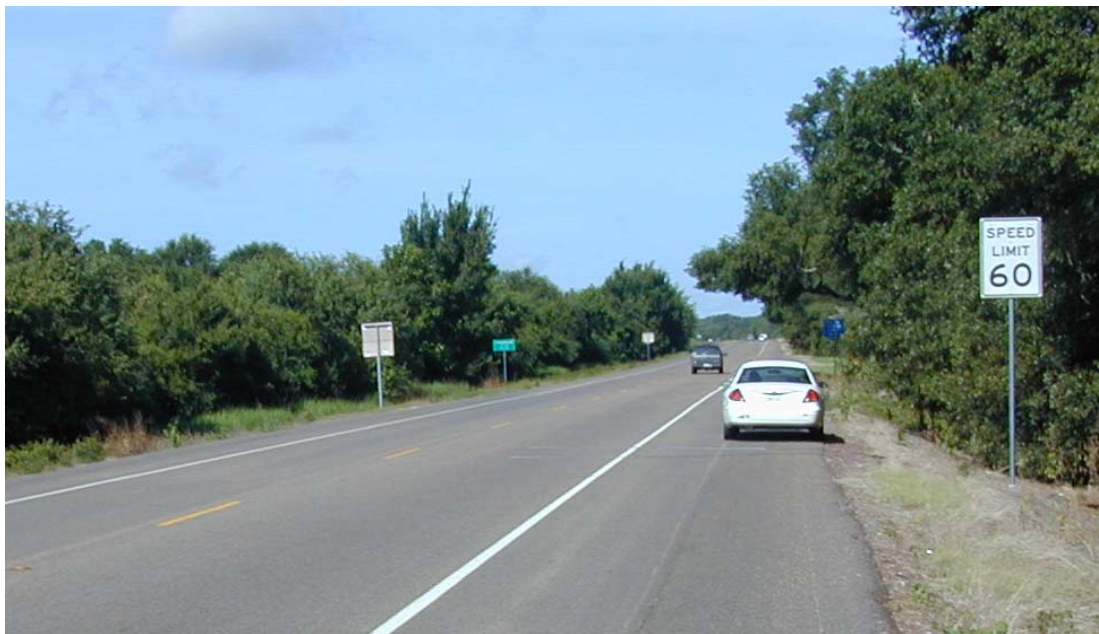
**Figure 4-6. Site 3—Franklin before 3 Inch Red Border Treatment.**

Site 3 is also located in advance of a small town. The cross section at this location consists of a two-lane road with 12 ft wide shoulders in either direction. The red border was installed on a 55 mph Speed Limit sign located just upstream of the Milano city limits sign. The speed limit in advance of this sign is 70 mph. [Figure 4-6](#) shows the site before the 3 inch red border treatment. The data at this site were collected using portable automated classifiers connected to piezoelectric sensors.

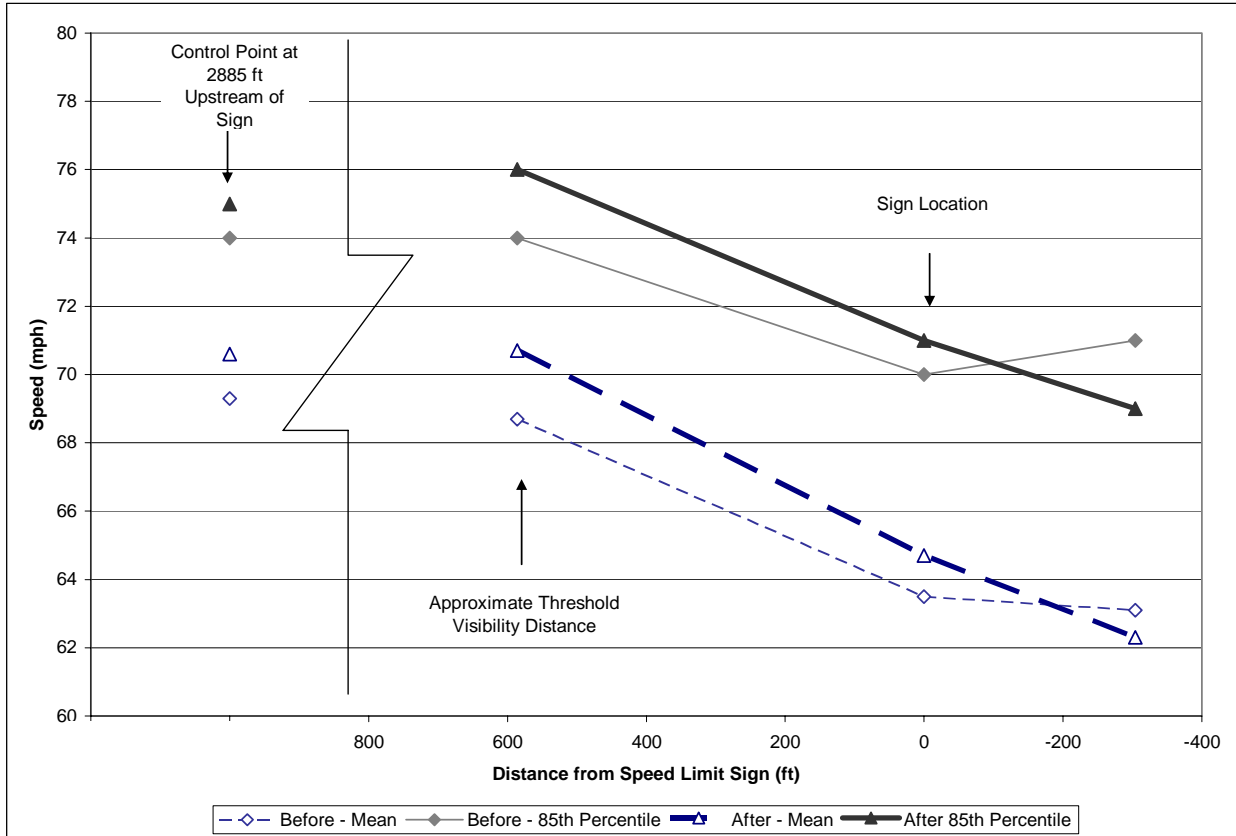
**Figure 4-8. SH 21, Caldwell—Mean and 85th Percentile Speeds before and after Red Border Installation, Passenger Vehicles, Day Data Only.**

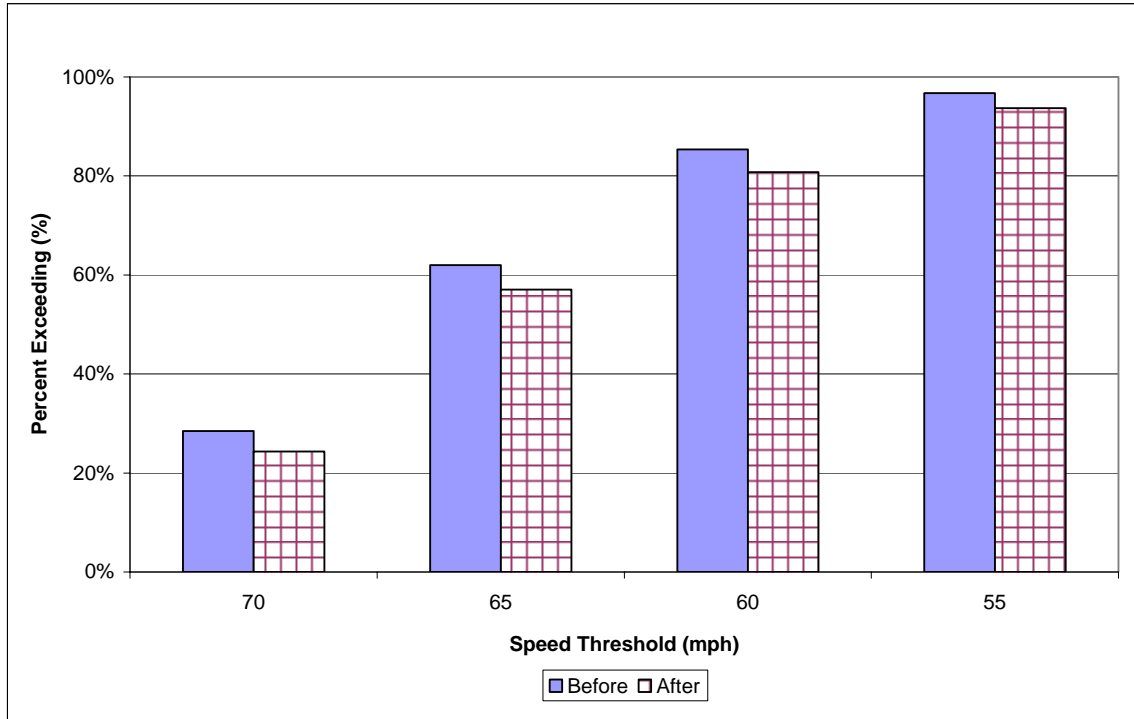
**Figure 4-16. FM 60, Snook—Percent of Passenger Vehicles during Daylight Exceeding Speed Thresholds at Speed Sign before and after the Installation of the Red Border.**

For the proportion of vehicles exceeding 55 mph, statistically significant differences between before and after data for passenger vehicle data collected during daylight were found at points 3 and 4. At point 3 (halfway between the legibility threshold and the treatment Speed Limit sign), the proportion of vehicles exceeding 55 mph dropped from 96.5 to 93.7 percent, a difference of 2.8 percent. The proportion is still quite high, but technically the speed limit has not changed to 55 mph at point 3. At point 4, the location of the 55 mph treatment Speed Limit sign, the proportion of vehicles exceeding 55 mph dropped from 96.7 to 93.7 percent. The proportion of vehicles at point 5 dropped from 93.6 to 90.7 percent between the before and after study, but the reduction was not statistically significant. No significant differences were found between before and after night, passenger vehicle data exceeding 55 mph. [Figure 4-16](#) shows the comparisons of proportions of passenger vehicles exceeding the various speed thresholds during daylight at point 4. [Figure 4-17](#) shows the proportion of passenger vehicles exceeding the various speed thresholds during daylight at point 5. [Figure 4-18](#) shows the proportion of passenger vehicles exceeding the various speed thresholds at night at point 5.

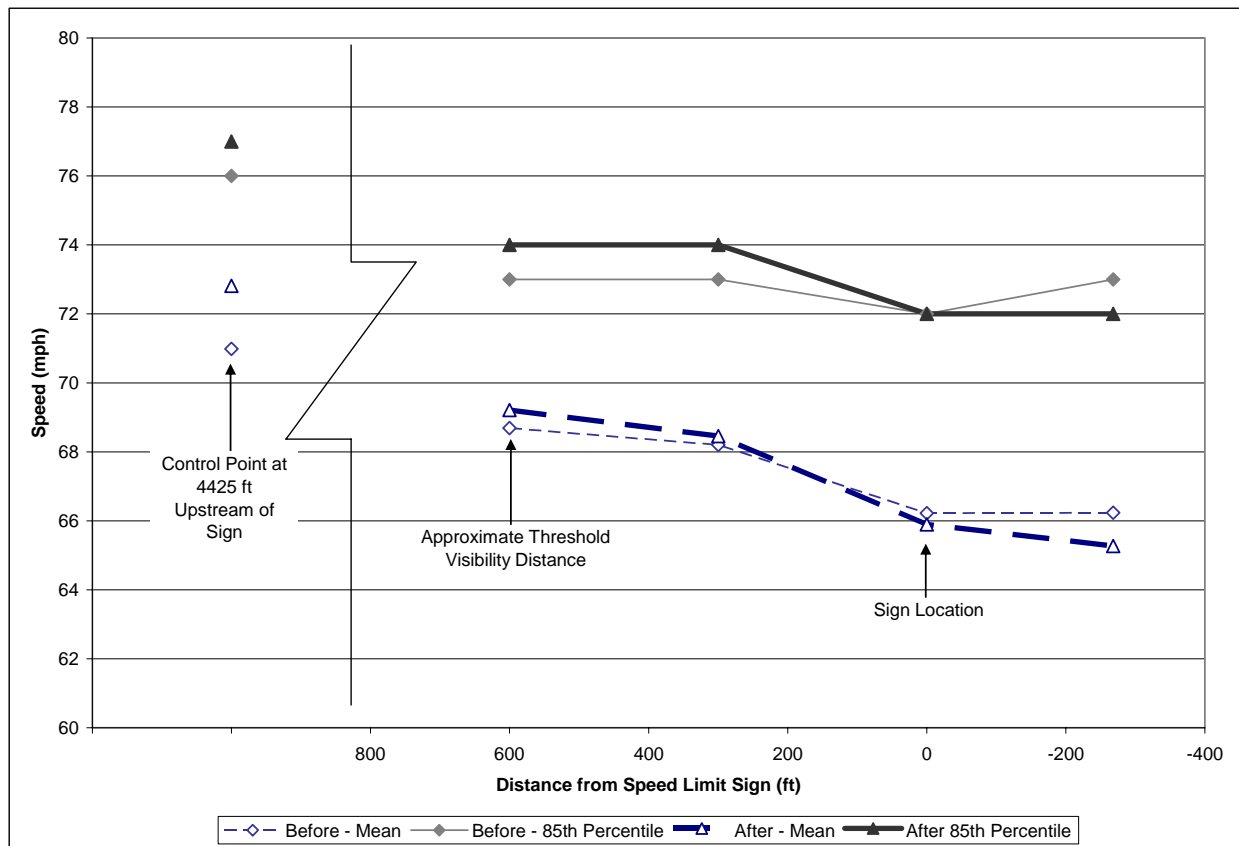
**Figure 4-19. FM 36, Milano—Mean and 85th Percentile Speeds before and after Red Border Installation, Passenger Vehicles, Day Data Only.**

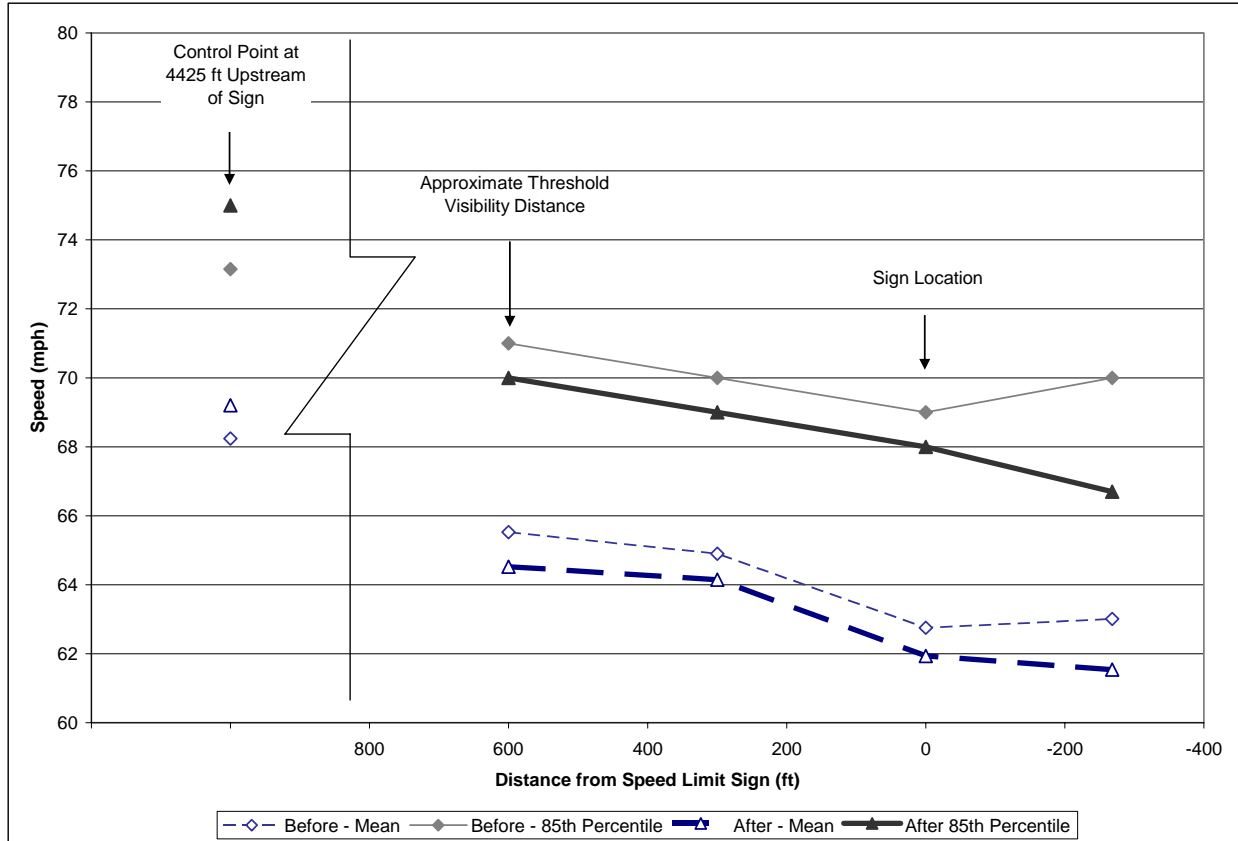
**Figure 4-20. FM 36, Milano—Mean and 85th Percentile Speeds before and after Red Border Installation, Passenger Vehicles, Night Data Only.**
