1. Report No. FHWA/TX-05/0-4701-1		2. Government Accession No.		3. Recipient's Catalog No.	
4. Title and Subtitle EVALUATION OF TRAFFIC CONTROL DEVICES: FIRST YEAR ACTIVITIES				5. Report Date October 2004

9. Performing Organization Name and Address Texas Transportation Institute The Texas A&M University System College Station, Texas 77843-3135				10. Work Unit No. (TRAIS)

**EVALUATION OF TRAFFIC CONTROL DEVICES:  
FIRST YEAR ACTIVITIES**

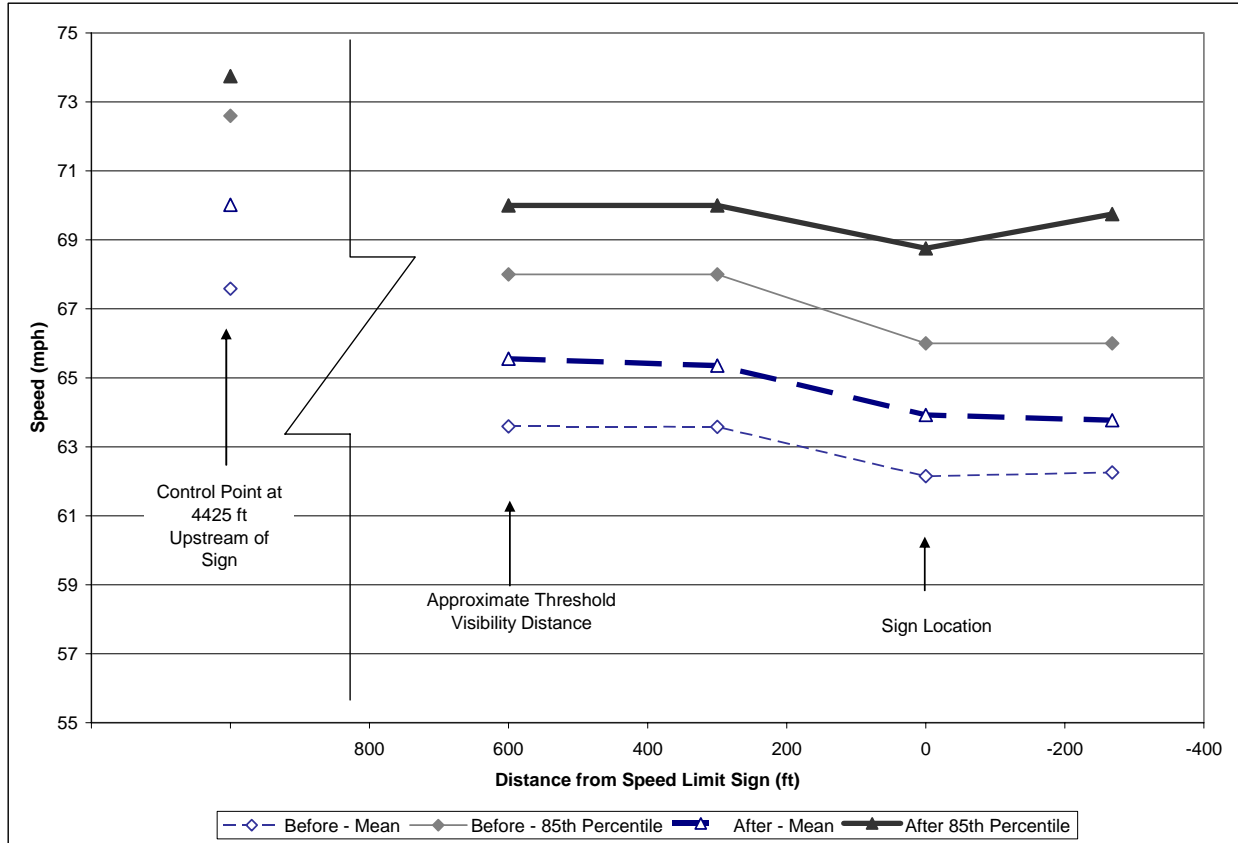
**Figure 4-21. FM 36, Milano—Mean and 85th Percentile Speeds before and after Red Border Installation, Heavy Vehicles, Day Data Only.**

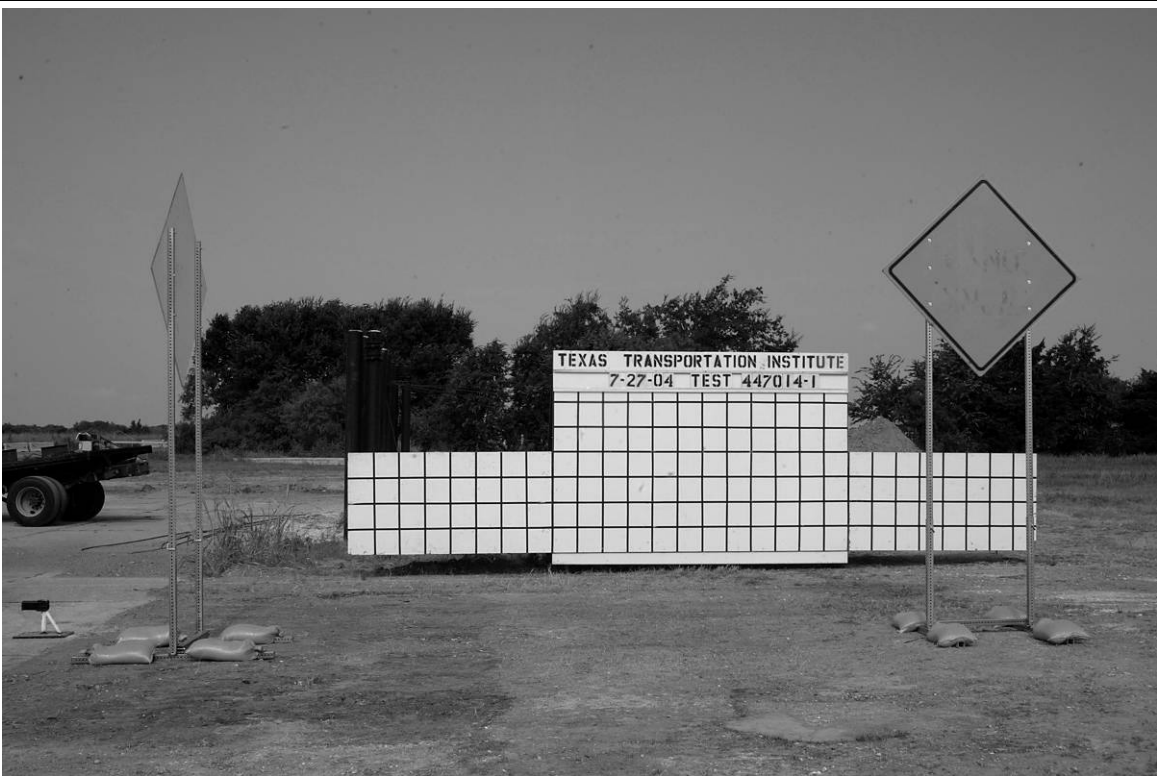
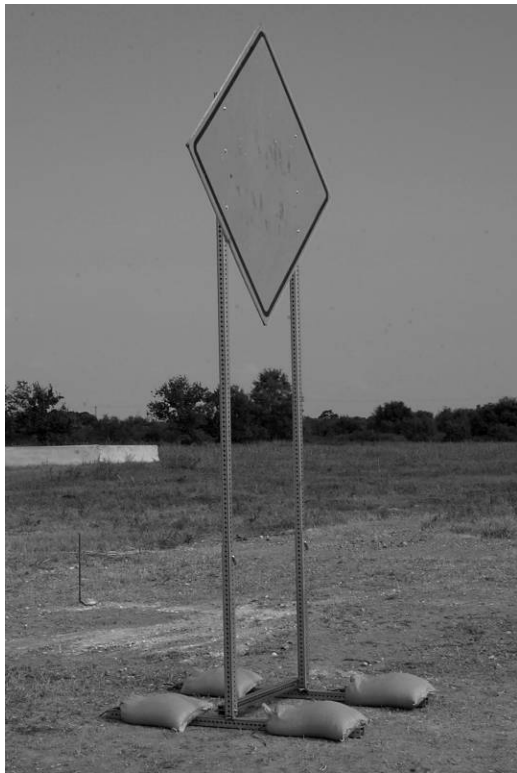
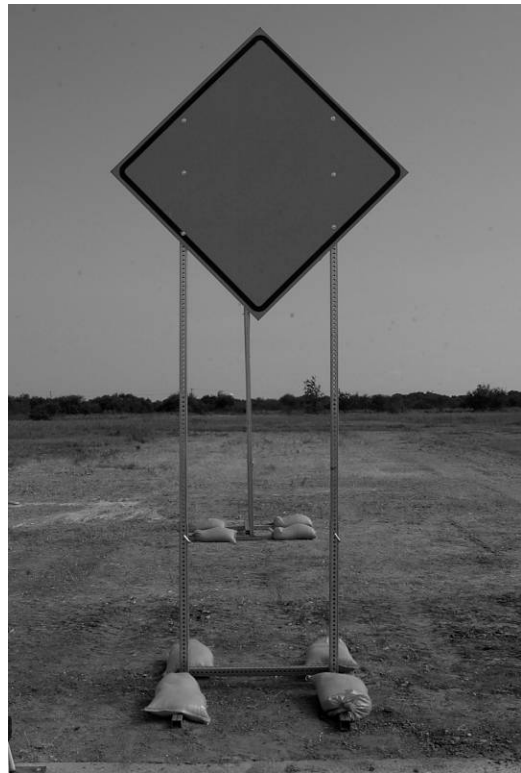
**Figure 5-1. Sign Supports Used for Test.**

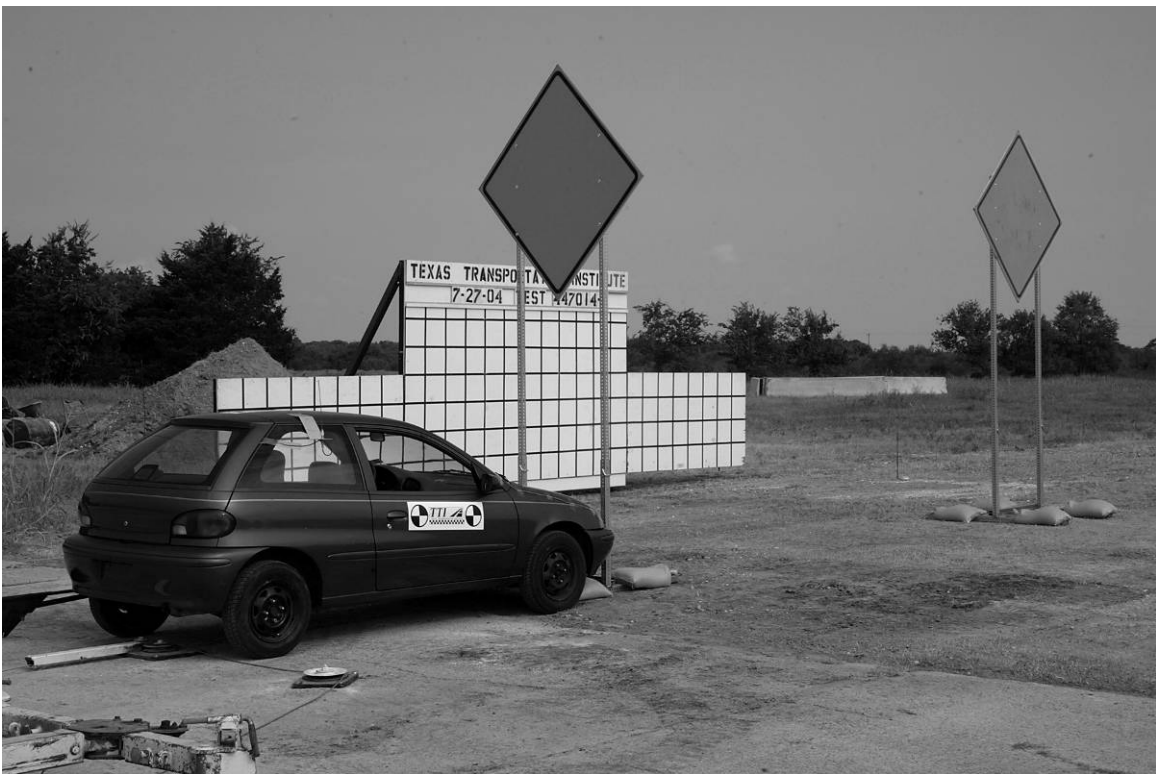
A 1997 Geo Metro, shown in Figures 5-2 and 5-3, was used for the crash test. Test inertia weight of the vehicle was 1,918 lb (871 kg), and gross static mass was 2,092 lb (950 kg). The height to the lower edge of the vehicle's front bumper was 15.7 inches (400 mm), and the height to the upper edge of the front bumper was 20.7 inches (525 mm). The vehicle was directed into the installation using the cable reverse tow and guidance system, and was released to be free-wheeling and unrestrained just prior to impact.

**Figure 5-2. Vehicle and Support Geometrics before Test.**

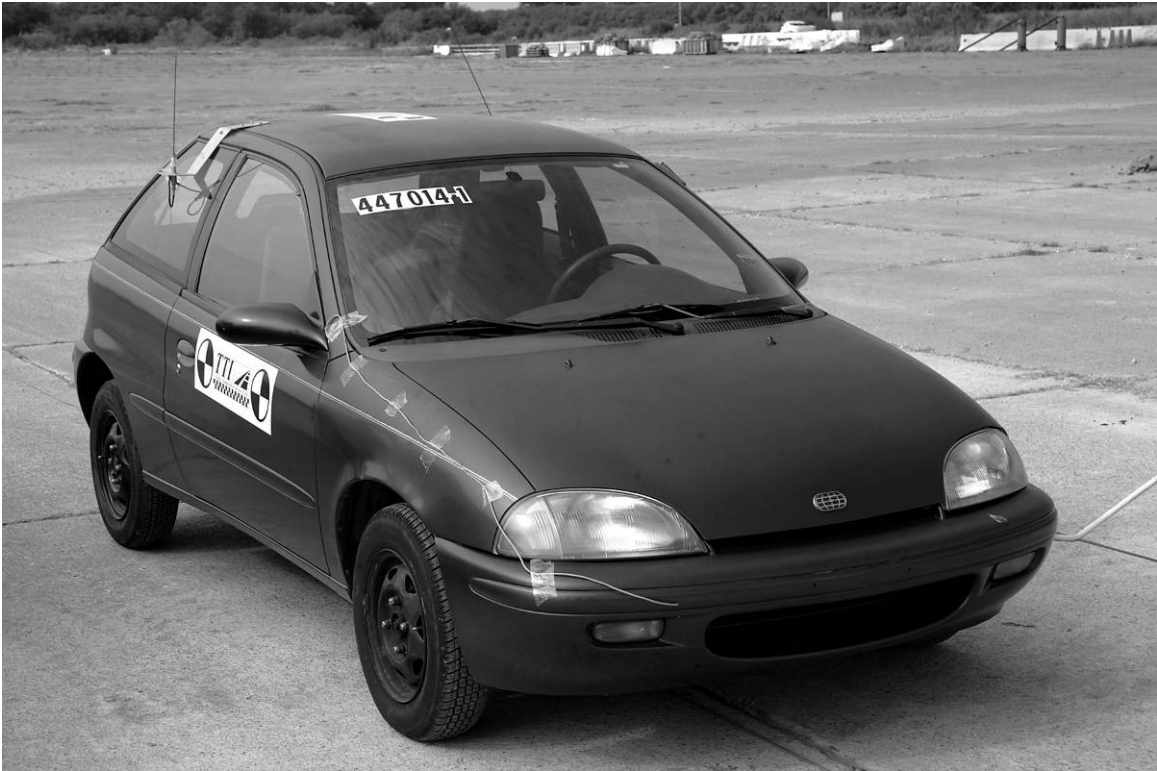
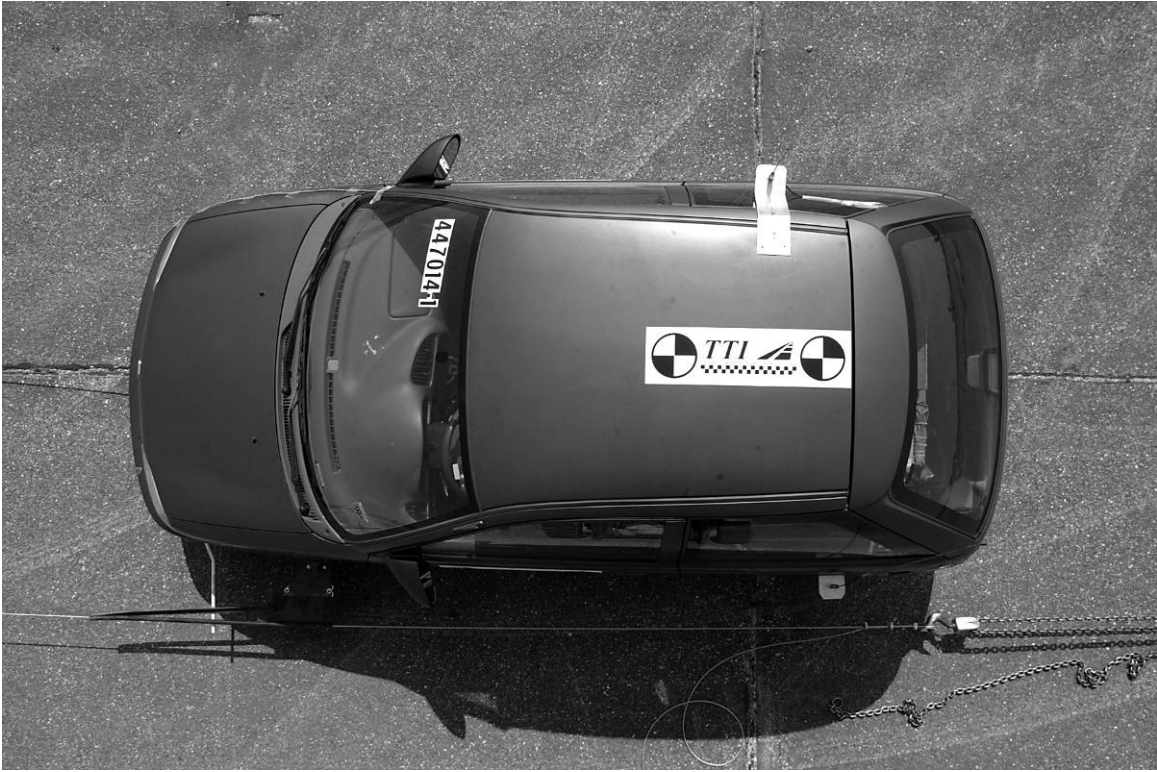
**Figure 5-3. Vehicle before Test.**

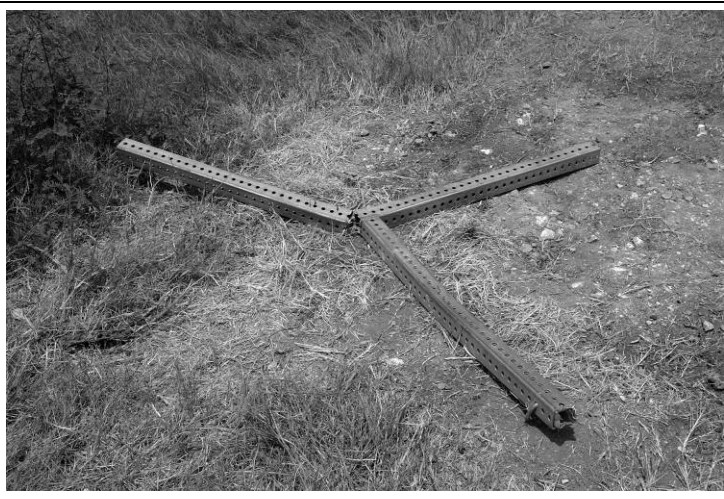
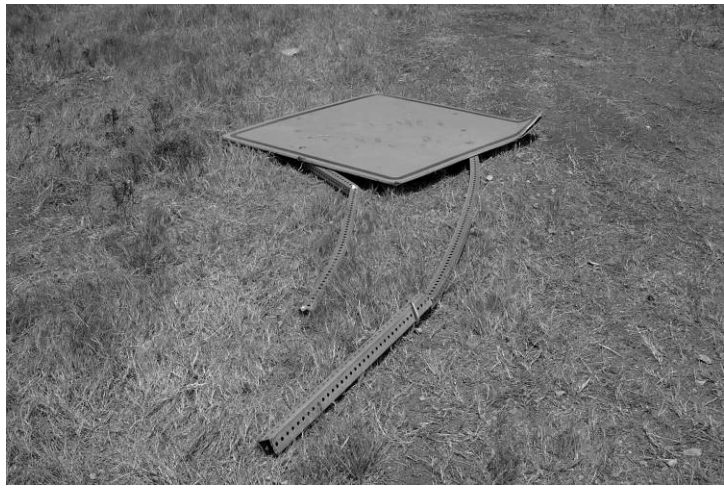
**Figure 5-4. Supports after Test.**

As shown in [Figure 5-4](#), the upper section of the first support remained intact after separating from its base. The second support separated into several pieces.

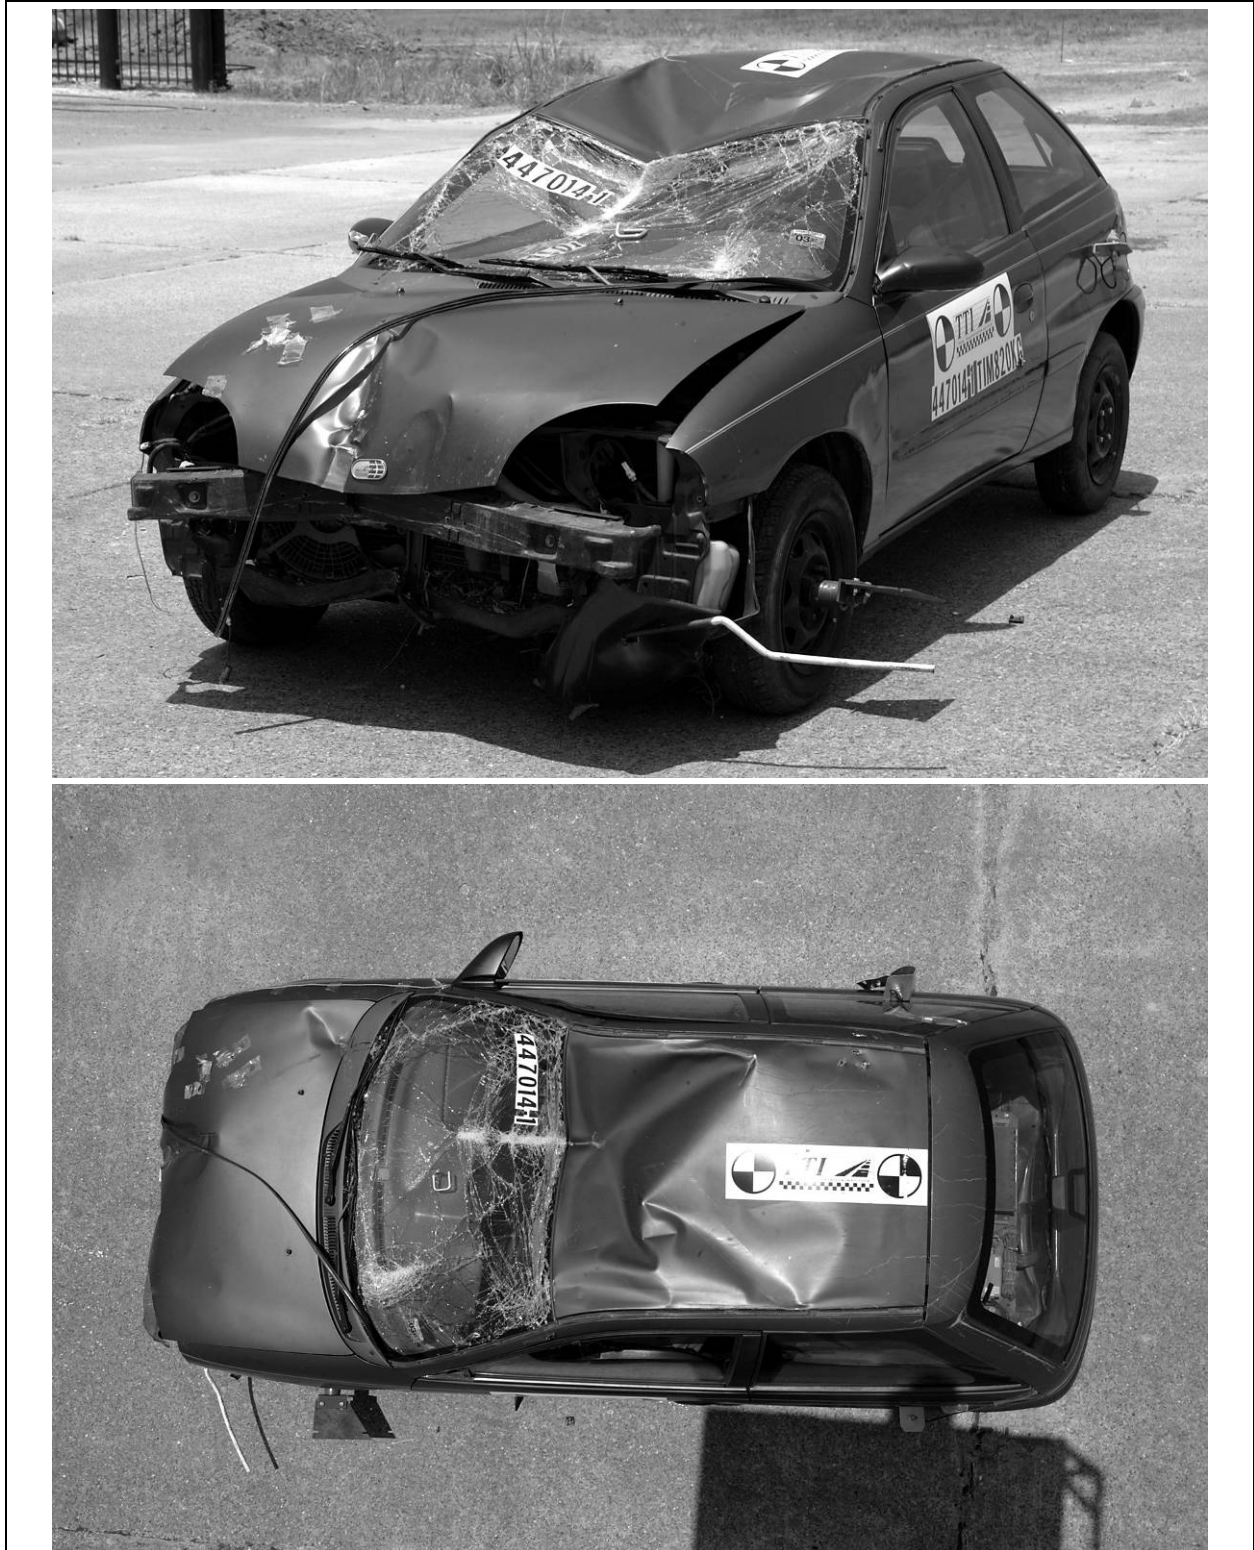
**Figure 5-5. Vehicle after Test.**

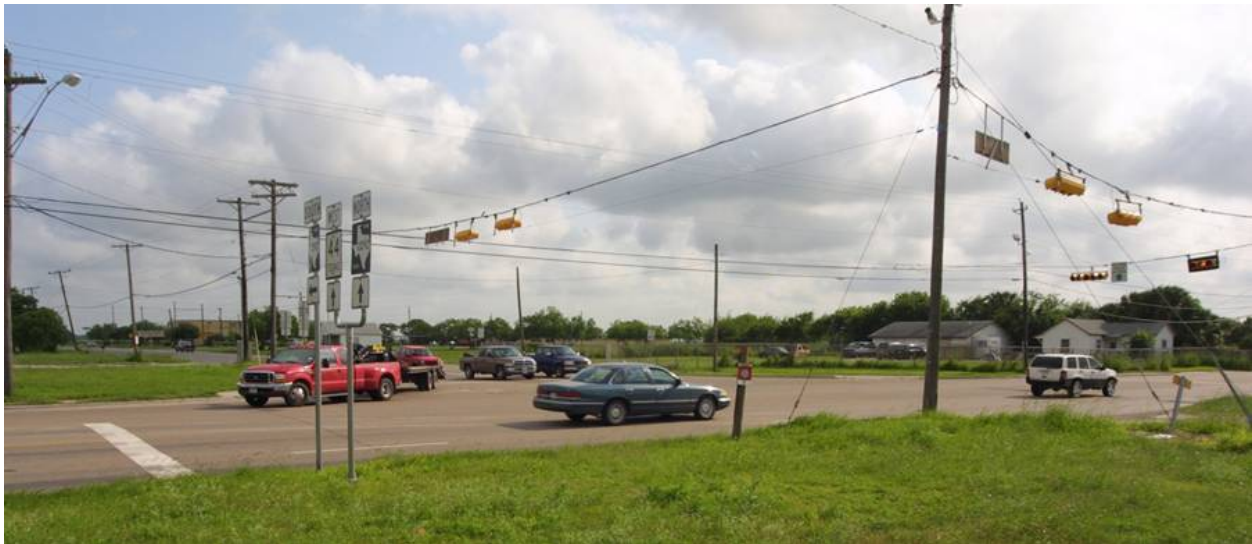
**Figure 6-2. Intersection of SH 44 and FM 2292 Southbound.**

The intersection chosen for this study is located at SH 44 and FM 2292 Southbound in Corpus Christi, Texas. It is a three-leg intersection consisting of four lanes with a left-turn lane on the main lanes and two lanes with a left-turn lane on the minor road. The speed limit at the intersection is 45 mph. The leg of the intersection used in this study was the westbound (WB) through lanes of SH 44. The westbound direction has three signal heads. The two signal heads for the through lanes have backplates, while the left-turn signal head does not have a backplate. [Figure 6-2](#) illustrates the study location.

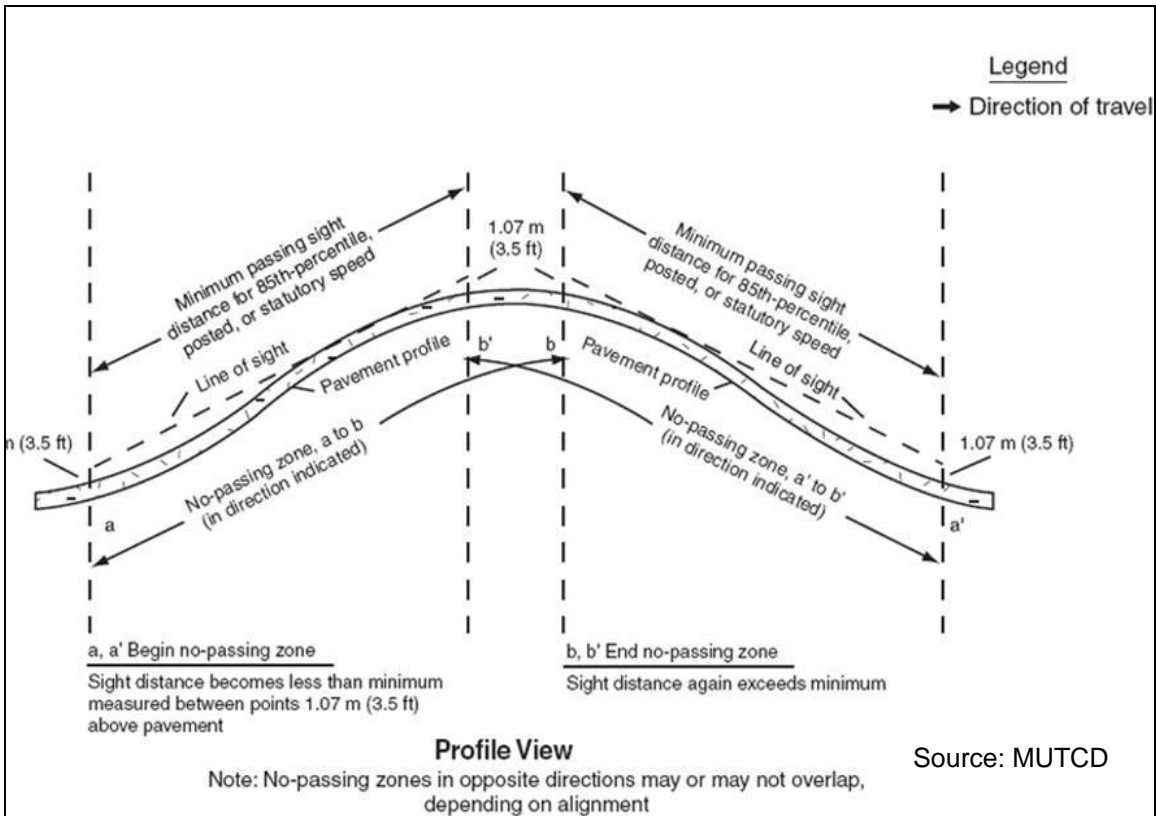
**Figure 7-1. Locating No-Passing Zones on a Vertical Curve.**

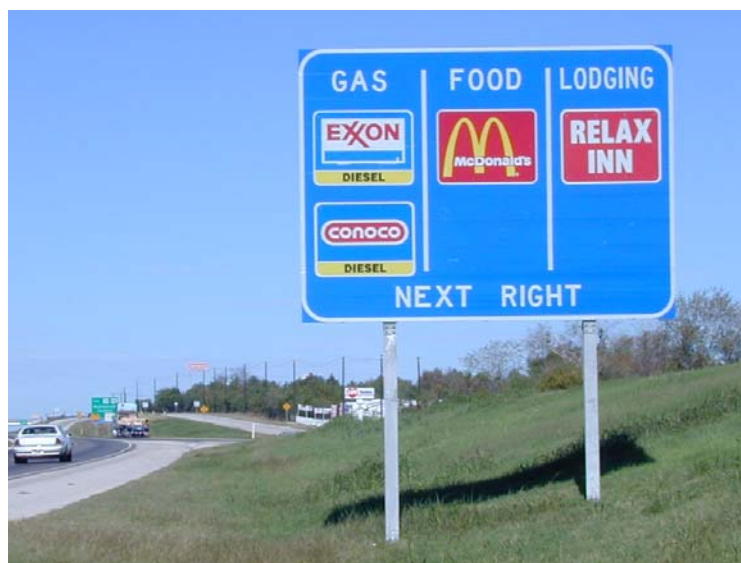
- Logo signs are guide signs placed on interstates and other similar roads that let the motorist know about specific services offered at the next exit
- Food, Gas, Lodging, and Camping are typical services represented on these signs
