1. Report No. FHWA/TX-08/0-4701-4		2. Government Accession No.		3. Recipient's Catalog No.	
4. Title and Subtitle EVALUATION OF TRAFFIC CONTROL DEVICES: FOURTH-YEAR ACTIVITIES				5. Report Date October 2007 Published: May 2008

**EVALUATION OF TRAFFIC CONTROL DEVICES:  
FOURTH-YEAR ACTIVITIES**

Report 0-4701-4

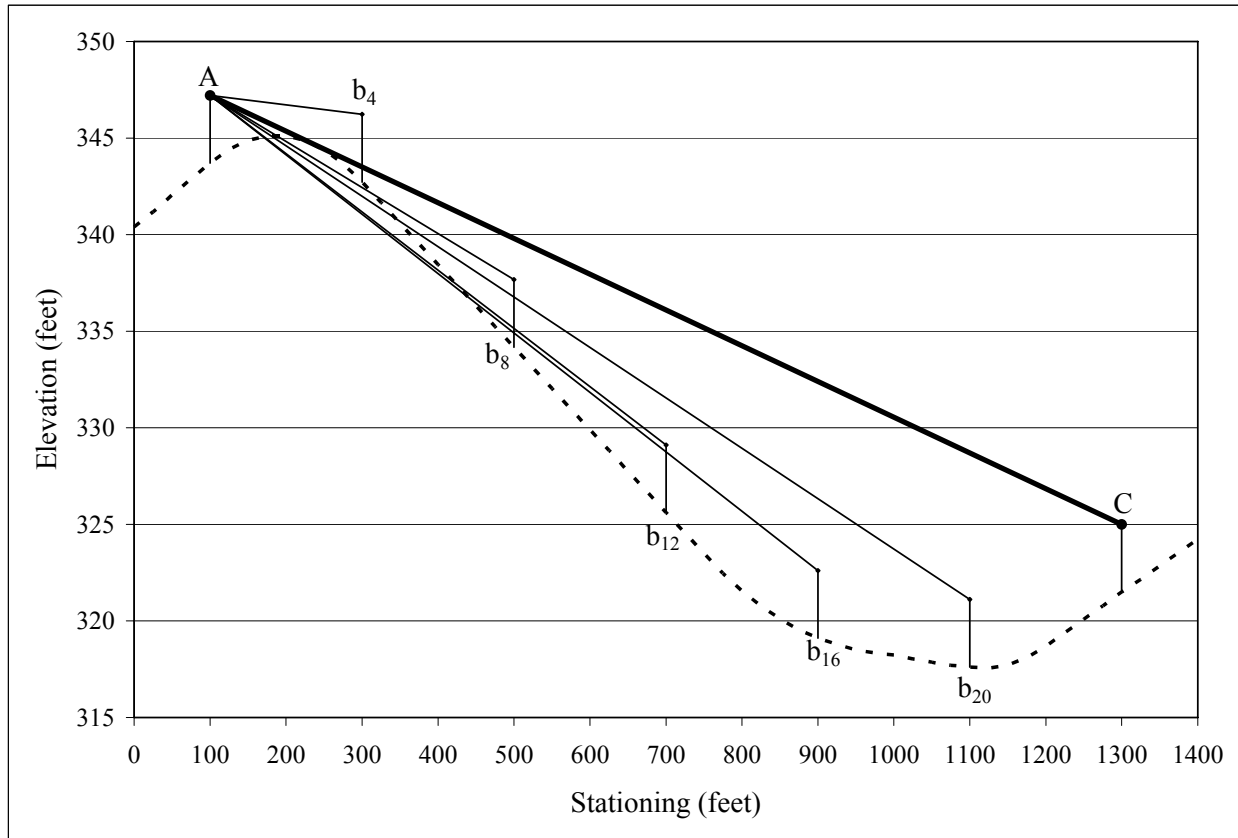
**Figure 2-1. No-Passing Algorithm Iteration Example.**

In this iterative process, there are two separate and distinct intervals. The first interval is that of testing points to determine if they should be identified as a no-passing zone or passing zone location. In general this point is referred to as point A. The algorithm changes the station of point A iteratively so that it tests points every 10 feet along the roadway. The second interval pertains to testing each iterative location of A that is located every 10 feet along the roadway. A secondary point, referred to as  $b_i$ , is selected 50 feet from point A. The interval between point A and point  $b_i$  is tested for sight restrictions. If the algorithm does not find a sight restriction, then another interval from the next  $b_i$ , 50 feet further down the roadway from the current point A, whose location has not been changed, is tested for sight restrictions. Assuming no sight restrictions are found in each successive interval from A to the increasing station of  $b_i$ , the algorithm repeats the process until it reaches a distance equal to the minimum sight distance as set by the MUTCD. The point at this location is called point C. A visual depiction of this process is presented in [Figure 2-1](#).

The algorithm, in general terms, calculates the theoretical sightline for each interval from point A to point  $b_i$  as follows. First, it adds 3.5 feet to the roadway elevations at point A and point  $b_i$ . The line between these two points, which are 3.5 feet above the pavement surface in space, is the theoretical sightline. Next, it determines the equation of the line between these two points, where stationing is the independent variable and elevation is the dependent variable (y). After determining the equation of this line, the algorithm identifies 10-foot station increments and their elevations between point A and the ending station of the theoretical sightline, which is point  $b_i$ . These elevations are then compared to the corresponding roadway elevations at those precise stations as determined by the geometric model with the help of the smoothing process. If over the entire sightline station span the sightline elevations are greater than the roadway profile, then there are no sight restrictions in this interval. However, if at any station a roadway pavement elevation is greater than its corresponding sightline elevation, a no-passing zone exists. If this is the case, the loop of checking successive A- $b_i$  intervals is broken. This process is

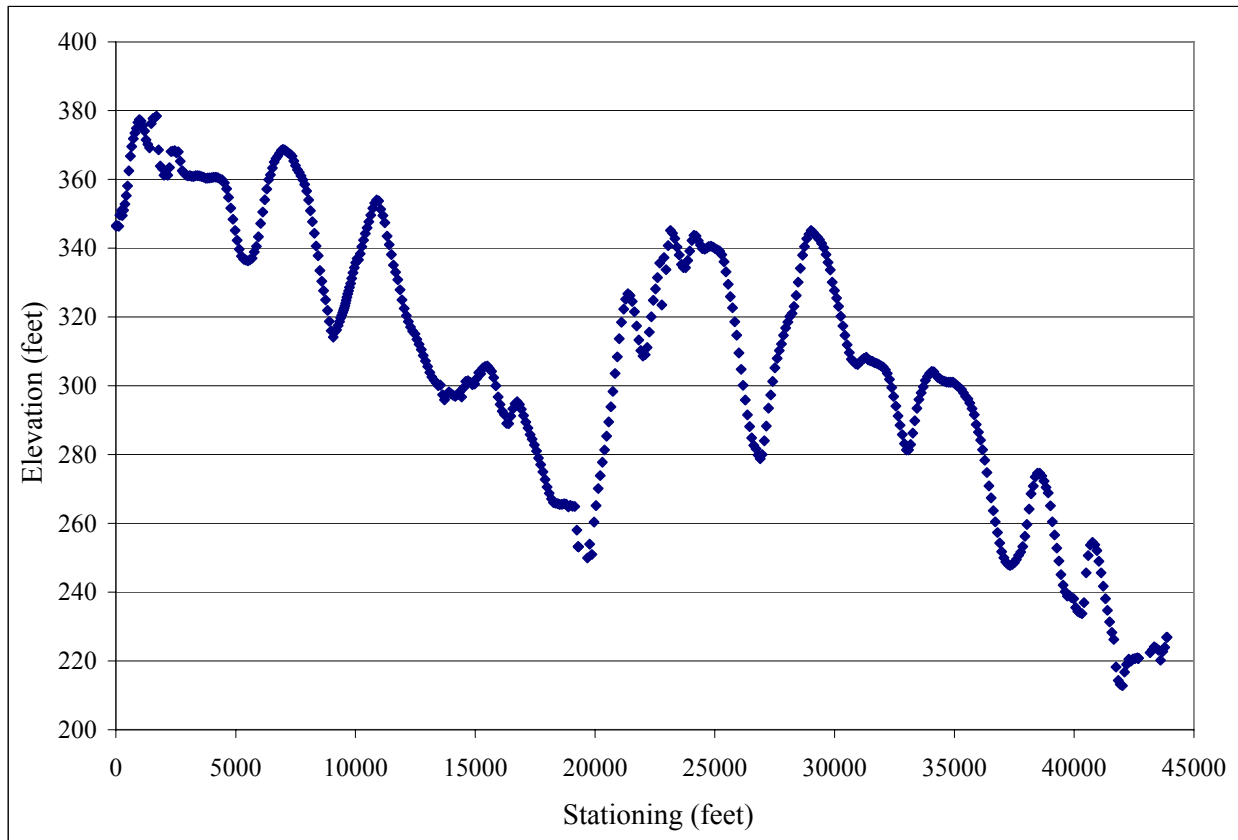
**Figure 2-2. FM 50 Southbound Run 1 Raw GPS Data.**

Presented in this section are the results of the no-passing algorithm for each of the tested roadways. [Figure 2-2](#) is an example of roadway profile obtained from raw GPS data, and [Figure](#)

2-3 is an example of the resulting profile from smoothed GPS data. These are given as examples of figures that are found in Appendix A for the runs of the tested roads in each of their major directions of travel. These figures are important because they help explain the no-passing zone algorithm results that are reported in this section and will be referenced as such. Figure 2-2 below is the roadway profile of the raw GPS data for run 1 in the southbound direction of FM 50.

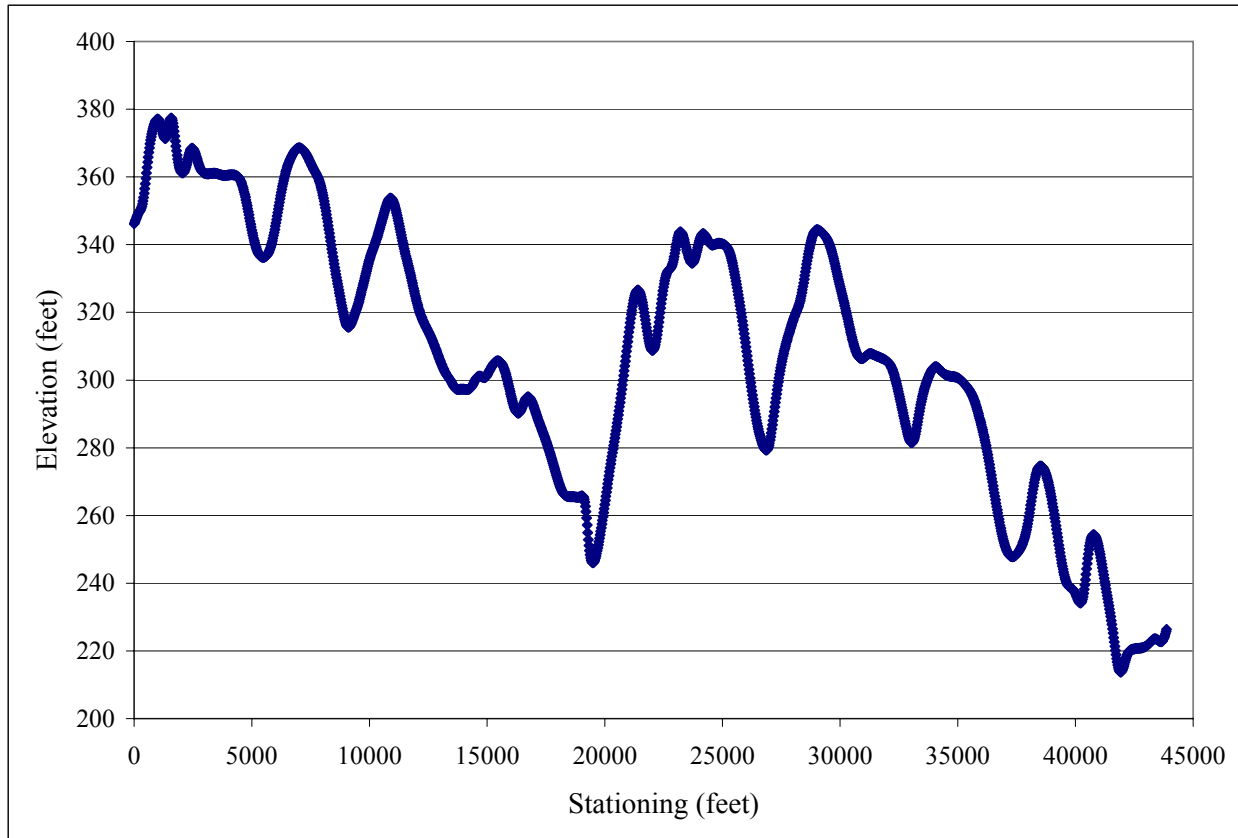
**Figure 2-3. FM 50 Southbound Run 1 Smoothed Data.**

Figure 2-3 is the smoothed representation of the FM 50 run 1 southbound data. These plots give examples of how the smoothing process smooths the GPS data and gives consistent elevation data at constant interval stations on the roadway. However, it will be seen that in some cases the error in the GPS data is beyond the scope of the smoothing process and leads to incorrect location of no-passing zones.

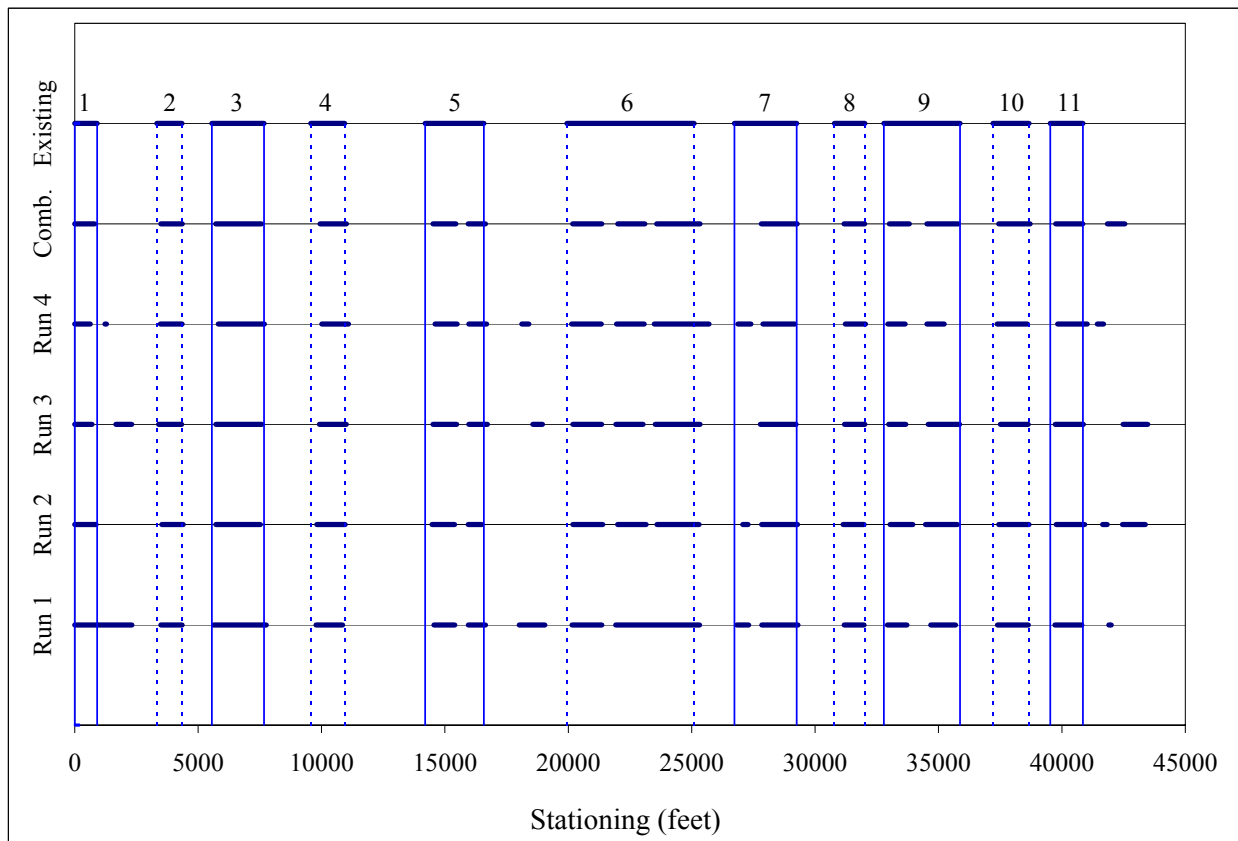
**Figure 2-4. FM 50 Southbound No-Passing Zones.**

Figure 2-4 shows the results of the collected roadway GPS data for the southbound direction of FM 50 processing using the no-passing algorithm. In Figure 2-4 the horizontal line segments represent the location of no-passing zones according to stations. Runs 1, 2, 3, and 4 are results computed from the no-passing zone algorithm for each single run. In Figure 2-4

“Comb.” refers to the no-passing algorithm results from combining the data from runs 1, 2, 3, and 4. Additionally, “Existing” refers to the actual no-passing zone markings observed from DMI distances on the video taken during data collection. Also, in [Figure 2-4](#) the vertical lines (solid and dashed) are for reference purposes only. These lines represent the existing markings as seen at the top of the figure and are used to help delineate how well the no-passing zone algorithm performed on each of the runs. The pairs of solid and dashed lines represent individual no-passing zones. To further delineate the no-passing zones and help in distinguishing them in discussion they have been sequentially numbered at the top of the figure as the stationing increases.

[Figure 2-4](#) shows definite matches between the existing no-passing zone locations and those found from the GPS data using the no-passing zone algorithm. However, there are definite differences as well. For example, between no-passing zones 5 and 6, runs 1, 3, and 4 show no-passing zone segments. These segments occur due to inaccuracies and inconsistencies in the

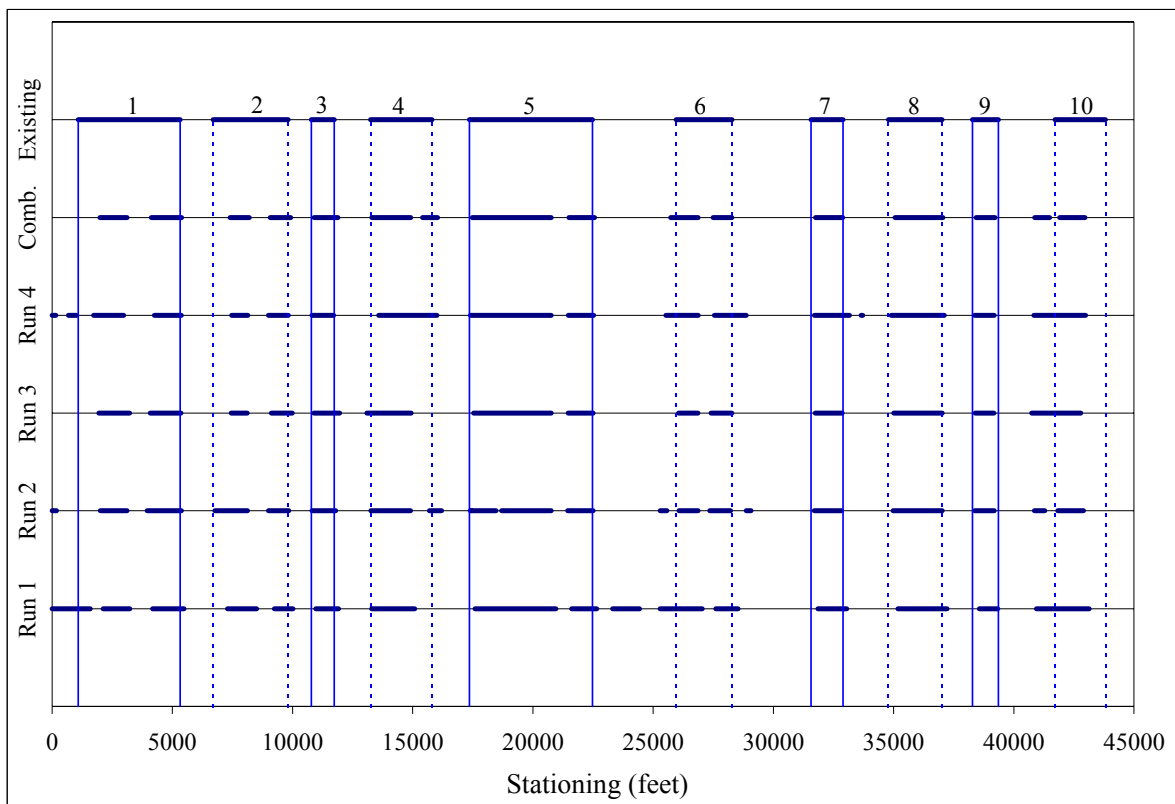
**Figure 2-5. FM 50 Northbound No-Passing Zones.**

Figure 2-5 presents the no-passing zone algorithm results for the runs in the northbound direction of FM 50. Once again the general trends seem to be captured by the no-passing zone location process. However, the term “general” should be emphasized. There are notable differences, especially on run 1 before the first no-passing zone and between no-passing zones 5 and 6.

As for run 2, GPS data inconsistencies can be seen in Figure A-11 at the beginning of the run, surrounding station 25+00, and in the stationing between 400+00 and 450+00. These all correspond to locations on Figure 2-5 where no-passing zones were found where they should not

be. Additionally, the problem seen in run 2 occurring between stations 400+00 and 450+00 is almost consistent among all of the runs. The researchers reasoned that this is the cause for no-passing zones starting before the tenth no-passing zone because all of the runs either show dips in the data or excessive vertical jumps that cause the algorithm to register no-passing zones. All of the runs ended the tenth no-passing zone well before what the existing conditions show. Upon further inspection, at this location the segment is entering the town of Independence and the intersection of FM 50 with FM 390. These two characteristics call for a no-passing zone despite there being sufficient distance for a passing zone according to the MUTCD. These are circumstances that the GPS no-passing zone algorithm cannot account for, and thus the system user must identify these situations and apply good engineering judgment.

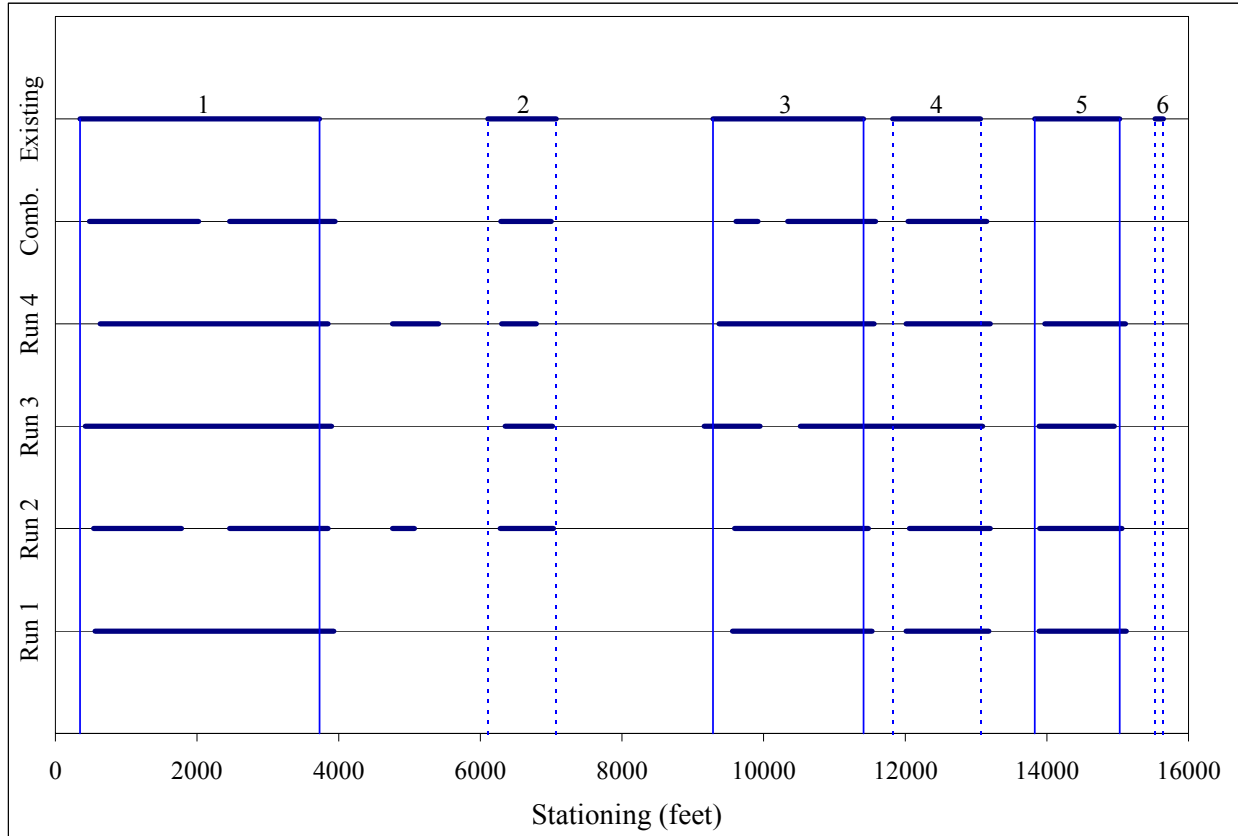
**Figure 2-6. FM 912 Eastbound No-Passing Zones.**

No-passing zone results for FM 912 eastbound are presented in [Figure 2-6](#). FM 912 is an extremely straight roadway segment. As such, there is no concern with no-passing zones existing due to horizontal curves. The one concern that the no-passing zone algorithm does not address is the approach of a highway intersection, as was the situation on FM 50 northbound. At the very end of the run in the eastbound direction FM 1155 intersects perpendicularly with FM 912. Researchers believed this is the cause for no-passing zone 6, along with the fact there are insufficient data at the end of the runs to identify the sixth no-passing zone. What is meant by insufficient data is that in order to obtain an accurate reading of whether there is a passing or no-passing zone at a location data are needed for the roadway ahead of the location in question for a distance equal to the minimum required passing sight distance.

As with FM 50, FM 912 results show some similarities, along with some errors. For example, in run 1 the most glaring difference is that existing no-passing zone 2 does not appear in the results of the no-passing analysis. When looking at the raw GPS data for run 1 in [Figure A-19](#) it is somewhat difficult to see why this occurs. The GPS data seem to show a slight vertical curve at this location; however, the curve is not as prominent as the ones seen in runs 2 or 3 or even 4. Because of this, the researchers hypothesize that the smoothing process eliminates the significance of the curve because the GPS data do not show its true effect. In response, sight restrictions at this location are not detected and a no-passing zone is not located.

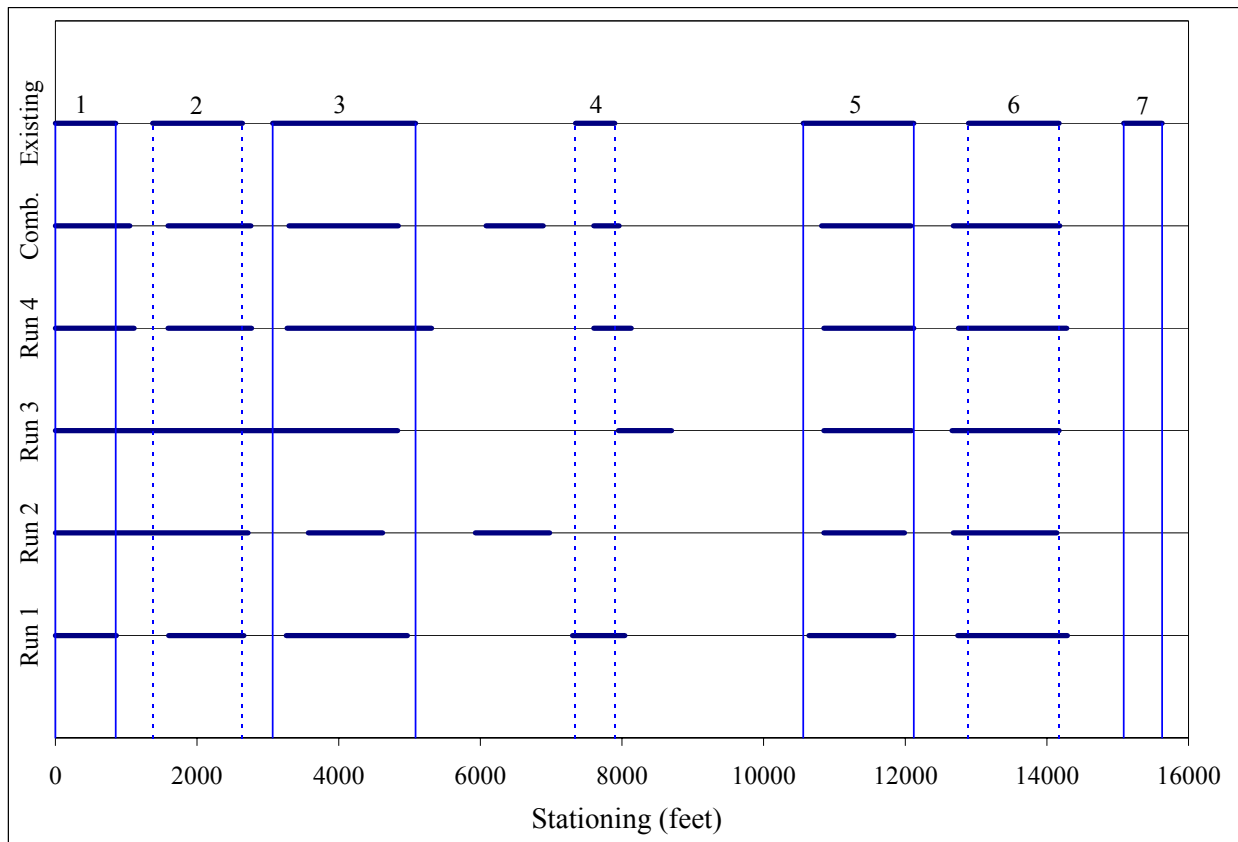
**Figure 2-7. FM 912 Westbound No-Passing Zones.**

[Figure 2-7](#) shows the results from the westbound runs on FM 912. These results reiterate the importance of retrieving good GPS data. From observation, run 1 seems to conform the best of the four runs to existing conditions. This is despite what appear in [Figure A-29](#) to be some inaccurate data points around stations 22+00, 50+00, and 125+00. This speaks to the importance

of smoothing the data points. In run 2, the third no-passing zone is definitely out of place and the reason can be seen in [Figure A-31](#), where the vertical crest curve surrounding station 70+00 is much more prominent than what is seen in the other runs or even the plan sheet profile. This causes inaccurate placement of the no-passing zone. Alternatively, in the same run the vertical curves following station 80+00 are not as defined as in the other runs, resulting in existing no-passing zone 4 being left out.

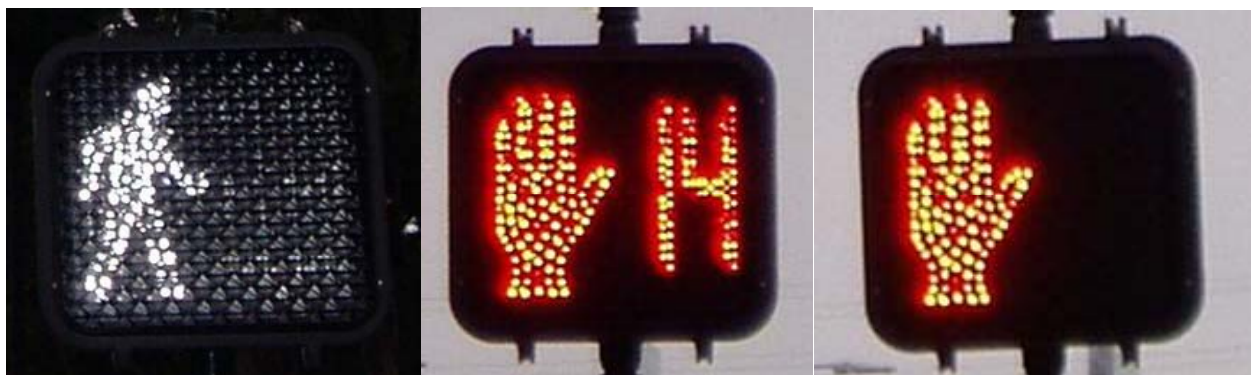
**Figure 3-2. Displays in a Pedestrian Countdown Timer.**

The intent of pedestrian countdown signals is to increase pedestrian understanding of the FDW interval by informing the pedestrians of the number of seconds remaining in the pedestrian change interval. The Texas MUTCD states that the PCT may be added to inform the pedestrian of the number of seconds remaining in the pedestrian clearance interval (4). The displays in a PCT are illustrated in Figure 3-2. The MUTCD also states that countdown displays shall not be used during the walk interval or during the yellow change interval of a concurrent vehicular phase.

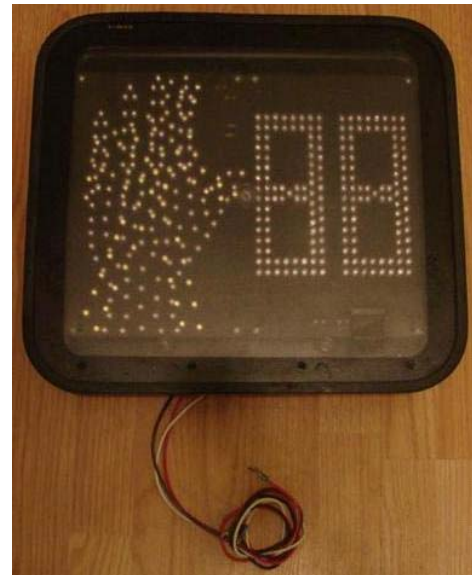
**Figure 3-3. Pedestrian Countdown Lens.**

The PCT can be implemented by changing the lens of the pedestrian signal. Most of the existing conventional pedestrian signals can be retrofitted with no additional wiring. A typical pedestrian lens is illustrated in Figure 3-3. The cost of retrofitting an existing pedestrian signal with a new PCT lens ranges from \$300 to \$800 (22). Enquiries in Texas have found that a new lens can be purchased for approximately \$250. Since the remaining infrastructure does not change for a PCT when compared to a traditional pedestrian signal, the cost of implementing PCT at a new traffic signal does not have significant financial impact.

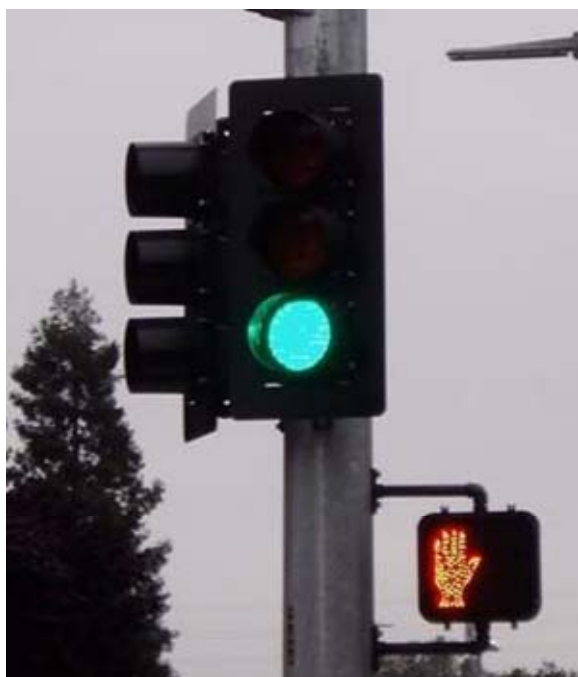
**Figure 3-4. Illustrating the Onset of SDW before the Onset of Yellow.**

An ideal pedestrian signal operation is one in which the onset of the SDW and the yellow indication in the traffic signal happen at the same time, as illustrated in [Figure 3-5](#). Such an operation will not give any displays that will cause confusion in the pedestrian about opportunities to cross the intersection.

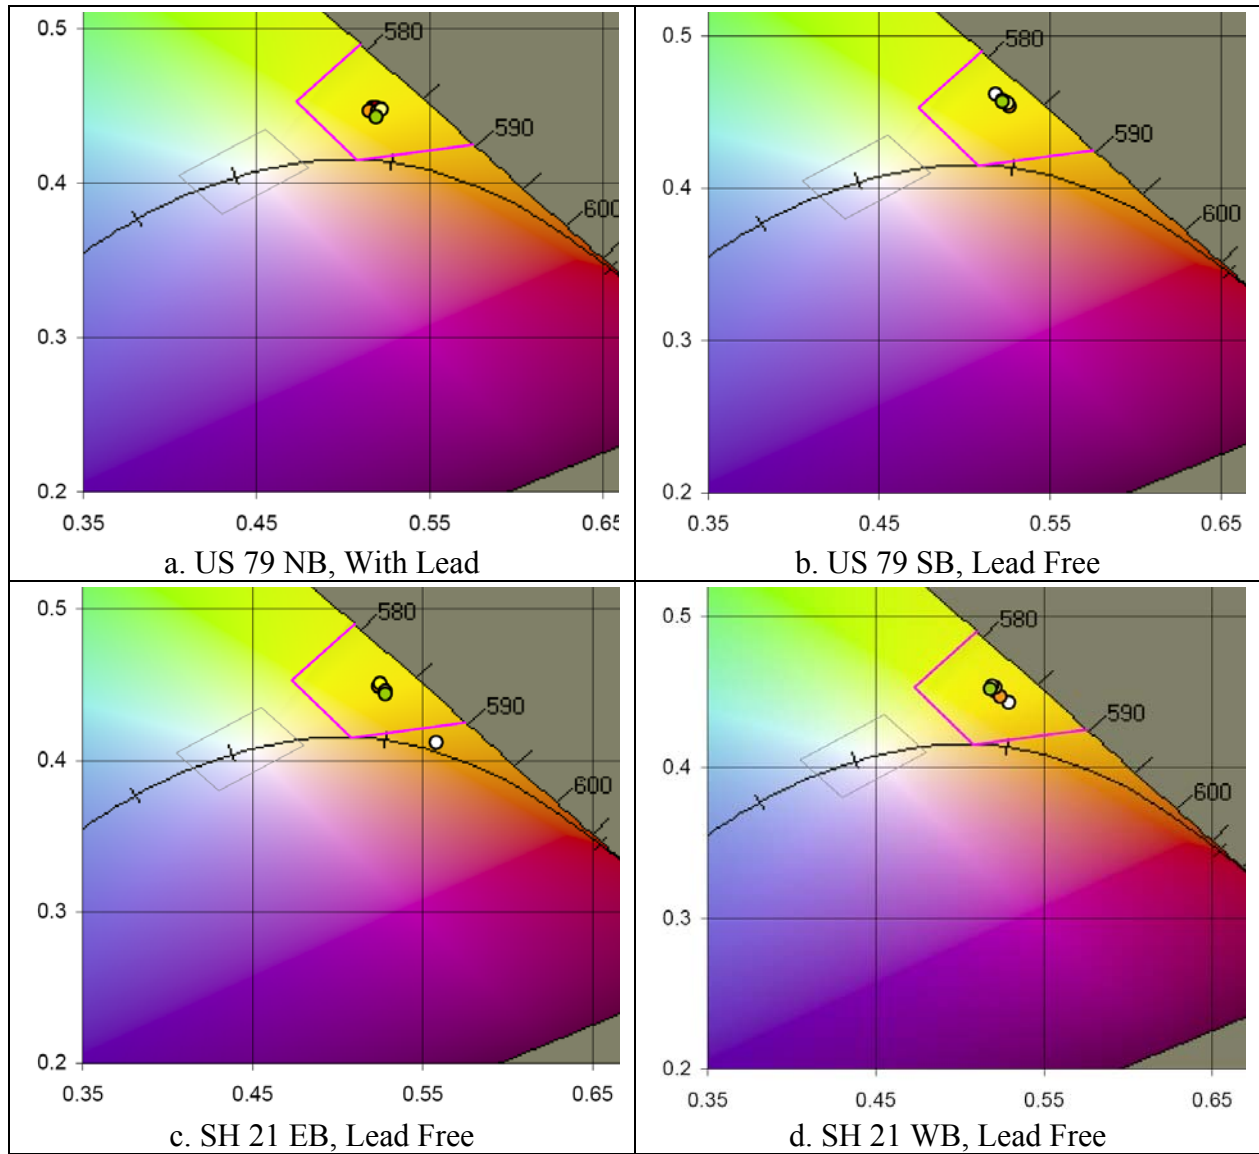
**Figure 4-1. Color Findings for 30 Meter Geometry Measurements.**

The 30 meter color measurements are indicated in [Table B-3](#). The individual color values were plotted against the x-y points defining the color box from the FHWA final rule on marking color. This color box is based on Illuminant A and a viewing geometry that is the same as the 30 meter retroreflectivity geometry. [Figure 4-1](#) illustrates the plot of the color points for the various color measurements with the LTL 2000Y. All of the measurements are within the FHWA color box. It is worth noting that the markings measured on the pavement were applied to surface treatment (seal coat). As with the retroreflectivity measurement, this surface represents a very rough pavement surface, which may have an impact on the measured color. However, there were not application sites included in the initial evaluation where the lead-free marking material was applied to a smoother pavement surface.

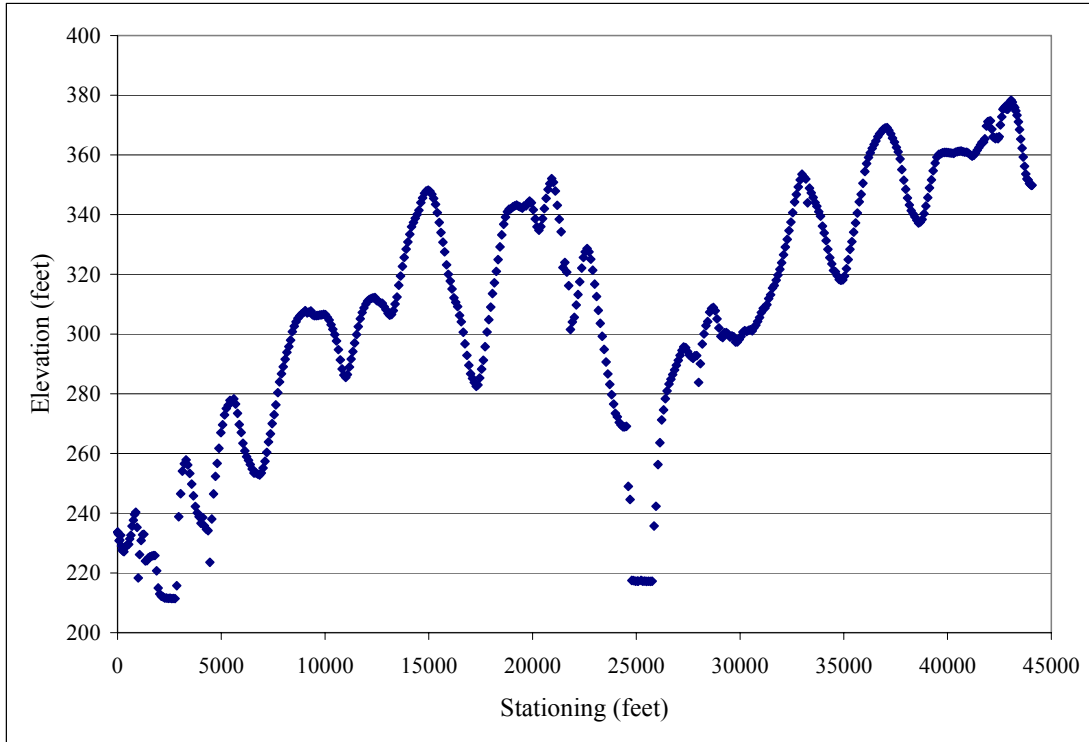
**Figure A-9. FM 50 Northbound Run 1 Raw GPS Data.**

When examining the GPS profile for run 1 in Figure A-9, major discrepancies can be found around stations 25+00 and 250+00. The GPS data show decreases in elevation that are not present in the plan sheet profile shown in Figure A-18. These elevation decreases are modeled in the smoothing process, causing the no-passing algorithm to establish no-passing zones at these locations where they should not be.

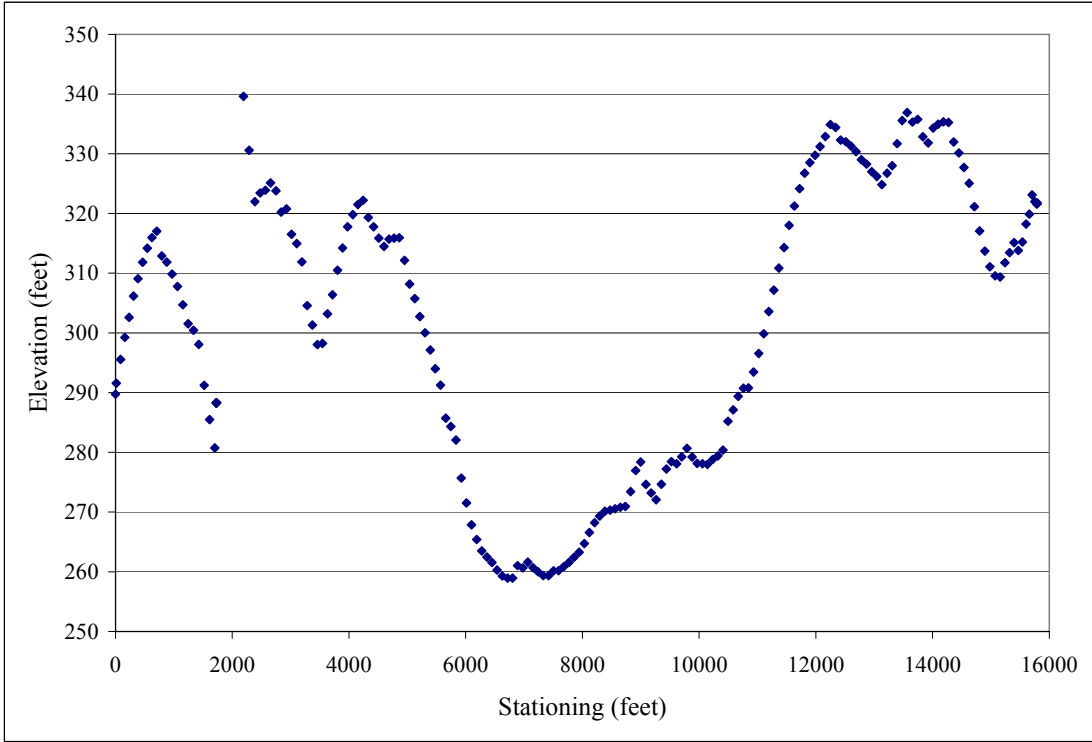
**Figure A-33. FM 912 Westbound Run 3 Raw Data.**

In run 3 a continuous no-passing zone extends from the beginning of the run through most of existing no-passing zone 3. The cause of this is clearly seen in [Figures A-33](#) and [A-34](#). A huge skew in the vertical curve at the location surrounds station 20+00. This is definitely in contrast to what is seen on the plan sheet profile of [Figure A-38](#). Also, as in run 2 the vertical curve just past station 80+00 is not as evident or as extreme as it should be and thus it is not caught by the no-passing zone algorithm. Additionally, at this same location, actually closer to stations 90+00 and 100+00, the data fluctuate, causing multiple sag and crest curves. These

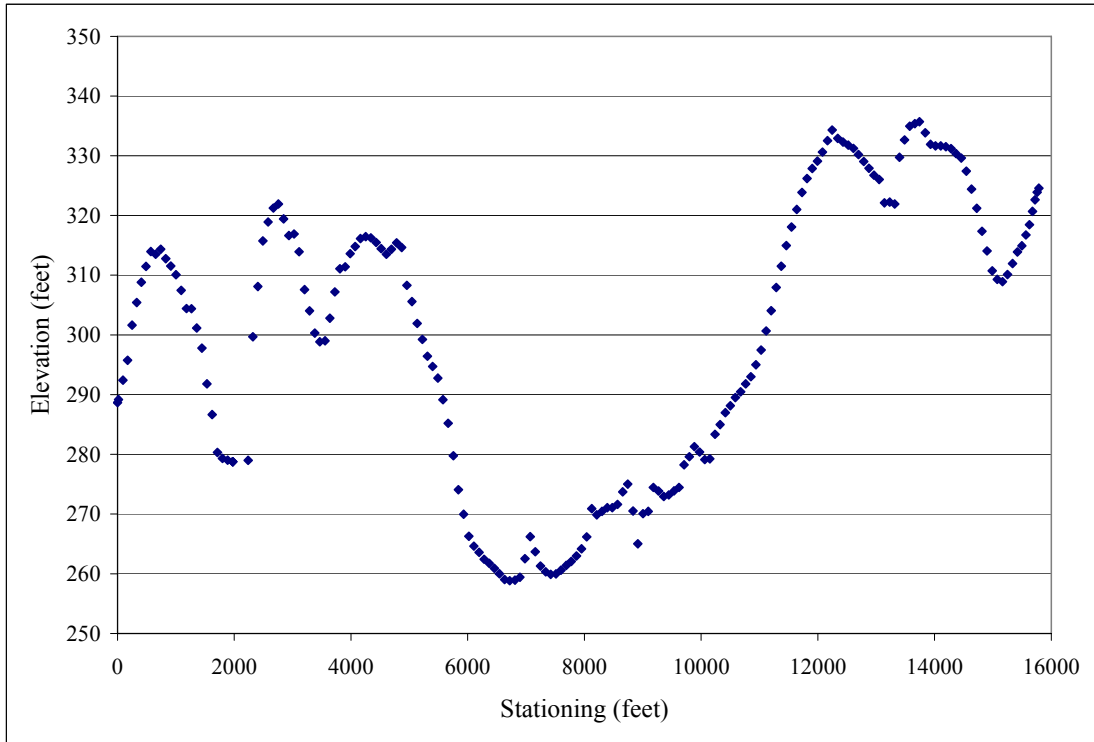
**Figure A-35. FM 912 Westbound Run 4 Raw Data.**

Run 4, as with run 1, does a good job of locating the no-passing zones as compared to the existing conditions, despite some GPS data variability as seen in [Figure A-35](#). Run 4 has some of the same problems arise in inaccurate data that the previous runs did; however, because the jumps between data points are not as great, the smoothing process enables the no-passing zone algorithm to approximately locate the existing no-passing zones. The last item to mention on FM 912 westbound is the fact that none of the runs identify the seventh existing no-passing zone. This no-passing zone occurs as FM 912 intersects into SH 105. So the seventh existing no-passing zone is a result of this intersection and the no-passing zone algorithm will not address this issue. It is something that must be identified in the field.

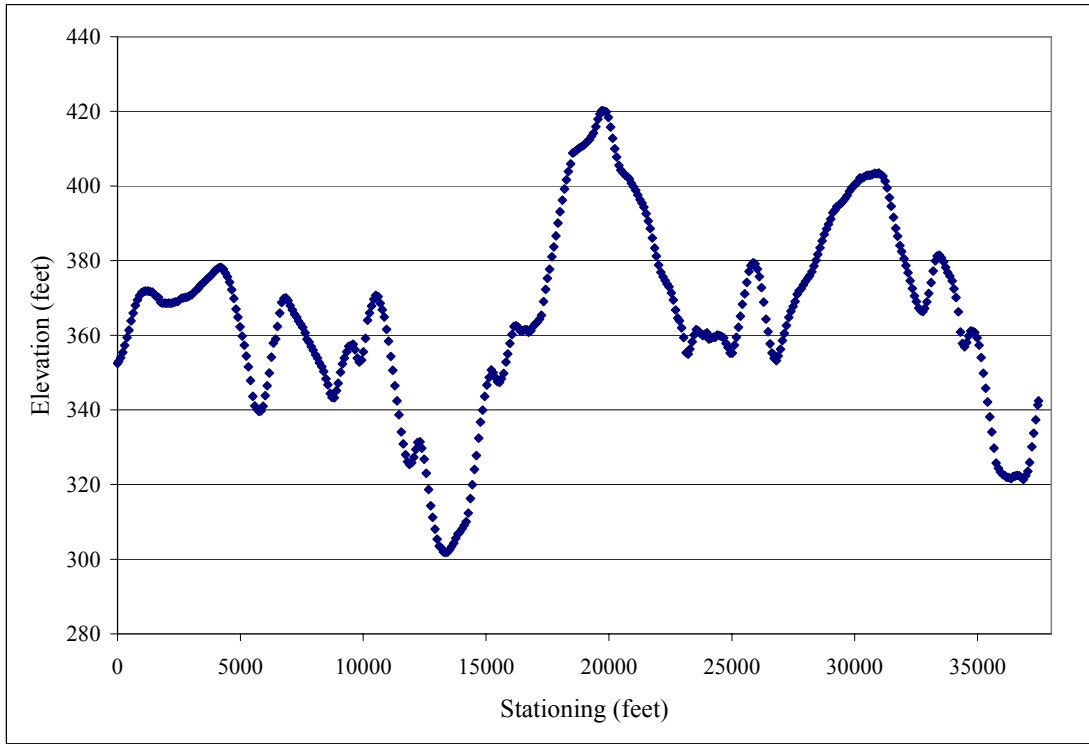
**Figure A-49. FM 1940 Northbound Run 1 Raw Data.**

In the northbound direction, the first two runs produced smooth GPS profiles, as seen in [Figures A-49](#) and [A-51](#). In contrast, the third and fourth runs in the northbound direction had very poor GPS profiles that were not smooth. The consequences can be seen in the no-passing zone algorithm results in [Figure 2-9](#). Runs 1 and 2 conform much better to the existing conditions than do runs 3 and 4. No further discussion is provided on FM 1940 northbound. Many of the same trends that held true for the previous cases hold true here.
