**AN ASSESSMENT OF VARIOUS RUMBLE STRIP DESIGNS AND
PAVEMENT MARKING APPLICATIONS FOR CROSSWALKS AND
WORK ZONES**

Report 0-4728-2

Project 0-4728

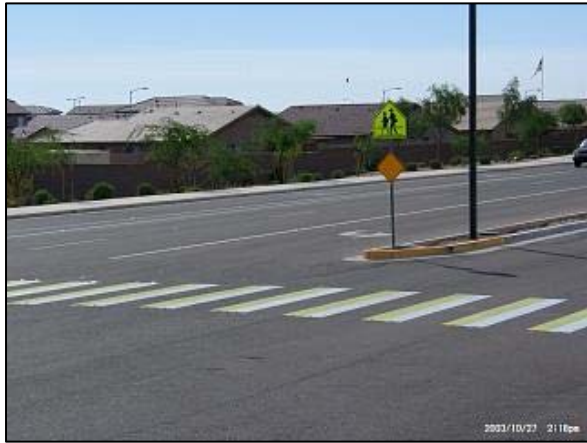
A. Full View.

B. Close-up.

Figure 3. Variation of YG and White Continental Crosswalk Used by the City of Goodyear.

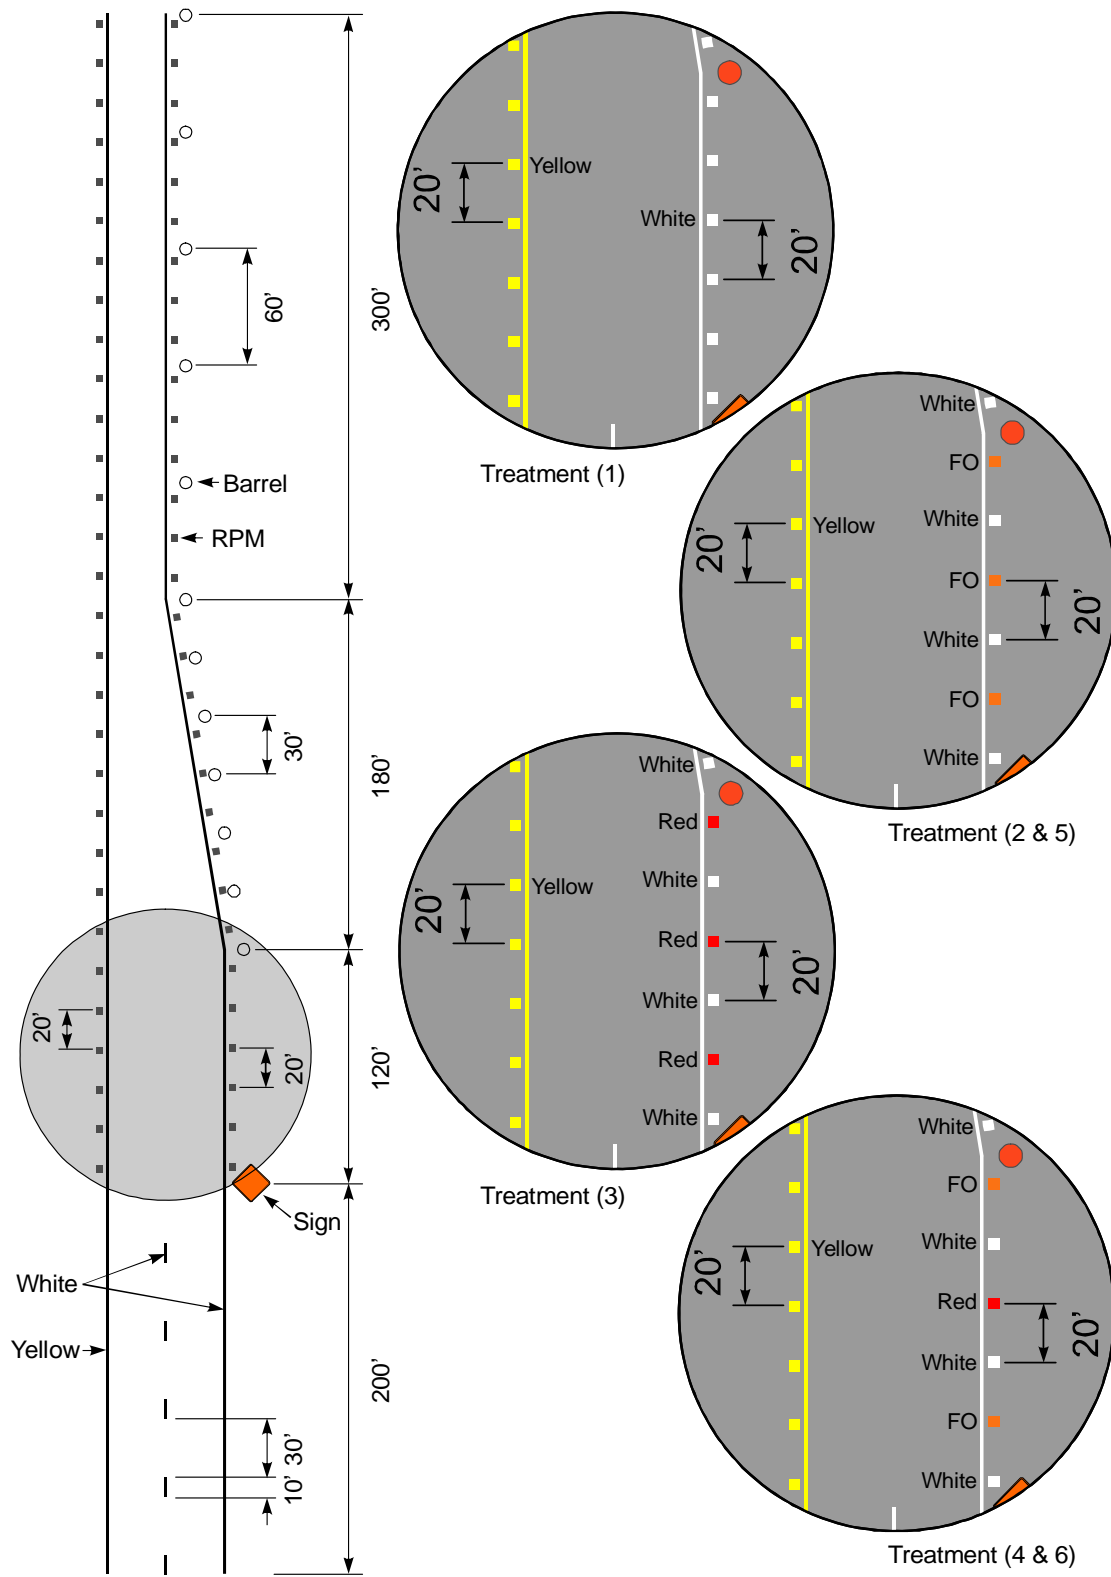
Figure 8. Layout of Treatments.

6	✓	✓		✓	✓	Treatment 1 replacing every other white RRPM with either a Type 2 fluorescent orange or red RRPM. RRPMs are still spaced at 20-ft intervals, with the white RRPMs spaced at 20-ft intervals and the fluorescent orange and red RRPMs spaced at 80-ft intervals.

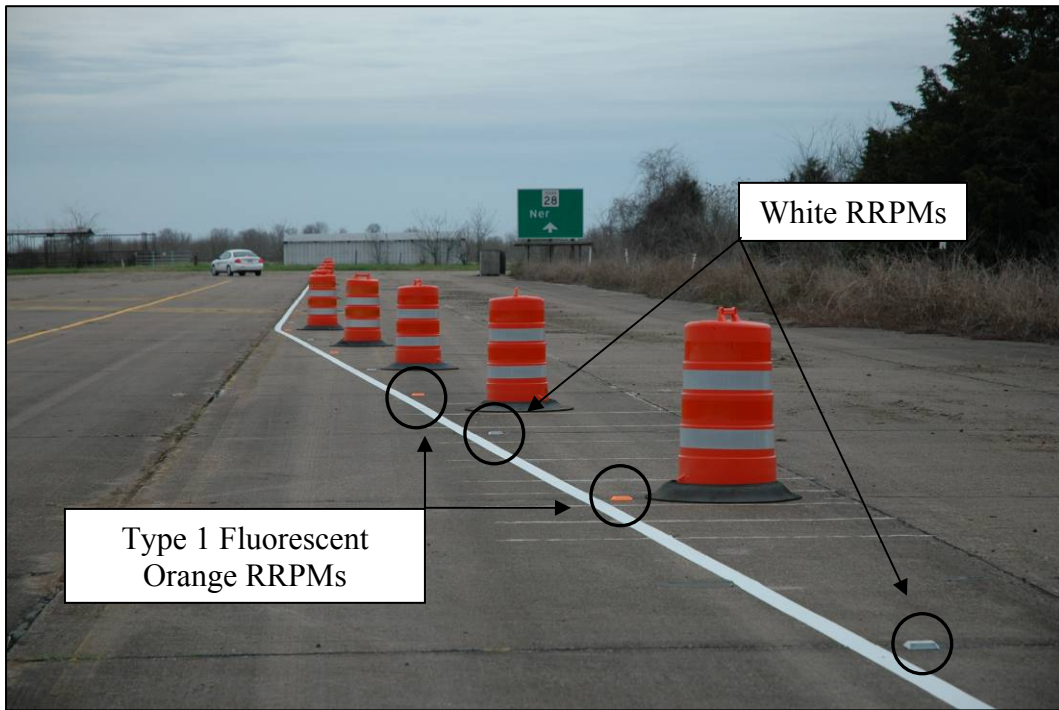
Figure 10. Treatment 2 – White RRPMs and Type 1 Fluorescent Orange RRPMs Adjacent to Right Edge Line.

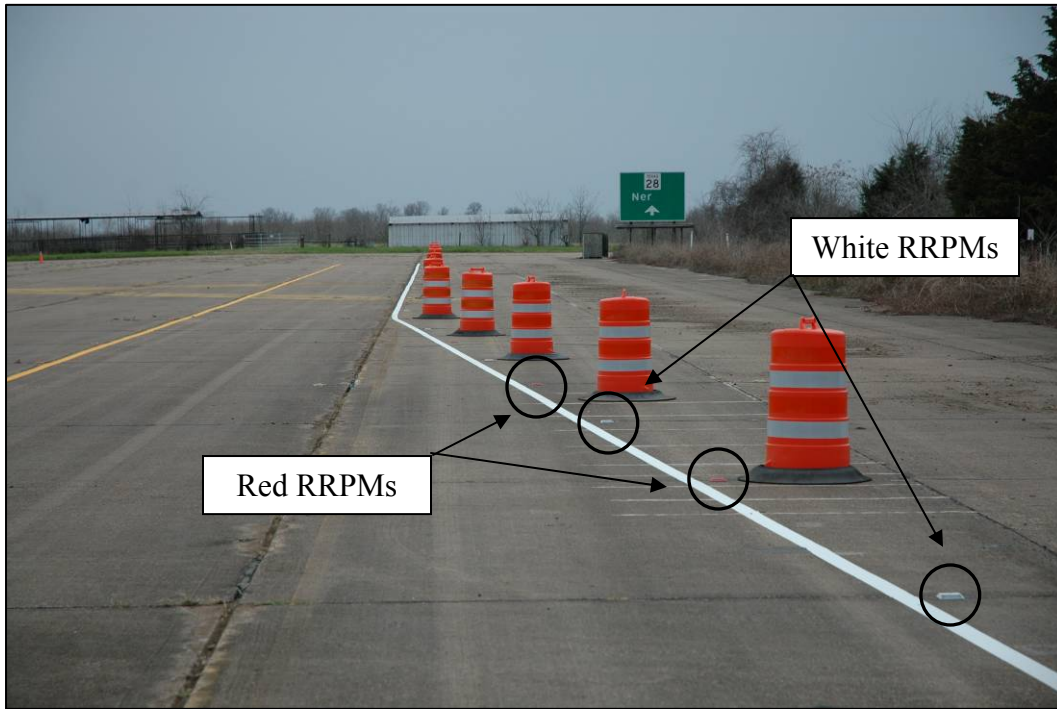
Figure 11. Treatment 3 – White RRPMs and Red RRPMs Adjacent to Right Edge Line.

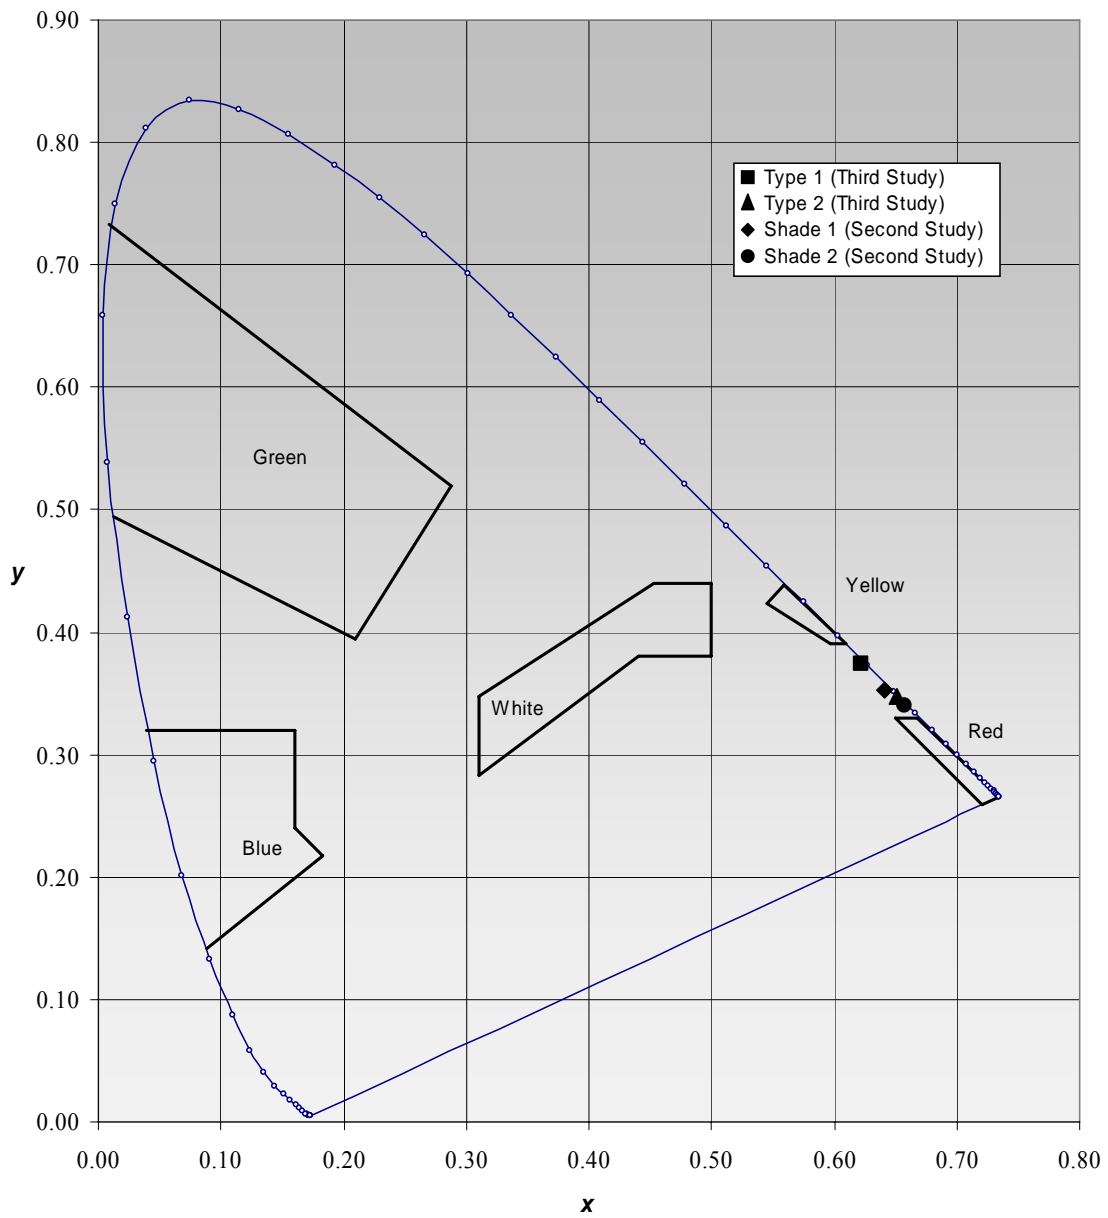
Figure 15. Chromaticity of Four Shades of Fluorescent Orange RRPMs.

In the second study, researchers determined that at night 90 percent of the subjects (all but one) correctly identified the color of the shade 1 fluorescent orange RRPMs. However, at night only 50 percent of the subjects correctly identified the color of the shade 2 fluorescent orange RRPMs. All incorrect responses (10 percent for shade 1 and 50 percent for shade 2) were red. These findings are not surprising since according to the color measurements the shade 2 fluorescent orange RRPMs were located closer to the red color region than the shade 1 fluorescent orange RRPMs.

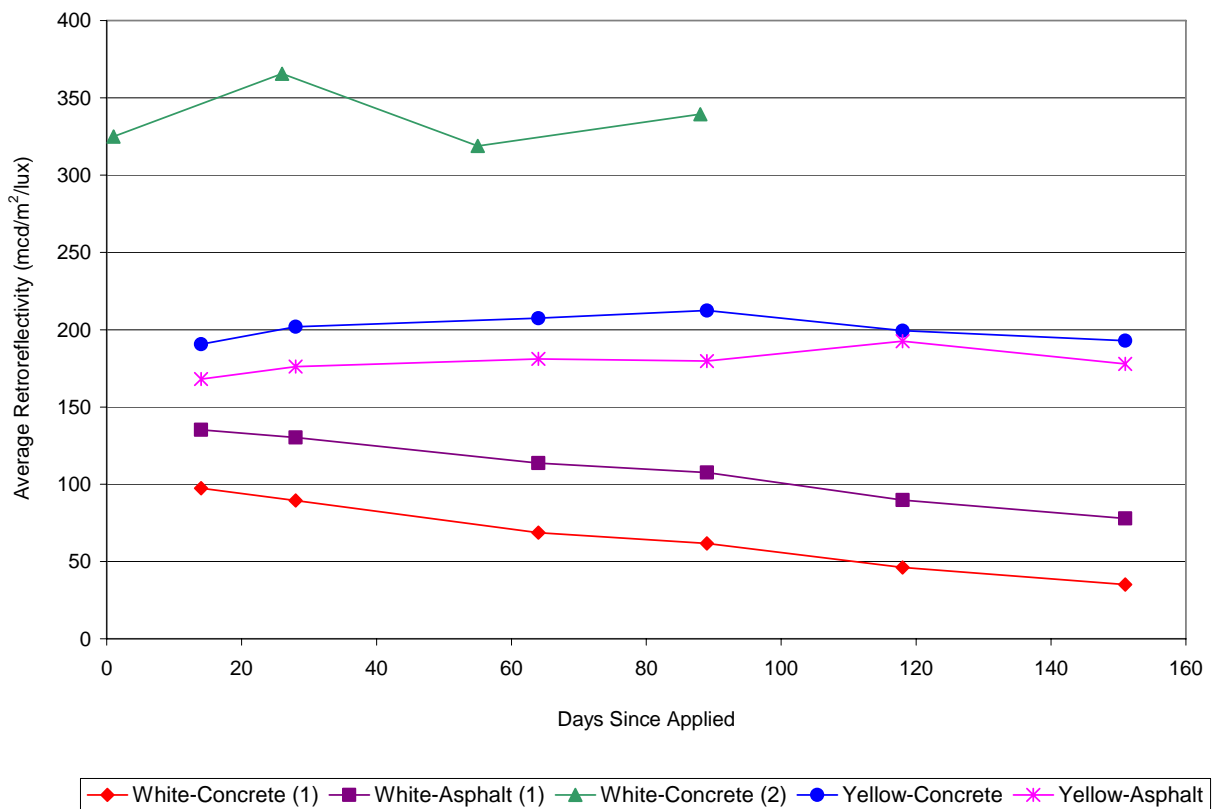
As seen in Figure 16, the retroreflectivity of the yellow “removable” paint remained relatively constant over the five month period (averaging 200 mcd/m²/lux on concrete and 180 mcd/m²/lux on asphalt). In contrast, the retroreflectivity of the white “removable” paint decreased steadily over the five month period (97 to 35 mcd/m²/lux on concrete and 168 to 78 mcd/m²/lux on asphalt). This degradation in the retroreflectivity of the white “removable” paint was discussed with the manufacturer and a second version of the white “removable” paint was provided to TTI. As shown in Figure 16, the second white “removable” paint had a higher initial retroreflectivity value (325 mcd/m²/lux) than the first white “removable” paint and maintained its retroreflectivity for approximately three months (averaging 337 mcd/m²/lux).

Figure 16. Retroreflectivity Results – Texas A&M University Riverside Campus.

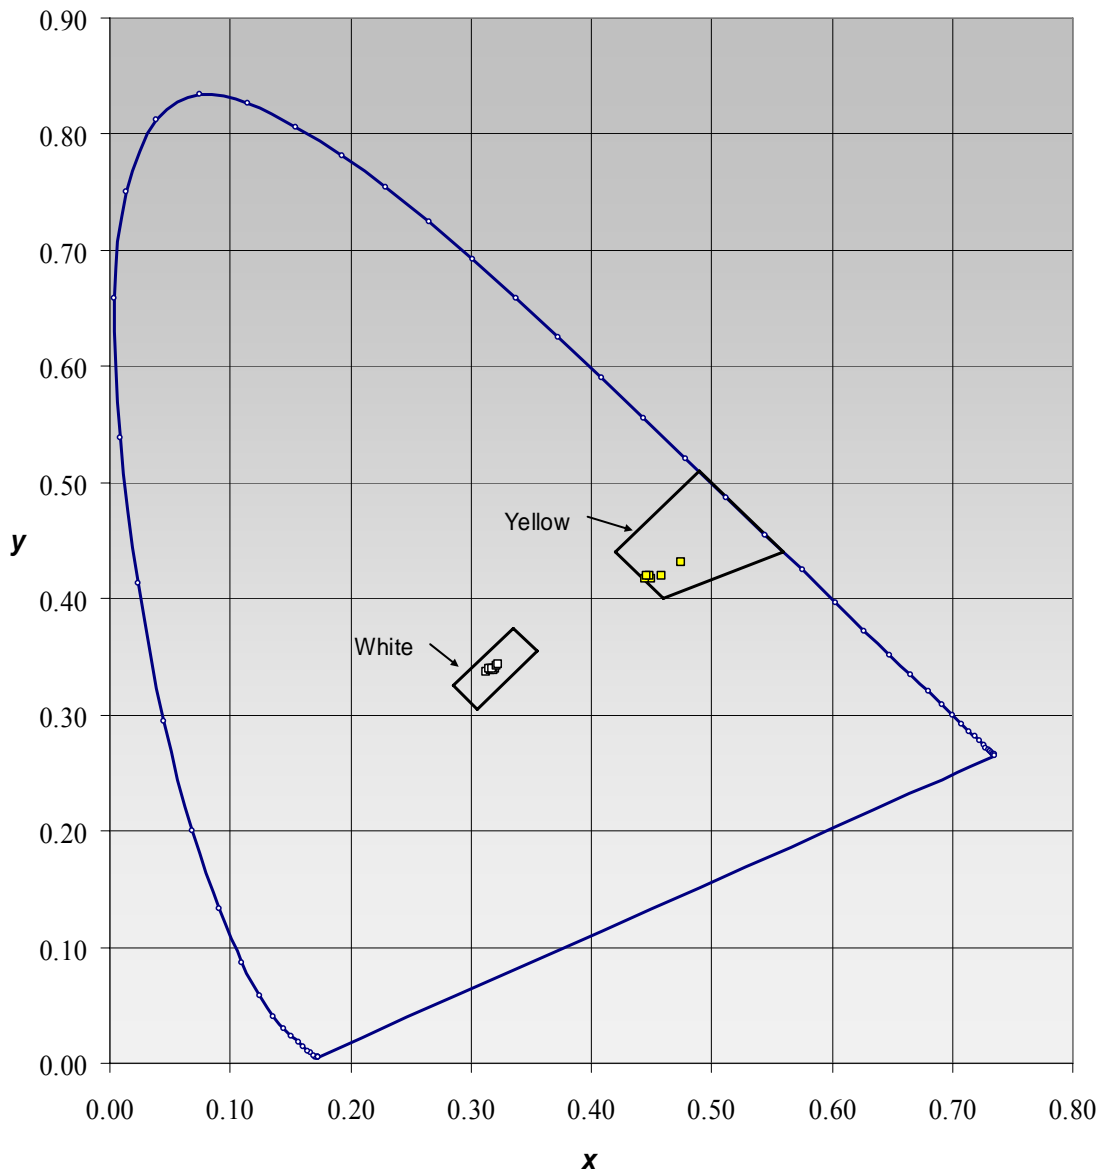
paint. The color of the white markings remained relatively constant over the five month period, remaining well inside the acceptable color region. The color of the yellow “removable” paint barely remained within the acceptable color region as it tended toward the white color region as time progressed.

Figure 17. Chromaticity Results – Texas A&M University Riverside Campus.

The chromaticity of both of the yellow samples shifted over time toward the white color region, with the color of the yellow sample without beads falling outside of the yellow color region after 1480 hours. These results are similar to the measurements taken at the Texas A&M Riverside campus over a five month period (Figure 17).

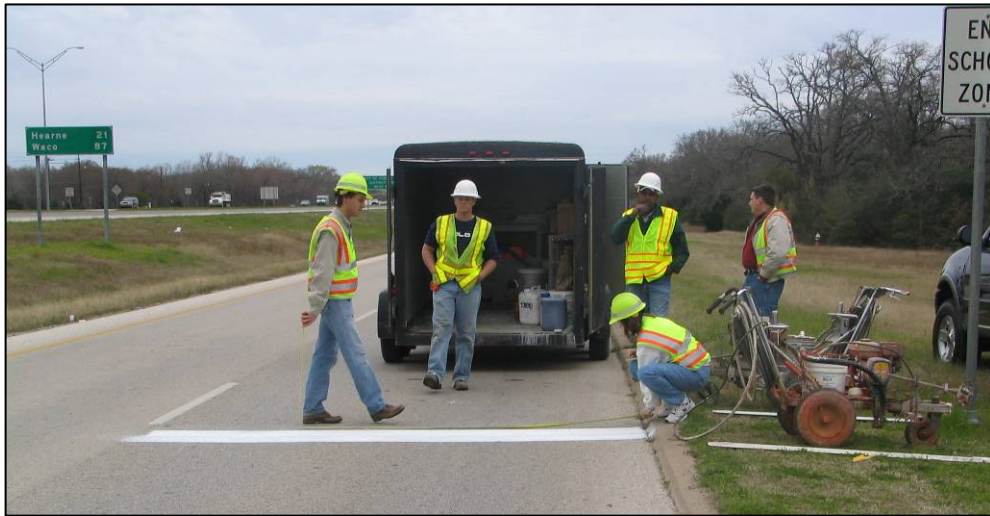
a) Stop Bar.

b) End School Zone.

Figure 18. Applications of "Removable" Paint on Frontage Road of State Highway 6.

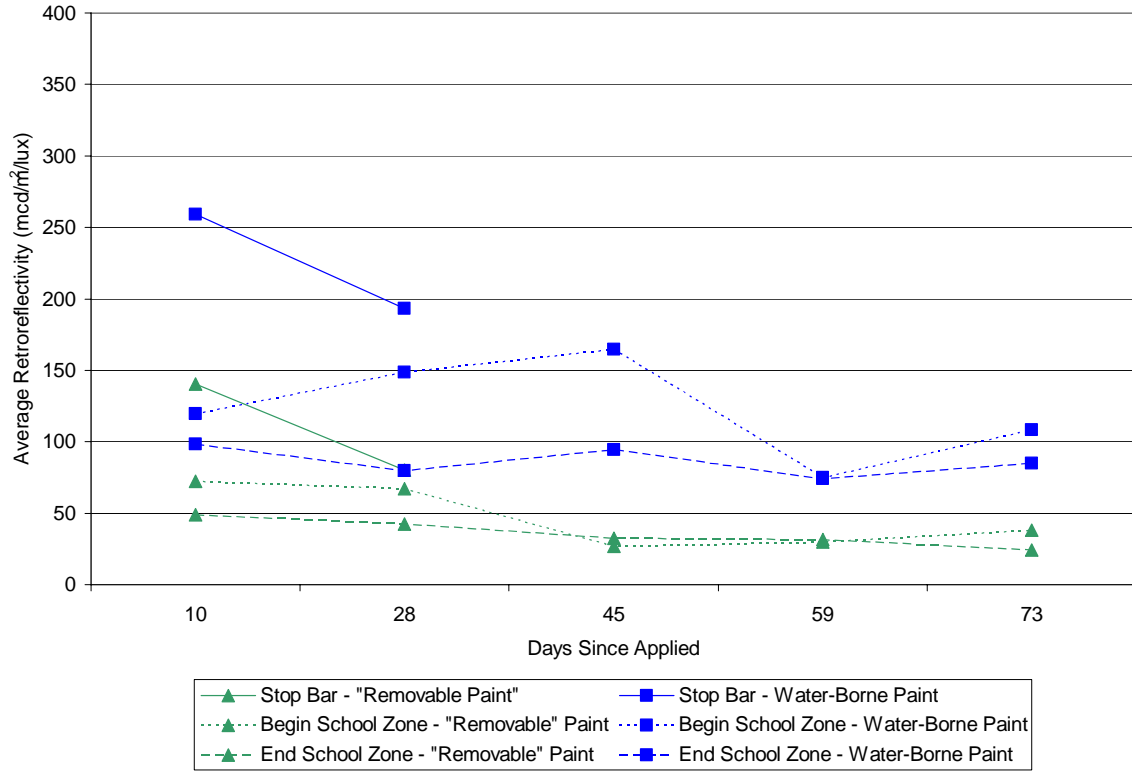
Figure 19 also shows the retroreflectivity data for the school zone markings. The retroreflectivity of the “removable” paint sections was always less than the retroreflectivity of the water-borne paint sections. In addition, for the school zone markings the retroreflectivity of the “removable” paint was never above 75 $\text{mcd/m}^2/\text{lux}$. However, researchers believe that this might have been a result of the field crew’s lack of experience applying this new product. Both products were applied with hand-operated applicators, but the second white “removable” paint was more viscous than typical water-borne paint, which the field crew usually applies with the hand-operated applicator. This resulted in a thicker than normal application of the “removable” paint at the stop bar location and a thinner than usual application of the “removable” paint at the school zone locations.

Figure 19. Retroreflectivity Results – State Highway 6 Frontage Road.

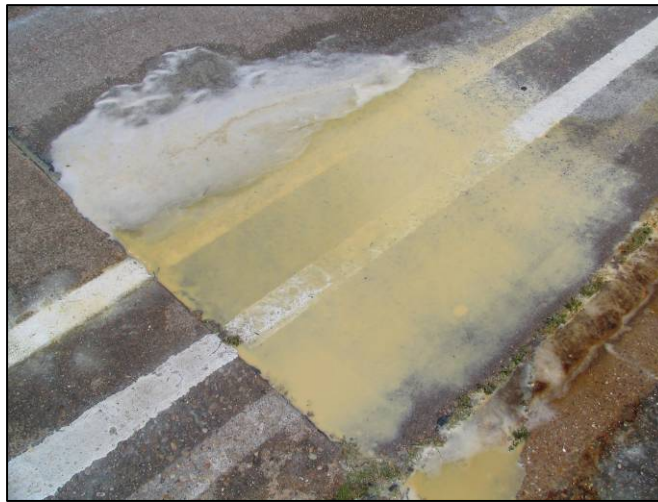
- After the liquid mixture dried on the pavement, researchers noticed that the paint residue was left behind on the surface. (Prior to drying the paint residue was suspended in the liquid mixture.) Based on limited testing of a new remover product received from the manufacturer, it appears that this issue has been corrected (i.e., the paint is now dissolved by the remover).

Figure 26. Liquid Mixture Remaining after Removal.

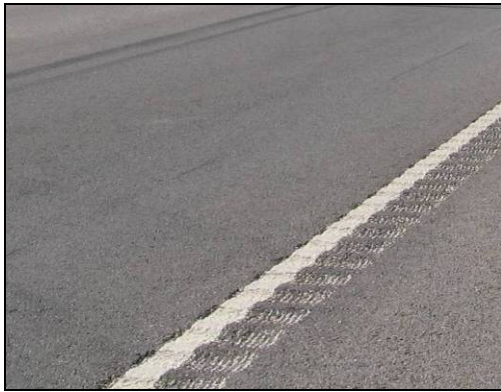
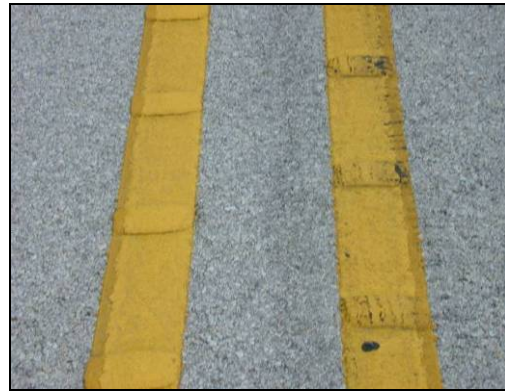
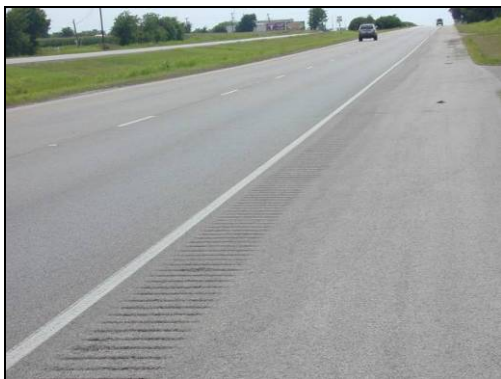
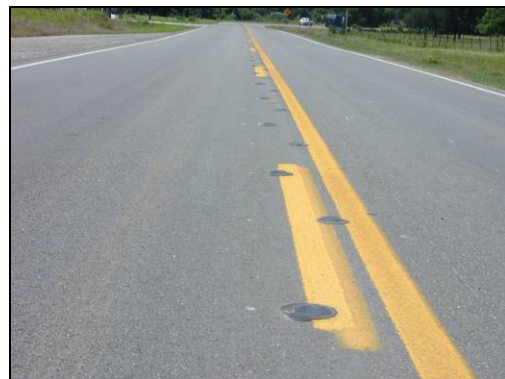
the milled strips (35). Metal forms are used to install what could be termed “rolled” rumble strips in new concrete.

a) Milled.

b) Raised (Profile).

c) Rolled.

d) Raised (Button).

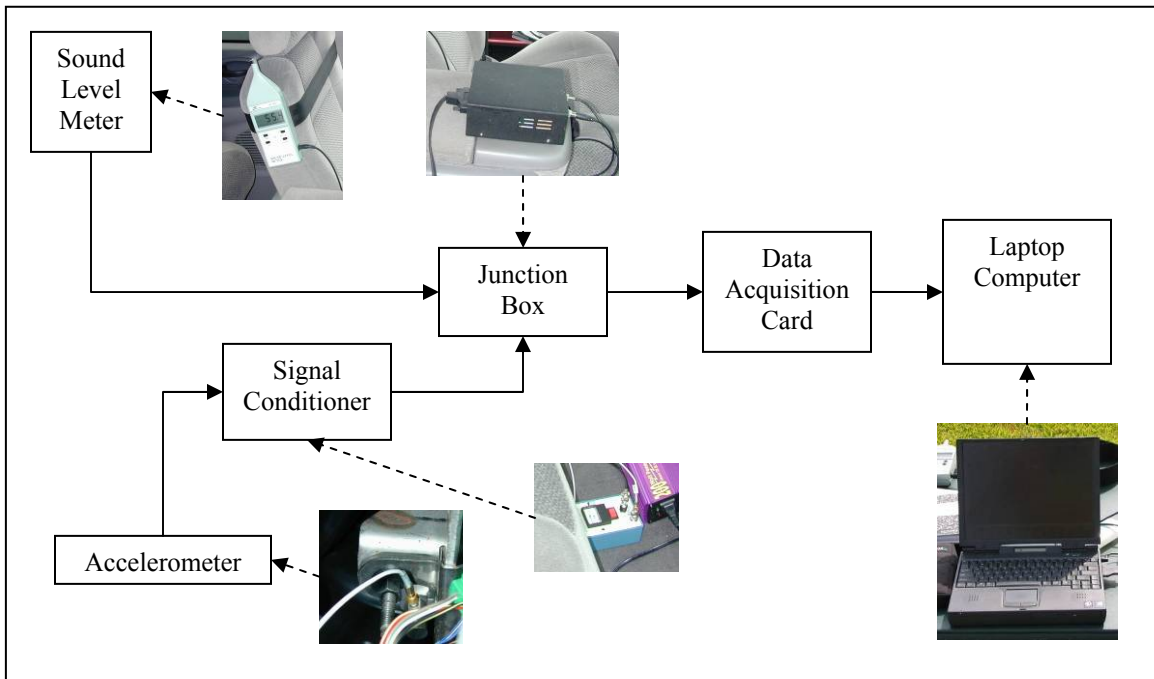
- collect sound and vibration data from inside vehicles, and
- collect sound data from outside vehicles.

Figure 31. Instrumentation Schematic.

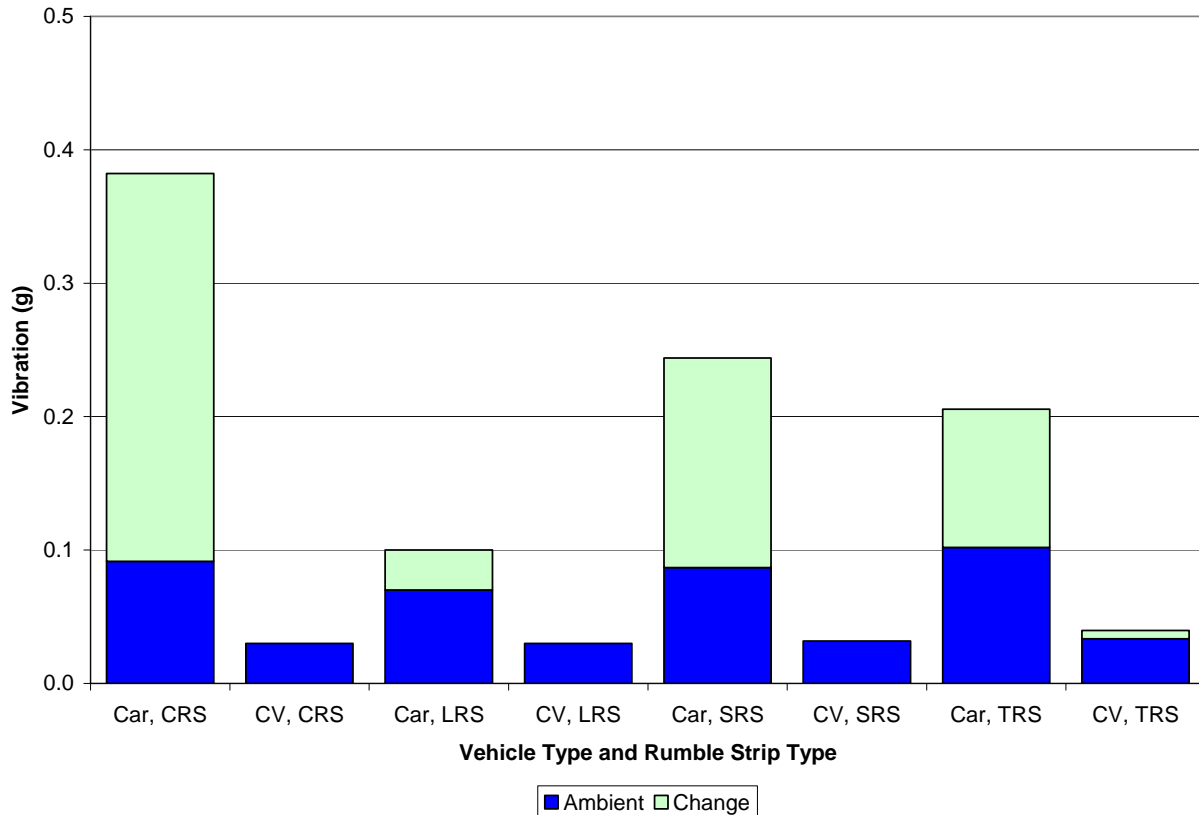
The ambient vibration and the change in vibration caused by crossing rumble strips are shown in [Figure 36](#). The sedan experienced greater ambient vibration and change in vibration than the commercial vehicle. For the sedan, the increase in vibration was between 0.03 g and 0.29 g (43 and 311 percent). The only observed change in vibration in the commercial vehicle occurred while it contacted TRSs, but the increase was only 0.006 g.

Figure 36. Change in Vibration inside Vehicle at 55 mph by Rumble Strip Type.

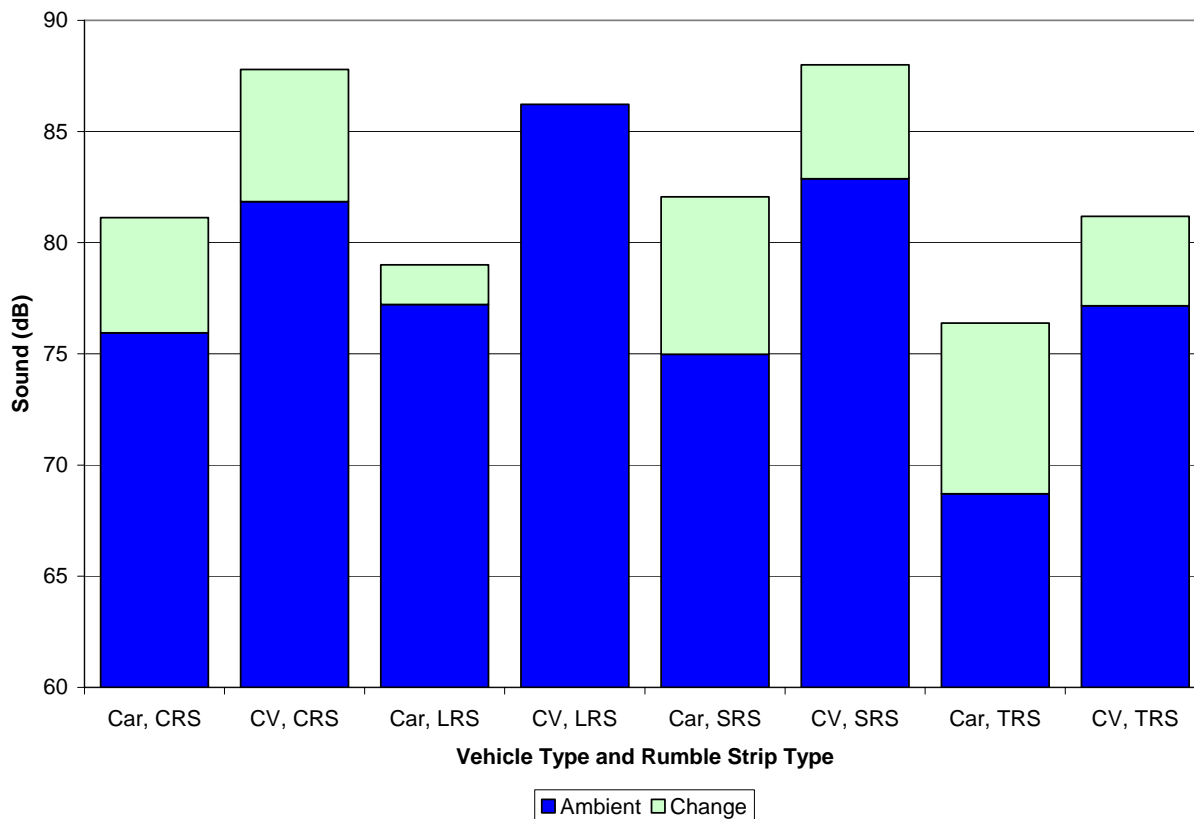
As shown in [Figure 37](#), the outside sound was louder than the inside sound, but the overall change was less. The ambient outside sound ranged from 69 to 86 dB, and the increase ranged from 2 to 8 dB. The highest reading (88 dB) occurred when the commercial vehicle contacted CRSs and SRSs. It should be noted that the change was -1 dB for the LRS when crossed by the commercial vehicle. It is believed that this was an anomalous finding resulting from the difficulty associated with trying to keep the commercial vehicle tires situated over the LRS which were only 4 inches wide. The issue of width is discussed later in this chapter in further detail.

Figure 37. Change in Sound outside Vehicle at 55 mph by Rumble Strip Type.

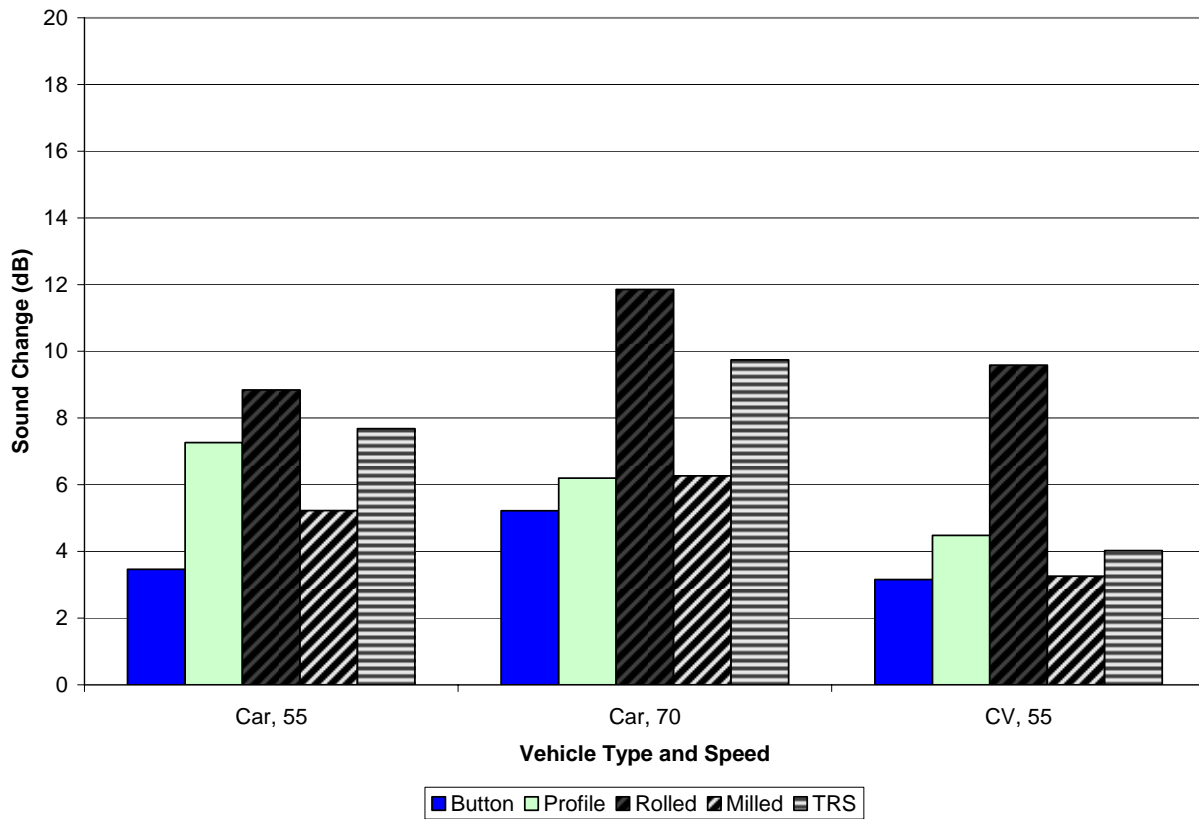
In [Figure 40](#), rolled rumble strips create the largest increase in outside sound (9 to 12 dB) resulting in outside sound levels between 84 and 91 dB. TRSs produced a 4 to 10 dB change in the outside sound, raising the outside sound between 76 and 81 dB. The other three applications preformed similarly (3 to 7 dB change generating 78 to 88 dB), with buttons typically yielding the lowest change across the applications, vehicles, and speeds. In general, the change in the outside sound was greater in the sedan than in the commercial vehicle and greater at higher speeds.

Figure 40. Change in Sound outside Vehicle by Rumble Strip Application.

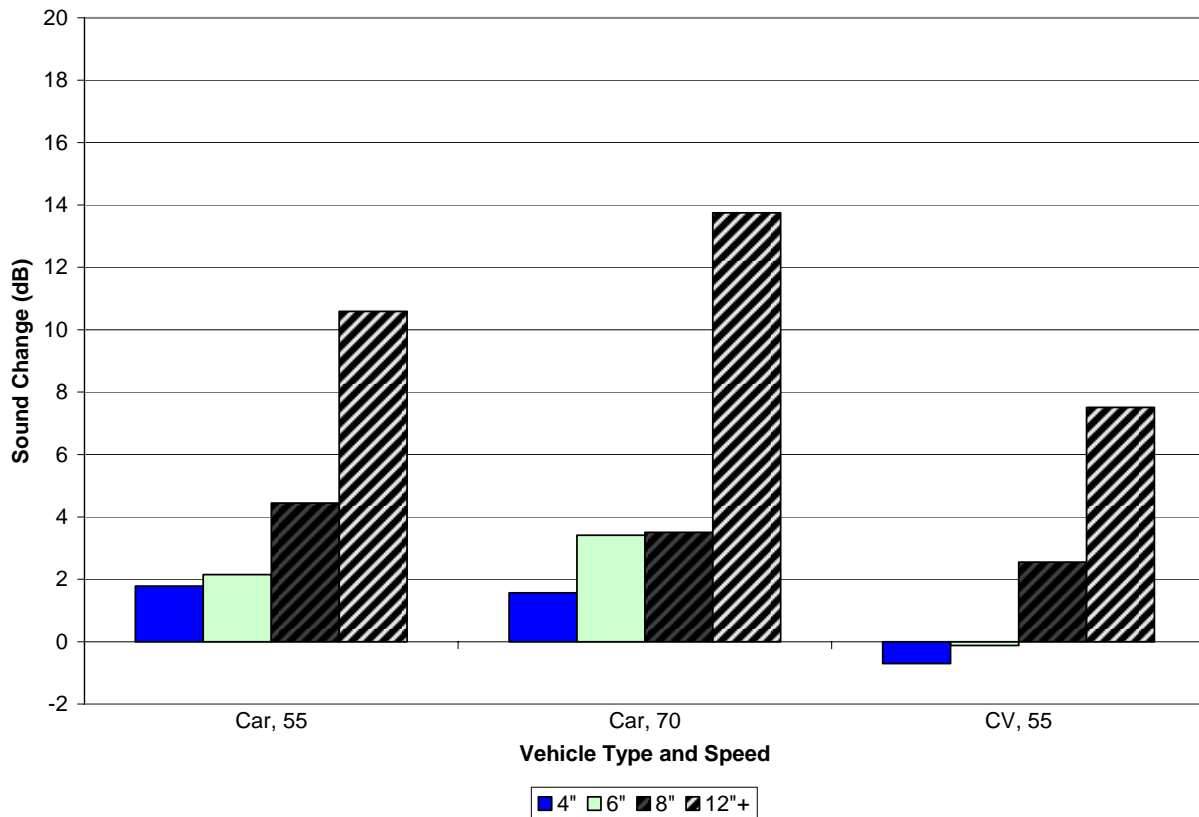
Figure 46. Change in Sound outside Vehicle for Milled by Width.
