16. Abstract As of December 2005 TxDOT has four perpetual pavement sections in service and another four under construction. Project 0-4822 was initiated to perform a structural assessment of these thick asphalt pavements, to identify strengths and weaknesses in the existing structures, and to provide guidance for future designs. This Year 1 report provides an evaluation of the existing sections. It is based on extensive nondestructive testing with Ground Penetrating Radar (GPR), Falling Weight Deflectometers (FWD), field coring, and limited laboratory testing. On a positive note, the stone-filled mixes used in these structures are considerably stiffer than the dense graded mixes traditionally used in Texas. Design moduli values of 750 ksi and 1000 ksi are recommended for future designs with the Stone Matrix Asphalt (SMA) and 1-inch stone-filled (SF) layers. However, three major problems were identified. Firstly, the 1-inch stone-filled layers are prone to vertical segregation. Several of the sections were found to have severe honeycombing at the bottom of the lifts. These mixes are excessively coarse with low asphalt binder contents around 4 percent. Mix design procedures must be m

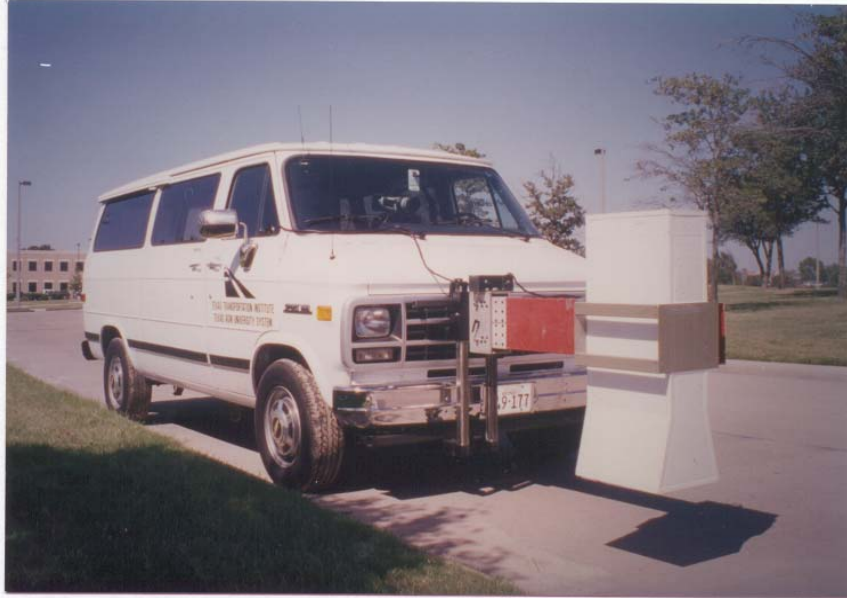
Figure 2. GPR Equipment and Principles of Operation.

The Texas Transportation Institute’s (TTI’s) 1-Gigahertz (1-GHz) air-launched Ground Penetrating Radar unit is shown in [Figure 2](#). This system sends discrete pulses of radar energy into the pavement system and captures the reflections from each layer interface within the structure. Radar is an electromagnetic wave and, therefore, obeys the laws governing reflection and transmission of e-m waves in layered media. This particular GPR unit can operate at highway speeds (70 mph), transmit and receive 50 pulses per second, and can effectively penetrate to a depth of 2 feet. A typical plot of captured reflected energy versus time for one pulse is shown in [Figure 2\(b\)](#), as a graph of volts versus arrival time in nanoseconds.

The reflection A_1 is the energy reflected from the surface of the pavement, and A_2 and A_3 are reflections from the top of the base and subgrade respectively. These are all classified as positive reflections, which indicate an interface with a transition from a low to a higher dielectric material. As documented elsewhere, these amplitudes of reflection and the time delays between reflections are used to calculate both layer dielectrics and thickness ([3](#)). The dielectric constant of a material is an electrical property that is most influenced by moisture content and density. An increase in moisture will cause an increase in layer dielectric; in contrast an increase in air void content will cause a decrease in layer dielectric.

(a) TTI GPR Equipment

(b) Principles of GPR. The incident wave is reflected at each layer interface and plotted as return voltage against time of arrival in nanoseconds.

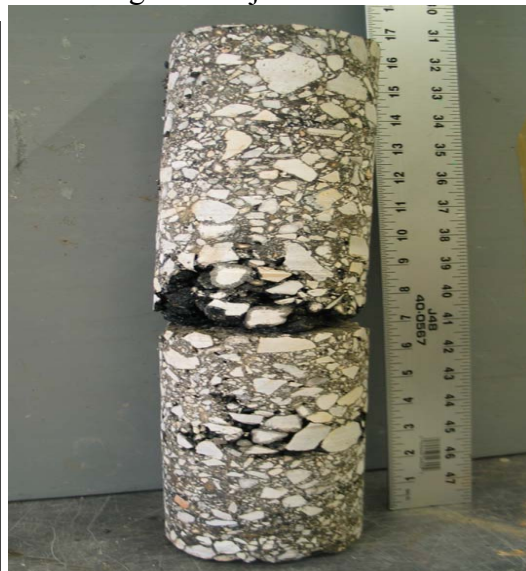
Figure 7. GPR Data from a Perpetual Pavement on IH 35 in New Braunfels.

a) Blue marks indicate location of longitudinal joints

b) Trapped water

c) Resulting core

Note: These data were collected over longitudinal joints. The markers in the upper figure are when the GPR unit passed over a joint. The core was taken close to a longitudinal joint. The red areas in the middle of the layers indicate trapped moisture.

[Figure 7](#) shows a different section of the perpetual pavement being constructed in New Braunfels. These data were collected to evaluate the longitudinal joints in this section. The vertical lines in [Figure 7\(a\)](#) indicate areas when the GPR unit was directly over a longitudinal joint. The trace shown in [Figure 7\(b\)](#) shows an area with a strong positive reflection about 9 inches below the surface. The core from this location is shown in [Figure 7\(c\)](#); the top 12 to 13 inches are the three SF layers, and the lower lift is the rich bottom layer. The core shows major honeycombing at the interface about 9 inches down, plus more compaction problems at the bottom of the lower layer of SF. From the core, it appears that the 1-inch SF layer has segregated vertically with many of the large aggregates moving to the bottom of the lift.

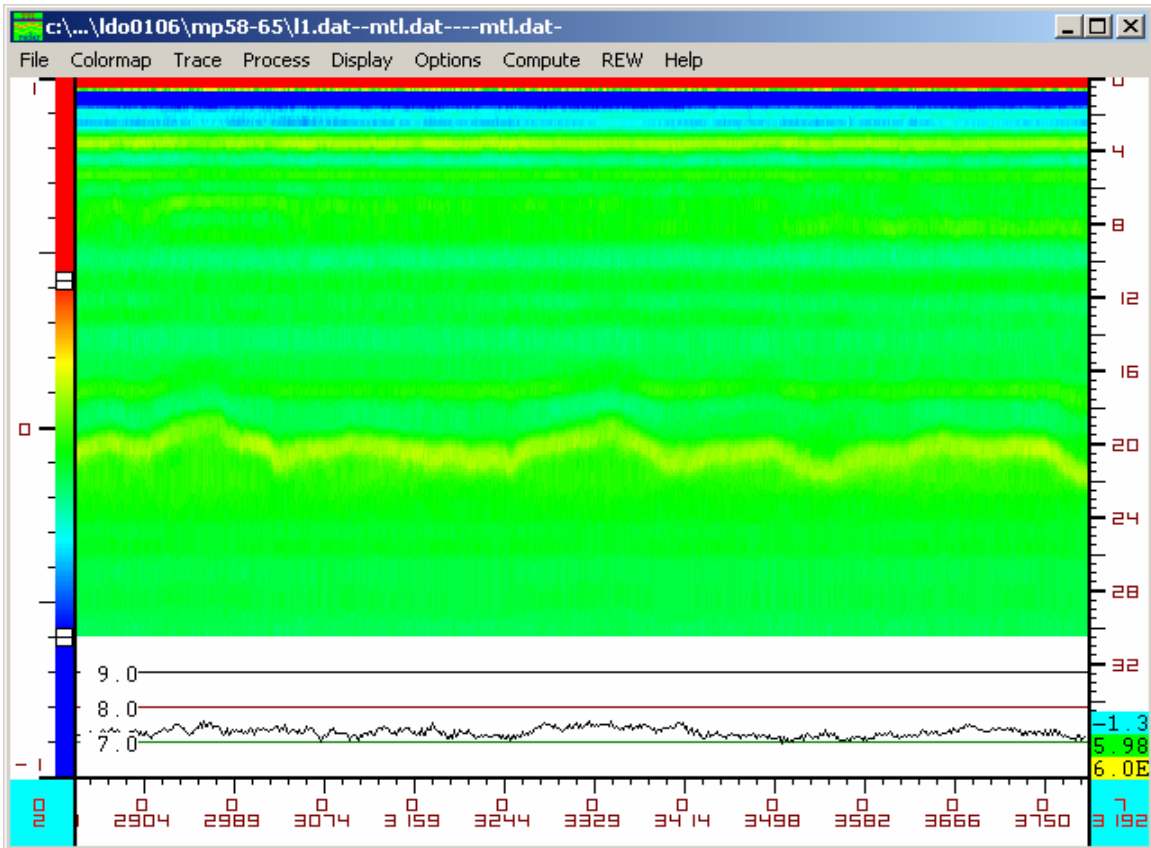
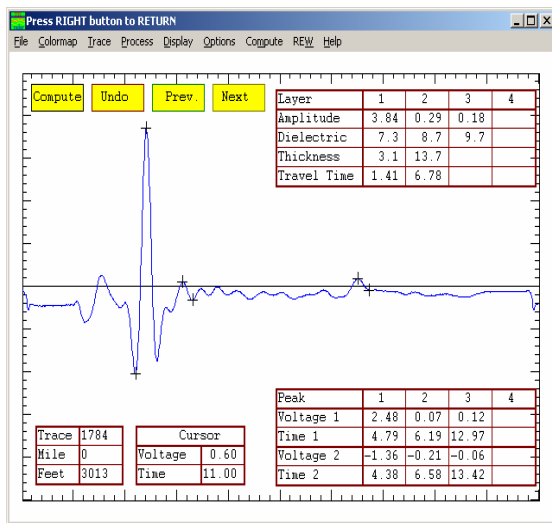
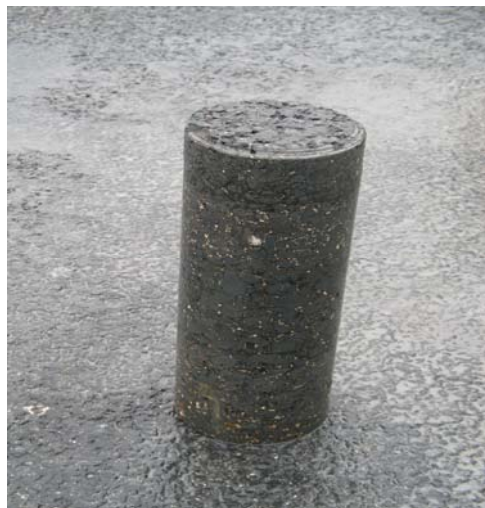
Figure 8. GPR Data from Gilbert Job (CSJ 0018-01-063) in the Laredo District.

a) Ideal GPR data

b) No defects

c) Solid core

Note: GPR data judged as good, few subsurface defects, solid core.

[Figure 8](#) shows GPR data from IH 35 (CSJ 0018-01063, Gilbert) in the Laredo District. The project was complete at the time of testing and performing very well. The GPR data from this projects looks to be ideal. This project appears to be one of the best sections in Texas. The GPR testing did not locate any subsurface defects. No strong reflections from any intermediate layer interfaces were found. The cores from the pavement were solid. This was the only section cored where the layers bonded together. In every other pavement cored, the asphalt layers debonded at one or two locations.

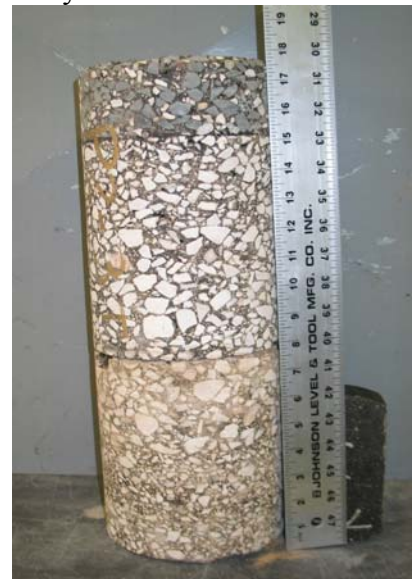
Figure 9. GPR Data from the First Mile of the Zumwalt 1 Project in the Laredo District (CSJ 0017-08-067).

a) Strong negative reflection (blue) at approximately 12 inches below surface

b) Negative peak at middle of 1 inch SF

c) De-bonding in core

Note: The only subsurface reflection from this area is a strong blue reflection at approximately 12 inches below the surface. All cores debonded in the middle of the 1-inch SF layer.

[Figure 9](#) shows data from another perpetual pavement in the Laredo District (CSJ 0017-08-067); this is known as the Zumwalt 1 job. These data are from the first 1 mile of the project. The only potential defect in the GPR data is shown in [Figure 9\(b\)](#) as a negative reflection about mid depth in the asphalt layer. The indication here is that the bottom of the second lift of 1-inch SF has compaction problems. Also, it is noted that all of the cores taken from this location were debonded in the middle of the 1-inch SF layer.

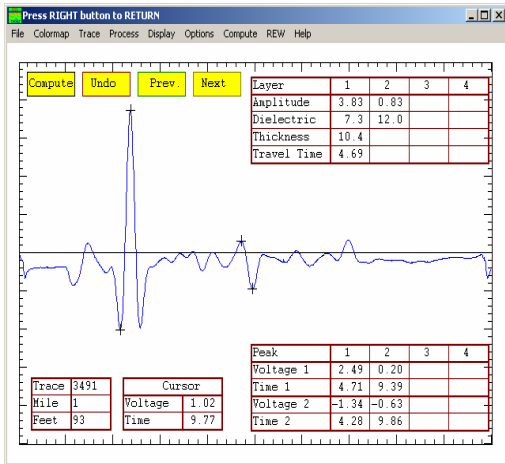
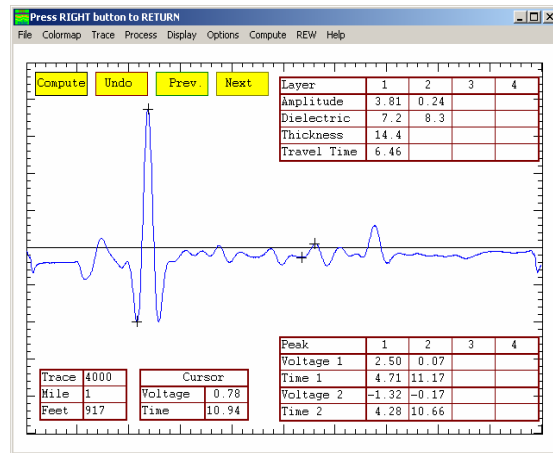
Figure 10. GPR Data from the Transition Section on the Zumwalt 1 Job.

a) GPR data from transition area

b) Low density at bottom of layer

c) No major problems after transition

Note: A change in the type of breakdown roller was initiated 1 mile from the start of the project. The steel wheel was used initially; after 1 mile, this was replaced with a pneumatic roller. The GPR indicates a change in compaction levels after 1 mile. The pneumatic compactor appears to produce more uniformly compacted material.

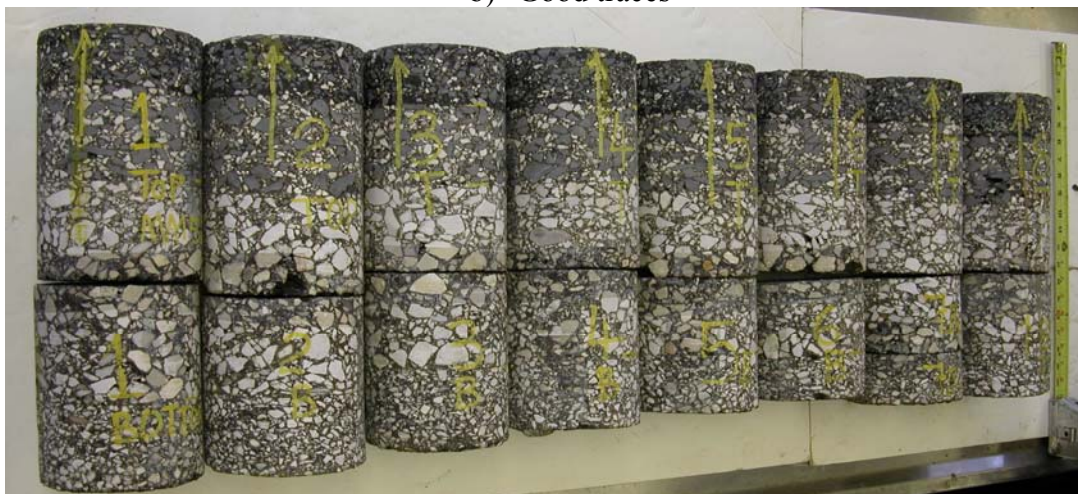
Figure 11. GPR Results and Cores from the Zumwalt 2 Job (CSJ 0018-02-049) in the Laredo District.

a) No major defects

b) Good traces

c) De-bonding of cores

Note: The only defect is the debonding in the middle of the 1-inch SF layer.

[Figure 11](#) shows GPR data and field cores from the most recently completed project in Laredo, CSJ 0018-02-049 (Zumwalt 2). The GPR images from this section are very clean as

shown in [Figure 11\(b\)](#), and no major reflections are noted in the middle of the mat. The cores taken from this section all appear to be in good condition. The only defect in the cores is debonding in the middle of the 1-inch SF; every core broke at the same location.

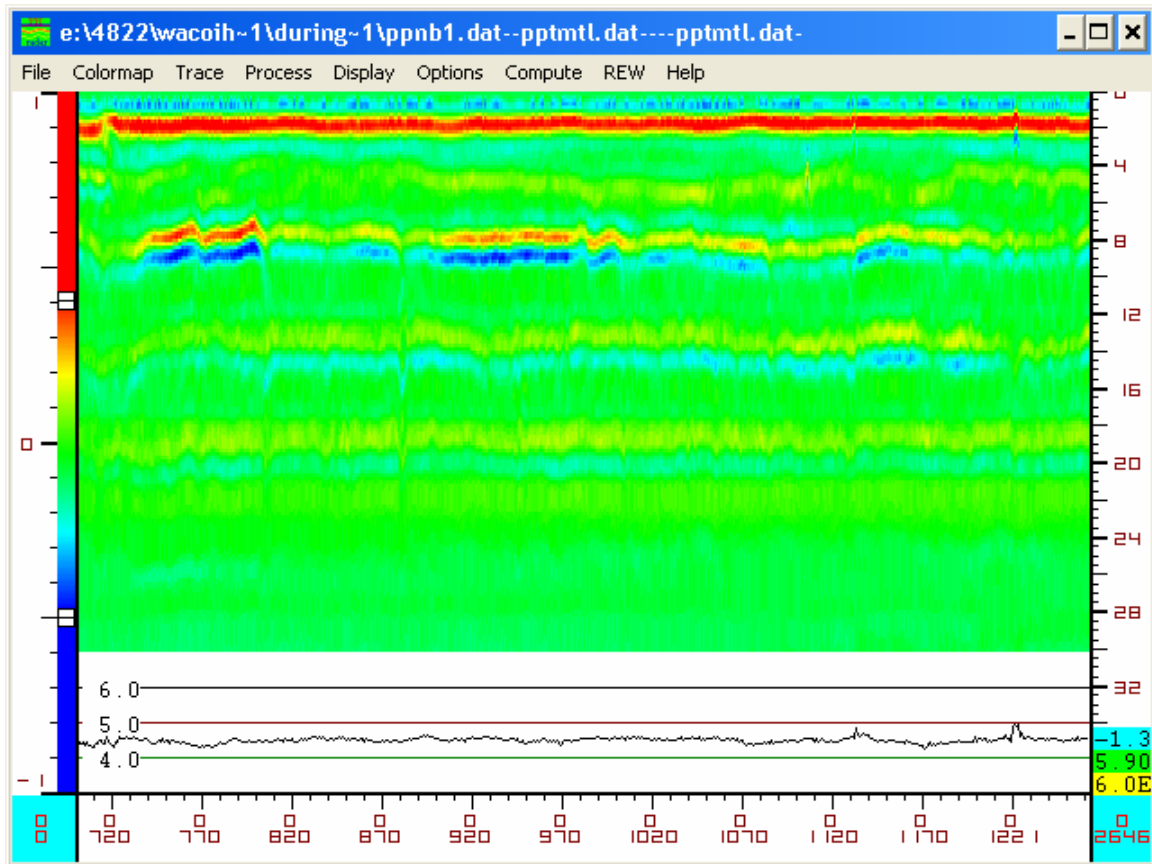
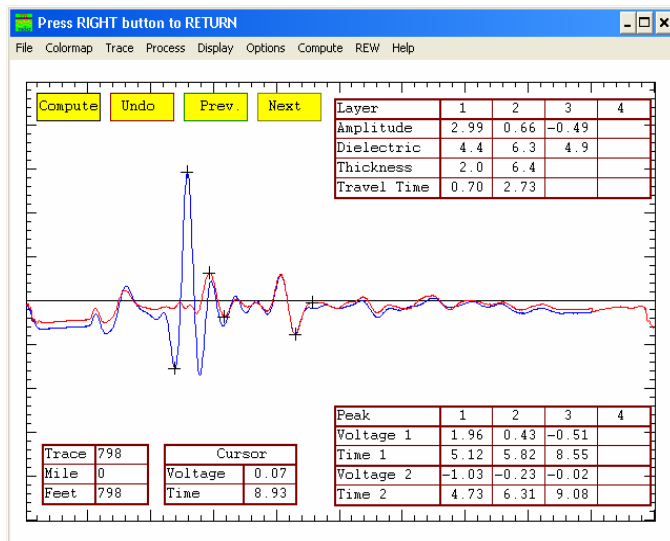
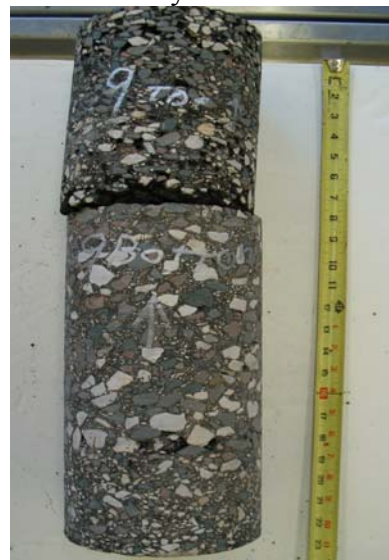
Figure 12. GPR Results and a Core from the IH 35 Job in Waco.

a) Defect 8 inches down at bottom of 3/4-inch SF layer

b) GPR trace from defect location

c) Core from defect location

Note: At this location poor compaction was observed at the bottom of the 3/4-inch SF layer. The core also debonded.

[Figure 12](#) shows data from the existing perpetual pavement in Waco (CSJ 0015-01-164). In general, the GPR data and the field cores showed a similar trend to that observed in San Antonio and Fort Worth. However in Waco, some of the compaction problems were found in cores taken from both the $\frac{3}{4}$ -inch and 1-inch SF layers. The GPR data shown in [Figure 12](#) indicates that at this location the compaction problem is at the bottom of the $\frac{3}{4}$ -inch SF layer; this was confirmed in the core shown in [Figure 12\(c\)](#).

The upper figure shows the COLORMAP display for this section. The one difference with this structure is that there is a solid red line at a depth of 2 inches below the surface. This, however, is the only section with a porous friction course as the surface layer. The red line is an indication of a change from a lower dielectric to a higher dielectric, which would signify the transition from the PFC with a designed air void content of 18 percent to a more dense SMA layer. If the reflection at this interface increases markedly, that would indicate an area of trapped moisture. The red/blue interface at a depth of approximately 8 inches is a cause for concern; this is a location with high air voids and some trapped moisture.

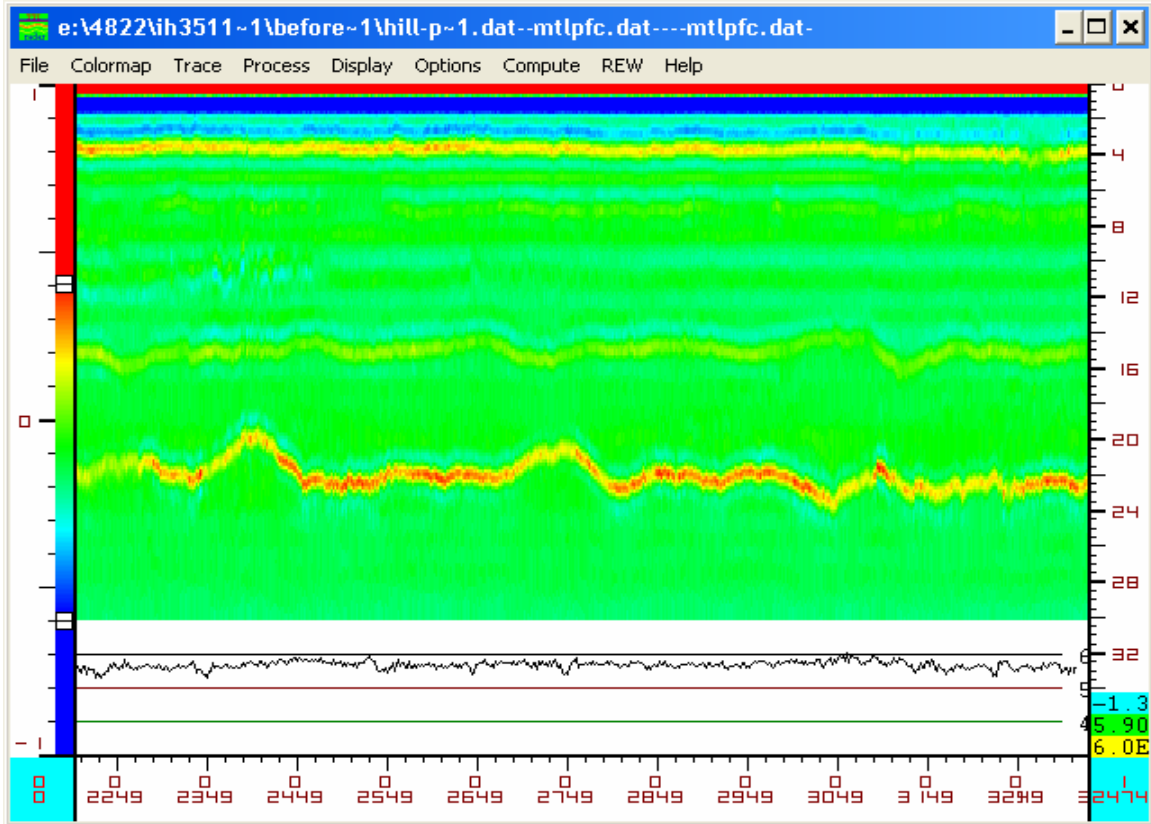
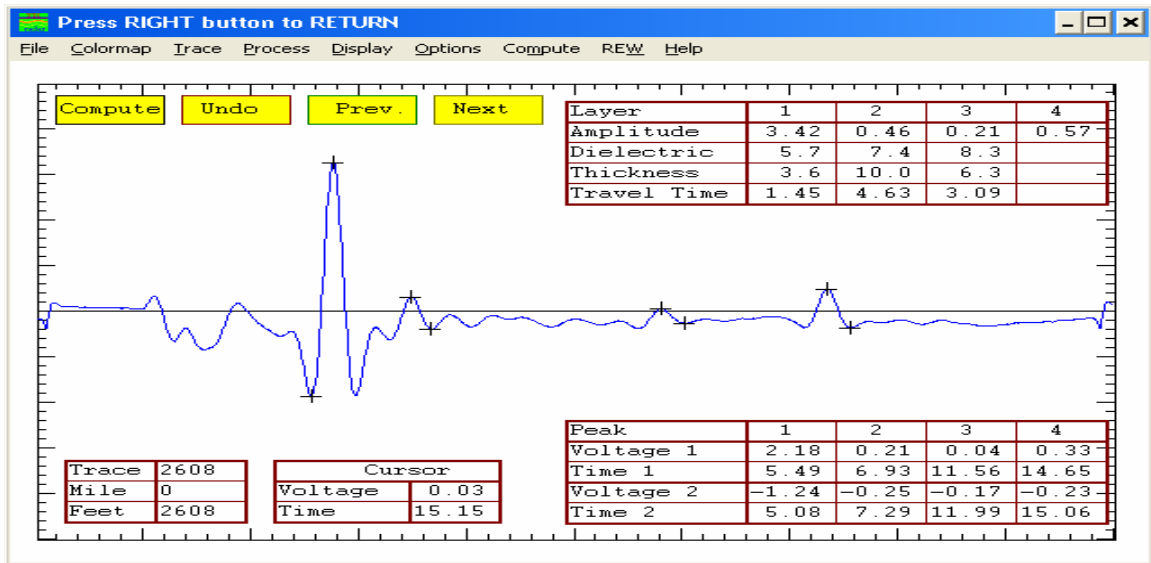
Figure 13. GPR Data Collected on the Hillsboro Perpetual Pavement during Construction.

a) Ideal data with no obvious defects

b) Ideal traces

Note: GPR data collected during prolonged dry spell. Data collected on top of the 1-inch SF layer. No defects apparent in this mat.

[Figures 13](#) and [14](#) show data from the new section of IH 35 in the Waco District just north of Hillsboro. This section is currently (as of January 2006) under construction, and these data were collected on top of the 1-inch SF layer. [Figure 13](#) was collected during a prolonged dry spell, and [Figure 14](#) was collected on the same project 2 days after heavy rainfall. Both the before and after rainfall data look very good. Unlike the other sections, there is no evidence of moisture entering this structure. The strong reflection 20 to 24 inches below the surface is the reflection from the top of the lime-treated subgrade layer. The fainter reflection 14 to 16 inches down is from the top of the flexible base, which is part of the foundation layer.

The data from this section are encouraging when compared with the earlier Waco project and the sections in San Antonio and Fort Worth. The one important difference with this project is that the contractor opted to change the lift thickness for the 1-inch SF from 4 to 3 inches. No special handling of the mix was used. The material was dumped directly into the paver hopper.

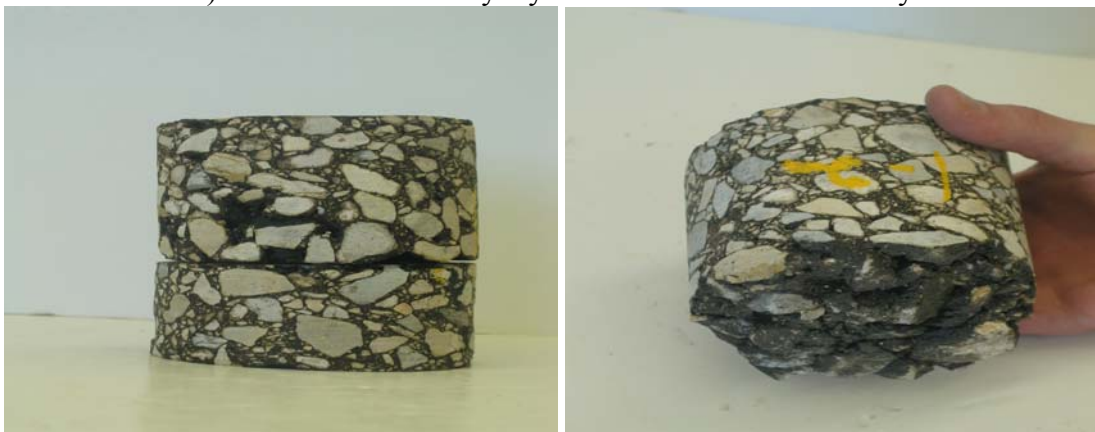
a) Raw data - periodic reflections from layer interfaces

b) Indicates low density layer at bottom of 1-inch SF layer

c) Cores from defect area

Figure 15. GPR Results and Cores from the SH 114 Project in Fort Worth.
 Note: Compaction problems found at bottom of 1-inch SF layers. The 1-inch SF layer segregated vertically with large aggregates migrating to the bottom of the lift.

The GPR data shown in Figures 15 (a) and (b) and the field cores show that vertical segregation was occurring especially in the lower layer of the 1-inch SF. This is somewhat problematic as this layer is sitting on a dense-graded rich bottom layer; any moisture entering these layers will tend to become trapped on top of the RBL layer. This was confirmed by permeability testing conducted on the core shown in Figure 15(c); the 1-inch SF layer and RBL combination were found to be impermeable in the test of the combined layers. However, the core was broken apart, and the test was repeated on the individual cores. This time the RBL was found to be impermeable, but the 1-inch SF layer was very porous with a measure permeability of 1.1-inch/sec, indicative of a very open mix.

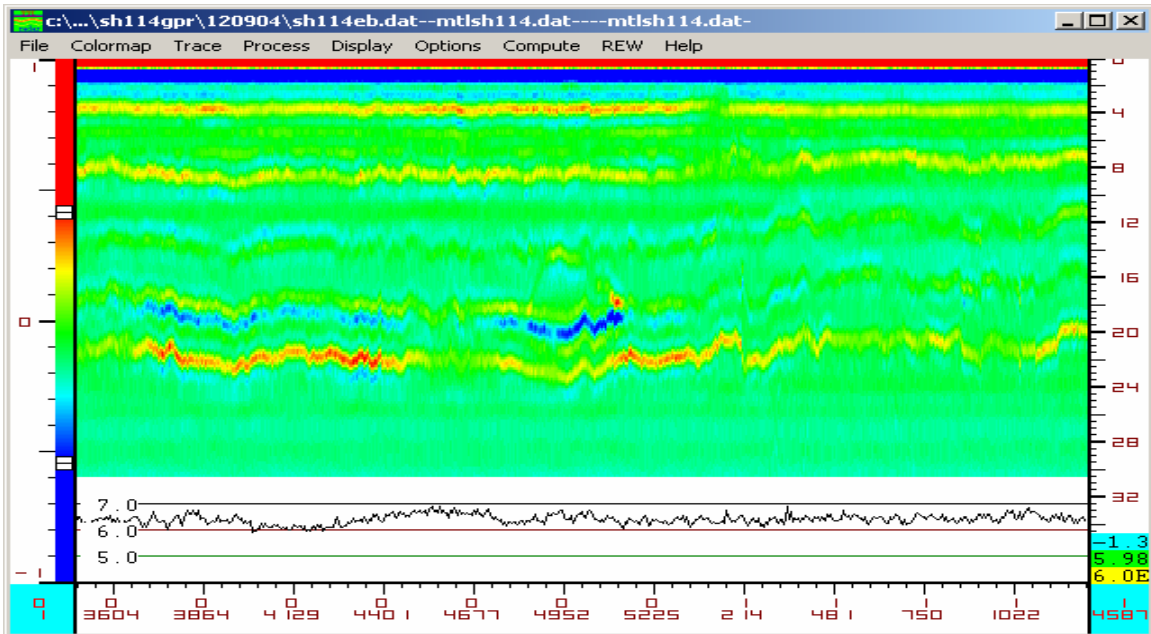
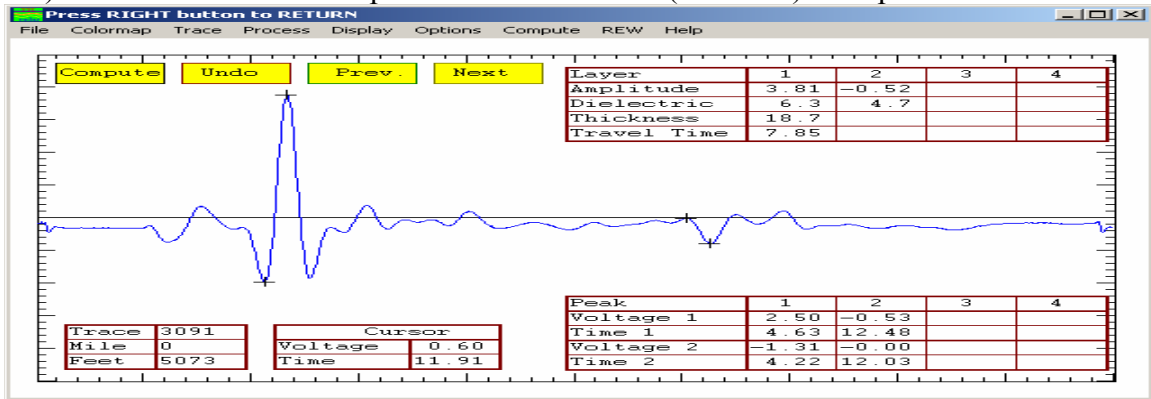
Figure 16. GPR Data from SH 114 Collected after the Edge Drains Were Installed.

a) Raw data before 1 mile placed in cold weather (Jan 2003) after paved in warm weather

b) Cold weather trace

c) Warm weather trace

constructed in the colder months of early 2004, and the remainder of the project (right side of [Figure 16](#)) was constructed in the May/June periods with temperatures in the 70- to 80-°F range. The data shown in the COLORMAP display has some interesting features. The strong blue reflection at a depth of 16 inches in the first half of the figure indicates an area of low density, but no significant moisture. Prior to placement of the edge drains, a strong red reflection was observed at this location indicating the presence of moisture.

The data to the right of the transition, which was placed in warmer temperatures, generally do not show any significant defects. Therefore, temperature at the time of placement has a big impact on the compactability of these SF layers.

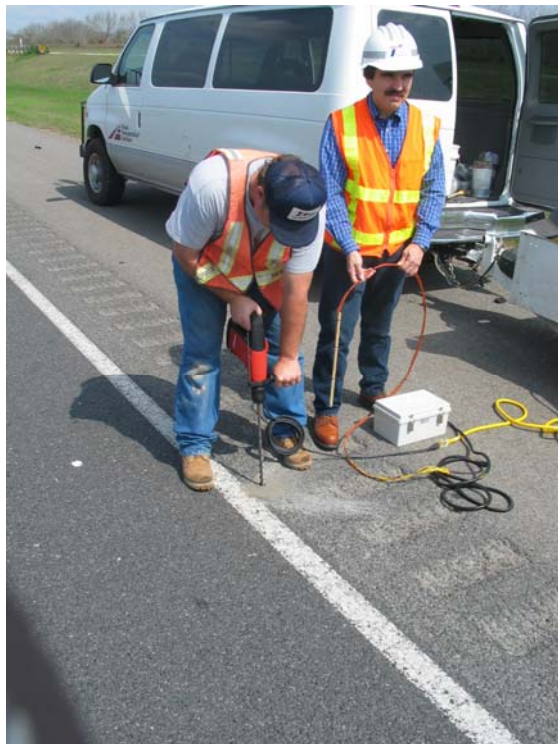
Figure 17. Temperature Probe Installation.

One concern about this system is measuring the temperature of the mat at the time of testing. Traditionally, TxDOT data collectors drill holes to a depth of 2 inches. With these perpetual pavements, some with 20 inches of asphalt, a more complete temperature profile is required. For that, a thermocouple string shown in [Figure 17](#) was developed. A string of six thermocouples is mounted at a 3-inch spacing on a wooden dowel. This is fitted inside a hole drilled through the entire asphalt layer. Temperature data with depth are collected regularly throughout the FWD data collection.

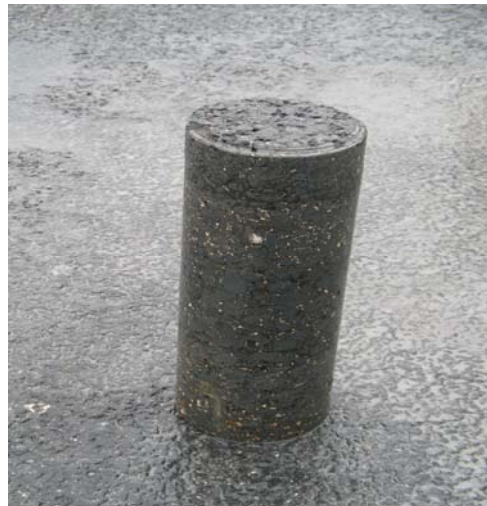
Figure 18. Intact Cores from the Gilbert Project in Laredo.

Some of the best cores taken on the perpetual pavements in Texas were taken from the Gilbert job in the Laredo District. Of the six sections cored, this is the only project where intact cores were removed. A typical example of a 6-inch core is shown in [Figure 18](#). This issue was discussed with the Laredo District staff, and they commented that the contractor did a good job at applying a 100 percent coverage tack between all lifts.

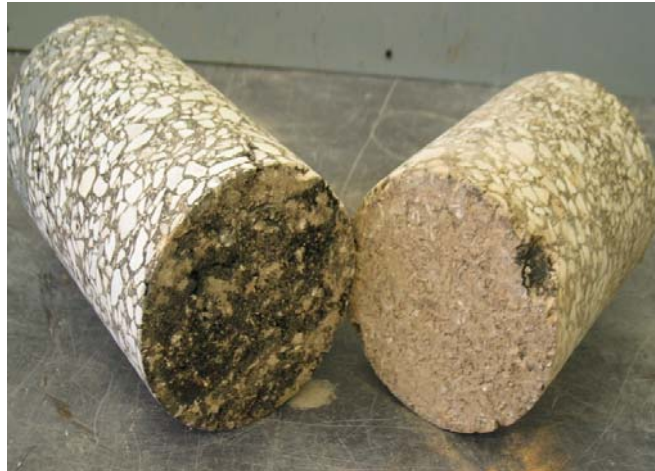
Figure 19. Debonded Core from the Zumwalt 1 Job in Laredo.

In all other projects, the cores debonded at one or two locations. An example of a debonded core is shown in [Figure 19](#); this is from the Zumwalt 1 project in Laredo. The debonding was not the result of the coring process as often the interfaces were dirty and did not show any indication of tack coat. This is a major structural concern. All of the mechanistic design procedures work on the premise that the asphalt layers are bonded together and that the traffic loads will bend the composite beam of asphaltic materials and induce tensile strains at the bottom of the RBL layer, which was specifically designed to accommodate tensile strains without initiating fatigue cracking. Having debonded layers within the HMA structure will

defeat the purpose of the RBL as the fatigue cracking will initiate at the debonded interface, and the higher the debonding occurs in the pavement structure, the more severe the consequence will be on the pavement's fatigue life.

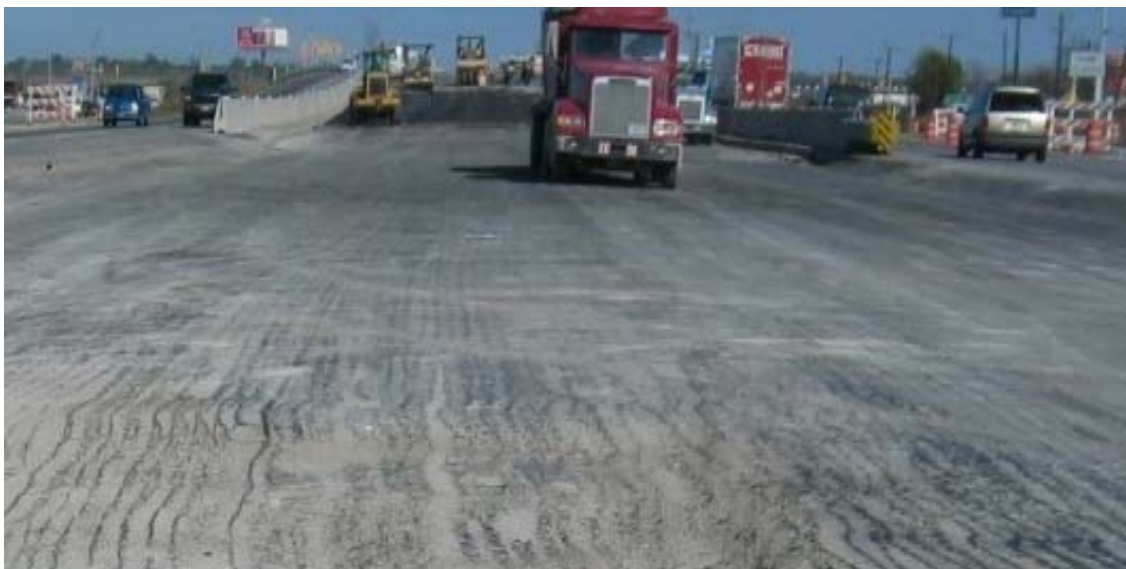
Figure 20. Inadequate Tack Coat on a Perpetual Pavement.

TxDOT needs to enforce its tack coat requirements on these perpetual pavements. In some instances, the tack coat is applied in “streaks” as shown below in [Figure 20](#). In other instances, it is not applied as several districts are of the opinion that if the asphalt layers are placed one on top of another during construction, then tack coat is not required. The coring results from this study indicate that some layers in the existing perpetual pavements are not effectively bonded together. This is a major structural concern.

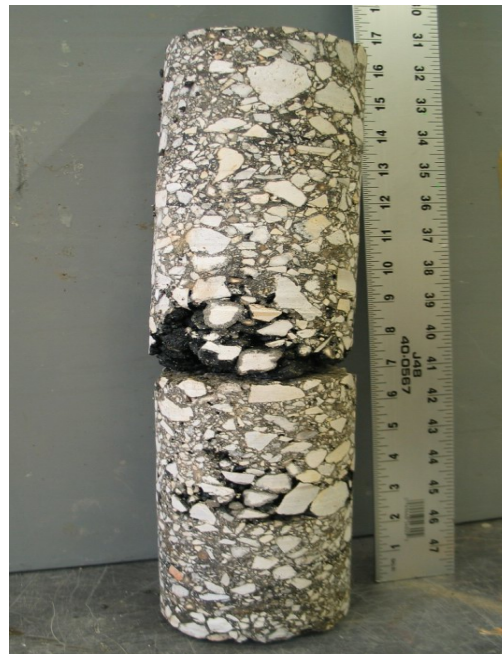
Figure 21. Severe Vertical Segregation in SF Layers.

The major concern raised during the GPR testing and the subsequent field coring is the problems detected with compacting the 1-inch SF layers. The SF layers are typically placed in 4-inch lifts; it appears that in many instances the mix segregates very badly in the vertical direction, and the bottom 1 inch of the mat is honeycombed. The severe example of this is the cores taken from the “old-mix” on the San Antonio project, as shown in [Figure 21](#). One concern is that this may go undetected with traditional density measuring systems as the top 2 to 3 inches of the lift appears to be well-compacted.

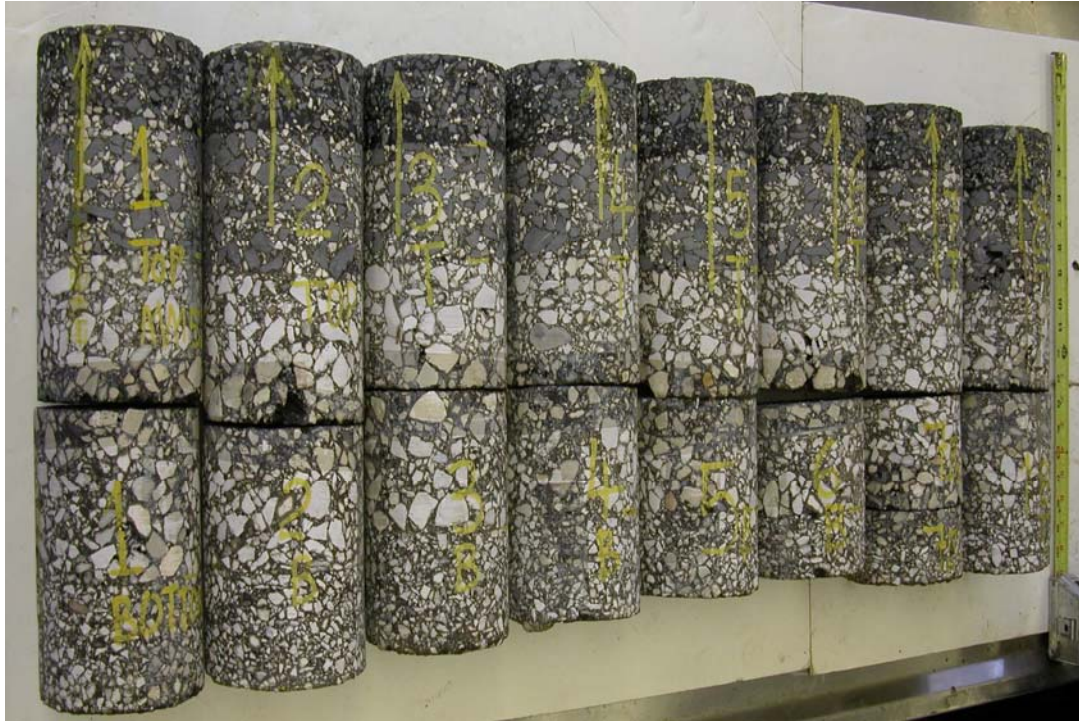
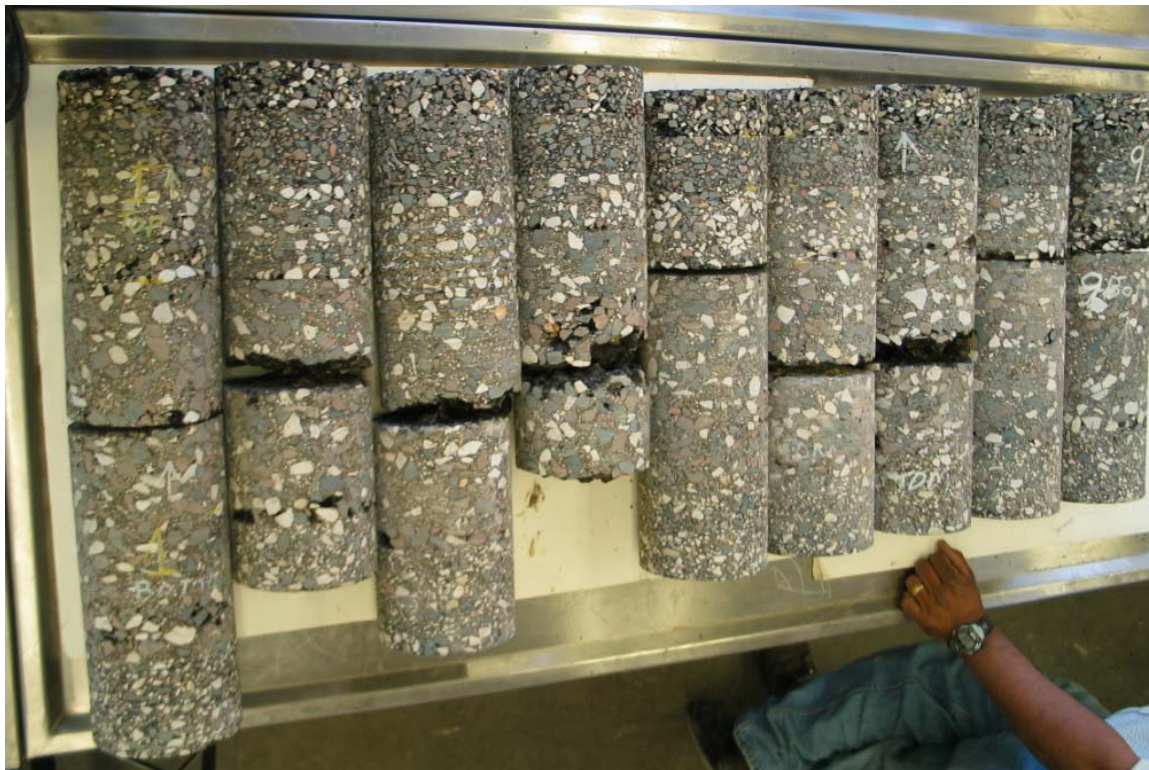
Figure 23. Cores Taken from the Zumwalt 2 Project in Laredo (Upper) and Young Brothers Project in Waco (Lower).

Figure 23 provides a comparison of the cores taken from two projects. The cores in the upper photo were taken from the Zumwalt 2 project in Laredo. In general, the condition of these cores is reasonable; however, each core was found to be debonded at the same location, the middle of the 1-inch SF layer. These are to be compared with the cores taken from the Waco project. These cores showed deterioration at several different locations. Several of the cores exhibited stripping in the middle of the 1-inch SF lift; some of the other cores had deterioration at the bottom of the $\frac{3}{4}$ -inch SF layer.

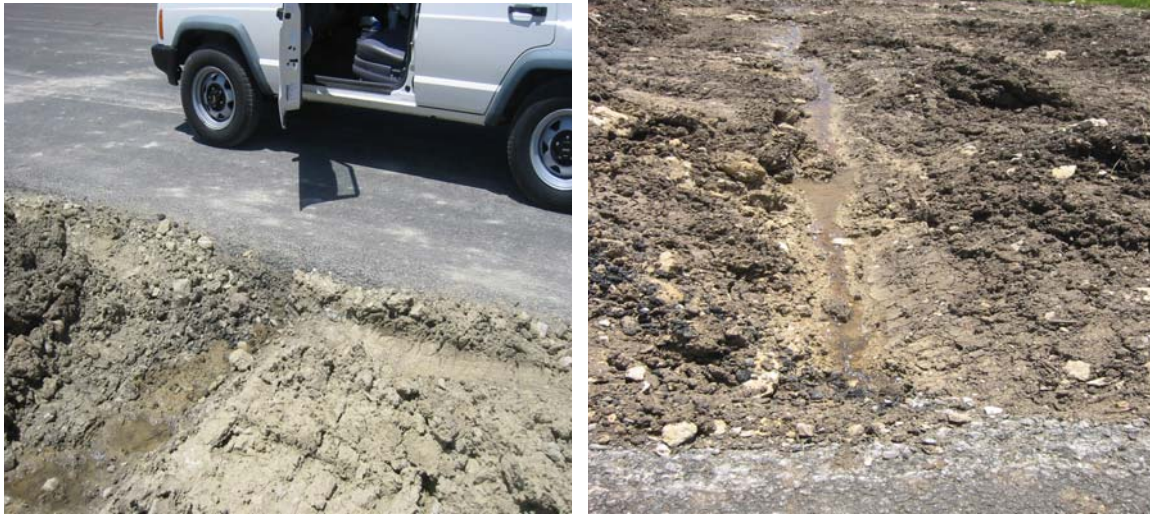
Figure 26. Releasing Trapped Water from the Stone-Filled Asphalt Layers on SH 114.

The problems of compacting the 1-inch stone-filled layers was recognized by many of the contractors and districts during the construction process. The Fort Worth District was very concerned about the permeability of its structure. With its construction sequence, the initial intention was to place all of the stone-filled layers and then let the traffic drive on the section for a period of 12 to 18 months while the other side of the four-lane divided highway was reconstructed. However, it was noted that during periods of heavy rainfall that little water would flow off the edge of the pavement; most of it appeared to be entering the SF layers. This reinforced the concerns that had already been raised from the GPR data shown earlier in [Figure 15](#). To evaluate this, the area engineer (Bill Nelson, P.E.) had a small trench cut in the shoulder material that had been backfilled against the structure. This is shown in [Figure 26](#). Upon cutting the trench, water flowed from the pavement for several days.

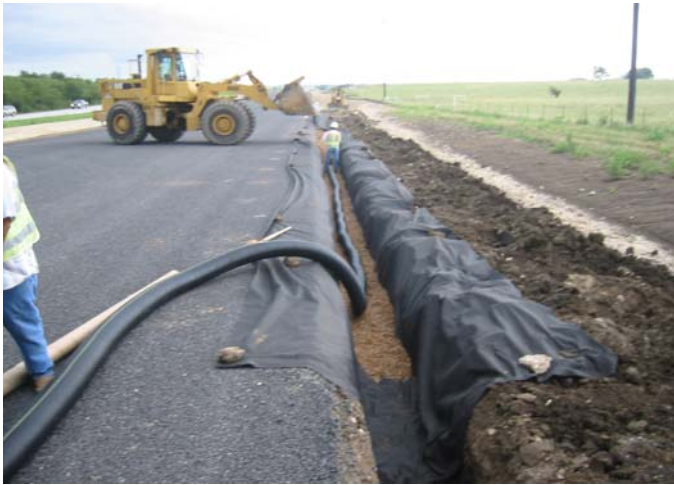
Figure 27. Installing Edge Drains in SH 114 to Drain Water Trapped within the SF Layers.

Based on these observations, the Area Office had serious concerns that the pavement might deteriorate if traffic is allowed to run on it with water trapped at the layer interfaces. To address this, a field change was instigated to install edge drains in the section and to place a chip seal over the top of the 3/4-inch SF layer. [Figure 27](#) shows this work. GPR testing before and after the placement of the edge drains found that the drains were working effectively; see [Figure 16](#). No problems have been found with this pavement since these modifications were made.

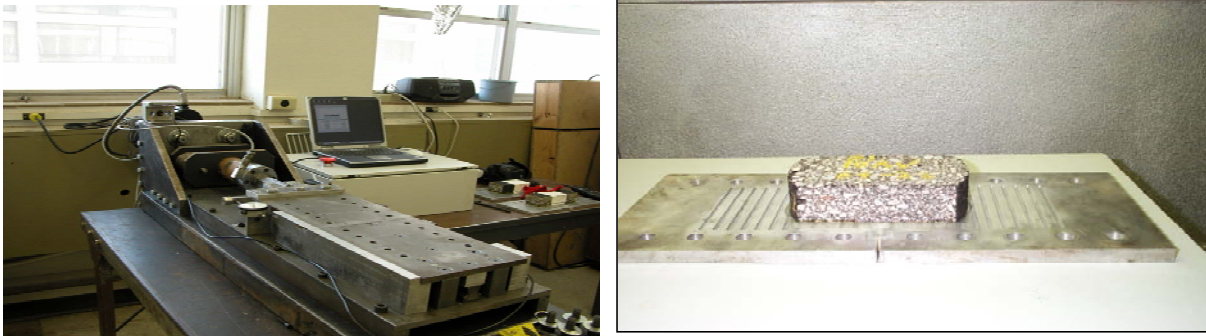
Figure 29. Overlay Tester.

Figure 29 is a schematic illustration of the Overlay tester and an HMAC test specimen (6). The test loading parameters are summarized in the subsequent text.

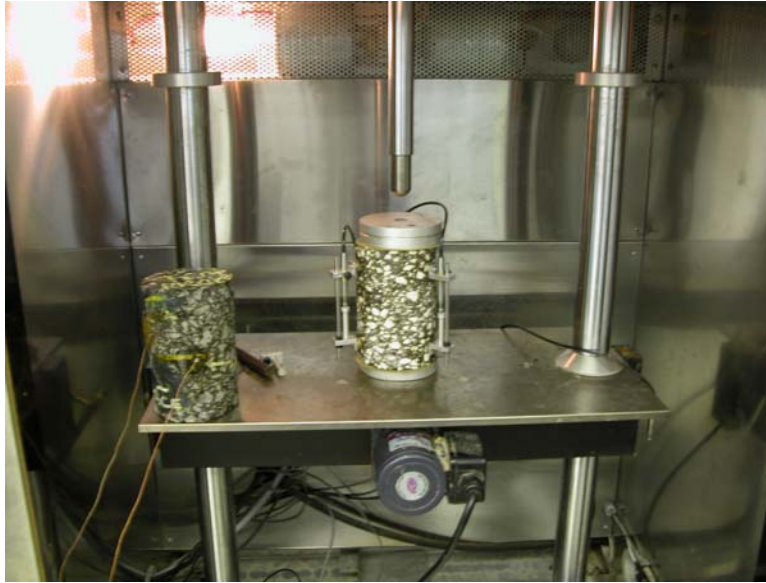
Figure 30. UTM-25 and HMAC Specimen Setup.

DM is a stress-controlled test using compressive axial loading. The test protocol in this project involved applying a sinusoidal dynamic compressive stress to gyratory-compacted cylindrical HMAC specimens of 6 inches in height by 4 inches in diameter. TTI's Universal Testing Machine (UTM-25) was used for conducting the DM test. Figures 30 and 31 show the UTM-25 test setup and the loading configuration, respectively.
