**GUIDELINES FOR EVALUATION OF EXISTING  
PAVEMENTS FOR HMA OVERLAY**

Report 0-5123-2

Project 0-5123

Project Title: Development of an Advanced Overlay Design System Incorporating Both Rutting  
and Reflection Cracking Requirements

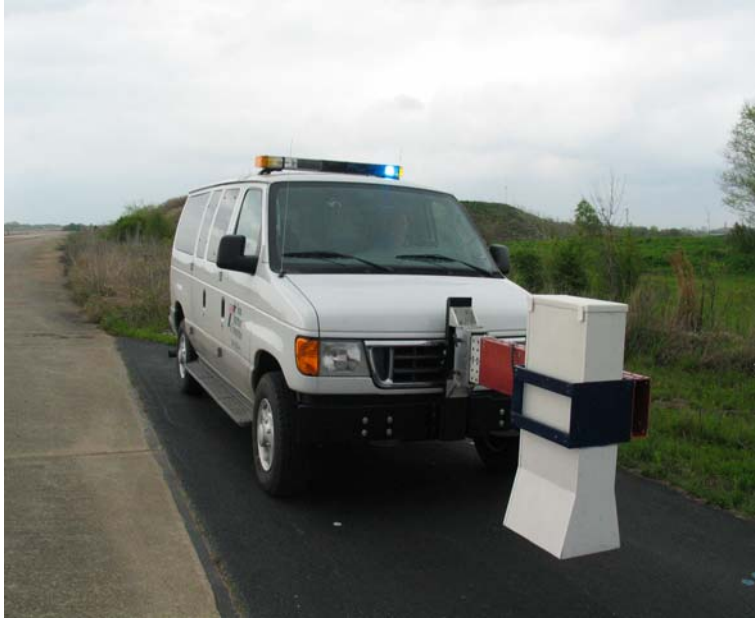
**Figure 1. TxDOT's Air-Coupled GPR Unit.**

[Figure 1](#) shows one of TxDOT's 1 GHz air-coupled GPR units. This system sends discrete pulses of radar energy into the pavement system and captures the reflections from each layer interface within the structure. Radar is an electro-magnetic (EM) wave and, therefore, obeys the laws governing reflection and transmission of EM waves in layered media. This particular GPR unit operates at highway speeds (70 mph), transmits and receives 50 pulses per second, and can effectively penetrate to a depth of 24 inches. A typical plot of captured reflected energy versus time for one pulse is shown in [Figure 2](#) as a graph of amplitude in volts versus arrival time in nanoseconds. The reflection,  $A_1$ , is the energy reflected from the surface of the pavement, and  $A_2$  and  $A_3$  are reflections from the top of the base and subgrade, respectively. These are all illustrated as positive reflections, which indicate an interface with a transition from a low to a high dielectric material. As described later, these amplitudes of reflection and the time delays between reflections are used to calculate both layer dielectrics and thickness. The dielectric constant of a material is an electrical property that is most influenced by moisture content

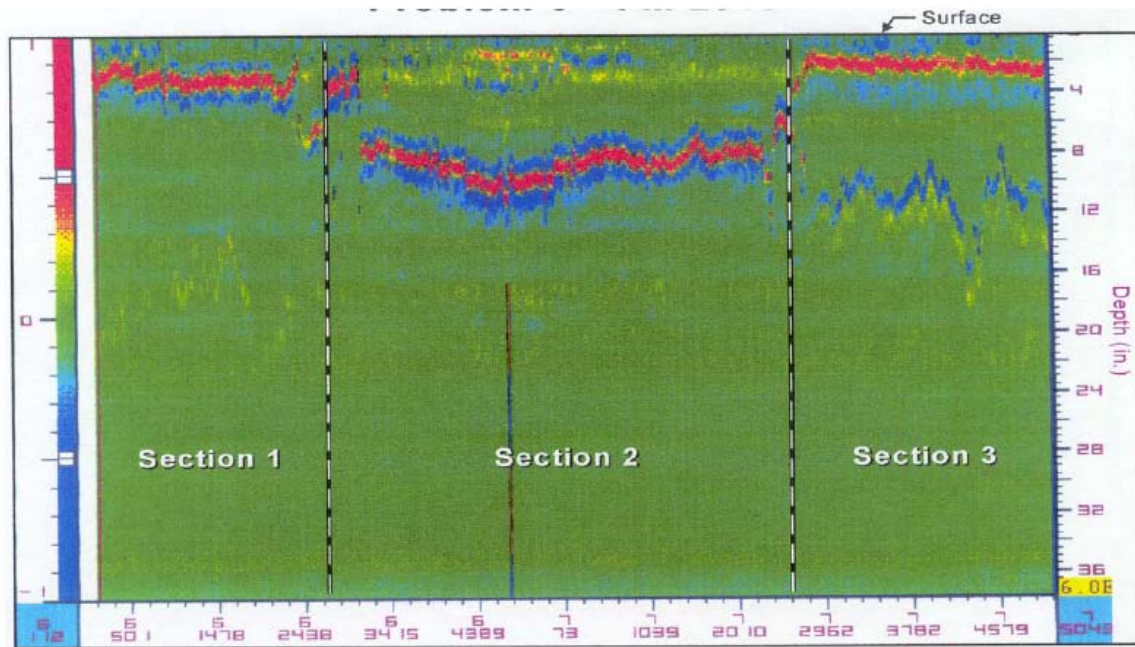
Figure 4. Raw GPR Data with Interpretation from FM 2818, near College Station, Texas (1).

The data shown in [Figure 4](#) is a short 2-mile section from a 14-mile project. The highway was exhibiting some localized failures, and only limited thickness information was available. The surface condition looked similar because the section had recently received a thin resurfacing. From the data shown in [Figure 4](#), this short section had three distinctly different pavement structures. The interpreted structure information is at the bottom of the figure. The highway had been widened, and the old roadway had been buried beneath a flexible base overlay and a new thin surfacing. The widened sections consisted of a stabilized subgrade, flexible base, and thin HMA surfacing. The GPR rapidly identified the old pavement (section 3), the new pavement (section 1) as well as areas of localized full-depth rehabilitation (section 2). With this information plus necessary FWD data, the pavement engineer can make a clear decision on HMA overlay strategy.

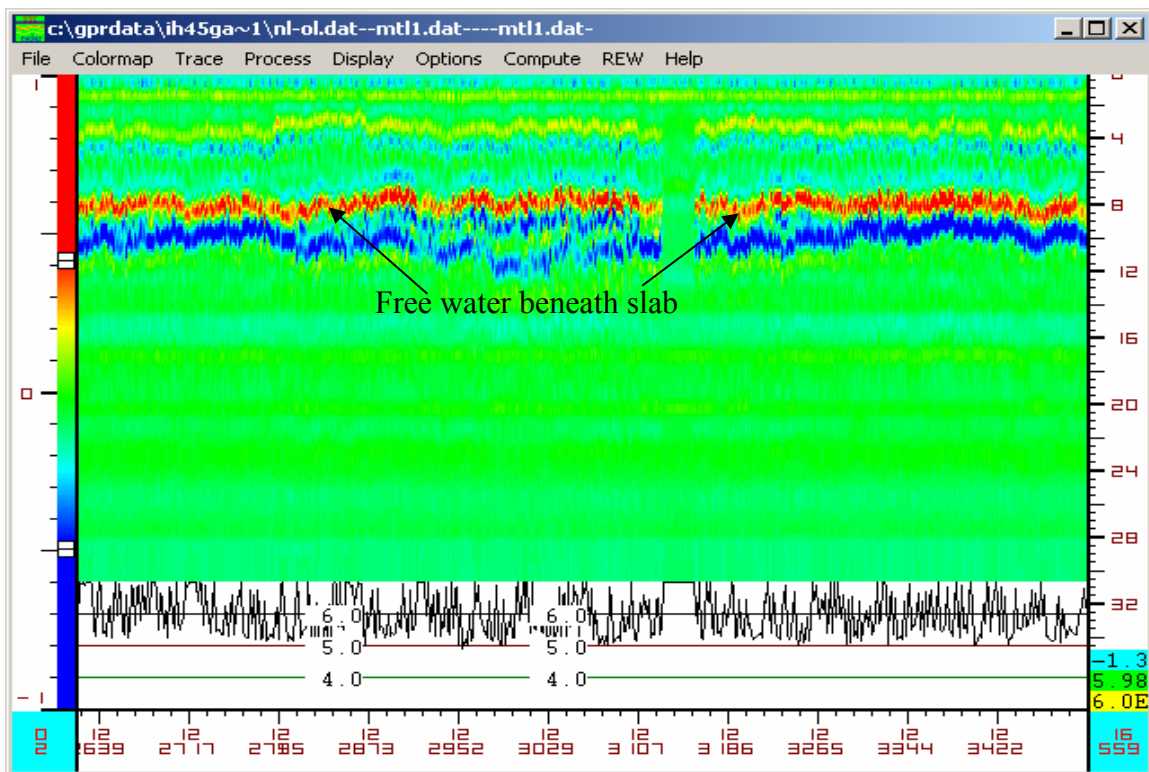
**Figure 7. COLORMAP Display from an Area Where Free Water Exists beneath the Slab.**

The third case shown in Figure 7 displays a different portion of the same highway. In this case, there is almost a continuous strong red reflection followed by a continuous blue reflection. The one gap in the middle of the plot is where a full depth patch has been placed. This location had already been undersealed; however, there was substantial staining along the shoulder of the pavement. This section was cored, and it was found that free water was present beneath the slab. In places, there was a localized 2 to 3 inch thick void beneath the slabs. Clearly, the rehabilitation options for this highway are limited because of the presence of the water.

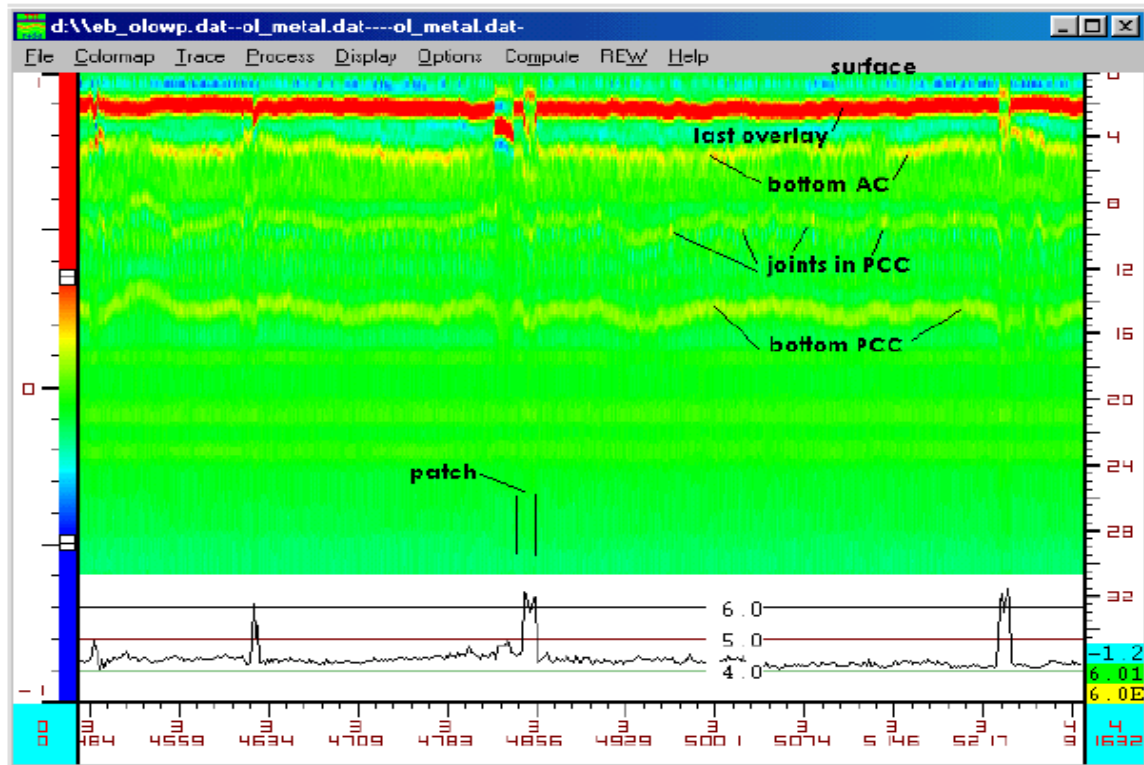
**Figure 8. Typical COLORMAP Display from a Representative Area in the Eastbound Direction.**

Figure 8 is a representative COLORMAP display from the eastbound lanes. Similar data were obtained for much of the eastbound direction. At this location, the surfacing consists of two 2-inch thick lifts of asphalt concrete. The dielectric of the upper layer is relatively low at around 4.2 and 4.5. A strong reflection is observed at the top of the second layer of asphalt concrete (AC). The dielectric of the lower asphalt layer appears normal, in the range of 5.5 to 6. In several locations, full depth AC patches have been placed on this lane. The dielectric values of these patches are close to 6, which is normal for AC. It is also possible to identify the bottom of the PCC slab in Figure 8. A faint reflection is observed from the middle of the PCC slab. The periodic, slightly brighter reflections could be from tie bars in the joints.

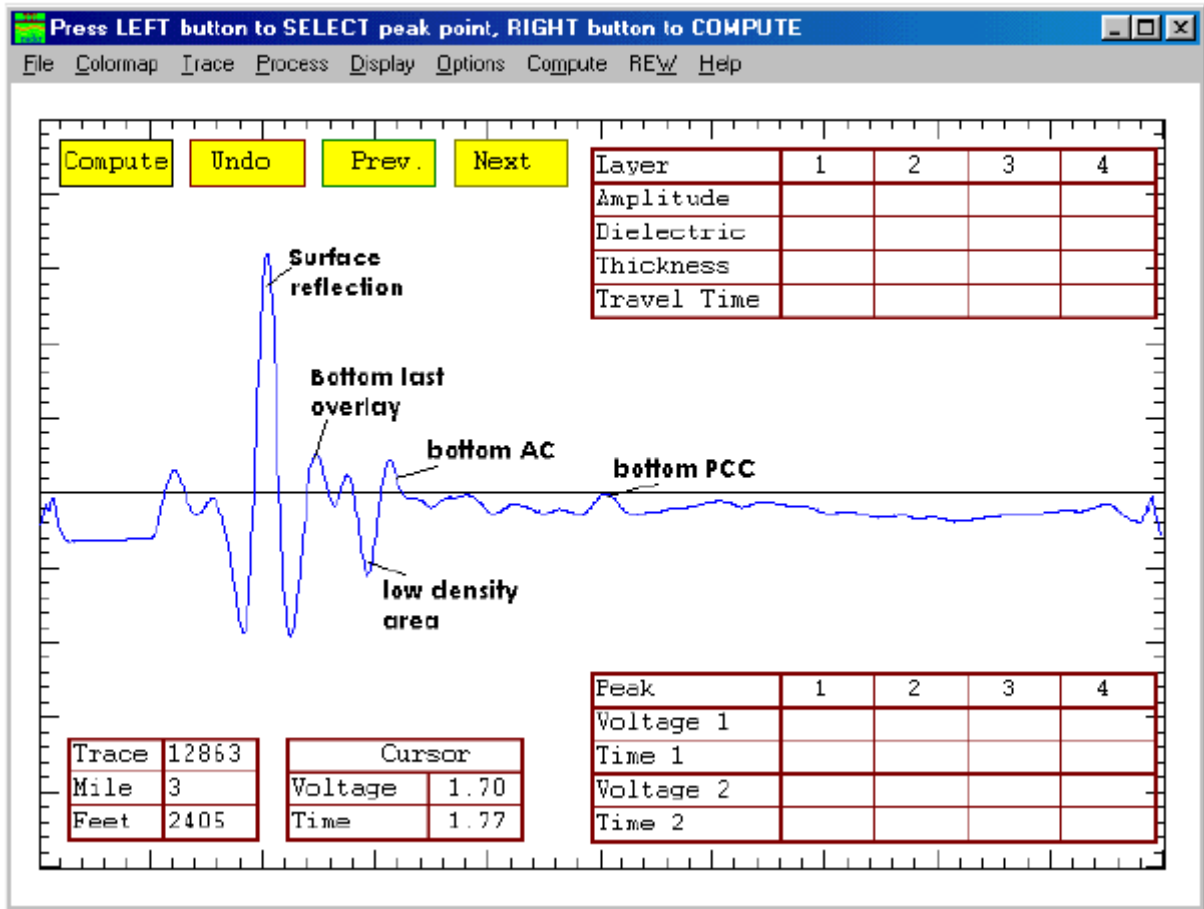
**Figure 10. Individual Trace from an Area on the Westbound Outside Lane Where Lower AC Layer Gives a Strong Negative Reflection.**

Figures 10 and 11 show two individual traces from locations 100 feet apart in the westbound outside lane of I20 (Figure 9). Figure 10 shows a strong negative reflection from the lower AC layer. The negative reflections are associated with the transition from a higher to a lower dielectric (density) area. In the past, this has been found to be associated with stripping in the lower AC layer. Figure 11 is a trace from a normal area in the westbound direction. No defects are apparent at this location. The reflection from the top and bottom of the PCC are faint, but still clear in the data.

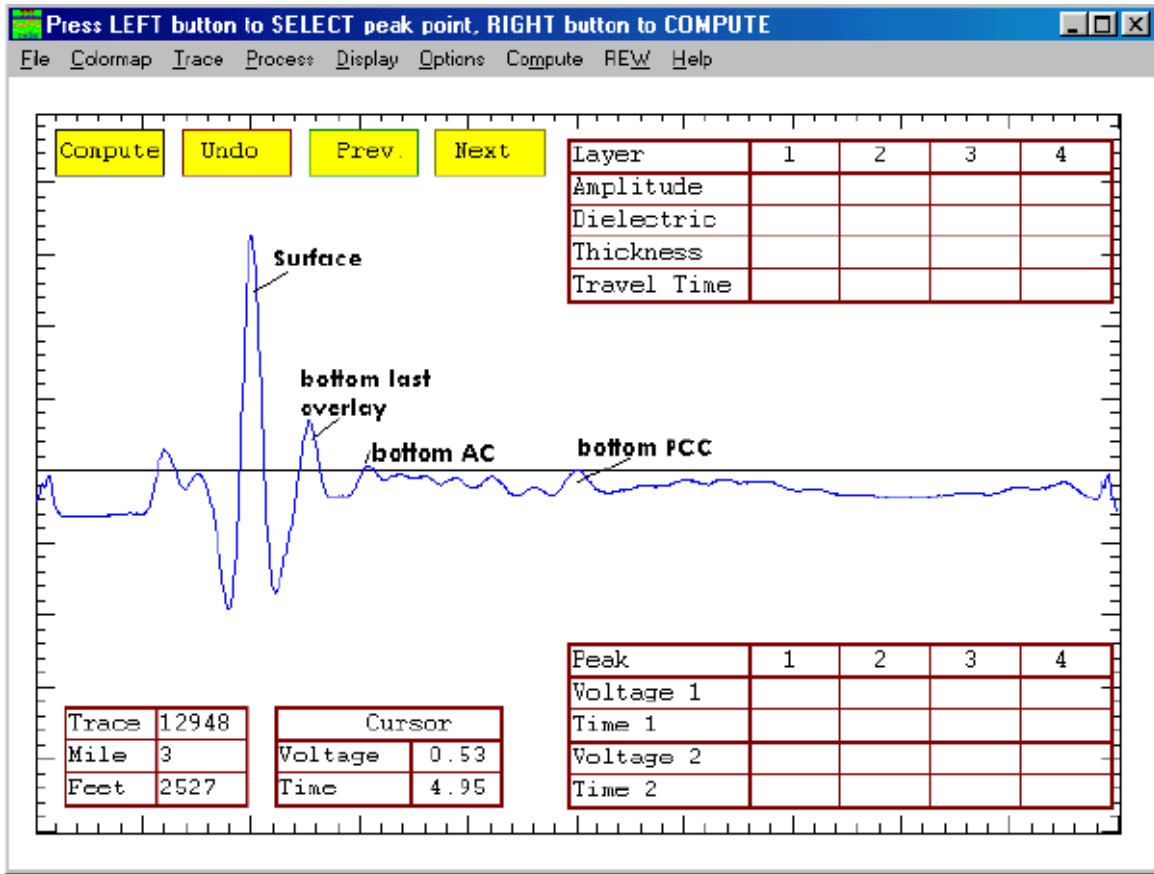
**Figure 11. Individual Trace from a Normal Location on the Westbound Outside Lane.**

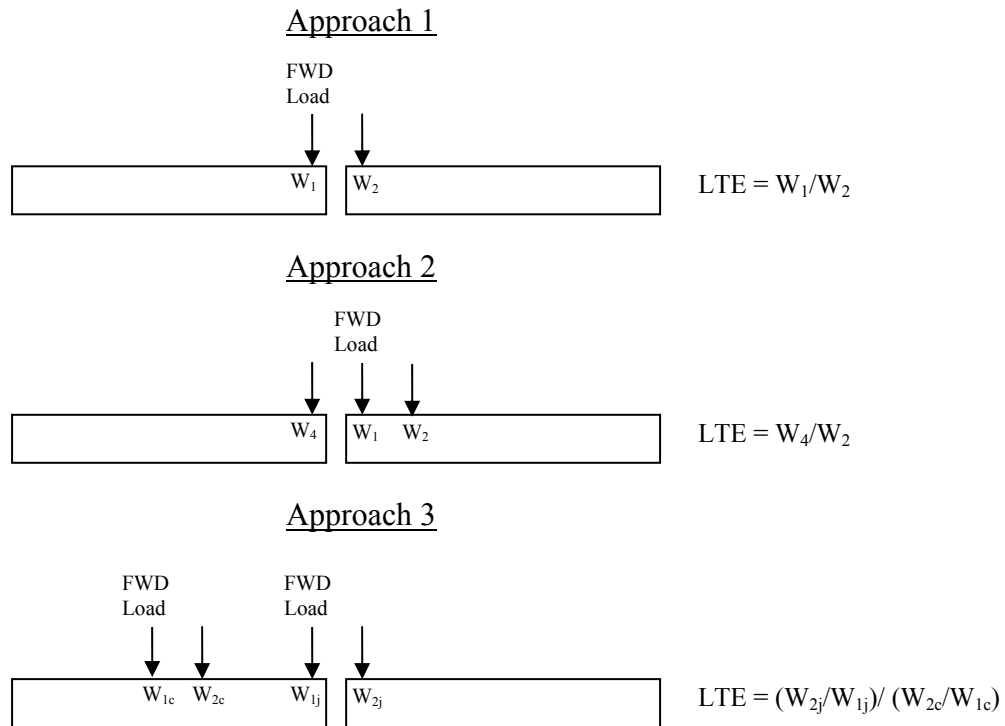
**Figure 14. FWD Based LTE Definitions.**

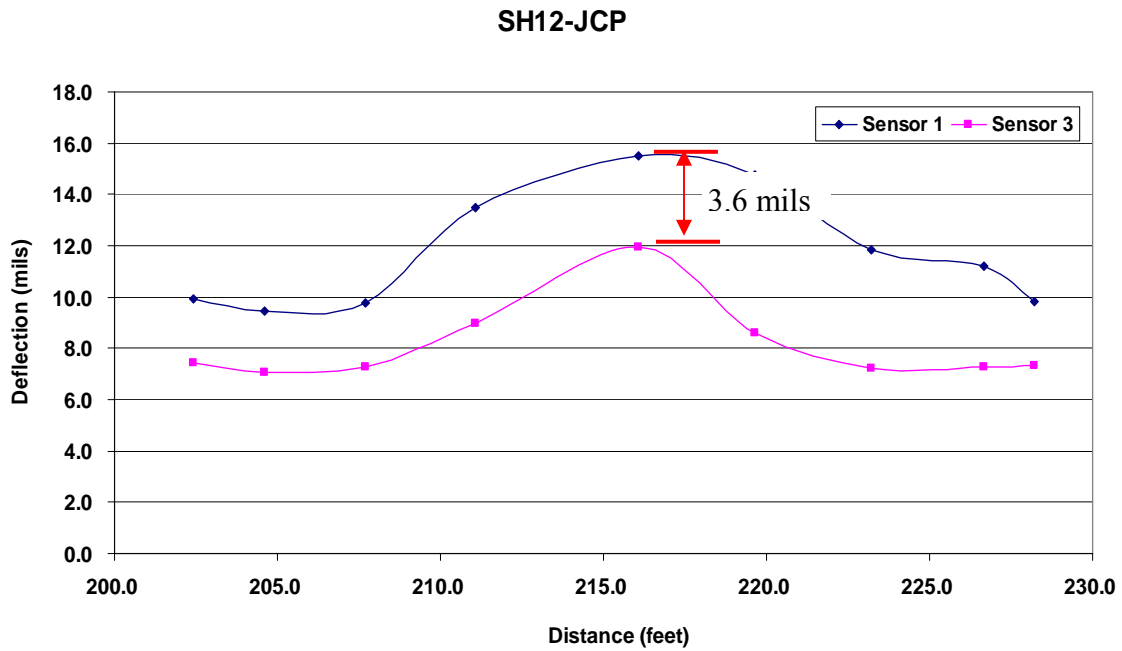
Figure 21. RDD Deflection Plot for a JCP Section on SH12.

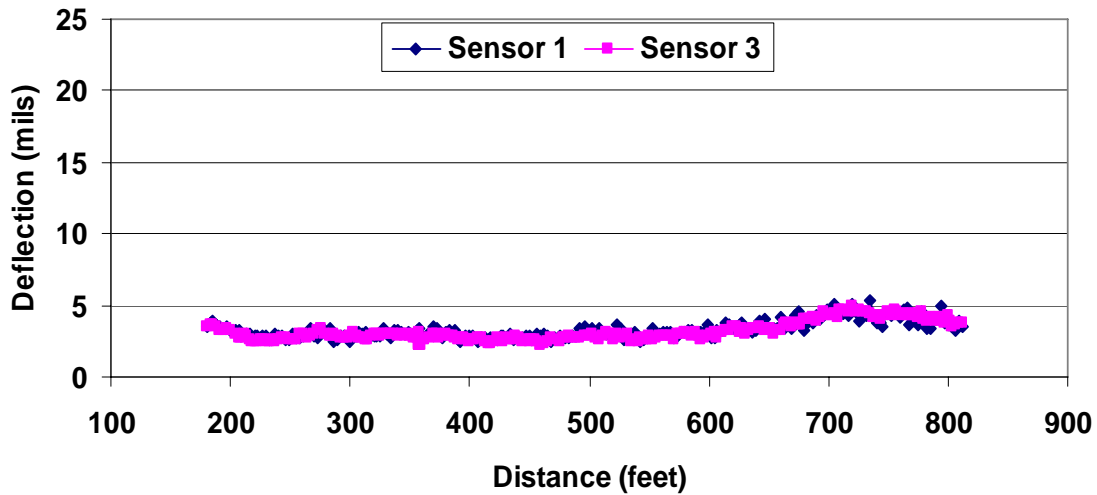
**Figure 23. RDD Deflection Plot for a JCP Section on US82.**

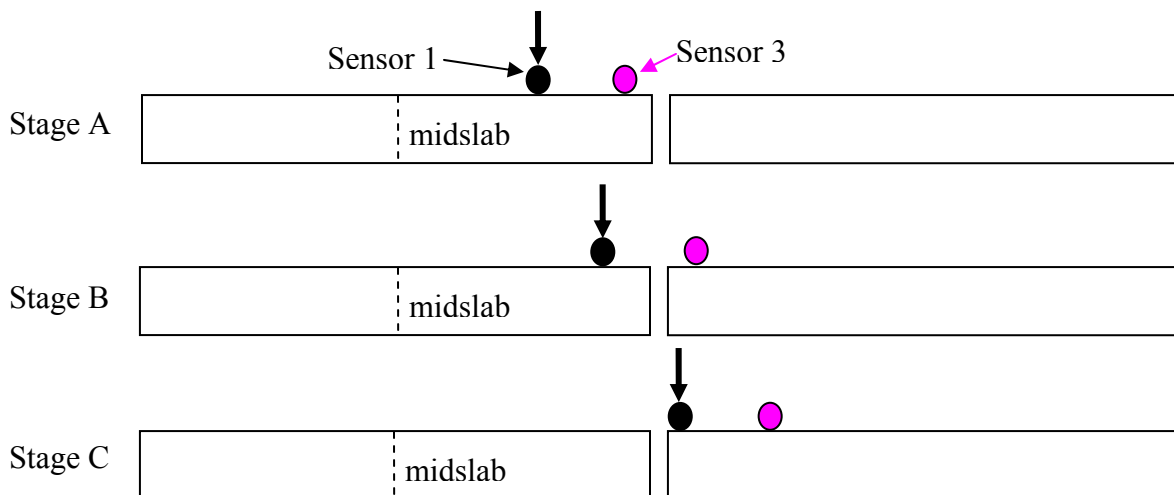
Figure 25. Sketch of Moving Process of Sensors 1 and 3.

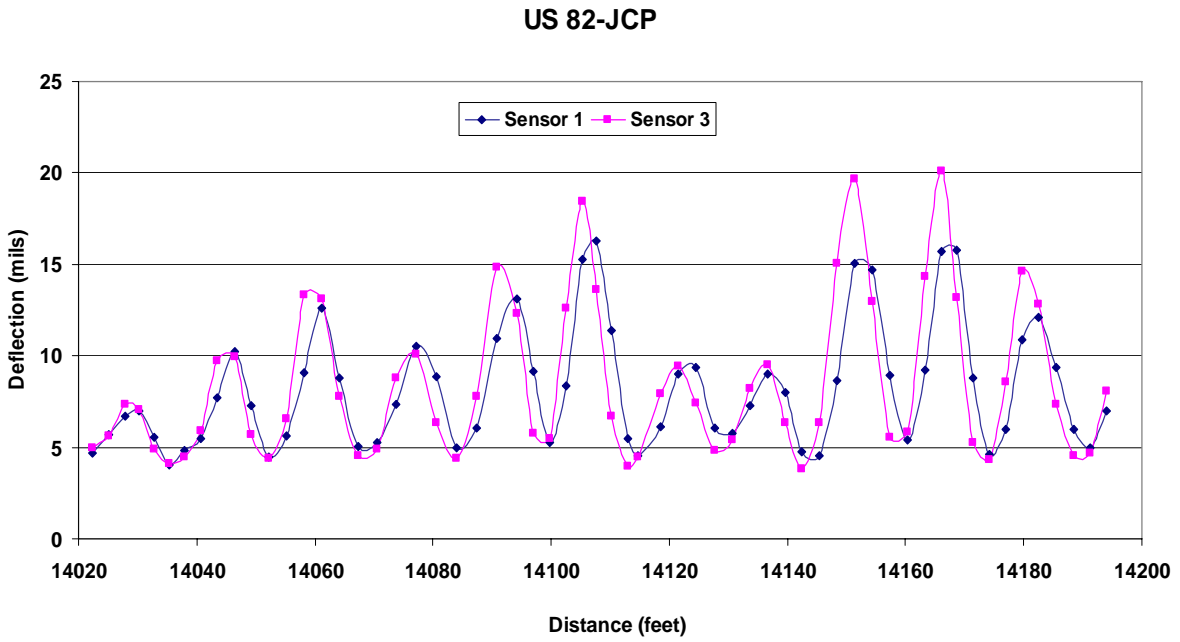
**Figure 27. Reversal RDD Deflection Data Collected on US82.**

In general, the deflection in Sensor 1 should be larger than that of Sensor 3, as shown above, because Sensor 1 is between the load wheels, and Sensor 3 is 38 inches away. However, some RDD data collected on US82 under TxDOT research project 0-4517 (12) show reversal phenomena that the deflections in Sensor 3 are larger than that measured at Sensor 1, as indicated in Figure 27. Similar phenomena have also been observed on IH45, which is plotted in Figure 28. In these sections, there is no visual distress on the surface of slabs, as shown in Figure 29. It is not difficult to imagine that these slabs are rocking under the RDD dynamic loading, as demonstrated in Figure 30. This type of deflection pattern also indicates poor support beneath the slab. To further validate this interpretation, DCP testing was conducted at this section on US82. It was found that the top of the subgrade penetrations ranged from 2.2 to 3.2 inches/blow, which is much higher than that at section under strong subgrade support (shown in Figure 23). If this is the case, slab undersealing or other treatments must be performed before HMA overlay; otherwise, no HMA overlay will work for these active and rocking slabs.

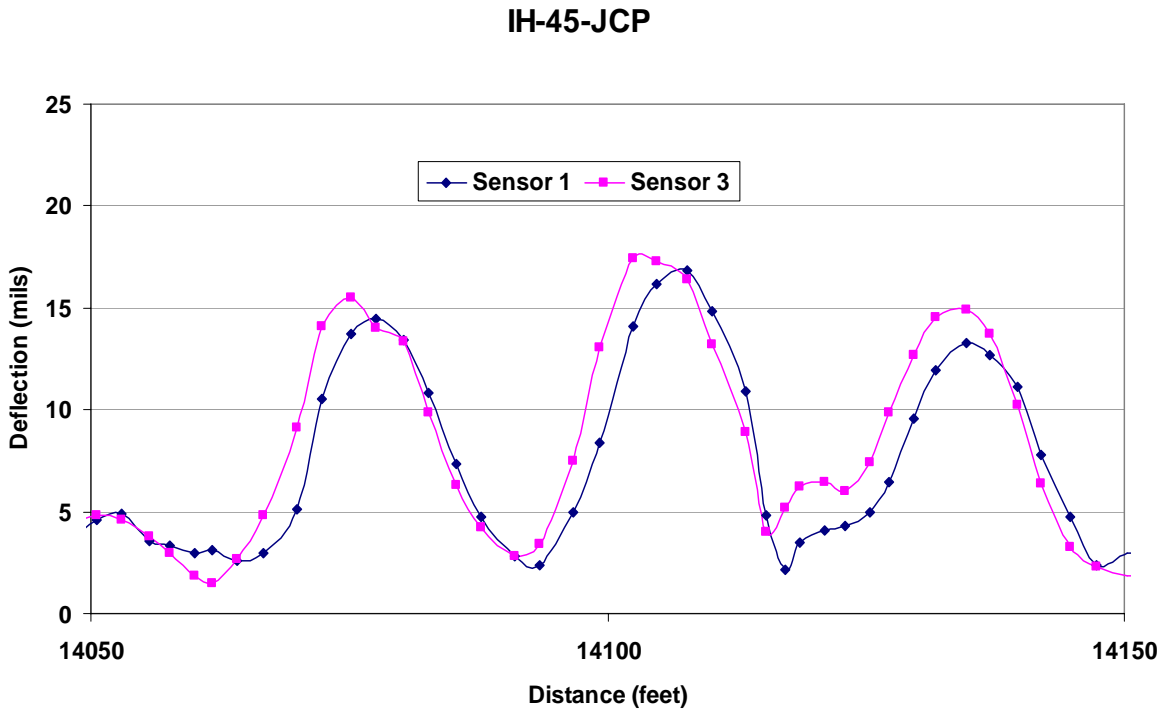
**Figure 28. Reversal RDD Deflection Data Collected on IH45.**

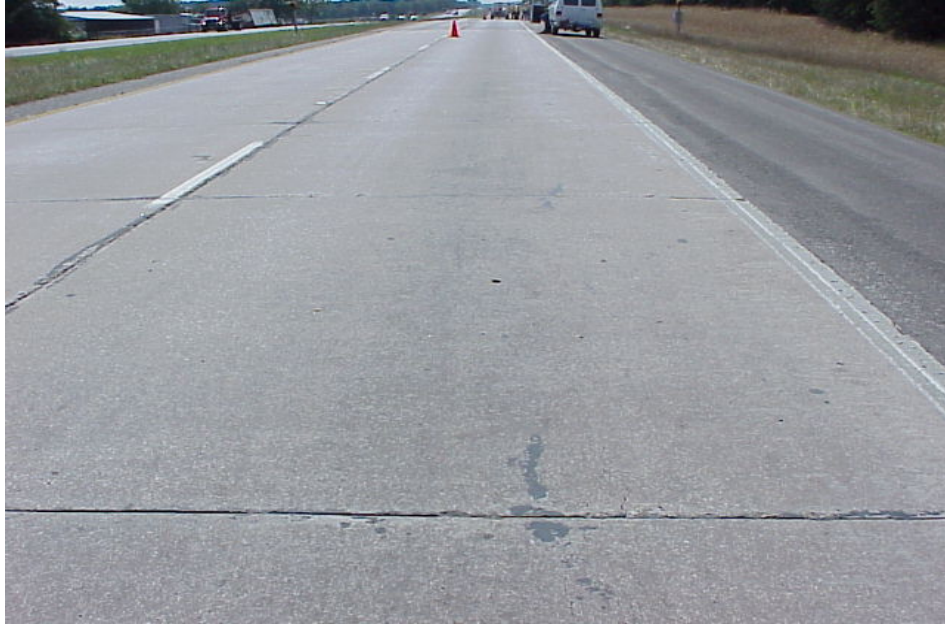
**Figure 29. In-situ Conditions of Reversal Deflection Site on US82 (12).**

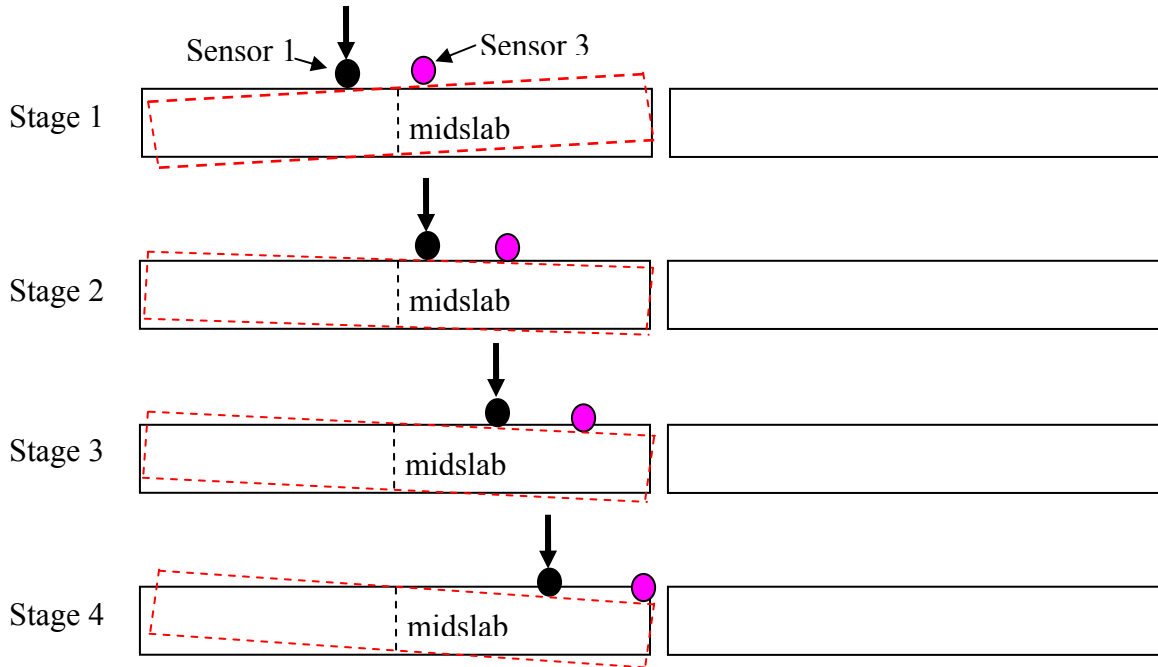
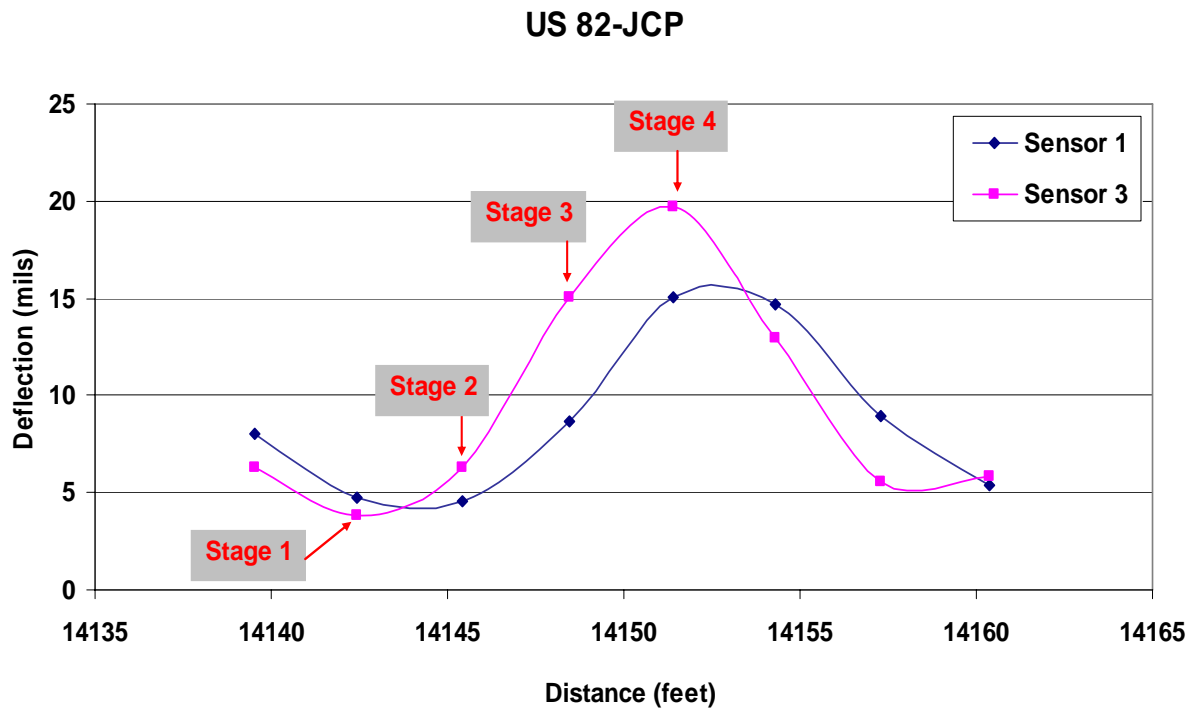
**Figure 30. Sketch for Demonstration of Rocking Slab under RDD Dynamic Loading.**

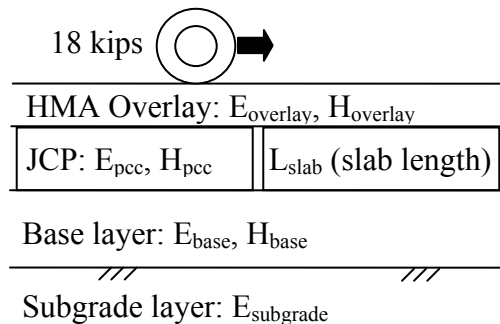
**Figure 35. An Example of an HMA Overlay on a JCP.**
