CRASH TESTING AND EVALUATION OF F-SHAPE BARRIERS ON SLOPES

Report 0-5210-3

Project Title: Roadside Crash Testing Program
for Design Guidance and Standard Detail Development

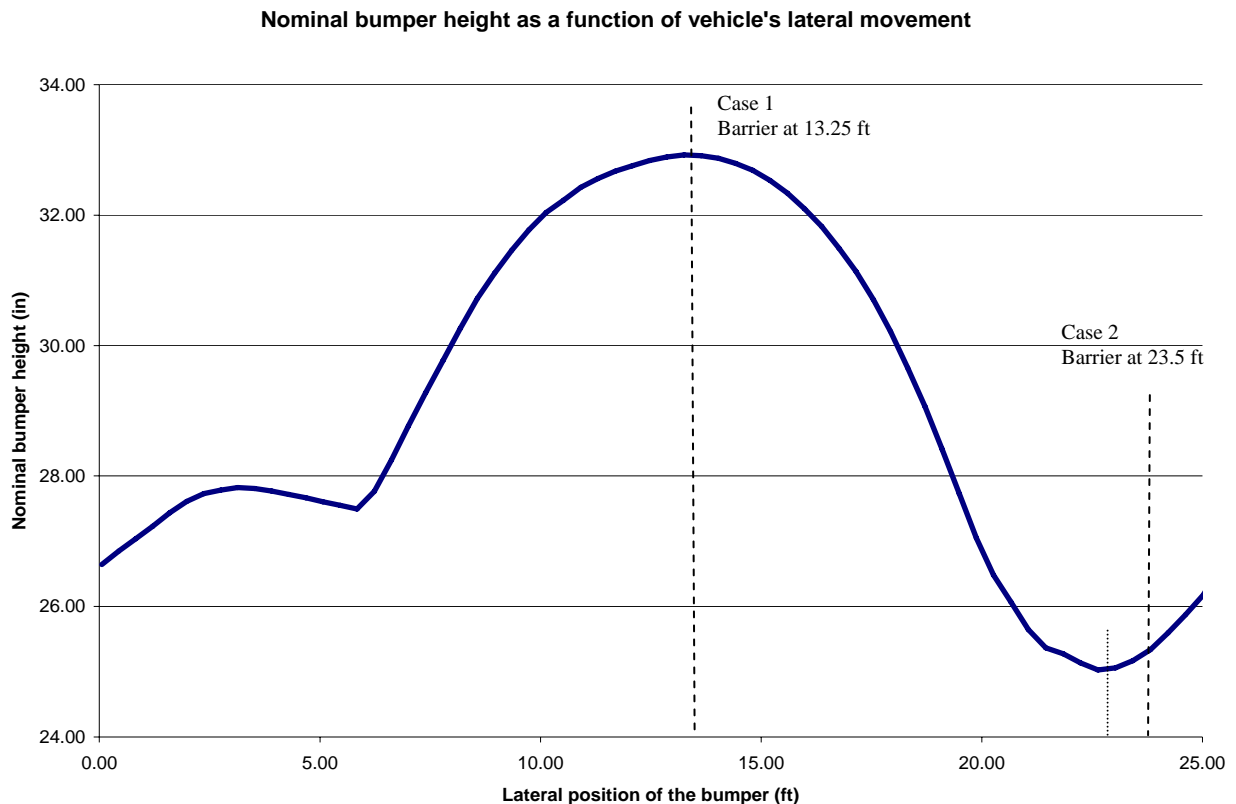
Figure 1. Height of Vehicle Bumper Relative to Local Terrain Elevation.

Given that median width can vary, it was important to determine the lateral offset position(s) of the barrier most likely to result in vehicle override and/or overturn. It can be inferred from a successful impact at this critical offset location(s) that the impact performance of the barrier at other offsets would also be acceptable. Toward this objective, an initial simulation was performed to determine the encroachment trajectory of the vehicle as it travels freely across an infinite 6H:1V slope in absence of a barrier. This simulation also included a 6-ft shoulder with a 20H:1V cross-slope. The simulation was conducted with a 4409-lb pickup truck departing the travelway at a speed of 62 mi/h and an angle of 25 degrees. The pickup truck was considered to be a more critical design vehicle than the 1800-lb passenger car in terms of potential for overturn, barrier override, and occupant compartment deformation. Researchers used the results of this simulation to obtain the height of the vehicle's bumper (impact side corner) with respect to the local ground elevation as a function of the vehicle's lateral movement down the 6H:1V slope (see Figure 1).

From this bumper trajectory plot, researchers identified two locations for further analyses:

Case 1: point of maximum nominal bumper height above the local terrain elevation (i.e., 7.25 ft offset from shoulder edge, 13.25 ft from roadway edge) and,

Case 2: just beyond the point of minimum nominal bumper height at which the vehicle suspension has been compressed to its greatest extent and is beginning to rebound (i.e., 17.5 ft offset from shoulder edge, 23.5 ft from roadway edge).

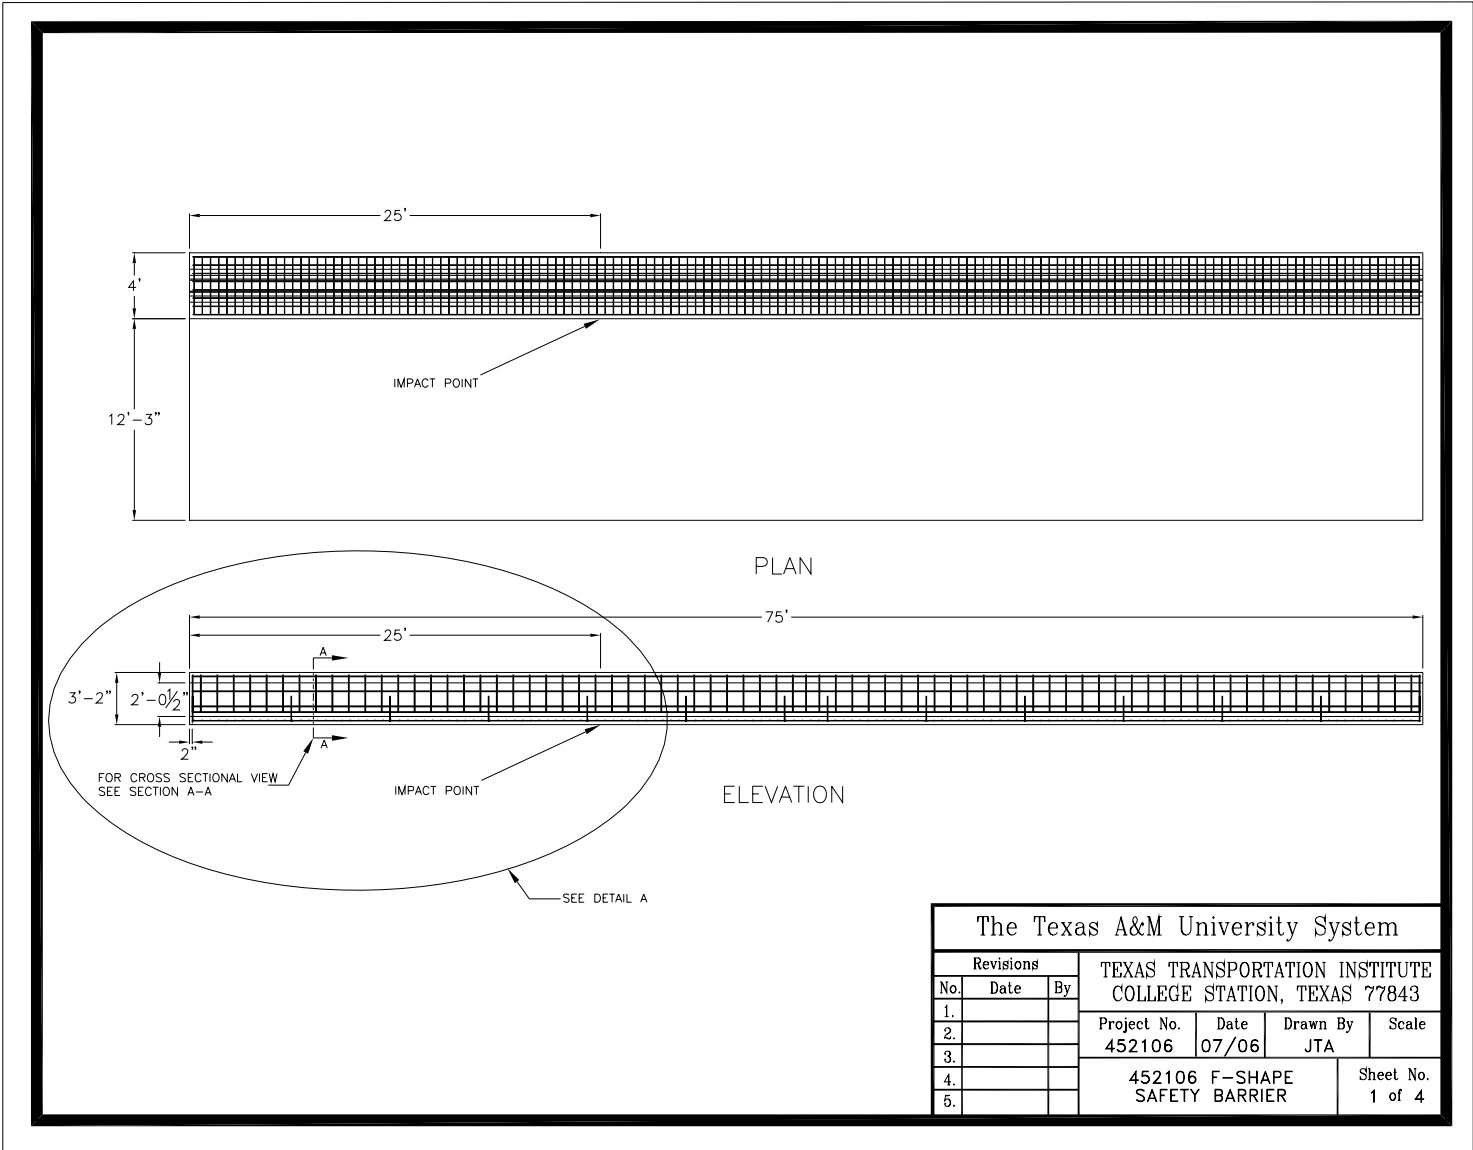
Figure 2. Details of the Permanent F-Shape Barrier.

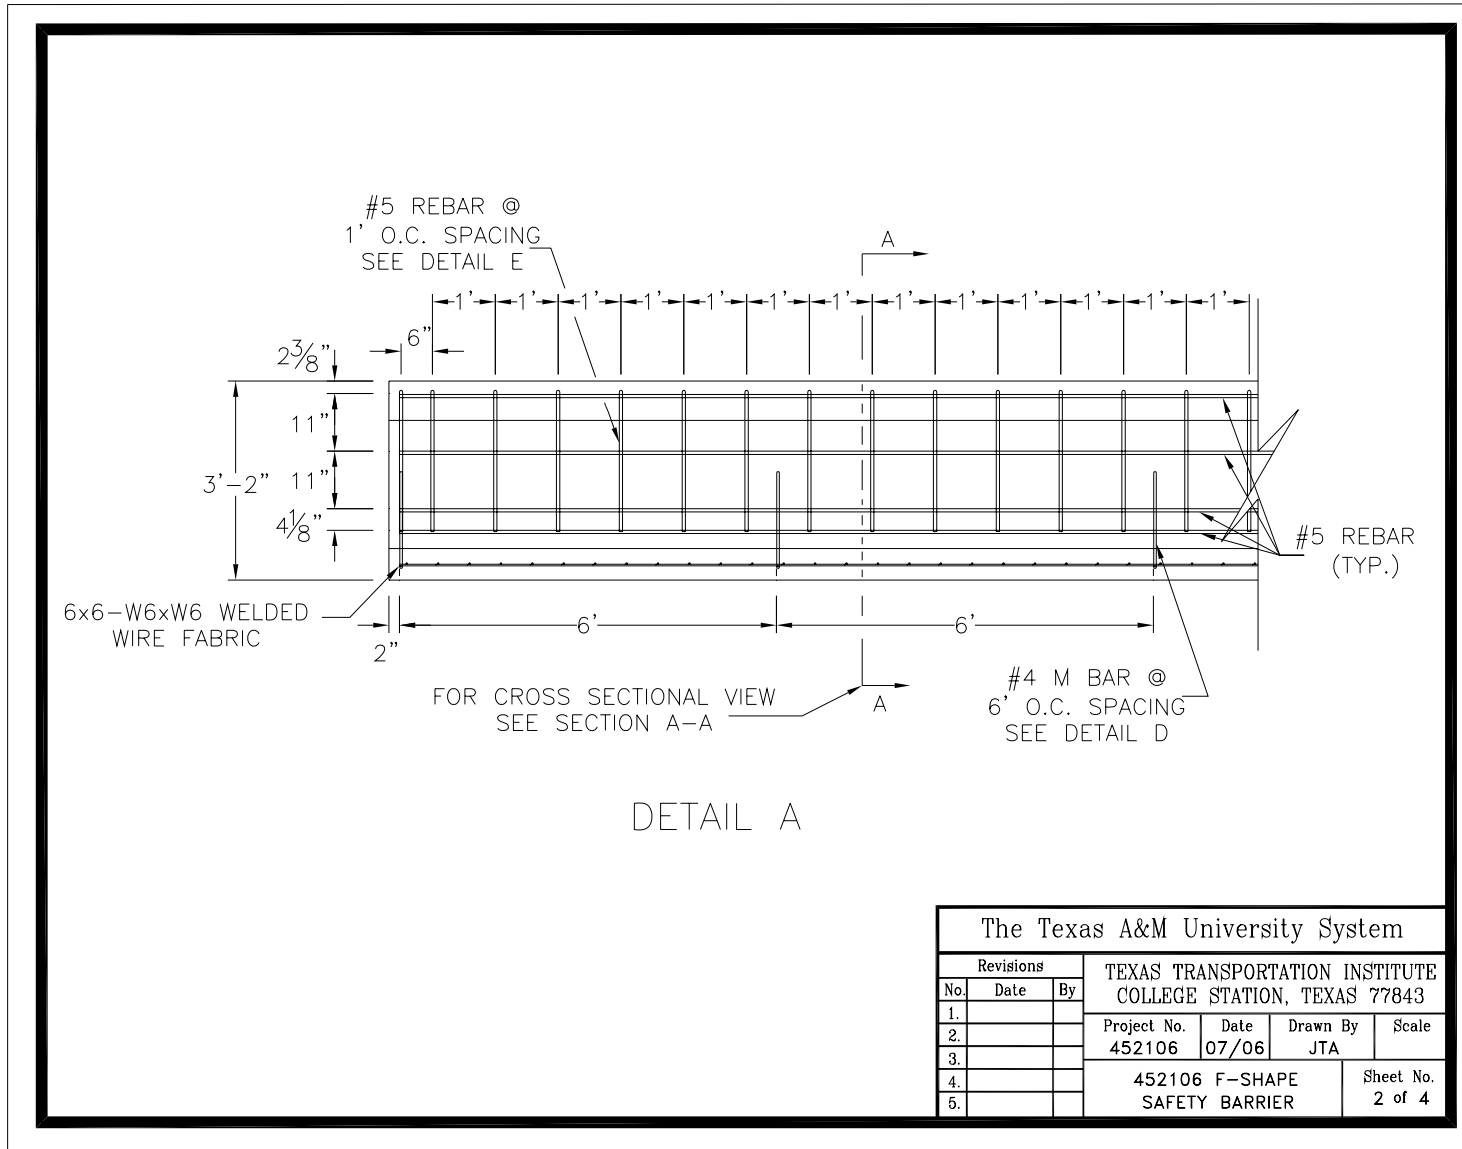
Figure 3. Details of Rebar Placement of the Permanent F-Shape Barrier.

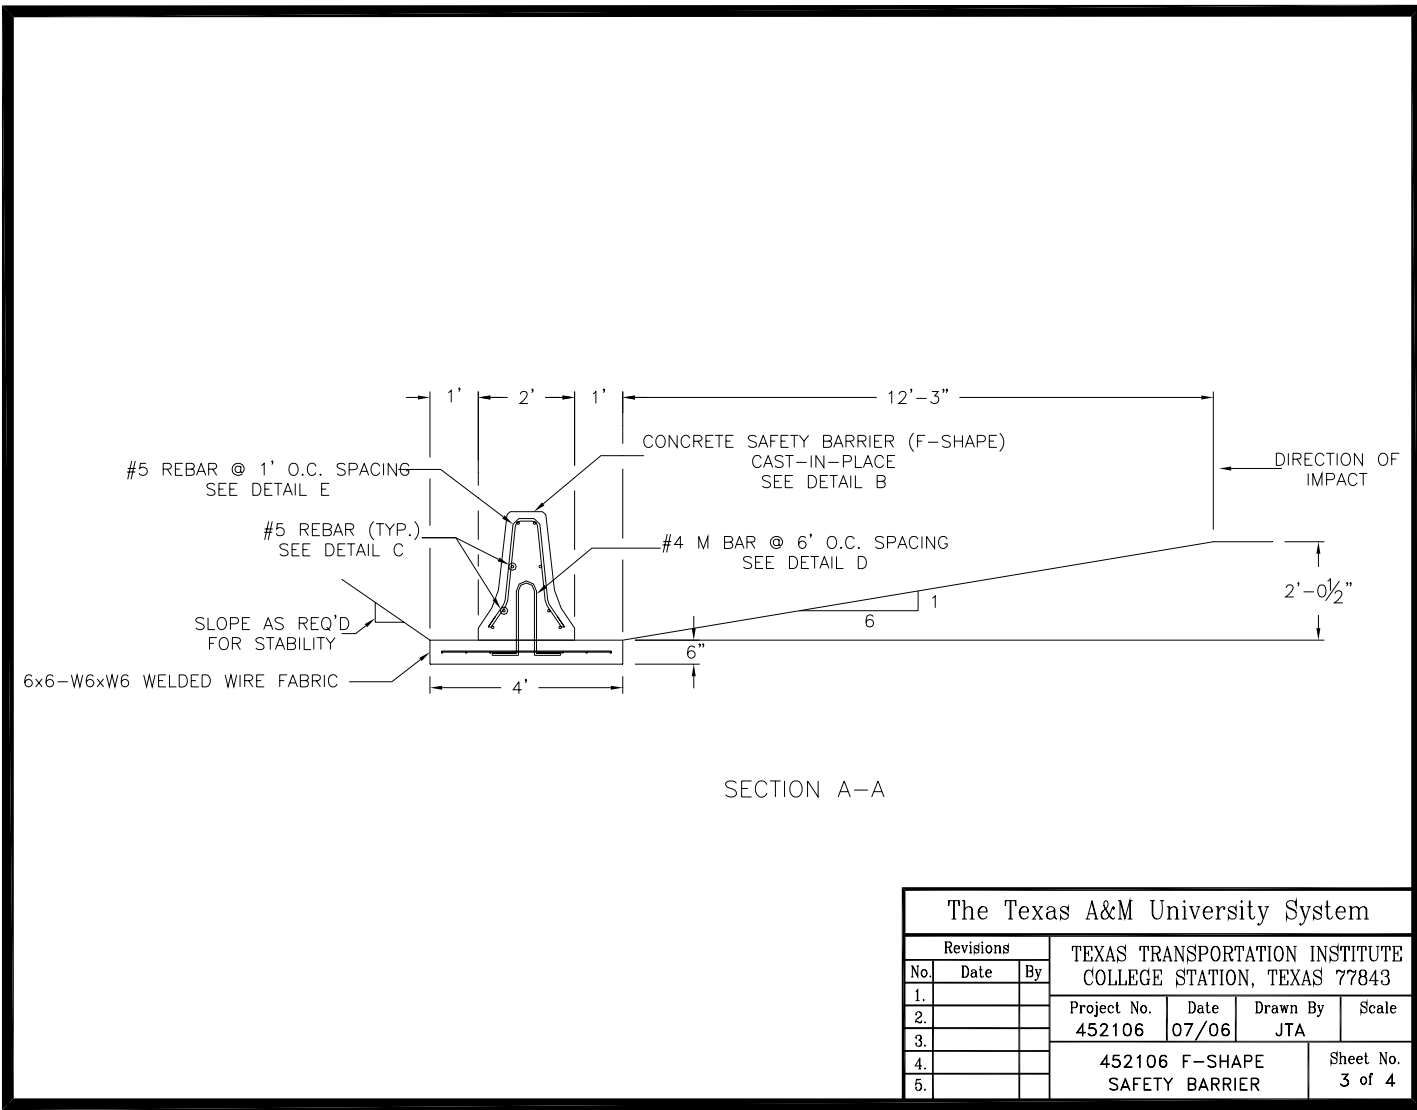
Figure 4. Cross Section of the Permanent F-Shape Barrier.

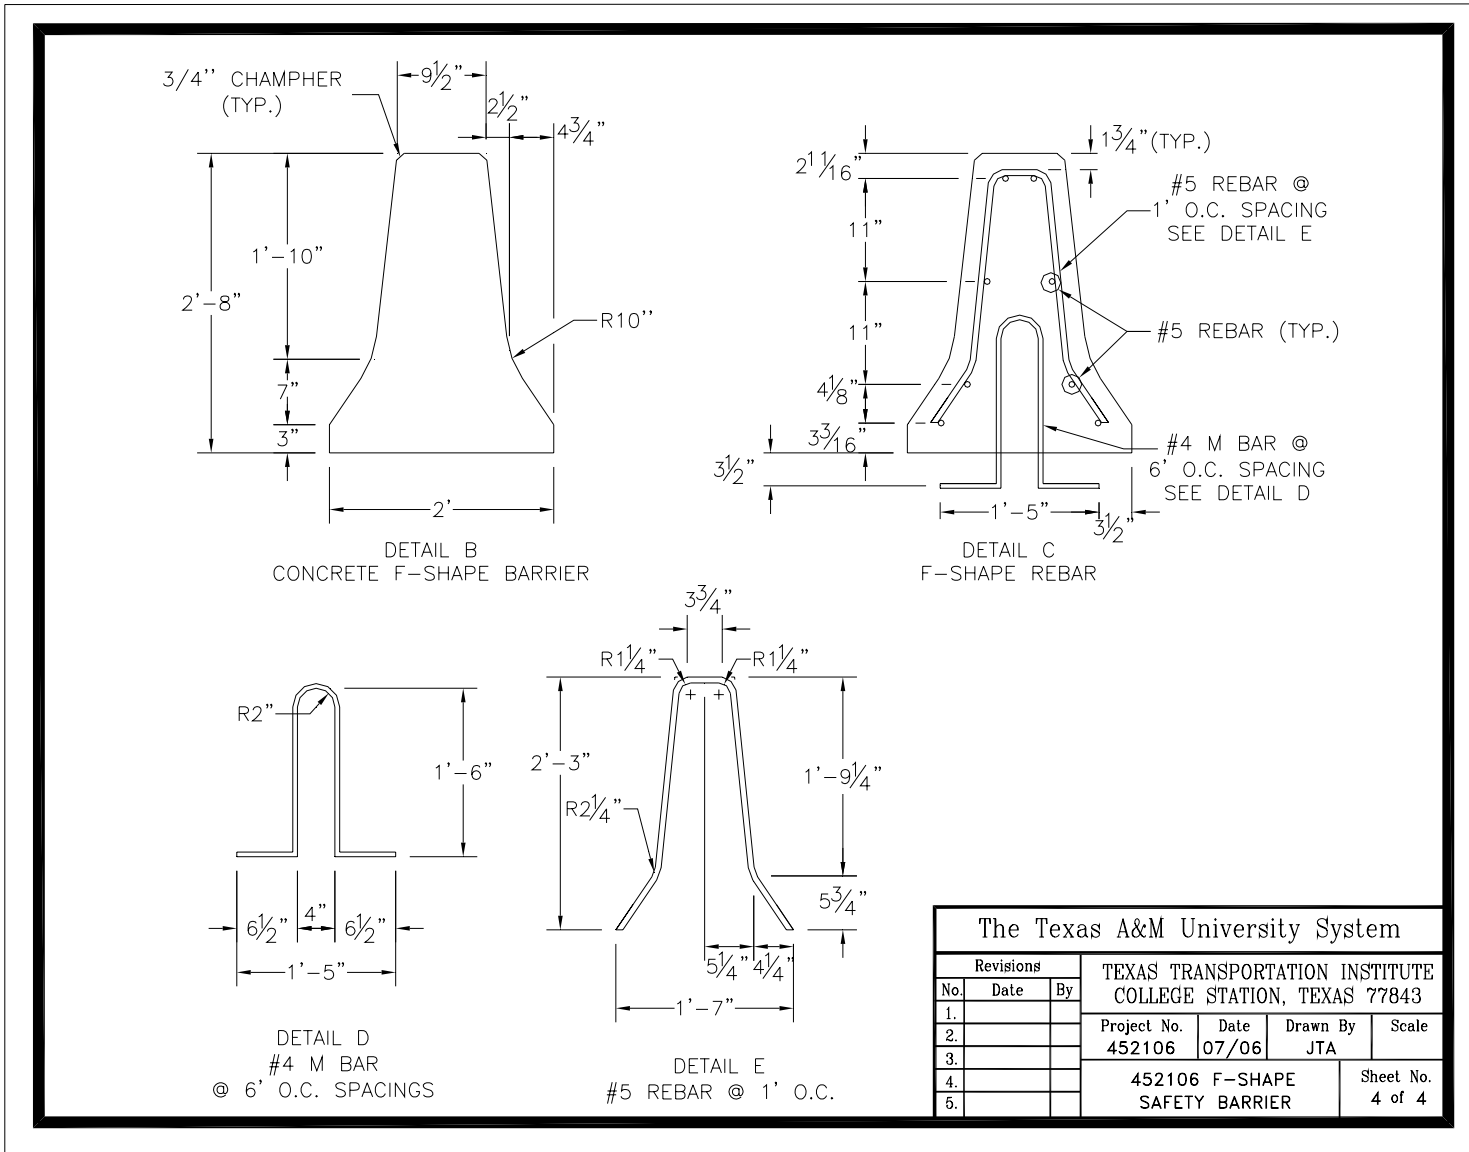
Figure 5. Details of Rebar for the Permanent F-Shape Barrier.

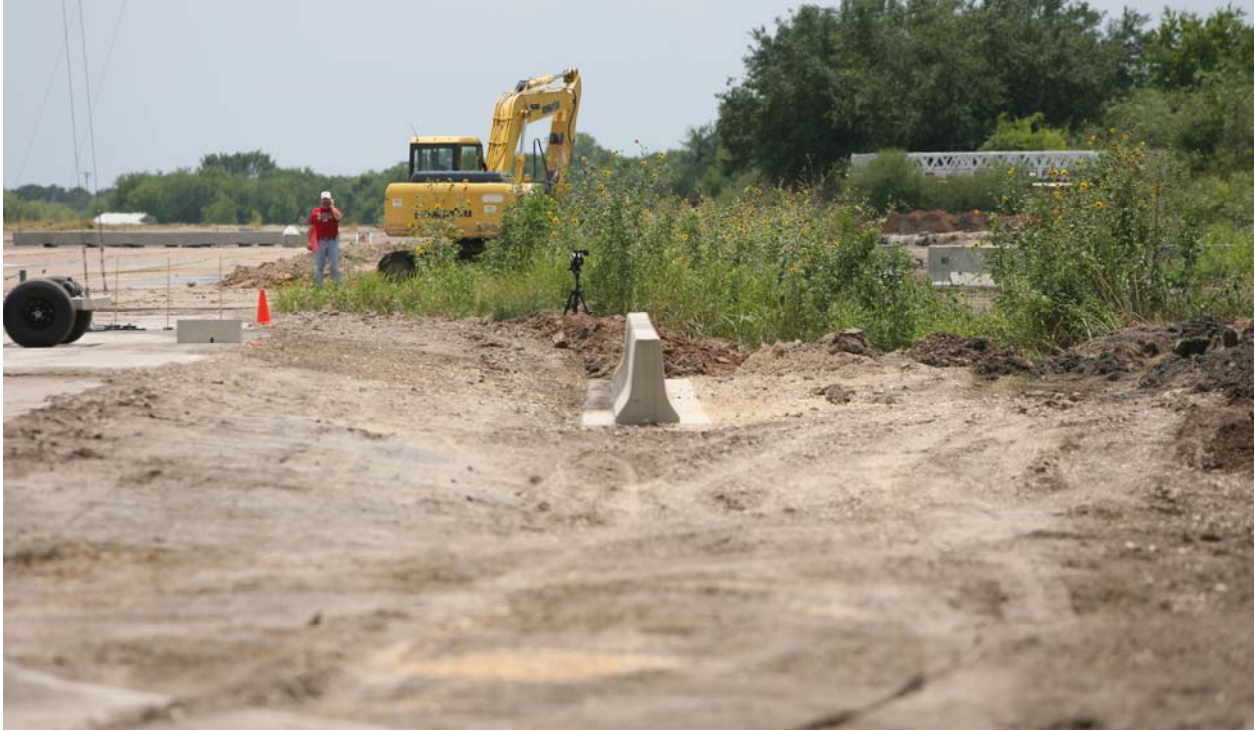
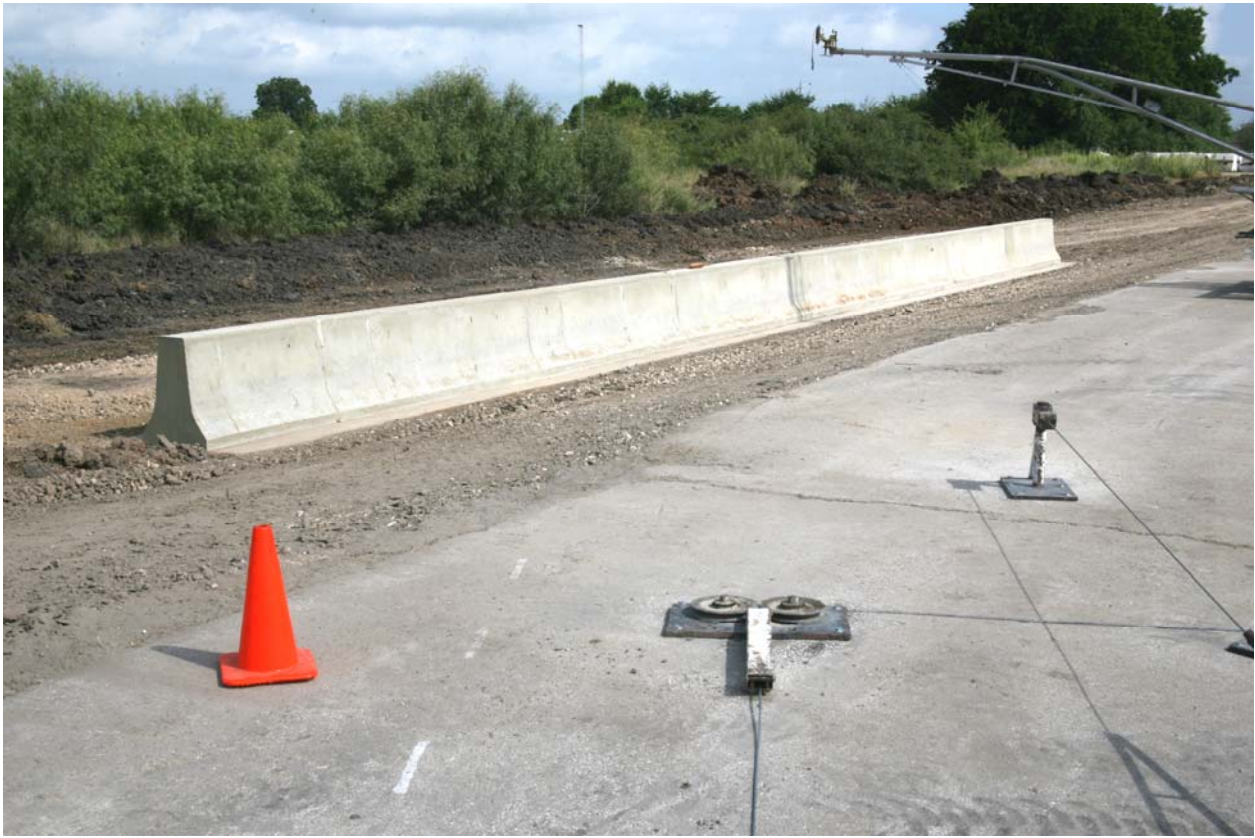
Figure 6. Permanent F-Shape Barrier on 6V:1H Slope before Test No. 452106-3.

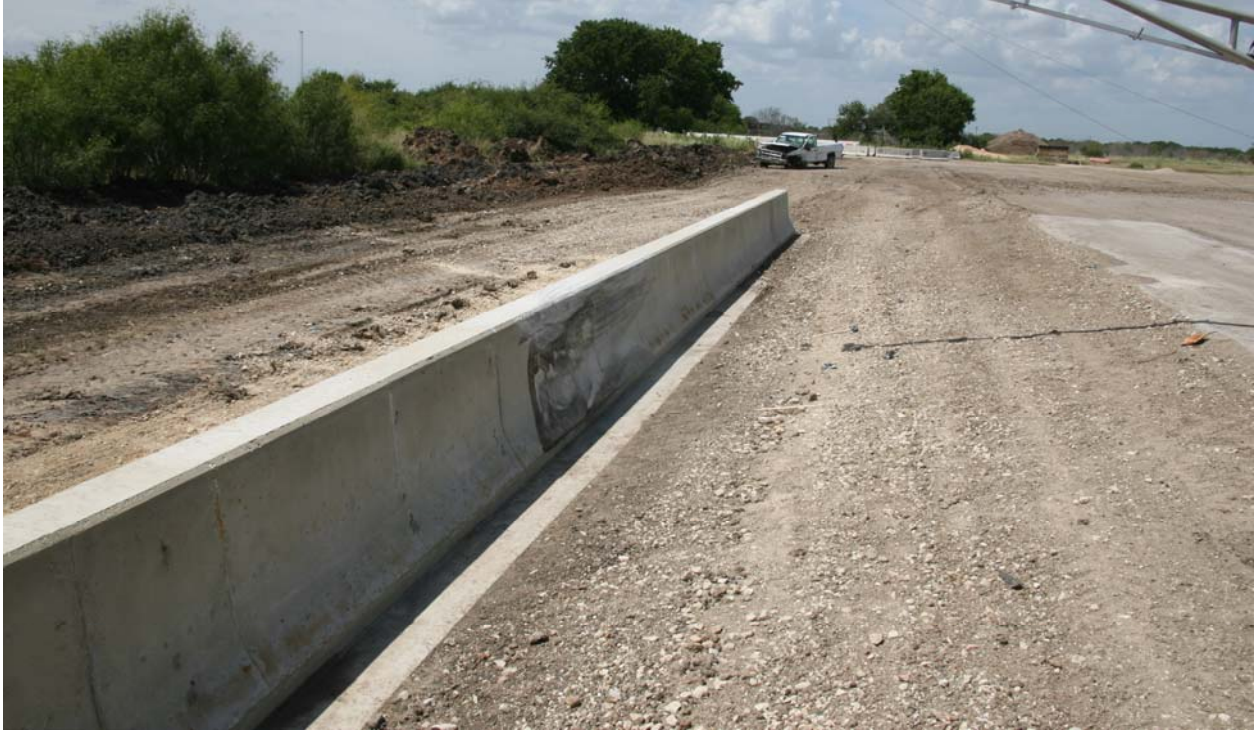
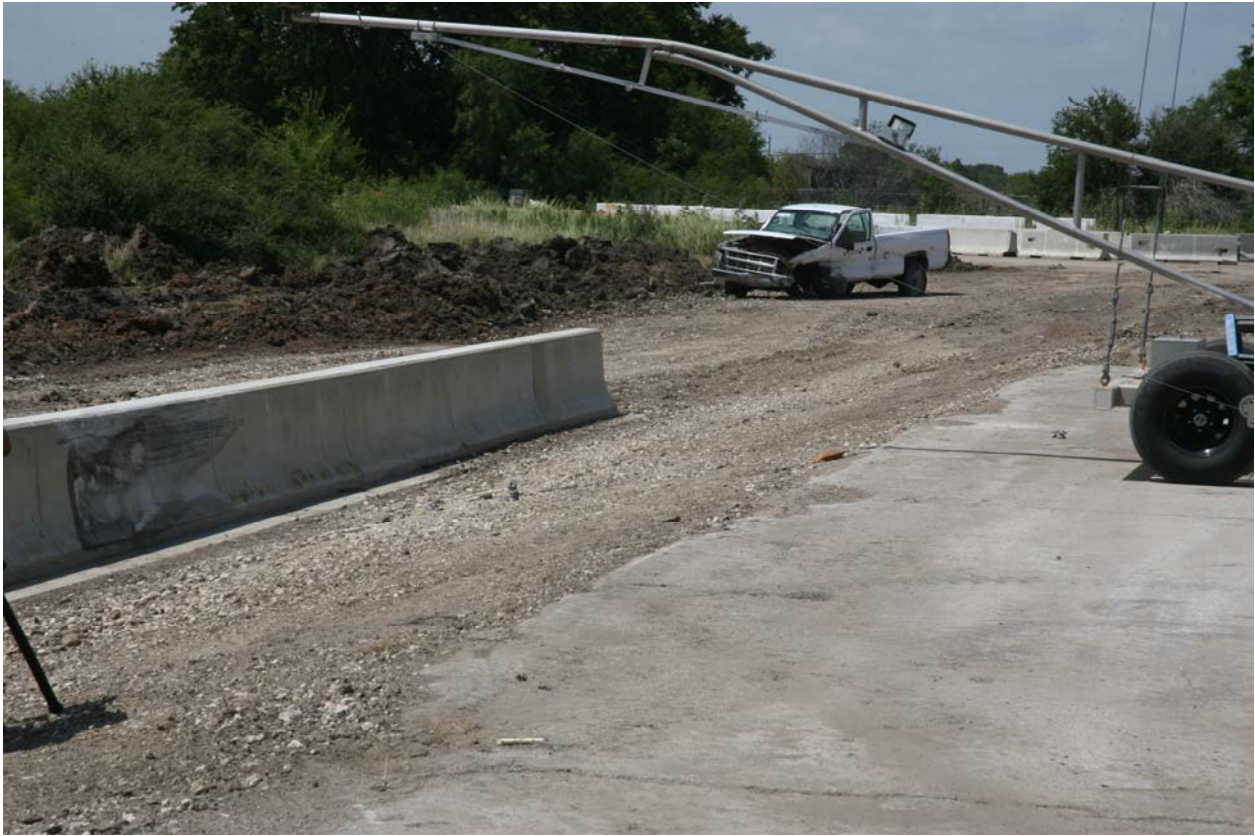
Figure 9. After Impact Trajectory Path for Test No. 452106-3.

The barrier sustained only cosmetic damage, as shown in [Figures 9](#) and [10](#). Tire marks marred the traffic face of the barrier. There were no cracks in the barrier and no measurable deflection of the barrier. Length of contact of the vehicle with the barrier was 11.5 ft.

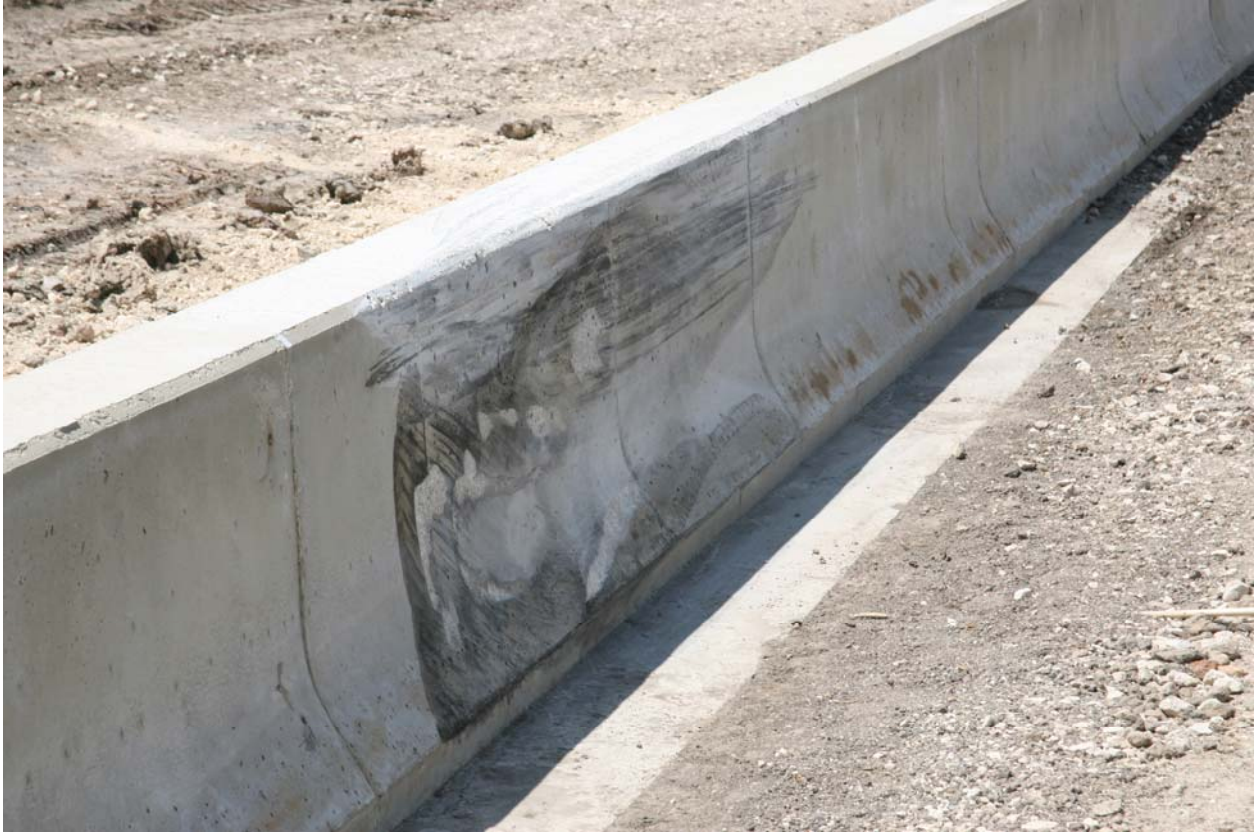
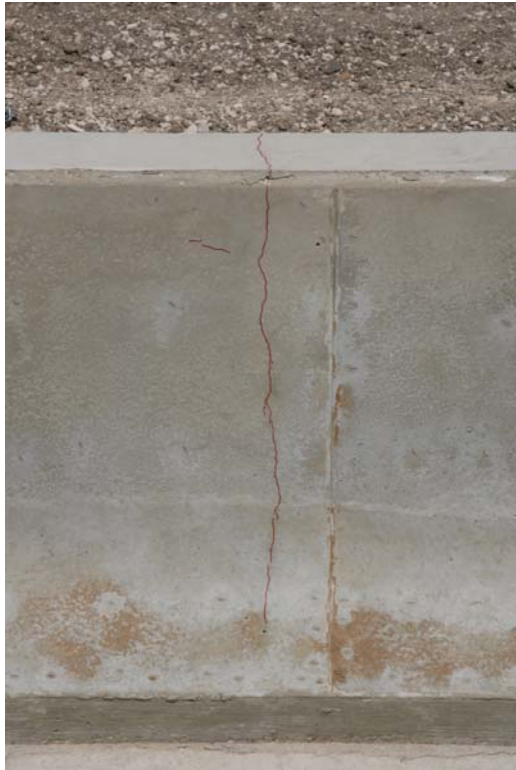
Figure 10. Installation after Test No. 452106-3.

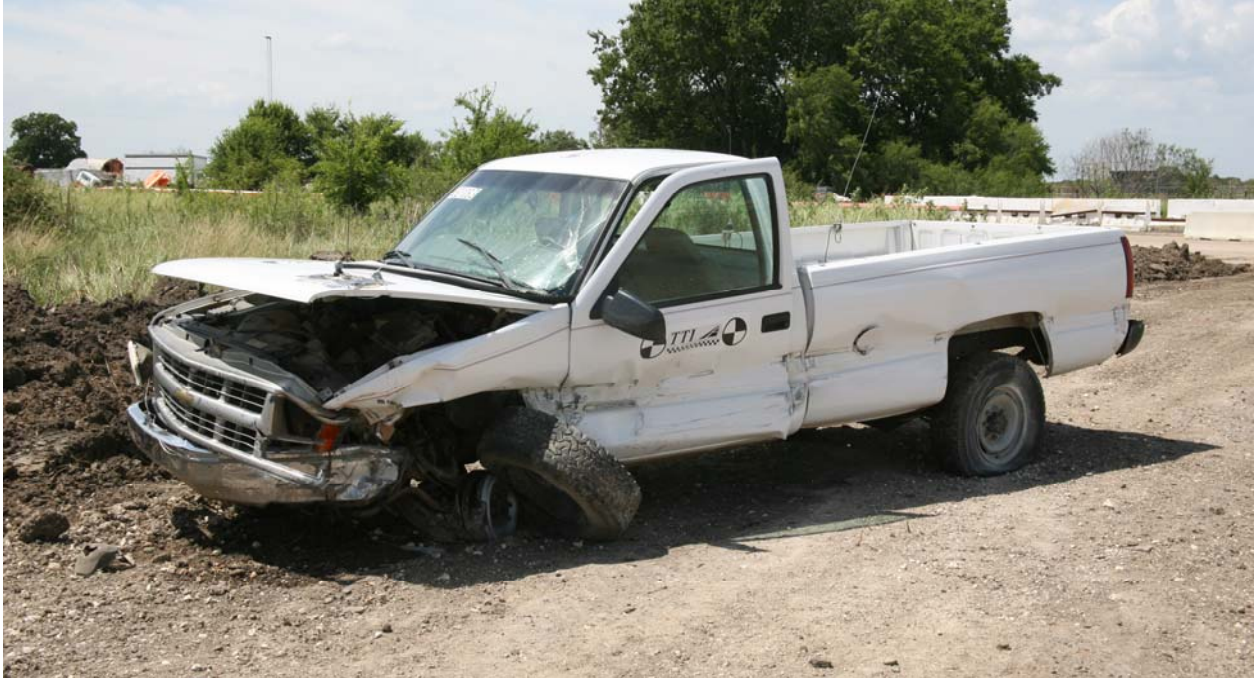
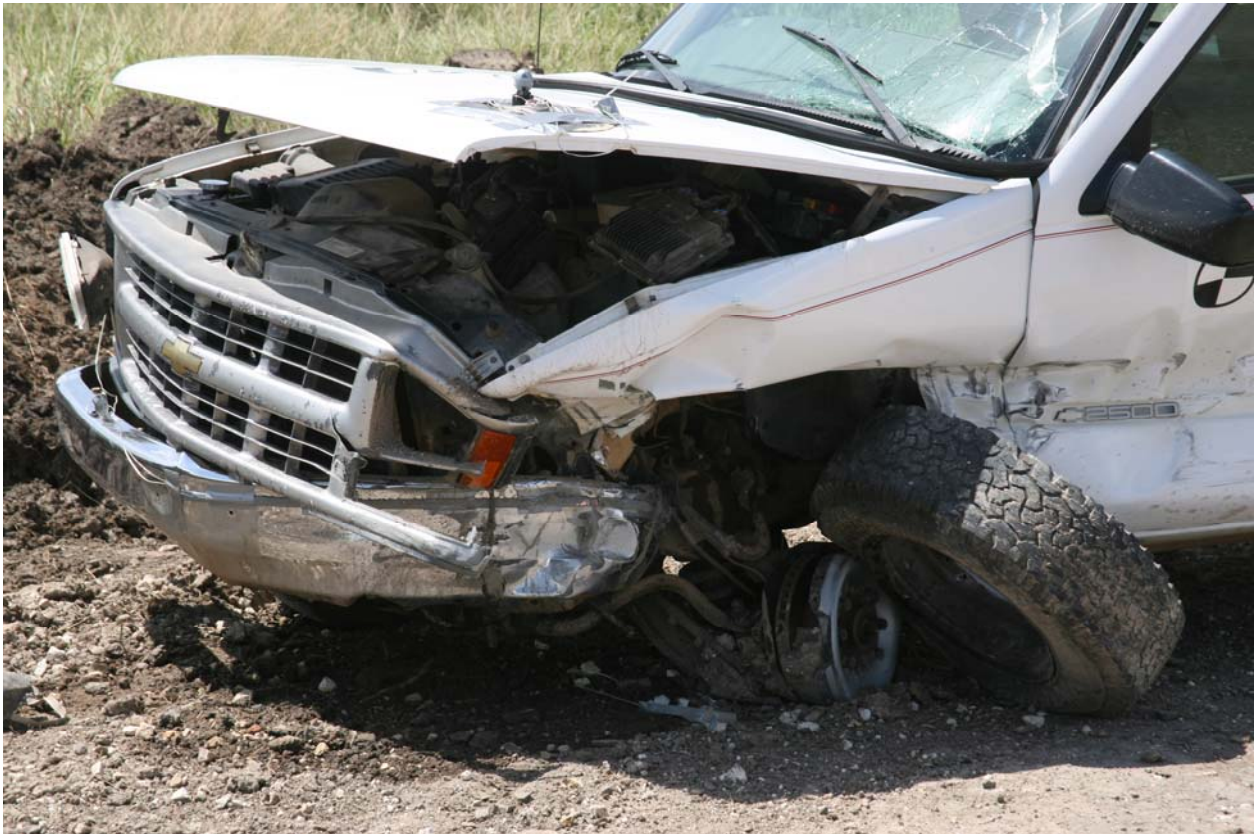
Figure 11. Vehicle after Test No. 452106-3.

Damage to the vehicle is shown in [Figure 11](#). Structural damage included deformed upper and lower A-arms and deformed frame rail. In addition, the front bumper, hood, grill, left front quarter panel, left side door, left rear exterior bed and rear bumper were damaged. The inner wheel rim separated from the outer rim on the left front wheel, and the tire was deflated. The left rear tire was deflated, and the wheel rim was deformed. The windshield sustained stress cracks. Maximum exterior crush to the frontal plane at the left front corner at bumper height was 21.6 inches. The seam in the floor pan on the left side separated, and the maximum occupant compartment deformation was 5.4 inches in the lateral area across the floor pan from kick panel to kick panel. Photographs of the interior of the vehicle are shown in [Figure 12](#). Exterior crush measurements and occupant compartment deformation are given in [Appendix B](#), [Tables 3](#) and [4](#).

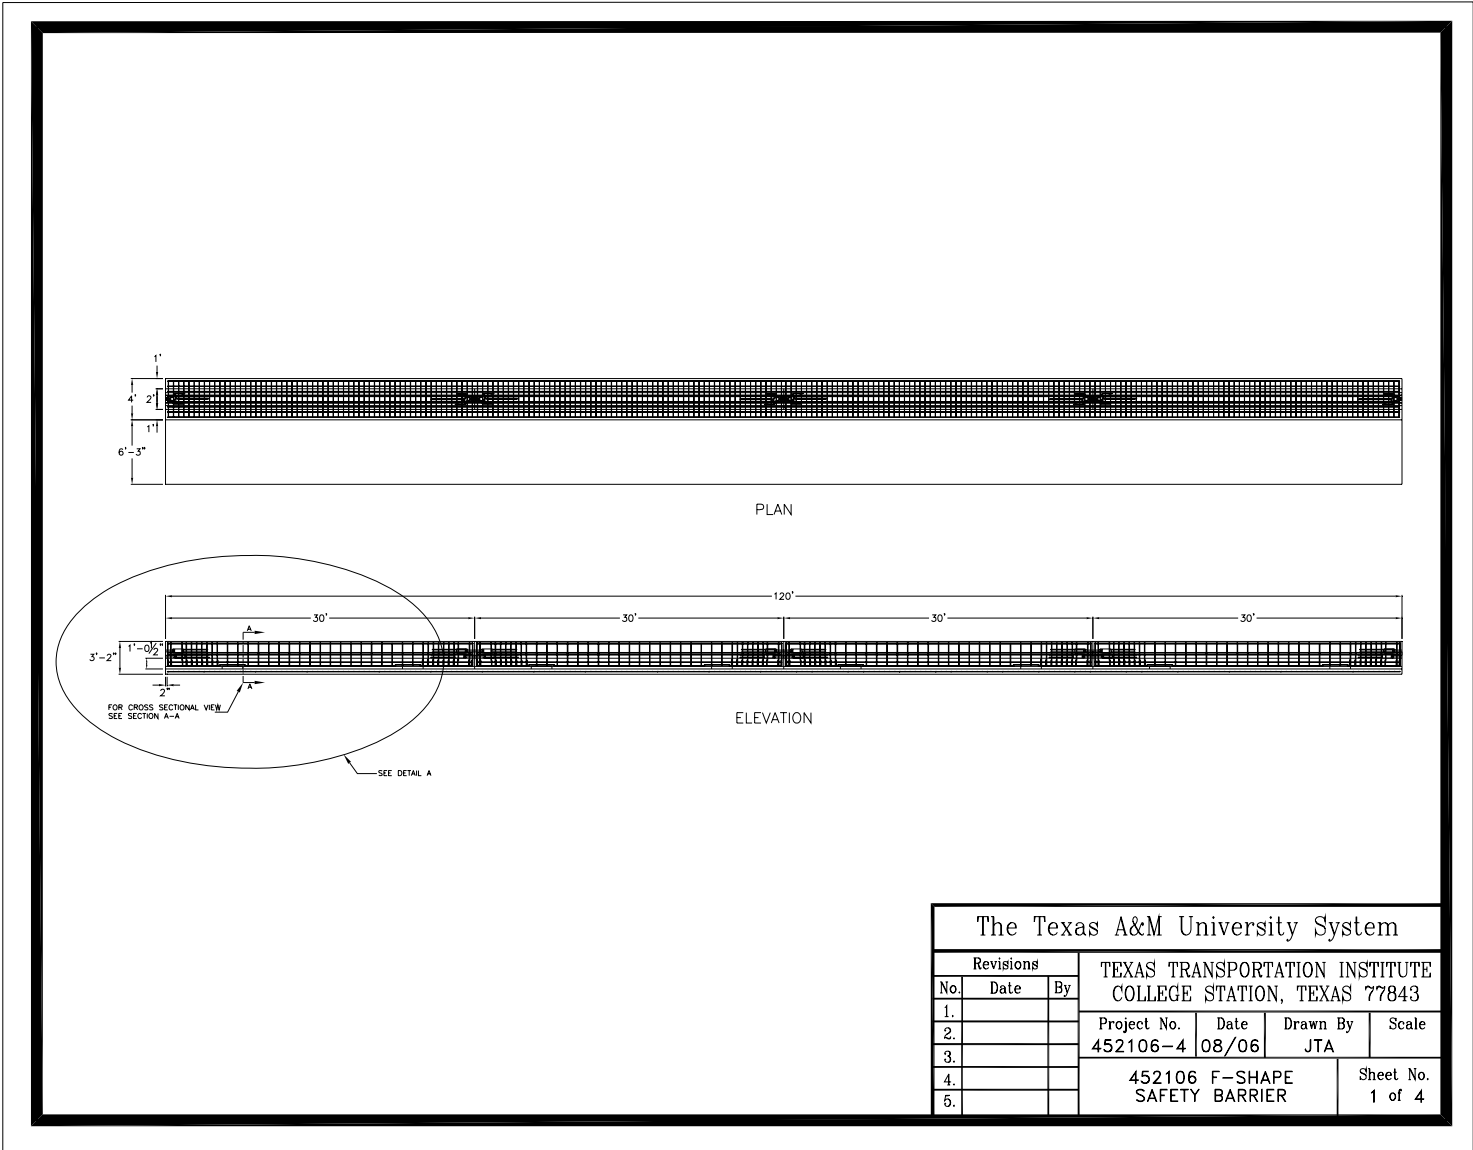
Figure 14. Details of Free-Standing, Precast F-Shape Barrier.

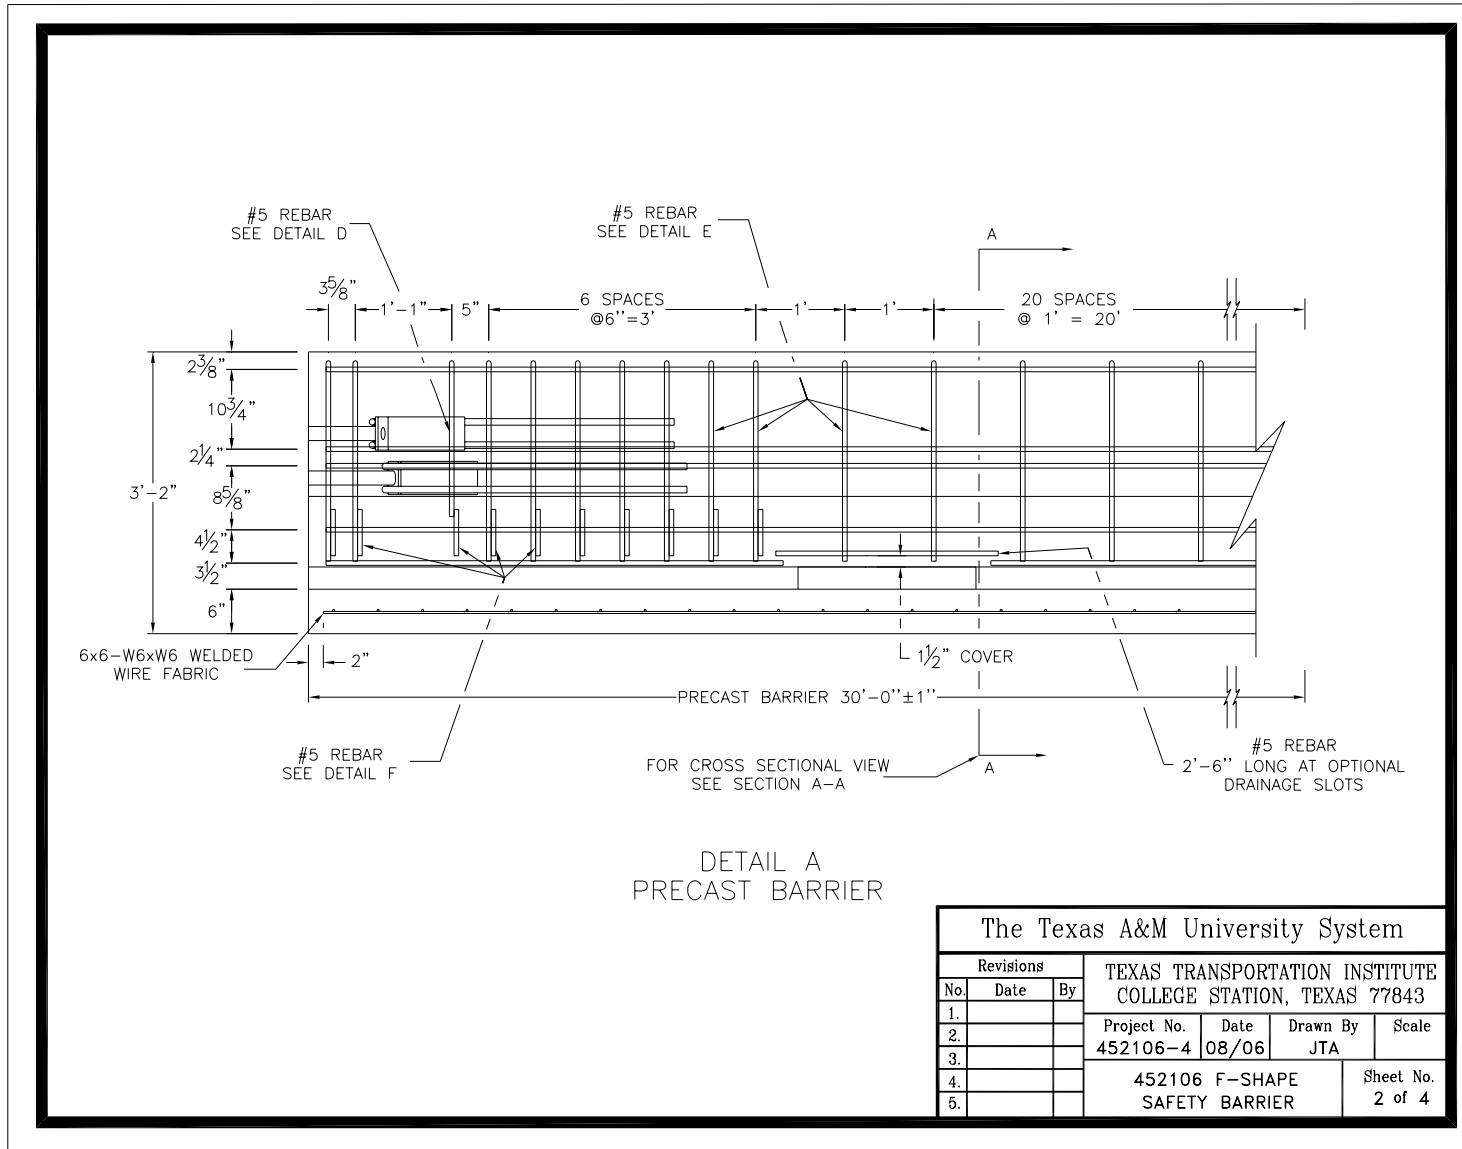
Figure 15. Details of Rebar Placement in Free-Standing, Precast F-Shape Barrier.

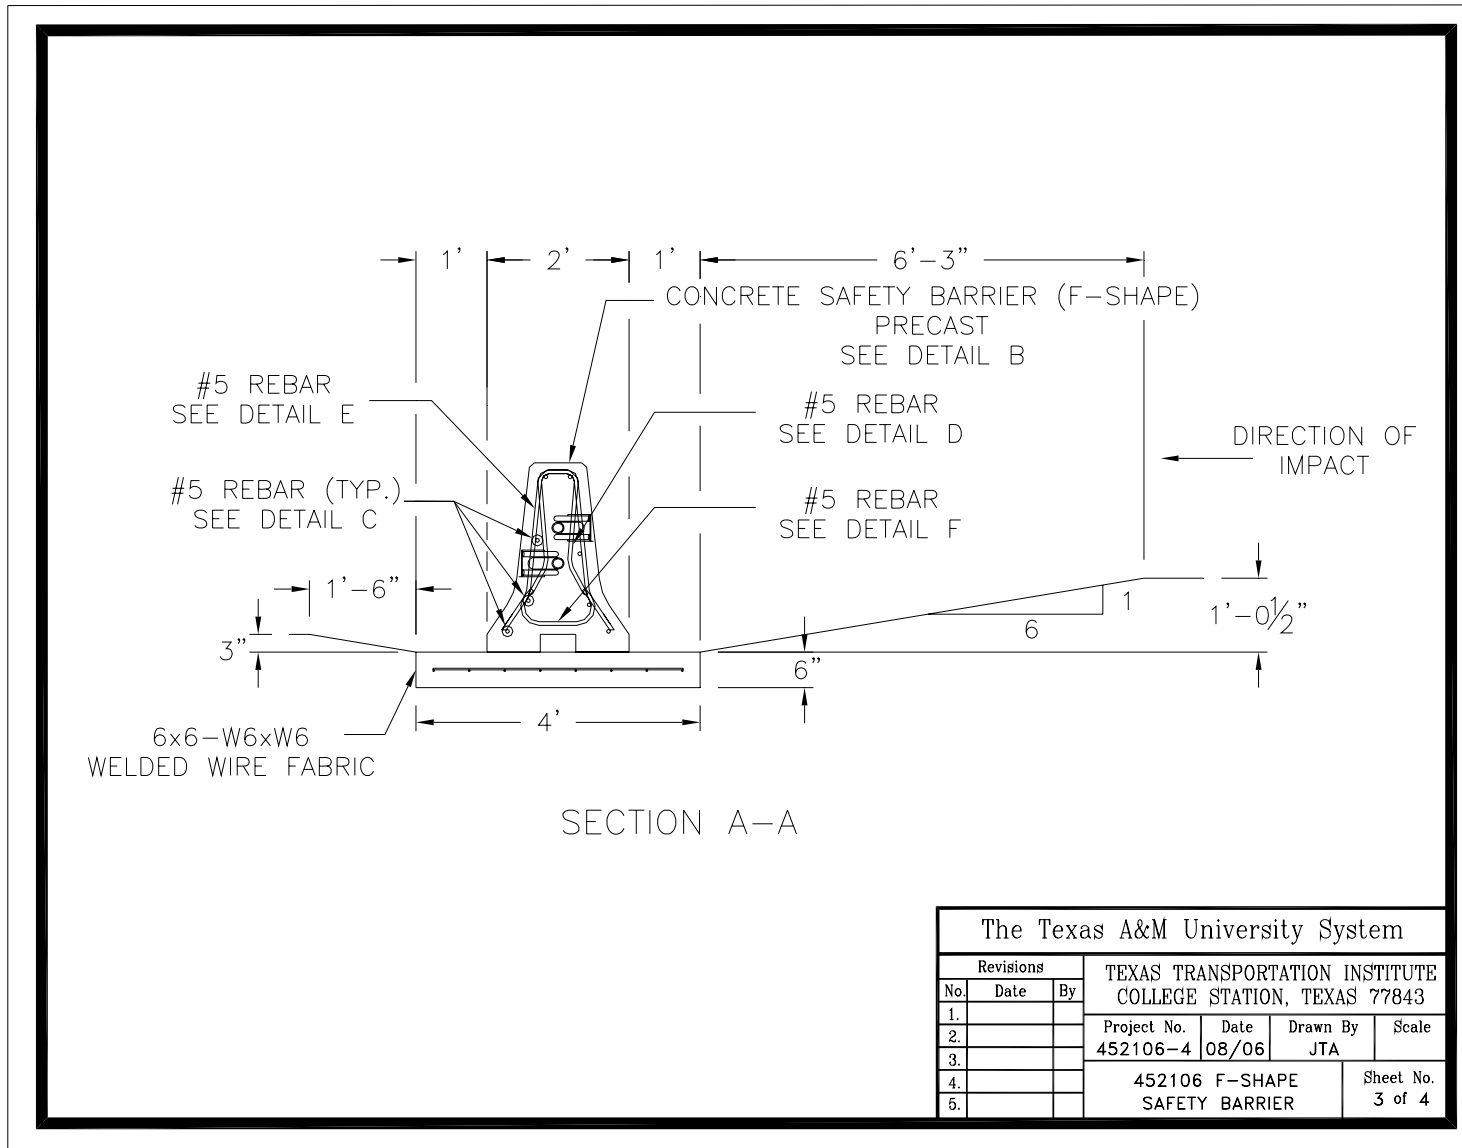
Figure 16. Cross Section of Free-Standing, Precast F-Shape Barrier.

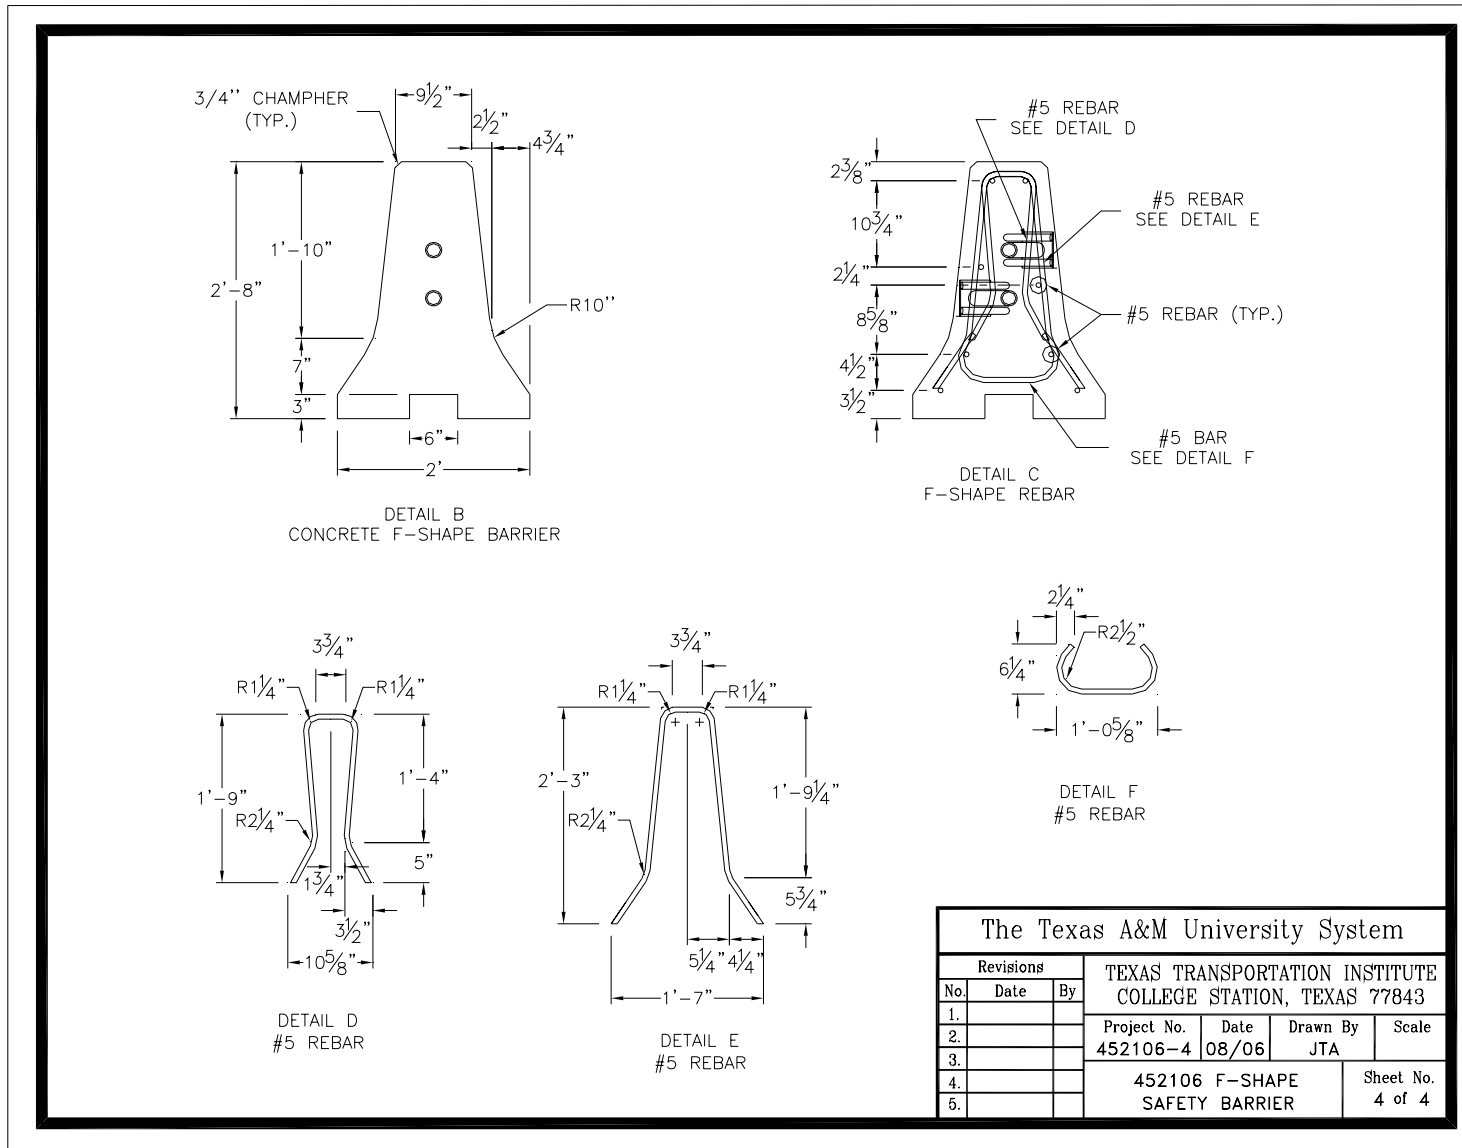
Figure 17. Cross Section of Free-Standing, Precast F-Shape Barrier.
