CRASH TESTING AND EVALUATION OF F-SHAPE BARRIERS ON SLOPES

Report 0-5210-3

Project Title: Roadside Crash Testing Program
for Design Guidance and Standard Detail Development

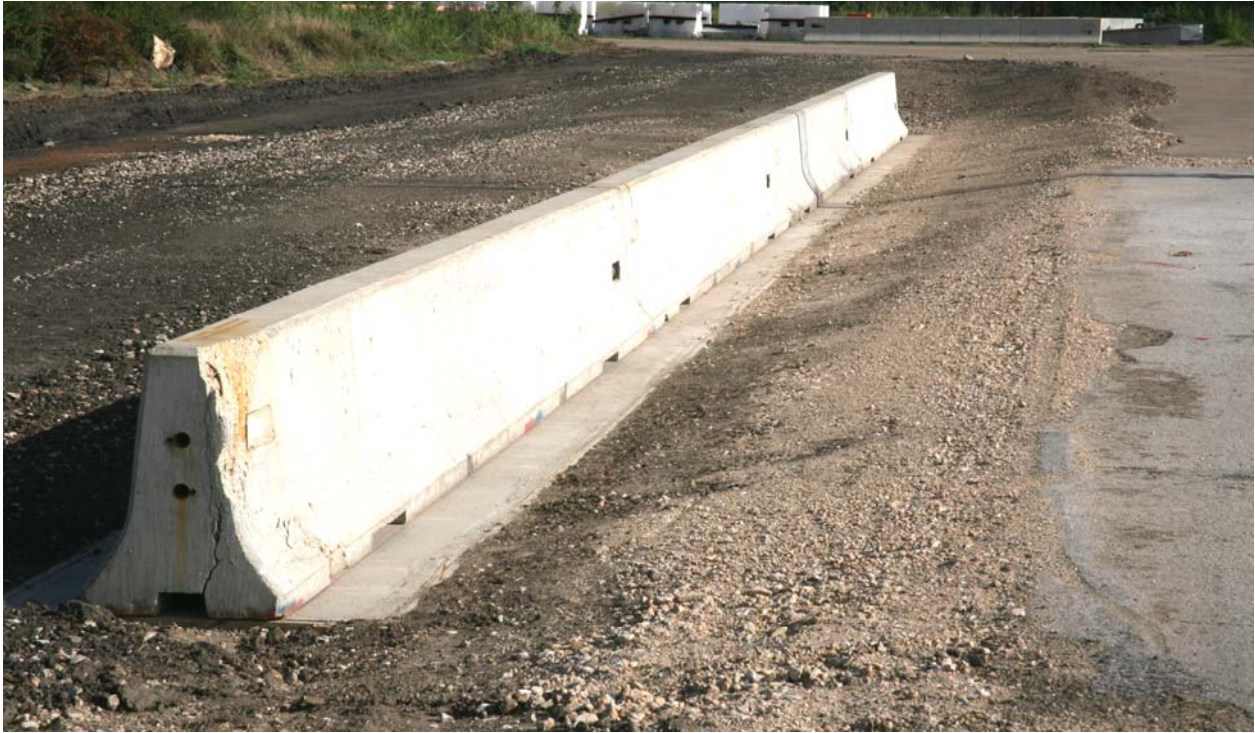
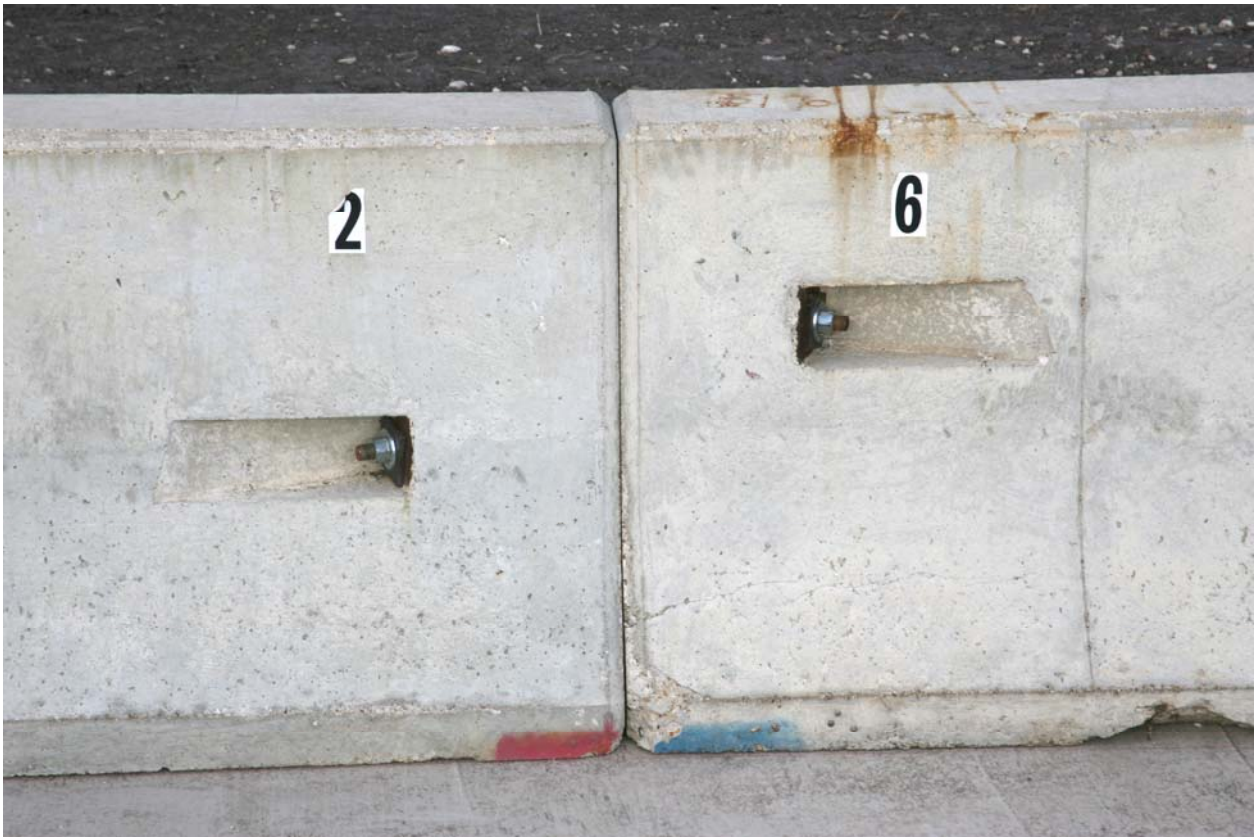
Figure 18. Free-Standing, Precast F-Shape Barrier on 6H:1V Slope before Test No. 452106-4.

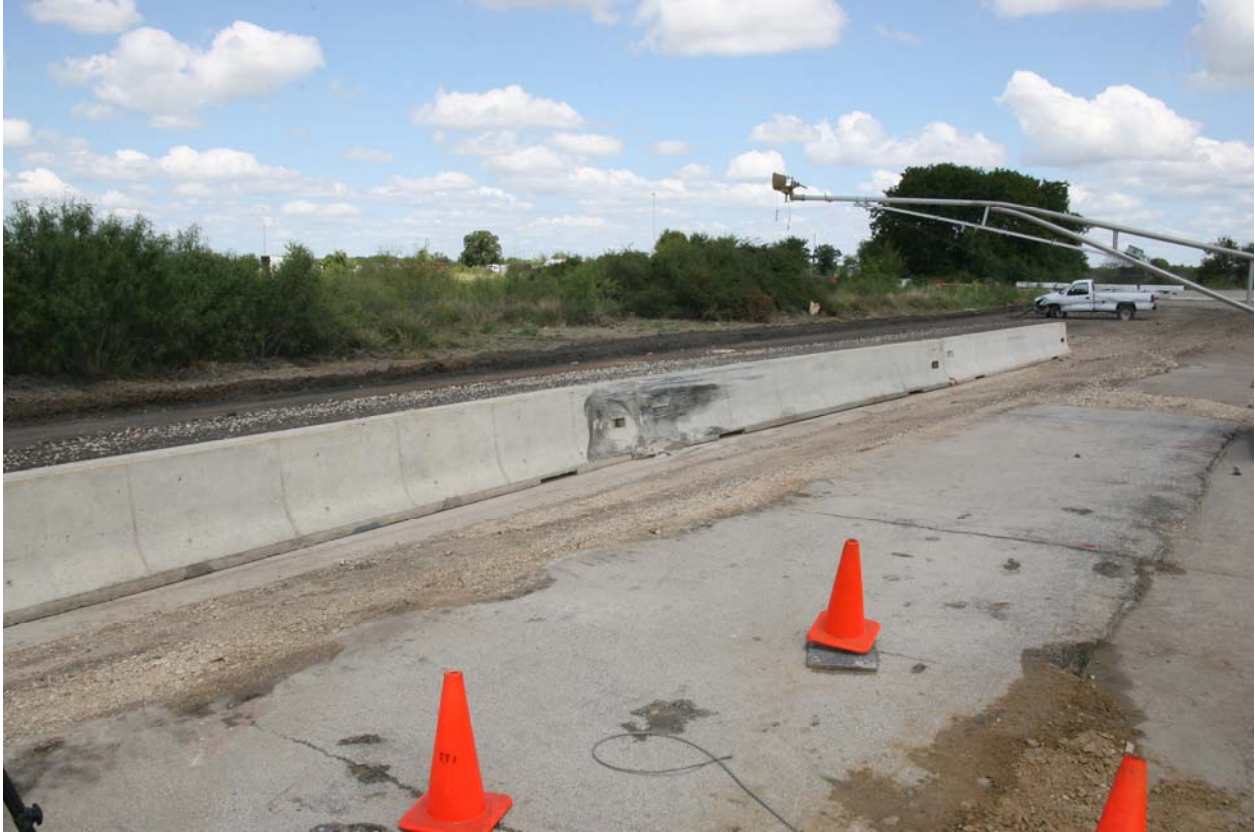
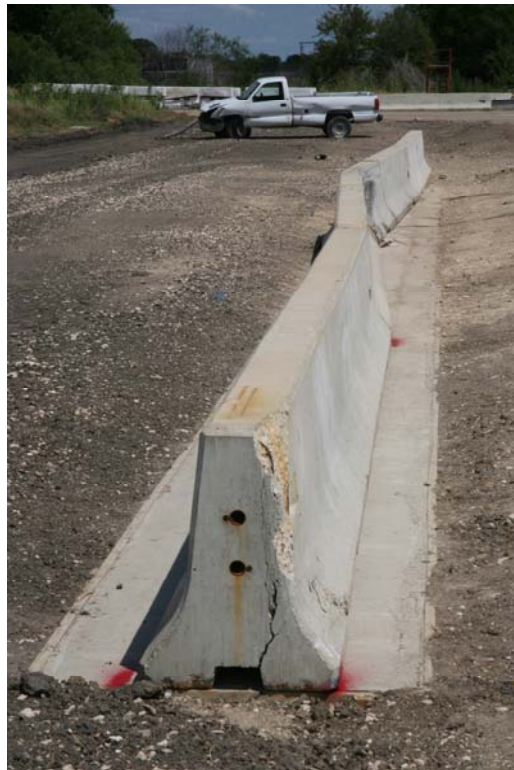
Figure 21. After Impact Trajectory Path for Test No. 452106-4.

Damage to the F-shape barrier is shown in [Figures 21 and 22](#). The upstream end of segment 1 was pushed toward the traffic side 1.6 inches. No movement was noted at the joint between segment 1 and 2, but the lower rear corner of segment 2 at the joint was spalled. The barrier was pushed toward the field side 13.4 inches at the joint between segments 2 and 3, and both segments were spalled on the traffic side of the barriers at this joint. The barrier was pushed toward the field side 0.6 inch at the joint between segments 3 and 4; the lower corners on the field side of both segments were spalled, as were the top corners on the field side of segment 4 and the top corner of the traffic side of segment 4. The downstream end of segment 4 was pushed toward the traffic side 2.8 inches. Length of contact of the vehicle with the barrier was 44 ft. Maximum dynamic deflection during the test was 1.15 ft, and maximum permanent deflection was 1.12 ft.

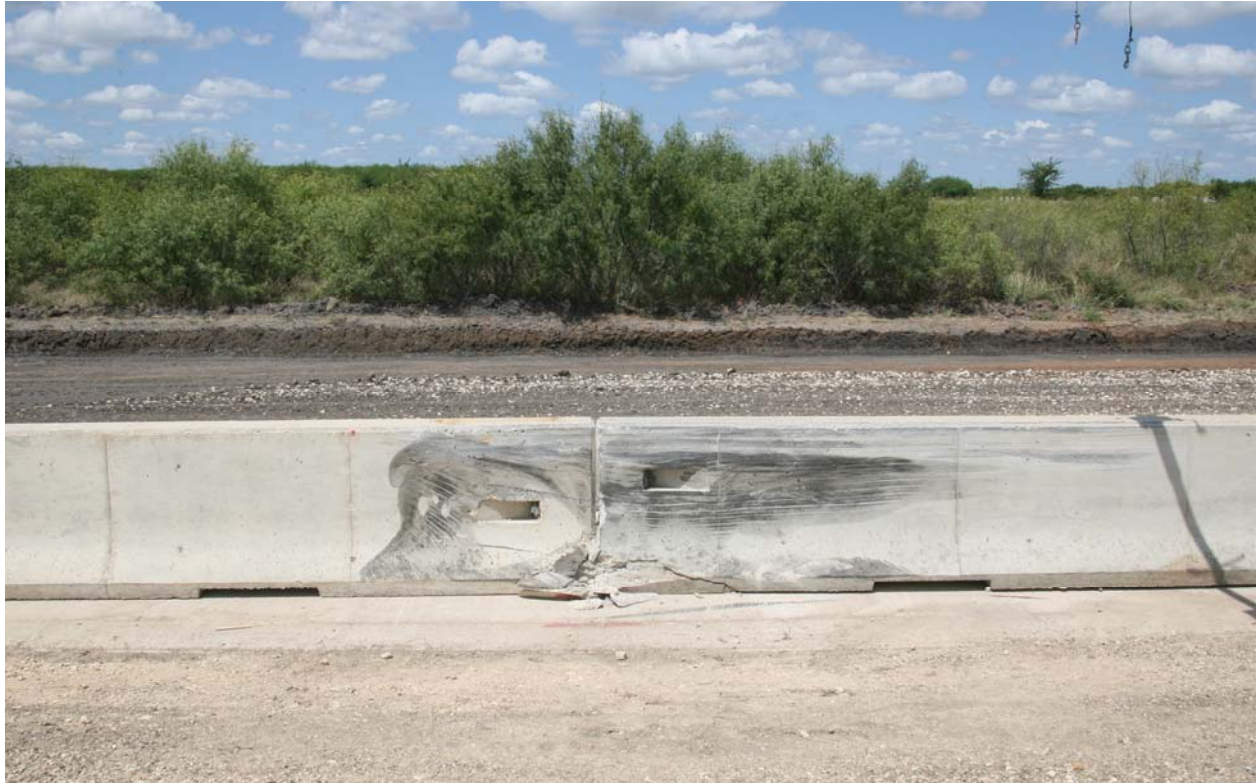
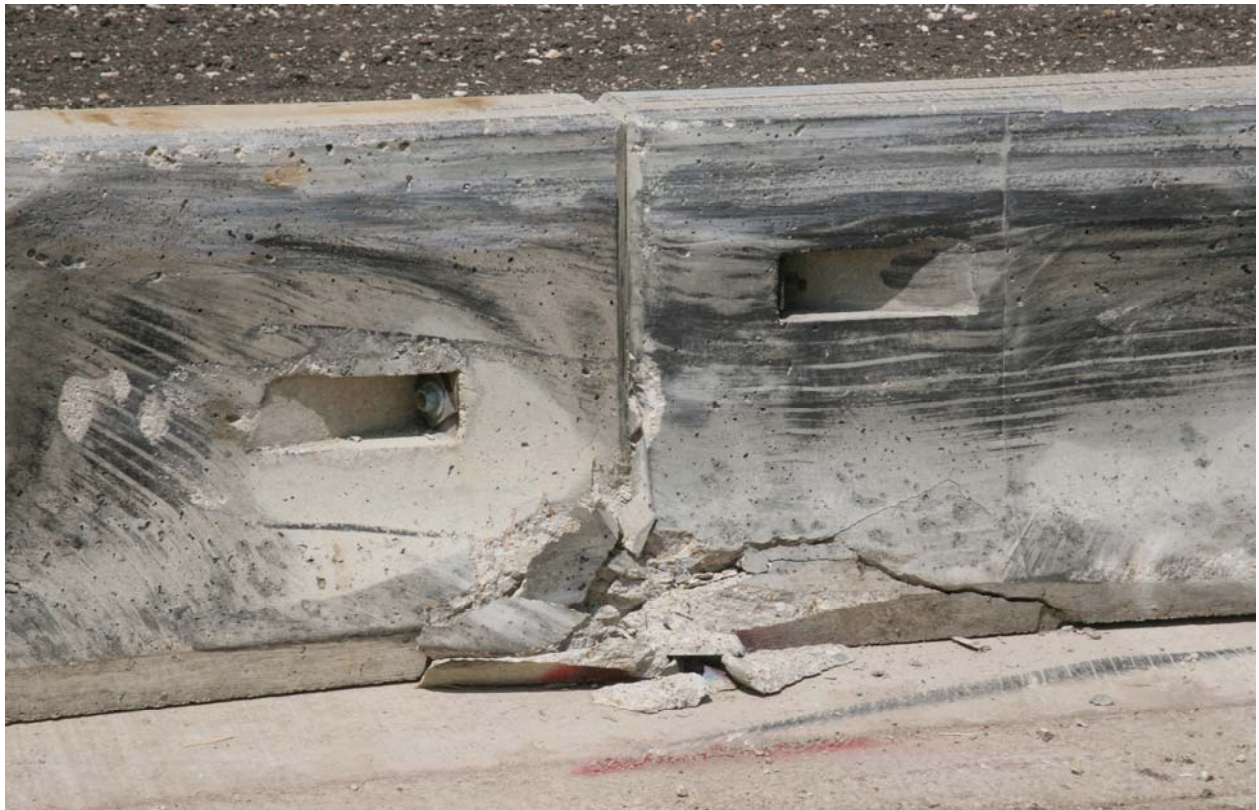
Figure 22. Installation after Test No. 452106-4.

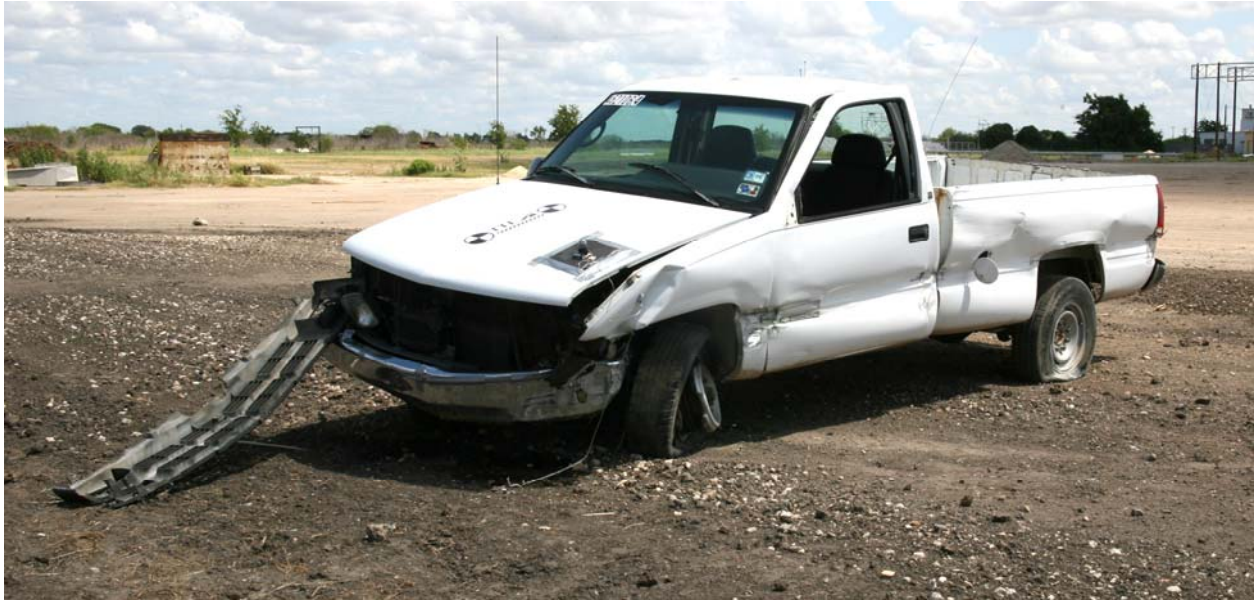
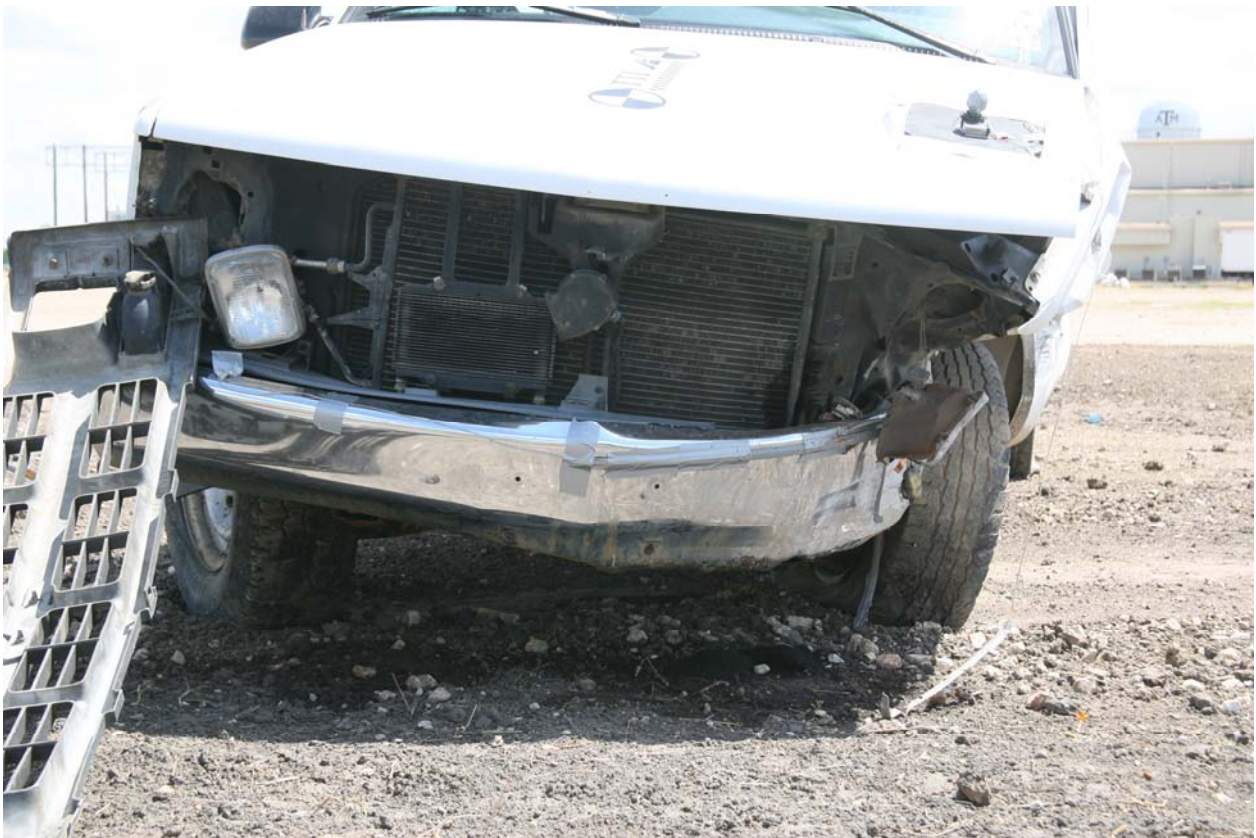
Figure 23. Vehicle after Test No. 452106-4.

The vehicle sustained damage to the left side, as shown in [Figure 23](#). Structural damage was imparted to the left upper and lower A-arms, left tie rod, sway bar and left frame rail. Also damaged were the front bumper, hood, grill, radiator and fan, left front quarter panel, left door and glass, left rear exterior bed, and rear bumper. The inner wheel rim separated from the outer wheel rim on the left front and the tire was deflated. The left rear wheel rim was deformed, and the tire was deflated. Maximum exterior crush to the vehicle was 22 inches in the side plane at the left front corner at bumper height. Maximum occupant compartment deformation was 5 inches in the floor pan to instrument panel area on the left side. Photographs of the interior of the vehicle are shown in [Figure 24](#). Exterior crush measurements and occupant compartment deformation are presented in [Appendix B, Tables 5 and 6](#).

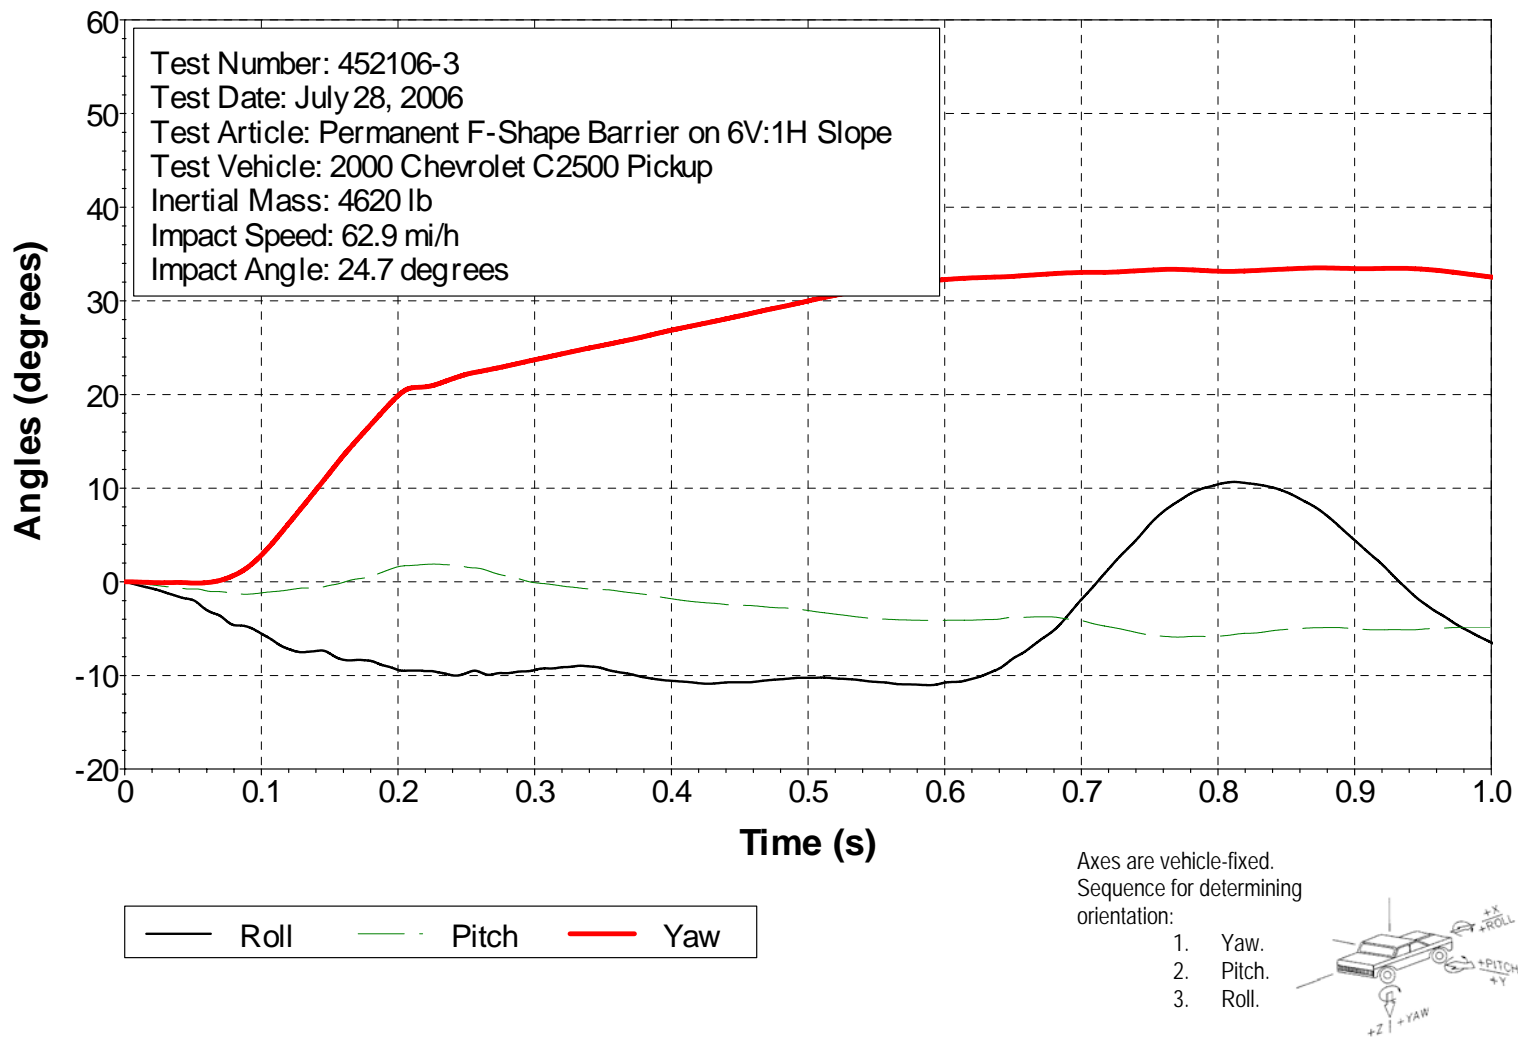
Figure 32. Vehicle Angular Displacements for Test 452106-3.

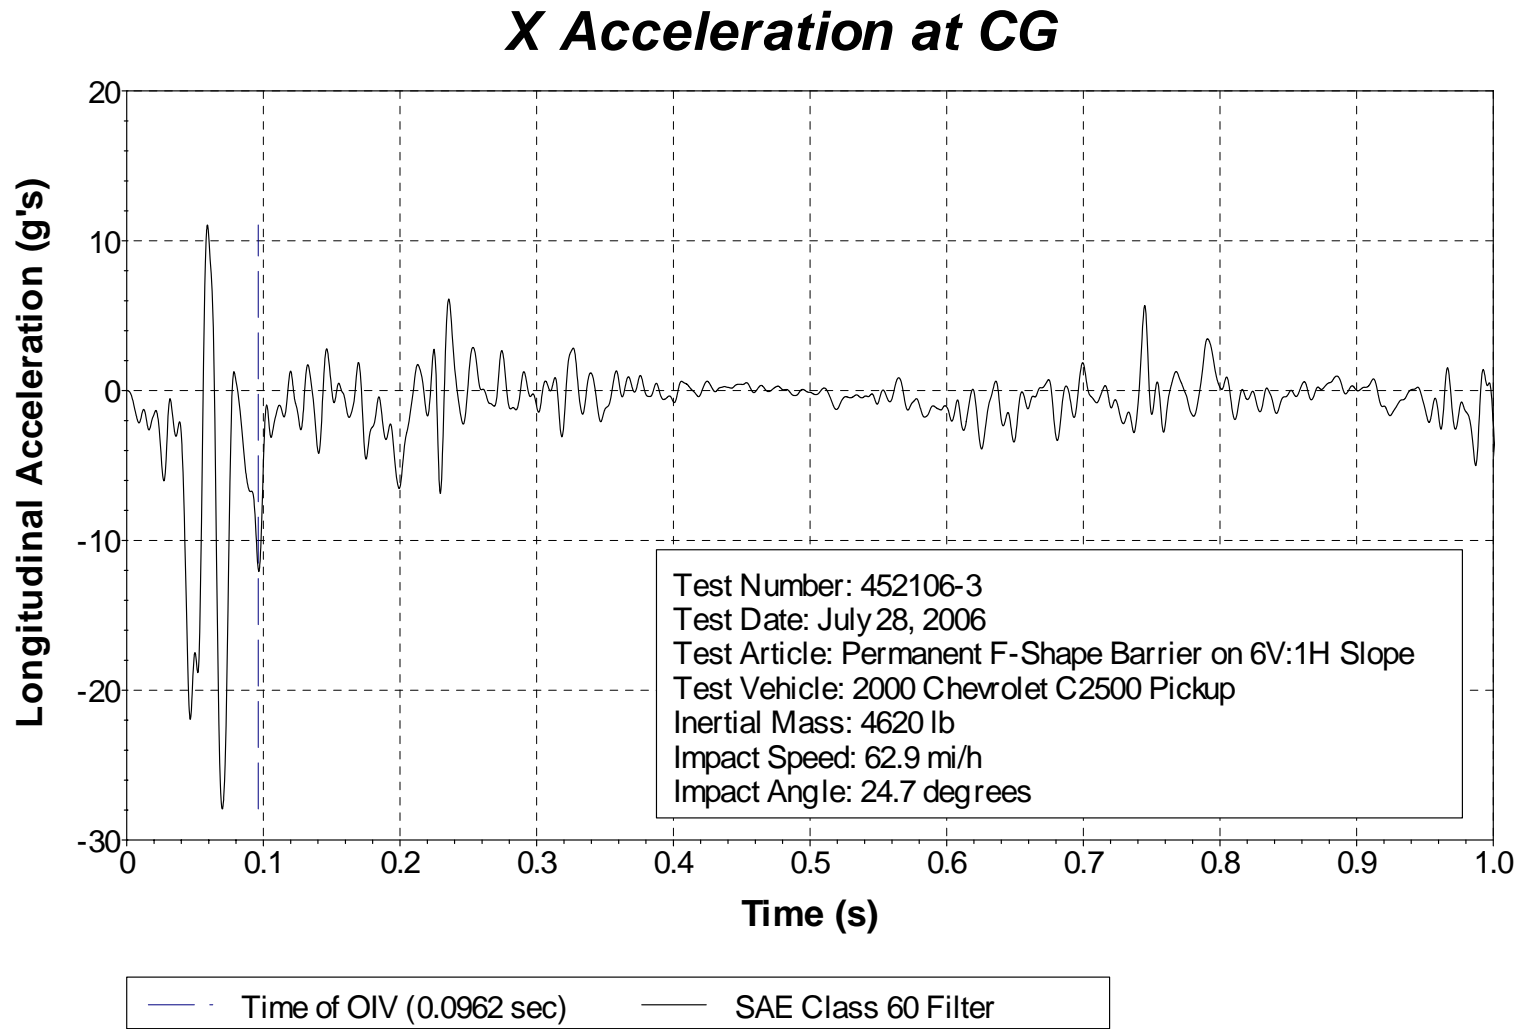
**Figure 33. Vehicle Longitudinal Accelerometer Trace for Test 452106-3
(Accelerometer Located at Center of Gravity).**

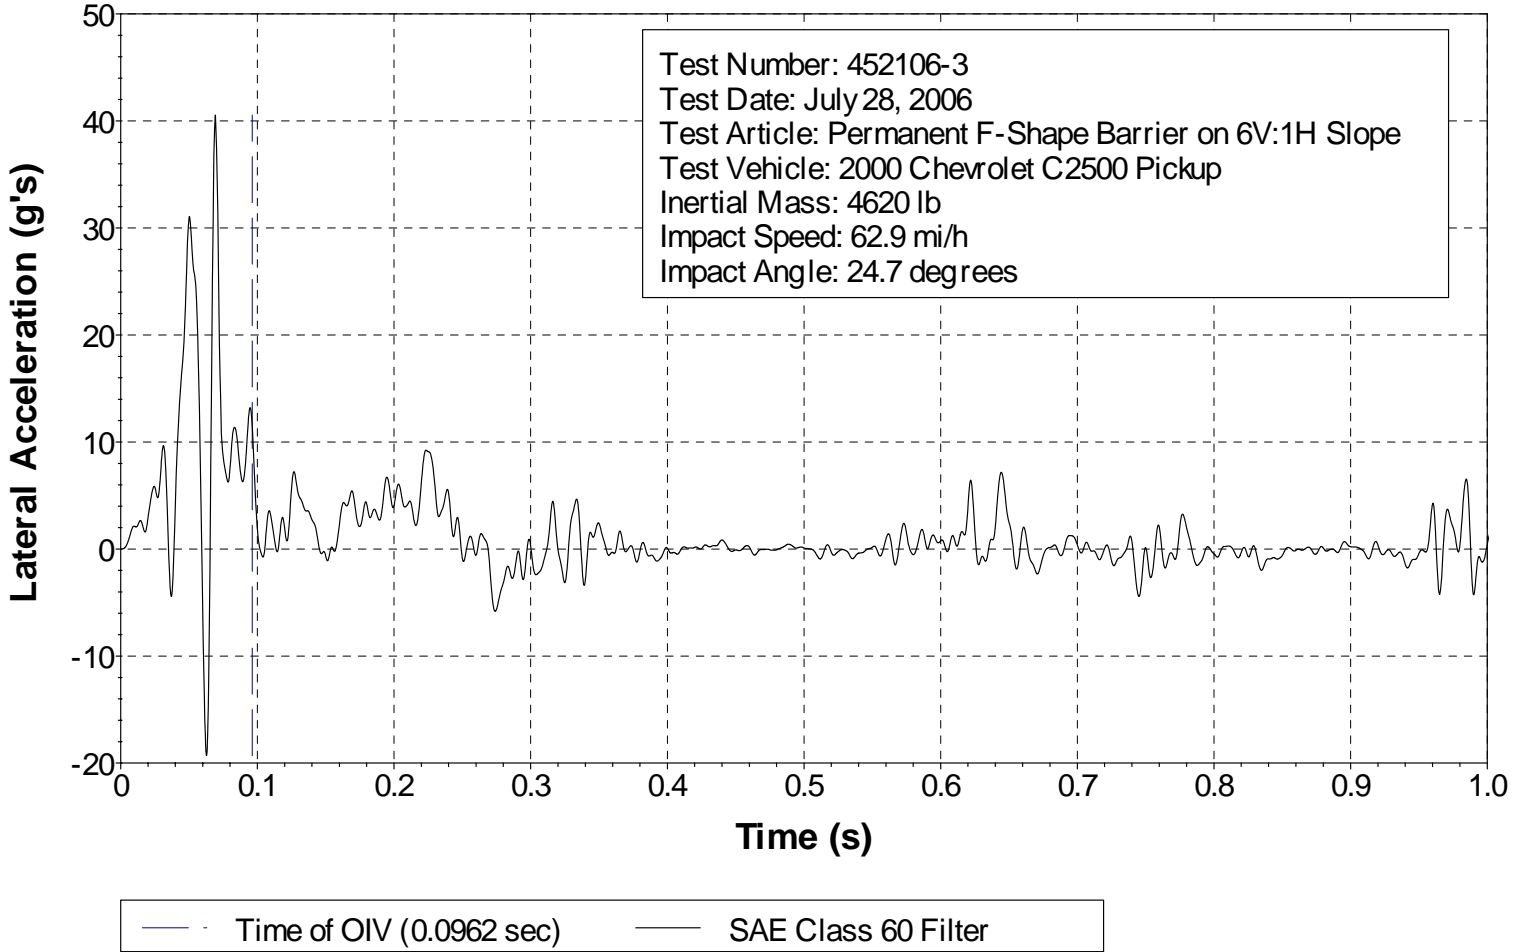
Figure 34. Vehicle Lateral Accelerometer Trace for Test 452106-3 (Accelerometer Located at Center of Gravity).

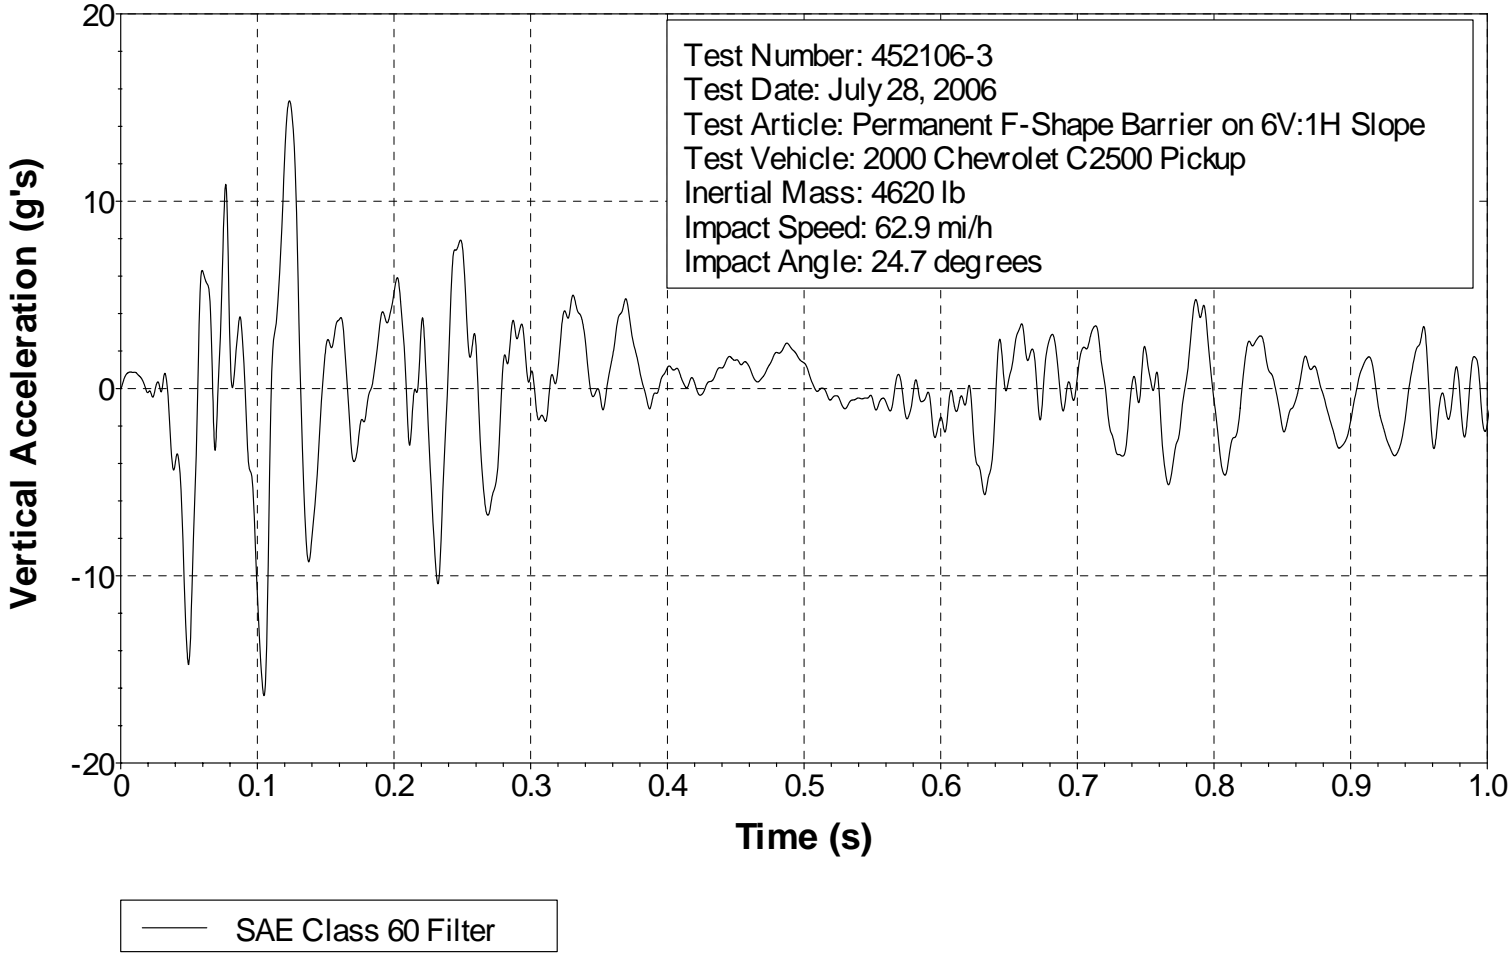
Figure 35. Vehicle Vertical Accelerometer Trace for Test 452106-3 (Accelerometer Located at Center of Gravity).

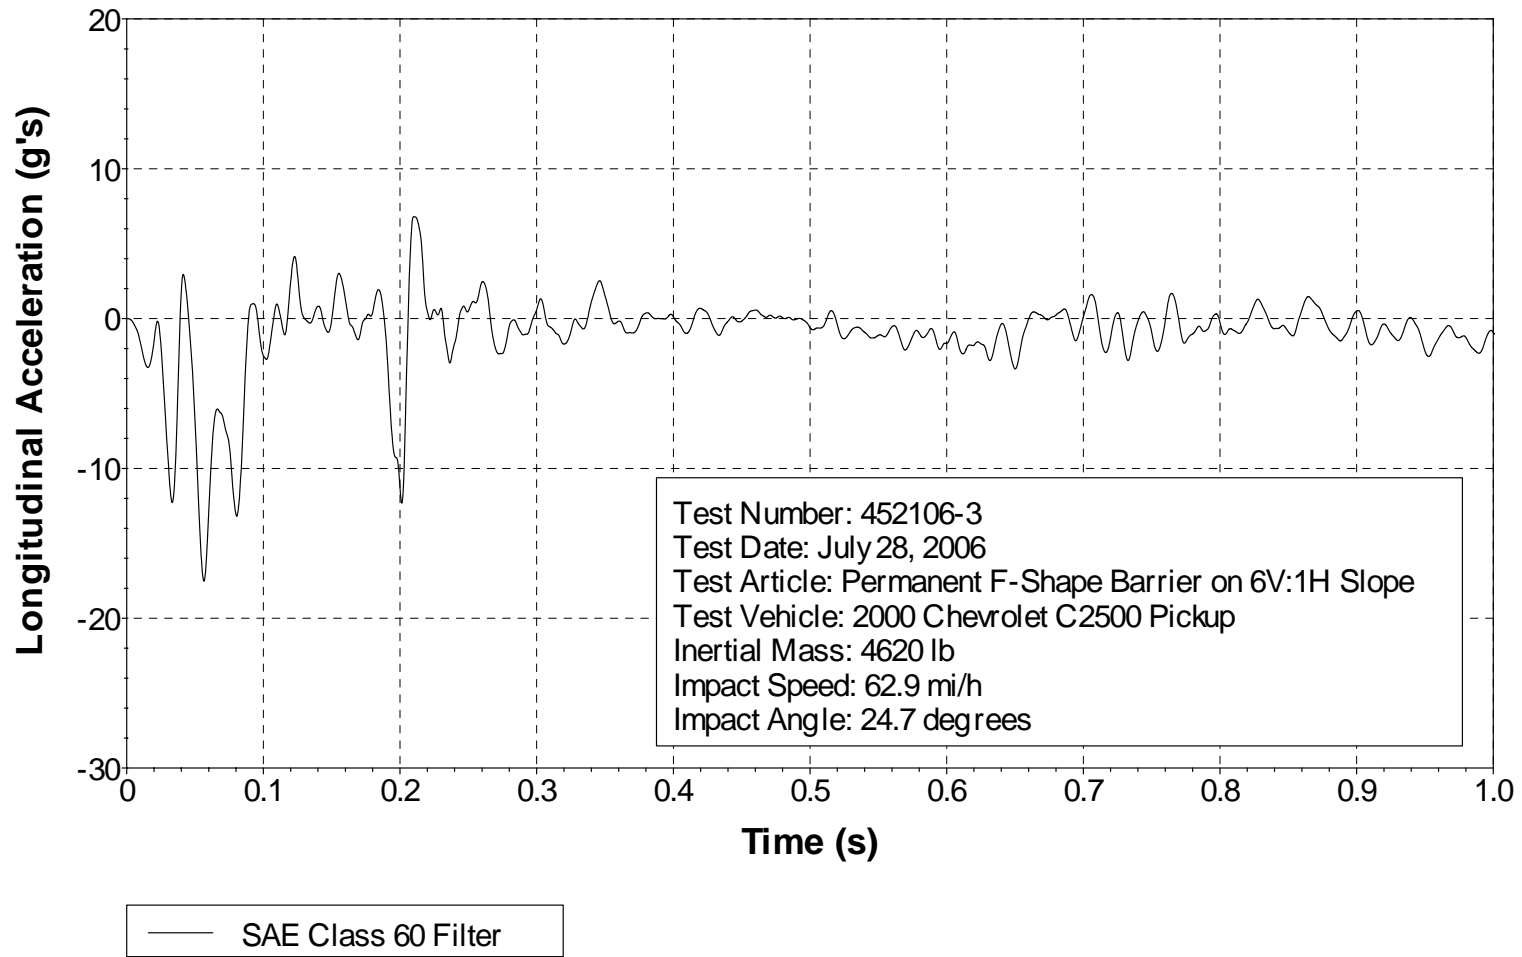
Figure 36. Vehicle Longitudinal Accelerometer Trace for Test 452106-3 (Accelerometer Located over Rear Axle).

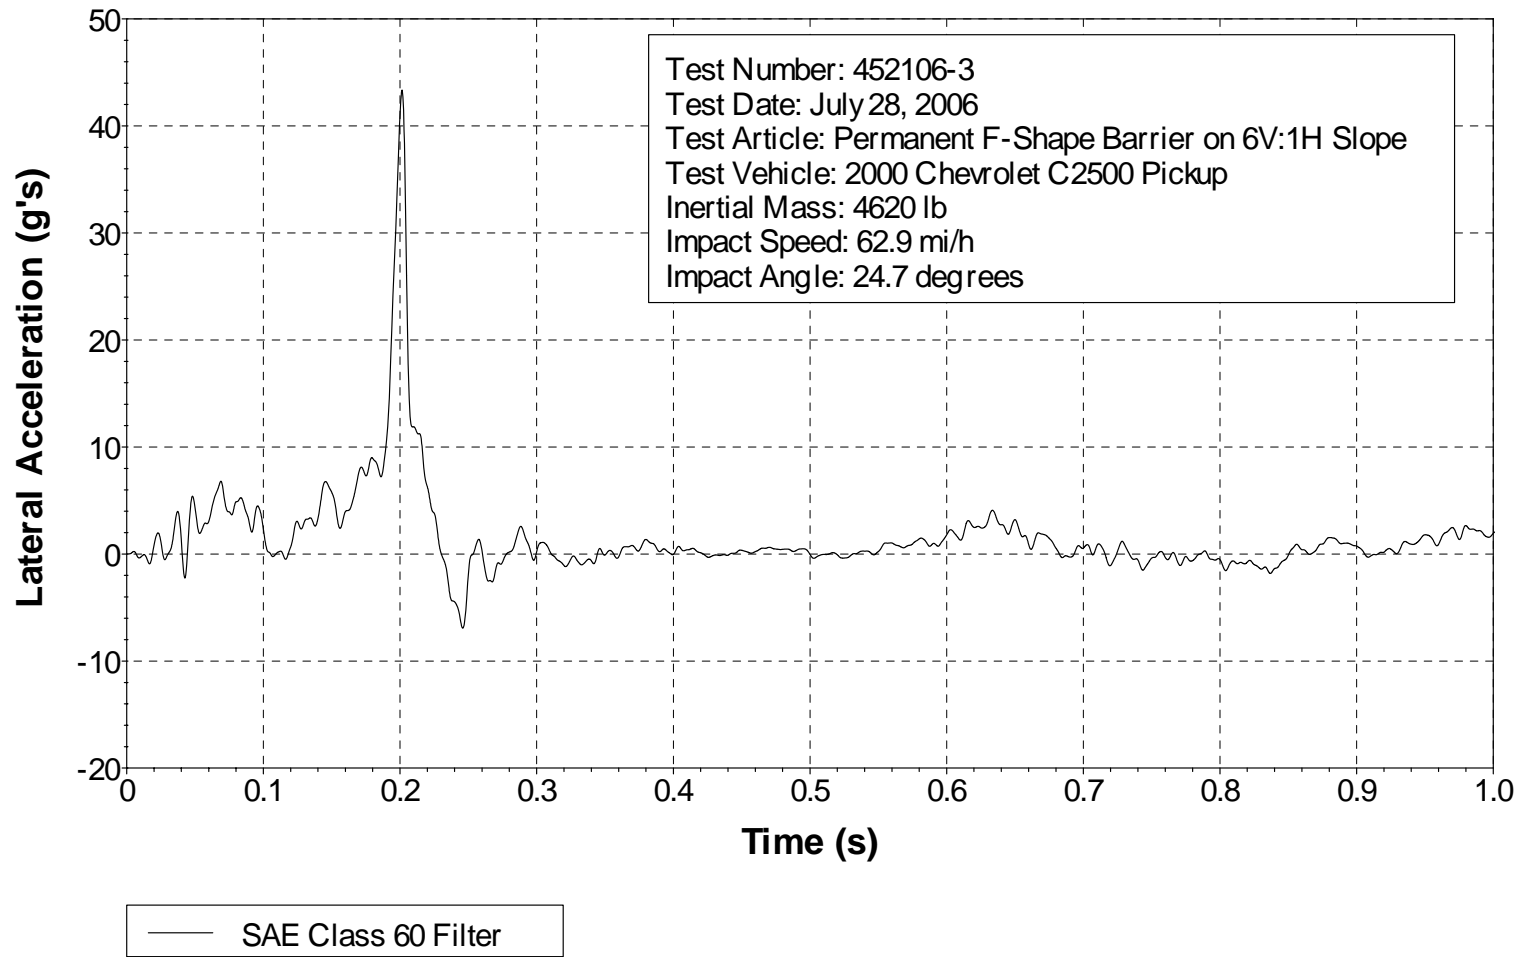
**Figure 37. Vehicle Lateral Accelerometer Trace for Test 452106-3
(Accelerometer Located over Rear Axle).**

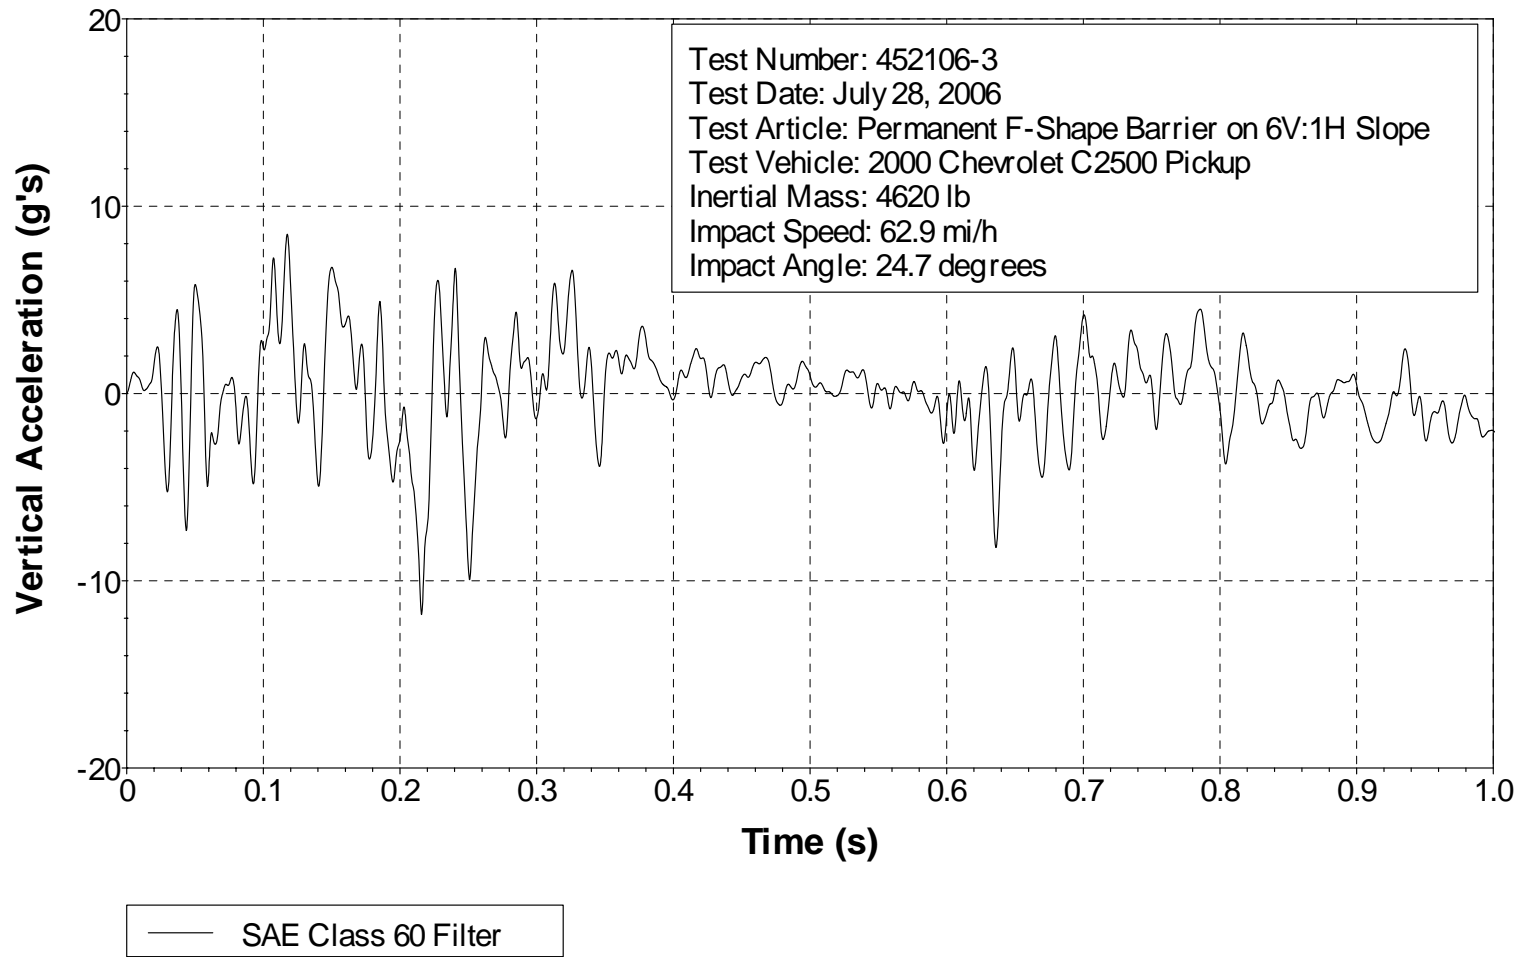
**Figure 38. Vehicle Vertical Accelerometer Trace for Test 452106-3
(Accelerometer Located over Rear Axle).**

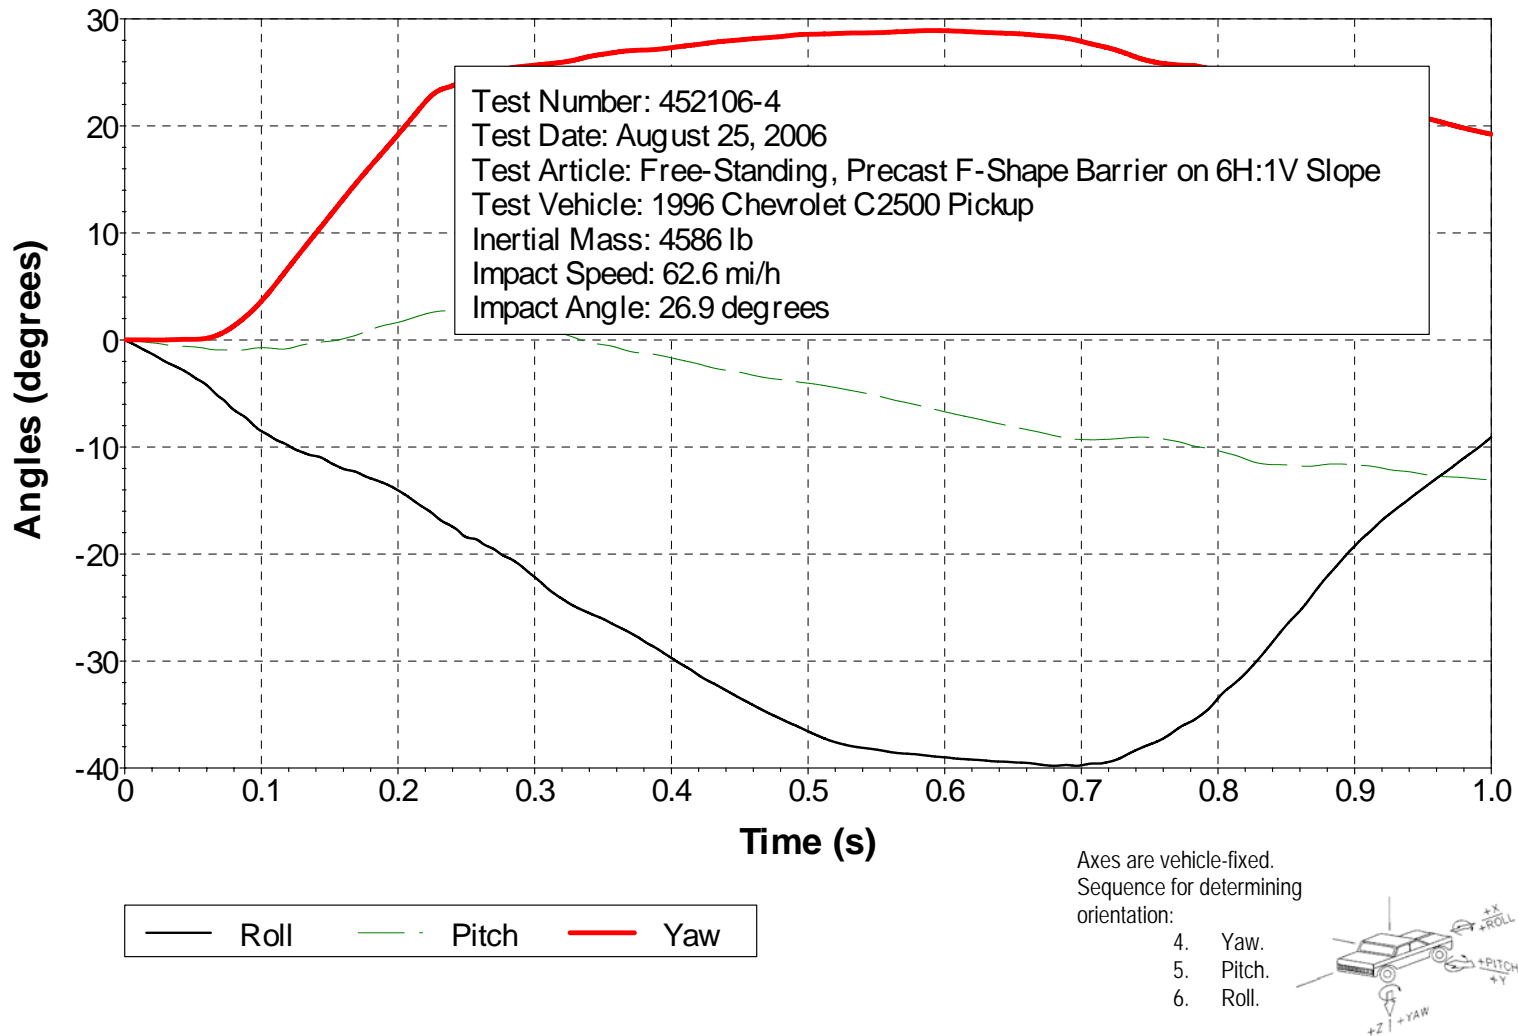
Figure 39. Vehicle Angular Displacements for Test 452106-4.

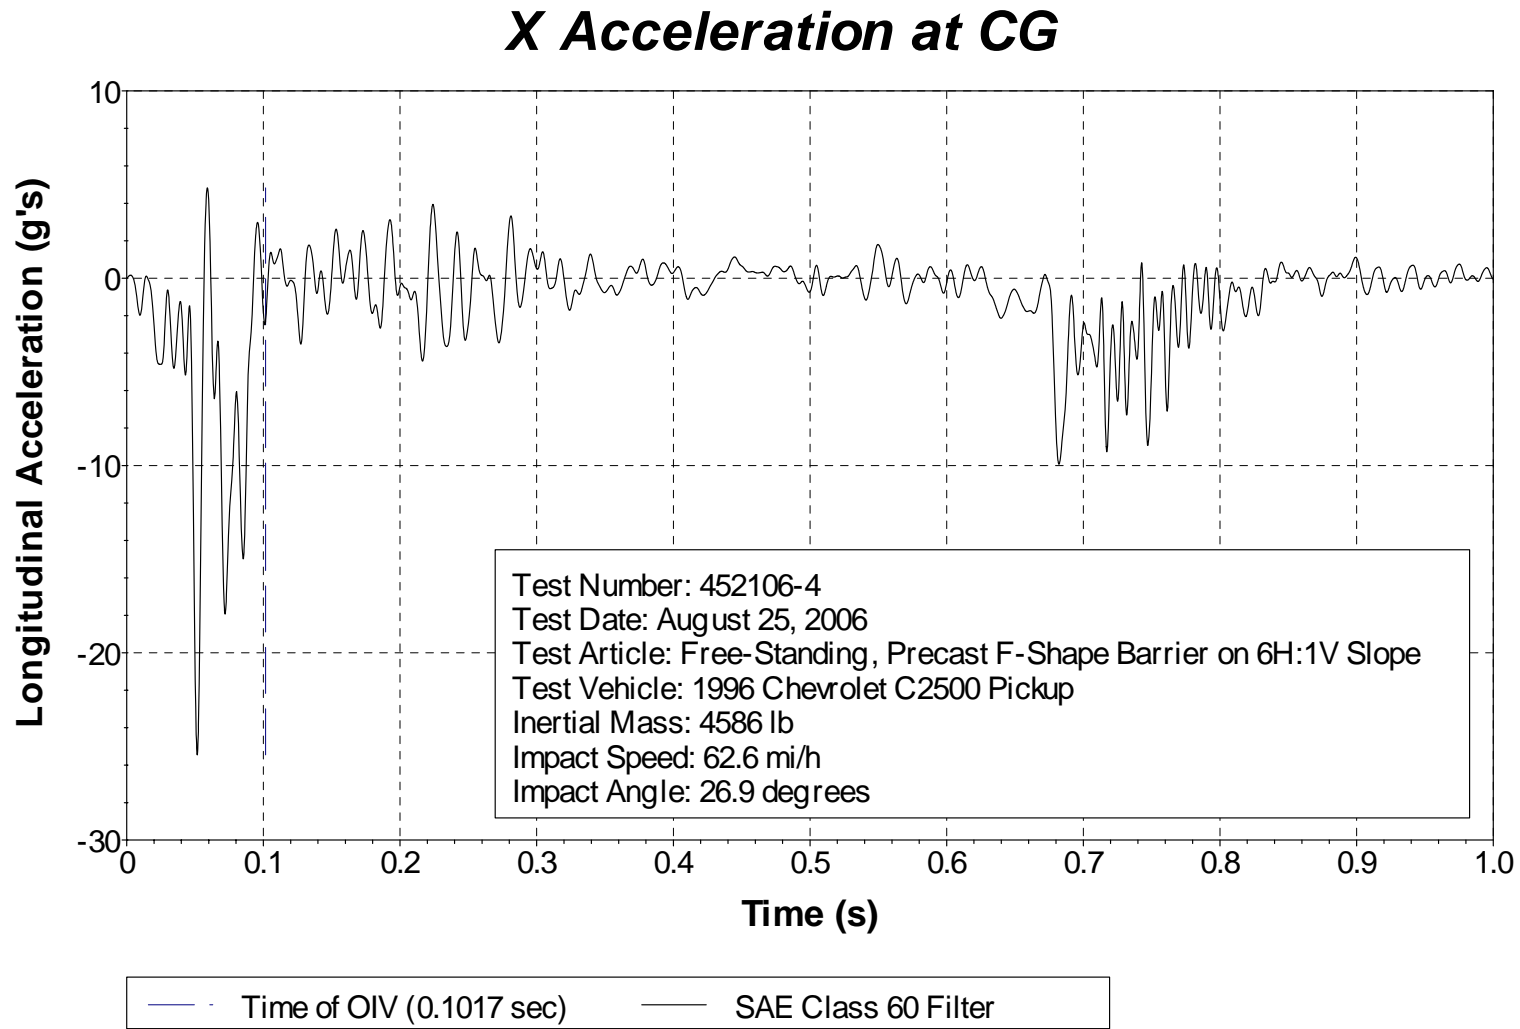
**Figure 40. Vehicle Longitudinal Accelerometer Trace for Test 452106-4
(Accelerometer Located at Center of Gravity).**

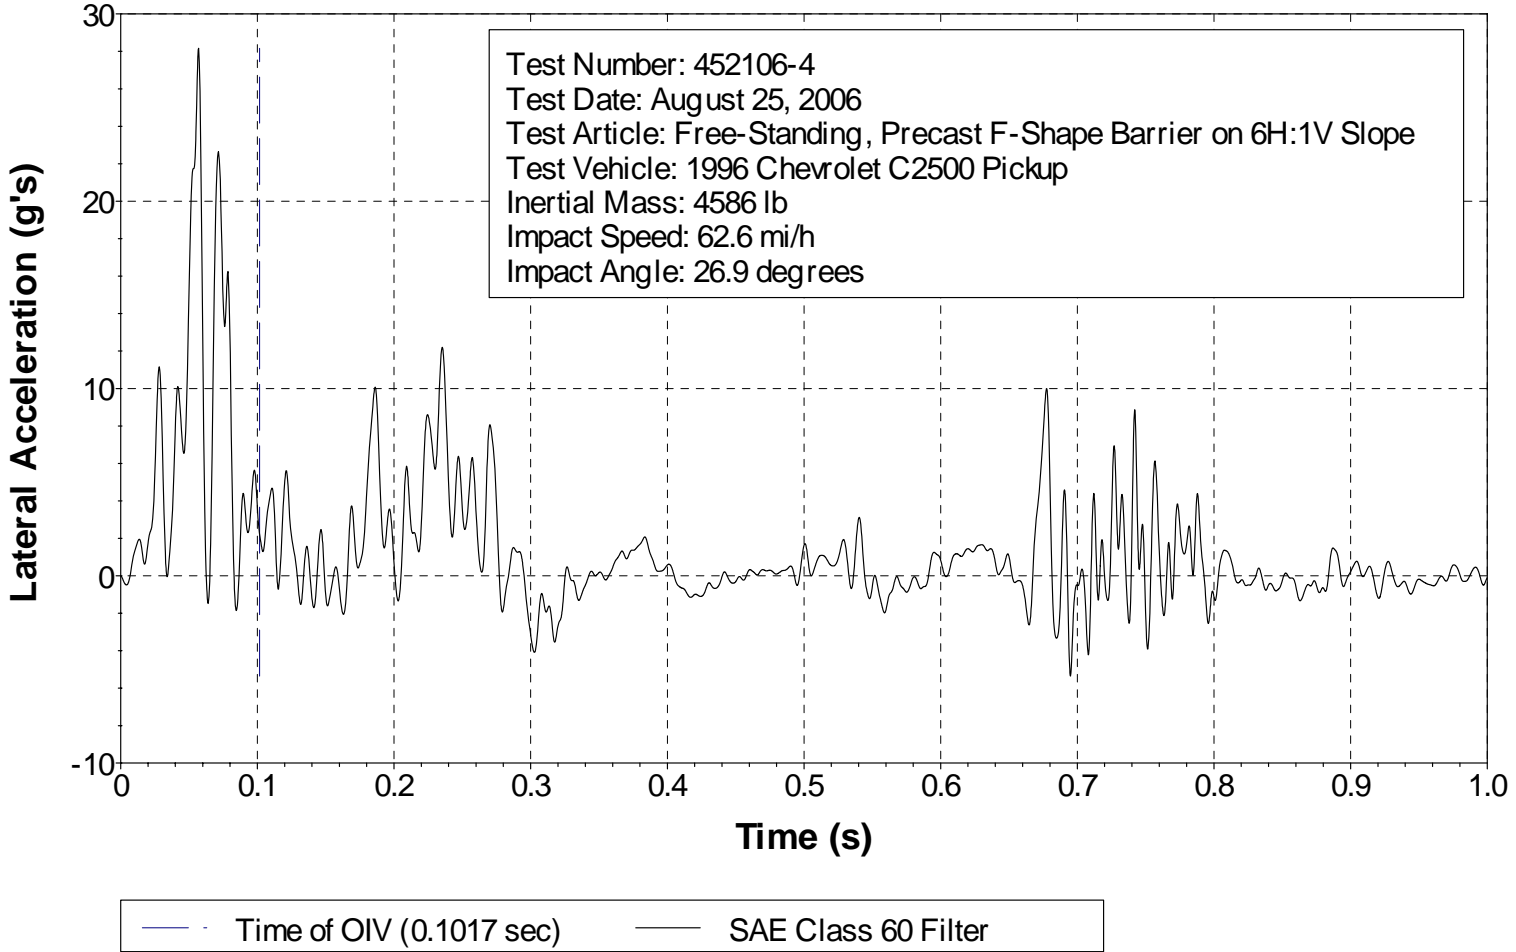
Figure 41. Vehicle Lateral Accelerometer Trace for Test 452106-4 (Accelerometer Located at Center of Gravity).
