CRASH TESTING AND EVALUATION OF F-SHAPE BARRIERS ON SLOPES

Report 0-5210-3

Project Title: Roadside Crash Testing Program
for Design Guidance and Standard Detail Development

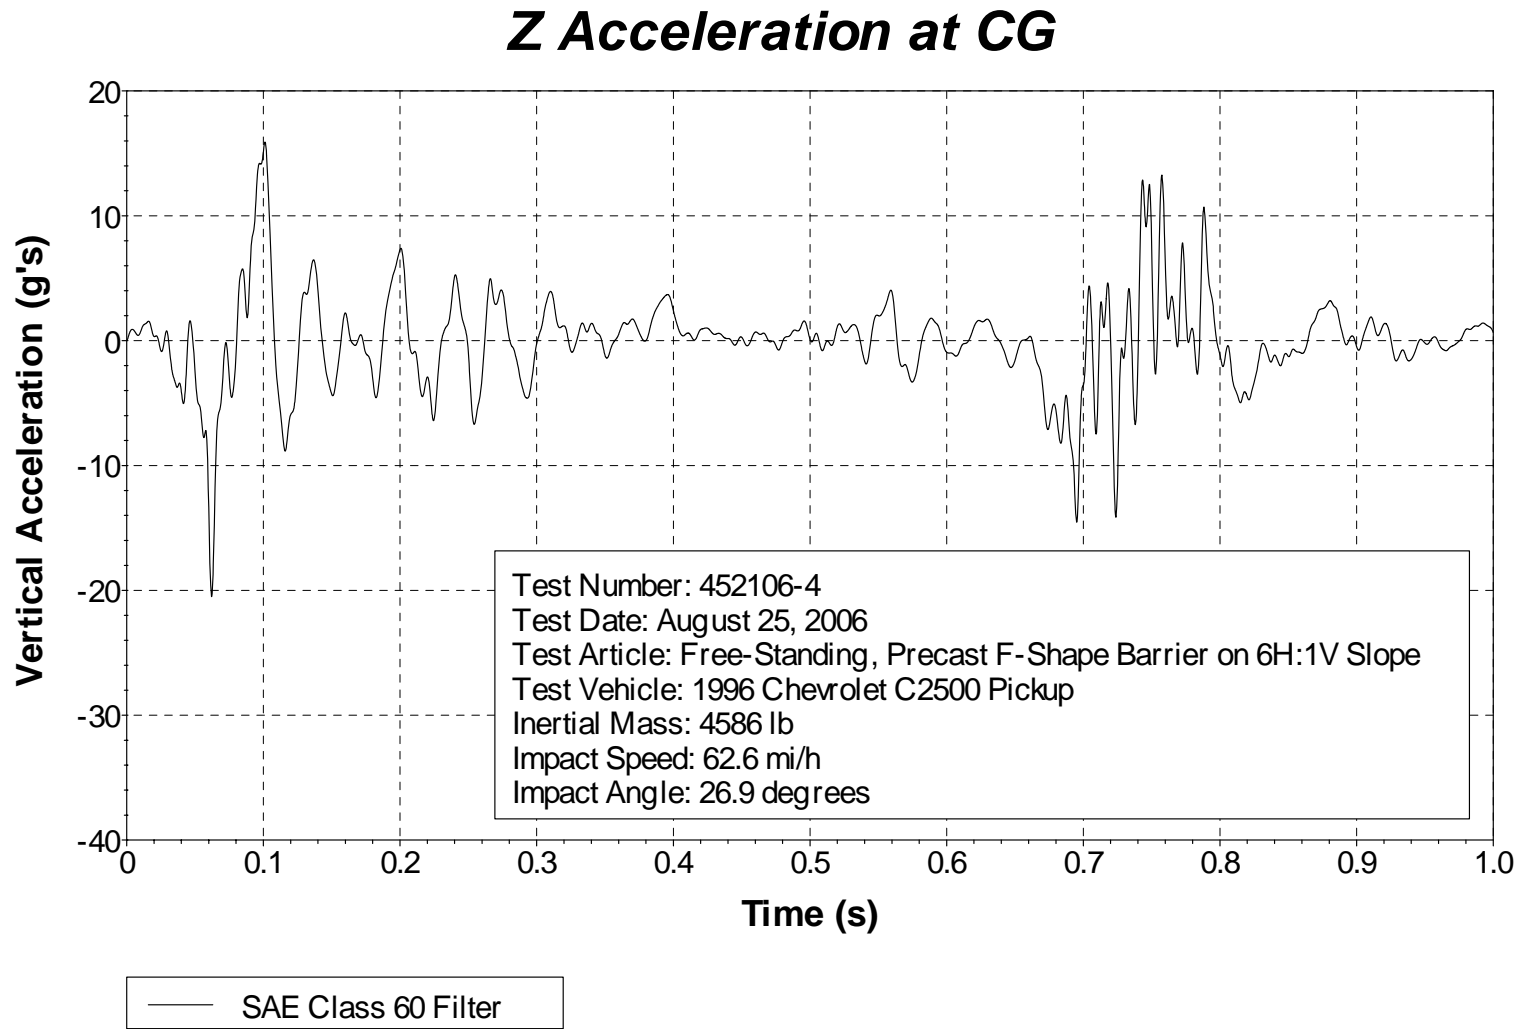
**Figure 42. Vehicle Vertical Accelerometer Trace for Test 452106-4
(Accelerometer Located at Center of Gravity).**

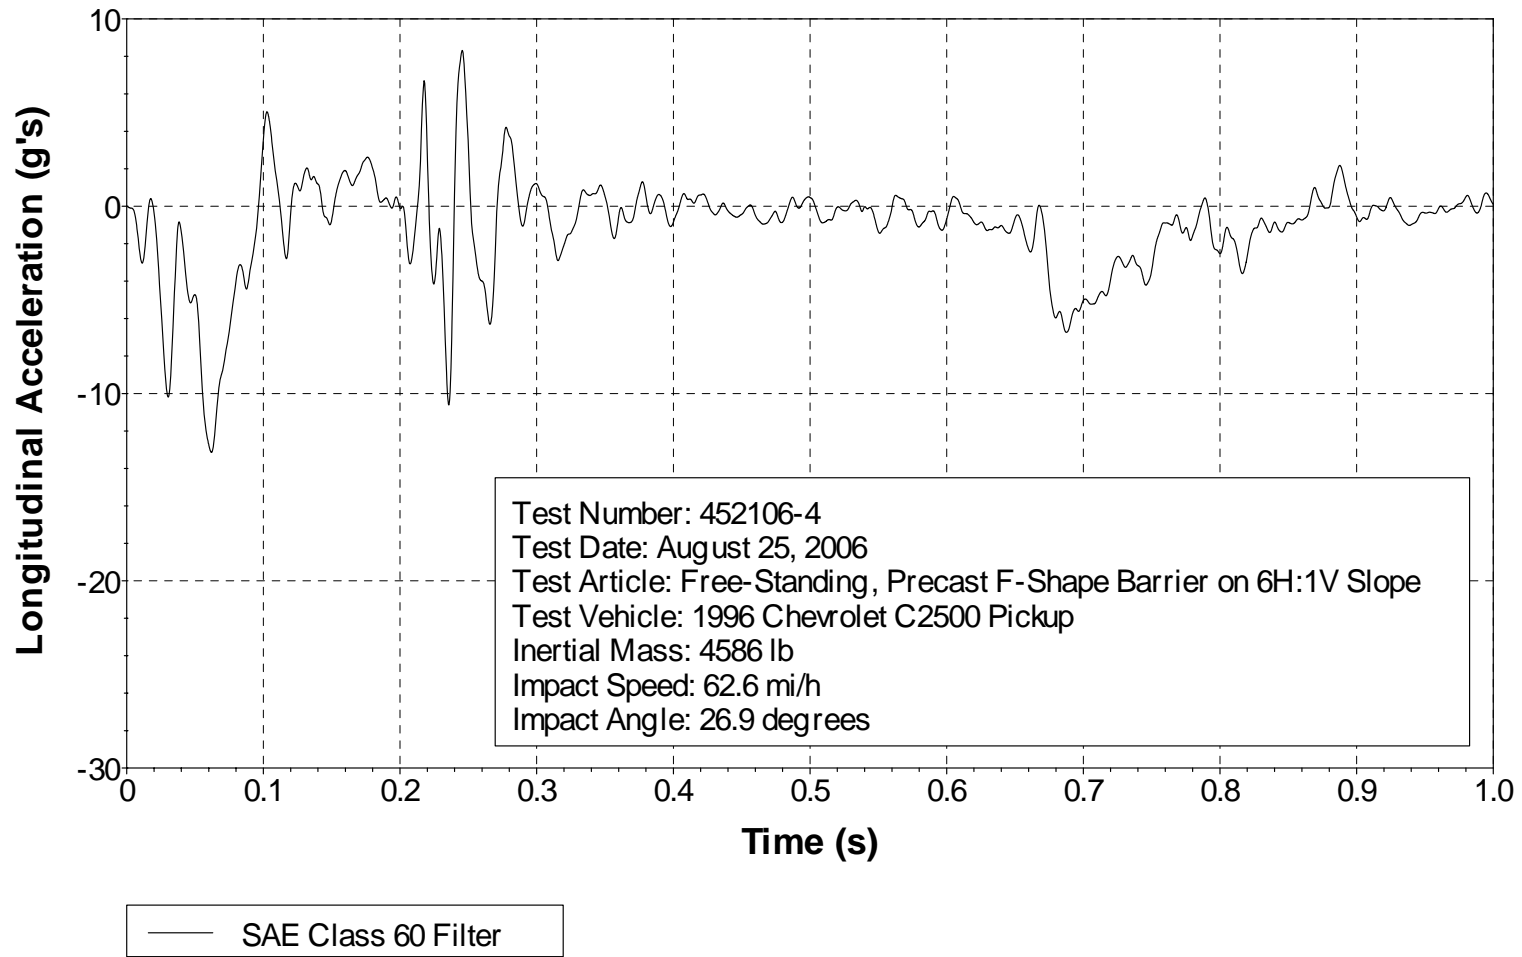
Figure 43. Vehicle Longitudinal Accelerometer Trace for Test 452106-4 (Accelerometer Located over Rear Axle).

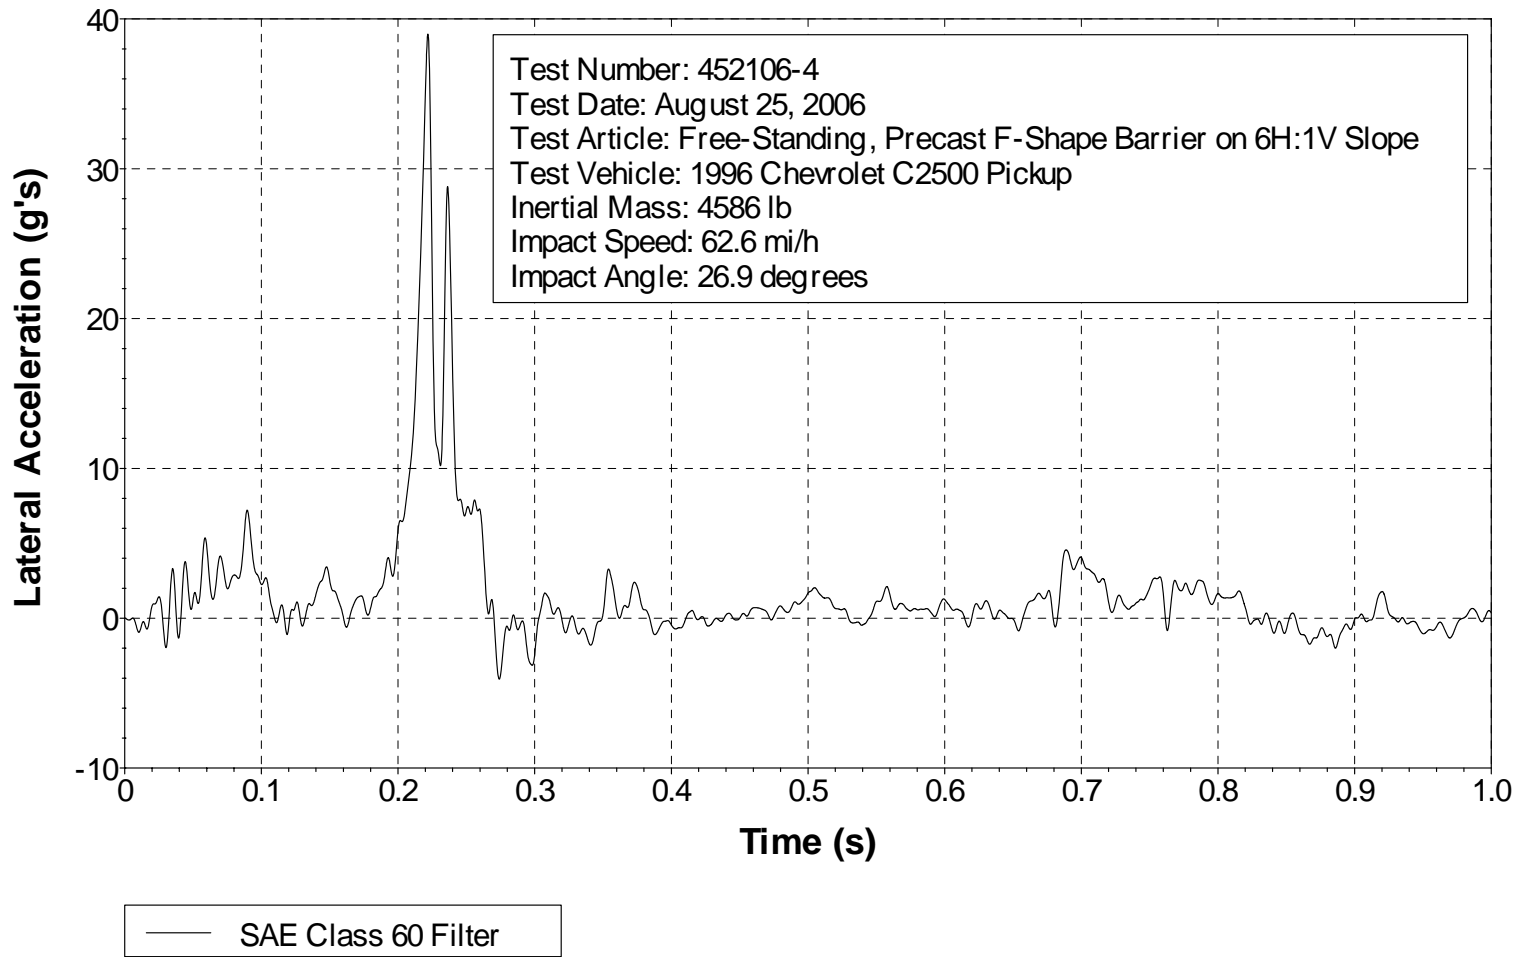
**Figure 44. Vehicle Lateral Accelerometer Trace for Test 452106-4
(Accelerometer Located over Rear Axle).**

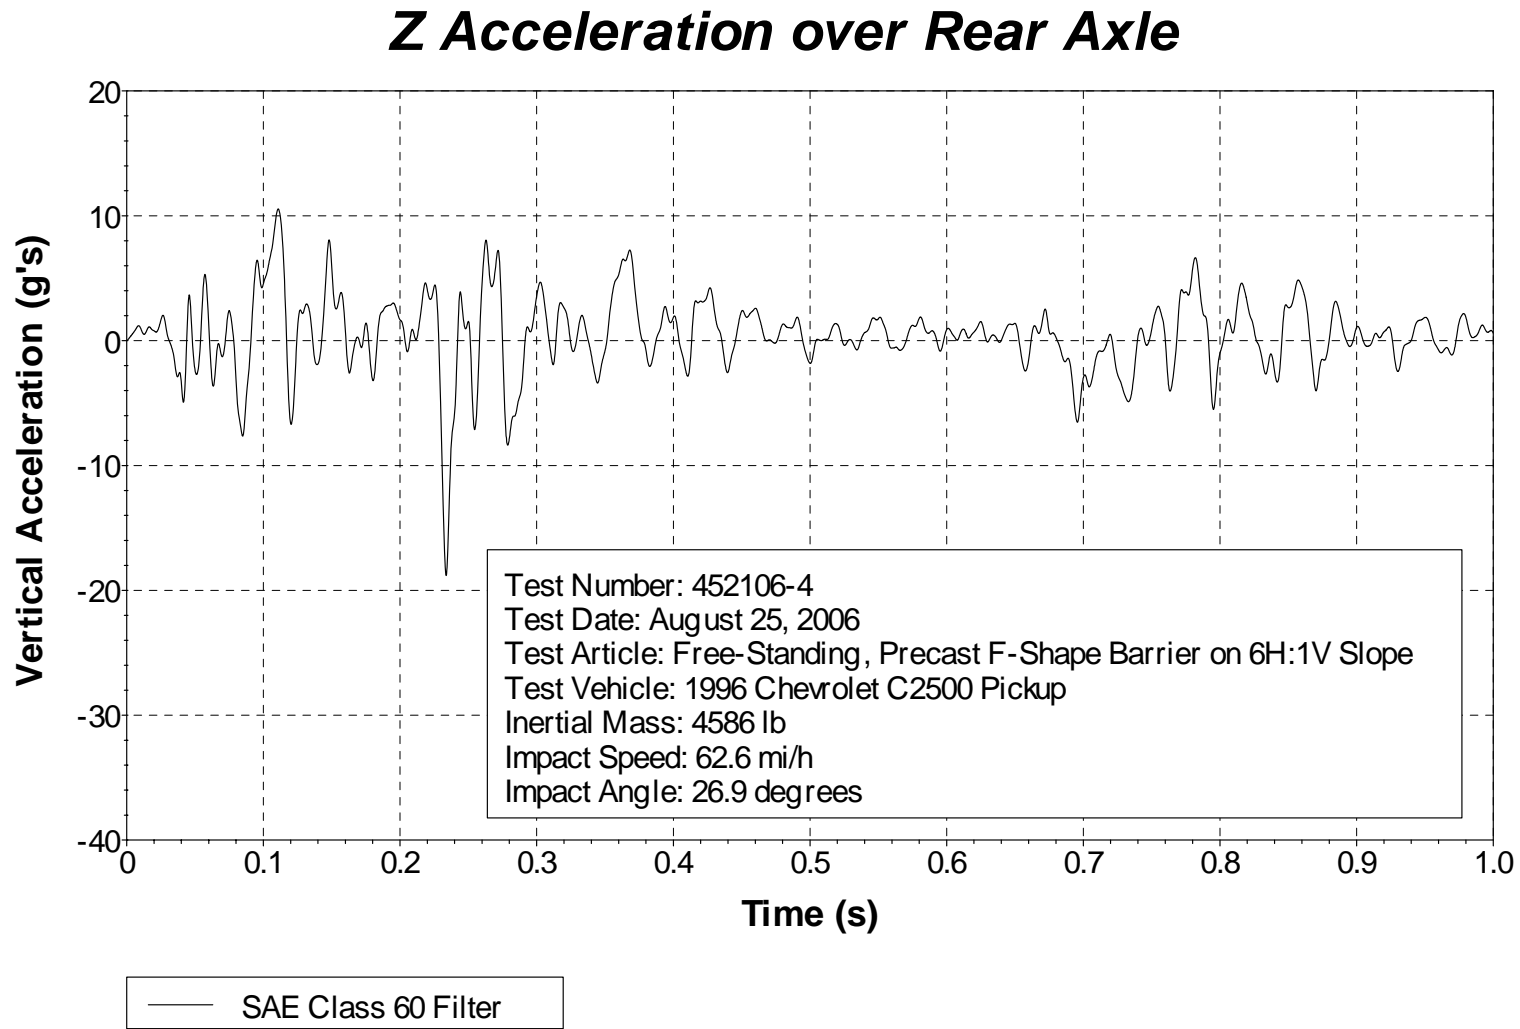
**Figure 45. Vehicle Vertical Accelerometer Trace for Test 452106-4
(Accelerometer Located over Rear Axle).**
