1. Report No. FHWA/TX-08/0-5237-1		2. Government Accession No.		3. Recipient's Catalog No.	
4. Title and Subtitle INVESTIGATING PEDESTRIAN COMPONENTS IN TEMPORARY TRAFFIC CONTROL				5. Report Date October 2007 Published: January 2008

INVESTIGATING PEDESTRIAN COMPONENTS IN TEMPORARY TRAFFIC CONTROL

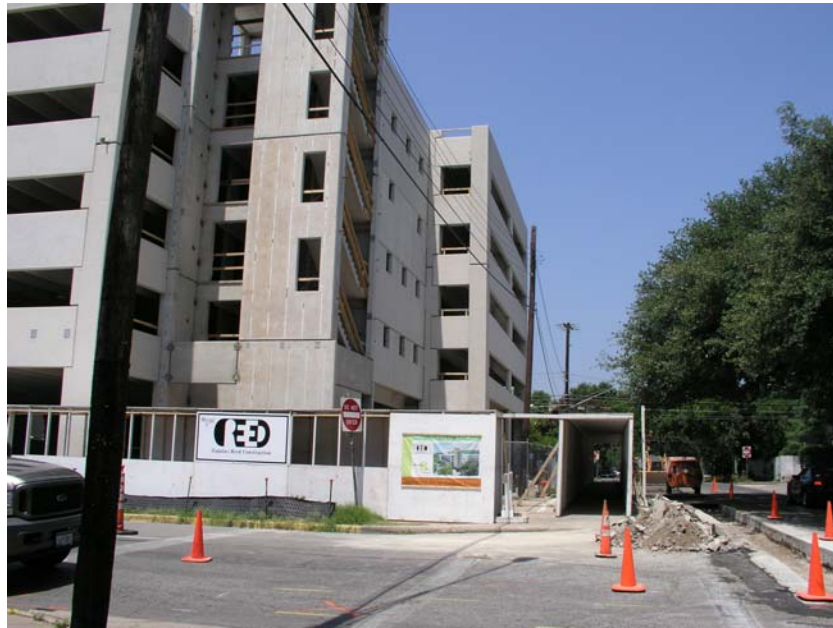
Figure 3. Parking Garage Construction in Austin.

Figure 3 shows a site where a parking garage was being constructed along with work on the neighboring streets. The construction affected the sidewalks and the path to cross the street (see Figure 4). This site experiences a high number of pedestrians, especially when the University is in session. The covered pedestrian walkway is a reflection of the type of construction (high rise building) and the environment (urban setting) along with the expected high number of pedestrians. The sites identified in Austin were in densely developed areas with long-term construction where the temporary pedestrian treatments were more extensive.

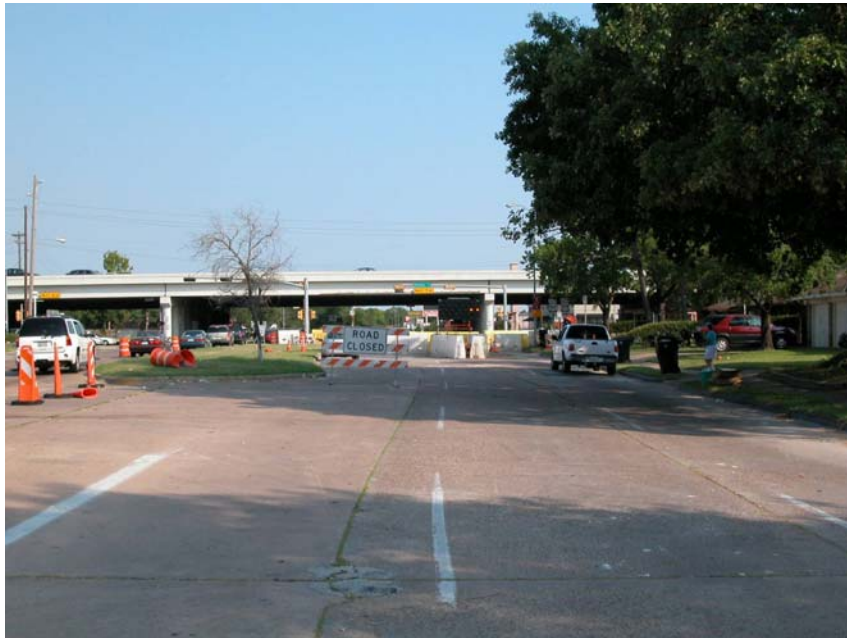
Figure 5. US-59 at Fondren, Looking West.

The first site, shown in [Figure 5](#), was a partially closed roadway due to the replacement of a broken water line. The westbound lanes on Fondren were closed, and traffic was diverted to the other side of a raised median into a single lane while eastbound traffic was reduced from three lanes to two. The sidewalk adjacent to the westbound lanes was also closed near the intersection (see [Figure 6](#)), requiring pedestrians to cross Fondren upstream of the road work or travel through the work area.

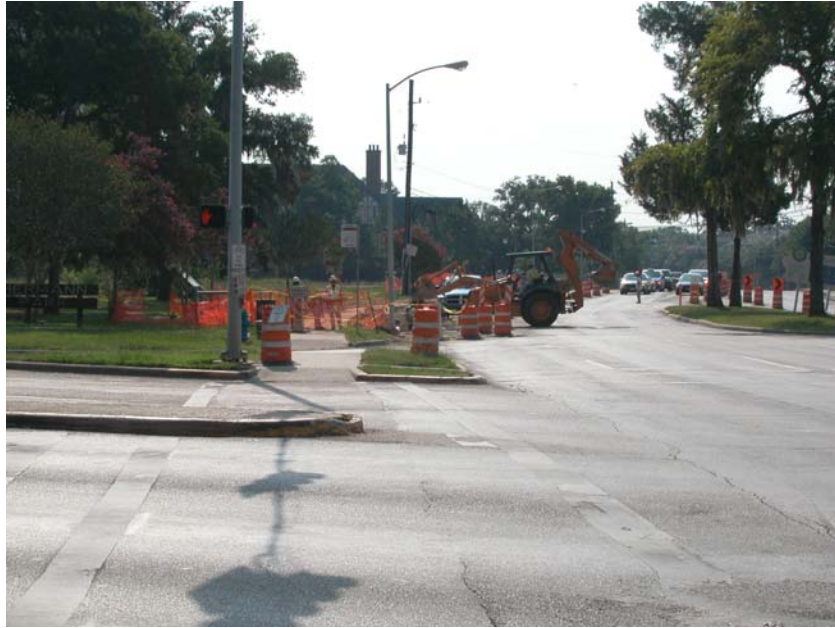
Figure 7. Holcombe at Braeswood, Looking East.

The second site, shown in [Figure 7](#), was in downtown Houston near the Texas Medical Center. Portions of westbound lanes on Holcombe were closed to replace a water main, and the adjacent sidewalk on the north side of Holcombe was also closed. Some advance signing was in place ([Figure 8](#)), and a partial alternate path around the closed sidewalk was evident ([Figure 9](#)), which pedestrians could use to plan their route through or around the work zone.

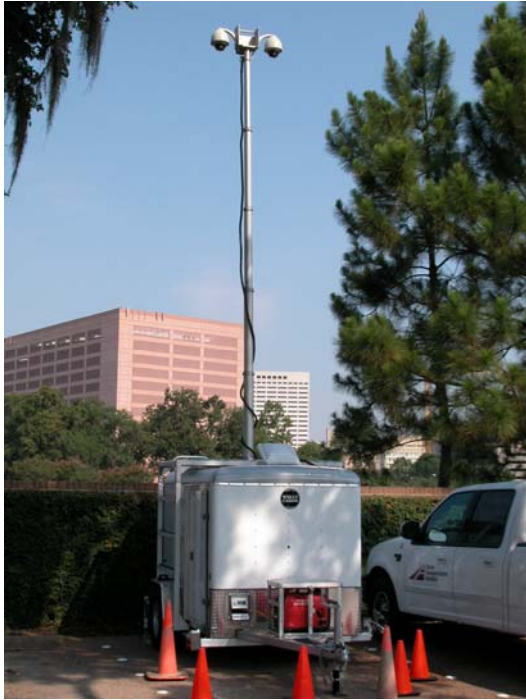
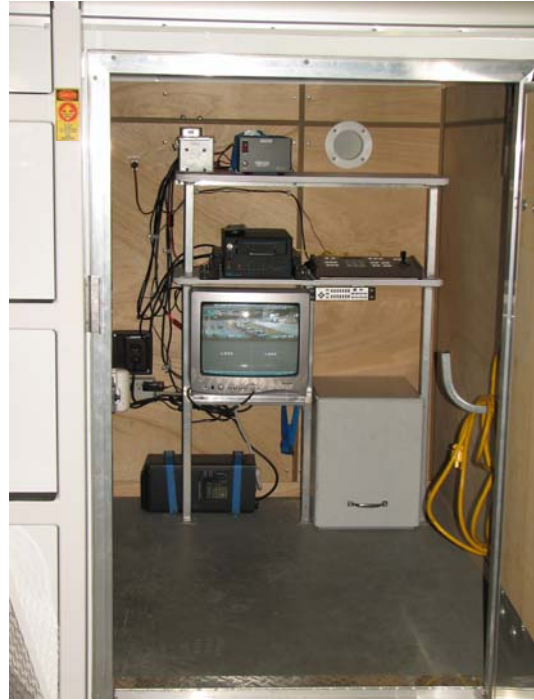
Figure 10. Video Trailer.

In addition to completing the worksheets, observers made a video record of the maneuvers using a video trailer. This trailer, shown in [Figure 10](#), has two cameras mounted on a 30-foot high telescoping pole, which can capture an overhead view of the study site and its surroundings. Images from the cameras are stored digitally on a portable industrial hard drive contained within the trailer; the images are then downloaded onto a desktop computer in the office after data collection is complete. The viewing angle allows researchers to get a complete view of the study site from a distance, which allows the data collection process to be more unobtrusive and less likely to influence pedestrian behavior. This is illustrated in [Figure 11](#).

(a) Video Trailer with Camera Pole Extended

(b) Interior of Video Trailer

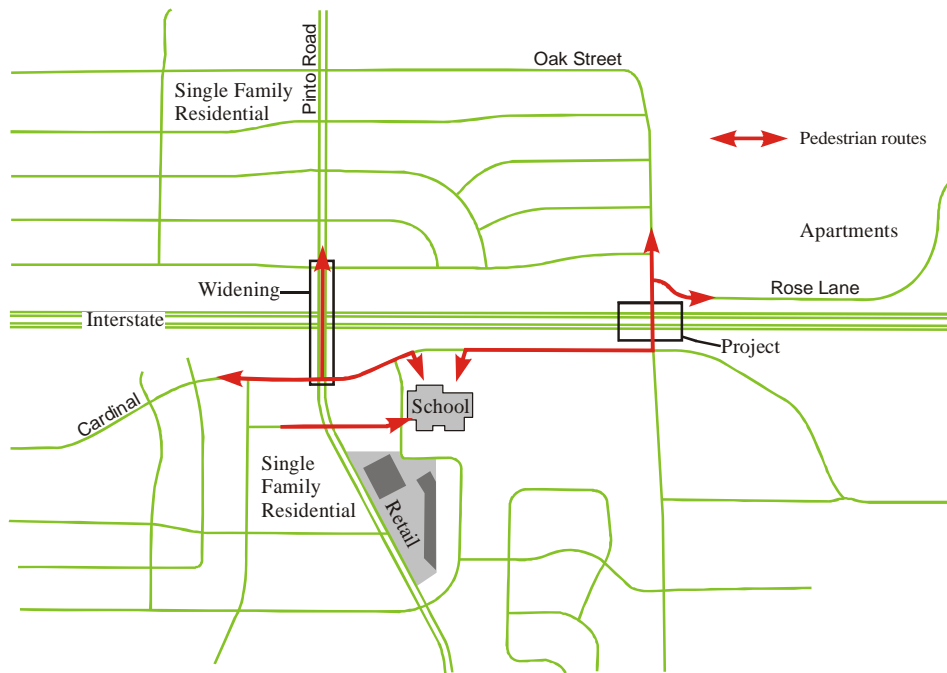
Figure 13. Map of Pedestrian Routes to Consider in Project Scope.

are all important considerations for defining the scope of the project. Figure 13 shows a fictionalized example that identifies pedestrian routes near a proposed project.

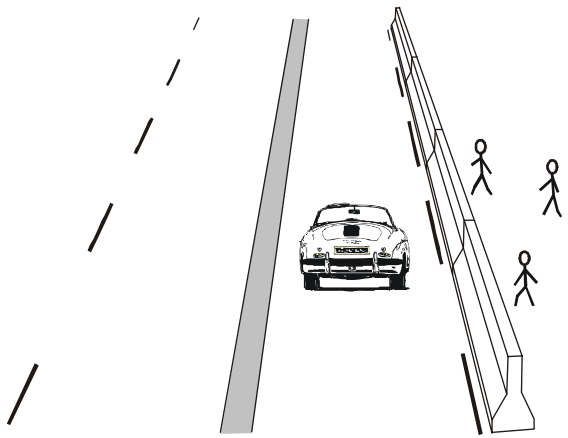
Figure 14. Example of Topic in Checklist.

<p>The diagram shows a car in a lane on the left, separated from a pedestrian detour route on the right by a temporary barrier. The barrier is a long, narrow, light-colored rectangular structure. Pedestrians are shown walking along the detour route. Dashed lines indicate the original path of the pedestrians, which is crossed by the barrier.</p> <p>Figure 3-2. Example of Temporary Barrier.</p>

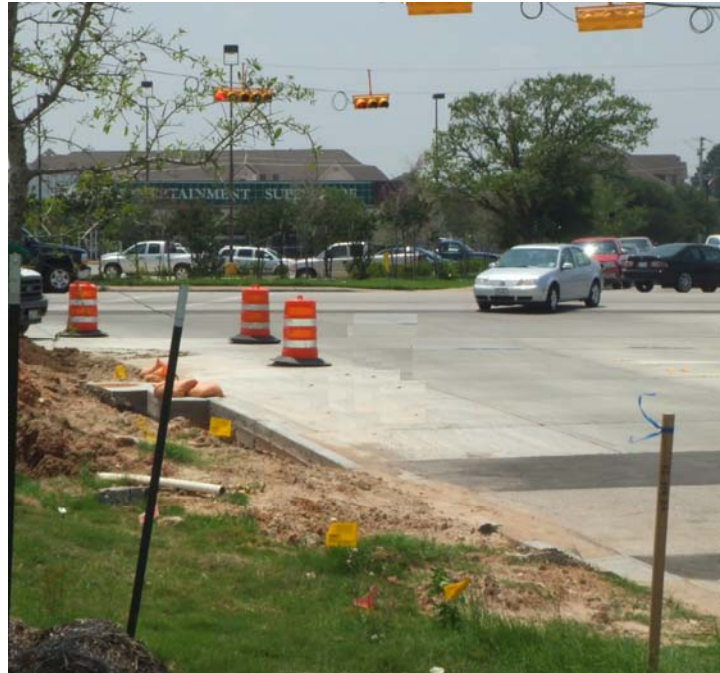
Figure 15. Drop-off near a Sidewalk Edge.

The first situation introduced to the participants was a drop-off of approximately 8 inches near the edge of a sidewalk they are walking on. [Figure 15](#) shows the photograph used in this scenario.

Initially, pedestrians were asked what they would do if they encountered this situation. In this situation, since the obstacle was not in the pathway, the participants agreed that they would stay on the sidewalk, possibly moving further away from the drop-off area. Participants were then asked what other information they thought should be provided to pedestrians. All of the participants agreed that there needed to be a fence or barricade used in this situation that would block the edge of the pavement near the drop-off. Also, the San Antonio and College Station groups stated a desire to have a warning sign of this condition. Possible text for this sign was suggested as “Caution, Drop-off” or that the sign be a guide sign to identify the path that pedestrians should take to avoid the drop-off. For these signs, the College Station group specified that the signs should be orange and black to represent that it is in a work zone. For the visually impaired participants, they believed that no additional information would be necessary because the obstacle was not in their path.

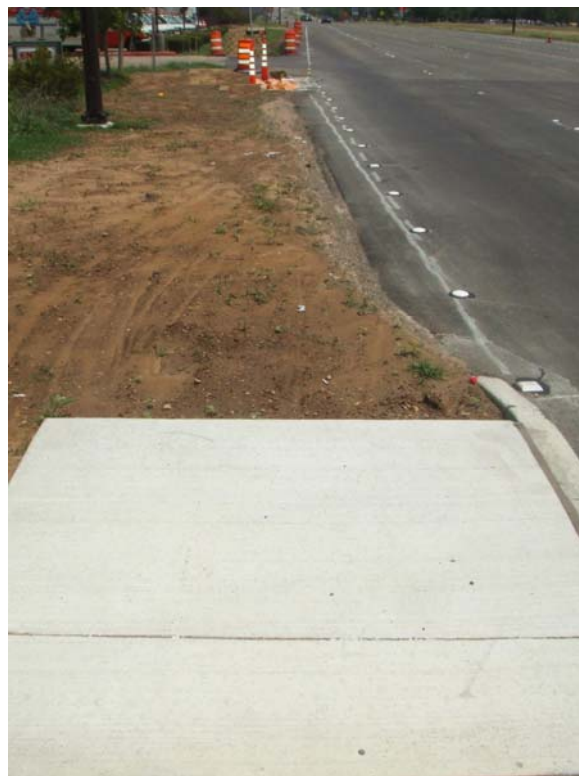
Figure 16. Pathway Paving Removed.

The next situation shown to participants was that the paving of a sidewalk ended or had been removed due to work being conducted in the area. [Figure 16](#) illustrated this situation for the groups.

In this situation, the majority of the participants in San Antonio and College Station agreed that they would walk in the street to avoid the dirt area past the end of the pavement. All

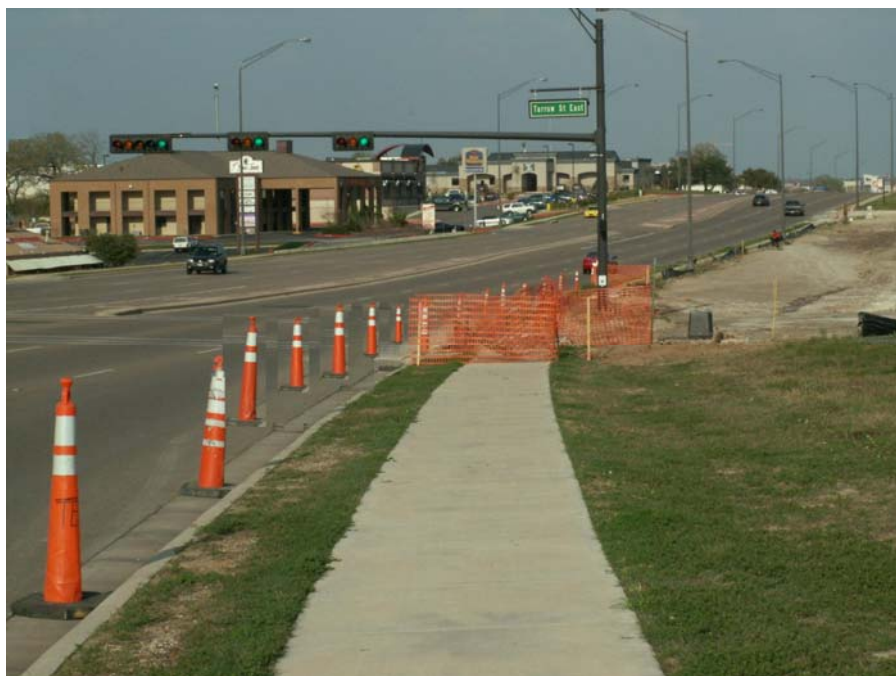
Figure 17. Alternate Path Provided in Roadway.

In this situation, participants were shown the image contained in [Figure 17](#). In this circumstance, researchers were hoping to portray a scenario where a designated pathway had been established along the curb for pedestrians; however, this was not initially explained to the participants in order to garner their unbiased reaction on what they would do if they encountered this situation. For the visually impaired group, the setup was explained as the cones being set away from the curb by approximately 2 feet.

There were 11 participants (38 percent), including four visually impaired participants, who indicated they would go around the work area by walking in the street. Six of the participants (21 percent) stated that they would go to the right side of the work area, walking in the dirt around the area (opposite the street side of the sidewalk), and 12 participants (41 percent) indicated they would turn around.

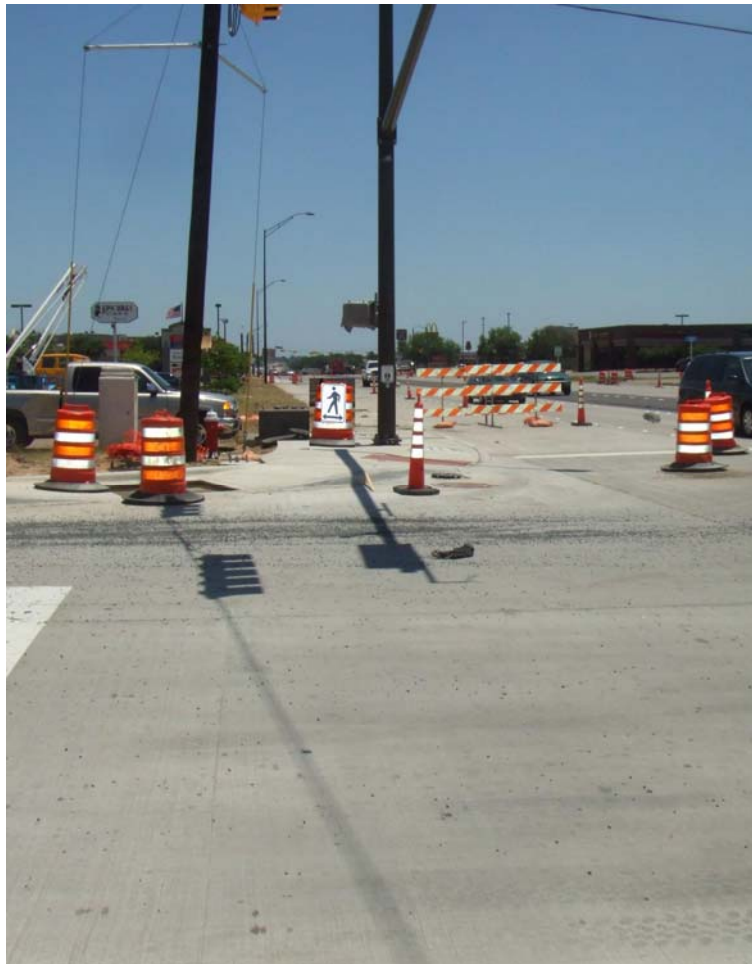
Figure 18. Walking Man Sign with Double-ended Arrow.

In this scenario, researchers displayed the picture shown in [Figure 18](#) and discussed with the group their interpretations of the situation.

When presented with this information, the majority of the participants in College Station (90 percent) stated that they would continue along the sidewalk because the sign did not indicate closed to them, but was only giving pedestrians options about other paths they could take. However, all of the participants in San Antonio indicated that they would leave the sidewalk because the sign meant that pedestrians had to go either right or left, but could not continue straight on the sidewalk.

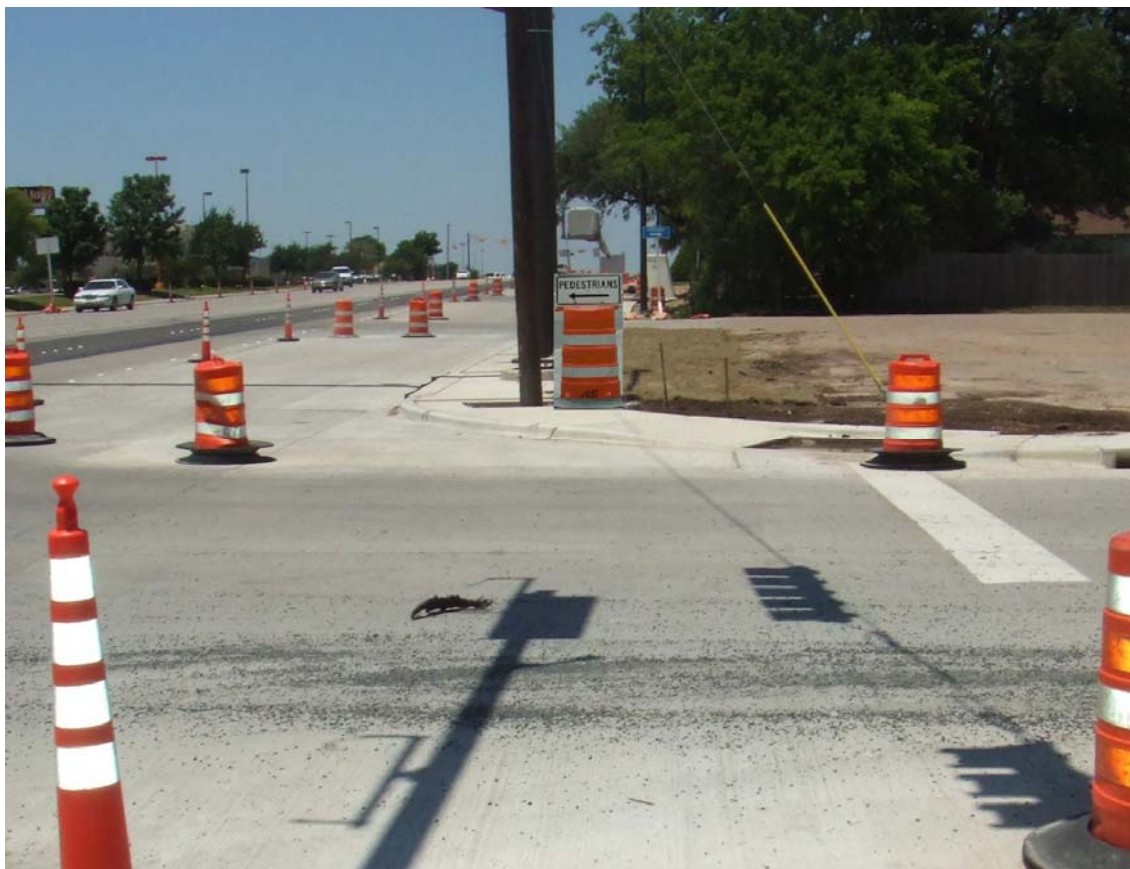
Figure 19. Pedestrian Text Sign.

The next sign replaced the graphic representation of a pedestrian with the word “pedestrian” on the sign. Also, the arrow shown on the sign indicated a single direction. [Figure 19](#) shows the picture used for this scenario

In this scenario, the participants of both groups were split with half indicating that they would cross the street to the left and the other half indicating that they would continue going straight on the sidewalk. One participant in College Station indicated that at this particular location there was no wheelchair ramp provided to the left and therefore they believed that this could not be the intended action for pedestrians (particularly mobility impaired pedestrians). The group thought that in situations like this, there may need to be signs that differentiate between what actions are required if a pedestrian needs wheelchair access and what pedestrians should do if they do not need wheelchair access because there may be cases where there are different actions needed for different mobility requirements. Interestingly, the San Antonio group all agreed that the previous sign with the walking man symbol was preferable to them because “pedestrian” would be a large word that many people would not be able to read and understand.

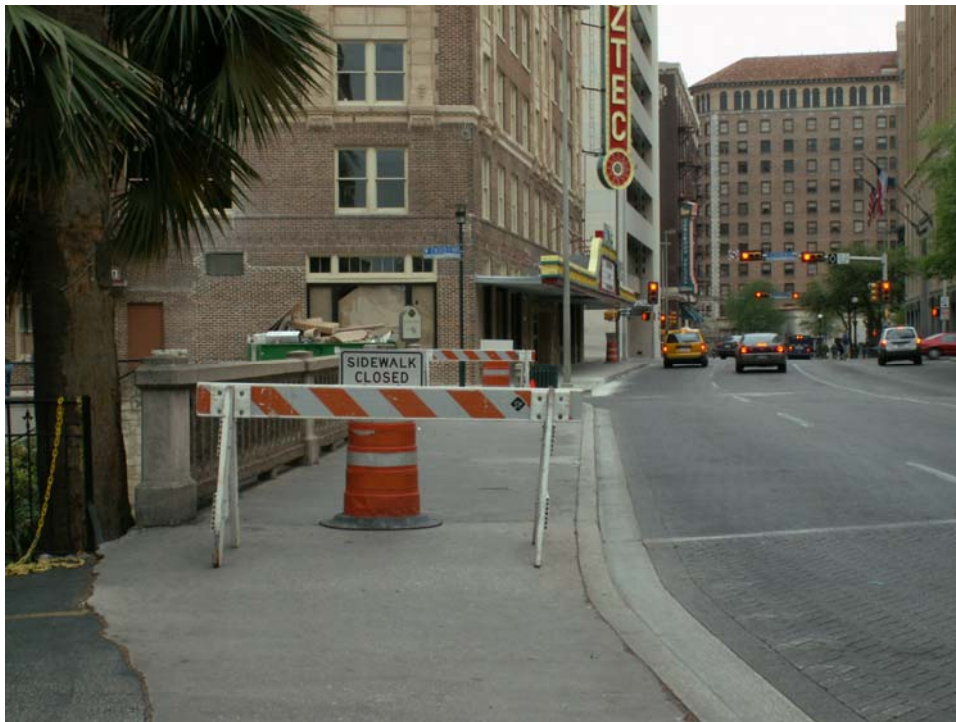
Figure 20. Sidewalk Closed but No Visible Work.

In the next scenario presented to the group, the temporary traffic control situation pictured was very short in length and showed no visible work occurring in the closed area. [Figure 20](#) shows the image used for this scenario.

Given this situation, the majority of the participants in both College Station and San Antonio indicated that they would walk in the street around the closed area. These participants indicated that since the closed area shown was only a short distance, they felt it would be easiest to just go around the closure instead of having to cross the road. Only two participants in San Antonio indicated that they would cross the street at the previous intersection crossing. The two participants based their response on knowledge of the pictured area (the photo had been taken in San Antonio) as a busy street that they would not want to walk in as a means of detouring around the area.

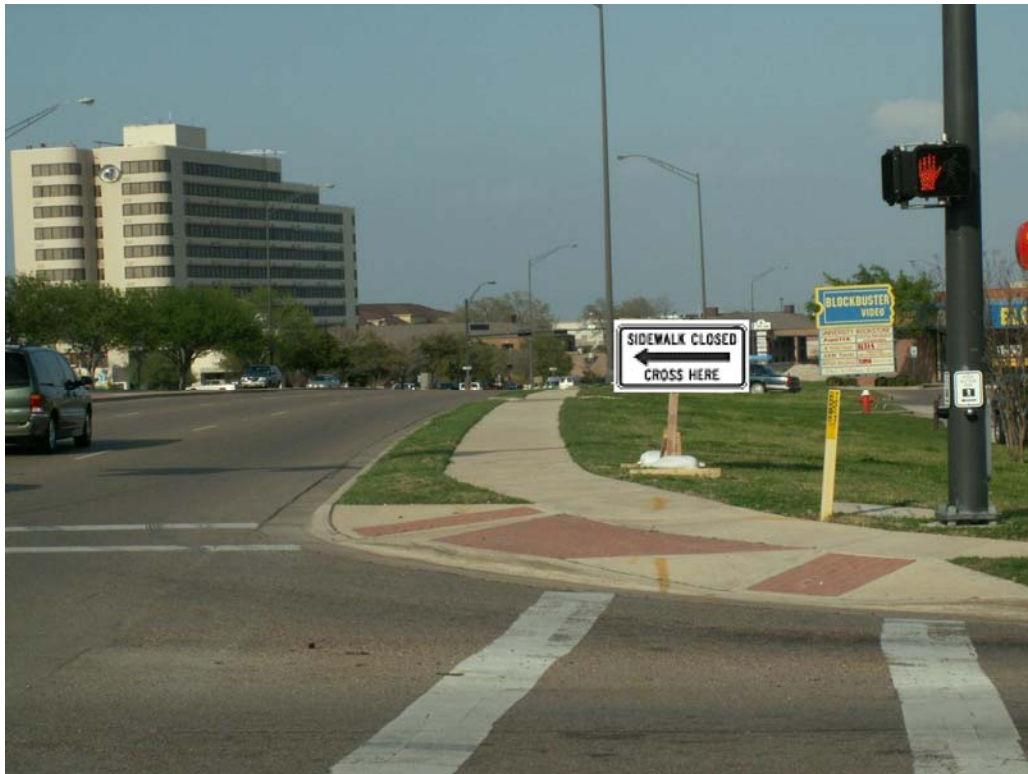
Figure 21. Sidewalk Closed, Cross Here.

The research team presented the next scenario to all three focus groups. It illustrated a situation with advance warning of an upcoming sidewalk closure. [Figure 21](#) shows the image used for this discussion.

When presented with this situation, all of the participants in San Antonio and Austin (visually impaired) and 60 percent of the College Station participants indicated that they would continue on the sidewalk. In San Antonio, the participants indicated that they would continue because they could not see any work and therefore thought the sign might have just been forgotten and didn't need to be followed. In College Station, the participants felt that they would continue until something was obstructing the path. Many of these participants indicated that they were hesitant to cross the street because they didn't know if they would be able to get back across to access businesses on this side of the street once they had detoured. Obviously the visually impaired had a much different perspective on this situation. Given that there was nothing blocking the path, there would be nothing detectable to them to indicate that they should

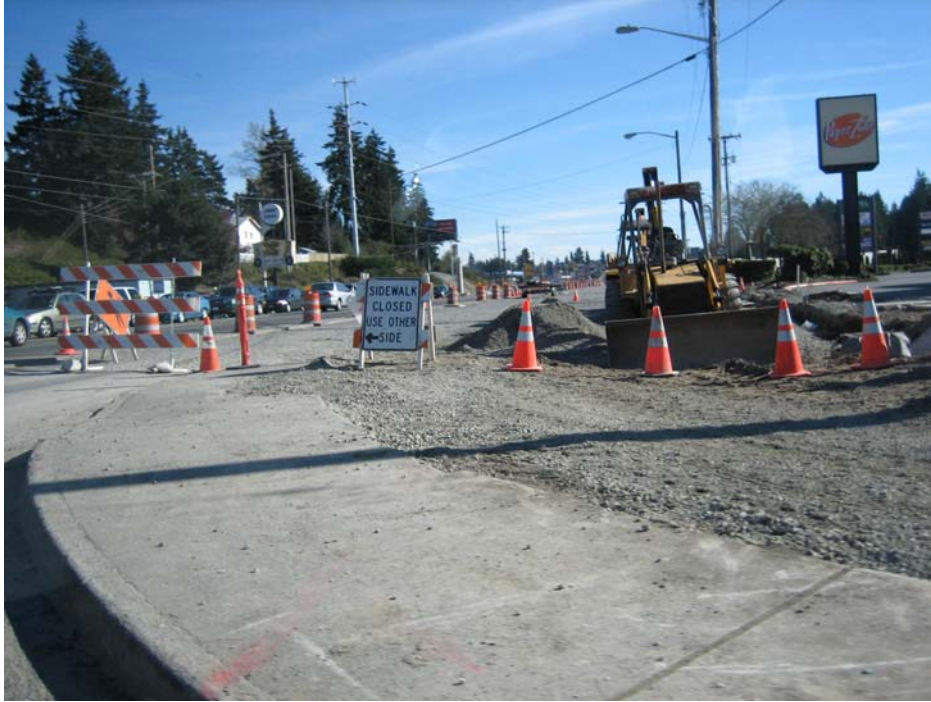
Figure 22. Sidewalk Closed with Visible Construction in Path.

The final scenario presented to the groups involved a sidewalk closure near a very active work area. [Figure 22](#) shows the image used for this situation.

Given this scenario, none of the focus group participants would continue ahead into the work area. The majority of participants from all locations indicated they would cross the street and continue along the opposite side of the road. However, four of the visually impaired participants (40 percent) indicated that they may have to turn around because of the activity at the location that would drown out traffic noise making it impossible for them to assess traffic conditions for crossing. The other participants who were visually impaired agreed that this is a concern, but believed they would cross the street given this situation if they were familiar with the area.

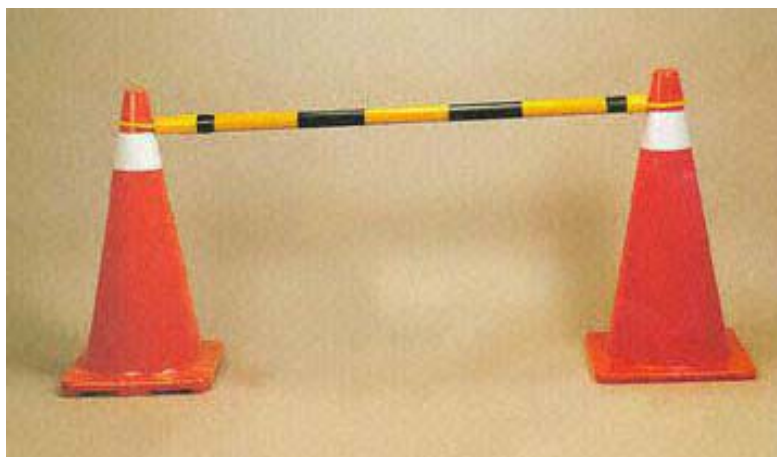
Figure 23. Cones with Connecting Bar.

The image shown in [Figure 23](#) was introduced to the groups as a new device that could be used in temporary traffic control areas.

Upon viewing this picture, both the San Antonio and College Station groups believed that the device may have limited application within short duration work areas. However, they were concerned that it would be a tripping hazard for pedestrians. A suggestion was made in both groups to increase the height of the device (e.g., use barrels with a connecting bar) to reduce the tripping hazard and make the device more effective in blocking the area from pedestrians.

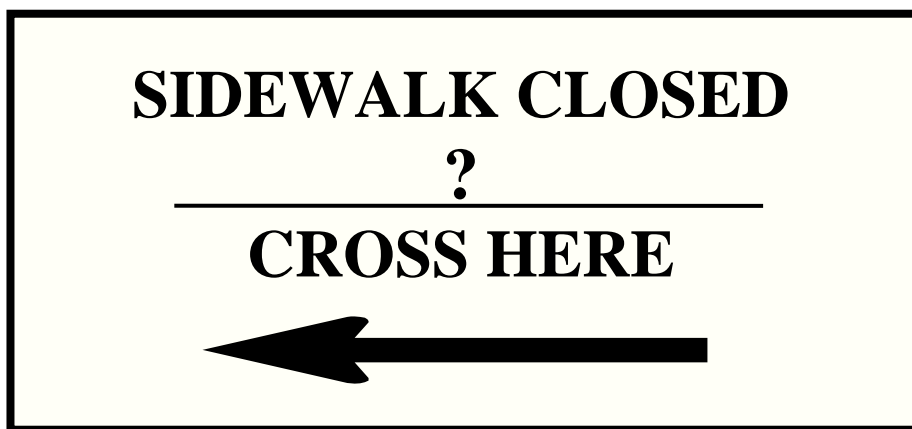
Figure 26. Distance Question Sign.

Lastly, based on focus group suggestions, researchers investigated different ways to provide information to pedestrians regarding how far ahead a temporary traffic control area is located from their current location. [Figure 26](#) illustrates the sign that was shown to participants when they were asked to identify what information should be included in the blank where the “?” was located.

They were given four alternatives to select from for this task, two giving landmark points and two giving distances. Table 9 shows the results for which option participants felt would be best to include on the sign.

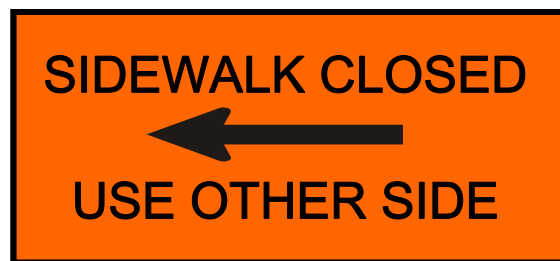
Figure 27. Recommended Sidewalk Closed Sign.

Based on the findings detailed above, researchers would recommend the signs in [Figure 27](#) and [Figure 28](#) to be used as closure and advance warning signs, respectively.

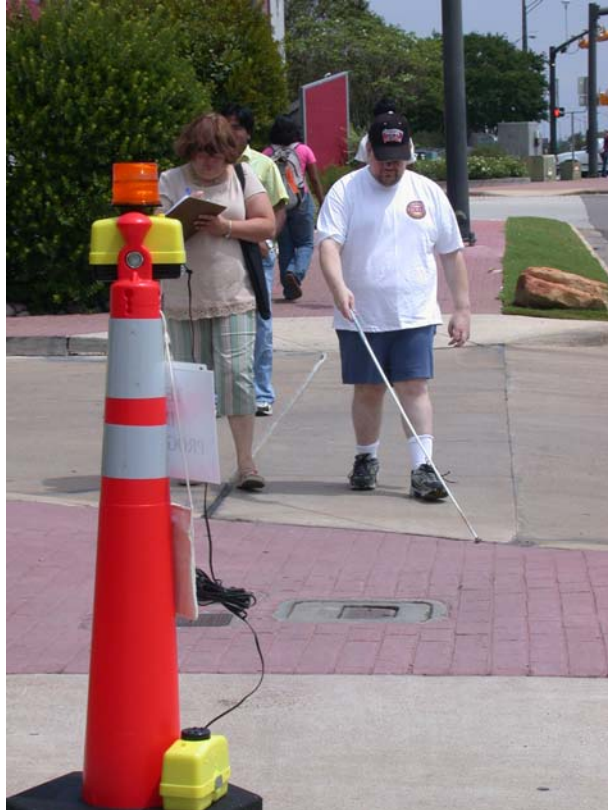
Figure 29. Phase 2 Wayfinding Task.

During the Phase 2 study, the first message of the experiment was presented to visually impaired participants while they were traveling on a sidewalk near an active roadway. Researchers observed the participant's ability to follow a designated alternate route provided in an audio message to a known destination to determine the effectiveness of the message. For this portion of the study, participants started at a designated point and began their trip as normal. Approximately ½ block into the trip, they encountered a motion-activated audio message device as shown in [Figure 29](#). The audio message device was playing one of two messages evaluated during this portion of the study. Two messages were included in the study to determine if the combination of both street names and distance identifiers (i.e., blocks) improved the ability of visually impaired pedestrians to follow the information in the message.

Attention westbound University Dr. pedestrians. Sidewalk closed. Alternate path on opposite side of road. Cross at next intersection and continue 2 blocks.

After listening to the message, pedestrians continued their trip based on this new sidewalk closure information provided to them. As each pedestrian walked the instructed route, a researcher would walk with them to record their actions as well as to ensure the safety of the pedestrians. The researcher would in no way lead or give the pedestrian's information about the route they were to take; they would, however, provide assistance, if needed, in crossing sidewalk areas and intersections safely. Upon reaching a destination (approximately four blocks away), researchers asked the participants questions regarding their reactions to the message and their recall of specific elements.
