# DESIGN CONSIDERATIONS FOR FLEXIBLE PAVEMENT WIDENING

Report 0-5429-1

Project Title: Considerations for Flexible Pavement Widening Projects

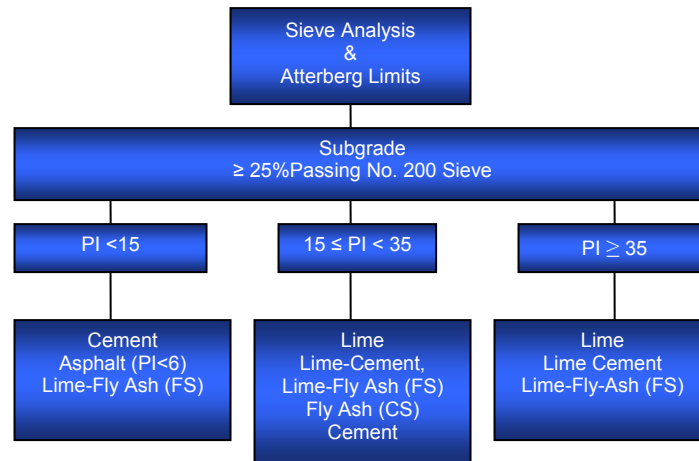
**Figure 1. Additive Selection for Subgrade Soils (TxDOT 2005a).**

The decision tree shown in [Figure 1](#) offers assistance in selecting a stabilizer for subgrades, given certain soil properties. [Figure 2](#) offers assistance in selecting a stabilizer type for base and salvaged existing materials.

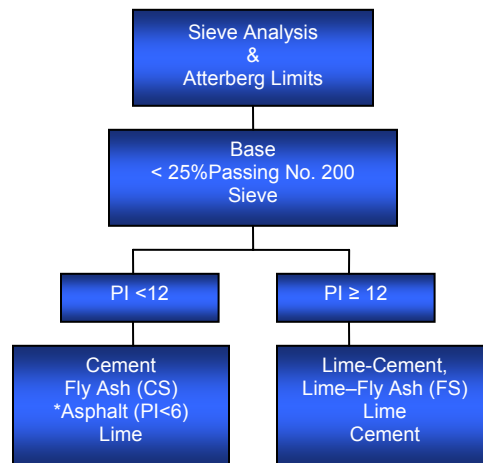
**Figure 2. Additive Selection for Base and Salvaged Existing Material (TxDOT 2005a).**

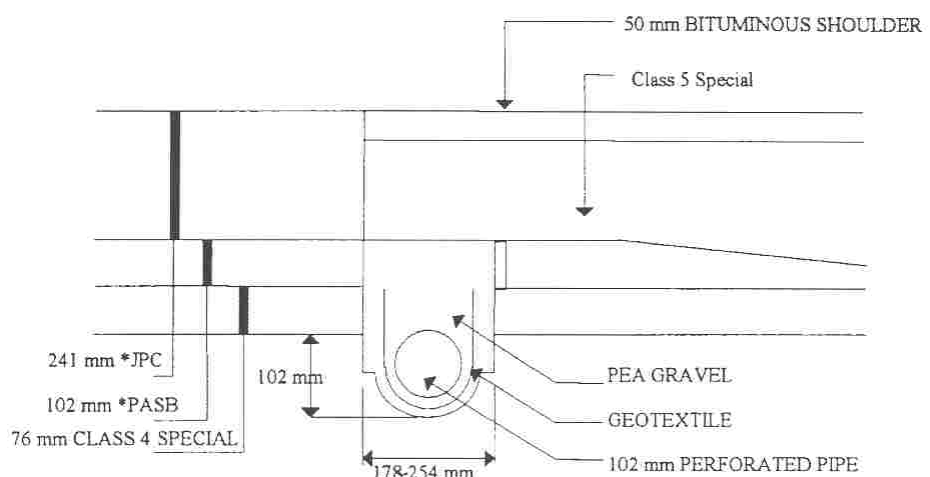
**Figure 5. Typical Edgedrain Configuration (Birgisson, et al. 2000).**

Longitudinal edgedrains were constructed along the entire length of the test sections using a 100 mm diameter, corrugated and slotted polyethylene pipe that was wrapped in a geotextile fabric. These edgedrains were connected to tipping buckets, which collect water that infiltrates the base material as a result of a precipitation event. The lane-shoulder joint was trenched; the pipe was placed so that the top of the pipe was at the bottom of the base layer, and the trench was backfilled with pea gravel. Base material was then placed over the trench; and the shoulders were graded, sloped, and paved with hot-mix asphalt. A typical edgedrain configuration is shown in Figure 5. Time Domain Reflectometry (TDR) was also used to monitor the volumetric moisture contents of the base and subgrades.

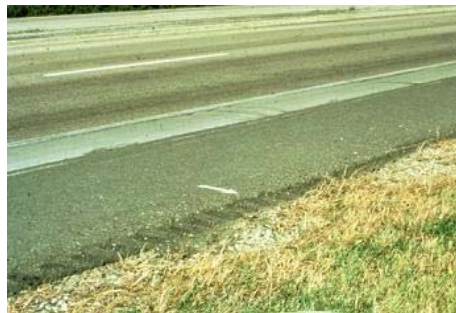
**Figure 6. Painted Arrow Reference Marker (Baumgardner 2002).**

Baumgardner suggested that these drains be inspected at least once a year, and he recommended the use of video equipment to better determine the condition of the drain. Also, vegetation should be mowed from around outlet pipes at least twice a year, and all ditches should be mowed and kept clean of debris. Painted arrows on the shoulders, such as is shown in [Figure 6](#), offer an easier means of locating edgedrain outlets that may be overgrown with vegetation.

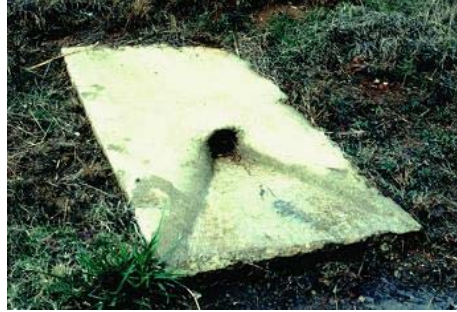
**Figure 7. Outlet Pipe Headwall (Baumgardner 2002).**

The advantages of having larger headwalls for outlet pipes, such as the one shown in [Figure 7](#), was also discussed. The advantages of such a headwall include:

- easier for maintenance personnel to locate,
- vegetation is located farther away from the outlet pipe,
- reduced erosion, and
- prevents cutting/crushing of the outlet pipe.

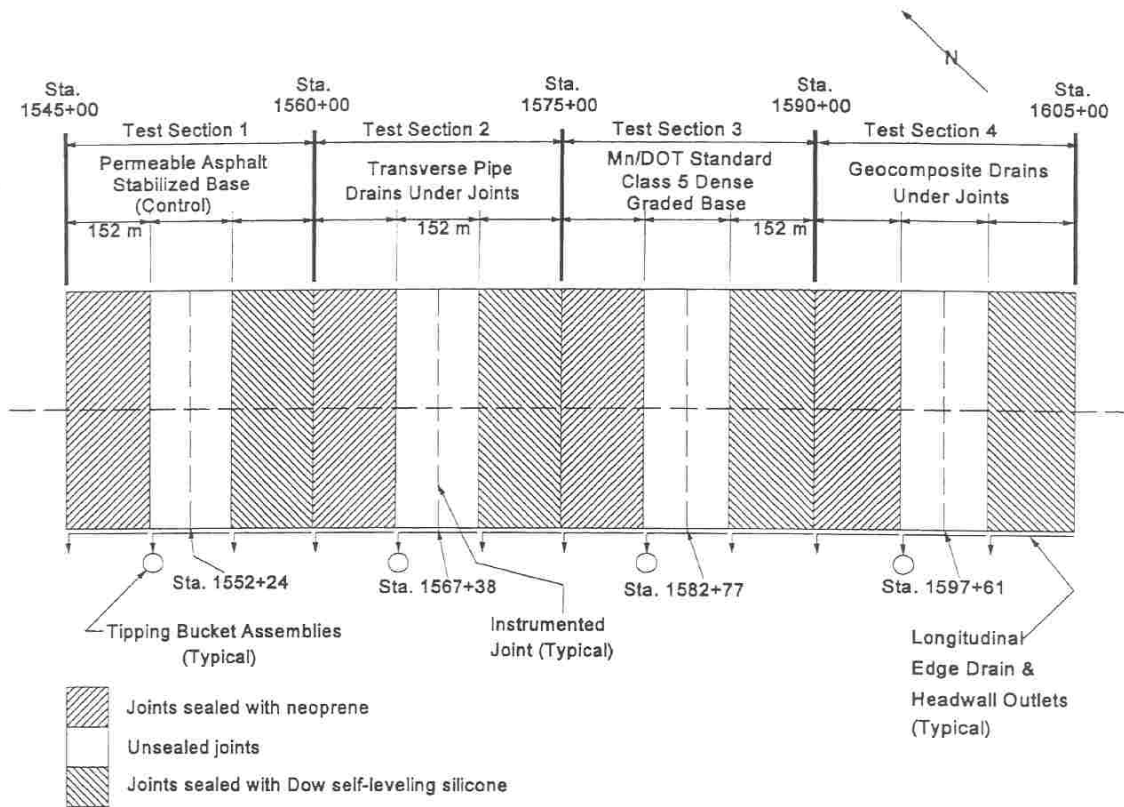
**Figure 8. Test Section Configurations for I-94 Project (Hagen & Cochran 1996).**

The objective of Hagen's report was to evaluate the relative performance of various drains and their effect on pavement performance. The project included the construction of four drainage test sections along I-94 in two counties in Minnesota. Each section was 457 m long and joints were spaced at 8.2 m, which were further divided into three subsections that were 152 m in length as is shown in [Figure 8](#).

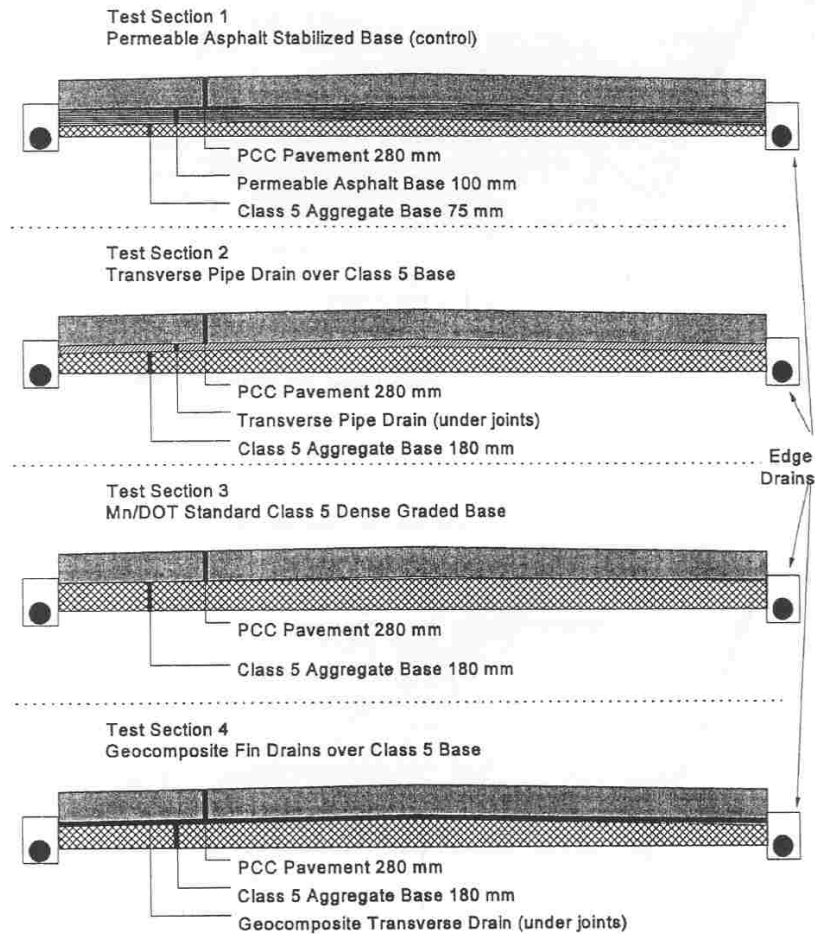
**Figure 9. Typical Pavement Sections for I-94 Project (Hagen & Cochran 1996).**

Each test section constructed consisted of 280 mm of Portland cement concrete (PCC) over a permeable base. Typical pavement sections for this project are shown in Figure 9.

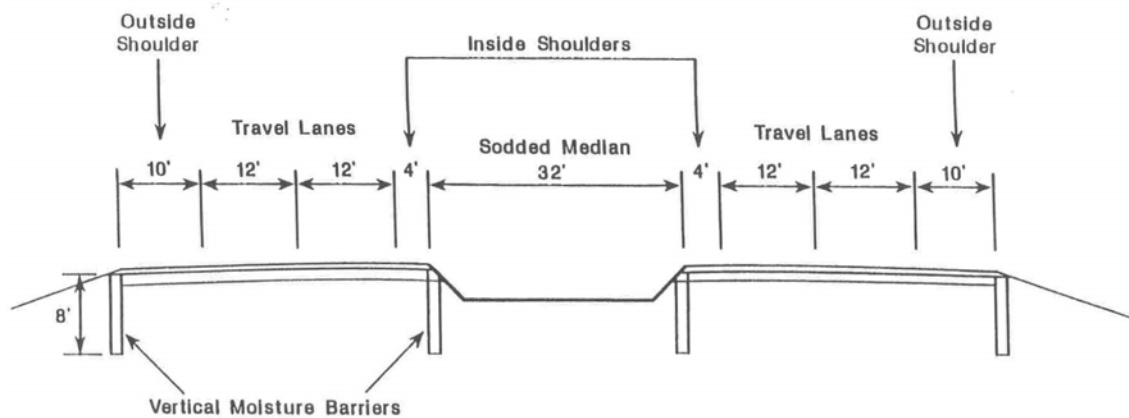
**Figure 10. Typical Cross Section for Pavement with Vertical Moisture Barriers (Ranesinghege, et al. 1992).**

To accomplish the first objective, vertical moisture barriers were installed along both edges of the pavement at eight test sections, and either calibrated thermal moisture sensors or thermocouple psychrometers were installed at different depths in the subgrades both inside and outside of the moisture barriers. A typical cross section for a pavement with vertical moisture barriers is shown in Figure 10. Laboratory testing was conducted on disturbed soil samples from all the test sites to characterize the subgrades. Also, profilometer readings were taken bi-annually to monitor the development of pavement roughness.

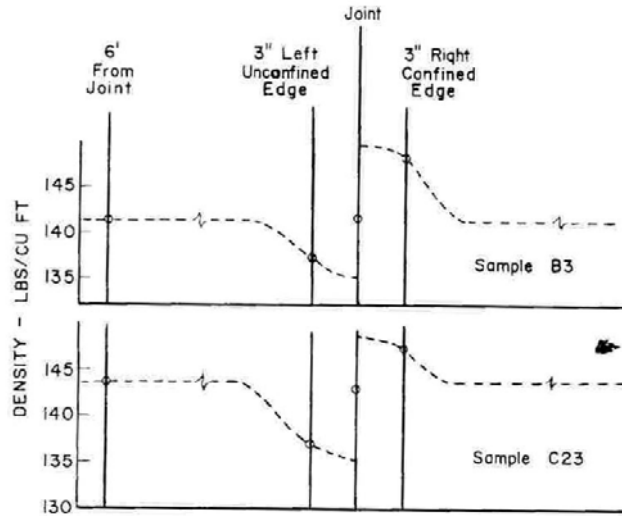
**Figure 11. Density Gradient across Cold-Joint Construction (Foster 1964).**

Foster used the 3 inch square coupons to determine densities, and the 3 x 9 inch coupons were used to find the tensile strength. Results for this investigation showed that a low density zone at the edge of the initial lane and a high density zone at the edge of the subsequent lane were not present in the hot joints constructed with pavers operating in echelon, but were present in cold-joint construction. This density gradient is shown in [Figure 11](#).

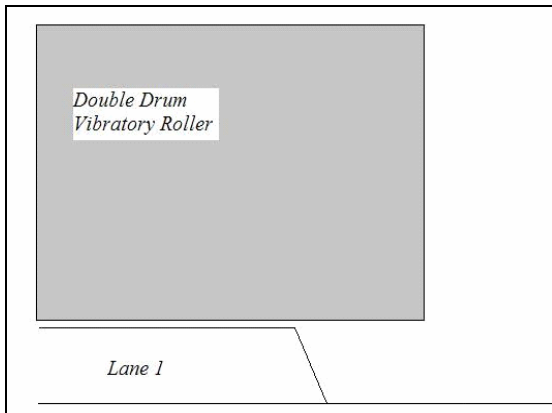
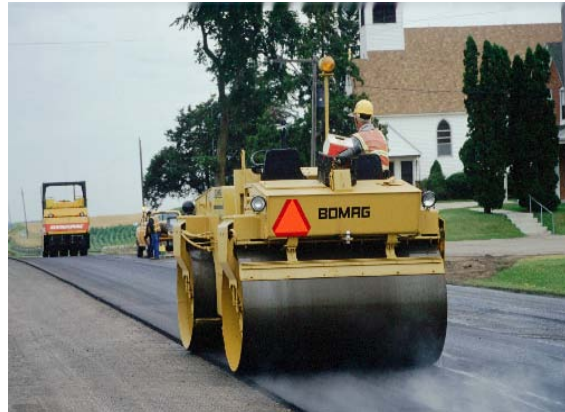
**Figure 12. Proper Location of the Steel Wheel Roller over the Unsupported Edge of the First Paved Lane (Scherozman 2004).**

For successful compaction of the unsupported edge of the first paved lane, the type and position of the roller is critical. Scherocman states that a pneumatic tire roller normally cannot be used within about 6 inches of the unsupported edge of the lane without pushing the material sideways. He suggests that a steel wheel roller, either in vibratory or static mode, is more effective at achieving proper compaction for the required density, and the proper location for the edge of the steel drum is extended over the edge of the first lane by about 6 inches, as shown in [Figure 12](#). By placing the roller at this location, there will be no transverse movement of the mix.

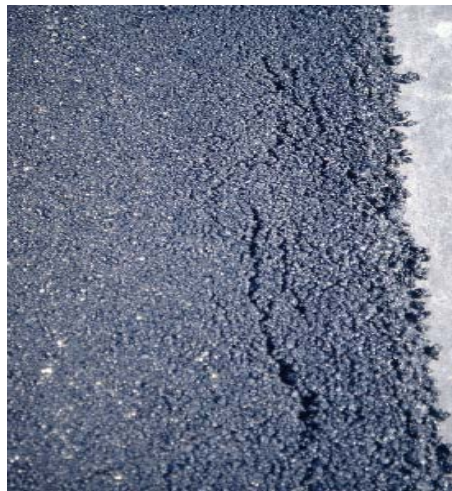
**Figure 13. Crack Development in the Mix at the Unsupported Edge of Pavement (Scherozman 2004).**

He also states that placing the roller either inside of or directly over the edge of the unsupported edge will result in transverse movement of the mix, and a crack typically forms at the edge of the drum, as is shown in Figure 13. The amount of movement will depend on the properties of the asphalt. Also, the transverse movement of the mix creates a dip, which makes matching the joint with the second lane difficult.

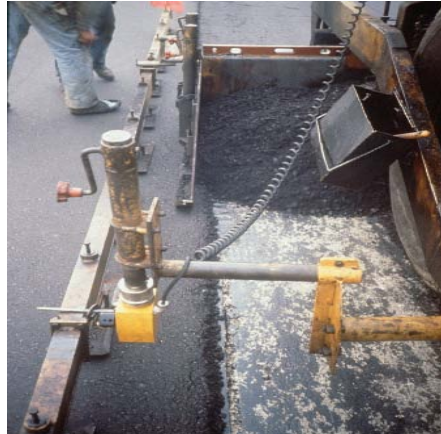
**Figure 14. Proper Amount of Overlap from Lane 2 to Lane 1 (Scherozman 2004).**

The second critical factor in successfully constructing a longitudinal joint, according to Scherozman, is overlapping the mix of the second lane over the top of the first. If an excessive amount of mix is placed over the edge of the first lane, it will have to be removed by raking the joint. If too little mix is placed over the edge of the first lane, then a depression will occur on the lane 2 side of the joint. The amount of overlap needed is about 1 to 1-½ inches for proper joint construction. Also, since a dense-graded asphalt concrete mix compacts at a rate of ¼ inch per foot, to achieve a compacted thickness of 1 inch the mix must be placed from the back of the paver screed at an uncompacted thickness of about 1-¼ inches. An example of the proper amount of lane overlap is shown in Figure 14, for which no mix will have to be raked off of lane 1.

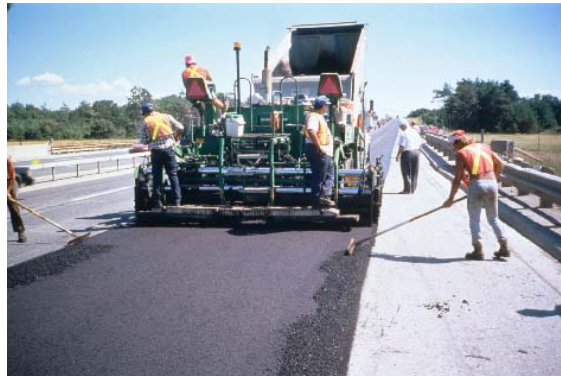
**Figure 15. Improper Raking of the Longitudinal Joint (Scherozman 2004).**

Consequently, the third key to proper joint construction is not to have to rake the joint during construction. When raking the joint, the amount of mix that is needed at the joint is usually pushed into the hot mix on lane 2 by setting the rake down on the compacted mix of lane 1 and shoving the mix on top of the hot mix on lane 2. This procedure will result in a low density on the lane 2 side of the joint. Improper raking of the longitudinal joint is shown in Figure 15.

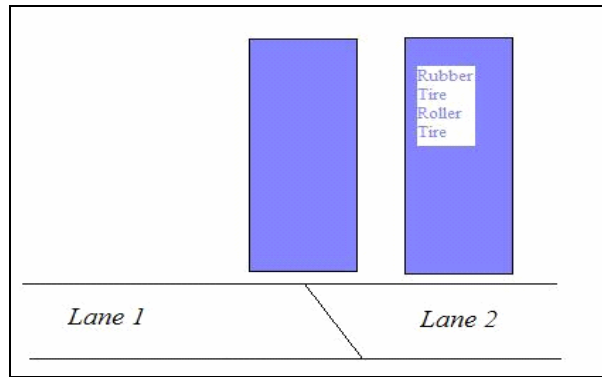
**Figure 16. Proper Placement of Pneumatic Tire Roller on the Hot Side (Scherozman 2004).**

The final key to successful longitudinal joint construction is compaction of the joint, which is dependent upon the location of the rollers. In the past, it was often common practice to compact the longitudinal joint from the cold side of the joint, which proved to be very inefficient. Since most of the drum was located on lane 1 with only 6 to 13 inches of the width of the drum extending over the joint onto lane 2, most of the weight of the roller was on the previously compacted section. While the roller is moving over the cold mix, the temperature of the new hot mix is decreasing, which reduces the opportunity to obtain the desired density. A better location for a pneumatic tire or steel wheel roller would be on the hot side with the roller extended over the top of the joint a short distance. For a pneumatic tire roller, the center of the outside tire should be placed directly over the top of the joint, as shown in Figure 16. Figure 17 shows the proper placement for a steel wheel roller; the majority of the weight of the drum should be placed on the lane 2 side with only about 6 inches extended over the first lane.

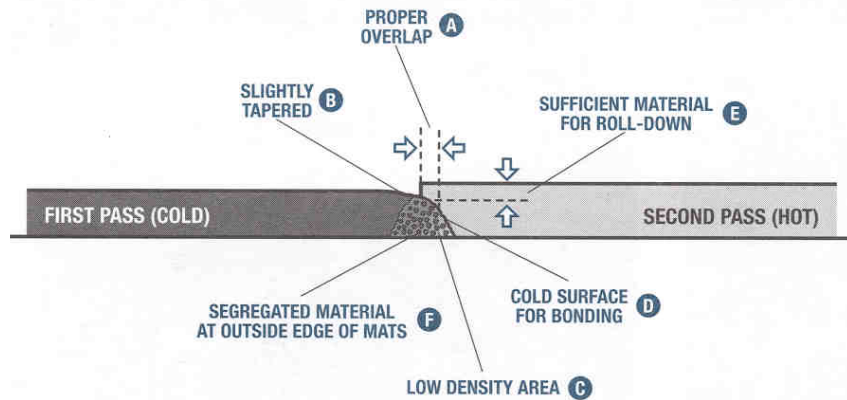
**Figure 18. Challenge in Longitudinal Joint Construction (NAPA 2002).**

- developing the proper overlap for the second pass;
- creating the proper taper for the first pass;
- reducing or eliminating a low-density, partially compacted area;
- achieving proper bond between the first and second passes;
- placing sufficient material to allow for roll down to match final grade between the two passes; and
- reducing or eliminating mix segregation at the outside edge of each pass

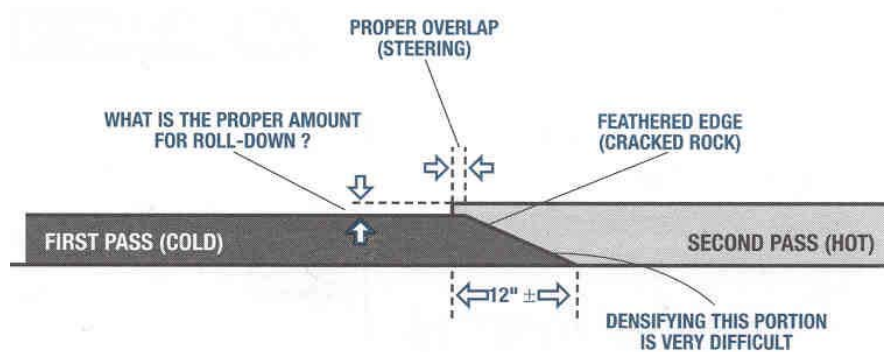
**Figure 19. Tapered Joint Technique (NAPA 2002).**

A study on longitudinal joints conducted by the National Center for Asphalt Technology (NCAT) in the early 1990s found that there was an area of low density and high air voids from the center of the joint over 6 to 8 inches. This area allowed water to enter the areas of low density, and freezing would break out the asphalt and lead to premature failure. As a result, the tapered joint technique shown in Figure 19 was developed.

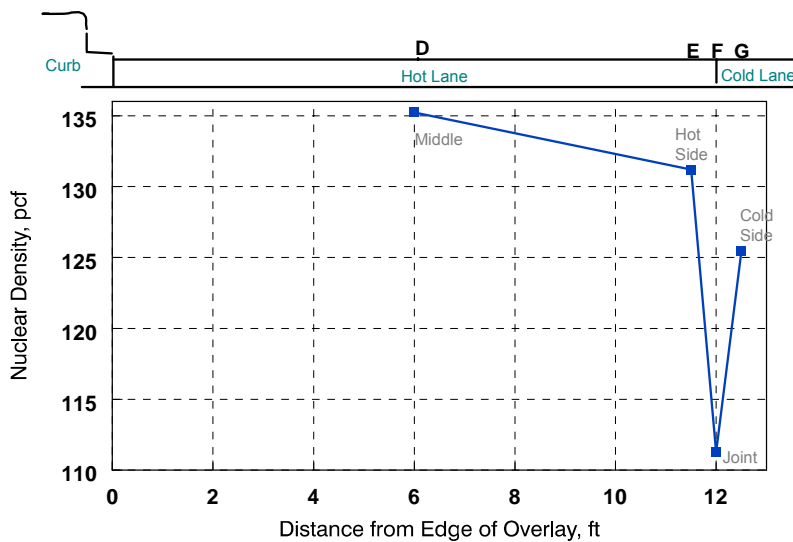
**Figure 20. Mean Density Profile for Loop 323 in Tyler, Texas (Estakhri, et al. 2001).**

The researchers consistently found that there was an area of low density at the edge of the first paved lane. This area is demonstrated in Figure 20, which was the mean density profile for one the sections tested on Loop 323 in Tyler, Texas.

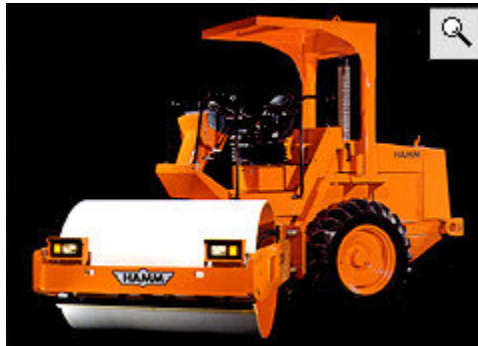
Figure 22. Hamm® Model 2220 D (<http://www.hammcompactors.com>).

The Hamm® Model 2220 D vibratory soil compactor features a 54-inch smooth drum, with a 5-ton operating weight and 62 hp engine. This soil compactor is shown in [Figure 22](#), and its specifications are shown in [Table 6](#).

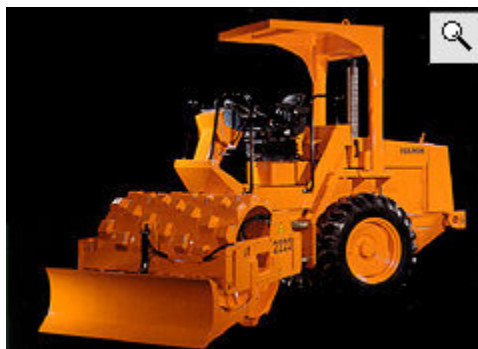
Figure 23. Hamm® Model 2222 DS (<http://www.hammcompactors.com>).

The Hamm® Model 2222 DS padfoot vibratory soil compactor features a 54-inch padfoot drum, with a 5-ton operating weight and 62 hp engine. This soil compactor is shown in [Figure 23](#), and its specifications are shown in [Table 7](#).

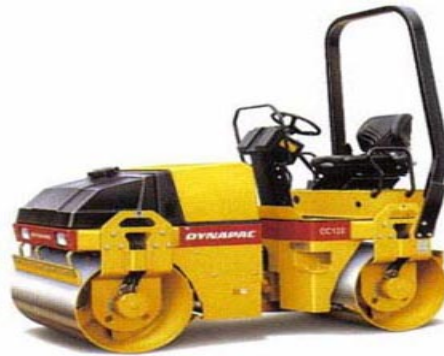
**Figure 24. Dynapac CC-122 Tandem Roller (<http://www.constructioncomplete.com>).**

The Dynapac CC-122 Tandem Roller is designed for patching and repairs but is also ideal for town work on small streets, pavements, driveways, cycle paths, parking lots, etc. This soil compactor is shown in [Figure 24](#), and its specifications are shown in [Table 8](#).

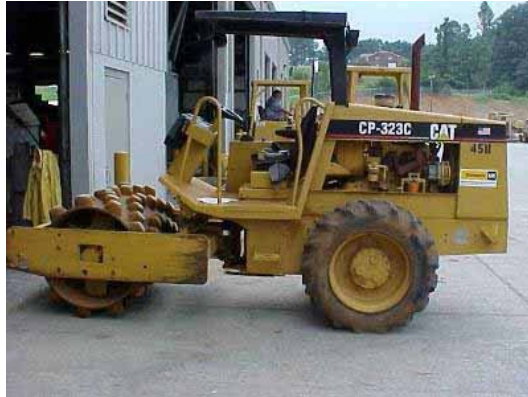
Figure 25. Caterpillar CP-323C (<http://www.cat.com.cda>).

The compact size of the Caterpillar CP-323C is designed specifically for utility construction with narrow working widths like trench compaction or job sites with limited space. It features a 54-inch working width. This soil compactor is shown in [Figure 25](#).

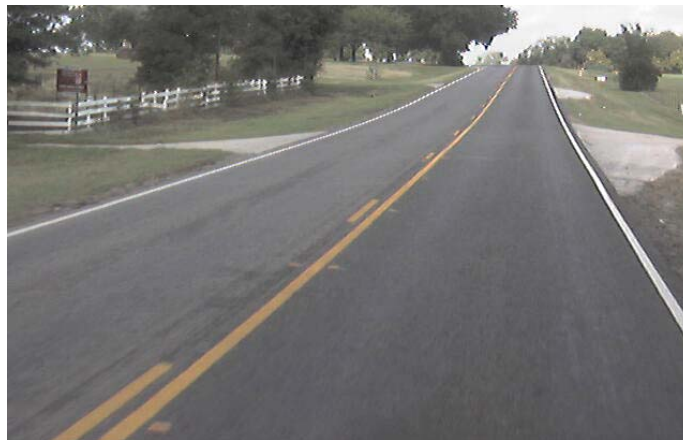
**Figure 26. Flexible Pavement Section in Good Condition.**

A flexible pavement in good condition is one on which there are no structural failures, and there is no need for rehabilitation. Typically, the pavement widening will be accomplished through the construction of 1– 4 foot shoulders. An example of a flexible pavement in good condition is shown in [Figure 26](#).

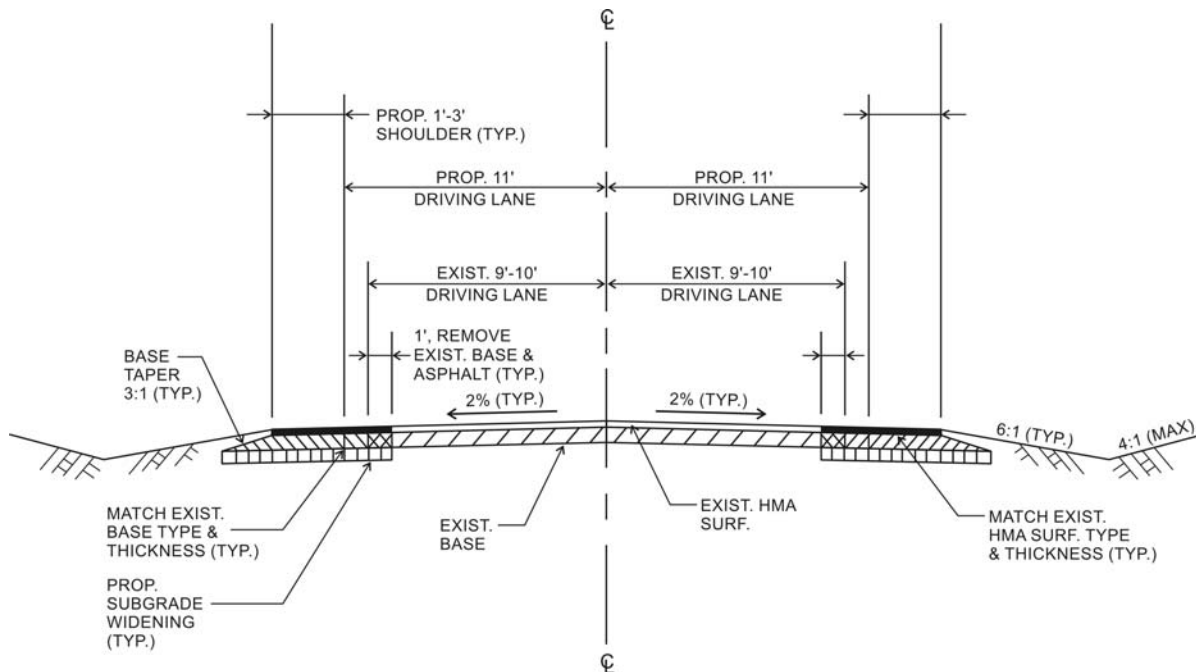
**Figure 27. Typical Section for Widening Flexible Pavements in Good Condition.**

Several Districts provided typical construction drawings for this particular widening construction. These were incorporated into the flexible pavement widening guideline, which is provided in TxDOT Product 0-5429-P2 (Hilbrich and Scullion), and an example of this is also shown in [Figure 27](#).

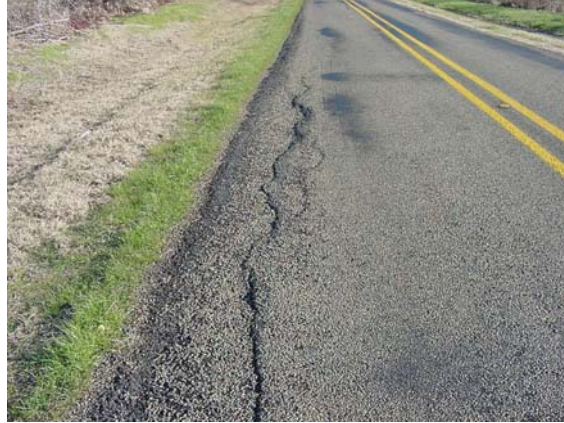
**Figure 28. Flexible Pavement Section in Poor Condition.**

A flexible pavement in poor condition will have severe rutting, may require heavy maintenance, and will be a candidate for reconstruction/rehabilitation. An example of a flexible pavement in poor condition is shown in [Figure 28](#).

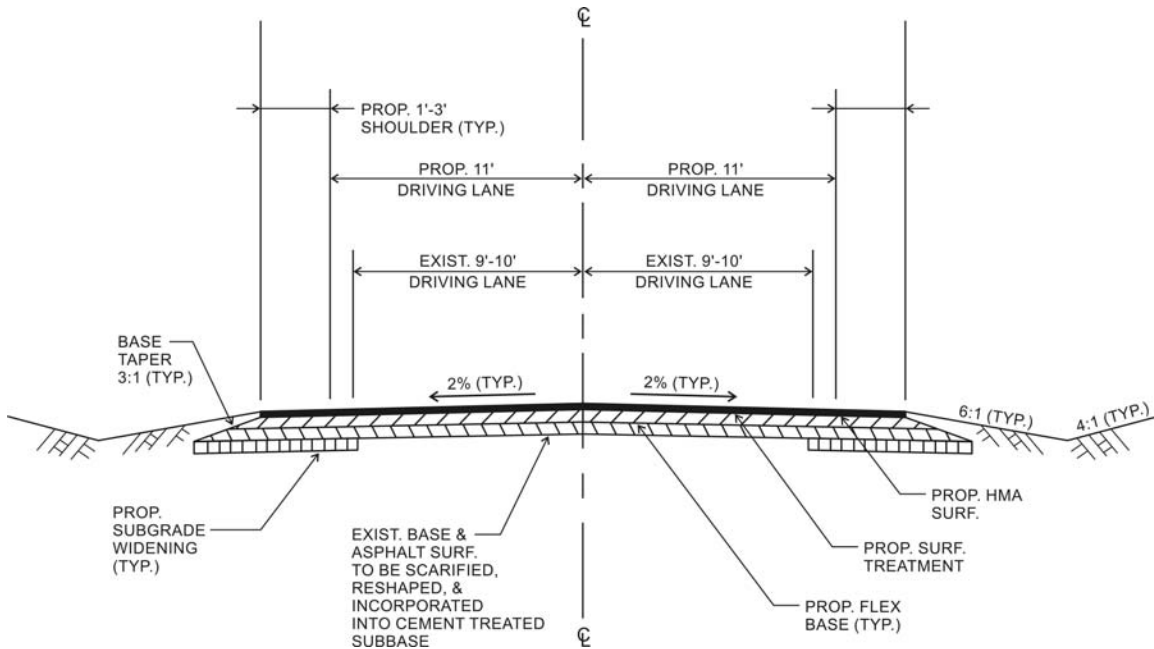
**Figure 29. Typical Section for Widening Flexible Pavements in Poor Condition Using Full Depth Recycling.**

Several Districts provided typical construction drawings for these this particular widening construction. These drawings were incorporated into the flexible pavement widening guideline, which is provided in TxDOT Product 0-5429-P2 (Hilbrich and Scullion), and an example of this is also shown in [Figure 29](#).

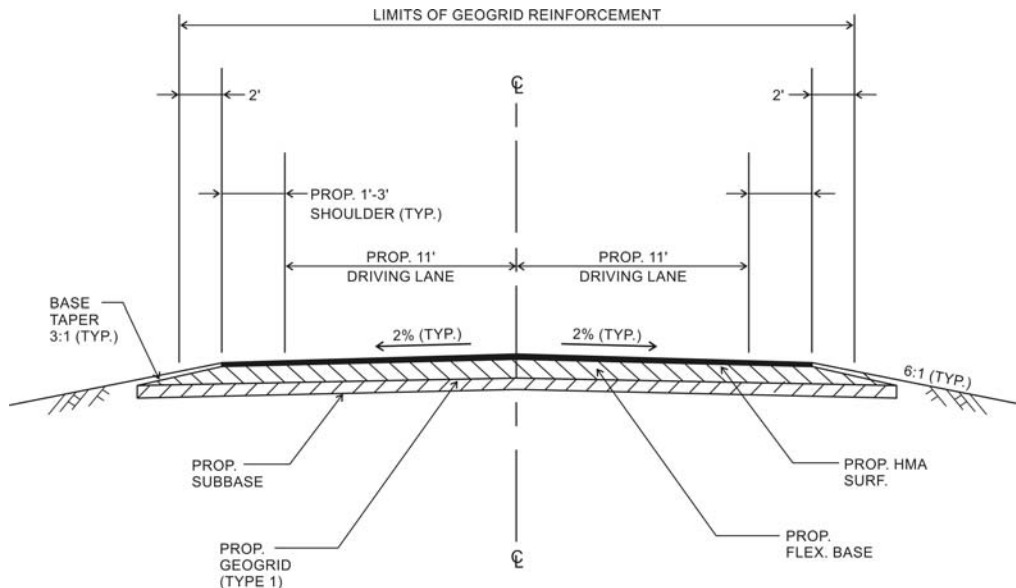
**Figure 30. Typical Section for Widening Flexible Pavements in Poor Condition on Highly Plastic Subgrades.**

A viable alternative when the flexible pavement to be widened is on top of a highly expansive subgrade, PI > 35 was found based on the experience of the Bryan District. Use of the Tensar Grid is very effective at intercepting reflection cracks from the lower layers and, thus, minimizing the longitudinal cracks that are often a result of edge drying. The Bryan District now routinely uses this procedure on its widening projects. [Figure 30](#) shows a typical construction drawing incorporating the use of geogrid.

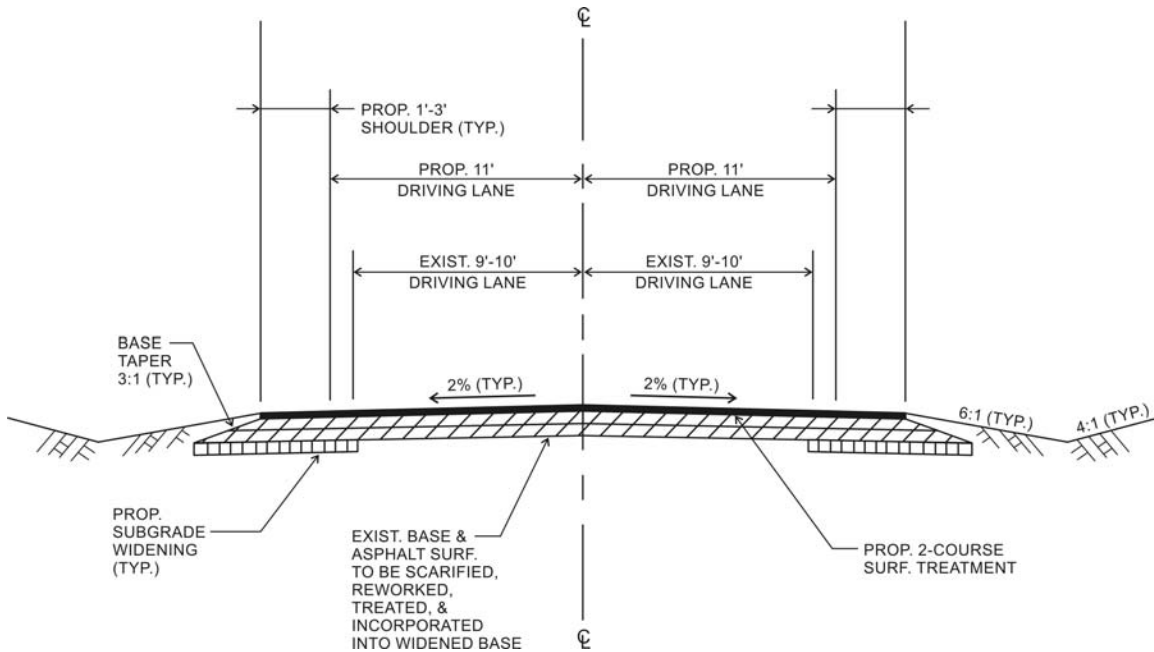
**Figure 31. Typical Section for Widening Flexible Pavements in Poor Condition by Reworking the Existing Base.**

Another cost-effective alternative for widening low volume roads when there are less than 1000 vehicles per day (vpd) and the existing pavement is in poor condition is to rework and treat the existing base before widening to the desired width. A two-course surface treatment would then be applied. Care must be taken to avoid contamination of the reworked base with the subgrade soil. Since the existing material thicknesses can vary, it is highly recommended that a GPR survey or coring of the pavement to be reworked be conducted to verify layer thicknesses. Also, this testing will verify whether there is sufficient existing base thickness to construct with this method. Figure 31 provides a typical construction drawing for this method.

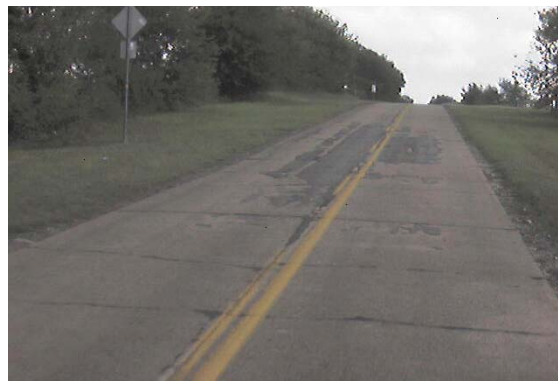
**Figure 32. Jointed Concrete Pavement.**

A jointed concrete pavement may or may not have any structural failures and will be a candidate for widening. An example of a jointed concrete pavement (JCP) is shown in Figure 32.

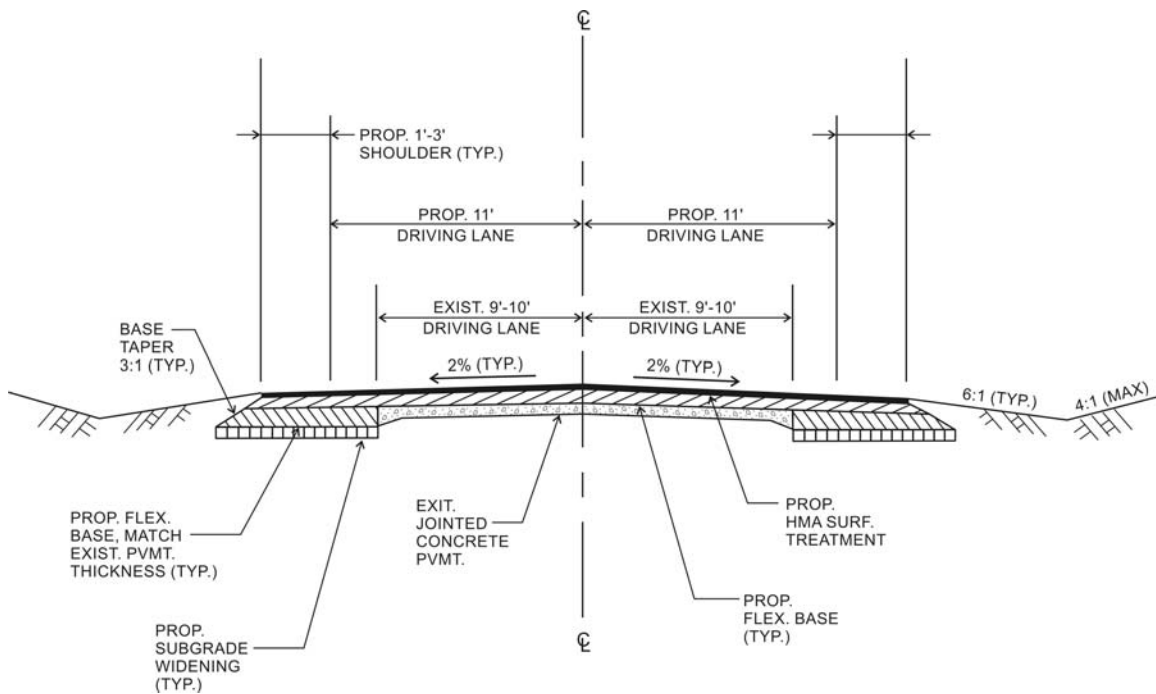
**Figure 33. Typical Section for Widening Jointed Concrete Pavements.**

Researchers found that when widening JCP, it is not critical to match sections. Matching sections is critical when the existing base material is moisture susceptible, such as flexible base. Widening JCPs is often performed with full depth hot mix or cement-treated base. However, widening with flexible base material is not recommended. As was previously mentioned under “Flexible Pavement in Good Condition,” there is usually little laboratory investigation or pavement design involved. As is the case with a flexible pavement in good condition, it is extremely important to get a good density in the subgrade widening, as not doing so will adversely affect the densities in the subsequent layers. Once again, it is critical to confirm with the contractor prior to construction that there is equipment available that can adequately compact these narrow sections. This construction detail is provided in [Figure 33](#).

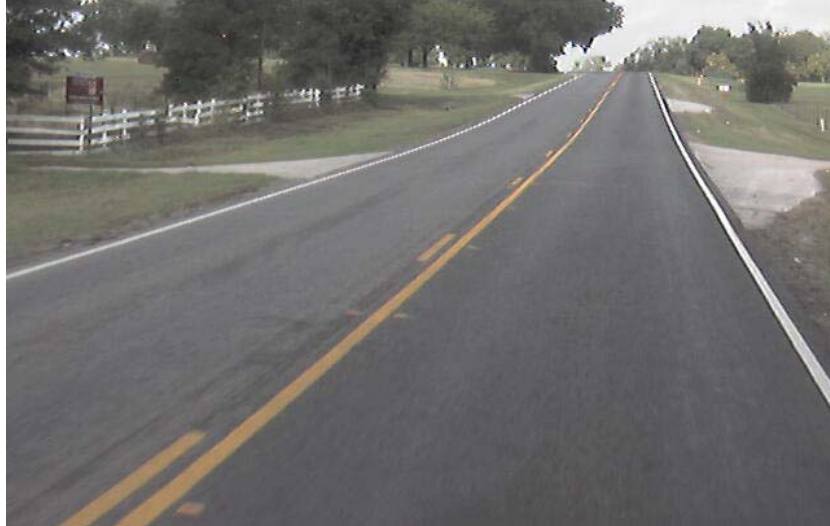
**Figure 1:** Flexible Pavement Section in Good Condition

### *Case 1: Flexible Pavement Section in Good Condition (See Figure 1) No structural failures*

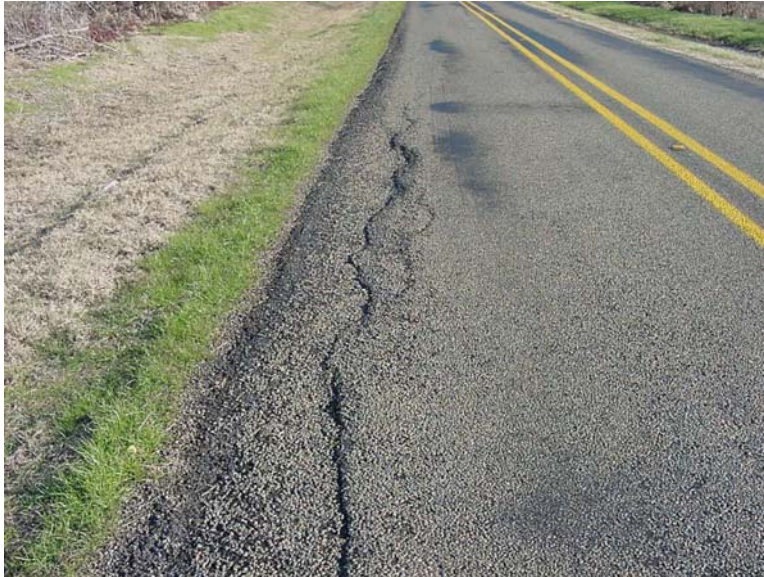
**Figure 2:** Flexible Pavement Section in Poor Condition

***Case 2: Flexible Pavement Section in Poor Condition (See Figure 2) Rutting/heavy maintenance***

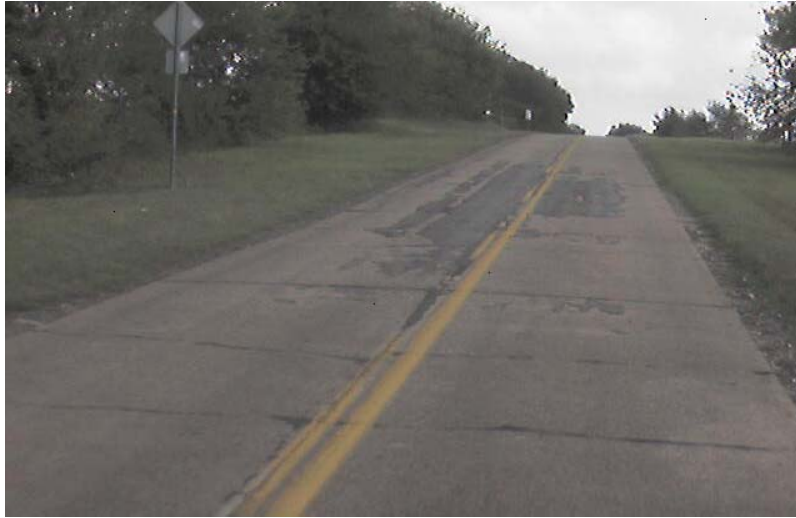
**Figure 3: Jointed Concrete Pavement**

*Case 3: Jointed Concrete Pavement (see Figure 3)*

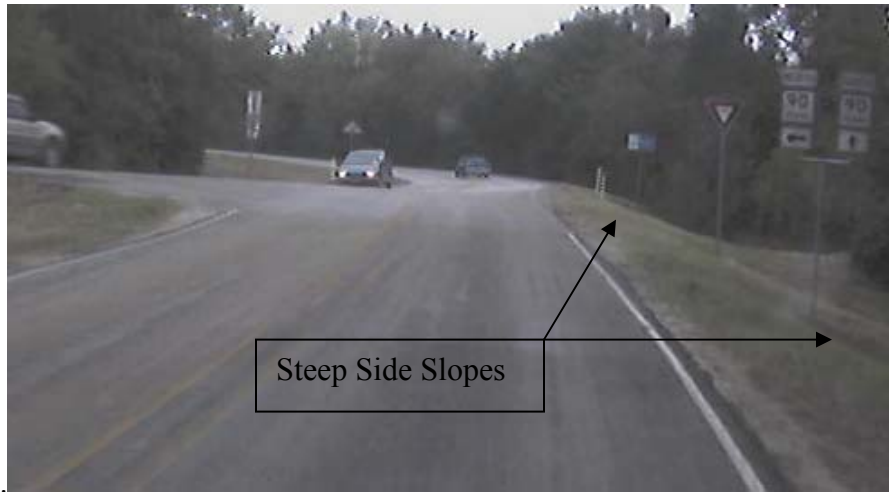
**Figure 4:** Flexible Pavement with Steep Side Slopes

***Special Case 1: Flexible Pavement with Steep Side Slopes (See Figure 4)***

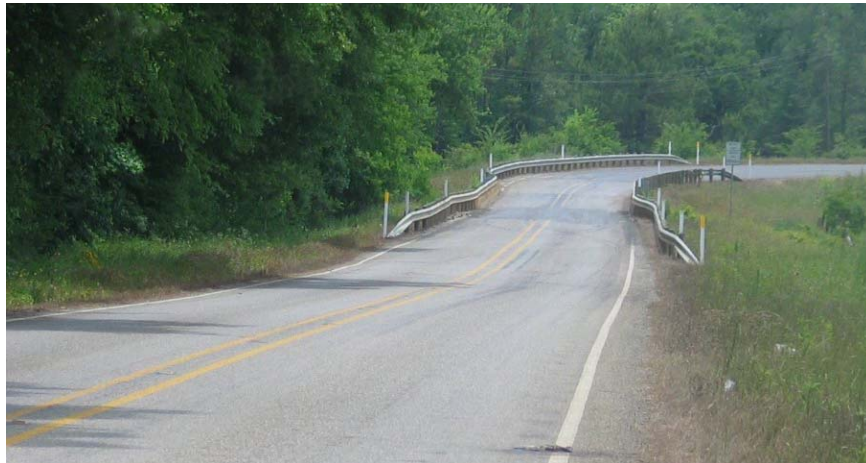
**Figure 5:** *Narrow Bridge Approach*

***Special Case 2: Flexible Pavement Widening at Narrow Bridge (See Figure 5)***
