**ANALYSIS OF SUCCESSFUL FLEXIBLE PAVEMENT SECTIONS IN
TEXAS – INCLUDING DEVELOPMENT OF A WEB SITE AND
DATABASE**

Report 0-5472-1

Project 0-5472

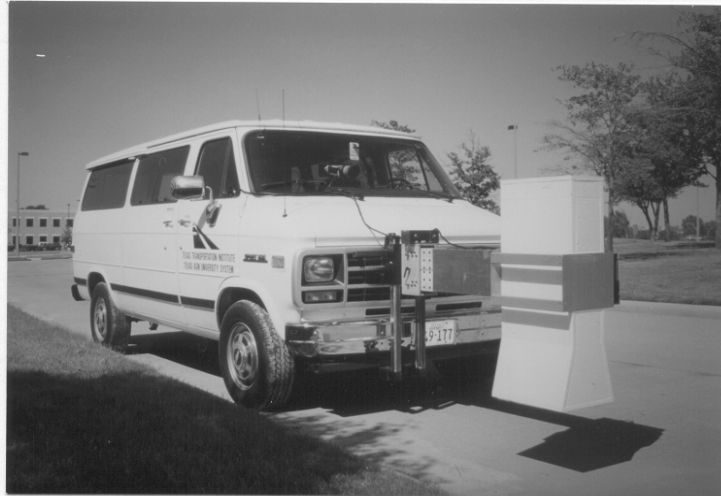
(a) TTI GPR Equipment

(b) Principles of GPR. The incident wave is reflected at each layer interface and plotted as return voltage against time of arrival in nanoseconds.

Figure 13. GPR Equipment and Principles of Operation.

The objective of GPR testing was to investigate subsurface conditions and observe variations in layer thicknesses, if any. TTI's one gigahertz (1 GHz) air-launched ground penetrating radar unit was used and is shown in Figure 13. This system sends discrete pulses of

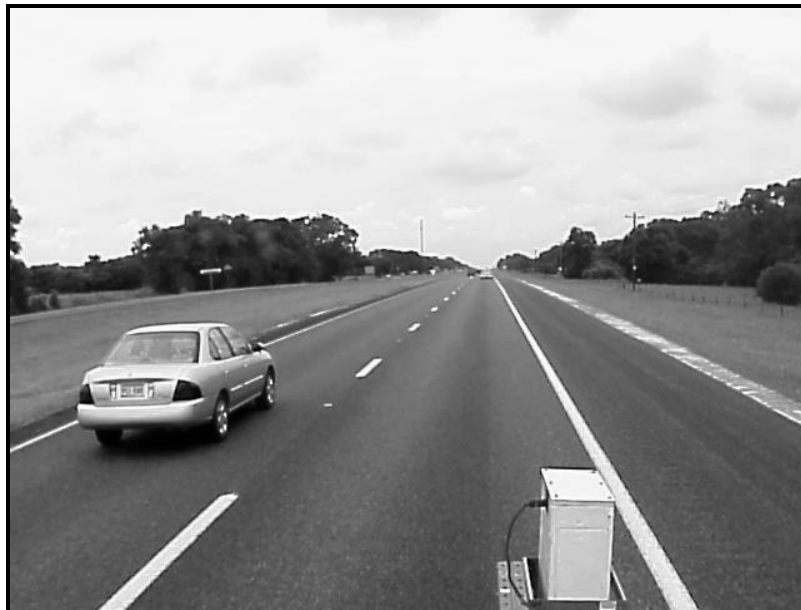
Figure 14. Still Picture from GPR Video Data – SH 6, Houston.

Typically, GPR data were obtained from the right wheel path of the outside lane of the nominated pavement section. GPR data were usually obtained for the entire length of the nominated pavement section, in one direction, at pulse distance intervals of 1 foot. Pavement video was captured during GPR test runs to assist in evaluating GPR data. [Figure 14](#) shows a typical still picture from the video data.

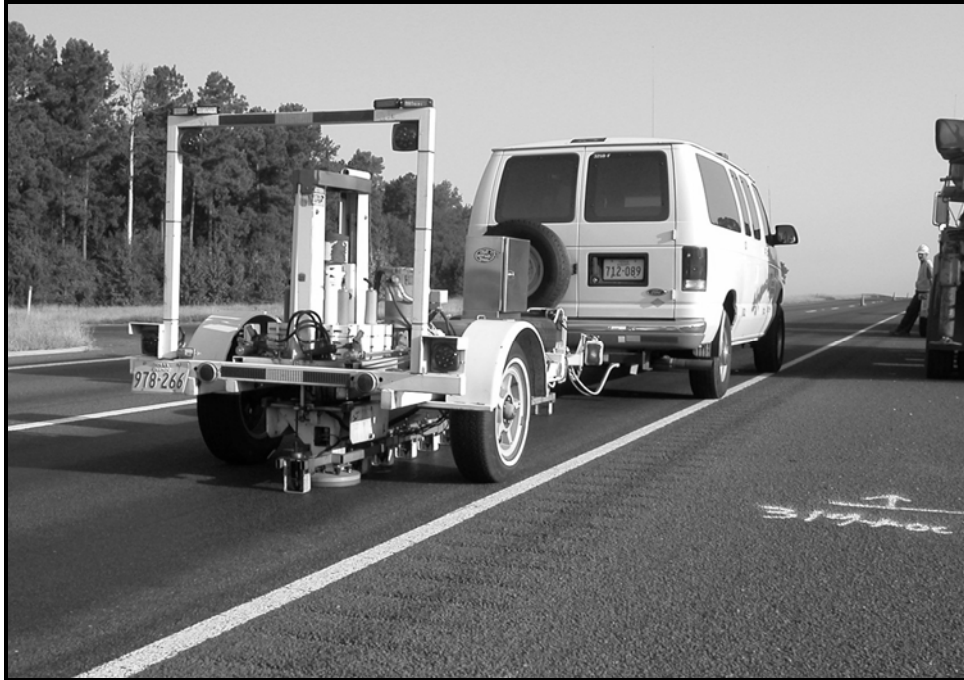
Figure 16. FWD Testing – US 59, Atlanta.

TxDOT’s project level data collection protocol was followed during testing. The tests were conducted in the outer wheel path of the designated lane, and 30 test points were evenly distributed over the one-mile length. In most cases the test load was 9000 lbs, with three test drops being made at each test point. Pavement temperature was measured at the beginning and the end limits of the one-mile test length. [Figure 16](#) shows a typical FWD test in progress on the outer wheel path.

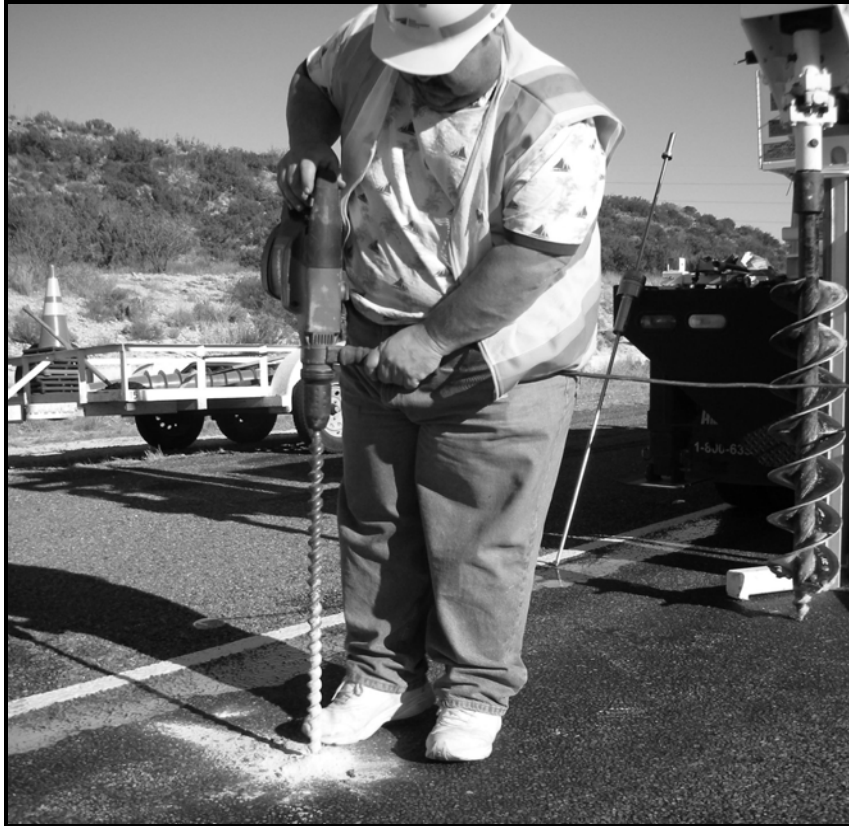
Figure 17. Drilling Asphalt Mixture before DCP Testing.

research team drilled somewhat further, into the flexible base layer, prior to beginning testing. This additional drilling was necessary when the depth of penetration was zero or was bouncing after as many as 40 drops. The problem was believed to be caused by a large rock directly beneath the cone tip. The research team took DCP measurements at two locations for each one-mile test length—one near each end of the test section.

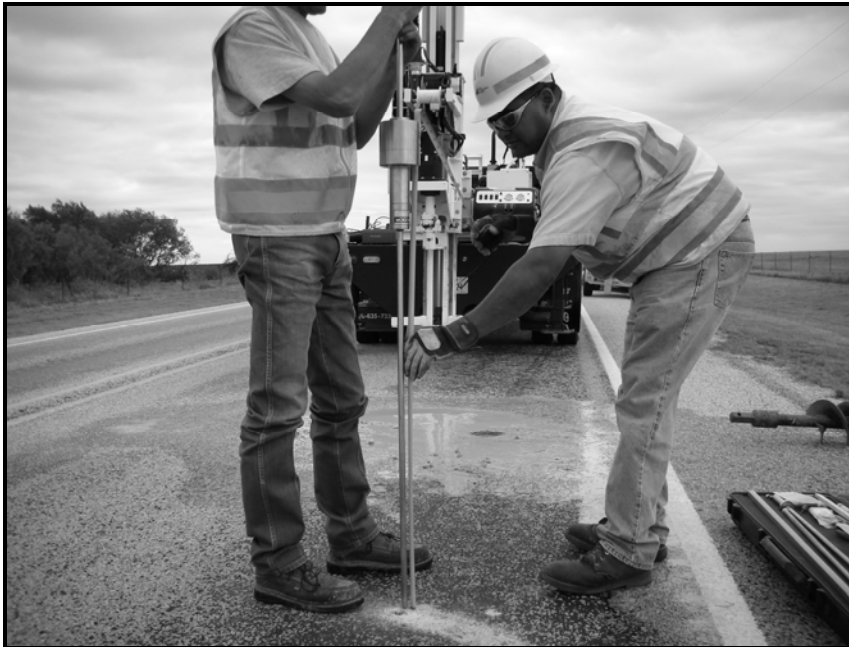
Figure 18. DCP Testing in Outer Wheel Path.

The objective of DCP testing was to measure the in situ stiffness of flexible base and subgrade layer(s). This test was conducted following the general guidelines from ASTM D6951-03 “Standard Test Method for the Use of the Dynamic Cone Penetrometer in Shallow Pavement Applications.” An 8 kilogram sliding hammer was used for this testing. Before testing, asphalt concrete layers and surface treatment layers were penetrated with a drill (see [Figure 17](#)) so that the tip of the DCP cone rested on the top of the flexible base layer to begin testing. [Figure 18](#) depicts personnel taking DCP measurements at one test location. The number of drops between penetration measurements varied widely depending on the layer stiffness. A smaller number of drops were used for softer layers and a larger number for stiffer layers. In several cases the

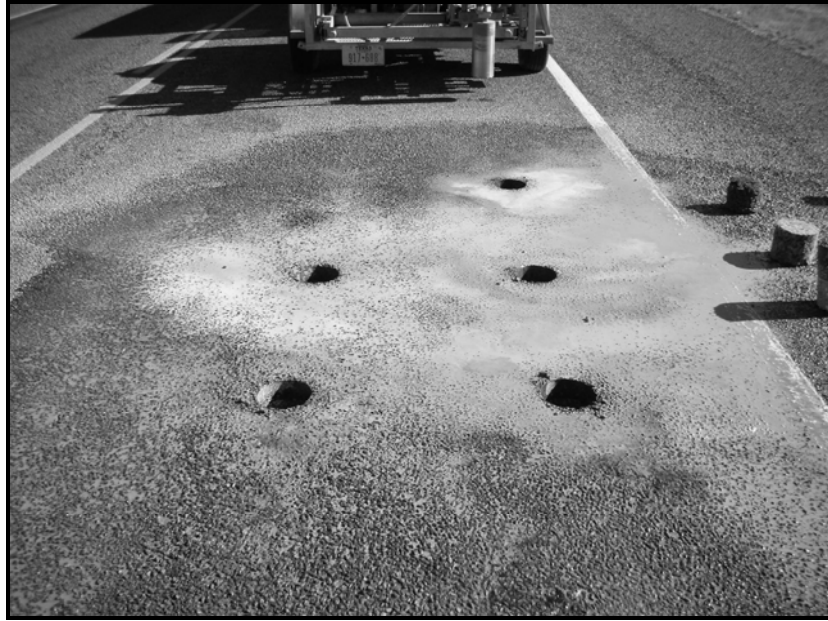
Figure 21. Typical Coring Layout at Section with HMA Layer (SH 176 in Odessa).

Except for samples from FM 1472 and SH 121, the research team used TTI coring equipment to obtain core samples, as shown in [Figure 21](#) after completing coring at a typical location. The Laredo District Laboratory generously obtained their pavement's core samples during the research team visit. The asphalt cores from SH 121 in the Fort Worth District were obtained by district personnel prior to the asphalt overlay being milled. Only four 6-inch diameter cores were available for testing from this pavement.

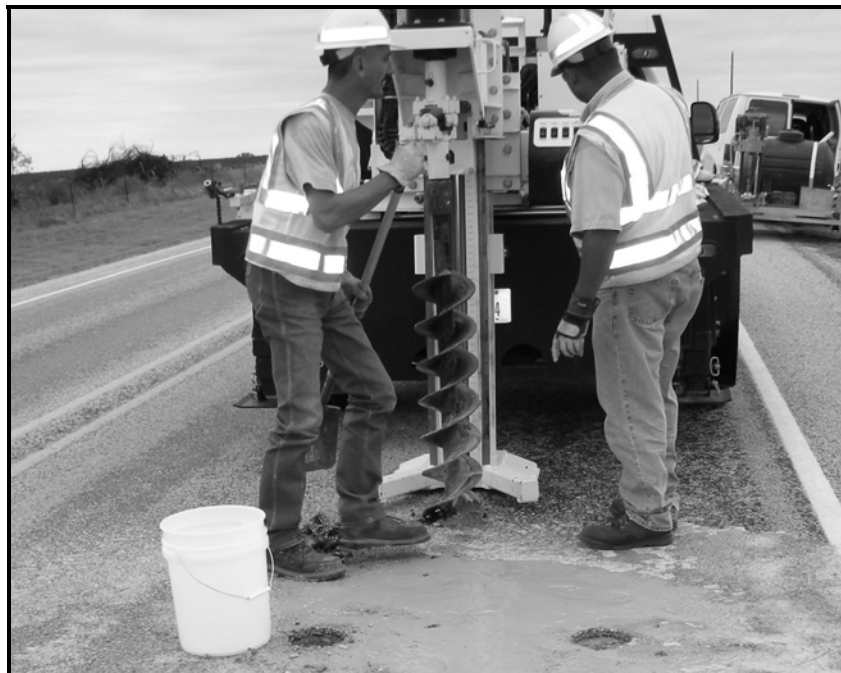
Figure 22. TTI Auger Used to Obtain Flexible Base and Subgrade Samples.

Flexible base and subgrade samples were typically obtained from two 10-inch diameter holes near the coring location. These samples were taken with a TTI auger, shown in [Figure 22](#). These sampling holes were located between the wheel paths in order to minimize the potential for roadway performance damage.

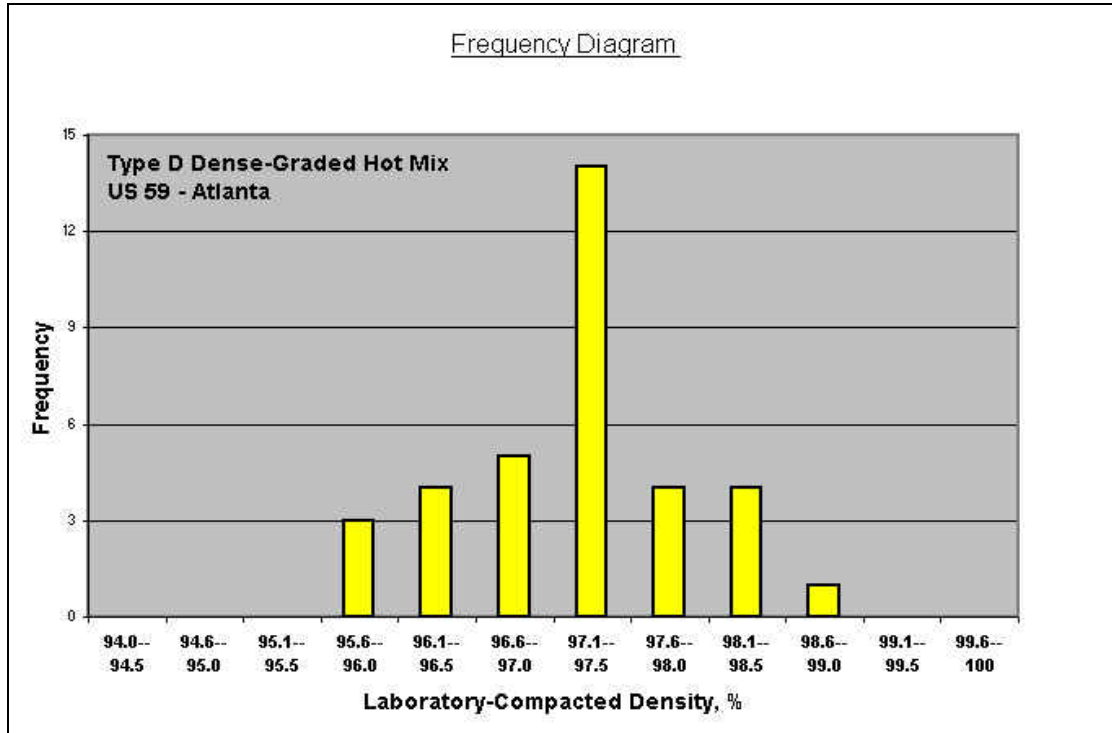
Figure 27. Frequency Diagram of Daily Laboratory-Compacted Densities - US 59, Atlanta.

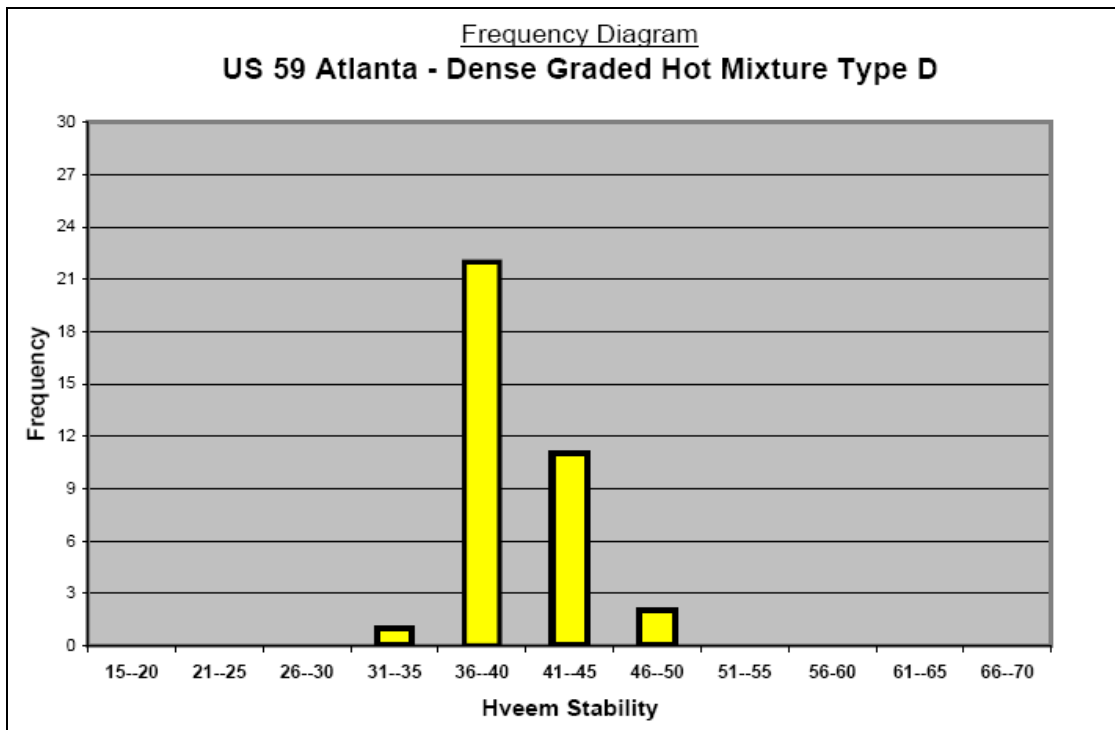
Figure 28. Frequency Diagram of Daily Hveem Stability Test Results - US 59, Atlanta.

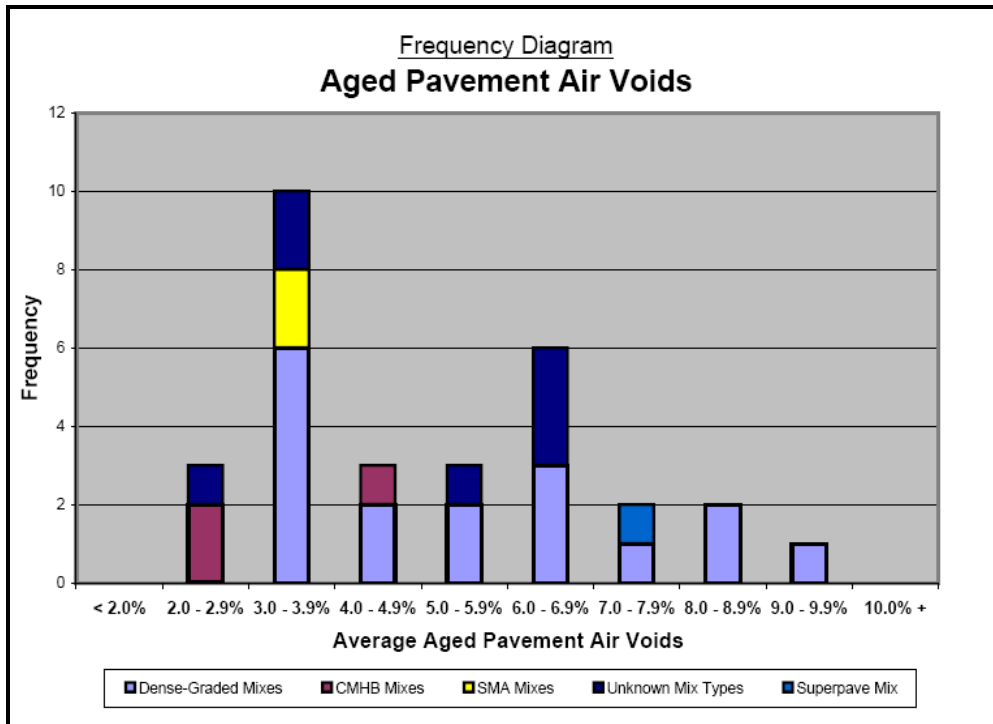
Figure 29. Frequency Diagram of Air Voids in Aged Pavement Layers – All Asphalt Concrete Mix Types.

Several interesting observations may be made about the levels of air voids found in these successfully performing pavement layers after years of traffic compaction. [Figure 29](#) shows the frequency distribution of pavement air void average values as found in the 30 dense asphalt pavement layers that were cored and tested. The data show an apparent skew toward the 3 to 4 percent air void levels. It is noteworthy that this has been the targeted design air void level in Texas for many decades. However, there also appears to be a secondary factor involved with the data distribution, as a second peak in the distribution curve is noted in the 6 to 7 percent air void range.

Researchers investigated two possible causes for the secondary peak in the distribution curve. First, the data distributions were separately plotted based on each pavement layer’s vertical position in the pavement structure. [Figure 30](#) shows test results from only the surface layers, while [Figure 31](#) shows the results from underlying layers. The apparent difference in the skew of these two data distribution indicates the likelihood that vertical location of the layer in the pavement structure is a contributing factor toward the secondary data distribution peak seen in [Figure 29](#). While difference in the data skew stood out, the average air void levels did not differ substantially. The average air void level found in the surface courses was 4.9 percent, while the average air void level found in the underlying layers was 5.5 percent. Additional data would help clarify these relationships. A greater difference may in fact be found with a larger data set, possibly much closer to the approximate 3 percent difference between the two data peaks seen in [Figure 29](#).

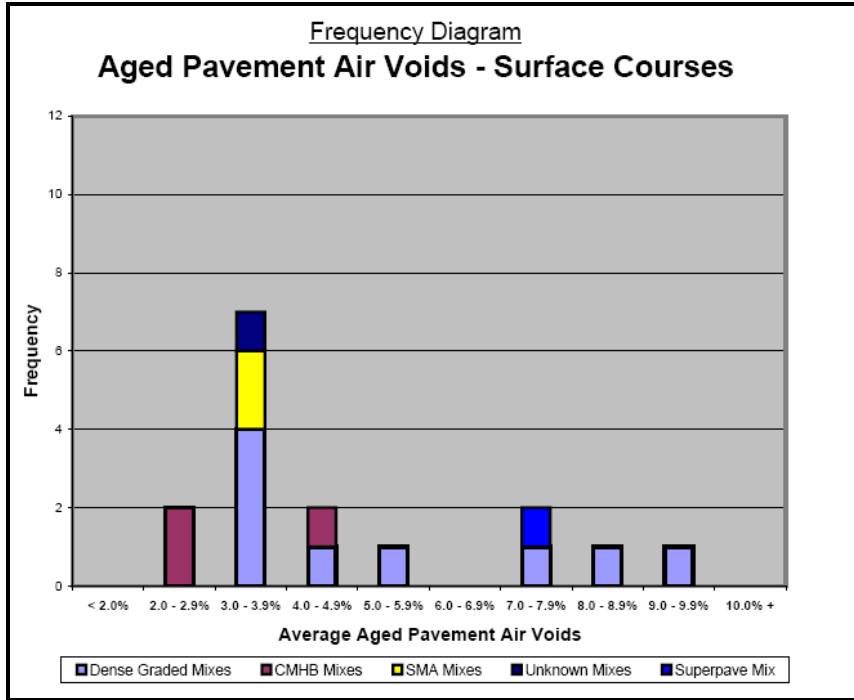
Figure 30. Frequency Diagram of Air Voids in Asphalt Concrete Pavement Surface Layers.

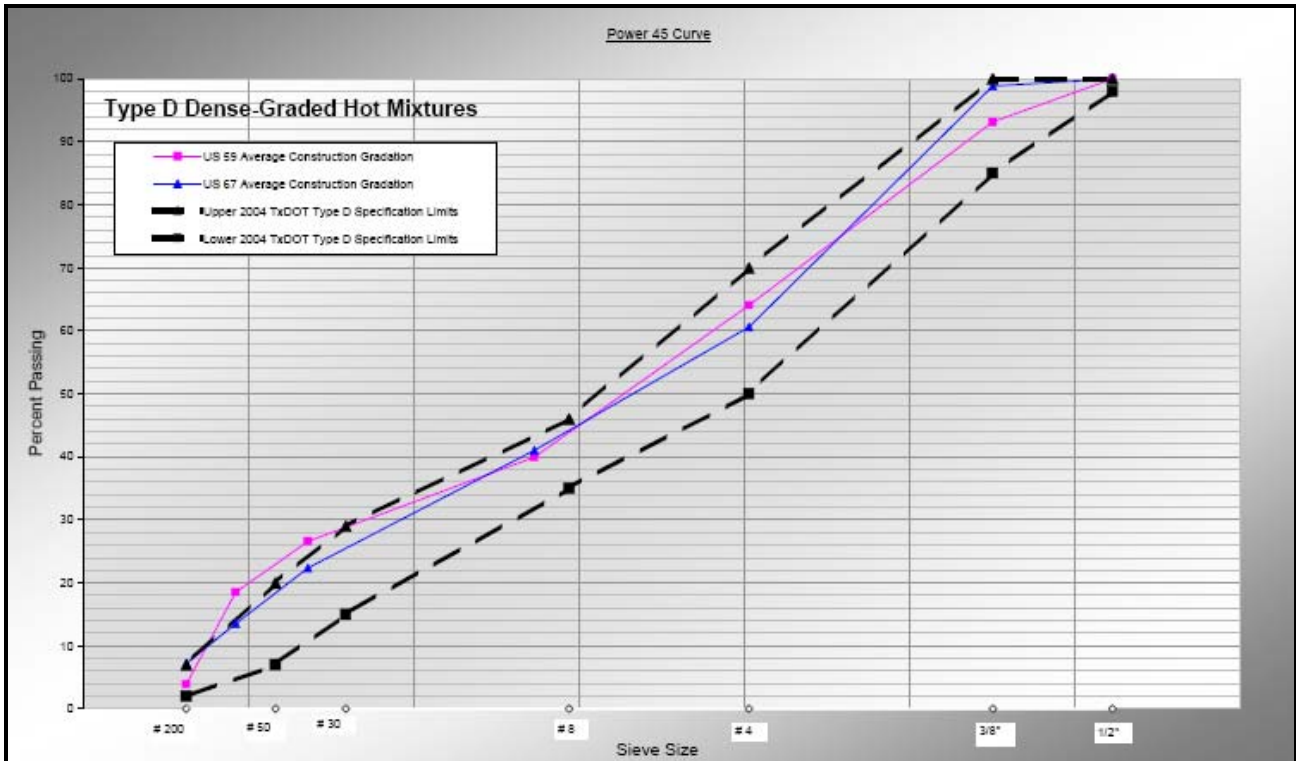
Figure 34. Power 45 Average Construction Job Control Gradations – Type D Mixes.

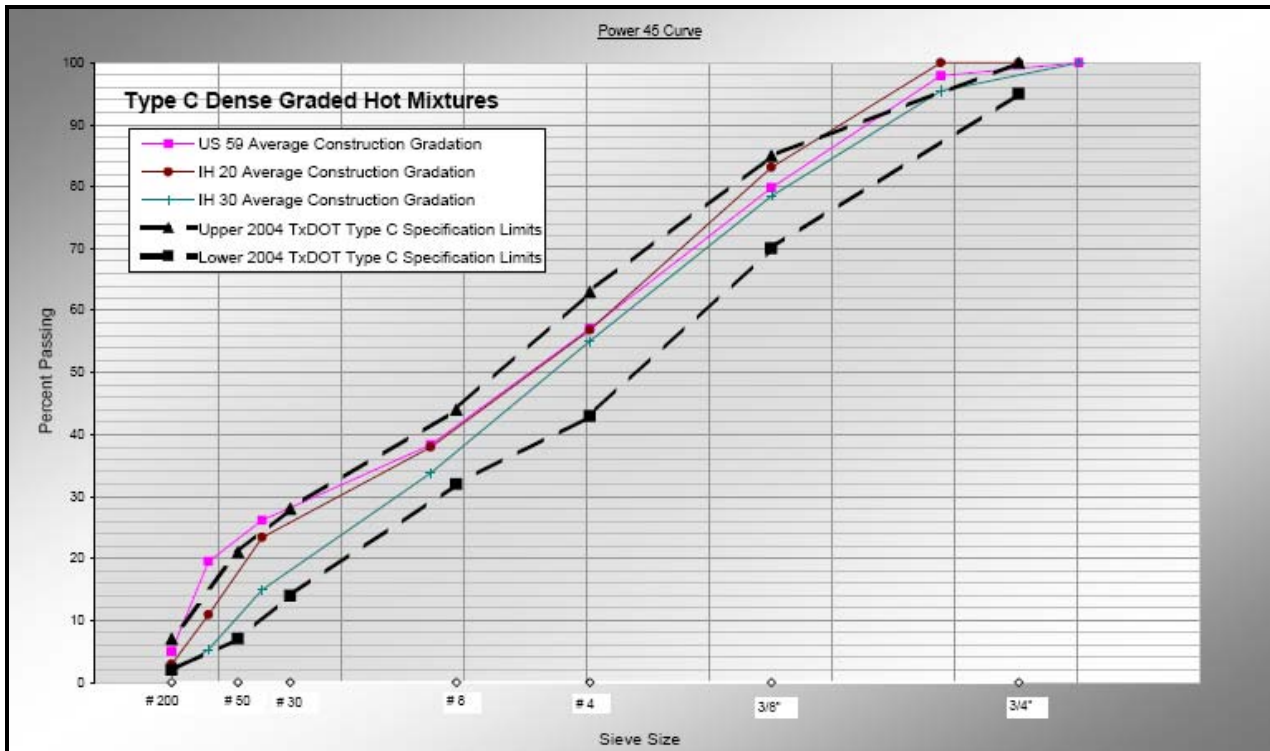
Figure 35. Power 45 Average Construction Job Control Gradations – Type C Mixes.

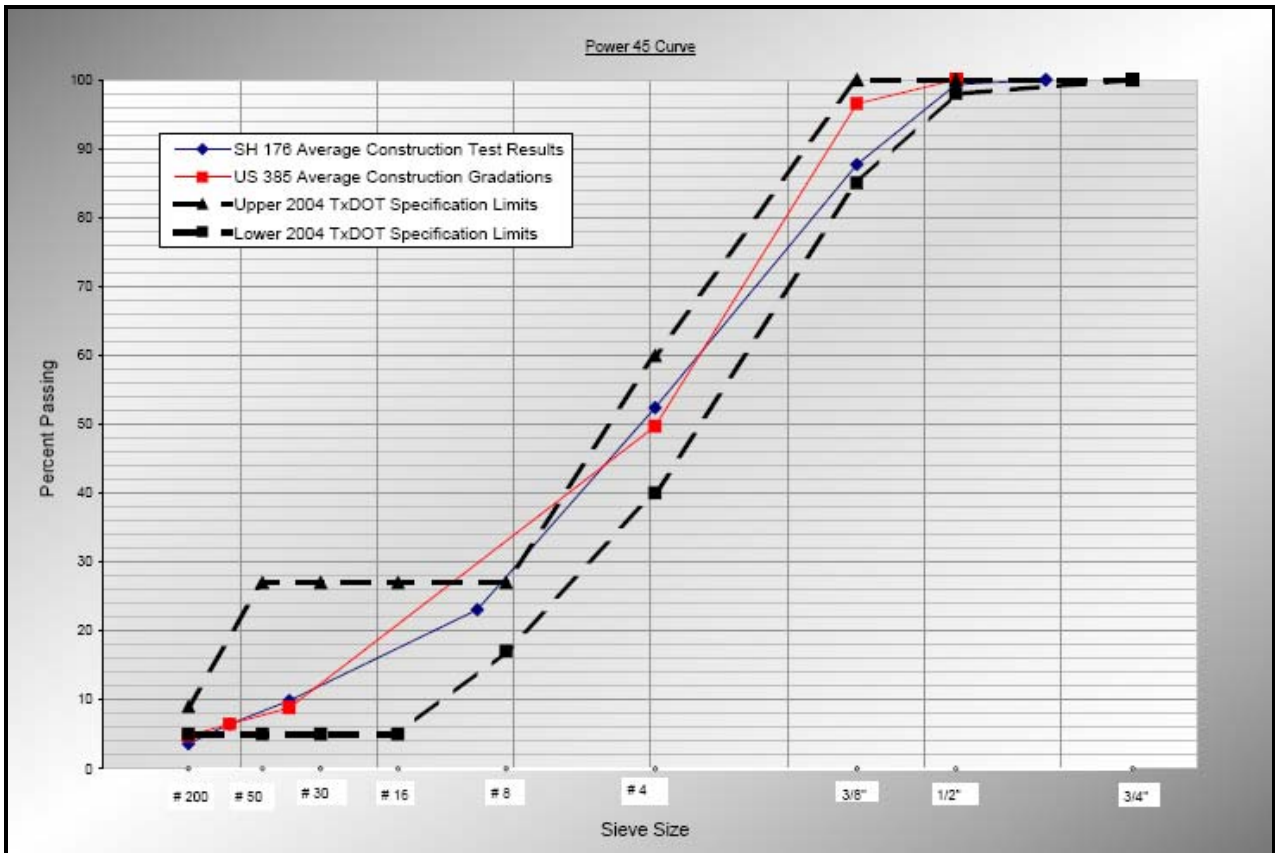
Figure 36. Power 45 Average Construction Job Control Gradations – CMHB-F Mixes.

control gradations determined at the mix plants during production on these projects, which also displays current specification upper and lower gradation requirements for CMHB-F mixtures.

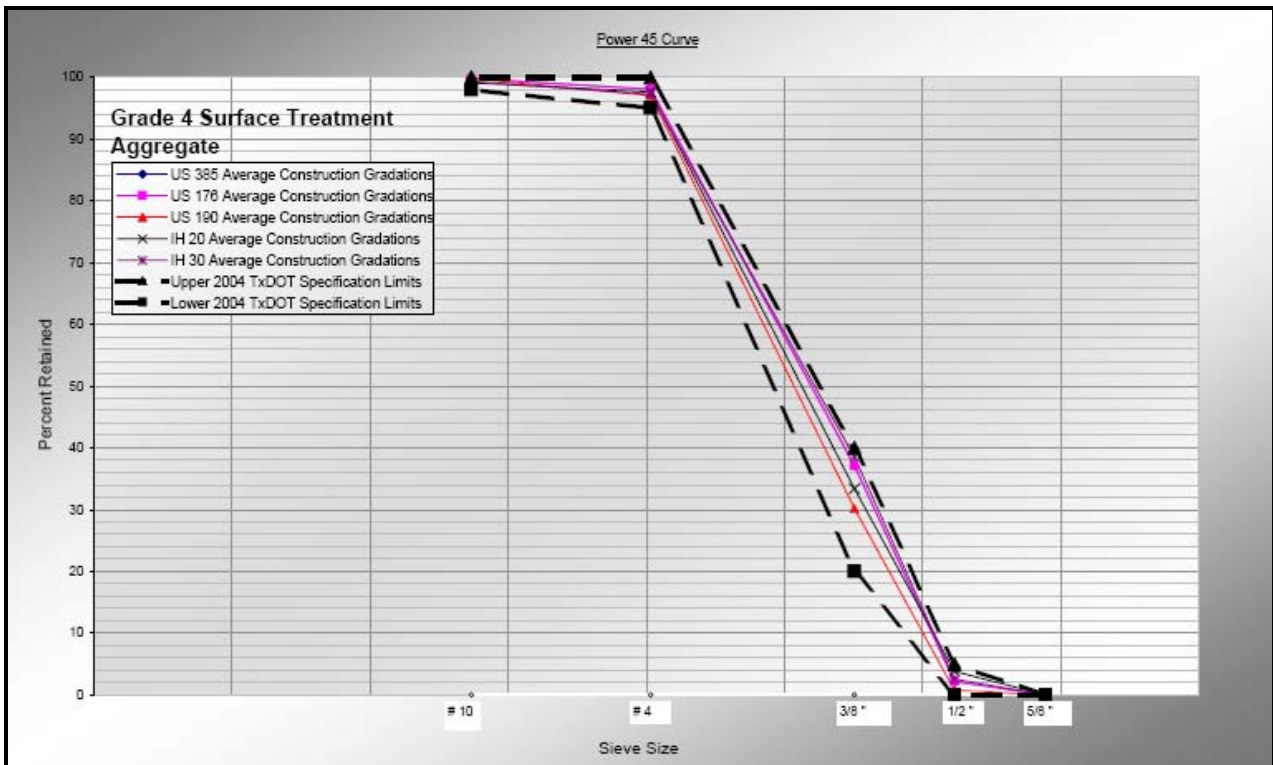
Figure 37. Power 45 Average Construction Job Control Gradations – Grade 4 Surface Treatment Aggregate.

Construction inspection gradation test results were located for five projects with Grade 4 surface treatments. Aggregate types represented were limestone, rhyolite, and lightweight. The average job control gradations on these projects are shown on [Figure 37](#), which also displays current specification upper and lower gradation requirements for Grade 4 surface treatment aggregate.

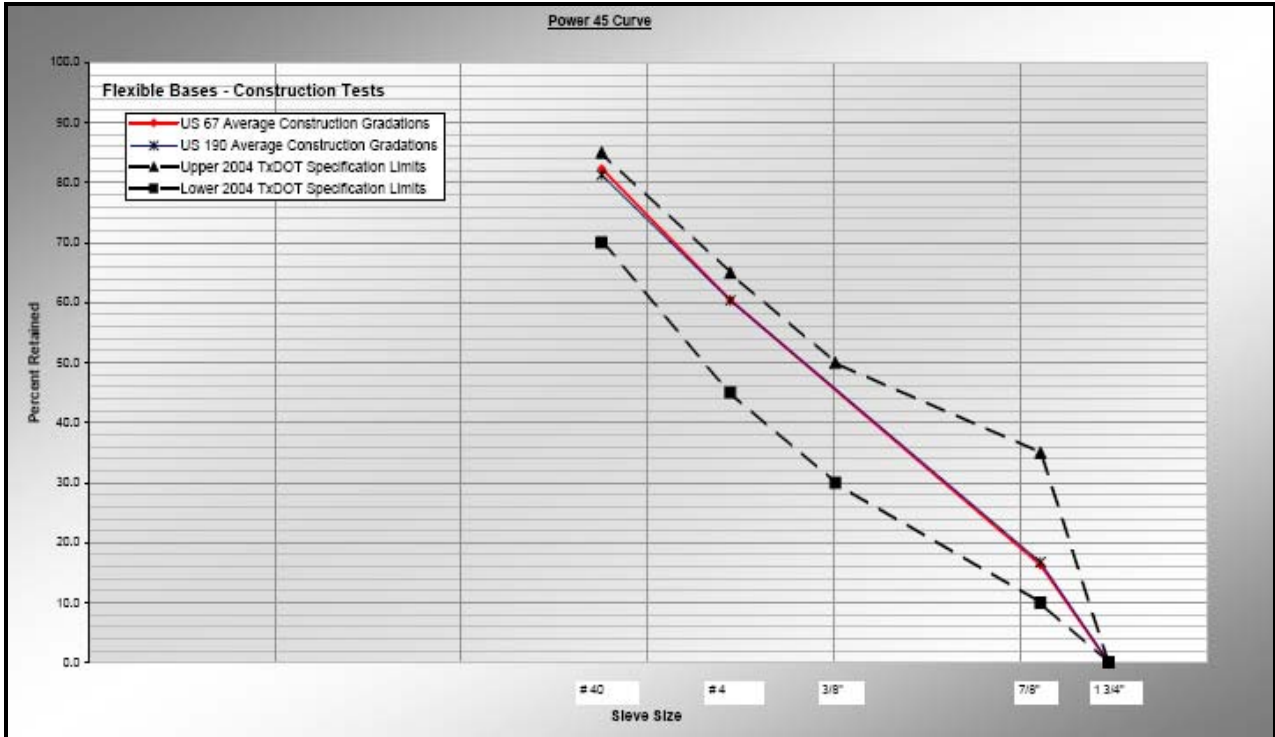
Figure 38. Power 45 Average Construction Job Control Gradations – Flexible Bases.

Construction inspection gradation test results were located for two flexible base projects, both of them composed of Grade 4 limestone in the Brownwood District. The average job control gradations from these two projects are shown on [Figure 38](#), which also displays current specification upper and lower gradation requirements for Grade 1 flexible base. Similarly, [Figure 39](#) displays the gradations found in flexible base field samples from all sampled pavements.

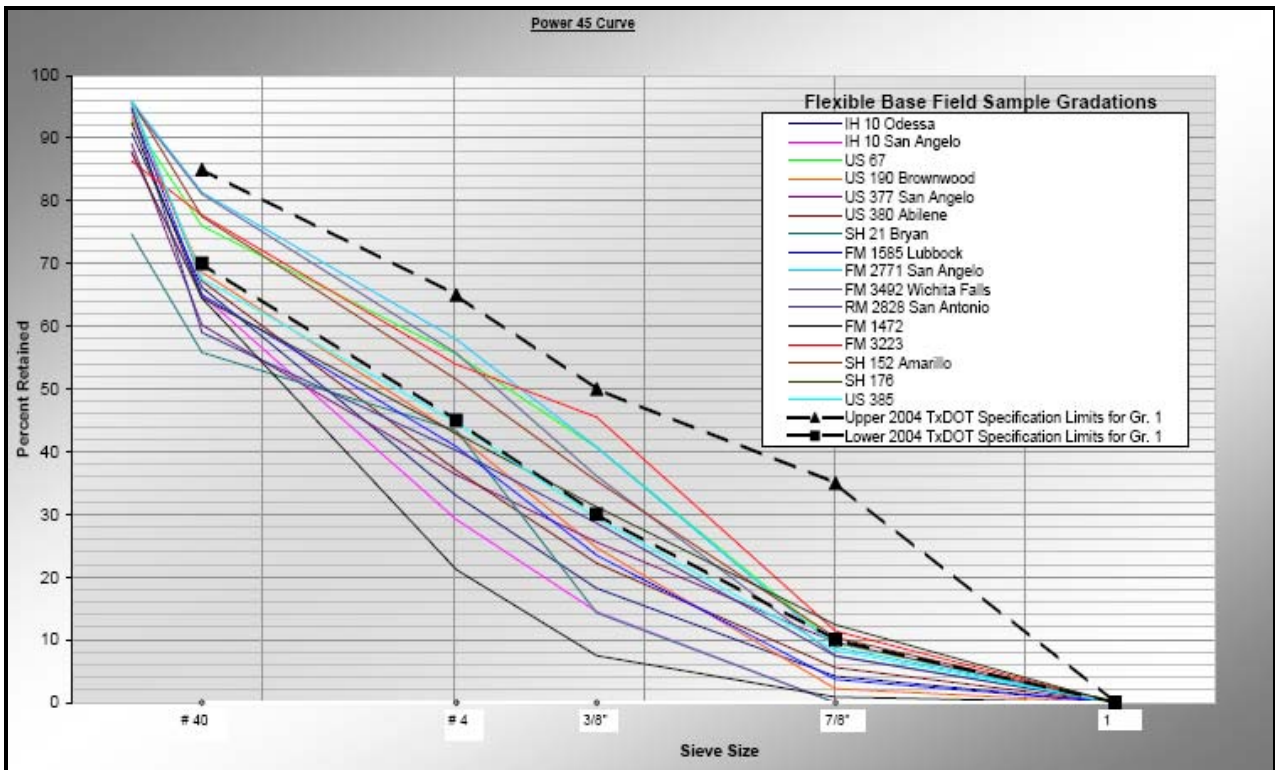
Figure 39. Power 45 Average Field Sample Gradations – Flexible Bases.

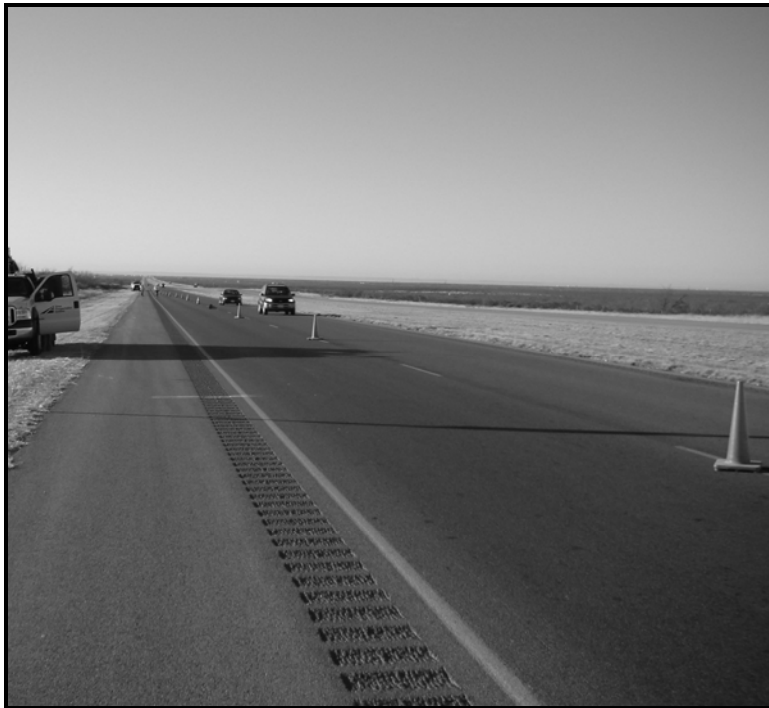
Figure 40. CMHB-F Pavement Containing Type II Tire Rubber – US 385, Odessa.

Three pavements included Type II crumb rubber blended into the surface treatment asphalt cement by the contractor and two pavements used AC-15-5TR in the underseal being placed below the new asphalt paving mixture layers. The single pavement mixture containing tire rubber was a CMHB-F with Type II crumb rubber. This is the pavement on US 385 in the Odessa District. The researcher visiting this pavement site found it to be one of the very best appearing pavement sections seen among all nominations, despite the fact that it was eight years old at that time and had not yet received any type of preventative maintenance seal application. A review of PMIS performance data also shows it clearly among top performers at this point in its service life. [Figure 40](#) is a photograph of this pavement at the time of field sampling, and [Figure 41](#) clearly shows the binder-rich nature and yet excellent macro-texture after eight years of service.

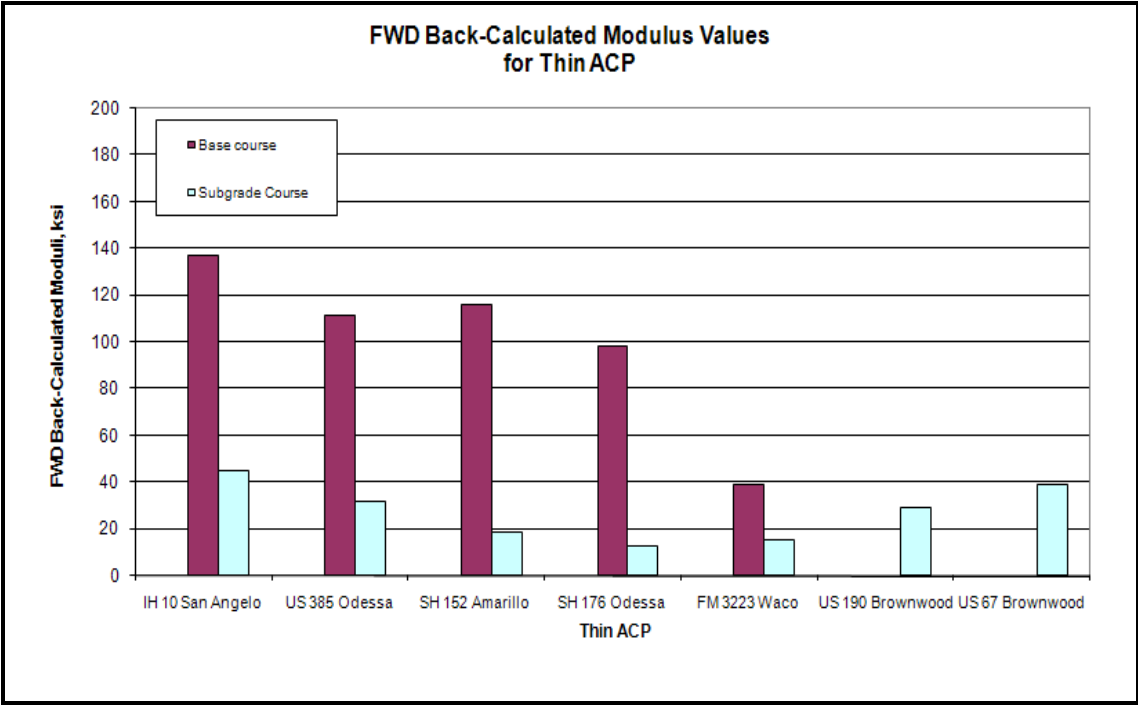
Figure 43. FWD Moduli in Thin Asphalt Concrete Pavements.

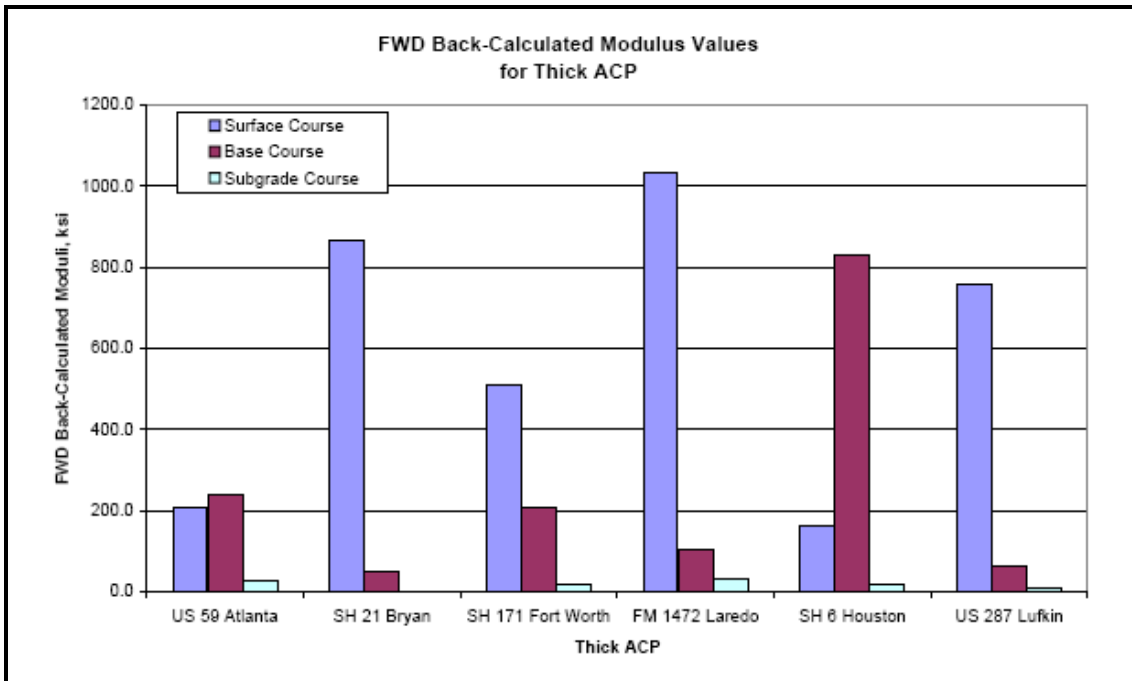
Figure 44. FWD Moduli in Thick Asphalt Concrete Pavements.
