1. Report No. FHWA/TX-07/0-5526-1		2. Government Accession No.		3. Recipient's Catalog No.	
4. Title and Subtitle INITIAL ASSESSMENT OF COMPLIANCE OF TEXAS ROADSIDE SAFETY HARDWARE WITH PROPOSED UPDATE TO NCHRP REPORT 350				5. Report Date April 2007 Published: September 2007

14. Sponsoring Agency Code	
15. Supplementary Notes Project performed in cooperation with the Texas Department of Transportation and the Federal Highway Administration. Project Title: Impact Performance Assessment of Roadside Safety Appurtenances URL: http://tti.tamu.edu/documents/0-5526-1.pdf

**INITIAL ASSESSMENT OF COMPLIANCE
OF TEXAS ROADSIDE SAFETY HARDWARE
WITH PROPOSED UPDATE TO NCHRP REPORT 350**

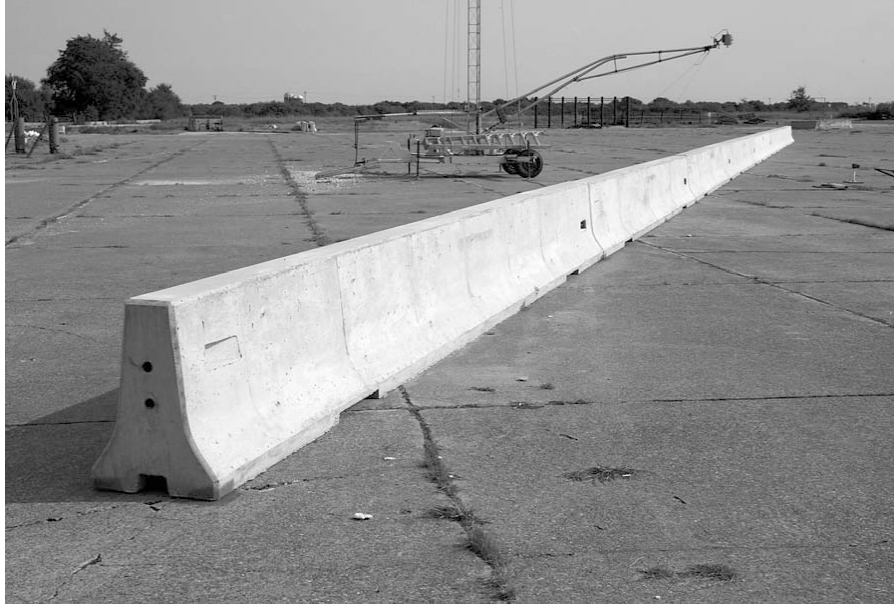
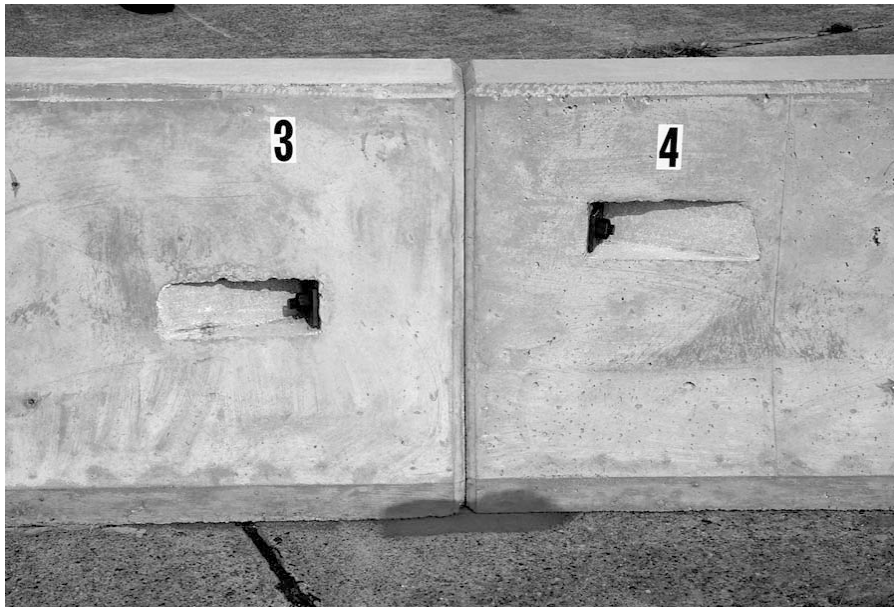
Figure 3-5. F-Shape Concrete Safety Barrier with X-Bolt Connection.

The precast segments used with the Type X connection are 30 ft in length and have a standard F-shape profile. The segments are 32 inches in height, 24 inches wide at the base, and 9½ inches wide at the top. Horizontal barrier reinforcement consists of eight #5 bars spaced liberally within the vertical reinforcement. Vertical barrier reinforcement consists of #5 bars spaced 12 inches on center. Within 5 ft of the barrier ends, the spacing of the vertical bars is reduced to 6 inches. A U-shaped bar is tied to the bottom of the vertical bars to provide closed stirrups in this region. A photograph of the F-shape concrete safety barrier with Type X connections is shown in [Figure 3-5](#). For complete fabrication details of this precast barrier system, the reader is referred to TxDOT standard detail sheets CSB(1)-04 and CSB(2)-04.

The F-shape concrete median barrier with Type X connection and 30-ft long precast segments was successfully tested under *NCHRP Report 350* guidelines (19). A $\frac{3}{4}$ -ton Chevrolet 2500 pickup with a test inertia weight of 4531 lb impacted the barrier at a speed of 62.3 mph and an angle of 25.7 degrees. The vehicle was successfully contained and redirected in a stable and upright manner. Occupant risk measures were below desirable levels, and the maximum roll angle was 23.3 degrees. The maximum occupant compartment deformation measured in the vehicle was 2.6 inches. Maximum dynamic deflection of the barrier was only 19.0 inches, which is the lowest deflection of any free-standing, unanchored concrete barrier system accepted under *NCHRP Report 350* guidelines.

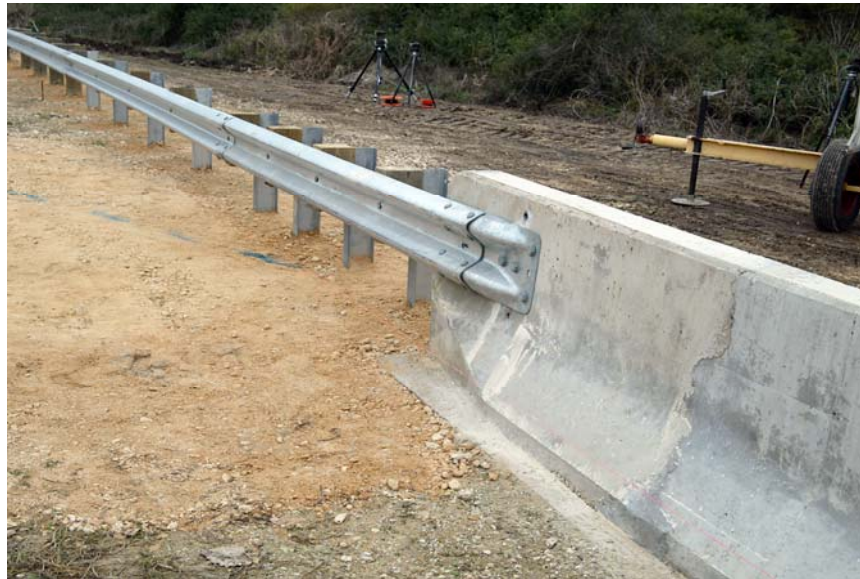
Figure 3-8. Photo of Texas TL-2 Guardrail-to-Concrete Bridge Rail Transition.

rail parapet. Additional details of the TL-3 transition are presented in TxDOT standard detail sheet MGBF (TL2)-05.

Test Designation 2-21 was performed in accordance with the guidelines and procedures set forth in *NCHRP Report 350* (22). This test consisted of a 4409-lb, $\frac{3}{4}$ -ton pickup truck impacting the critical impact point of the transition at a speed of 43.5 mph and an angle of 25 degrees. The test vehicle was successfully contained and redirected in a stable manner, and the TL-2 transition system met all applicable *NCHRP Report 350* evaluation criteria. The maximum dynamic deflection of the transition rail was only 2.6 inches. The maximum roll angle of the pickup truck was 13.4 degrees, and the maximum occupant compartment deformation was only 0.4 inches.

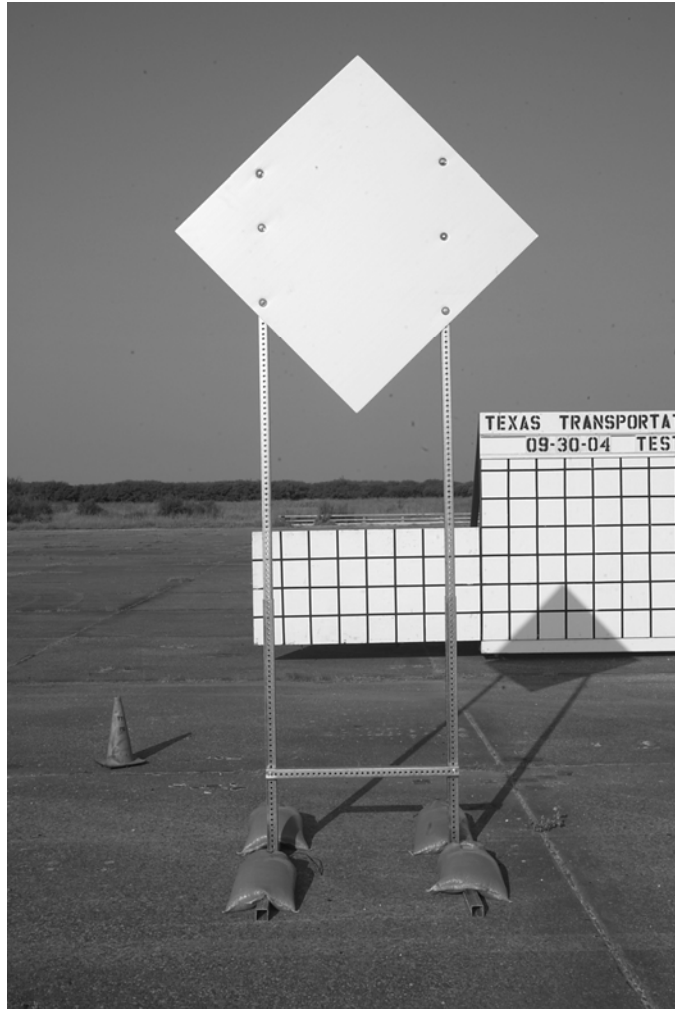
Figure 3-18. High-Mounting Height Sign Support with Perforated Steel Tube Uprights.

The other high-mounting height sign support system used in Texas has a frame fabricated from perforated steel tube. In this design, a 48 inch long vertical sleeve fabricated from 2 inch square, 12-gauge perforated steel tubing is welded to the center of a 5 ft long skid fabricated from the same material. A 1-3/4-inch square x 11 ft long, 12-gauge perforated steel upright is inserted into the sleeve until it rests on a bolt passing through the bottom of the sleeve.

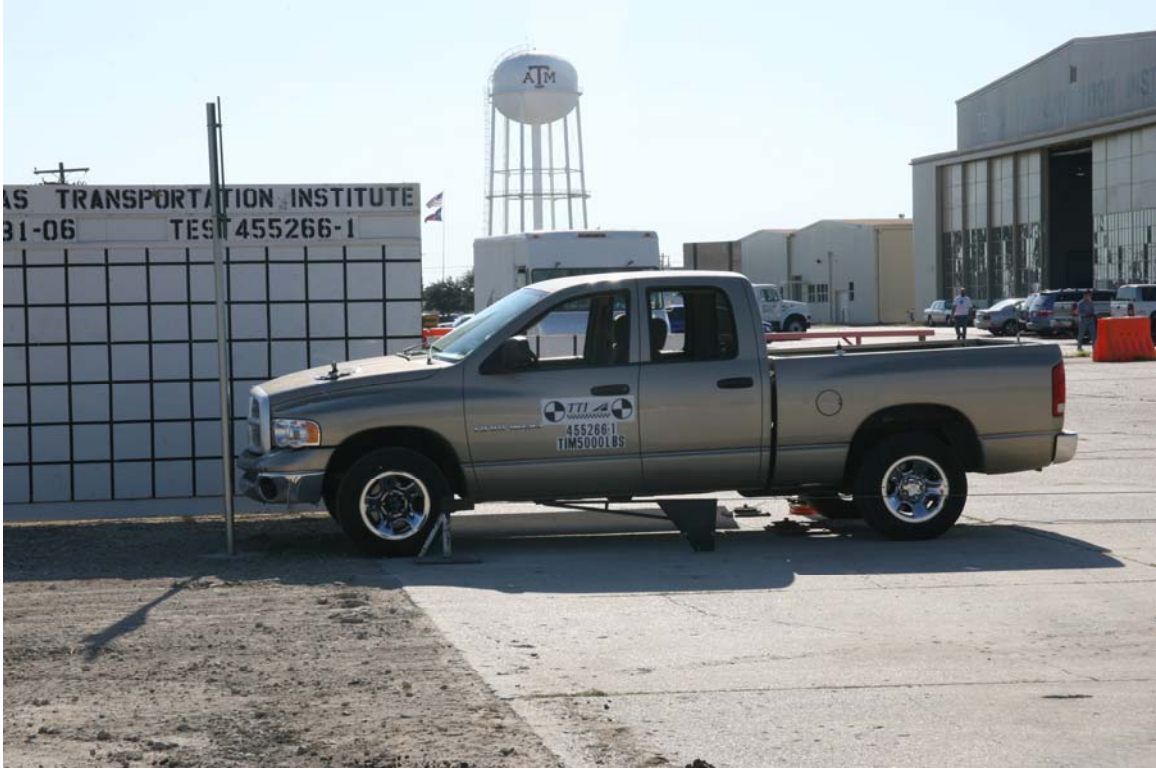
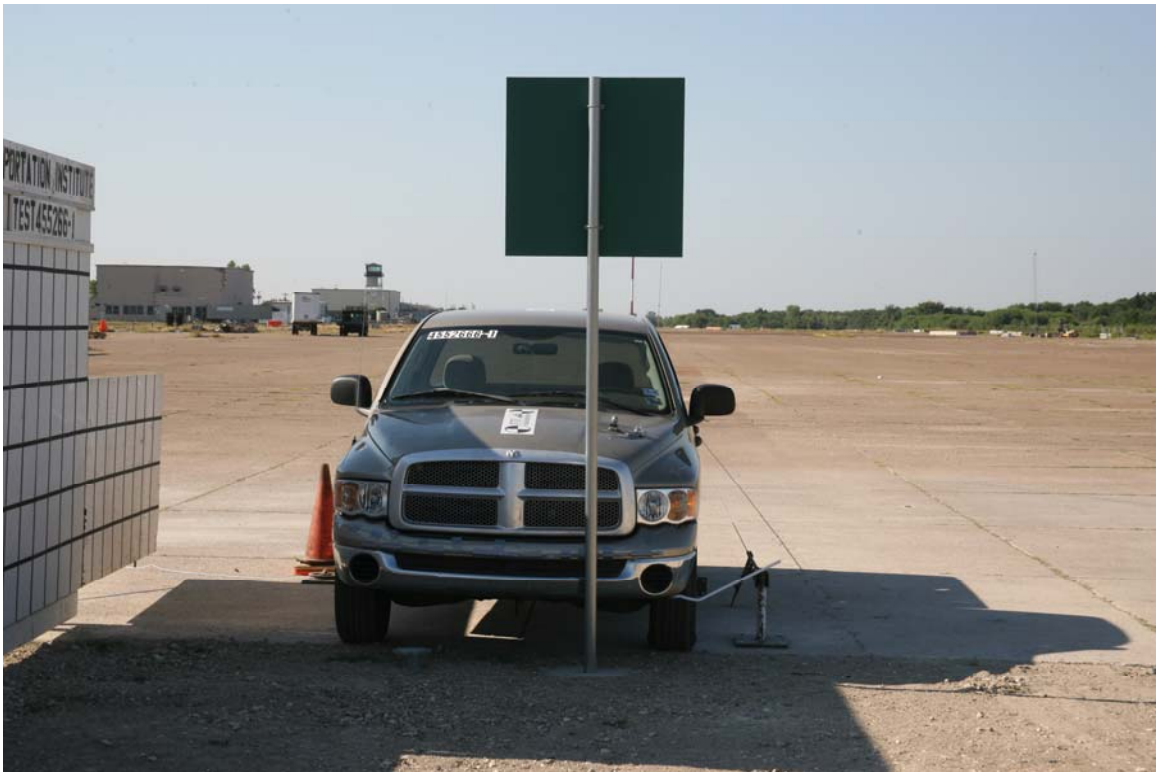
Figure 4-3. Vehicle/Installation Geometrics for Test 455266-1.

A 2003 Dodge Ram 1500 quad-cab pickup truck, shown in [Figures 4-3](#) and [4-4](#), was used for the crash test. Test inertia weight of the vehicle was 5013 lb, and its gross static weight was 5013 lb. The height to the lower edge of the vehicle bumper was 14.4 inches, and the height to the upper edge of the bumper was 26.9 inches. [Figure B1-1](#) in [Appendix B](#) gives additional dimensions and information on the vehicle. The vehicle was directed into the installation using the cable reverse tow and guidance system, and it was released to be free-wheeling and unrestrained just prior to impact.

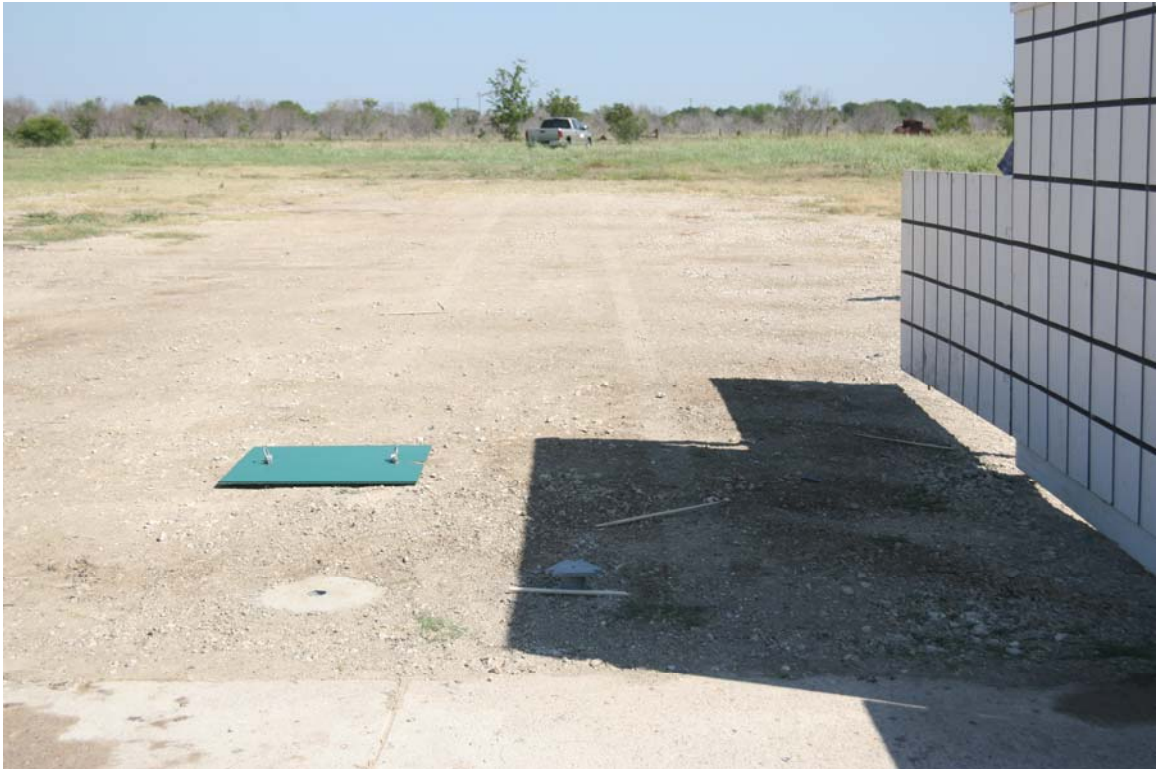
Figure 4-5. After Impact Trajectory Path for Test 455266-1.

Figures 4-5 and 4-6 show the damage to the support. No movement of the concrete footing was noted. The wedge fell down inside the socket after release of the support post. The sign panel came to rest 8 ft downstream of the socket. The mounting brackets were intact indicating that the sign panel slid off the support. The support came to rest 185 ft downstream and 32 ft to the left of centerline of the vehicle path. The support was bent at a 15 degree angle 11.4 inches from the bottom of the support, and at a 100 degree angle 18.9 inches from the bottom of the support.

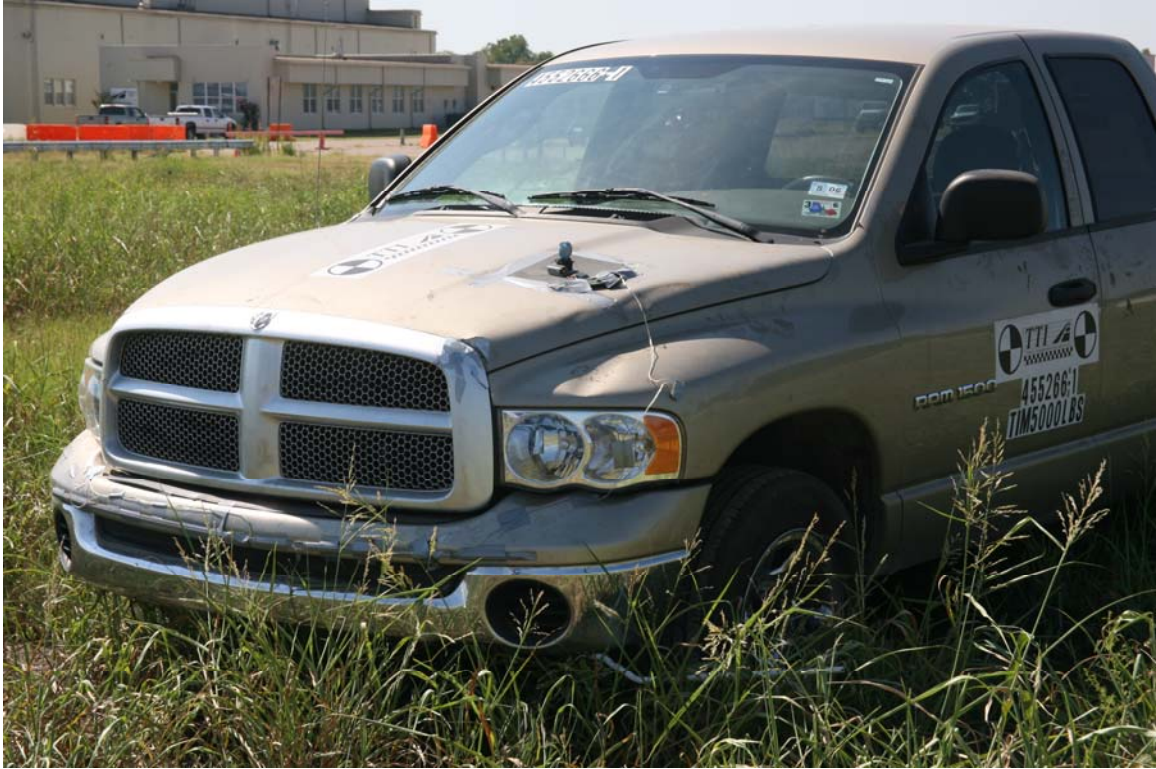
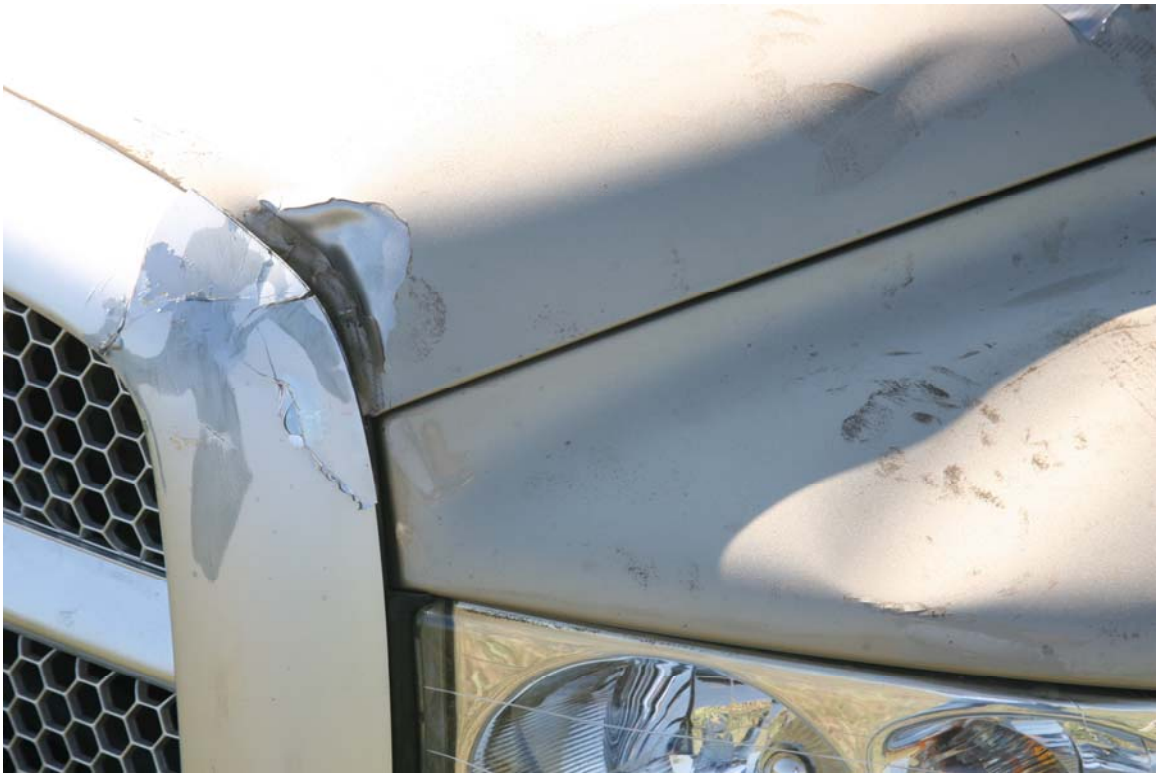
Figure 4-7. Vehicle after Test 455266-1.

The vehicle sustained minimal damage, as shown in Figure 4-7. The front bumper, hood, left front quarter panel, roof, and stop light on the cab were deformed. The dent in the roof caused by the sign panel measured 9.8 inches wide \times 21.2 inches long \times 0.3 inch deep; and the dent in the left front quarter panel measured 3.9 inches wide \times 7.9 inches long \times 0.2 inch deep. No occupant compartment deformation occurred. Photographs of the interior of the vehicle are shown in Figure 4-8. Exterior crush measurements and occupant compartment measurements are noted in Tables B1-1 and B1-2 of Appendix B.

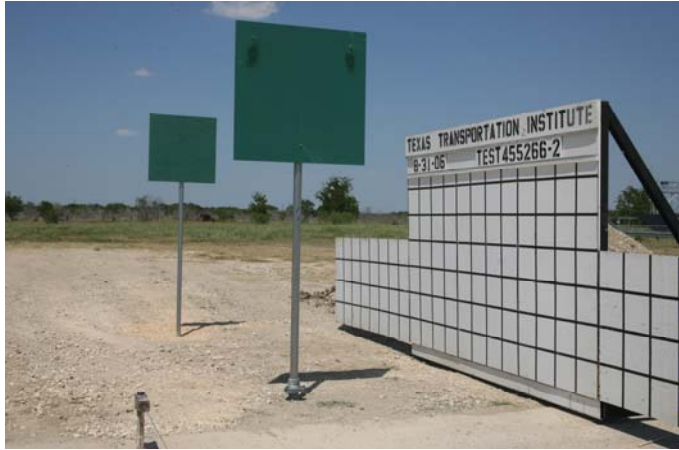
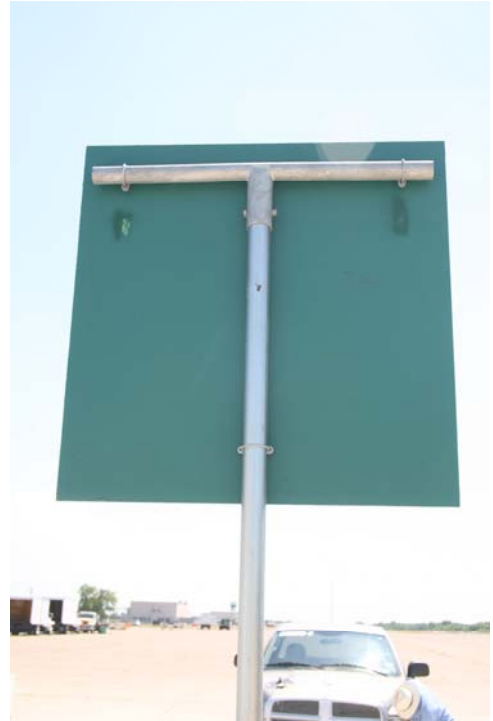
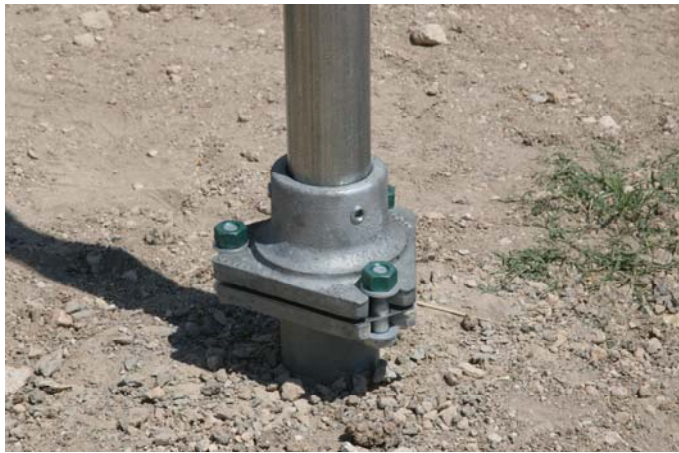
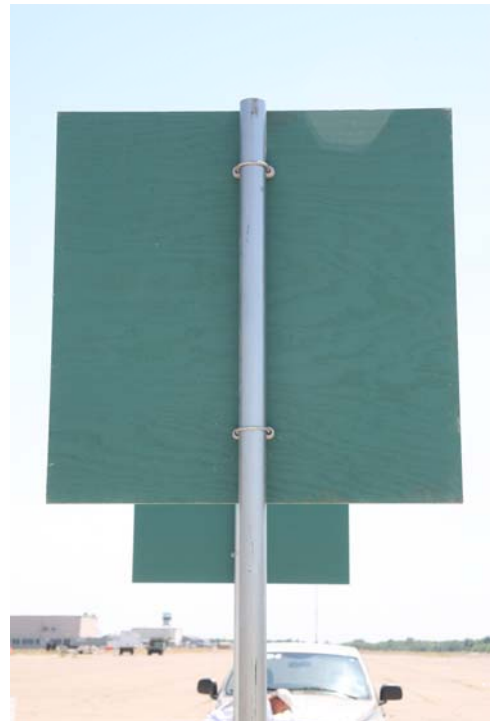
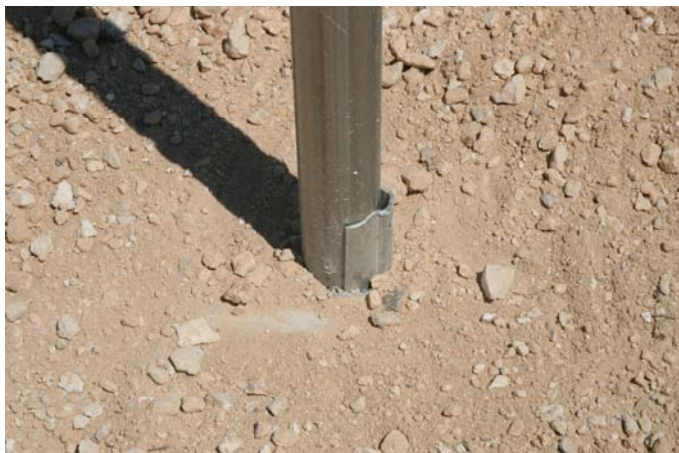
Figure 4-11. Test Article/Installation before Test 455266-2.

Figure 4-10 shows schematic of the triangular slip base sign support installation. Photographs of the completed test installation are presented in Figure 4-11.

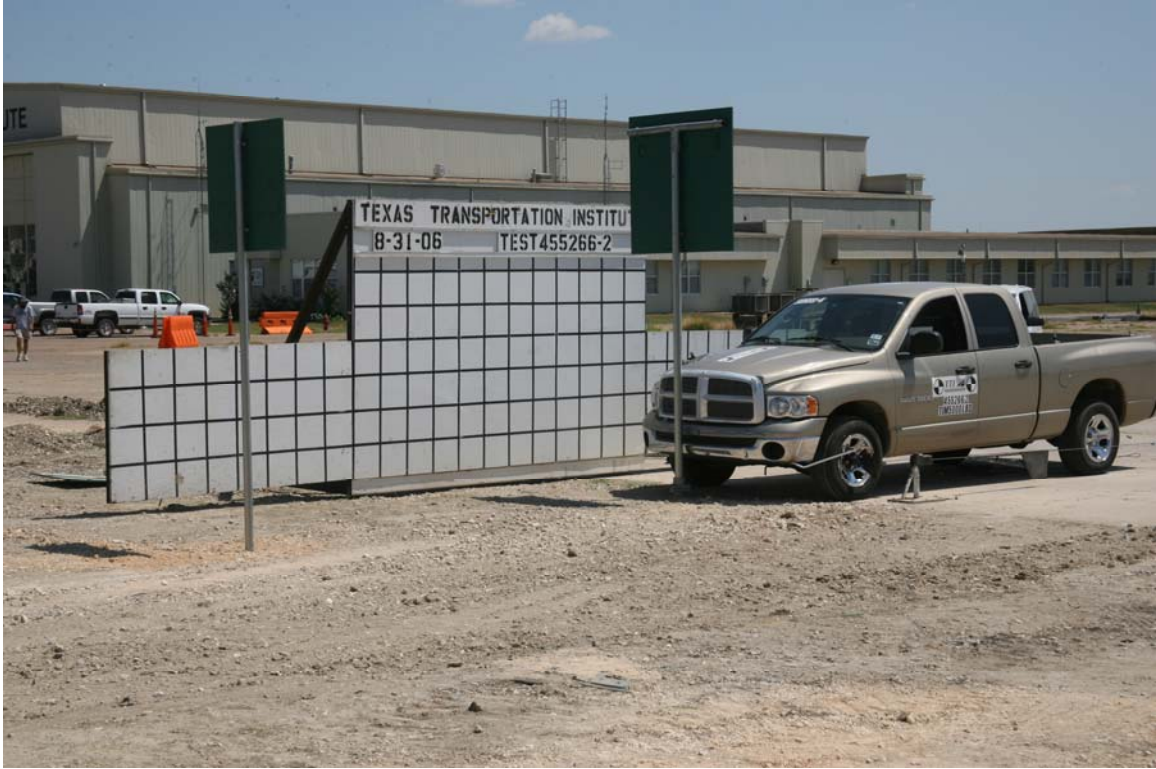
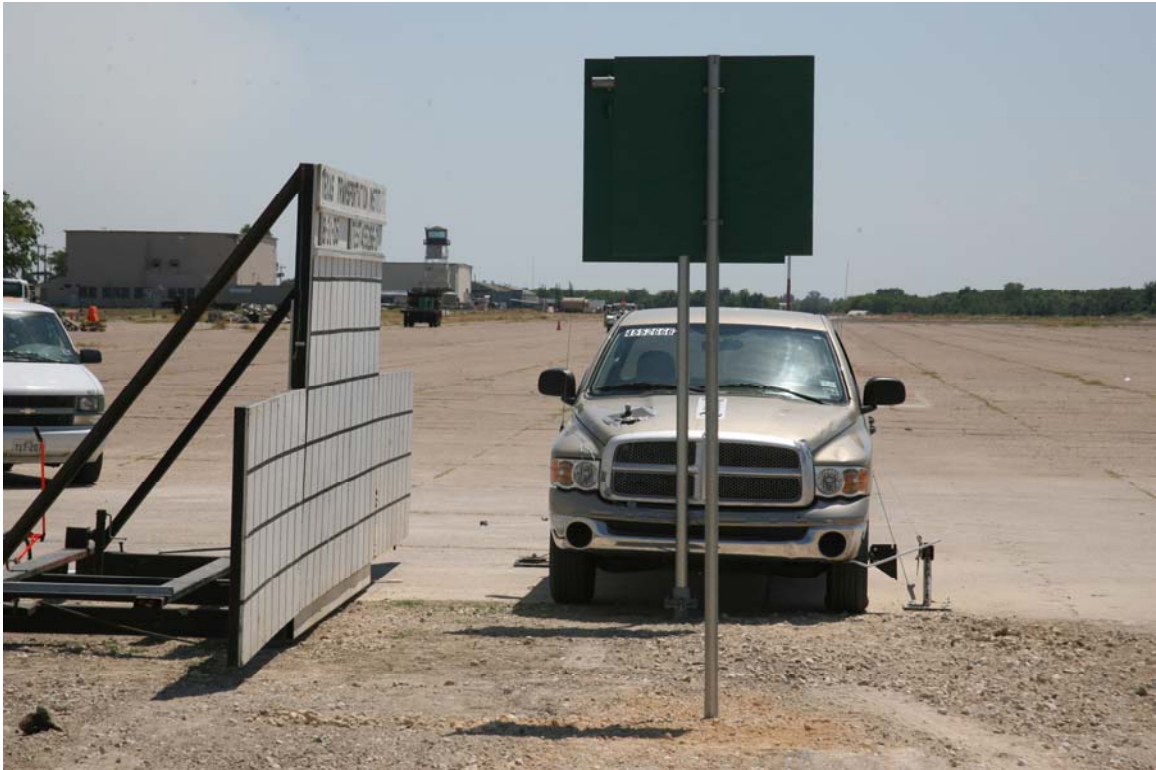
Figure 4-12. Vehicle/Installation Geometrics for Test 455266-2.

A 2003 Dodge Ram 1500 quad-cab pickup truck, shown in Figures 4-12 and 4-13, was used for the crash test. Test inertia weight of the vehicle was 5013 lb, and its gross static weight was 5013 lb. The height to the lower edge of the vehicle bumper was 14.4 inches, and the height to the upper edge of the bumper was 26.9 inches. Figure C1-1 in Appendix C gives additional dimensions and information on the vehicle. The vehicle was directed into the installation using the cable reverse tow and guidance system, and it was released to be free-wheeling and unrestrained just prior to impact.

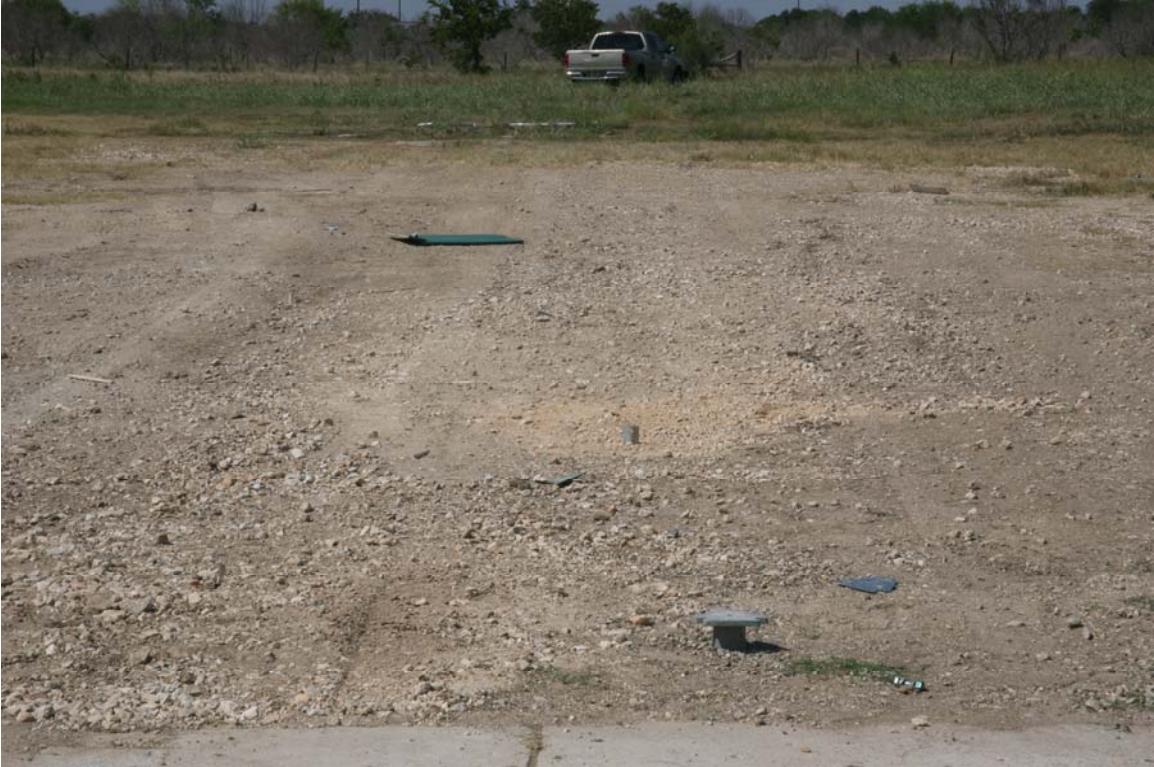
Figure 4-14. After Impact Trajectory Path for Test 455266-2.

The 2003 Dodge Ram 1500 quad-cab pickup truck, traveling at an impact speed of 63.7 mph, impacted the triangular slip base sign support at an angle of 0.4 degrees. Upon impact, the support deformed slightly approximately 18.5 inches above ground. At 0.009 s, the slip base began to activate and release the sign support. The upper support lost contact with the base at 0.017 s. At 0.066 s, the vehicle lost contact with the support, and the vehicle was traveling at a speed of 60.6 mph. The sign panel and support contacted the roof of the vehicle at 0.116 s, and the slip base casting separated from the support at 0.135 s.

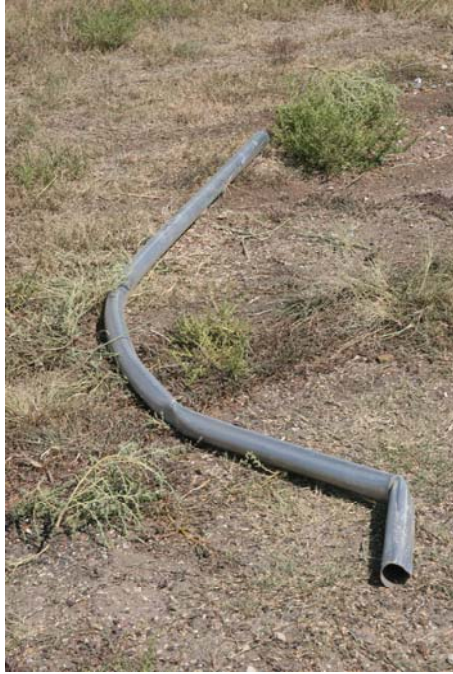
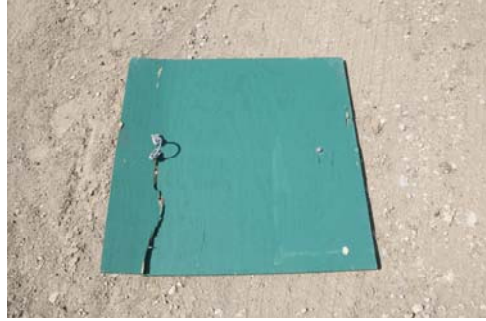
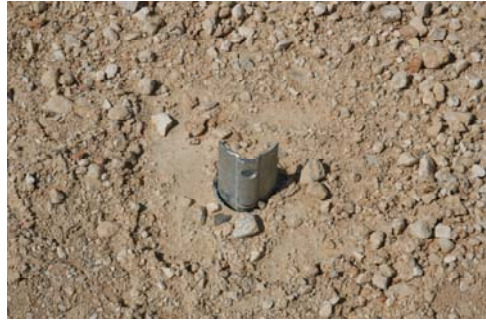
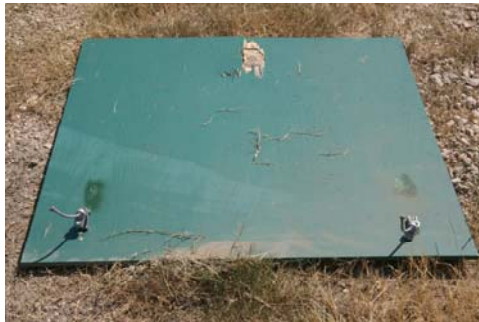
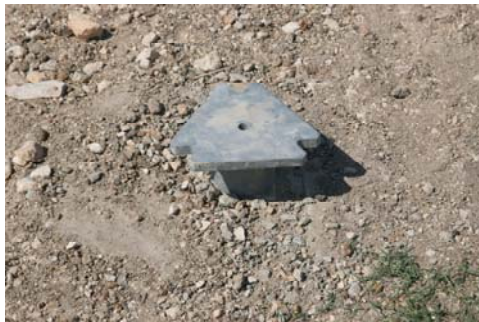
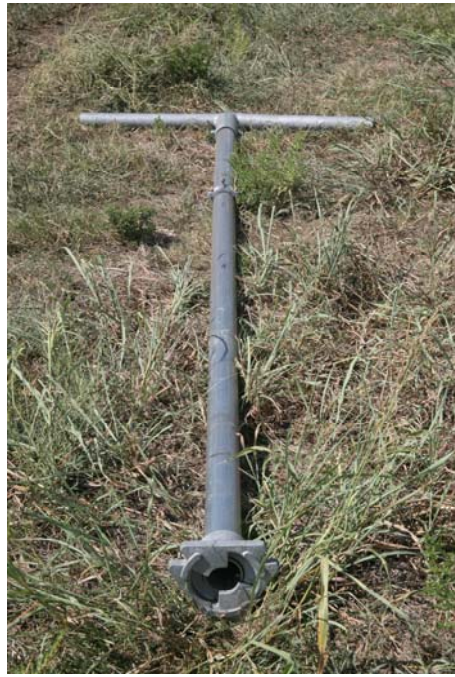
Figure 4-15. Installation after Test 455266-2.

The soil around the concrete footing was slightly disturbed. The upper slip base casting separated from the support post and came to rest near the concrete footing, along with the keeper plate and slip bolts. The plywood sign panel separated from the support post and came to rest 79 ft downstream and 16 ft to the right of centerline of the path of the vehicle. The support post came to rest 173 ft downstream and 5 ft to the right of centerline of the path of the vehicle. Photographs of the damaged triangular slip base sign support system are shown in [Figures 4-14](#) and [4-15](#).

The wedge anchor sign support pulled out of its socket. The plywood sign panel separated from the support and came to rest 54 ft downstream and 3 ft to the left of centerline of the path of the vehicle. The support post came to rest 141 ft downstream and 5 ft to the left of centerline. The support was kinked at an angle of 45 degrees a distance of 12 inches from the bottom of the support post and an angle of 15 degrees a distance of 27.5 inches from the bottom. The top 4 ft of the support post had some permanent curvature and flattening. Photographs of the damaged wedge anchor sign support system are shown in [Figures 4-14](#) and [4-15](#).

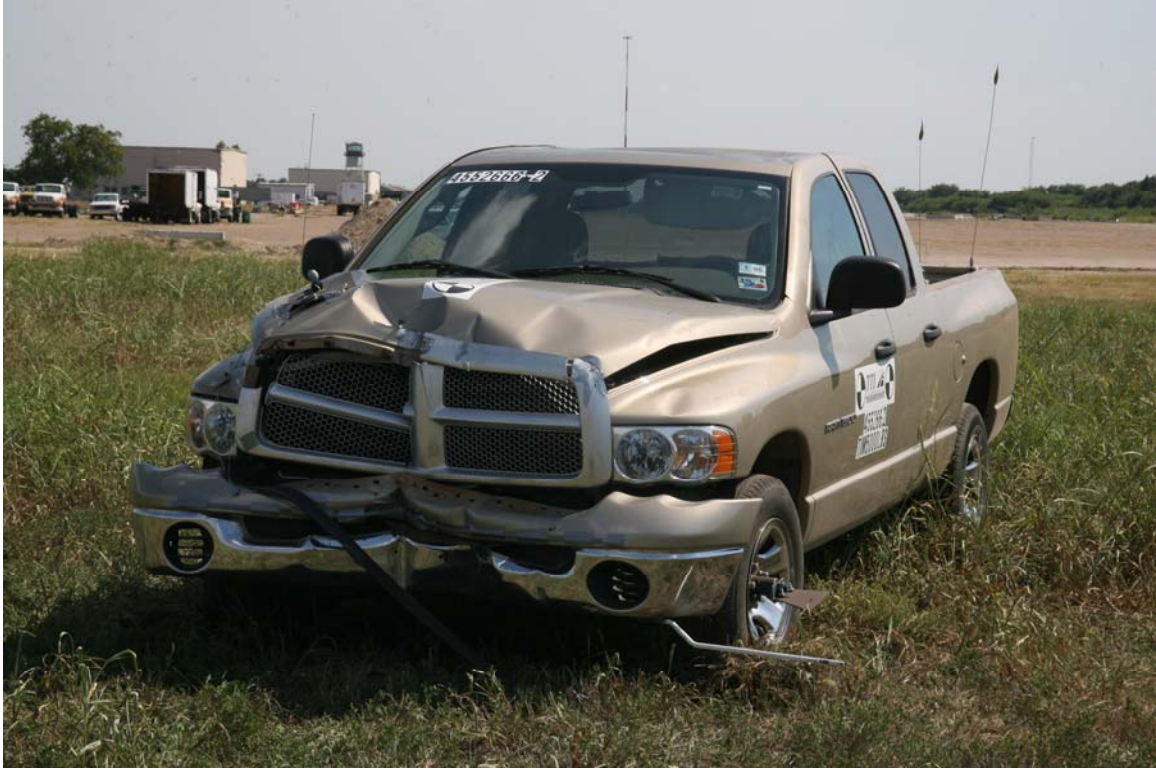
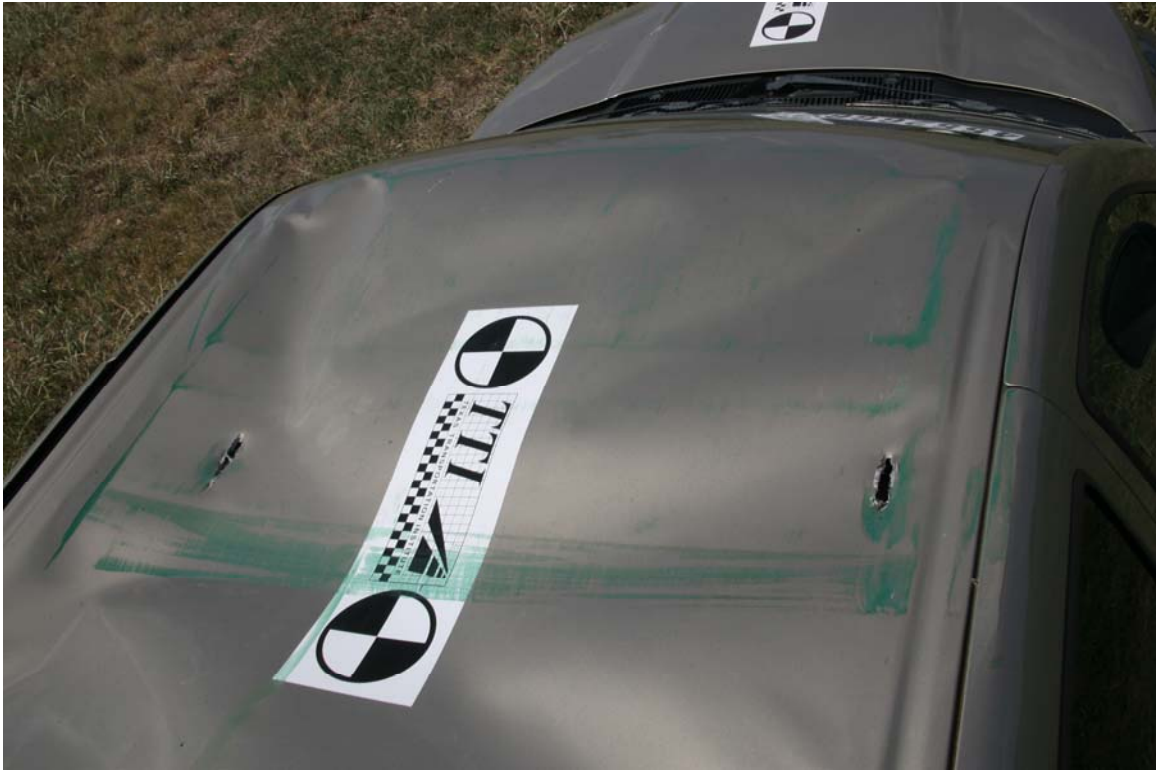
Figure 4-16. Vehicle after Test 455266-2.

Review of the high-speed video indicated that most of the damage to the test vehicle was attributed to impact with the triangular slip base sign support system. The vehicle front bumper, hood, grill, radiator support, and roof were damaged. A small cut or tear was observed on each side of the roof due to contact with the sign panel mounting bolts of the triangular slip base system; one cut measured 4.3 inches x 0.8 inches, and the other measured 2.6 inches x 0.6 inches. Contact with the triangular slip base sign panel and support post caused the roof to deform downward 3 inches over a roughly circular area measuring approximately 52 inches in diameter. Maximum exterior crush to the front of the vehicle was 9.8 inches just to the right of centerline, which was the point of contact with the triangular slip base support post. [Figure 4-16](#) presents photographs of the vehicle. Maximum occupant compartment deformation was 3.0 inches in the roof area on the passenger side. Photographs of the interior of the vehicle are shown in [Figure 4-17](#). Exterior crush measurements and occupant compartment measurements are noted in [Tables C1-1](#) and [C1-2](#) of [Appendix C](#).

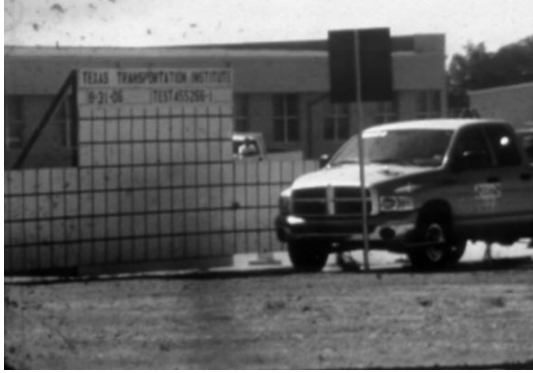
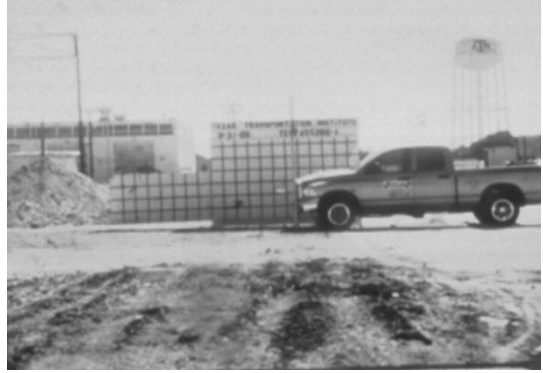
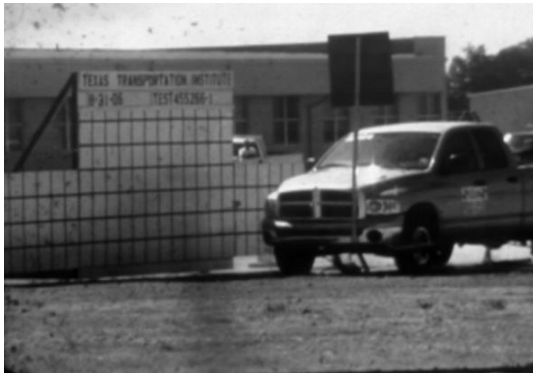
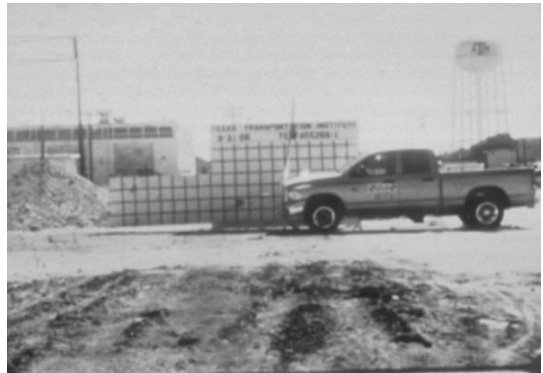
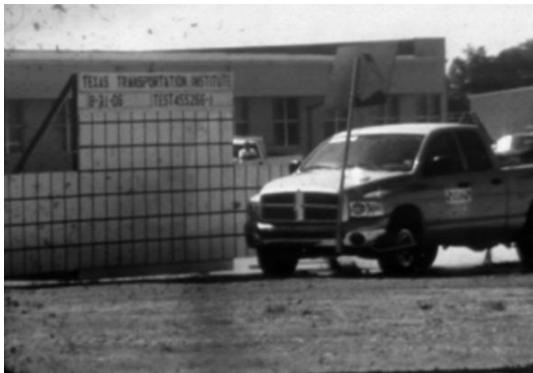
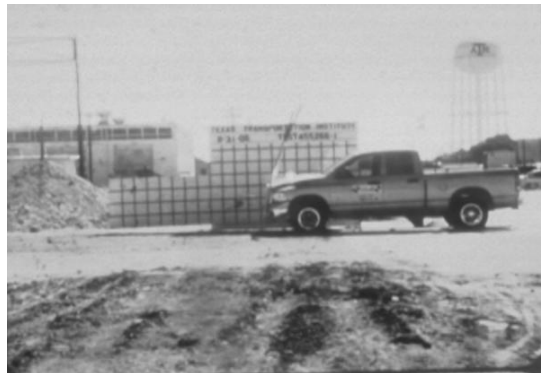
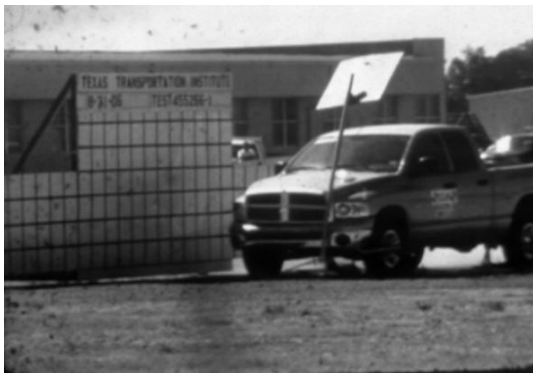
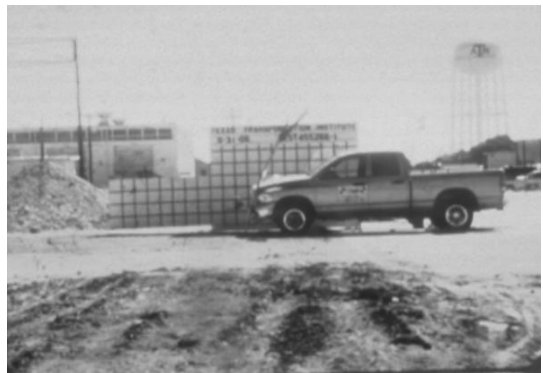
Figure B2-1. Sequential Photographs for Test 455266-1 (Oblique and Perpendicular Views).

The 2003 Dodge Ram 1500 quad-cab pickup truck, traveling at an impact speed of 63.2 mph and impact angle of 0.6 degrees, impacted the support 21.7 inches above the ground. Upon impact, the support began to deform, and at 0.005 s, the support contacted the hood. The support began to pull out of the socket at 0.008 s, and the support had completely pulled out of the socket by 0.021 s. At 0.045 s, the vehicle bumper lost contact with the support, and the vehicle was traveling at a speed of 62.8 mph. At 0.050 s, the support rolled off the hood onto the left front quarter panel. The sign panel separated from the support at 0.057 s, and the released sign panel contacted the roof at 0.097 s. The vehicle lost contact with the sign panel at 0.123 s while traveling at a speed of 62.4 mph. At 0.159 s, the support lost contact with the left front quarter panel, and the vehicle was traveling at a speed of 61.3 mph. Brakes on the vehicle were applied at 1.012 s at a location 161 ft downstream of impact, and the vehicle subsequently came to rest 275 ft downstream of impact. [Figure B2-1](#) in [Appendix B](#) shows sequential photographs of the test period.

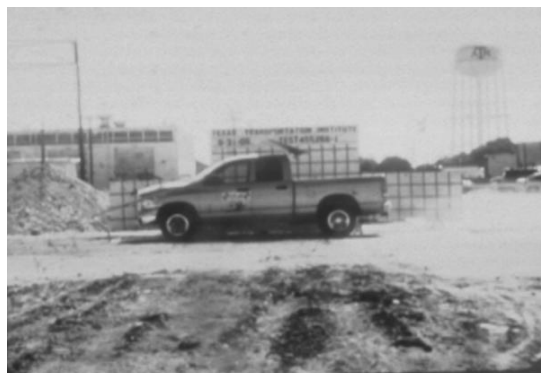
Figure B2-1. Sequential Photographs for Test 455266-1 (Oblique and Perpendicular Views) (Continued).

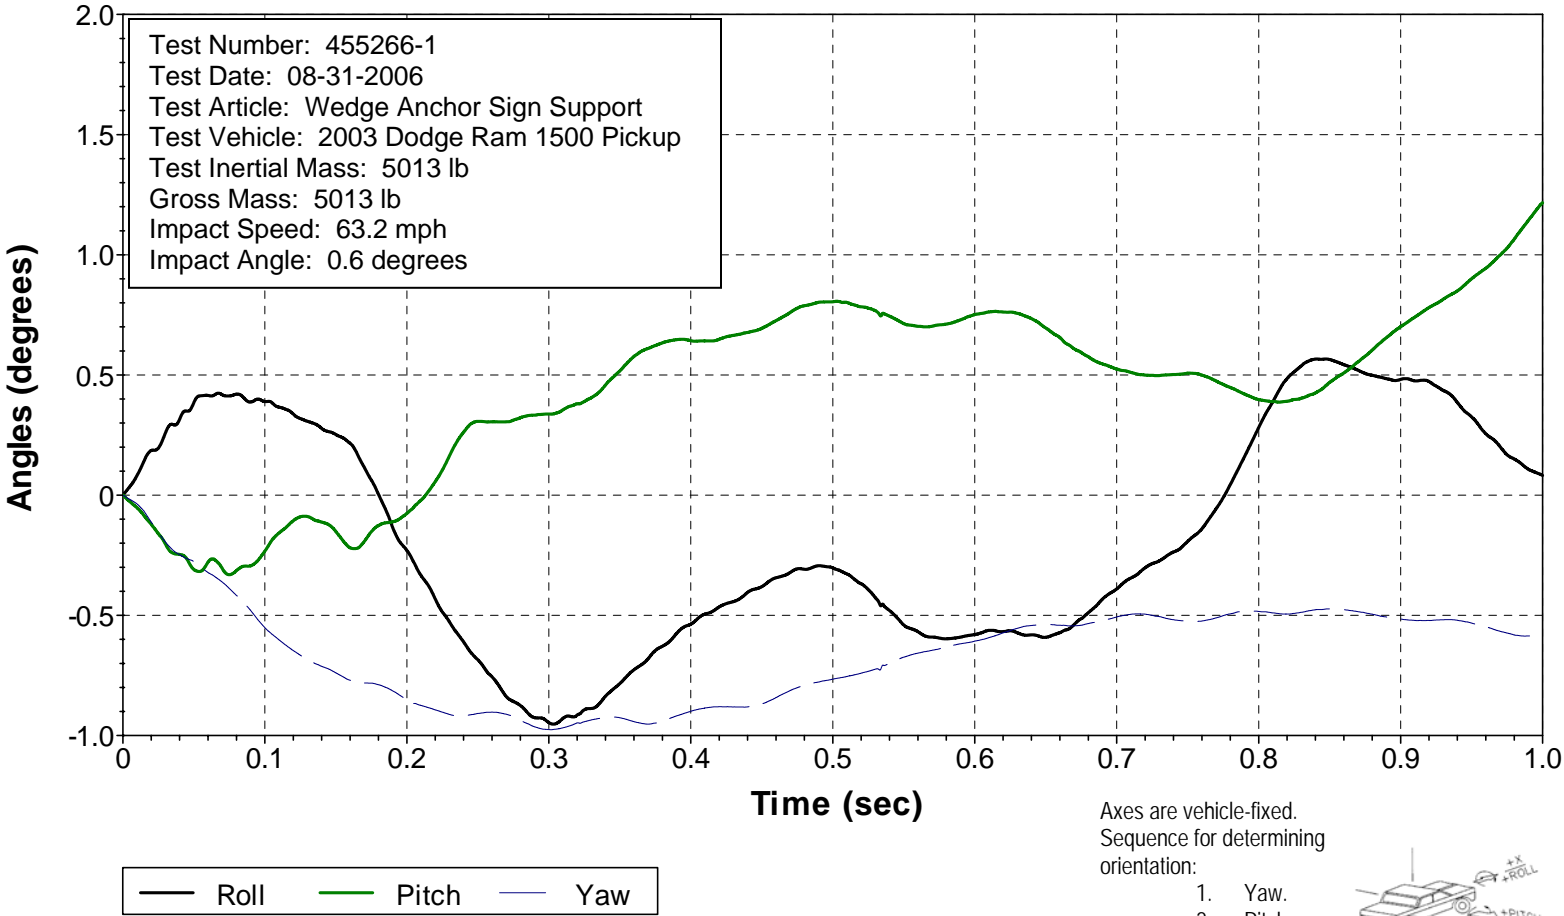
Figure B3-1. Vehicle Angular Displacements for Test 455266-1.

Roll, Pitch and Yaw Angles

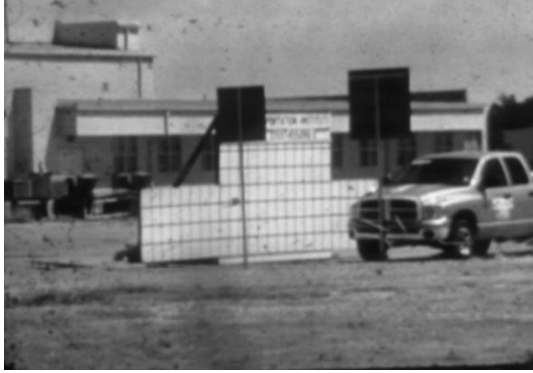
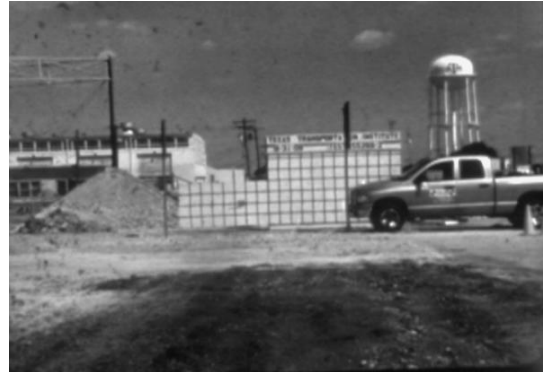
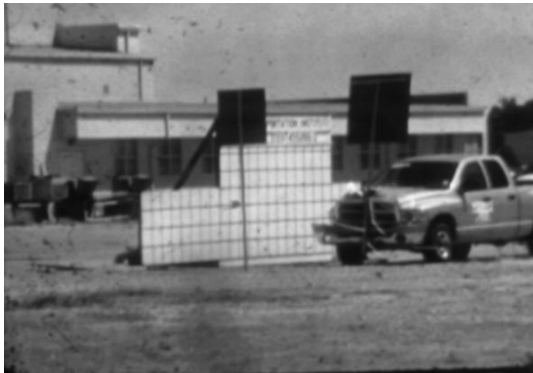
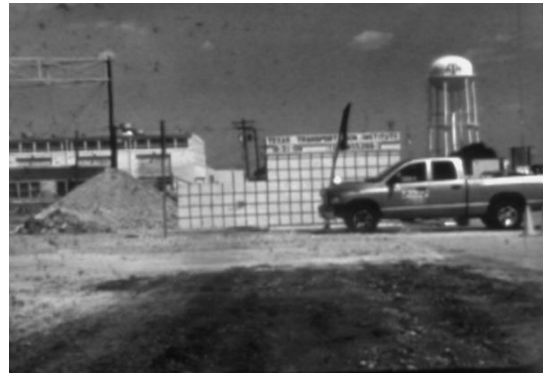
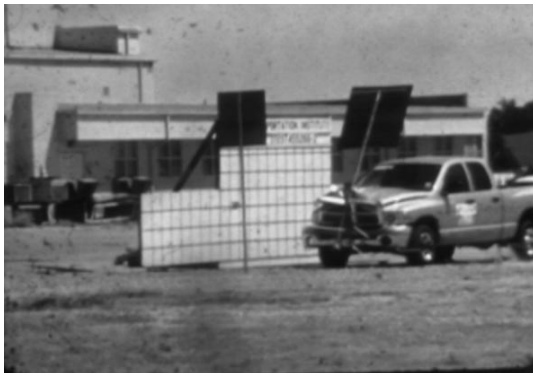
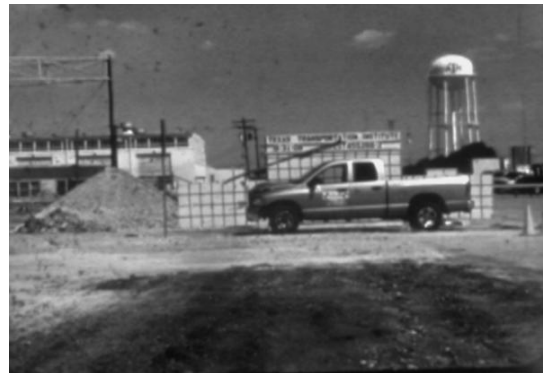
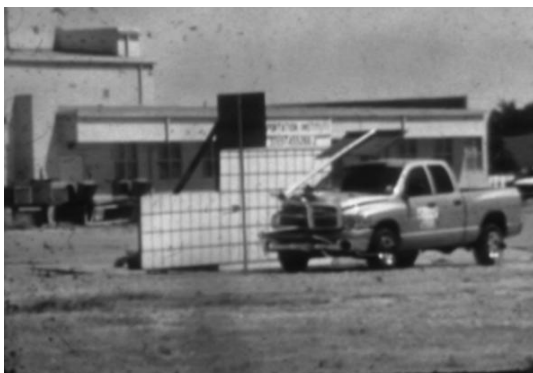
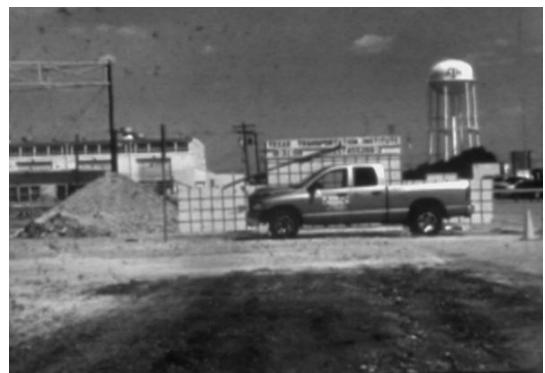
**Figure C2-1. Sequential Photographs for Test 455266-2
(Oblique and Perpendicular Views).**
