1. Report No. FHWA/TX-07/0-5526-1		2. Government Accession No.		3. Recipient's Catalog No.	
4. Title and Subtitle INITIAL ASSESSMENT OF COMPLIANCE OF TEXAS ROADSIDE SAFETY HARDWARE WITH PROPOSED UPDATE TO NCHRP REPORT 350				5. Report Date April 2007 Published: September 2007

14. Sponsoring Agency Code	
15. Supplementary Notes Project performed in cooperation with the Texas Department of Transportation and the Federal Highway Administration. Project Title: Impact Performance Assessment of Roadside Safety Appurtenances URL: http://tti.tamu.edu/documents/0-5526-1.pdf

**INITIAL ASSESSMENT OF COMPLIANCE
OF TEXAS ROADSIDE SAFETY HARDWARE
WITH PROPOSED UPDATE TO NCHRP REPORT 350**

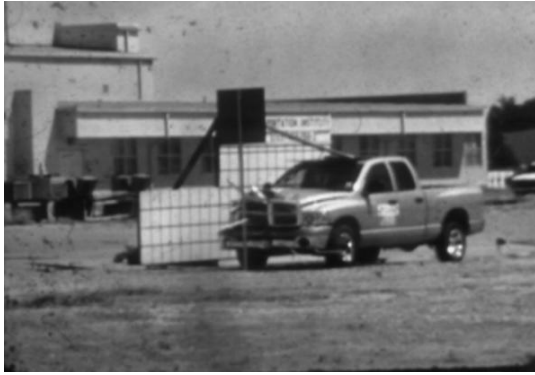
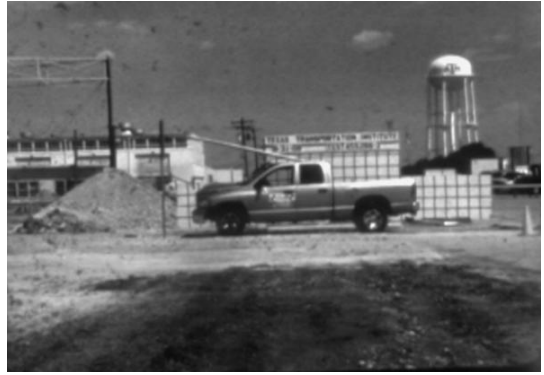
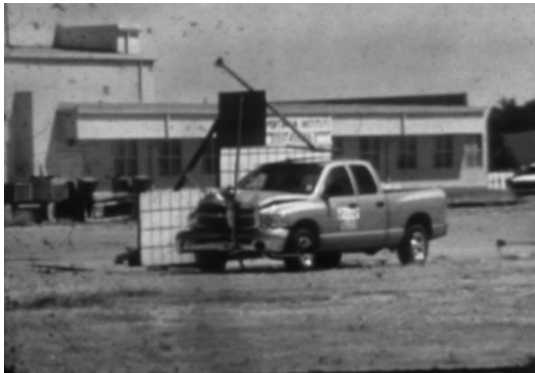
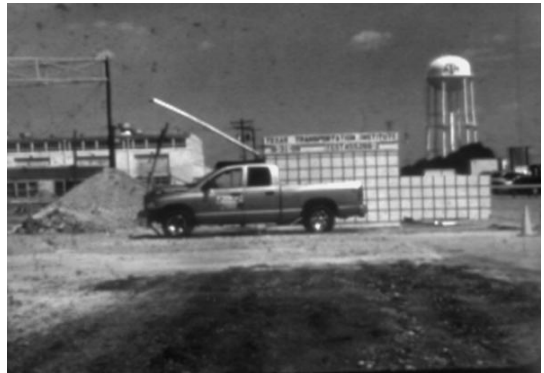
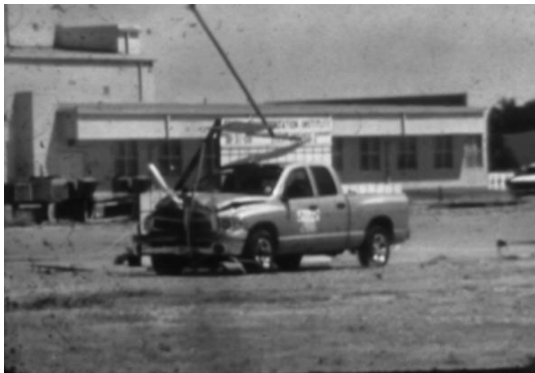
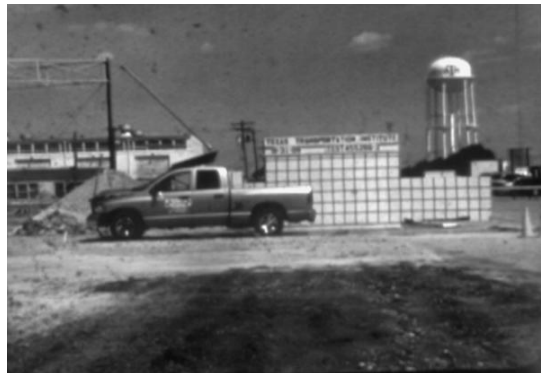
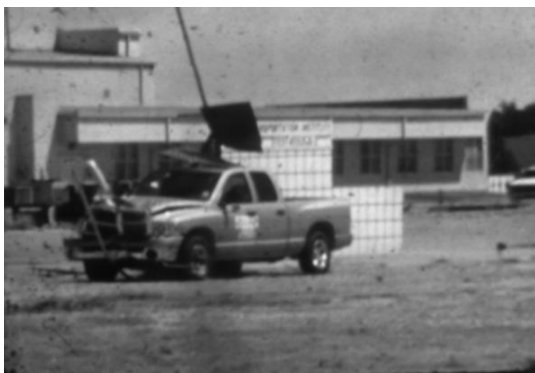
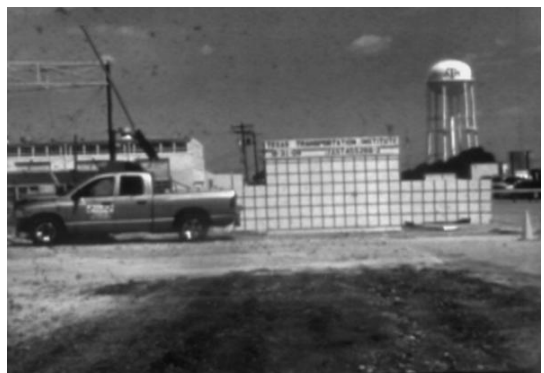
**Figure C2-1. Sequential Photographs for Test 455266-2
(Oblique and Perpendicular Views) (Continued).**
