1. Report No. FHWA/TX-07/0-5527-1		2. Government Accession No.		3. Recipient's Catalog No.	
4. Title and Subtitle DEVELOPMENT OF A LOW-PROFILE TO F-SHAPE TRANSITION BARRIER SEGMENT				5. Report Date September 2006 Published: January 2007

# **DEVELOPMENT OF A LOW-PROFILE TO F-SHAPE TRANSITION BARRIER SEGMENT**

Report 0-5527-1  
Project 0-5527

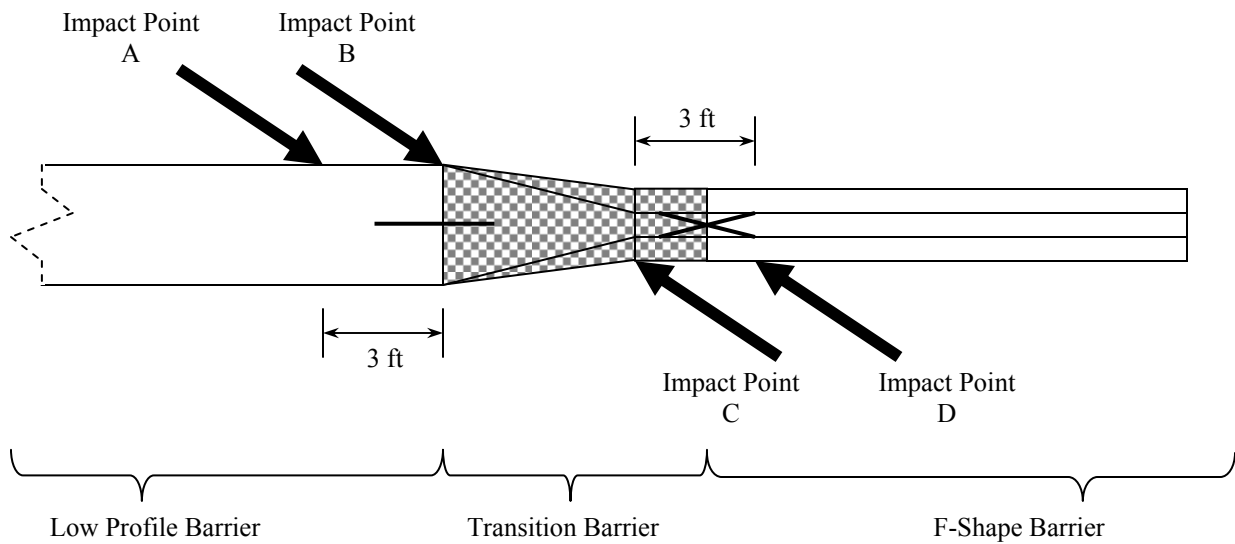
Both the low-profile barrier and the F-shape barrier segments are structurally capable of redirecting TL-3 impacts. Therefore, the only question with regard to the design of the new transition barrier segment, which is only required to resist a TL-2 impact, is whether the new shape will destabilize an errant vehicle. To investigate this effect, researchers performed initial vehicular impact simulations with a rigid barrier model that was assumed to be fixed to the ground. Using a fixed, rigid barrier model reduces the size of the finite element model and thus allows a large number of design iterations to be performed in a relatively short period of time. These initial rigid barrier system simulations were also used to evaluate critical points for vehicular impact. Four different impact points were investigated, as shown in [Figure 2](#).

**Figure 2. Impact Point Locations.**

Pickup truck impact simulations with the rigidly fixed barrier were performed for all four impact points shown in [Figure 2](#). In the case of impact points A and B, the vehicle traveled from the low-profile barrier to the F-shape barrier. For impact points C and D, the vehicle traveled from the F-shape barrier to the low-profile barrier. Impact points B and C were at the locations of slope change on the transition barrier segment. Impact points A and D were located 3 ft (1 m) upstream of these slope initiation points. The objective of conducting impact simulations 3 ft (1 m) upstream of the slope change points was to determine if the lateral slope changes (transition in barrier width), coupled with the vertical slope changes (transition in barrier height), would have a greater effect on vehicle stability once the vehicle had undergone some initial deformation and was fully engaged with the barrier in the impact region.

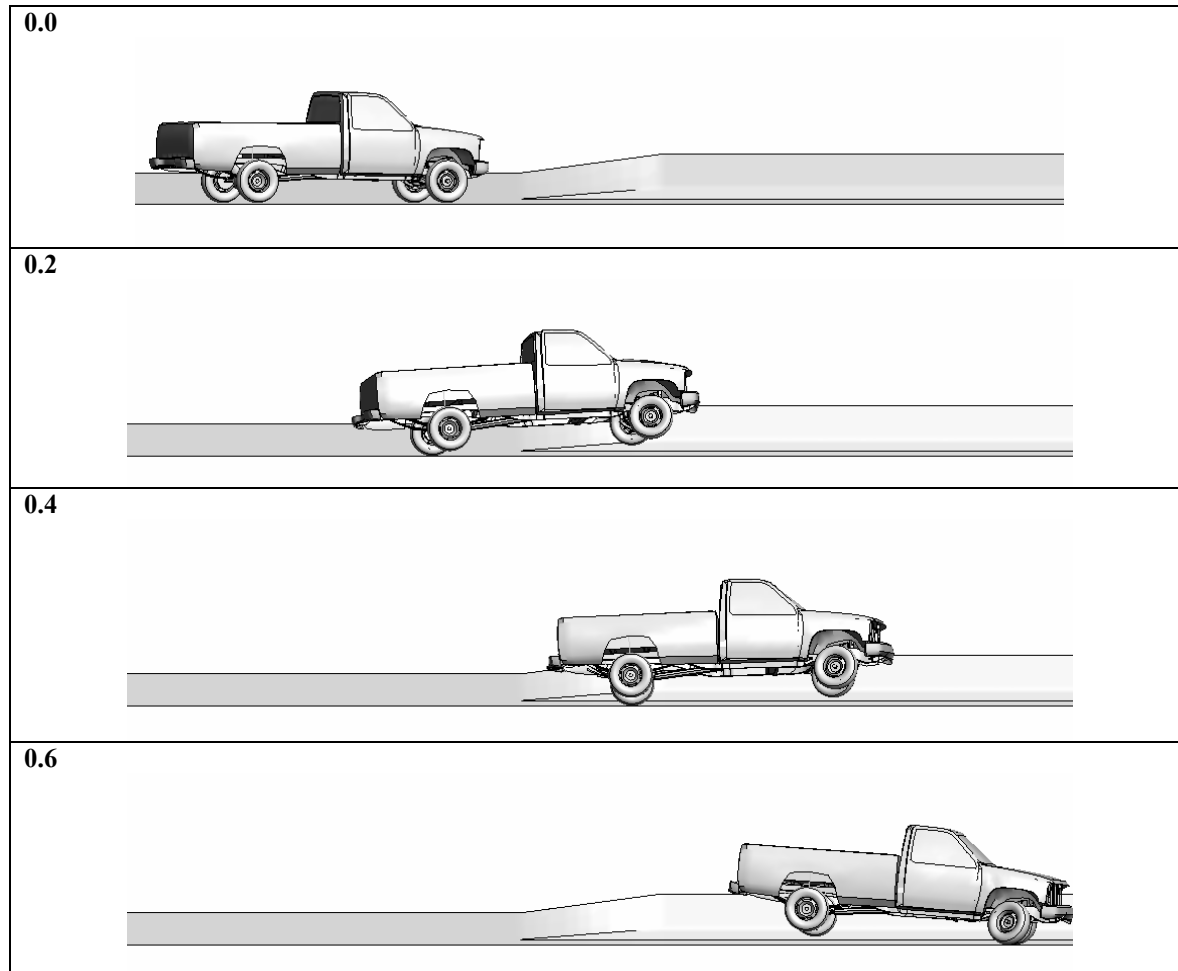
[Figure 3](#) shows simulation results for the pickup truck impact transitioning from the low-profile barrier to the F-shape barrier, 3 ft (1 m) upstream of the slope change point (impact point A). [Figure 4](#) shows simulation results for the pickup truck impact transitioning from the low-profile barrier to the F-shape barrier, at the slope change point (impact point B). [Figure 5](#) shows simulation results for the pickup truck impact transitioning from the F-shape barrier to the low-profile barrier, 3 ft (1 m) upstream of the slope change point (impact point D). [Figure 6](#) shows simulation results for the pickup truck impact transitioning from the F-shape barrier to the low-profile barrier, at the slope change point (impact point C). It can be seen from the simulation results presented in [Figures 3](#) through [6](#) that the pickup truck was successfully redirected with no concerns regarding vehicular stability. As expected, impacts A and B, while the pickup was transitioning from the low-profile barrier to the F-shape barrier, resulted in a slightly higher vehicle climb. However, this increase in climb did not lead to any vehicular instability concerns.

**Figure 3. Pickup Truck Impact from Low-Profile Barrier to F-Shape Barrier, 3 ft (1 m) Upstream of the Slope Change Point (Impact Point A).**

Examination of the pickup truck results presented in Figures 3 through 6 shows that there is very little difference in the vehicle stabilities between impacts at A and B, and C and D. Thus, it is shown that whether the transition section was impacted at the point of slope change or 3 ft (1 m) upstream of the slope change, there was little difference in the simulation outcome. In the case of a TL-2 small car impact, the vehicle is lighter and the impact angle is less. Thus, it is to be expected that the differences between impacts at points A and B, and C and D would be even less pronounced than was the case for the pickup truck simulations. Therefore, researchers performed small car simulations for the rigidly fixed barrier only for impact points B and C as shown in Figure 2.

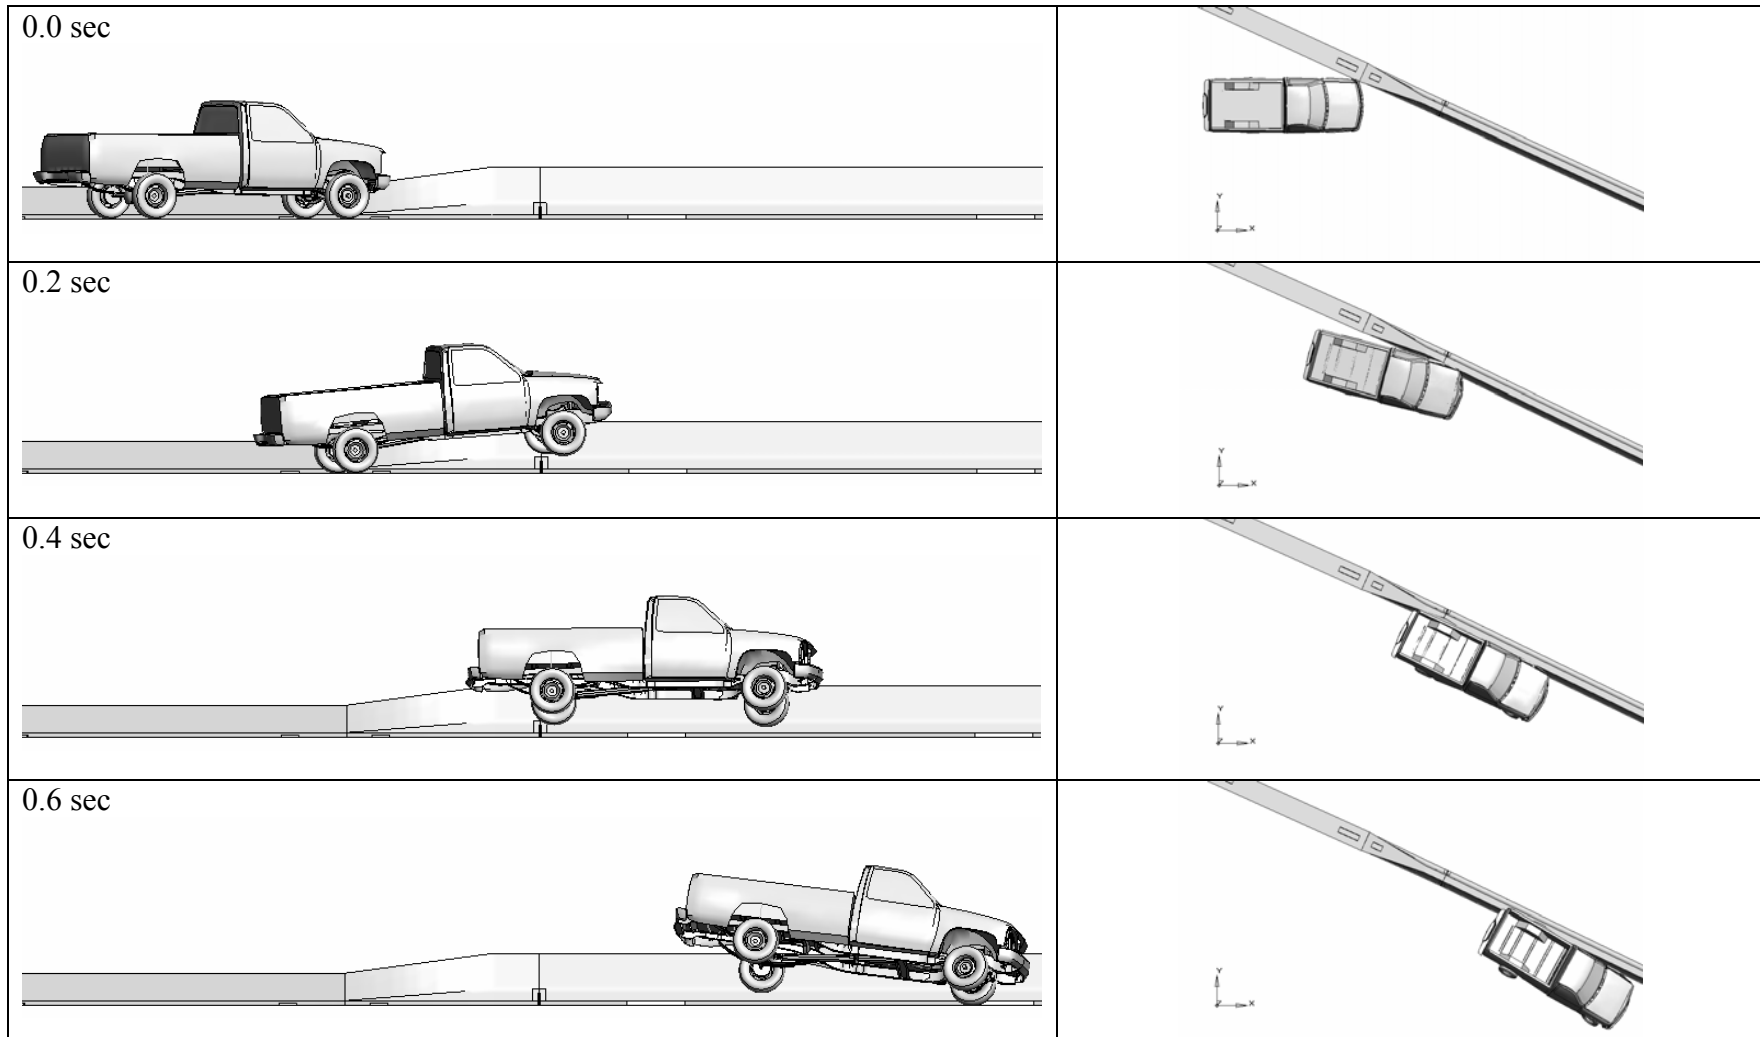
**Figure 12. Pickup Truck Impact Transitioning from Low-Profile Barrier to F-Shape Barrier, at the Slope Change Point (Impact Point B).**

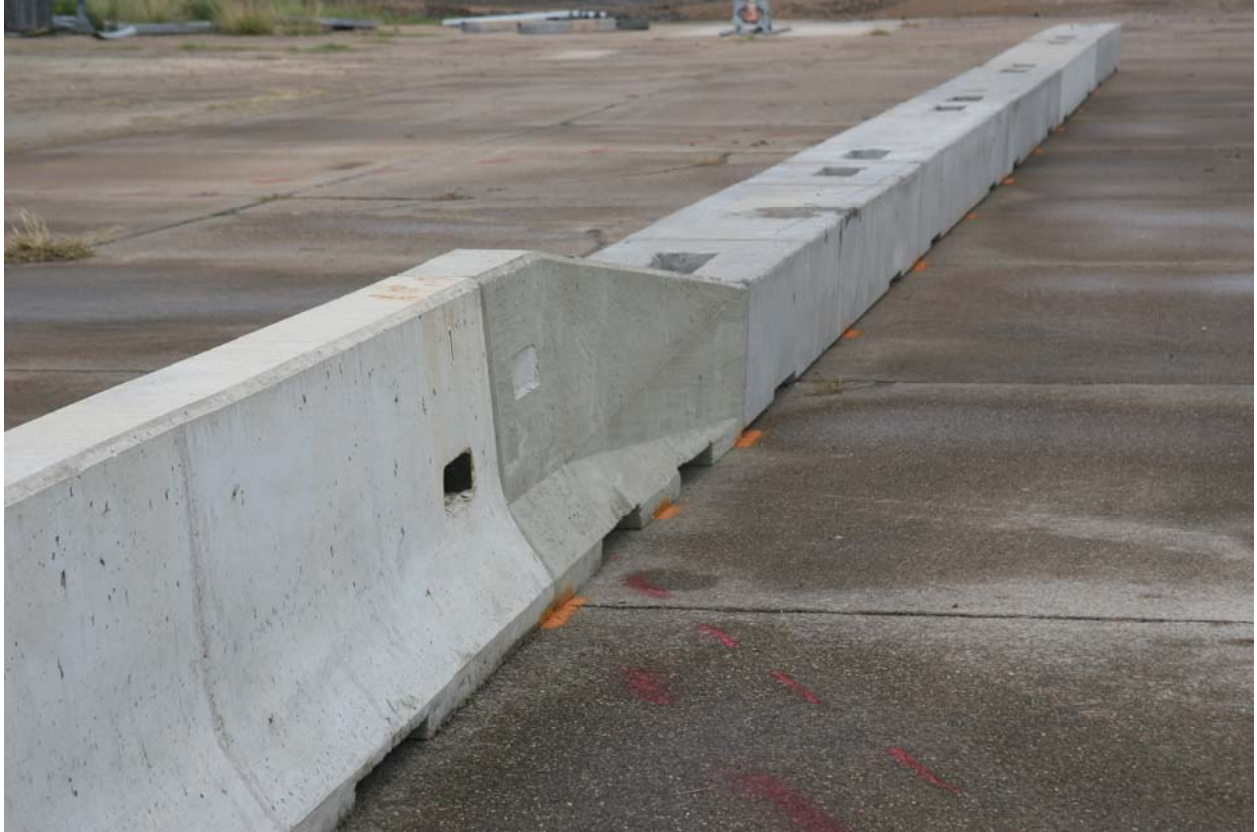
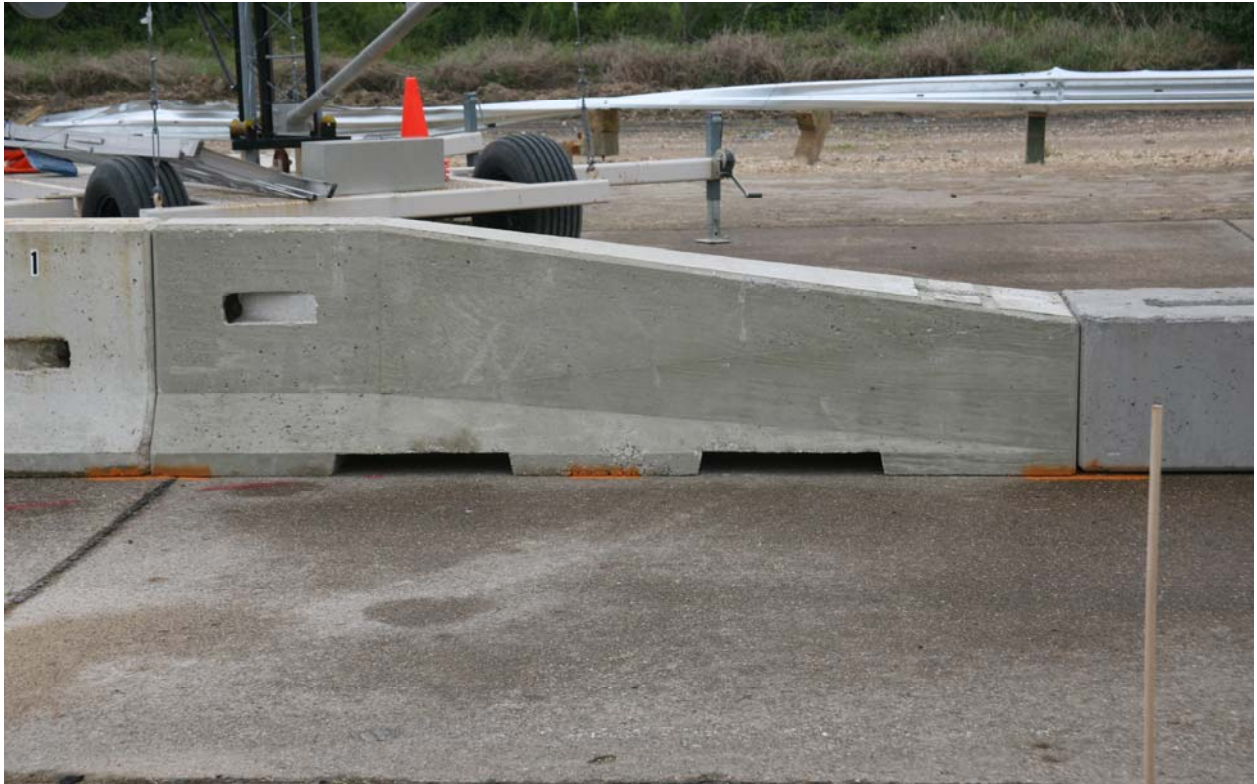
**Figure 14. Low-Profile Transition Installation before Testing.**

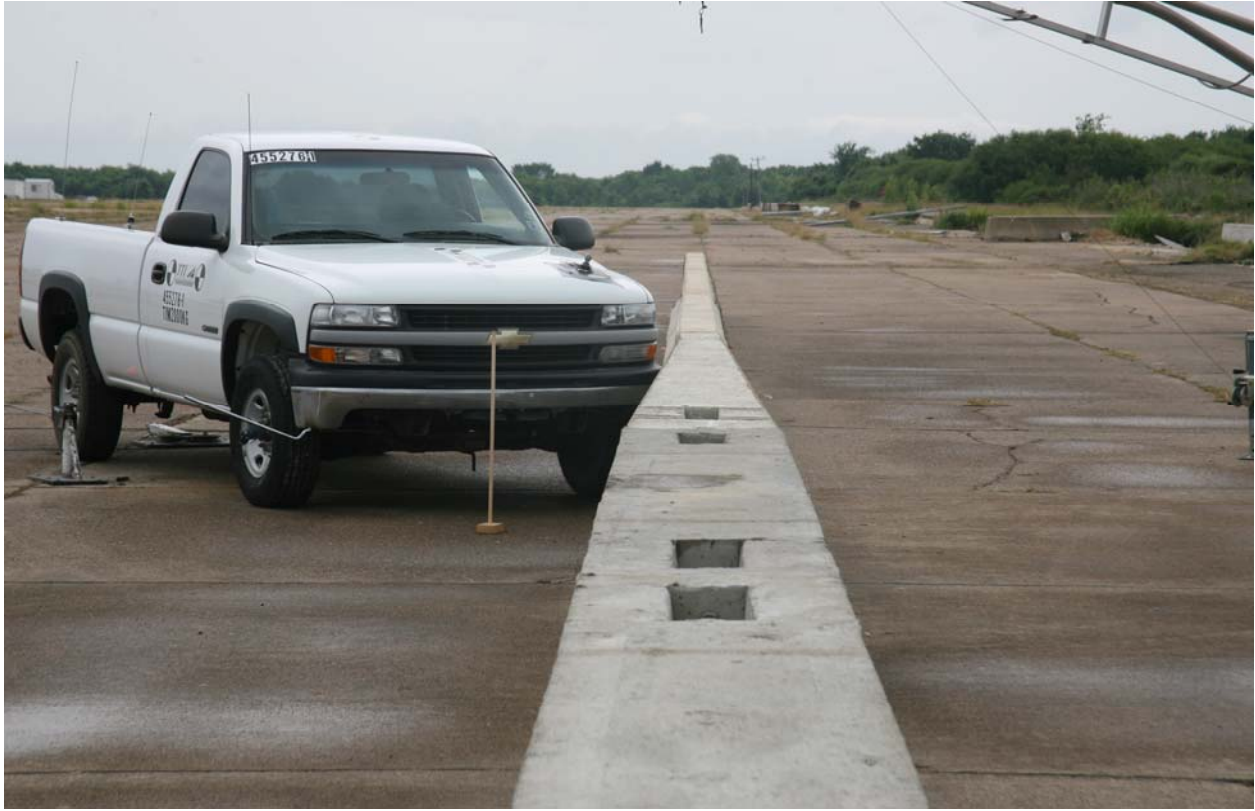
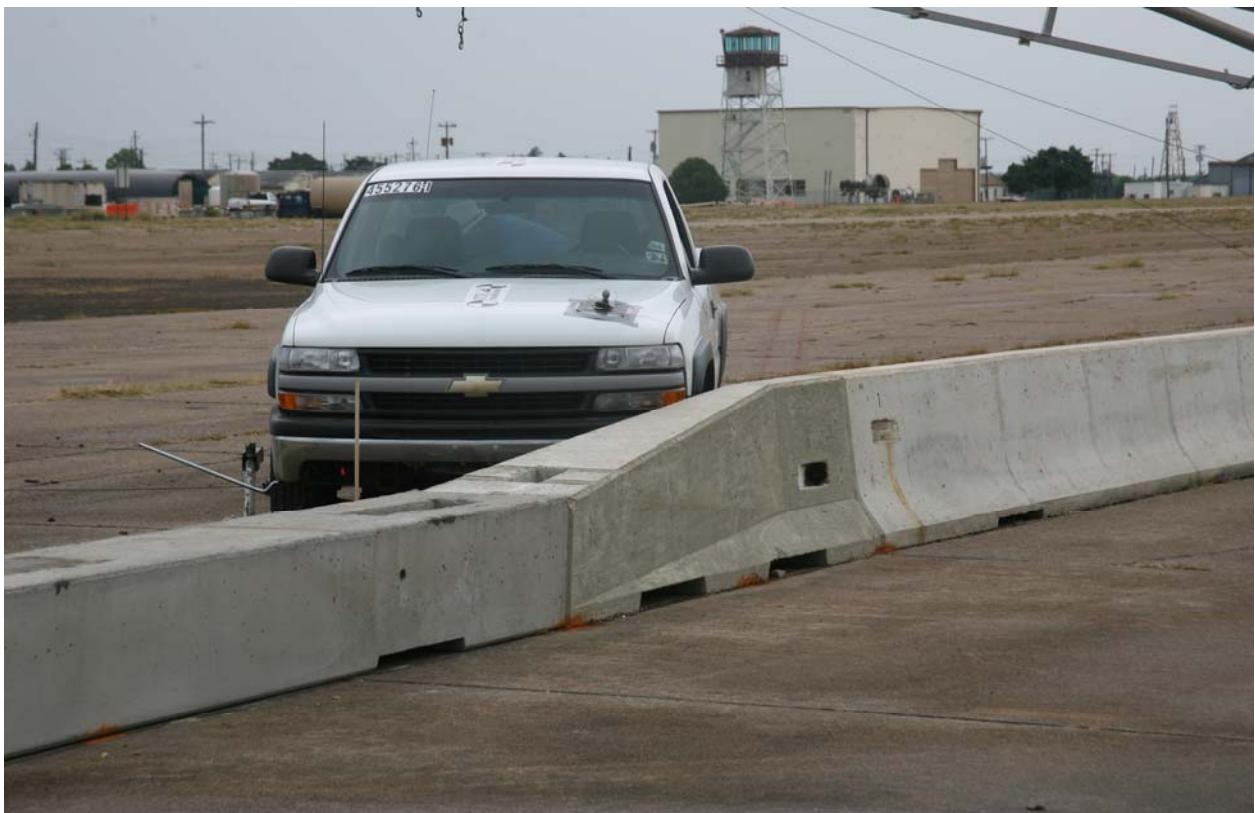
**Figure 15. Vehicle/Installation Geometrics for Test No. 455276-1.**

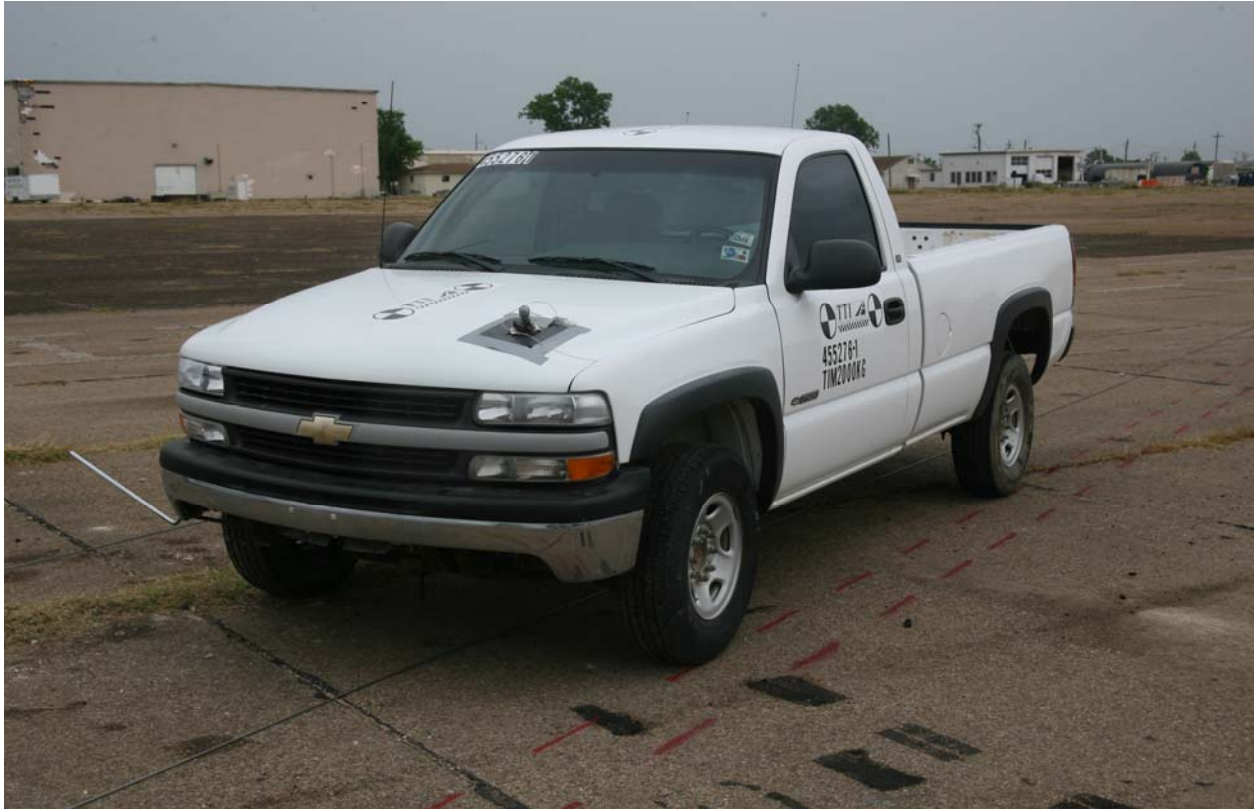
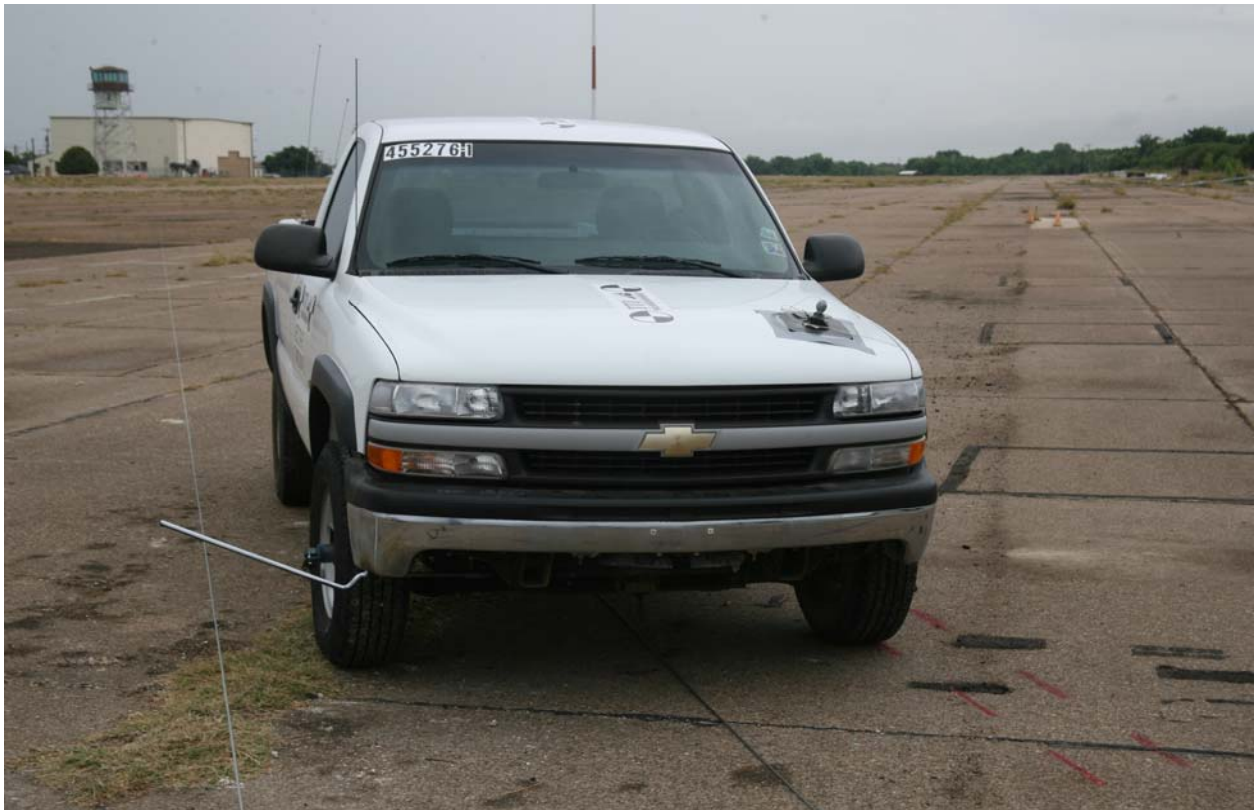
**Figure 16. Vehicle before Test No. 455276-1.**

A 2001 Chevrolet C2500 pickup truck, shown in Figures 15 and 16, was used for the crash test. Test inertia weight of the vehicle was 4725 lb (2143 kg), and its gross static weight was 4725 lb (2143 kg). The height to the lower edge of the vehicle bumper was 14.6 inches (370 mm), and it was 25.6 inches (650 mm) to the upper edge of the bumper. Figure 35 in Appendix C gives additional dimensions and information on the vehicle. The vehicle was directed into the installation using the cable reverse tow and guidance system, and was released to be free-wheeling and unrestrained just prior to impact.

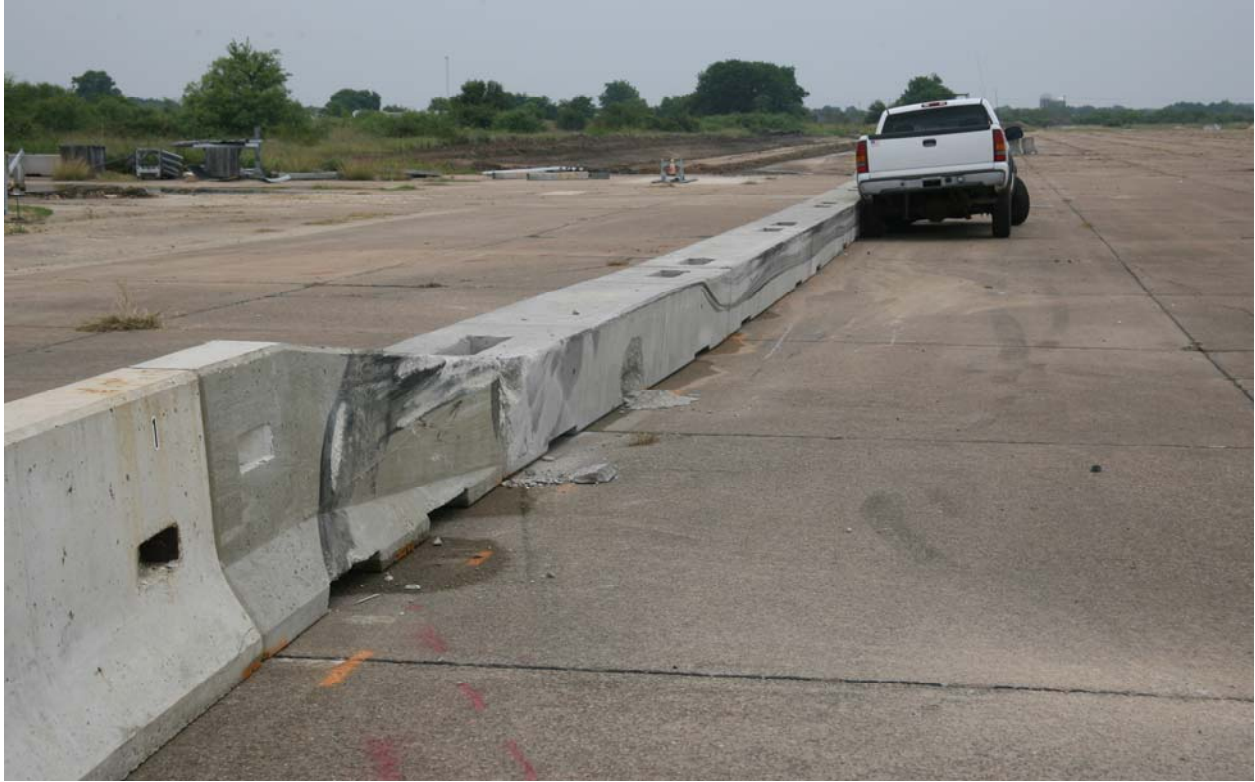
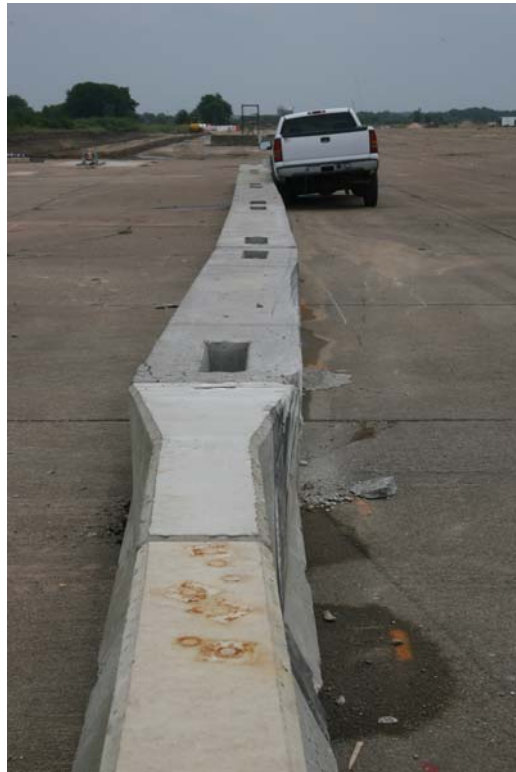
**Figure 17. After Impact Trajectory Path for Test No. 455276-1.**

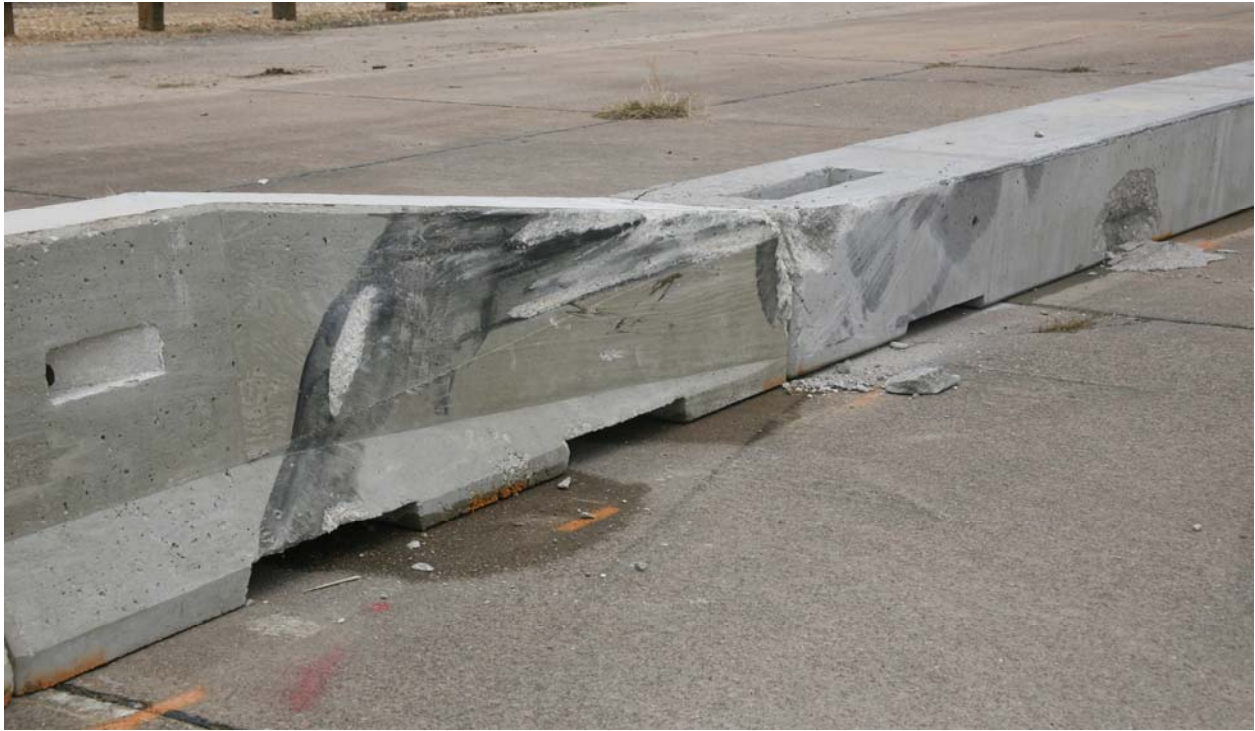
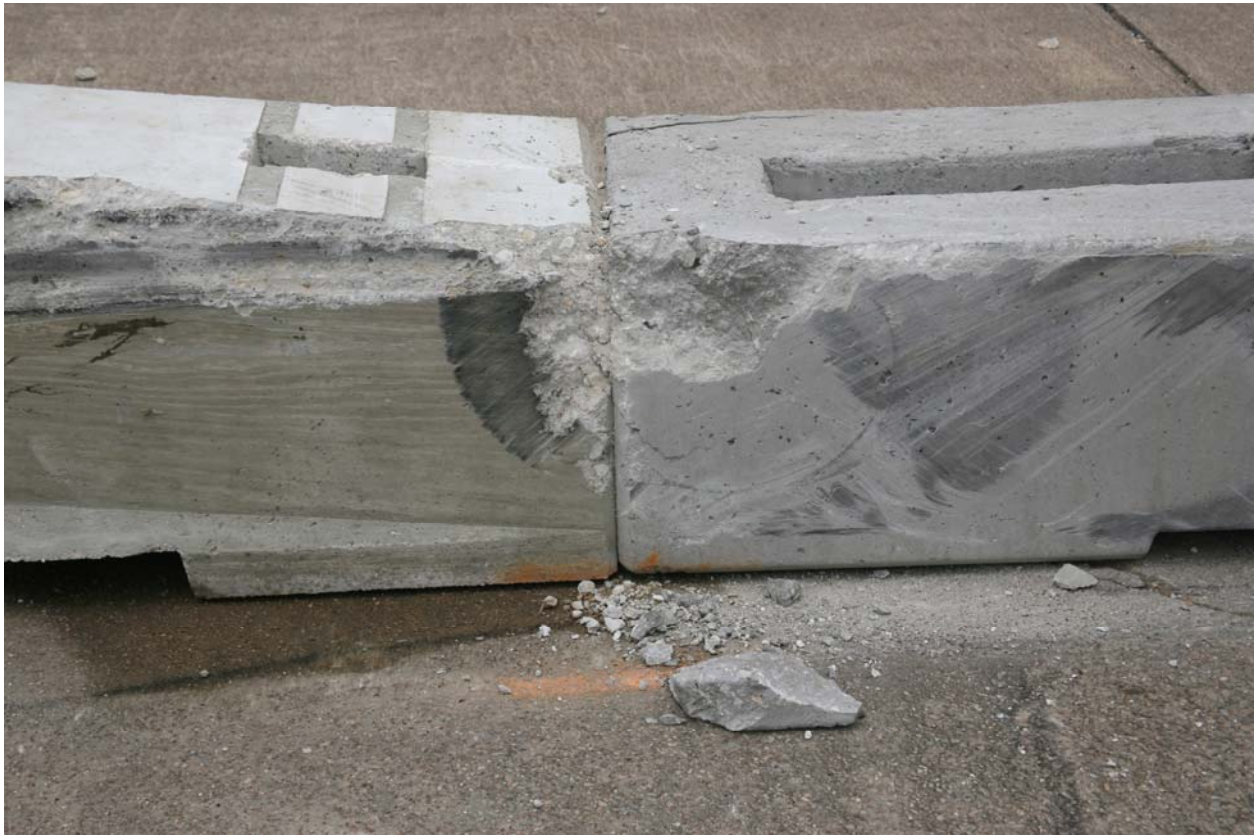
Figures 17 and 18 show damage to the barrier system. The F-shape barrier moved toward the traffic side 2.6 inches (65 mm) at the joint between segments 2 and 3, and moved toward the field side 8.1 inches (205 mm) at the joint between segments 3 and the transition barrier segment. The transition barrier segment was moved toward field side 10.2 inches (260 mm) at the joint between the transition barrier segment and the low-profile segment 5. The low-profile barrier was also pushed toward field side 2.0 inches (50 mm) at the joint between segment 5 and 6. The concrete was spalled off segment 3 at the joint between segments 2 and 3 of the F-shape barrier. A piece of concrete also broke off the top of the transition barrier segment at the joint between the transition barrier segment and the low-profile barrier, and another piece broke off near ground level near the middle of the same segment of low-profile barrier. Length of contact of the vehicle with the barrier was 83 ft (25.3 m), and working width was 38.2 inches (971 mm). Maximum dynamic deflection of the barrier was 10.2 inches (260 mm), and maximum permanent deflection of the barrier was 10.2 inches (260 mm).

**Figure 18. Installation after Test No. 455276-1.**

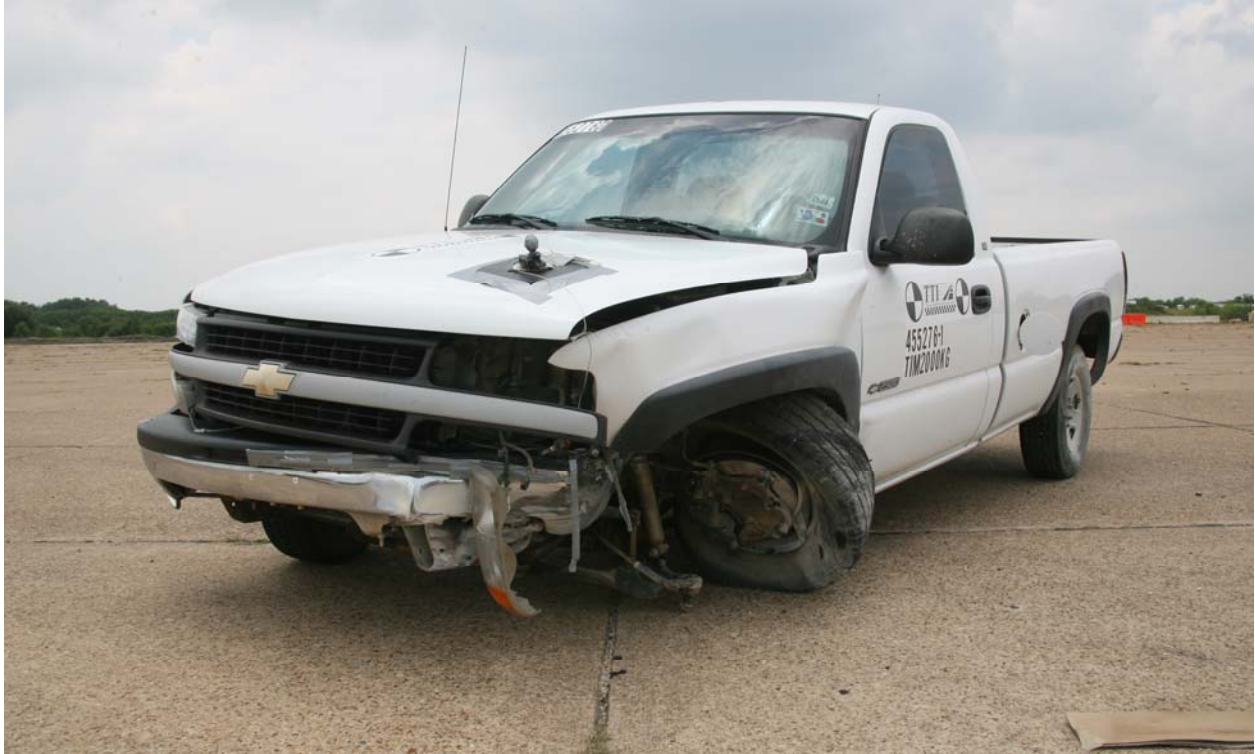
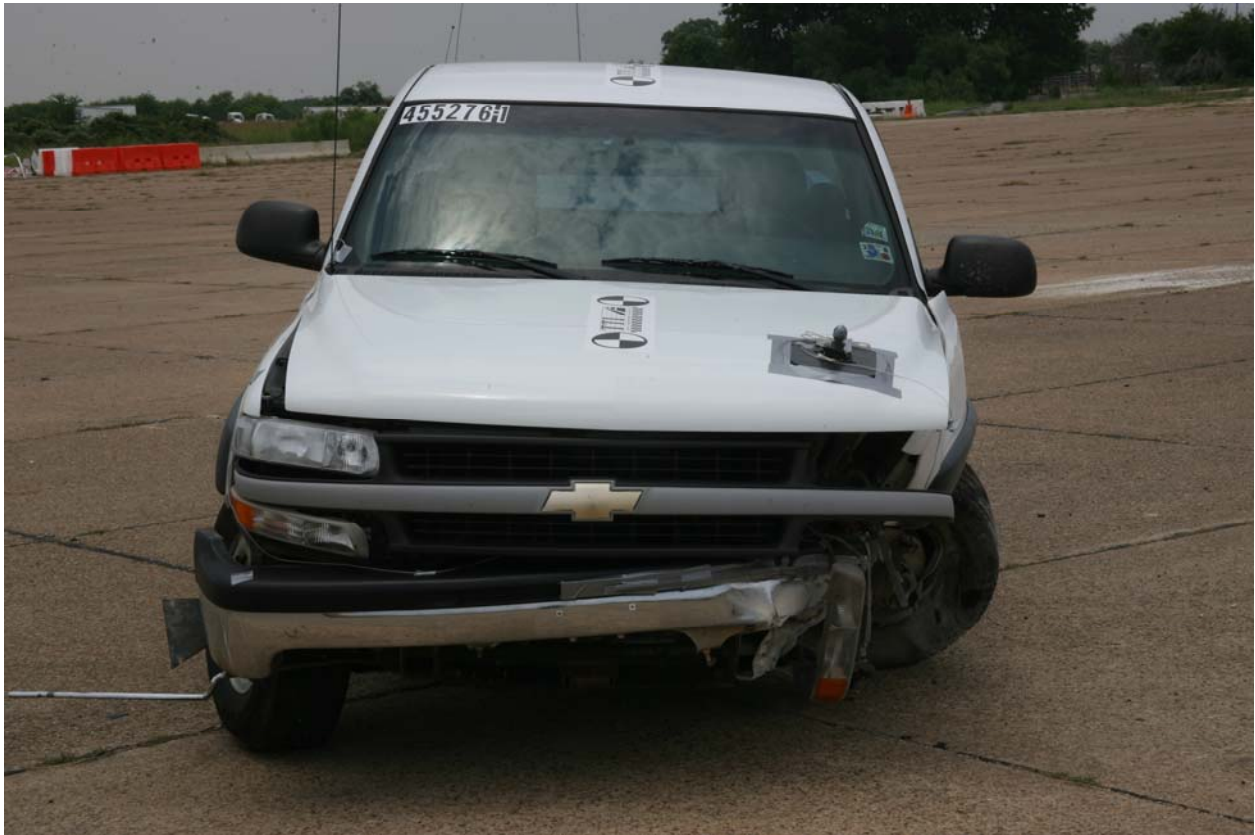
Damage to the vehicle is shown in Figure 19. Structurally, the left upper and lower A-arm were deformed; the left upper ball joint pulled out of the socket; the left outer ball joint broke at the steering knuckle, and the left outer tie rod end broke. Also damaged were the front bumper, radiator and fan, left front quarter panel, left front tire and rim, left door, and left rear wheel rim (but no loss of air from the tire). Maximum exterior crush to the vehicle was 19.7 inches (500 mm) in the left side plane at the front corner at bumper height. Maximum occupant compartment deformation was 2.8 inches (70 mm) in the firewall area on the left side. Photographs of the interior of the vehicle are shown in Figure 20. Exterior crush measurements and occupant compartment deformation are shown in Appendix C, Tables 3 and 4, respectively.

**Figure 19. Vehicle after Test No. 455276-1.**

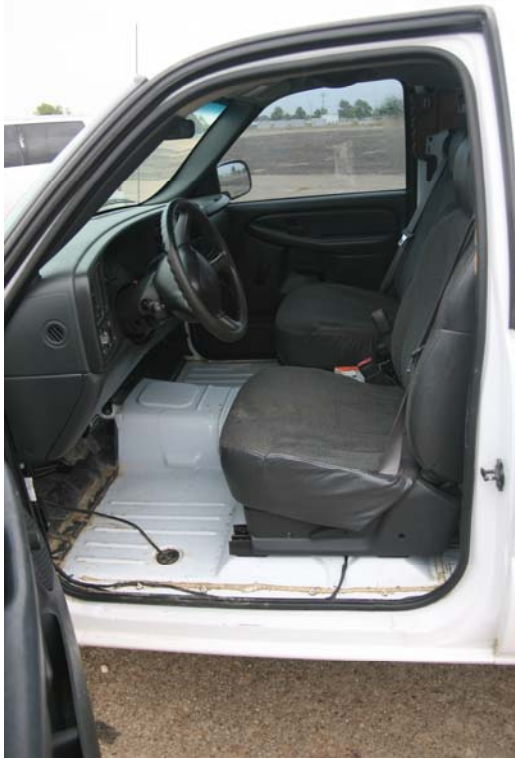
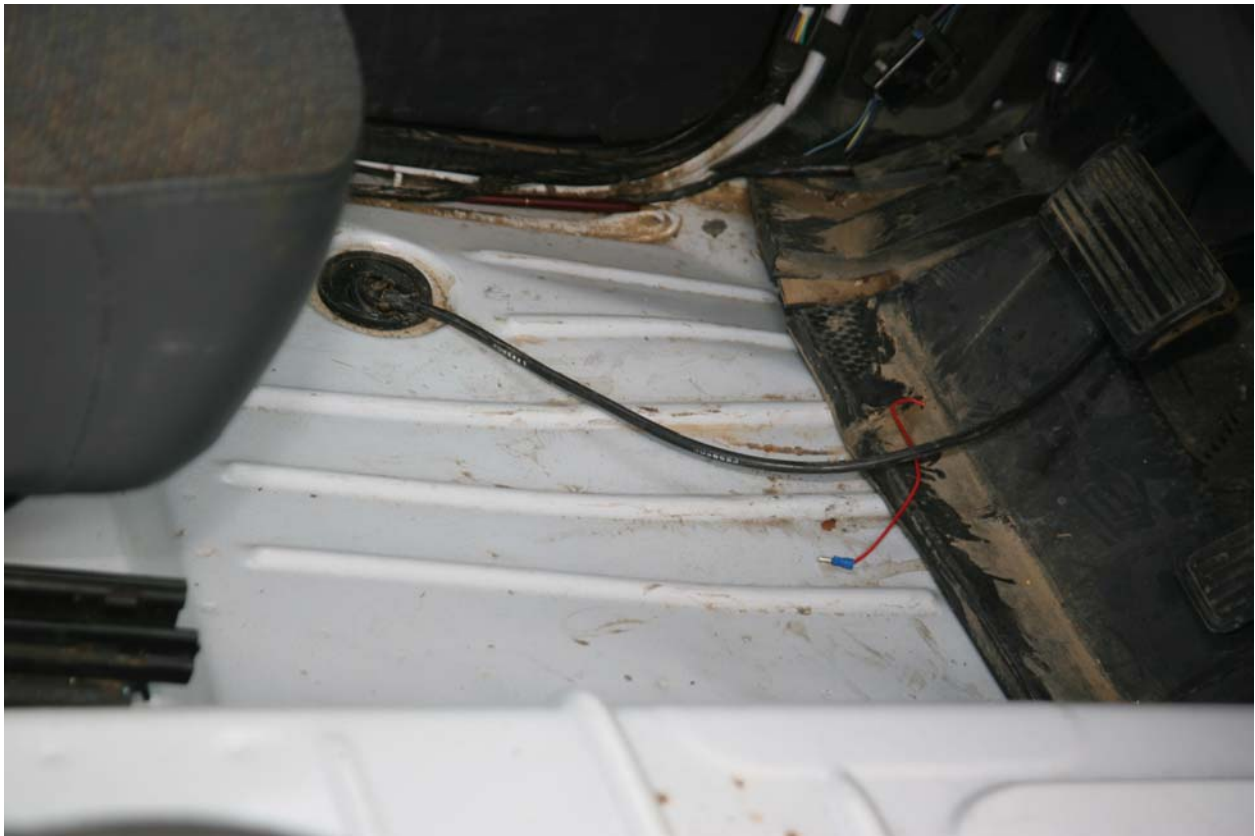
**Figure 20. Interior of Vehicle for Test No. 455276-1.**

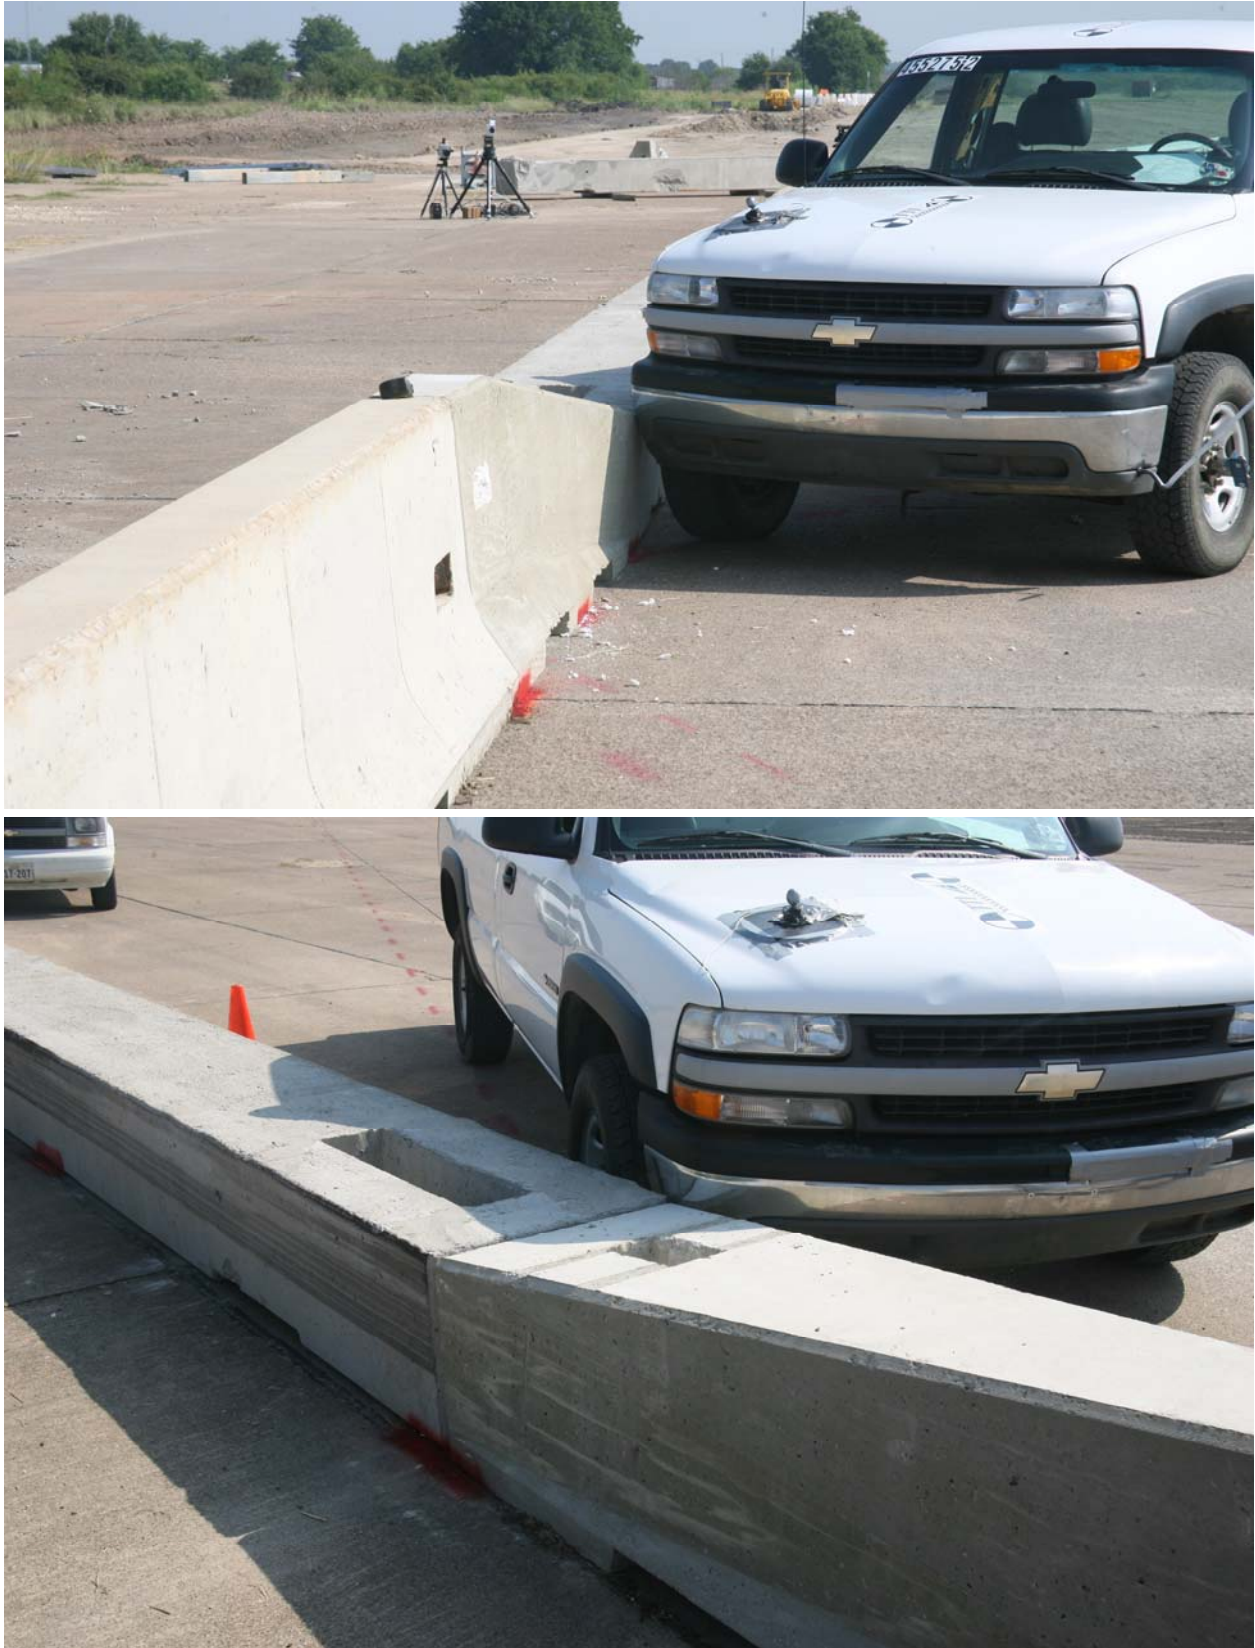
The 2001 Chevrolet C2500 pickup truck, traveling at an impact speed of 44.7 mi/h (71.9 km/h), impacted the transition barrier segment at the joint between the low-profile barrier segment and the transition barrier segment at an impact angle of 25.9 degrees. At approximately 0.047 s after impact, the right front tire blew out. The transition barrier segment began to deflect toward the field side at 0.056 s, and the vehicle began to redirect at 0.059 s. At 0.382 s, the vehicle was traveling parallel with the installation, and the vehicle was traveling at a speed of 34.0 mi/h (54.8 km/h). The vehicle became totally airborne at 0.399 s, and the front tires touched the ground at 0.734 s. At 0.788 s, the vehicle lost contact with the installation and was traveling at an exit speed of 31.6 mi/h (50.8 m/h) and an exit angle of 4.2 degrees toward the installation. Brakes on the vehicle were applied at 1.7 s, and the vehicle subsequently came to rest 245 ft (74.7 m) downstream of impact and 28 ft (8.5 m) forward of the face of the barrier. Figure 38 in Appendix D show sequential photographs of the test period.

**Figure 22. Vehicle/Installation Geometrics for Test No. 455276-2.**

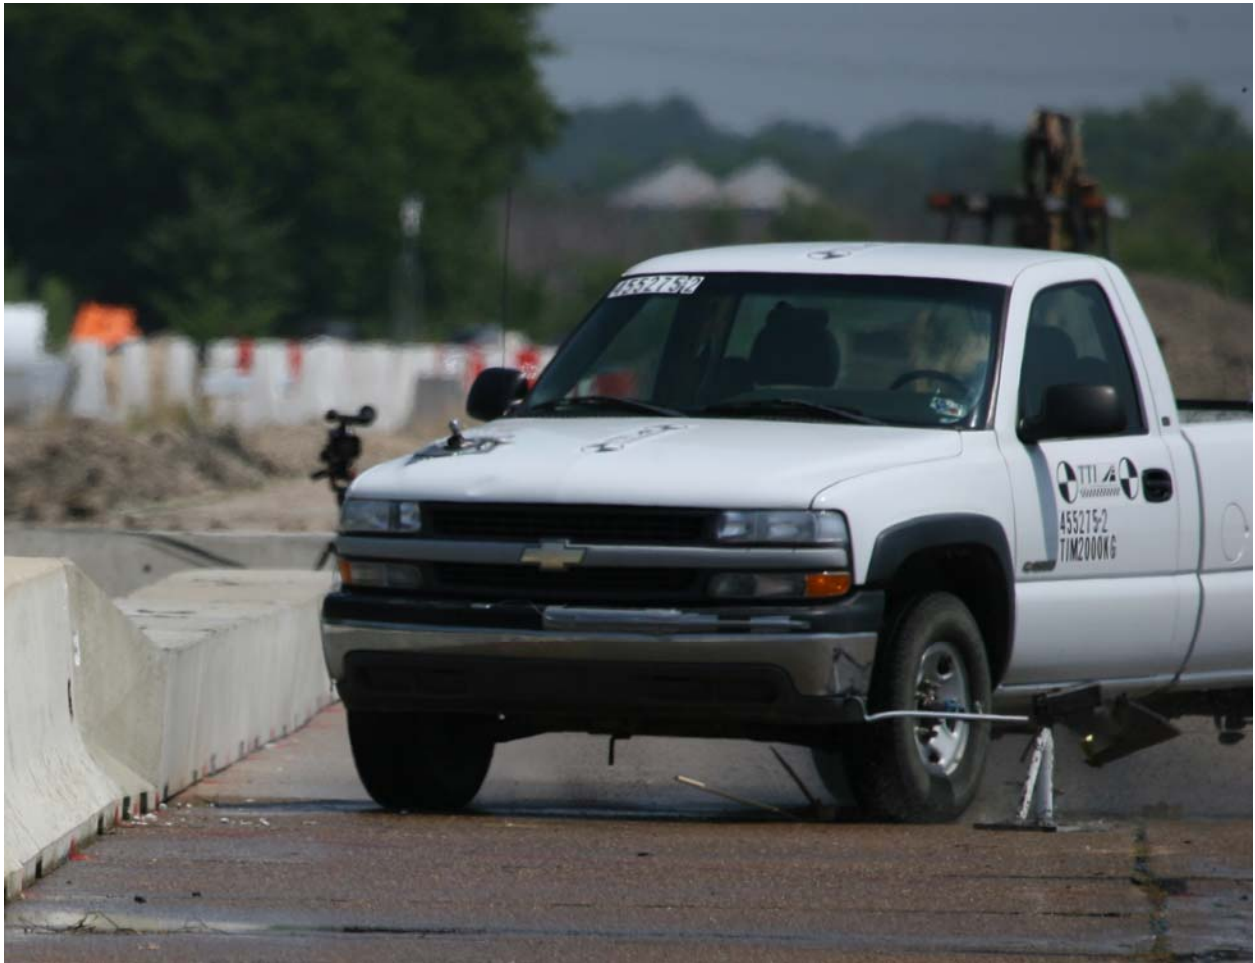
**Figure 23. Vehicle before Test No. 455276-2.**

A 2001 Chevrolet C2500 pickup truck, shown in Figures 22 and 23, was used for the crash test. Test inertia weight of the vehicle was 4744 lb (2152 kg), and its gross static weight was 4744 lb (2152 kg). The height to the lower edge of the vehicle bumper was 14.6 inches (370 mm), and it was 25.6 inches (650 mm) to the upper edge of the bumper. Figure 36 in Appendix C gives additional dimensions and information on the vehicle. The vehicle was directed into the installation using the cable reverse tow and guidance system, and was released to be free-wheeling and unrestrained just prior to impact.
