1. Report No. FHWA/TX-07/0-5527-1		2. Government Accession No.		3. Recipient's Catalog No.	
4. Title and Subtitle DEVELOPMENT OF A LOW-PROFILE TO F-SHAPE TRANSITION BARRIER SEGMENT				5. Report Date September 2006 Published: January 2007

# **DEVELOPMENT OF A LOW-PROFILE TO F-SHAPE TRANSITION BARRIER SEGMENT**

Report 0-5527-1  
Project 0-5527

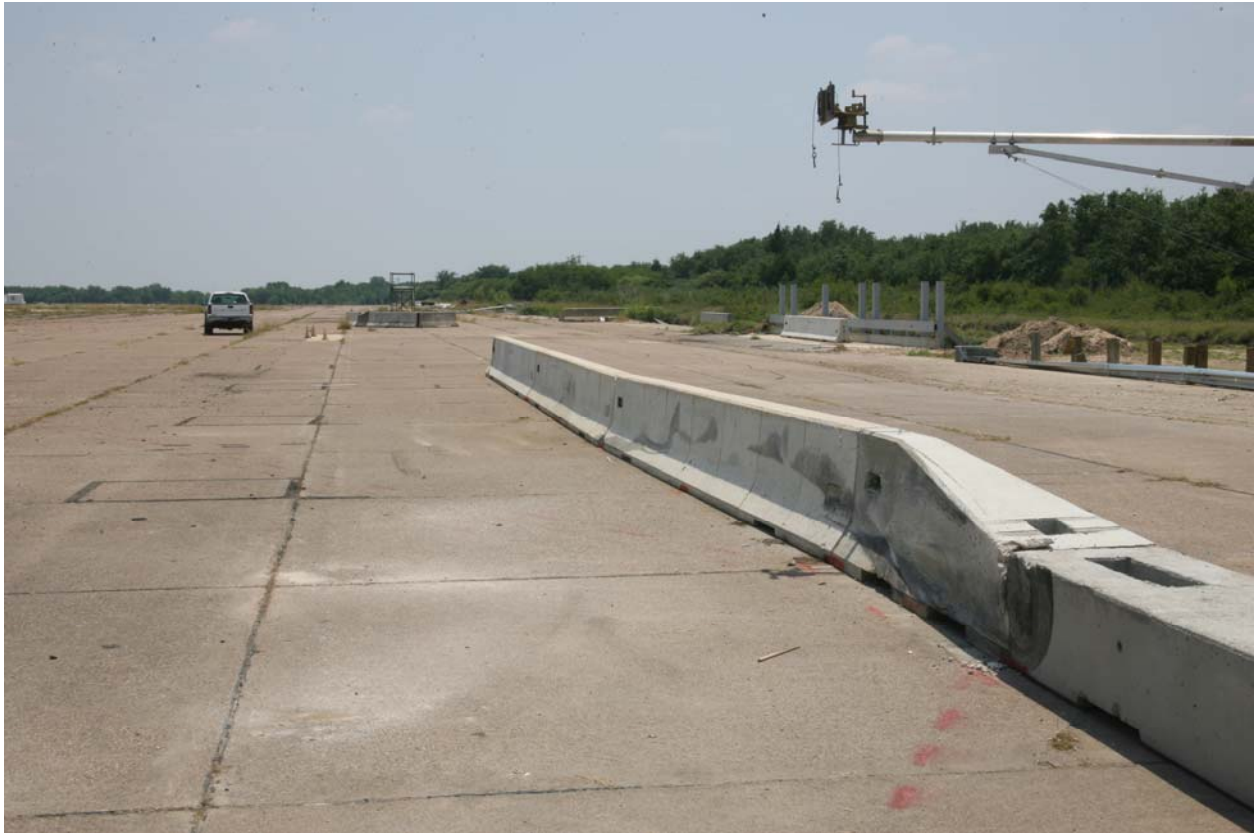
**Figure 24. After Impact Trajectory Path for Test No. 455276-2.**

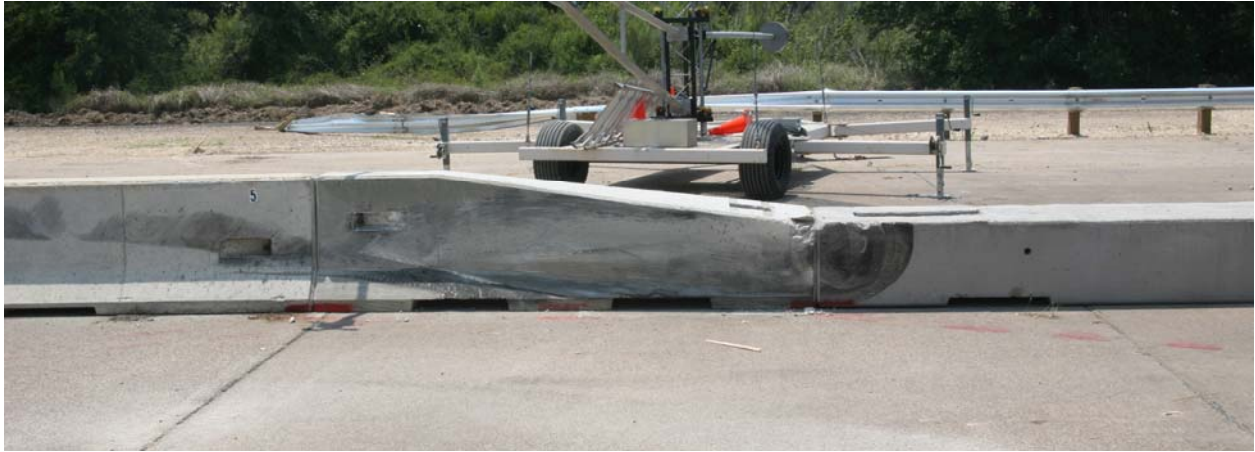
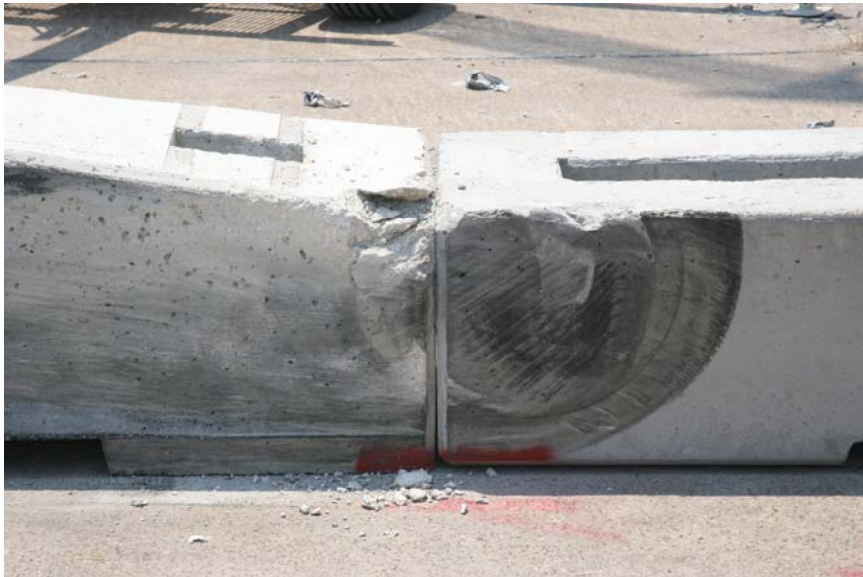
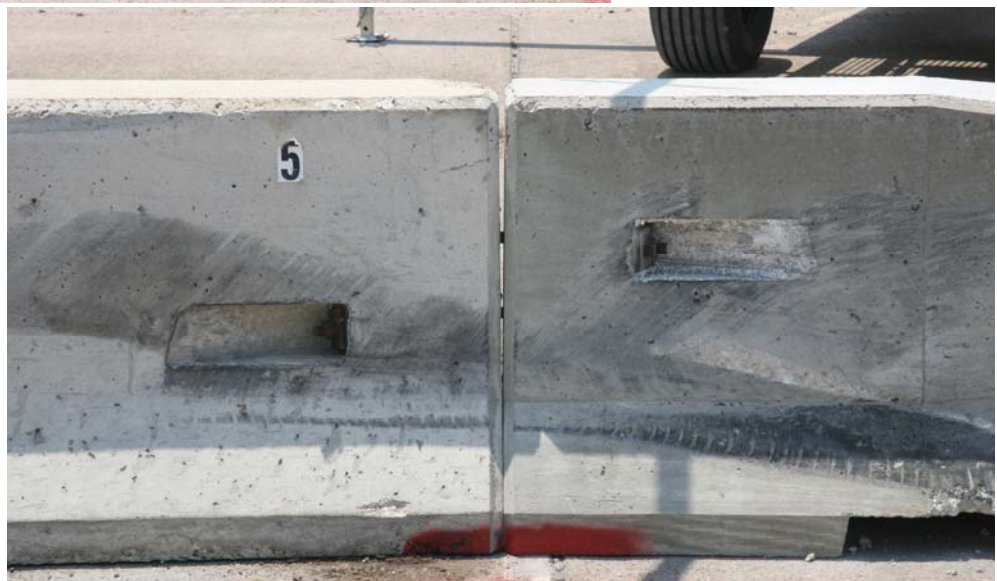
Figures 24 and 25 show damage to the barrier installation. The top corner of the barrier transition segment at the joint with the low-profile barrier segment spalled off. The low-profile barrier moved toward field side 0.4 inches (10 mm) at the joint between low-profile segments 4 and 5, and 6.7 inches (170 mm) at the joint between low-profile segment 5 and the barrier transition segment. The F-shape barrier moved toward field side 5.5 inches (140 mm) at the joint between the transition barrier segment and the F-shape barrier segment 7, while the barrier moved forward 4.7 inches (120 mm) at the joint between F-shape barrier segments 7 and 8. Length of contact of the vehicle with the barrier was 32.5 ft (9.9 m), and working width was 2.9 ft (0.89 m). Maximum dynamic deflection during the test was 7.0 inches (177 mm), and maximum permanent deflection was 6.7 inches (170 mm).

**Figure 25. Installation after Test No. 455276-2.**

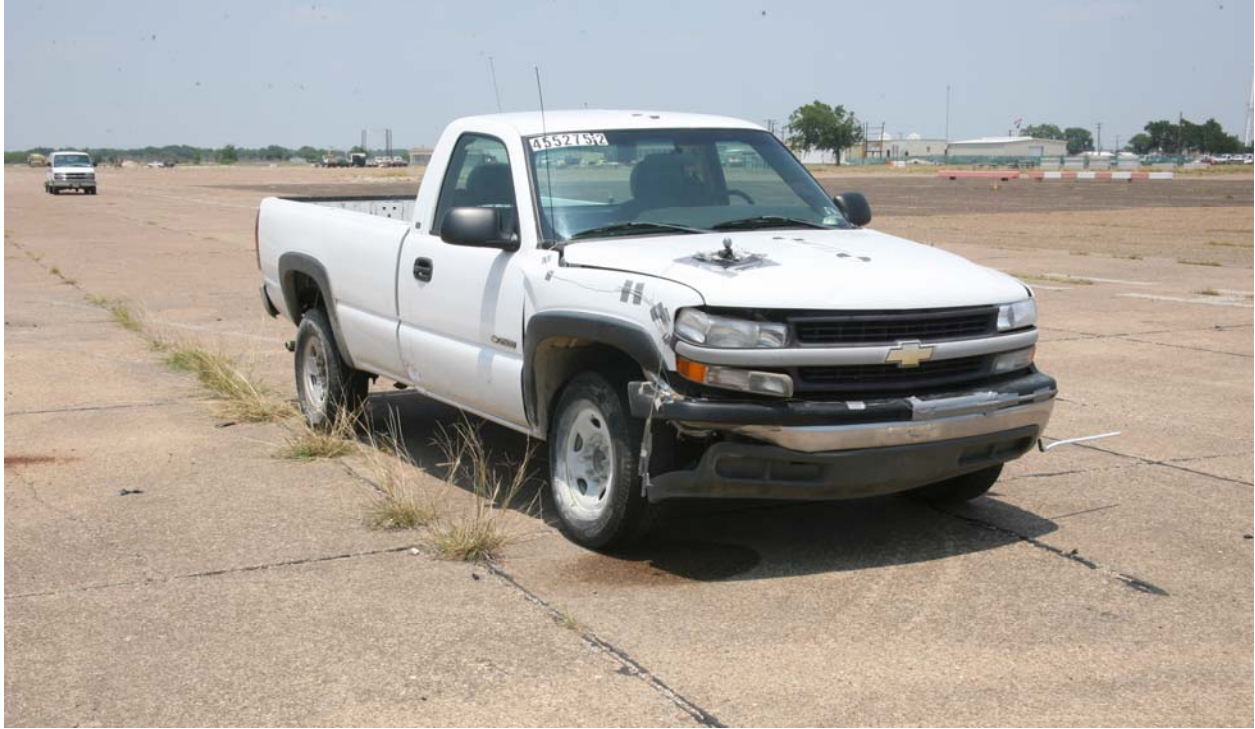
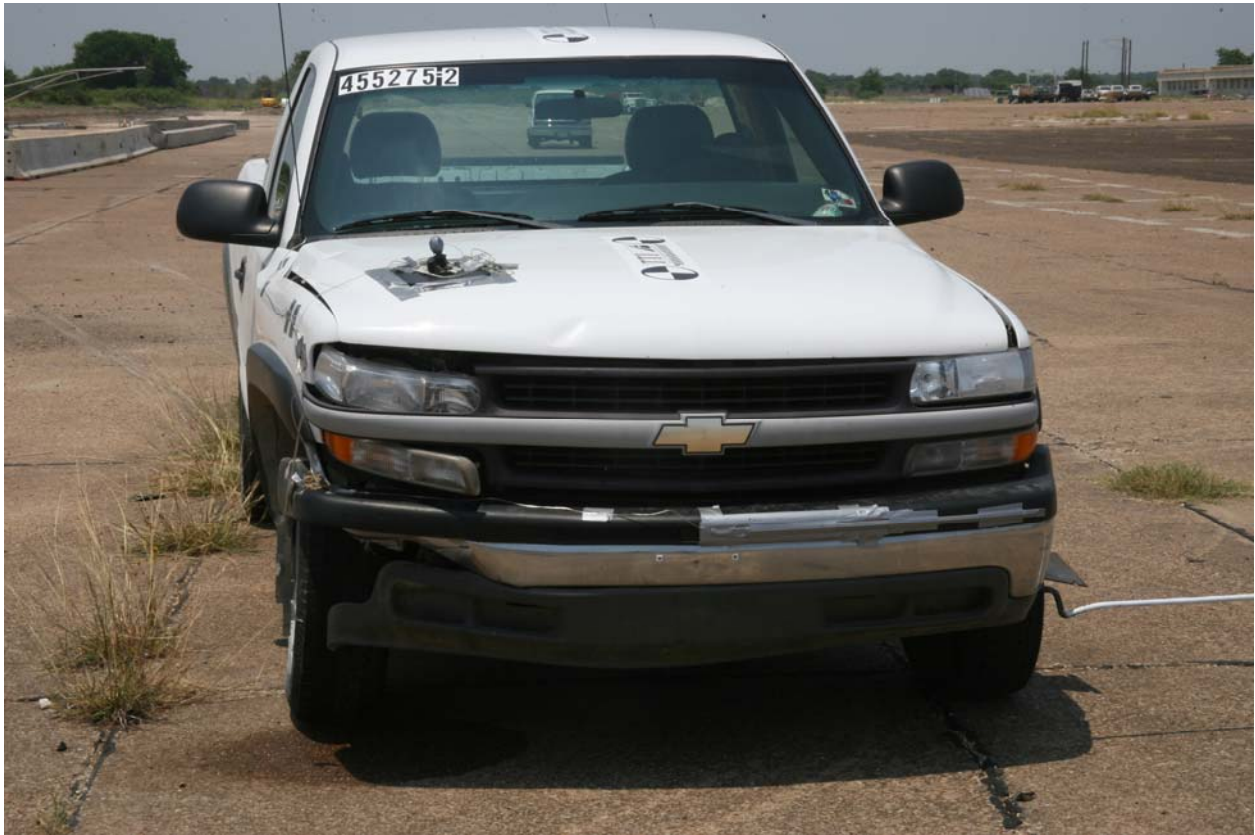
Damage to the vehicle is shown in Figure 26. Structurally, the right upper and lower A-arms and right side frame rail were deformed. Also damaged were the front bumper, radiator, right front quarter panel, and right door. Both wheel rims on the right side were deformed, but there was no loss of air in the tires. There was also a scuff mark on the lower forward edge of the exterior bed. Maximum exterior crush to the vehicle was 13.8 inches (350 mm) in the side plane on the right side at the front corner at bumper height. No occupant compartment deformation occurred. Photographs of the interior of the vehicle are shown in Figure 27. Exterior crush measurements and occupant compartment measurements are shown in Appendix C, Tables 5 and 6, respectively.

**Figure 26. Vehicle after Test No. 455276-2.**

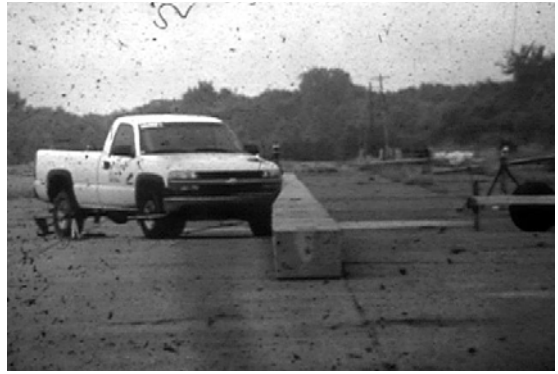
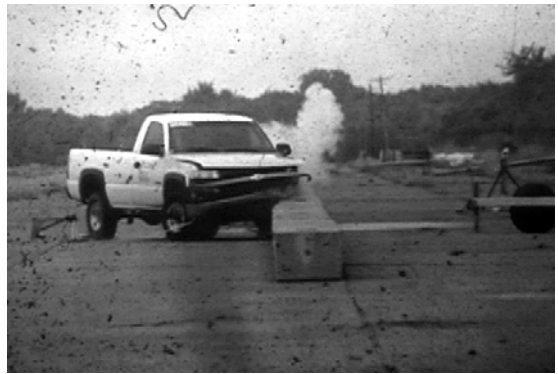
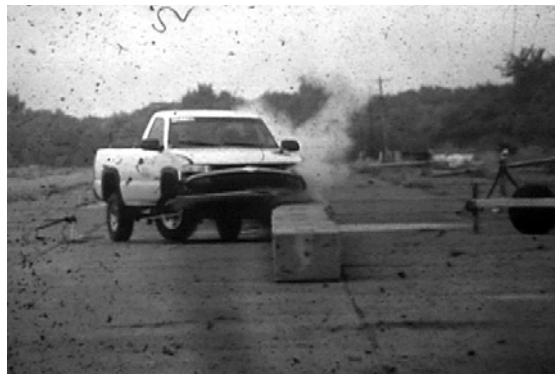
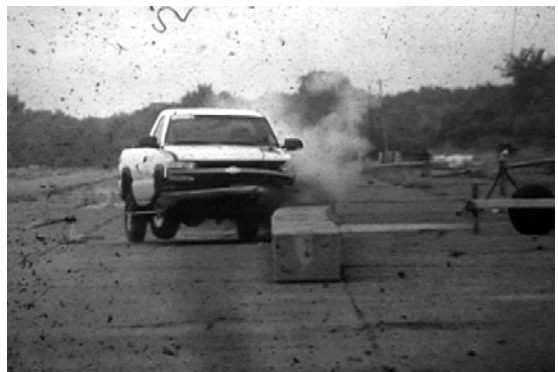
**Figure 37. Sequential Photographs for Test No. 455276-1 (Overhead and Frontal Views).**

The 2001 Chevrolet C2500 pickup truck, traveling at an impact speed of 44.0 mi/h (70.8 km/h), impacted the transition barrier segment 25.6 inches (650 mm) downstream of the joint between the F-shape barrier segment and the transition barrier segment at an impact angle of 25.1 degrees. At approximately 0.034 s after impact, the left front tire blew out. The vehicle began to redirect at 0.081 s, and the transition began to deflect toward the field side at 0.088 s. At 0.318 s, the vehicle was traveling parallel with the installation and was traveling at a speed of 33.9 mi/h (54.5 km/h). The rear of the vehicle contacted the installation at 0.367 s. At 0.543 s, the rear of the vehicle lost contact with the installation while the front of the vehicle was still in contact. Speed of the vehicle at this time was 28.5 mi/h (45.9 km/h), and heading angle was 0.8 degrees. The vehicle remained in contact with the low-profile barriers and came to rest adjacent to the fourth low-profile barrier segment downstream of impact, approximately 83 ft (25.3 m). Figure 37 in Appendix D shows sequential photographs of the test period.

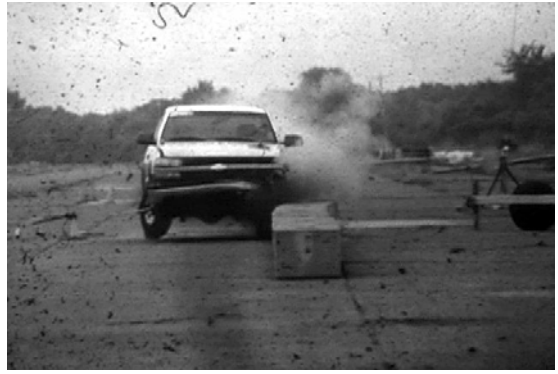
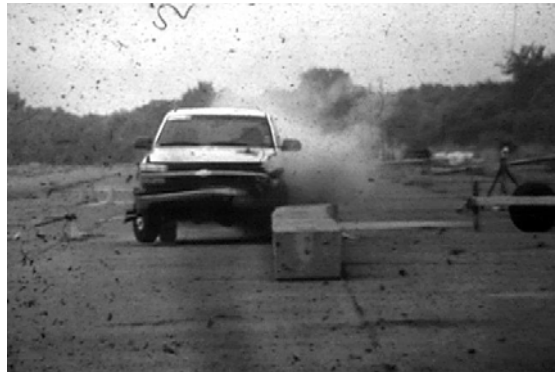
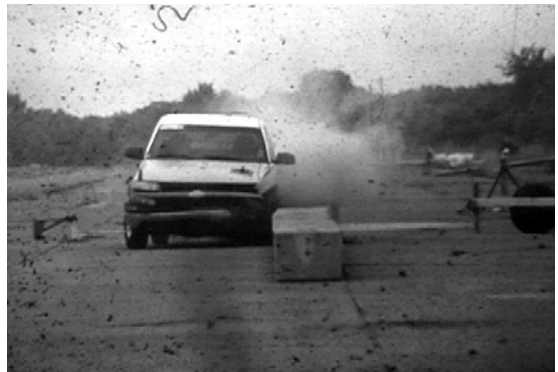
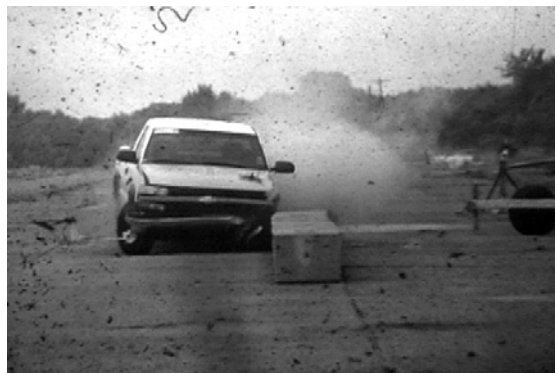
**Figure 37. Sequential Photographs for Test No. 455276-1 (Overhead and Frontal Views) (Continued).**

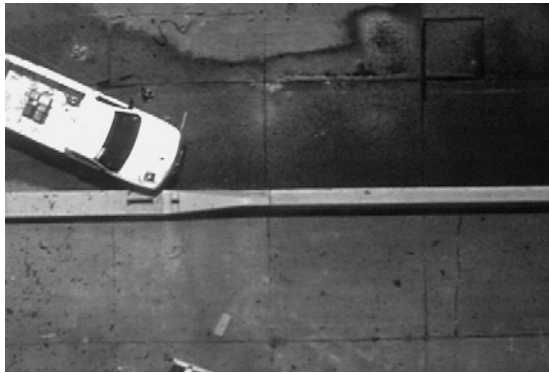
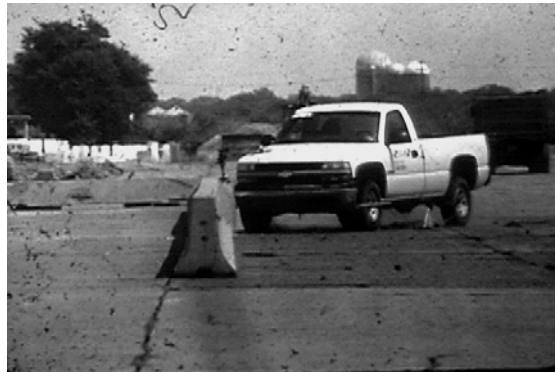
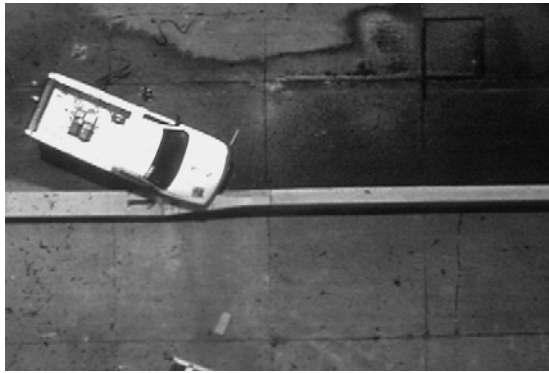
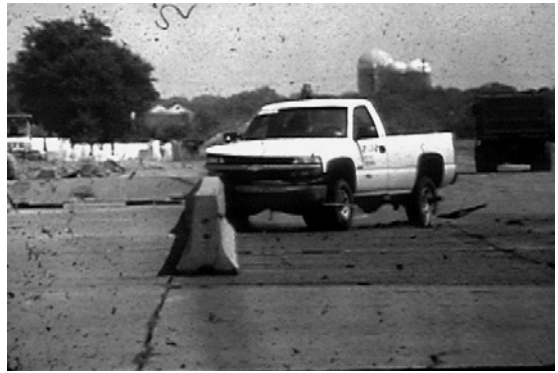
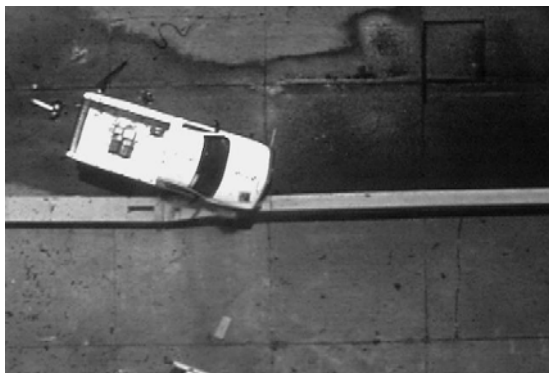
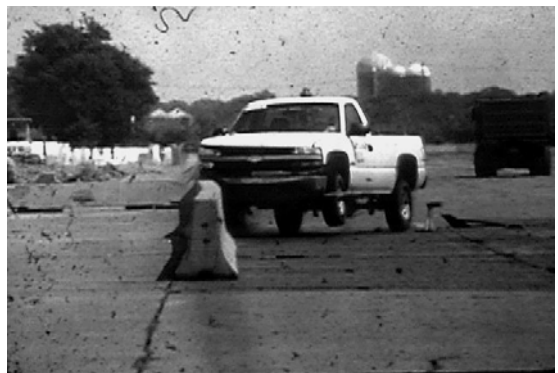
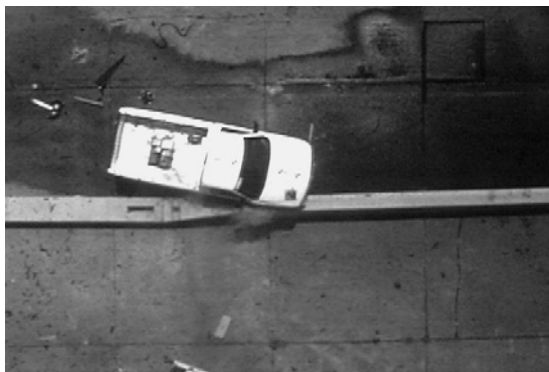
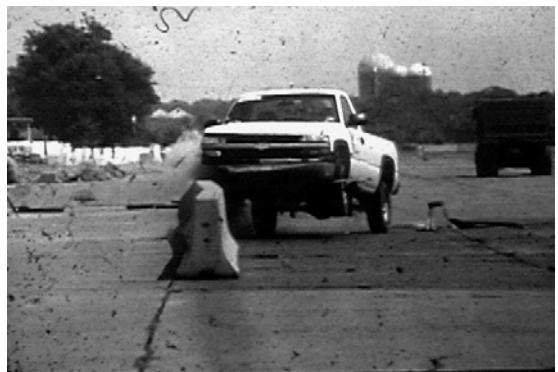
**Figure 38. Sequential Photographs for Test No. 455276-2 (Overhead and Frontal Views).**

The 2001 Chevrolet C2500 pickup truck, traveling at an impact speed of 44.7 mi/h (71.9 km/h), impacted the transition barrier segment at the joint between the low-profile barrier segment and the transition barrier segment at an impact angle of 25.9 degrees. At approximately 0.047 s after impact, the right front tire blew out. The transition barrier segment began to deflect toward the field side at 0.056 s, and the vehicle began to redirect at 0.059 s. At 0.382 s, the vehicle was traveling parallel with the installation, and the vehicle was traveling at a speed of 34.0 mi/h (54.8 km/h). The vehicle became totally airborne at 0.399 s, and the front tires touched the ground at 0.734 s. At 0.788 s, the vehicle lost contact with the installation and was traveling at an exit speed of 31.6 mi/h (50.8 m/h) and an exit angle of 4.2 degrees toward the installation. Brakes on the vehicle were applied at 1.7 s, and the vehicle subsequently came to rest 245 ft (74.7 m) downstream of impact and 28 ft (8.5 m) forward of the face of the barrier. Figure 38 in Appendix D show sequential photographs of the test period.

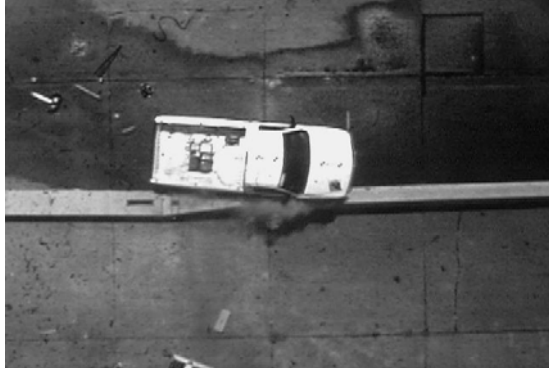
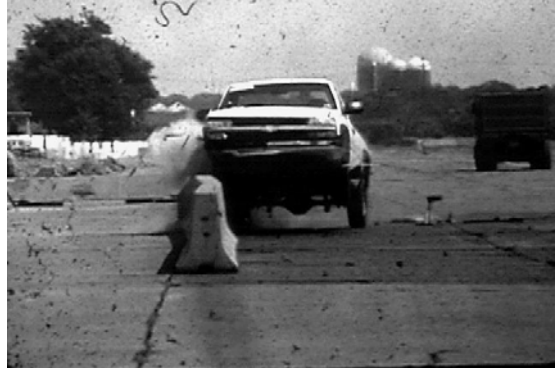
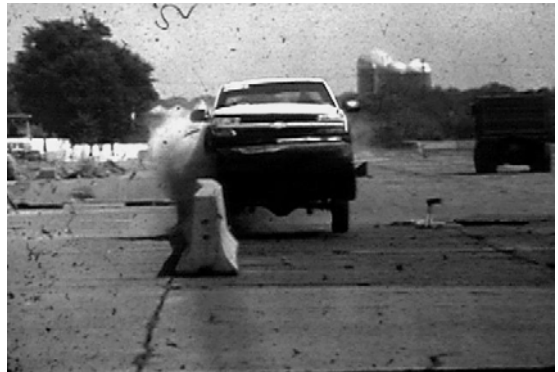
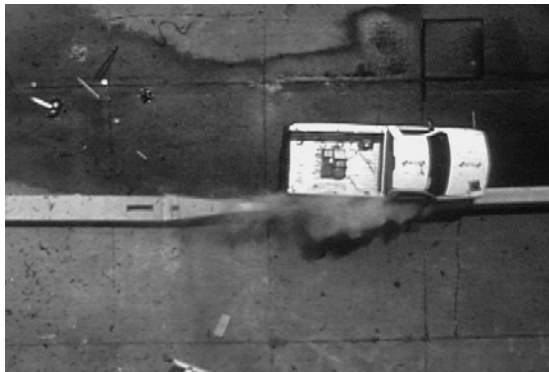
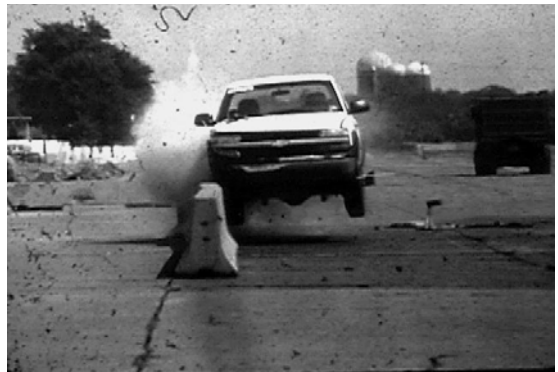
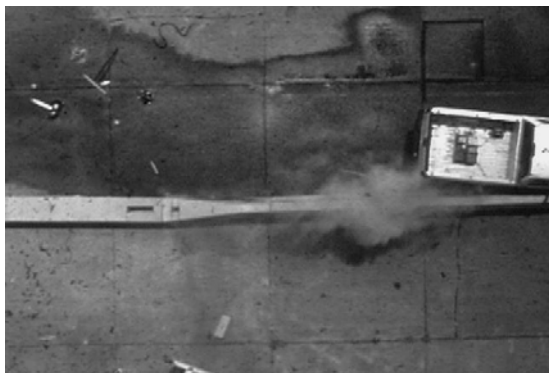
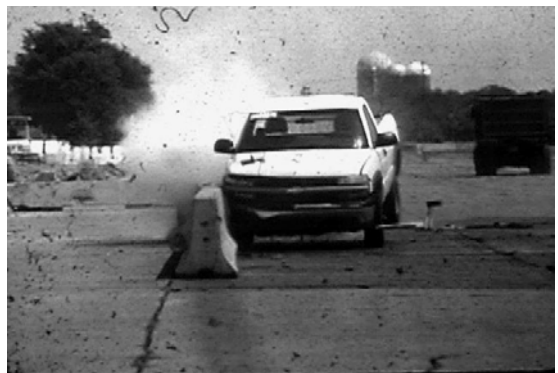
**Figure 38. Sequential Photographs for Test No. 455276-2 (Overhead and Frontal Views) (Continued).**

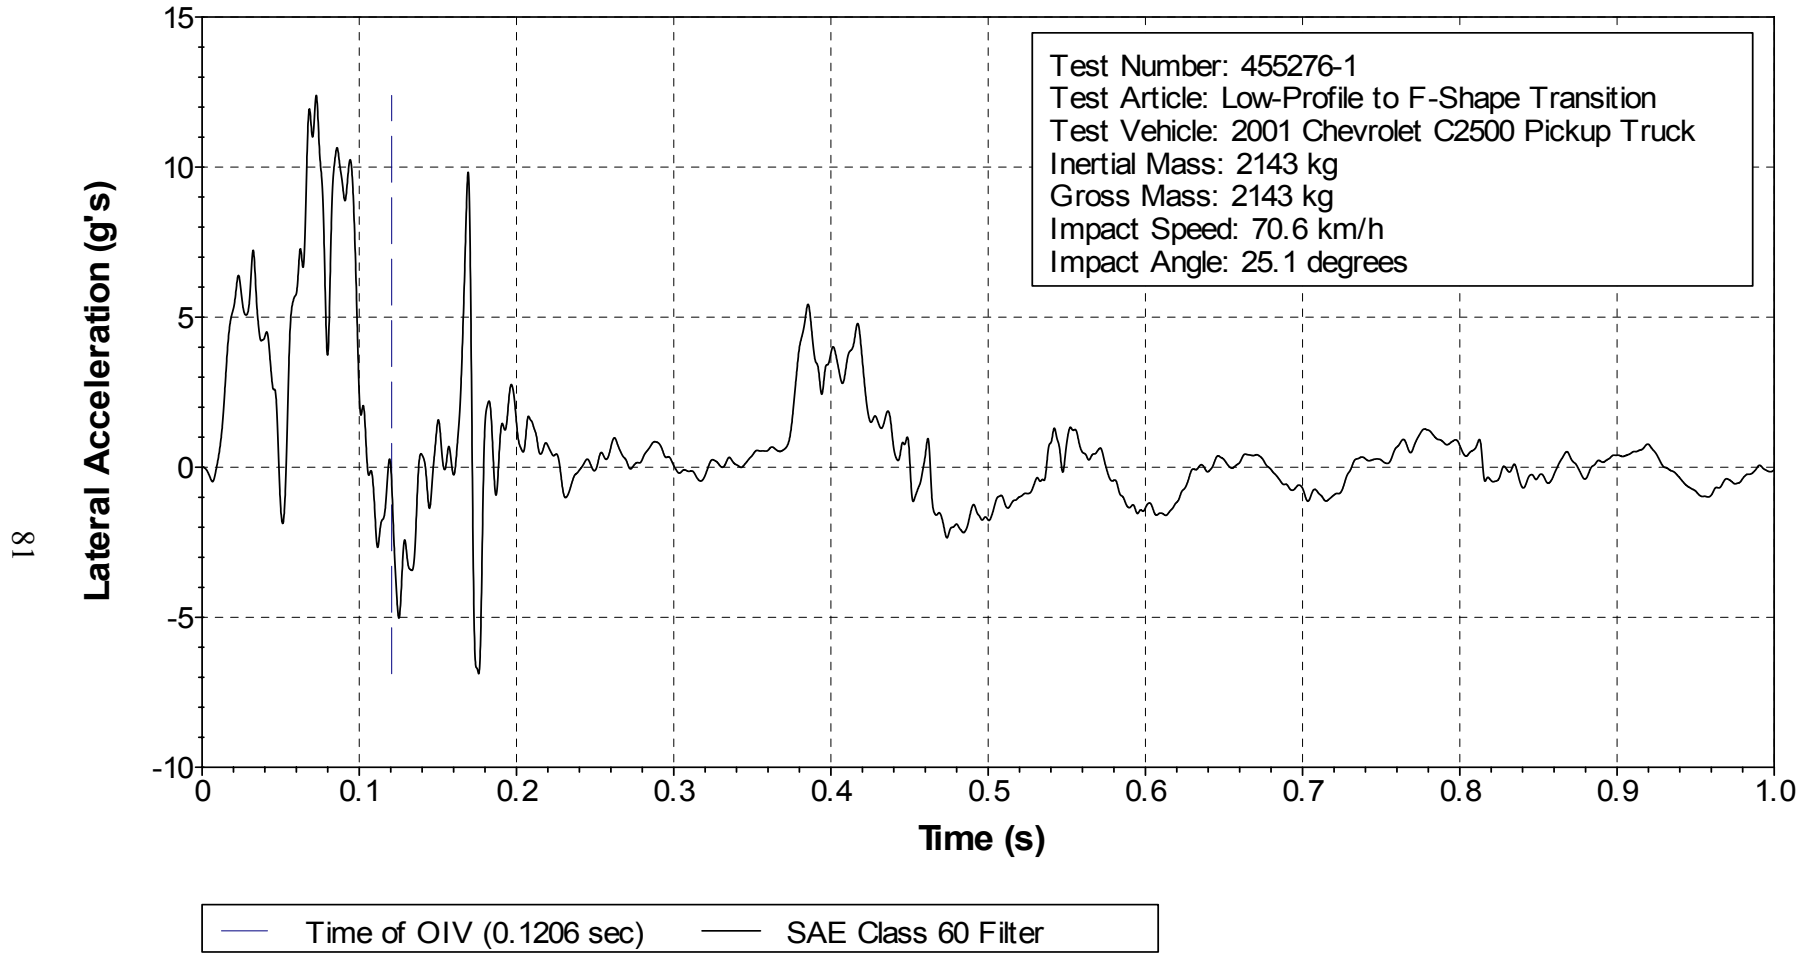
**Figure 41. Vehicle Lateral Accelerometer Trace for Test No. 455276-1 (Accelerometer Located at Center of Gravity).**

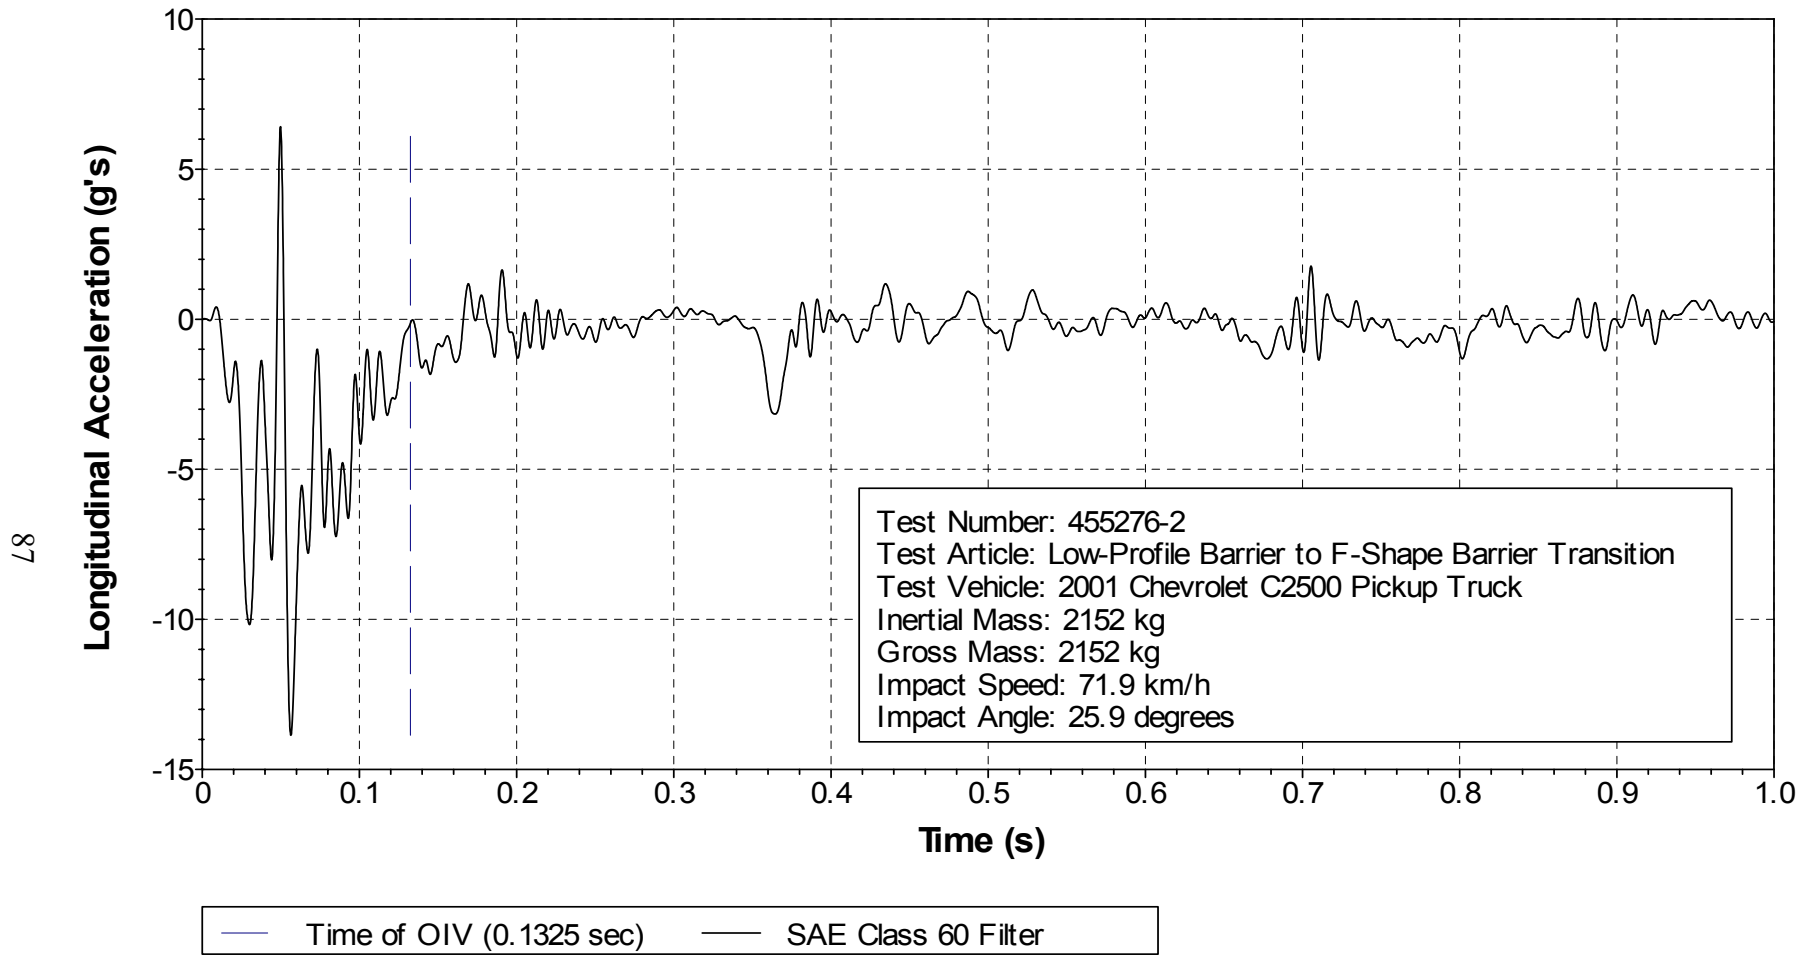
**Figure 47. Vehicle Longitudinal Accelerometer Trace for Test 455276-2  
(Accelerometer Located at Center of Gravity).**
