1. Report No. FHWA/TX-09/0-5598-2		2. Government Accession No.		3. Recipient's Catalog No.	
4. Title and Subtitle DESIGN AND PERFORMANCE EVALUATION OF VERY THIN OVERLAYS IN TEXAS				5. Report Date January 2009 Published: June 2009

# DESIGN AND PERFORMANCE EVALUATION OF VERY THIN OVERLAYS IN TEXAS

Report 0-5598-2

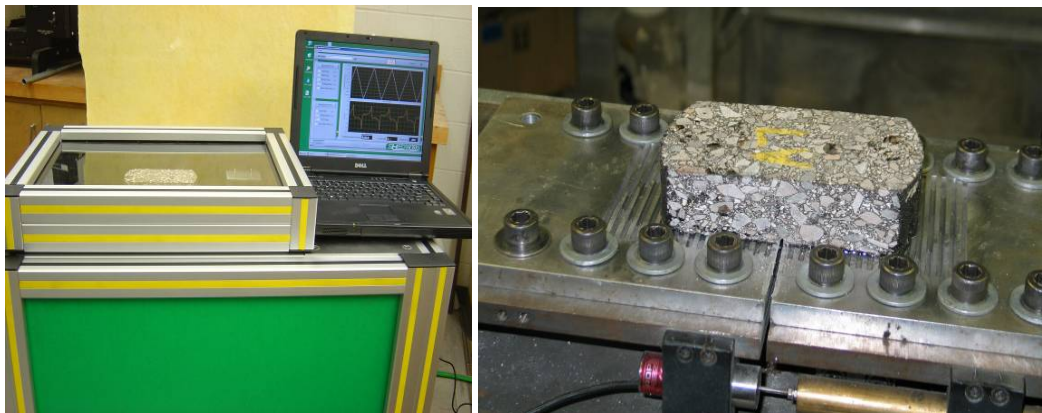
**Figure 2. Overlay Tester Equipment and Sample.**

The upgraded TTI Overlay tester shown in [Figure 2](#) is the standard test for measuring the reflection cracking potential of HMA surface layers in Texas (Tex Method 248-F). This new version of the device has been implemented within TxDOT (Cedar Park). Three TxDOT districts have been given this equipment (Atlanta, Childress, and Houston).

- Loading: cyclic triangular displacement-controlled waveform at 0.025 in (0.63 mm)
- Loading rate: 10 seconds per cycle
- Test temperature: 25 °C (77 °F)
- Tentative cracking failure criterion: 300 load cycles (for surface mixes), higher for crack attenuating layers
- Specimen size: 6-inch total length by 3-inch width by 1.5-inch

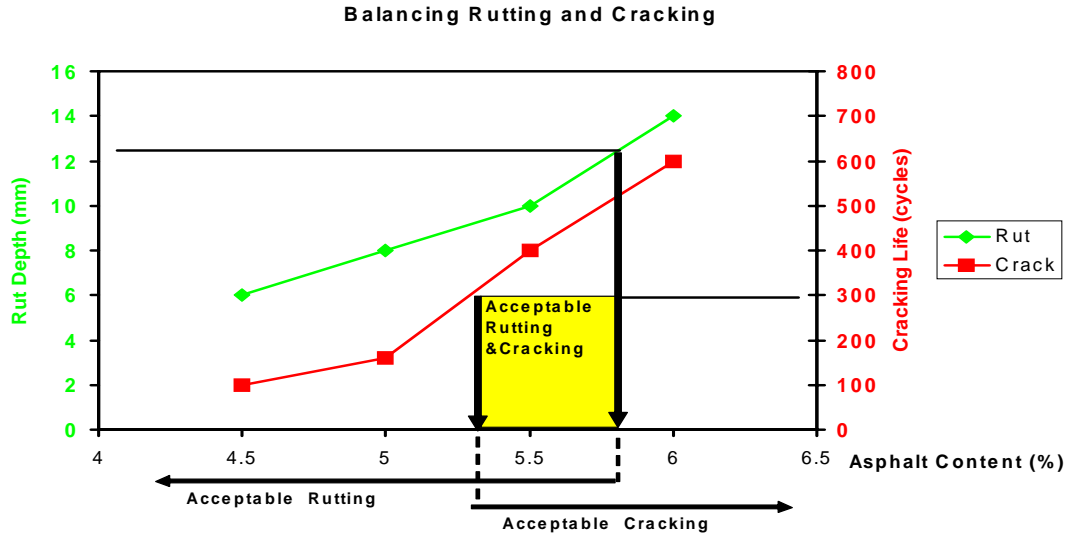
**Figure 3. Determining the Binder Content to Meet Rutting and Cracking Requirements.**

The concept of a balanced mix design is shown in Figure 3. The green line represents the Hamburg rut depth for different binder contents; rut depths below 12.5 mm (0.5 inches) are acceptable. The red line shows the performance in the overlay tester; in this case samples that last over 300 cycles to failure are judged as acceptable. This figure clearly shows the concept of a balanced design. As the percent asphalt increases the rutting resistance decreases, but the cracking resistance increases. The balanced design is the zone of asphalt contents that passes both rutting and cracking requirements. Studies at TTI (Zhou 2006) have shown that the window of acceptable asphalt contents is narrow for the lower PG grades. For PG 64-22 binders adding additional binder often get the mixes to rut excessively. The window for PG 76-22 has been found to be substantially wider as these binders are not highly rut susceptible. Zhou's studies also showed that for some combinations of aggregate and binder, it is impossible to meet both requirements.

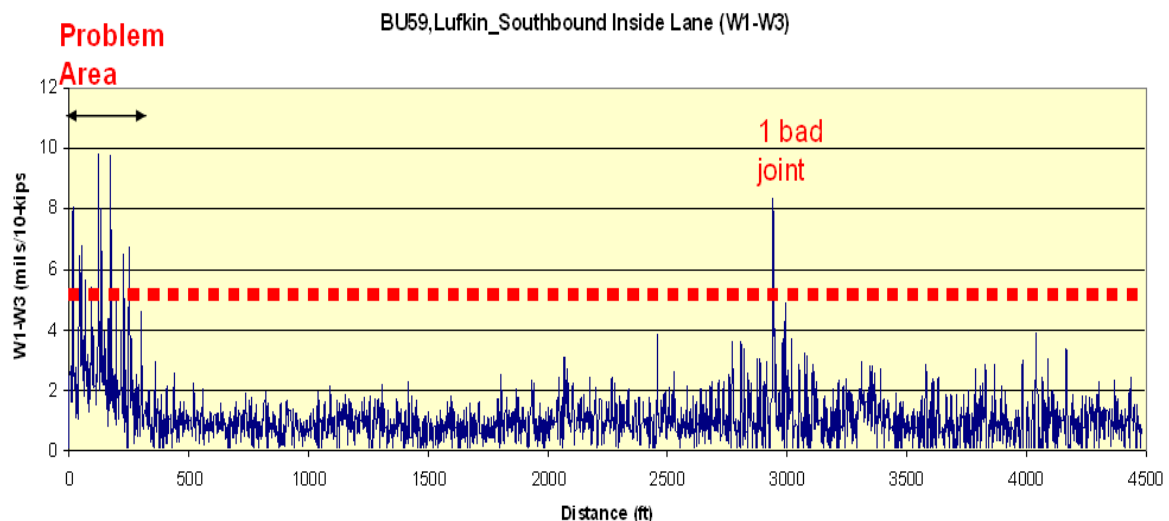
Figure 5. RDD Data (W1 – W3) for the CAM Project in Lufkin.

The mix was placed in the summer of 2007 as a 1-inch overlay to resurface an existing pavement in downtown Lufkin on business highway US 59. The existing underlying pavement structure was jointed concrete with approximately 2 to 3 inch of existing Hot Mix Asphalt (HMA). Rolling Dynamic Deflectometer (RDD) and Ground Penetrating Radar (GPR) data were collected along this project. The complete RDD for the entire project 4500 feet is shown in [Figure 5](#).

The data shown in [Figure 5](#) is the difference in deflections between two sensors under the RDD. Sensor W1 is directly between the loading wheels and W3, which is 38 inches away. As the RDD rolls over a joint or crack the value of W1-W3 is an indication of the vertical movement or load transfer efficiency (LTE). Studies have found that if this value is greater than 5 mils then there will be a potential for a reflection cracking problem with that joint ([Zhou and Scullion 2007](#)). The 5 mils level is marked with the red line in [Figure 5](#). The load transfer efficiency for this highway looks good. There is one small area at the beginning of the project about 250 feet long where the deflections are high, and there is one bad joint near 3000 feet from the beginning. The remainder of the section looks very good. This indicates that the section is a very good candidate for a thin overlay and that the design should be based on cracking caused by thermal movements of the underlying slabs. This is exactly the failure mode that is modeled in the overlay tester.

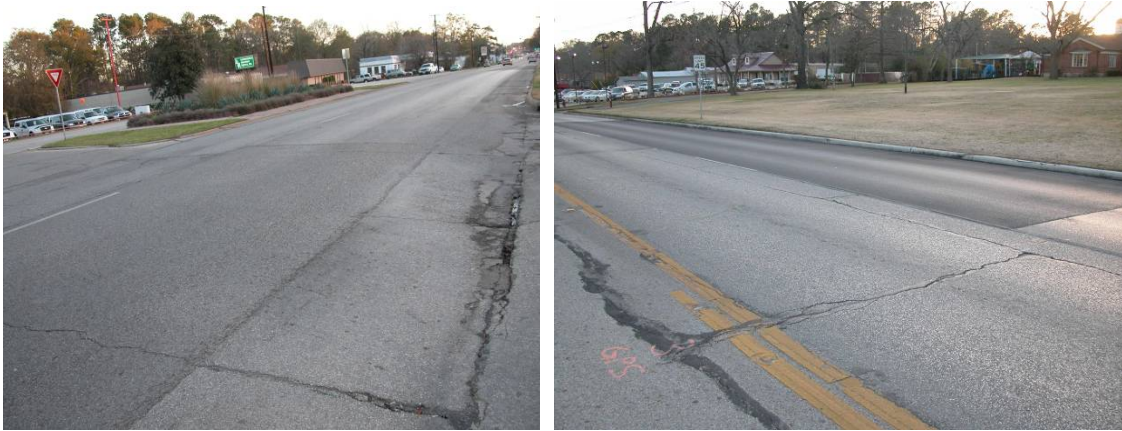
**Figure 7. Location of Poor LTE on US 59 Prior to CAM Placement.**

[Figure 7](#) shows the problem area. At this location it was proposed that the contractor perform joint repair before the placement of the CAM mix. The areas requiring repair were identified before the project was let and incorporated into the plan sheets for this project.

As shown in the photo on the right in [Figure 7](#), this section of US 59 is continually receiving maintenance patches. This work was underway in a preliminary visit to the project, and samples of the widely used maintenance mix were obtained for testing at TTI. The existing limestone maintenance mix and the proposed CAM mix are shown side by side in [Figure 8](#), prior to overlay testing.

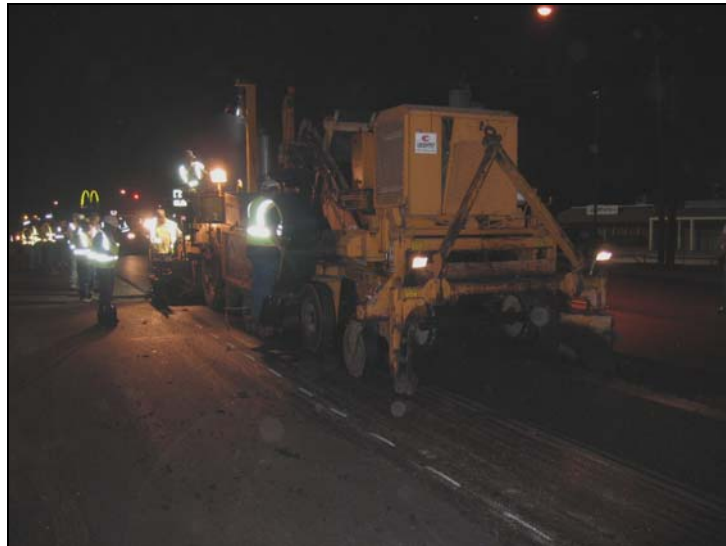
**Figure 9. CAM Paving Operation on Business 59.**

The contractor used belly-dump trucks to place the mix in windrows. A Lincoln 660 windrow elevator and a Blaw Knox PF-3200 paving machine then placed the CAM. [Figure 9](#) shows the paving operation. [Figure 10](#) shows the contractor's primary compaction roller was a CAT CB-634D. The contractor used an Ingersoll Rand DD130 for the finish roller.

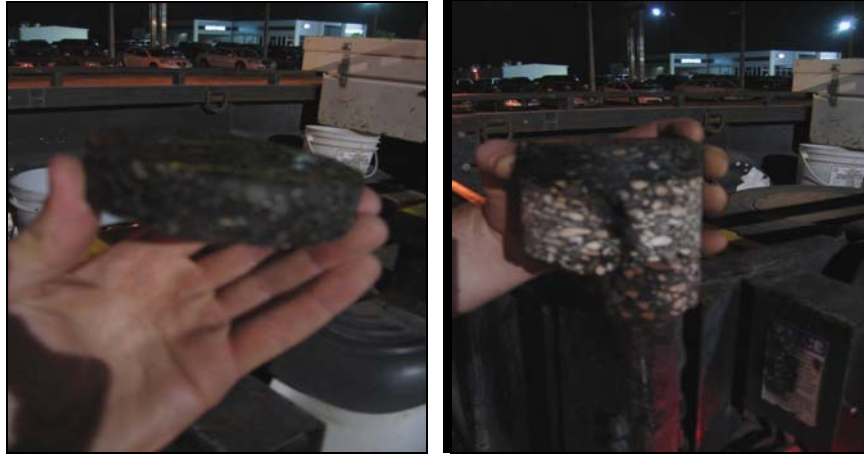
**Figure 16. CAM Cores 1 and 2 (L to R).**

During TTI's visit the contractor obtained density results for two cores. These core densities were 93.6 and 91.8 percent. [Figure 16](#) shows the cores.

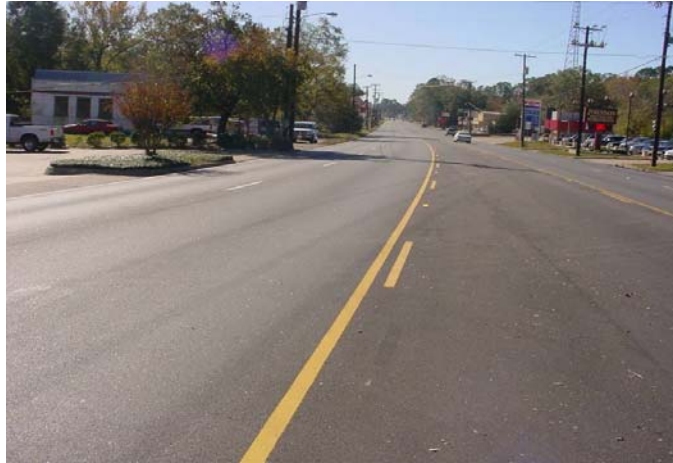
**Figure 17. CAM Mix on US 59 Three Months after Placement.**

After three months in service, a visual inspection and skid data were collected on this project. A photo of the CAM mix is shown in [Figure 17](#).

No performance problems were reported, and no reflection cracks were found. This inspection will be repeated in the spring of 2009. TxDOT also performed skid testing on this section, and the results are shown in [Figure 18](#). This is with a bald tire locked wheel trailer traveling at 40 mph. The average value is reasonable at 23.5, but this section does have some low values with three values below 20. There are no standards for acceptable skid numbers, but values for new pavements are normally above 20. The cause for these low numbers is not known at this time. These measurements will be repeated on a semi-annual basis. The CAM mix has a high asphalt content, and the surface rocks are coated in asphalt. With trafficking perhaps the surface aggregates will become exposed and the skid numbers increase.

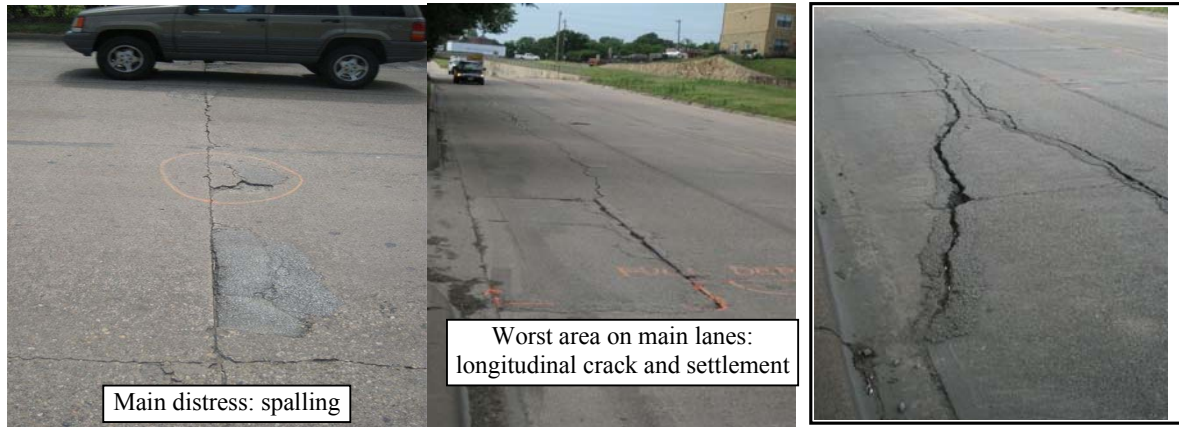
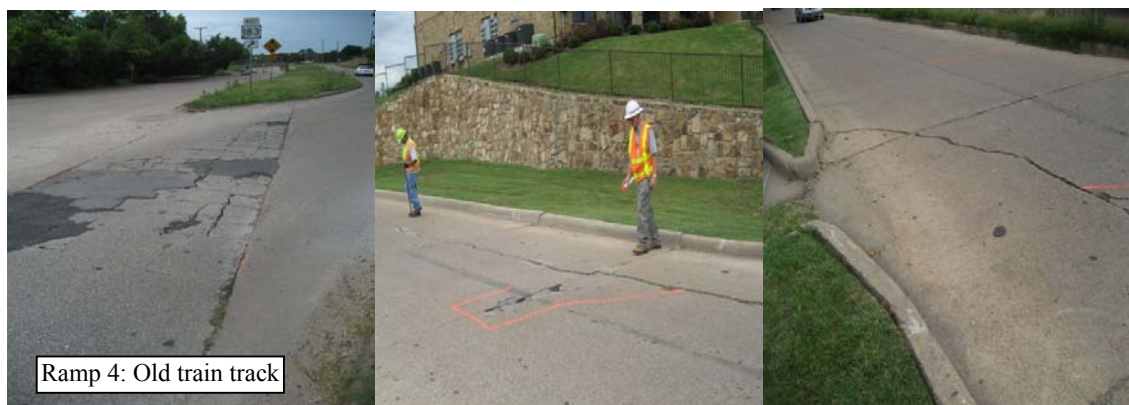
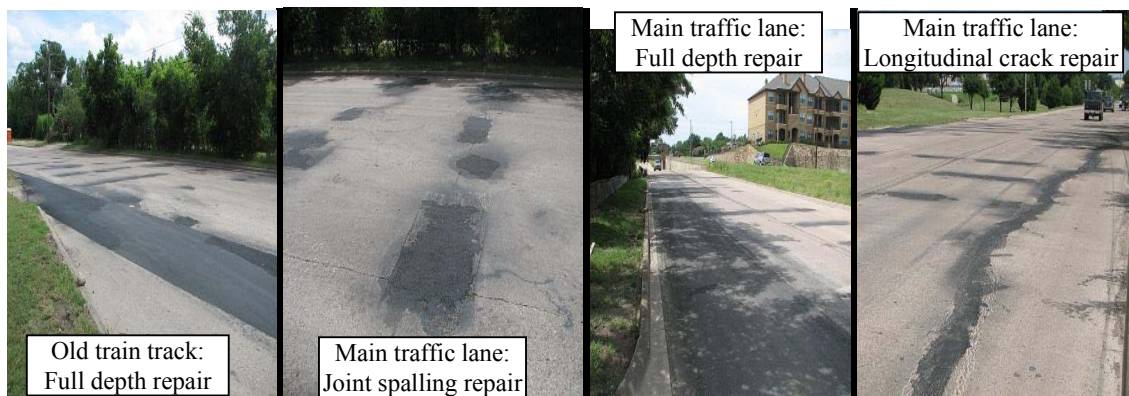
Both Richard Williammee, P.E., Fort Worth District Materials Engineer and the TTI researchers evaluated the existing PCC pavement conditions on June 14, 2007, and made recommendations on the areas that needed to be repaired before placement of the thin HMA overlay. The main distress observed was spalling at the joints. The overall conditions of the main traffic lanes were acceptable except in two large areas with longitudinal cracks, settlements, and block cracking. [Figure 21](#) shows examples of the existing conditions of the main traffic lanes before the HMA overlay. The general conditions of the PCC pavement on the ramps were substantially worse than those of the main traffic lanes as shown in [Figure 22](#). [Figure 23](#) presents some areas after repairs were made.

**Figure 21. Observed Distresses on the Main Traffic Lanes, Pumphrey Drive, FTW.**

**Figure 22. Observed Distresses on the Ramps, Pumphrey Drive, FTW.**

**Figure 23. Repairs of Existing Distresses Before the HMA Overlay.**

The load transfer efficiency of the joints in the main lanes was judged as good. Limited measurements were made with the FWD and all joints were in the 90 to 100% LTE range. None of the main lane joints exhibited any faulting and the main distress was spalling around the joint. The joints on the exit and entrance ramps were in poorer condition; the ramps themselves were badly cracked, and several of the joints were faulted.

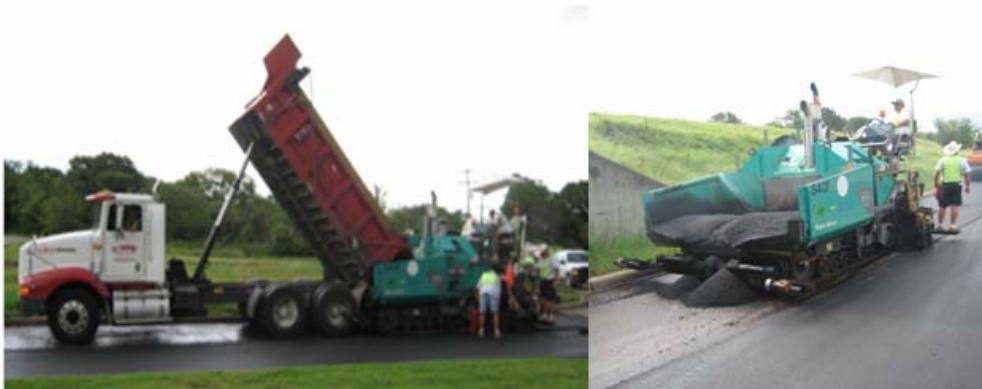
**Figure 24. Paver Operation on the Pumphrey Drive, FTW.**

The pavement surface temperature was about 106 °F, which meets the CAM SS 3109 recommendations ([TxDOT, 2007](#)). According to the Tarrant County construction crew, the air temperature should at least be 42 °F and rising for lay-down operations such as the Pumphrey Drive project. The air temperature was about 78 °F at the start of the construction operation which satisfied the  $\geq 42$  °F recommendation. No material transfer device was engaged in this lay-down operation. The trucks dumped the hot mix directly into the paver. This operation is shown in [Figure 24](#).

It is worth noting that two overlay mat thicknesses were used in this overlay project due to different traffic levels. The HMA overlay was 1.5-inch thick starting from the Naval Air Base entrance to the middle of the overlay project where the traffic volume is much higher than the rest of the project in which only 1-inch thick mat was used.

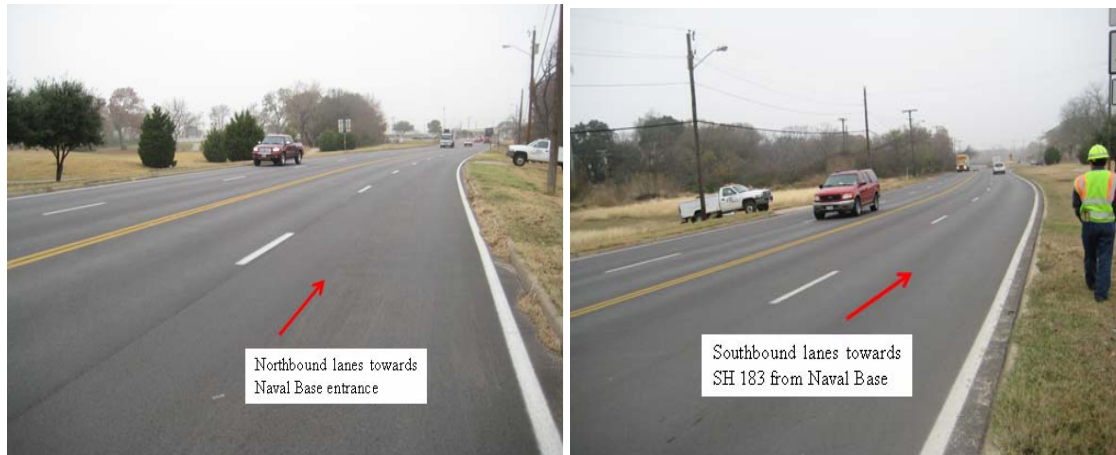
**Figure 25. Overview on the Main Lanes between SH 183 and the Naval Base Entrance.**

The visual inspection that was conducted on the overlay is presented in this section. This includes photos of the main lanes, on/off ramps, and the surface distresses observed. [Figure 25](#) gives an overview of the main lanes and indicates satisfactory performance.

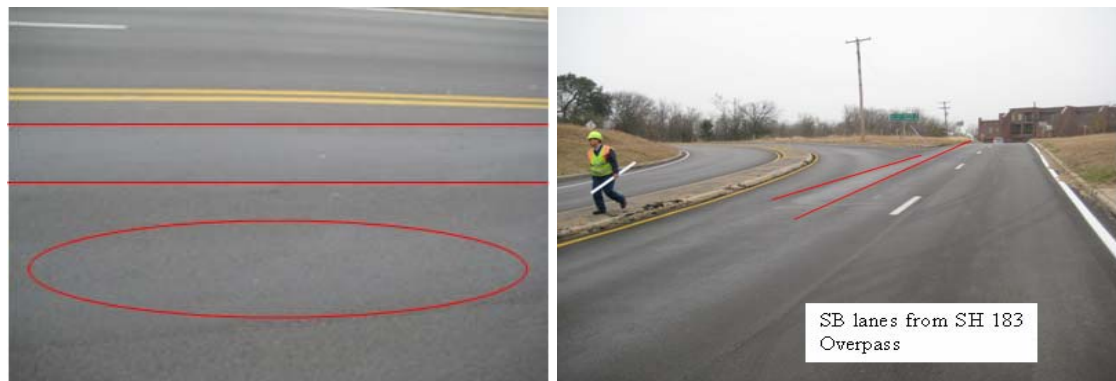
**Figure 26. Potential Spots for Flushing/Bleeding (Mostly on the Latex Surface).**

There were some indicative spots of minor bleeding/flushing in the wheel path, in particular on the latex surface. This observation is consistent with the higher than design asphalt-binder content used in the latex mix, i.e., the contractor applied more asphalt-binder than the design recommendations. The extracted asphalt-binder content was found to be 7.2% as opposed to the design value of 6.8%. [Figure 26](#) shows some spots of potential for wheel path bleeding. None of these were considered serious defects.

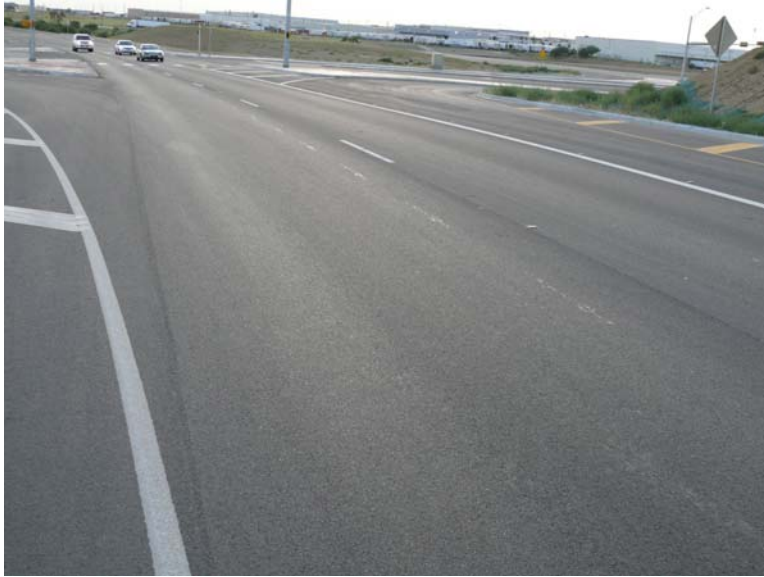
**Figure 32. CAM Mix on Loop 20 in Laredo – Six Months after Placement.**

This design used the recommended design procedure from SS 3109. The only problem found with the mix was that it did not meet the Overlay Tester requirement of 750 cycles (lasted 678). In this case the district decided to waiver the 750 requirement. The mix was placed after the traffic light in both the EB and WB directions for a distance of approximately 1200 feet. The district reported that most of the application was placed at a thickness of 0.75 inches. No problems were reported during construction. A photo of the location six months after construction is shown in [Figure 32](#). On the other side of the intersection the district used the traditional Type C mix, and in the initial visual evaluation the CAM mix was thought to look more uniform than the dense graded material.

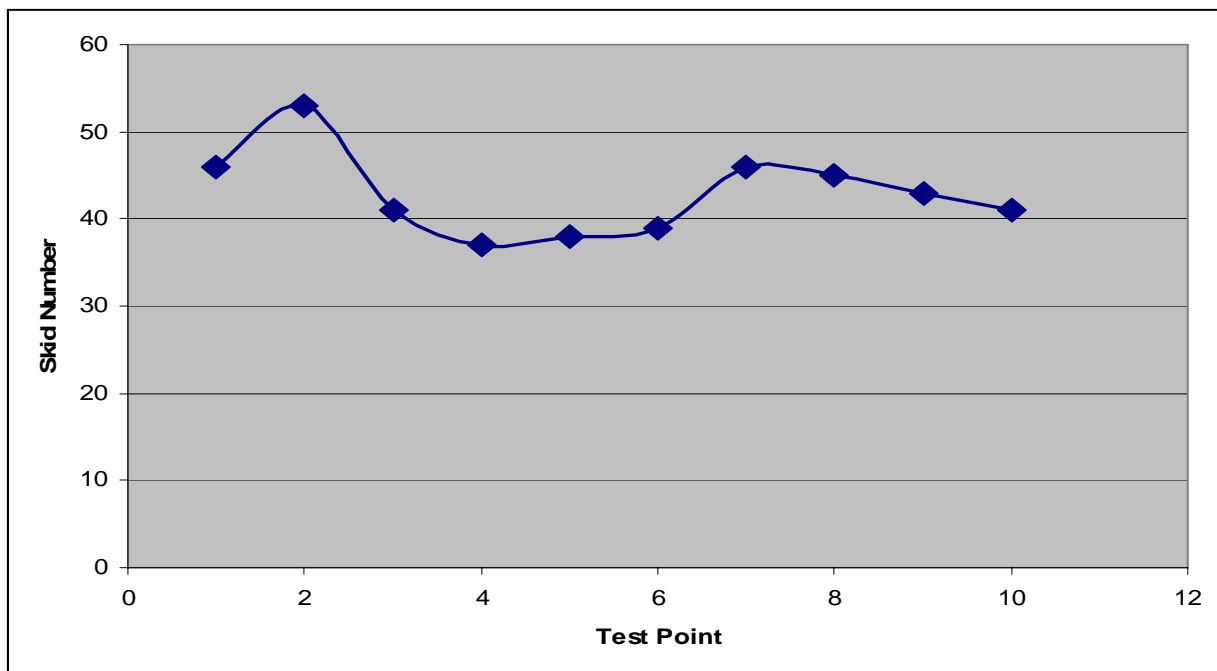
**Figure 33. Skid Numbers from Loop 20 in Laredo.**

Locked wheel skid measurements were made on lanes of the CAM mix. [Figure 33](#) graphs the results. The skid numbers for this gravel mix are outstanding with an average value of 42.9.

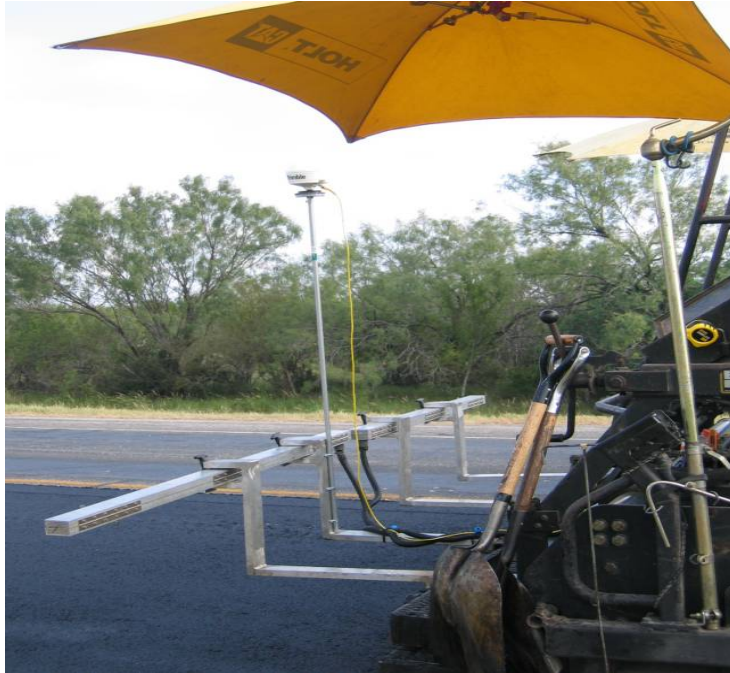
Figure 38. Infra-Red Monitoring of CAM Placement on US 90.

The lab design and test on both trial batch and field materials found this to be a good CAM design. This material was placed on US 90 in September 2008 and problems were encountered during construction of this thin mat. Because of scheduling issues TTI could only monitor the last day of placement of this mat. The infra-red bar was placed on the paver as shown in [Figure 38](#), and typical temperature data are shown in [Figure 39](#).

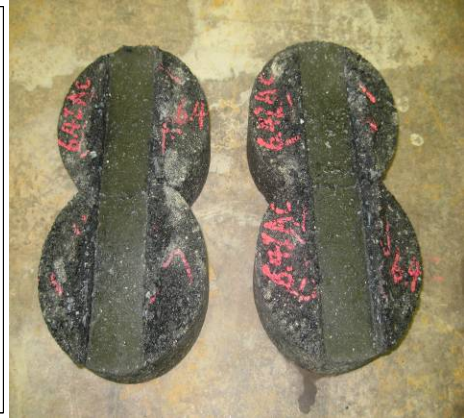
**Figure 47. Hamburg Test Results.**

The simplified version of balanced mix design approach was employed. The three trial asphalt contents used are 6.4, 6.8, and 7.2 percent. The results are presented in Table 6, and especially, the Hamburg test results are shown in Figure 47. The acceptable asphalt content meeting both Hamburg-rutting and Overlay-cracking requirement ranges from 6.4 to 7.1 percent. Beyond 7.1 percent asphalt binder, the mix will have rutting problem. Based on this approach the optimal asphalt content for this mix would be 6.8% (as opposed to the 7.6% obtained from the SS 3109 specification).

Trial Asphalt Content	Hamburg Test		Overlay Test	
	Rutting Depth (mm)	Pass/Fail	No. of Cycles	Pass
6.4%	5.2@15,000	Pass >750	Pass	
6.8%	6.4@15,000	Pass >750	Pass	
7.2%	12.7@15,000	Fail	>750	Pass

Additionally, TTI researchers also tried the SS3109 approach with 50 gyrations and 98 density. [Figure 48](#) presents the volumetric results. Apparently, the OAC with the 50 gyrations and 98 density is beyond 7.5 percent. As shown in [Table 6](#) and [Figure 47](#), the CAM mix will fail the Hamburg-rutting requirement when the asphalt content is more than 7.2 percent. This further demonstrates the limitation of current SS3109 volumetric approach.

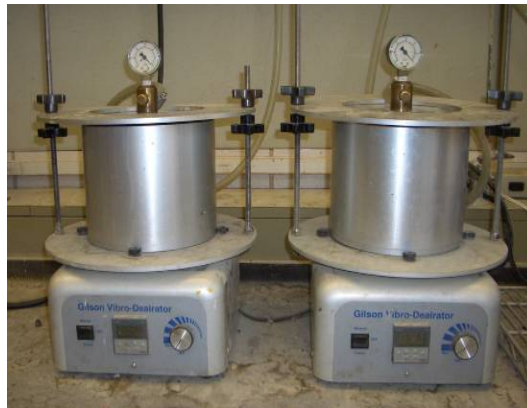
**Figure 50. RICE Testing using Metal Vacuum Pycnometer.**

Before molding tested samples, for each trial asphalt content, determine the RICE maximum theoretical density. The standard methods for determining the Rice should be used including using the Metal Vacuum Pycnometer shown in [Figure 50](#).

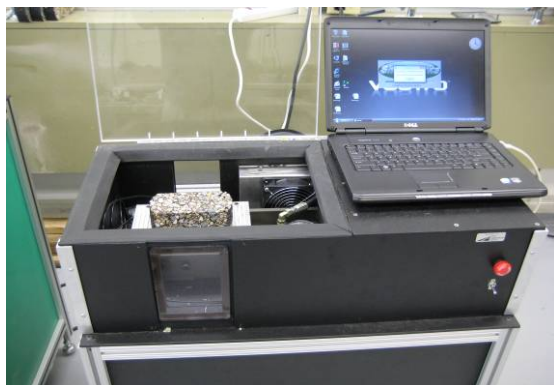
**Figure 52. Overlay Testing and Hamburg Testing.**

In accordance with Tex-248-F, run the Overlay test and in accordance with Tex-242-F, run the Hamburg test; see [Figure 52 \(a\)](#) and [\(b\)](#), respectively. Record the test results.

(a) Overlay Testing
