1. Report No. FHWA/TX-09/0-5609-1		2. Government Accession No.		3. Recipient's Catalog No.	
4. Title and Subtitle PERFORMANCE EVALUATION OF CABLE MEDIAN BARRIER SYSTEMS IN TEXAS				5. Report Date August 2008 Published: August 2009

**PERFORMANCE EVALUATION OF
CABLE MEDIAN BARRIER SYSTEMS IN TEXAS**

Report 0-5609-1
Project 0-5609

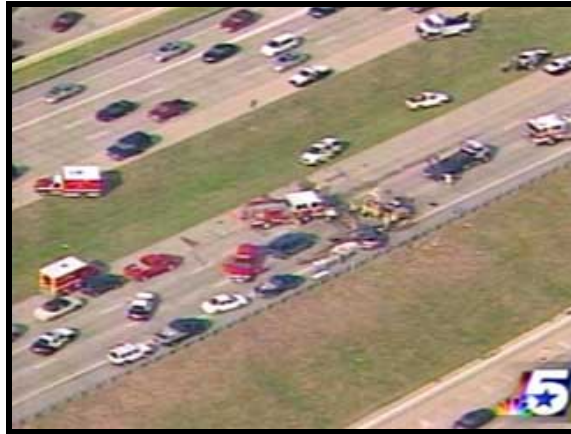
When they occur, cross-median crashes (CMCs) are typically very violent in nature and have a high probability of multiple serious injuries and deaths (Figure 1-1). Research shows that CMCs are responsible for a disproportionately high rate of fatalities in Texas and other states. Many of these severe CMCs can be prevented with adequate barrier protection. However, barriers should not be used indiscriminately as they too constitute a hazard to motorists. A barrier is typically warranted when the consequences of encroaching into or across the median are judged to be more severe than striking the barrier.

Figure 1-1. Aerial Photograph of Cross-Median Crash Scene.

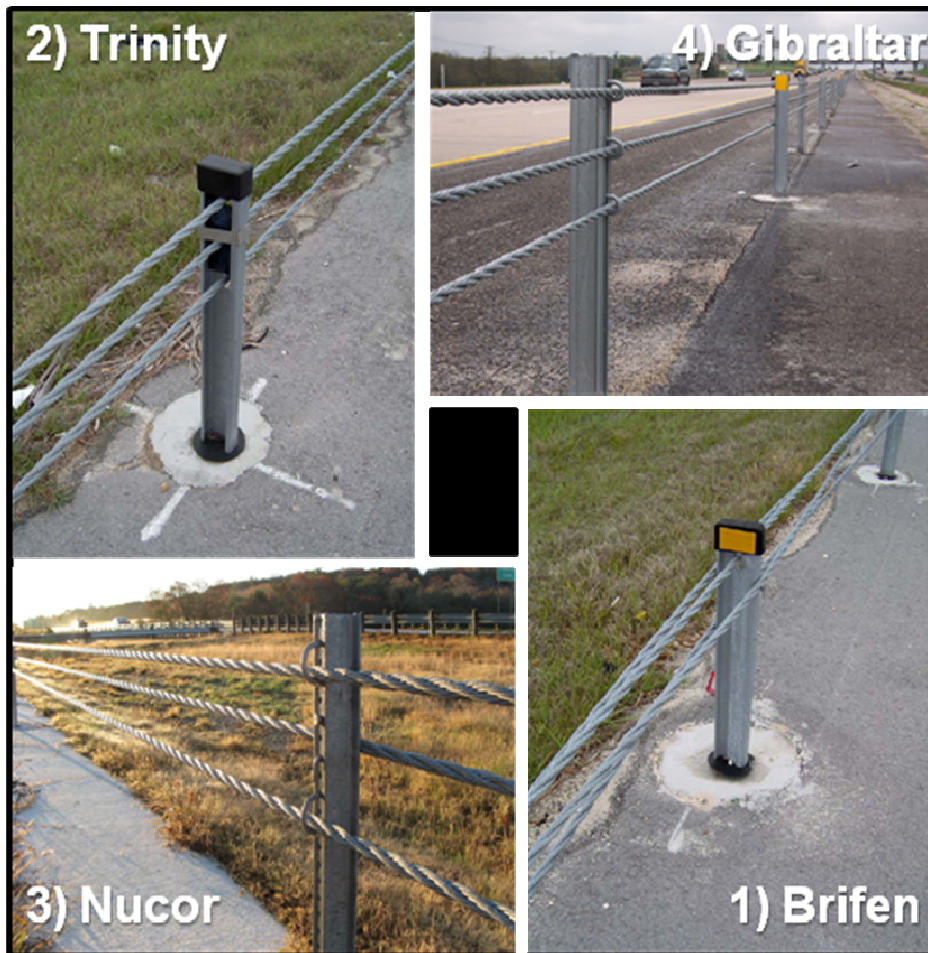
Figure 1-3. TxDOT Approved Cable Barriers (3).

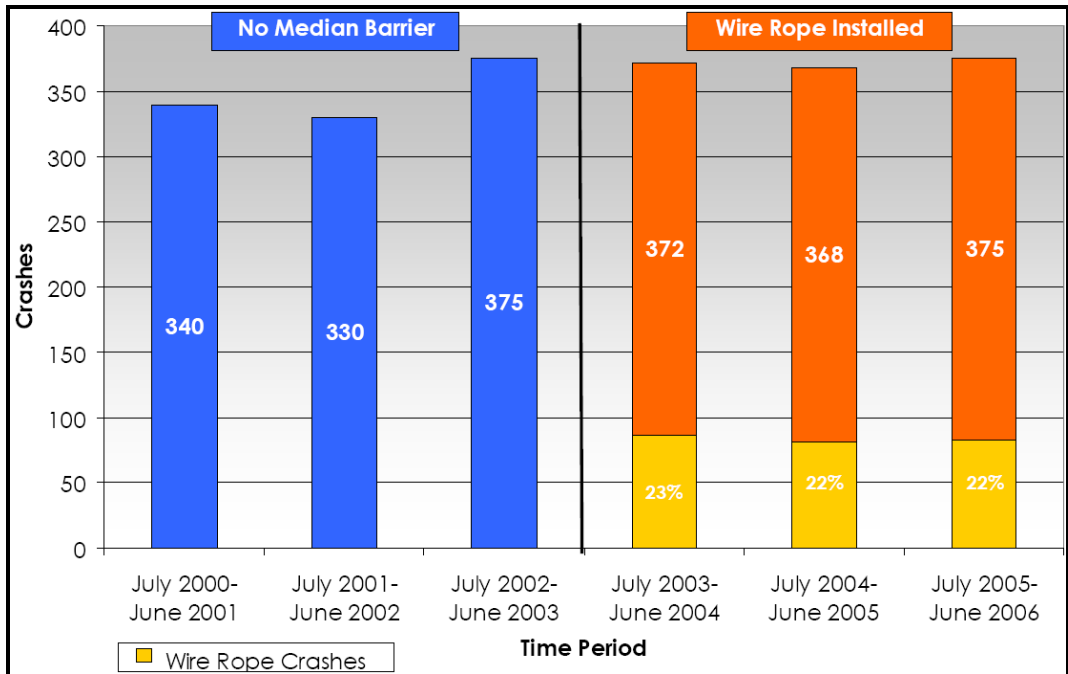
Figure 3-2. Comparison of Total Crashes before and after Installation of WRSF in Ohio.

Figure 3-2 shows a comparison of total crashes before and after installation of WRSF in Ohio. This figure shows that total crashes increased by approximately 7 percent after the barrier installation.

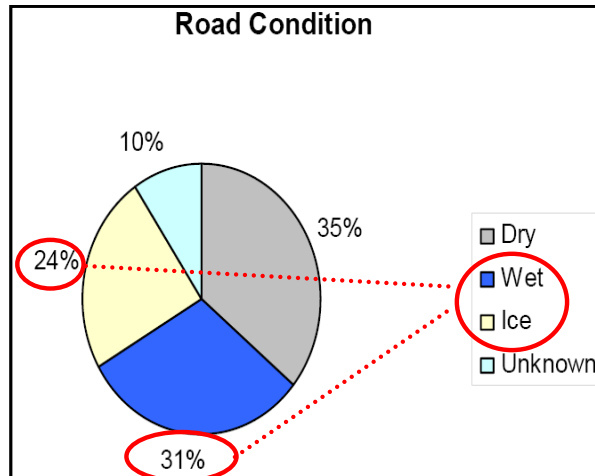
Figure 4-3. Effect of Road Surface Condition on Cable Barrier Impacts in Weatherford.

Previous ISPE analysis of cable barriers has revealed that impacts are much more likely to occur when roadway conditions are wet from rain, ice, or snow. This finding makes sense because vehicles are more likely to lose control and hydroplane into the median when the roadway surface is wet. It also seems logical to make the connection that maintenance and repair activities will likely increase during the seasons of the year where these road conditions are more prevalent. Data from the Weatherford maintenance section supports this assertion, finding that over half (55 percent) of impacts occur when the roadway is wet or icy (Figure 4-3). Again, the Texas data are similar to findings in Ohio where 60 percent of cable barrier impacts on I-75 during a three-year period occurred when the roadway was slick (Figure 4-4) (3).

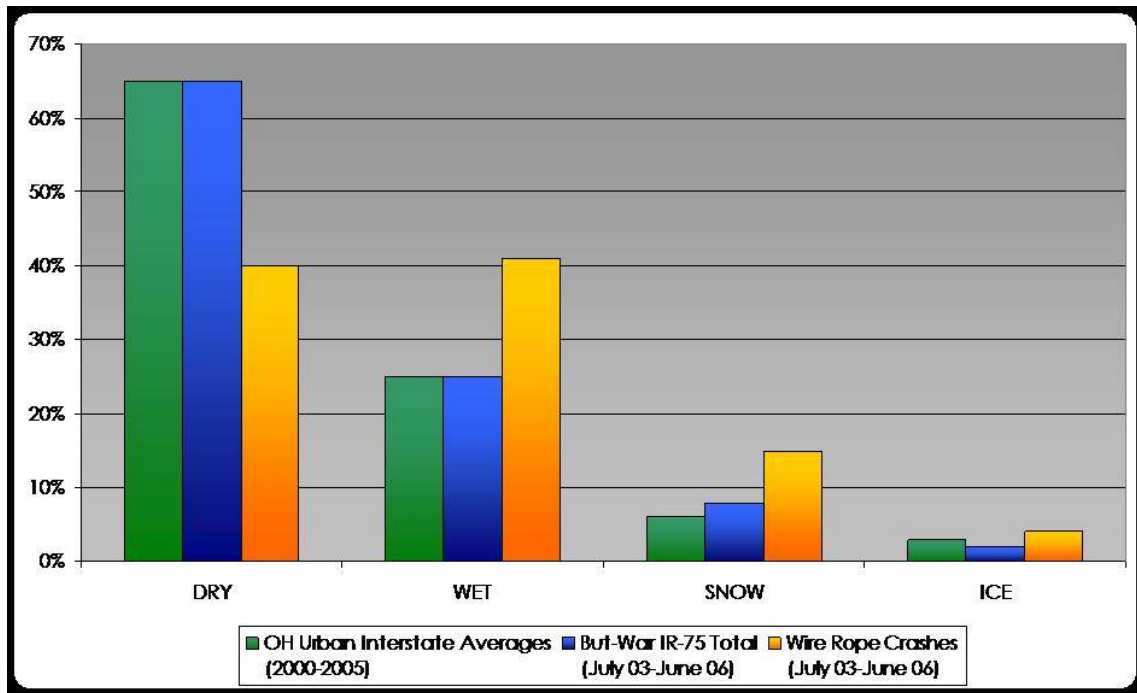
Figure 4-4. Effect of Road Surface Condition on Cable Barrier Impacts in Ohio.

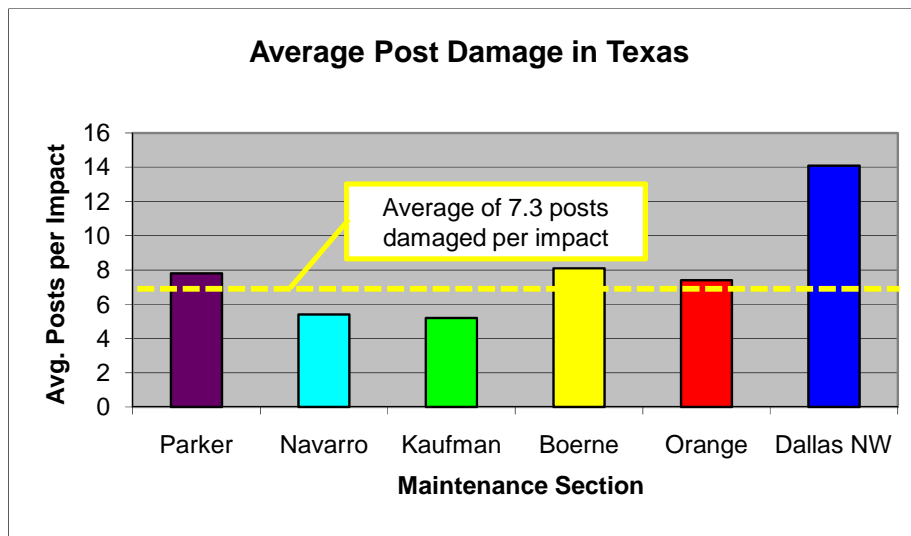
Figure 4-5. Average Post Damage from Cable Barrier Impacts in Texas.

The number of posts that need to be replaced in a cable barrier impact is a good indicator of damage level and correlates strongly to the amount of repair time that will be necessary. Several states have collected data on the average number of damaged posts per impact, with Ohio reporting an average of 5.7 and Washington an average of 6.5. The research team analyzed the maintenance and impact data from the six maintenance sections and found that an average of 7.3 posts are damaged, with a low average of 5.2 in a rural location and a high average of 14.1 in an urban location (Figure 4-5). The maintenance data showed that the highest number of damaged posts for a single impact was 77 on IH 10 in the San Antonio District.

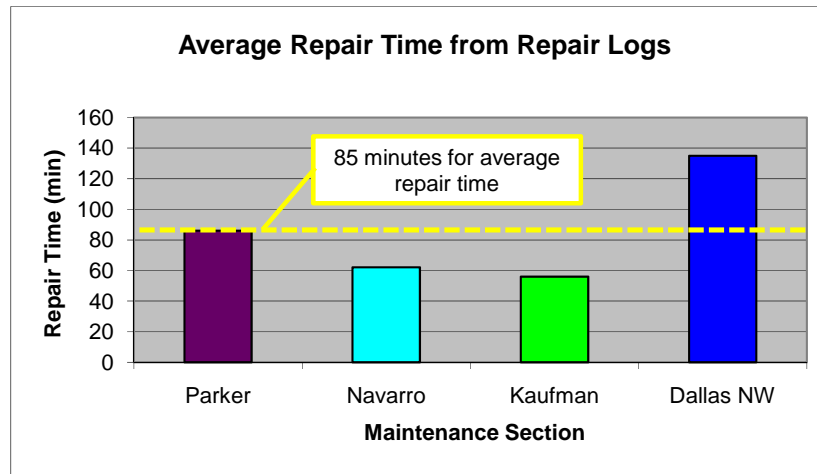
Figure 4-6. Average Repair Time from Maintenance Repair Logs.

The 32 responses from the cable barrier survey estimated that 100 minutes were spent on site for an average level of repair. Similarly, the data from repair logs in the Dallas Northwest, Kaufman County, Navarro County, and Parker County maintenance sections showed that 85 minutes were spent on site for an average repair (Figure 4-6).

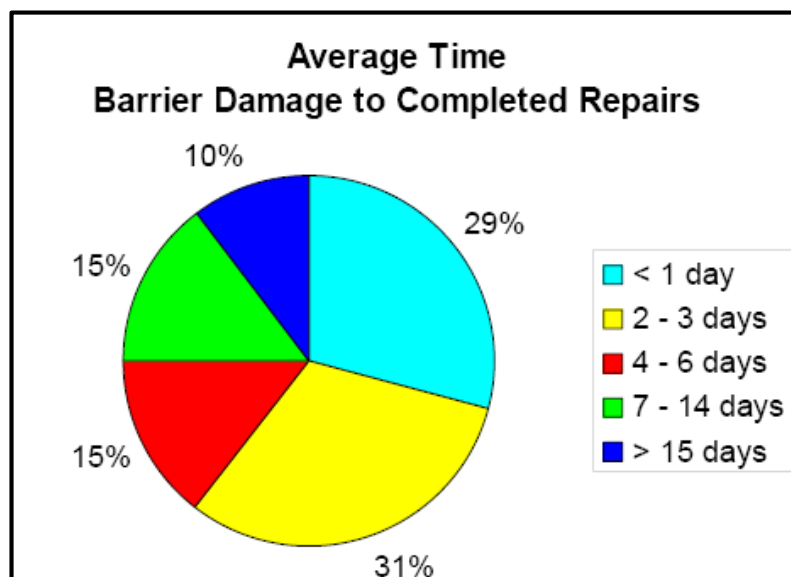
Figure 4-7. Average Time from Barrier Damage to Completed Repair in Kaufman, Texas.

Several states have also evaluated the amount of time that elapsed between when the cable barrier system was damaged and when repairs were completed. These evaluations showed that the elapsed time ranged from 4–6 days in Ohio and 2–14 days in Washington. One TxDOT maintenance section provided sufficient data to assess the amount of time that elapsed between when the cable barrier system was damaged and when the repairs were completed (Figure 4-7). This data showed that the average elapsed time was approximately 5 days, with a high value of 26 days. Further analysis by researchers indicated that 60 percent of the repairs were completed in less than a 3-day timeframe.

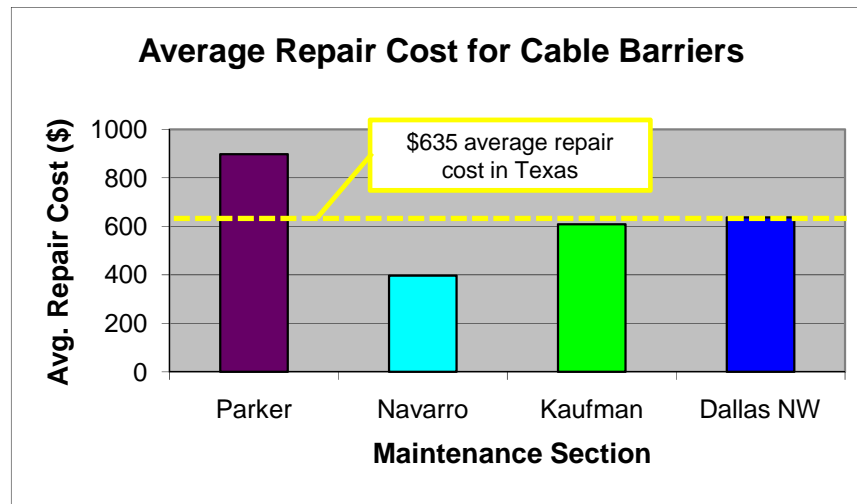
Figure 4-9. Average Repair Cost for Cable Barriers per Impact.

Limited funding and resources for maintenance activities make it important to adequately gauge the costs of repairs for cable barrier systems. Data from several TxDOT maintenance sections revealed that average costs ranged from \$400 to \$900 dollars per repair, including labor, equipment, and materials (Figure 4-9). The average repair cost for cable barriers for each impact based on Texas data was \$635. National data fall into this range and are close to the Texas average, with Ohio reporting an average repair cost of \$631 and Washington reporting \$800 (5).

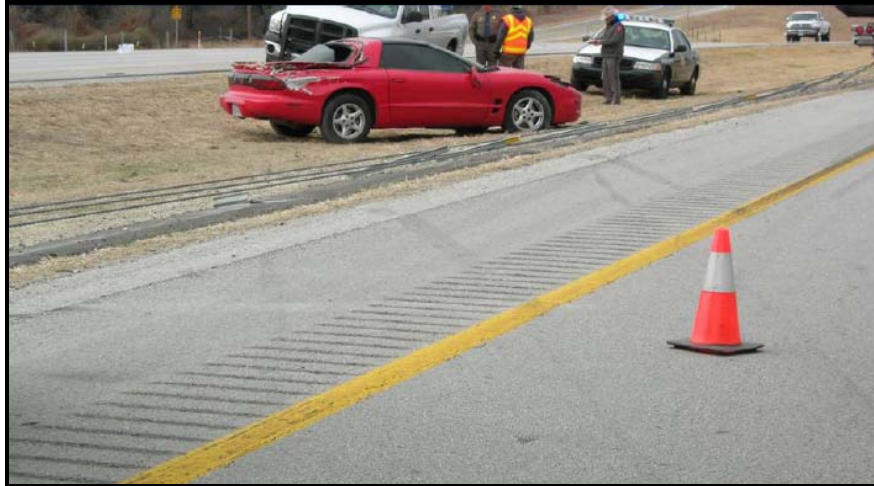
Figure 4-11. Example of a Passenger Car Cable Barrier Penetration Event.

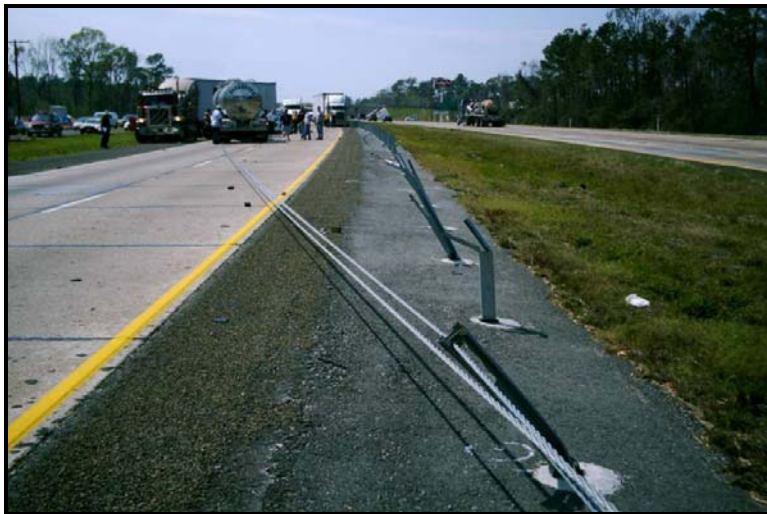
Figure 4-12. Example of a Semi-Tractor Trailer Cable Barrier Penetration Event.

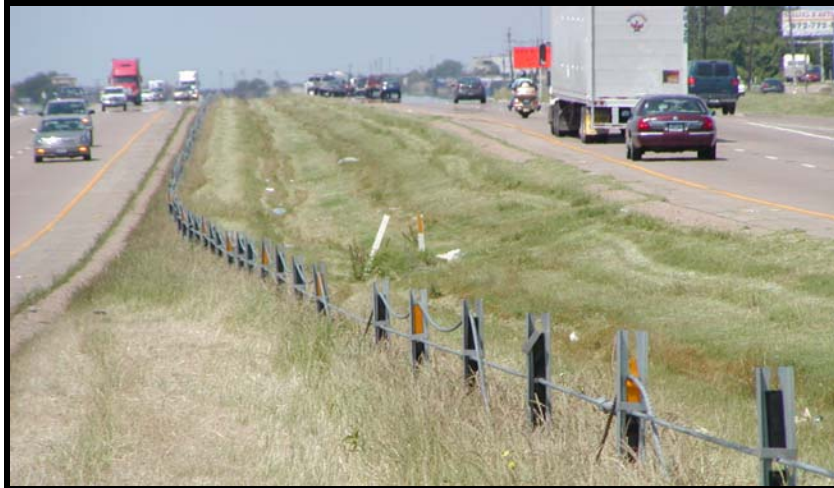
Figure 4-13. IH 30 in Rockwall – Top Cable Is Not Tensioned.

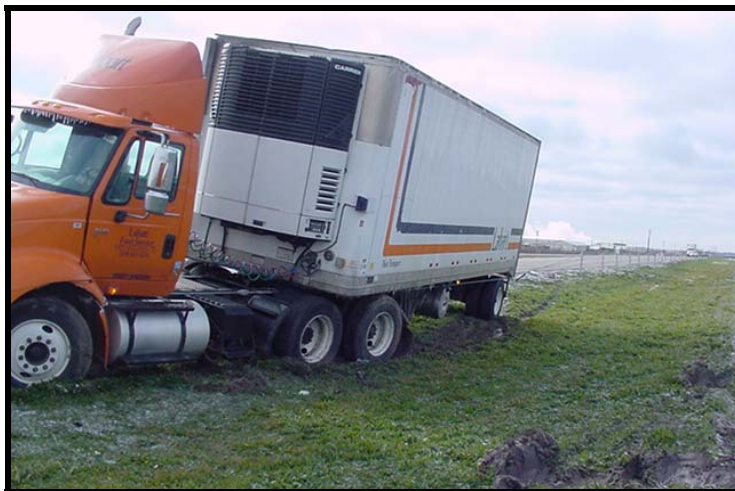
Figure 4-14. IH 20 in Kaufman – Restraint of Semi-Tractor Trailer during Ice Storm.

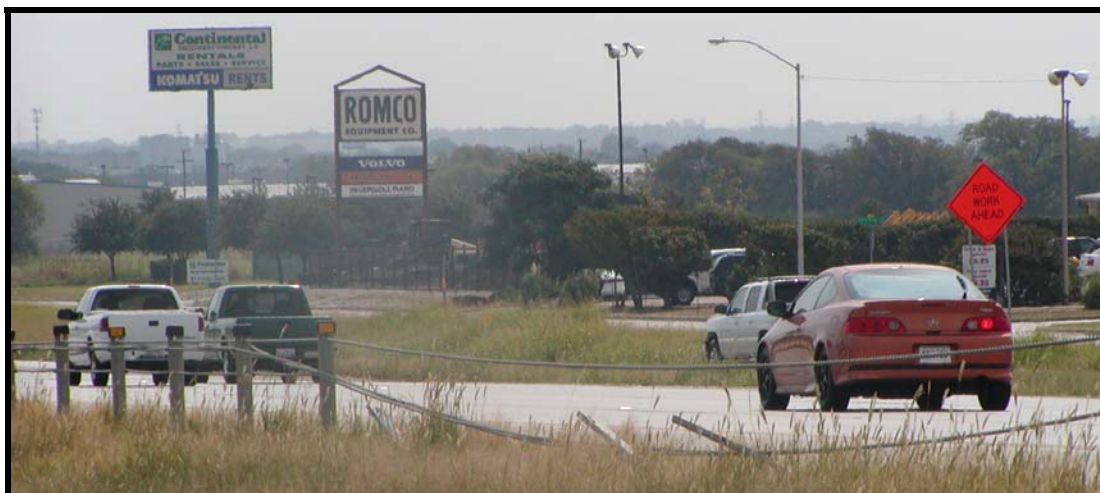
Figure 4-15. IH 820 Northwest Loop in Fort Worth – Damage Is Not Repaired.

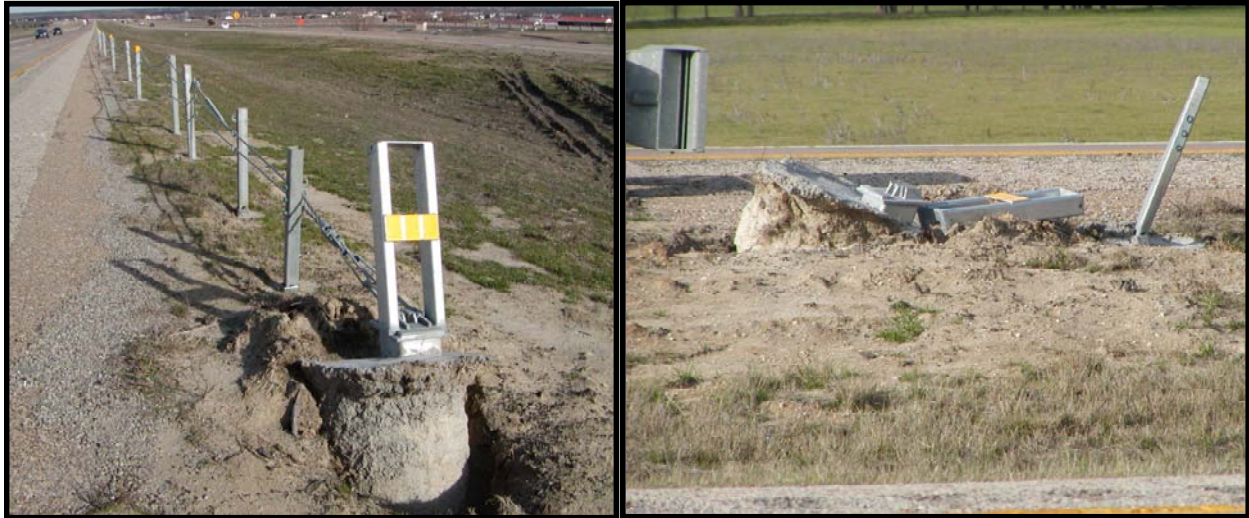
Figure 4-21. Anchor Failure on IH 20 Cable Barrier System in Kaufman County.

Currently, the TxDOT Design Division memorandum on cable barrier systems does not provide any guidance on soil considerations for barrier performance (11). In the foundation design chapter of the TxDOT Geotechnical Manual, it recommends that an engineer should “*study all the available soil data, and choose the type of foundation most suitable to the existing soil conditions and the particular structure*” (12). Currently, study of soil data is not done in the case of cable barrier installation in Texas because TxDOT does not require it; therefore, it allows manufacturers to use their standard designs.

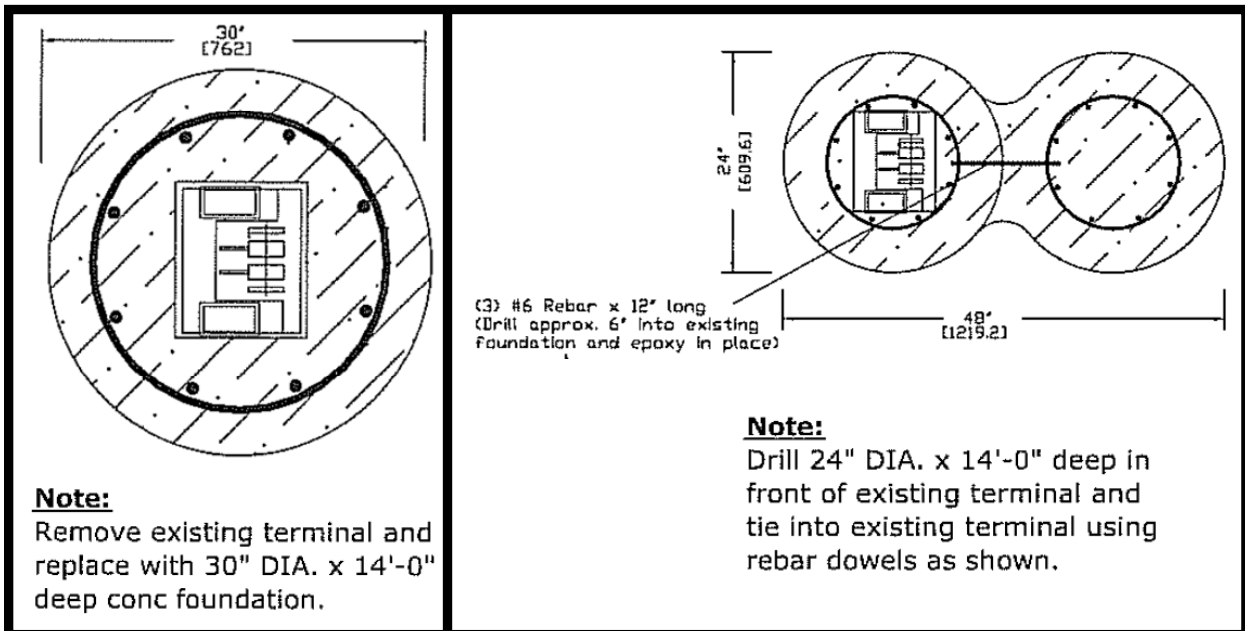
Figure 4-22. Kaufman County Anchor Repair (Option 1 Left Panel, Option 2 Right Panel).

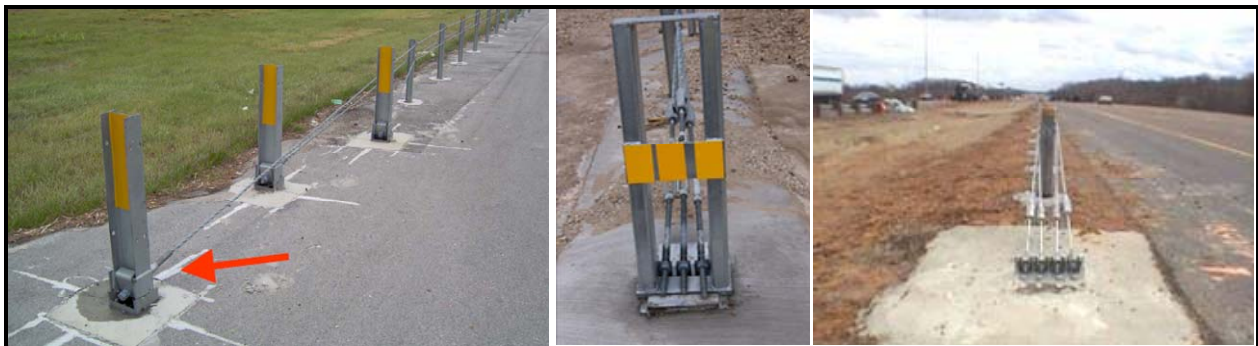
**Figure 5-1. Cable Anchor Terminals
(Left: Trinity/Nucor; Center: Gibraltar; and Right: Brifen).**

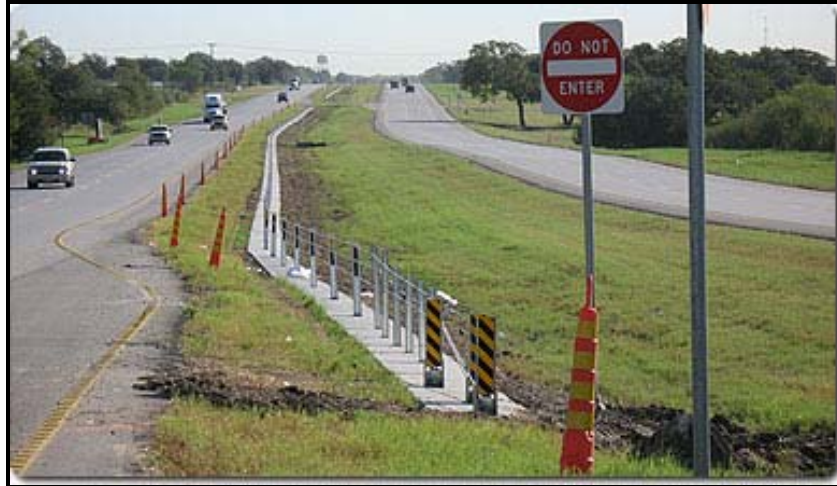
Figure 5-2. Cable Barrier System on State Highway 71 near Bastrop.

- Mow strips, particularly the concrete ones, are approximately equivalent in average cost per mile as the cable barrier system component (\$48,000) (see [Figure 5-2](#)).

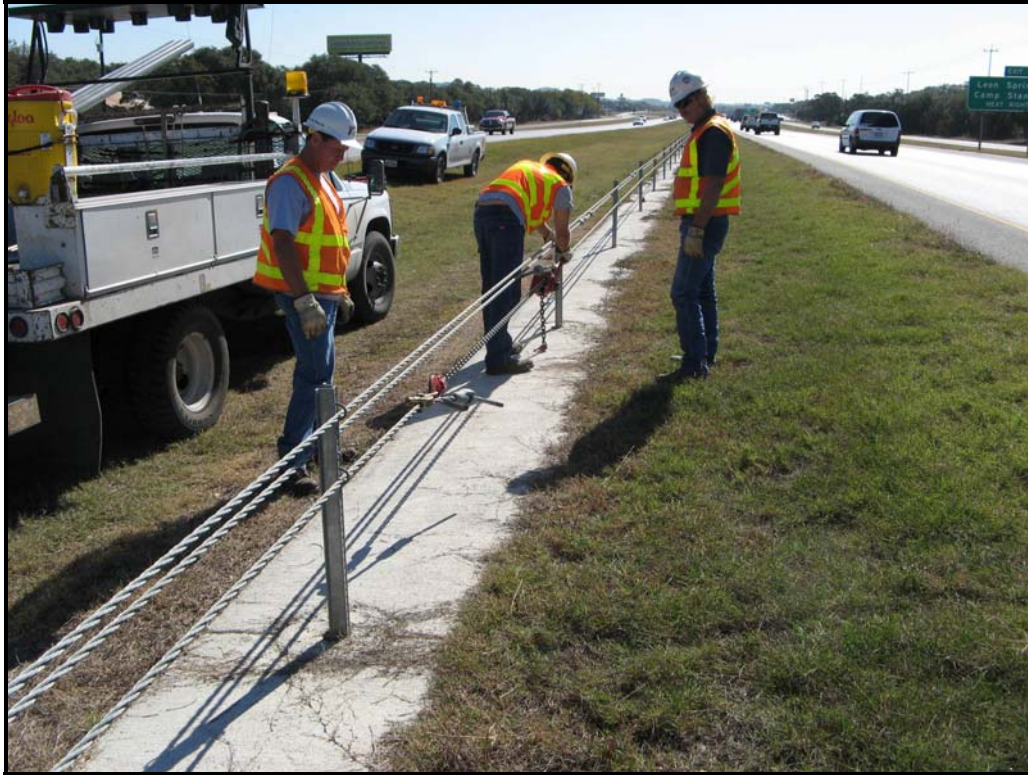
Figure 5-3. Simple Repair of Impact on IH 10 in Boerne.

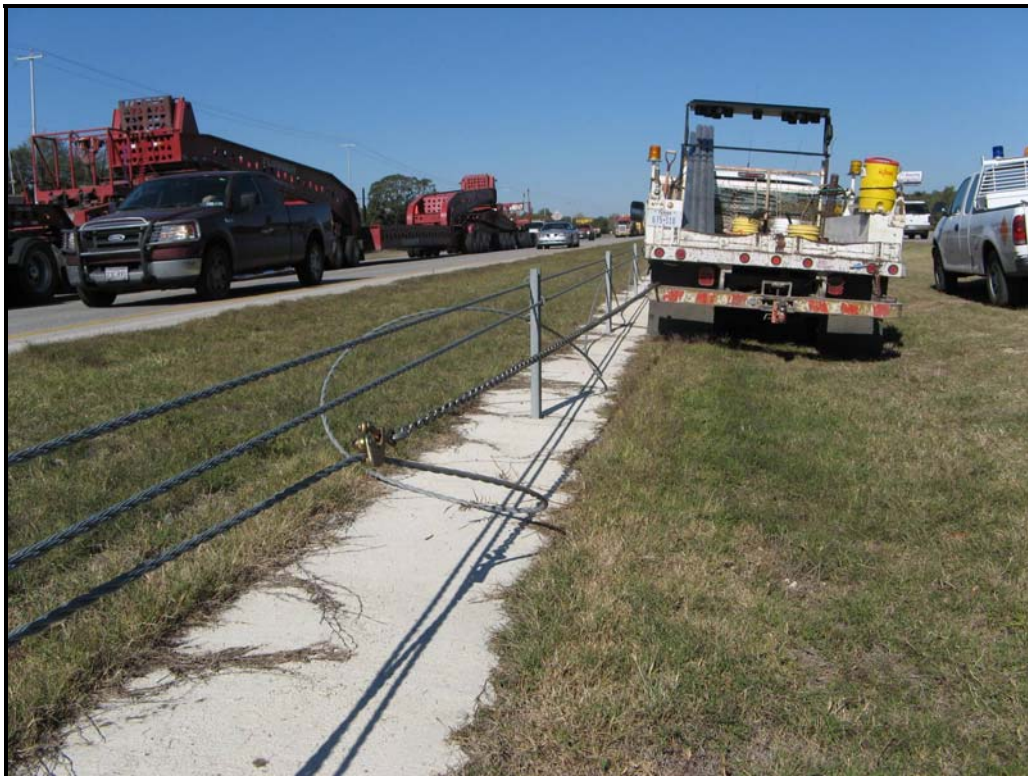
Figure 5-4. More Difficult Repair with Turnbuckle-Cable Separation on IH 10 in Boerne.

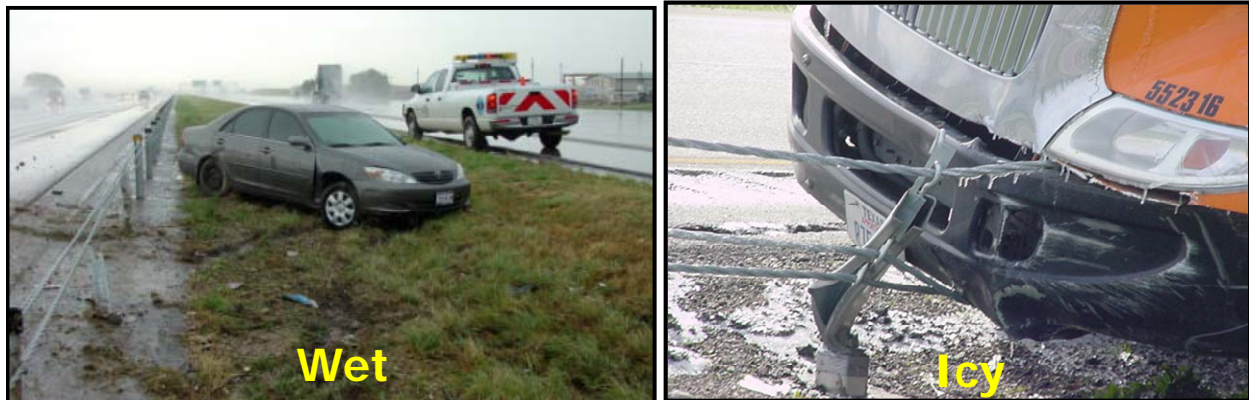
- Analysis of cable barriers has revealed that impacts are much more likely to occur when roadway conditions are wet from rain, ice, or snow (Figure 5-5). This finding makes sense because vehicles are more likely to lose control and hydroplane into the median when the roadway surface is wet. It also seems logical to make the connection that maintenance and repair activities will likely increase during the seasons of the year where these road conditions are more prevalent.

Figure 5-5. Weather Conditions Have a Significant Impact on Cable Barrier Impacts.

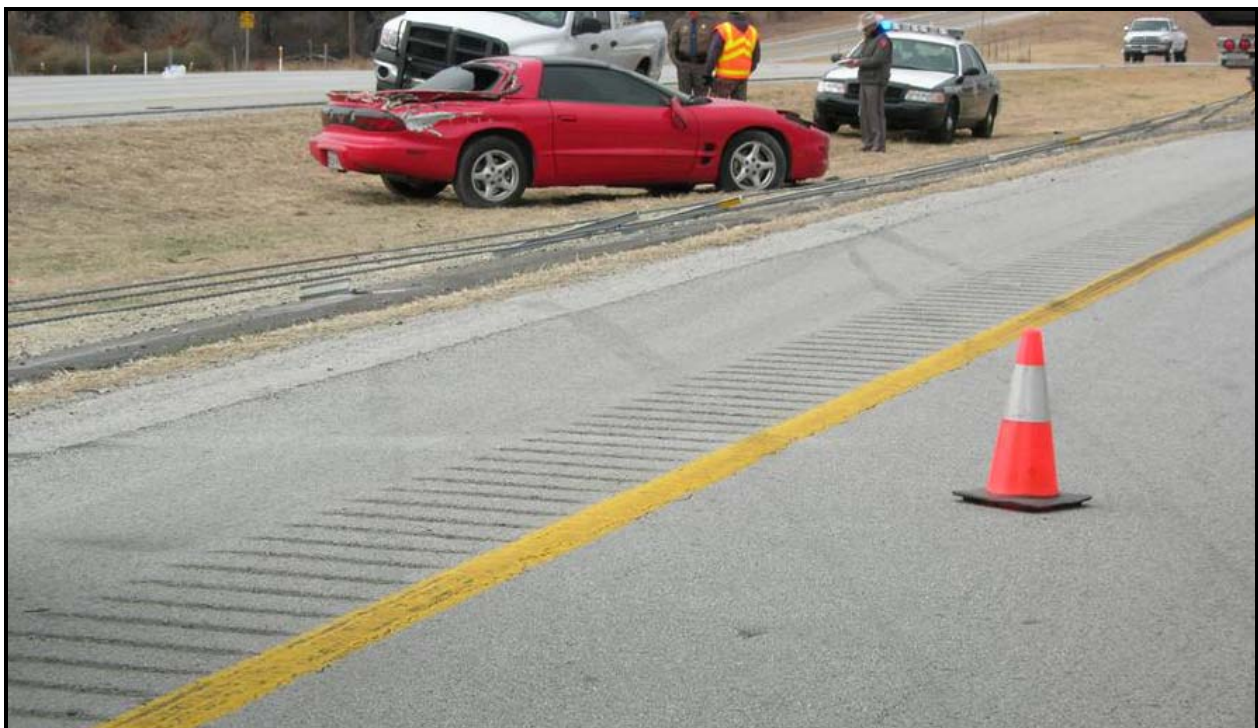
Figure 5-7. Non-Standard Impact Conditions: Low Bumper and High Impact Angle.
