**PERFORMANCE OF LAP SPLICES IN LARGE-SCALE COLUMN
SPECIMENS AFFECTED BY ASR AND/OR DEF—EXTENSION PHASE**

Report 0-5722-2
Project 0-5722
Project Title: Lap Splice and Development Length Performance in ASR and/or DEF Damaged
Concrete Elements

Published: March 2015

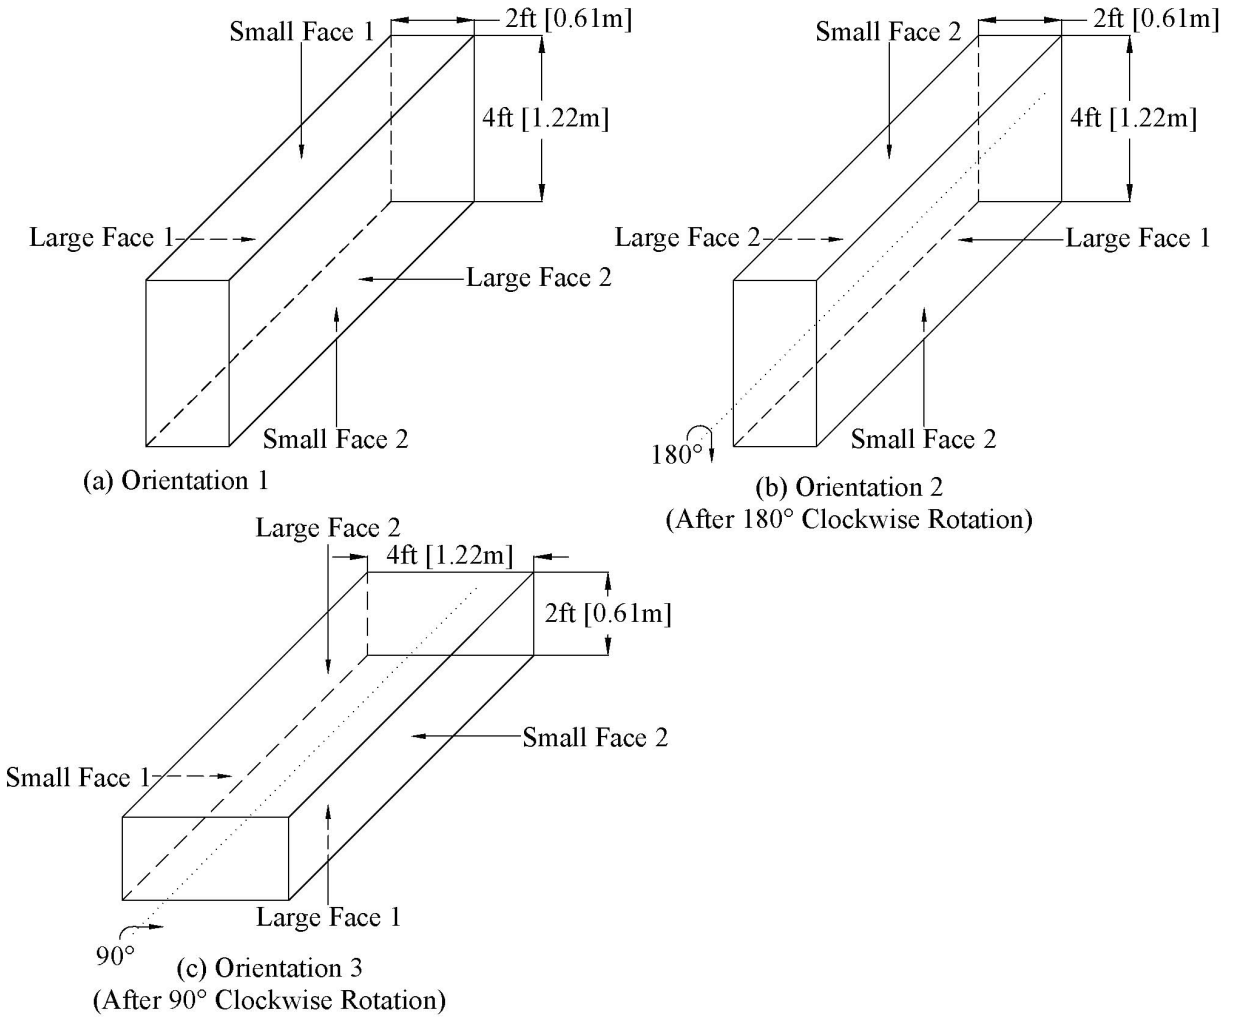
Figure 3-1. Orientations of the LSC Specimens.

After the LSC specimens were rotated 90° for the third and final orientation, Large Face 1 was placed on the bottom (Figure 3-1). Figure 3-2 shows the LSC specimens during the third orientation with Large Face 2 on top. The distance between each specimen in this orientation was approximately 1 ft. Since Small Face 1 and Small Face 2 were now mostly in the shaded and in tight conditions, no surface data were measured on these faces during the third orientation. Figure 3-3 shows the DEMECs on Large Face 2 in a 5 × 5 grid, resulting in four transverse (TS1, TS2, TS3, and TS4) and five longitudinal (LS1, LS2, LS3, LS4, and LS5) averaged strains measured along the splice length of the LSC specimens.

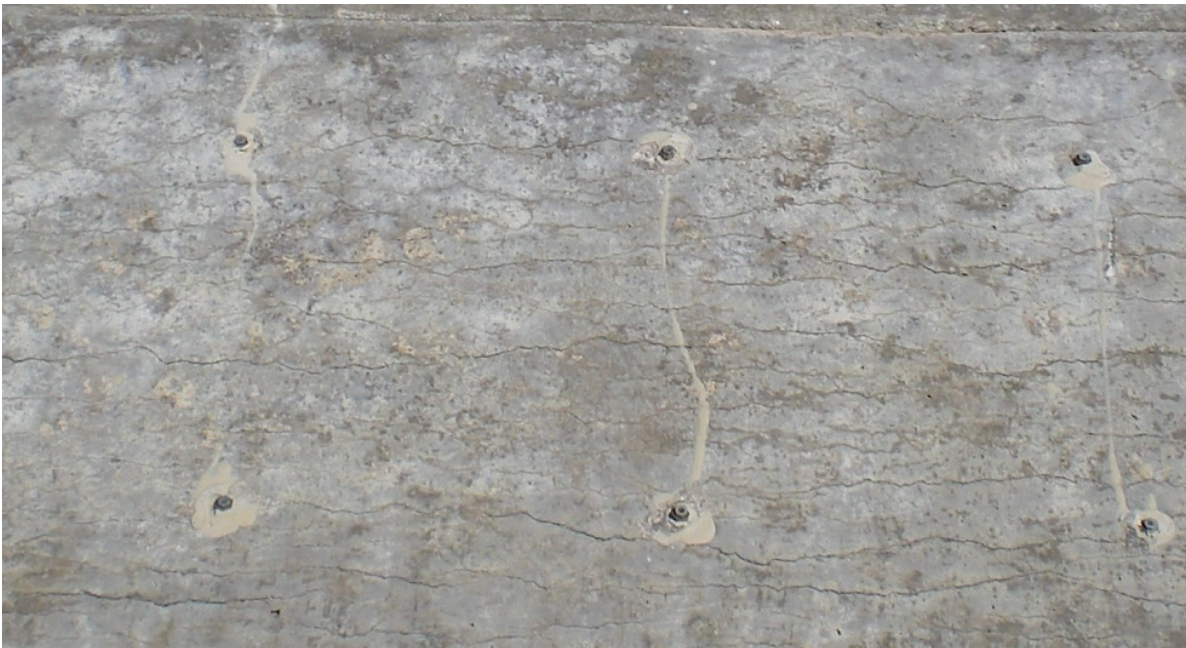
Figure 3-8. Typical Longitudinal Crack in Specimens.

In existing bridge columns, cracks can be measured quite easily using crack width card indicators or crack width measuring devices, while other strain data are more difficult to obtain since instrumentation was not installed prior to bridge construction. However, in this research, the surface strains calculated using the DEMEC points more accurately represent the total surface expansion, since crack width card indicators cannot measure small cracks and concrete expansion between the cracks due to ASR/DEF. Therefore, the strains from crack width measurements in the large-scale specimens were compared to the strains computed using the DEMECs. [Figure 3-8](#) shows that typical surface cracks develop primarily in the longitudinal direction of the LSC specimens, noting that the DEMEC points shown are approximately 10 inches (0.25 m) apart. Therefore, only longitudinal crack widths were measured in this research using a crack width card indicator. This card can be used to measure crack widths as small as 0.004 inches (0.1 mm) to as large as 0.06 inches (1.5 mm). [Figure 3-9](#) shows a larger longitudinal crack on specimen LSC4 with a crack width of about 0.04 inches (1.0 mm). For specimens LSC4 and LSC12, the largest crack width measured was about 0.12 inches (3.0 mm) and 0.06 inches (1.5 mm), respectively.

room. The figure clearly shows that the extent and width of concrete surface cracking was greater on cylinders stored at the field exposure site as compared to the wet room (maximum widths of about 0.01 and 0.006, respectively). However, the extent of this map cracking and the width of surface cracking in all cylinders were significantly less than what developed in the LSC specimens (see Figure 3-8, Figure 3-9, and Figure 3-13).

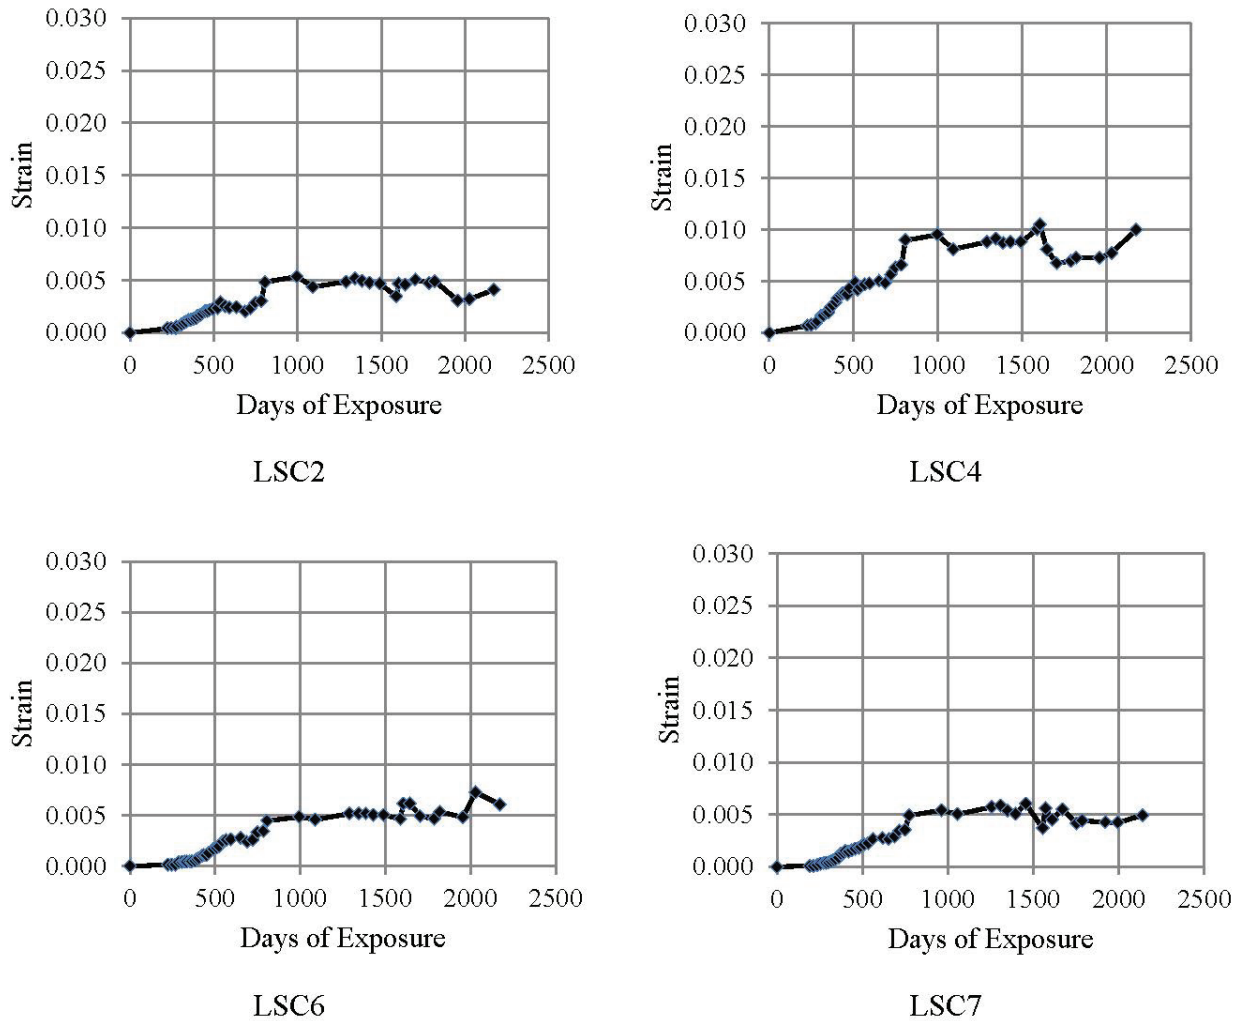
Figure 3-10. Transverse Strain Measurements by Summing Crack Widths on Large Face 2 for LSC2, LSC4, LSC6, and LSC7.

The transverse surface strains on Large Face 2 were calculated by summing the longitudinal crack widths along a line of DEMEC points according to Eq. 3-1. Figure 3-10 shows these strains for specimens LSC2, LSC4, LSC6, and LSC7 and Figure 3-11 shows these strains for specimens LSC11, LSC12, LSC13, and LSC14. The figure shows that strains by summing the crack widths across the specimen section ranged from about 0.005 to about 0.010. By comparing Figure 3-10 and Figure 3-11 with Figure 3-4 and Figure 3-5, the researchers found the strain values by summing the crack widths along one line of DEMEC points are smaller than the

average surface strains, which are calculated from the average of the measured distance between DEMECs along the five lines in the transverse directly. The transverse expansion strain by summing the crack widths generally are about 50 percent of the average surface strain using the DEMEC point measurements, consistent with measurements prior to the extension phase (Bracci et al. 2012). This reduced strain from the sum of the crack widths can be explained by the expansion of the concrete between cracks that was not accounted for and other cracks that were too small to measure with the crack width card indicator.

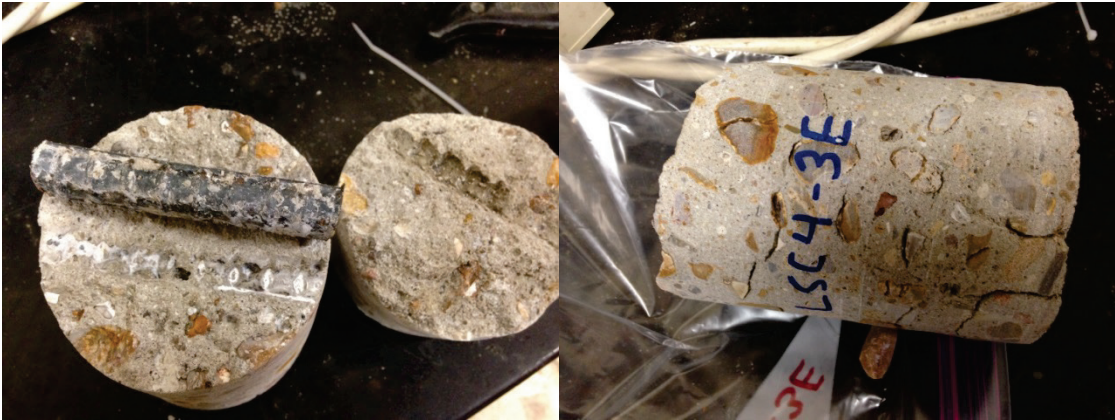
To determine if ASR and/or DEF was evident in the LSC specimens, researchers took a series of concrete cores from the specimens LSC4 and LSC12 following their structural testing. [Figure 3-12](#) shows some sample cores and clearly shows that extensive cracking has developed at the concrete surface and internally within the cores. In particular, note the evidence of ASR reaction particles (ASR gel) that has accumulated in voids and at the boundary of the transverse reinforcing steel and surrounding concrete. The accumulation of ASR gel at the steel-concrete interface was a concern for TxDOT in that it may have a negative effect on the bond strength of column-spliced bars. This research documents the development of ASR and the formation of ASR gel throughout the

(a) Side Face Core from LSC4

(b) End Core from LSC4

Cores taken from LSC4 and LSC12 has surface crack widths of about 0.04 inches (1 mm) that extended up to 2.75 inches (70 mm) into the concrete core, which is the approximate location of the transverse and longitudinal reinforcement. [Figure 3-12](#) shows that ASR gel had accumulated at the interface of the transverse reinforcing and surrounding concrete. In addition, [Appendix A](#) includes microscopic documentation that provides evidence of primarily ASR-caused micro damage and distress, and recent evidence of some DEF distress in the concrete cores.

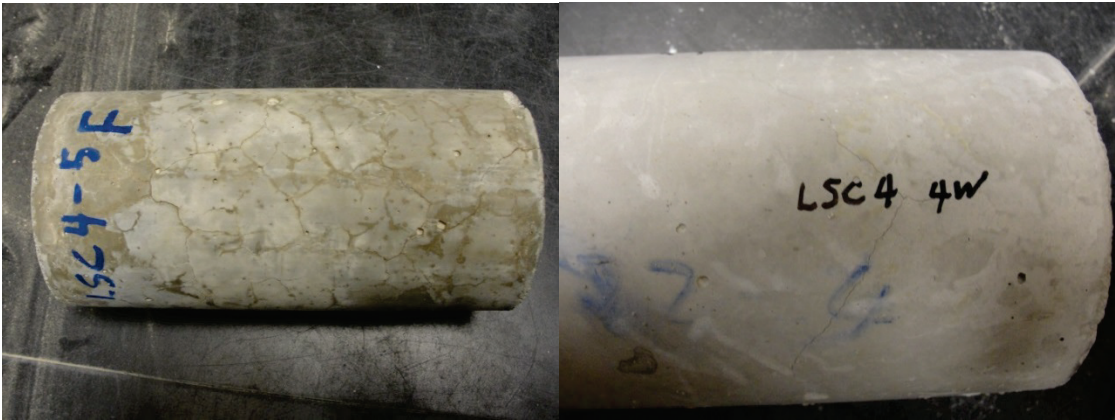
Figure 3-13 shows sample concrete cylinders that were cast with the same concrete used to construct specimens LSC4 and LSC12, and were exposed to different environmental conditions. Some cylinders were stored on top of the LSC specimens at the exposure site in the presence of weather and supplemental watering, while the others were stored in a humidity-controlled wet

(a) LSC4—Exposure Site Storage

(b) LSC4—Wet Room Storage

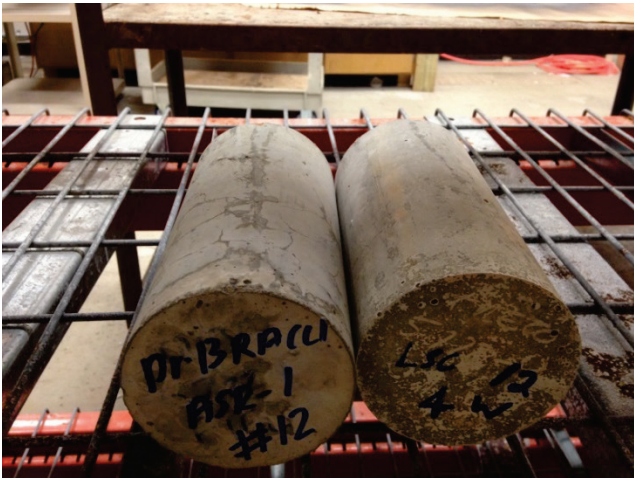
Figure 3-13. Sample Concrete Cylinders.

(c) LSC12—Exposure Site and Wet Room Storage, Respectively

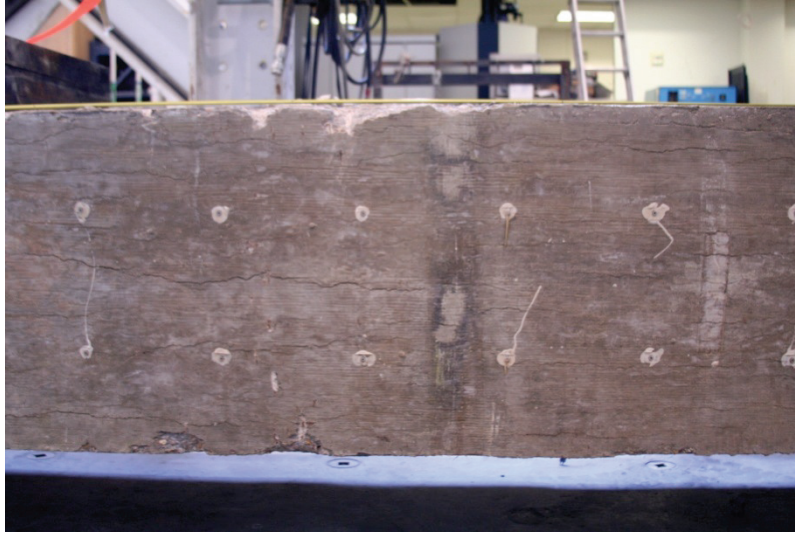
Figure 4-1. Cracking of Specimen #1 prior to Structural Load Testing.

[Figure 4-1](#), [Figure 4-2](#), [Figure 4-3](#), and [Figure 4-4](#) show sample cracking that developed throughout the exposure phase for Specimens #1, #8, and #12, with about 2.3, 3.0, and 5.8 years of exposure, respectively. The figures show that substantial cracking resulted and the cracking pattern was similar between the specimens, even though the exposure periods of the specimens varied. Specimens #1 and #8 had similar crack widths; however, Specimen #12 had much larger crack widths (about twice that in Specimens #1 and #8, as reported in [Table 3-3](#)). Note that the specimen cracking as shown in [Figure 4-5](#), [Figure 4-6](#), [Figure 4-7](#), [Figure 4-8](#), and [Figure 4-9](#) is comparable to the cracking in actual field structures affected by ASR (see [Bracci et al. 2012](#)).

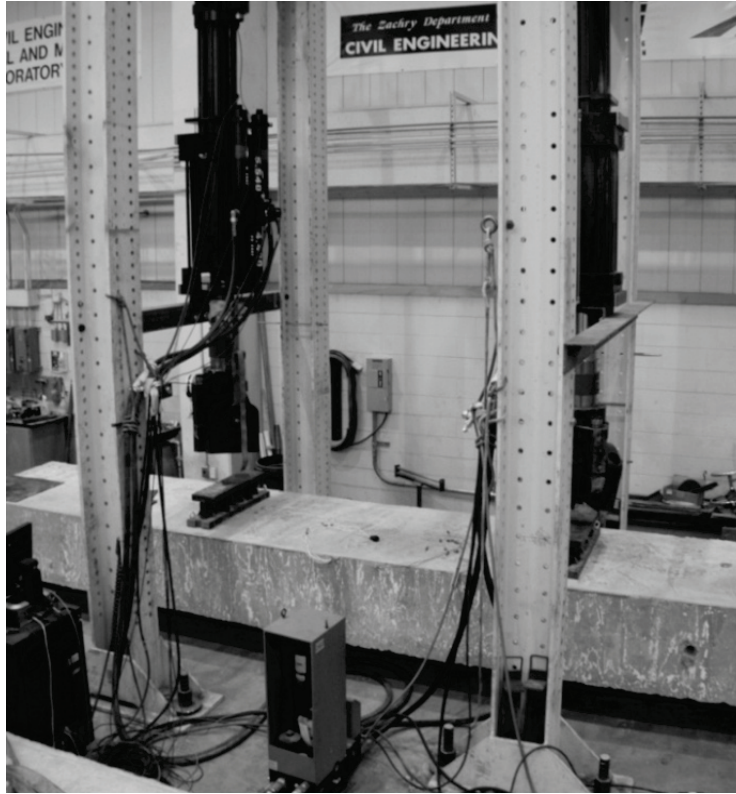
Figure 4-7. Specimen in the Four-Point Test Setup.

Two 220 kips (979 kN) actuators attached to an overhead steel frame were used to load the specimen in displacement control loading. The steel frame was anchored to the strong floor in the Structure and Materials Testing Laboratory. [Figure 4-7](#) shows the actuators positioned over one of the LSC specimens.

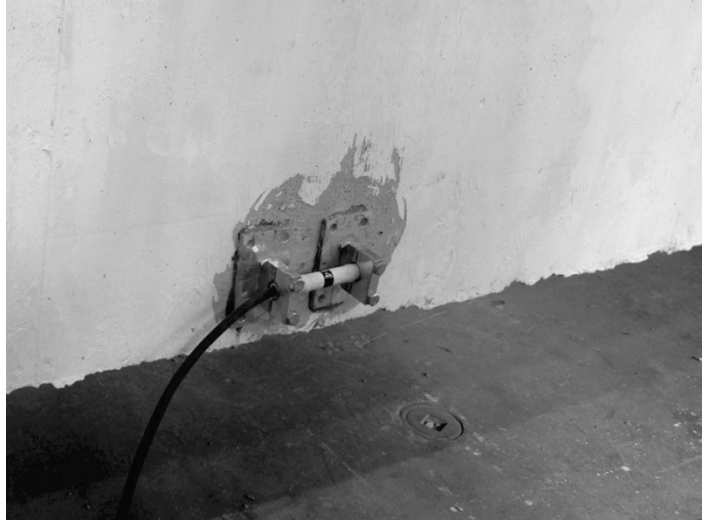
Figure 4-11. KM Gage Installation prior to Testing.

KM gages were attached to the surface of the LSC specimens using adhesive epoxy. First, the research team smoothed the surface by sanding across the entire footprint of the KM base plates. A spacing bar was placed between the KM base plates to keep the base plates a proper distance apart (with a 4-inch [102 mm] gage length). Before testing, the base plates were epoxied to the concrete surface, the spacing bars were removed, and the KM gages were then attached to the base plates. [Figure 4-11](#) shows a KM gage attached to the LSC specimen.

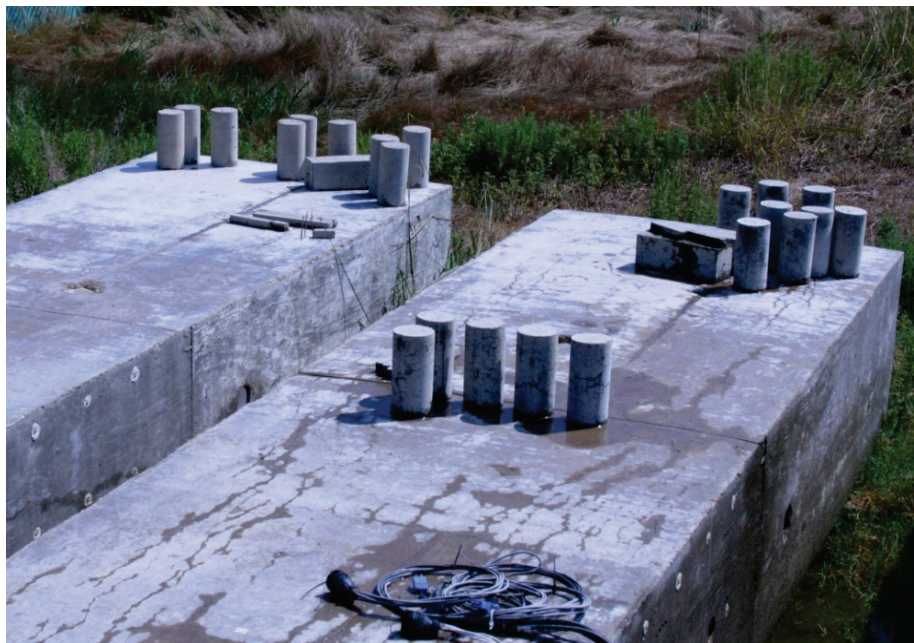
Figure 4-13. Cylinders at the Riverside Campus.

Figure 4-13 compares cylinders from the batch of specimens LSC4 and LSC12. Some were stored in the humidity controlled wet room and others were stored at the exposure site on top of specimens (see Figure 4-13). The figure shows that very few, small surface cracks developed in the cylinders stored in the wet room. The largest crack width measured on these cylinders was about 0.006 inches (0.15 mm) for LSC4 and LSC12 concretes. Note that some cylinders from all concrete LSC specimens had a white residue that leached from cracks. In comparison, cylinders stored at the exposure site in the same environmental conditions as the LSC specimens (exterior weather conditions and supplemental watering four times a day) had more numerous, larger surface cracking than the cylinders taken from the wet room. The largest crack width on these cylinders was about 0.01 inches (0.25 mm).

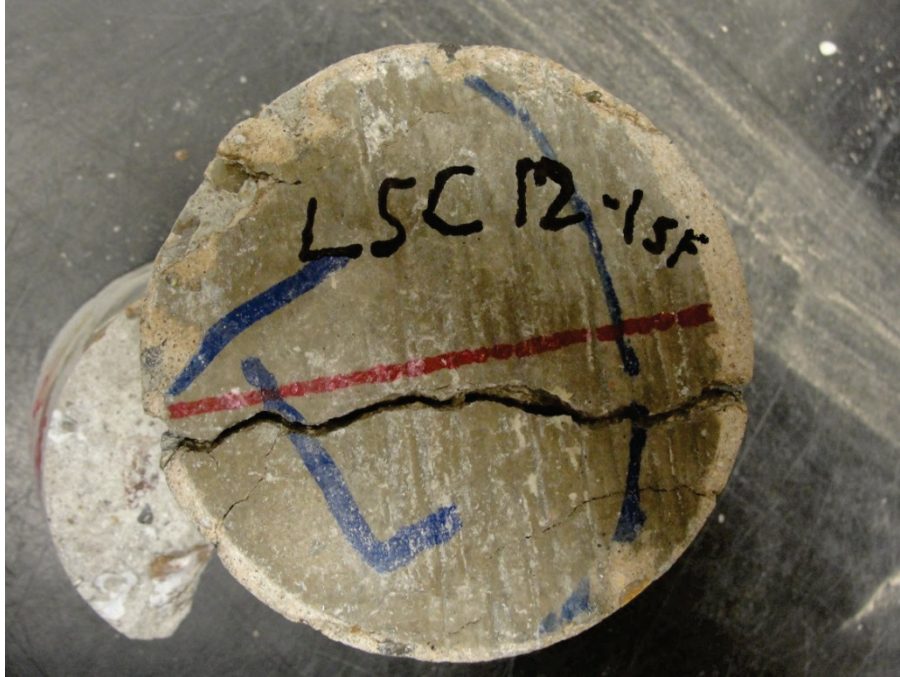
Large surface crack (approximately 1mm) on top surface of core LSC12 ISF

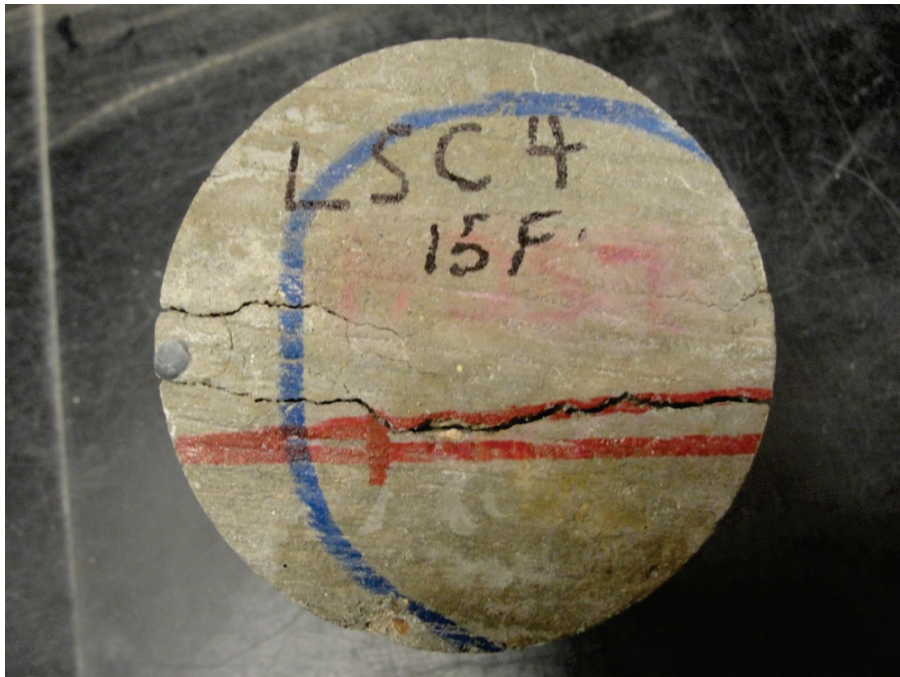
Large cracks illustrated on top of core LSC4 ISF

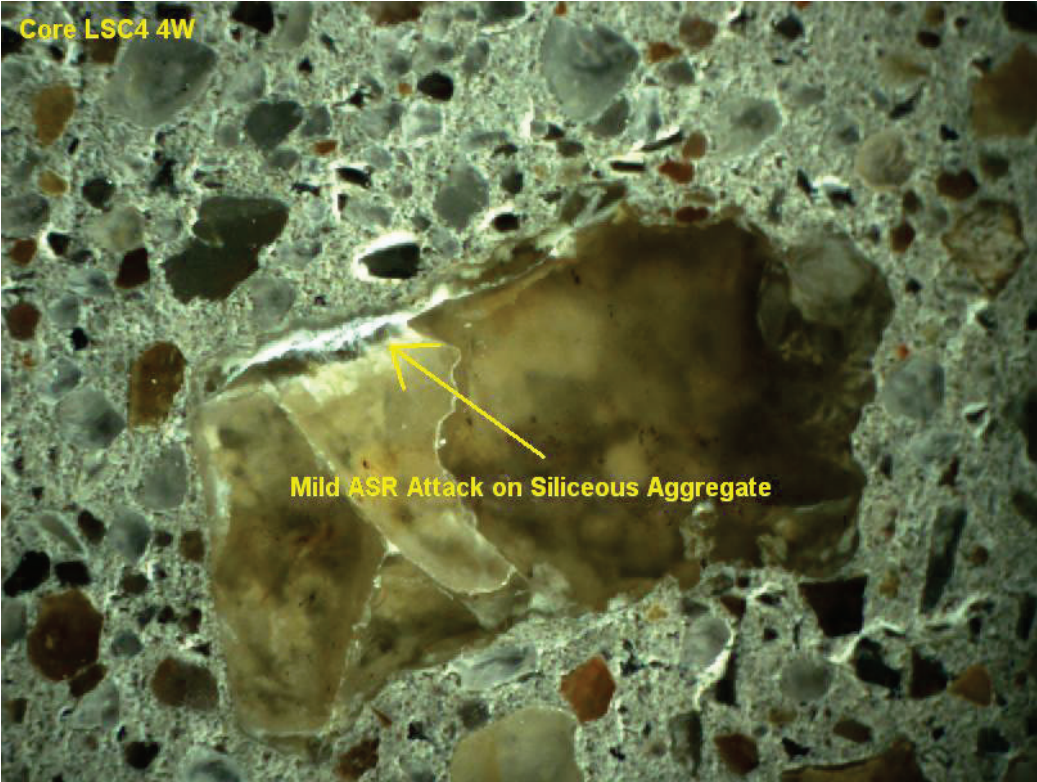
Optical image illustrating ASR activity
