1. Report No. FHWA/TX-12/0-5836-2		2. Government Accession No.		3. Recipient's Catalog No.	
4. Title and Subtitle PERFORMANCE AND COST EFFECTIVENESS OF PERMEABLE FRICTION COURSE (PFC) PAVEMENTS				5. Report Date Published: February 2013

PERFORMANCE AND COST EFFECTIVENESS OF PERMEABLE FRICTION COURSE (PFC) PAVEMENTS

Report 0-5836-2
Project 0-5836

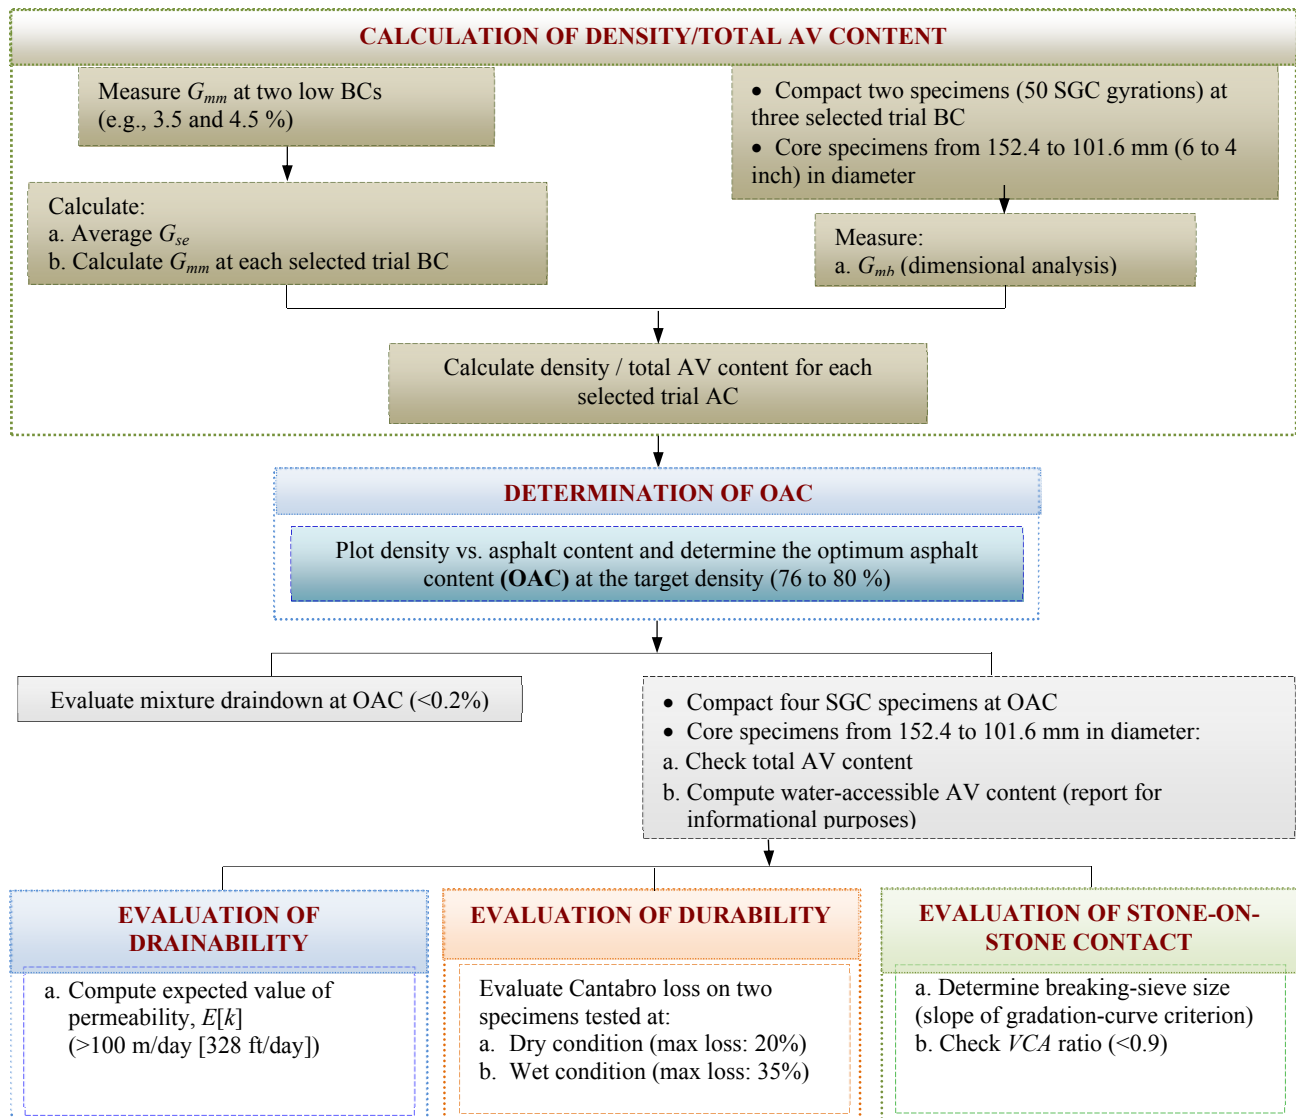
Figure 1. Improved Mix Design Method for PFCs.

The current TxDOT PFC mix design method specifies a minimum total AV content of 18 percent to guarantee functionality, but there is no durability test included in this approach to assess the resistance to raveling of compacted PFC specimens. A recent research study developed an improved mix design method for PFCs based on the guidelines of the current method that TxDOT (20) applied. Proposed modifications, which are indicated in Figure 1 by dashed-lined boxes, included improvements in the computation of volumetric properties (density, total AV content, and water-accessible AV content) and the assessment of drainability, durability, and SOS contact. Recommendations extracted from an analysis of the effects of densification in PFCs as well as their internal structure were also integrated.

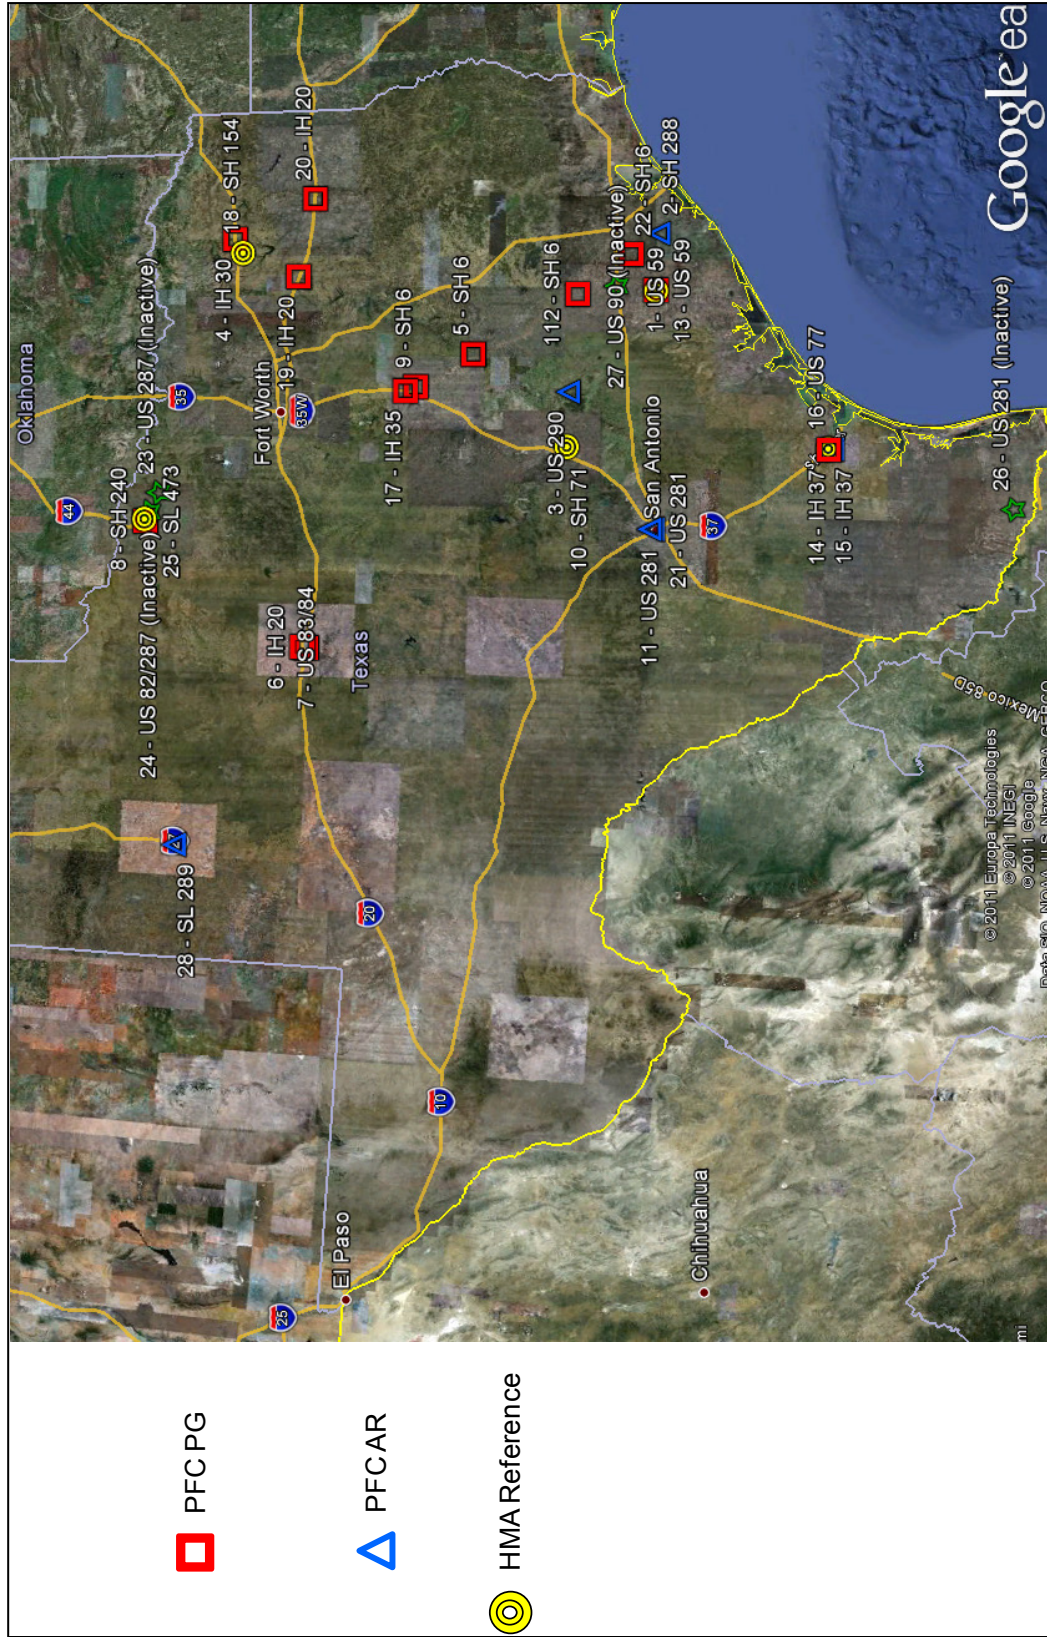
Figure 2. Location of the Pavement Sections Included in the Experimental Design.

In order to populate the multiyear performance database ([Appendix A](#)) and compare the performance of PFCs to other type of wearing pavement surfaces; PFCs, thin-bonded PFCs (TBPFC), ultra thin-bonded HMA (UTBHMA), and conventional dense-graded HMA pavement sections were selected. These pavement sections are located as far north as Wichita Falls to Pharr in the south and from Houston in the east to Abilene in the west (see [Figure 2](#)); therefore, all five climatic zones in the state are represented ([Figure 3](#)). There are 20 sections that remained fixed in the experimental design throughout the project as well as several rotating sections that were included year-to-year as part of forensic studies. At least four of these rotating sections were included in each performance monitoring session, with some sections being carried over for multiple years and others only being visited once. Of the 20 permanent sections, four are conventional dense-graded HMA pavement sections that serve as reference to compare changes in the performance of the PFC sections, one is a TBPFC, one is an UTBHMWC, and the rest are PFCs. The dense-graded HMA sections, which are highlighted in [Table 1](#) and labeled with REF under mixture type, are located in different climatic zones. Details of all sections are listed in [Table 1](#) and detailed maps of individual pavement sections including coordinates are included in [Appendices B](#) and [C](#).

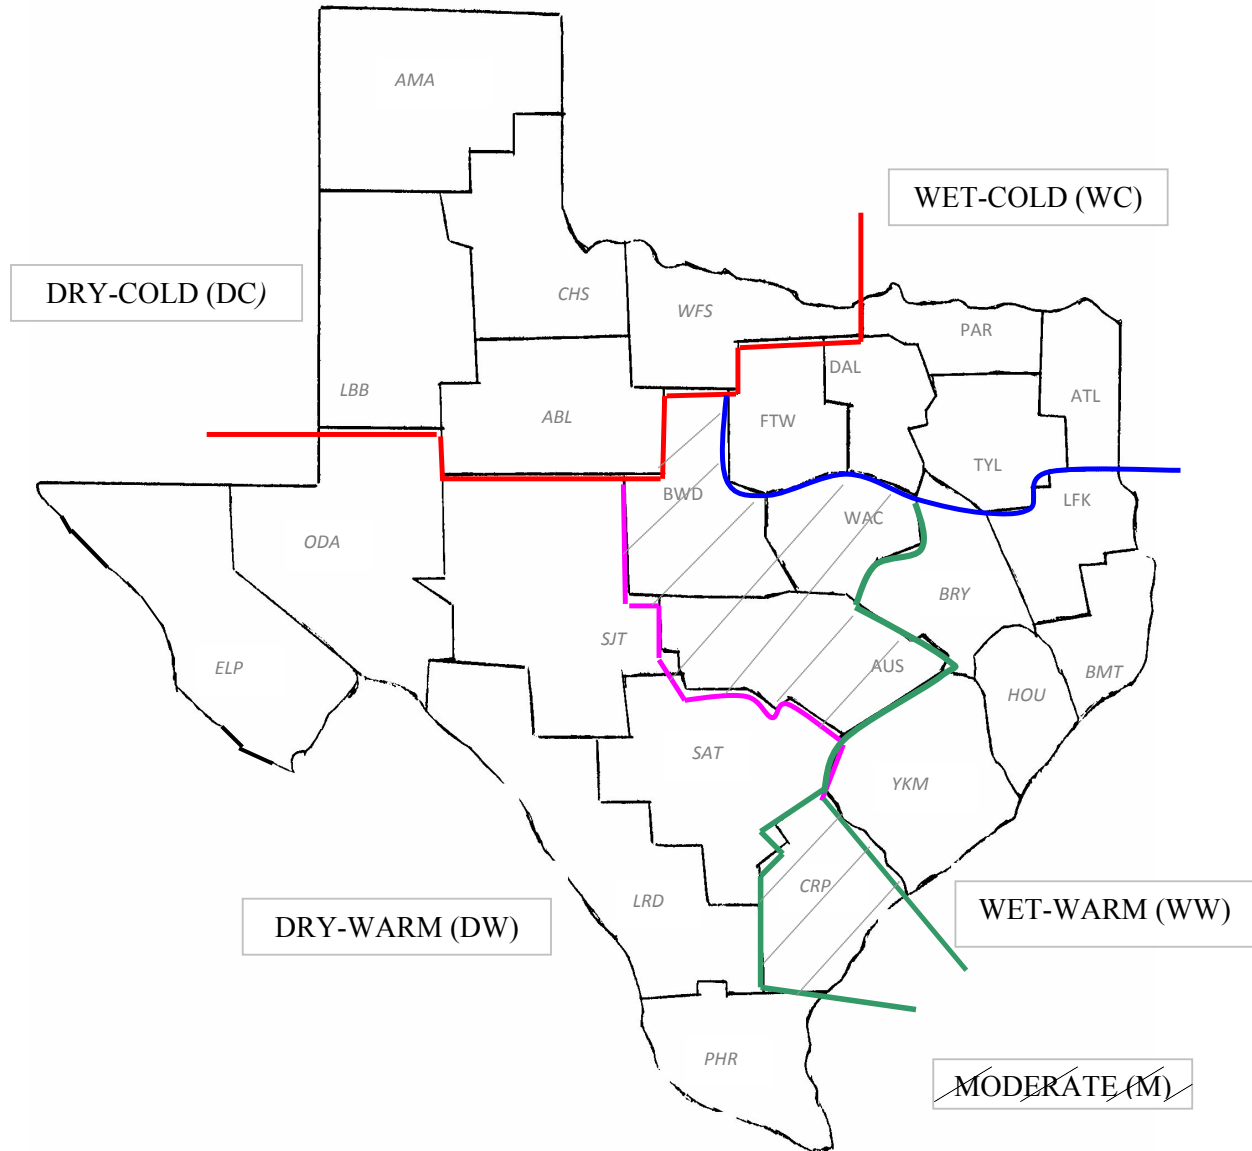
Figure 3. Texas Climatic Regions.

The effect of climate on noise levels was explored based on the climatic regions within the state of Texas (Figure 3): dry cold (DC), dry warm (DW), moderate (M), wet cold (WC), and wet warm (WW). Table 4 lists the classification of the sections where noise was measured. Graphs presenting the noise measurements for each of the sections, grouped by climatic region and sorted by noise level within each region, are shown for the 2009, 2011, and 2012 in Figure 27, Figure 28, and Figure 29, respectively.

To take into account the effect of environmental conditions, the research group selected the test sections in five Texas climatic regions (see [Figure 3](#)). [Table 15](#) presents the selected pavement sections. The 22 sections shown in this table fall into three main groups:

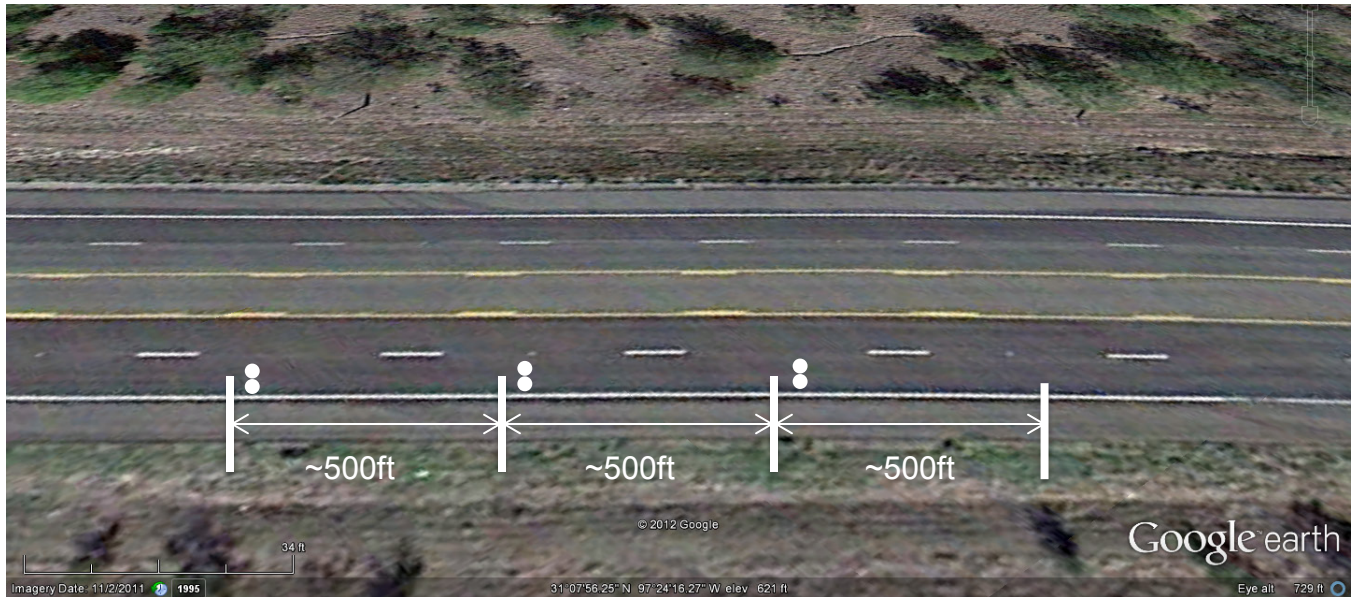
Figure 4. Schematic of the Pavement Subsections Used to Measure WFV, Texture, and Friction.

TTI personnel conducted on-site tests (i.e., WFV, texture, and friction) on three equally spaced subsections approximately 152 m (500 ft) apart (see [Figure 4](#)). Testing OWP and BWP was done in all three subsections and the average of the measurements reported as the OWP or BWP result for that pavement section. One WFV measurement was performed OWP and BWP in each subsection unless there was a reason to believe the result was inaccurate due to localized bleeding or clogging. In the case of the CTM, two replicate tests about 2 inches apart from each other are performed in each subsection. The average of the six replicate measurements was reported as the OWP or BWP texture for that pavement section. Friction was measured once in each subsection by placing the DFT in the same spot where the first texture measurement was acquired. It was important to measure texture and friction on the same location because these variables are used to calculate the International Friction Index (IFI) as will be explained later.

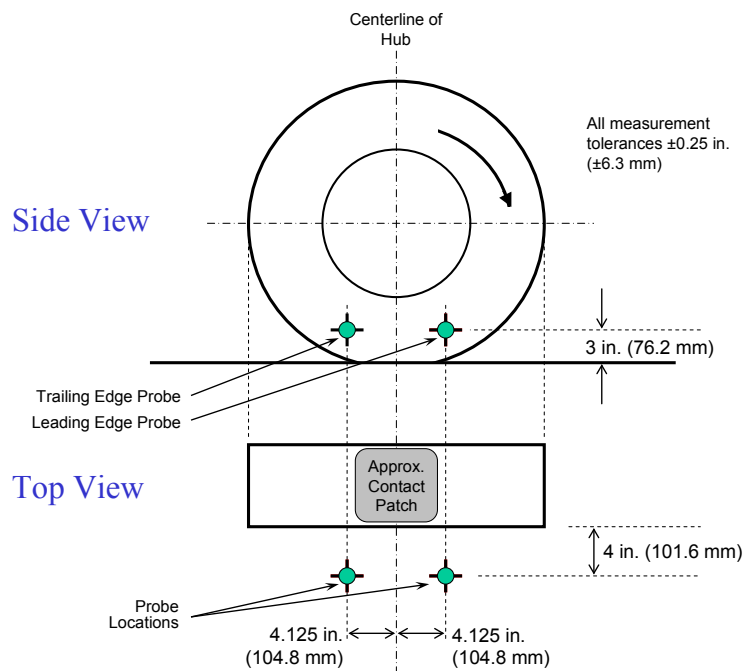
Figure 5. Sound Intensity Probe Showing Leading and Trailing Edges.

The procedure utilizes a fixture positioned close to the tire to hold the sound intensity probe. Details of the equipment utilized are presented in the next section. A single sound intensity probe, such as the one utilized throughout this project, consists of two 25 mm (1 inch) microphones spaced 16 mm (0.6 inch) apart and preamplifiers in a side-by-side configuration. A

dual probe consists of two pairs of microphones. A foam windscreen is placed over the microphones to reduce the wind noise. The probe is positioned 100 mm (4 inch) away from the plane of the tire sidewall and 75 mm (3 inch) above the pavement surface, mounted to the rear tire on the passenger side of a car. Signals from the microphones are input into a real-time analyzer. Measurements are taken at 97 kph (60 mph) at two intensity probe locations. One location corresponds to the leading edge and the other to the trailing edge of the tire/pavement contact patch. [Figure 5](#) shows the intensity probe positions and distances in relation to the tire and pavement. A dual probe allows testing at both the leading and the trailing edge positions simultaneously. With a single probe, the tests must be run for one microphone position, and then the microphones must be switched to the other position. Therefore, runs with a single probe take twice as much time.

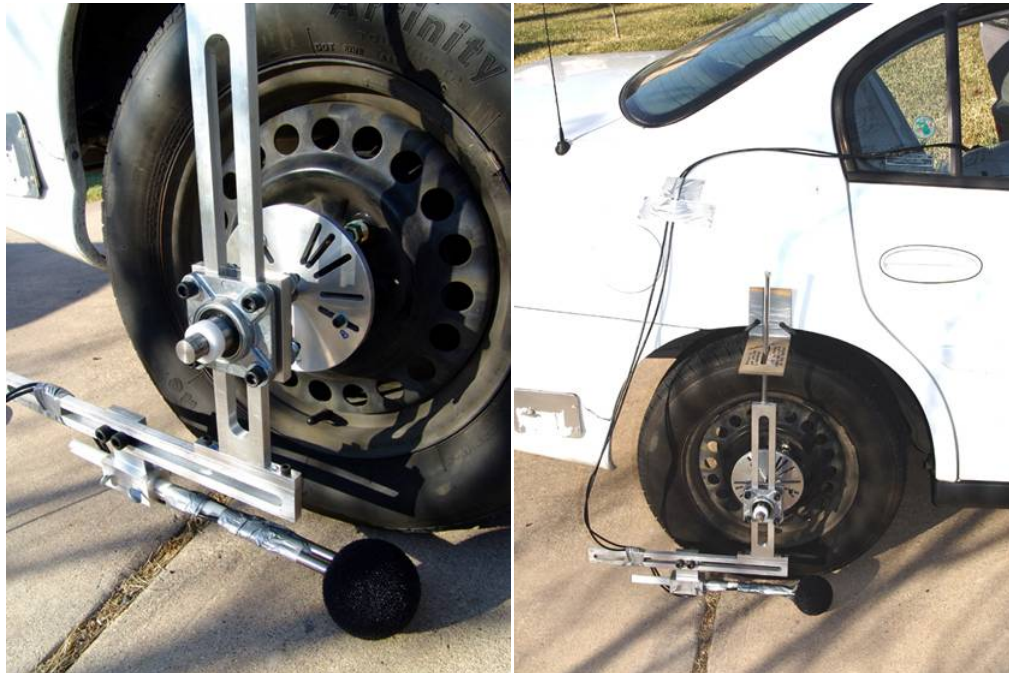
Figure 6. Single Probe Fixture with Microphone Pair in Horizontal Position.

the assembly and provide resistance to the small amount of rotational force generated by friction in the bearing. As mentioned before, the measurements throughout this research project were conducted using a single probe. The first OBSI fixture can be seen attached to one of the test vehicles (see [Figure 6](#)). In this fixture, the microphones are in a horizontal position, parallel to the ground.

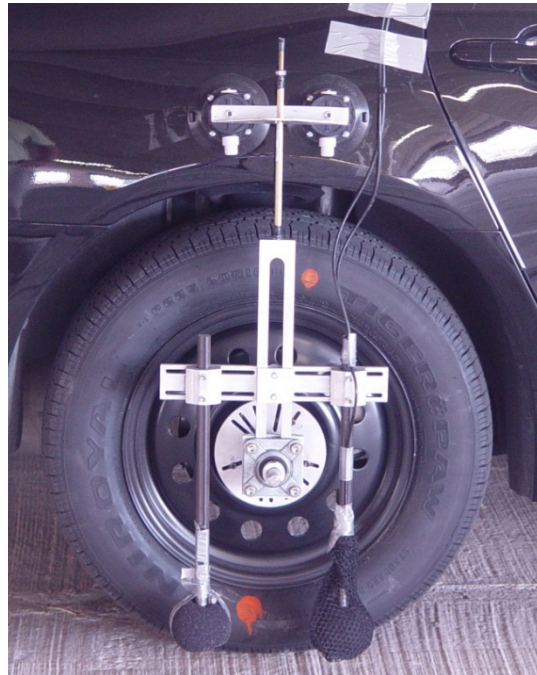
Figure 7. New OBSI Fixture.

In 2010, CTR and TxDOT started using a new fixture, featuring an improved design that allowed for better stability of the microphone pairs and reduced vibration. Although this new fixture is designed as a dual probe, the fixture could only be utilized as a single-probe because the analyzer used for the measurements is a two-channel device. This means that the microphone pair must still be switched between leading and trailing edges halfway through the runs to complete the measurements. The new fixture holds the microphone pairs in a vertical position (see [Figure 7](#)).

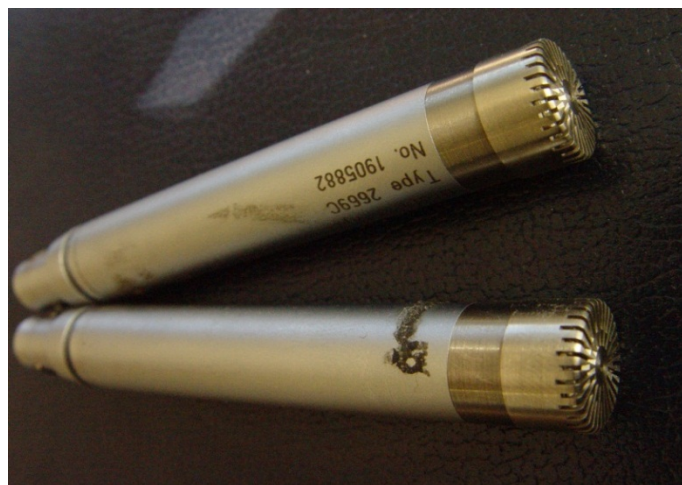
Figure 8. Half-Inch Sound Intensity Microphone Pair.

The system utilizes two 12.5 mm (0.5 inch) phase-matched condenser free-field microphones (see [Figure 8](#)). Preamplifiers are affixed to each individual microphone for signal amplification, and these, in turn, are attached to a plastic probe holder that keeps a space of 16 mm (0.63 inch) between microphones, in a side-by-side configuration. The microphones are fitted with a spherical windscreen.

G.R.A.S. manufactured the microphones and preamplifiers utilized for this project. These items comply with the requirements of the international standard IEC 1094 for Measurement Microphones, and as required by the AASHTO OBSI Standard, and also comply with the Class 1 requirements of ANSI S1.9. These devices are able to measure the real part of a complex sound intensity in sound fields with a high level of background noise, such as occurs on the highway.

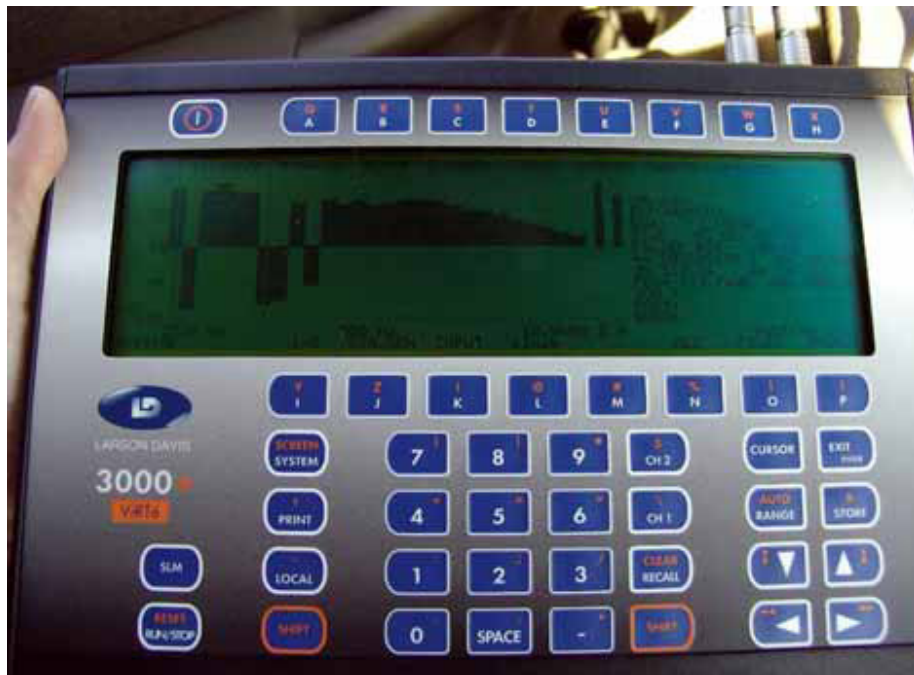
Figure 9. Larson Davis 3000+ Sound Intensity Analyzer.

OBSI data are not only collected in raw form, but also analyzed in real time using an in-vehicle device, the Larson Davis 3000+ Analyzer (see [Figure 9](#)). The analyzer affords the advantage of analyzing and displaying the sound intensity for each frequency band in real time, allows the operator to listen to the noise being recorded, and stores the processed data inside the analyzer itself. A separate, flash card audio recorder captures the raw output from the LD 3000 for reprocessing later, if needed.

Seeing the data display and hearing the noise during the test is extremely useful, as it allows the operator to immediately detect any anomalies during testing, and flag the data as suspicious for later examination. Often, mechanical problems with the jig or vehicle occur that the operator can easily detect and correct in the field, so that testing can resume.

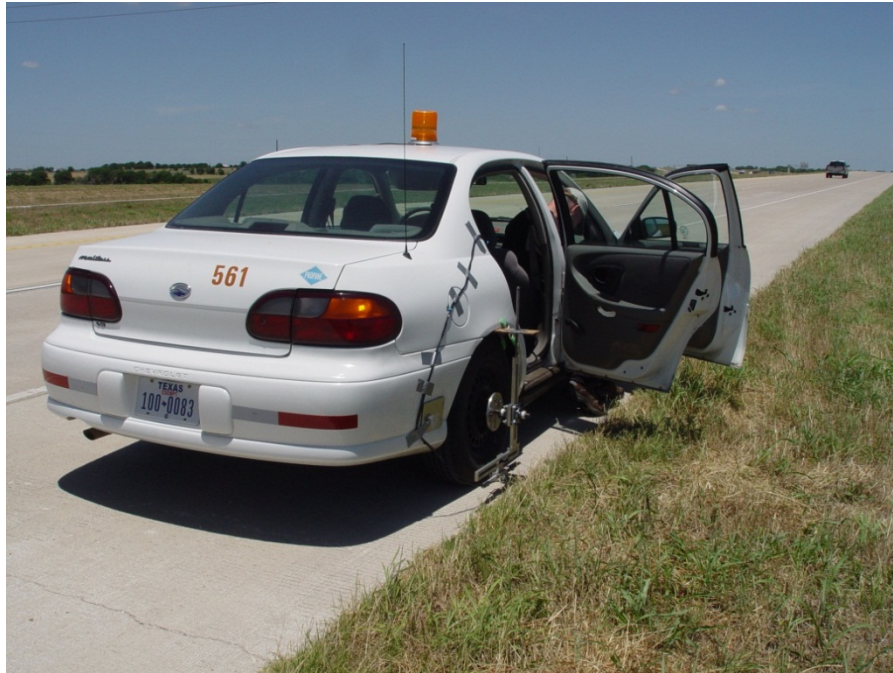
Figure 10. Chevy Malibu Test Vehicle.

Two types of vehicles were utilized throughout this project: a Chevrolet Malibu and a Chevrolet Impala. The use of two vehicle types is directly related to the test tires. When the project began, CTR had the Chevy Malibu vehicle ([Figure 10](#)) equipped with Uniroyal Tiger Paw All-Weather Performance (AWP) tires. The AWP is a P205/50R15 tire. This type of tire and vehicle were common among the various options that OBSI practitioners used at the time, when the AASHTO standard started to be drafted. At this time, there was no specification for tires, so there were three or four common types of tires that were normally selected for OBSI tests. Testing for this project took place with that vehicle-tire combination until 2010.

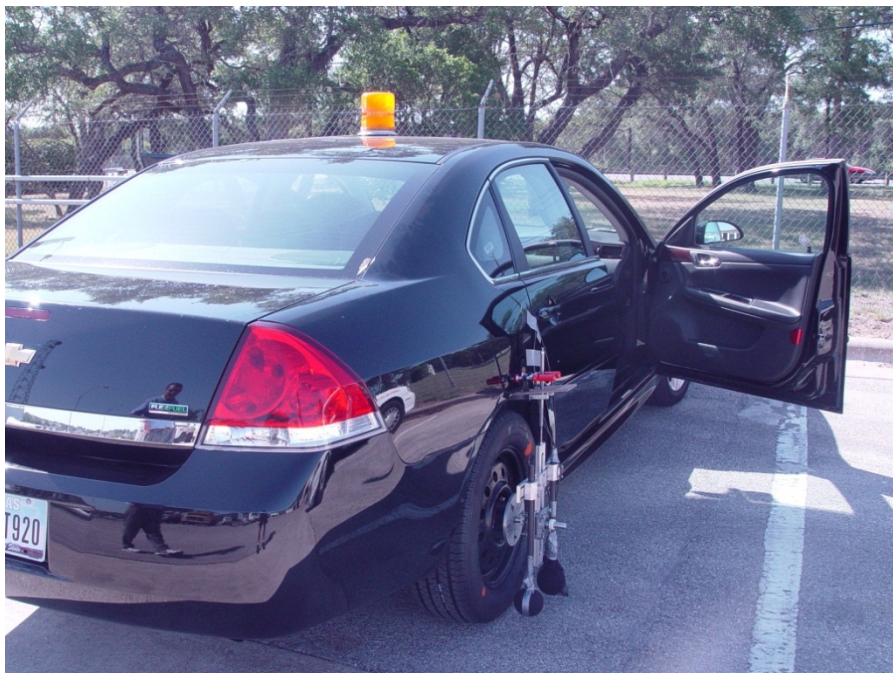
Figure 11. Chevy Impala Test Vehicle.

Later on, the AWP tire stopped being manufactured, and it became increasingly difficult to find commercially. In order to transition to a more available tire and to devise a uniform test procedure capable of producing comparable results among different agencies utilizing the OBSI method, the expert panel group drafting the standard decided to adopt the ATSM P225/60R16 Standard Reference Test Tire (SRTT) as the standard tire for OBSI tests. Therefore, halfway through the project the research team had to proceed with new tires and a new vehicle. The SRTT does not fit in the Malibu vehicle, so for the remaining part of the project a Chevy Impala equipped with SRTTs had to be utilized (see [Figure 11](#)).

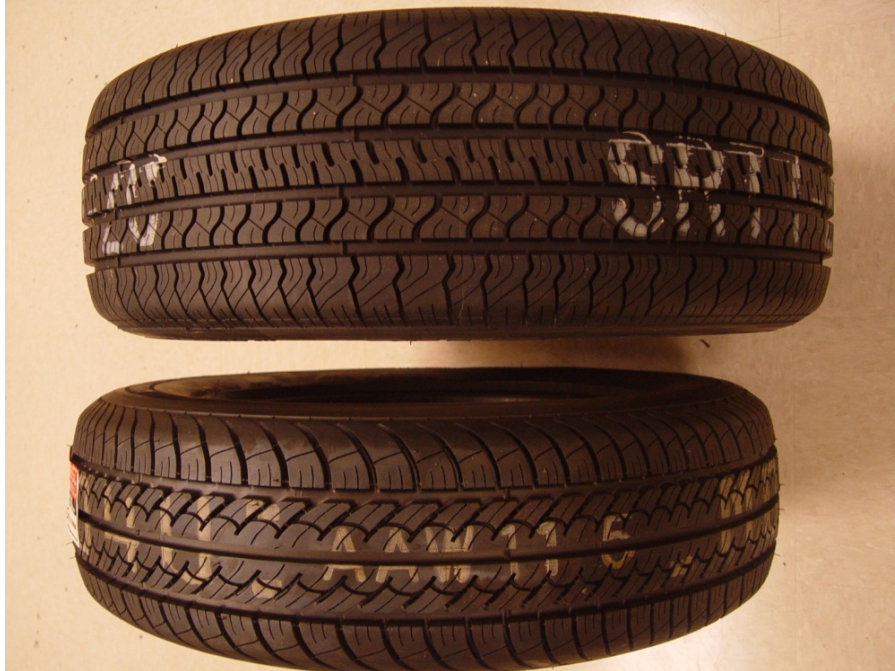
Figure 12. SRTT Tire (top) and AWP Tire (bottom).

life of the tire. The standard for the tire is ASTM F 2493, Standard Specification for P225/60R16 97S Radial Standard Reference Test Tire (27). The change in tires that occurred during this project had a definitive influence on the test results, as the tire size and tread pattern are substantially different (see Figure 12).

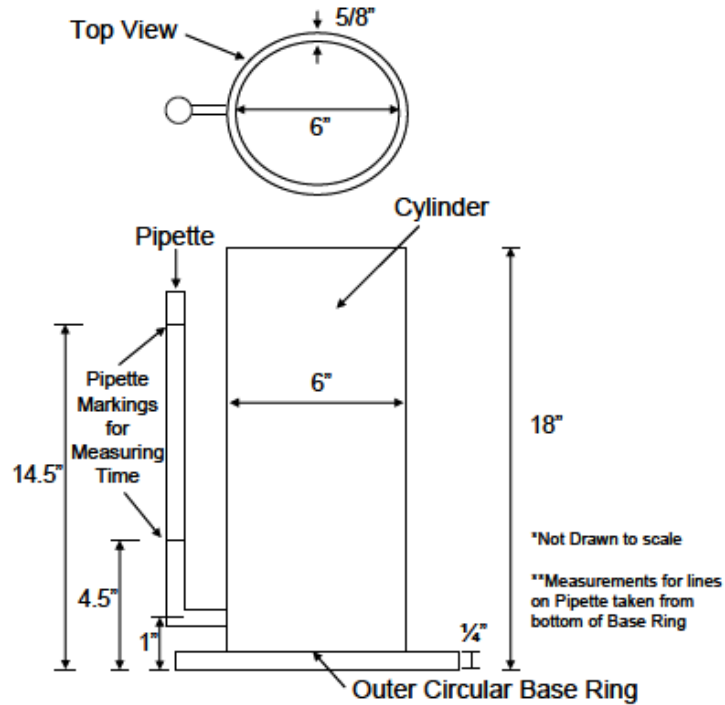
Figure 13. WFV Permeameter Dimensions (28).

One of the main functions of a PFC pavement is to drain water quickly from the surface. WFV is a measure of how quickly a known volume of water will drain through an area of the PFC pavement surface, and serves as an indicator of how the pavement will perform during a rain event. Based on Tex-246-F, the apparatus used to measure WFV is a 150 mm (6 inch) diameter by 450 mm (18 inch) tall permeameter made of PVC with a clear pipette attached to the side that allows the user to see the water level in the permeameter (see [Figure 13](#)). Plumber's putty is used around the base of the permeameter to create a watertight seal between the permeameter and the pavement. It is important that no water can seep through the putty at the base of the permeameter since that would yield a false indication of the WFV of the pavement.

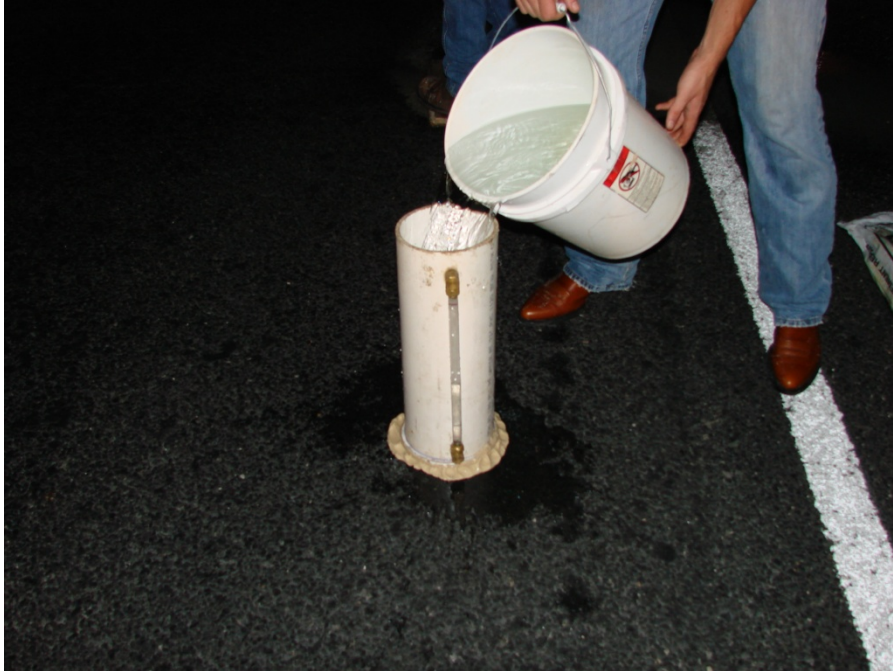
Figure 14. WFV On-Site Test Setup.

To perform the test, water is poured into the permeameter to a few inches above a marking line on the pipette. [Figure 14](#) shows the permeameter setup at the start of the test when water is poured in. When the water level gets to the top start line, timing begins. The test concludes when the water level has reached a second line located 10 inches below the start line on the pipette. This stop line is 114 mm (4.5 inch) above the pavement surface. The time it takes for the water level to go from the start line to the stop line is the recorded WFV. The test is performed both OWP and BWP and occasionally on the shoulder of the road. At the time of construction, an acceptable WFV is less than 20 seconds ([28](#)). Subsequent measurements can

TTI researchers recommend the use of Tex-246-F ([Figure 14](#)) to verify that the compacted mixture has adequate permeability. The test evaluates the time required to discharge a given volume of water channeled onto the pavement surface through a 150 mm (6 inch) diameter opening. This time corresponds to the WFV expressed in seconds.

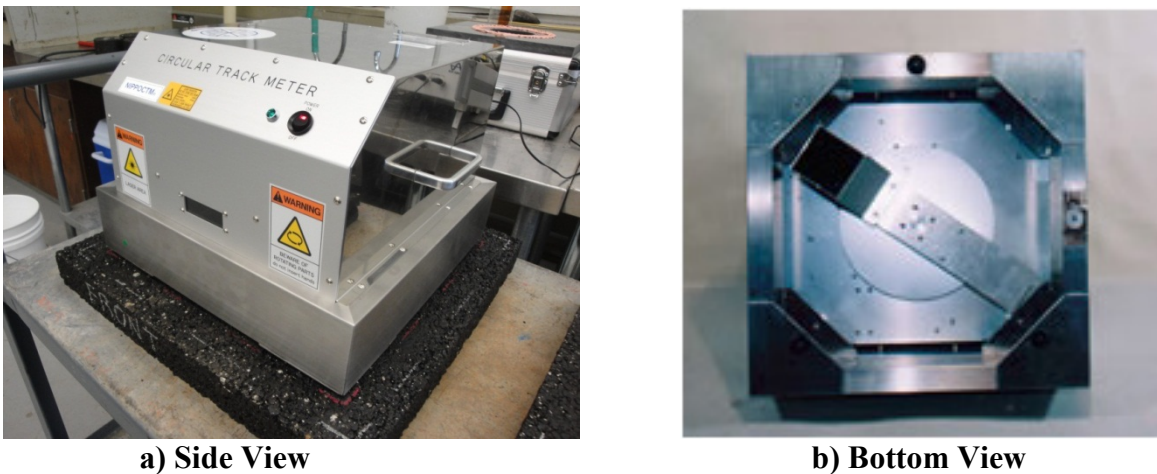
Figure 15. CTM Apparatus.

The equipment used to measure MPD on PFC pavements is the CTM that Nippo Sangyo Company of Japan developed. The ASTM Standard E2157-09 describes the proper use of the CTM. This machine has a laser displacement sensor that rotates on an arm for a specific circumference and records the measurement of the texture approximately every 0.9 mm (0.035 inch). On other wearing surface pavement layers besides PFCs, the sand-patch method and the CTM are shown to correlate well. Figure 15 shows the apparatus used in the field.

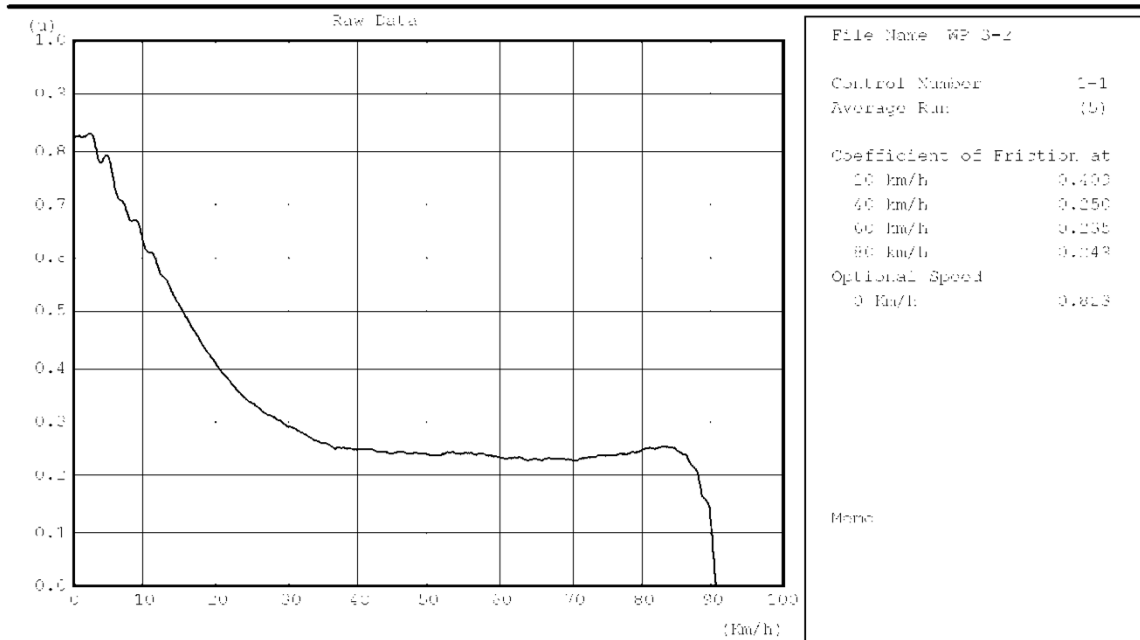
Figure 16. Typical DFT Output.

In addition to texture, wet pavement friction is another important variable used to assess the performance of PFC pavements in terms of safety. Both microtexture and macrotexture influence the pavement friction coefficient with microtexture playing a larger role at lower speeds. As speed increases, the macrotexture gradually overtakes microtexture in the influence over friction coefficient. Additionally, as speed increases, pavement friction tends to decrease (see Figure 16), where the x-axis shows the speed in kph and the y-axis is the coefficient of friction.

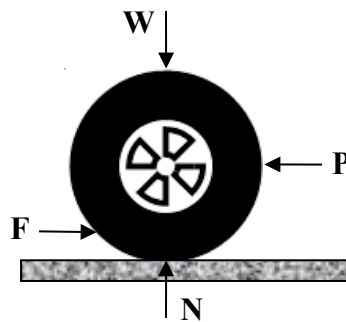
Figure 17. Tire-Pavement Friction Force Diagram.

The calculation for pavement friction is relatively straightforward. As shown in the simple diagram of Figure 17, when a rubber tire skids on the pavement from braking action, the weight of a portion of the vehicle (W) causes an equal and opposite normal force (N) with the pavement. The momentum of the moving vehicle causes a force (P) in the direction of travel,

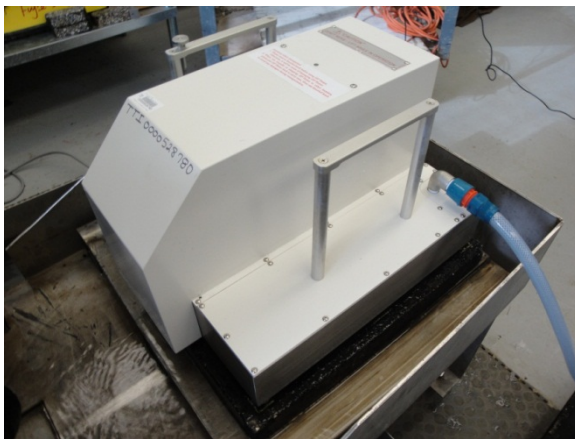
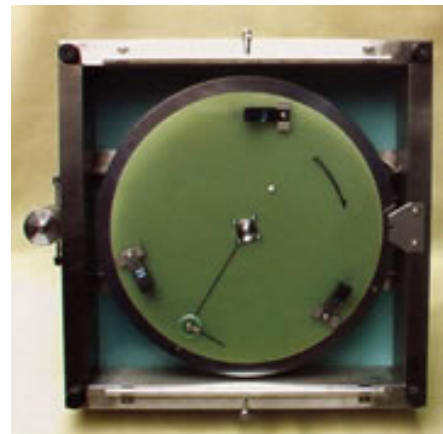
Figure 18. DFT Apparatus.

The DFT is a portable tool for measuring the dynamic friction coefficient. [Figure 18](#) shows the equipment used for on-site testing. In addition to the apparatus, a steel water bucket connects to a nozzle on the DFT through a plastic hose. The bucket provides gravity-fed water to the DFT, which is then discharged through the bottom of the unit during testing to wet the pavement. A portable processing unit and laptop computer connects to the DFT to control and monitor the apparatus and collect the test results.

The DFT has three rubber sliders that are spring-mounted to the bottom of a disk with a diameter of 350 mm (14 inch) (see [Figure 18b](#)). The disk is held above the pavement as the electric motor in the DFT spins the disk so that the tangential velocity of the sliders reaches 90 kph (56 mph). The DFT sprays water onto the pavement. Upon reaching the target testing velocity, the motor disengages and the rubber sliders are lowered onto the pavement surface. After contact with the pavement surface, the disk maintains a constant load and begins to decelerate. A transducer on the disk measures the friction force and accompanying speed of the disk. From this data, a continuous spectrum of the resulting friction coefficient is generated from 90 to 0 kph (56 to 0 mph) as previously shown in [Figure 16](#). Of this spectrum, the friction coefficients at 20, 40, 60, and 80 kph (12, 25, 37, and 50 mph) are recorded into the 0-5836 project database.

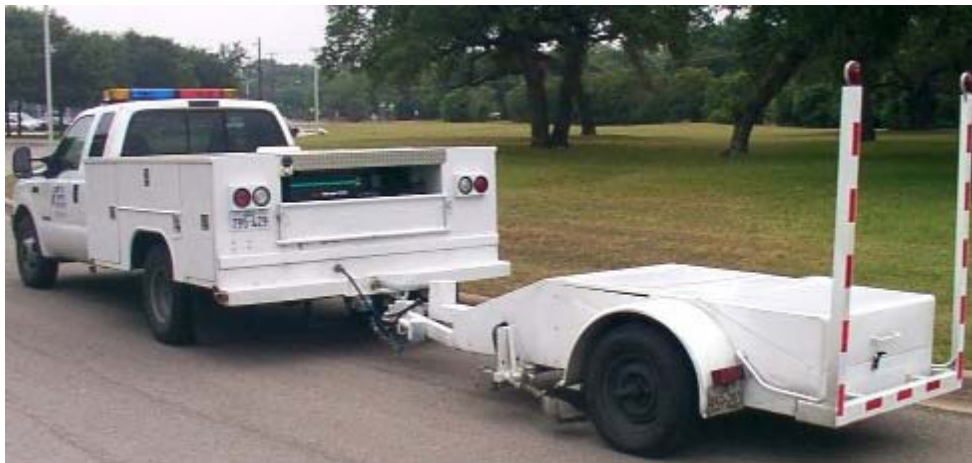
Figure 19. Two-Wheeled Trailer with Left Wheel Path Locking Tire.

TxDOT conducts skid testing using a two-wheeled trailer that is towed behind a truck (see Figure 19). The left tire of the trailer locks during testing and an electronic torque ring strain gauge located on the axle of the skidding tire measures strain that is further recorded on an on-board computer. During testing, a pressurized water sprayer wets the road in front of the locking tire. The water serves to lubricate the road to avoid causing the trailer to jerk to one side. In addition, the water serves to simulate skid resistance during wet conditions.

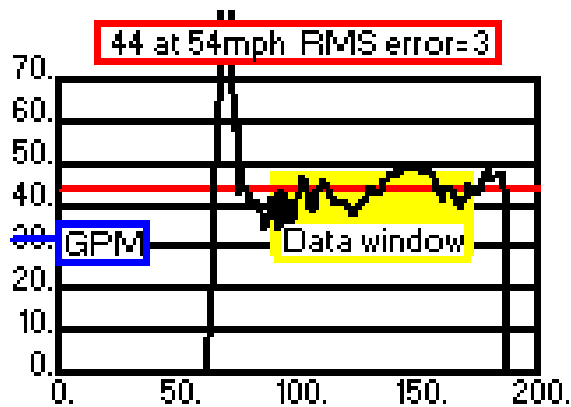
Figure 20. Typical Graph Output Obtained after a Skid Cycle.

Figure 20 shows an example of the data collected after a single cycle. The x-axis is time in hundredths of seconds and the y-axis is the skid resistance as calculated from the torque resistance. The SN is calculated from the data in the yellow area of the figure and the red line shows the SN. The blue box labeled GPM marks the water flow in gallons per minute.

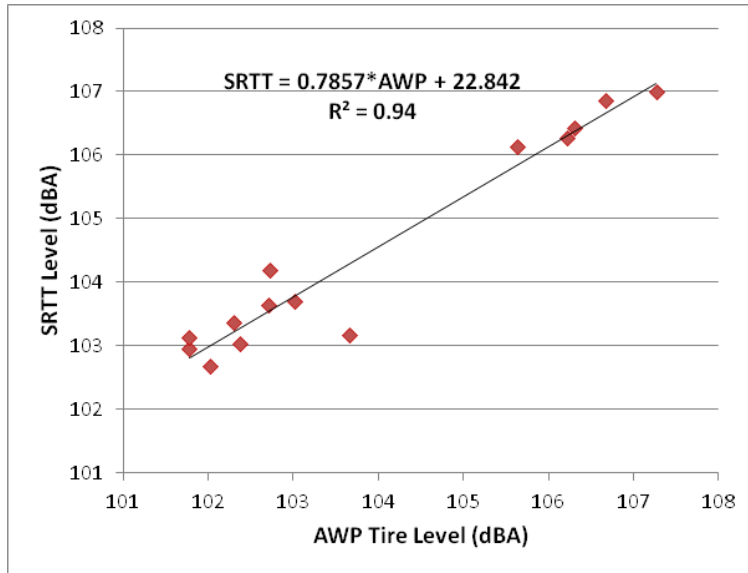
Figure 21. AWP-SRTT Correlation Using the Same Test Vehicle.

In early 2008, a second rodeo was conducted with TxDOT, but this time TxDOT incorporated the use of SRTTs into their system, while CTR kept using the AWP tires. Both agencies were still using the Chevy Malibu as test vehicle. TxDOT made some modifications to its vehicle to accommodate the installation of the larger SRTT in the rear axle. A third rodeo was conducted in July 2008. ANOVA was used to produce such correlation model, in which every other variable was controlled except for the tire type. A 94 percent correlation was obtained in this model, which was developed with the data from the second and third rodeos (see [Figure 21](#)).

The correlation model was developed with data collected on different pavement types, with the same vehicle type (Chevy Malibu), utilizing a brand-new SRTT, and a fairly new AWP tire. The data points that were collected in the measurements indicate that the SRTT levels were higher than their corresponding AWP tire values. This fact confirms that the SRTT tire is slightly louder than the AWP tire, as is commonly accepted. This model was used to make the AWP tire measurements comparable to the SRTT measurements.

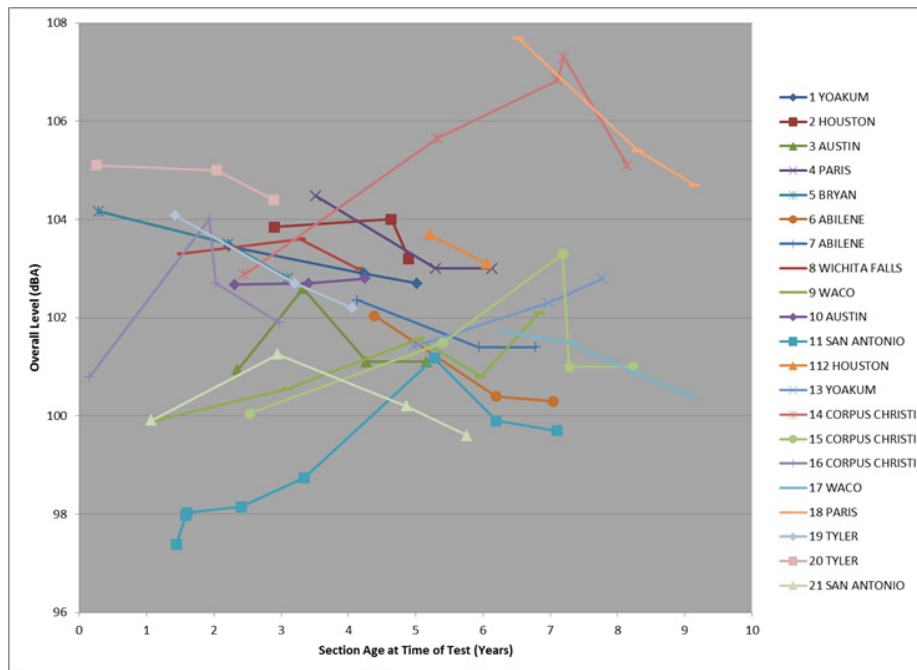
Figure 22. OBSI Noise Levels with Pavement Life.

In order to analyze the noise measurements obtained in this project from the pavement age standpoint, the OBSI overall sound levels were plotted for each section against the age of the section at the time of each particular test. Age was computed in years, from the time of construction for each pavement to the date when the OBSI test was performed. The results are shown in Figure 22, which includes both PFCs and dense-graded HMA reference sections.

As shown in Figure 22, there was not a clear pattern of noise level trend with age; even some sections showed that these got quieter with time. A possible explanation for the reduction of noise levels with age is that, as indicated before, the last set of measurements (summer 2012) was performed with a brand-new tire, whereas the 2011 tests were conducted with an almost-new tire, and the measurements prior to 2011 were conducted with older AWP tires.

As tires age, the rubber hardens, resulting in higher noise levels. Therefore, a brand-new tire is expected to provide lower noise levels. The correlation model was applied to noise measurements performed prior to 2011 (measured with AWP tires) in an effort to make the results comparable with tests conducted with SRTTs. However, no adjustment was made to account for tire age.

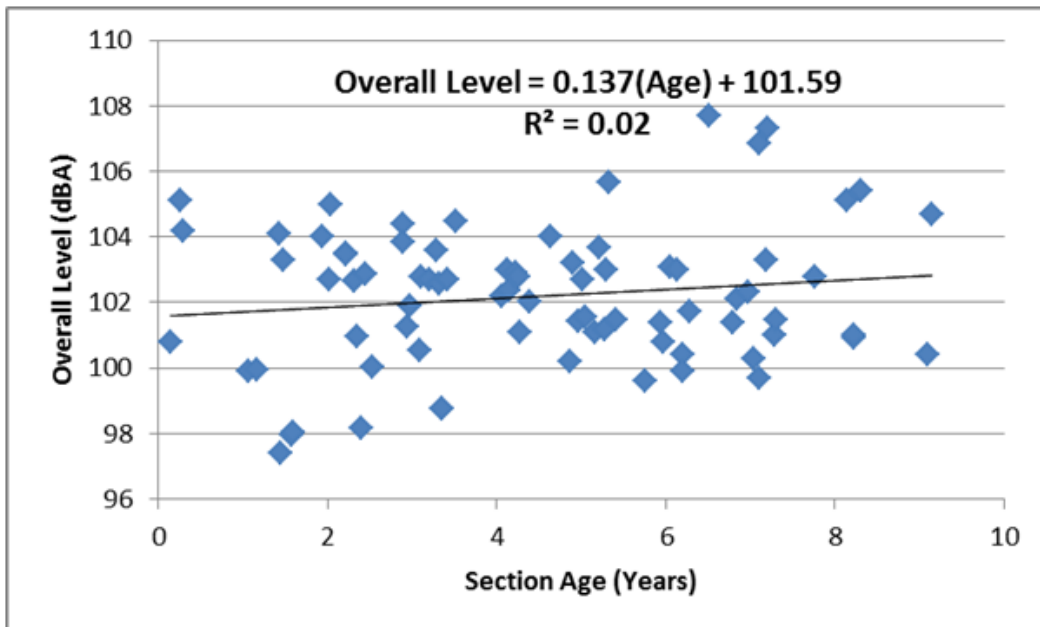
Figure 23. Correlation between Noise Levels and Pavement Age.

If the overall levels are plotted against pavement age as shown in [Figure 23](#), disregarding the association of each measurement with its pavement section, it can be seen that there is a slight upward trend in noise levels with pavement age. The correlation between noise levels and age, however, is rather poor ($R^2=0.02$).

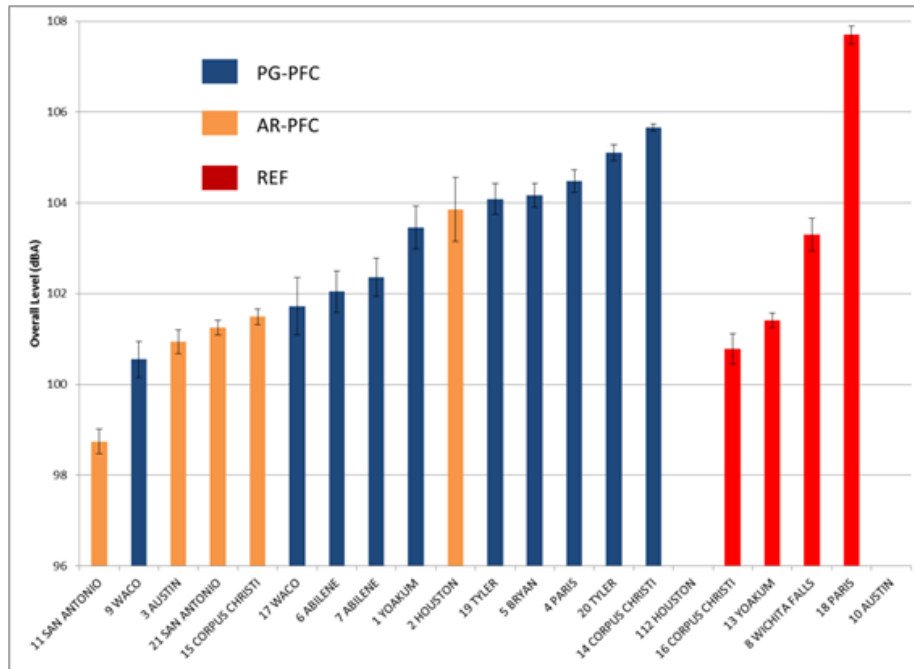
Figure 24. Effect of Binder/Mixture Type on Noise Levels for Measurement Year 2009.

Figure 24, Figure 25, and Figure 26 show that, in general, AR-PFCs appear to be quieter than the PG-PFCs, and that PFCs in general are quieter than dense-graded HMAs, although the differences are small, but the trends are consistent throughout the years. Unfortunately, the number of AR-PFC sections is very small and thus drawing more definitive conclusions in this regard is difficult. Another important aspect that can be observed is that not all dense-graded HMA reference sections are louder than PFCs. In addition, a few sections are consistently quiet (e.g., Sections 11 and 21, in San Antonio) and some are consistently loud (e.g., Sections 20 in Tyler, and 14 in Corpus Christi, both PFCs, and Section 18 in Paris, a reference section).

Graphs for the overall levels for each section corresponding to 2009, 2011, and 2012, sorted by pavement type and showing the binder type are presented in [Figure 24](#), [Figure 25](#), and

Figure 26, respectively. Figure 24, Figure 25, and Figure 26 also display the variability of the measurements for each of the sections in the form of standard deviation bars. The chart for the 2010 measurements is omitted because only a few sections were tested that year.

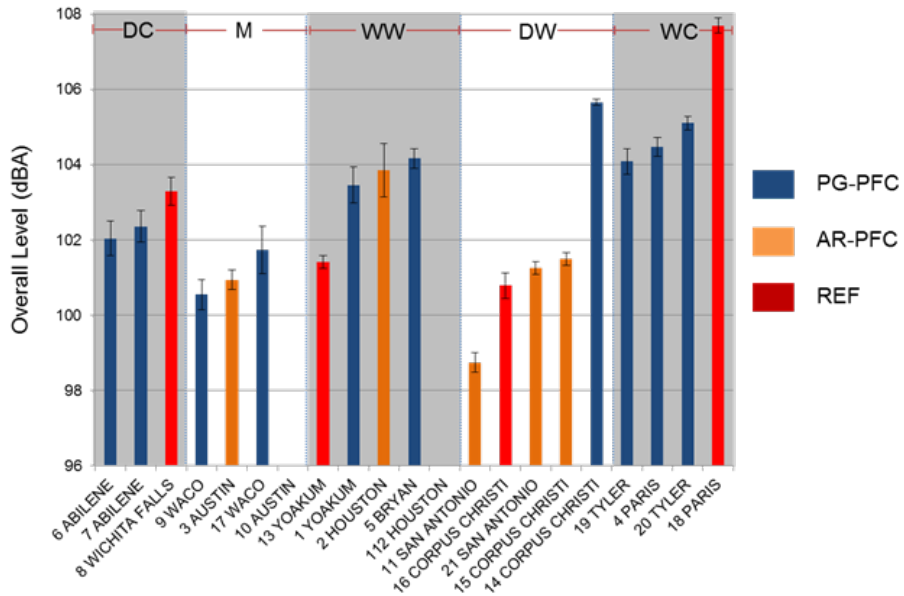
Figure 27. Effect of Climate on Noise Levels for Measurement Year 2009.

In general, AR-PFCs seem to perform acoustically well in the DW climatic region, but it may be that the quietest PFCs are AR, and happen to be located in San Antonio. There is also one fairly quiet AR-PFC in Corpus Christi, which corresponds to that climatic region as well. Reference sections appear to have higher noise levels in the cold regions. Figure 30 summarizes the OBSI noise measurements taken over the years by climatic region, showing the average throughout the life of the project. Figure 30 shows that the M region has the lowest noise levels, and that the WC region has the loudest pavements. The DC and DW regions have very similar noise levels over the years.

It can also be observed that the variability for measurements taken in regions classified as M and WW is very small compared to the other regions, and that the results corresponding to the DW region have a very large variability.
