1. Report No. FHWA/TX-12/0-5836-2		2. Government Accession No.		3. Recipient's Catalog No.	
4. Title and Subtitle PERFORMANCE AND COST EFFECTIVENESS OF PERMEABLE FRICTION COURSE (PFC) PAVEMENTS				5. Report Date Published: February 2013

PERFORMANCE AND COST EFFECTIVENESS OF PERMEABLE FRICTION COURSE (PFC) PAVEMENTS

Report 0-5836-2
Project 0-5836

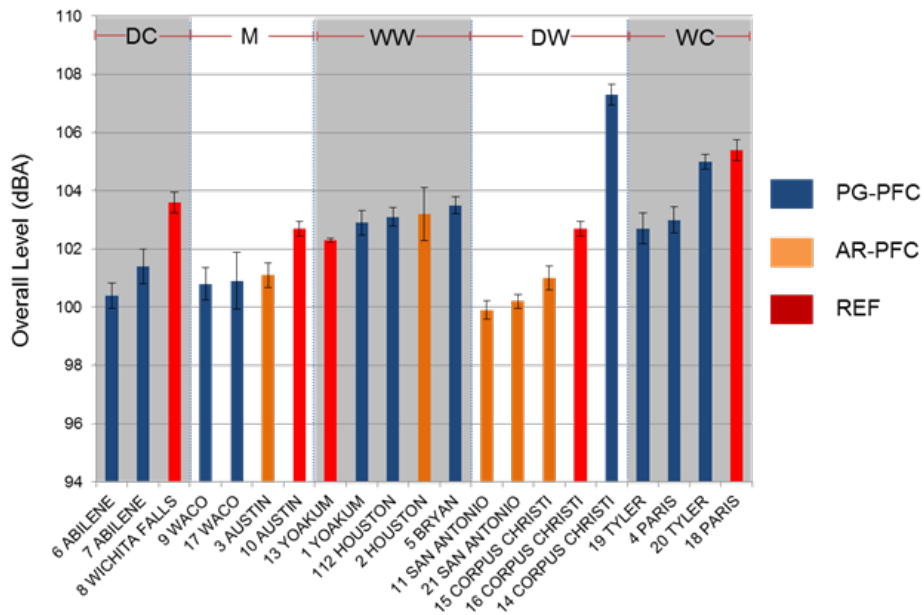
Figure 28. Effect of Climate on Noise Levels for Measurement Year 2011.

In general, AR-PFCs seem to perform acoustically well in the DW climatic region, but it may be that the quietest PFCs are AR, and happen to be located in San Antonio. There is also one fairly quiet AR-PFC in Corpus Christi, which corresponds to that climatic region as well. Reference sections appear to have higher noise levels in the cold regions. Figure 30 summarizes the OBSI noise measurements taken over the years by climatic region, showing the average throughout the life of the project. Figure 30 shows that the M region has the lowest noise levels, and that the WC region has the loudest pavements. The DC and DW regions have very similar noise levels over the years.

It can also be observed that the variability for measurements taken in regions classified as M and WW is very small compared to the other regions, and that the results corresponding to the DW region have a very large variability.

The effect of climate on noise levels was explored based on the climatic regions within the state of Texas (Figure 3): dry cold (DC), dry warm (DW), moderate (M), wet cold (WC), and wet warm (WW). Table 4 lists the classification of the sections where noise was measured. Graphs presenting the noise measurements for each of the sections, grouped by climatic region and sorted by noise level within each region, are shown for the 2009, 2011, and 2012 in Figure 27, Figure 28, and Figure 29, respectively.

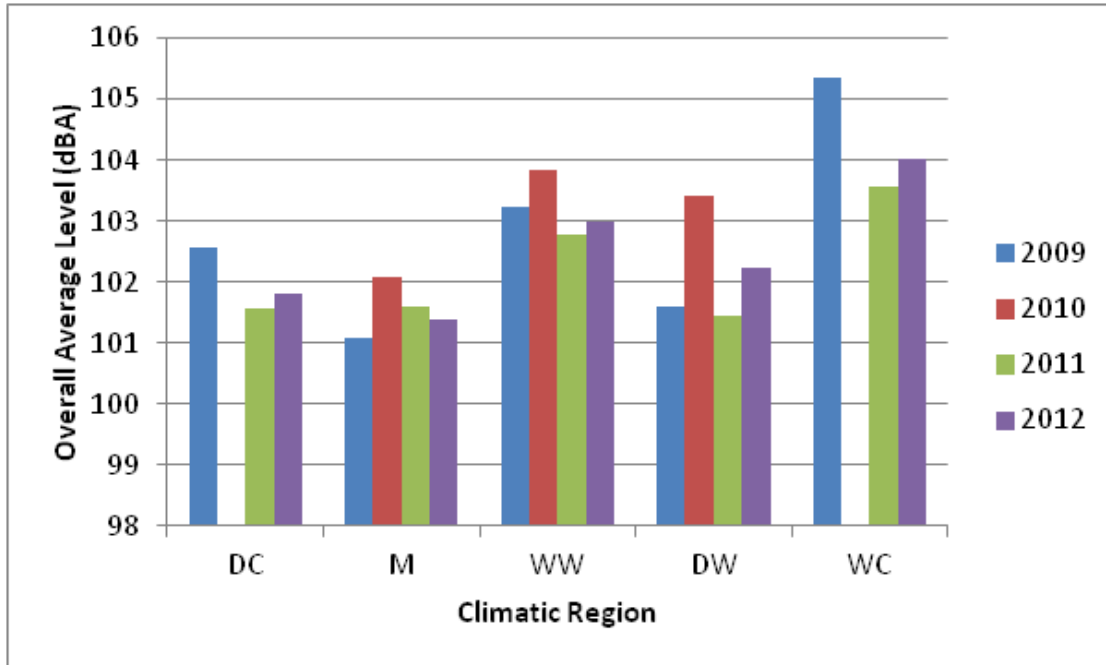
Figure 30. Average OBSI Noise Levels by Climatic Region.

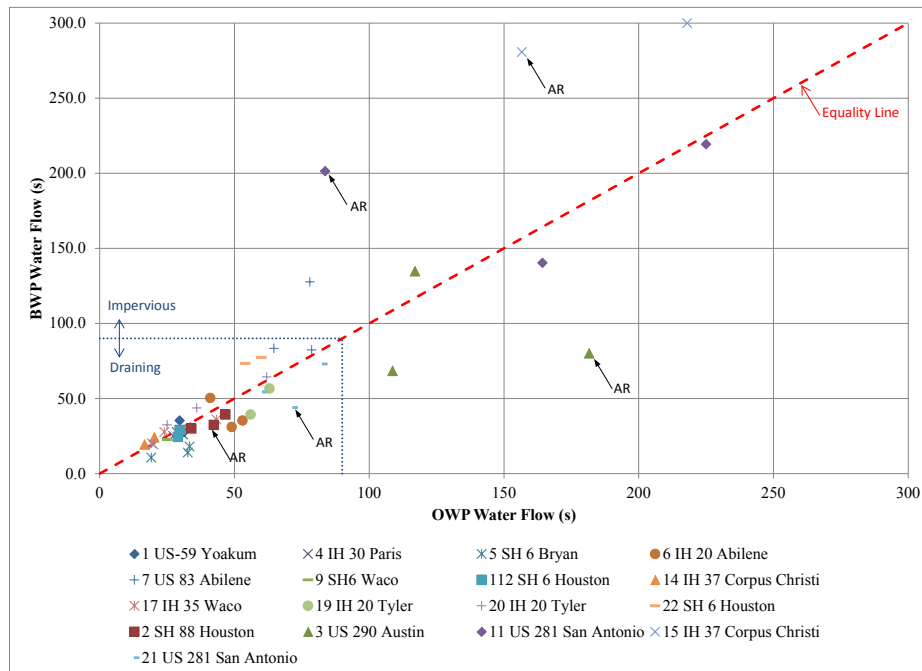
Figure 31. Effect of Traffic on Drainability.

In general, more variability was observed for AR-PFCs (Avg. Coefficient of Variance [COV] = 34 percent) than for PG-PFCs (Avg. COV = 18 percent). In addition, it is apparent that after a WFV of about 90 seconds, the correlation of BWP vs. OWP becomes weaker. Therefore, 90 seconds was established as the threshold to define draining PFC pavements vs. impervious ones. All OWP drainability measurements for PG-PFC pavements were below the established threshold.

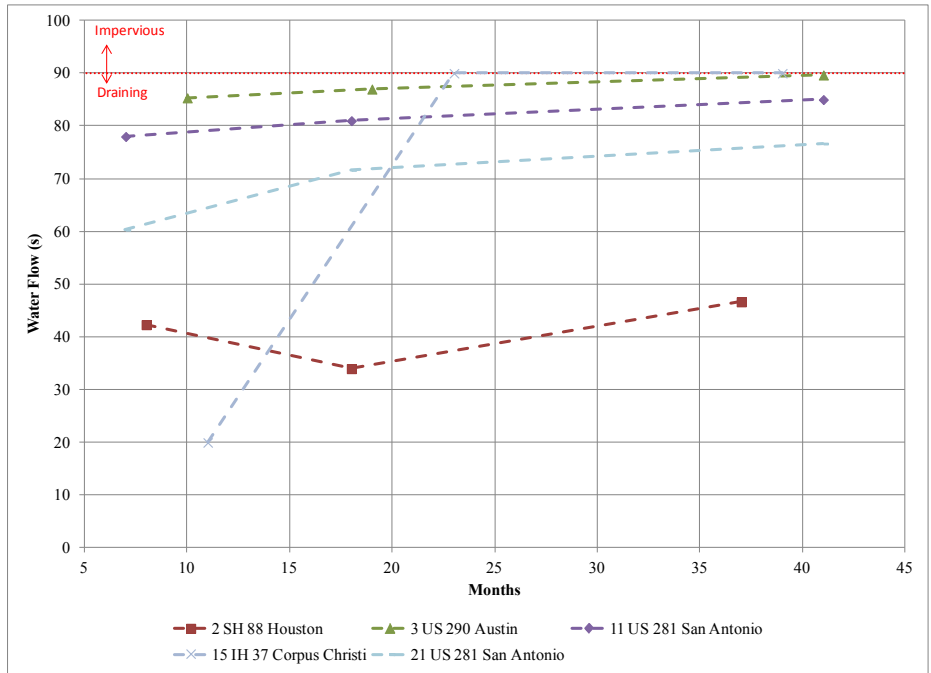
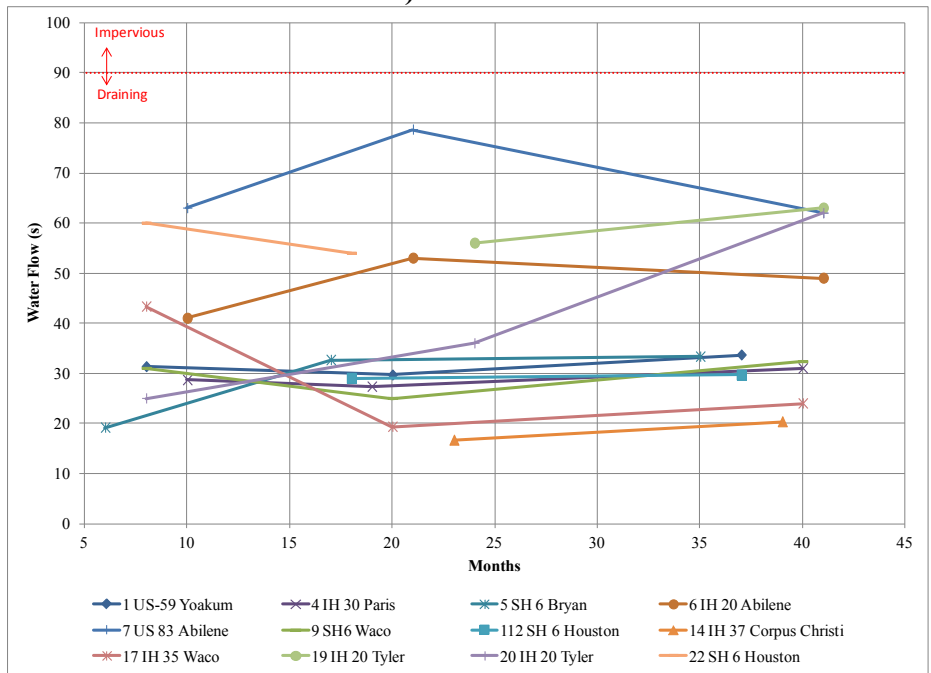
Figure 32. OWP Drainability Measurements throughout the Life of the Project.

The effect of time in drainability is illustrated in [Figure 32](#) and [Figure 33](#) for AR-PFCs and PG-PFCs after applying the 90-second impervious threshold criteria to the subsection measurements. Only OWP measurements are presented due to the strong correlation between

BWP and OWP values. In Figure 32, the values are shown based on the duration of the project, while in Figure 33, the results are presented taking into account the age of the pavement sections.

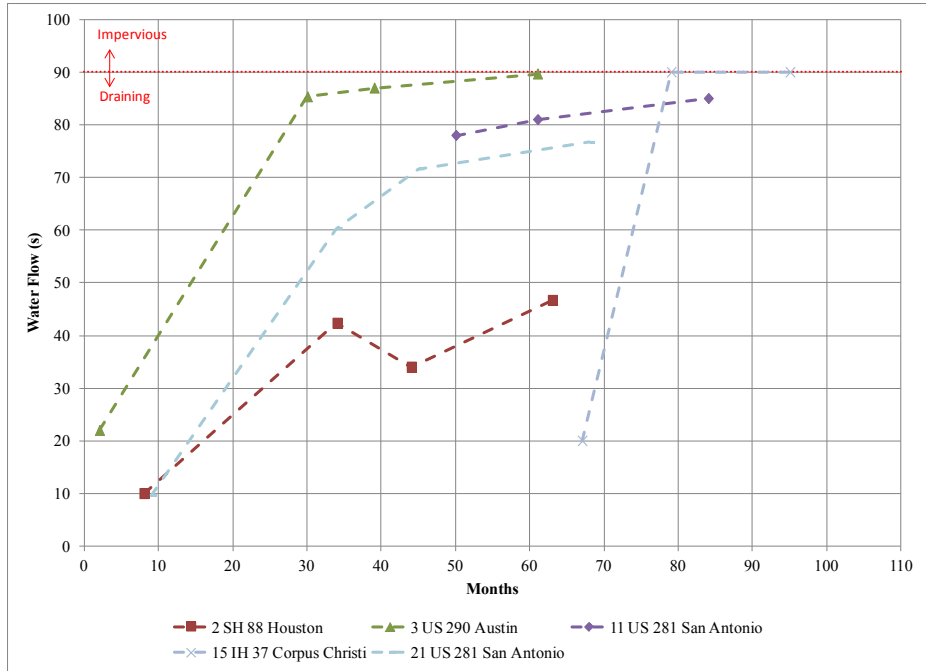
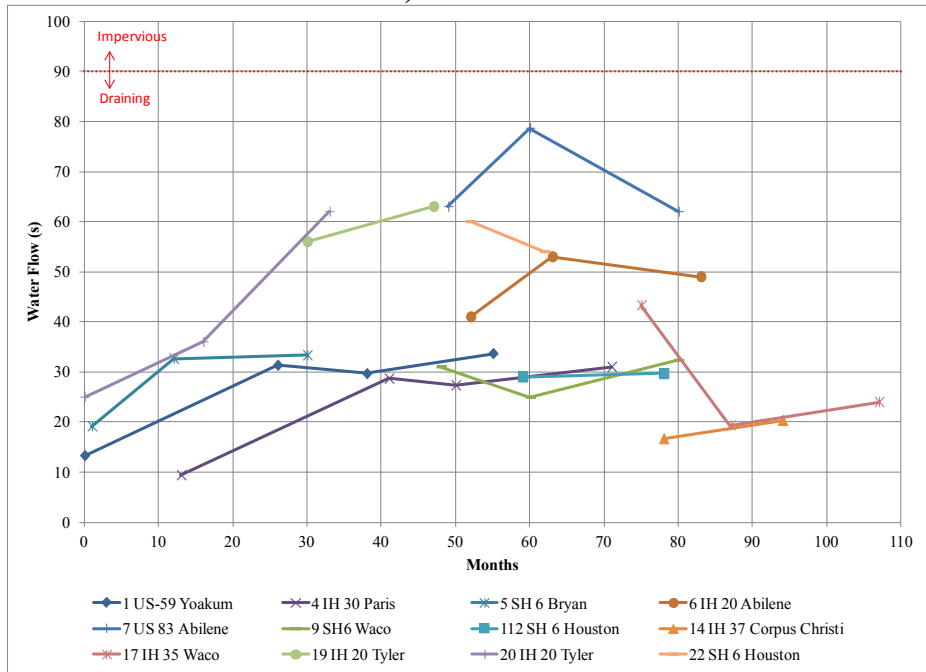
Figure 33. OWP Drainability Measurements with Pavement Life.

In Figure 33, WFVs from five field sections (i.e., 1, 2, 3, 4, and 21) that were collected in 2007 soon after construction as part of previous TxDOT Project 0-5262 *Optimizing the Design of Permeable Friction Courses (PFC)* are also included. All 2007 values were below 20 seconds.

For the PG-PFC pavements, after the initial increase in WFV, the drainability of more than one-third of the pavement sections remained constant at around 30 seconds (see [Figure 33b](#)). On the other hand, the WFVs for three out of the five AR-PFC sections were close to or beyond the impervious threshold of 90 seconds. Section 15, IH 37 in Corpus Christi, had a fog seal treatment applied between the 1st and 2nd measurement years, which explains the steep increase in WFV. Based on the measurements performed in this project, it is likely that the AV structure of the AR-PFC pavements is more prone to clogging, possibly due to the finer gradation and higher binder content that TxDOT specifications required.

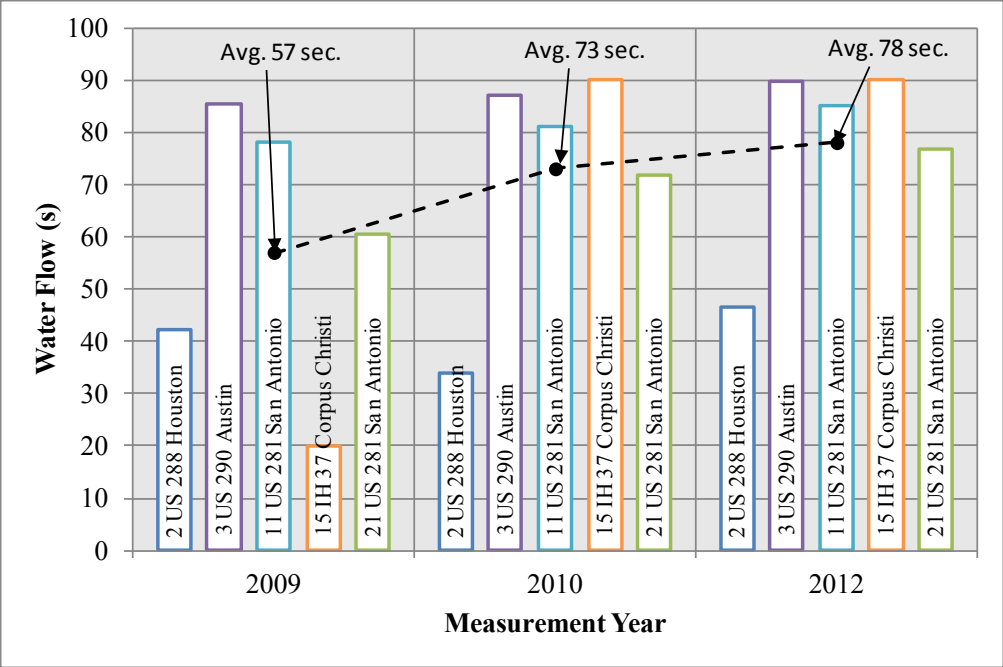
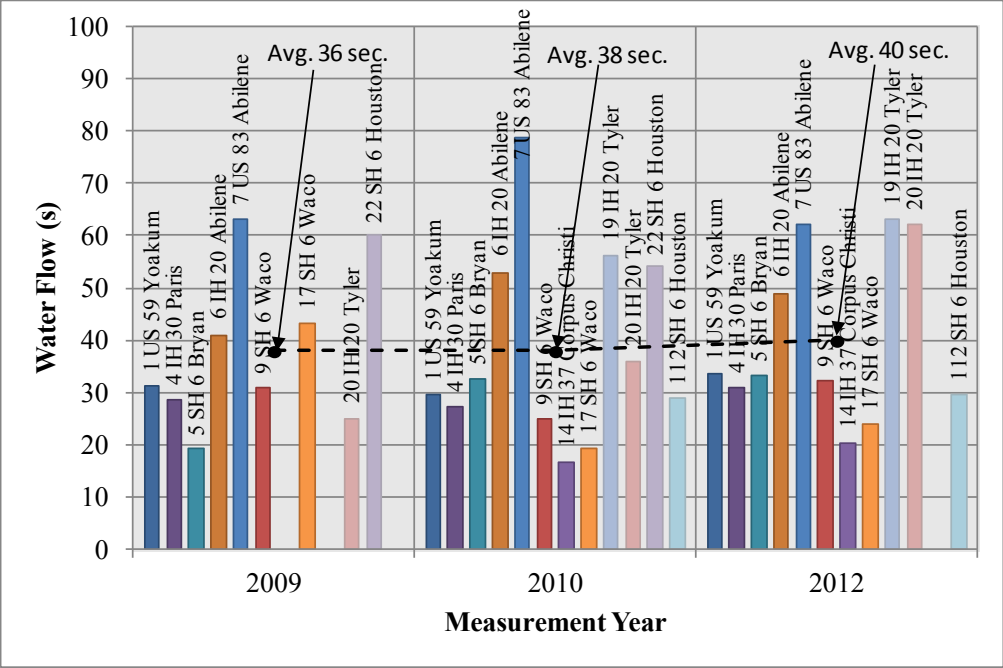
Figure 35. OWP Drainability for Each Measurement Year with 90-Second Impervious Threshold.

With regard to type of binder used in the PFC pavements, the statistical comparison between the AR-PFC and PG-PFC WFVs revealed differences. On average, considering only the 5-minute field threshold on the subsection measurements, the WFV for the AR-PFC pavements increased almost twofold from 63 seconds in 2009 to 122 seconds in 2010, and then stabilized at around 138 seconds in 2012. By contrast, the average WFV for PG-PFCs remained constant at 38 seconds in 2009 and 2010, and 40 seconds in 2012 (see [Figure 34](#)). When the 90-second impervious threshold criteria was applied to the subsection measurements, the average WFVs for AR-PFCs changed from 57 to 73 and to 78 seconds, while for PG-PFCs the average WFVs were 36, 38, and 40 seconds for years 2009, 2010, and 2010, respectively (see [Figure 35](#)).

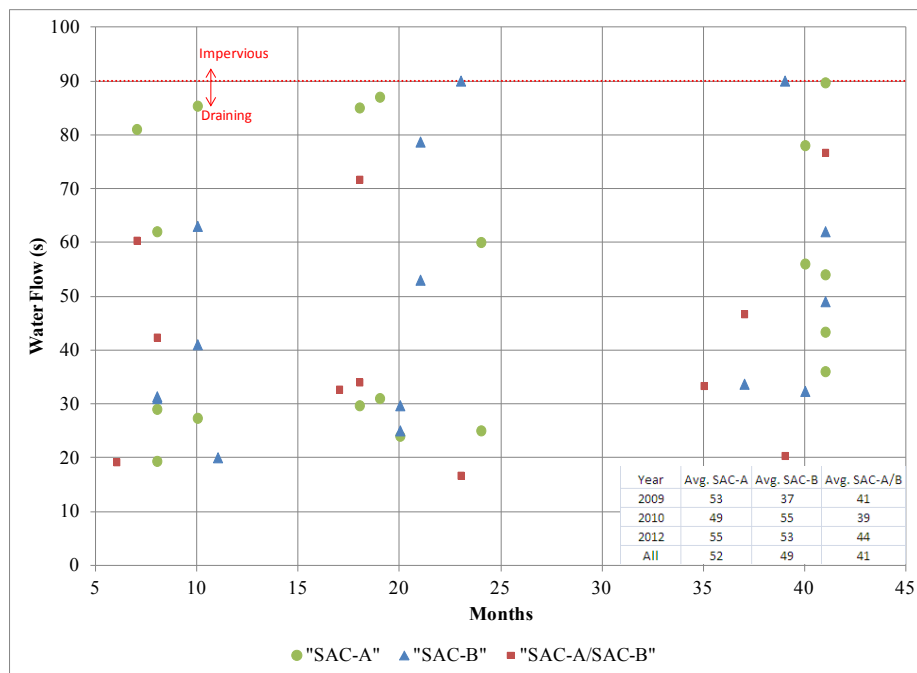
Figure 36. Effect of Aggregate Classification on Drainability OWP Measurements.

A statistical comparison of the WFVs obtained for the pavement sections with SAC-A, SAC-B, and combination of SAC-A/B aggregates showed no significant differences. Figure 36 illustrates how the WFVs for the different type of aggregates are not clustered. The averages for each measurement year and for all years combined are also shown in Figure 36.

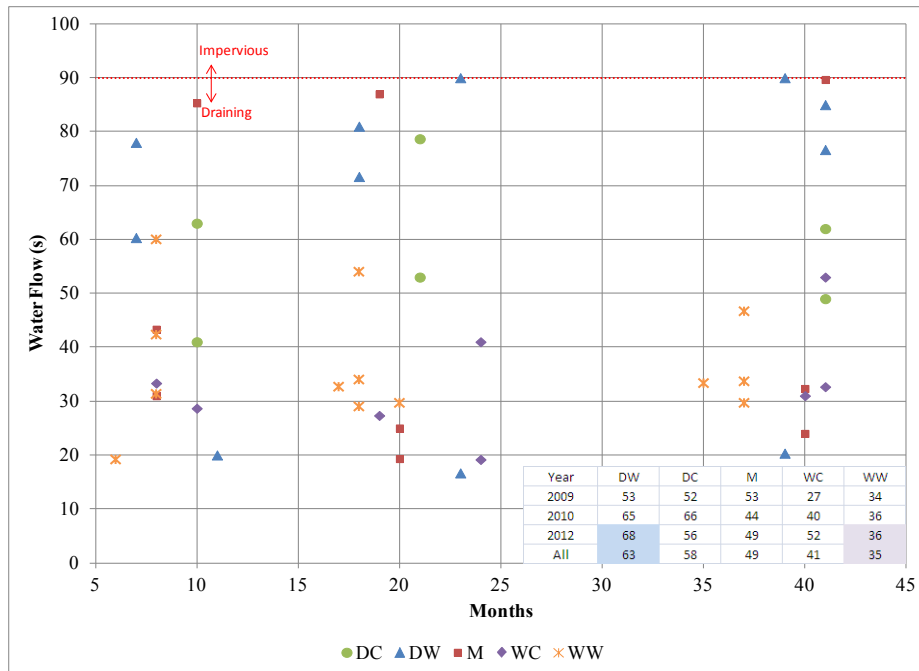
Figure 37. Effect of Climate on Drainability OWP Measurements.

Another factor that was explored was the effect of climate on drainability. Figure 37 shows the results for each measurement year. A statistical analysis using ANOVA and Tukey’s HSD resulted in no statistical significant differences for measurement years 2009 and 2010. However, in year 2012 as well as when all three years were analyzed together, the WW and DW climatic regions were statistically different from each other. The WFVs in the WW climate were significantly lower when compared to the other climatic regions, around 35 seconds in average,

while the WFVs in the DW climate were much larger, around 63 seconds. The WFVs for the other three climatic regions arranged in increasing order as follows: WC with an average of about 40 seconds, M with an average of almost 50 seconds, and DC with an average of 58 seconds. This seems to indicate that the amount of rainfall in a particular climatic region does play an important role in the continued drainability of PFCs, especially in warm climates.

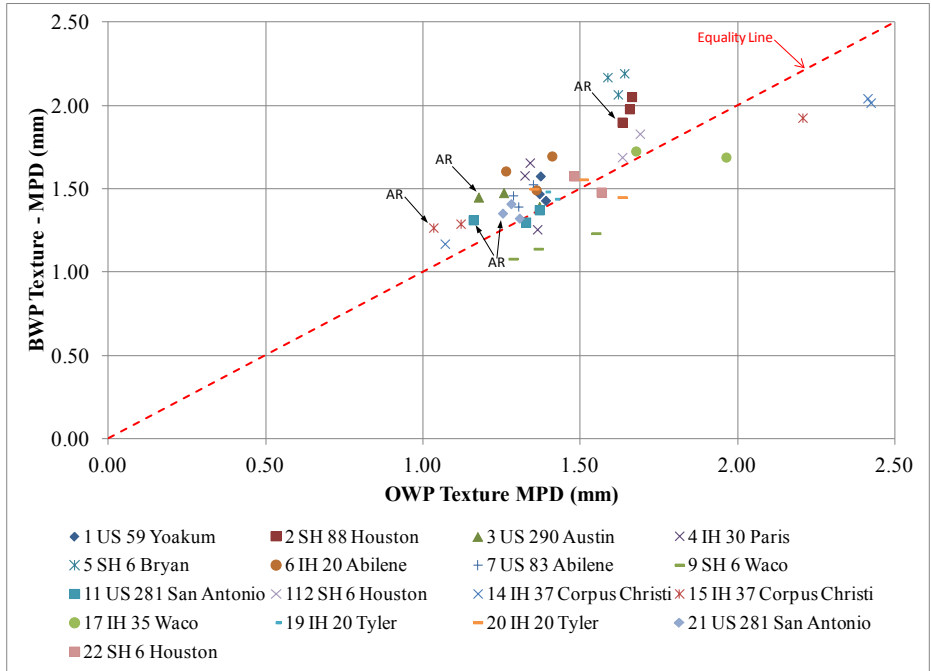
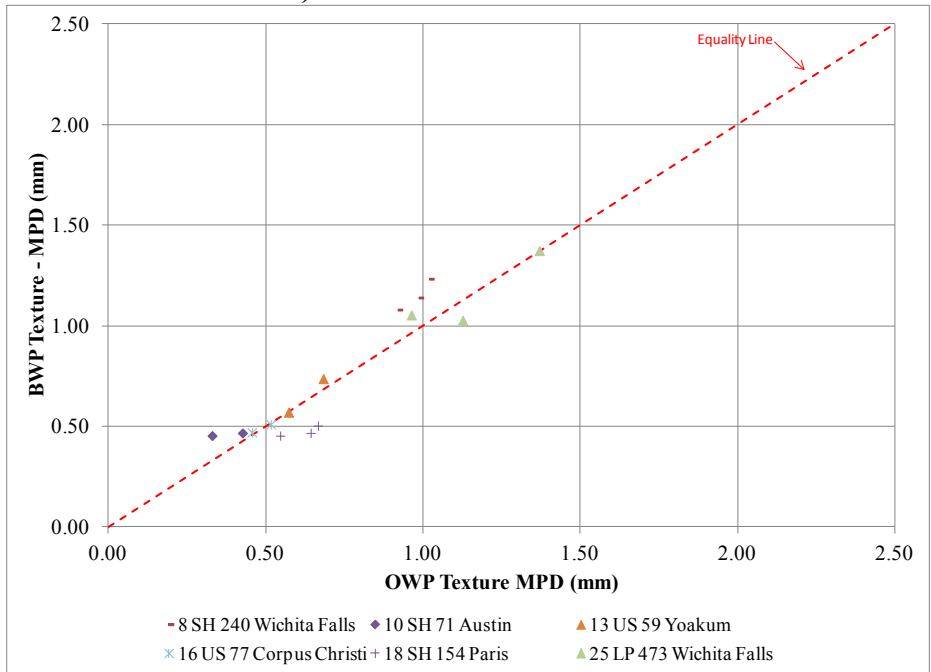
Figure 38. Effect of Traffic on Texture Measurements.

Texture measurements were performed on all pavement sections in years 2009, 2010, and 2012. The effect of traffic on texture was assessed by comparing OWP vs. BWP MPD values. [Figure 38](#) illustrates the relationship between these measurements. There is a strong correlation between the MPD values acquired OWP and BWP for both PFC and non-PFC pavements. For PFCs, the MPD values acquired BWP align slightly above the equality line, which implies that texture BWP is somewhat larger than texture OWP (see [Figure 38a](#)). The average MPD BWP is 1.59 mm (0.063 inch) and 1.47 mm (0.057 inch) for OWP.

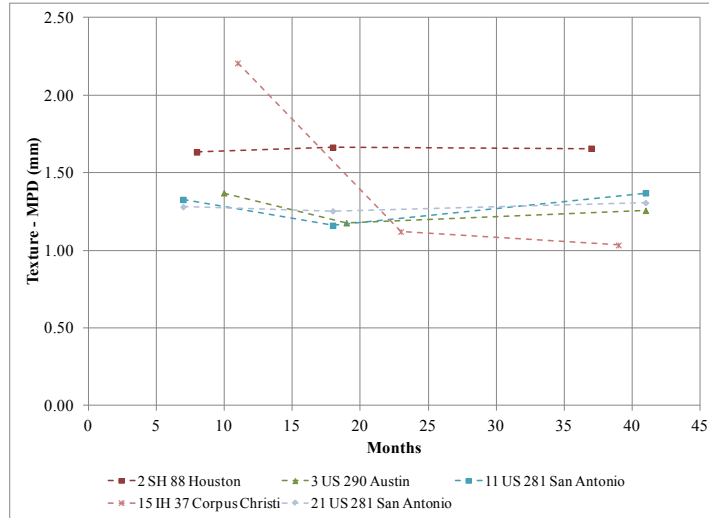
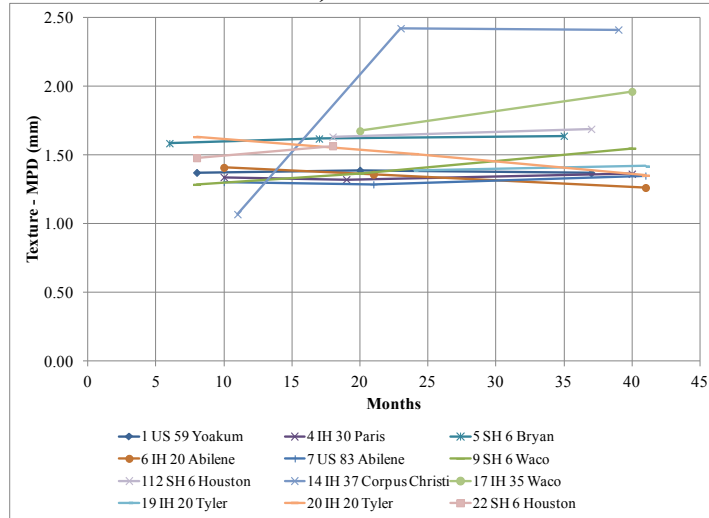
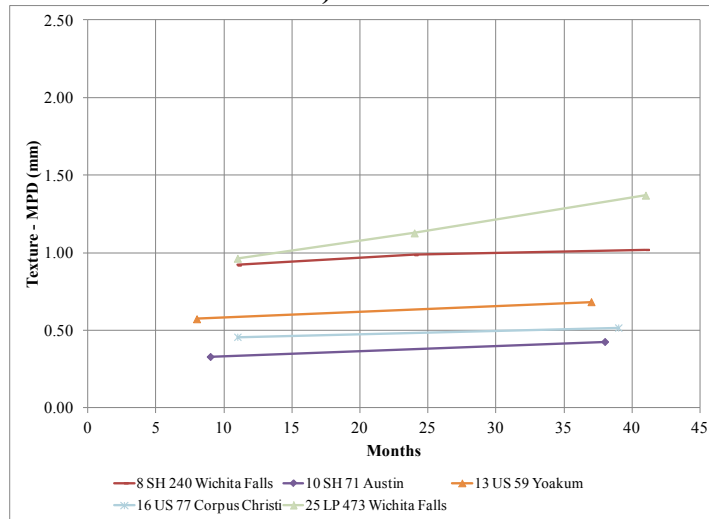
Figure 39. OWP Texture Measurements throughout the Life of the Project.

The change of texture with time is illustrated in [Figure 39](#) and [Figure 40](#). [Figure 39](#) shows the data with respect to the duration of the project, while [Figure 40](#) takes into account the age of the pavement. All pavement sections with the exception of section 14 and 15 in Corpus Christi show relatively flat texture trends. A statistical comparison using a paired two-sample t-test (two-tailed) with a significance level of 5 percent ($\alpha = 0.05$) for OWP texture values showed significant differences between MPD values collected in 2009 vs. 2010 for only these two sections. The rest of the sections resulted in no statistical significant differences.

In the case of section 15, a fog seal was applied between the measurements performed in years 2009 and 2010, causing the significant decrease in texture. For Section 14, the raveling experienced by the pavement towards the end of its service life more likely has caused the increase in texture. In addition, this pavement section was laid on top of an existing surface with considerable amounts of cracking. Also, between years 2009 and 2010, several freeze/thaw cycles were experienced in that region. Sections 14 and 15 were considered extreme cases and excluded from the subsequent analysis.

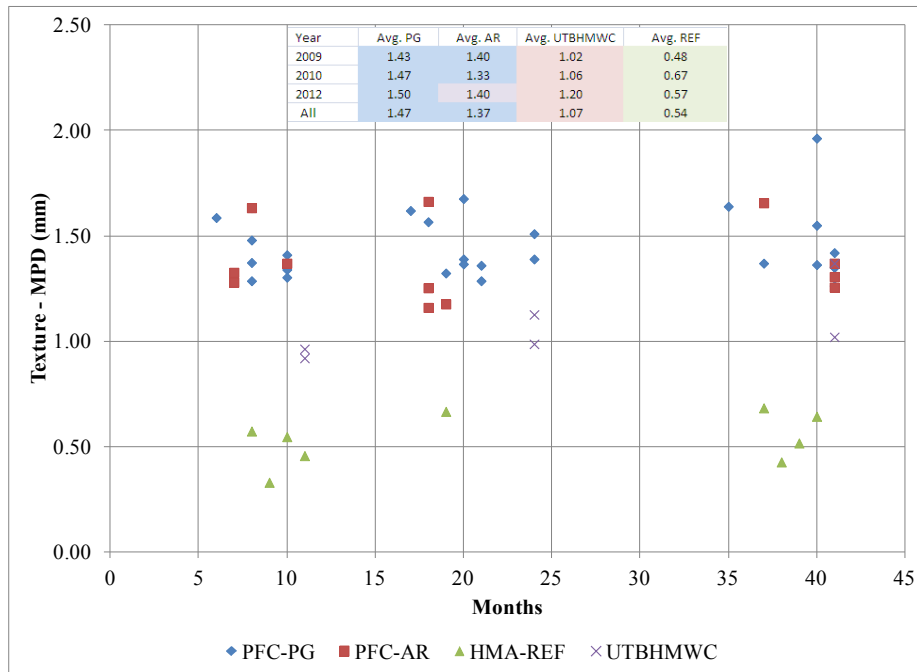
Figure 41. Effect of Binder/Mixture Type on OWP Texture Measurements

Figure 41 illustrates the effect of binder/mixture type. A statistical comparison of the results using ANOVA and Tukey’s HSD showed that both AR and PG-PFCs had a statistical equivalent texture and superior than the dense-graded HMA pavement sections used as reference. The UTBHMWC texture values aligned between the PFCs and HMAs. The statistical results for the mixtures and average texture values are presented in table format in Figure 41 with color-coding indicating the mixtures that belong to the same statistical group. Texture values for AR-PFCs were statistically equivalent to both PG-PFCs and UTBHMWC in 2012. These results indicate that PFCs offer better texture characteristics than conventional dense-graded HMA and the texture values stay somewhat constant over time.

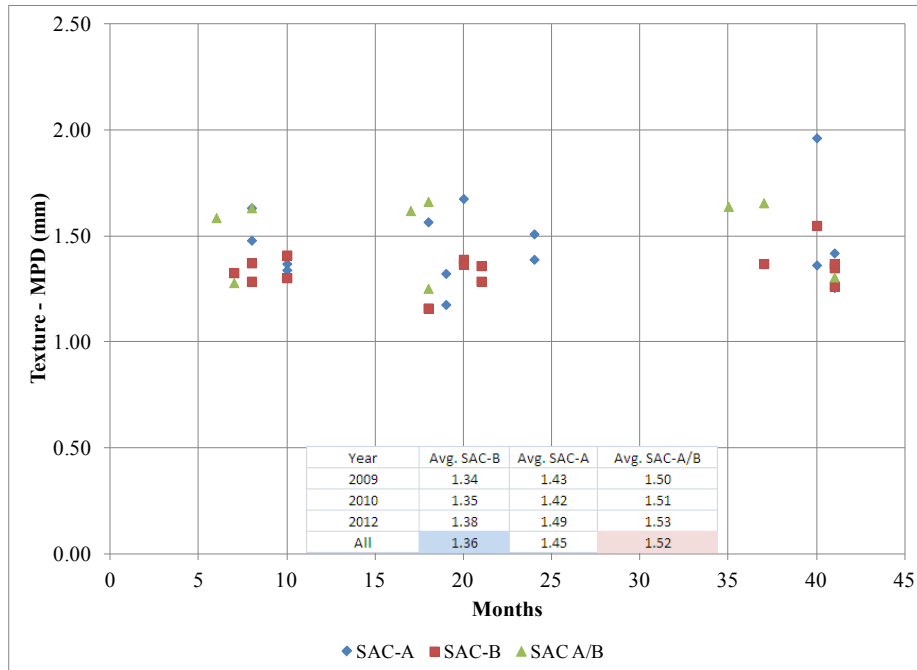
Figure 42. Effect of Aggregate Classification on OWP Texture Measurements for PFC Pavements.

The effect of aggregate classification on PFC texture was also evaluated. Results show that the average texture for the PFC sections with SAC-A aggregates were around 1.45 mm; (0.057 inch), for SAC-B aggregates 1.36 mm (0.053 inch); and for a combination of SAC-A/B aggregates, 1.52 mm (0.060 inch) (see Figure 42). For each measurement year, the difference in MPD values was statistically insignificant. When results for all years were combined, the texture values for the sections with SAC-A/B aggregates were statistically different from the SAC-B aggregates, while the texture values for the sections with SAC-A aggregates was statistically

equivalent to sections with either SAC-B or SAC-A/B aggregates. Overall, one can assume that the use of aggregates with different classifications in the PFC mixtures has no significant impact on the texture values. Moreover, texture on PFC pavement sections seems to remain unchanged over time.

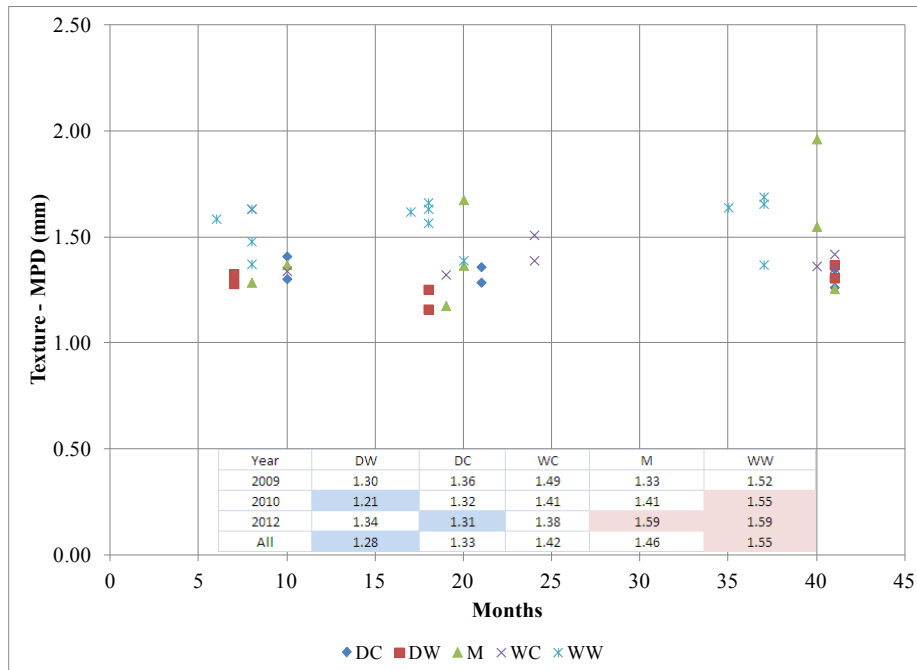
Figure 43. Effect of Climate on Texture OWP Measurements for PFC Pavements.

With respect to the effect of climate on texture, a statistical analysis using ANOVA and Tukey’s HSD was performed, taking into account the climatic region of the PFC pavement sections. The climatic regions with significant differences are color-shaded in the table included in Figure 43. The largest texture values corresponded to the pavement sections located in the WW climatic region, while the lowest texture was measured in the sections located in the DC and DW climatic regions. These differences are consistent with each measurement year, and as previously discussed, texture values remain unchanged with time. This indicates that the texture achieved in PFCs soon after construction is more critical than the climatic region where the pavement section is located.

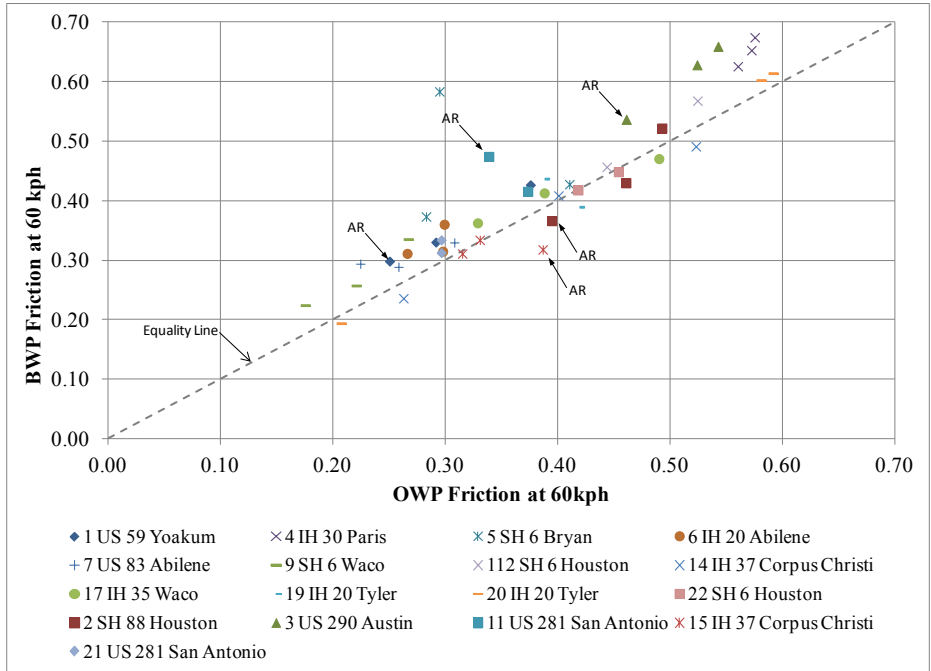
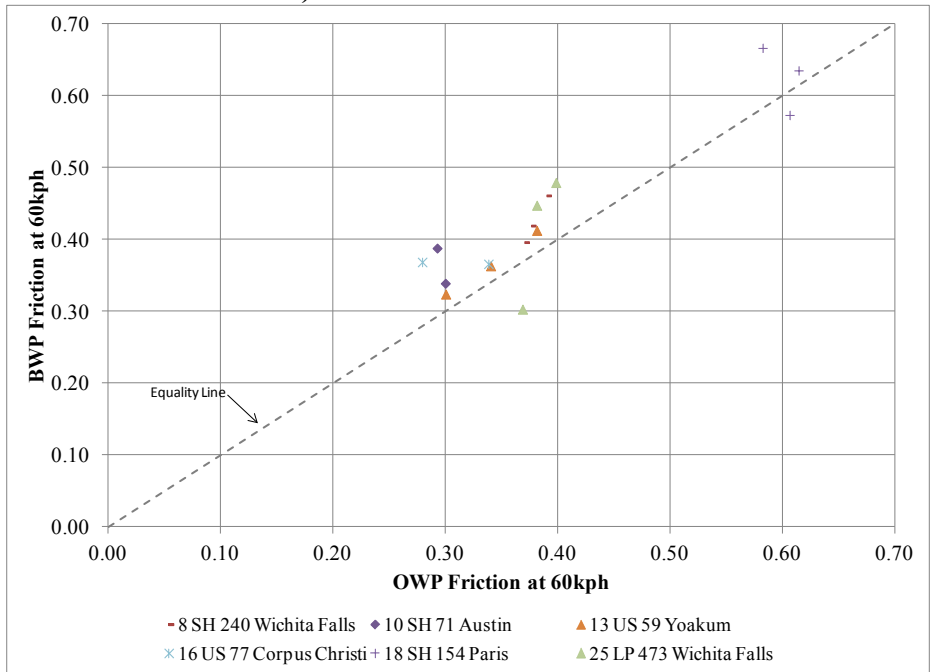
Figure 44. Effect of Traffic on Friction Measurements.

An important characteristic of PFCs is their ability to provide adequate friction in order to aid in reducing the number of accidents, especially during wet weather events. The effect of traffic on friction was evaluated using OWP and BWP DFT measurements acquired at 60kph. Figure 44 illustrates the comparison. There was a strong correlation between the OWP and BWP, which aligned close to the 45-degree equality line. The friction values BWP were slightly higher BWP than OWP, especially for non-PFC pavements (Figure 44b). For PFCs, the average friction at 60 kph BWP was 0.42 and 0.39 for OWP, while for non-PFCs the average friction BWP and OWP was 0.44 and 0.39, respectively.

A statistical comparison between texture measured BWP and OWP was performed using a paired two-sample t-test (two-tailed) with a significance level of 5 percent ($\alpha = 0.05$). Sections with statistical significant different friction values taken at the same locations within the same measurement year are listed in Table 7. Very few sections resulted in statistical significant differences, and the majority of these occurred in the first measurement (i.e., 2009). For PFCs, the BWP friction measurements for PFCs were slightly more variable (Avg. COV 10.0 percent) than OWP (Avg. COV 9.1 percent).

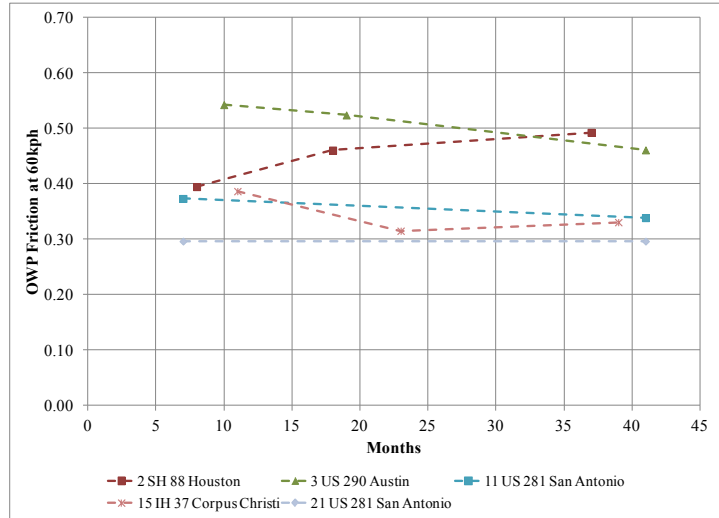
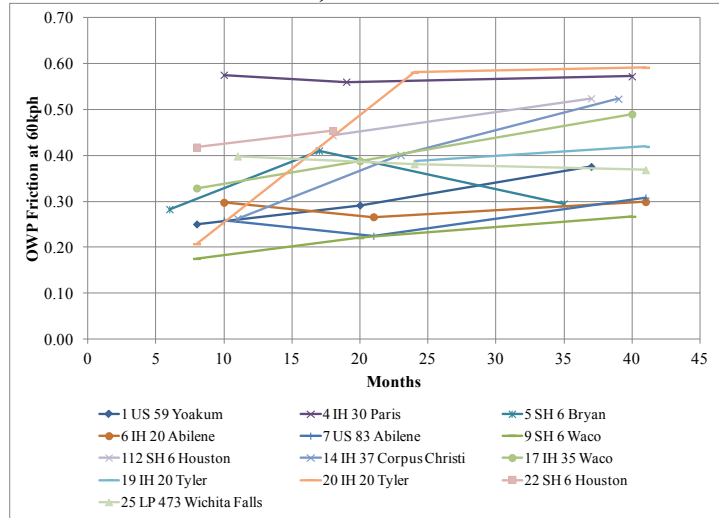
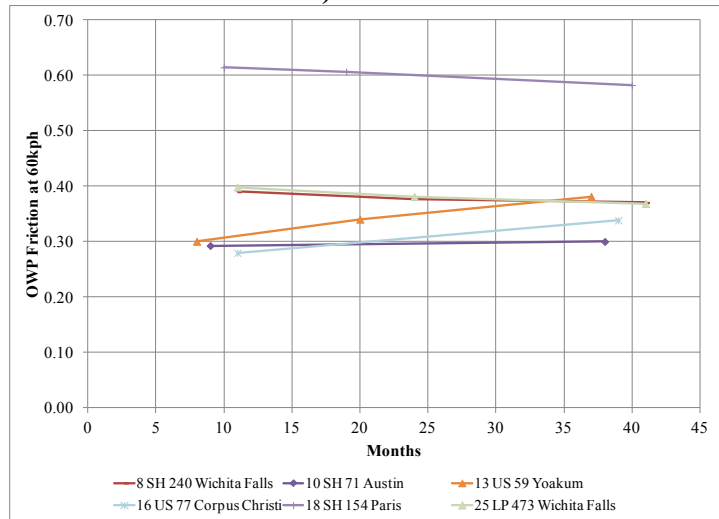
Figure 45. OWP Friction Measurements throughout the Life of the Project.

The change in friction with time is illustrated in [Figure 45](#) and [Figure 46](#). [Figure 45](#) illustrates the trends with respect to the duration of the project, while the friction measurements in [Figure 46](#) are plotted against the life of the pavement sections. In general, PG-PFCs show upward friction trends, while AR-PFCs and non-PFC pavement sections show flat or downward friction trends with time. A statistical comparison using a paired two-sample t-test (two-tailed) with a significance level of 5 percent ($\alpha = 0.05$) was done to compare the friction data acquired during the different measurement years. For PFCs, sections with statistically significant OWP friction values from measurement years 2009 vs. 2010 included sections 5, 6, 14, and 20, and from measurement years 2010 vs. 2012 sections 7 and 14. For non-PFC pavements, only section 13 showed statistical differences.

As previously mentioned, Section 14 experienced raveling, which could explain the significant increase in measured texture. Section 15, which was treated with a fog seal between years 2009 and 2010, showed a decrease in friction, although not statistically significant. The significant increase in friction observed in pavement Section 20 is likely due to the fact that this pavement section was constructed just before the first measurement was acquired, and it is known that after traffic wears down the asphalt binder at the surface of the pavement the friction values tend to increase.

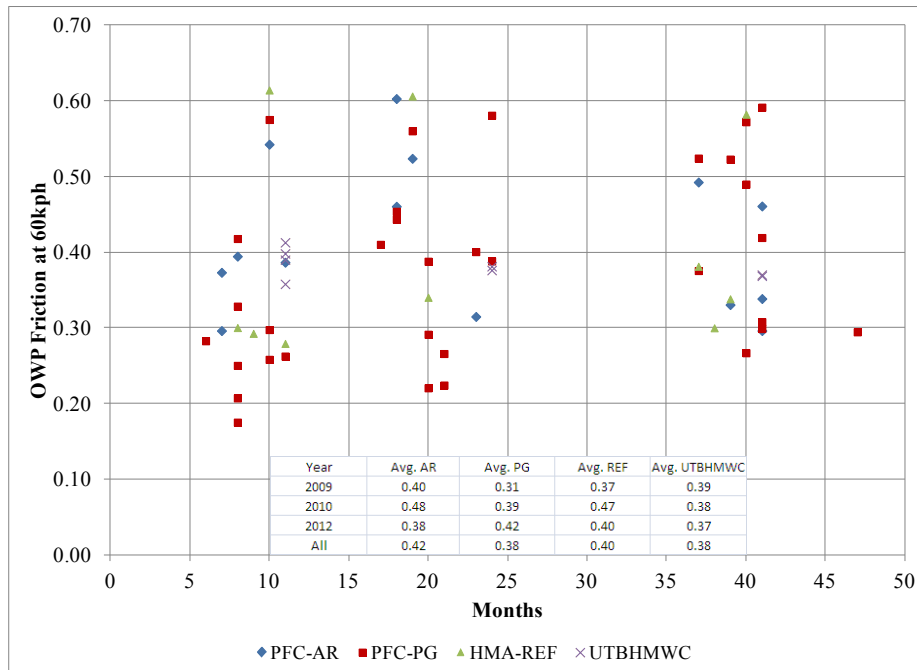
Figure 47. Effect of Binder/Mixture Type on OWP Friction Measurements.

The effect of binder/mixture type in friction was also quantified. [Figure 47](#) shows the comparison. ANOVA and Tukey's HSD analysis showed that the texture values for all mixtures were statistically equivalent. Based on the average friction values included in the summary table in [Figure 47](#), it is apparent that the friction measurements had more variability year to year. Overall the values did not cluster in distinct groups and stayed somewhat constant with time.

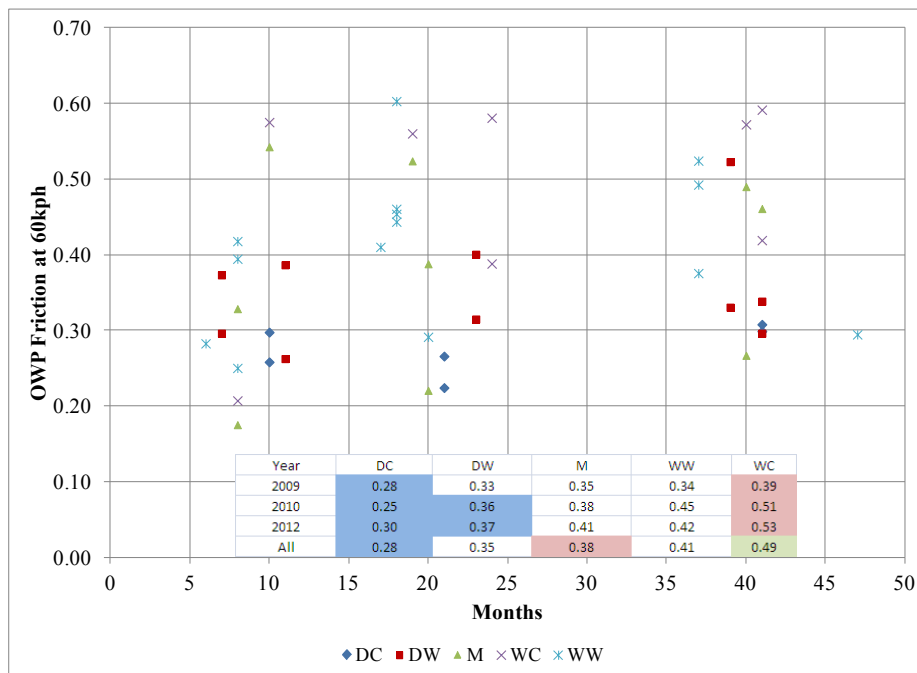
Figure 50. Effect of Climate on Friction OWP Measurements for PFC Pavements.

The last factor analyzed was climate using ANOVA and Tukey’s HSD. The results of the statistical analysis are summarized in the table included in Figure 50. Results that are statistically

different from each other are shaded with different colors. The cells that are not shaded are statistically equivalent to other climates. The dry climates had lower friction values, which stayed relatively constant with time. The friction values for the M climatic region were in between the values for the dry and wet climates and had a small but steady increase with time. The WC climatic region had the highest friction values. Both the WC and WW climatic regions have an increase in friction from measurement years 2009 vs. 2010; subsequently, the values remained relatively constant.

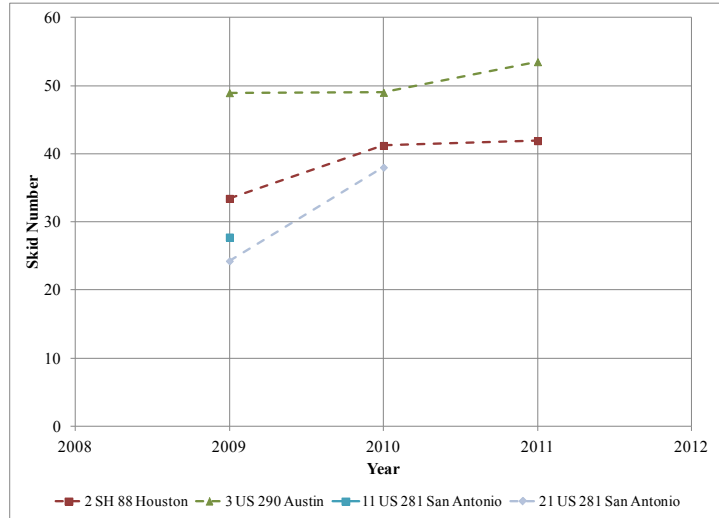
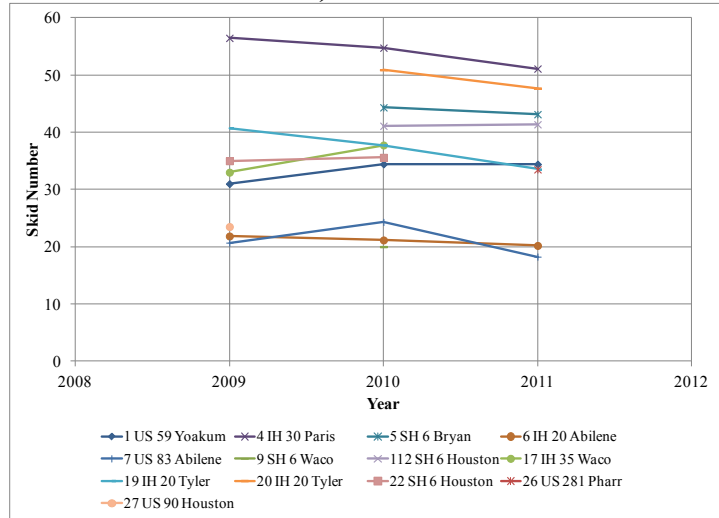
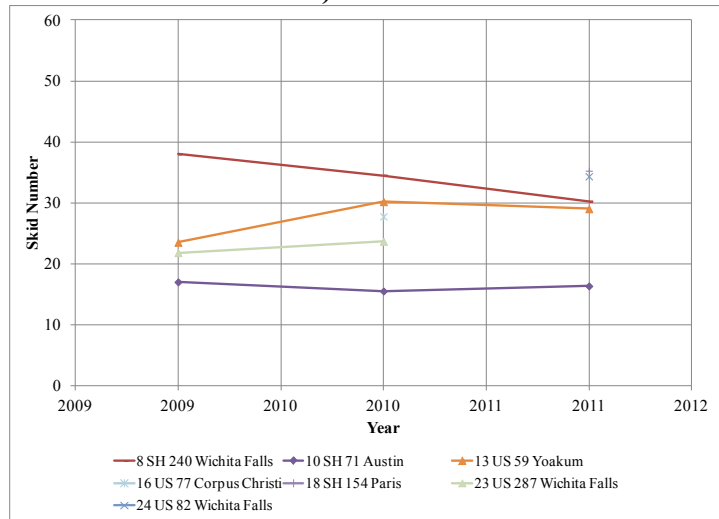
Figure 51. SN Measurements with Time.

TxDOT extracted the skid numbers for the pavement sections from the PMIS database. Not all values were available for all sections and/or all years; [Figure 51](#) presents the available data. As compared to the WFV, MPD, and friction measurements, the SNs seem to have more variability and not follow a consistent trend. For some sections, the values increase; for others, decrease; and some others stay constant.

The differences in SN with time were assessed using a paired two-sample t-test (two-tailed) with a significance level of 5 percent ($\alpha = 0.05$). PFC pavements with significant changes between 2009 vs. 2010 included sections 1, 2, 3, 7, 17, 19, and 21. Sections with statistical significant changes between 2010 vs. 2011 were 3, 4, 7, 19, and 20. For non-PFC sections, significant changes were noted only in Sections 8 and 13.

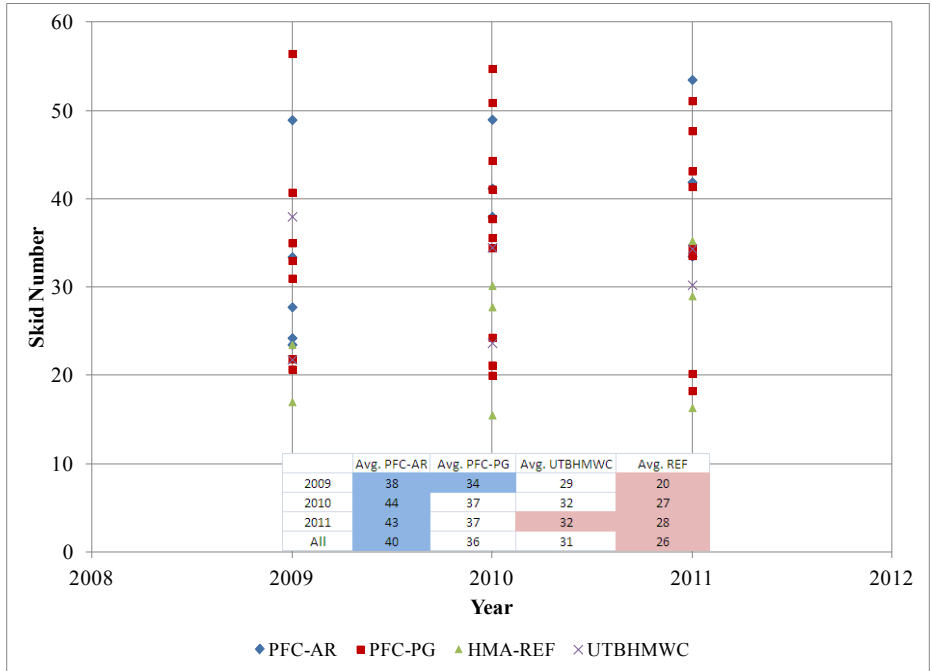
Figure 52. Effect of Binder/Mixture Type on SN.

The effect of binder/mixture type in SN was also evaluated. ANOVA and Tukey's HSD were used to assess the differences in values. The results are shown in the summary table included in [Figure 52](#). Sections with statistically significant differences are shaded with distinct color; the cells with no shading were statistically equivalent to one or more mixture types. From the results, it is apparent that AR-PFCs and PG-PFCs have higher SN values compared to both UTBHMWC and dense-graded HMA, with AR-PFCs having the largest SN values. When only PFCs and dense-graded HMA are included in the analysis, PFCs cluster together and are statistically different from HMA.

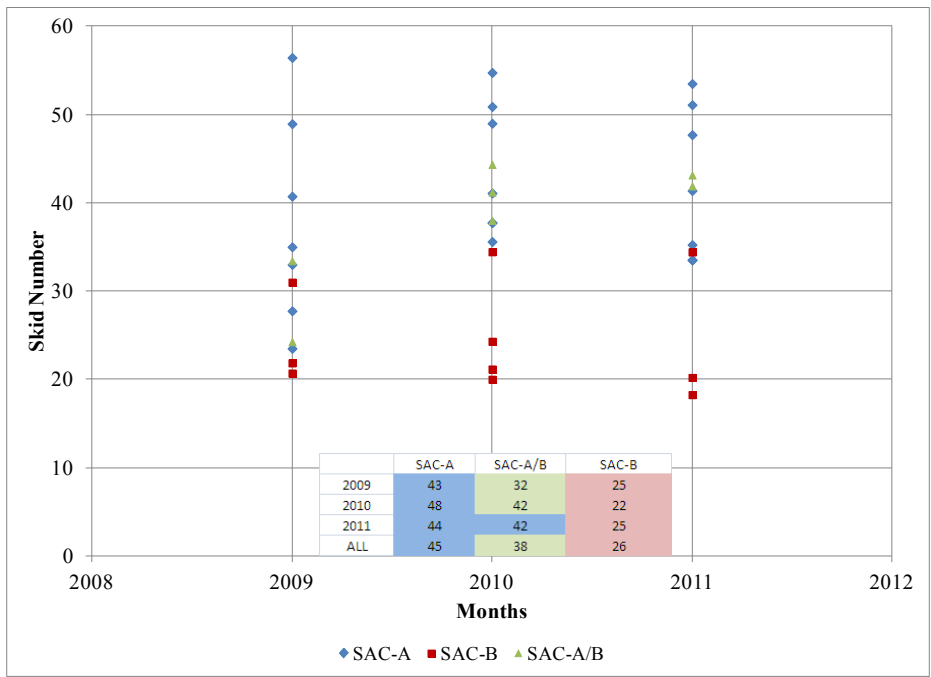
Figure 53. Effect of Aggregate Classification on SN for PFC Pavements.

The effect of aggregate classification on SN was quantified as well as illustrated in [Figure 53](#). ANOVA and Tukey's HSD resulted in statistical significant differences between all aggregate classes (except in 2011 where SAC-A and SAC-A/B were statistically equivalent). Sections employing SAC-A aggregates had the highest SNs, while sections in which mixtures were comprised of only SAC-B aggregates had the lowest SNs. This confirms the friction observations, that also showed that the sections with SAC-B aggregates had the lowest friction as opposed to the sections with SAC-A aggregates, and that resulted in the largest friction values.

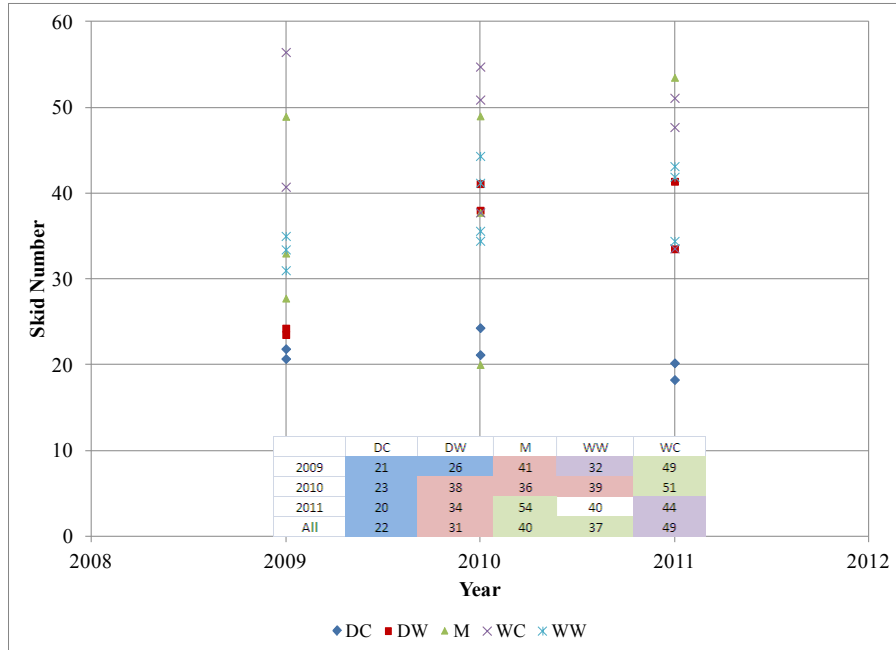
Figure 54. Effect of Climate on SN for PFC Pavements.

Finally, the effect of climate was assessed using the SN measurements. [Figure 54](#) presents the results. The summary table included in the figure illustrates the results of the ANOVA and Tukey's HSD results with same color shading for the same statistical groups and no shading if a particular instance was statistically equivalent to other climates. From the results, it is apparent that SN was significantly lower in the DW climatic region, while WC had the highest SNs. The other climatic regions had values in between these two extremes.
