1. Report No. FHWA/TX-12/0-5836-2		2. Government Accession No.		3. Recipient's Catalog No.	
4. Title and Subtitle PERFORMANCE AND COST EFFECTIVENESS OF PERMEABLE FRICTION COURSE (PFC) PAVEMENTS				5. Report Date Published: February 2013

PERFORMANCE AND COST EFFECTIVENESS OF PERMEABLE FRICTION COURSE (PFC) PAVEMENTS

Report 0-5836-2
Project 0-5836

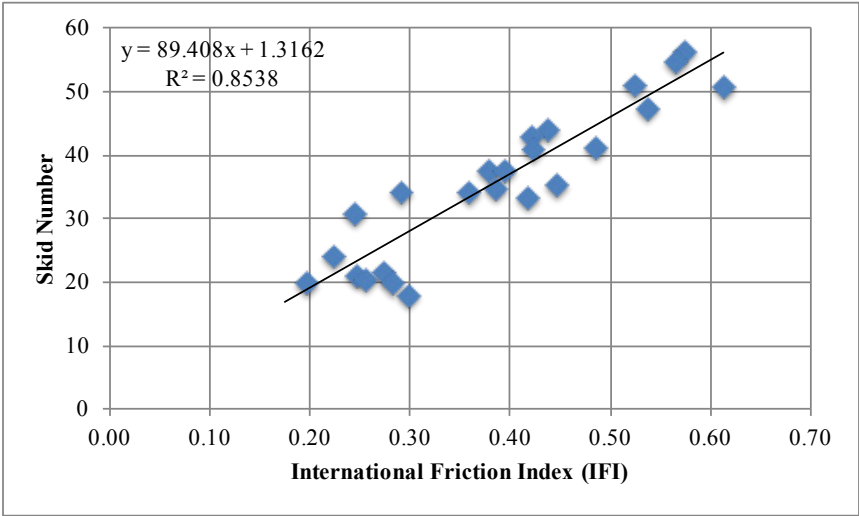
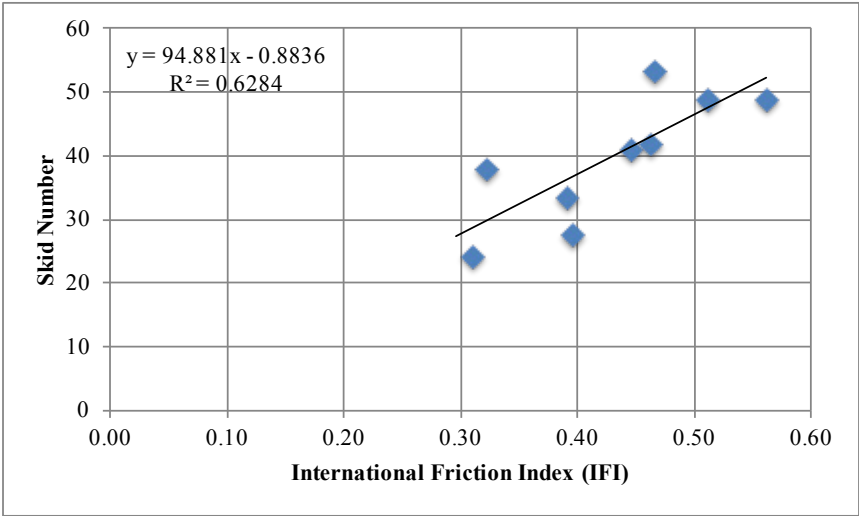
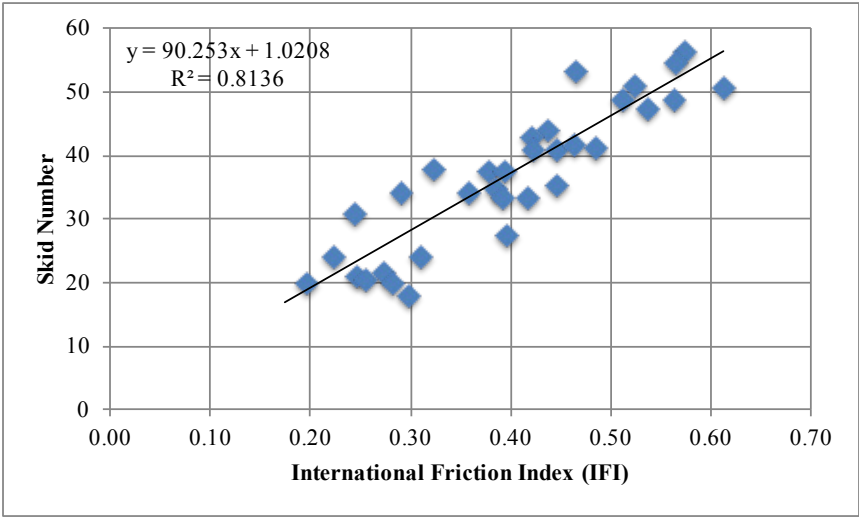
Figure 55. Relationship between SN and IFI.

IFI is reported in terms of $F60$ and S_p . Figure 55 illustrated the relationship between $F60$ and skid number. A good correlation between these two values exists, especially for AR-PFCs. The regression equation for each case is shown, and the R-squared for all PFC pavement sections was 0.81 (see Figure 55c). The IFI threshold corresponding to a SN of 20 is 0.2, and 0.3 for a SN of 30.

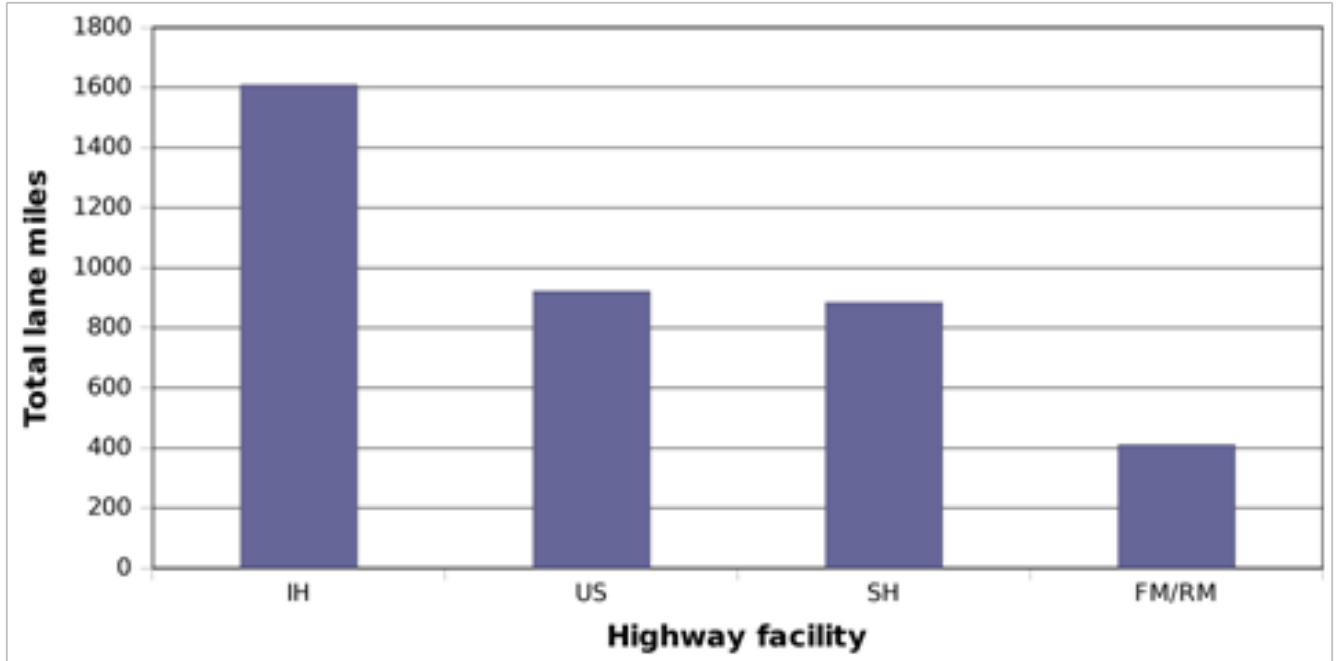
Figure 56. Breakdown of PFC Projects by Highway Facility.

The lengths of the projects selected for the analyses ranged from 1 to 20 miles, and included both undivided and divided roads with two to six lanes per direction. The average lane miles for all the PFC projects considered is about 24 miles. [Figure 56](#) shows the relative breakdown of these PFC projects by highway facility. PFC is targeted for high-volume interstate highways (IH) and is generally only used on higher volume farm- or ranch-to-market (FM/RM) roads as well as national (US) and state highways (SH).

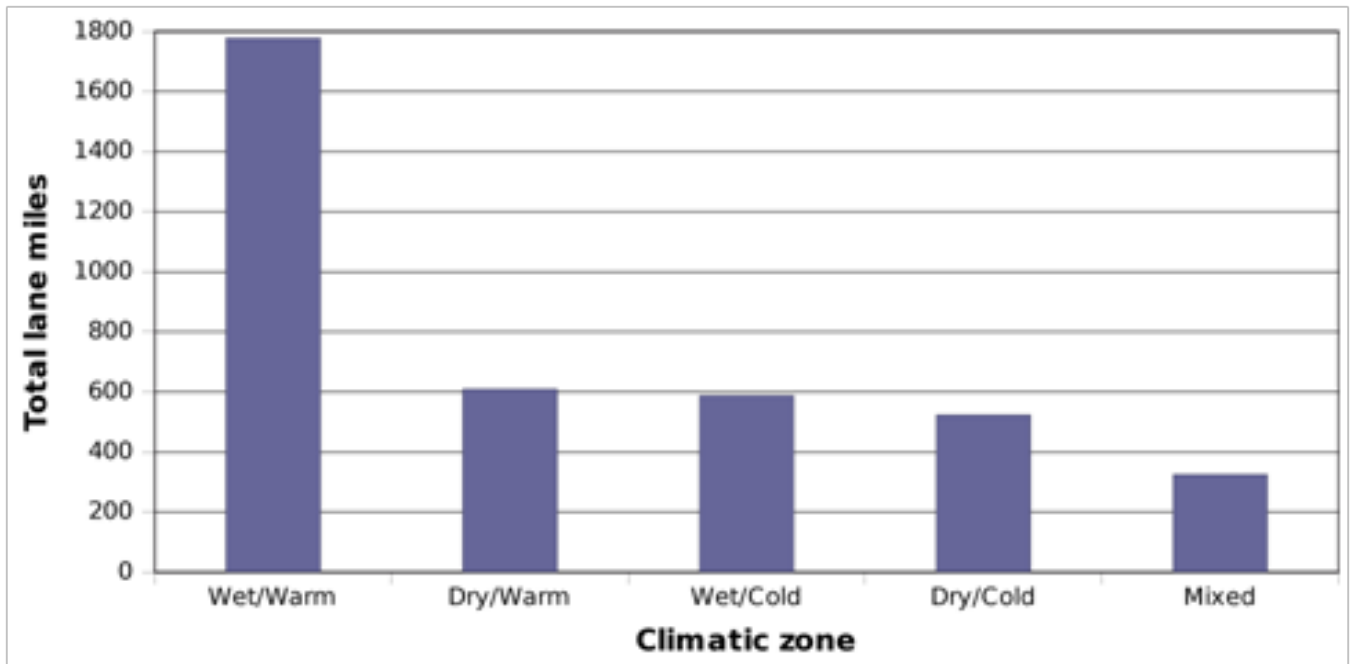
Figure 57. Breakdown of PFC Projects by Climatic Region.

The projects identified for the crash analyses are distributed throughout Texas and span the five climatic zones (see [Figure 57](#)). As a general rule, PFC is no longer used in very cold/wet regions where the possibility of black-ice conditions severely impacts the safety and performance of these mixes. [Figure 57](#) shows that PFC is favored in wet/warm climates.

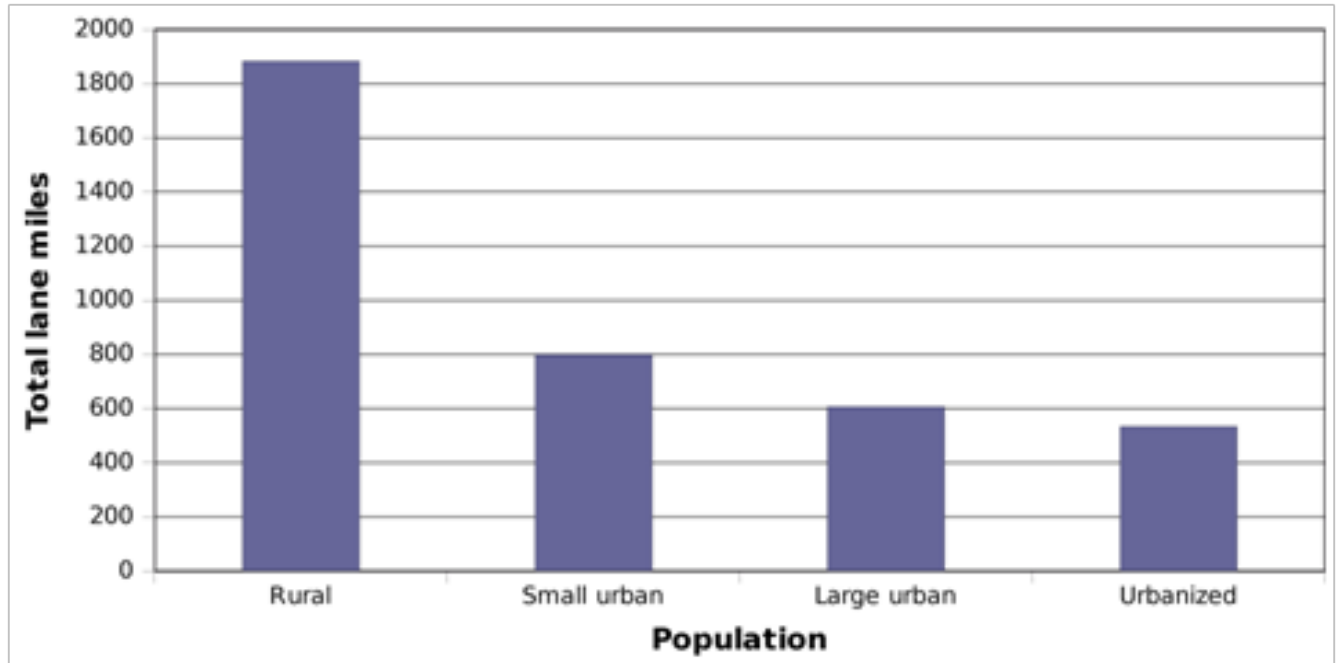
Figure 58. Breakdown of PFC Projects by Population.

Figure 58 shows the breakdown of PFC projects by population area. The majority of PFC is constructed in rural areas (< 5k people), but includes sections in small (5k–50k), large (50k–200k), and urbanized (> 200k) regions. This breakdown is relevant when evaluating the relative

safety of PFC compared to other HMA types since the vehicle miles traveled (VMT) and exposure density is generally larger in urbanized areas.

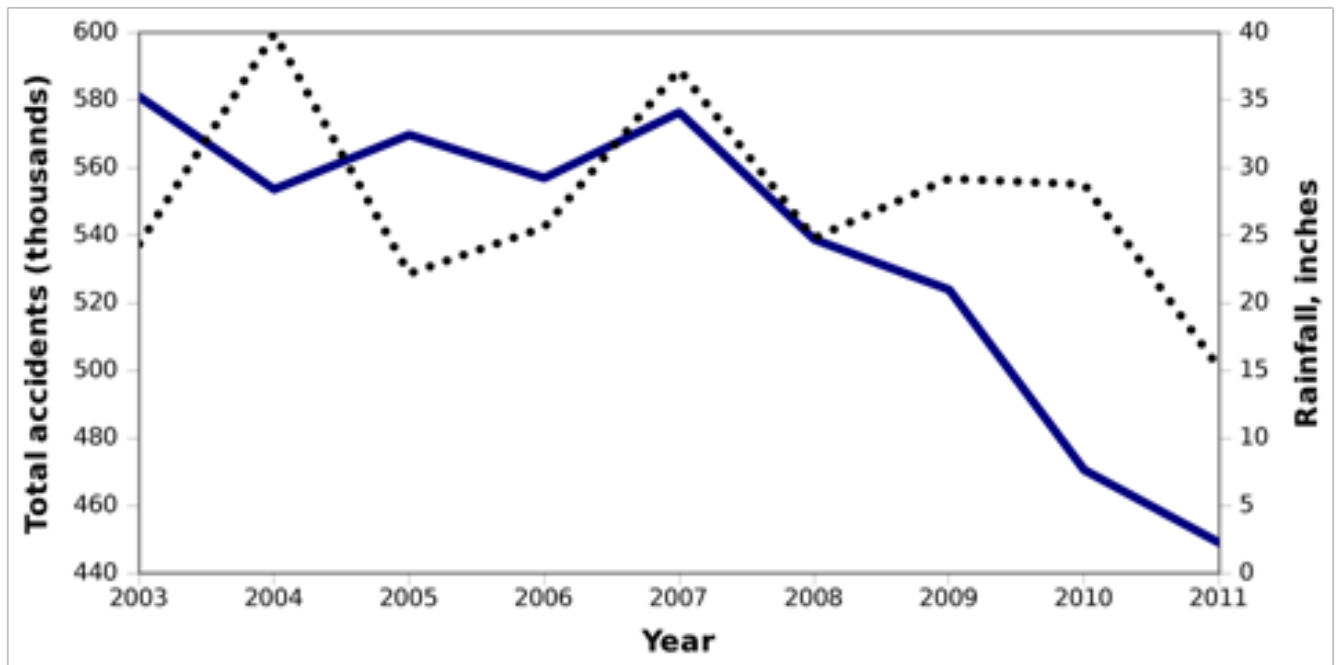
Figure 59. Accident and Rainfall Data for Texas.

Figure 59 shows the annual total number of accidents reported in Texas on all roads compared with the annual statewide rainfall totals obtained from National Oceanic and Atmospheric Administration (33). A decreasing trend in the number of annual accidents is

evident after 2007. The sudden and continuing decrease in accidents is in line with national statistics that the National Highway Traffic Safety Administration (34) reported and is related to the slowing economy and the subsequent drop in vehicle miles traveled (VMT). Although there appears to be a relationship between observed rainfall and accidents, the trend is rather weak when considering the many other factors influencing the causes of road accidents.

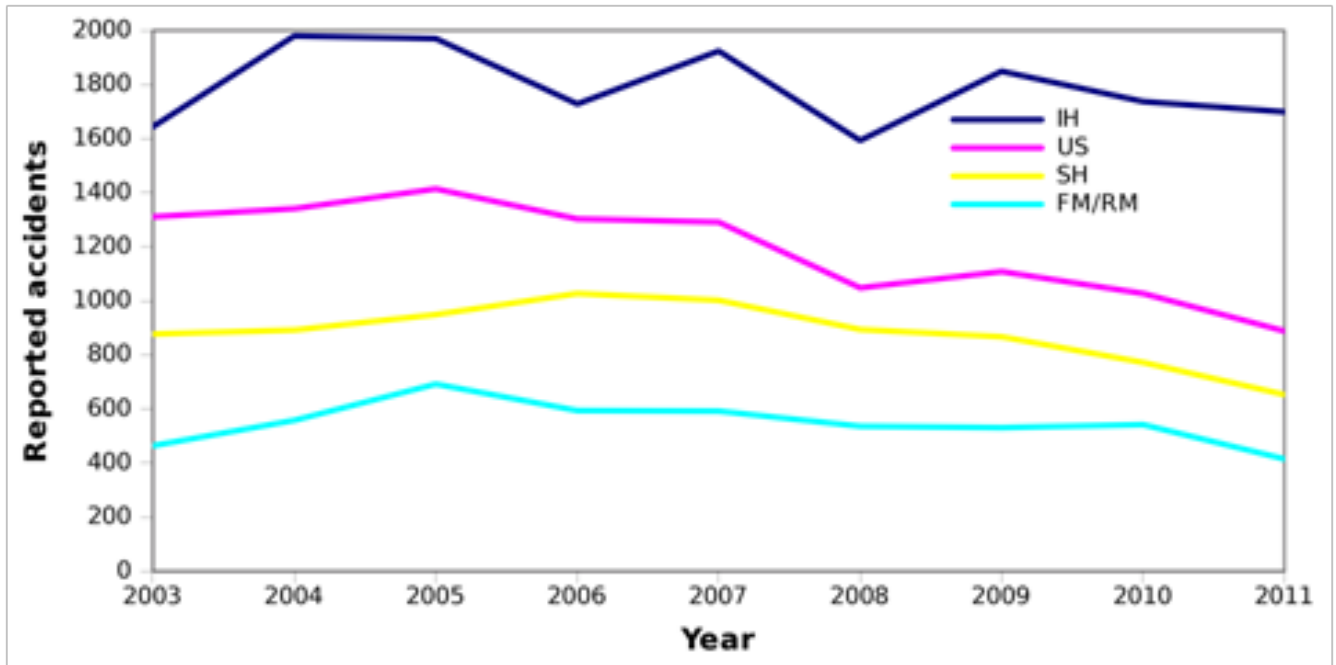
Figure 60. PFC Accidents on Highway Facilities.

For the 161 PFC project locations identified, a total of 39,712 accidents were reported between 2003 and 2011. Figure 60 shows the number of reported accidents on the highway facilities between 2003 and 2011. The proportion of accidents on the various highway facilities matches the respective lane miles of project sections on these facilities. While the number of accidents fluctuate from year to year, a decreasing trend post-2007 in the number of accidents is evident, which coincides with the general decreasing trends observed throughout Texas. A similar breakdown in number of accidents was observed in the different climatic zones, as shown in Figure 61. While the number of reported accidents in rural areas is greater given the larger number of projects in these areas, the number of accidents in small urban areas is less compared to large urban areas, which again may be related to the greater VMT with higher population density.

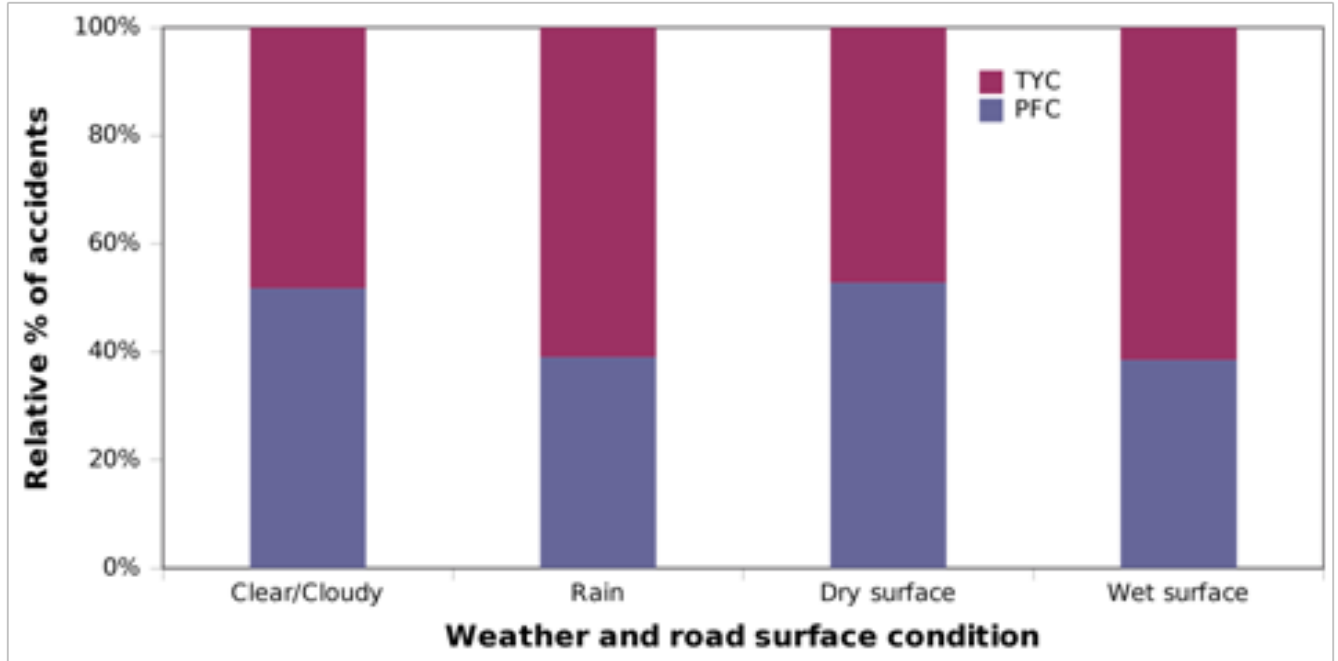
Figure 62. Relative Breakdown of Accidents by Weather and Road Condition.

CRIS reports the weather condition at the time of the accident. Of the accidents reported, 84 percent occurred under clear or cloudy conditions and 14 percent occurred in rainy conditions with the balance occurring under windy, snowy, sleet, hail, or unknown conditions. CRIS also reports the road condition at the time of the accident, i.e., whether wet or dry. Of all the accidents, 78 percent occurred when the road was reportedly dry and 19 percent when wet. [Figure 62](#) shows a breakdown of the accidents on the projects by weather and road condition with the relative proportion of the accidents that occurred under these conditions when the surface was a PFC and prior to rehabilitation (TYC), providing a general indication that accidents on PFC are comparatively lower under wet conditions. The analyses showed no significant difference in the proportion of accidents on PFC and TYC as influenced by lighting (light, dark, dawn, or dusk) or road alignment at the accident site (straight or curved sections).

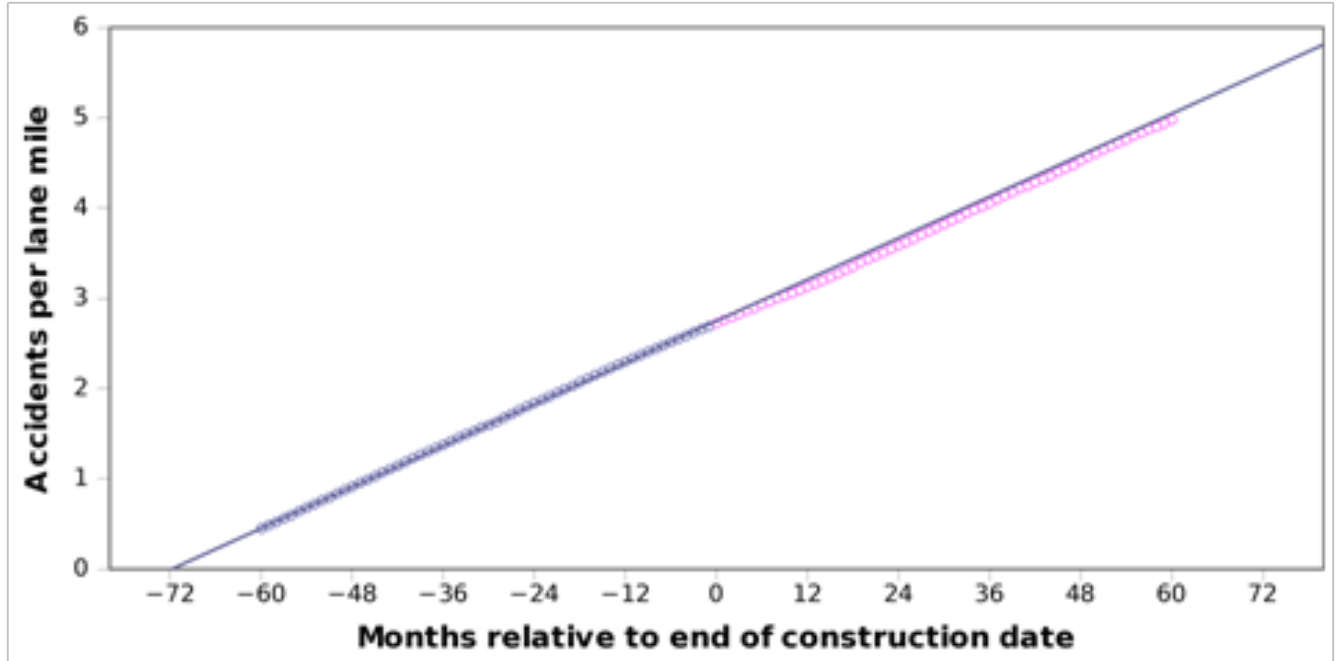
Figure 63. Accident Rates of CRIS Reported Wet PFC Sections.

While indications are that PFC appears to reduce the number of accidents occurring under wet conditions, the CRIS statistics are not conclusive. As indicated previously, there is a disparity in the percentage of accidents that occurred under reported rain conditions and accidents on wet roads, indicating that the road condition as reported in CRIS does not necessarily reflect the weather condition at the time of the accident, or vice versa. An analysis of the accident data indicated that 6 percent of the accidents reported occurred when the road was wet under clear or cloudy conditions. Furthermore, no clear difference in the accident rates observed before or after construction of PFC was found when comparing statistics on accidents occurring on wet surface as CRIS reported. [Figure 63](#) illustrates the cumulative number of accidents on the PFC sections per lane mile. The x-axis indicates the time in months before and after construction of the PFC sections. The analysis was done by adding the accidents per lane mile 72 months before and 72 months after construction for all the PFC sections. No distinct difference in the accident rates before and after construction of PFC is observed when the road was reportedly wet. A trend line of the pre-construction accidents has been superimposed. Based on the derivative of the data in [Figure 63](#), the annual accident rate on the sections before construction of PFC is 0.46 accidents per lane mile and remains the same after construction. For similar analyses including all data under all conditions, the pre-construction rates remain at 0.46

accidents per lane mile while the post-construction rates reduce slightly to 0.43 accidents per lane mile. This was also the case for the projects when the road surface was reported dry.

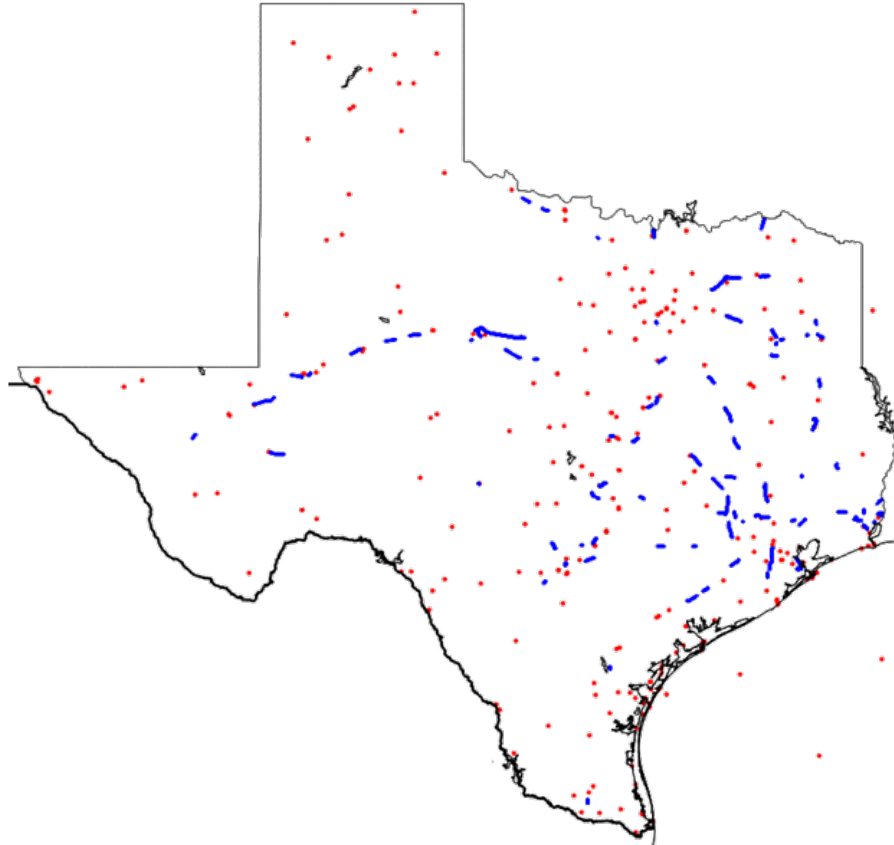
Figure 64. PFC Accidents and Weather Stations in Texas.

To evaluate more accurately the possible effect of rain on PFC safety, rainfall data collected at 280 weather stations throughout Texas was used, as archived in the Global Surface Summary of Day (GSOD) database that the National Oceanic and Atmospheric Administration maintained (35). This database includes daily rainfall totals reported at mainly municipal airport facilities across Texas. Daily rainfall totals at these weather stations between 2003 and 2011 were used to indicate rain conditions on the dates and in the vicinity of the accidents reported in CRIS. Figure 64 shows locations of the PFC accidents and GSOD weather stations in Texas.

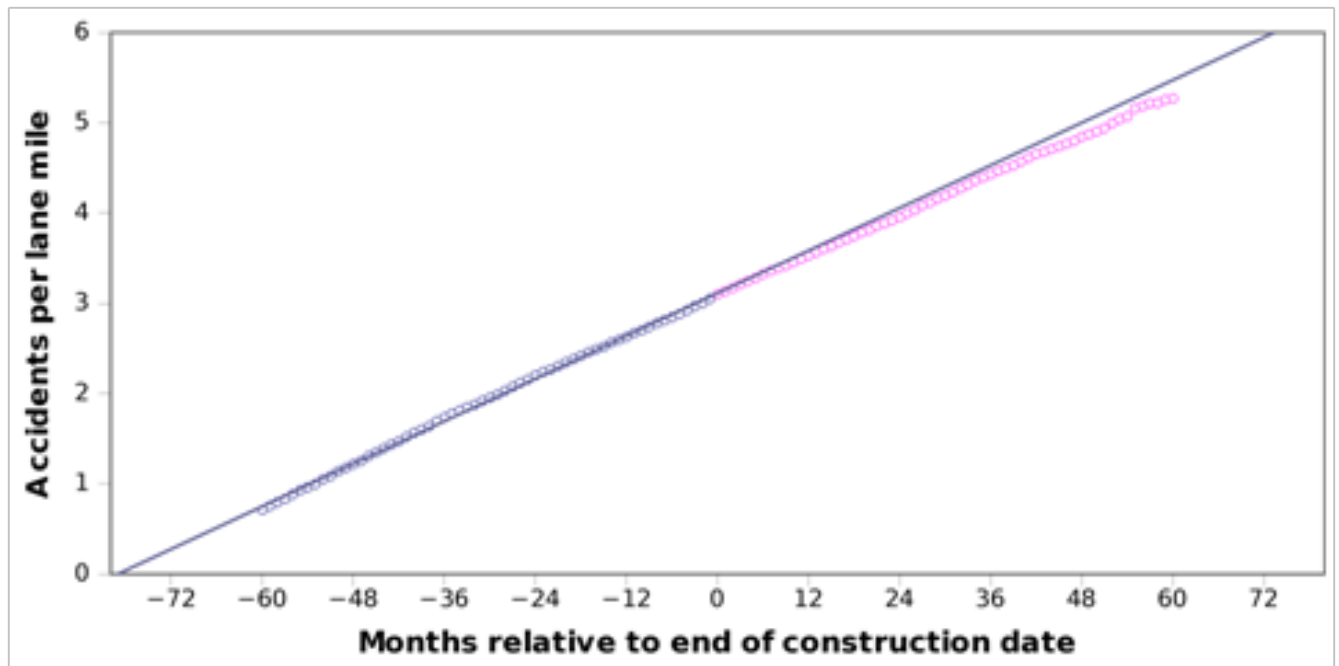
Figure 65. Accident Rates of PFC Sections with Daily Rainfall Exceeding 0.1 Inch.

Figure 65 shows the accident rates for PFC sections having estimated daily rainfall totals exceeding 0.1 inches. These are based on accidents that occurred within 5 miles of a weather station. From these data, the annual accident rate for the sections prior to PFC construction was 0.47 accidents per lane mile; for the PFC sections, this is reduced to 0.44 accidents per lane mile, a marked reduction. Similar analyses were done for accidents that occurred within 10, 15, and 20 miles of a weather station. Table 8 summarizes the accident rates determined for these

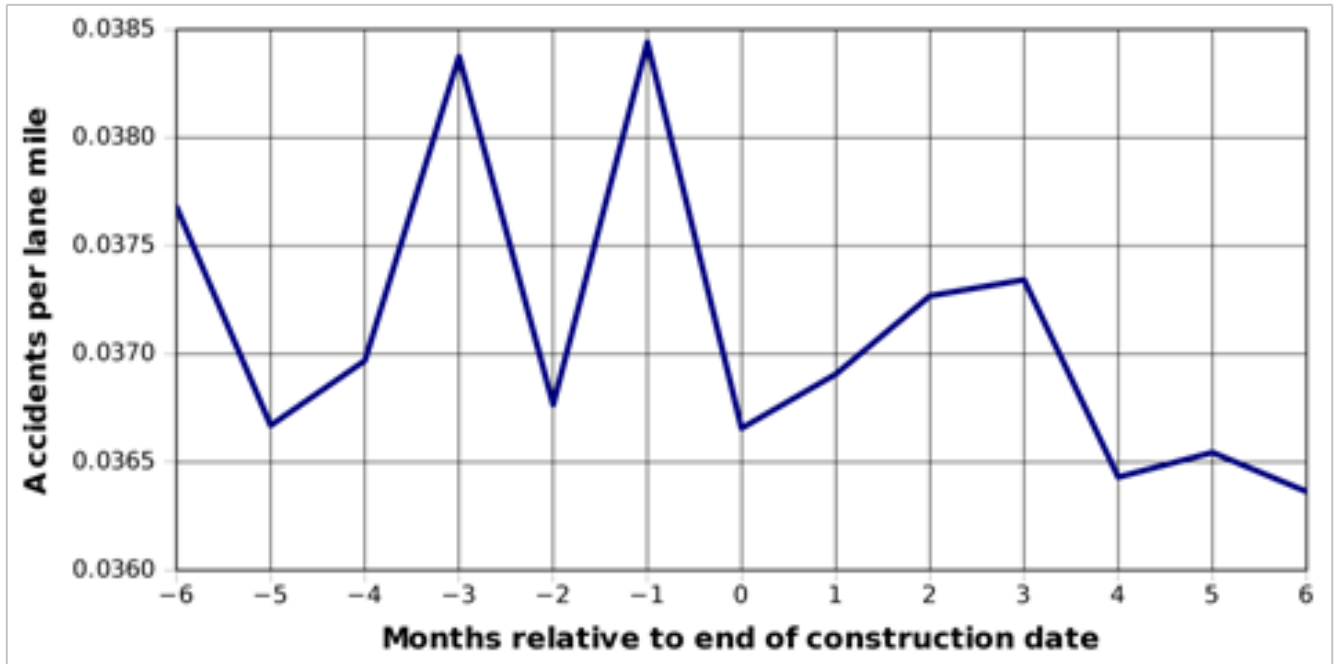
Figure 66. Accidents per Lane Mile on PFC Sections under Varying Conditions.

To investigate the reported higher accidents on PFC immediately following construction, a plot of all the accidents per lane mile on the PFC sections was made (see Figure 66). Some research studies have reported similar observations claiming that apparently drivers take advantage of the reduced splash and spray on PFCs during rain events, driving faster at shorter following distances and causing more accidents (36,37). Figure 66 shows the accidents per lane mile six months before and after construction of the PFC sections regardless of weather or surface condition, i.e., considering all accidents reported in CRIS.

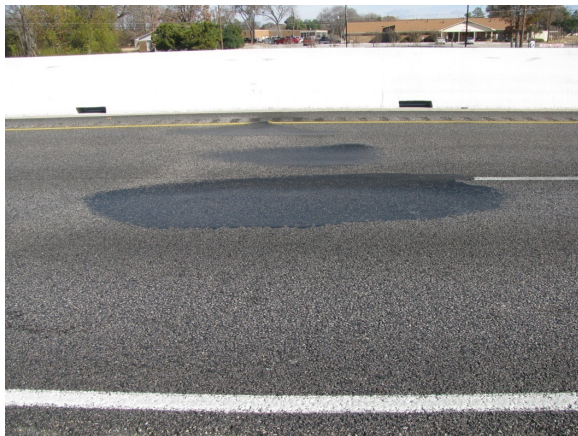
a) Overview of the Bleeding Patches

This pavement section was located on IH 20, north of the town of Canton in Van Zandt County, Tyler District. The overall performance was adequate, with WFVs between 56 and 63 seconds OWP, and between 39 and 54 seconds BWP, and adequate texture and friction. However, in three small areas of the eastbound lanes, excessive bleeding and rutting was observed. The areas or patches were about 1.8 m (6 ft) long by 0.9 m (3 ft) wide. Two of the patches were located on the inside lane, while the third and largest patch spanned from the inside lane over into the outside lane's left wheel path (see [Figure 67a](#)). [Figure 67b](#) shows that rutting occurred within the areas of bleeding, and a slight ridge formed along the centerline where the softened mixture shoved away from the wheel path.

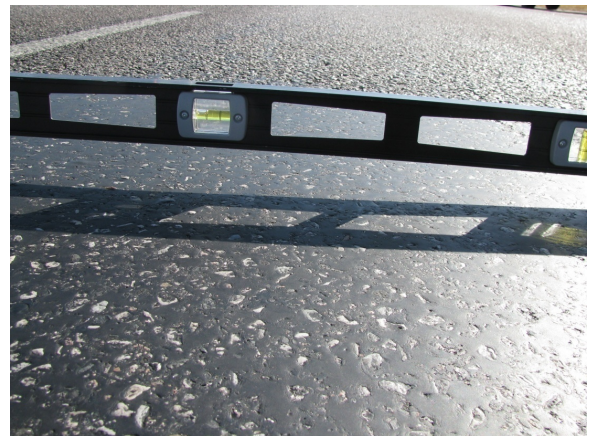
b) Detailed View of Bleeding and Rutting

Figure 67. Pavement Section on IH 20 in Tyler.

Several cores were obtained from the site for forensic testing to determine the possible cause of the distress. In the laboratory, researchers noted a noticeable heavy smell of either gasoline or diesel fuel coming from the cores. A fuel leak at the location could explain the smell and observed bleeding of the binder. When a solvent like gasoline leaks onto asphalt pavements, it affects the asphalt binder, making it softer. Over time, gravity and repeated traffic loads cause the denser aggregates in the pavement to settle, leaving the soft binder on the surface of the pavement. In the case of PFCs, the highly connected AV structure could allow solvents to easily permeate the pavement structure. It is likely that an accident and subsequent fuel leak occurred at that location.

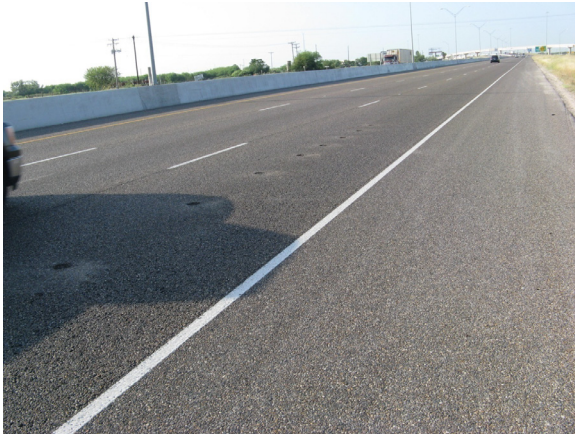
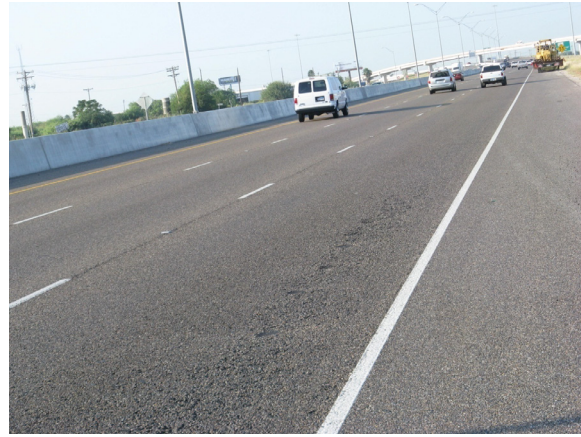
a) Area in Good Condition

b) Area with Raveling Distress

This pavement section was located on US 281 in Edinburg, Hidalgo County, within the Pharr District. The test section spanned from SH 495 to Trenton Road. The PFC pavement was constructed in year 2004 using 9.1 percent AC-10 + 17.7 percent AR binder, gravel aggregate (SAC-A), and 1 percent lime per mix design. In 2010, severe raveling was apparent in certain areas of the pavement section. An area of the test section was in good condition as compared to another area that the distress had affected. That year, on-site WFV and cores were obtained from the pavement. Texture and friction measurement were not performed due to conflicting scheduling of the equipment. Fourteen cores were extracted for completing a forensic analysis; seven cores BWP in the good performing area, and seven OWP in the area with raveling. Figure 68 shows pictures of the areas where the cores were acquired. Out of the seven OWP cores, two were damaged while grinding and thus only five were available for the forensic tests.

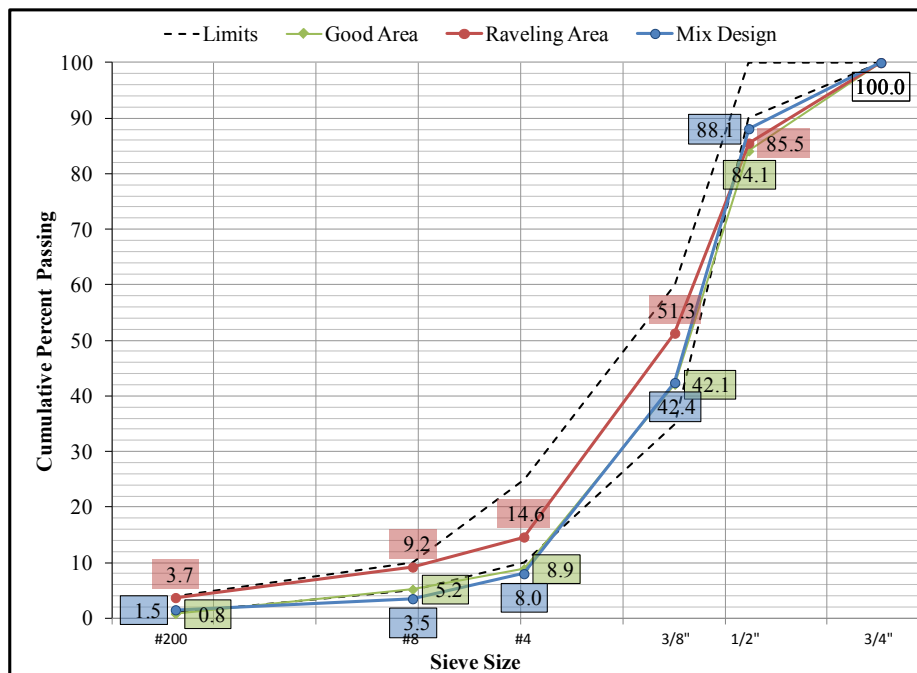
Figure 69. Aggregate Gradation after Binder Extraction for US 281 in Pharr.

Following the extraction procedure, the aggregates were sieved to determine the actual aggregate gradation used in the field. Results are shown in Figure 69. A note in the mix design clarified that the district lab allowed the use of the master gradation corresponding to PG-PFC mixtures. The mix design gradation was outside of these limits for sieve sizes 1/2 inch, No. 4, and No. 8. The aggregate gradation of the good performing area followed closely the mix design. The raveled area had a finer aggregate gradation, yet, except for sieve size 1/2 inch, it fell between the boundaries of the gradation limits.

The cause for the observed raveling is possibly due to the low asphalt binder content in the mixture, combined with poor construction practices in the area of the pavement section that showed this distress. Given that some portions of the PFC pavement section were in good condition, it is also possible that the performance issues were caused by asphalt draindown during transportation of the mixture from the plant in Harlington, which was around 35 miles away. During a hot day in South Texas and over that distance, it is plausible for draindown to occur. In addition, binder aging could explain some of the observed asphalt-aggregate separation (especially from the small river gravel aggregate) and the tendency of the field cores to easily lose aggregates and crumble.

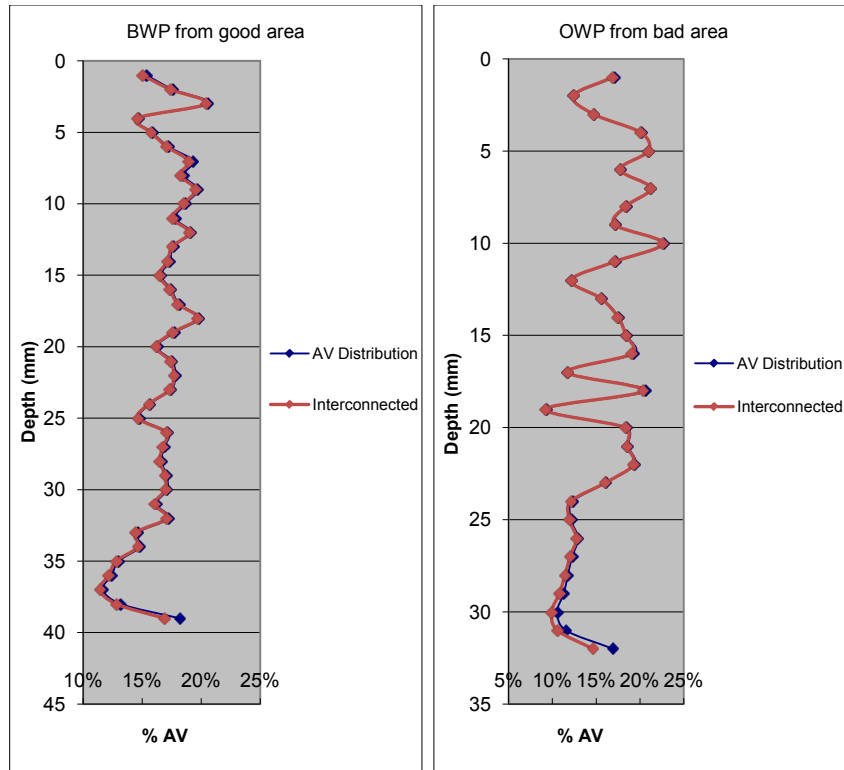
Figure 70. Total and Interconnected AV Distribution for Cores Obtained from US 281.

X-ray computed tomography (CT) and image analysis techniques revealed the AV distribution as well as the interconnected AV content of two of the cores taken from the site (Figure 70). The CoreLok® AV content was used to calibrate the image analysis. The interconnected AV resulting from the image analysis overlapped with the total AV content curves, demonstrating no loss in AV interconnectivity.

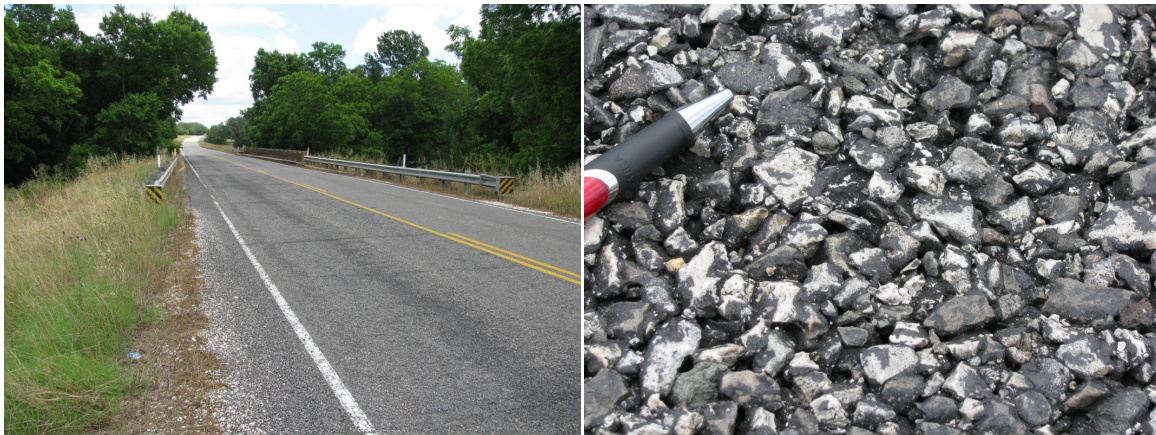
Figure 71. Raveling Distress on US 90 in Houston.

year 2010 after reports of excessive raveling (Figure 71). The performance of this pavement was adequate for about five years, but started deteriorating rapidly afterwards. Within the town of Brookshire, the raveling was much more severe, especially places where vehicles turned to access businesses. Continuing east into town, the crumb rubber eventually gave way to another PG-PFC pavement section that appeared to be in good condition. Recently, the AR-PFC was overlaid from the PG-PFC boundary, west, to a point just short of the test site for this project.

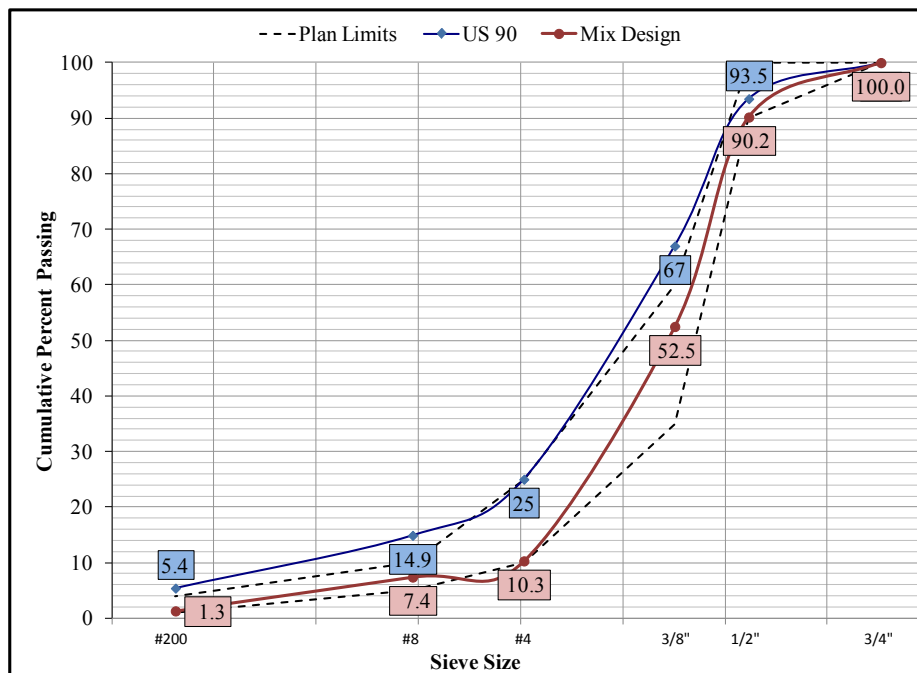
Figure 72. Aggregate Gradation after Ignition Oven for US 90 in Houston.

Ignition oven test were also performed to estimate the binder content in the mixture. The average binder content was 9.1 percent, which is typical for AR-PFCs, although the design content was 8.3 percent. Following the ignition oven procedure, the aggregates were sieved to determine their actual gradation. Figure 72 shows the results. All cores had similar aggregate gradations that were much finer than the mix design and above the upper specification limit for sieve sizes 9.5 mm (0.38 inch), No. 8, and No. 200. It is relevant to note that the limits did not follow TxDOT specifications for either AR-PFCs or PG-PFCs, but were noted as shown on plans.

The cause of reduced drainability for this AR-PFC pavement is likely related to the aggregate gradation and asphalt binder content. Figure 73 shows that the actual mixture gradation was finer than both the design and plan specification limits. The binder content was also on the upper threshold for PFCs. With regard to the observed raveling, a contributing factor could be the amount and type of traffic on this section. The researchers observed during testing and coring that a high portion of the traffic was comprised of trucks traveling on US 90 to get to I-10. Further into the town of Brookshire, the raveling was most severe at the entrances to industry locations where heavy trucks were the primary mode of hauling materials.

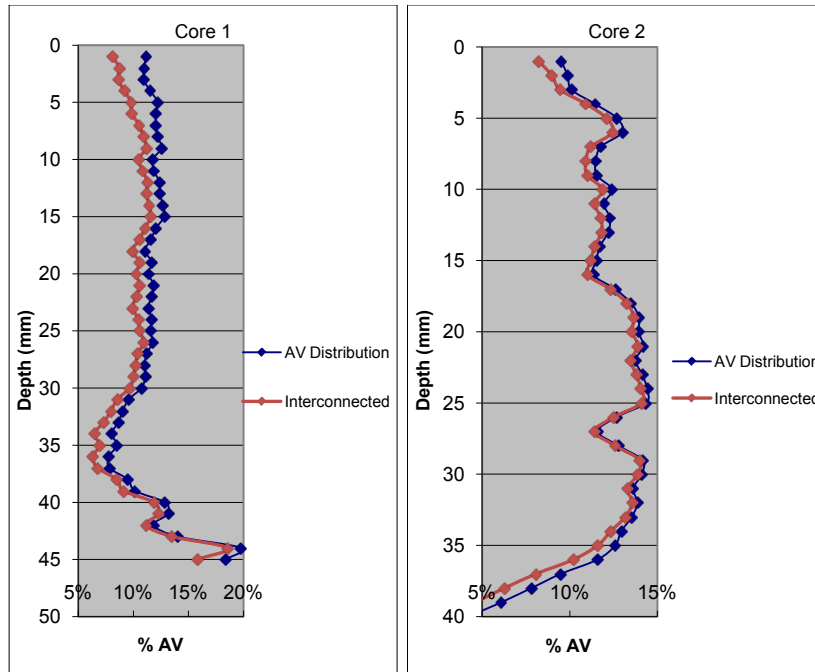
Figure 73. Total and Interconnected AV Distribution for Cores Obtained from US 90.

Application of X-ray CT and image analysis techniques revealed the AV distribution as well as the interconnected AV content of the road cores. Results are presented in Figure 73. For the X-ray CT analysis, images were acquired at intervals of 1 mm (0.039 inch) in the vertical direction. The CoreLok® AV content was used to calibrate the image analysis and generate the profiles in Figure 73. The average interconnected AV resulting from the image analysis was 10.2 percent for Core 1 and 10.7 percent for Core 2. These values are similar to the percent porosity value of 10.9 percent resulting from the CoreLok® test. The interconnected AV was extremely low for PFCs, which usually have over 95 percent AV interconnectivity.

From Figure 73, it is apparent that near the surface of the cores is where the loss of pore interconnectivity was most severe (especially for Core 1), with the level of severity steadily decreasing with depth. Ideally, the total and interconnected AV should be homogeneous and very similar to each other. In Figure 73, this would translate into practically straight and overlapping AV distribution and interconnected lines at the designed AV content value of around 18 to 22 percent.

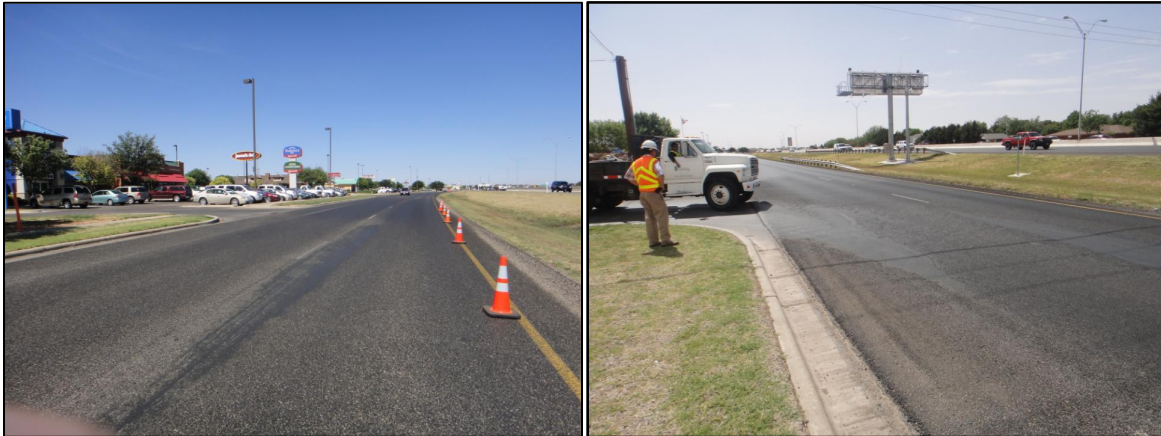
Figure 74. Raveling Distress on SL 289 in Lubbock.

8.6 percent AR + 18 percent AR. Construction took place late in 2010. Within a month of construction, the section experienced severe raveling that was more prominent at intersections and turn lanes (see [Figure 74](#)).

The cause of the observed raveling in this section was likely due to the time of the year the pavement was constructed combined with poor construction practices. In addition, the lower binder content in the mixture was also a contributing factor in explaining the early raveling

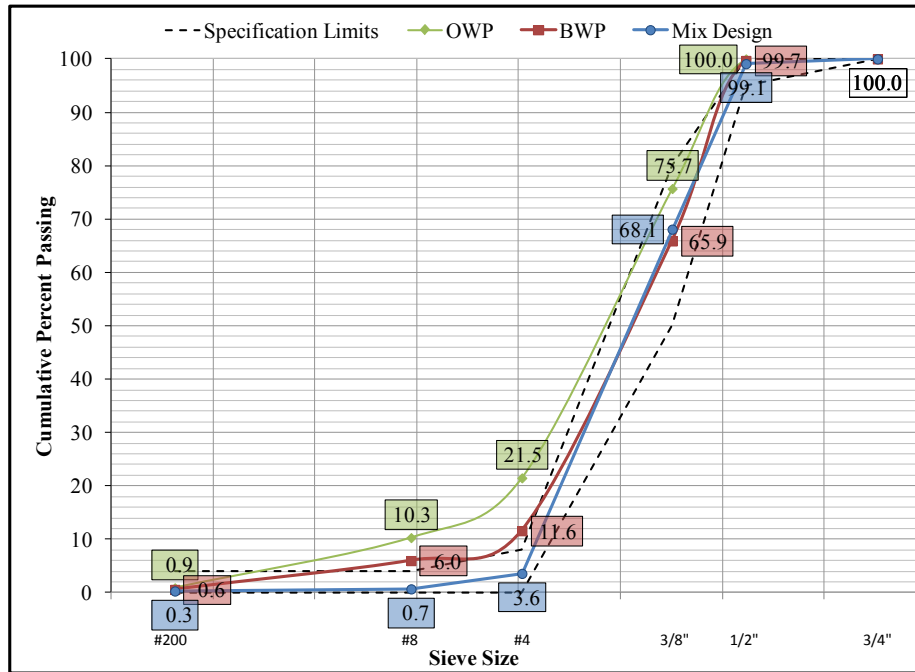
Figure 75. Aggregate Gradation after Ignition Oven for SL 289 FR in Lubbock.

After binder extraction, the aggregates were sieved to determine the actual mixture gradation. Results are illustrated in [Figure 75](#). The gradations were finer when compared to the design aggregate gradation and above the specification limit for sieve sizes No. 4 and No. 8. The aggregate gradation for the OWP core had even finer gradation than the one obtained BWP. This explains the higher WFVs measured in that area (i.e., 90 seconds).

observed in this section. The variations in WFVs were possible due to the inconsistent aggregate gradations and differing total AV contents at the surface of the pavement.

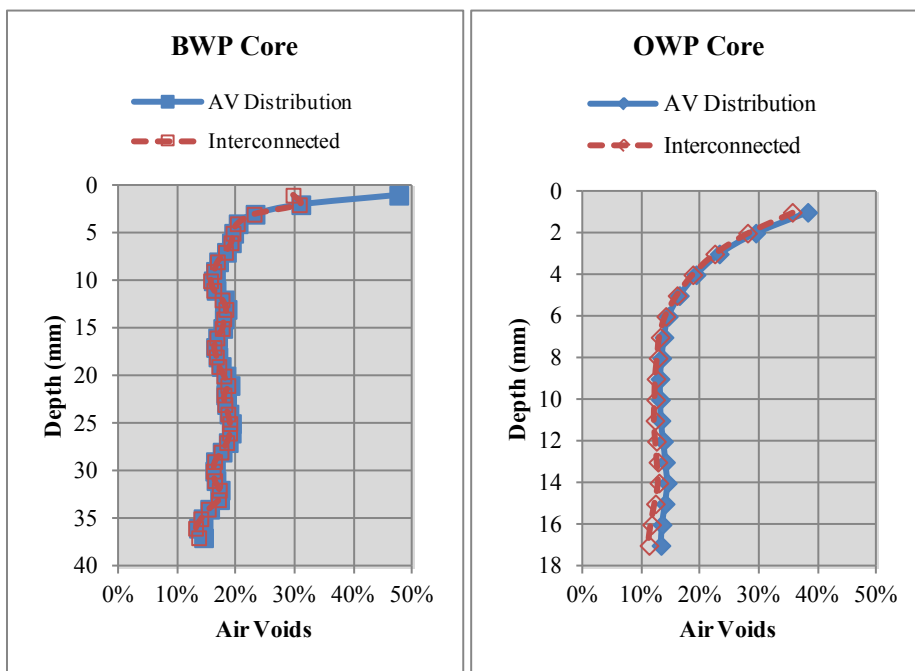
Figure 76. Total and Interconnected AV Distribution for Cores Obtained from SL 289.

Application of X-ray CT and image analysis techniques were used to quantify the AV distribution and the interconnected AV content of the road cores. Results are presented in [Figure 76](#). For the X-ray CT analysis, researchers acquired images at intervals of 1 mm (0.039 inch) in the vertical direction. The CoreLok® AV content was used to calibrate the image analysis and generate the profiles in [Figure 76](#). The total and interconnected AV profiles overlap, which is consistent with the percent porosity CoreLok® results. The total AV at the surface of the OWP Core is somewhat lower than the BWP core (i.e., less than 40 percent vs. almost 50 percent). In addition, the interconnected AV profiles diverge in the case of the OWP core with depth.

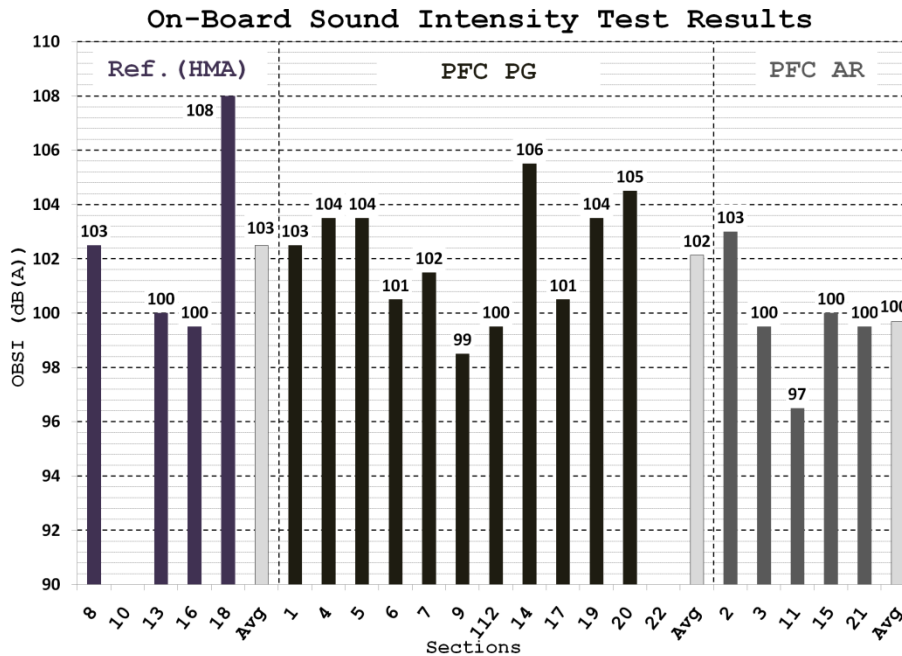
Figure 77. OBSI Noise Levels Grouped by Mixture Type.

Figure 77 shows the results of the OBSI test on the field sections. The results are grouped by type of mixture. The first five sections from the left are the non-PFCs (reference sections), the middle bars are PG-PFC sections, and the bars in the right represent the AR-PFC sections. The rightmost bar in each group (in grey) represents the average value for each group. While the average value of sound intensity in PG-PFC sections is almost equal to the non-PFC sections, the average value for AR-PFC sections is lower. On average, AR-PFCs are quieter.

These results were used to define the metrics for the noise attribute and scoring the sections. The noise level was divided into three ranges (see Table 16).

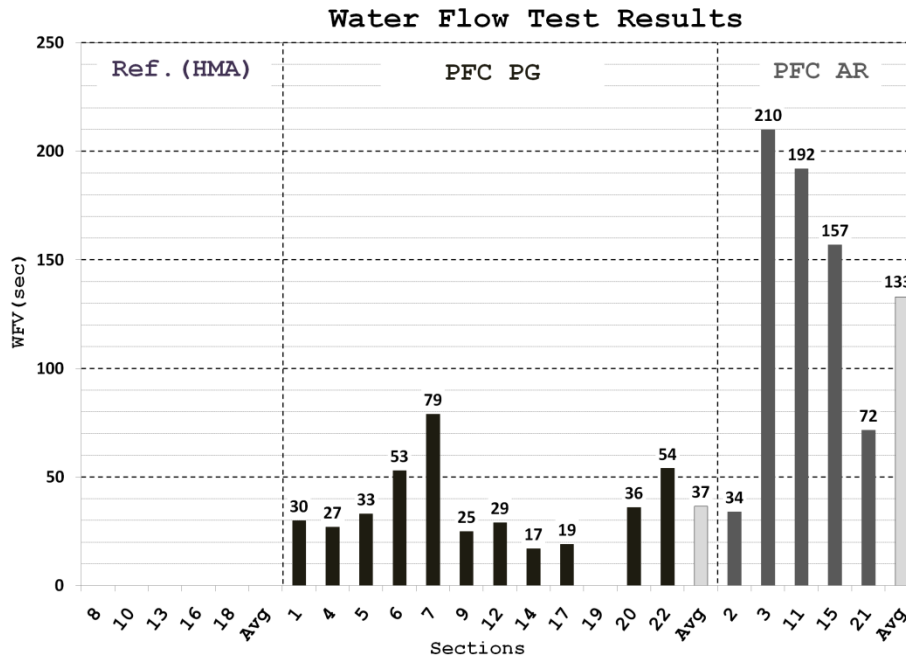
Figure 78. WFVs Results Grouped by Mixture Type.

Permeability of the field sections is evaluated via the WFV. Smaller numbers for WFV means faster drainage of water through the pavement surface and better permeability performance. Figure 3 illustrates the WFV numbers for the PG-PFC and AR-PFC sections. The rightmost bar in each group represents the average value for the sections in that group. PFC-PG sections show better performance than PFC AR sections.

According to the results presented in Figure 78, permeability performance of test sections is divided into the cases listed in Table 17.

Since the HMA sections are almost impermeable, these are not able to drain off any water within reasonable time. Therefore, Figure 78 does not show WFV numbers for these sections. Correspondingly, the assigned score for these sections would be zero.
