1. Report No. FHWA/TX-12/0-5836-2		2. Government Accession No.		3. Recipient's Catalog No.	
4. Title and Subtitle PERFORMANCE AND COST EFFECTIVENESS OF PERMEABLE FRICTION COURSE (PFC) PAVEMENTS				5. Report Date Published: February 2013

PERFORMANCE AND COST EFFECTIVENESS OF PERMEABLE FRICTION COURSE (PFC) PAVEMENTS

Report 0-5836-2
Project 0-5836

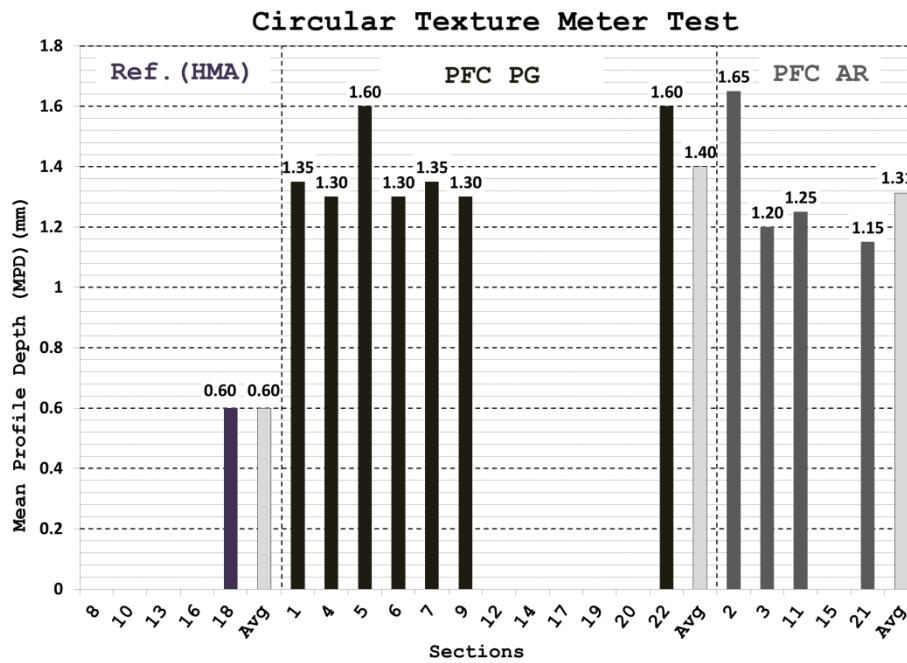
Figure 79. Texture Results Grouped by Mixture Type.

The porous surface of PFCs does not allow the conventional sand-patch testing to be accurately performed. Therefore, the CTM test was used to determine the texture of the road surface in terms of MPD. Figure 79 shows the most recent CTM results. Unfortunately, the results were not collected for a number of sections; however, the available data show a significant difference between the MPD value of PFC sections and the MPD value of the reference sections.

These results were used to determine the metrics and scores for texture. Table 18 lists the four groups to which the macrotexture of the roads was divided ranging from MPD < 0.5 mm (0.020 inch), the worst texture, to MPD > 1.5 mm (0.059 inch), the best texture. For those sections where CTM testing results were not available, the research team assumed the average value of the corresponding group for this preliminary analysis.

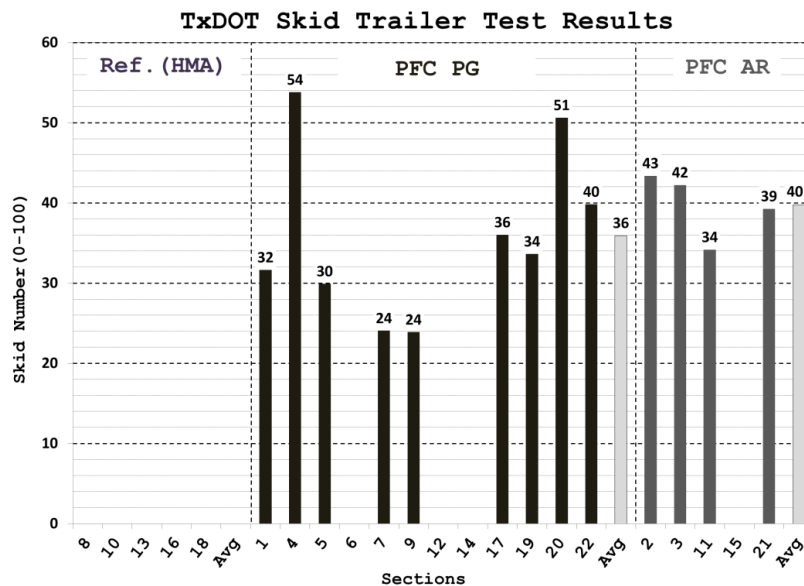
Figure 80. SN Results Grouped by Mixture Type.

Skid resistance was measured using two types of tests: TxDOT’s Skid Trailer Test and the Dynamic Friction Tester (DFT). TxDOT’s Skid Trailer test uses the procedure in ASTM E 274-06 and ASTM E 524-06. The coefficient of friction between the wheel and the pavement surface is calculated as the Skid Number (also called Friction Number, FN) on a scale of 0 to 100. A higher value for Skid Number means a higher coefficient of friction between the road and the tire. [Figure 80](#) shows the results of the TxDOT Skid Trailer tests.

The Skid Trailer Testing data were not available for several sections, so DFT measurements were used. DFT measures the friction performance of the road in terms of a number between 0 and 1. DFT is a portable test but it requires traffic control. [Figure 81](#) shows the data collected with the DFT. By comparing [Figure 80](#) and [81](#), one can observe that for most of the sections the results of TxDOT’s Skid Trailer Test are consistent with the results of the DFT. Therefore, in the absence of direct test data for either one of these tests, the available information from the results of the other test can be used. Furthermore, analysis of the results shows that, on average, the skid resistance of the PFC-PG sections is similar to the PFC-AR sections, but lower than that of the HMA group. [Table 19](#) presents the metrics for FN and SN used for the purpose of the CEA.

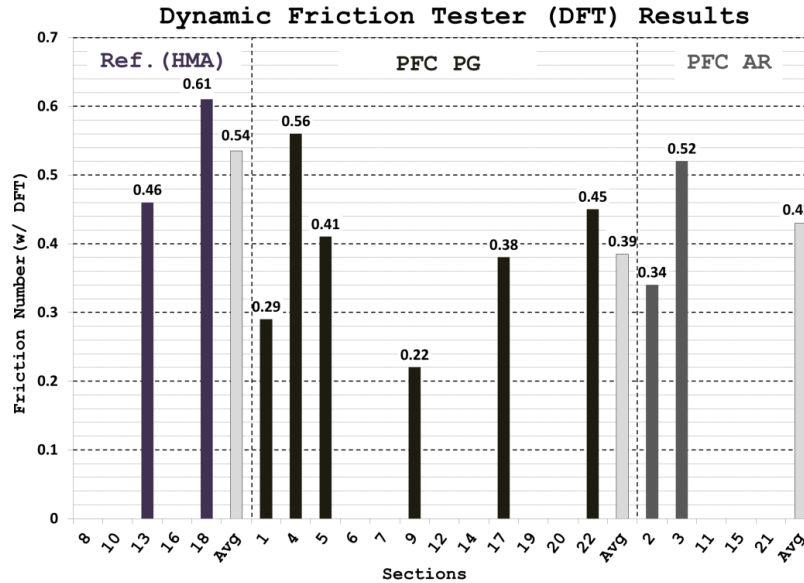
Figure 81. DFT Results Grouped by Mixture Type.

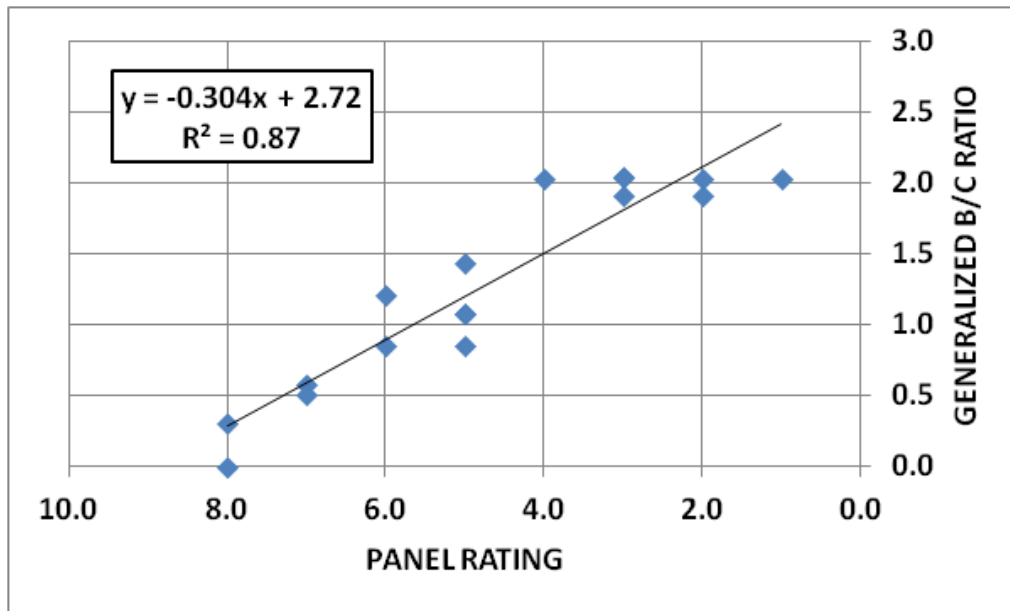
The following equation gives the final model and it is presented against the data in [Figure 82](#). The variables Performance, Drainability, Binder Type, and SAC in the equation were scored according to the values listed in [Table 26](#).

$$B/C \text{ Ratio} = \frac{2.42\text{Performance} + 0.32\text{Drainability}}{1 + 0.12\text{BinderType} + 0.29\text{SAC}}$$

Figure 82. Correlation between B/C Ratio and Panel Rating.

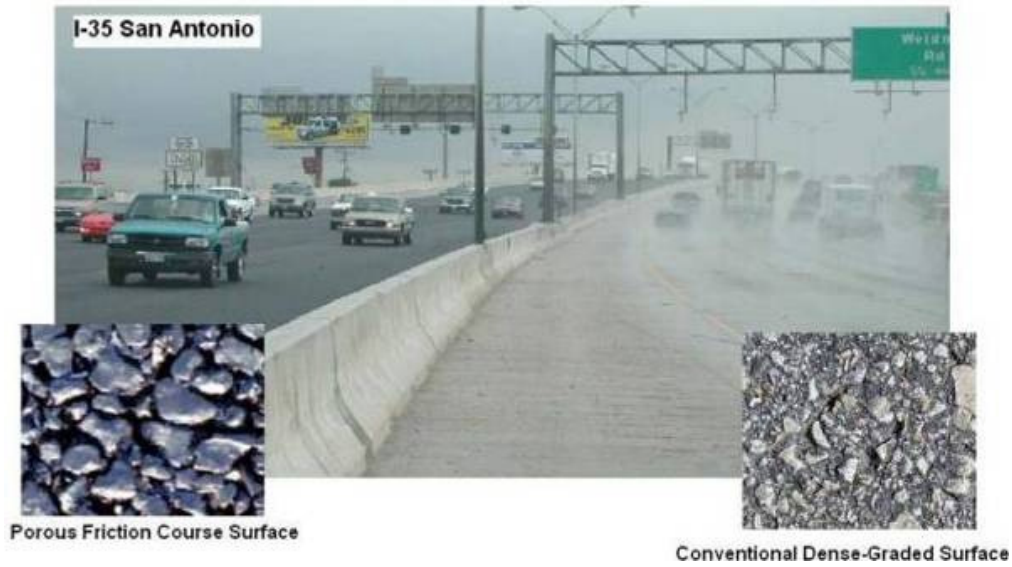
Figure 83. PFCs in Urban Areas to Reduce Splash and Spray (San Antonio IH 35).

- Urban interstates as shown in [Figure 83](#) where the left portion of the photo shows the reduced splash and spray associated with the PFC compared to the dense-graded mix on the right half of the photo.
- Rural interstates ([Figure 84](#)).
- Rural US highways to mitigate bleeding surface treatment ([Figure 85](#)).
- Accident-prone severe curves ([Figure 86](#)).
- US highways including areas with stop-and-go intersections as shown in the Lufkin District in [Figure 87](#). This PFC is more than 8 years old and is still in excellent condition.

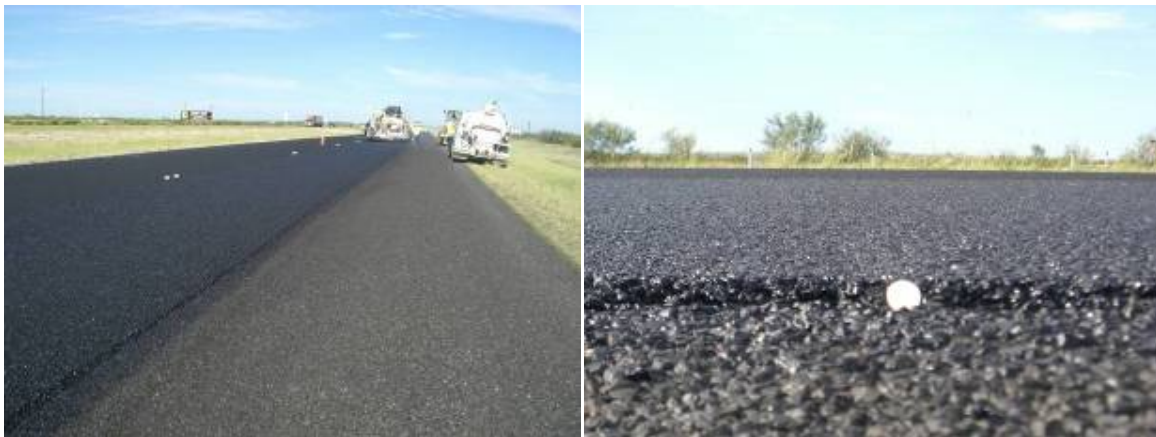
Figure 84. PFCs on Rural Interstates (Odessa District IH 10, AR Underseal Followed by AR-PFC).

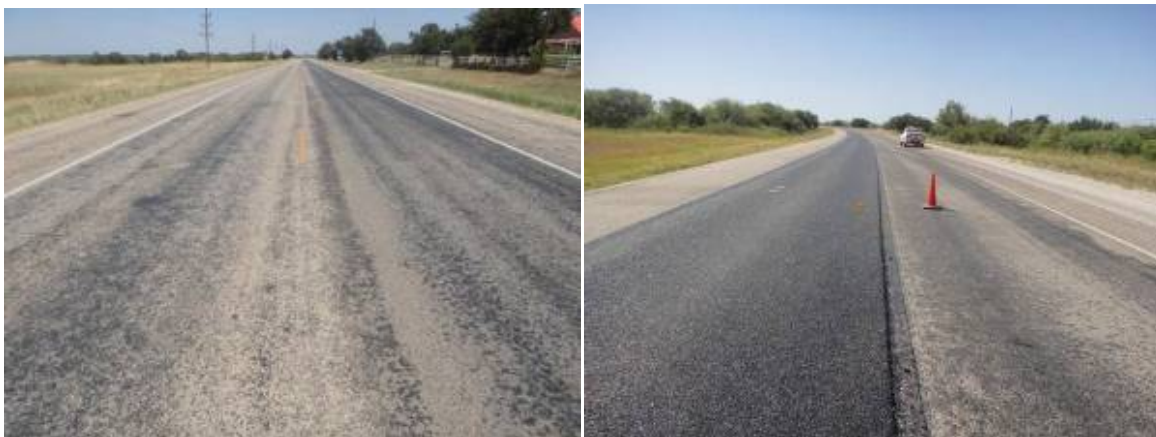
Figure 85. US 183 Brownwood District (PFC Used to Remediate Bleeding Surface Treatment).

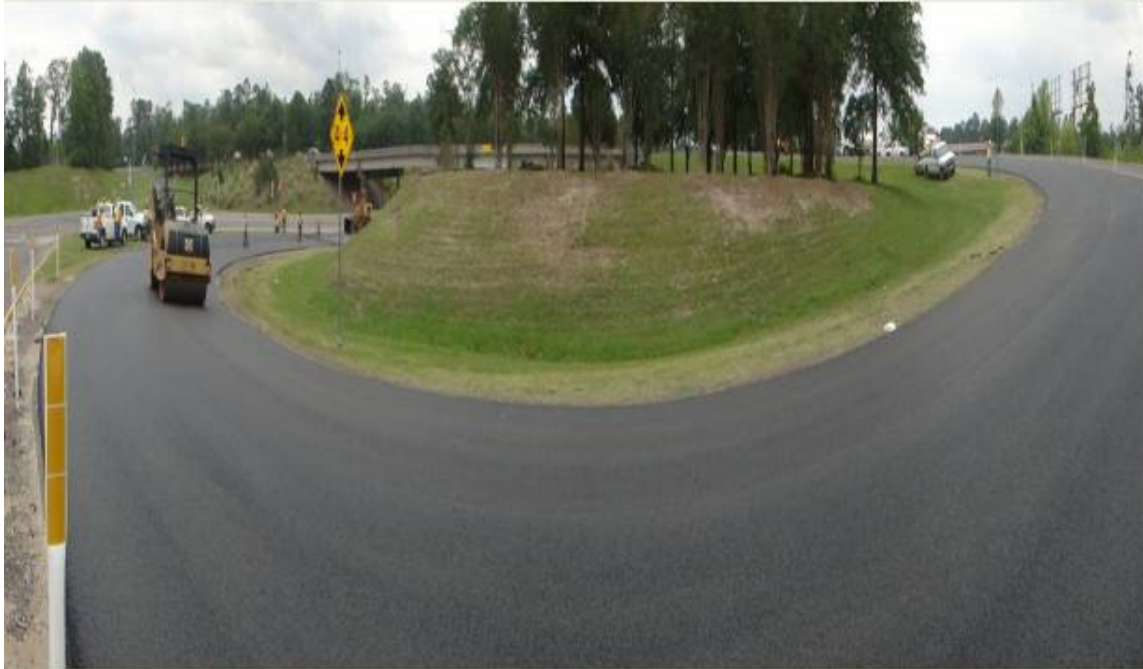
Figure 86. Lufkin District US 59 Cloverleaf (PFC Used to Remediate Wet Weather Accidents).

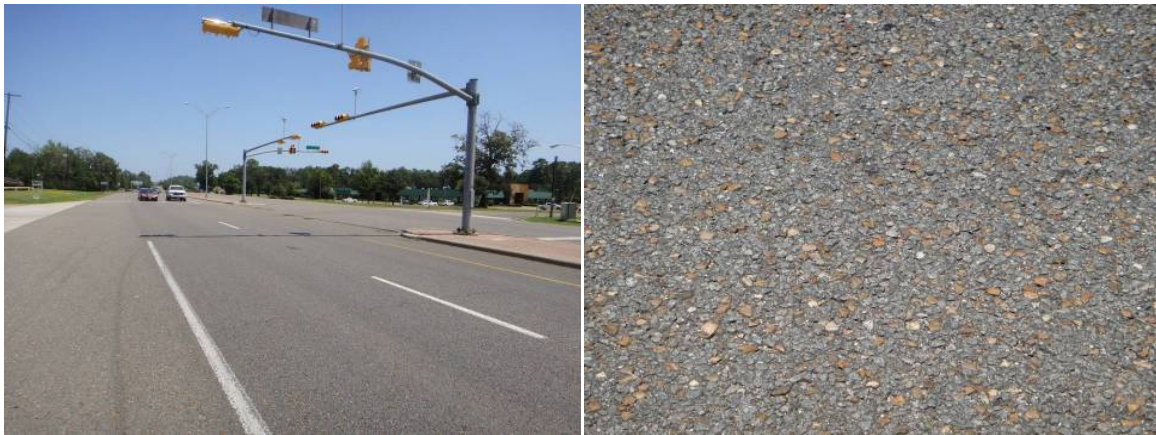
Figure 87. Lufkin District US 59 through Diboll.

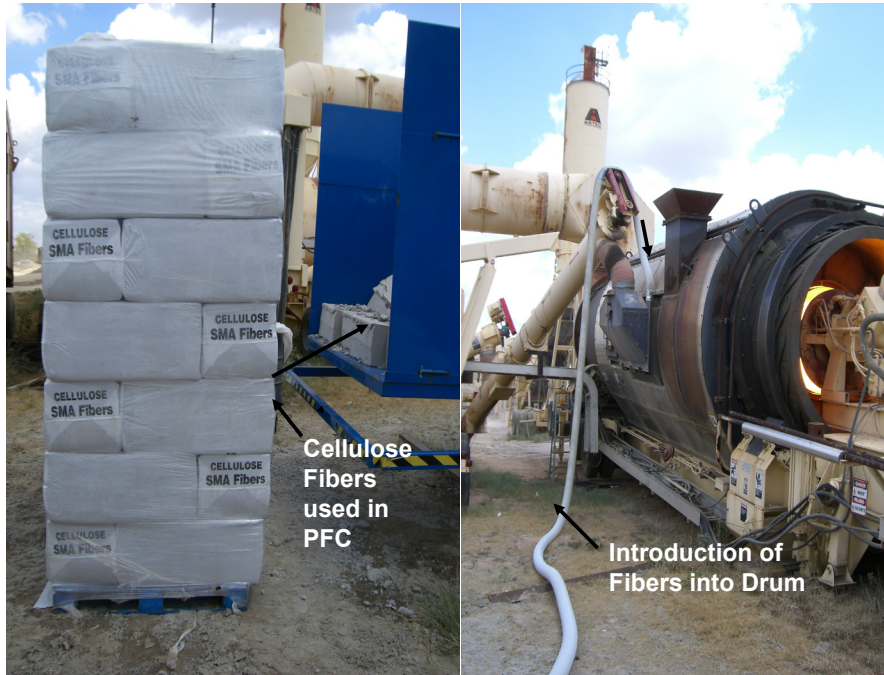
When asphalt rubber binders are specified, fibers are not incorporated. Cellulose or mineral fibers should be used when a PG 76-XX binder is specified. Conventional asphalt plants can be adapted to allow the incorporation of fibers with the installation of a fiber feed device as shown in [Figure 88](#).

Figure 88. Introduction of Fibers into Drum on IH-30 Project in Paris District.

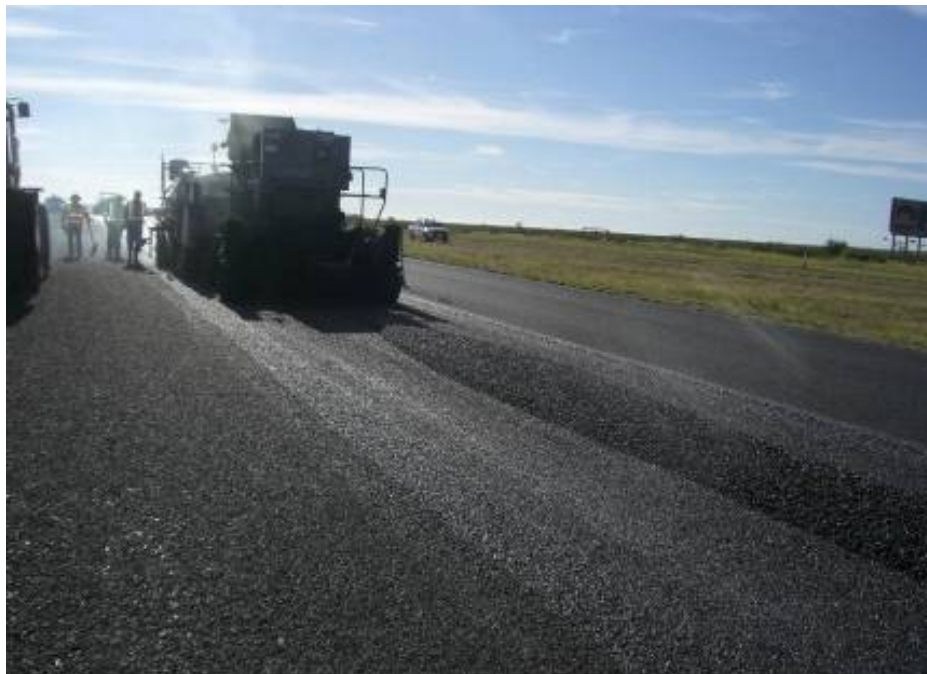
Figure 89. Application of PFC on Tacked, Newly Seal Coated Surface of IH 10 in Odessa District.

It is important to have an adequate tack coat to bond the PFC to the underlying surface. A good tack coat can also help to seal the surface from the intrusion of water from the surface. Item 342 states that the tack should be uniform and should be applied at a rate between 0.04 and 0.10 gal/sy residual asphalt as directed by the engineer. If there is a new seal coat underneath the PFC, some districts do not require a tack, although the Odessa District still required a tack coat on the new seal shown in [Figure 89](#) prior to placement of the PFC.

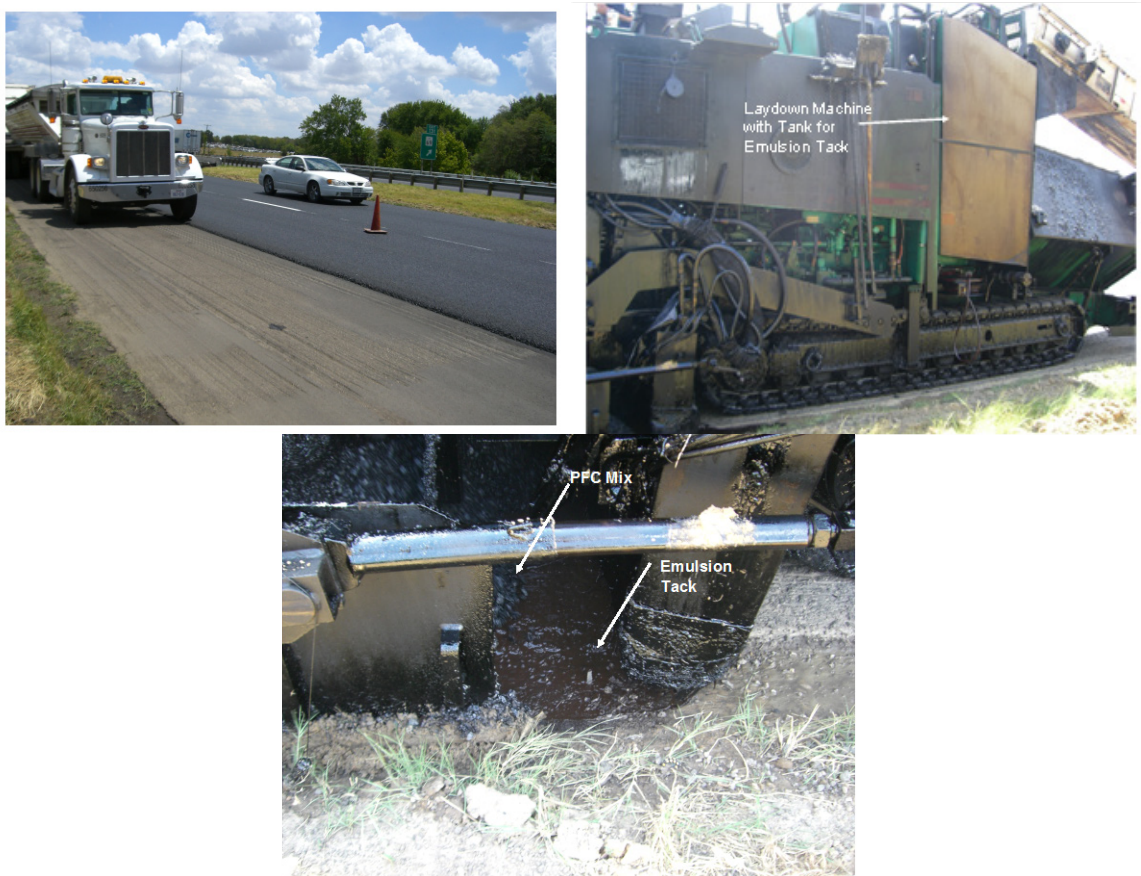
Figure 90. Laydown Machine with Tank for Applying Tack on IH-30 in the Paris District.

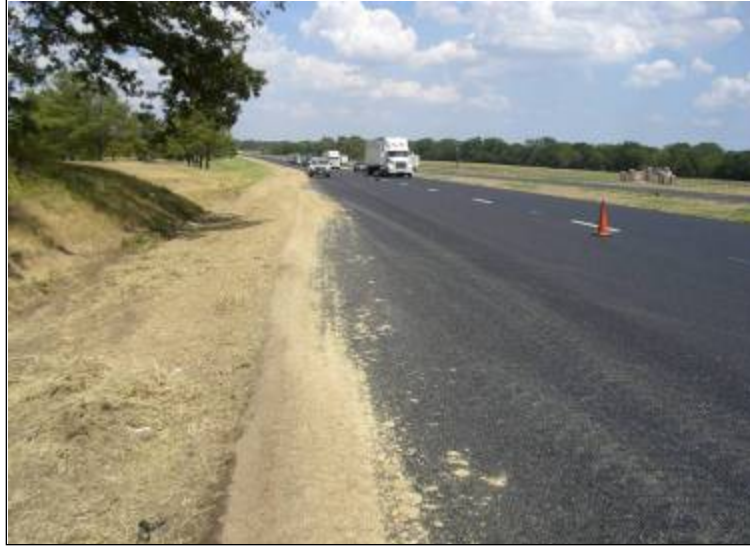
Figure 91. Edge Clearing that Can Cause Clogging of PFC Restricting Lateral Water Flow.

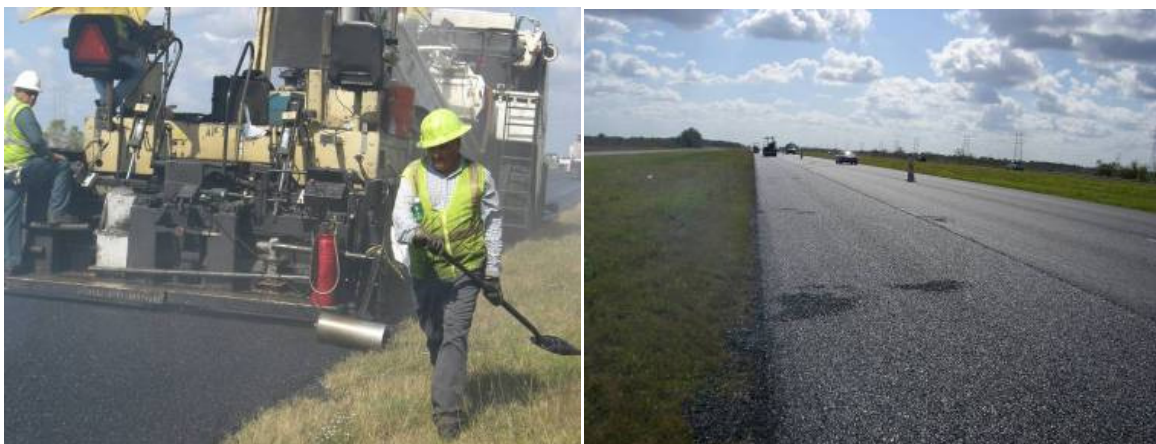
Figure 92. MTV Paving Operation (left photo) and Areas in the Mat Where Cold Chunks Required Removal and Patching (right photo) on US 288 in the Houston District.

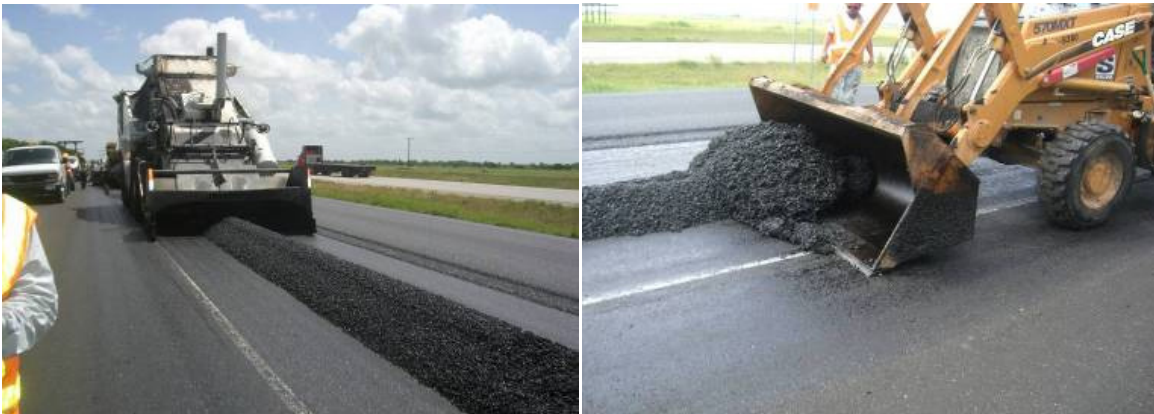
The windrow pickup process tends to exhibit more thermal segregation for PFC. Several districts report that while this process can be used on hot, summer days, it should not be used for PFC mixes on cooler days. A windrow pickup process used in the Yoakum District is shown in [Figure 93](#). Even on an August day in Yoakum, the end of the windrow portion representing the end of the truckload sometimes formed large chunks, which required removal with a front end loader.

Figure 93. Windrow Pick-Up Process on US 59 in the Yoakum District with Cold Lumps Forming at the End of the Windrow.

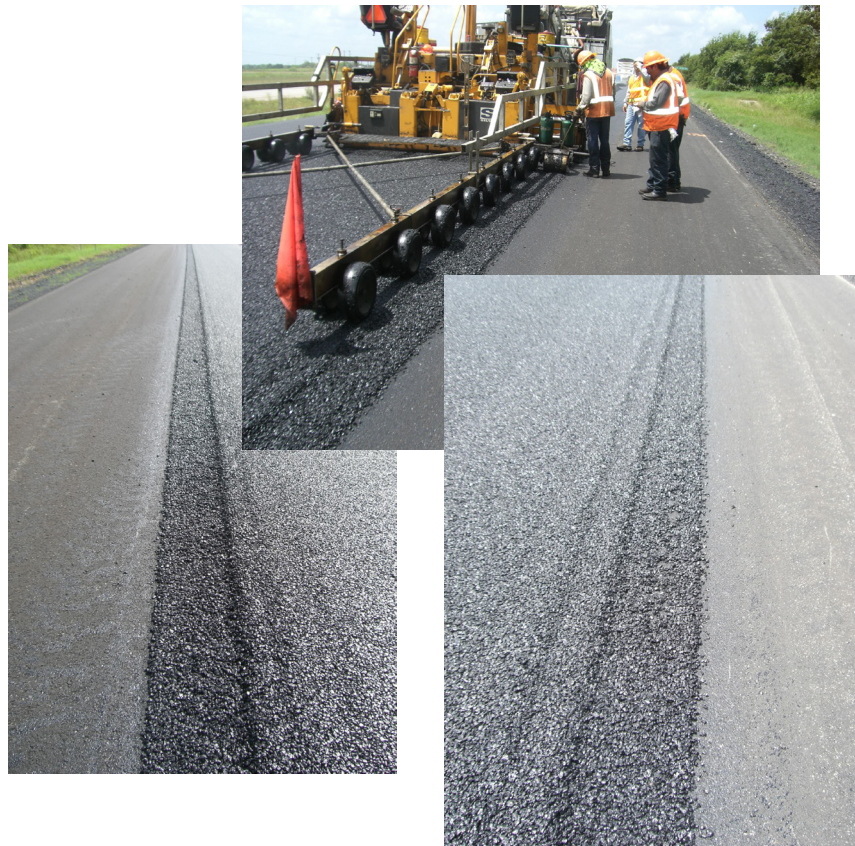
Figure 94. Notched Wedge Joint Construction in PFC.

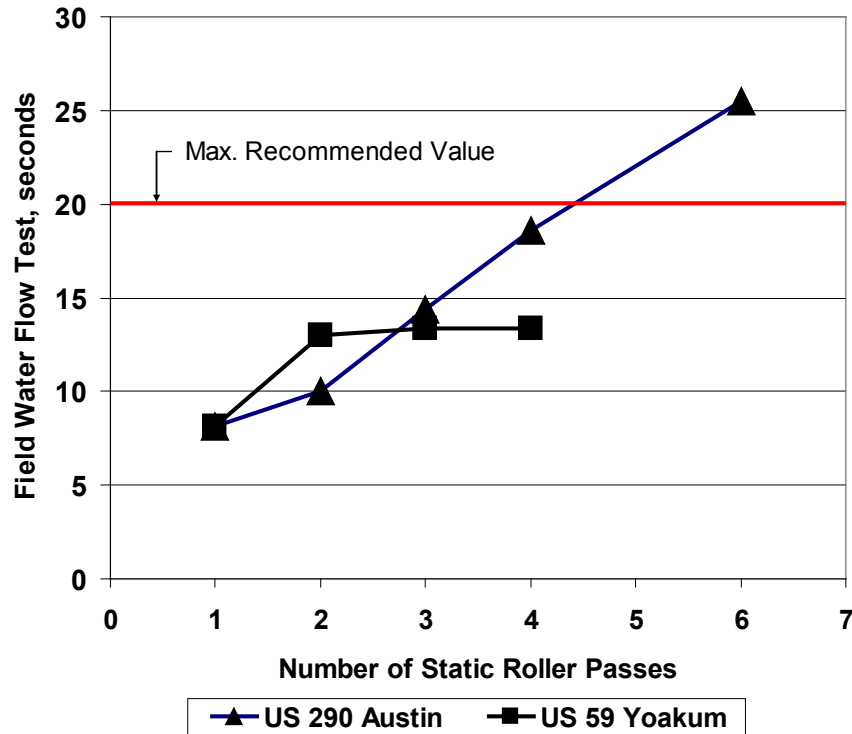
[Figure 95](#) shows how the field water flow values change with each roller pass and how two different mixes (both constructed under Item 342) can behave very differently. To ensure adequate permeability, the field water flow value should not exceed 20 seconds ([28](#)). For the US 290 mixture shown in [Figure 95](#), this water flow value of 20 seconds corresponds to a compaction effort of not more than four passes. For the US 59 mix in Yoakum shown also in

Figure 95, the field water flow value did not change significantly after the first two passes. Mixture differences are shown in Table 27.

Figure 95. Field Water Flow Value versus Field Compaction Effort.

overlap in the center of the PFC mat for the US 290 mixture in Austin (Figure 95) could restrict the lateral flow of water through the mix.

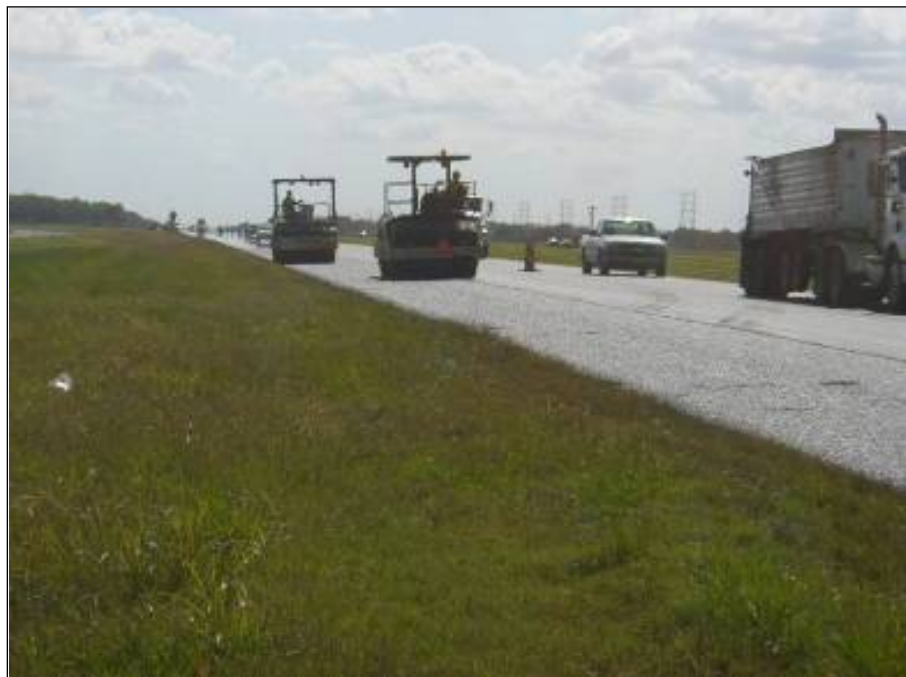
One of the requirements implemented by the Houston District is that only one roller pass is allowed (i.e., rollers are not permitted to back up). This requires two rollers operating in tandem, at a very slow speed, to achieve one full coverage of the mat (Figure 96). Water flow values for this pavement after one roller pass was about 10 seconds. Stopping the roller on the mat for an extended length of time may leave a roller mark.

Figure 96. A Single Roller Pass as Allowed in the Houston District (No Roller Back Up Allowed).

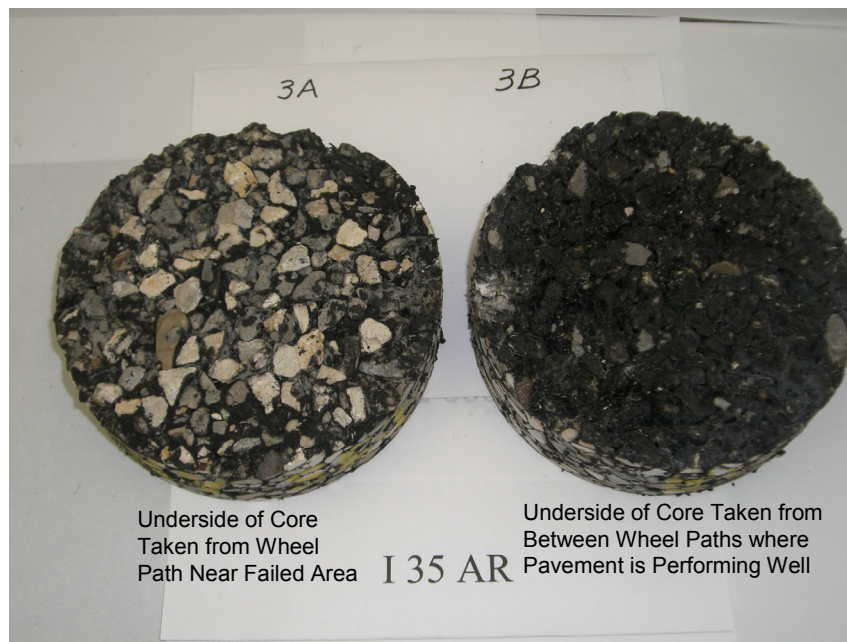
Figure 97. Cores Taken from Distressed PFC on IH-35 in San Antonio.

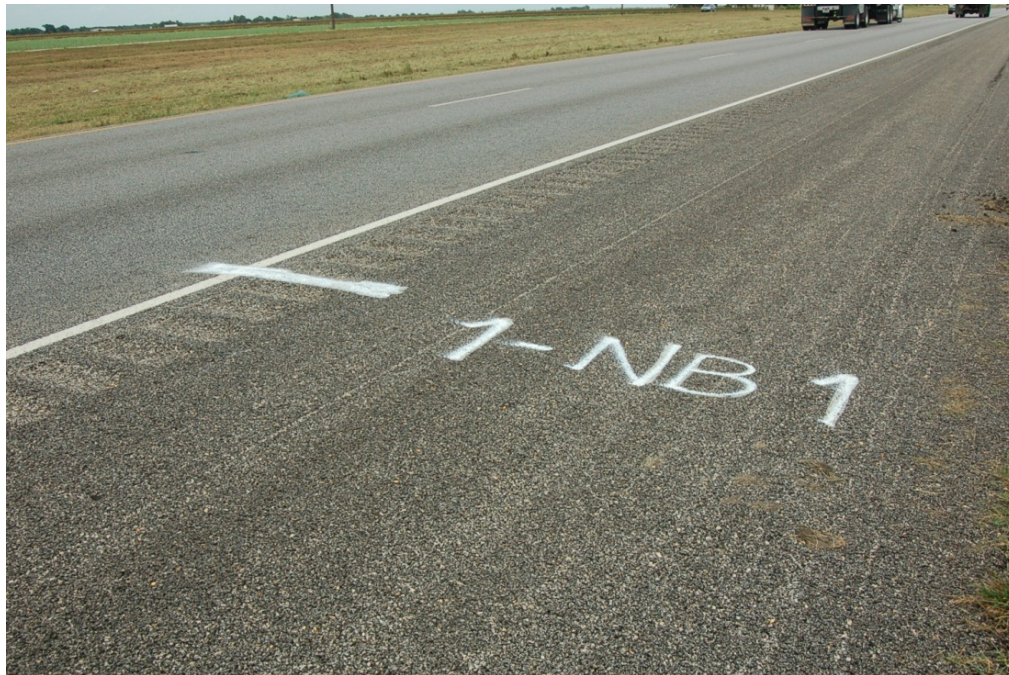
Figure C.2. PFC Pavement Section on US 59 (Section 1).

This section of highway in the Yoakum District, near Hillje, featured two pavement types, as each direction had a different type of surface. Therefore, two pavement sections for this study were evaluated in the same highway. The northbound (NB) section corresponds to Section 1 of this project. The southbound (SB) pavement is a dense-graded HMA that was used as a reference pavement (i.e., Section 13); [Figure C.1](#) has a map showing the location. Views of the sections on US 59 are shown in [Figures C.2–C.4](#).

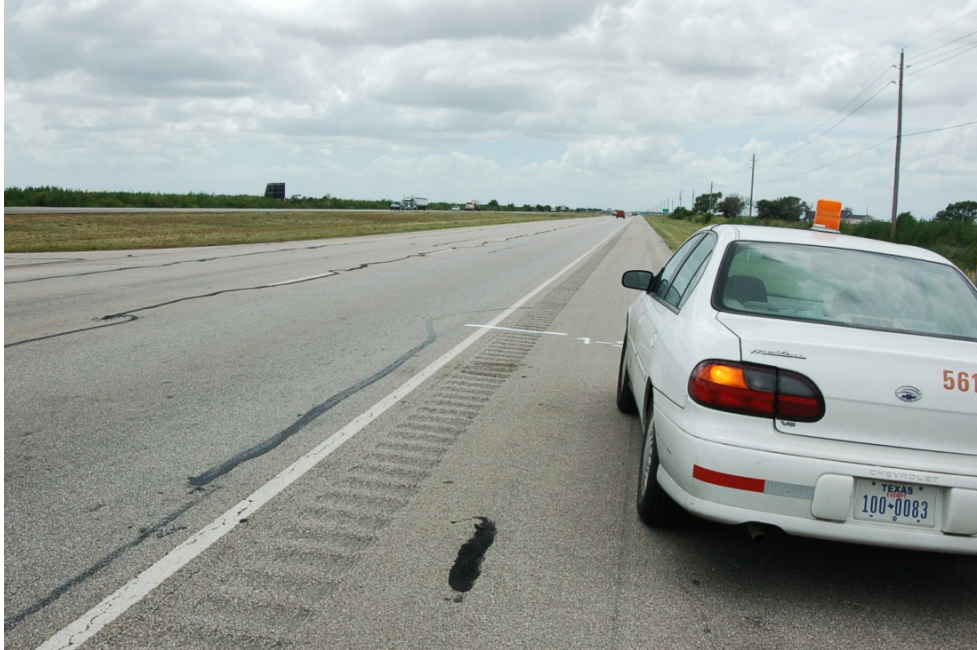
Figure C.3. HMA Pavement Section on US 59 (Section 13).

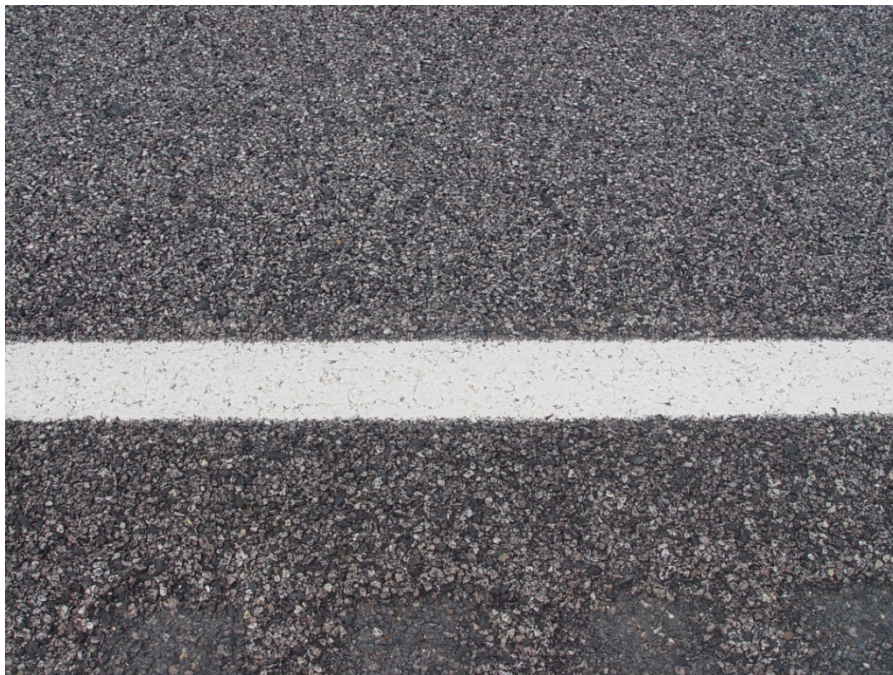
Figure C.8. Detailed View of the PFC Surface on SH 288, Section 2, Northbound.

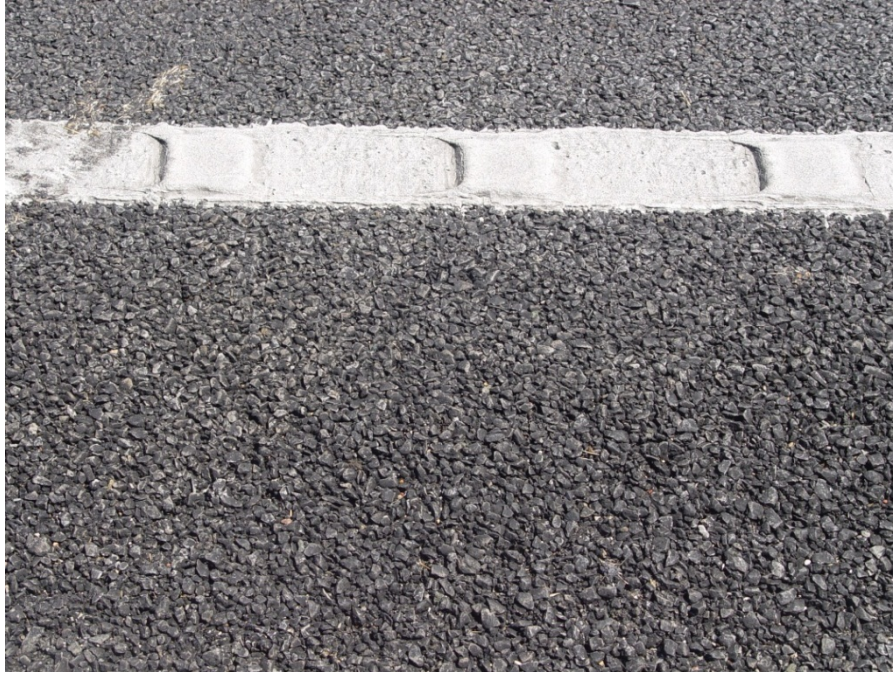
Figure C.12. Detailed View of the PFC Surface on US 290, Section 3, Subsection 3-3, EB.

This AR-PFC section was located east of the City of Austin, near Paige, in Bastrop Count (see Figure C.9). Six subsections were located for OBSI testing: three in the eastbound direction (3-1, 3-2, and 3-3), and three in the westbound direction (3-4, 3-5, and 3-6). Pictures of the highway and pavement details are shown in Figures C.10–C.12.

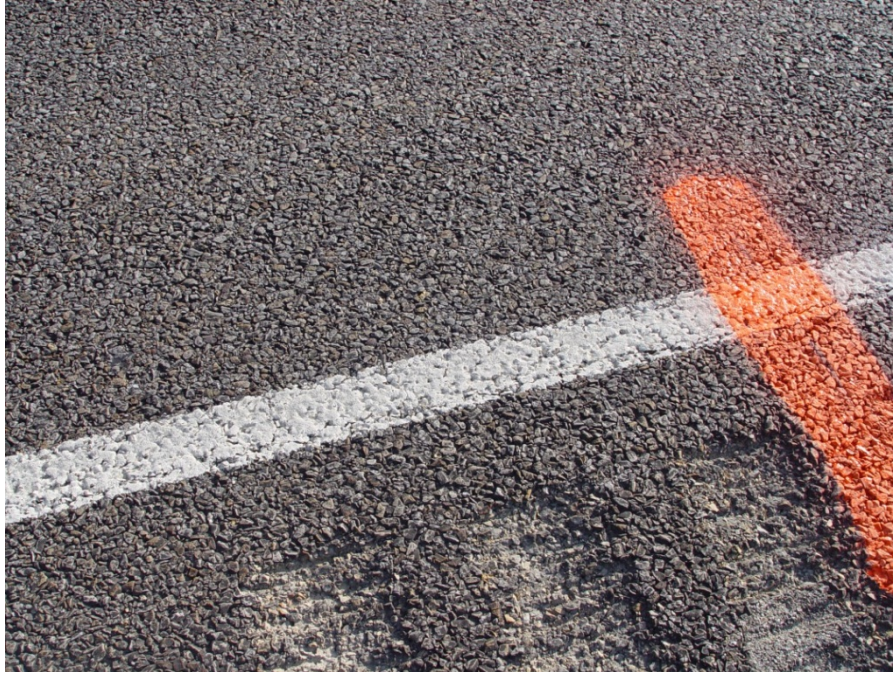
Figure C.15. Detailed View of the PFC Surface on IH-30, Section 4, Subsection 4-1, WB.

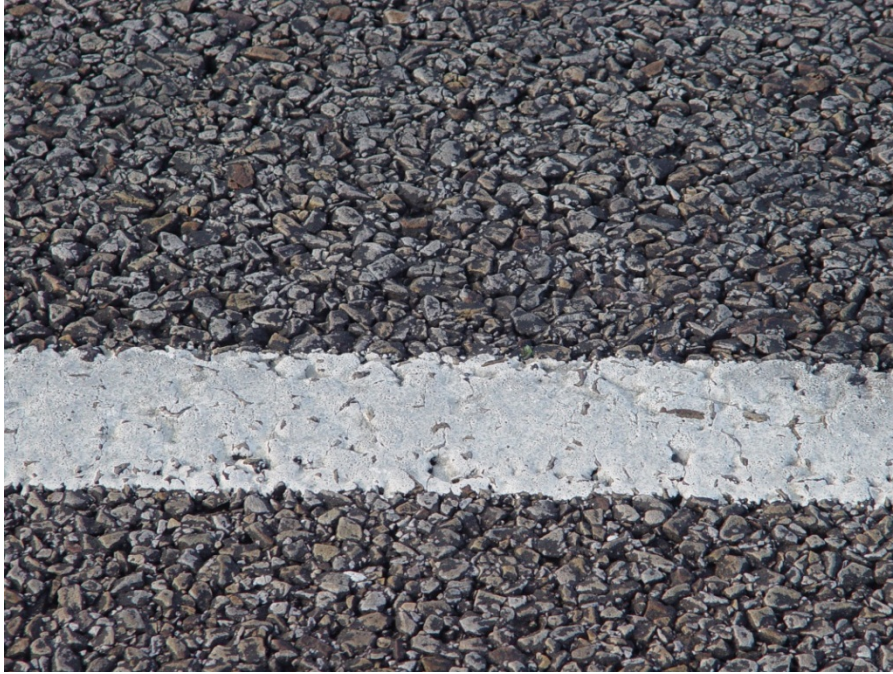
Figure C.17. Detailed View of the PFC Surface on IH-30, Section 4, Subsection 4-6, EB.

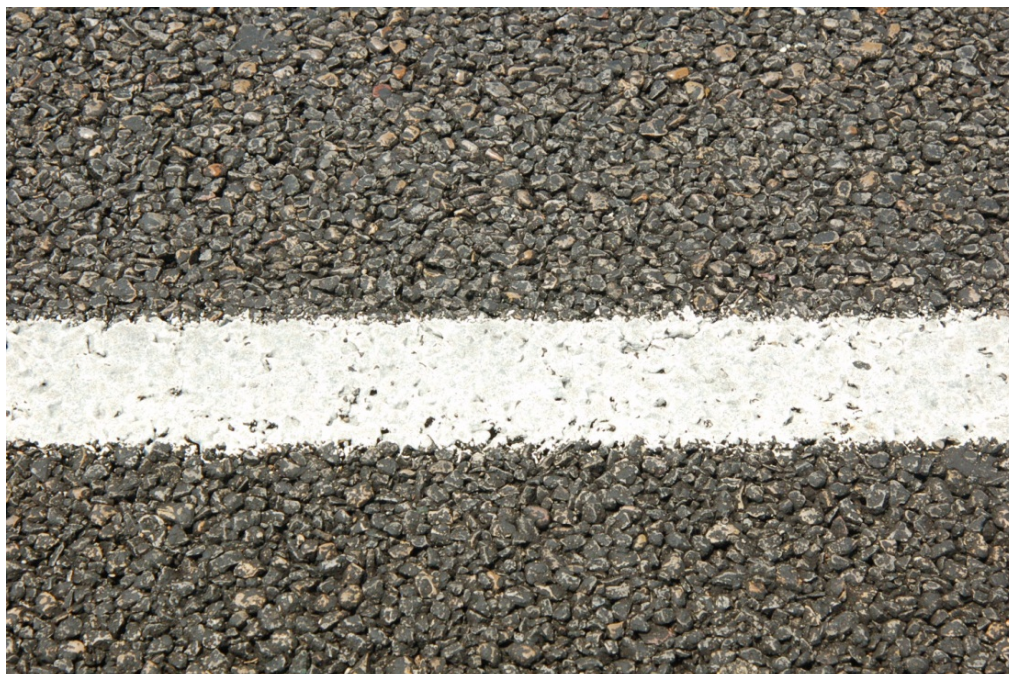
Figure C.20. Detailed View of the PFC Surface on SH 6, Section 5, Subsection 5-1, NB.

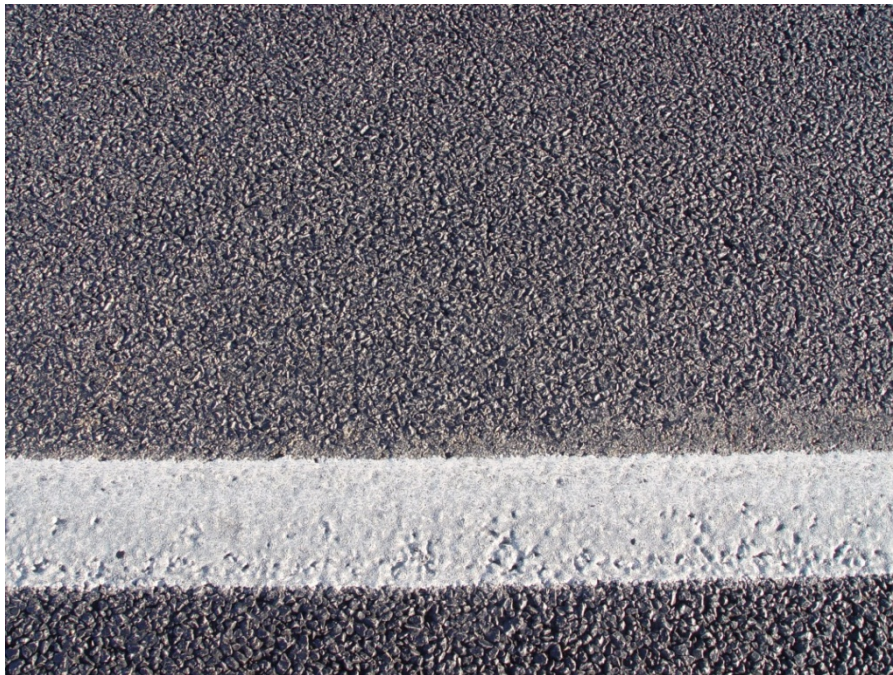
Figure C.24. Detailed View of the PFC Surface on IH 20, Section 6, Subsection 6-1, WB.

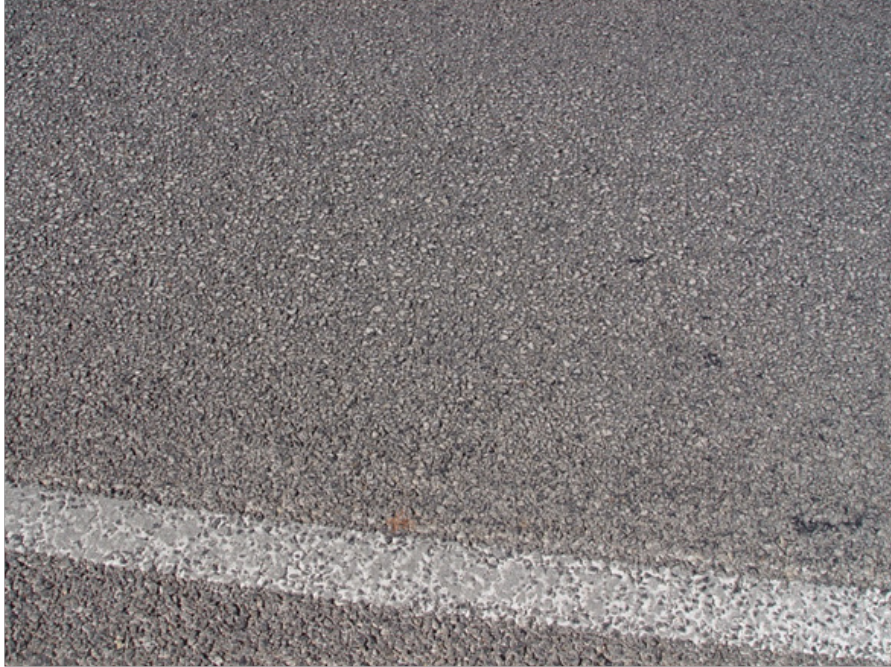
Figure C.27. Detailed View of the PFC Surface on US 83, Section 7, Subsection 7-2, NB.

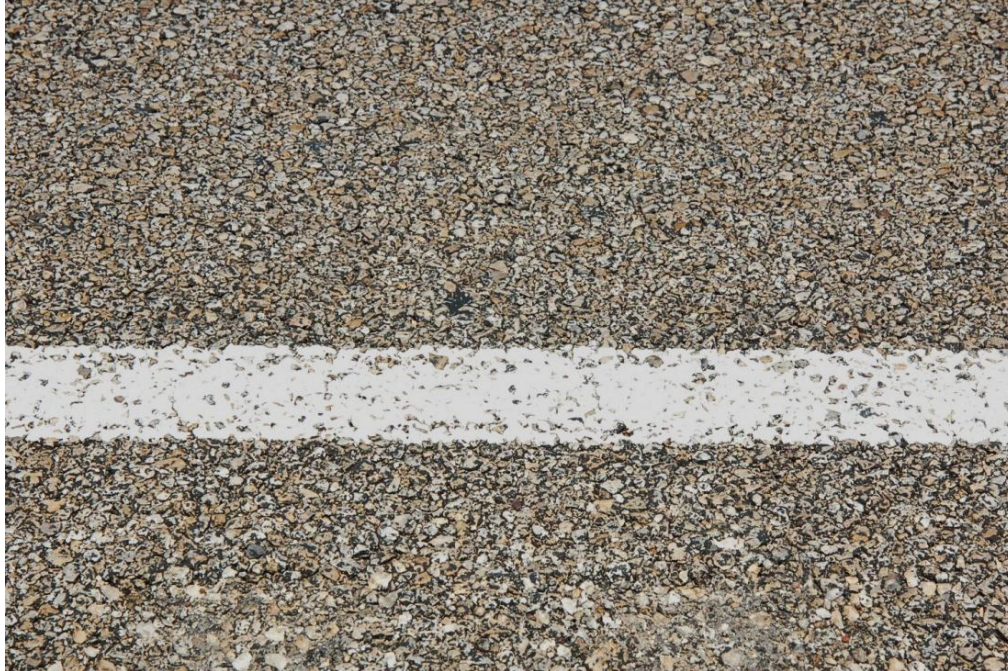
Figure C.32. Detailed View of the PFC Surface on SH 6, Waco.

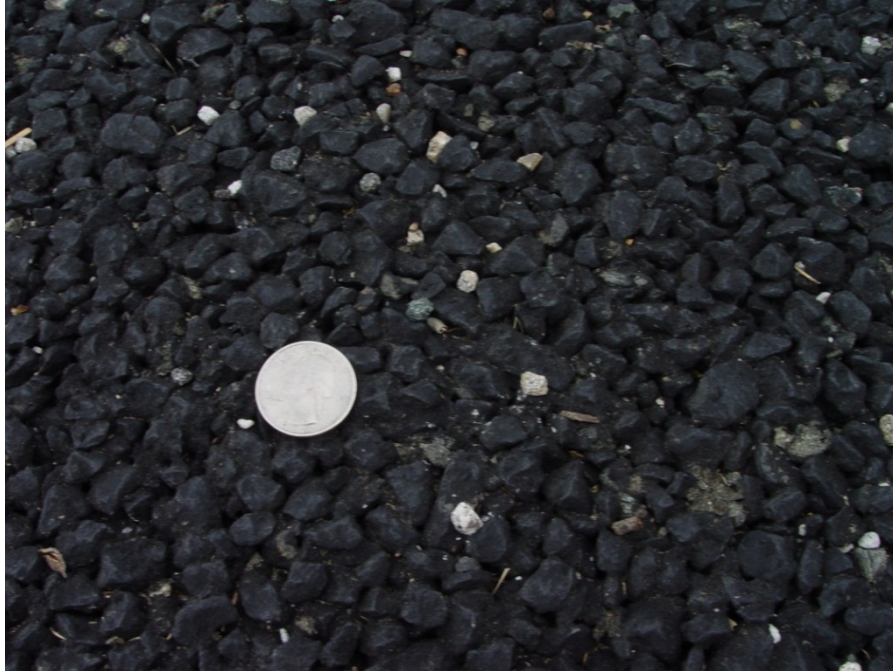
Figure C.35. Detailed View of the PFC Surface on US 281, Section 11, Northbound.

The sections appear to have gotten slightly louder over the years, while still remaining among the quietest. However, these sections started being studied for noise when they were almost brand new, so a noise increase from that time was expected to occur, since compaction and clogging took place over the years. According to other parts of this study, Section 11 has been found to have very poor drainability, which apparently has not caused a decline of its acoustic performance.

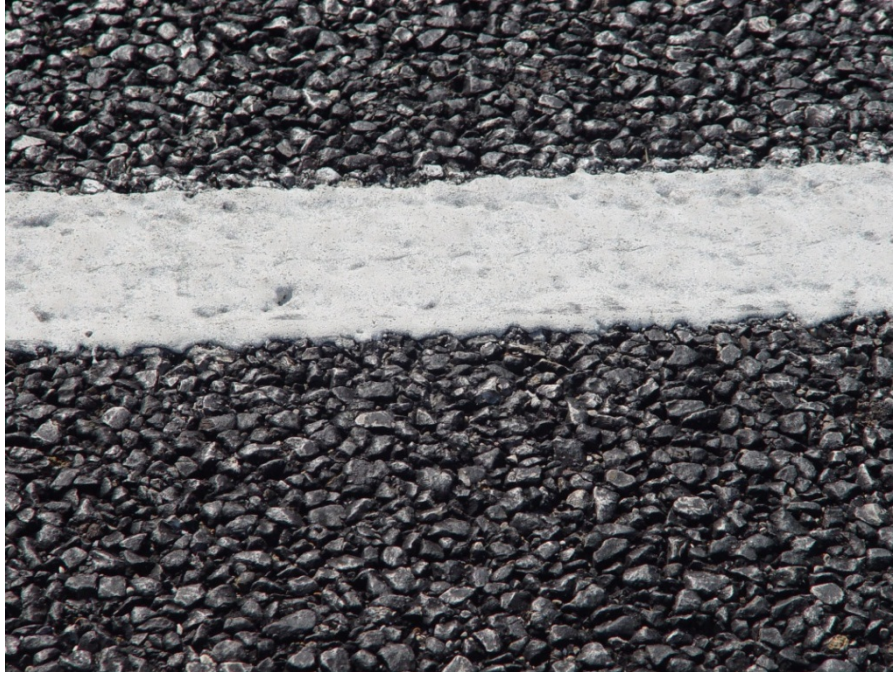
Figure C.38. Detailed View of the PFC Surface on US 281, Section 21, Subsection 17T, SB.

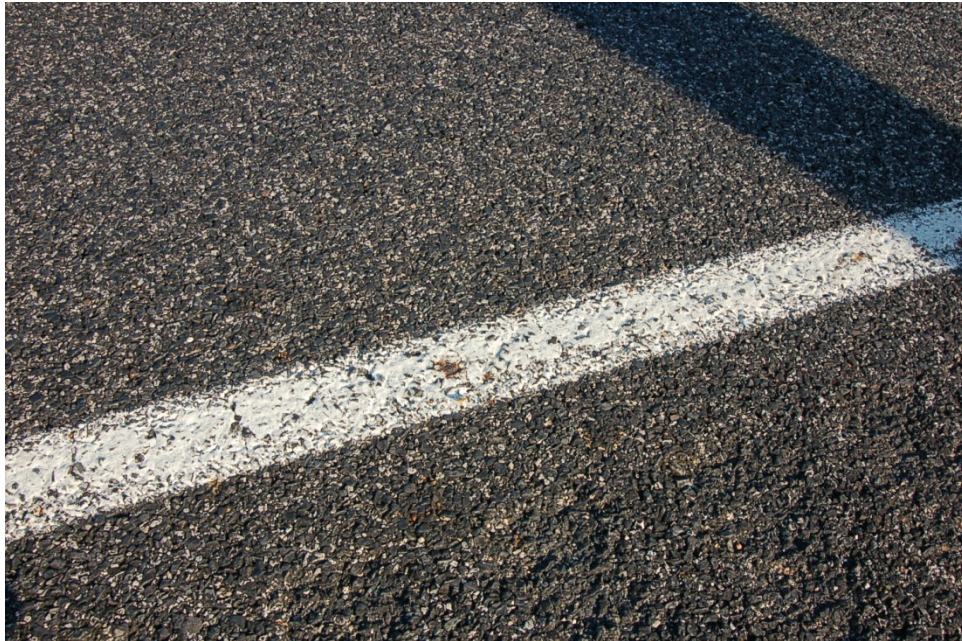
Figure C.42. Detailed View of the PFC Surface on SH 6, Section 112, Southbound.

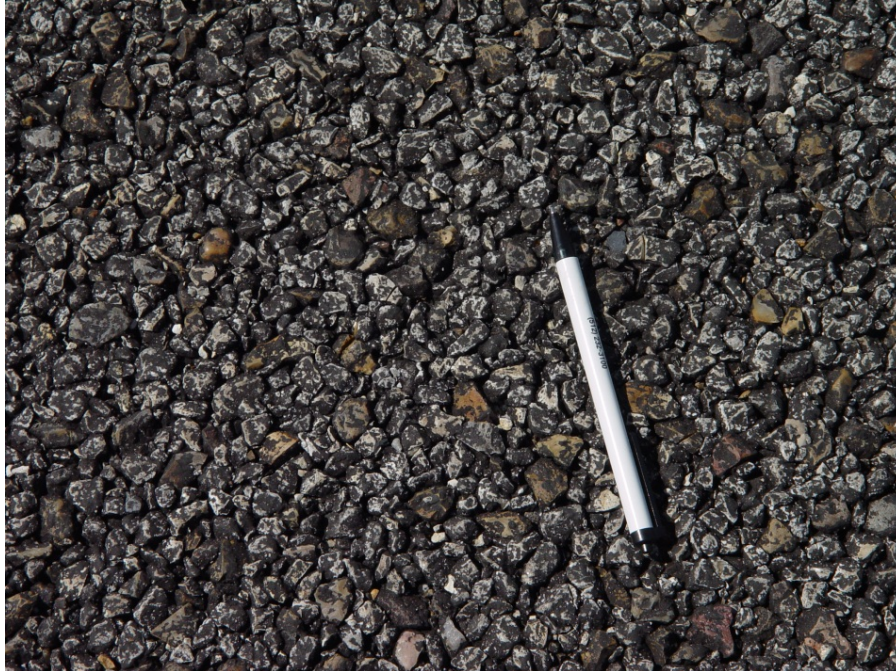
Figure C.45. Detailed View of the PFC Surface on IH-37, Section 14, Corpus Christi.

This section was the quietest PG-PFC in this study before the more recent measurements in 2012. Two factors caused an increase in the measured noise levels: 1) severe raveling on this section, possibly due to binder aging or the PFC pavement reaching the end of its service life (constructed in 2005), and 2) the subsequent repairs that unfolded to restore the quality of the riding surface. Also, the variability within subsections went up as a result of the patching and repairs. The latest noise measurements ranked this pavement section near the average level for PFCs in this project.
