1. Report No. FHWA/TX-12/0-5836-2		2. Government Accession No.		3. Recipient's Catalog No.	
4. Title and Subtitle PERFORMANCE AND COST EFFECTIVENESS OF PERMEABLE FRICTION COURSE (PFC) PAVEMENTS				5. Report Date Published: February 2013

PERFORMANCE AND COST EFFECTIVENESS OF PERMEABLE FRICTION COURSE (PFC) PAVEMENTS

Report 0-5836-2
Project 0-5836

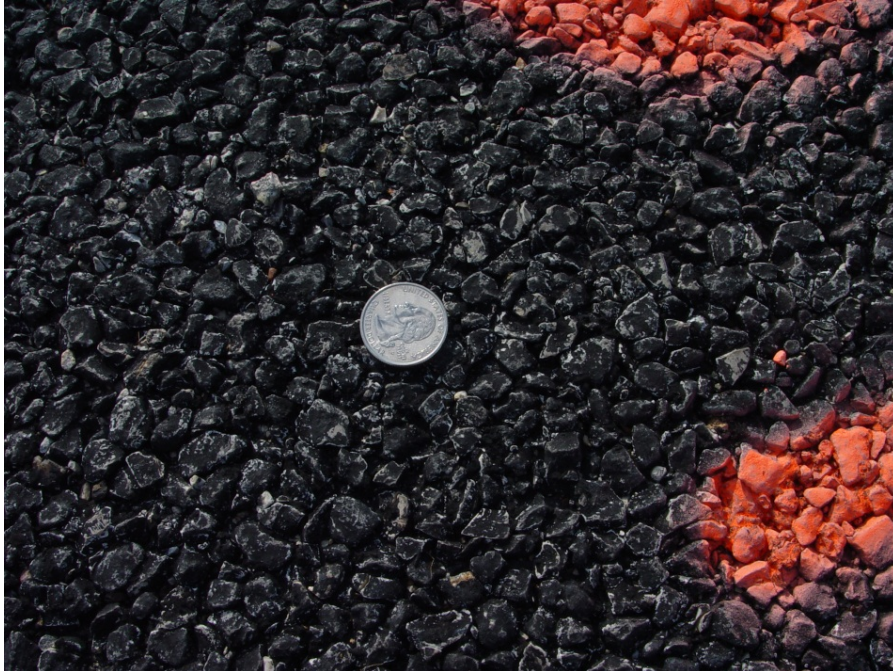
Figure C.47. Detailed View of the AR-PFC Surface on IH-37, Section 15, Corpus Christi.

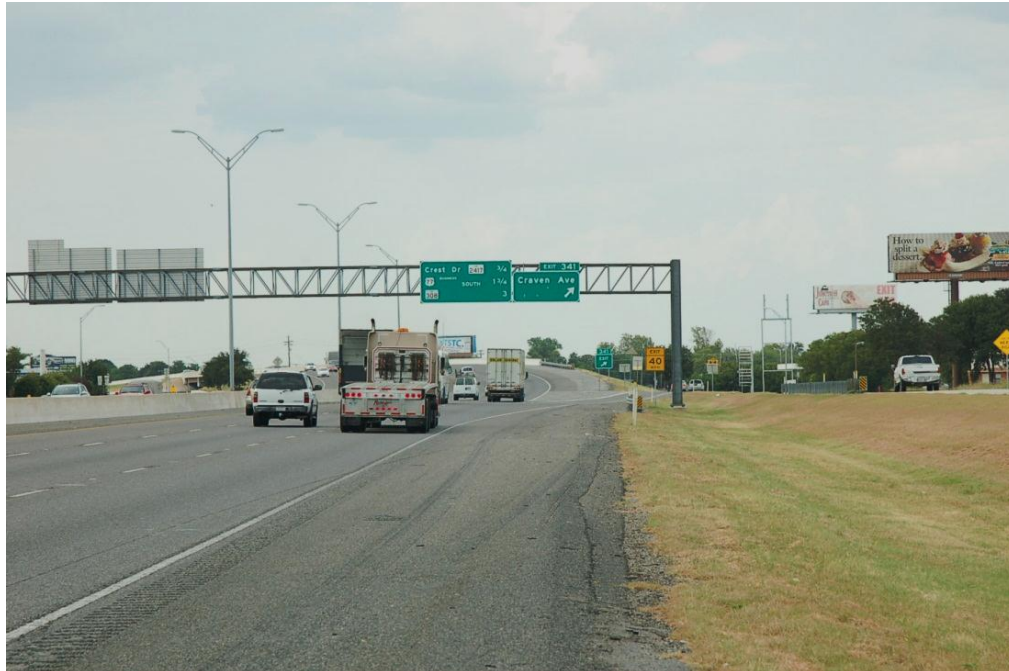
Figure C.50. View of IH 35, Section 17, Northbound (Old PFC).

This section has a very high variability within subsections, which is explained by the fact that there is an old and a new PFC within the same project. Also, other parts of this project have found loss of drainability problems due to clogging, caused by aggregate crushing and subsequent compaction, which judging from the acoustic standpoint, seem to be affecting the old PFC (northernmost end of the project).

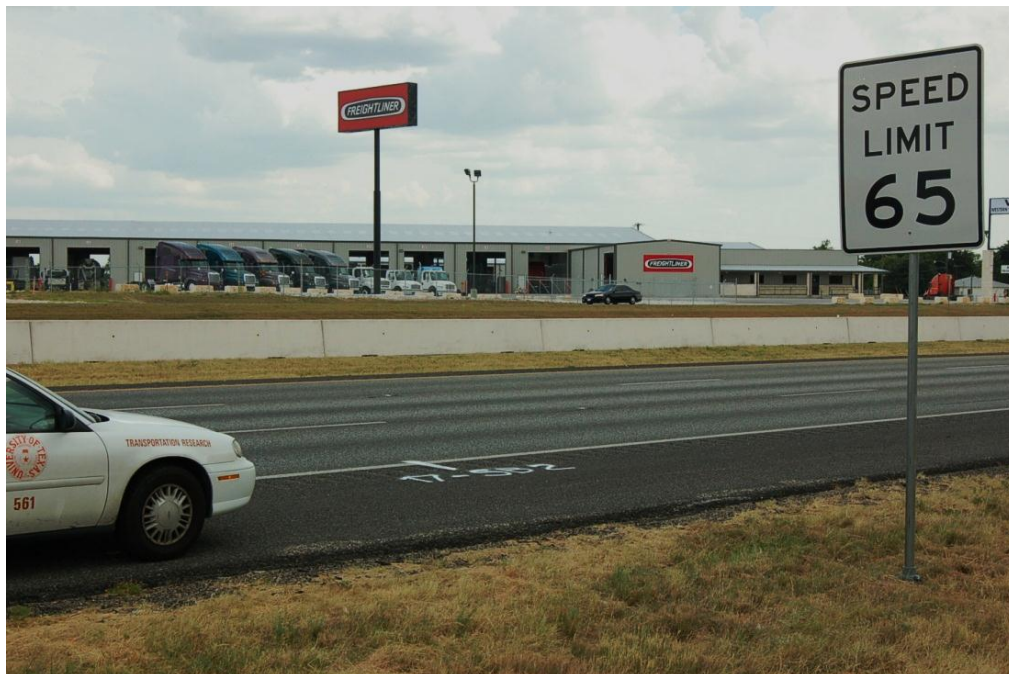
On a trip to this section around June 2008, the research team noticed that two of the original PFC subsections had been overlaid with new PFC pavement. The new overlay was placed on the southernmost subsections, designated as 17-NB1 and 17-SB2. During the last visit to this

Figure C.51. View of IH 35, Section 17, Subsection SB-2 (New PFC).

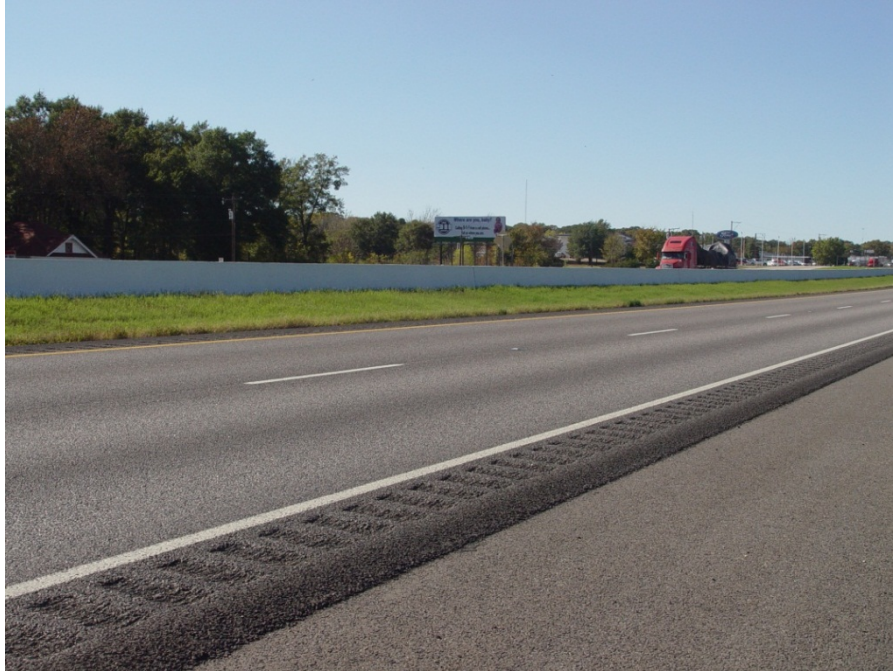
Figure C.53. View of IH 20, Section 19, Subsection 19-4, Westbound.

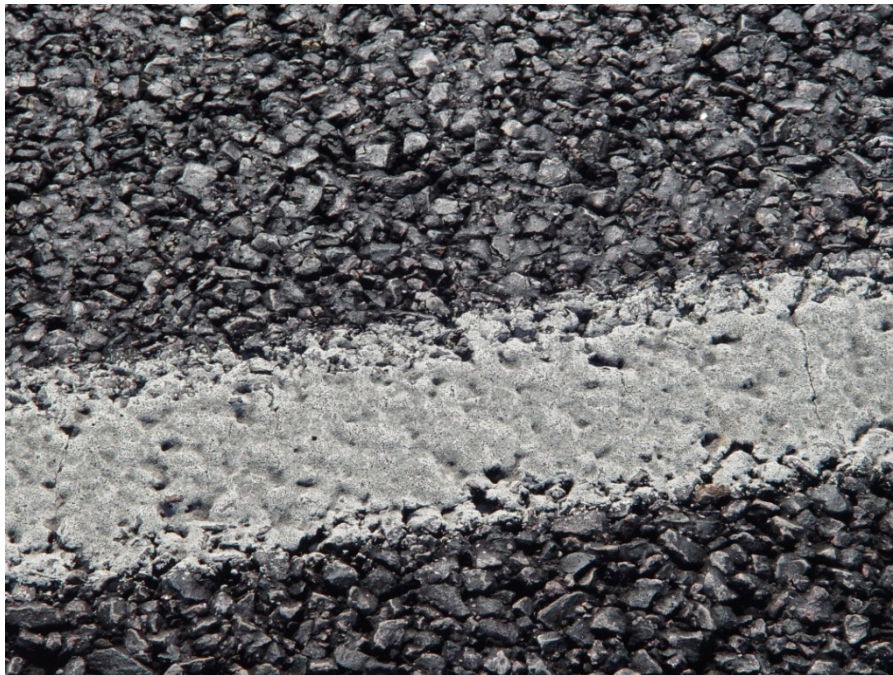
Figure C.54. Detailed View of the PFC Surface on IH 20, Section 19, Subsection 19-5, WB.

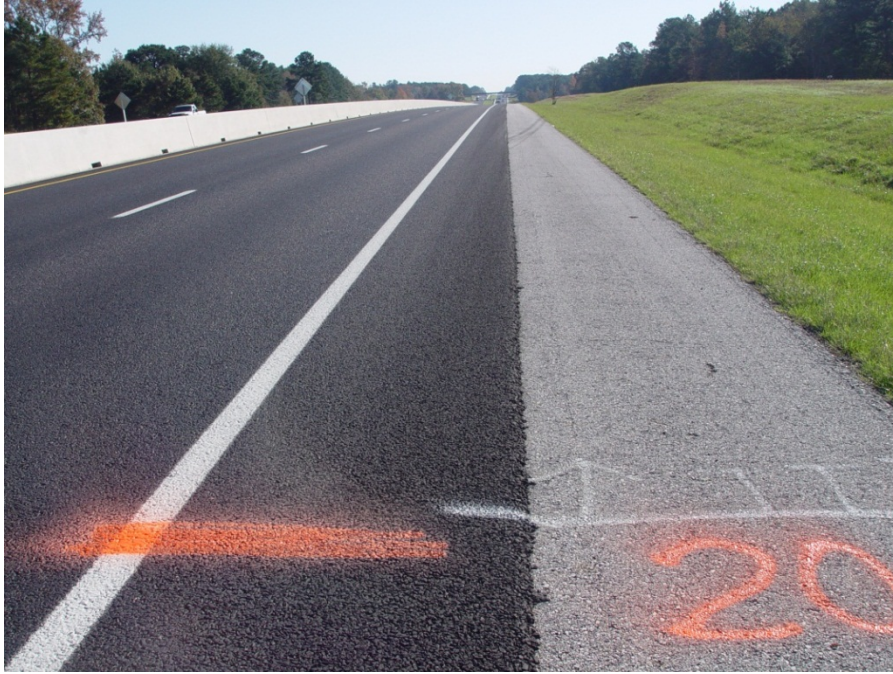
Figure C.56. View of IH 20, Section 20, Subsection 20-1, Eastbound.

Section 20, on IH-20 in Tyler District, is the newest PFC pavement analyzed in this study. The PFC was constructed in August 2009. [Figure C.55](#) shows the map with the project location. [Figures C.56–C.58](#) show pictures of the section. [Table C.14](#) presents the coordinates for Section 20.

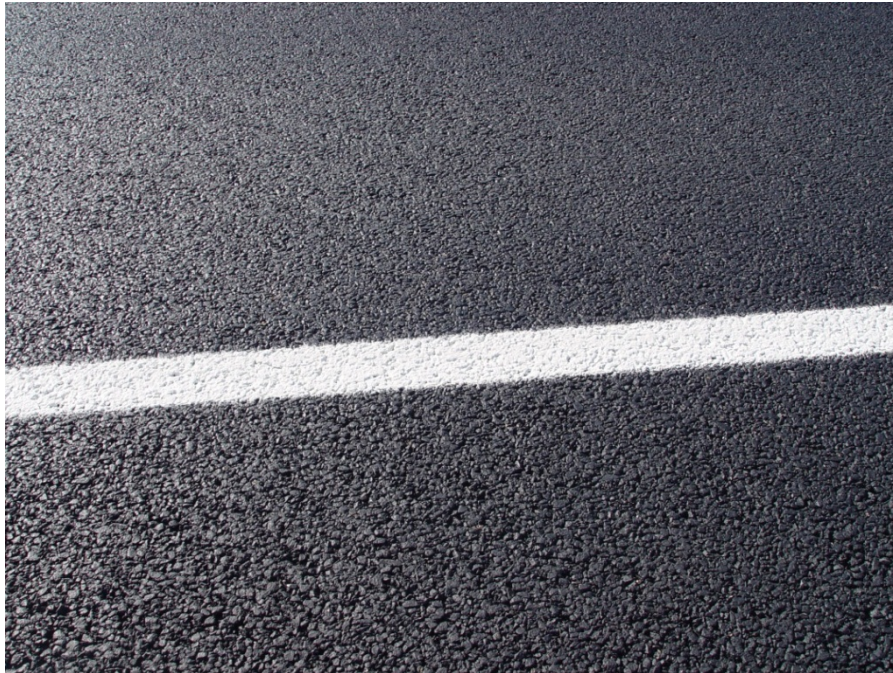
Figure C.57. Detailed View of the PFC Surface on IH 20, Section 20, Subsection 20-3, WB.

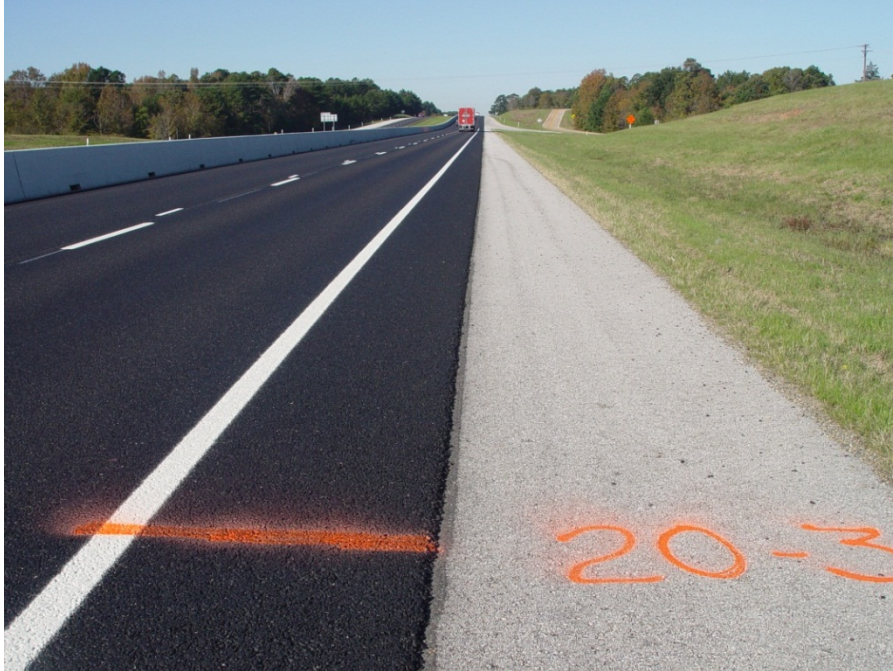
Figure C.58. View of IH 20, Section 20, Subsection 20-3, Westbound.

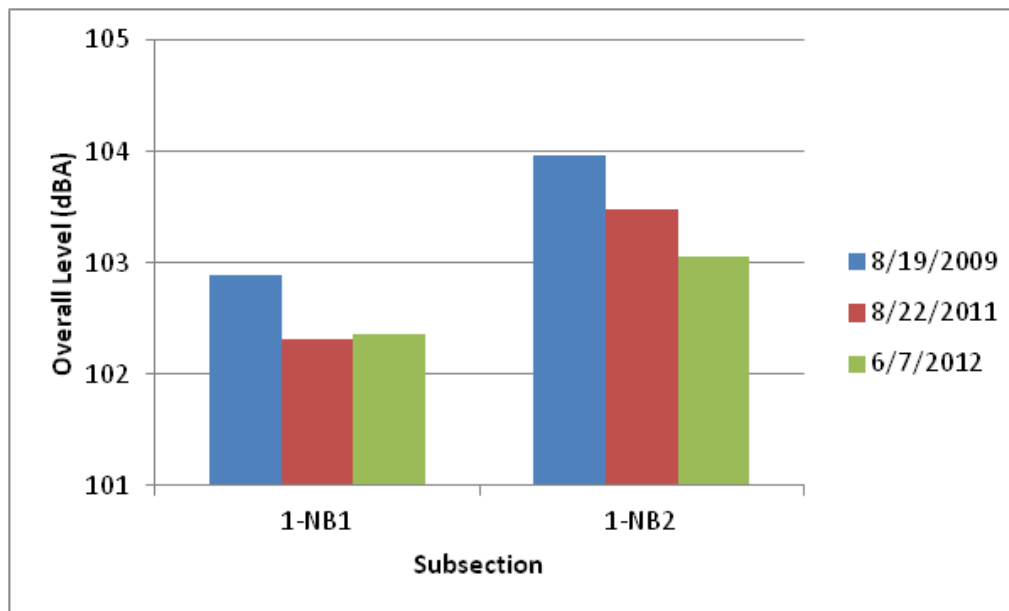
Figure D.1. Overall Noise Level for Section 1, US 59, Yoakum.

This section of highway in the Yoakum District, near Hillje, featured two different pavement sections: Section 1 corresponded to the northbound (NB) direction, while the southbound (SB) pavement corresponded to Section 13 (dense-graded HMA). The overall noise levels for Section 1 and frequency spectra for both pavement sections are shown in [Figures D.1](#) and [D.2](#), respectively.

An important difference in the shape of the spectral curves can be observed between the PFC (Section 1) and the dense-graded HMA pavement (Section 13), even though the overall levels for both sections are very similar. The PFC was expected to be quieter than its dense-graded counterpart was. Contrary to what was anticipated, the overall noise levels were evenly matched throughout the years. From a visual standpoint, the NB PFC appeared to be in better condition than the SB reference section.

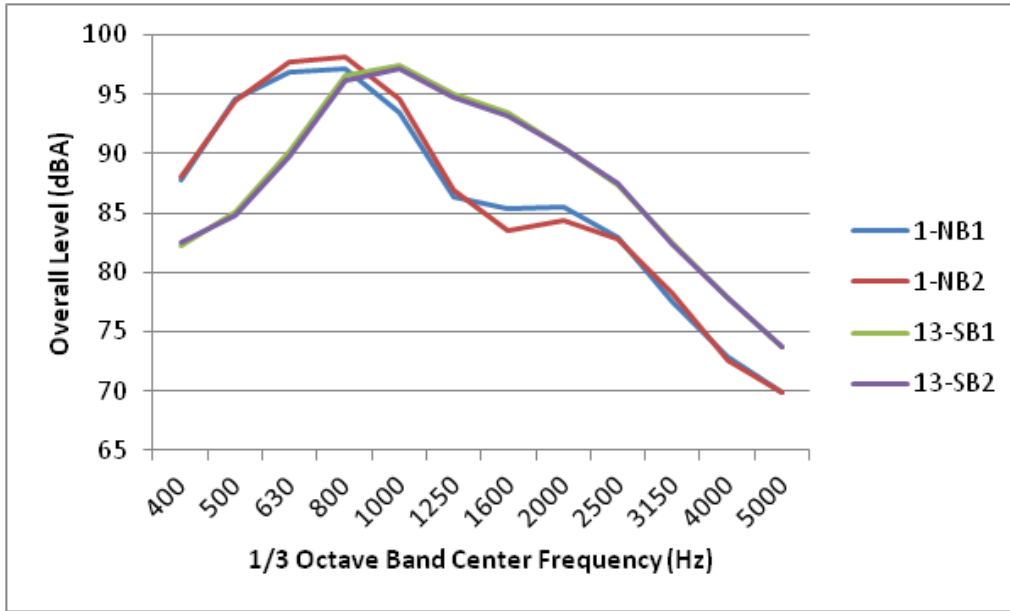
Figure D.2. Frequency Spectra for Sections 1 and 13 Measured 6/7/2012.

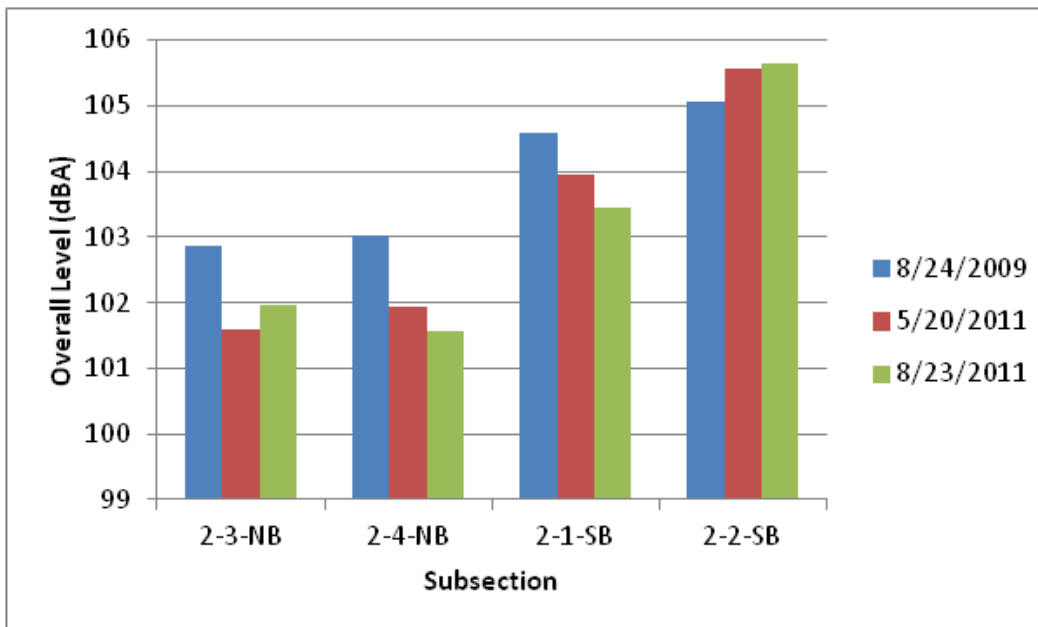
Figure D.3. Overall Noise Level for Section 2, SH 288, Houston.

The measurements for 2012 in this section yielded erroneous results due to a faulty microphone. Unfortunately, those measurements had to be discarded. The overall levels for Section 2 are shown in Figure D.3 shows the overall levels for Section 2, and Figure D.4 presents the frequency spectra for the subsections corresponding to the 2011.

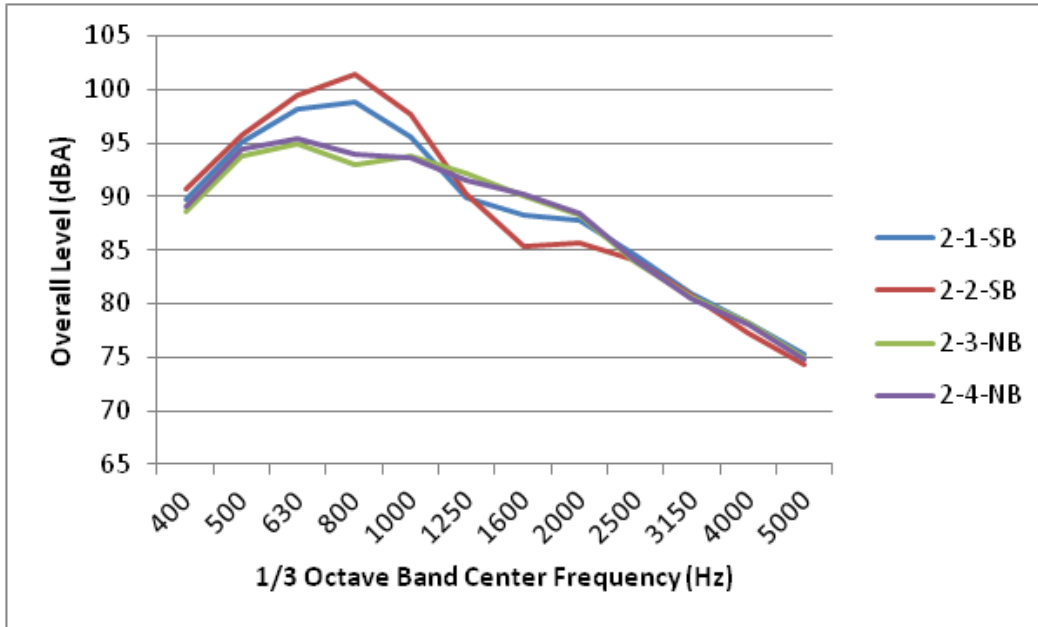
Figure D.4. Frequency Spectra for Section 2 Measured 8/23/2011.

This section presented substantial differences in overall levels between SB and NB subsections, and thus ranks among the highest in variability within subsections for the study. The acoustical differences between traveling directions were even more evident in the frequency spectra curves. The NB subsections were quieter and had flatter spectra, whereas the SB subsections presented a pronounced peak at 800 Hz. The peak is common at these frequencies for PFCs, but the magnitude at that frequency is high, resulting in the higher overall noise levels. This was the loudest pavement among the AR-PFCs included in the project.

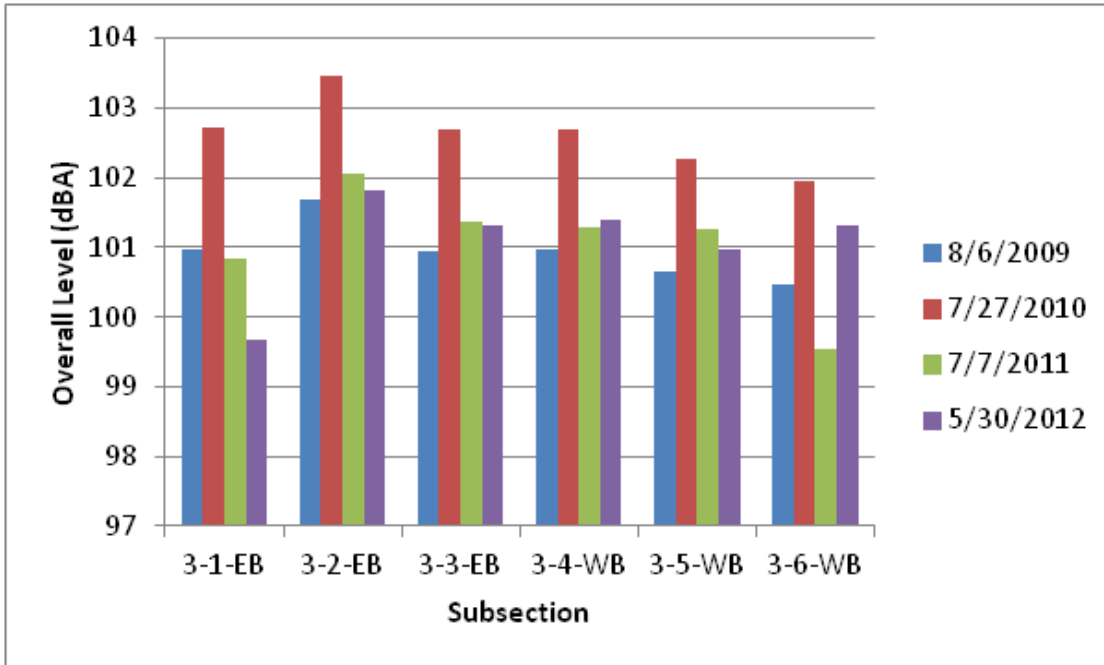
Figure D.5. Overall Noise Level for Section 3, US 290, Austin.

The measured noise levels for Section 3 throughout the years are presented in Figure D.5, and the most recent frequency graph is shown in Figure D.6. When the 2010 noise measurements are disregarded, the average noise level stayed consistent throughout the study, around 101 dBA. A good reason to disregard the 2010 result, not only for this section, is that the 2010 set of tests were conducted with the oldest tire, the AWP, as mentioned in Chapter 3. The average overall level for this section matches the average AR-PFC level for this project (101.4 dBA).

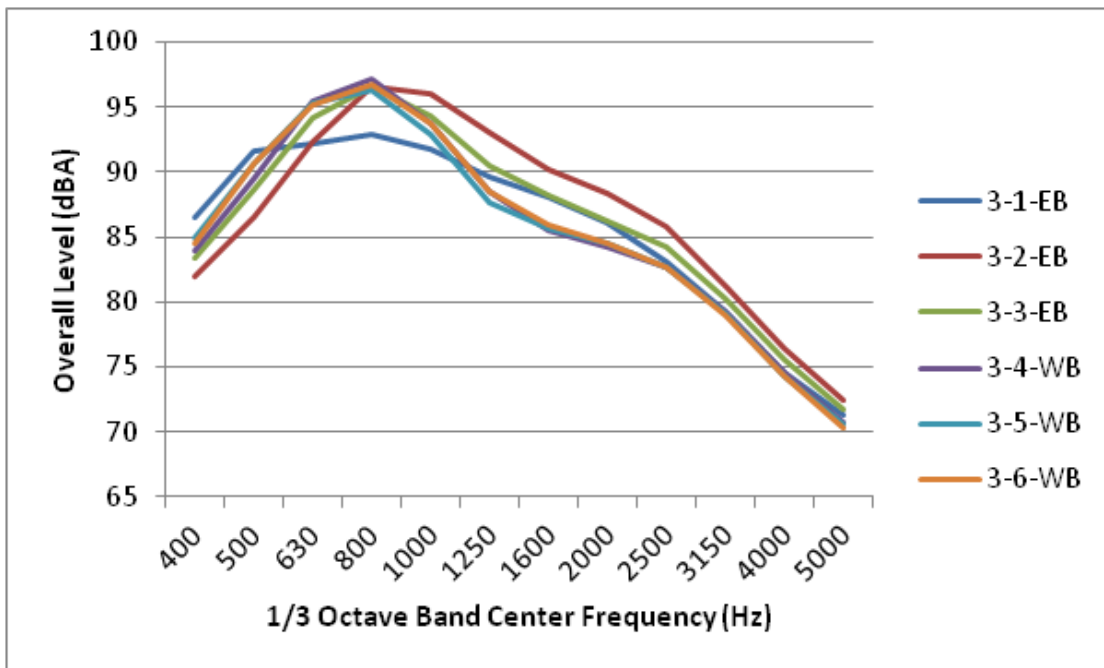
Figure D.6. Frequency Spectra for Section 3 Measured 5/30/2012.

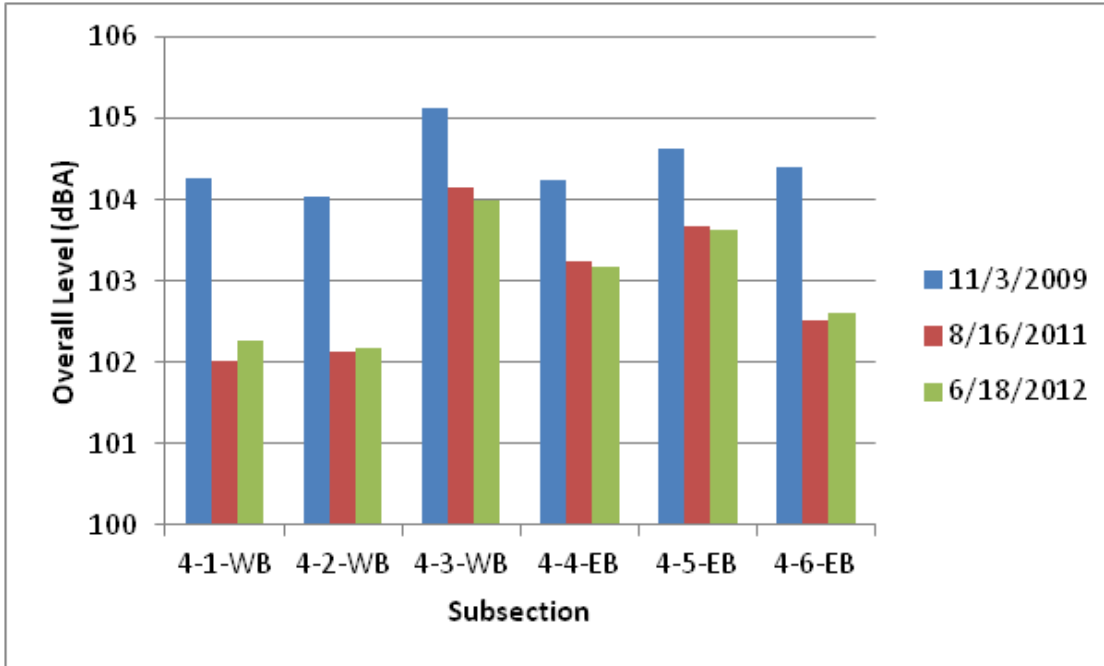
Figure D.7. Overall Noise Levels for Section 4, IH 30, Paris.

The overall noise levels for the IH-30 PFC are shown in [Figure D.7](#), and the most recent frequency spectra chart, from 2012, is displayed in [Figure D.8](#).

This section was one of the loudest PFCs in this study, perhaps due to the fact that it is a TBPFPC. Other studies have shown that the thickness of the pavement has an influence in noise absorption, with thicker layers being quieter. Also, the noise levels in measurement years 2011 and 2012 were lower, but this may be due to the influence of the ages of the test tires.

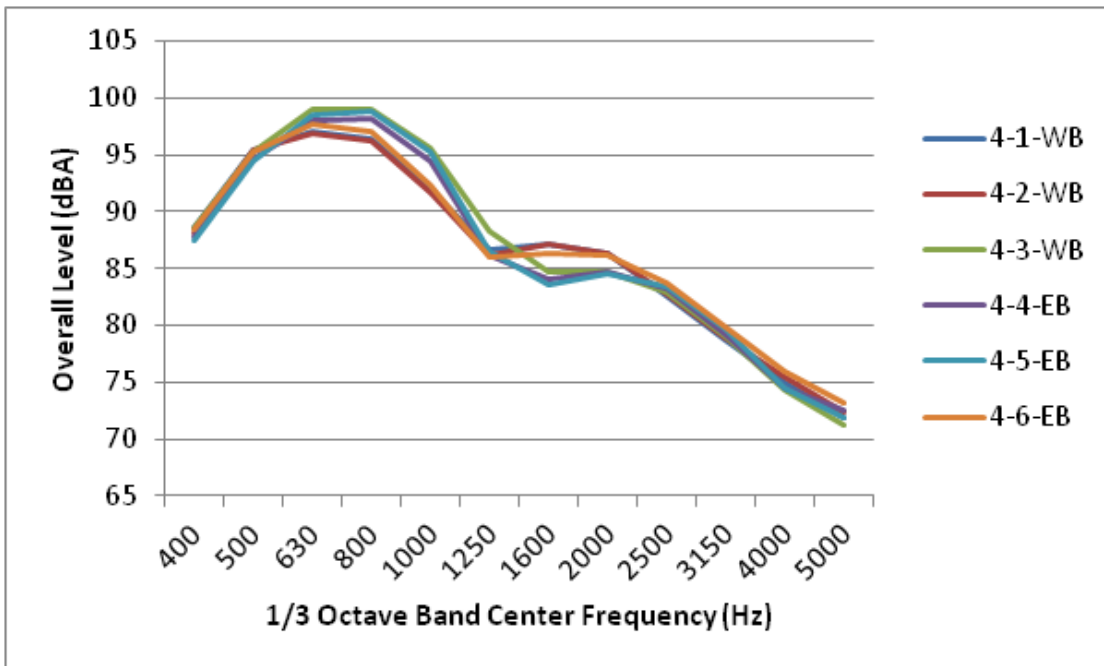
Figure D.8. Frequency Spectra for Section 4 Measured 6/18/2012.

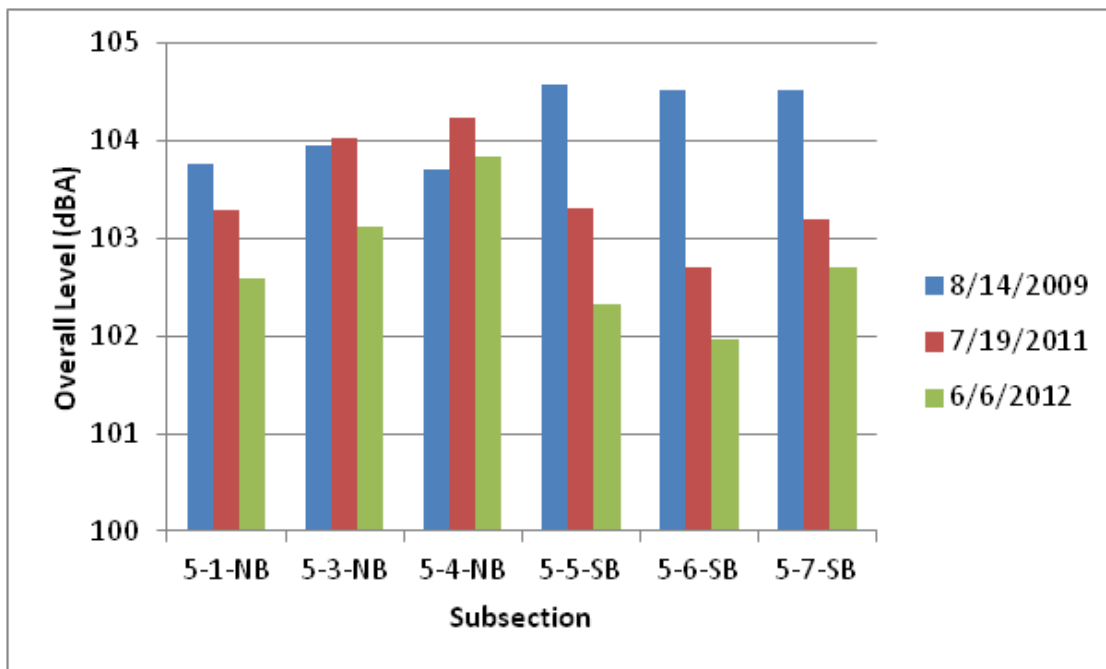
Figure D.9. Overall Noise Level for Section 5, SH 6, Bryan.

The OBSI measurements on Section 5 are presented in [Figure D.9](#), and the most recent frequency spectra are shown in [Figure D.10](#). This section was among the loudest PFCs in this project, despite being one of the more recently constructed pavements. The surface looked in good shape, shows no deterioration, and the traffic observed during noise testing was sparse. The first time the section was tested, the SB lanes were louder; however, this trend was reversed in the last two sets of tests (2011 and 2012). The recent frequency spectra show relatively uniform shapes for the subsections.

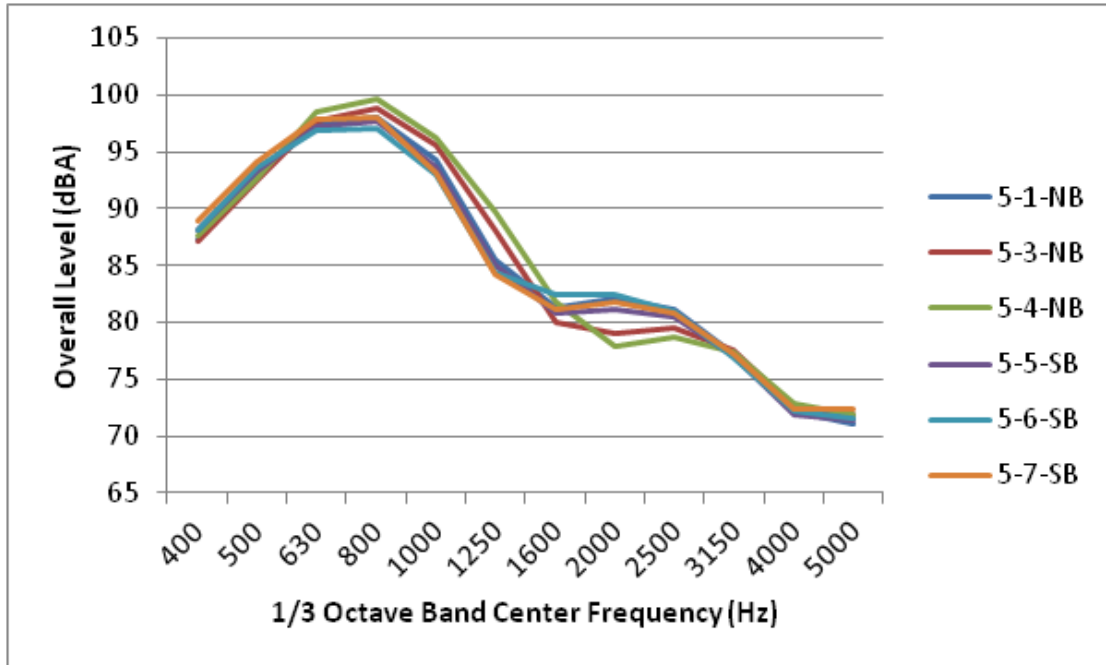
Figure D.10. Frequency Spectra for Section 5 Measured 6/6/2012.

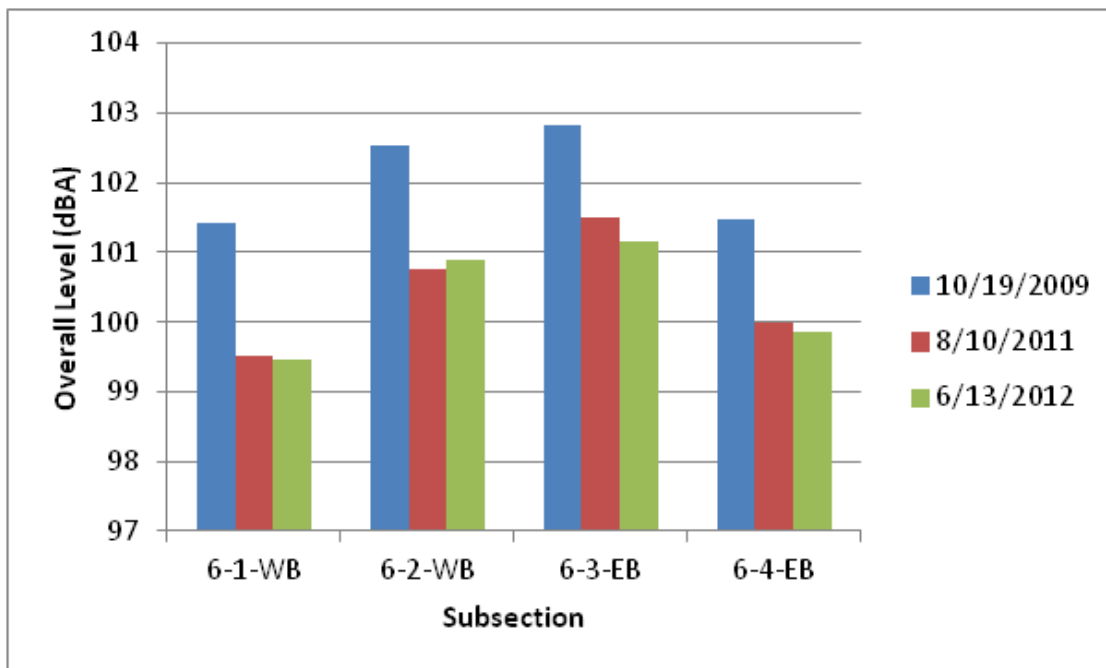
Figure D.11. Overall Noise Level For Section 6, IH 20, Abilene.

Measurements on IH-20 in Abilene are summarized in [Figures D.11](#) and [D.12](#).

Section 6 in Abilene can be classified as the quietest PG-PFC in this study and is among the quietest pavements. Its average noise level over time is 100.9 dBA. Like several other cases in the project, Section 6 appears to be quieter in measurement years 2011 and 2012.

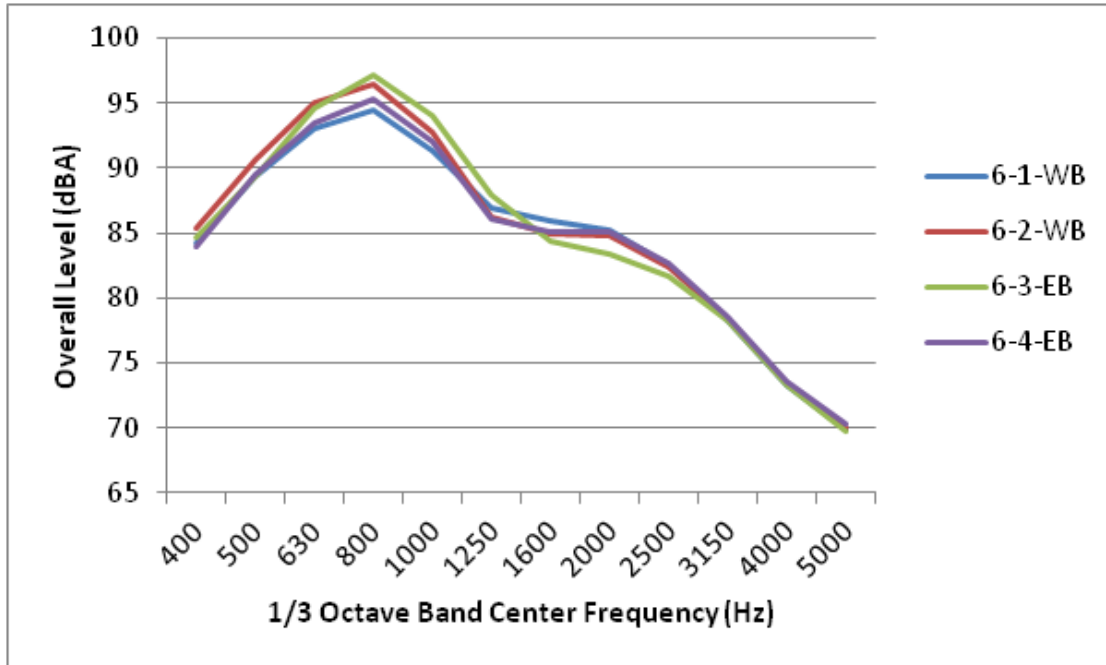
Figure D.12. Frequency Spectra For Section 6 Measured 6/13/2012.

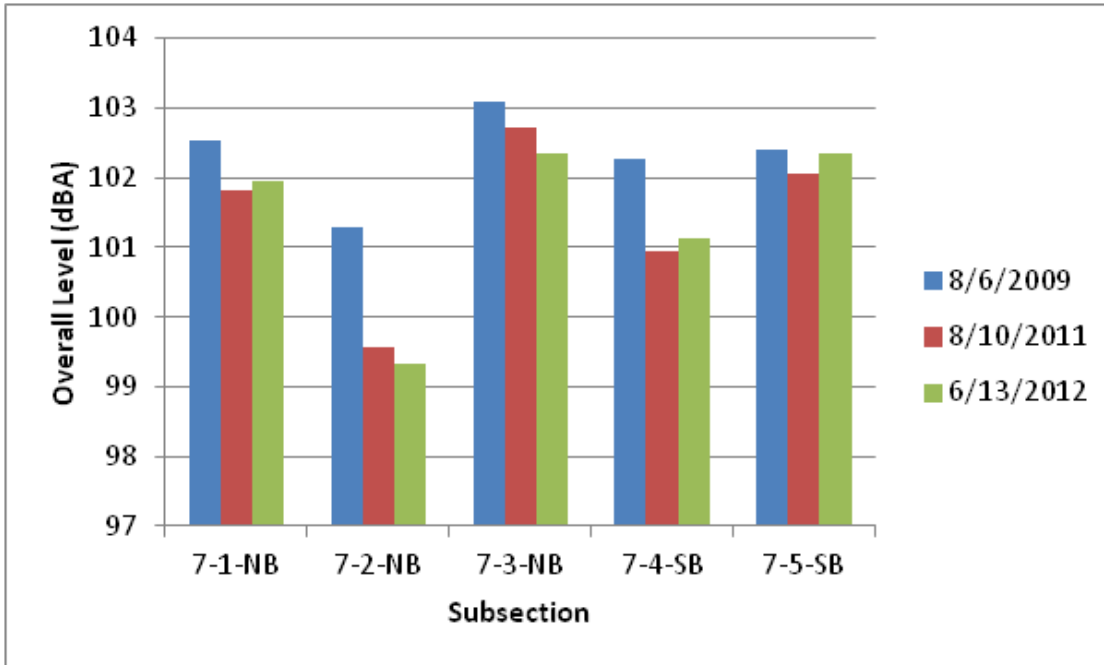
Figure D.13. Overall Noise Level for Section 7, US 83, Abilene.

OBSI overall levels for Section 7 are shown in [Figure D.13](#), and the 2012 frequency spectra for the subsections are presented in [Figure D.14](#). Noise levels on this pavement were consistent throughout the years. These levels remained in the middle range with respect to the other PFCs included the study, slightly under the overall PFC average, and well under the overall PG-PFC average.

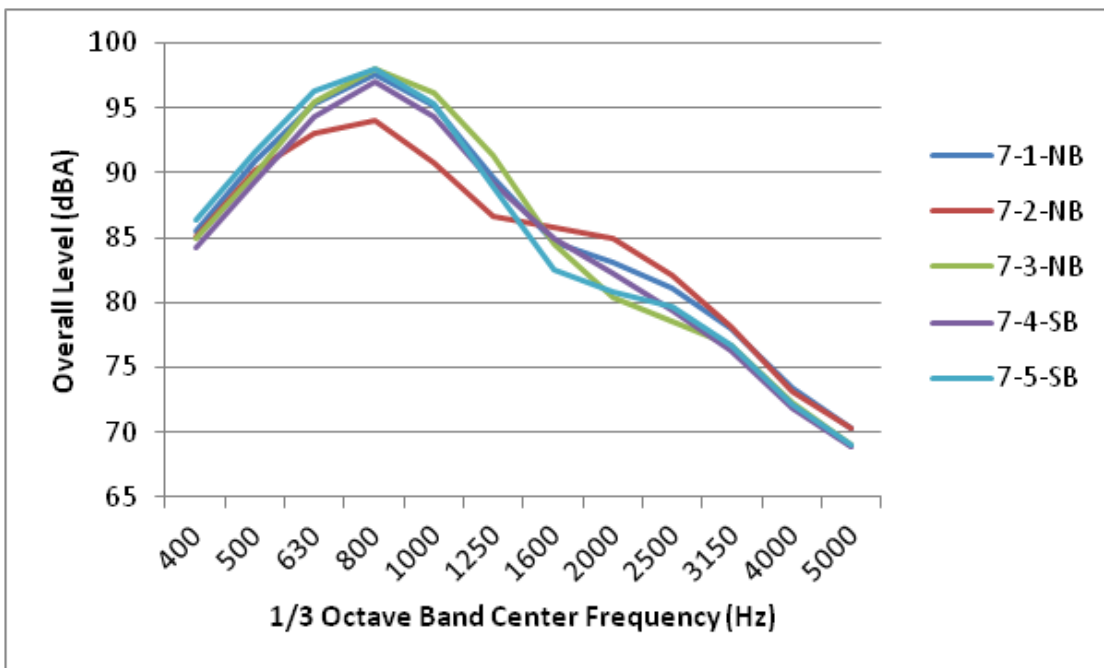
Figure D.14. Frequency Spectra for Section 7 Measured 6/13/2012.

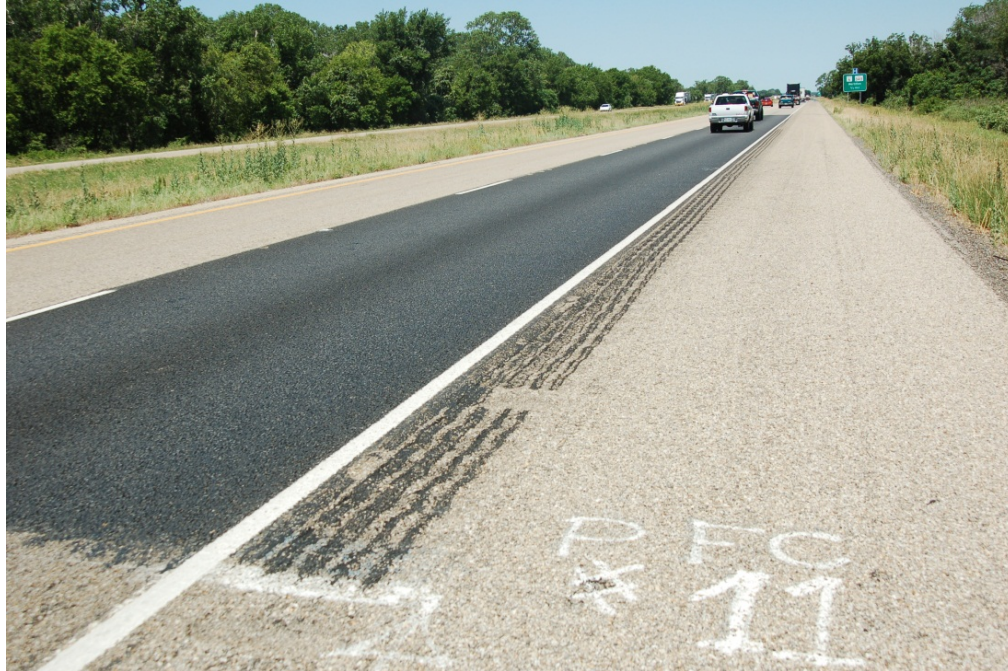
Figure D.15. Patch on SH6, Subsection WB-1, Waco.

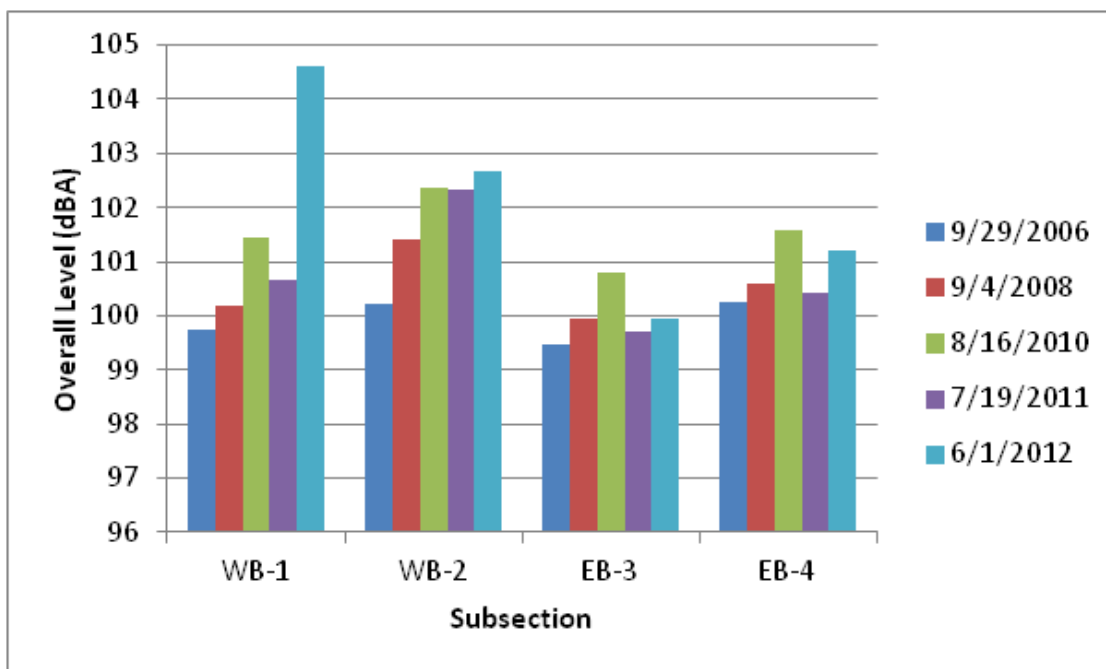
Figure D.16. Overall Noise Level for Section 9, SH 6, Waco.

The presence of such repairs had an impact on the measurements for that particular subsection as shown in [Figure D.16](#), which displays the historic overall levels for the SH 6 Waco subsections, including tests from TxDOT Project 0-5185. [Figure D.17](#) presents the frequency chart for 2012.

This section was the quietest PG-PFC in this study before the more recent measurements in 2012. Two factors caused an increase in the measured noise levels: 1) severe raveling on this section, possibly due to binder aging or the PFC pavement reaching the end of its service life (constructed in 2005), and 2) the subsequent repairs that unfolded to restore the quality of the riding surface. Also, the variability within subsections went up as a result of the patching and repairs. The latest noise measurements ranked this pavement section near the average level for PFCs in this project.

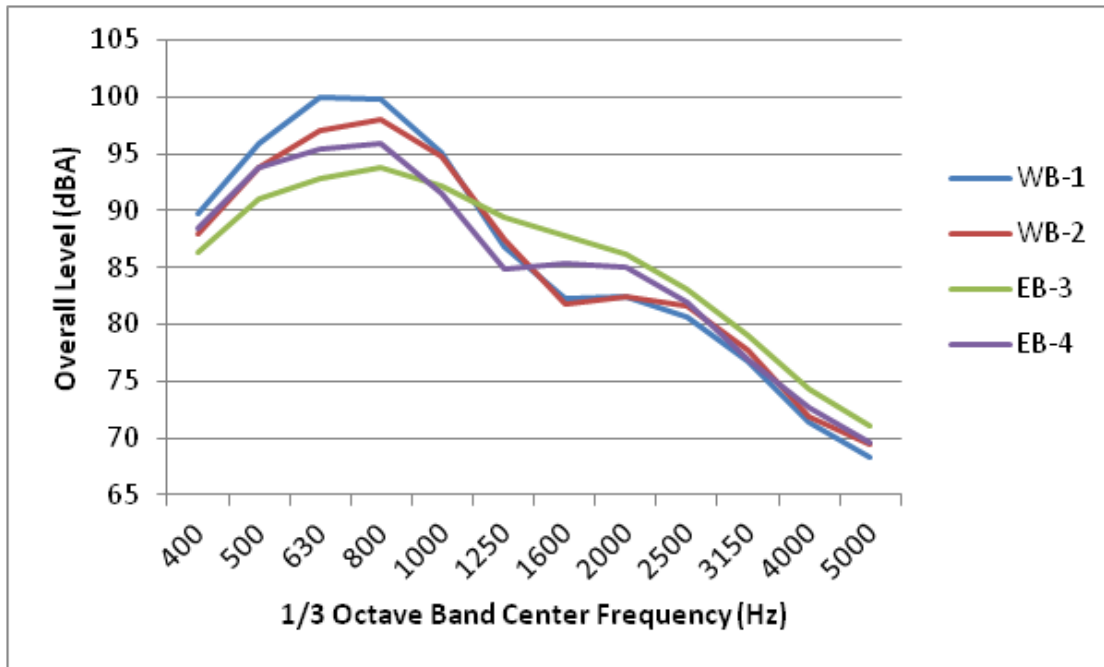
Figure D.17. Frequency Spectra for Section 9 Measured 6/1/2012.

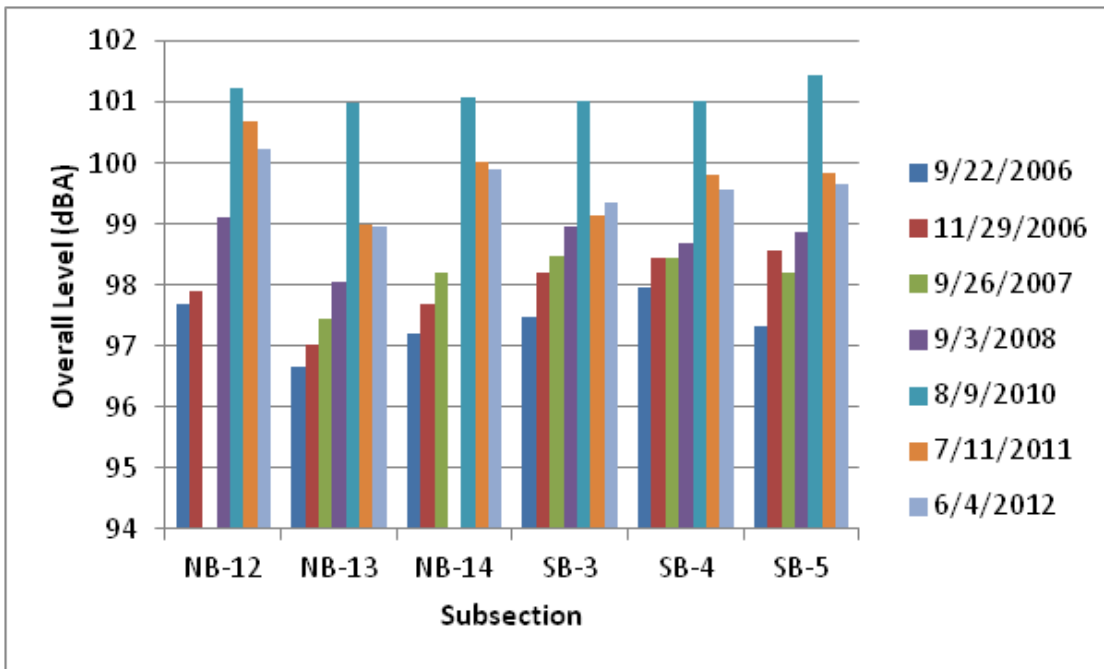
Figure D.18. Overall Noise Level for Section 11, US 281, San Antonio.

Overall measurements for Sections 11 and 21 are shown in [Figures D.18](#) and [D.20](#), respectively, and their frequency spectra for 2012 are shown in [Figures D.19](#) and [D.21](#), respectively. These values include tests performed under TxDOT Project 0-5185. Both of these sections are among the quietest in this study and the entire state. The overall frequency spectrum of Section 11 is that of a typical PFC, as opposed to other types of pavements. Even though there is a peak at around 800 Hz, the magnitude is low compared to other pavements. The overall frequency spectrum for Section 21 has an unusual shape with peaks at the 500 and 1000 Hz one-third octave frequency bands, but the magnitude of those are low.

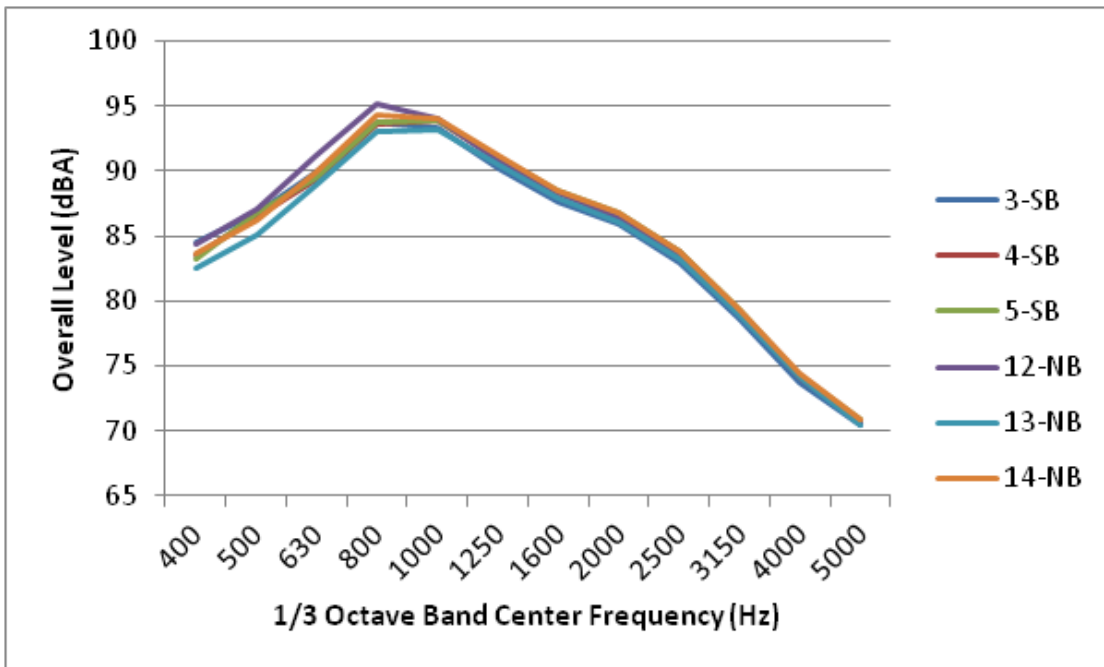
Figure D.19. Frequency Spectra for Section 11 Measured 6/4/2012.

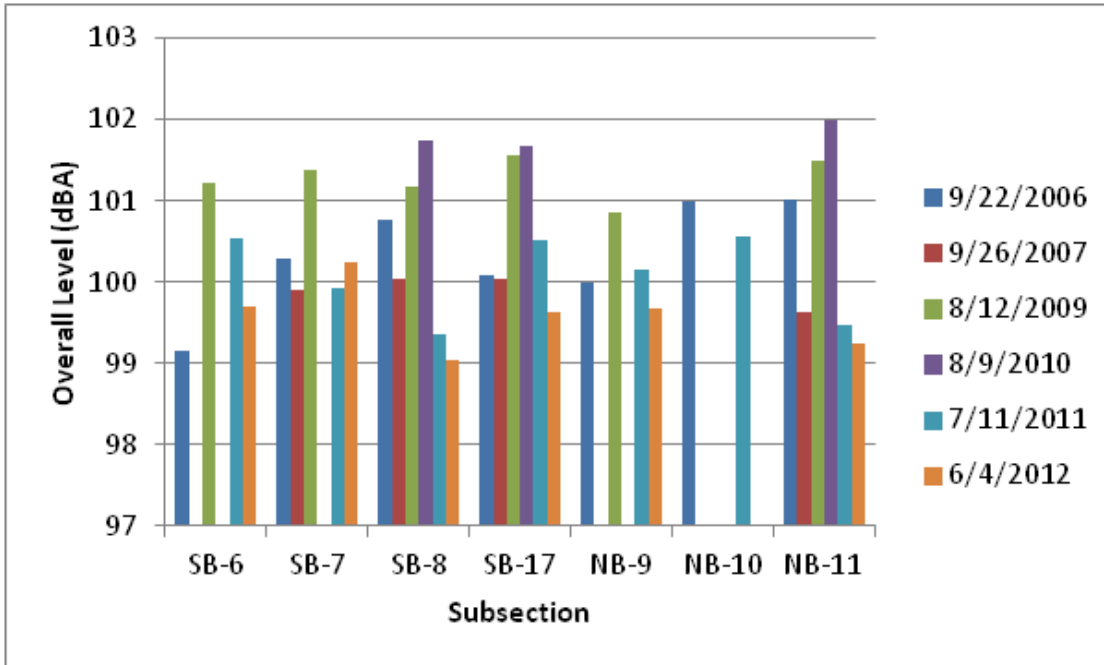
Figure D.20. Overall Noise Level for Section 21, US 281, San Antonio.

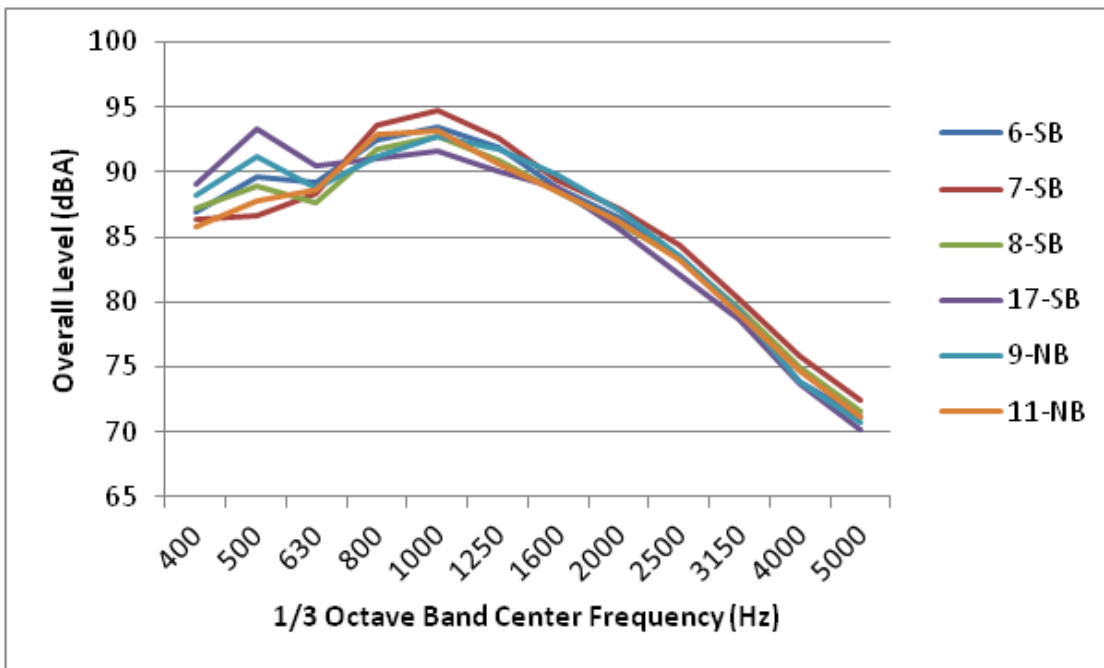
Figure D.21. Frequency Spectra for Section 21 Measured 6/4/2012.
