1. Report No. FHWA/TX-12/0-5836-2		2. Government Accession No.		3. Recipient's Catalog No.	
4. Title and Subtitle PERFORMANCE AND COST EFFECTIVENESS OF PERMEABLE FRICTION COURSE (PFC) PAVEMENTS				5. Report Date Published: February 2013

PERFORMANCE AND COST EFFECTIVENESS OF PERMEABLE FRICTION COURSE (PFC) PAVEMENTS

Report 0-5836-2
Project 0-5836

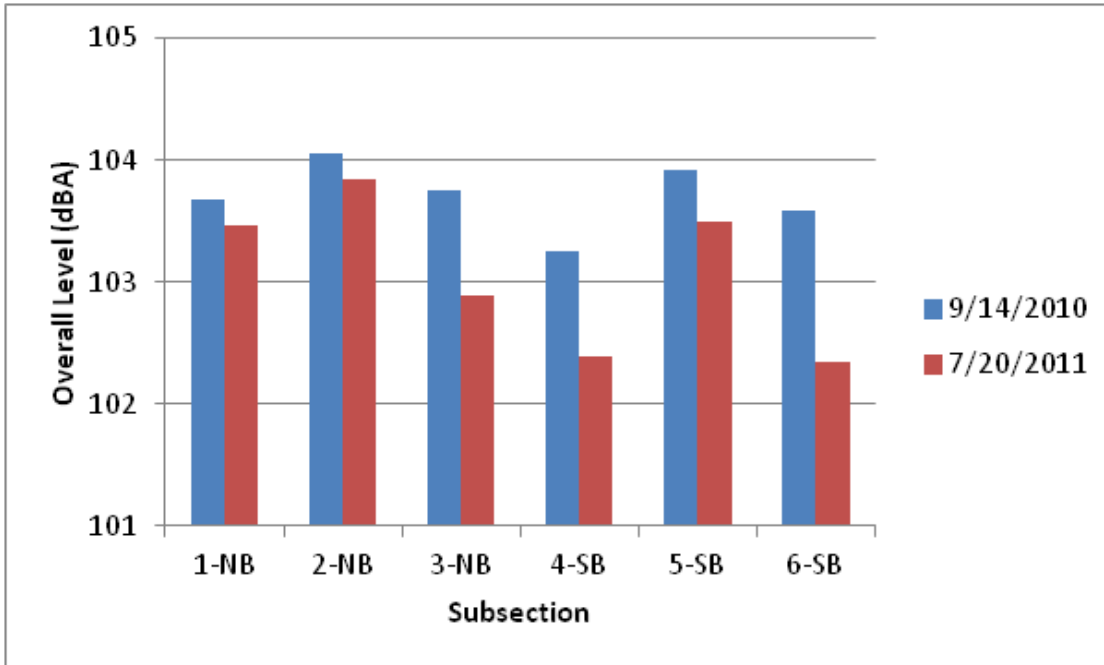
Figure D.22. Overall Noise Level for Section 112, SH 6, Houston.

[Figure D.22](#) presents the results of the measurements over time for Section 112. The 2012 measurements had to be discarded due to a microphone error, which is the same problem that affected Section 2 in measurement year 2012. Frequency spectra for this section, corresponding to the 2011 tests, are shown in [Figure D.23](#). This section is slightly louder than the average for PG-PFCs in this study. Only two sets of measurements were conducted on this pavement because the section was incorporated late in the study as a substitute for another section and because of the mishap with the microphones in the last round of testing. The pavement appeared to be in good condition.

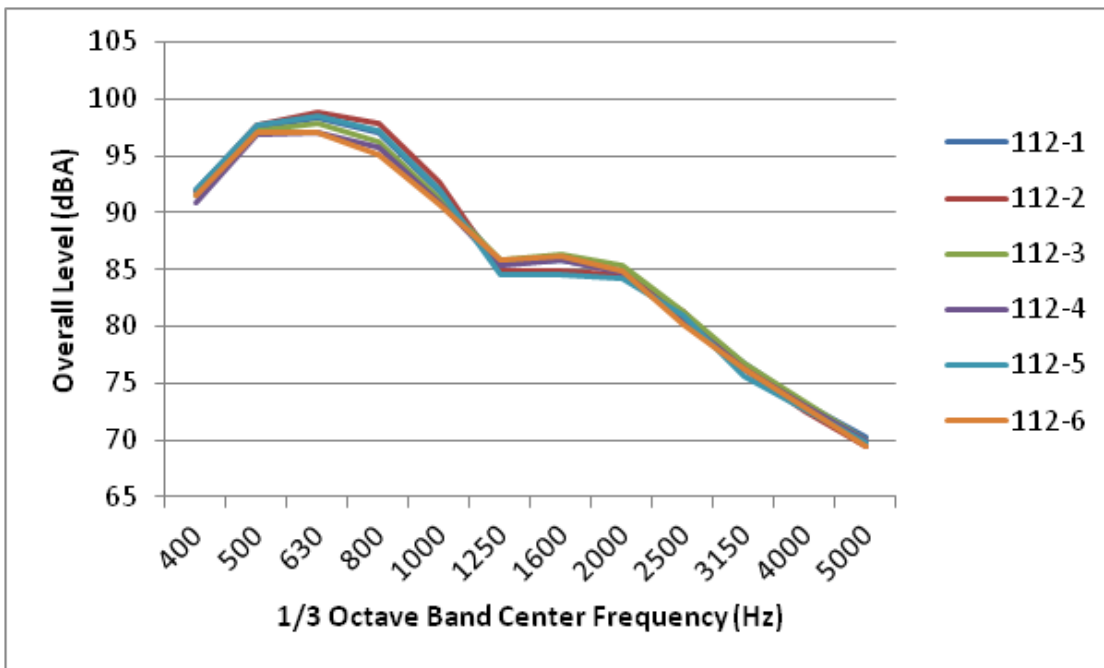
Figure D.23. Frequency Spectra for Section 112 Measured 7/20/2011.

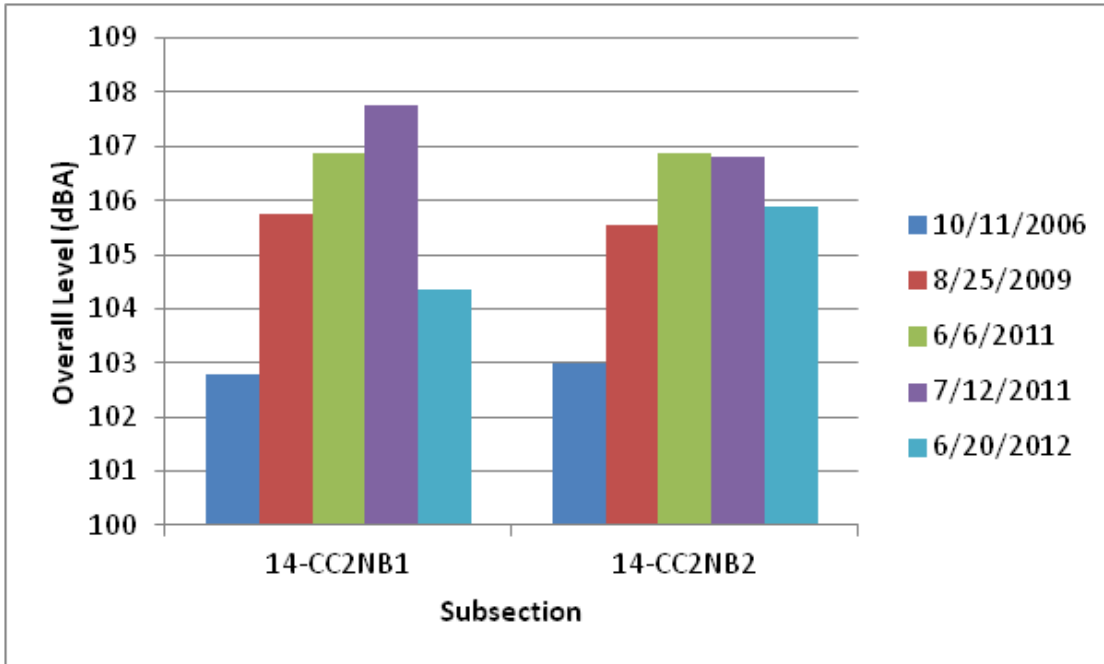
Figure D.24. Overall Noise Level for Section 14, IH-37, Corpus Christi.

Measurements for these PFCs, which include the historic noise levels from year 2006, are presented in Figures D.24 and D.26 for Sections 14 and 15, respectively. The frequency spectra are shown in Figures D.25 and D.27, respectively.

Even though these sections are adjacent to each other, their acoustic performance shows important differences. Section 14, the PG-PFC, was the loudest PFC throughout the study. However, its graph of noise levels over the years, including measurements prior to this project,

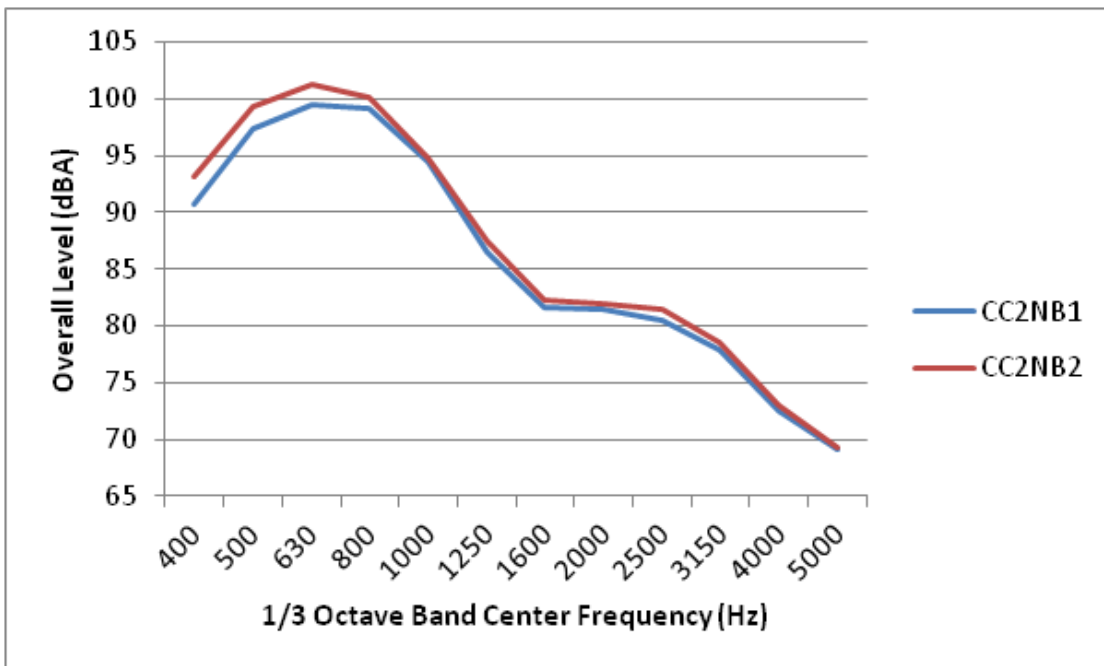
Figure D.25. Frequency Spectra for Section 14 Measured 6/20/2012.

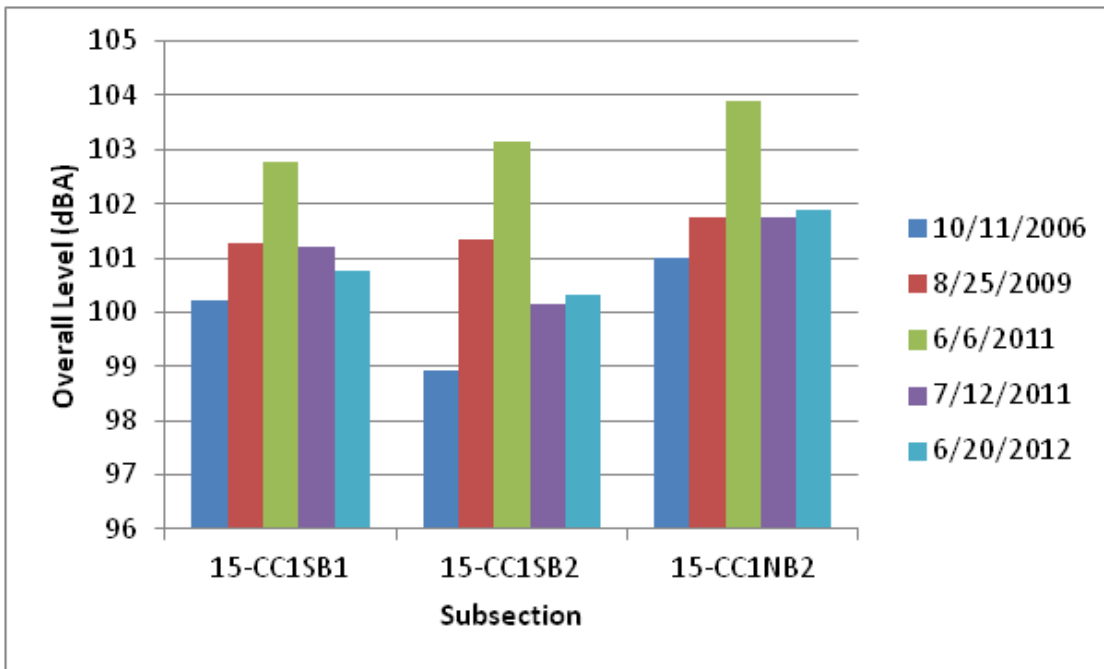
Figure D.26. Overall Noise Level for Section 15, IH-37, Corpus Christi.

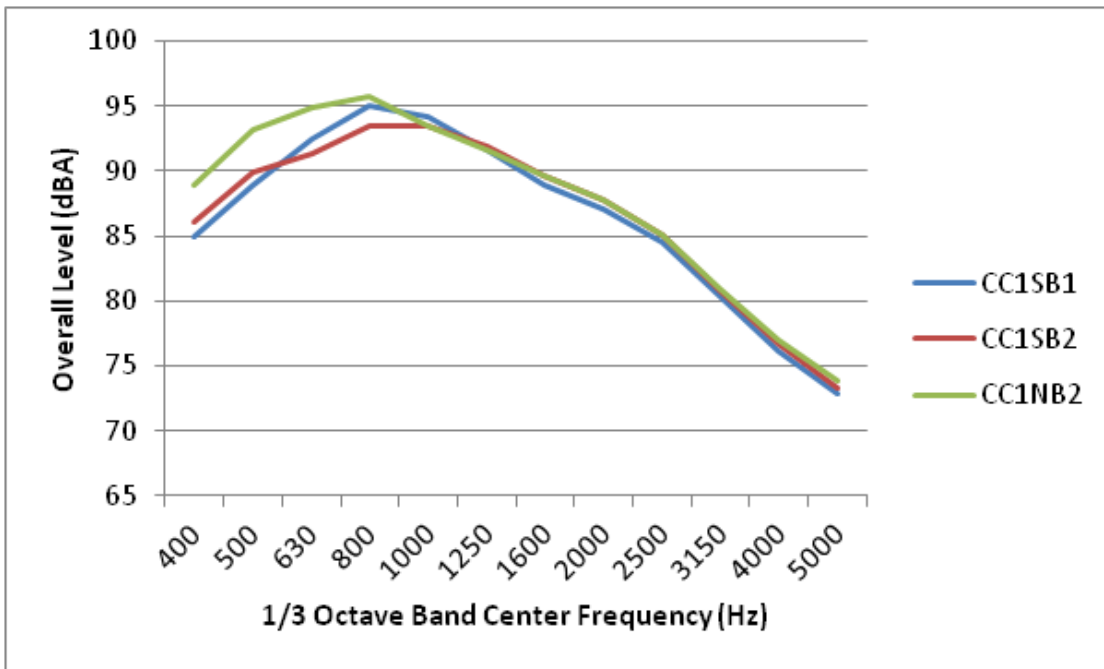
Figure D.27. Frequency Spectra for Section 15 Measured 6/20/2012.

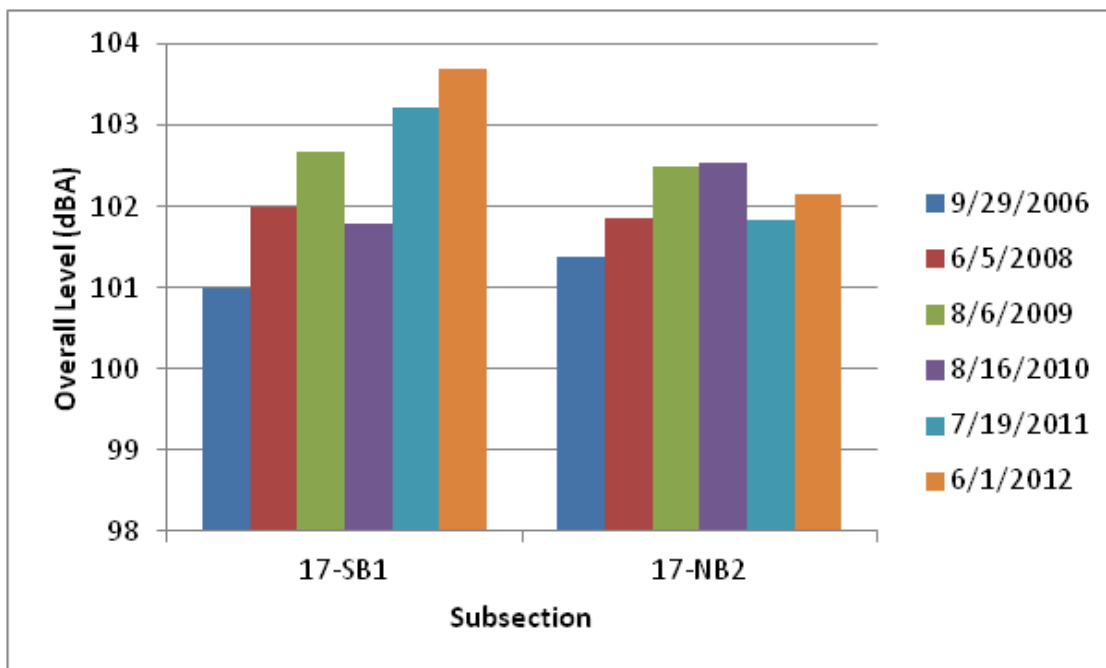
Figure D.28. Overall Noise Level for Section 17 (Old PFC), IH-35, Waco.

The results from these pavements are presented in [Figures D.28](#) and [D.29](#), for the old and the new PFCs, respectively. The frequency spectra for both the old and new PFCs are shown in [Figure D.30](#).

In this case, the new PFC is much quieter than the old PFC. The frequency spectra show that subsections 17-NB1 and 17-SB2, the new PFCs, have flatter curves, especially in the lower frequencies; for frequencies above 2000 Hz, the spectra for the four subsections are very similar.

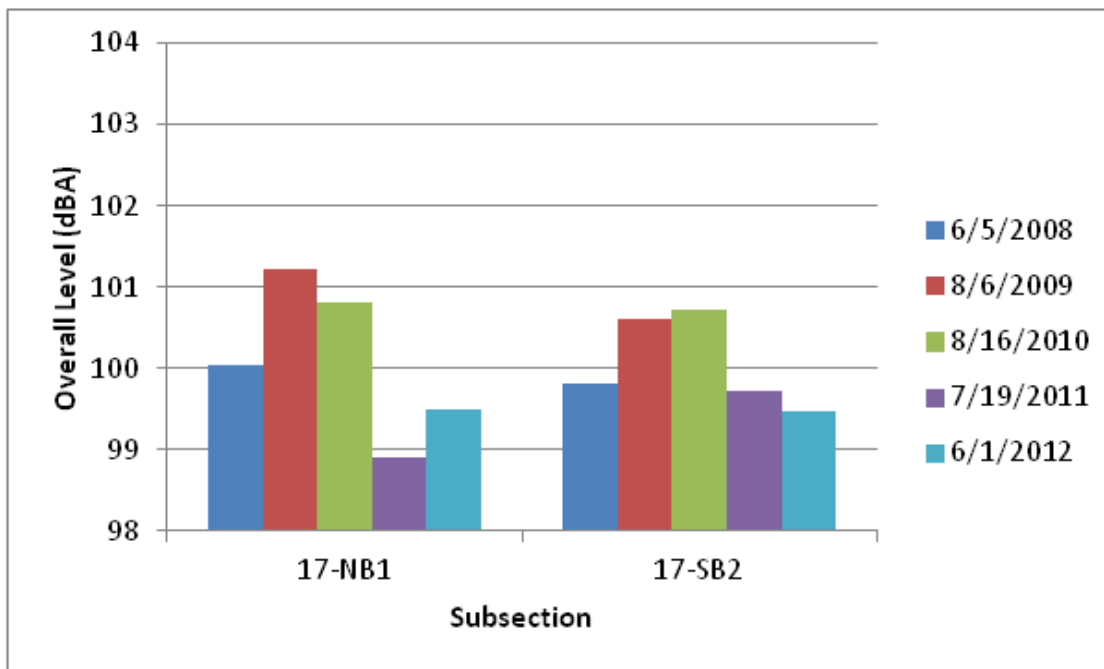
Figure D.29. Overall Noise Level for Section 17 (New PFC), IH-35, Waco.

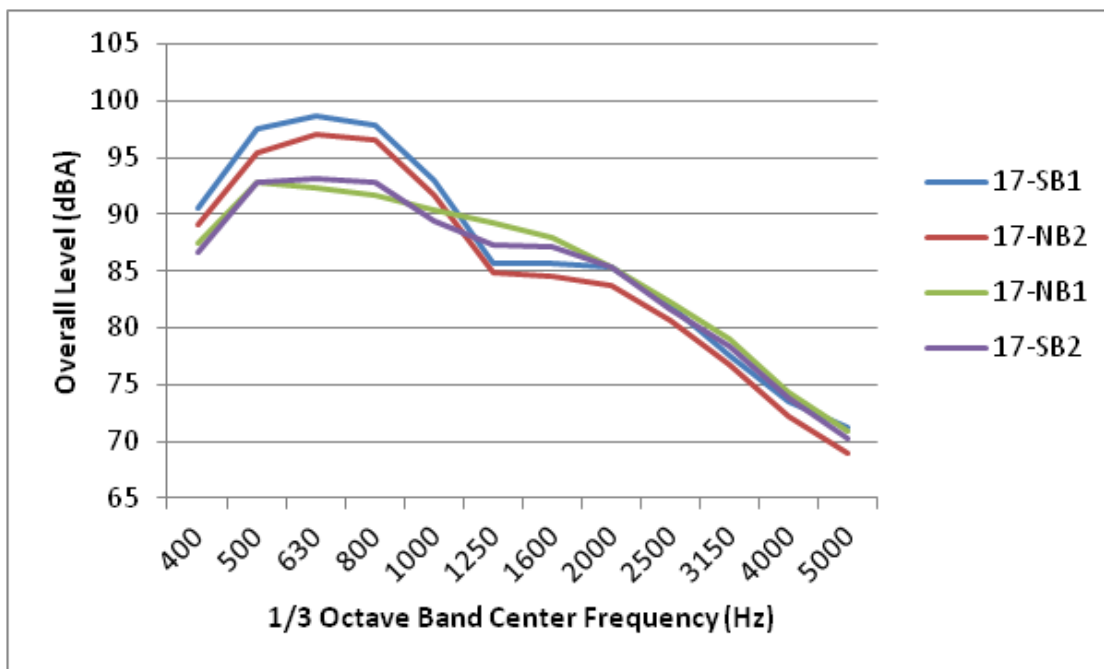
Figure D.30. Frequency Spectra for Section 17 Measured 6/1/2012.

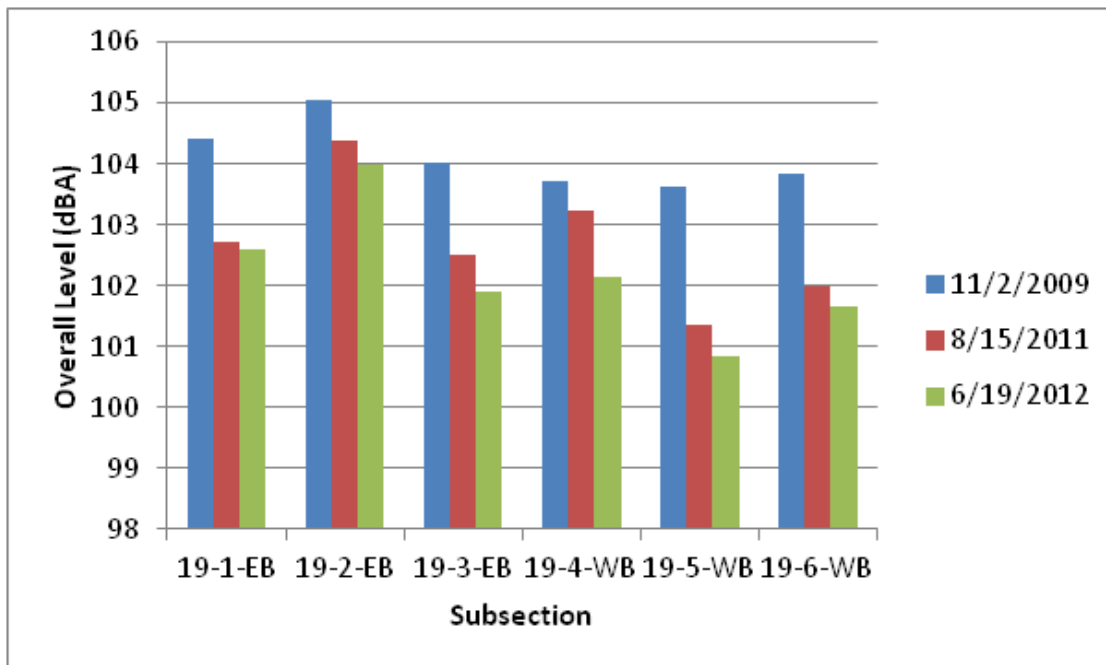
Figure D.31. Overall Noise Level for Section 19, IH 20, Tyler.

Results of the OBSI measurements on Section 19 are presented in [Figure D.31](#), and the frequency spectra chart is shown in [Figure D.32](#). The average sound level for this section over the years matches the average for PG-PFCs in this study (102.9 dBA). The pavement looked in very good condition during the visits for noise testing, in spite of the heavy traffic that the highway carries.

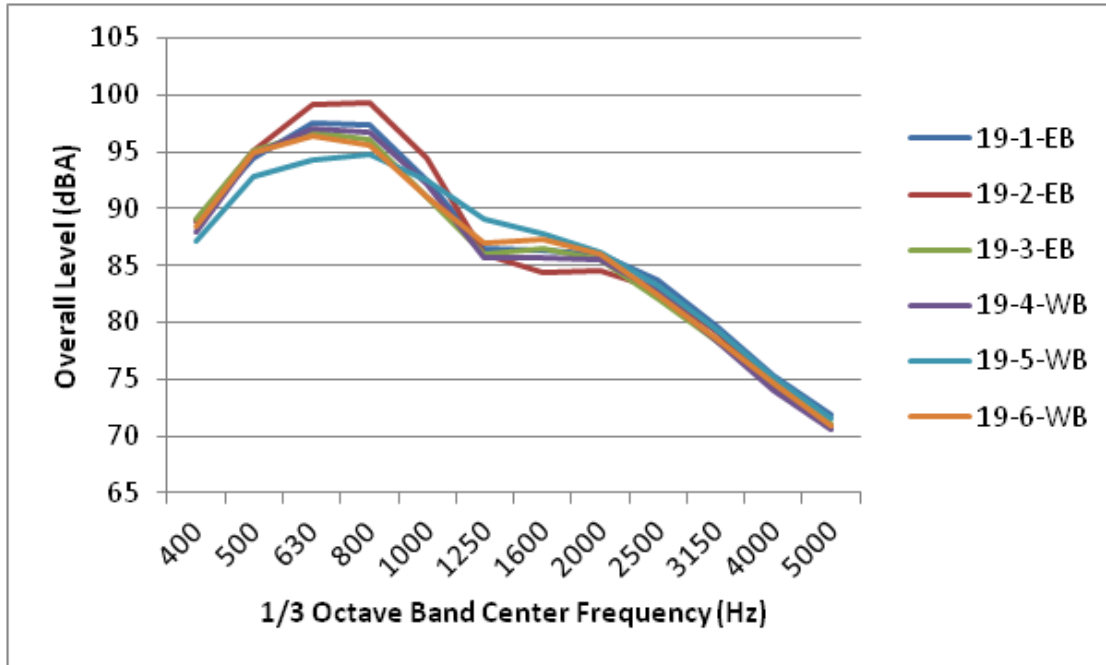
Figure D.32. Frequency Spectra for Section 19 Measured 6/19/2012.

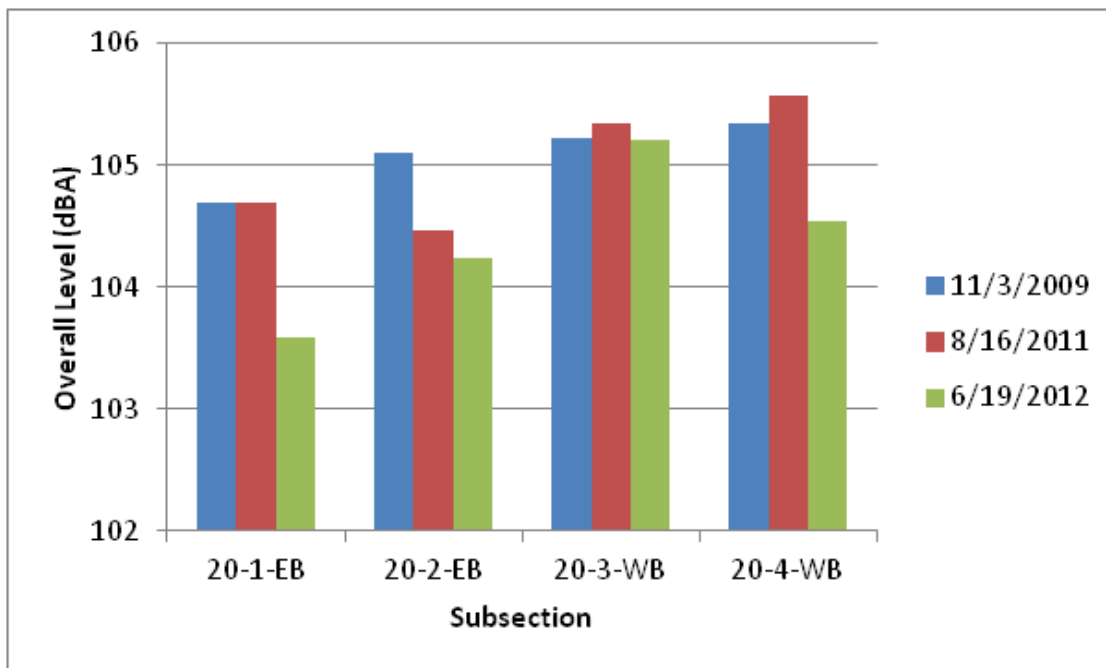
Figure D.33. Overall Noise Level for Section 20, IH 20, Tyler.

Figure D.33 shows the OBSI results from Section 20, and Figure D.34 presents the frequency spectra graph.

In spite of being the newest pavement in this study, and its apparent good condition, Section 20 in Tyler was consistently loud throughout the years. Its average overall level over time was close to 105 dBA. Section 20 was the second loudest PFC in the study, only surpassed by the aforementioned Section 14 in Corpus Christi caused by raveling.

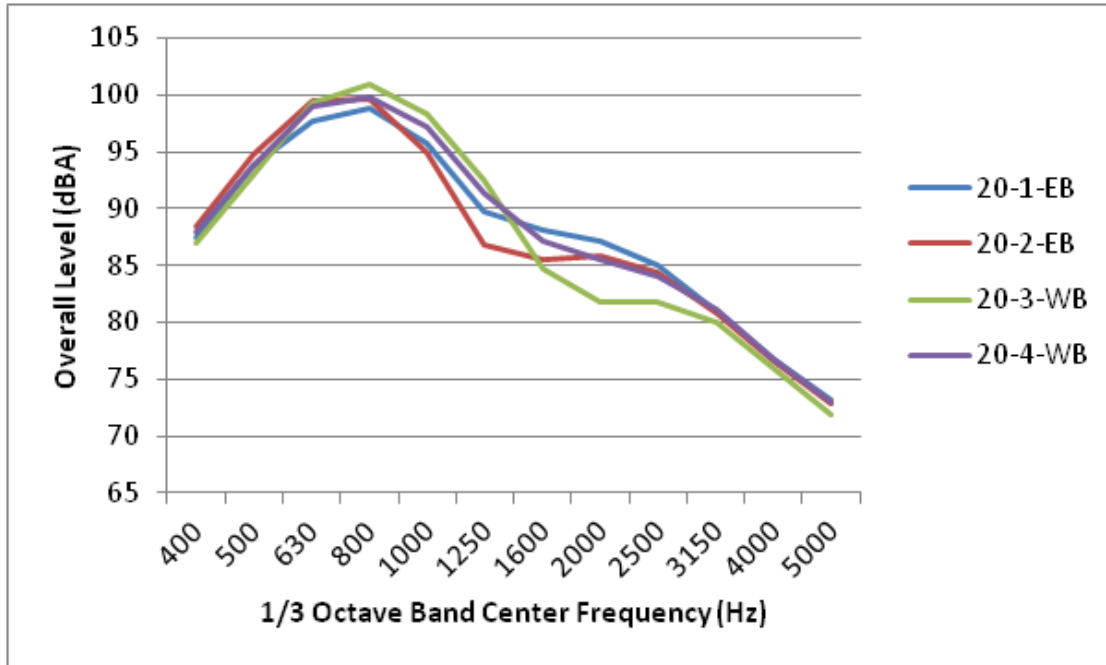
Figure D.34. Frequency Spectra for Section 20 Measured 6/19/2012.
