1. Report No. FHWA/TX-09/0-5845-1		2. Government Accession No.		3. Recipient's Catalog No.	
4. Title and Subtitle ALTERNATIVE VEHICLE DETECTION TECHNOLOGIES FOR TRAFFIC SIGNAL SYSTEMS: TECHNICAL REPORT				5. Report Date October 2008 Published: February 2009

ALTERNATIVE VEHICLE DETECTION TECHNOLOGIES FOR TRAFFIC SIGNAL SYSTEMS: TECHNICAL REPORT

Report 0-5845-1
Project 0-5845
Project Title: Alternative Vehicle Detection Technologies
for Traffic Signal Systems

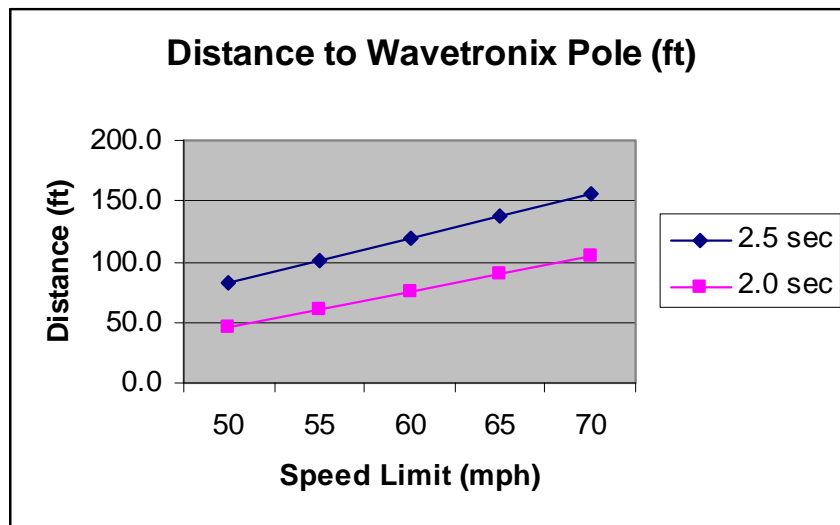
Figure 11. Maximum Distance of Advance Detector from Stop Line.

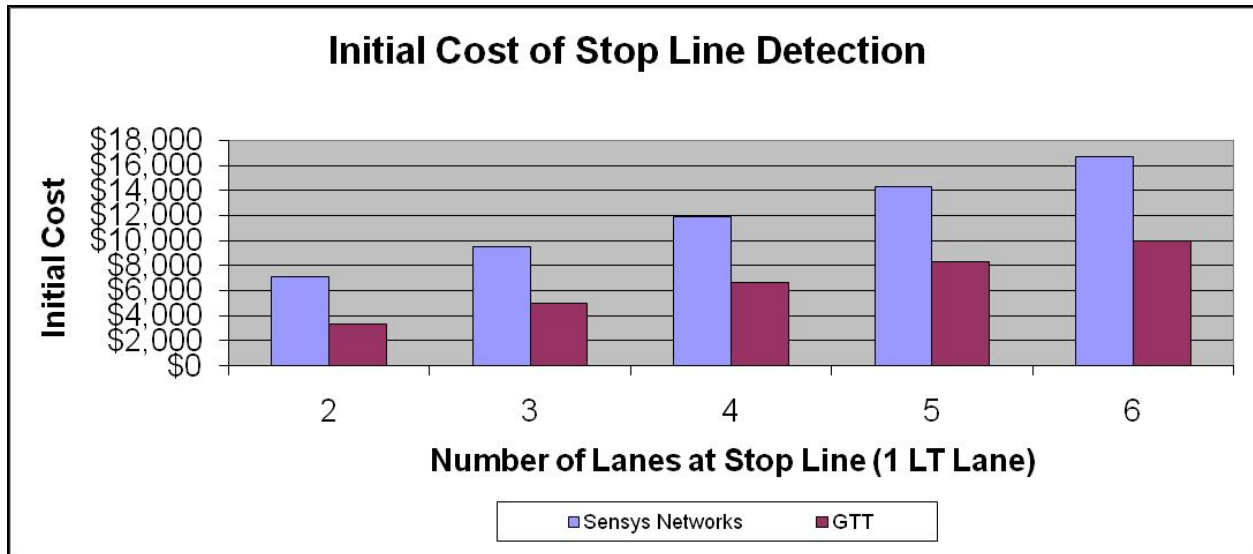
Figure 12. Initial Cost of Stop Line Detection per Intersection Approach.

It is appropriate to consider some of the assumptions that resulted in the TTI estimates. All of these factors had an impact on the cost estimates. Some assumptions apply to all three detectors while some apply to individual detectors. For all three detectors, costs are for n through lanes (1 to 5) and $n+1$ lanes at the stop line (2 to 6). In other words, these estimates always assume one turn lane, although stop line detection for the through and turn lanes are the same in all cases. Therefore, the total number of lanes is what is important. Installation for all detectors assumes contractor involvement at \$1000 per day. This installation cost is approximate, but applied to all three detector candidates is considered to be appropriate in a relative sense.

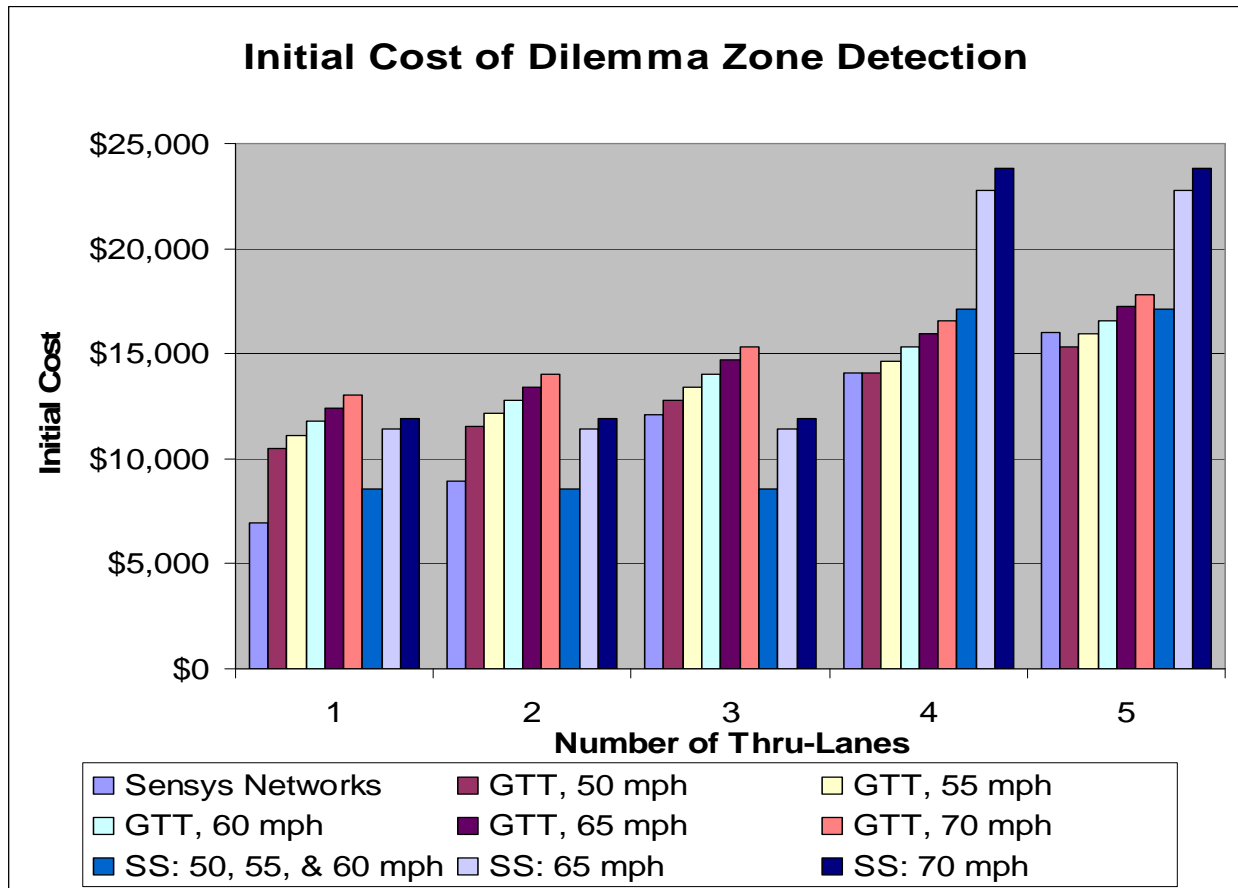
Figure 13. Initial Cost of Dilemma Zone Detection per Approach (No Stop Line Detection).

GTT costs vary with each speed increment because the length of conduit and wiring varies. These costs for the GTT assume no boring whatsoever. In other words, their installation would coincide with new construction if placed underneath a new pavement, or placement under

a bridge might be another option. Inclusion of cost for boring – even for driveways – would take these detectors beyond the competitive range.

SmartSensor Advance costs are relatively fixed when covering one, two, or three lanes and for speeds of 50, 55, and 60 mph. However, beyond these limits, the installing agency must consider whether moving the detector upstream a modest amount is worth the cost that might be involved. If it requires adding a new pole for speeds of 65 mph and higher and an additional detector on each approach for more than three lanes, its costs will likely exceed the competitive range

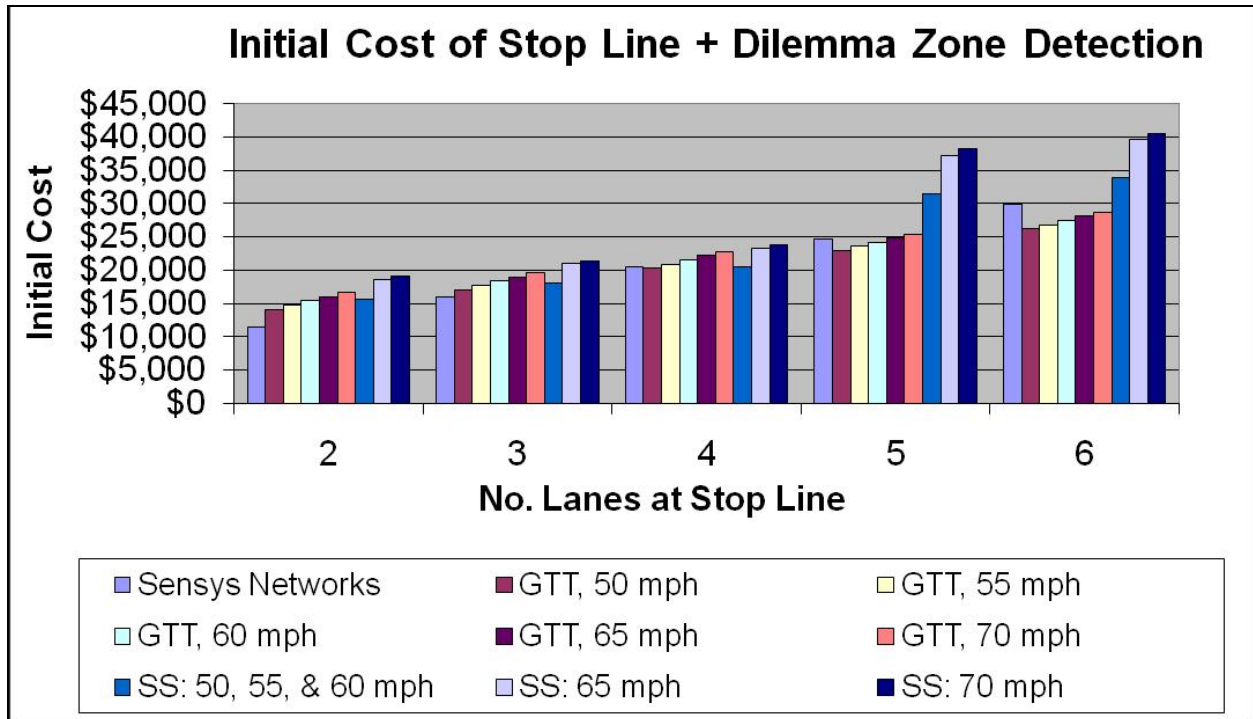
Figure 14. Initial Total Detection Cost per Intersection Approach.

Figure 14 shows a cost comparison of both stop line detection and dilemma zone detection for the three detection systems. Of course, these are not the only options, so an installing agency might choose something else such as inductive loops or even video detection for the stop line. The graphic indicates that the Sensys Networks magnetometers are less expensive than the competing detectors. Again, local policy will dictate whether intrusive detection should be used. The costs for the Wavetronix Advance include Sensys Networks magnetometers for stop line detection since the Advance does not provide detection there. Where no detection is needed at the stop line, the Advance would be the logical choice, especially for

approaches with up to three through-lanes. The graphic suggests that an agency might install a second Advance detector for sites with more than three lanes and that speeds higher than 60 mph would require upstream poles. These two extensions of the Advance might not be practical, but the authors chose to include their costs in case they might be helpful to TxDOT.

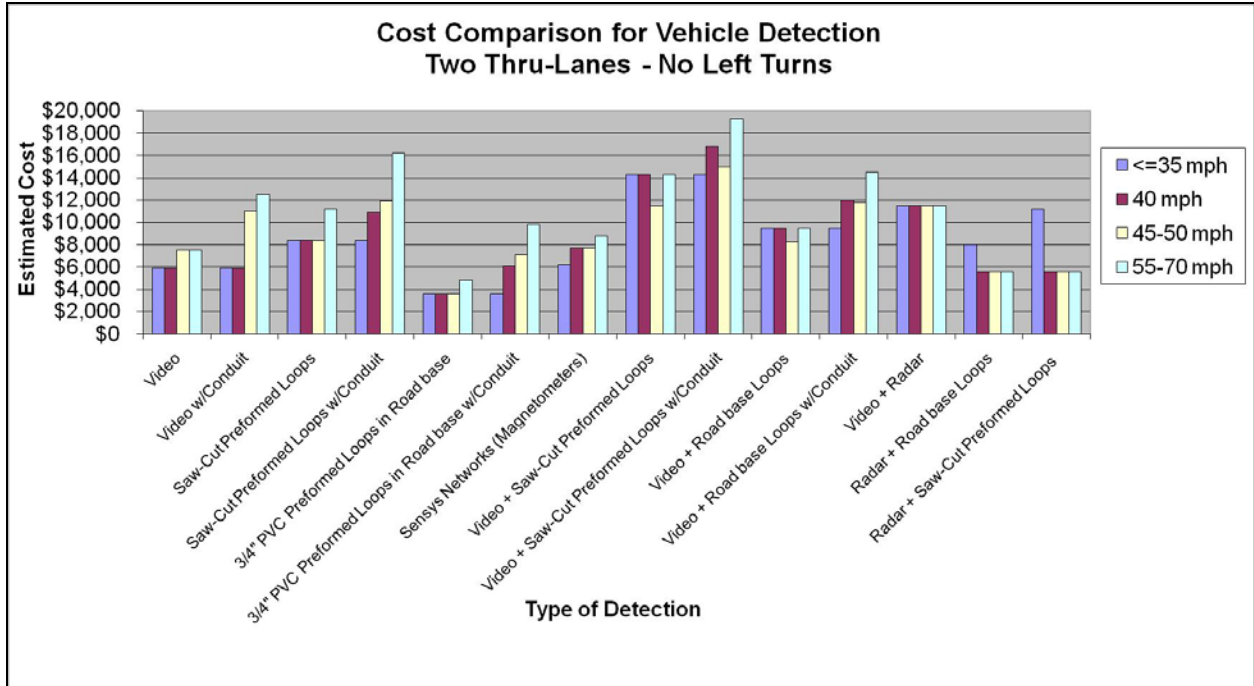
Figure 15. UDOT Cost Comparison for Two Thru-Lanes and No Left-Turn Lanes.

Cost comparisons by UDOT indicate that the Wavetronix Advance is sometimes less expensive than other alternatives, especially if no stop line detection is needed. In many cases, the cost of video detection is about the same as radar, but UDOT prefers the improvements in safety already noted with the Advance compared to video. If an intersection requires a left-turn phase, video will likely be less expensive than the Advance, since the Advance will need additional detection at the stop line. The cost of intrusive detection is sometimes significantly more than radar due to conduit and junction boxes in addition to the detector cost. [Figures 15 through 18](#) summarize the comparisons conducted by UDOT for different geometries and different design speeds.

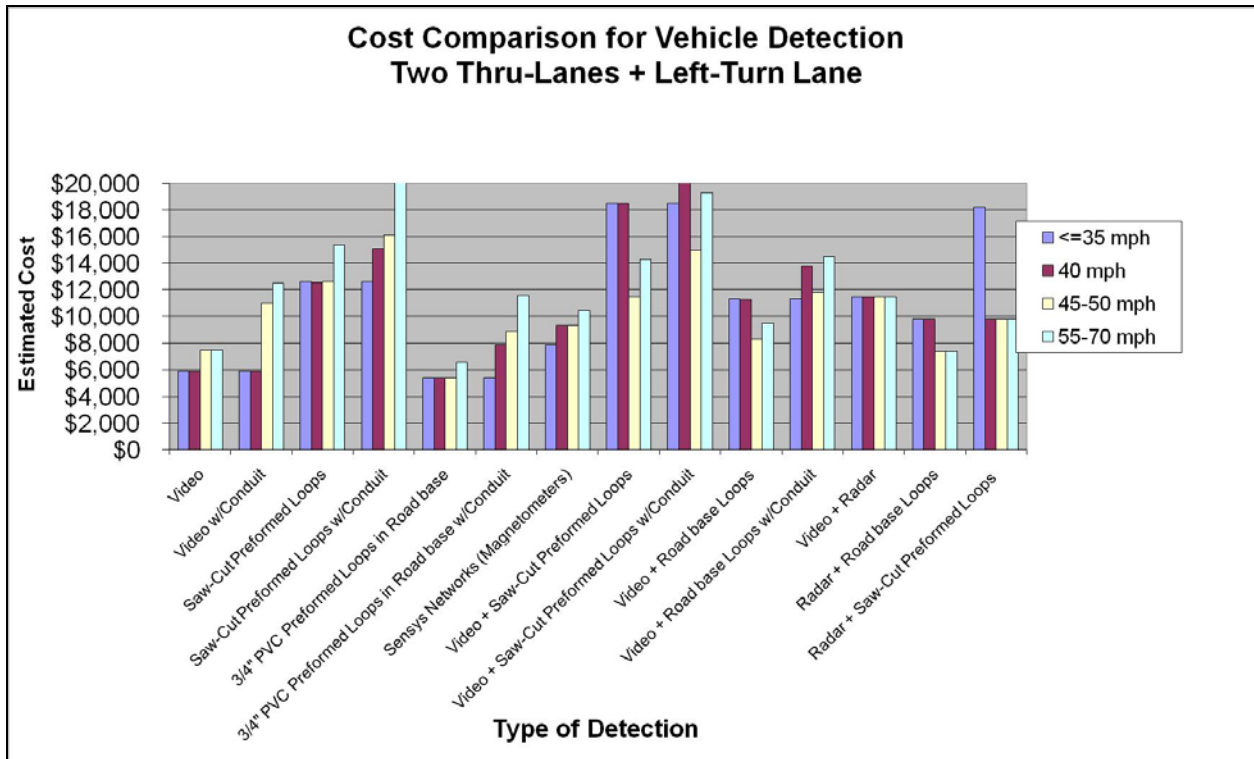
Figure 16. UDOT Cost Comparison for Two Thru-Lanes Plus Left-Turn Lane.

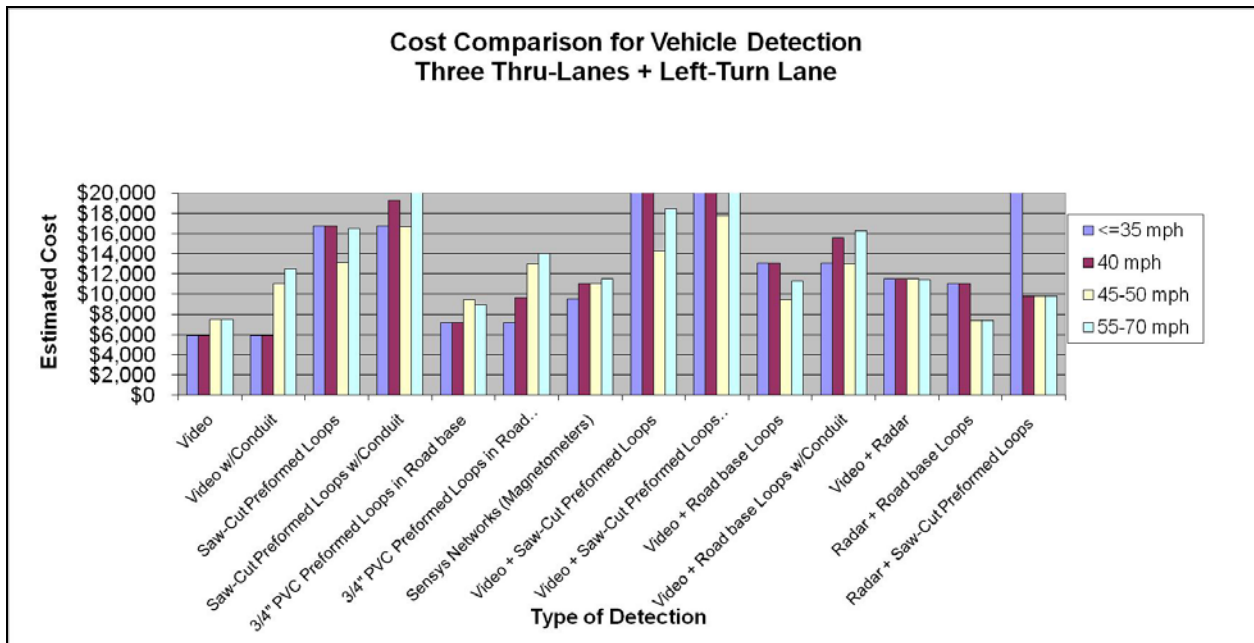
Figure 18. UDOT Cost Comparison for Three Thru-Lanes Plus Left-Turn Lane.

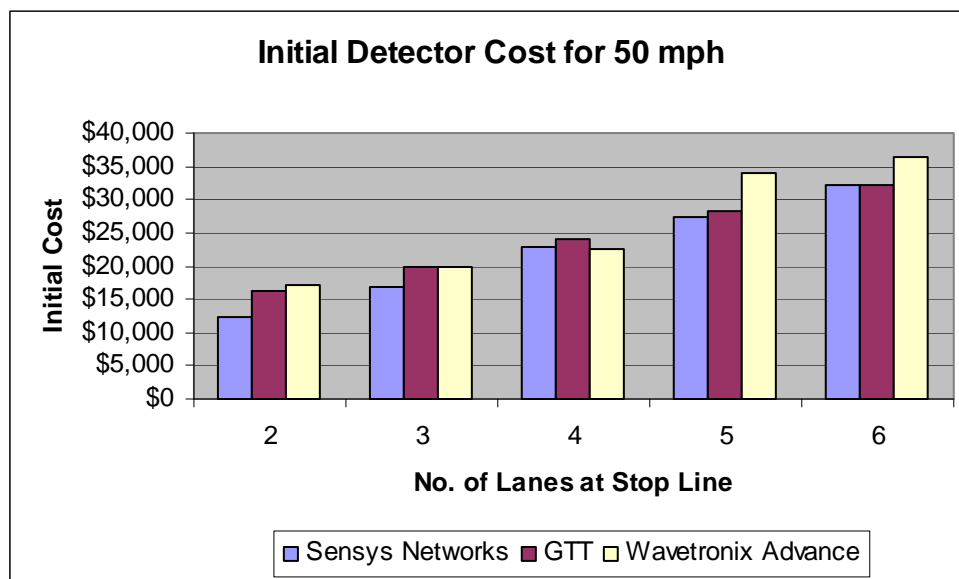
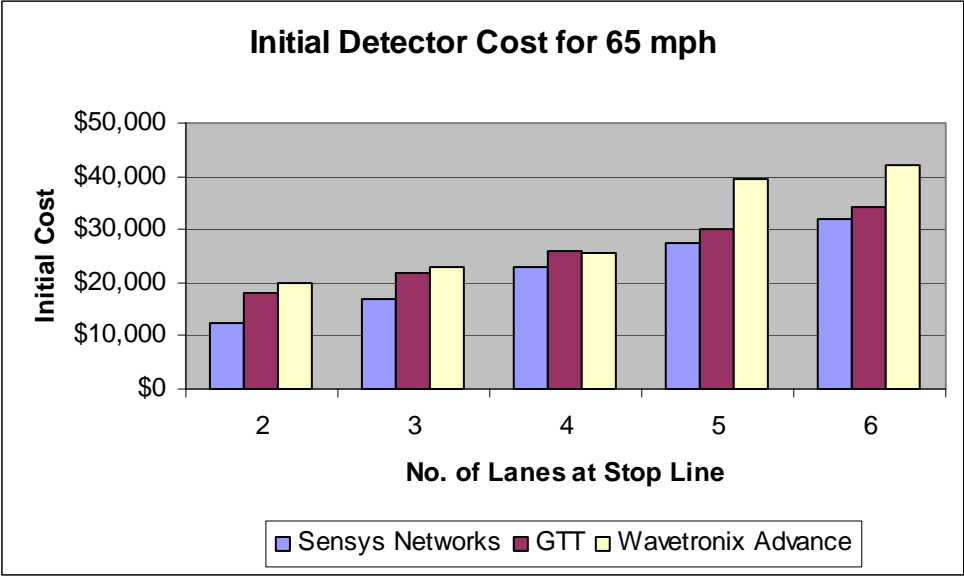
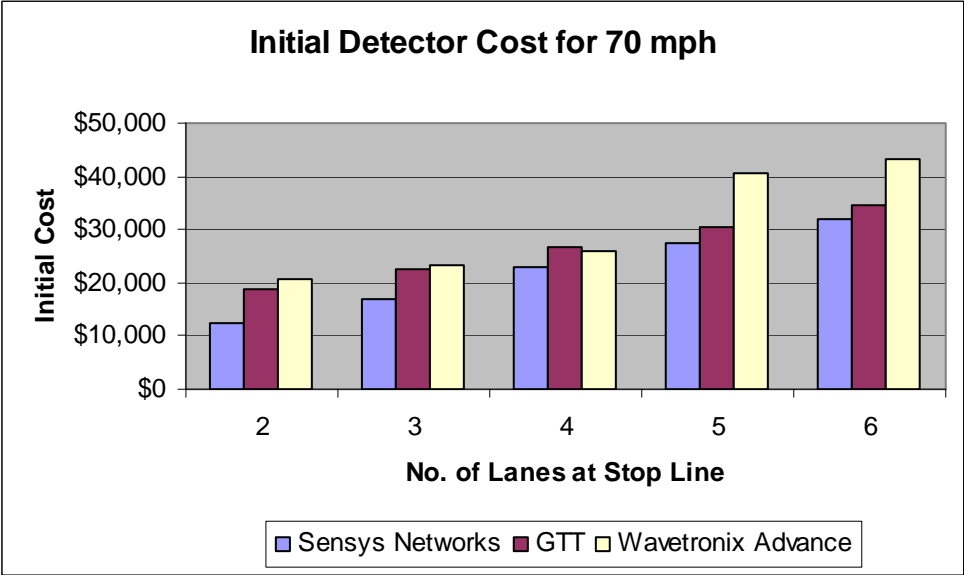
Figure 19. Initial Detector Cost Comparison for 50 mph.

Figure 20. Initial Detector Cost Comparison for 55 mph.

Figure 21. Initial Detector Cost Comparison for 60 mph.

Figure 22. Initial Detector Cost Comparison for 65 mph.

Figure 23. Initial Detector Cost Comparison for 70 mph.

For 50, 55, and 60 mph, these findings indicate that Sensys Networks magnetometers are the least expensive for all but one lane scenario. The Wavetronix Advance (combined with Sensys magnetometers at the stop line) is the least expensive for three through-lanes (four lanes at the stop line) by a narrow margin. For 65 and 70 mph, Sensys Networks magnetometers are the least expensive for all lane scenarios. Of course, eliminating stop line detection would reduce the costs significantly for all three systems.

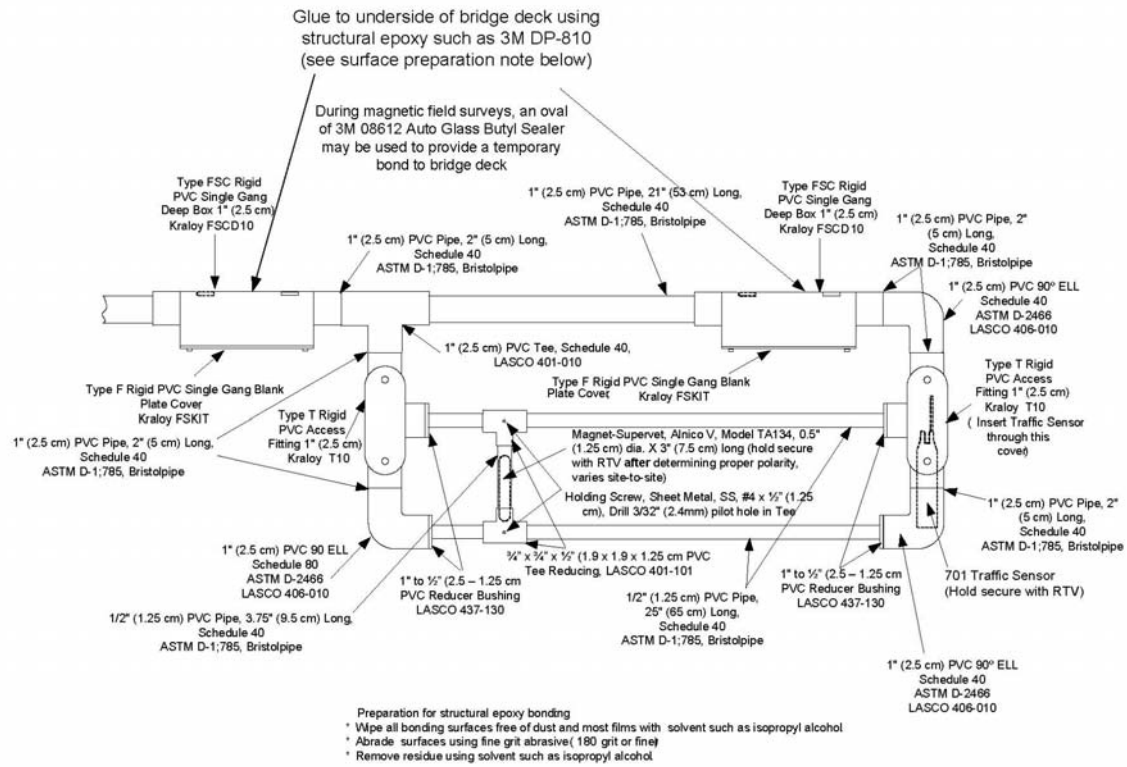
Figure 7. Ambient Magnetic Field Adjustment Device 2

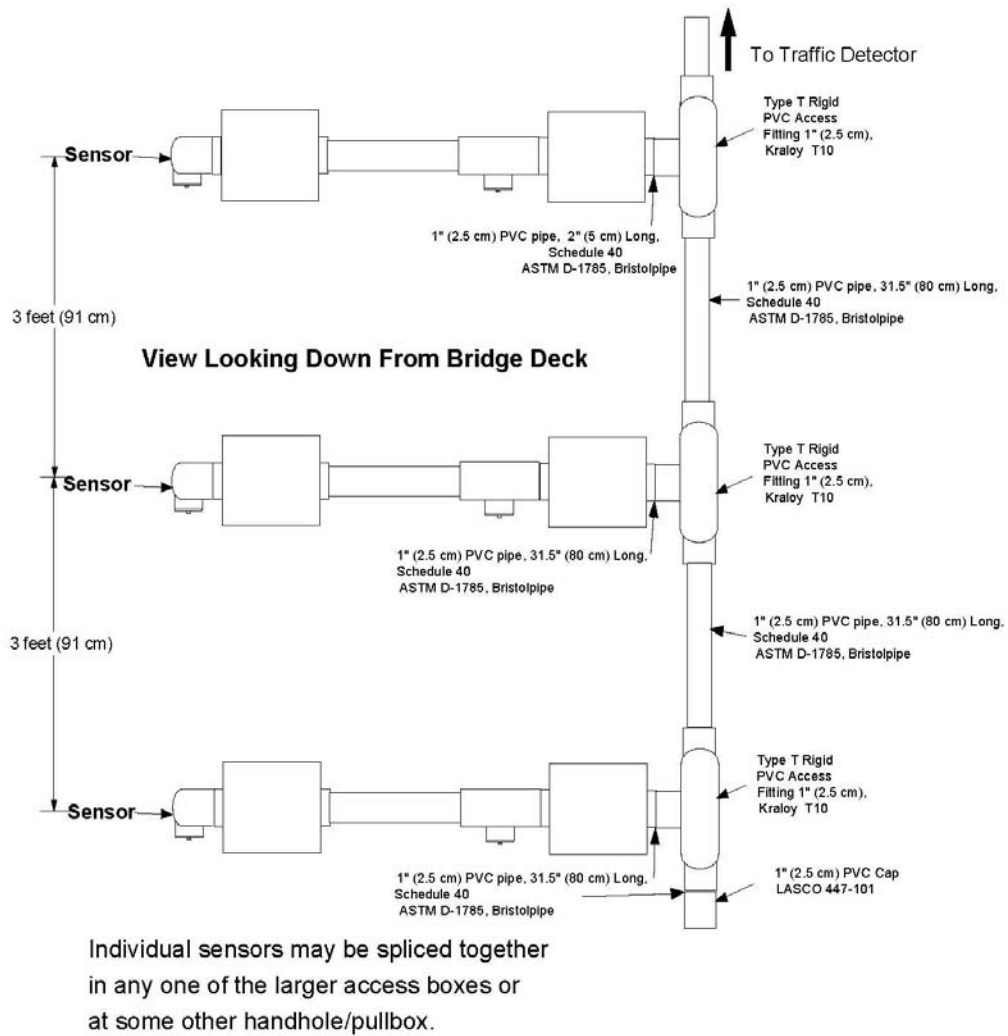
Figure 8. Triple Traffic Sensor Assembly Installation Using Ambient Magnetic Field Adjustment Device 2
