1. Report No. FHWA/TX-09/0-6037-1		2. Government Accession No.		3. Recipient's Catalog No.	
4. Title and Subtitle SUBBASE AND SUBGRADE PERFORMANCE INVESTIGATION FOR CONCRETE PAVEMENT				5. Report Date January 2009 Published: May 2009

# **SUBBASE AND SUBGRADE PERFORMANCE INVESTIGATION FOR CONCRETE PAVEMENT**

Report 0-6037-1  
Project 0-6037

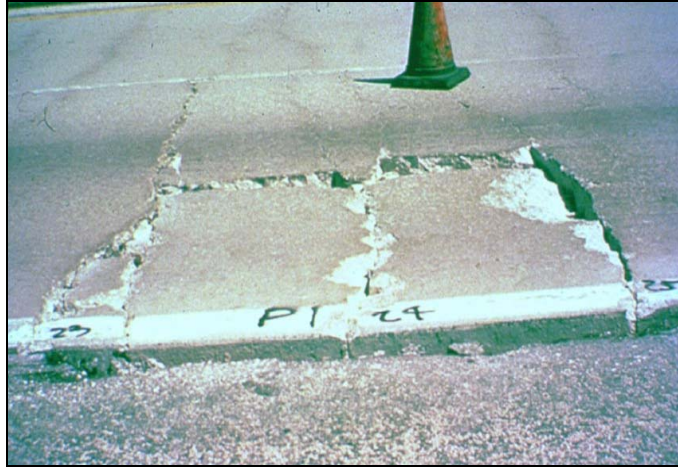
**Figure 1. Effects of Erosion on CRC Pavement Performance.**

Erosion potential is greatest where upward curling and warping along edge and corner areas debond the slab from the subbase enabling the slab to “pump” any water that may be trapped under applied wheel loads back and forth across the slab/subbase interface. This action, combined with the viscous nature of water, creates a shearing stress that carries eroded subbase material, further disrupting the continuity of the slab support. In this sense, one could argue that the third function is really a subset of the second function since erosion creates a nonuniform support condition that often leads to faulting in jointed pavements and punchouts in CRC pavements.

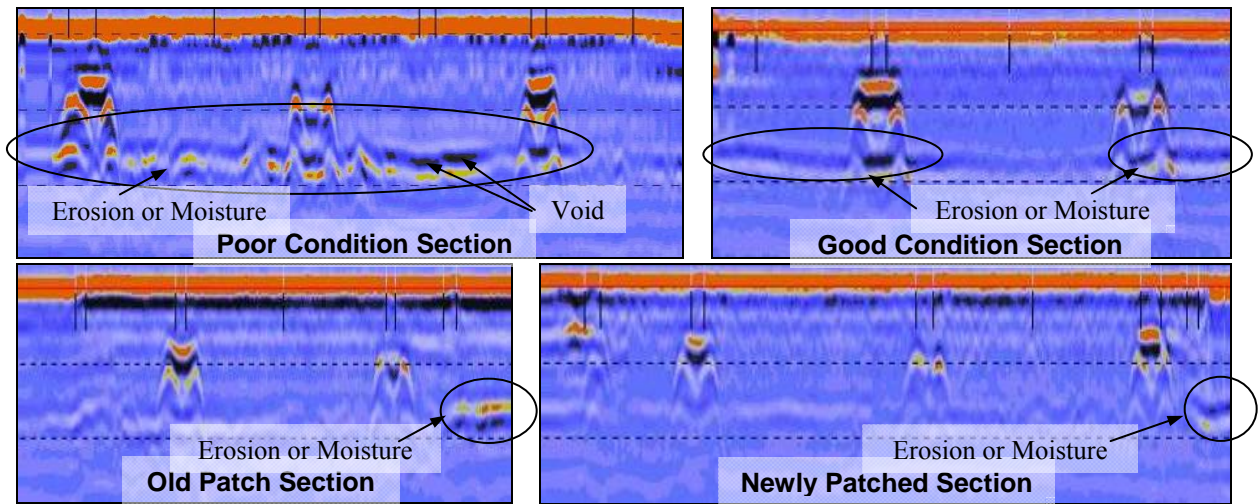
Figure 4 shows GPR images where the black or dark areas represent voids and yellow or orange strips (white strip in the grayscale image) represent eroded or wet areas. Most sections showed voided and eroded areas in the subbase layer, while patched sections showed none (as expected) but slabs adjacent to the patched areas did indicate voided areas. The blue line at the bottom in Figure 4 indicates the dielectric value, which indicates the amount of accumulated moisture in the subbase. Our experience indicates when a dielectric constant (DC) value is higher than about 9, a wet condition or erosion on the subbase may exist; much of test sections showed a DC value higher than 9.

a) GPR along FWD Lane Center Drop Points (Ground-Coupled System)

b) GPR along Edge Side Wheel Path (Air-Coupled Vehicle System)

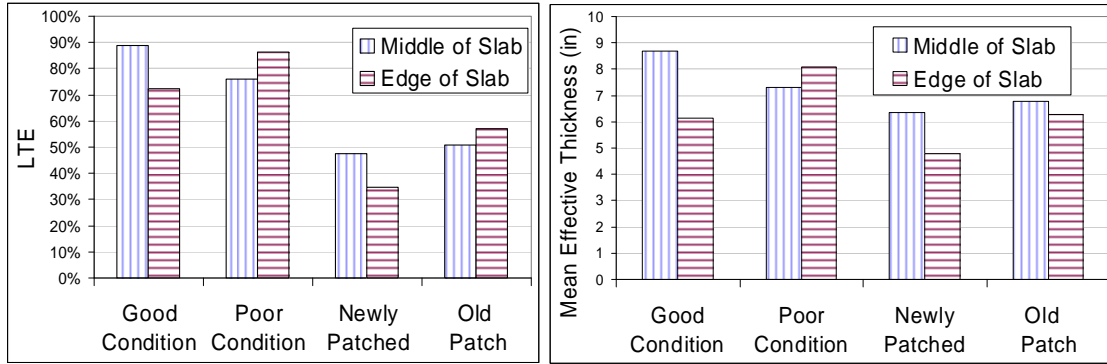
**Figure 5. LTEs and Effective Thickness of Test Sections on US 75.**

Figure 5 shows joint LTE and effective thickness along the center and the edge of slab. Interestingly, the patched sections had low LTE and effective thickness as if eroded conditions were present. The reason for low LTE in these sections is perhaps due to the lack of aggregate interlock along the joints. LTE and erosion are typically highly related to each other; joints with low LTE are often associated with high rates of erosion due to independent deflection behavior between two slabs; an eroded base also contributes to higher wear out rates of the aggregate interlock. Patches in pavements tend to create areas of low stiffness and consequently potential problem locations for future repair.

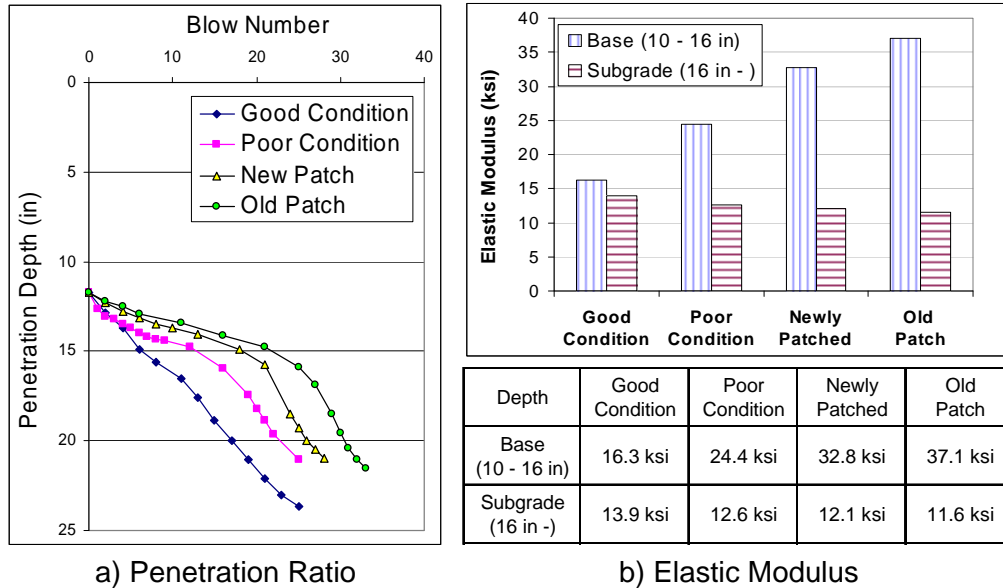
**Figure 6. DCP Testing Results of Test Sections on US 75.**

The base type for all sections investigated was an unbounded aggregate base (previously noted) where the estimated elastic moduli appeared to be quite low, as shown in Figure 6. Surprisingly, the base in the good performing areas was nearly the same modulus as that of the subgrade; perhaps the base material has been contaminated since

the elastic modulus for an unbounded aggregate base typically ranges from 15 to 45 ksi (3). Patched areas showed a base modulus to be about twice the base modulus of the unrepaired sections. This causes discontinuous base support between the patch and adjacent sections which may contribute to slab cracking. There was no significant difference in the subgrade layer modulus.

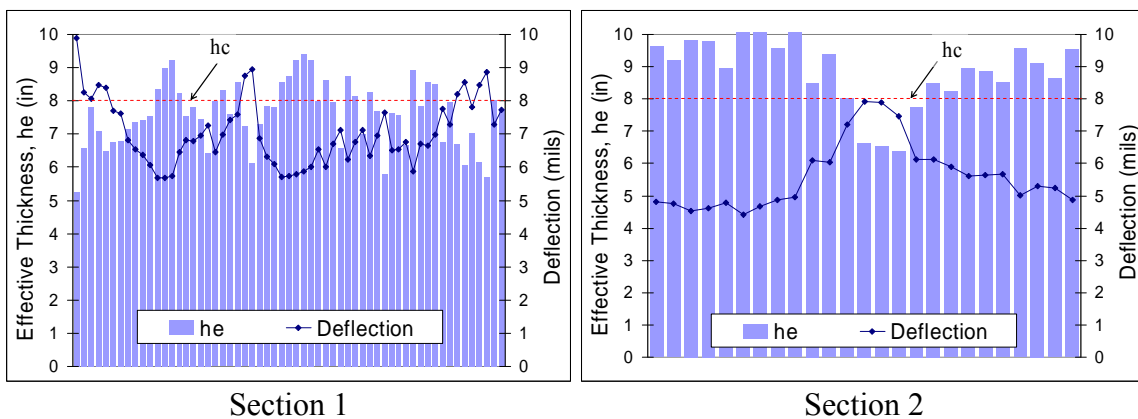
**Figure 12. Effective Thicknesses and Deflections of Test Sections on US 81/287.**

Figure 12 suggests evidence of subgrade erosion in portions of Sections 1 and 2. Combinations of low effective thickness and high deflections usually suggest that the base or subgrade layer could be eroded. Moreover, a high deflection condition means greater chance of mechanical and hydraulic shearing action taking place at the interface between the slab and the base under the effect of applied loading. If the LTE is high, erosive action would be reduced, but when LTE is diminished at a crack or joint, the independent vertical movements of adjacent slabs could accelerate the erosion process. The location of low effective thickness and high deflection noted in Section 2 was matched to the wet area noted by the GPR data as well as being verified through coring.

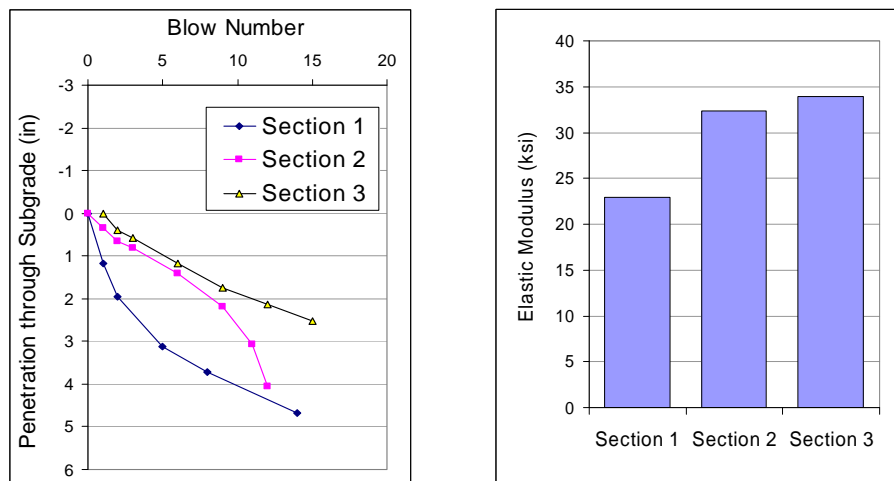
All sections were constructed over a 6 in lime-treated subgrade. Figure 13 shows DCP results from the three sample sections. Section 1 has the lowest elastic modulus, perhaps due to the wet subgrade conditions as noted by the GPR images. Section 3 showed the highest modulus although it is in the low end of the range of typical values. The natural subgrade material (sandy soil) is perhaps a low modulus material with a low resistance to erosion.

a) Penetration Ratio of Lime-Treated Subgrade  
b) Elastic Modulus of Lime-Treated Subgrade  
**Figure 13. DCP Testing Results of Test Sections on US 81/287.**

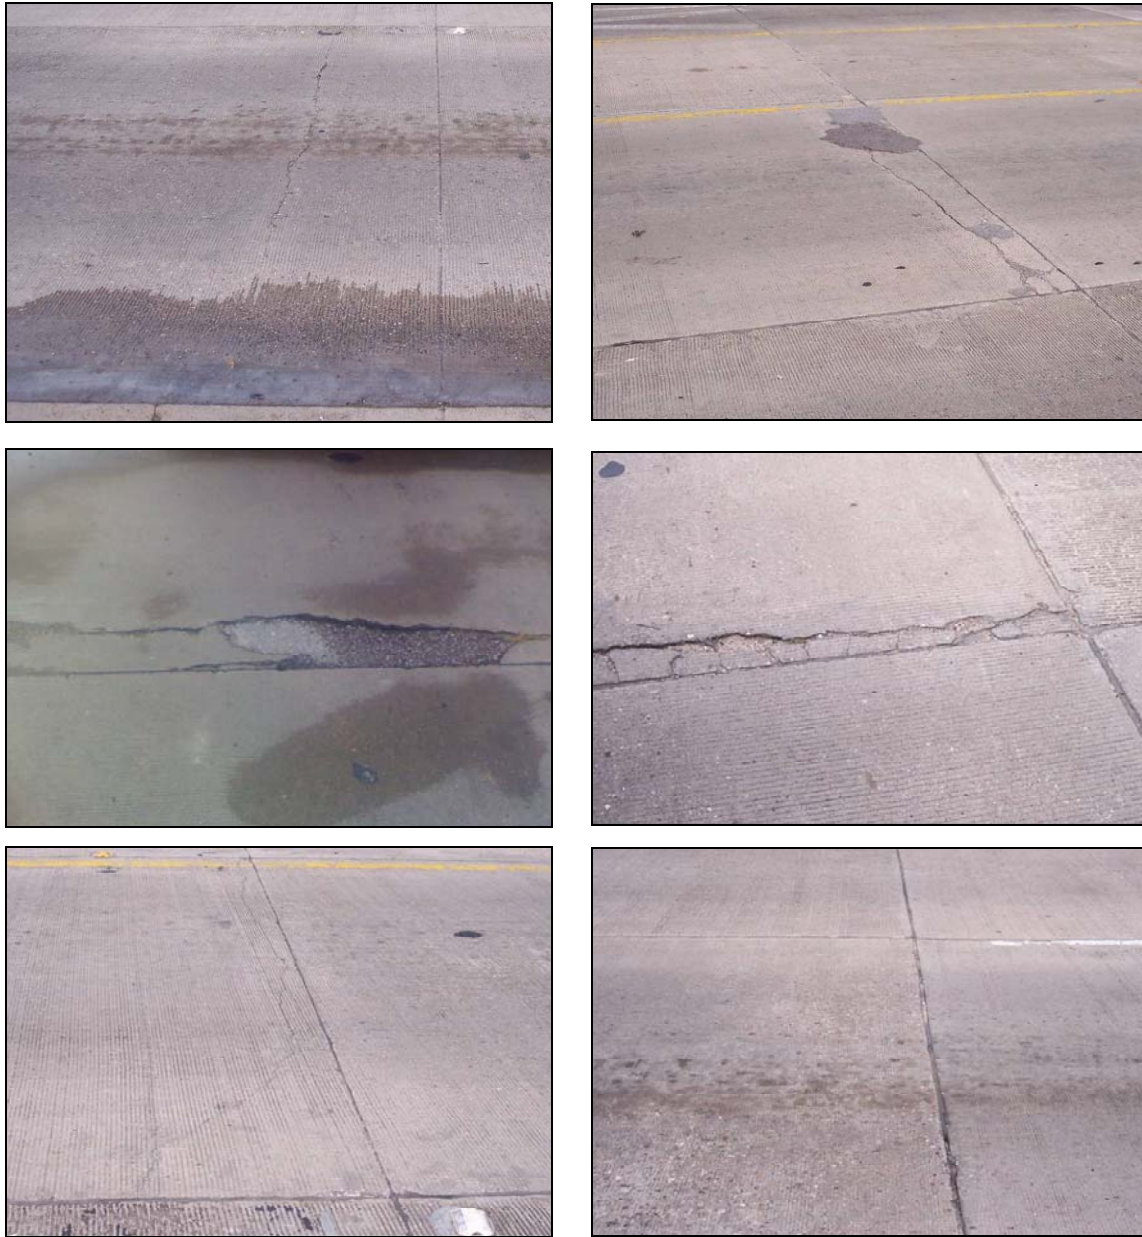
**Figure 17. Surface Conditions of Sampled Section on FM 364.**

[Figure 17](#) shows the surface condition of the sample section. Some slabs had transverse cracks near the joints (about 1 ft apart) possibly due to late sawcutting. The joint seal condition was generally good, but not all the cracks were sealed properly promoting water intrusion and erosion of the base.

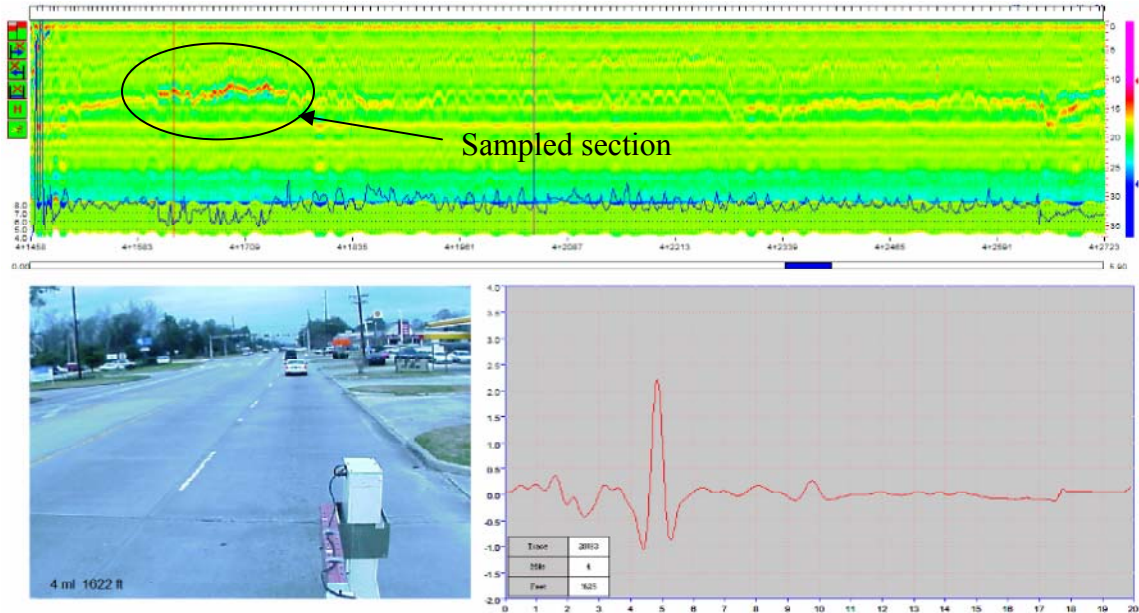
**Figure 18. GPR Image of Test Section on FM 364.**

Core sampling was selected based on the presence of the red strip in the GPR image (Figure 18) as an indication of erosion-related damage. However, moisture was scarcely present in the base, where there was little evidence of erosion damage. DC values were around 7 to 9 and fluctuated as shown at the bottom of the scanned image

suggesting a high chance of water being present at the interface of the slab and base layer.

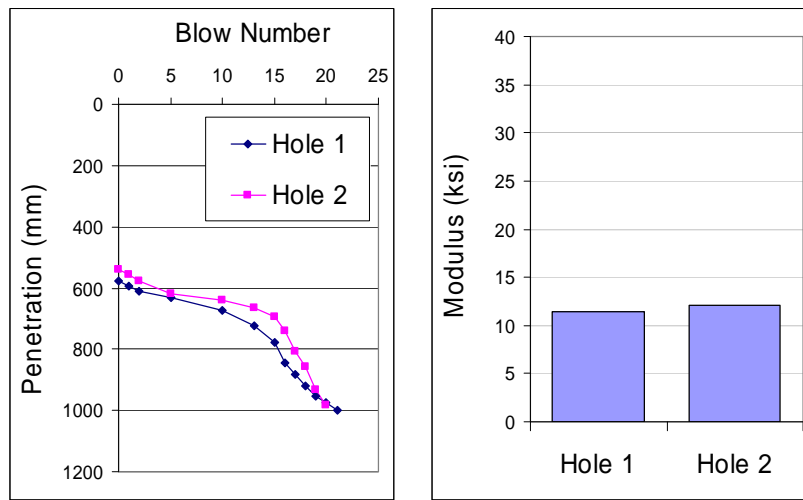
**Figure 20. DCP Testing Results of Test Section on FM 364.**

Figure 20 shows DCP results from two core holes made on site. Calculated modulus was around 12 ksi which is in the normal range of subgrade material moduli (3 to 40 ksi).

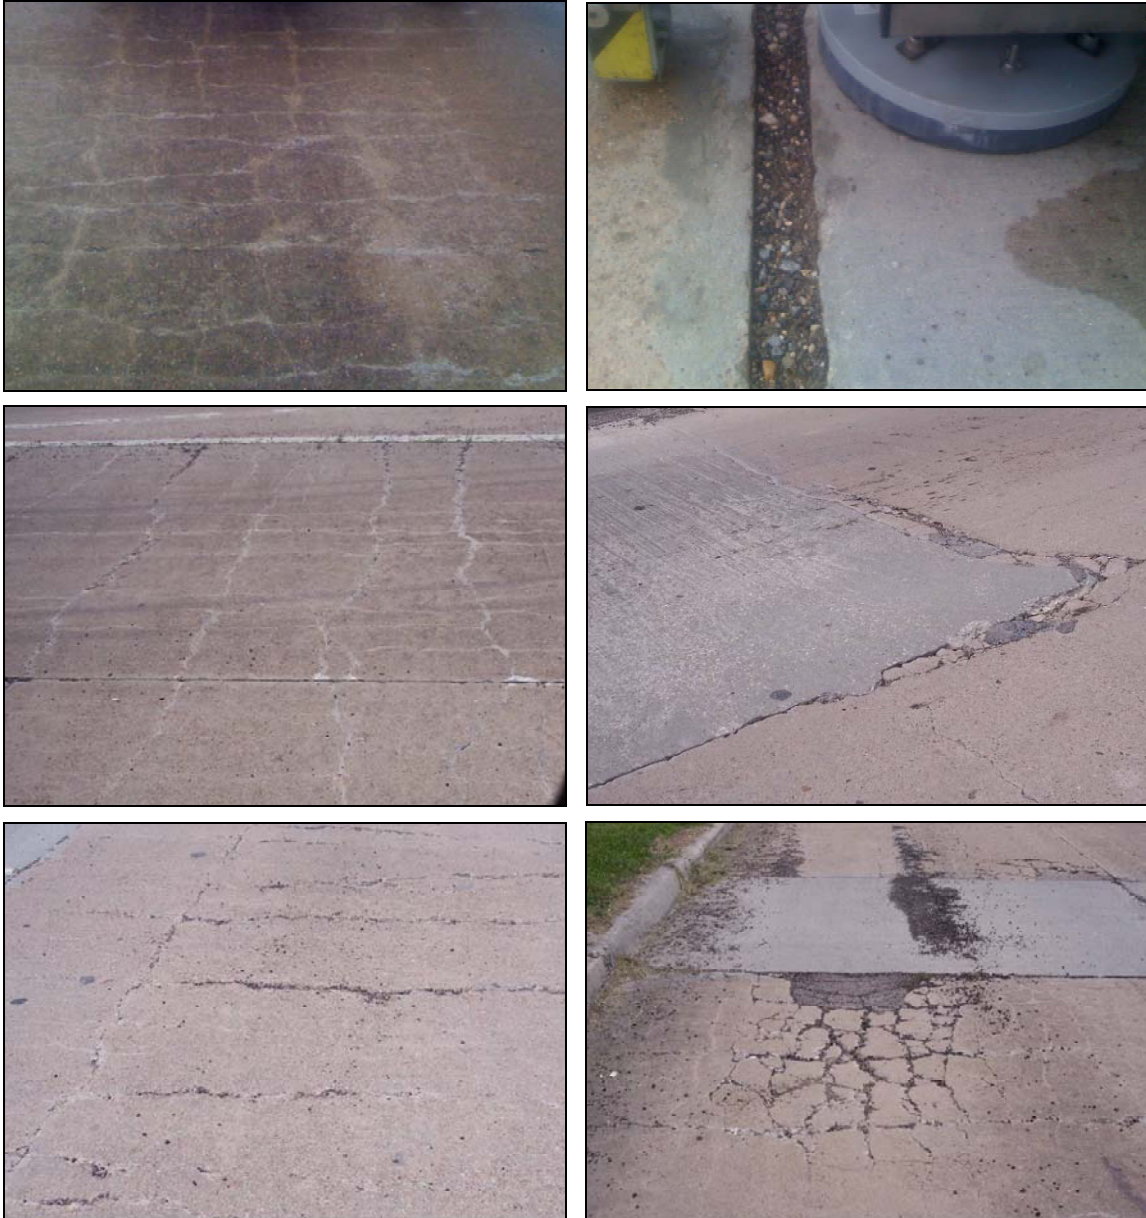
**Figure 22. Surface Conditions of Sampled Section on IH 10.**

The support conditions of a frontage road along IH 10 located in Beaumont, TX, which consisted of a 6 in CRC pavement over silty and sandy subgrade (no base layer) that was constructed in 1963 was investigated. The pavement carries approximately 100 ADT with 3.2 percent truck traffic. Distressed areas indicate signs of overloading are shown in [Figure 22](#) and consist of severe map cracking with spalling and pumping. Joint or crack sealing was practically nonexistent and the pavement was severely deteriorated in the vicinity of the expansion joints. Some patched areas had settled and broken at the corner or in the wheel path; areas adjoining to the patches typically had low LTE and poor support. Most of the damage appeared to be due to a weak subgrade.

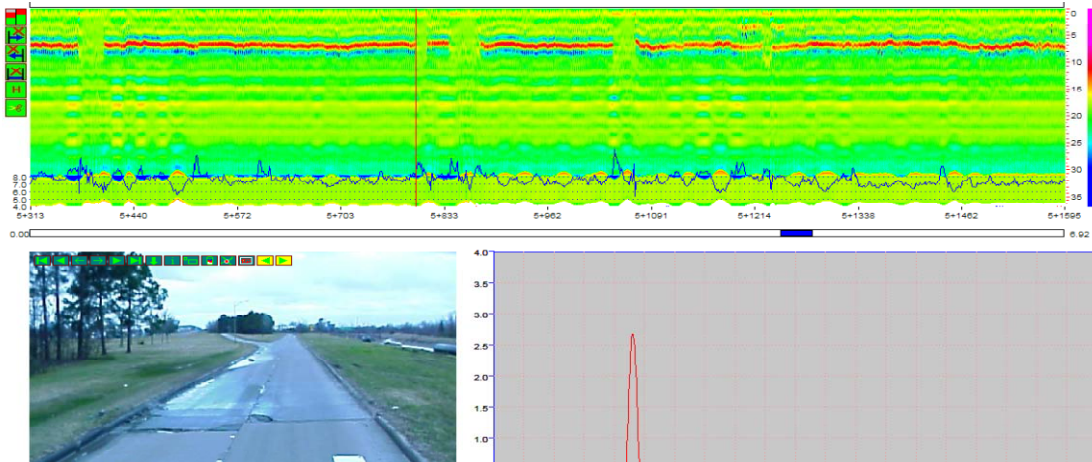
**Figure 23. GPR Image of Test Section on IH 10.**

Most of the survey sample area showed a high degree of moisture and voiding under the slab based on the GPR results in [Figure 23](#). DC values were around 7 to 9 and fluctuated (with high DC values near crack locations) as shown at the bottom of the

scanned image. Some peaks occurring at the beginning and end of the FDR patches may indicate the presence of moisture (there was no joint seal between patches and surrounding pavement) possibly leading to more settlement and discontinuous support conditions.

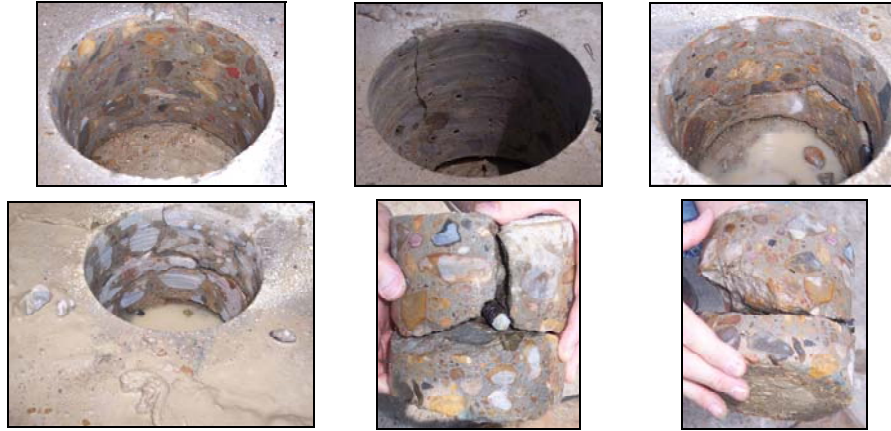
**Figure 26. Interface and PCC Layer Condition of Section on IH 10.**

All four cores showed eroded conditions and, of course, no bonding between the concrete and the subgrade (Figure 26). Since there is no base layer, subgrade material was directly subjected to subsurface water through cracks and spalling in the concrete surface exposing it to pumping action and vehicle loading. However, pumping was not excessive since the traffic loading was only approximately three trucks per day. The coring in Figure 26 shows horizontal cracking along the reinforcing bar.

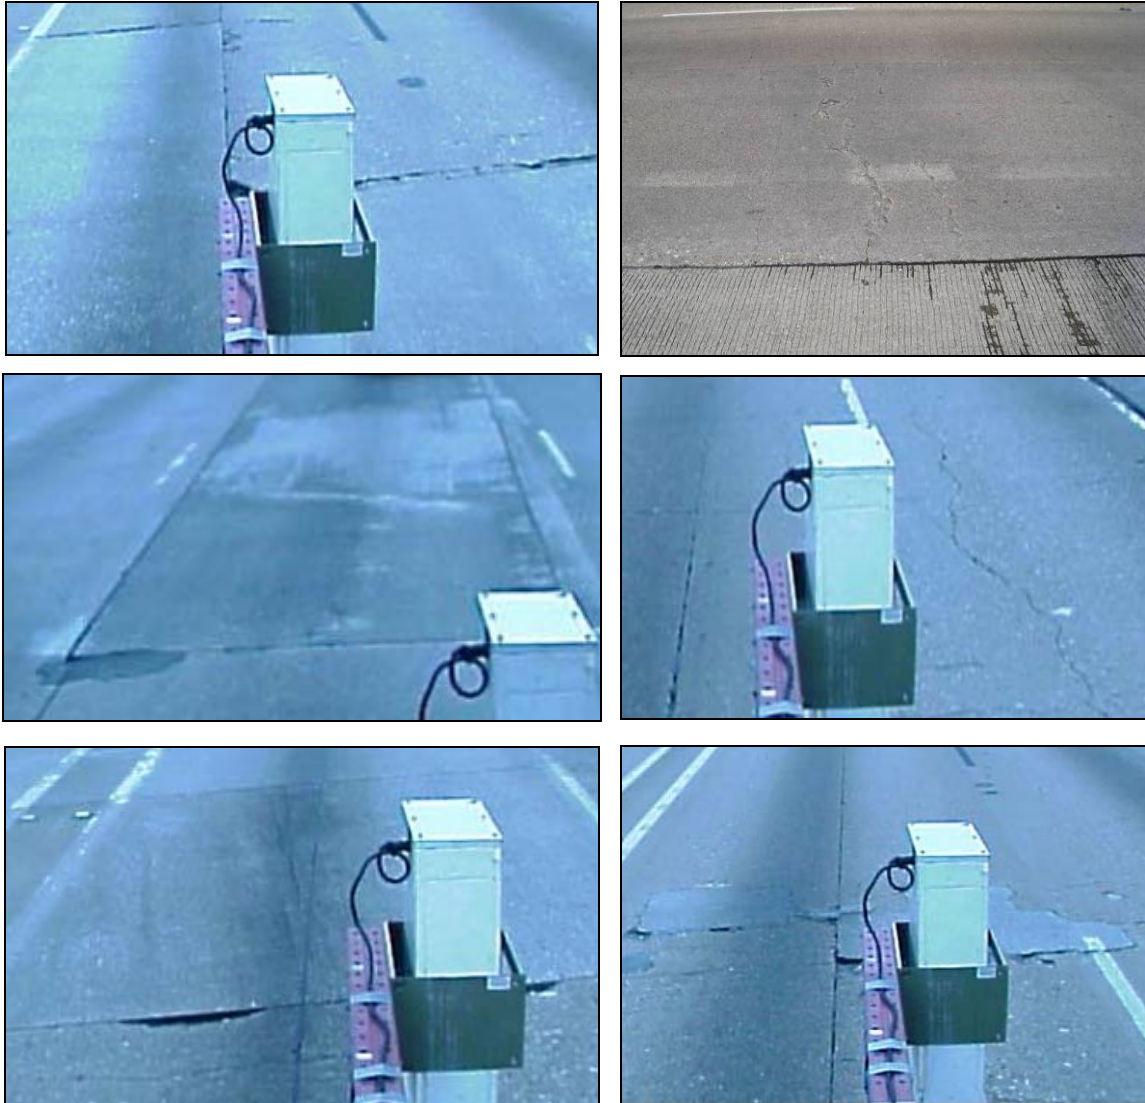
**Figure 27. Surface Condition of Sampled Section on IH 635.**

A CRC pavement section on IH 635 from IH 35E to US 75 was sampled to evaluate the base condition. Sampled sections consist of an 8 in CRC pavement with a concrete shoulder over a 4 in CSB that was opened to traffic in 1967 that currently carries an ADT of 200,000 with 12 percent trucks. Surface conditions shown in [Figure 27](#) were generally good except some spalled cracks and patches. The key distress types are the full-depth patches and the widened longitudinal joints although the overall condition of the pavement appears to be very good. The patches in the pavement are most likely repairs of punchout distress that are possibly a result of erosion and loss of support immediately below the slab since widened longitudinal joints are evident at a few locations. The patch density is not high, but in places, it is as high as 5 per mile.

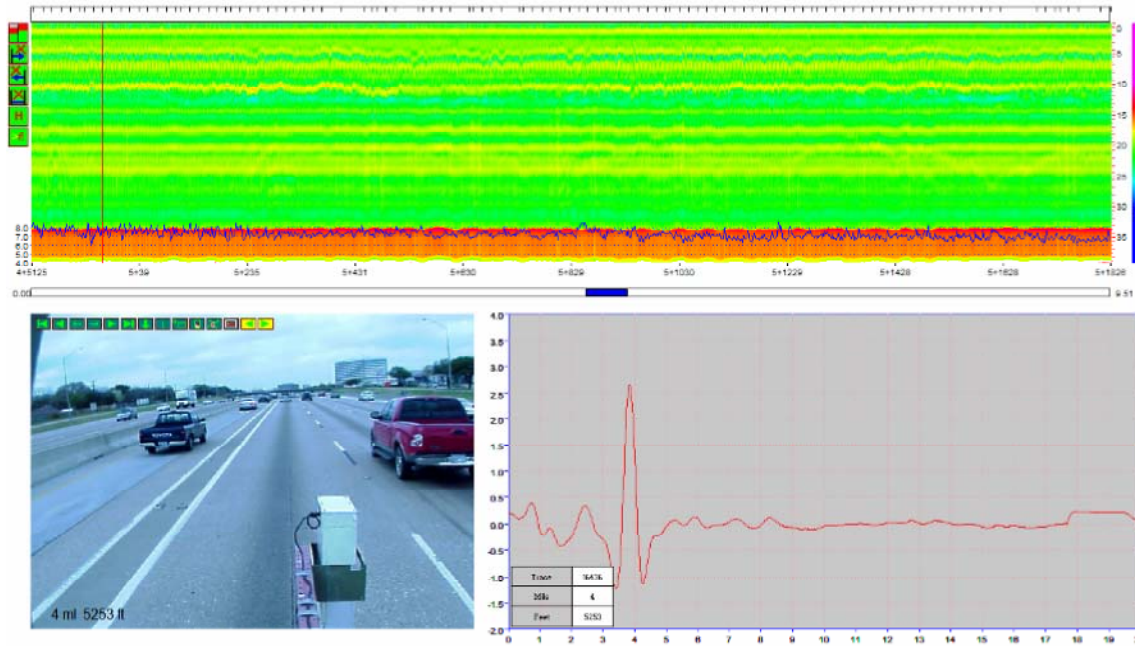
**Figure 28. GPR Image of Sampled Section on IH 635.**

GPR image in [Figure 28](#) showed some moisture areas under the concrete slab but no significant sign of erosion was identified. DC values of overall sections are around 7 to 8 representing a low level of moisture on the base layer.

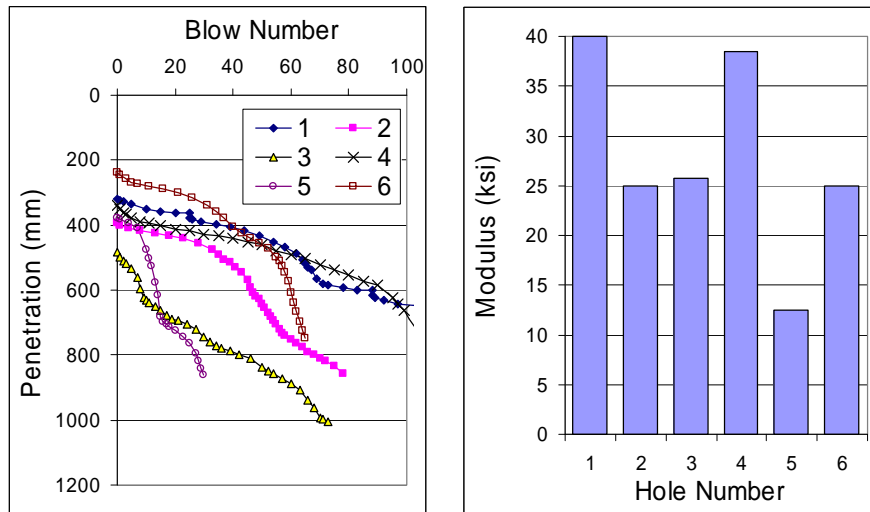
Figure 30. DCP Testing Results of Test Section on IH 635.

DCP testing was performed at core locations to assess the insitu strength characteristics of undisturbed soil and/or compacted materials below the subbase. The results of six representative holes in Figure 30 show good subgrade conditions except for one area showing a calculated modulus of 12.4 ksi.

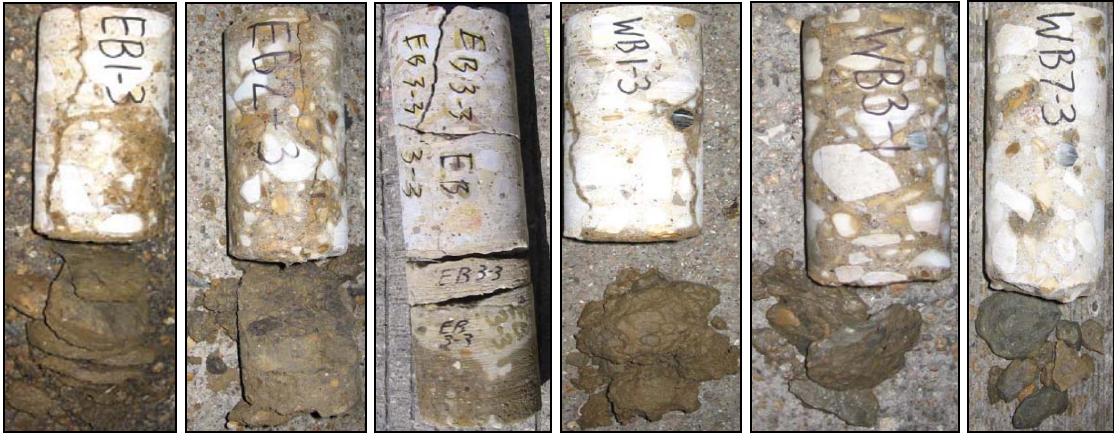
**Figure 31. Cores of Sampled Section on IH 635.**

Erosion was found only at areas where the condition of the longitudinal construction joint was not well maintained and moisture had penetrated the pavement (Figure 31). The stabilized base consisted of cemented sand with gravel and ranged in thickness from 3 to 5 in, while the subgrade mainly consisted of clay material. The pavement support is not presently as issue but could soon become serious if maintenance activities are terminated or diminished for an extended period of time. Life extension could be facilitated by addressing the areas in the pavement structure that do not drain well and allow water to penetrate below the surface of the pavement.

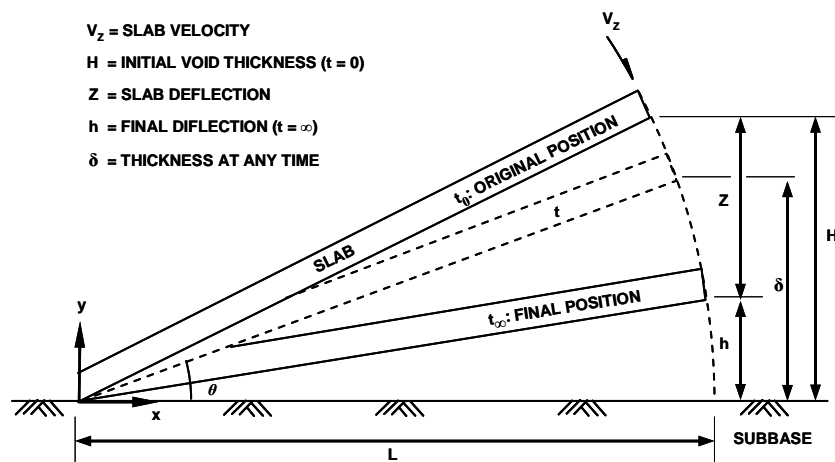
**Figure 32. Slab Configuration of Erosion Modeling by Pumping (4).**

Figure 32 shows conceptually the action of pumping at the corner of a concrete slab (4). The water induced shear stresses on the subbase are developed based on the slab movement simulated by a stiff plate rotating about an axis. The initial edge gap,  $H$ , is attributed to curling and warping of the concrete pavement.

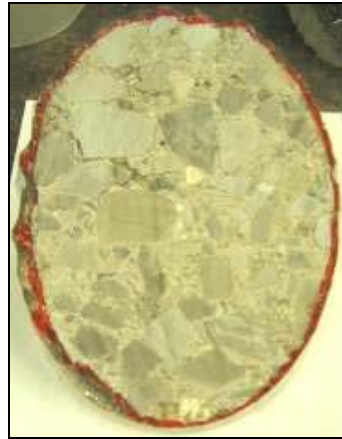
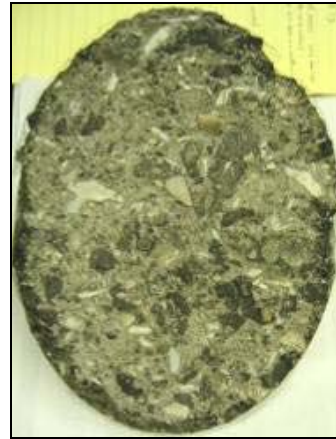
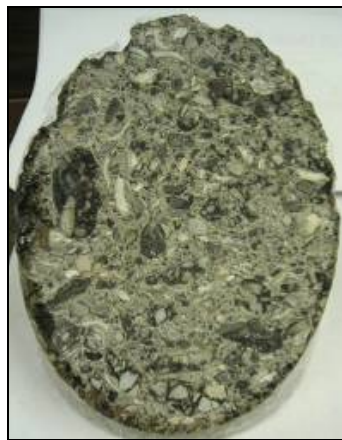
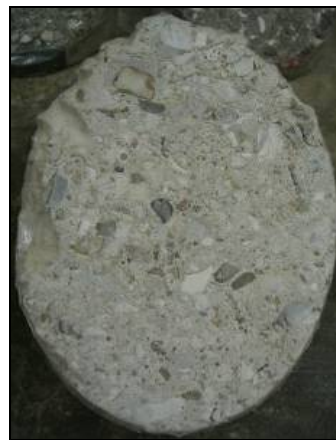
**Figure 41 Surface Condition of Samples.**

All samples were prepared according to the test method “Tex-120-E, Soil-Cement Testing” and compacted according to the test method “Tex-113-E, Laboratory Compaction Characteristics and Moisture-density Relationship of Base Materials,” using a 10 lb hammer, with an 18 in drop, at 50 blows/layer in a 6 x 8 in mold. All samples were cured more than 90 days under 100 percent relative humidity conditions. All samples were cut on a 40-degree slant. Special precautions were taken to prevent edge damage during cutting and testing. [Figure 41](#) shows sample surface conditions where the CTB sample shows the relatively larger size of aggregates on the surface.

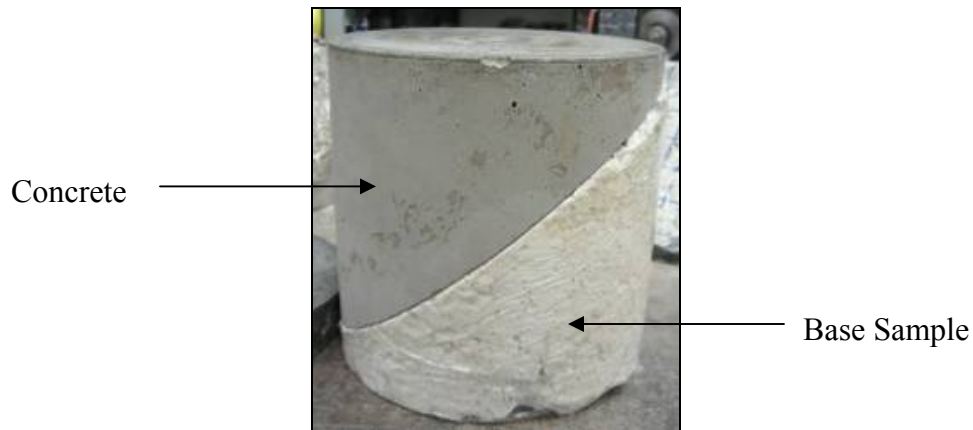
**Figure 42. Configuration of Test Sample.**

The erosion of stabilized materials is highly dependent upon the strength of the cementitious matrix and the durability of the aggregate. Since bound materials may have cohesive strength, the applied shear stress may not be sufficient to generate shear failure in the surface material. Shear stress induced by surface friction may erode the interface of concrete and base/subbase. [Figure 42](#) shows a test specimen configuration where the 40-degree angled concrete block is cycled against the base material under a load of 100 psi applied normally and at various levels of shear stresses by changing deviatoric stress and confining stress. Other angles were experimented with but were not able to generate

sufficient abrasion to wear away material at the interface. Weight loss was measured at five different levels of shear stress at the interface. Loading time was 0.2 s sinusoidal pulse loading and 0.8 s rest period per every second to simulate vehicle loading on concrete pavement.

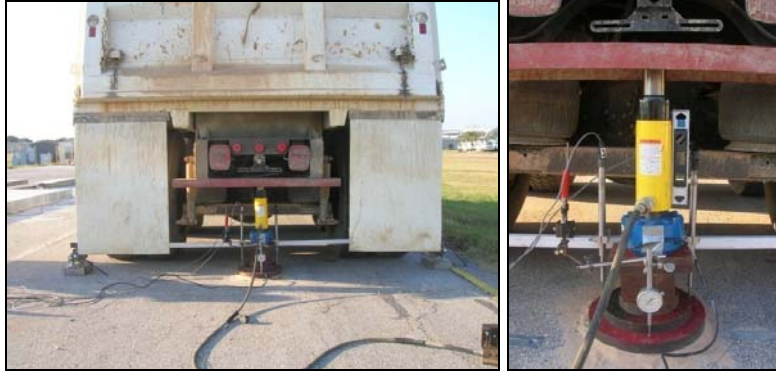
**Figure 62. Plate Load Field Test.**

After all equipment has been properly arranged, initial loading was applied for seating purposes. The preload was released after the LVDTs were stabilized. After stabilizing, load was applied again at a moderately rapid rate in uniform 0.005 in increments. Each increment of load was applied at a rate of deflection not more than 0.001 in/min. Load and deflection readings were recorded for each load increment. This process continued until the total deflection was more than 0.05 in. For all cases, more than 6 load-deflection points were obtained. The modulus of subgrade reaction was calculated at a 0.05 in deflection as is the TxDOT practice (21). Figure 62 shows the plate load field test.
