1. Report No. FHWA/TX-11/0-6060-1		2. Government Accession No.		3. Recipient's Catalog No.	
4. Title and Subtitle REALTIME MONITORING OF BRIDGE SCOUR USING REMOTE MONITORING TECHNOLOGY				5. Report Date October 2010 Published: February 2011

REALTIME MONITORING OF BRIDGE SCOUR USING REMOTE MONITORING TECHNOLOGY

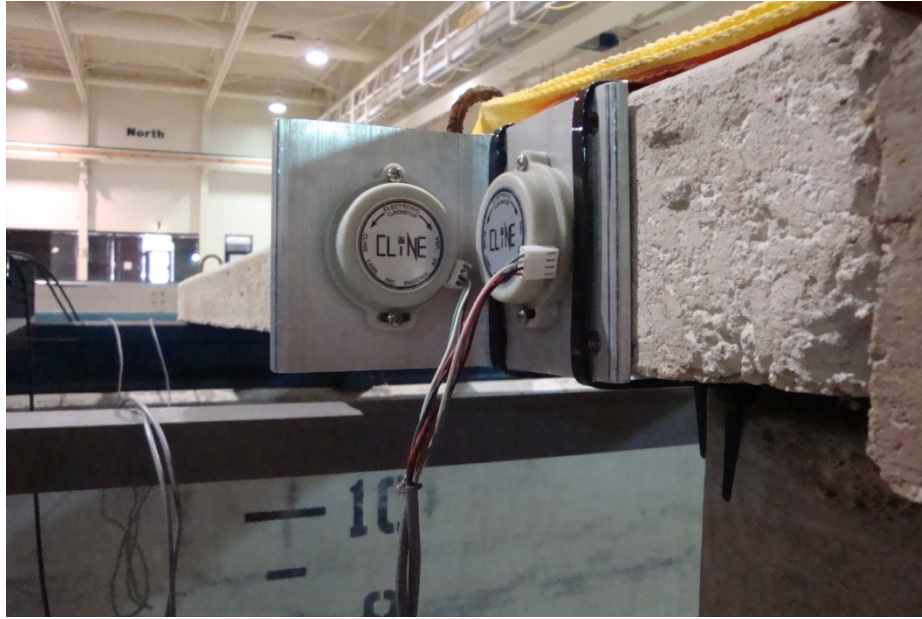
Figure 3-2. Tiltmeter Used in the Laboratory Experiment.

Two single-axis tiltmeters are mounted together along the perpendicular axis to form a dual-axis tiltmeter. [Figure 3-2](#) shows the dual-axis tiltmeter used in the laboratory experiment, which measures the tilt angle of the deck around the axis in the two directions (flow direction and traffic direction). [Figure 3-3](#) shows the single-axis and dual-axis tiltmeter installed on the bridges in the field. When the tiltmeter is installed in field, it is important to put the sensor in an enclosure to protect against environmental conditions.

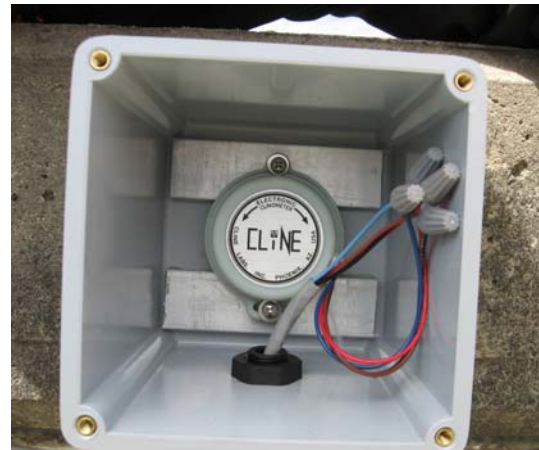
Figure 3-3. Tiltmeter Used on SH80 over San Antonio River Bridge: (a) Dual-Axis Tiltmeter and (b) Single-Axis Tiltmeter.

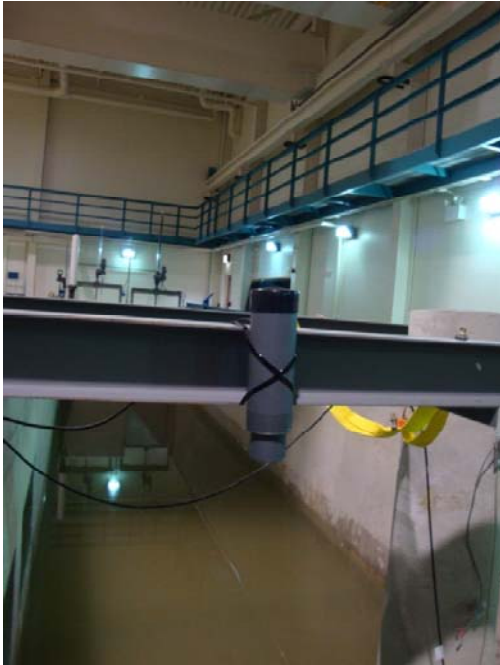
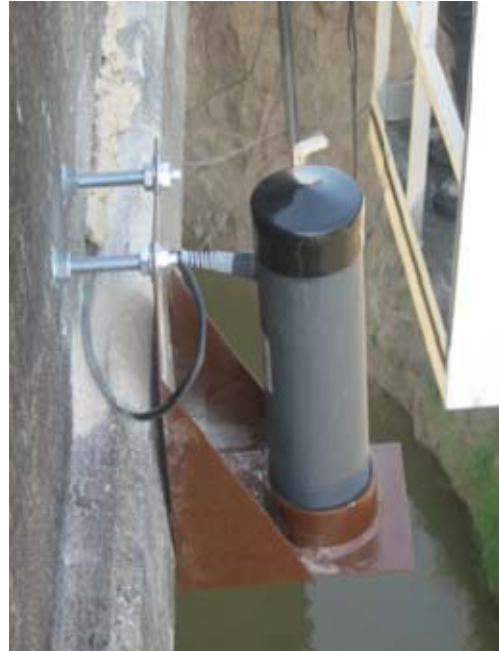
A water stage sensor is an ultrasonic distance finder, aimed from a fixed reference (e.g., from the side of the bridge deck) to the water surface. The water stage sensor is hardwired to the data acquisition system and measures the distance from its mounting on the bridge to the water surface. Occasionally in the field, the water stage sensor is used to directly indicate the water surface elevation by subtracting the measured distance of the sensor transducer to the water surface from the known elevation of the transducer. The water stage sensor is installed so that it has a minimum deviation from vertical axis. [Figure 3-4a](#) shows the water stage sensor used in the laboratory. In field, the stage sensor is mounted using a fixing bracket ([Figure 3-4b](#)).

Figure 3-4. Water Stage Sensor: (a) Used in Laboratory and (b) Used on US59 over Guadalupe River Bridge.

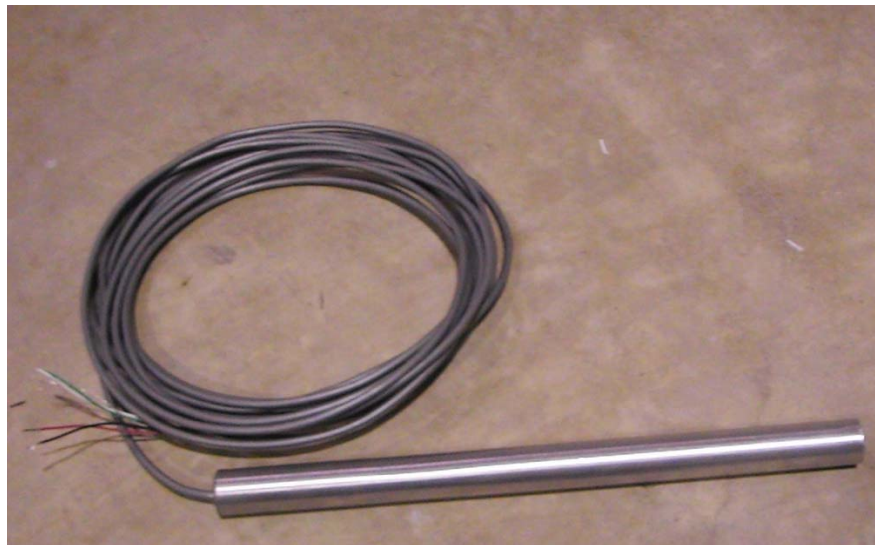
The tethered buried switch (TBS) is a type of float-out device, which is buried into the soil vertically in order to give an indication of the development of the scour around the bridge foundation. It consists of one 0.3 m (1 ft) long hollow aluminum rod containing an electrical switch (Figure 3-6). It is hardwired to the data acquisition system. The electrical switch triggers when the rod turns from the vertical to the horizontal position. It is caused by the hydraulic drag during the flood as the scour depth reaches the instrument buried level. It has three discrete values of 1, 2, and 3, corresponding to the three working states of the instrument. If the TBS is in the vertical position and the trigger has not been launched, the sensor will transmit a value of 1. If the switch is triggered and the scour reaches the buried level of the instrument, the sensor will transmit a value of 2. If the wire of the switch is broken, the sensor will transmit a value of 3. Figure 3-6 shows the TBS used in the laboratory, while Figure 3-7 shows the TBS used on US59 over Guadalupe River Bridge. The TBS used in the field is covered by a PVC pipe.

Figure 3-6. TBS Used in the Laboratory.

The TBS gives a direct and simple indication of the scour depth. TBS is simple, easy to install, inexpensive, and has an infinite lifespan as it is connected to the data acquisition system through a wire. The wire, however, is a drawback as the specific protection should be taken to avoid vandalism or damage due to debris. Another limitation is that the TBS sensor is only able to give an output for the scour up to the depth of embedment of the instrument. It only provides localized information about the scour.

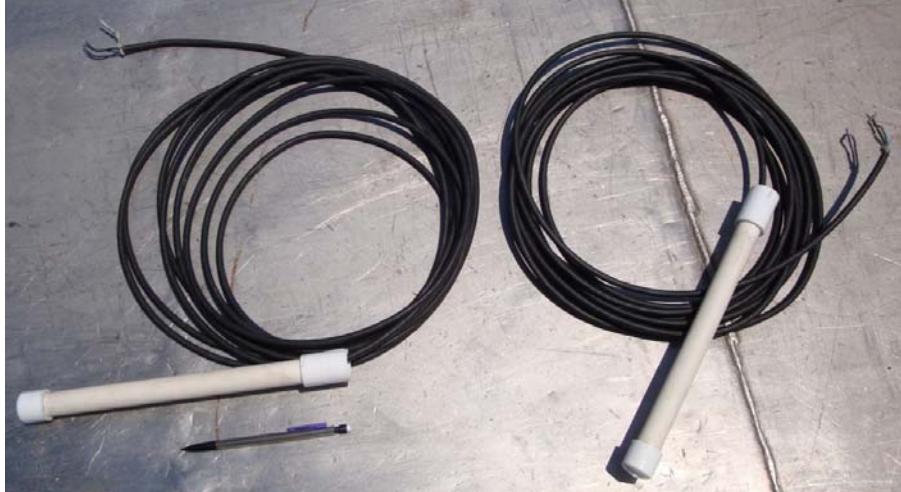
Figure 3-7. TBS Used on US59 over Guadalupe River Bridge.

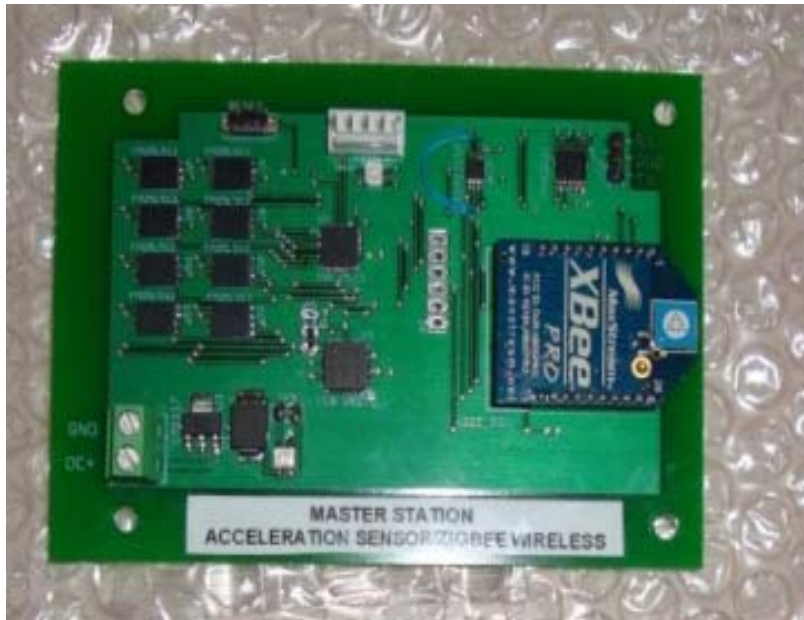
are used. The accelerometer data can be analyzed by a Fast Fourier Transform (FFT) to obtain the natural frequency of the bridge system, which shows great potential in the prediction of bridge scour. [Figure 3-8](#) shows the circuit board of accelerometer. [Figure 3-9](#) shows the hardwired accelerometer installed on US59 over Guadalupe River Bridge.

Figure 3-8. Circuit Board of Accelerometer.

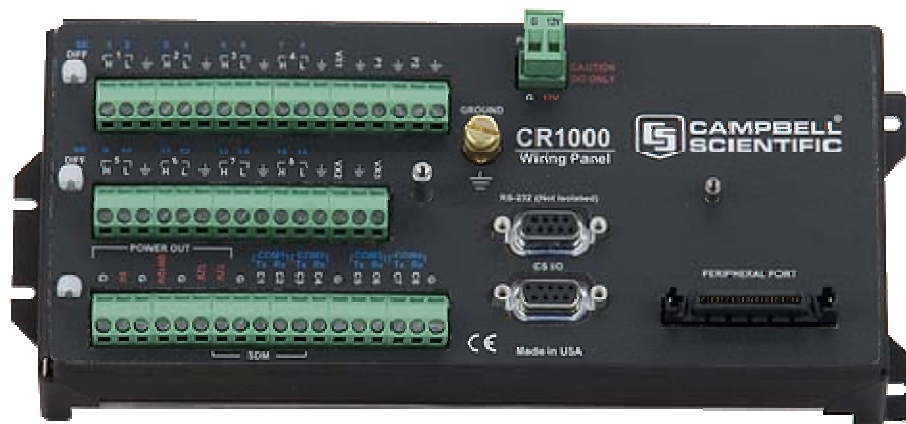
The data acquisition system receives the readings from the instruments and then stores and transmits the data via communication or data storage peripherals. The data acquisition system used in this project is a CR1000 datalogger from Campbell Scientific Inc. (Figure 3-11). It is designed for standalone operation in harsh, remote environments. The CR1000 is compatible with nearly every available sensor. In the field, solar panels are used to power the data acquisition system (Figure 3-12).

Figure 3-11. CR1000 Datalogger from Campbell Scientific Inc.

The datalogger is a reliable system. It is rugged so that it can sustain the extreme environmental conditions and be operational. It is also robust for complex configurations required by the current project. The CR1000's low power consumption allows it to operate for extended time periods on a battery charged with a solar panel, thus eliminating the need for AC power supply. This datalogger suspends execution when the primary voltage drops below 9.6 V, reducing the possibility of inaccurate measurements.

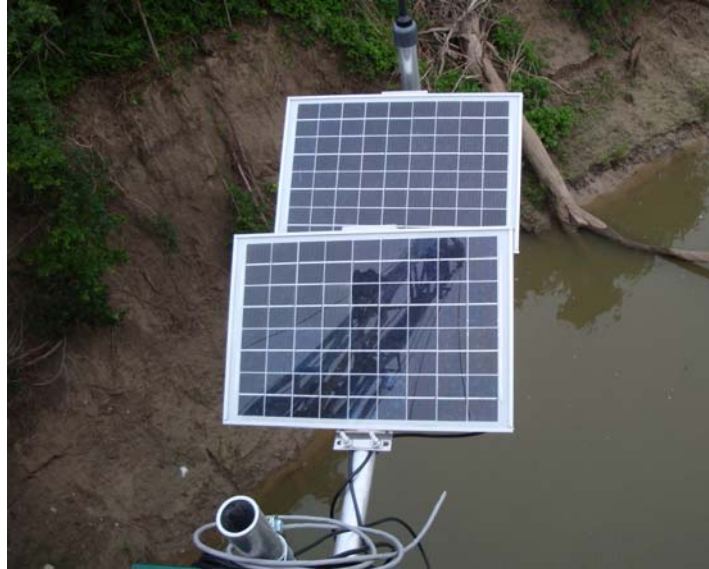
Figure 3-12. Solar Panel near the Data Acquisition System on the Bridge.

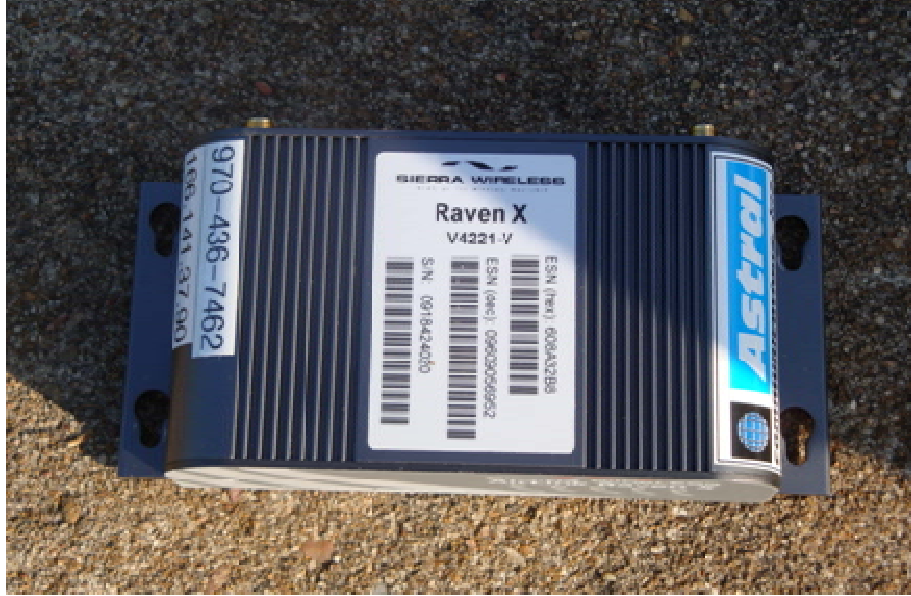
In the field, the system is equipped with a Raven X Airlink digital cellular data modem that is accessed through its IP address ([Figure 3-13](#)). Campbell Scientific LoggerNet software provides the required interface to communicate with the system to download the sensor data.

Figure 3-13. Raven X Airlink Cellular Modem.

Product manufacturer:	Campbell Scientific Inc.
Band:	800 MHz Cellular, 1900 MHz PCS
Transmit Power:	200 mW max
RS-232 Data Rates:	1200 bps to 230.4 kbps
Input Voltage:	9 to 28 Vdc
Input Current:	85 to 270 mA
Operating Temperature Range:	-30°C to +70°C (-22°F to +158°F) (10% duty cycle limit above 60°C (140°F))
Operating Humidity:	5% to 95% non-condensing

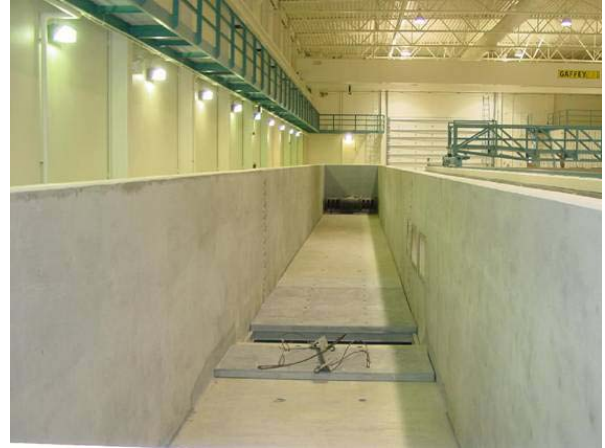
The experiments were performed at the Haynes Coastal Engineering Laboratory, which houses one of the largest and most modern flumes as well as a towing tank and a three-dimensional wave basin. The towing tank has dimensions of 45 m (150 ft) long, 3.6 m (12 ft) wide, and 3.3 m (11 ft) deep with a designed flow rate of $2.2 \text{ m}^3/\text{s}$ (35,000 gallon per minute). In the towing tank, there is a sediment pit that is 9 m (30 ft) long, 3.6 m (12 ft) wide, and 1.5 m (5 ft) deep. It is located about two thirds of the way down the tank from the flow inlet end to allow scour studies. The pit can be open or closed by steel plates. A carriage on the top of the flume is used to mount instruments and setup experiments. The carriage is controlled by a computer so the position and speed can be precisely controlled. Figure 4-1 shows the schematic of the towing tank. Figure 4-2 shows the tank and the carriage.

Figure 4-2. Haynes Coastal Engineering Laboratory: (a) the Carriage and (b) View of the Tank.

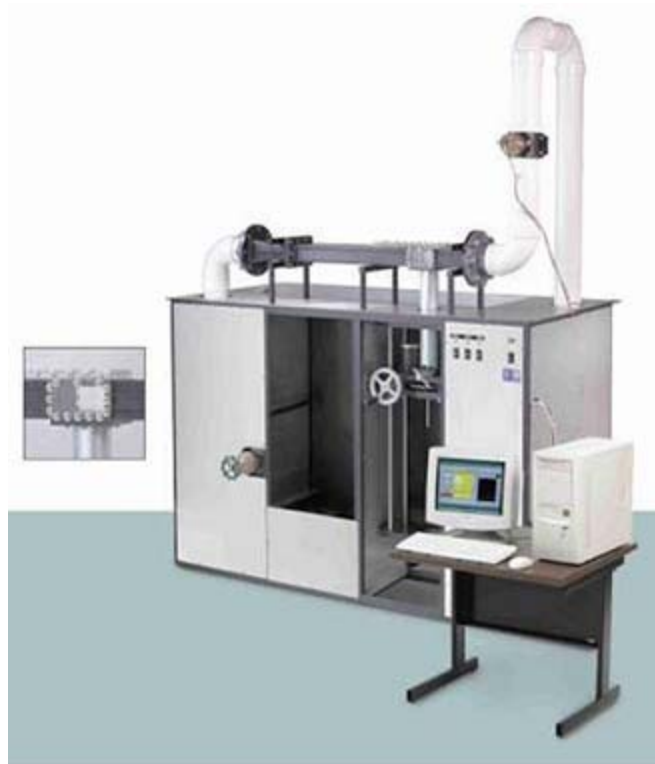
The Erosion Function Apparatus (EFA) was designed by Dr. Jean-Louis Briaud to estimate the erodibility of soil. [Figure 4-8](#) shows a picture of the EFA. EFA test results for the

Figure 4-8. Erosion Function Apparatus.

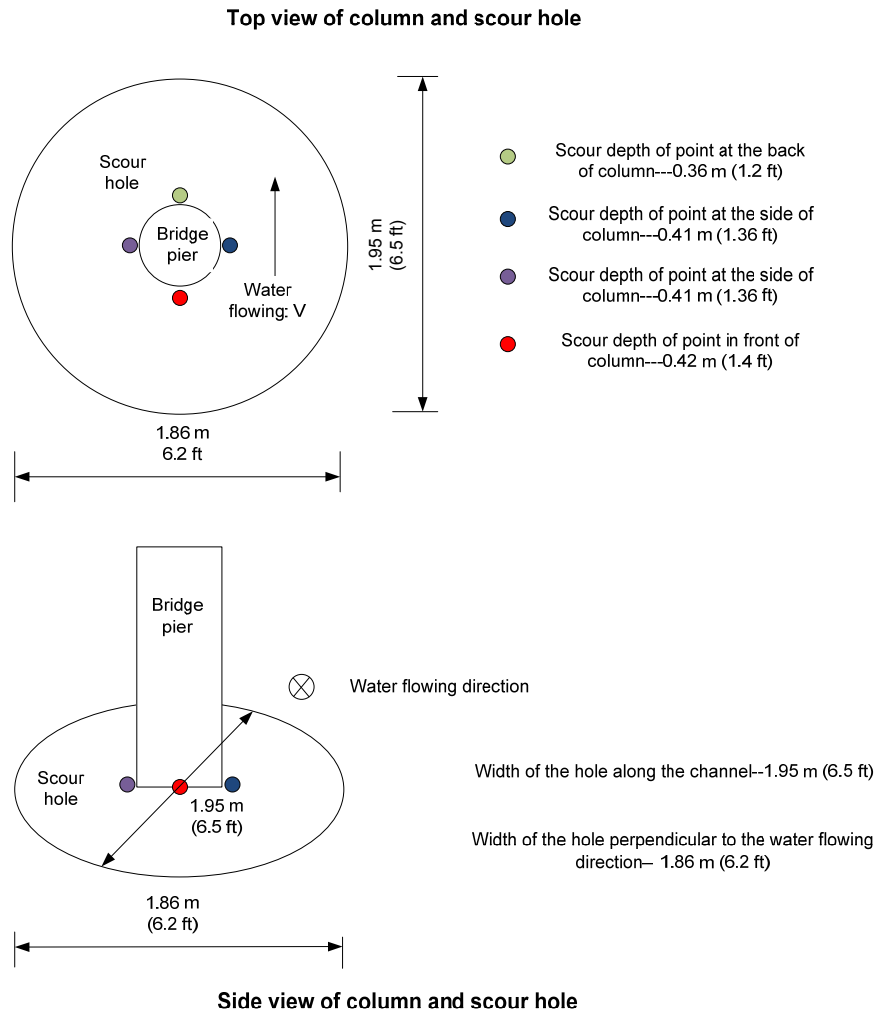
Figure 4-16. Schematic of the Scour Hole.

The data were continuously collected for the entire duration of the experiment. As the water velocity reached 0.6 m/s (2 ft/s), the column began to settle due to the scour, undermining the foundation. The final depth of the scour hole was about 0.42 m (1.4 ft). It had a conical shape with a top diameter of 1.91 m (6.35 ft). The depth of the hole was measured at four points and the width of the hole in two directions. Figure 4-16 shows the schematic of the measured scour hole after the completion of the experiment.

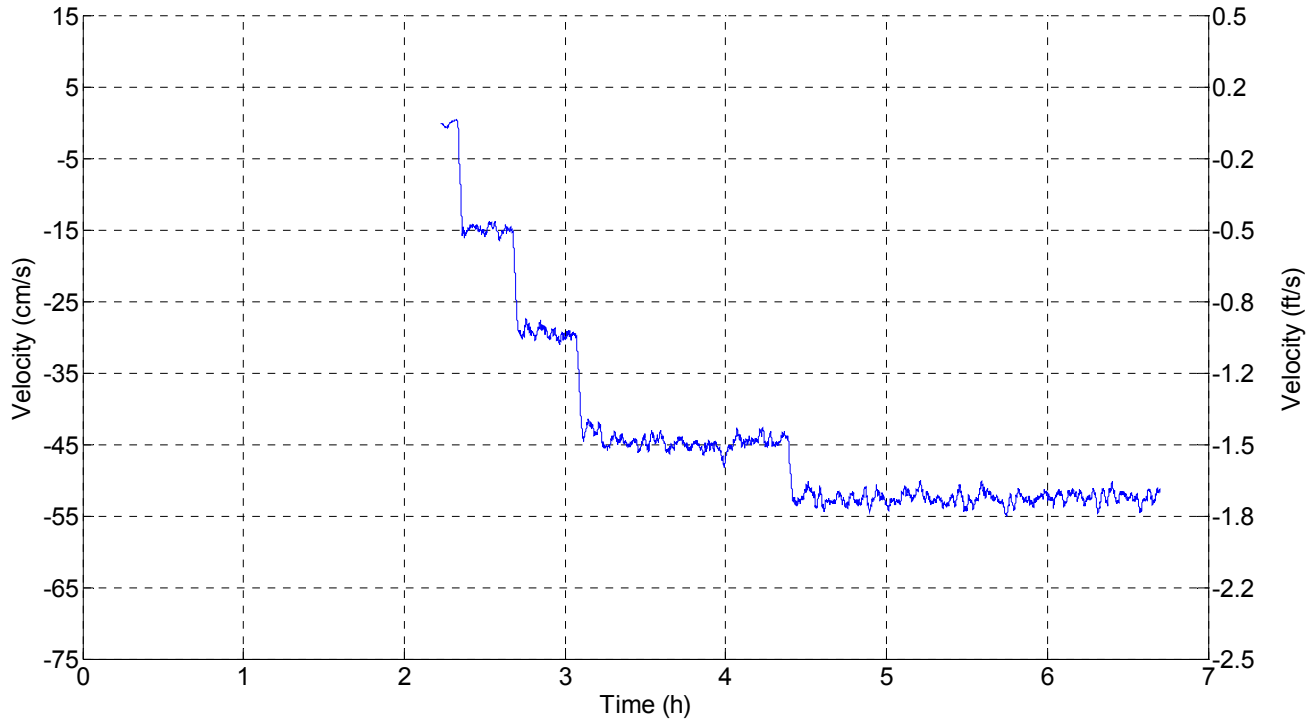
Figure 4-26. Response Time History of ADV.

The ADV was installed in the upstream side of the flume to measure the water velocity during the experiment. [Figure 4-26](#) shows the time history of the water velocity. The gap in data from 0 hour to 2.2 h is due to the fact that the water was given a velocity after 2.2 h when a hydrostatic condition was reached in the flume. Based on the analysis of the data obtained from the instruments it is inferred that the scour hole started to develop when the water velocity was 0.45 m/s (1.5 ft/s) in the experiment, and it reached the bottom of column when the water velocity was 0.60 m/s (2 ft/s). The water velocity data are used for the prediction of the scour hole by performing SRICOS-EFA simulation.

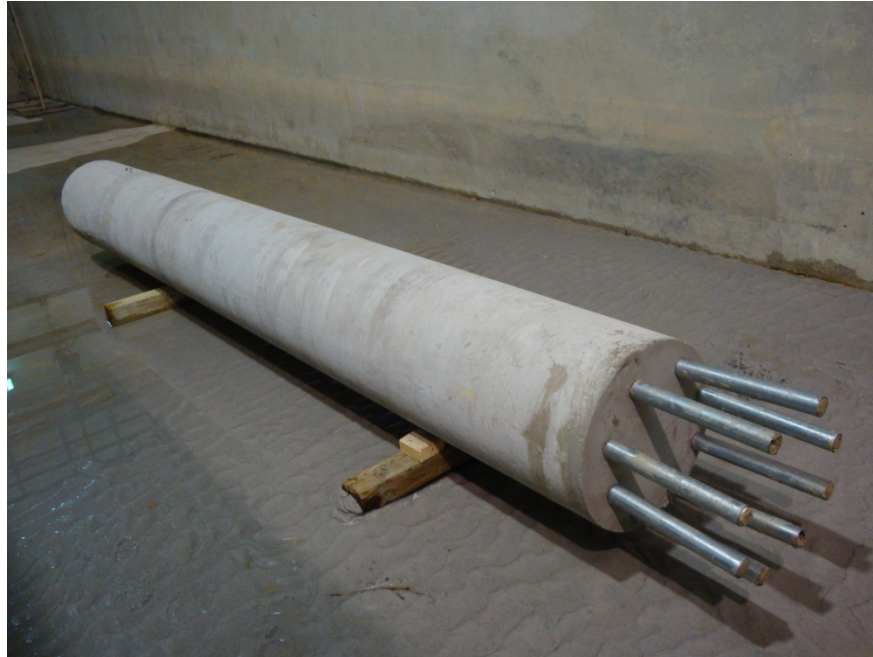
In the second experiment, the column was reconstructed to form a pile foundation. The concrete column was cut from the bottom to a length of 0.3 m (1 ft) thereby exposing the steel bars inside. The exposed steel bars were 0.19 m (7.5 inches) long. There were eight steel bars with a diameter of 1.6 cm (5/8 inch). Four of the bars were single and the other four bars were in groups of two. To model a pile foundation effectively, 0.3 m (1 ft) long PVC pipes and steel pipes were wrapped around the existing bars. For each single bar, a 1.9 cm (0.75 inch) diameter PVC pipe and a 2.54 cm (1 inch) diameter PVC pipe was used to wrap the bar layer by layer. After that, a 3.81 cm (1.5 inches) diameter steel pipe was used to wrap the 2.54 cm (1 inch) diameter PVC pipe. For each bar in the group, a 3.81 cm (1.5 inches) diameter steel pipe was used to wrap the steel bars. After that, glue was injected into the steel pipes to stabilize the foundation. Finally the column had a length of 3.68 m (12.1 ft) for the concrete part and 0.3 m (1 ft) long for the pile part. [Figure 4-28](#) shows the schematic of the pile foundation, and [Figure 4-29](#) shows the remolded pile foundation.

Figure 4-29. Column with Pile Foundation.

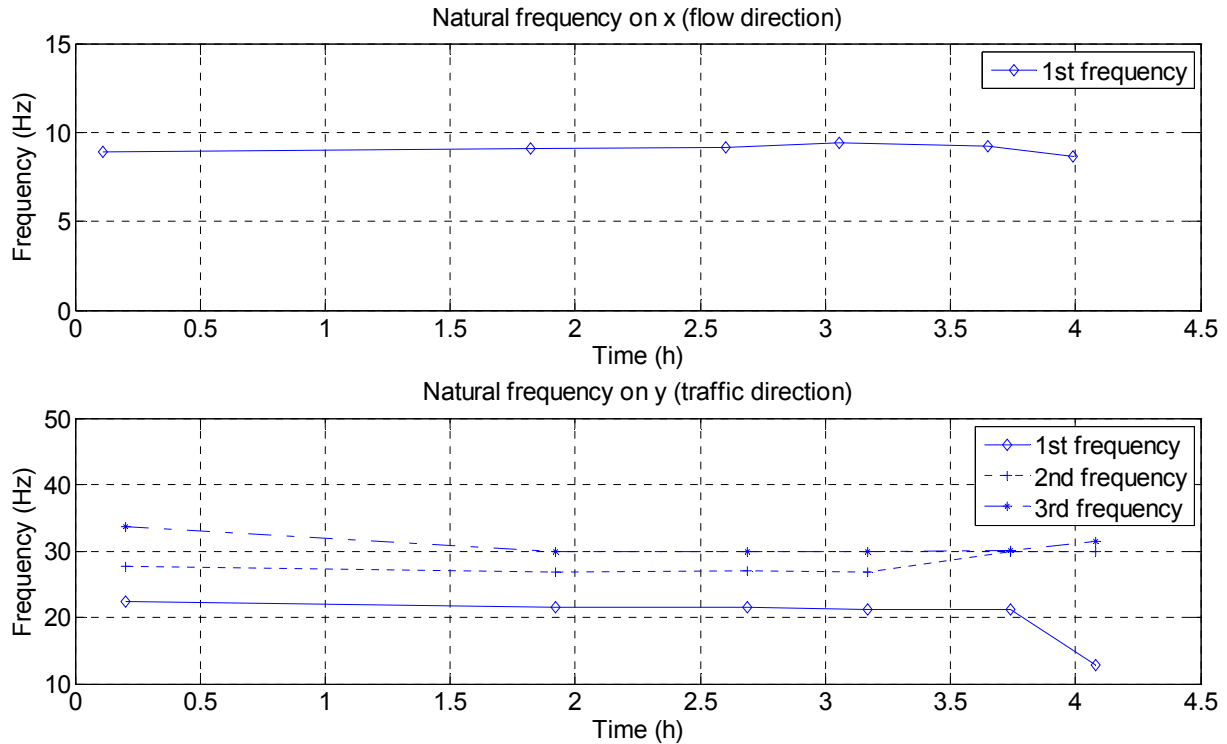
Figure 4-36. Time History of Frequency in Two Directions.

the experiment. Figure 4-36 shows the time history plot of the natural frequencies in two directions (flow and traffic). Figure 4-36 indicates that the natural frequencies remained steady until the column settled and rotated after 3.75 h. Unfortunately, due to sudden failure of the model bridge with the deep foundation, no data can be collected during the later part of the experiment.

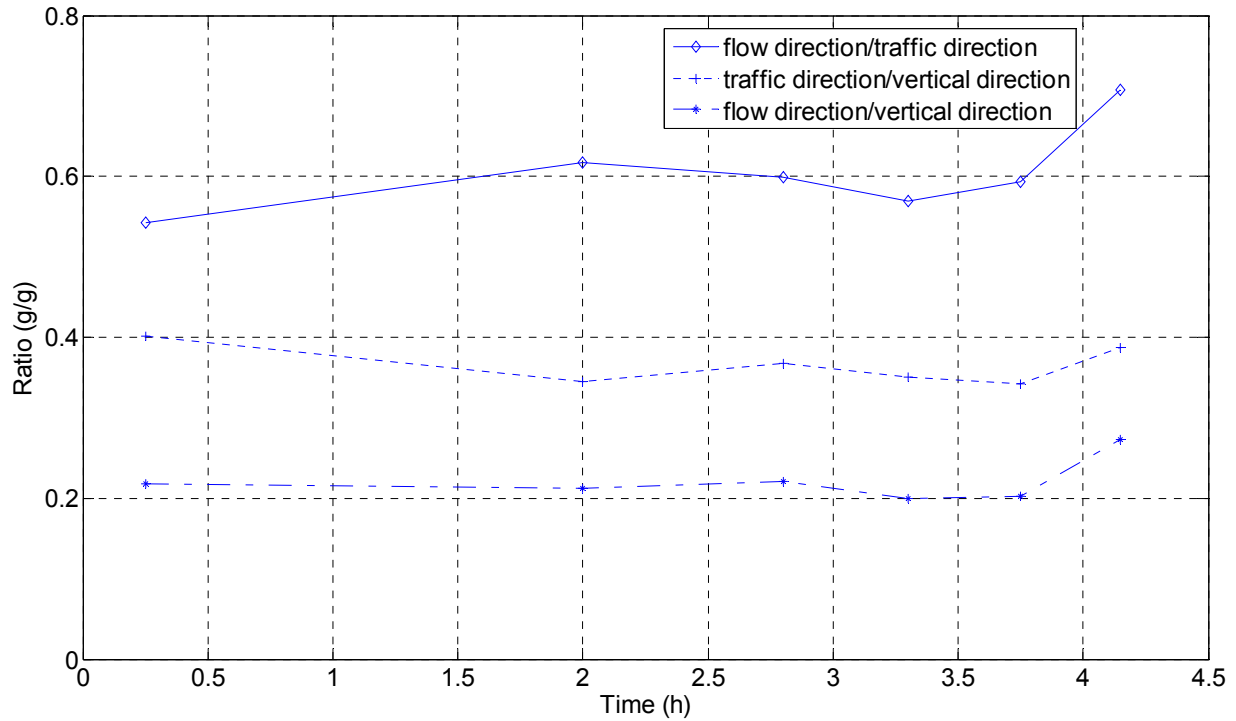
Figure 4-37. Time History of Ratio of RMS.

Similar to the analysis performed in the shallow foundation experiment, the ratio of RMS of acceleration analysis approach is followed for the deep foundation experiment. The time history of accelerations obtained during the experiment is divided into 12 time intervals as before. Here, the combined impact test in each time interval is taken into account as a whole. The RMS value is sensitive to the duration of impact test taken to perform the analysis, so only six periods of impact tests are chosen to do the RMS analysis. The time history of the ratio of RMS in two directions for the entire duration of the experiment is plotted in Figure 4-37, which shows a clear change in the ratio of RMS after 3.75 h, when the scour hole reached the bottom of the column and the column started to settle and rock. This trend is similar to that obtained by the FFT analysis.

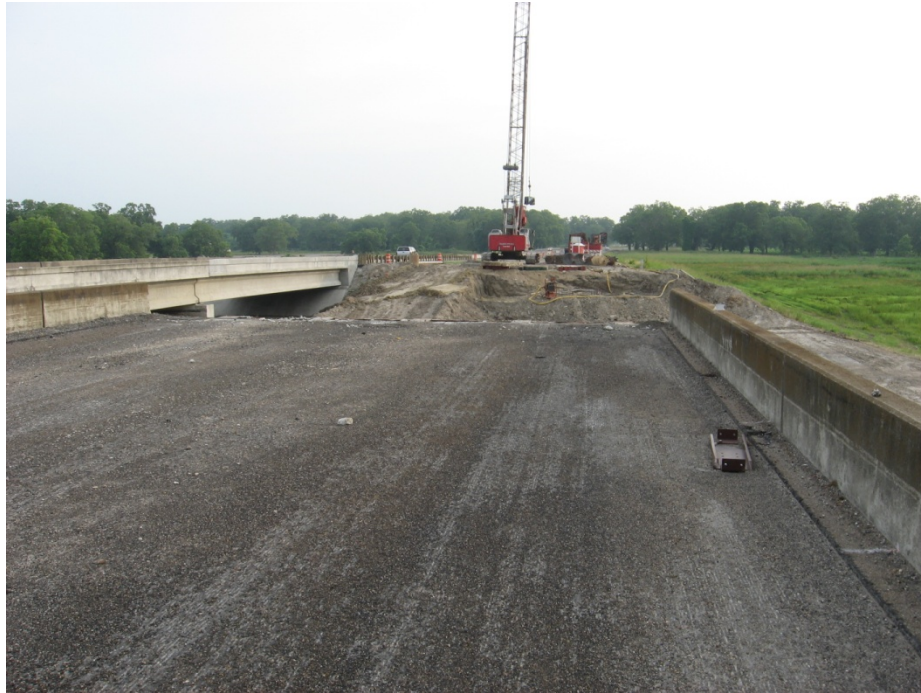
The existing bridge is originally a three span pre-cast multiple beam structure built in 1967. In October 1998, the northbound bridge was lengthened by one span to the west as a protective measure after the record flood that year. In 2001, both northbound and southbound bridges were lengthened to the east by two spans as the river channel continued eroding in that direction. Currently, TxDOT is constructing the extension for both eastern and western sides on the southbound bridge ([Figure 5-4](#)).

Figure 5-4. Construction on the Extension of the Southbound Lane of US59 over Guadalupe River Bridge.

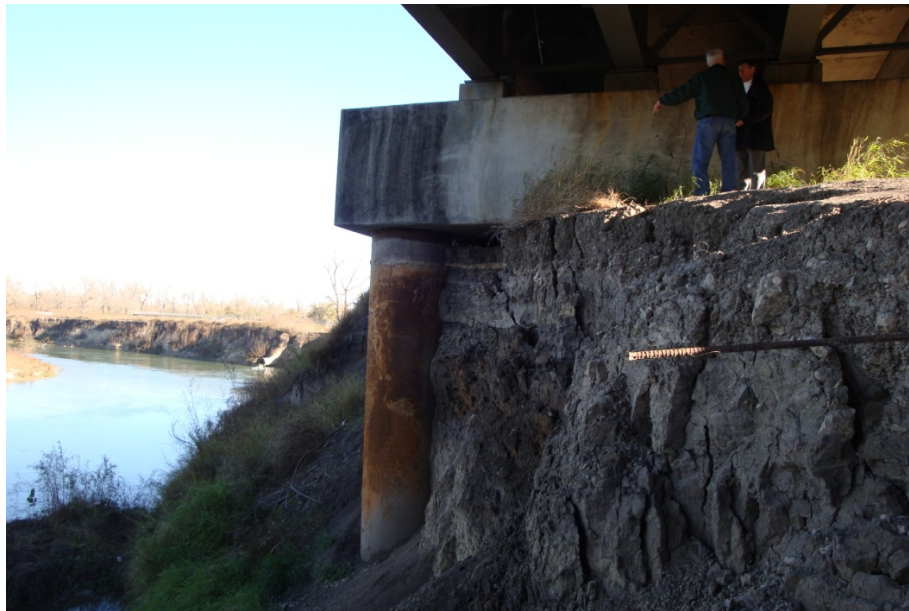
Due to the flood issue in Texas, the bridge is experiencing severe scour problem on both northeast side (SB0) and southwest side (SB3) of the river bank. This is seen in [Figures 5-5](#) and [Figure 5-6](#). On the northeast side of the bridge, the drill shaft was exposed in the 1998 flood. [Figure 5-5](#) shows the status of the drill shaft in 2009. [Figure 5-6](#) shows the drill shaft in 2010. From [Figure 5-6](#), we concluded that the soil around the top of drill shaft has been flushed away during floods.

Figure 5-5. Drill Shaft on Northeast Side (SB0) of US59 over Guadalupe River Bridge in 2009.

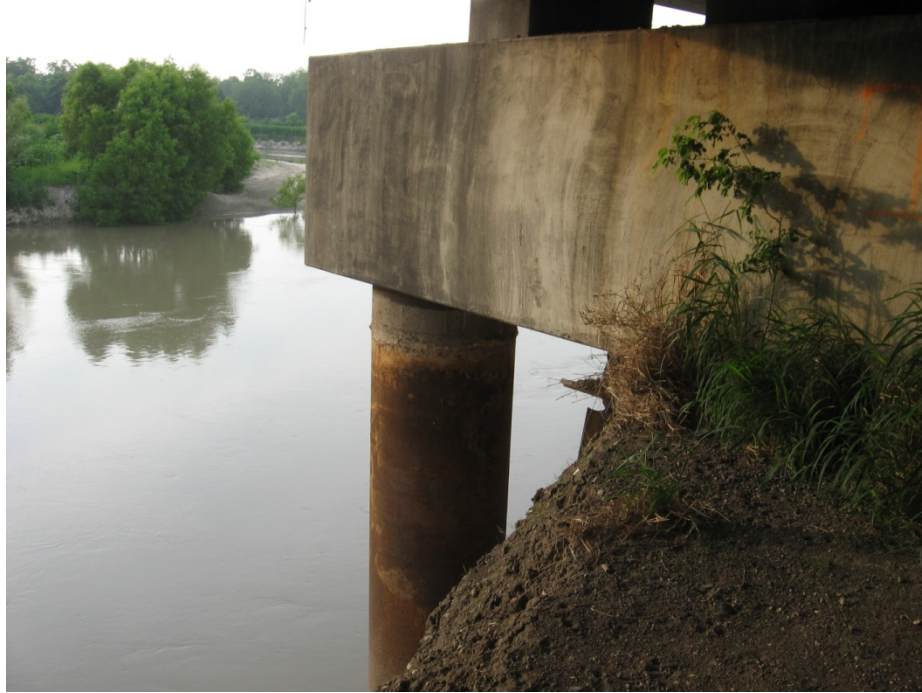
Figure 5-6. Drill Shaft on Northeast Side (SB0) of US59 over Guadalupe River Bridge in 2010.

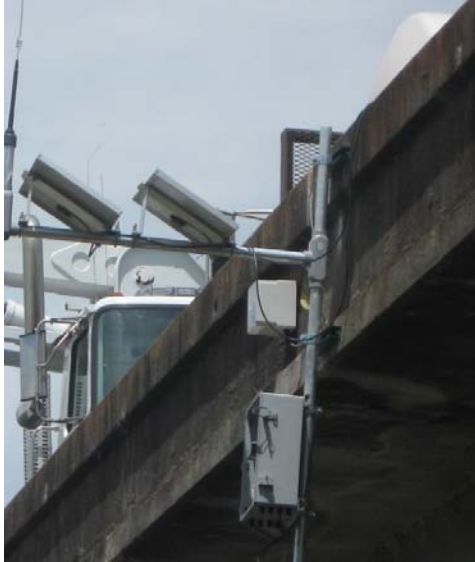
A dual-axis tiltmeter was bolted and glued to the bridge deck level at a distance of 0.5 m (1.7 ft) horizontally away from master station to measure the tilt angle of the deck around both the flow direction axis and the traffic direction axis. One single-axis tiltmeter, which measures the tilt angle of the deck around the flow direction axis (perpendicular to the traffic direction), was mounted in the back of the enclosure. The output is positive when the sensor is rotated clockwise (when facing the sensor). The other single-axis tiltmeter, which measures the tilt angle of the deck around the traffic direction axis, was mounted on the right side perpendicular to previously mentioned one (when facing the enclosure). The output is positive when the sensor is rotated clockwise. The wires of the tiltmeter were connected to the master station. [Figure 5-9](#) shows the installed dual-axis tiltmeter.

Figure 5-9. Installed Dual-Axis Tiltmeter.

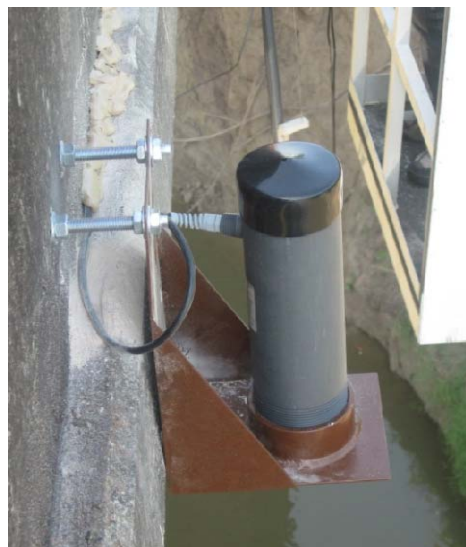
The water stage sensor was mounted in a bracket to the parapet of the bridge at the height of deck bottom. It measures the water surface elevation at the US59 over Guadalupe River Bridge. It is about 2.1 m (7 ft) horizontally away from the dual-axis tiltmeter. The bracket was fixed on the bridge deck by four bolts. The wires of the stage sensor were connected to the master station after installation. [Figure 5-10](#) shows the installed water stage sensor.

Figure 5-10. Installed Water Stage Sensor.

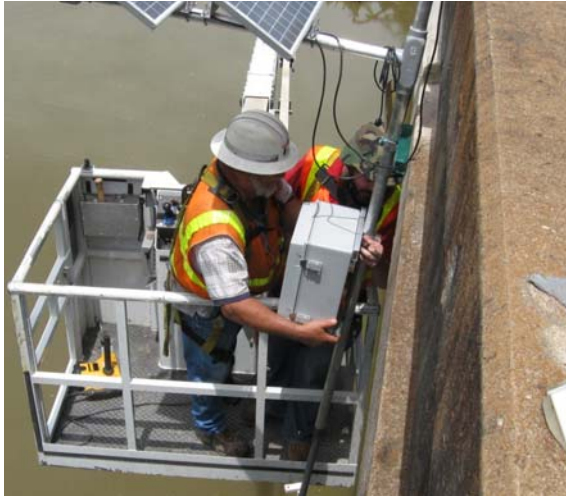
The master station was mounted on the same fixture as the solar panel. Two solar panels were installed near the master station to provide the power. One more solar panel was installed near the accelerometer on top of Pier SB1 to provide power. [Figure 5-11](#) to [Figure 5-12](#) shows the master station and solar panel installation.

Figure 5-11. Mount the Master Station.

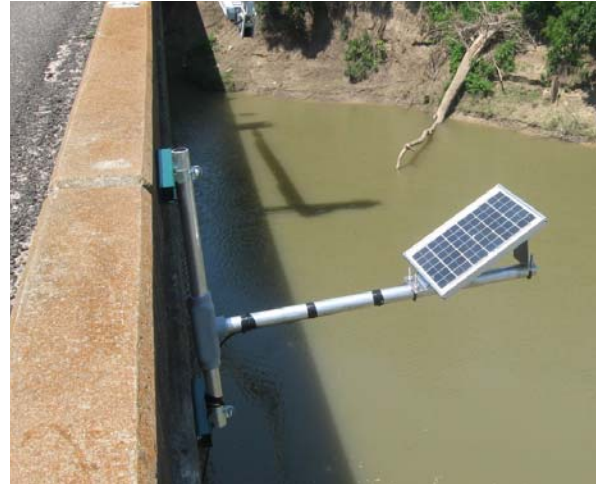
Figure 5-12. Solar Panel on the Pier SB1.

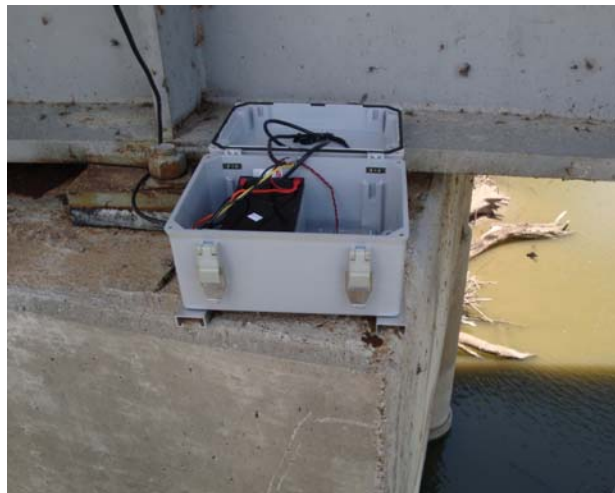
Two accelerometers were installed on the top of two in-river-piers in the initial monitoring system. The hardwired accelerometer was fixed on top of Pier SB2. The wireless accelerometer was fixed on top of Pier SB1 ([Figure 5-13](#)).

Figure 5-13. Wireless Accelerometer on Top of Pier SB1.

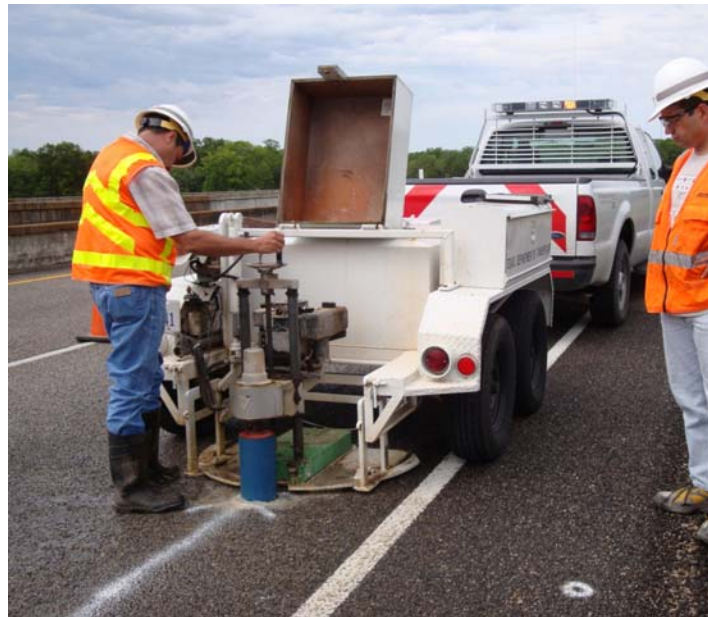
The float-out devices used in field are 0.6 m (2 ft) in length and 8.9 cm (3.5 inches) in diameter. To install the two float-out devices, one hole was cored through the bridge deck. The hole was about at a distance of 2.4 m (8 ft) away from the edge of the deck parapet and 2.85 m (9.5 ft) away from the center of Pier SB2. The TxDOT inspection team cored the hole through the deck. [Figure 5-14](#) shows the installation process.

Figure 5-14. Drill the Hole through the Deck.

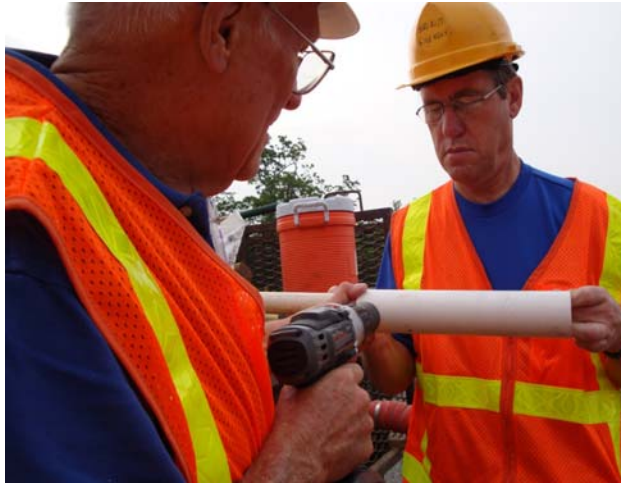
In order to ensure that the float-out devices are installed at the right position, a rebuilt PVC pipe was used as an extension of the device. [Figure 5-15](#) to [Figure 5-18](#) show the process of installation of float-out device.

Figure 5-15. PVC Pipe as an Extension of Float-Out Device.

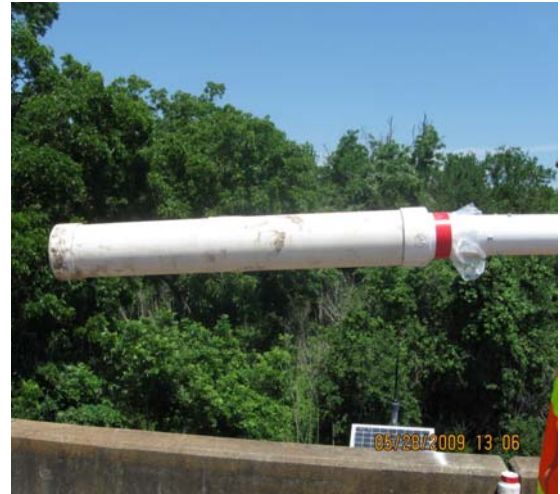
Figure 5-16. Float-Out Device.

After the final installation, one of the float-out devices (Float-out1) was buried 1.5 m (5 ft) below the surface of the soil at a distance of 16.2 m (54 ft) from the top of the deck. The other float-out device (Float-out2) was buried at a distance of 2.7 m (9 ft) below Float-out1 and at a distance of 18.9 m (63 ft) from the top of the deck.

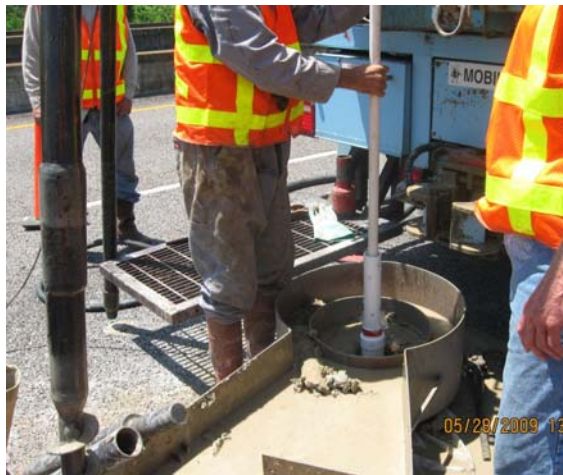
Figure 5-17. Lower the Float-Out Device.

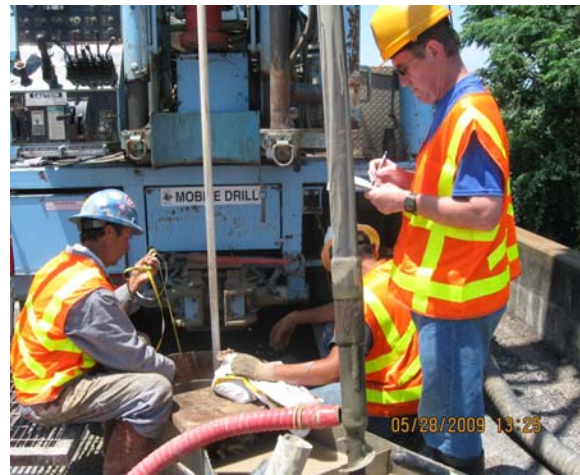
Figure 5-18. Refilling the Drilled Hole.

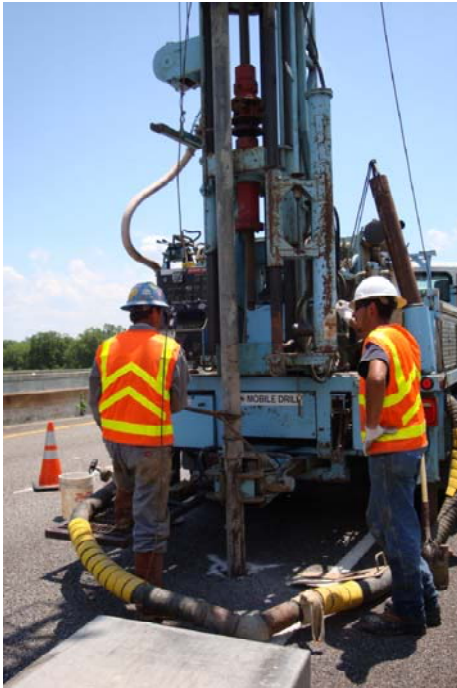
the deck first. Since the TBS is wired and thinner than the float-out device, it was easier to install than the float-out device. Three soil samples were obtained during this process. After the two TBS equipments were buried at the right position, the wire was connected to the master station. In order to protect the wire from vandalism and flood dragging force, a PVC pipe was used in this process. [Figure 5-19](#) to [Figure 5-23](#) shows the installation process of the TBS equipments.

Figure 5-19. Installation of TBS.

Two TBS equipments were buried in the soil near Pier SB3. TBS1 was buried 1.5 m (5 ft) below the ground surface near the southwest abutment at a distance of 7.2 m (24 ft) from the top of the deck. TBS2 was buried 3 m (10 ft) below TBS1 at a distance of 10.2 m (34 ft) from the top of the deck. Similar to the installation of the float-out devices, one hole was cored through

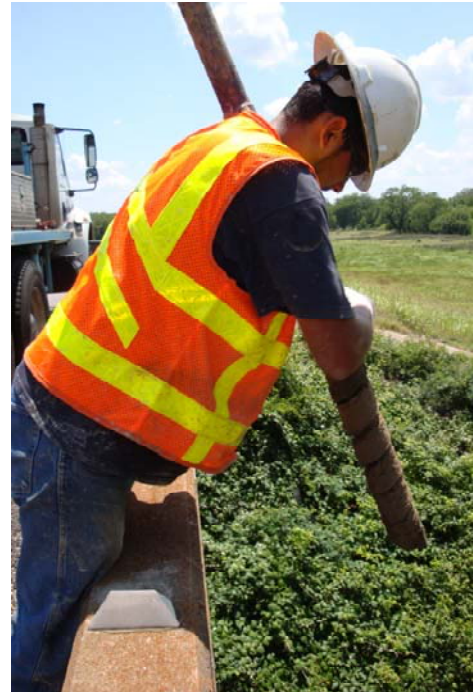
Figure 5-20. Remove Soil from the Drill Bit.

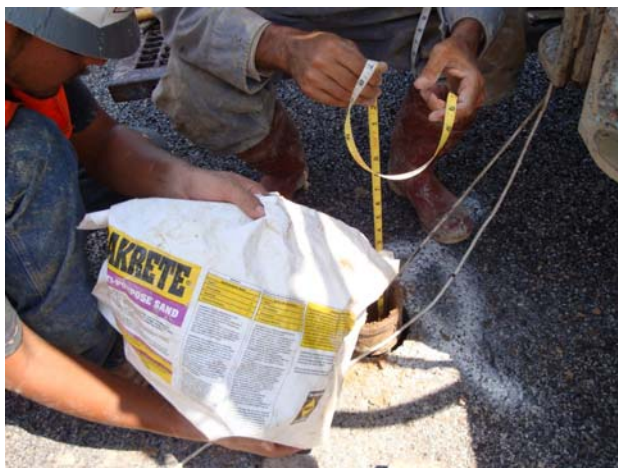
Figure 5-21. Fill the Hole.

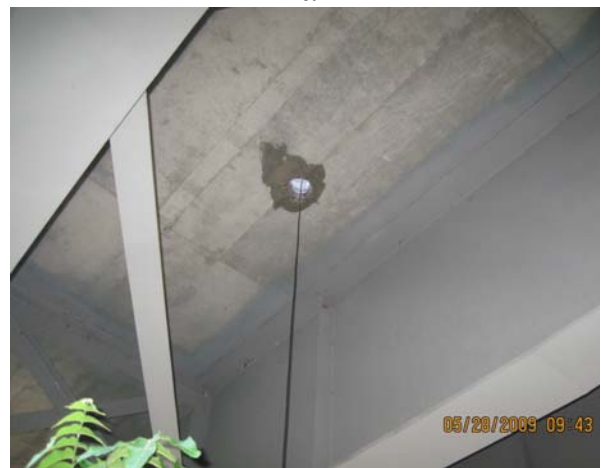
Figure 5-22. Installed TBS.

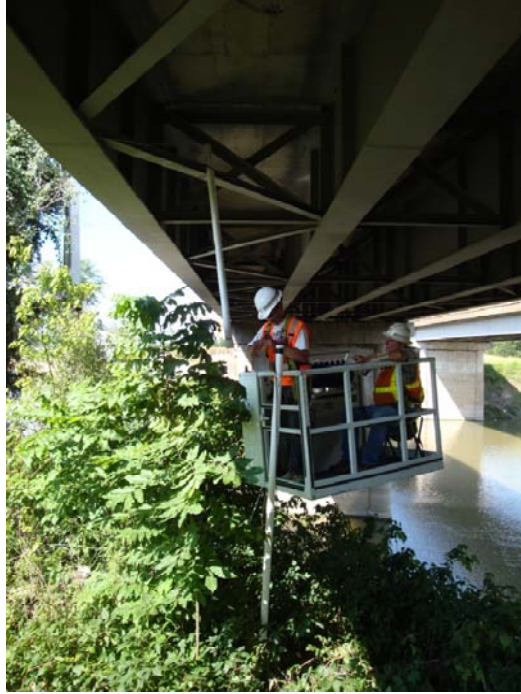
Figure 5-23. Wire the TBS to Master Station.

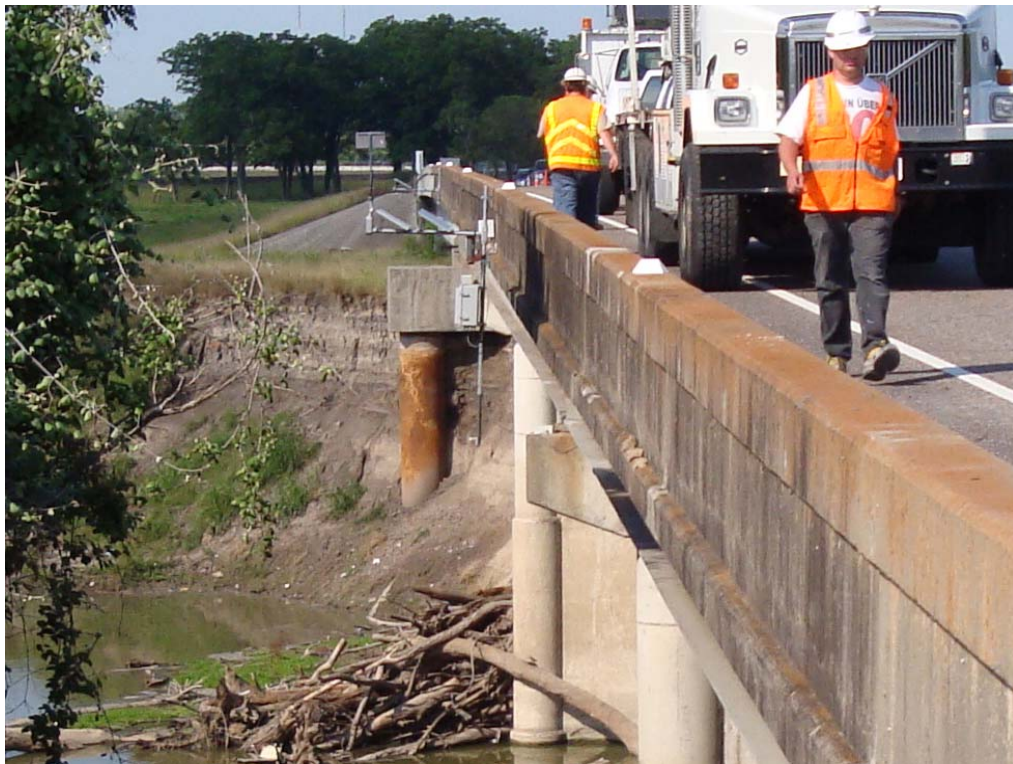
Figure 5-24 shows the initial installation of the bridge scour monitoring system.

Figure 5-24. Initial Bridge Scour Monitoring System.

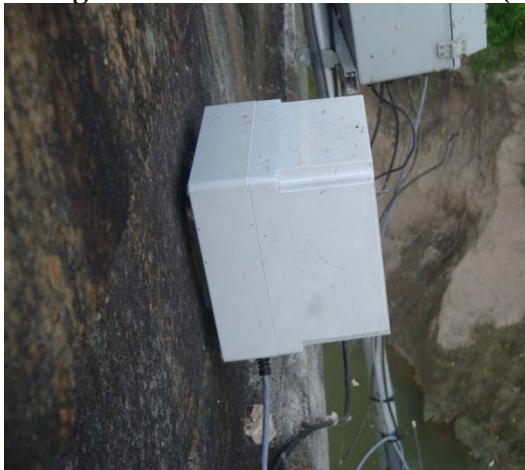
The two accelerometers were removed. One dual-axis tiltmeter was installed on top of Pier SB2 to measure simultaneously the tilt angle of the bridge pier around the flow direction axis and the traffic direction axis (perpendicular to the flow direction). The single-axis tiltmeter, which was located at the back of the enclosure on the deck remained at the same place, measured the tilt angle of the deck around the flow direction axis (perpendicular to the traffic direction). The other single-axis tiltmeter in the same enclosure was removed and installed at the back of another enclosure approximately at a distance of 47 m (154.3 ft) from the previous location. It is measuring of the tilt angle of the deck around the flow direction axis (perpendicular to the traffic direction). All tiltmeters were wired to the datalogger CR1000. The water stage sensor, float-out devices, and TBS equipments remained at the previous location. [Figure 5-25](#) to [Figure 5-27](#) show the new installed tiltmeters on the bridge.

Figure 5-26. Single-Axis Tiltmeter (Tiltmeter1) on the Deck (Near Pier SB2).

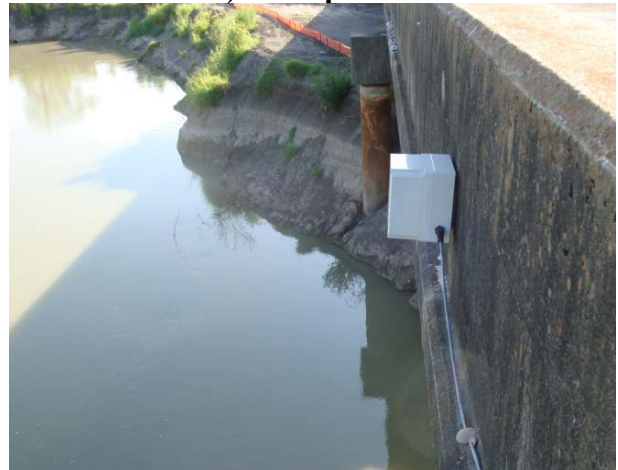
Figure 5-27. Single-Axis Tiltmeter (Tiltmeter2) on the Deck (Near Pier SB1).

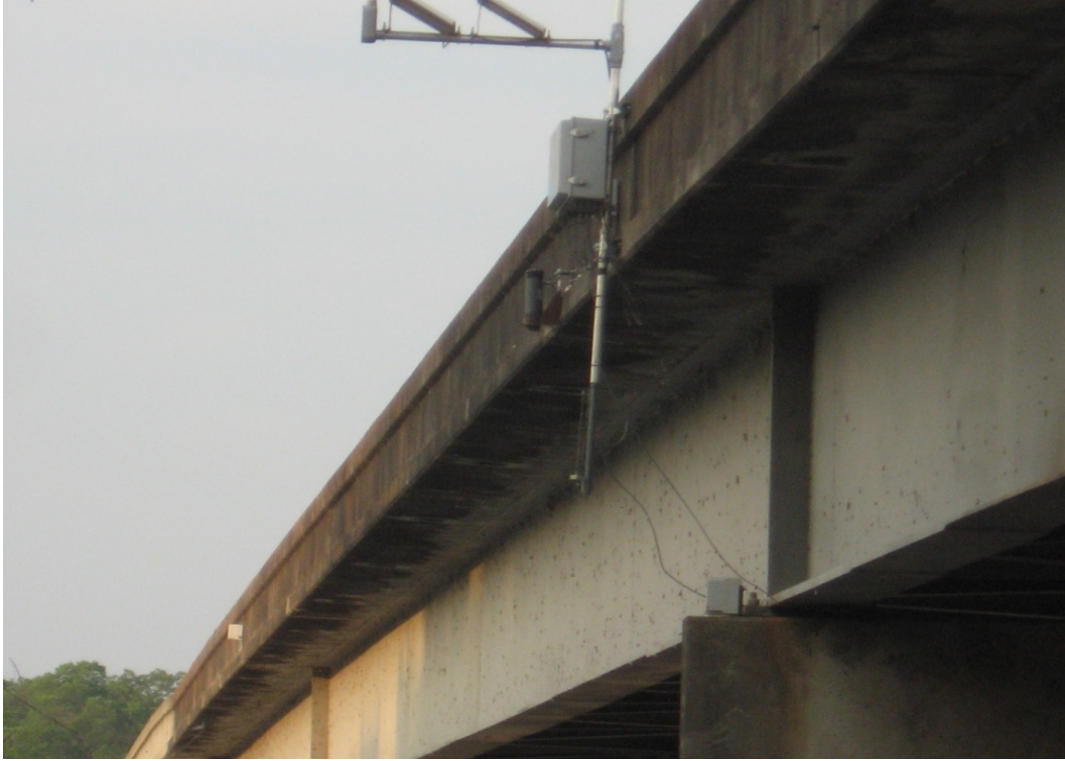
[Figure 5-28](#) and [Figure 5-29](#) show the modified bridge scour monitoring system installed on US59 over Guadalupe River Bridge.

Figure 5-28. Modified Bridge Scour Monitoring System.
