1. Report No. FHWA/TX-11/0-6060-1		2. Government Accession No.		3. Recipient's Catalog No.	
4. Title and Subtitle REALTIME MONITORING OF BRIDGE SCOUR USING REMOTE MONITORING TECHNOLOGY				5. Report Date October 2010 Published: February 2011

REALTIME MONITORING OF BRIDGE SCOUR USING REMOTE MONITORING TECHNOLOGY

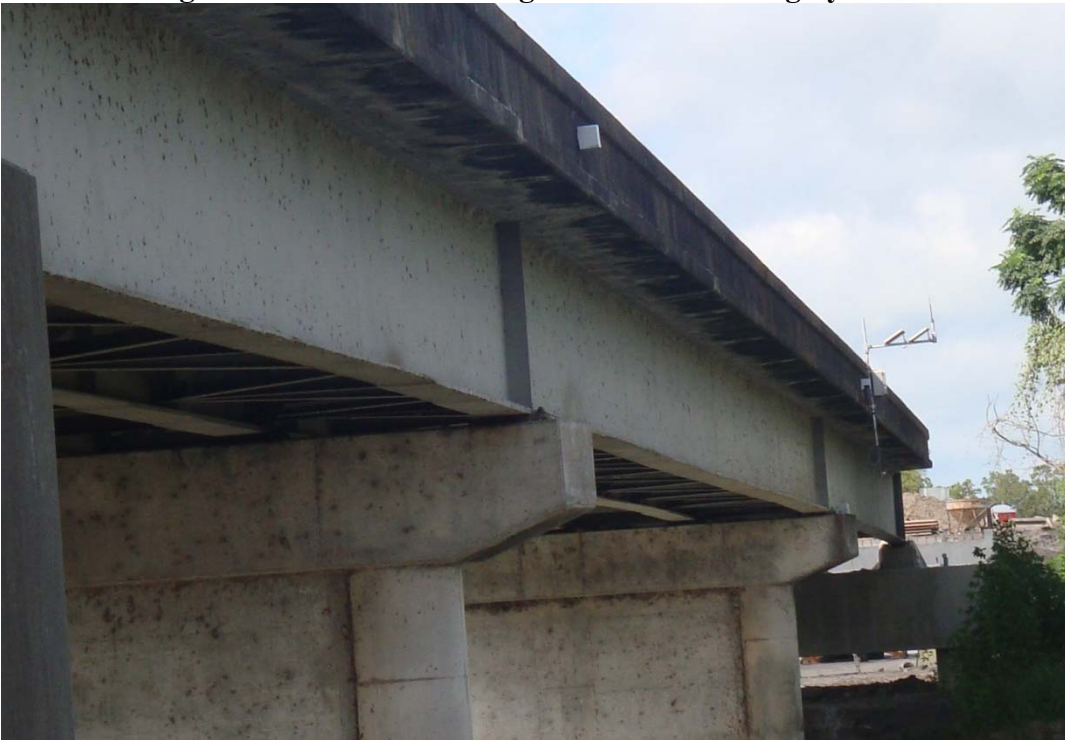
[Figure 5-28](#) and [Figure 5-29](#) show the modified bridge scour monitoring system installed on US59 over Guadalupe River Bridge.

Figure 5-29. Modified Bridge Scour Monitoring System.

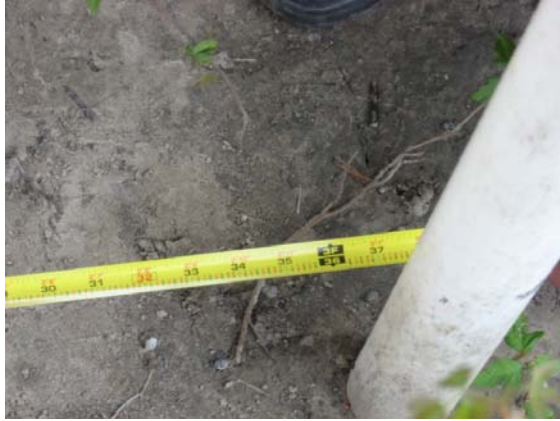
(a)

The site visits in March 2010 revealed the increased scour on the southwest side of the US59 over Guadalupe River Bridge at the location where TBS equipments were buried. In 2009, the TBS equipments were installed 2.4 m (8 ft) away from the edge of soil. In 2010 the TBS equipments were only 0.9 m (3 ft) away from the edge of soil (Figure 5-62).

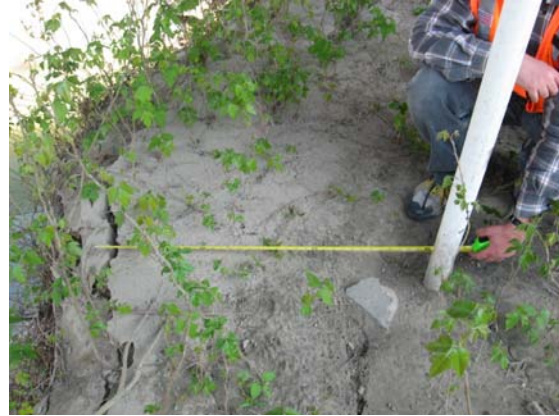
Figure 5-62. Scour Level at the Location of the TBS: (a) Tape Measure in Detail and (b) Tape Measure.

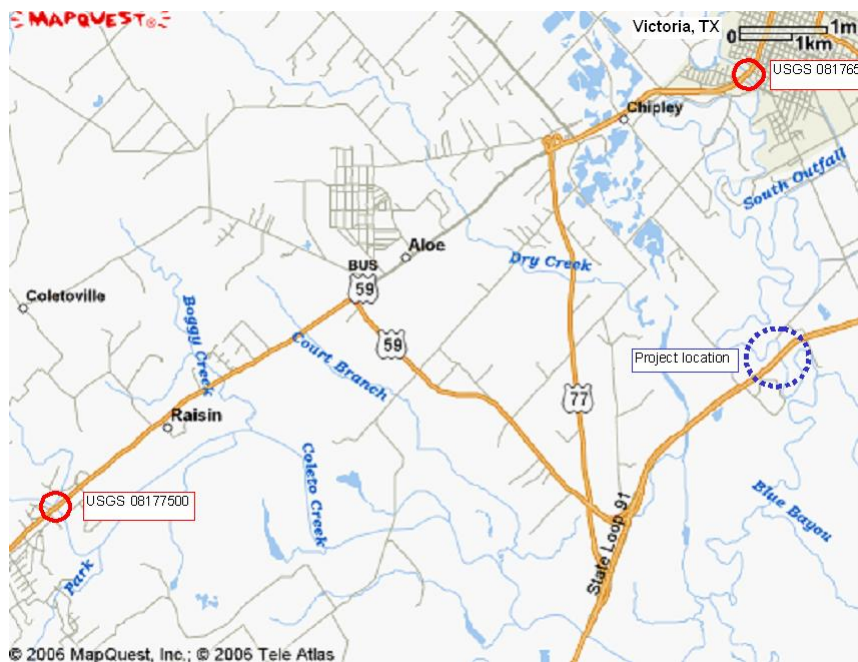
which is 8.74 m (29.15 ft) above the sea level NGVD 29. After doing the offset of the USGS gage reading, the water stage reading is compared with the gage reading. Figure 5-64 shows the description of measurement from water stage sensor. Figure 5-65 shows the location of project and USGS gages.

Figure 5-65. Location of USGS Gage Sensors.

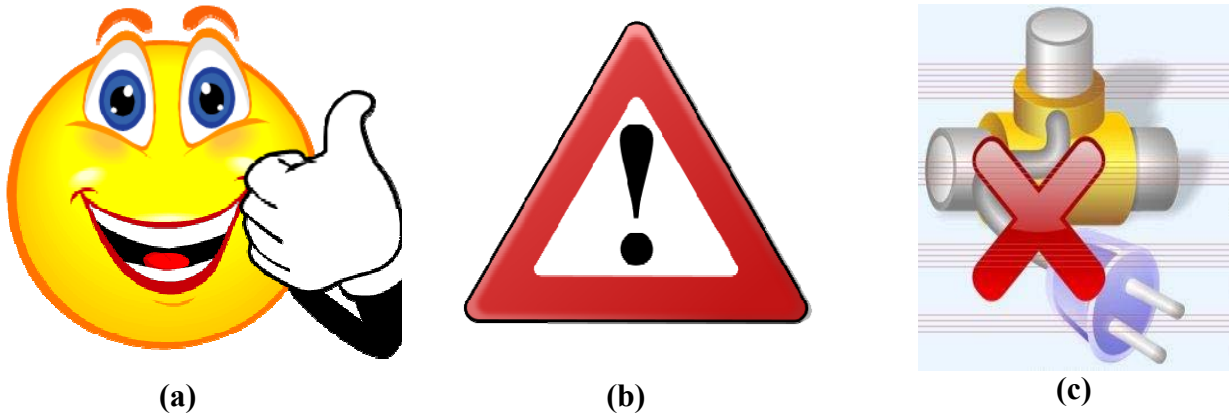
- If the float-out device is in the vertical position, and has not floated out, the plot will show a smiling face (Figure 5-82a).
 - If the float-out device has floated out, the plot will show a danger sign (Figure 5-82b).

- If the TBS is in the vertical position, and has not floated out, the plot will show a smiling face (Figure 5-82a).
 - If the TBS has floated out, the plot will show a danger sign (Figure 5-82b).

- If the wire of the switch is broken, the plot will show a disconnection logo (Figure 5-82c).
6. “Temperature” plot shows the temperature in the master station. The readings are taken every 20 minutes and are presented over a 20-hour period. The unit is °C.

Figure 5-82. Logos for Website: (a) Smiling Face, (b) Danger Sign, and (c) Disconnection.

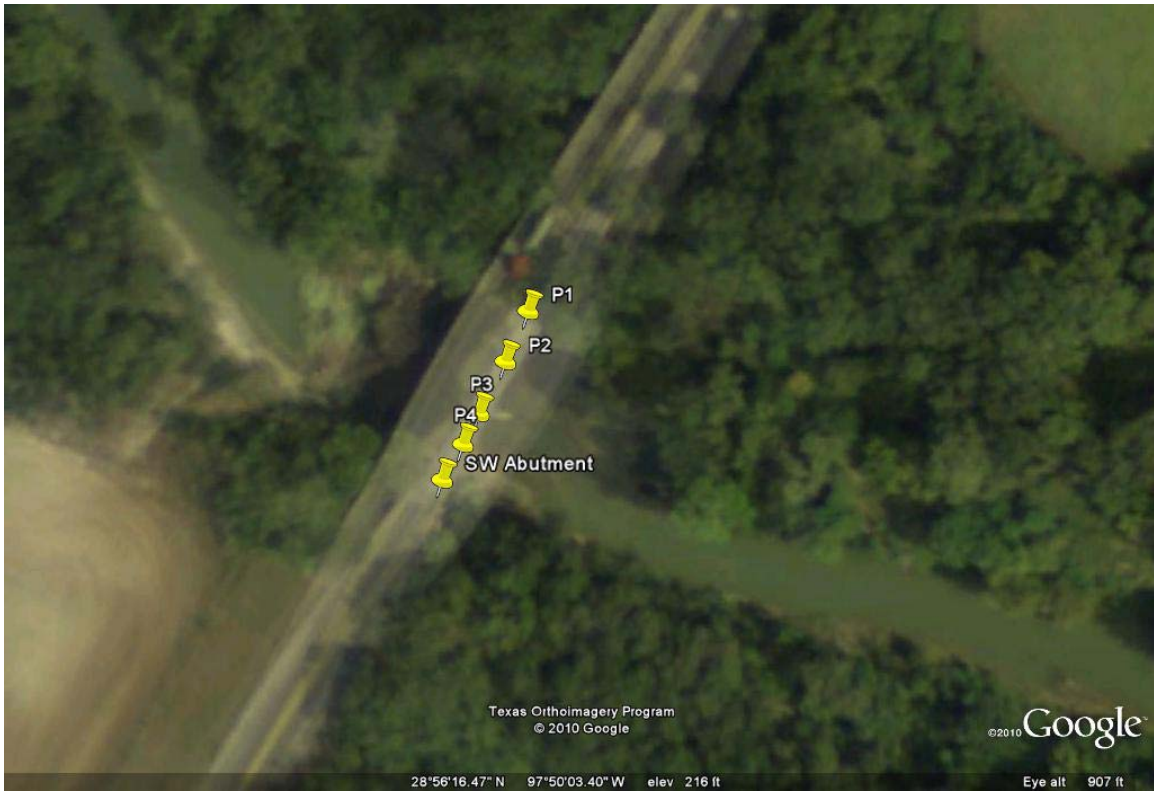
The bridge on SH80 crosses the San Antonio River northeast of the Karnes City, Texas. [Figure 6-1](#) and [Figure 6-2](#) show the general location of the bridge in Google Earth and Google Maps, respectively. In [Figure 6-1](#), P1 represents the compound web-wall in the northeast of the bridge. P2 represents the in-river-pier. P3 and P4 represent two compound web-walls in the southwest of the bridge. SW abutment is the southwest abutment of SH80 over San Antonio River Bridge.

Figure 6-1. Layout of the Bridge Displaying Naming Convention Used (from Google Earth).

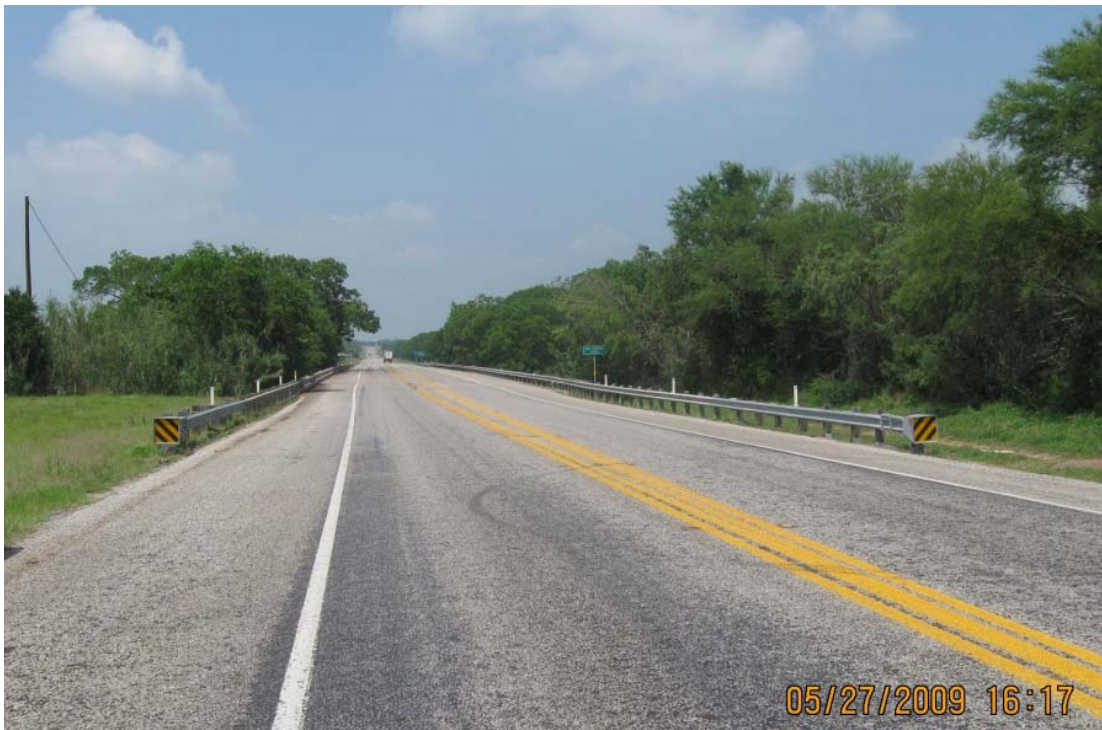
The bridge is a multi-span, 148 m (493 ft) long, two-lane bridge (Figure 6-3). The main bridge consists of three spans and is 63 m (207 ft 7 inches) long. It contains one in-river-pier (P2), which is a web-wall (Figure 6-4). The supporting structure of the main bridge is a compound web-wall of cylindrical and trapezoidal bridge bents (P1) (Figure 6-5). The supporting structure of the eastern line of the bridge consists of combination of cylindrical piers and square piers (Figure 6-6).

Figure 6-3. State Highway 80 over San Antonio River Bridge, Texas.

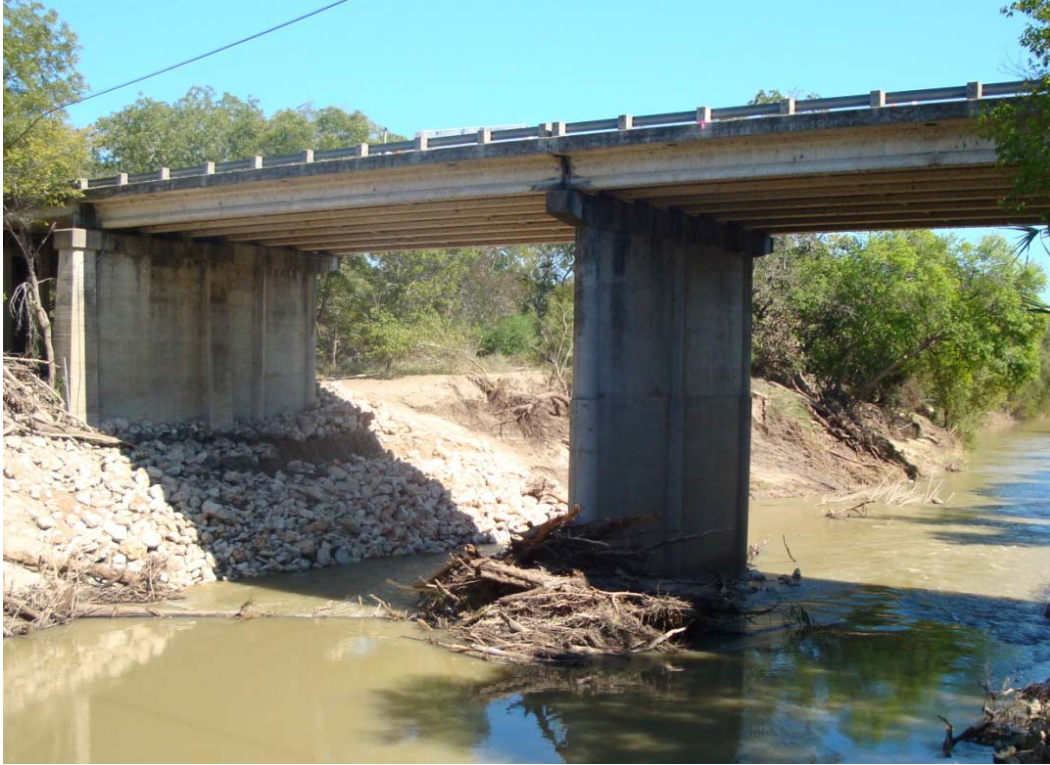
Figure 6-4. In-River Pier in the Form of Web-Wall (P2).

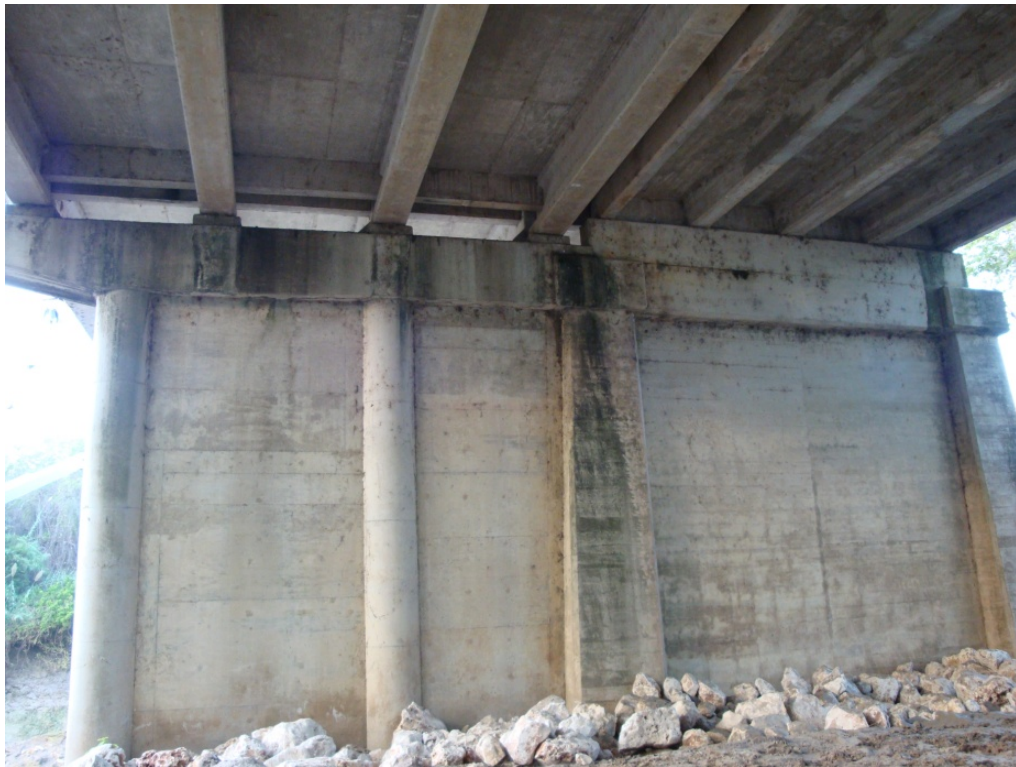
Figure 6-5. Compound Web-Wall on the Main Bridge Span (P1).

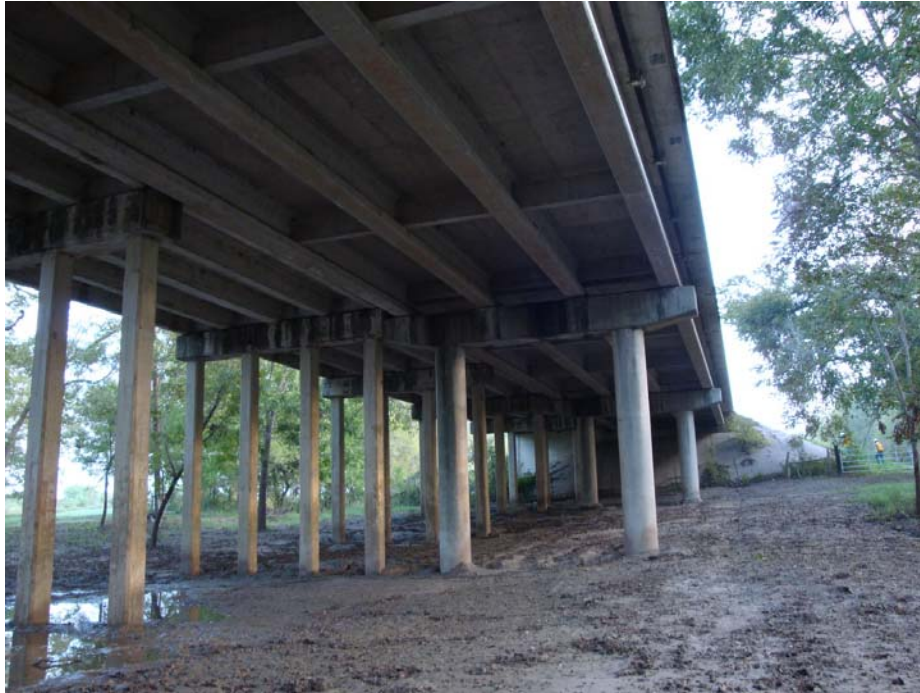
Figure 6-6. Eastern Line of the SH80 over San Antonio River Bridge.

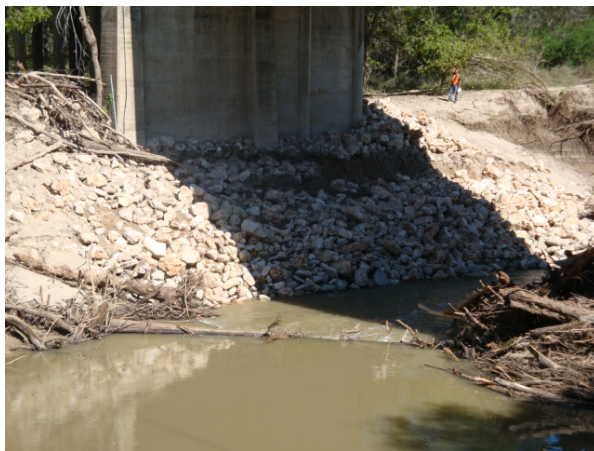
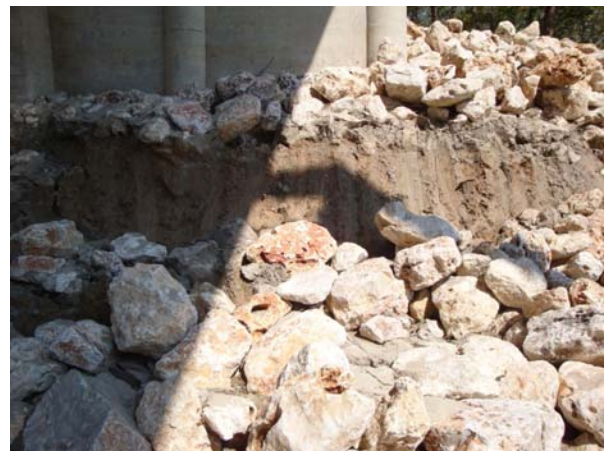
The soil beneath the bridge foundation has a large variation. Under the piers, there are two types of soil: clay and sand. [Figure 6-7](#) shows the riprap failure around Pier P1. This is the location where the TBS are buried. The soil sample was taken during the drilling process of the installation of TBS. Soil beneath the pier is silty clay (see [Figure 6-8](#)).

Figure 6-7. Rip Rap Failure near the Pier P1: (a) Zoom out View and (b) Zoom in View.

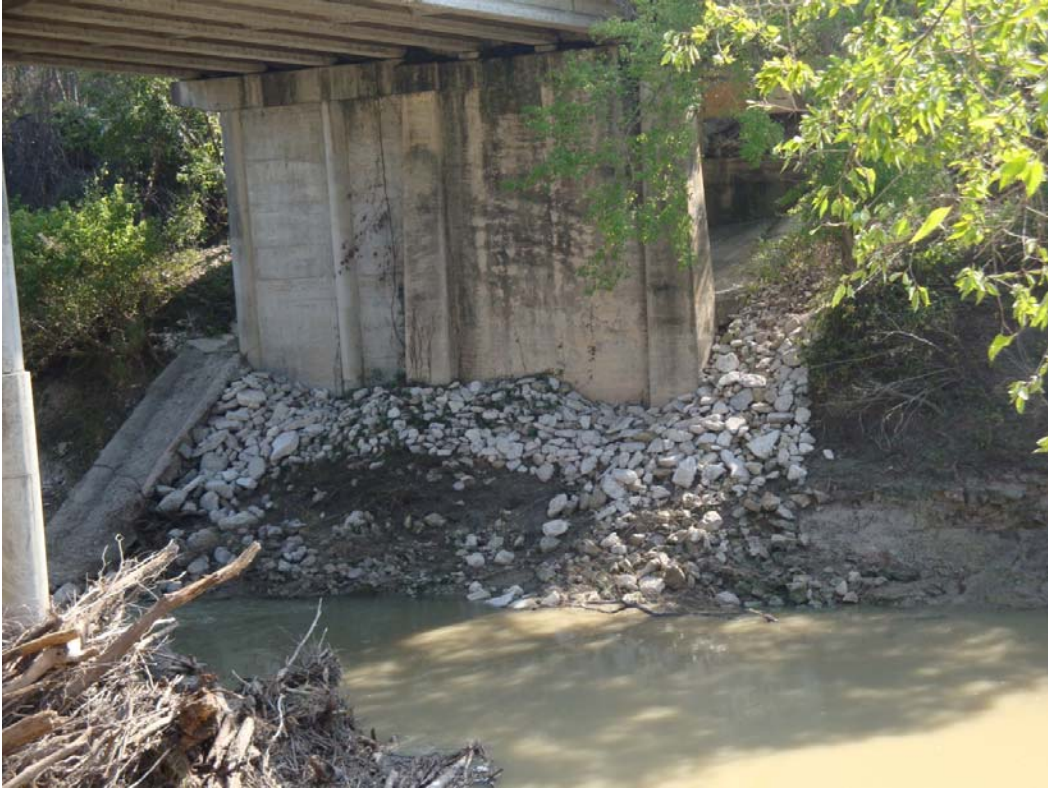
Figure 6-8. Silty Clay beneath Pier P3.

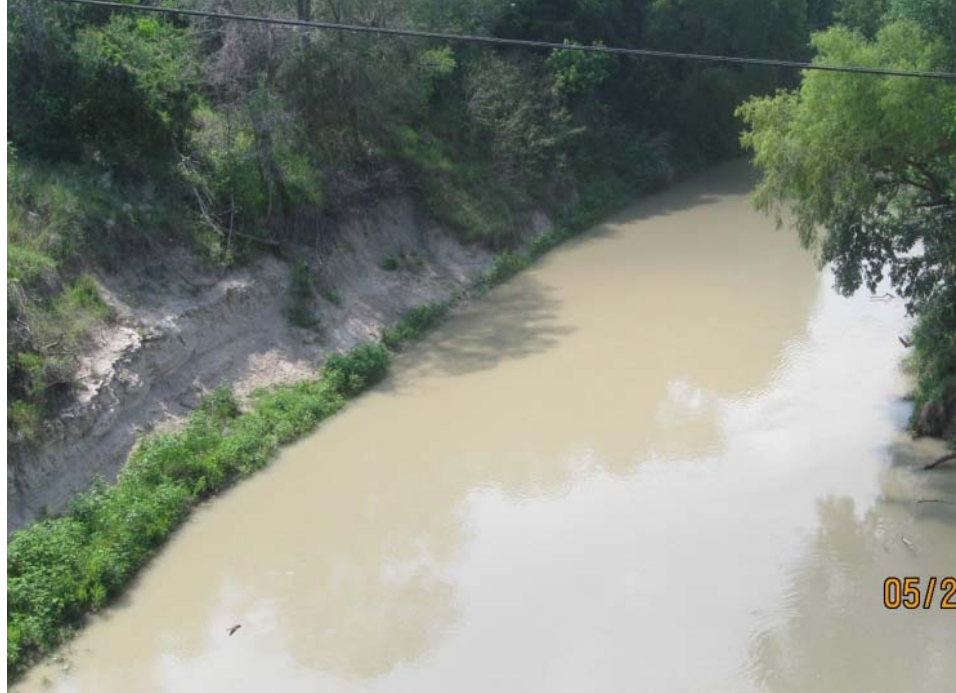
The northern and southern bank of the San Antonio River at the downstream are experiencing a meandering problem. Layered soil with vegetation can be seen clearly in [Figure 6-9](#) and [Figure 6-10](#).

Figure 6-9. Northern Riverbank of San Antonio River (Downstream).

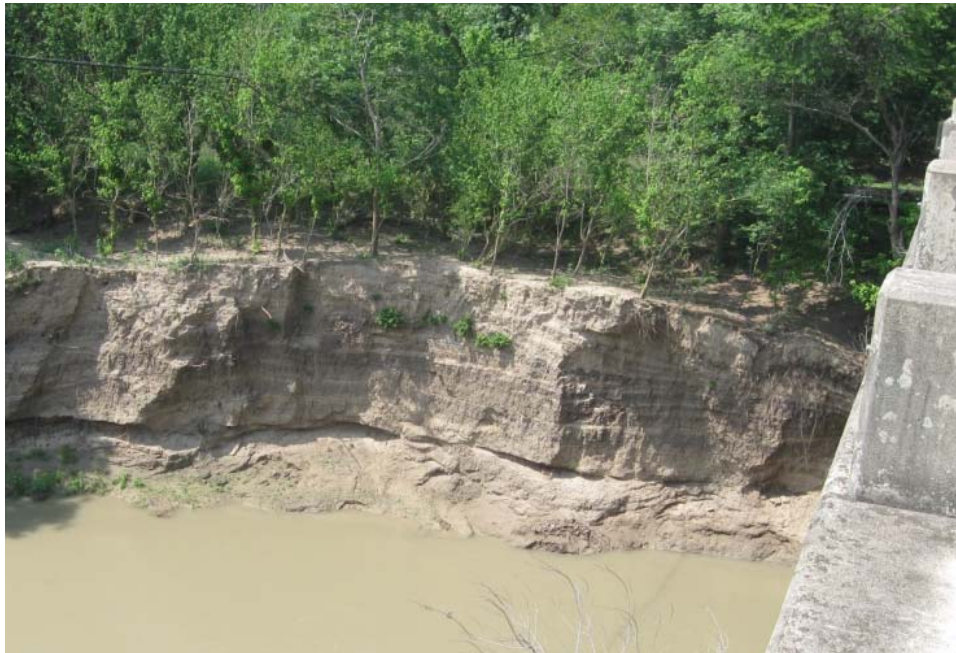
Figure 6-10. Southern Riverbank of San Antonio River (Downstream).

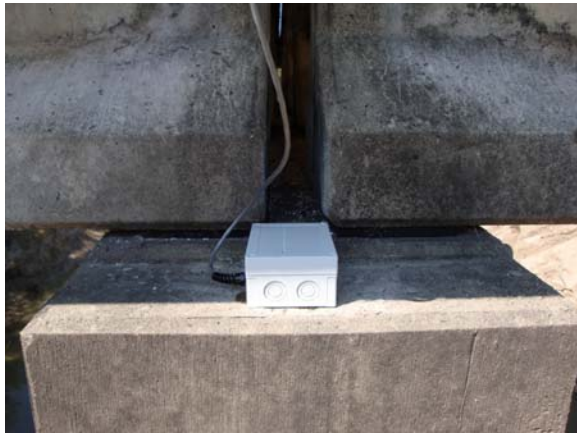
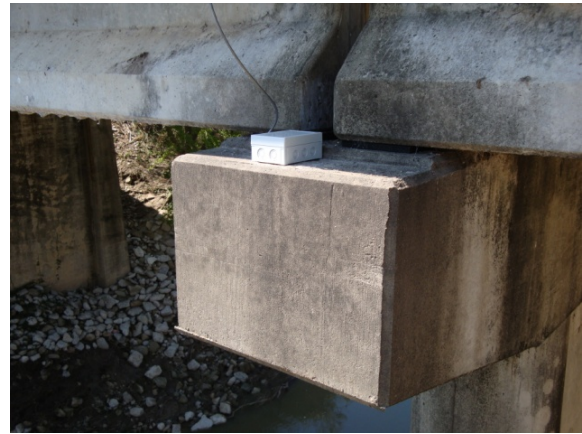
One hardwired accelerometer and one wireless accelerometer were installed on the top of piers in the initial monitoring system. The hardwired accelerometer was fixed on pier cap of the in-river-pier P2 and was wired to the master station ([Figure 6-13](#)). The wireless accelerometer was fixed on the pier cap of Pier P1 ([Figure 6-14](#)). The solar panel that was wound on the curb provided the power for the wireless accelerometer ([Figure 6-15](#)).

Figure 6-13. Accelerometer on the Cap Beam of Pier P2: (a) Front View and (b) Side View.

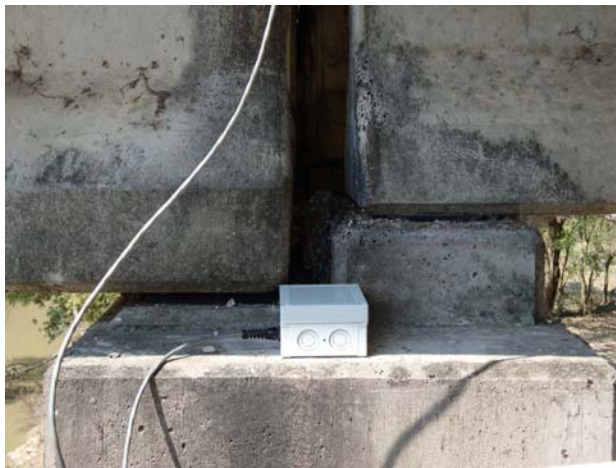
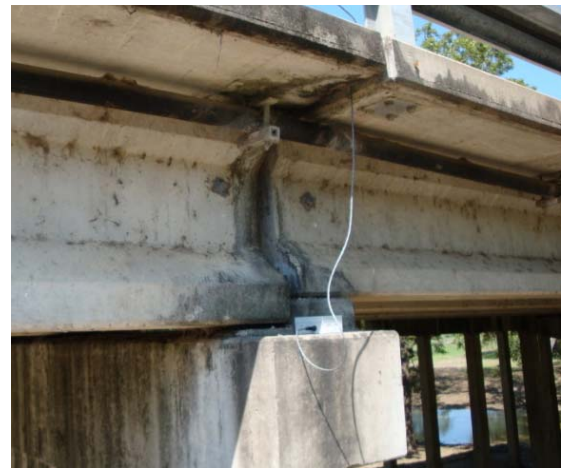
Figure 6-14. Accelerometer on the Cap Beam of Pier P1: (a) Front View and (b) Side View.

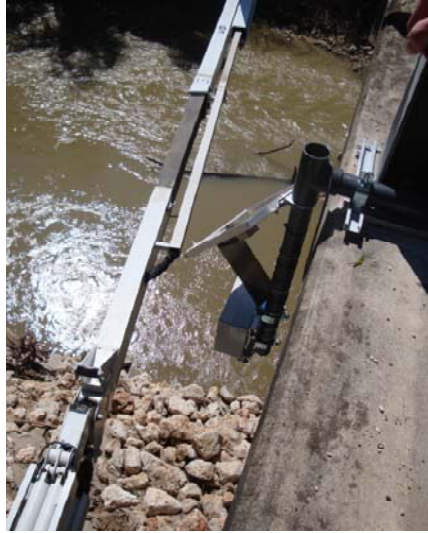
Figure 6-15. Solar Panel for the Accelerometer on the Cap Beam of Pier P1.

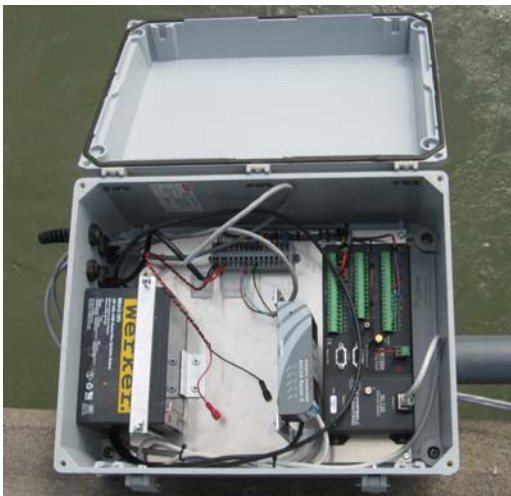
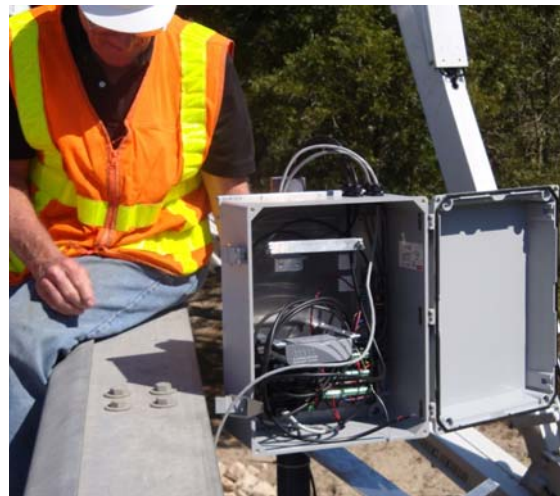
The master station was mounted near Pier P2. Two solar panels were installed on the bridge. One solar panel was installed near the master station to provide the power for monitoring system; the other one was installed near accelerometer on the cap beam of Pier P1 to provide power. [Figure 6-16](#) shows installation of the master station at SH80 over San Antonio River Bridge.

Figure 6-16. Master Station on SH80 over San Antonio Bridge: (a) During Installation and (b) After Installation.

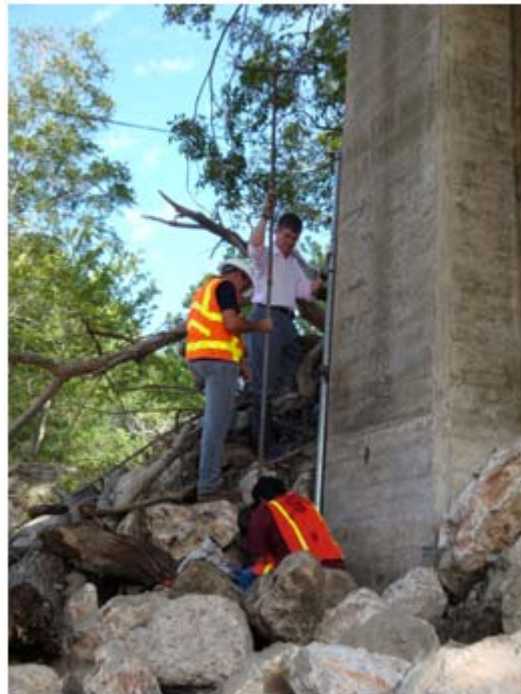
Two TBS equipments were installed in the soil near Pier P1. TBS1 was buried 2.4 m (8 ft) below the ground surface at a distance of 12.3 m (41 ft) below the top of the deck. TBS2 was buried 0.9 m (3 ft) above the TBS1 at a distance of 11.4 m (38 ft) from the top of the deck. A hand-auger was used to drill a hole into soil ([Figure 6-17](#)). The drilled hole was 2.7 m (9 ft) deep. [Figure 6-18](#) shows the photos after TBS installation.

Figure 6-17. Hand-Auger.

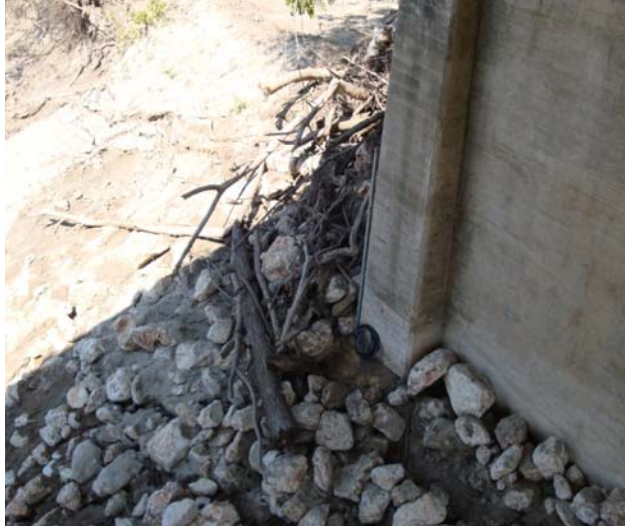
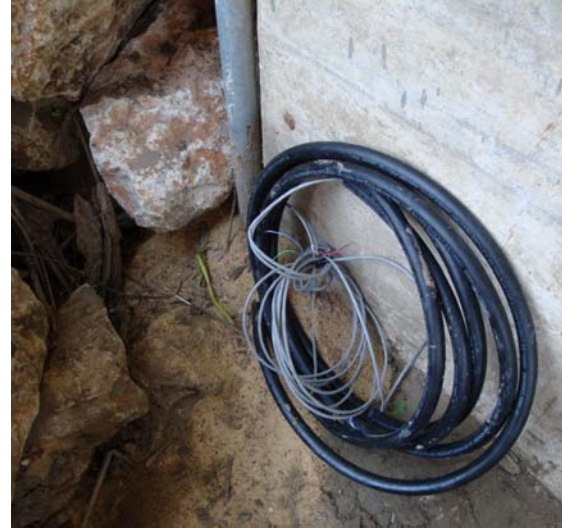
Figure 6-18. Installed TBS Equipments: (a) Conduit and (b) Zoom in View.

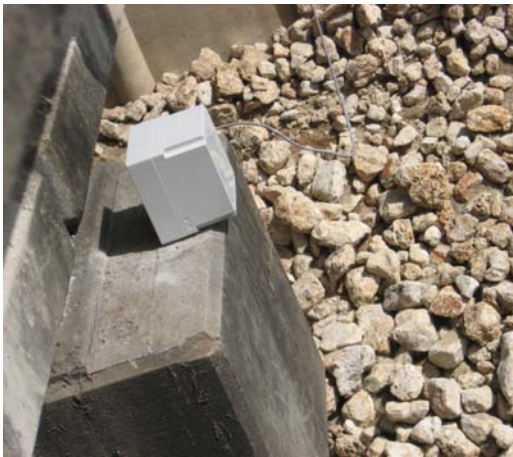
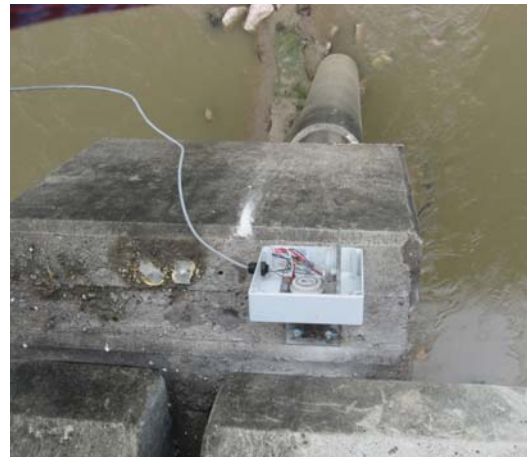
around the flow direction axis, was mounted at the back of the enclosure. The output is positive when the sensor is rotated clockwise (when facing the sensor). The other single-axis tiltmeter measuring the tilt angle of the pier around the traffic direction axis was mounted on the left side perpendicular to the other one (when facing the sensor). The output is positive when the sensor is rotated clockwise. [Figure 6-19](#) shows the dual-axis tiltmeter at SH80 over San Antonio River Bridge.

Figure 6-19. Installed Dual-Axis Tiltmeter: (a) Side View and (b) Top View.

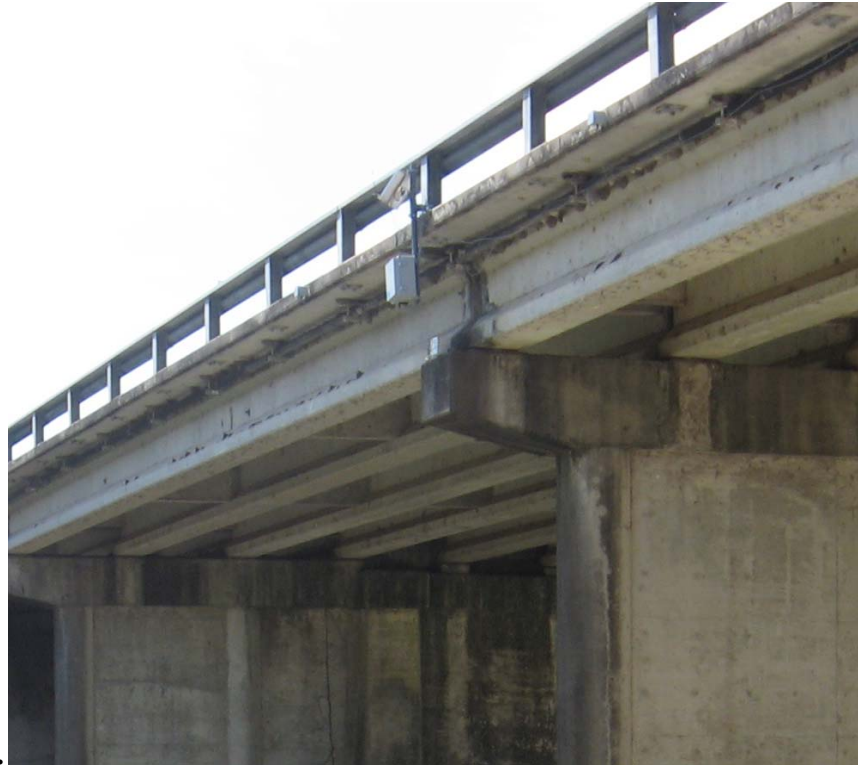
Two single-axis tiltmeters were installed on the bridge deck on the left and right side of in-river-pier (P2), respectively. Both of them are measuring the tilt angle of the deck around the flow direction axis. The horizontal distance between each single-axis tiltmeter and dual-axis tiltmeter is 3.75 m (12.5 ft). All the tiltmeters were wired to the datalogger CR1000. TBS equipments remained at the same location. [Figure 6-20](#) shows the modified monitoring system for the bridge.

Figure 6-20. Modified Bridge Scour Monitoring System.

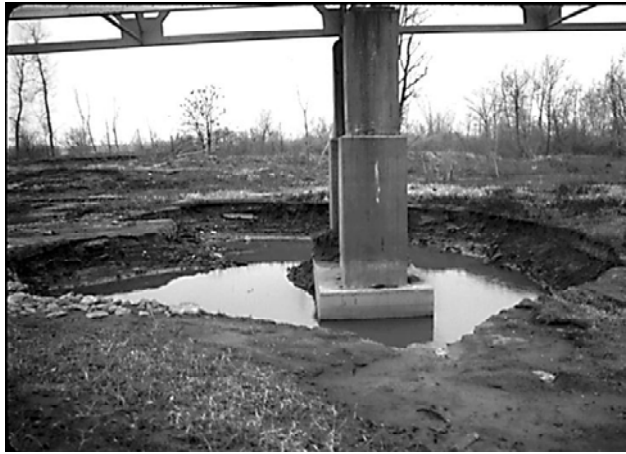
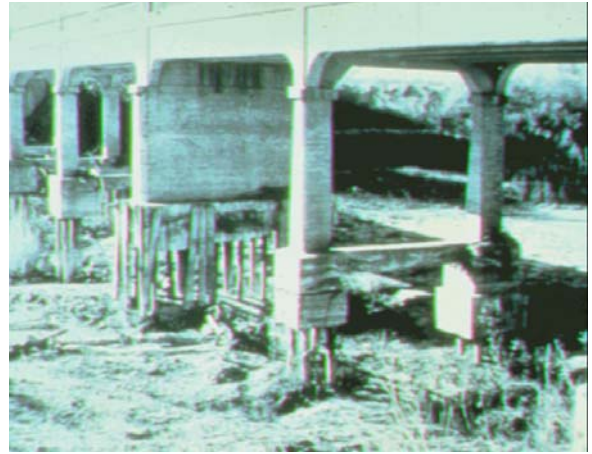
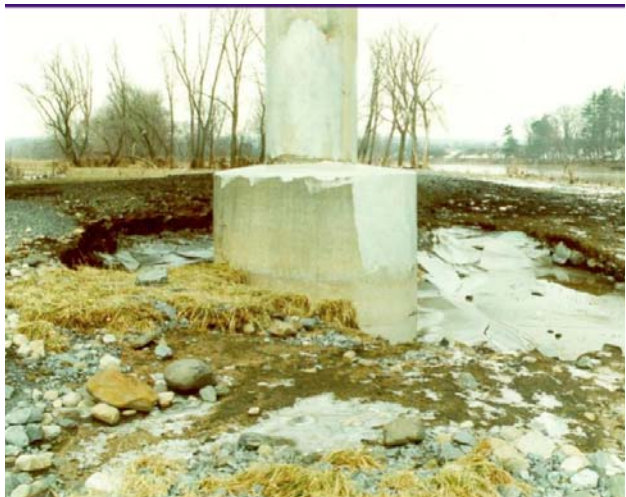
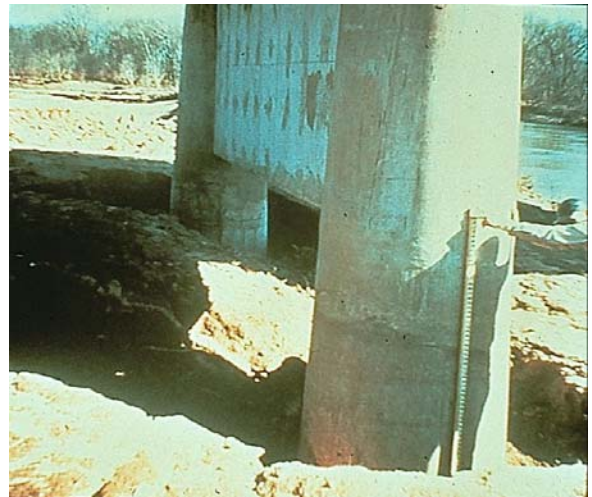
Among the 35 bridge failure cases, 9 bridges exhausted in the first mode, which means 26 percent observed occurrence. [Figure 7-2](#) shows four examples of bridge failure due to big scour hole.

Figure 7-2. Generation of Big Scour Hole: (a) Case 1, (b) Case 2, (c) Case 3, and (d) Case 4.

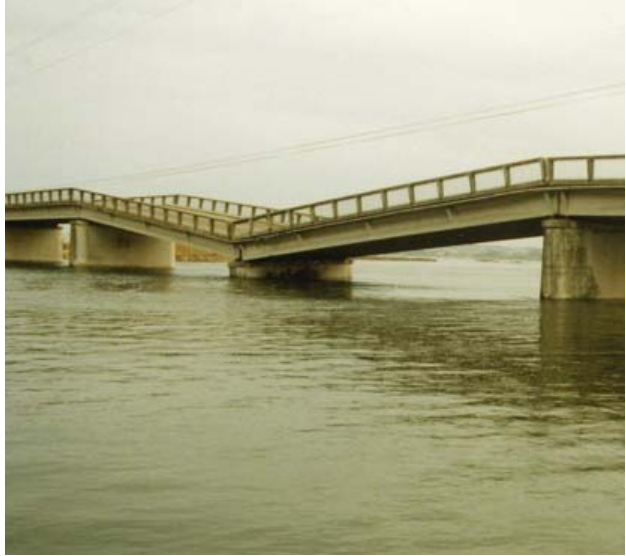
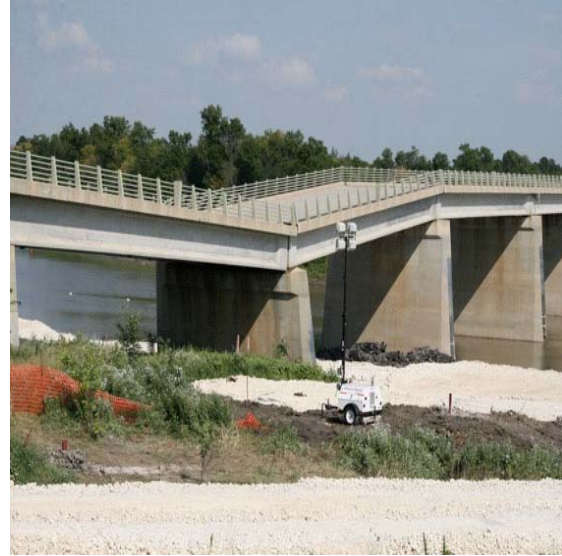
Among the 35 bridge failure cases, 13 bridges failed in the second mode, which means 37 percent observed occurrence. [Figure 7-4](#) shows the examples of the bridge failure due to settlement of the pier. [Figure 7-5](#) shows the examples of the bridge failure due to rotation of the pier.

Figure 7-4. Settlement of the Pier: (a) Case 1 and (b) Case 2.

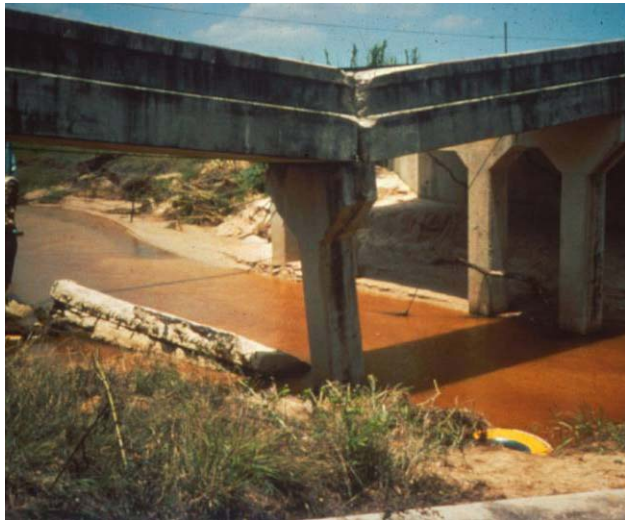
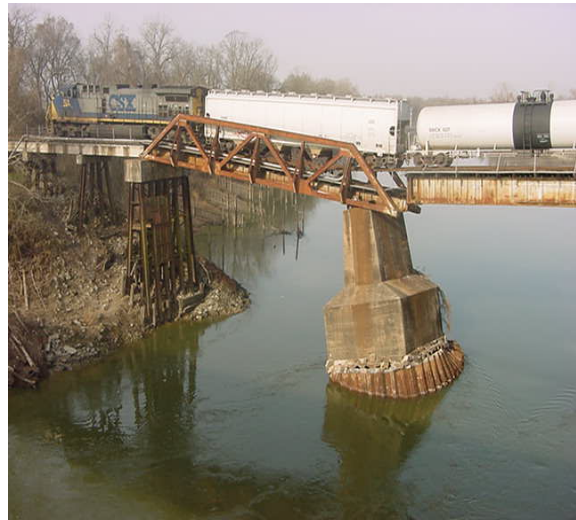
Figure 7-5. Rotation of the Pier: (a) Case 1 and (b) Case 2.

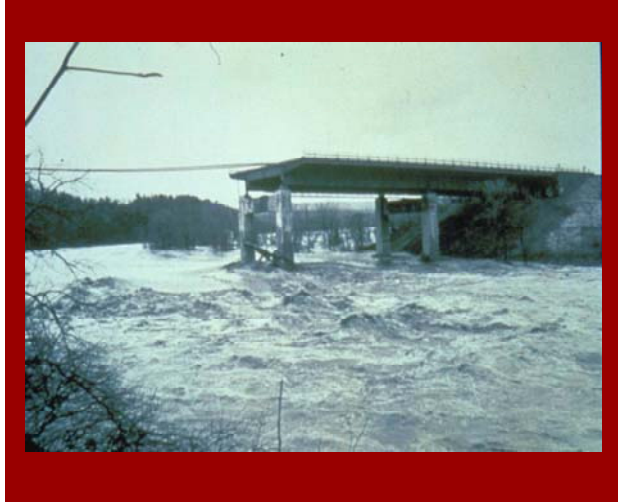
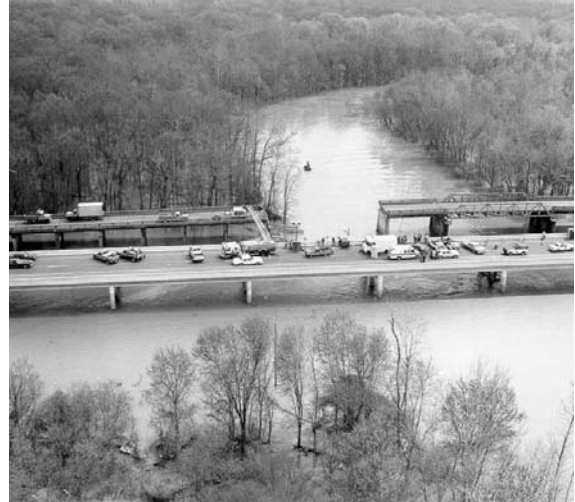
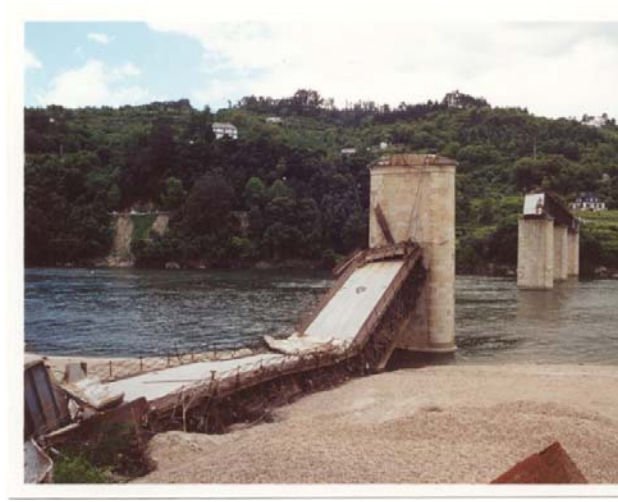
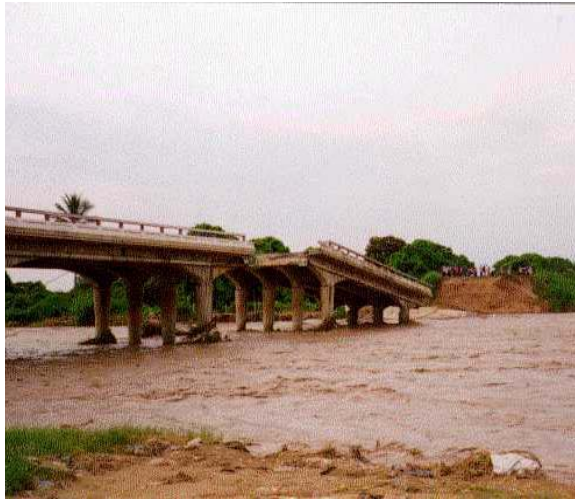
Figure 7-6 shows the third failure mode: loss of the deck. In this mode, a bridge fails due to the loss of the deck. One possible reason for loss of the deck is that the settlement of the pier is so large that the deck moves out of the pier support and it falls down. Another possible reason for loss of the deck is that the rotation of the pier is very large. The possibility of this type of failure can be reduced by increasing the width of the support (Figure 7-7).

Among the 35 bridge failure cases, 5 bridges failed in the third mode, which means 14 percent observed occurrence. [Figure 7-8](#) shows the examples of the bridge failure in the third failure mode.

Figure 7-8. Loss of the Deck: (a) Case 1, (b) Case 2, (c) Case 3, and (d) Case 4.

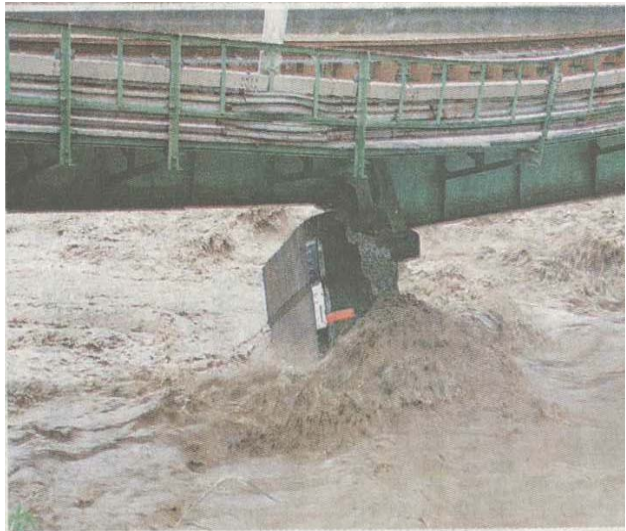
Figure 7-9 shows the fourth failure mode: loss of the pier. In this mode, a bridge fails due to the loss of the pier. Among the 35 bridge failure cases, 8 bridges failed in the third mode, which means 23 percent observed occurrence. Figure 7-10 shows a bridge failure process captured by two photos. Figure 7-10a shows the rotation of the pier before it falls down, while Figure 7-10b shows the falling down of the pier. Figure 7-11 shows two more examples of bridge failure due to loss of the pier.

Figure 7-10. Case of Loss of the Pier: (a) Rotation of the Pier and (b) Loss of the Pier.

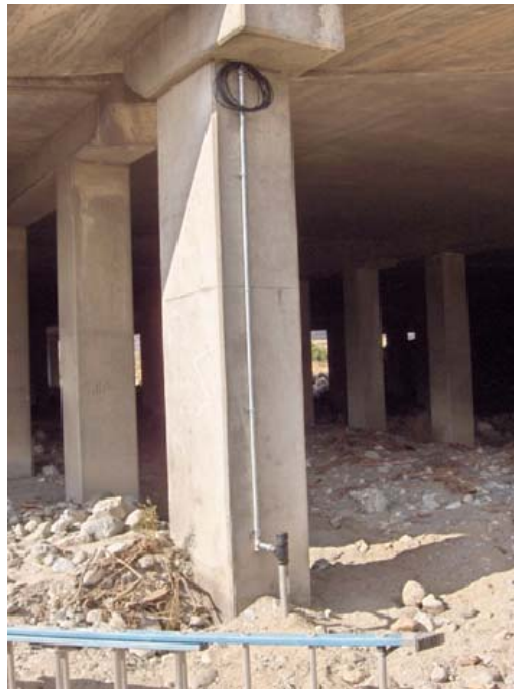
Figure C-4. Magnetic Sliding Collar Installation (Caltrans).

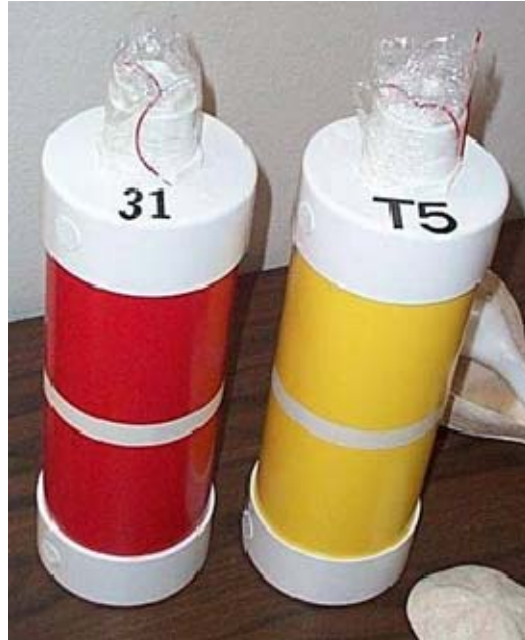
Figure C-6. Float-Out Devices Color Coded and Numbered for Identification (ETI Instrument Systems).

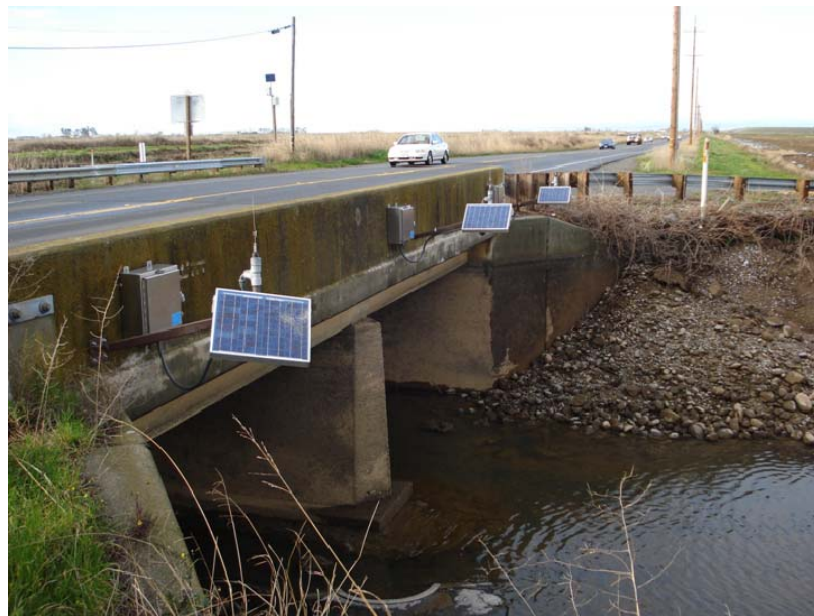
Figure C-8. Tiltmeter Installation (Caltran).

Caltrans ([Avila et al., 1999](#)) notes that the tiltmeters monitor the ever-changing position that normally occurs because bridges must be redundant enough to withstand some amount of

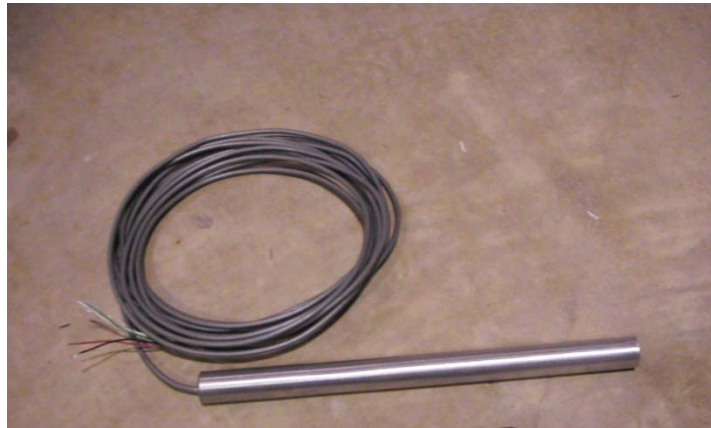
Figure C-11. Tethered Buried Switch Prior to Installation.

This is a buried device that is tethered to the bridge piers or abutments and incorporates tilt switches (Figure C-11). When activated by scour, the tilt switches inside sense the change in physical orientation and alert the bridge data system. Being tethered permanently to the bridge structure, these devices continue to provide data to the system data logger. Life span is in excess of up to 20 years for the tethered sensors.

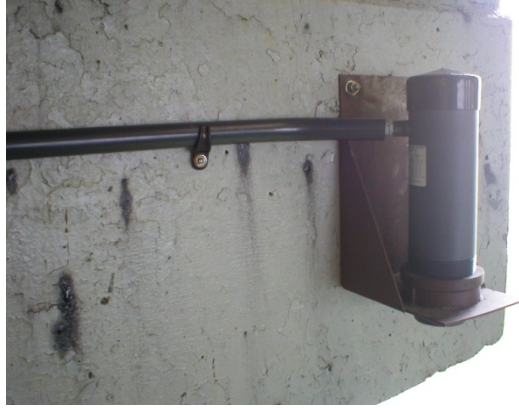
Figure C-13. Water Stage Sensor Mounted on Pier Cap (NYSDOT).

The stage sensor is an acoustic sounding device that measures the distance from its mounting on the bridge to the water surface (see [Figure C-13](#)). The elevation of the water surface is determined by subtracting the measured distance from the sensor transducer to the water from the known elevation of the transducer. Rising stage may indicate the need for closer analysis of the other system sensors that are measuring the scour or the movement of the bridge.

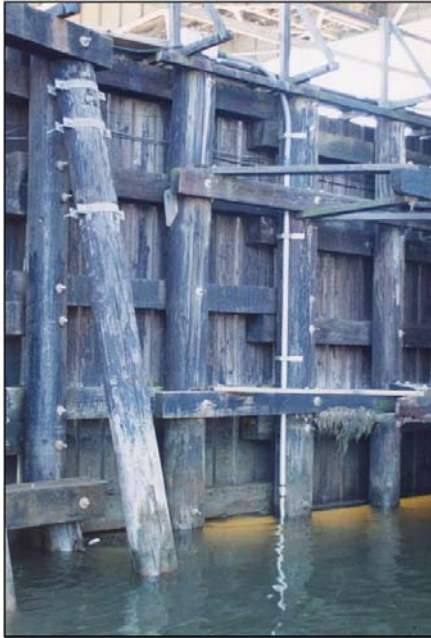
Figure C-14. Velocitymeter Mounted on Bridge Fender (MSHA).

Velocity meters may be installed at bridge sites to measure velocities in the vicinity of the piers or abutments (see [Figure C-14](#)). The acoustic doppler velocimeter device measures instantaneous velocity components at a single point. It has three acoustic receivers to measure velocity in three directions. The largest challenge with velocity meters is selecting appropriate locations to mount the meters in order to obtain useful data. If they are too close to the piers or abutments, then the measured velocities are influenced by the obstruction of the substructure units. Finding a location to install the velocity meter that is not affected by the substructure units or other obstructions needs to be considered during the selection and design of the velocity meters. Due to the location restrictions, the velocity meters may be difficult to protect and subject to damage from impact from debris, ice, marine traffic, or any construction.

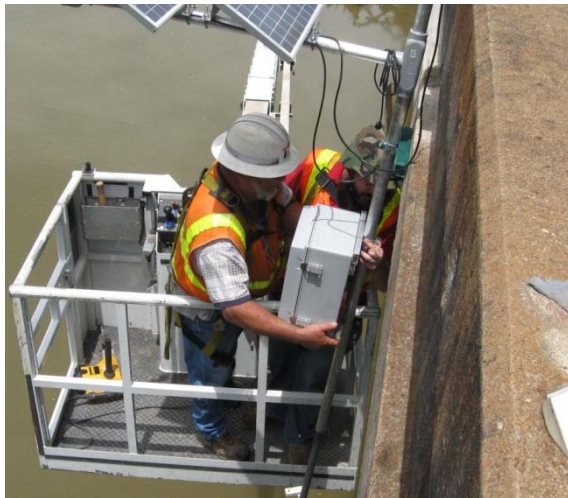
Figure D-4. Mounting the Master Station.

The master station was mounted on the bridge fascia on the outside of the concrete parapet. It is on the same fixture as the solar panels. Two solar panels were installed near the master station to provide the power. One more solar panel was installed near the wireless accelerometer to provide power for the wireless accelerometer, which is on the cap beam of the pier with debris (SB1). [Figures D-4 to D-5](#) show the installation of the master station and solar panels.

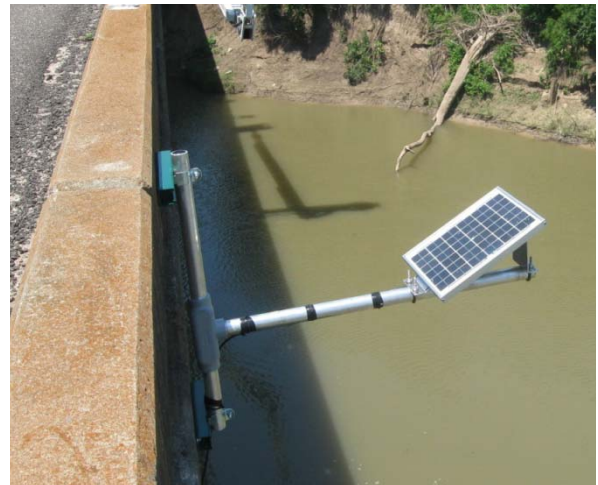
Figure D-5. Solar Panel on the Pier SB1 (with Debris).
