1. Report No. FHWA/TX-11/0-6060-1		2. Government Accession No.		3. Recipient's Catalog No.	
4. Title and Subtitle REALTIME MONITORING OF BRIDGE SCOUR USING REMOTE MONITORING TECHNOLOGY				5. Report Date October 2010 Published: February 2011

REALTIME MONITORING OF BRIDGE SCOUR USING REMOTE MONITORING TECHNOLOGY

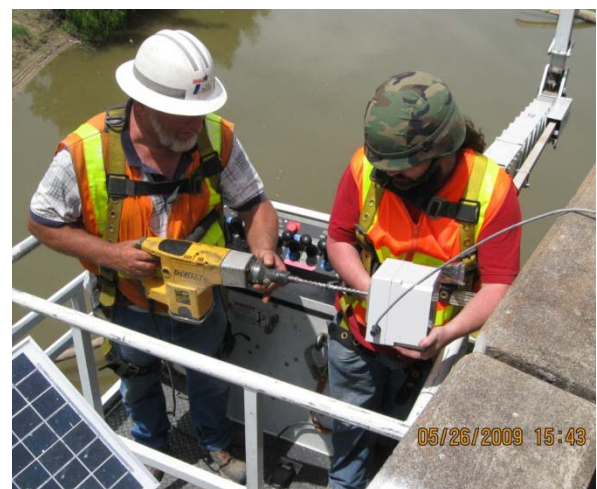
Figure D-8. Drilling a Hole in the Tiltmeter Enclosure to Install the Bolt.

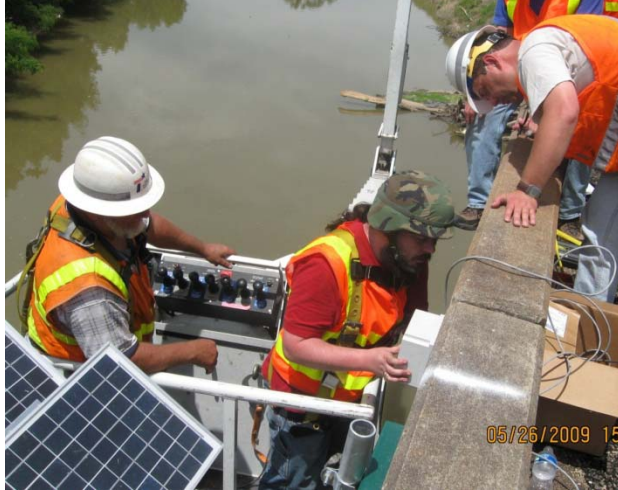
Figure D-9. Positioning the Tiltmeter.

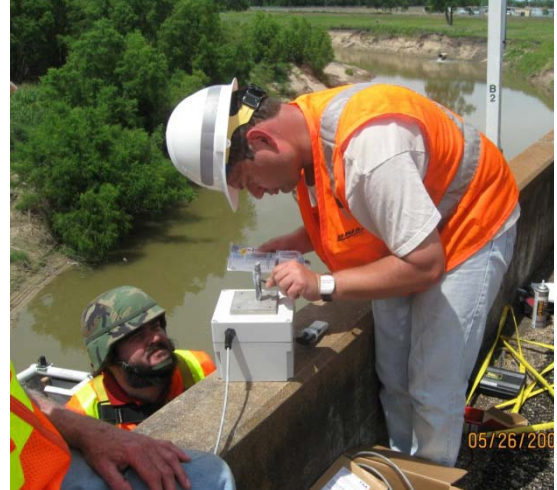
Figure D-10. Applying Glue to the Tiltmeter Enclosure.

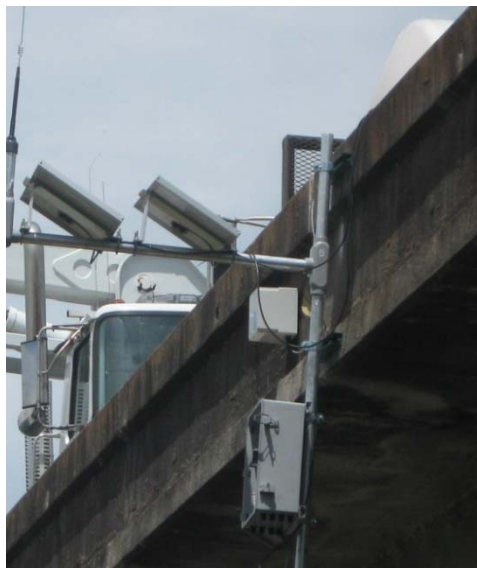
Figure D-11. The Installed Tiltmeter, Master Station, and Solar Panels.

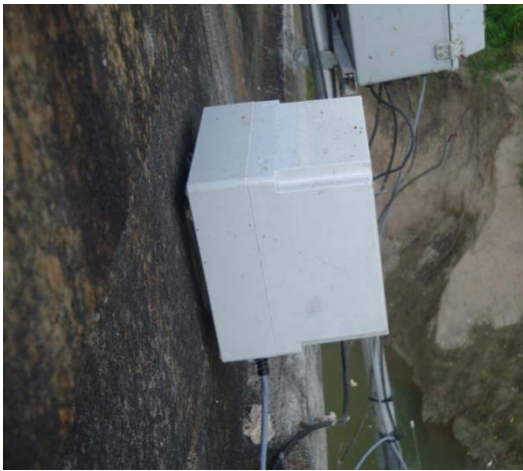
Figure D-13. Single-Axis Tiltmeter 1 on the Deck Adjacent to Master Station at Pier SB2.

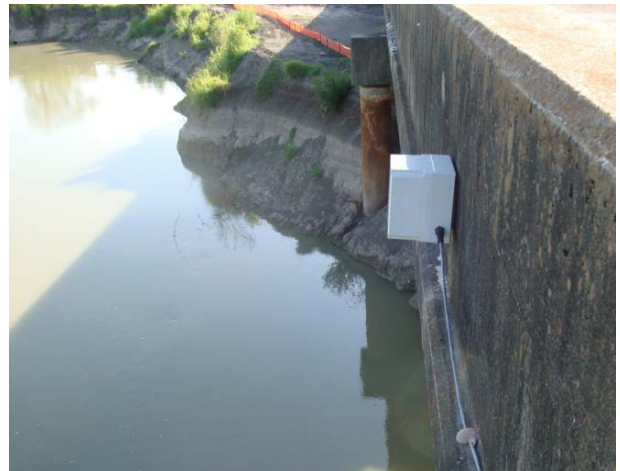
Figure D-14. Single-Axis Tiltmeter 2 on the Deck at Pier SB1.

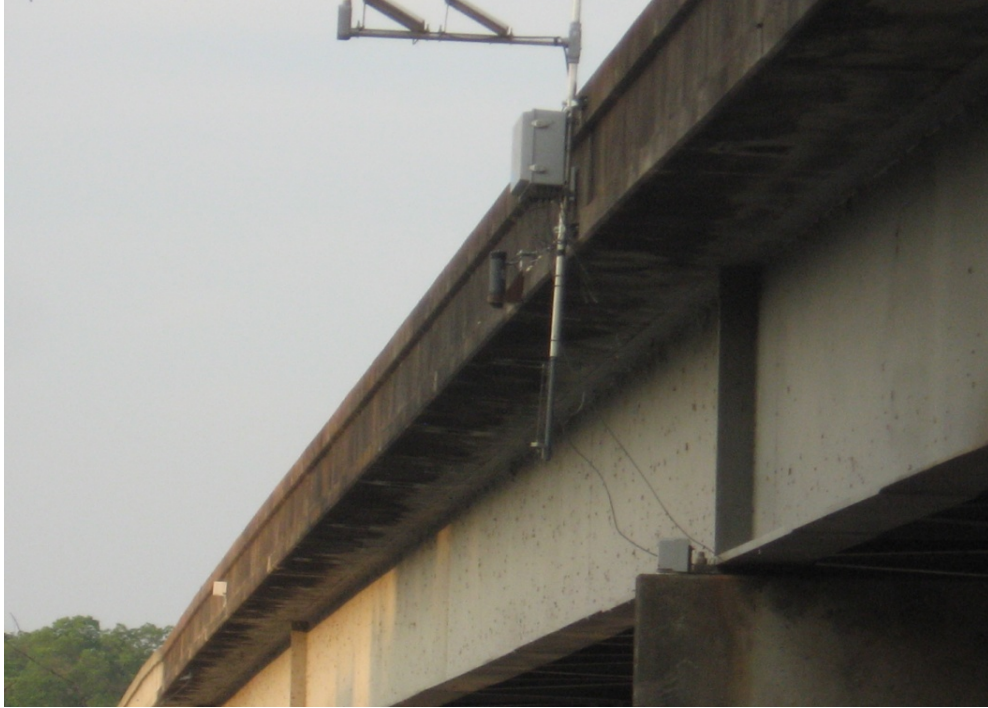
Figure D-15. Bridge Scour Monitoring System (View from South Side of the Bridge).

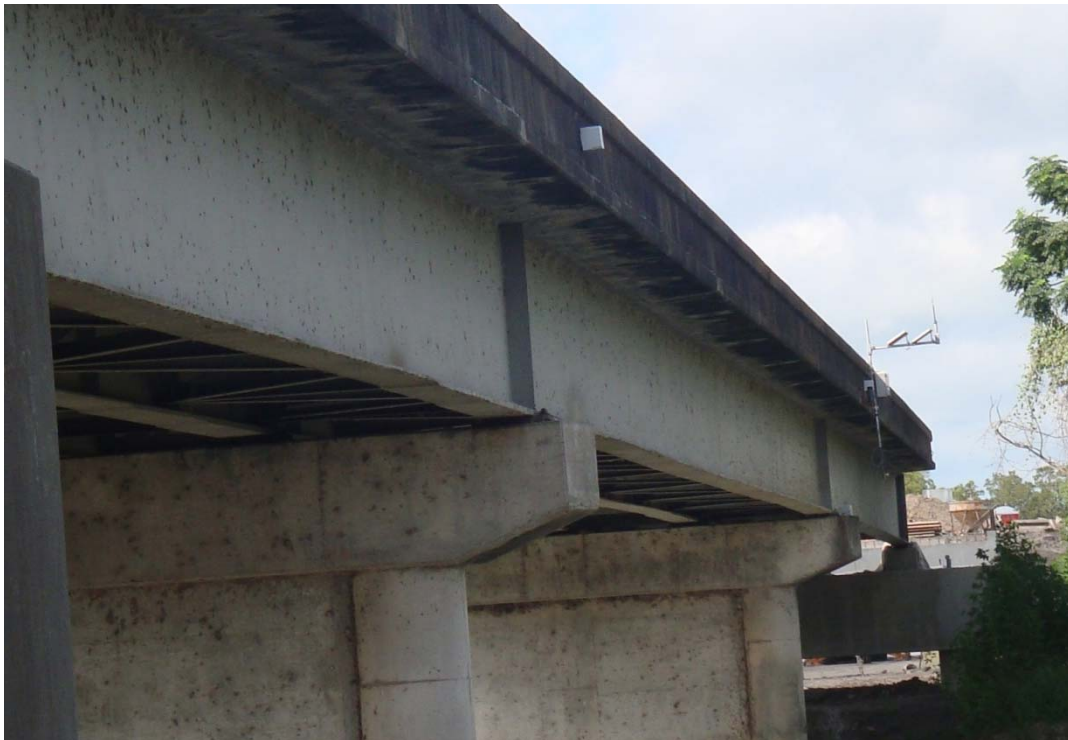
Figure D-16. Bridge Scour Monitoring System (View from North Side of the Bridge).

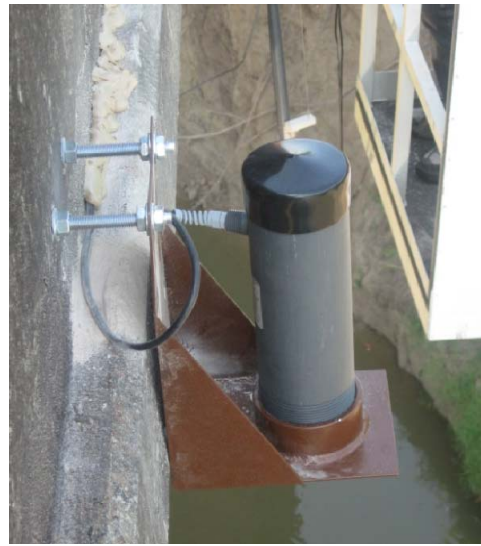
Figure D-18. Installed Water Stage Sensor.

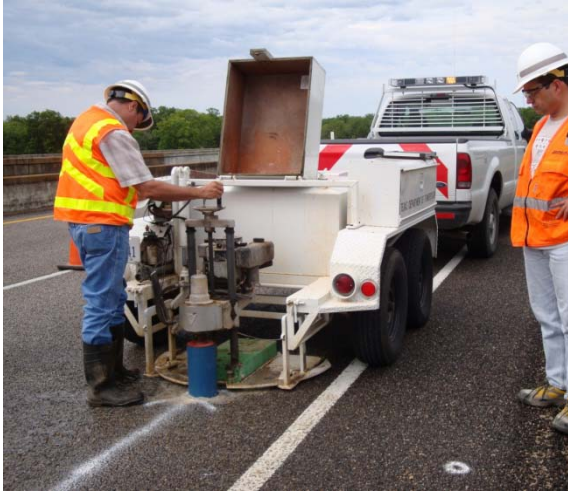
Figure D-19. Drilling the Hole through the Bridge Deck.

The float-out devices installed at the bridge are 0.6 m (2 ft) in length and 89 mm (3.5 inches) in diameter (see [Figure D-21](#)). To install the two float-out devices, one hole was drilled through the bridge deck. The hole was about at a distance of 2.4 m (8 ft) away from the edge of the deck parapet and 2.85 m (9.5 ft) away from the center of the Pier SB2. The TxDOT inspection team drilled the hole through the deck. The contractor Alpha Testing was responsible for the installation of float-out devices. [Figures D-19 to D-22](#) depict the installation process of the float-out devices.

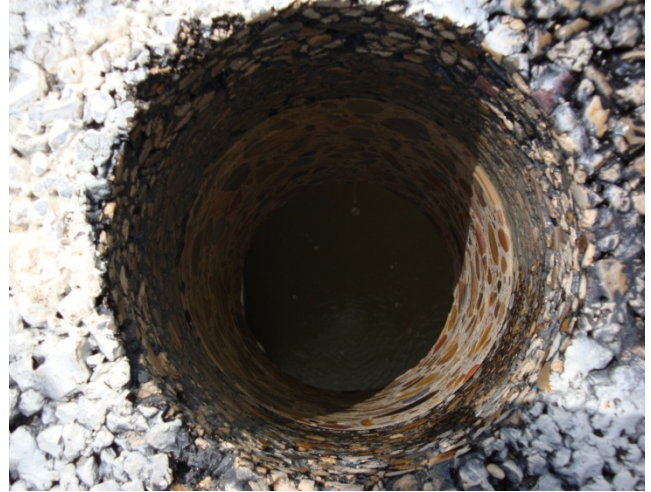
Figure D-20. Close-Up of the Drilled Hole in the Deck.

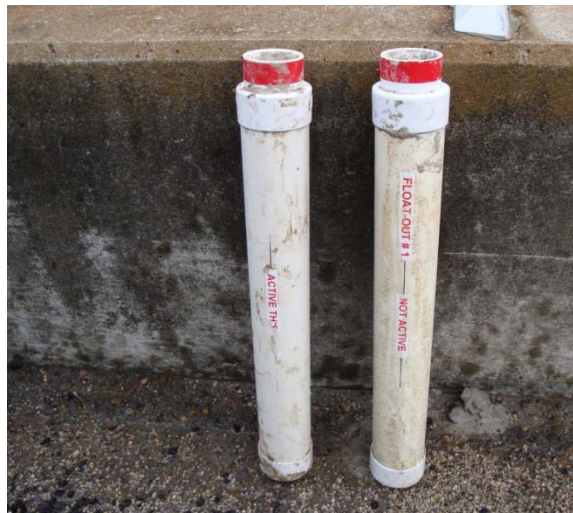
Figure D-21. Float-Out Devices prior to Second and Final Installation.

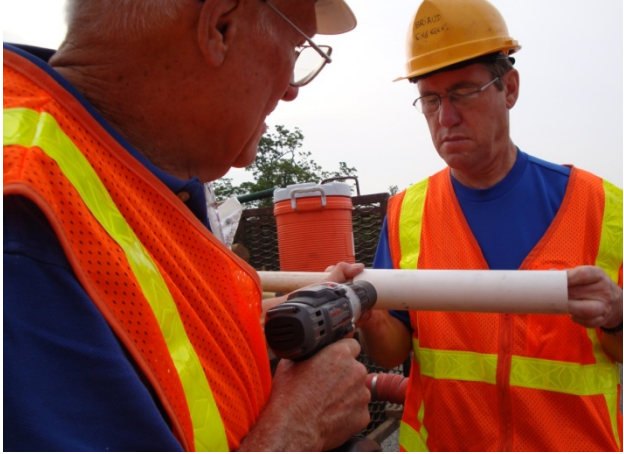
Figure D-22. PVC Pipe as an Extension of the Float-Out Device.

The first attempt at installation of the float-out devices was not successful. In order to ensure that the float-out devices are installed at the right position, a rebuilt PVC pipe was used as an extension of the device ([Figures D-22 to D-26](#)).

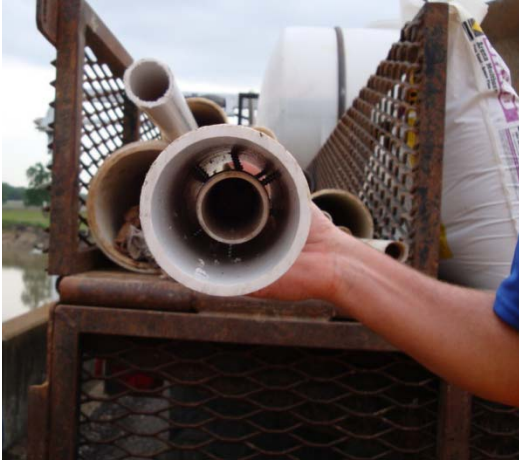
Figure D-23. View Looking inside the PVC Pipe.

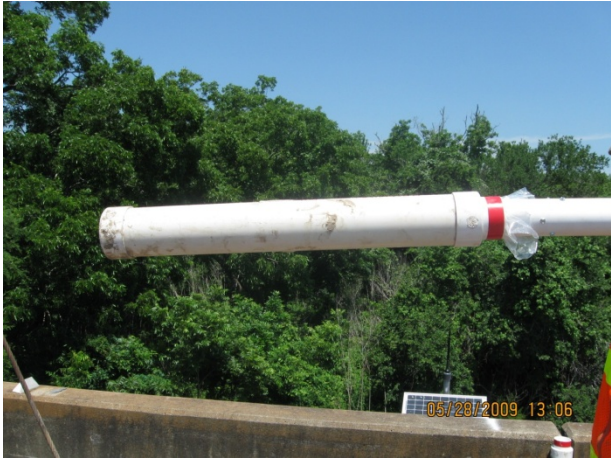
Figure D-24. Float-Out Device Mounted in the PVC Pipe.

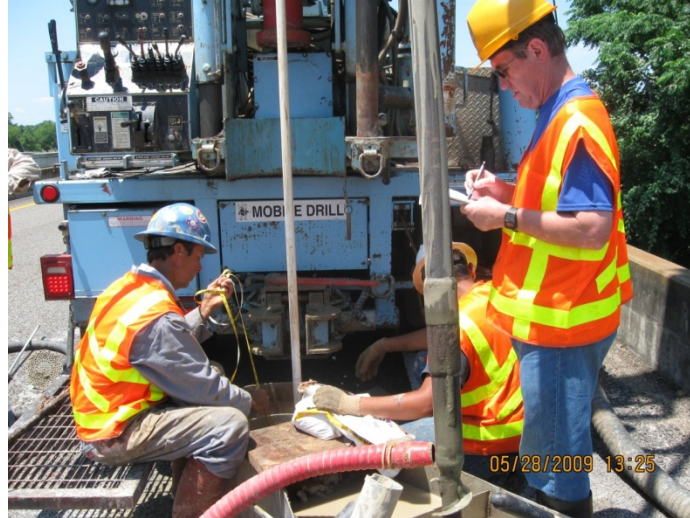
Figure D-26. Refilling the Drilled Hole after the Installation of the Float-Out Devices.

The final as-built elevations for the float-out devices were measured relative to the top of the bridge deck and the existing streambed. The Float-out1 was buried 1.5 m (5 ft) below the streambed at a distance of 16.2 m (54 ft) from the top of the bridge deck. The Float-out2 was buried at a distance of 2.7 m (9 ft) below the Float-out1 and at a distance of 18.9 m (63 ft) from the top of the deck.

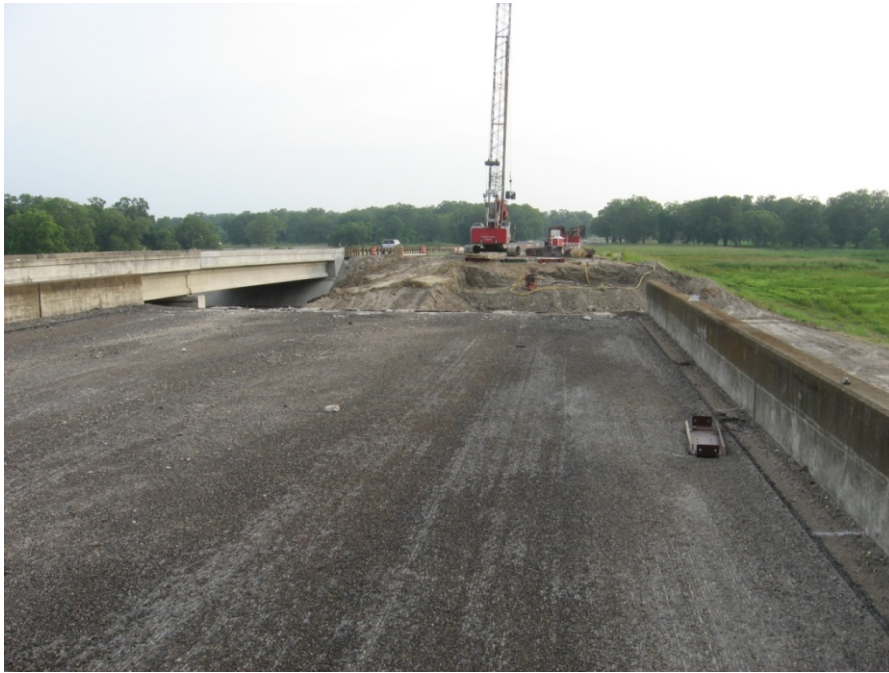
Figure D-40. Construction on the Extension of the Southbound Lane of US59 over Guadalupe River Bridge.

If any construction work is done near the fixed scour monitors, including work unrelated to the bridge, provisions shall be made to protect the scour monitoring system. Upon completion of the work, the monitors shall be checked to ensure the monitors had not been damaged. If they are damaged, they shall be repaired at the expense of the Contractor. [Figure D-40](#) depicts the current construction for the extension of the both bridges.

Due to the construction of the extension to the bridge, the two TBS originally installed at the bridge at the south abutment (SB3) were disconnected and are no longer active.

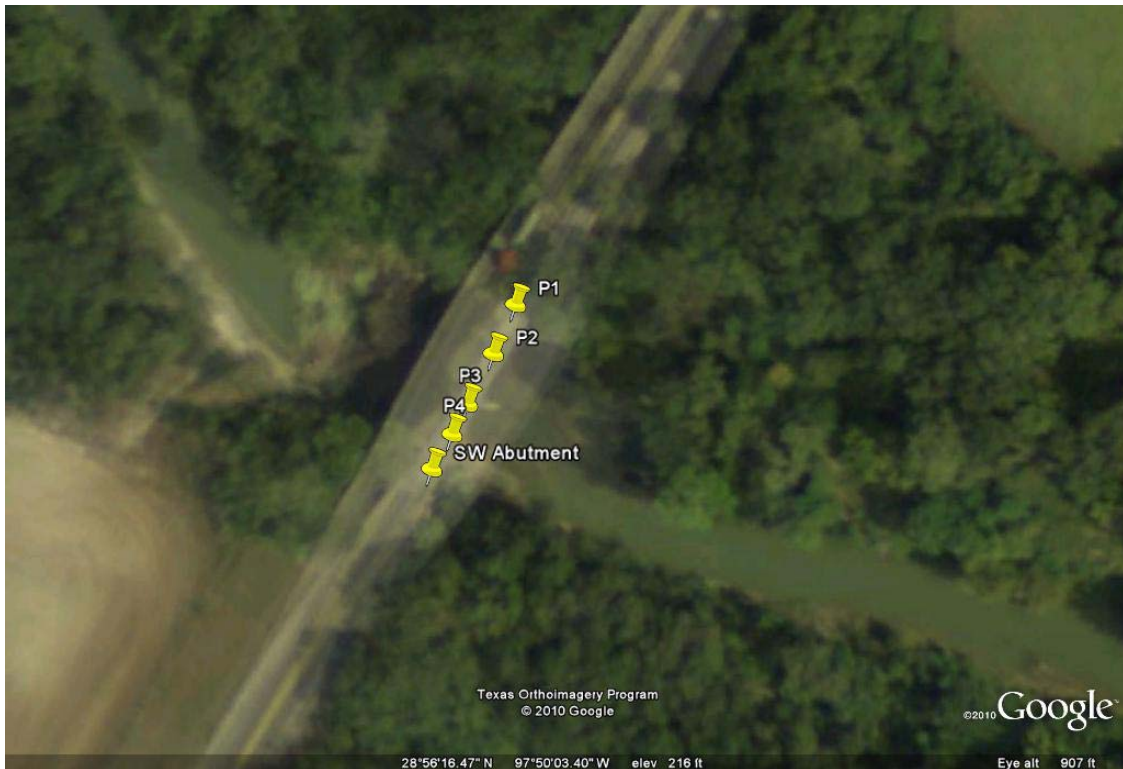
Figure E-1. Layout of the SH80 Bridge Displaying Naming Convention for the Substructure Units (Source: Google Earth).

Figures E-1 and E-2 show the general location of the bridge in Google Earth and Google Map, respectively. In Figure E-1, P1 represents the compound web-wall on the northeast bank of the bridge. P2 represents the river pier. P3 and P4 are the two compound web-wall piers on the southwest bank of the bridge. SW abutment is the Southwest Abutment of the bridge.

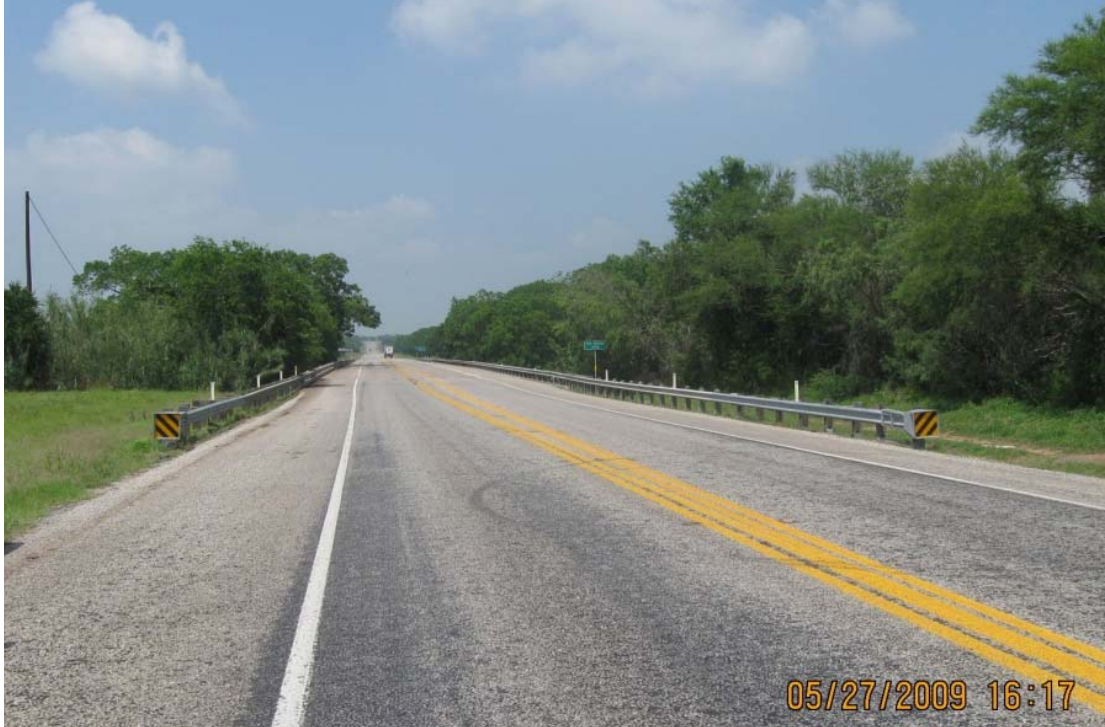
Figure E-3. State Highway 80 over San Antonio River Bridge, Texas.

The bridge is a multi-span, 148 m (493 ft) long, two-lane bridge (Figure E-3). The main bridge consists of three spans, and is 63 m (207 ft 7 inches) long. It contains one river pier (P2), which has a concrete web-wall (Figure E-4). The second main span pier is a compound web-wall of cylindrical and trapezoidal bridge bents (P1) (Figure E-5). The supporting structure of the eastern bridge approach consists of a combination of cylindrical piers and square piers (Figure E-6). The datum used for the bridge and the scour monitoring system is the National Geodetic Vertical Datum (N.G.V.D.) 1929, elevation 0.0 ft, which is also Mean Sea Level. An elevation and plans of the bridge may be found in Attachment A.

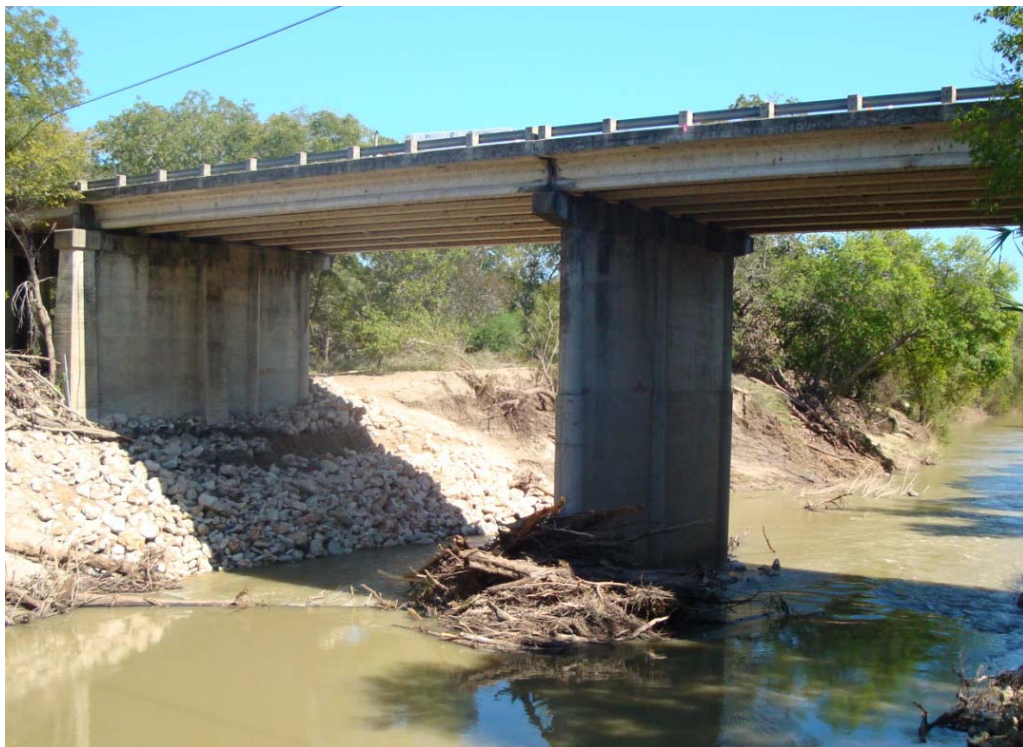
Figure E-4. River Pier with Concrete Web-Wall (P2).

The northern and southern banks downstream of the bridge are experiencing problems due to the meandering of the river. Vertical cut faces with layered soil with vegetation can be seen clearly in [Figures E-9](#) and [E-10](#). The river Pier P2, also has large accumulations of debris lodged at its upstream nose and this may contribute to scour ([Figure E-4](#)).

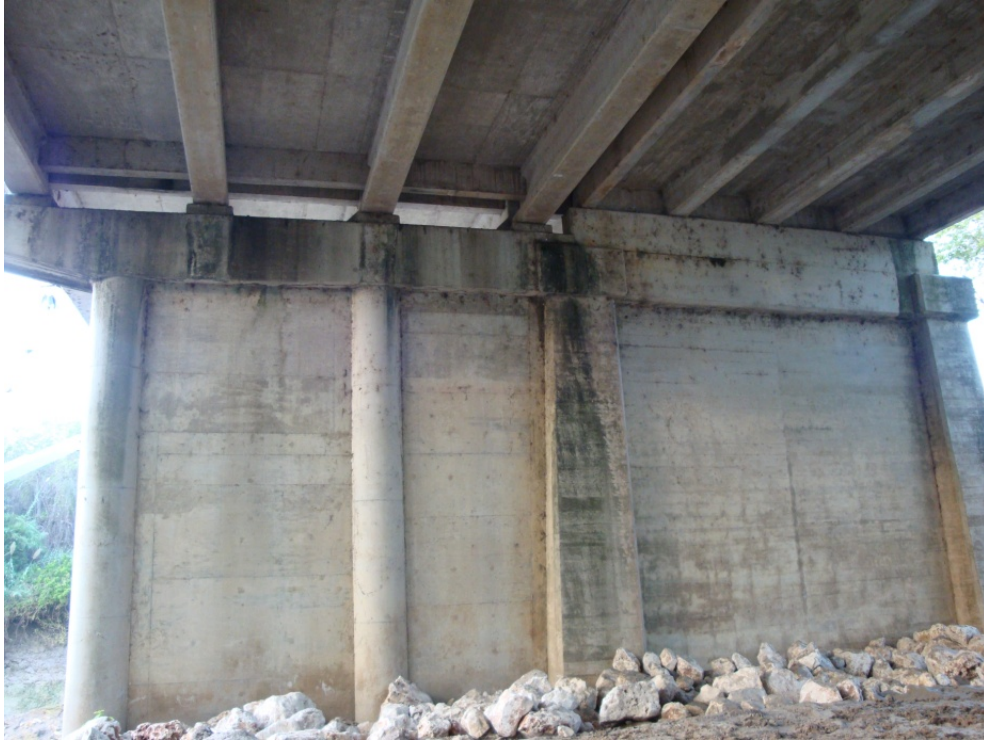
Figure E-5. Compound Concrete Web-Wall Pier P1 on the Bridge Main Span.

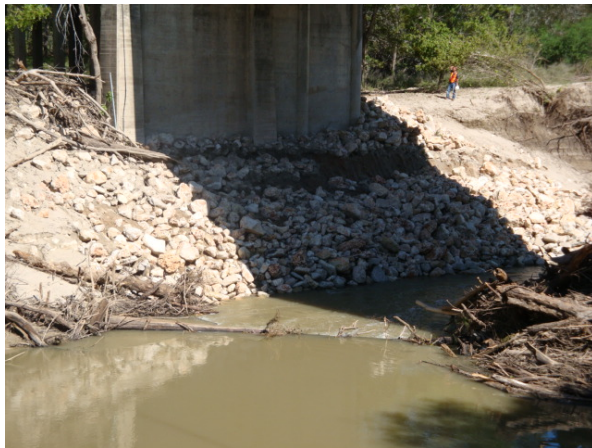
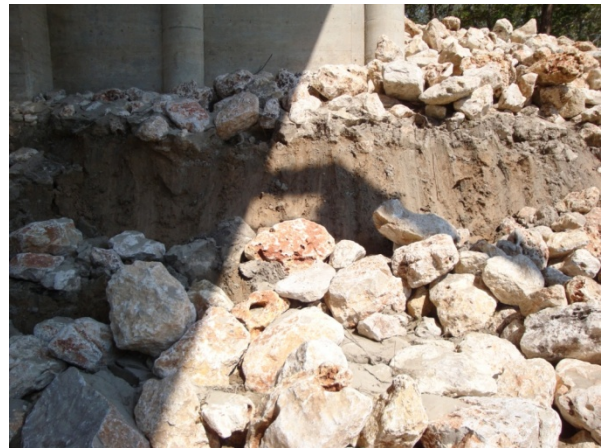
Figure E-7. Riprap Failure near Pier P1: (a) Elevation of Pier and (b) Close-Up View.

The soil beneath the bridge foundation has large variations. The foundations of the piers rest on two types of soil, clay, and sand. [Figure E-7](#) shows a riprap failure that occurred around Pier P1. This is the location where the TBS are buried. A soil sample was taken during the drilling process for the installation of the TBS. The soil beneath the Pier P3 is silty clay, which may be seen in [Figure E-8](#).

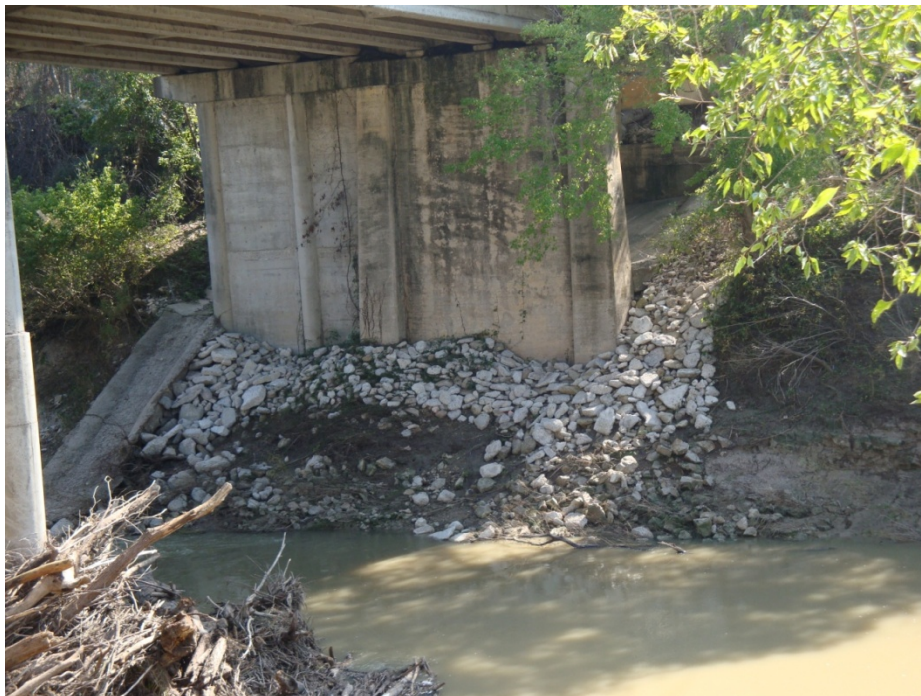
Figure E-8. Silty Clay at Pier P3.

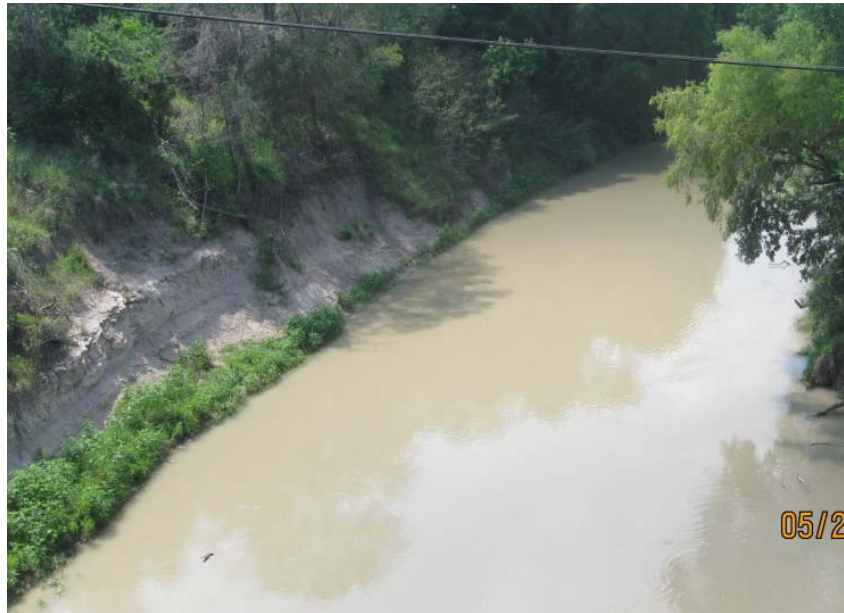
Figure E-9. Northern Bank of San Antonio River (Downstream of the Bridge).

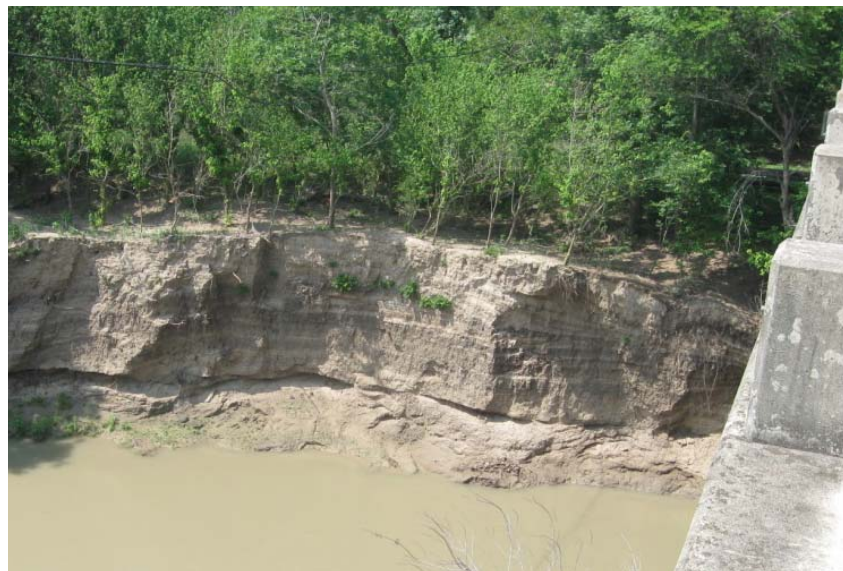
Figure E-10. Southern Bank of San Antonio River (Downstream of the Bridge).

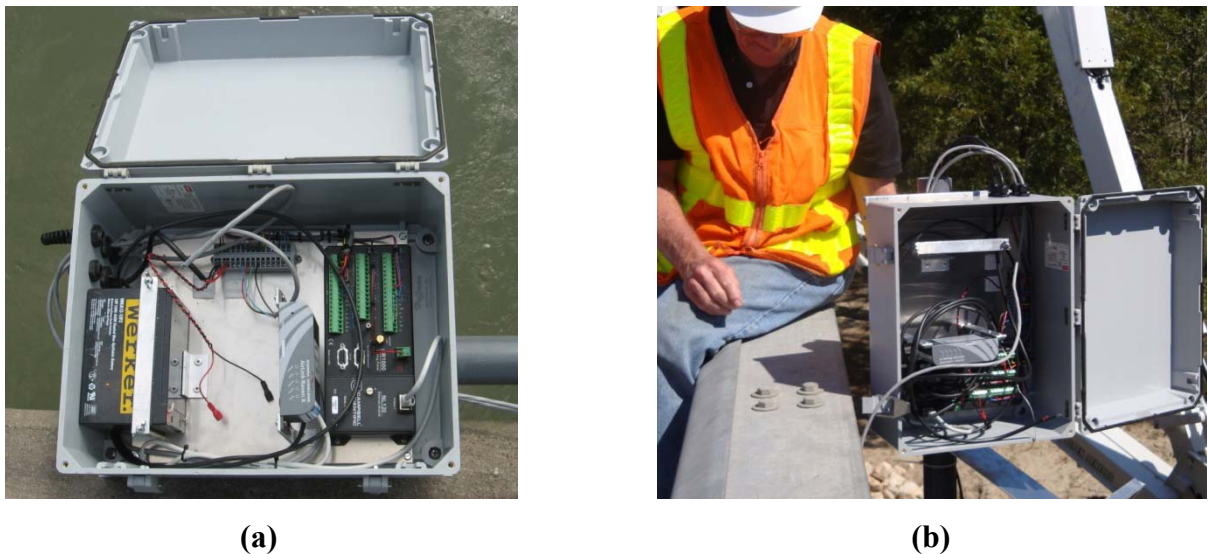
The master station is mounted near Pier P2. A solar panel was installed near the master station to provide power for monitoring system. [Figure E-12](#) shows the installation of the master station at SH80 over San Antonio River Bridge.

Figure E-12. Master Station on SH80 over San Antonio Bridge: (a) During Installation and (b) After Installation.

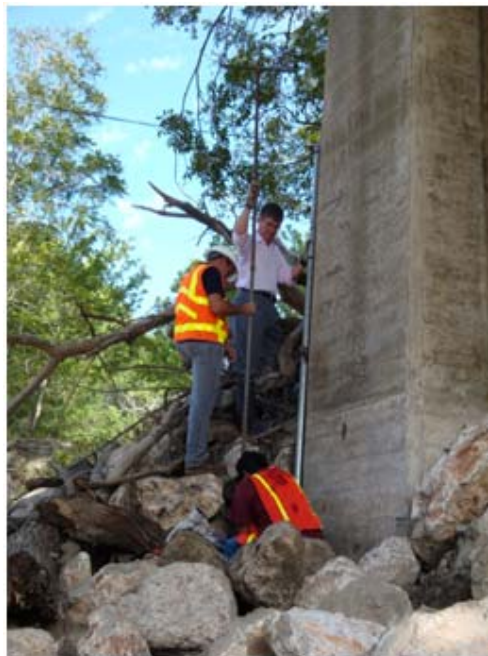
Two TBS devices were installed in the soil near Pier P1. TBS1 was buried 2.4 m (8 ft) below the ground surface at a distance of 12.3 m (41 ft) below the top of the bridge deck. TBS2 was buried 0.9 m (3 ft) above TBS1 at a distance of 11.4 m (38 ft) below the top of the deck. A hand-auger was used to drill a hole into soil ([Figure E-13](#)). The drilled hole was 2.7 m (9 ft) deep.

Figure E-13. Installation of the TBS Using a Hand-Auger.

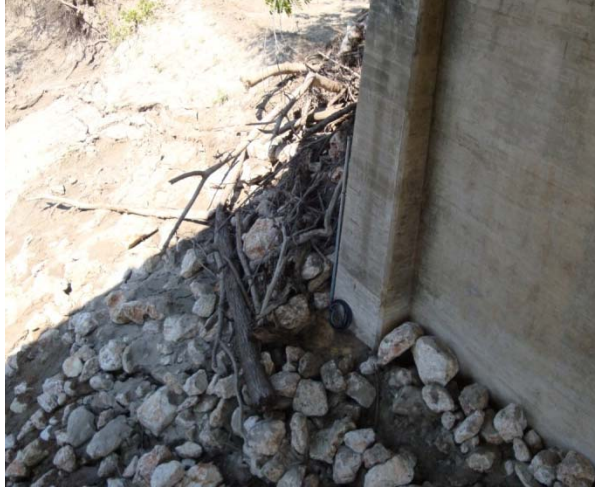
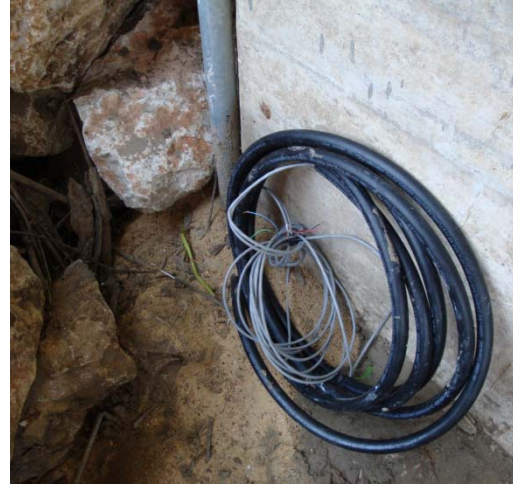
The second step is to wire the TBS to the master station. The conduit that was connected with the TBS wire directly was fixed on Pier P1 vertically. The wire coming from the master station in the downstream side of the bridge was mounted in an “L” route along the bridge deck and Pier P1, covered by a cable-protection-pipe. [Figure E-14](#) shows the photos after the installation of the TBS.

Figure E-14. Installed TBS Devices: (a) Conduit and (b) Close-Up View of Conduit.

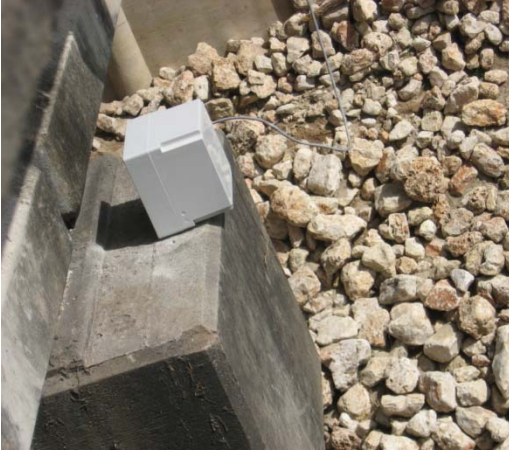
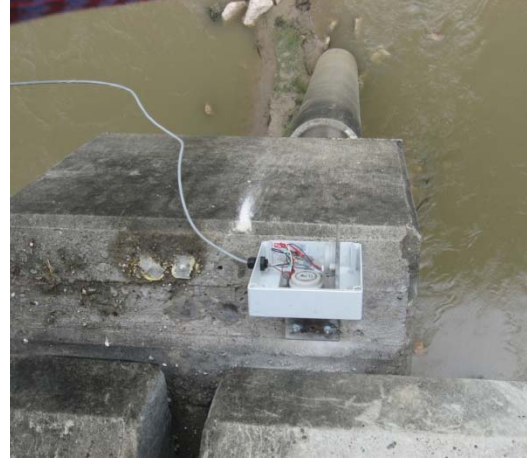
One dual-axis tiltmeter (Tiltmeter1 and Tiltmeter2) was installed on the pier cap of river Pier P2 to measure simultaneously the tilt angle of the bridge pier around two axes ([Figure E-15](#)). It measures the tilt angle of the pier in the flow direction axis and the tilt angle of the pier in the traffic direction axis (perpendicular to the flow direction). The two single-axis tiltmeters were installed on the bridge deck on the left and right side of river pier (P2), respectively. Both of them measure the tilt angle of the deck in the flow direction axis (perpendicular to the traffic direction). The horizontal distance between each single-axis tiltmeter and dual-axis tiltmeter is 3.75 m (12.5 ft).

Figure E-15. Installed Dual-Axis Tiltmeter: (a) Side View and (b) Top View.

Four tiltmeters were installed on the SH80 Bridge as shown in [Figure E-11](#). They are housed in three enclosures that are bolted and glued to the bridge at three locations. The sensors include one dual-axis tiltmeter and two single-axis tiltmeters. All the tiltmeters are wired to the data logger CR1000 located in the master station. The data logger is programmed to transmit data every 20 minutes. A snooper truck was used for the installation. [Figures E-15](#) and [E-16](#) show the tiltmeters installed on the bridge.

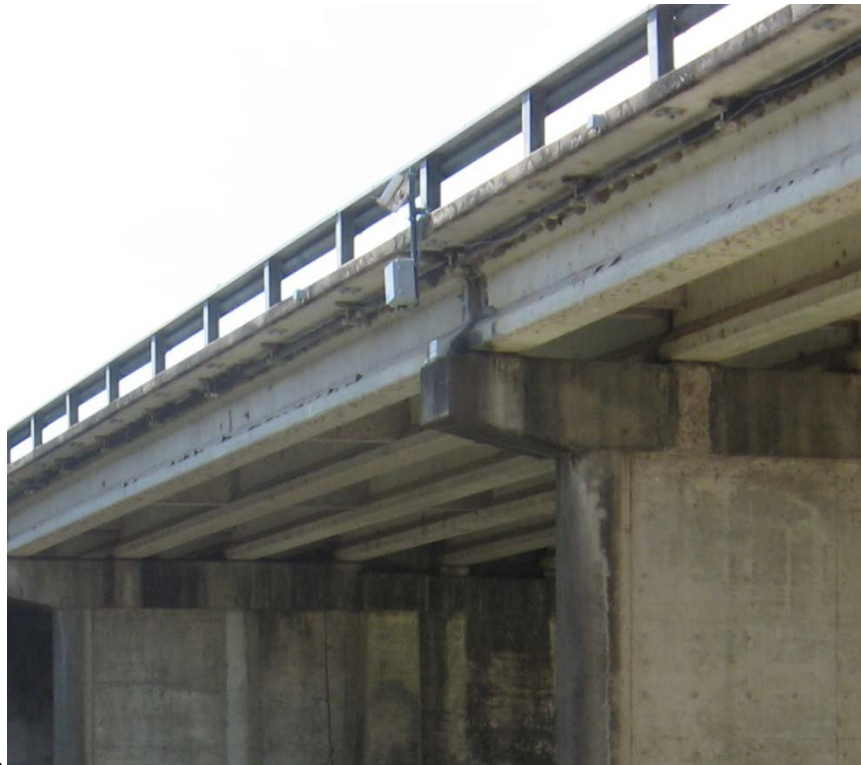
Figure E-16. Bridge Scour Monitoring System.

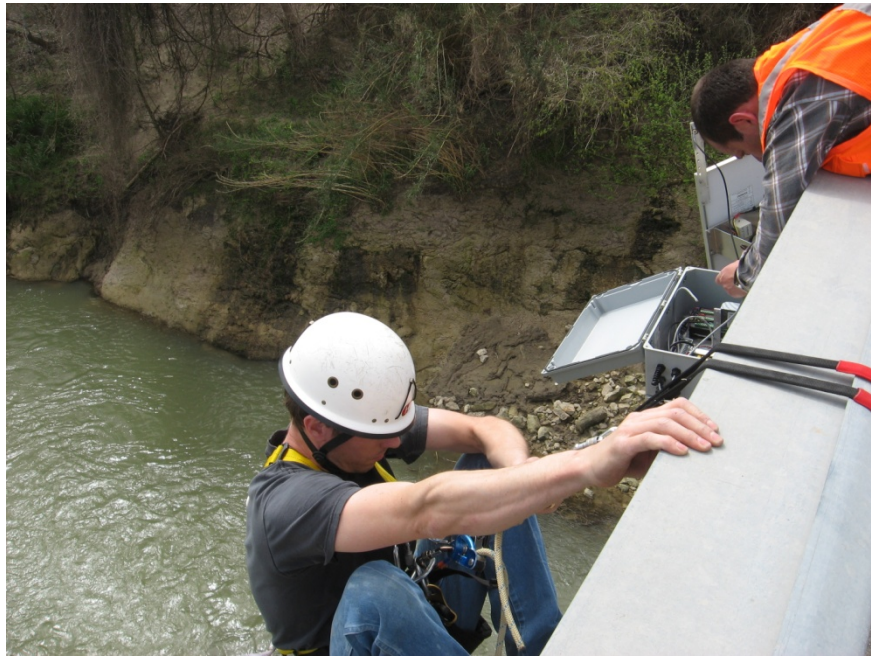
- **Figure E-24. Repairs Conducted by a Climber in Order to Avoid Lane Closures.**

- Keys may be required to open instrumentation boxes or doors.
- A snooper, manlift, or a climber is required to access portions of the instrumentation mounted on the pier and bridge fascia ([Figure E-24](#)).
- Lane closures may be required. Proper maintenance and protection of traffic as well as inspection/repair crew safety will be needed.
- Security clearance may be required to access parts or all of the bridge. Contact the appropriate authorities and notify them when and where the work is scheduled to take place.
