1. Report No. FHWA/TX-11/0-6103-1		2. Government Accession No.		3. Recipient's Catalog No.	
4. Title and Subtitle STUDIES TO DETERMINE THE EFFECTIVENESS OF LONGITUDINAL CHANNELIZING DEVICES IN WORK ZONES				5. Report Date October 2010 Published: January 2011

# **STUDIES TO DETERMINE THE EFFECTIVENESS OF LONGITUDINAL CHANNELIZING DEVICES IN WORK ZONES**

Report 0-6103-1

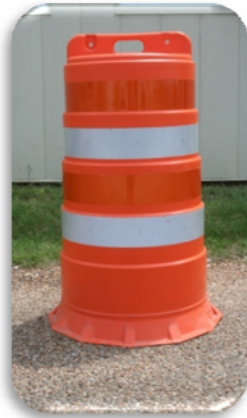
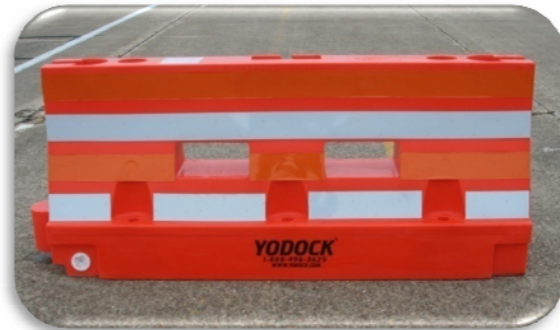
**Figure 5. Example of Devices Studied.**

Two types of devices were used during this study. The first was conventional channelizing drums, while the other was LCDs placed in a continuous alignment. Both devices are shown in [Figure 5](#).

**(a) Standard Drum**

**(b) LCD**

[Table 6](#) contains the dimensions of the devices studied. During a demonstration, TxDOT personnel and TTI researchers determined that taller LCDs (46 inches) blocked the view of the exit ramp opening when used in the upstream tangent and taper, which may cause confusion due to a lack of positive guidance. In addition, TxDOT personnel and researchers were concerned that the taller LCDs might block the view of a stalled passenger car on the exit ramp. Thus, researchers decided to use the 32-inch tall LCDs in this study.

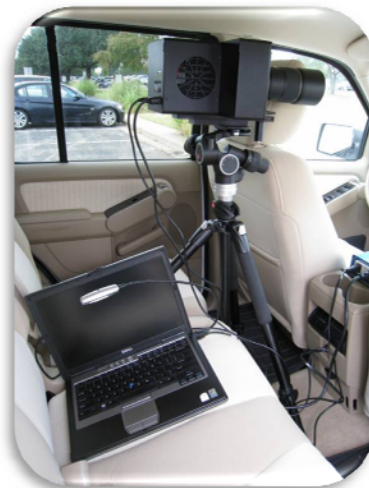
**Figure 7. Photometric Analysis Equipment.**

All of the photometric measurements were taken at night on the runway network of the Texas A&M University Riverside Campus. Researchers obtained all of the photometric measurements from a 2009 Ford Explorer using a Radiant Imaging ProMetric 16-bit Charge-Couple Device (CCD) Photometer (see Figure 7). The CCD measurements were captured from the driver's perspective. Researchers set the headlights in the low-beam configuration and placed the vehicle in the center of the travel lane adjacent to the closed lane. The elevation of the center of the headlights was 36 inches from the pavement surface, and the CCD elevation was 60 inches from the pavement surface.

measurements from a 2009 Ford Explorer using a Radiant Imaging ProMetric 16-bit CCD Photometer (see [Figure 7](#)). As discussed previously in [Chapter 3](#), the CCD measurements were captured from the driver's perspective. Researchers set the headlights in the low-beam configuration and placed the vehicle in the center of the travel lane adjacent to the closed lane. The elevation of the center of the headlights was 36 inches from the pavement surface, and the CCD elevation was 60 inches from the pavement surface. For each treatment, researchers took photometric measurements 100 ft upstream of the beginning of the lane closure. Researchers also measured the illuminance to ensure that the ambient lighting conditions were similar for each treatment during each phase and between phases.

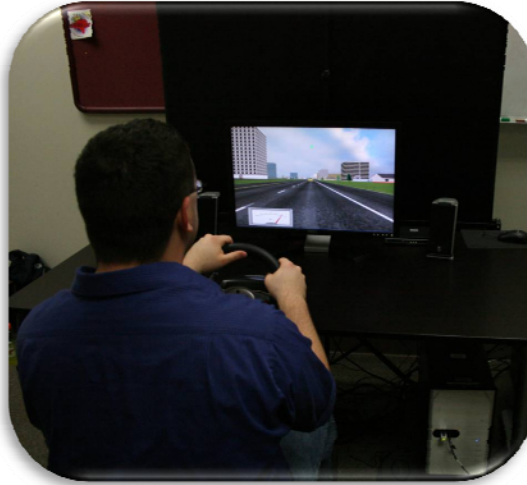
**Figure 12. TTI Desktop Driving Simulator.**

The driving simulator offers a library of different roadway cross-sections and interchanges. Using this library, simulator scenarios, or "worlds," were created to represent long drives on an urban four-lane arterial road.

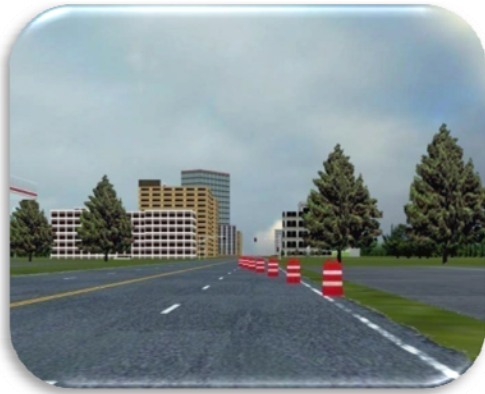
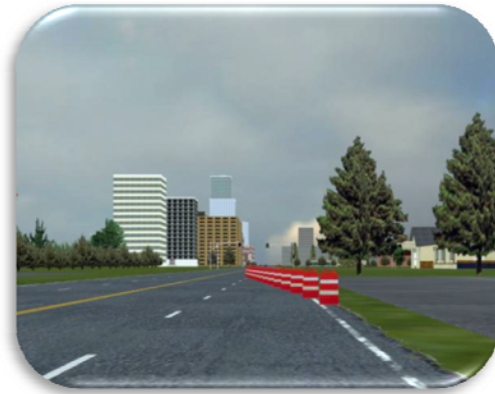
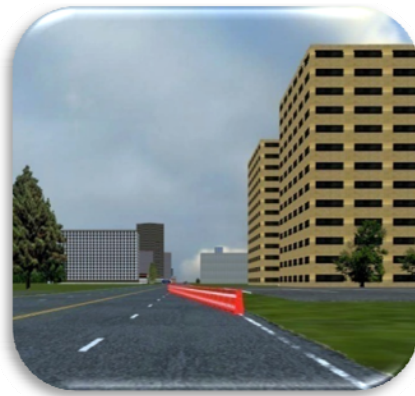
**Figure 13. Lane Closure Treatments for Simulator Study.**

Drivers encountered all three treatments in both the right and the left lane. In addition, for each treatment and lane position, the driver's view was either occluded by a large vehicle travelling in the lane ahead of them (i.e., lead vehicle) or not occluded (i.e., no other vehicles between them and the treatment). All participants viewed the treatments in both lanes under occluded and not occluded conditions. Thus, each participant drove through 12 lane closure treatments.

**(a) Drums Spaced at 30 ft**

**(b) Drums Spaced at 15 ft**

**(c) Continuous LCDs**

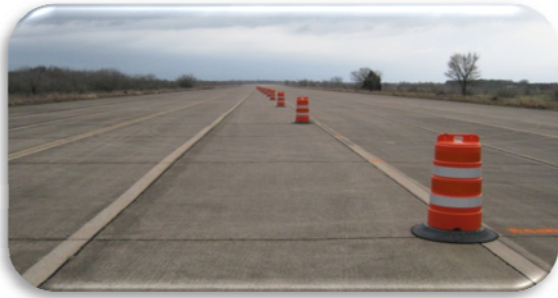
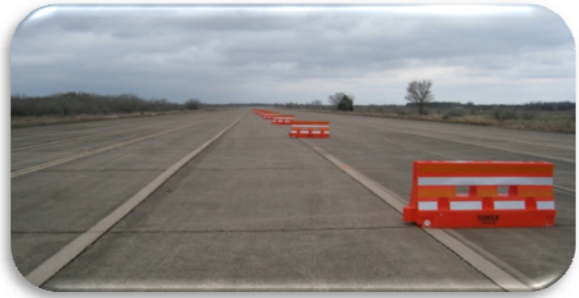
**Figure 14. Examples of the Lane Closure Treatments for the Detection Distance and Turning Movement Evaluations.**

the closer drum spacing (or every other lane stripe), and the 120-ft LCD spacing was two times the standard device spacing.

(a) Example of Drum Treatment

(b) Example of LCD Treatment

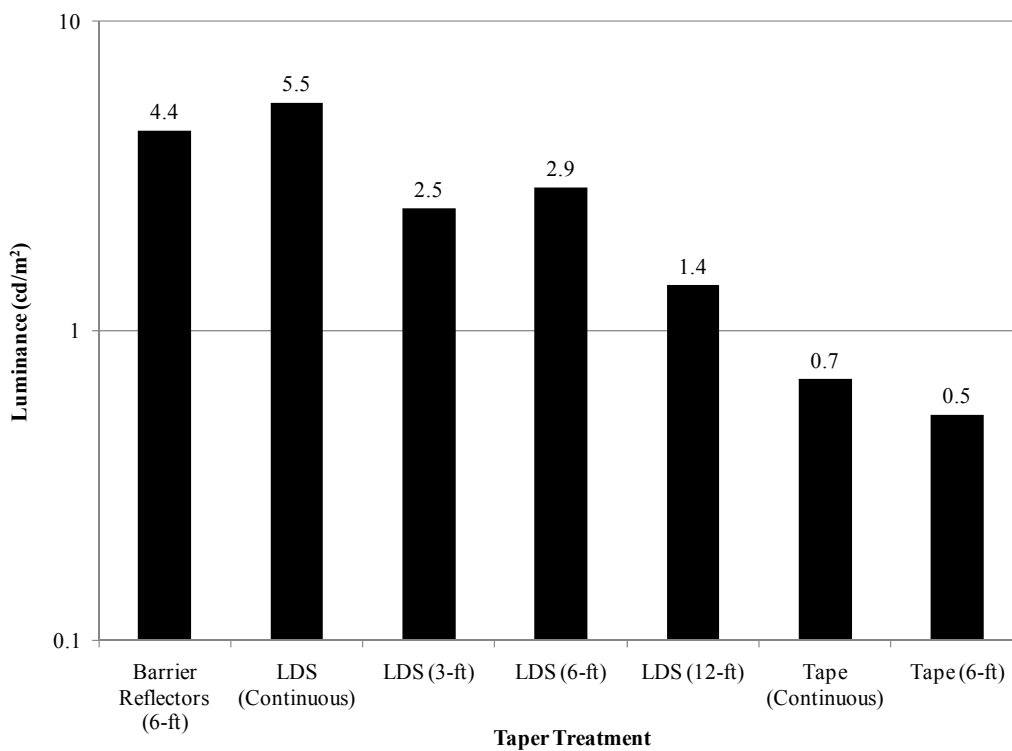
**Figure 23. Luminance Data for Phase II Taper Treatments.**

mean lane change distance upstream of the lane closure compared to the standard drum treatment (30-ft spacing). While participants did prefer the continuous LCD treatment because the solid line of devices pointed out the correct direction and attracted their attention better, the photometric analysis of various continuous LCD delineation treatments showed that none of the delineation treatments produced luminance values equal to a standard drum treatment. In addition, unlike drums, none of the continuous LCD delineation treatments clearly convey to drivers the actual size of the device. Therefore, researchers do not recommend the use of continuous LCDs to form a lane closure merging taper.

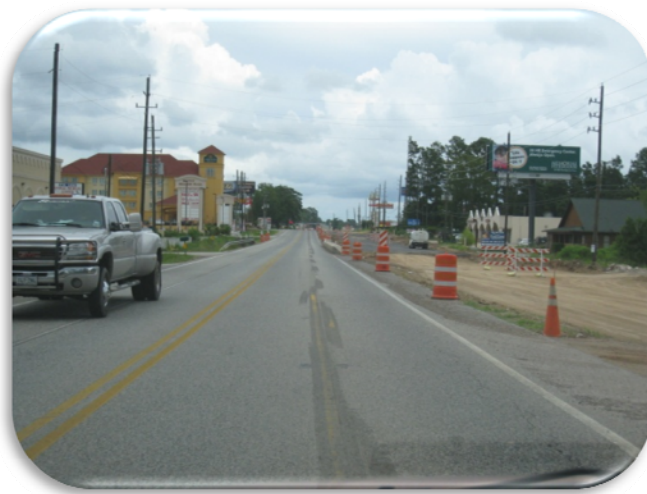
**Figure 24. Example of an Urban Roadway under Construction.**

As shown in [Figure 24](#), when an urban roadway is under construction the alteration of the driving environment (e.g., closed lanes, work activity, expanded right-of-way, etc.) may make it more difficult for drivers to determine the location of business and residence driveways. This could lead to driver confusion, erratic maneuvers like hard braking to make a sudden turn, and intrusions when drivers turn into the work zone in the wrong location.

NOTE: A business driveway is located between the second and third drum.

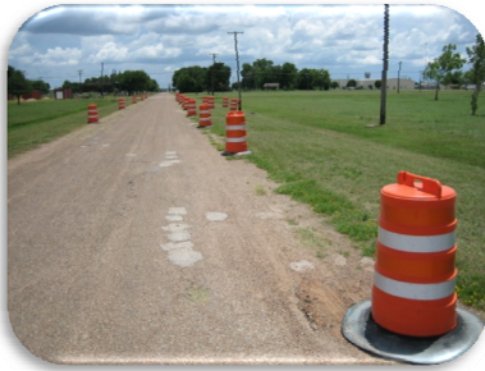
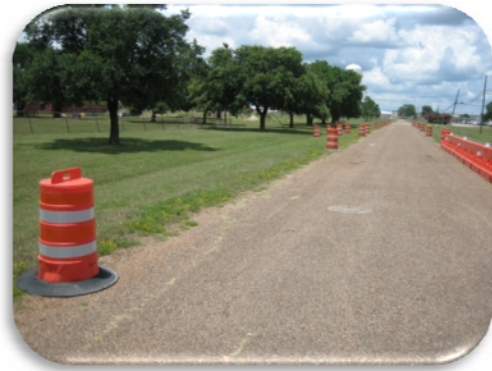
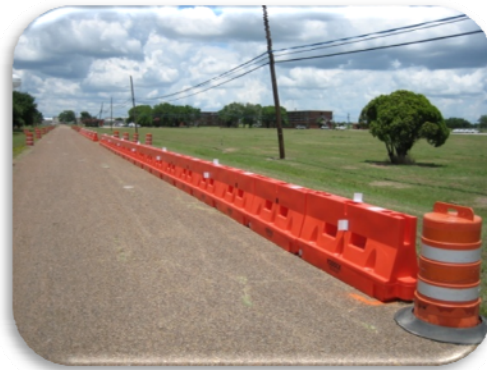
The other work zone was approximately 900 ft long and contained two simulated 24-ft driveways. Again, the driveways were marked on each side with three drums placed in a line perpendicular to the roadway. One driveway was located on the west side of the road approximately 300 ft from the north end of the work zone. Surrounding this driveway was Treatment 2, which consisted of drums spaced every 60-ft (standard spacing) in the area 120-ft upstream and 120-ft downstream of the driveway. The second driveway was located on the east side of the road approximately 600 ft from the north end of the work zone. Surrounding this driveway was Treatment 3, which consisted of 32-inch tall LCDs placed in a continuous alignment in the area 120-ft upstream and 120-ft downstream of the driveway. Based on the results from the exit ramp evaluations, researchers utilized barrier reflectors (two white barrier reflectors in the middle of every third device: one on top of the LCD and one mounted on the side of the LCD directly below the one on top) to delineate the LCDs. However, since researchers conducted the driveway study during the day, researchers did not expect this change in delineation from the previous human-factors closed-course studies to impact the results.

**(a) Treatment 1**

**(b) Treatment 2**

**(c) Treatment 3**

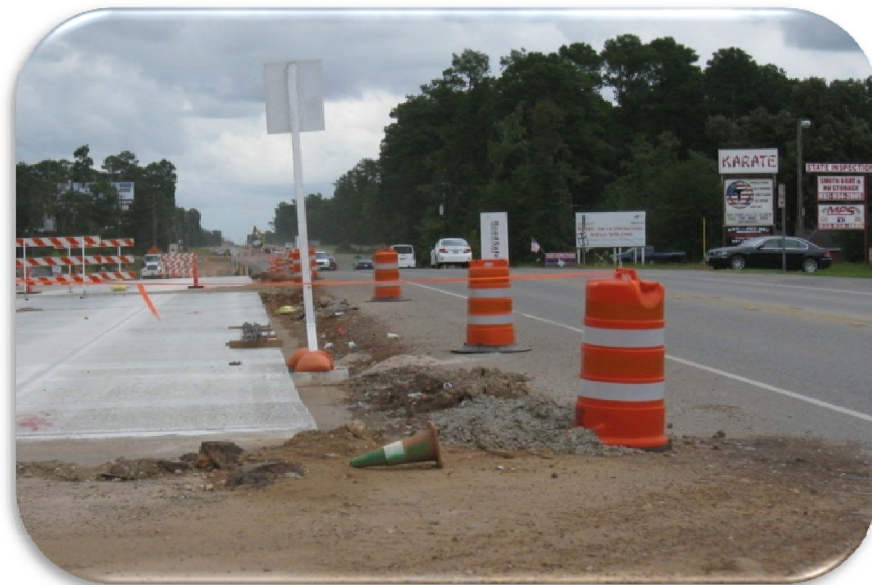
**Figure 26. Driver's View from a Passenger Car on a Minor-Road Approach in a Work Zone.**

Figure 26 shows the driver's view from a passenger car on a minor-road approach in a work zone using drums to delineate the edge of the roadway. In this example, it is possible to see approaching traffic by looking between the drums. If continuous LCDs were used to define the edge of the shoulder, drivers would need to be able to see approaching traffic by looking over the devices. In this case, vertical sight distance depends upon driver eye height, the height of the critical object that the driver is trying to see (i.e., the approaching vehicle), the height of any obstructing objects located between the driver and the critical object (such as LCDs), as well as the relative distances between these three heights. Researchers used the descriptive statistics for passenger cars shown in Table 25 (18).

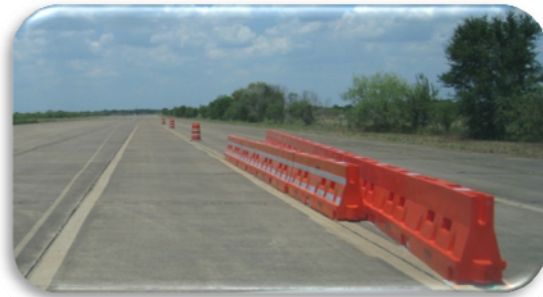
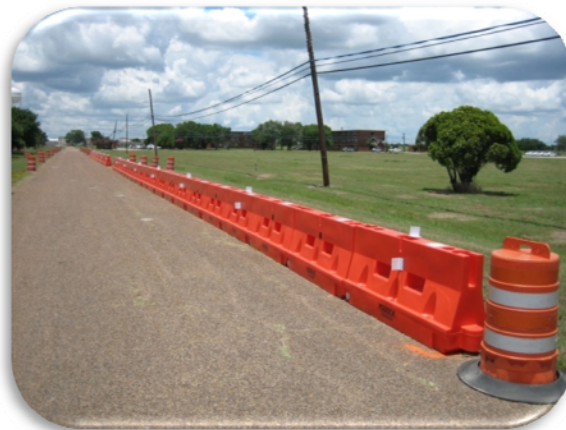
Again, all LCDs must be crashworthy; however, the test level for which each device is approved varies. Also, some LCDs can be used with and without ballast (i.e., water or sand), and some LCDs have been approved with or without the use of other traffic control devices (e.g., warning lights, delineators, and signs). As shown in [Figure 32](#), in the exit ramp and driveway scenarios studied, the blunt end of the continuous LCD sections was either exposed or shielded with a drum. Additional crash testing may be needed to determine the necessity for end treatments if there is a potential for instability when an end-on collision occurs.

**(a) Exposed Ends of the Downstream Taper and Tangent – Exit Ramp Scenario.**

**(b) Drum in Front of Upstream End of Continuous LCDs – Driveway Scenario.**
