1. Report No. FHWA/TX-10/0-6271-1		2. Government Accession No.		3. Recipient's Catalog No.	
4. Title and Subtitle FIELD AND LABORATORY INVESTIGATIONS FOR FULL DEPTH RECLAMATION PROJECTS				5. Report Date November 2009 Resubmitted: January 2011 Published: March 2011

**FIELD AND LABORATORY INVESTIGATIONS FOR
FULL DEPTH RECLAMATION PROJECTS**

Report 0-6271-1

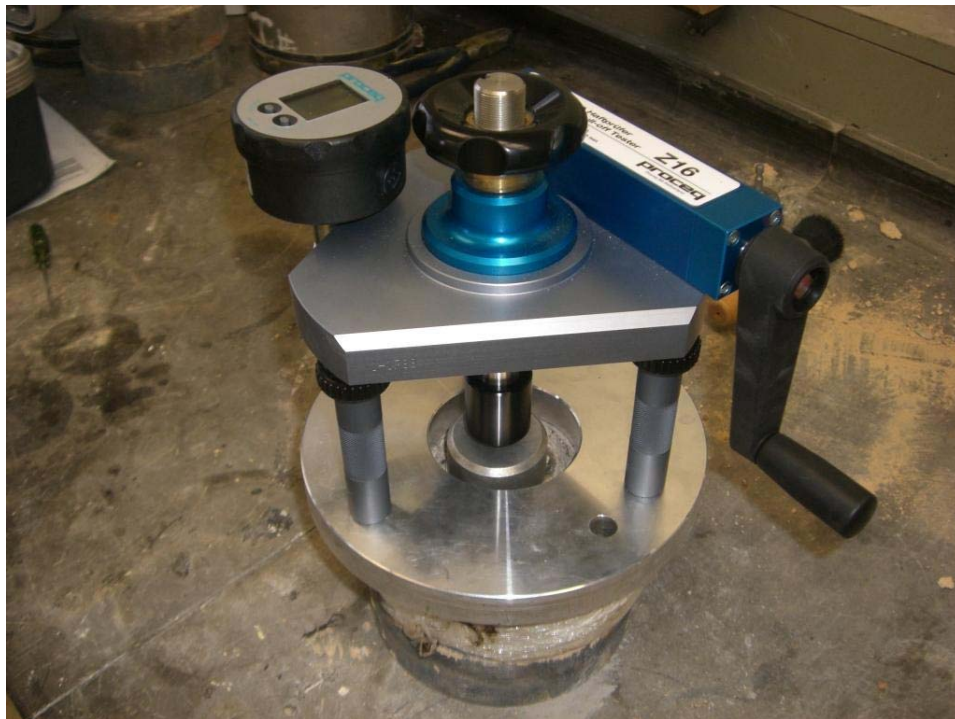
Figure 2.3. Photo of Direct Tensile Bond Test Apparatus.

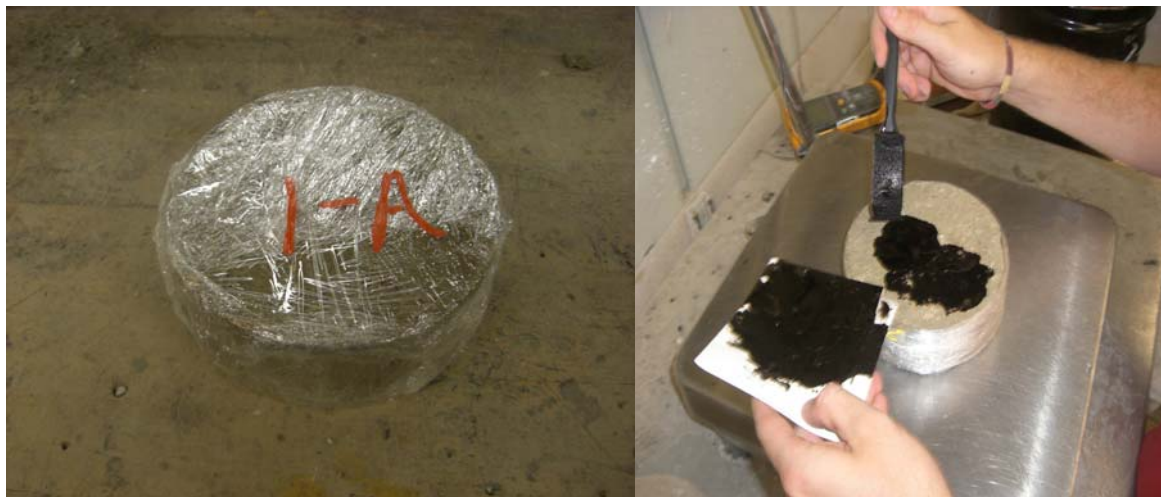
Step 3. Cover entire sample with plastic wrap for 1 hr. After 1 hr remove sample from plastic wrap and re-wrap the sample with plastic leaving only the top surface exposed. Apply prime material at predetermined application rate to the specimen surface ([Figure 2.4](#)).

Figure 2.4. Application of Prime to Base Sample.

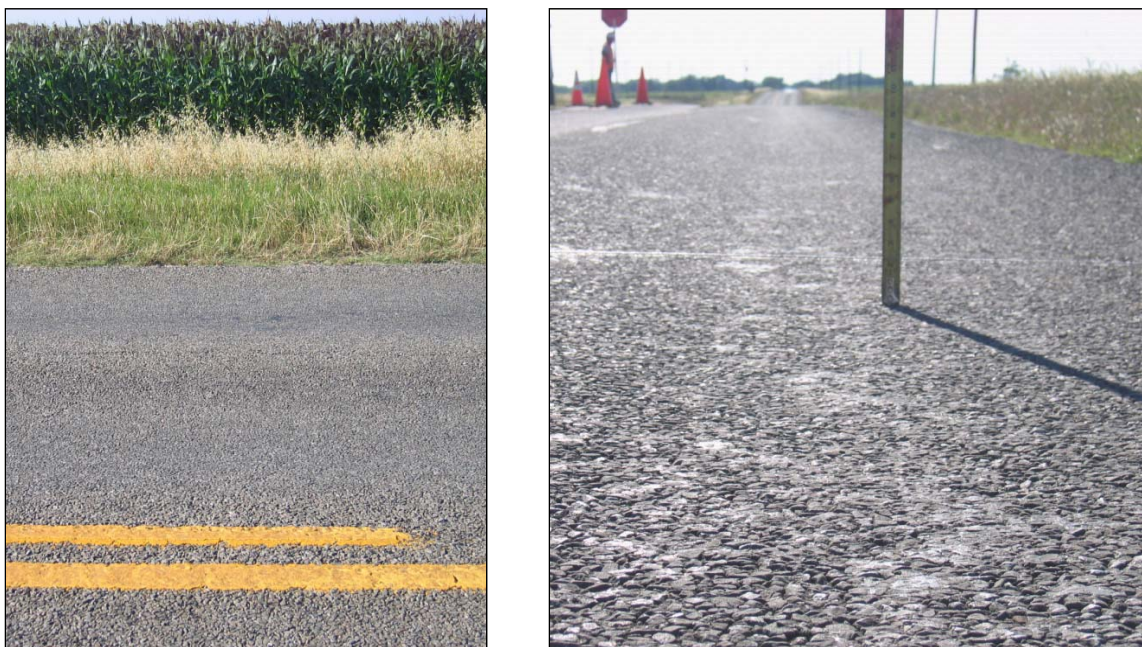
The primary distress is rutting, which exceeds 2 in. in some locations. The project also has some longitudinal cracking. [Figure 3.1](#) shows the pavement condition.

Figure 3.1. Rutting on FM 487.

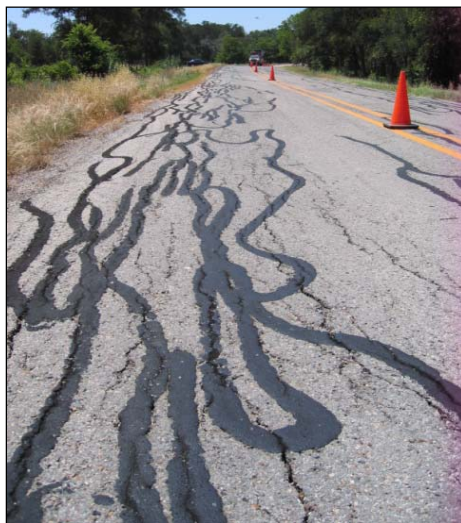
Figure 4.7. Longitudinal Cracking on FM 112.

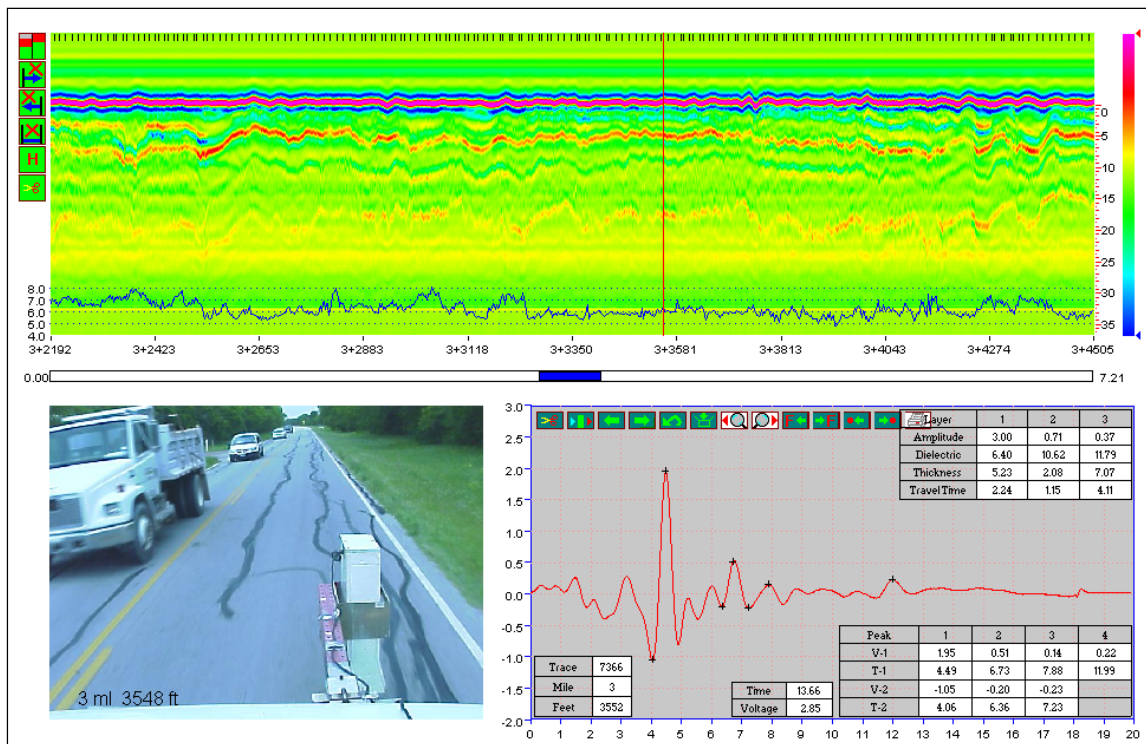
Figure 5.3. GPR Data Representative of Majority of FM 969 Project.

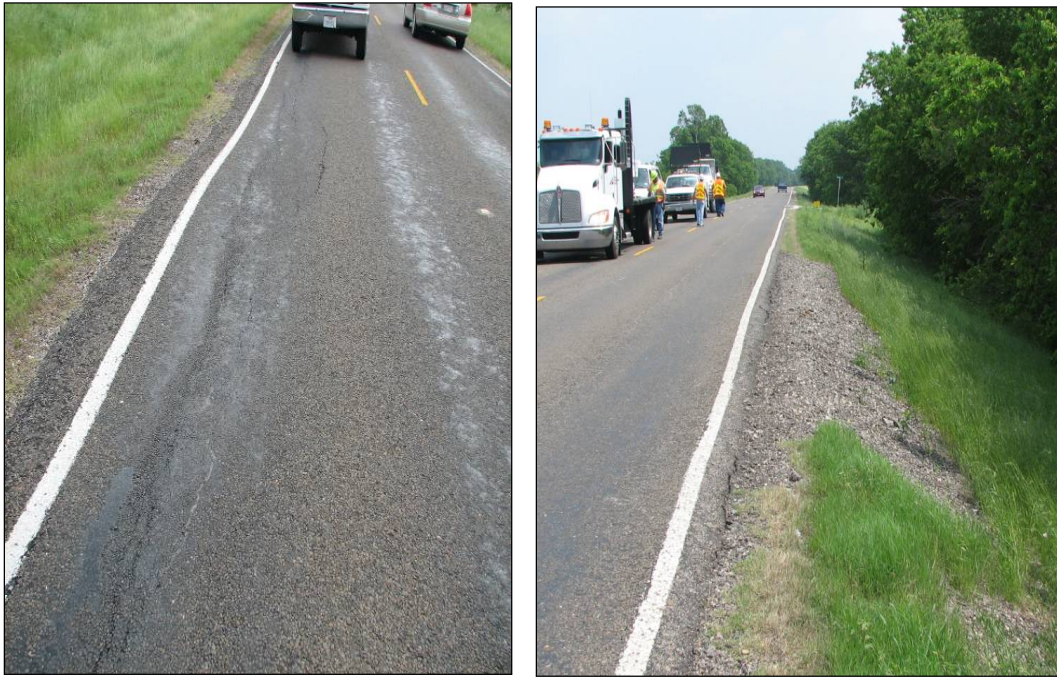
Figure 7.1. Typical Edge Failure on FM 148.
