1. Report No. FHWA/TX-10/0-6384-1		2. Government Accession No.		3. Recipient's Catalog No.	
4. Title and Subtitle ON-GOING EVALUATION OF TRAFFIC CONTROL DEVICES				5. Report Date November 2009 Published: September 2010

ON-GOING EVALUATION OF TRAFFIC CONTROL DEVICES

Report 0-6384-1

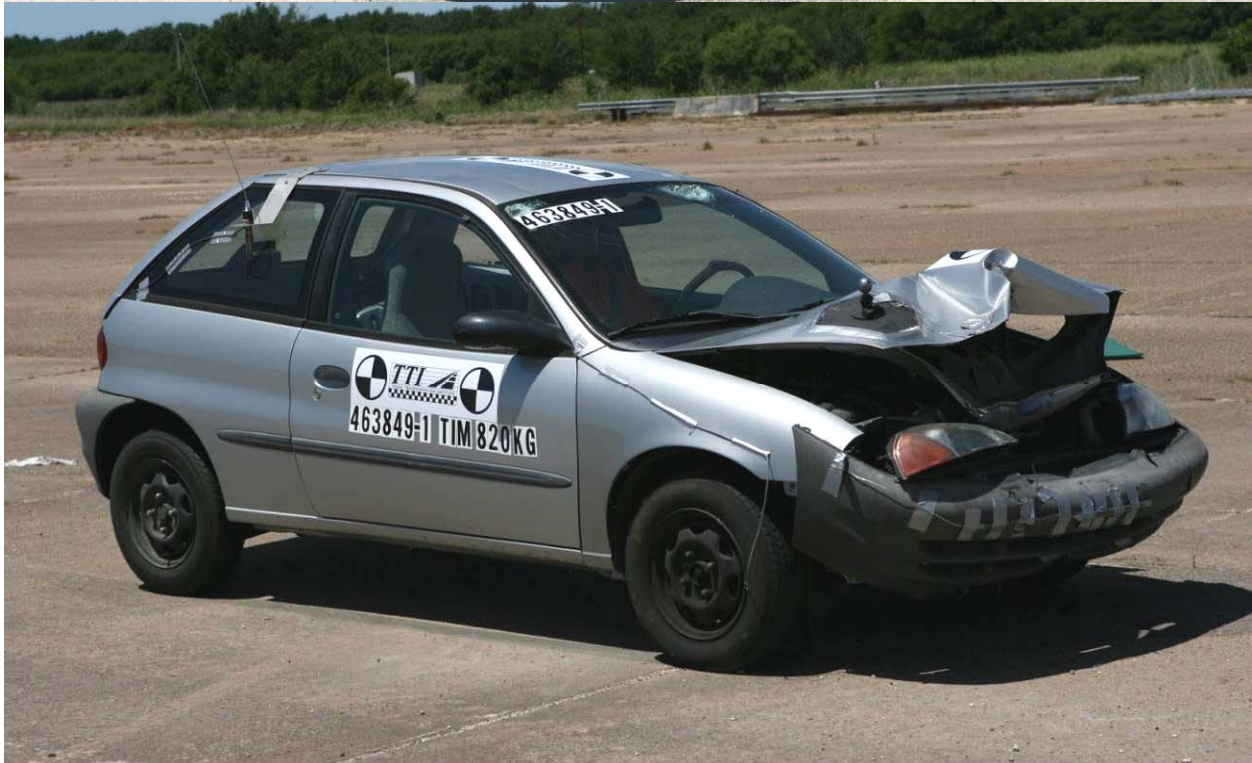
Figure 7. Vehicle after Test 463849-1.

Figure 7 shows the damage to the front of the vehicle, the windshield, and the roof of the vehicle. The hood was crumpled upward. Two pinprick holes were found in the windshield, one in the upper corner on the passenger side where the glass was cracked over an area measuring 6.3 inches × 5.5 inches × 0.8 inches deep, and the second in a damaged area that measured 8.3 inches × 5.7 inches × 1.2 inches deep. It is noted that the windshield damage resulted from the first sign support system being shoved into the windshield by contact with the second sign support system and was not attributable to the vehicle impacting the first sign support system. The roof had several dents, the deepest of which was 0.5-inch deep. The left rear window glass was also broken. Maximum exterior crush to the vehicle was 7.9 inches in the center front at bumper height. No occupant compartment deformation occurred. Figure 8 shows photographs of the interior of the vehicle. Exterior crush measurements and occupant compartment measurements can be found in Appendix B, Tables B1 and B2.

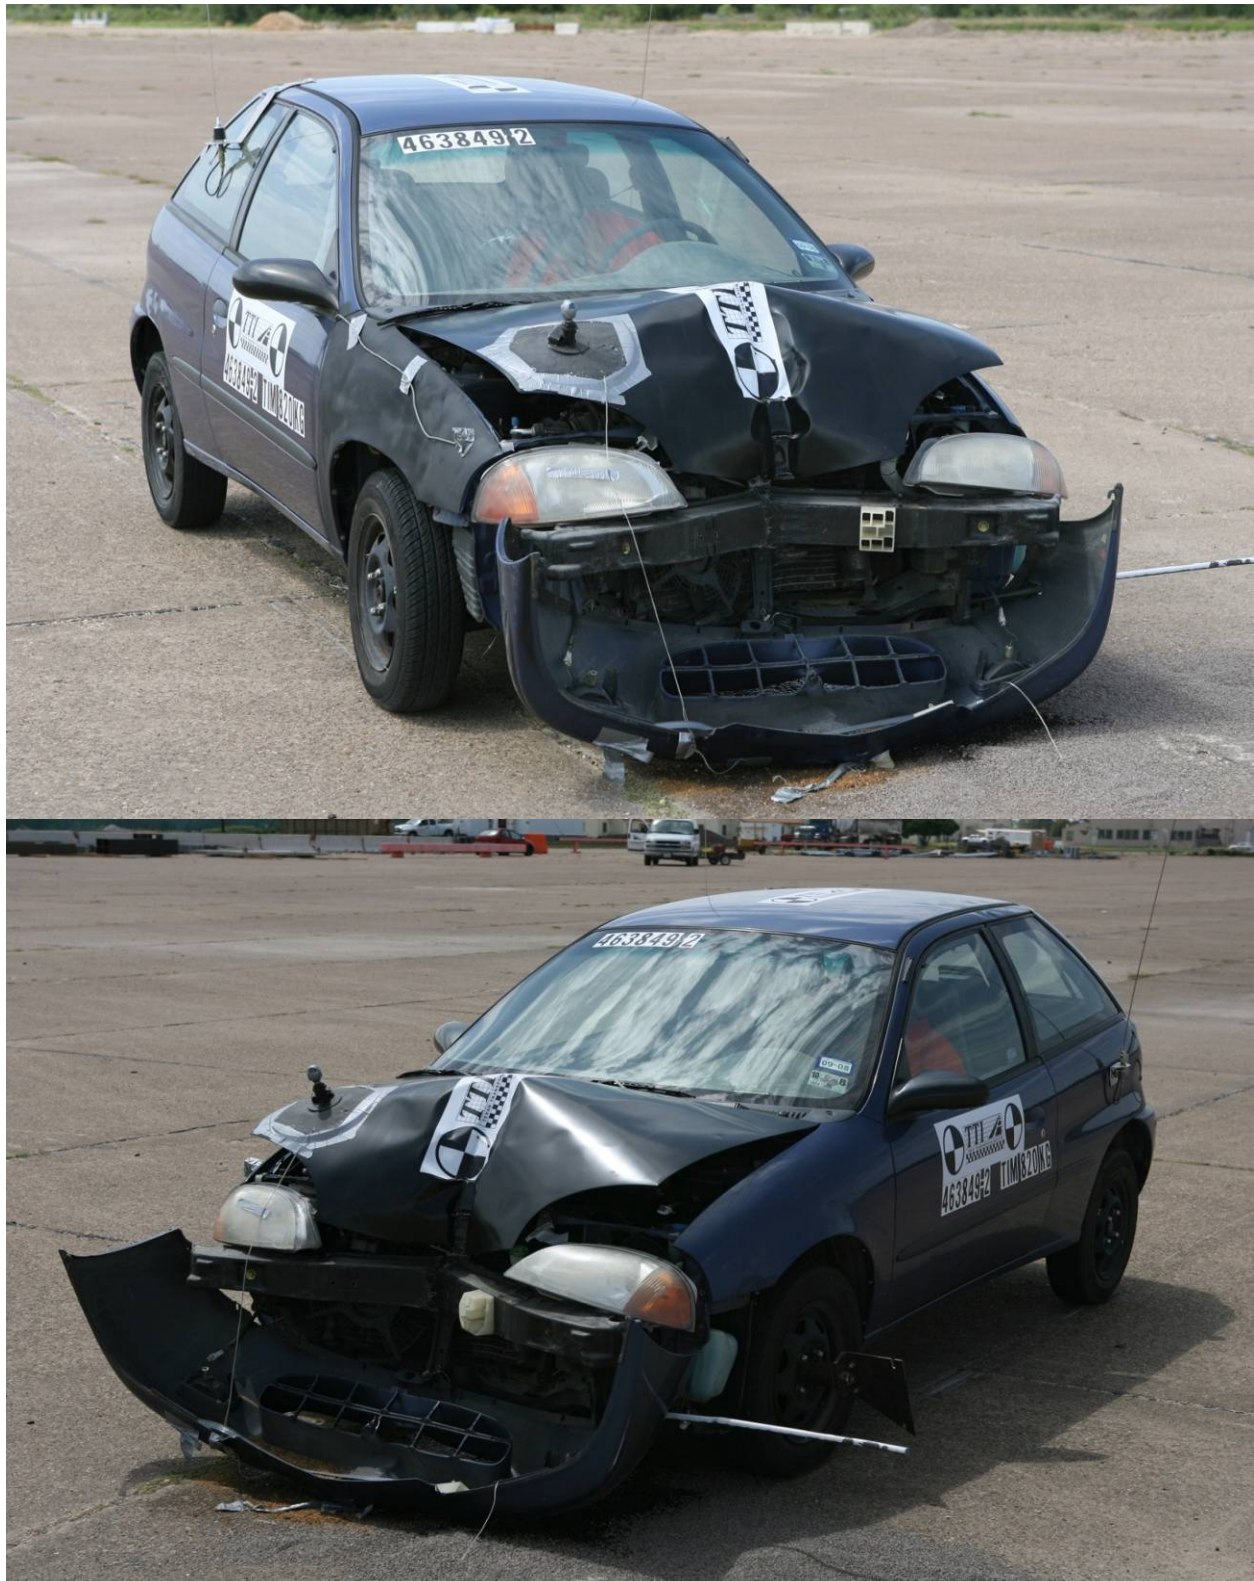
Figure 14. Vehicle after Test 463849-2.

Figure 14 shows the damage to the front of the vehicle, the hood and the roof of the vehicle. The hood was crumpled upward. Maximum exterior crush to the vehicle was 9.1 inches in the center front at bumper height. No occupant compartment deformation occurred. Figure 15 shows photographs of the interior of the vehicle. Exterior crush measurements and occupant compartment measurements can be found in Appendix B, Tables B3 and B4.

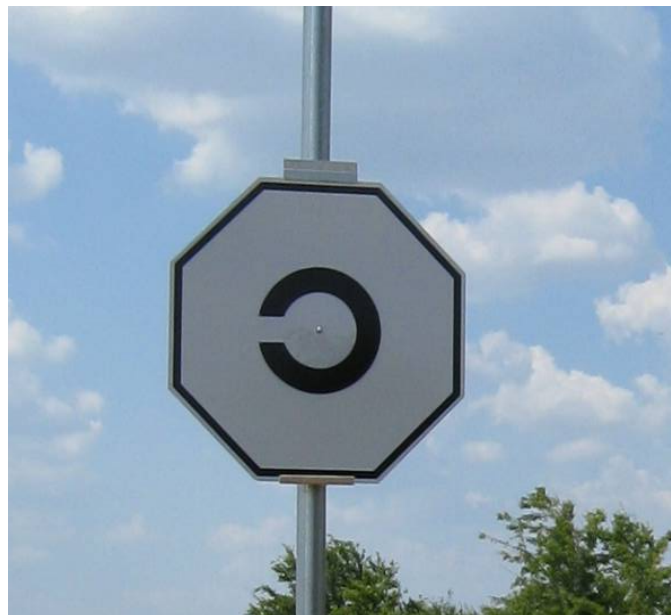
Figure 19. Example of a Test Sign with a Landolt C

The legend or target on each sign was a Landolt Ring, a standardized symbol used for testing vision, as shown in Figure 19. The Landolt Ring consists of a ring that has a gap, looking similar to the letter C, so the Landolt Ring has also been referred to as the Landolt C. The stroke width and the gap width are 1/5 of the diameter. The Landolt C was either 10 inches or 6 inches, and the gap was positioned at four locations (left, right, bottom, and top). A 10-inch Landolt C had a 2-inch wide stroke width with a 2-inch gap.

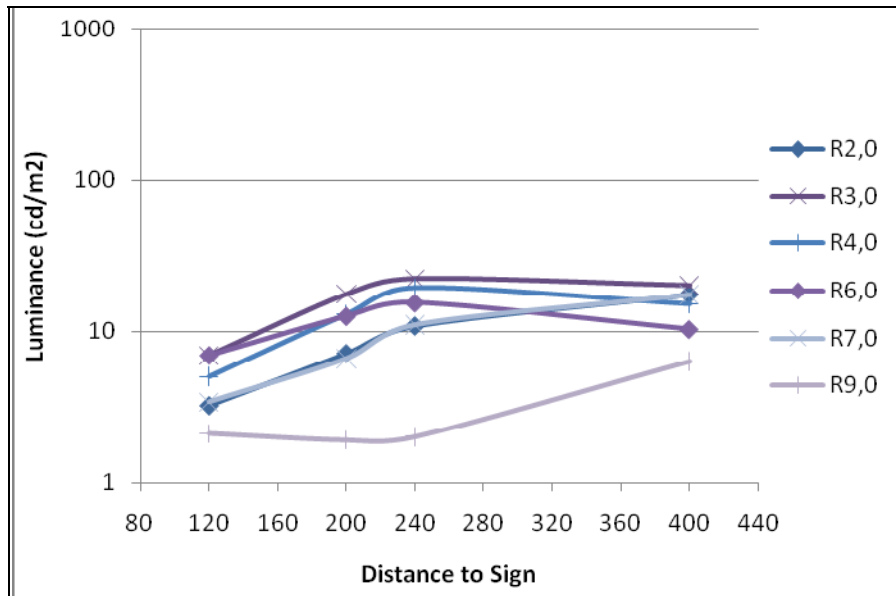
Figure 21. Luminance Levels under Lowbeam Illumination (19.75 ft Offset).

Table 8 and Table 9 list the luminance readings for each of the signs at the indicated distances of measurement. Figure 21 and Figure 22 show plots of the low beam and high beam data for the near offset.

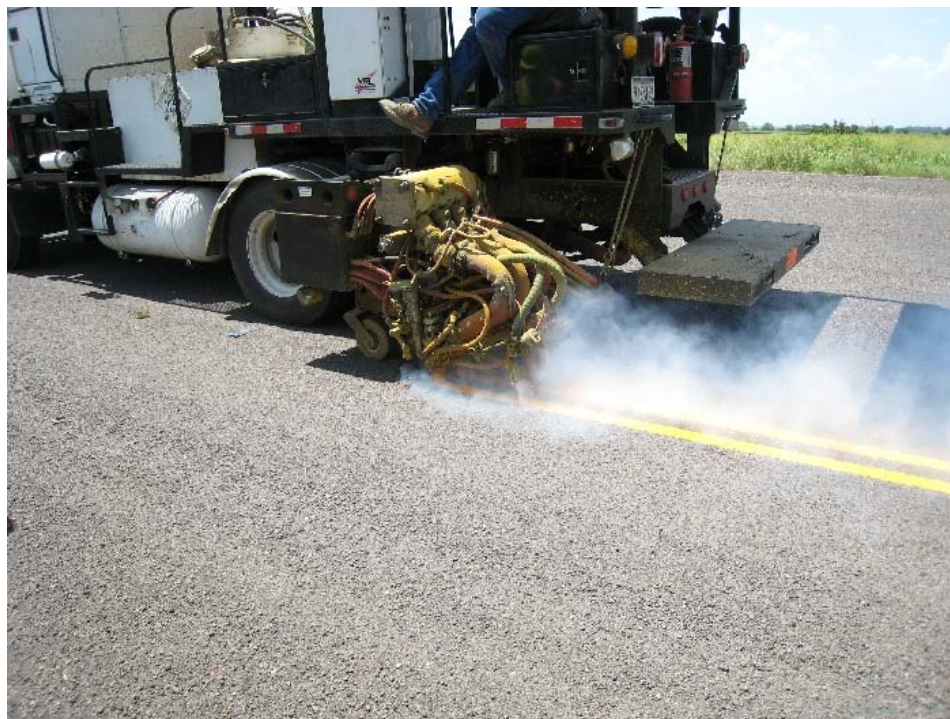
Figure 24. SH 21 Lead-Free Thermoplastic Installation.

The US 79 site included both lead-free and standard yellow thermoplastic materials that were installed on consecutive days in a two-way left-turn lane in the city. The SH 21 site consisted only of lead-free thermoplastic installed as the left edge line on a divided highway, transitioning to a double solid centerline on an undivided highway (see [Figure 24](#)). The US 79 section has an approximate average daily traffic (ADT) of 8000, and the SH 21 section has an approximate ADT of 12,000.

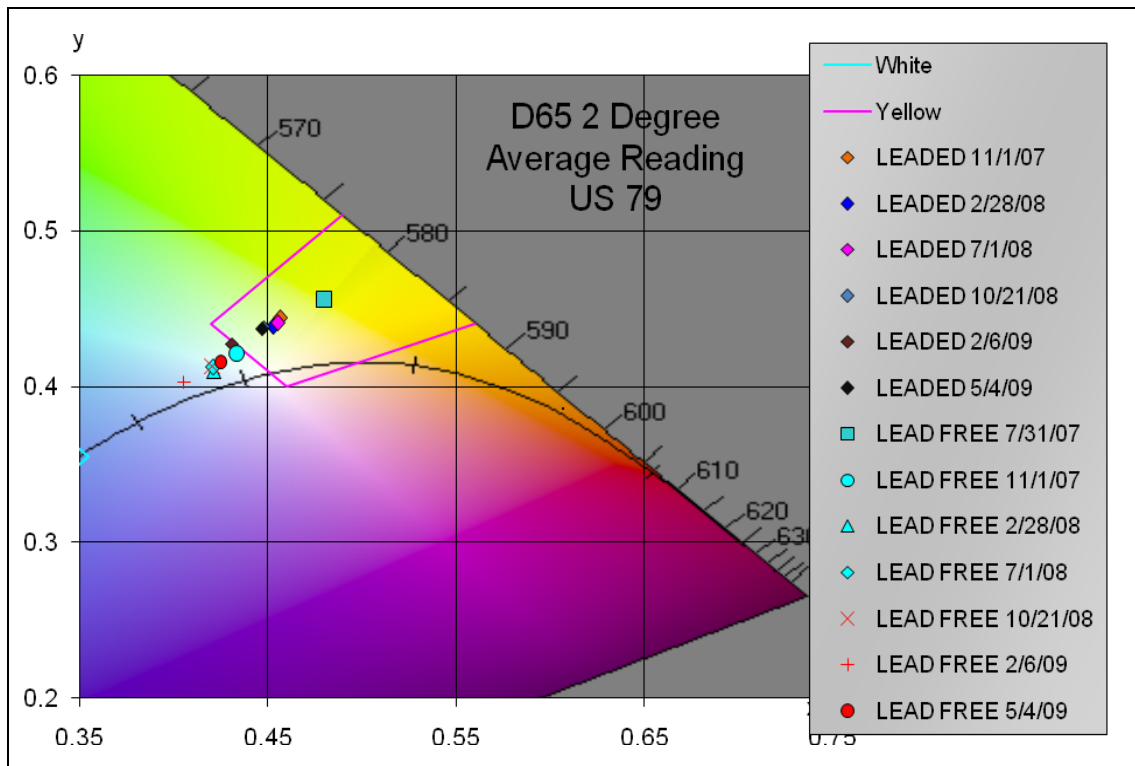
Figure 30. Avg Daytime Color with 2 Degree Standard Observer at US 79 Site.

measurements have fallen outside of the new TxDOT color box requirements. The D65 10° measurements of both the leaded and lead-free material at both sites fall outside of the new TxDOT color box. The leaded material was outside of the box but much closer to the box than the lead-free material was at the US 79 site. At the SH 21 site the D65 10° measurements are right at the border of the color box. The D65 2° measurements of the leaded material all fall within the FHWA color box except for one reading at the US 79 site. The majority of the lead-free material color readings at the US 79 site are outside the D65 2° color box, whereas the measurements at the SH 21 sites are within the color box. The SH 21 D65 2° color readings all fall within the FHWA color box for both leaded and lead-free materials but are less saturated in color than the initial readings. The D65 2° readings of the leaded and lead-free material at the SH 21 site do not show much of a difference between each other, compared to the large difference at the US 79 site.

Subjective visual inspection of color during the data collection indicated a reduction in yellow quality of the markings. This daytime visual inspection would seem to match the D65 color data that was collected on the markings as the color data showed that the markings were moving away from yellow and toward white during daytime conditions. [Appendix F Figure F1](#) shows images taken while conducting data collection at the US 79 site. From the pictures the color change and fading of the marking is noticeable. It should be noted that some of the color change is due to the accumulation of dirt while some of the color change is also due to the aging of the marking and its pigments. The lead-free marking visually appears to be slightly less saturated in yellow appearance than the leaded marking, which is supported with the D65 color data ([Figure 30](#)).
