1. Report No. FHWA/TX-12/0-6408-1		2. Government Accession No.		3. Recipient's Catalog No.	
4. Title and Subtitle RESEARCH AND RECOMMENDATIONS FOR A STATEWIDE SIGN RETROREFLECTIVITY MAINTENANCE PROGRAM				5. Report Date December 2011 Published: April 2012

# **RESEARCH AND RECOMMENDATIONS FOR A STATEWIDE SIGN RETROREFLECTIVITY MAINTENANCE PROGRAM**

Report 0-6408-1  
Project 0-6408  
Project Title: Development of a Statewide Sign Maintenance Program

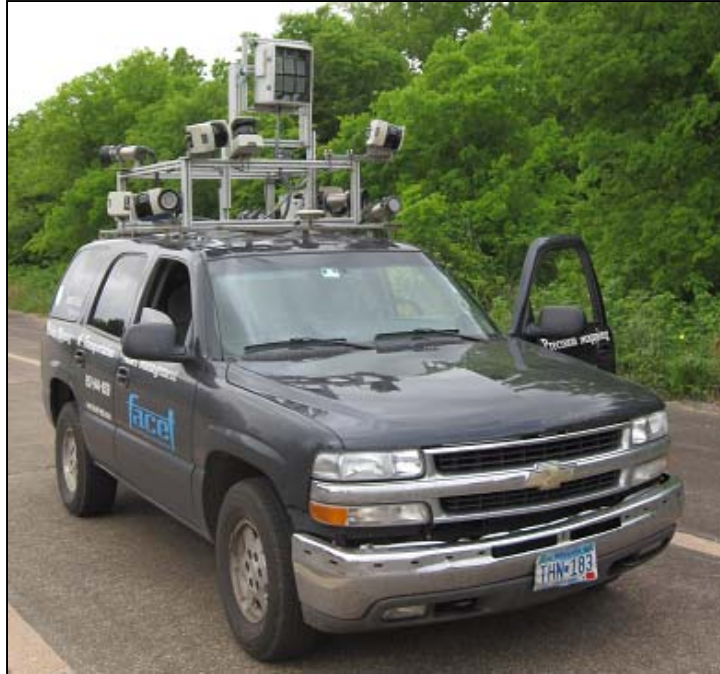
**Figure 3. Mandli Collection Vehicle.**

The data collection vehicle measures sign retroreflectivity during daytime hours. The specialized equipment is mounted on top of a vehicle, and the driver operates the system with a computer from within the vehicle. Once the driver initiates the system, the data will continuously be collected until the system is disengaged. The optimal operating range stated by the developers is collecting data below 55 mph and measuring signs within 50 to 200 ft of the data collection vehicle. [Figure 3](#) shows an image of the data collection vehicle and the assembled equipment.

The retroreflective measuring equipment consists of specialized digital cameras, orthogonal LiDAR scanners, retroreflectivity sensors, and an LED light source. There are up to eight cameras that are mounted at different positions on the roof. The cameras collect right-of-way imagery to be used in the post-processing of sign data, and other relevant roadway information. Similar imaging technology has been employed to create Google Map Street View application, which provides a near continuous 360 degree view of the roadway. The cameras are high resolution and capture color images. Orthogonal LiDAR scanners are mounted in the left, center, right side of the front of the vehicle. The scanners are able to collect in excess of 80,000 points per second and acquire spatial sign information such as GPS location, sign face direction, mounting height, face size, roadway offset, etc. Similarly, the retroreflectivity sensors are positioned in the left, center, and right sides of the vehicle to capture signs on both sides of the roadway and signs overhead. The retroreflectivity sensors consist of precision-aligned cameras that are synchronized to a full-spectrum LED light source. The LED lights exceed 70,000 lumens and strobes at a rate of 15 times per second. Each retroreflectivity sensor captures 45 frames per second.

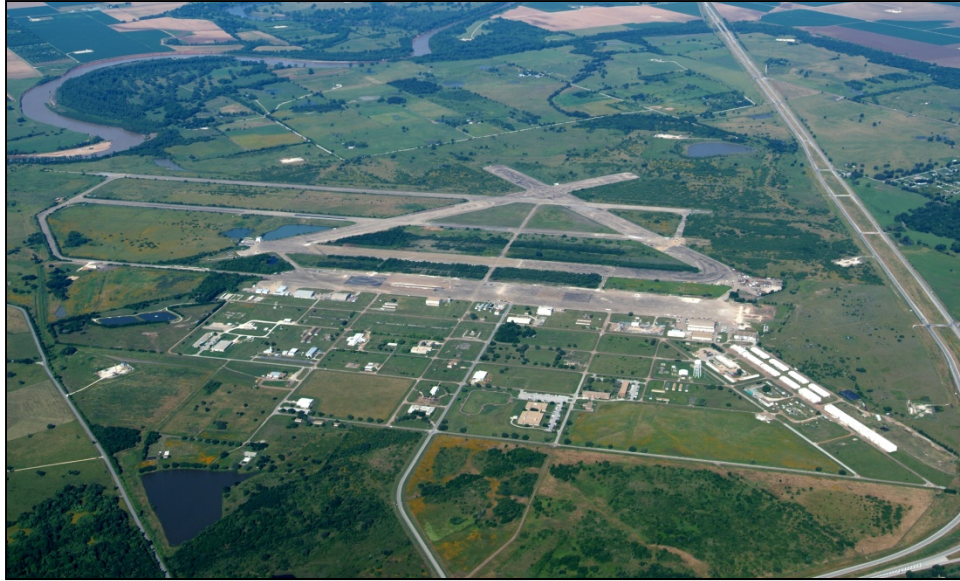
**Figure 4. Riverside Campus.**

The evaluation of the data collection vehicle began at the Texas A&M Riverside campus. The Riverside campus is a retired U.S. Air Force base that enabled the TTI researchers used to test the data collection vehicle in a controlled environment without outside interference. [Figure 4](#) depicts an aerial image of the Riverside campus.

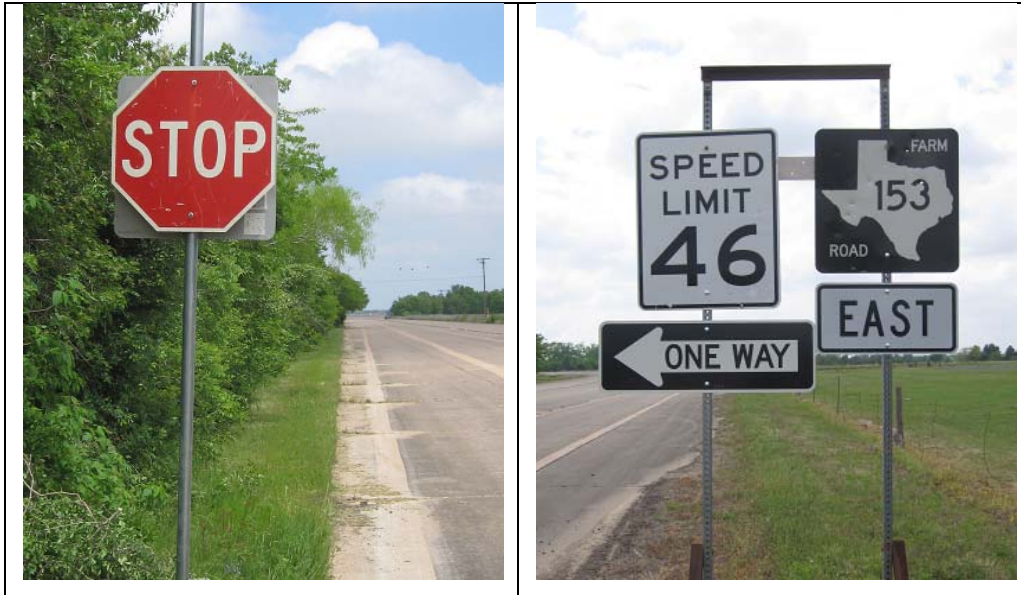
**Figure 5. Closed-Course Test Signs.**

Researchers placed a total of 22 different traffic signs on the closed course. Most signs had a mounting height of 7 ft and were located at a 12-ft offset from the nearest travel lane. Some signs were set at a farther offset distance to simulate measurements on a multilane roadway. The distance between consecutive signs was typically 500 ft or greater. One section of

the course contained three signs that were spaced 50 ft apart to replicate a high density sign area. Typically, sign post assemblies held one sign to be measured at a time but there was one assembly that displayed four signs of differing retroreflective values. Researchers installed the four sign assembly to test if measurements of one sign would be compromised by adjacent signs.

The 22 closed-course signs differed in color, contrast, material, and retroreflectivity. There were six red, eight white, four yellow, two green, and two orange signs. Material type was split among engineer grade (Type I), high-intensity beaded (Type III), and prismatic materials. Among the 22 signs, the handheld retroreflective measurements ranged from 6 to 698 cd/lx/m<sup>2</sup>. There were 16 signs that met the MUTCD requirements and six signs that fell below the minimum levels. Signs were placed to vary the viewing order. For example, a noncompliant white Type I regulatory sign followed a high performing yellow prismatic warning sign. The four sign assembly was also a mixture of different sign types; one prismatic, one Type III, and two Type I signs that all varied considerably in retroreflectivity and visual condition. [Table 20](#) in [Appendix B](#) contains all of the closed-course sign information and handheld retroreflective measurements.

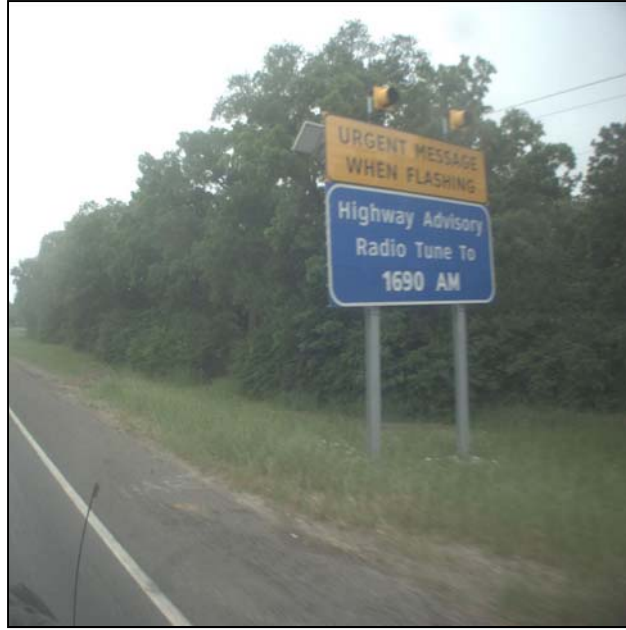
**Figure 6. Example of Image File.**

This section contains the researchers' analysis of the data set for both the closed-course and open-road evaluations. The final data set was delivered and enclosed in a zip folder that was approximately 26 megabytes. The folder contained one Excel® spreadsheet and 382 sign image files. Each sign image file was labeled with a sign ID number that corresponded to the appropriate sign information contained in the spreadsheet. The spreadsheet columns included sign ID number, color, message content, size, location, post and support information, face direction, GPS data, sheeting type, entrance angle, and computed retroreflectivity. The retroreflective measurements included only sign background measurements (no measurements were made of the signs' legends) and were at an observation angle of  $0.2^\circ$  and an entrance angle of  $-4.0^\circ$ . The spreadsheet and sign images provided sufficient information to cross-reference the information. [Figure 6](#) shows one of the sign images that were included in the zip folder.
