1. Report No. FHWA/TX-13/0-6615-1		2. Government Accession No.		3. Recipient's Catalog No.	
4. Title and Subtitle DESIGN AND CONSTRUCTION RECOMMENDATIONS FOR THIN OVERLAYS IN TEXAS				5. Report Date October 2012 Published: September 2013

# **DESIGN AND CONSTRUCTION RECOMMENDATIONS FOR THIN OVERLAYS IN TEXAS**

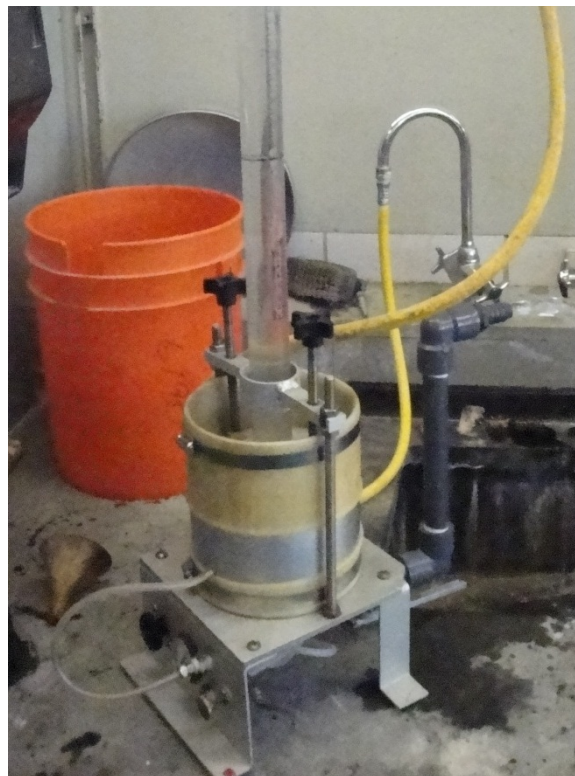
**Figure 4.4. Florida Falling-Head Permeameter.**

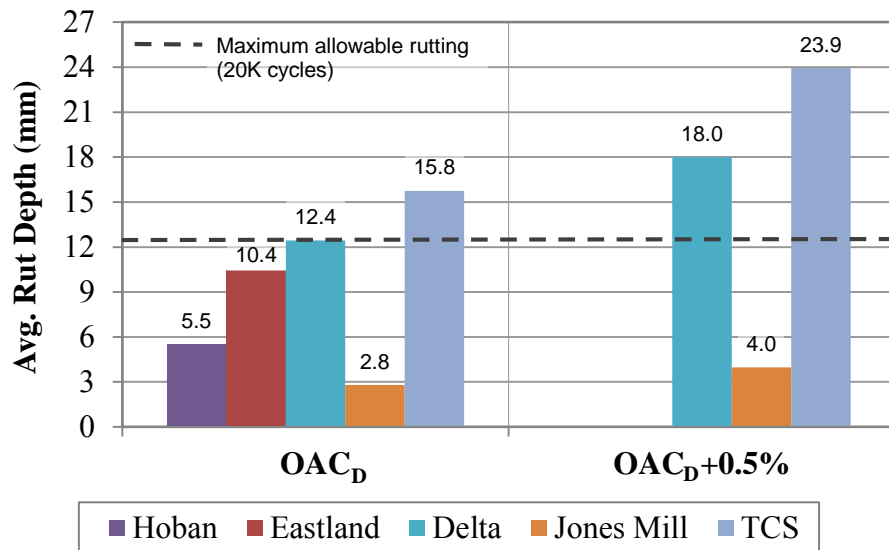
**Figure 4.9. Rutting Resistance Results for Fine DGMs.**

The fine DGM performance results in the HWTT and overlay test are shown in Figures 4.9 and 4.10. Results for the Hoban and Eastland materials at OAC+0.5 percent are not available. At OAC, all but the TCS mix rutted less than 12.5 mm in the HWTT. The Eastland and Delta mixes passed the test but were near failure. At OAC+0.5 percent, both Delta and TCS mixes

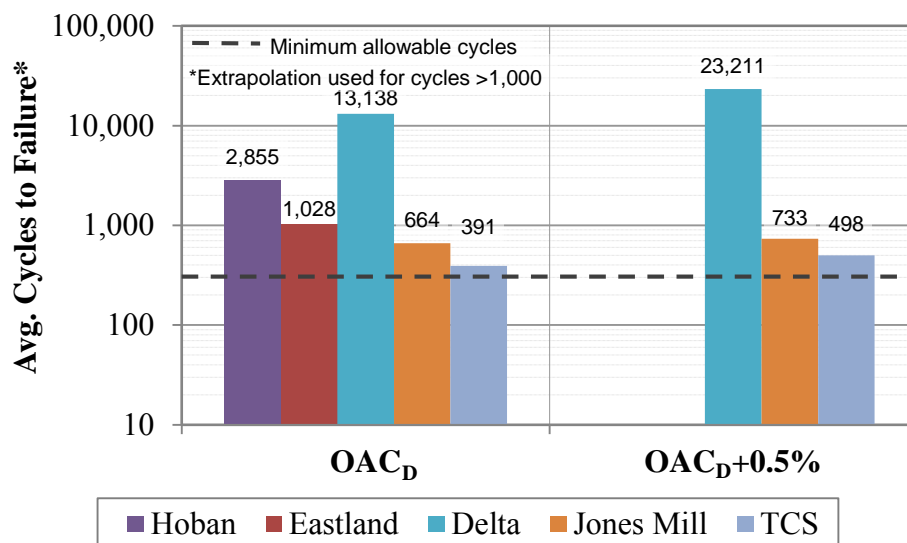
**Figure 4.10. Cracking Resistance Results for Fine DGMs.**

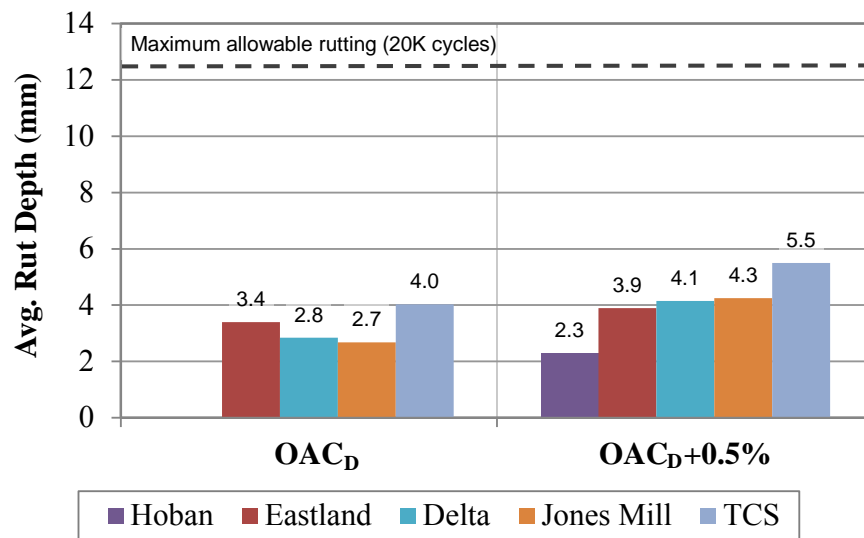
Figure 4.11. Rutting Resistance Results for Fine SMAs.

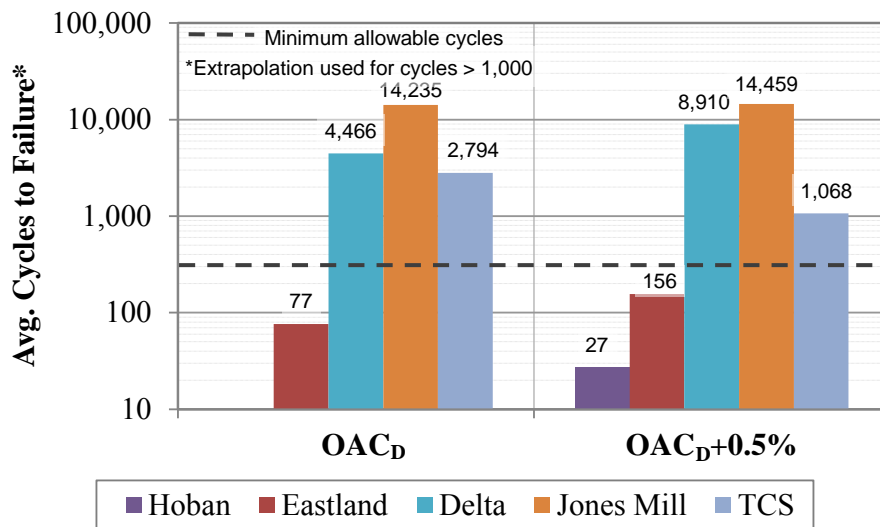
Figure 4.12. Cracking Resistance Results for Fine SMAs.

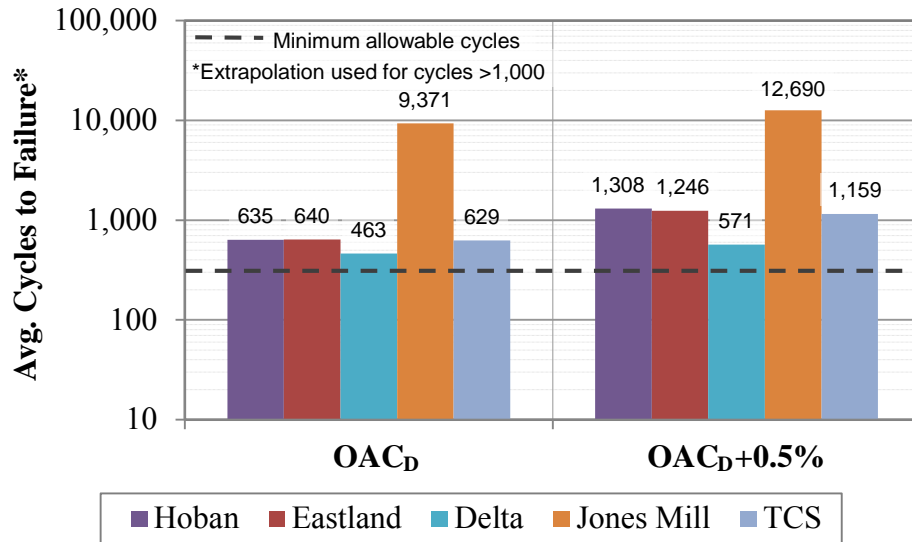
**Figure 4.15. Cracking Resistance Results for Fine PFCs.**

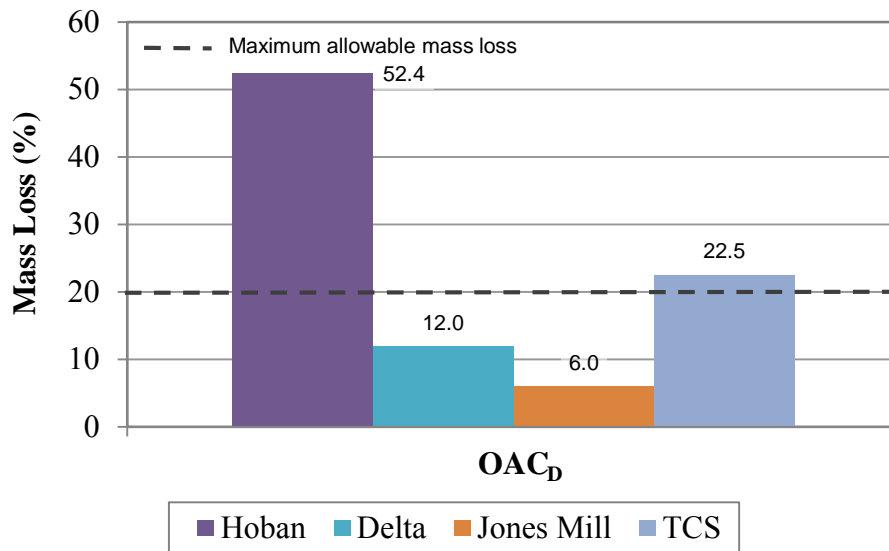
**Figure 4.16. Raveling Resistance Results for Fine PFCs.**

In light of the performance results, the OAC<sub>R</sub> percentages are shown in Table 4.9. Based on the Cantabro test, the Hoban mix exhibited potentially severe raveling problems and rutting; therefore, no acceptable design is recommended. The Eastland mix performed well in rutting and cracking but the raveling properties are still unknown; OAC<sub>R</sub> is the same as OAC<sub>D</sub>. The Delta mix performed well in all the tests; therefore, no change in OAC is recommended. This mix showed signs of shoving, but not rutting, in the HWTT. The Jones Mill mix also passed all the tests. It had exceptional cracking resistance and had signs of potential shoving from the Hamburg test. The recommended OAC is 6.0 percent, the minimum allowable asphalt content and slightly lower than the original OAC. The TCS mix had potential raveling problems at OAC<sub>D</sub>, but is

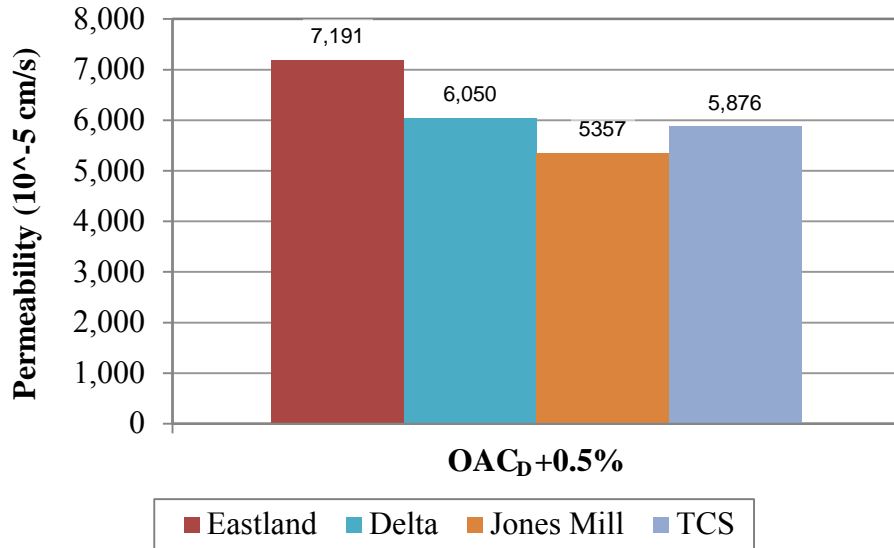
**Figure 4.17. Permeability Results for Fine PFCs.**

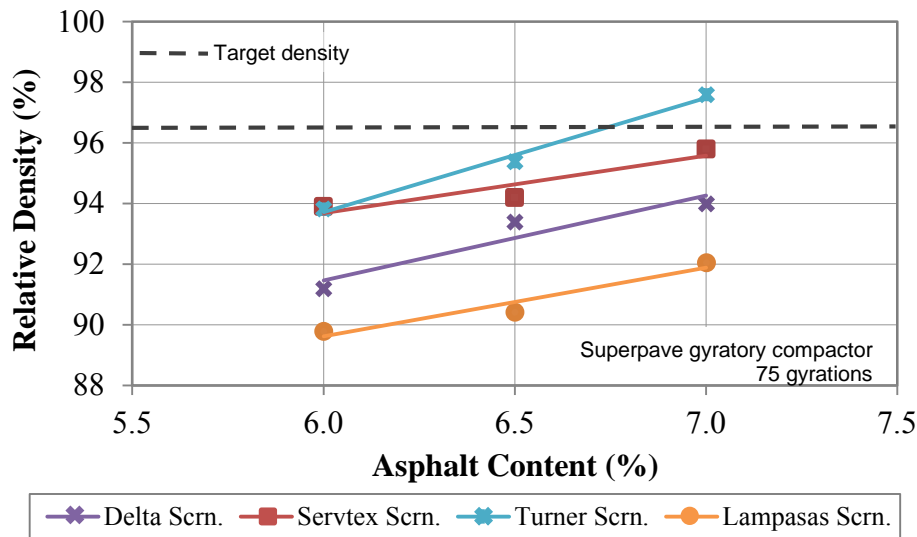
**Figure 4.25. Density Curves in SGC.  
(Screenings in Fine SMA)**

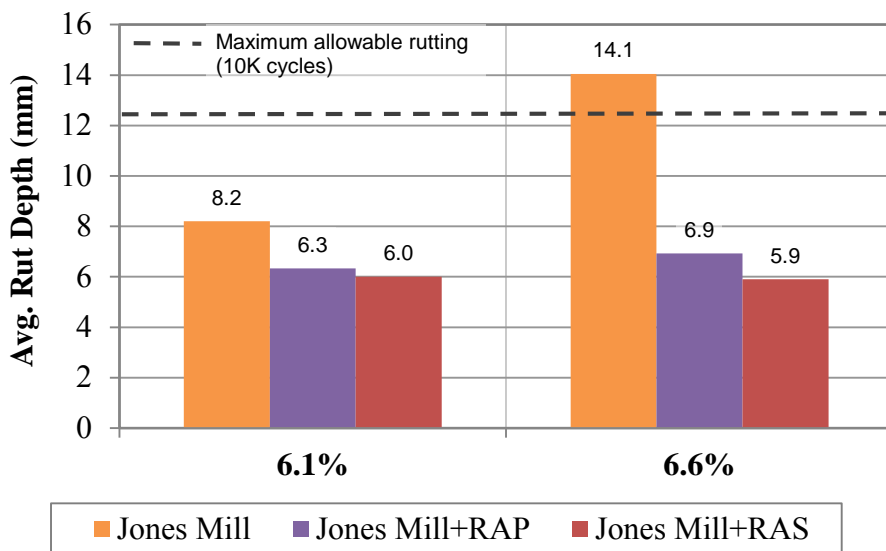
**Figure 4.34. Rutting Resistance Results for Fine FPC.  
(Effect of RAP and RAS)**

The HWTT and overlay test results are shown in Figures 4.34 and 4.35. All designs but Jones Mill at OAC+0.5 percent passed the HWTT. At both OAC and OAC+0.5 percent, this mix

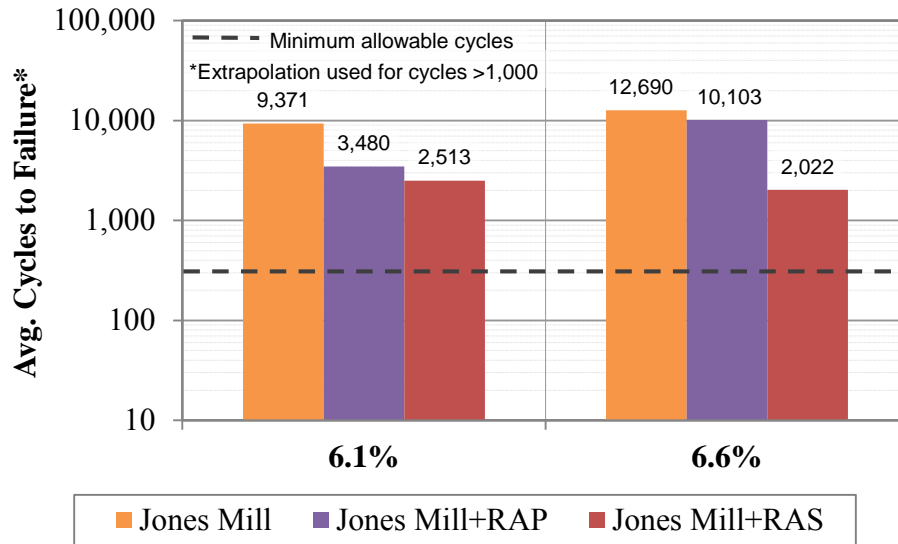
**Figure 4.35. Cracking Resistance Results for Fine PFC. (Effect of RAP and RAS)**

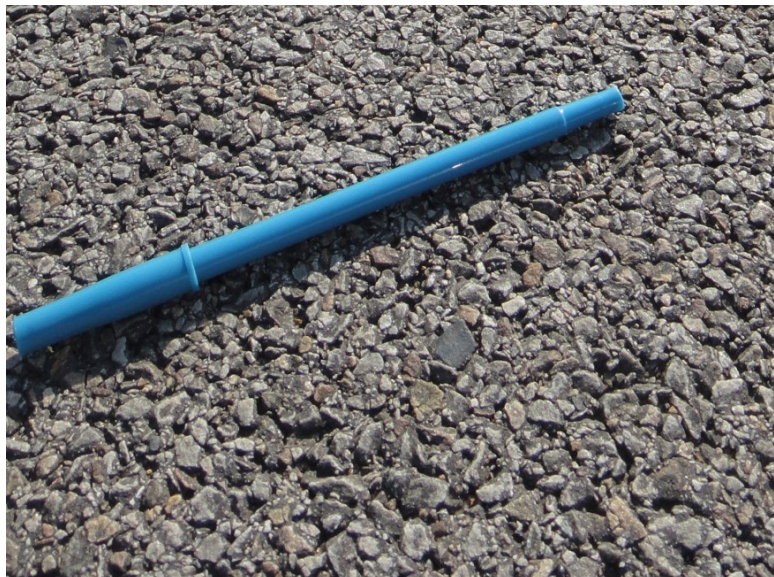
**Figure B.3. Surface Texture (Texarkana-CAM).**

The Texarkana-CAM is in very good condition for its age. The overlay was placed on transverse-cracked HMA over jointed concrete. These joints have reflected through most areas of the CAM, though cracks are of low severity. Though no skid measurements were available, the surface texture seems coarse enough to provide good skid resistance.

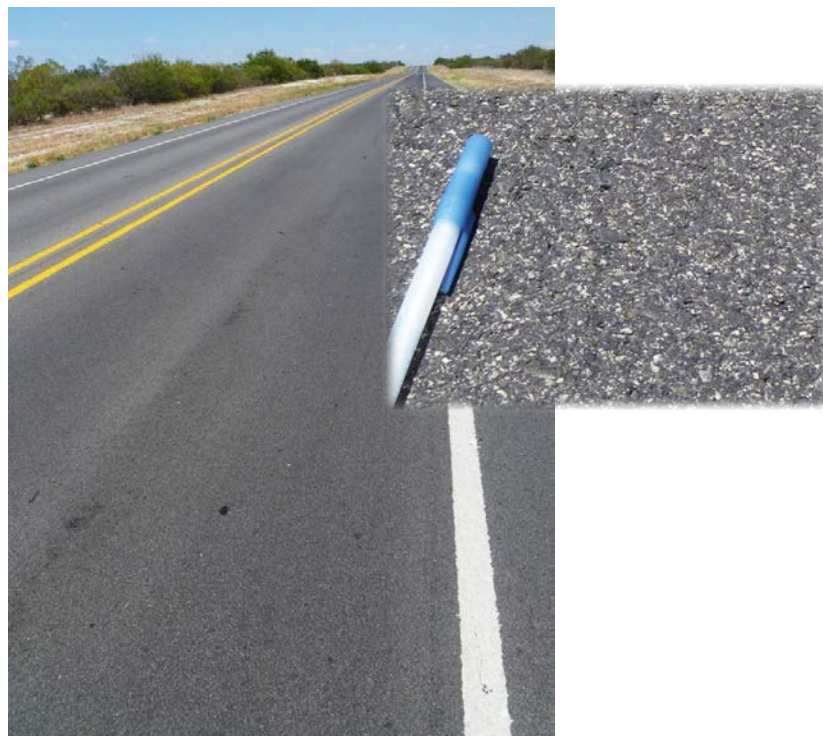
**Figure B.11. Project and Surface Texture (Uvalde-CAM).**

For the most part, this CAM was in good condition. Most locations on the project looked like the section in Figure B.11. There was no cracking or raveling noted here. The surface was

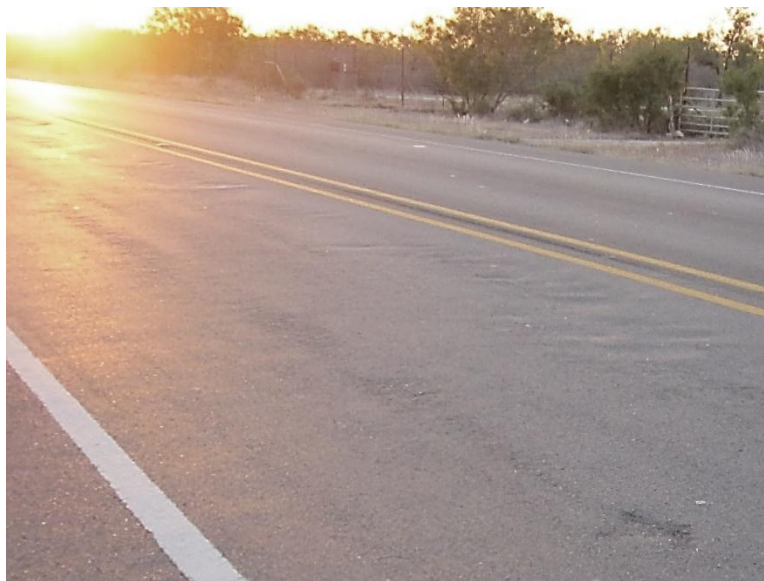
**Figure B.12. Subtle Pavement Roughness (Uvalde-CAM).**

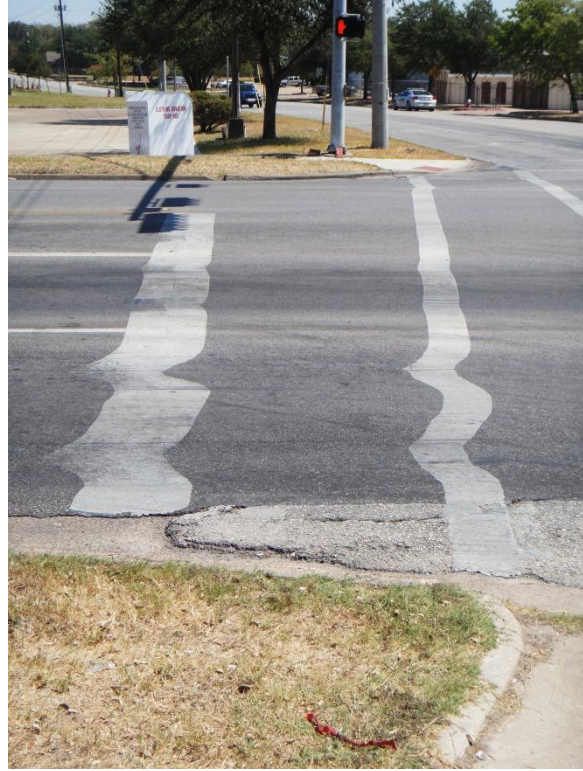
(a) Fatigue Cracking

(b) Rutting and Shoving at the Stop Light

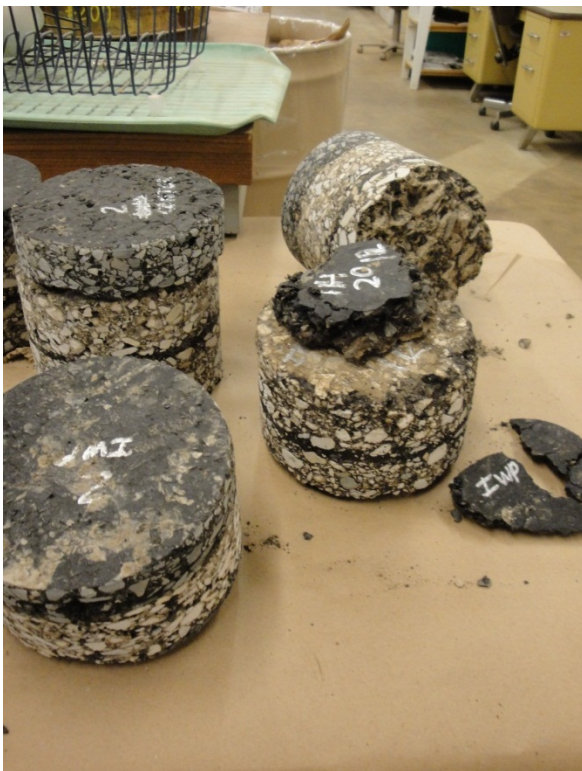
Figure B.24. Flushed and Moisture-Damaged Core Specimens (Atlanta-Fine SMA).

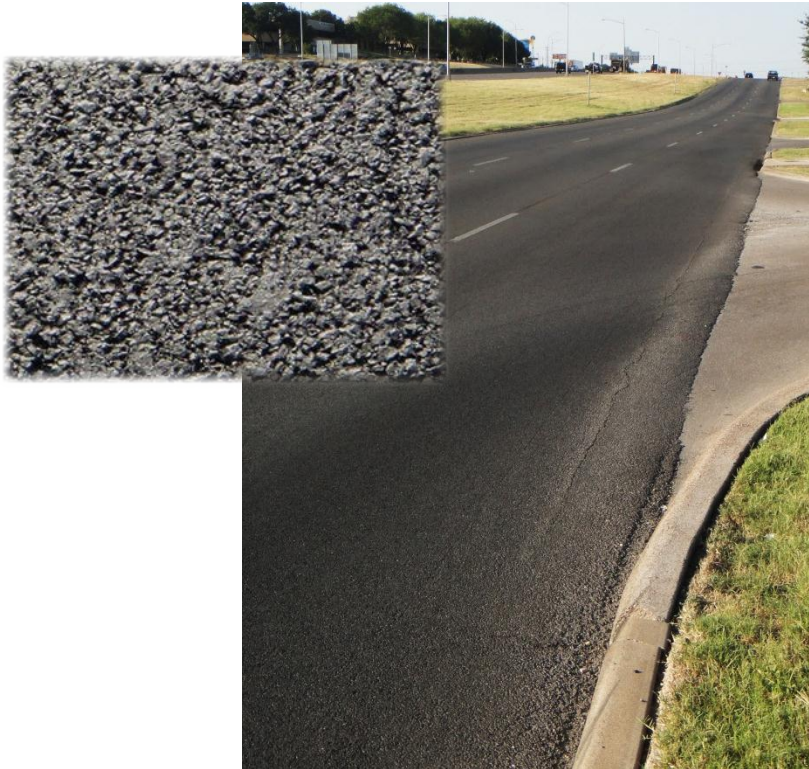
**Figure B.28. Project and Surface Texture (Austin-CMHB-F).**

This overlay is in good condition as shown in Figure B.28. This is expected since the project is not old. The only distress is a small longitudinal edge crack in the outer lane. The GPR profile in Figure B.29 shows the variability of the asphalt layer thickness and indicates there are several small areas of potential stripping. This may manifest itself as surface distress later on. The section had good skid, ride, and noise properties that are not reported here.

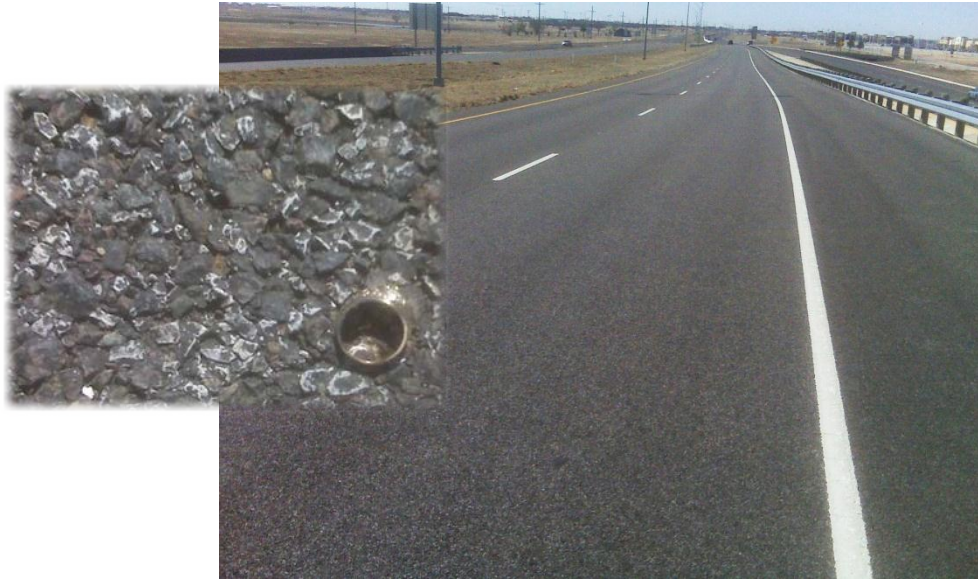
**Figure B.31. Project and Surface Texture (Lubbock-NM OGFC).**

The results of the skid measurements on the westbound and eastbound lanes were 32.2 and 36.8, respectively. The overall average SN<sub>50</sub> of the project was 35 with a standard deviation of 6.6. This is a good standard value for skid. Because of the excellent subsurface condition, this project is a best-case scenario for the performance of this thin overlay design.

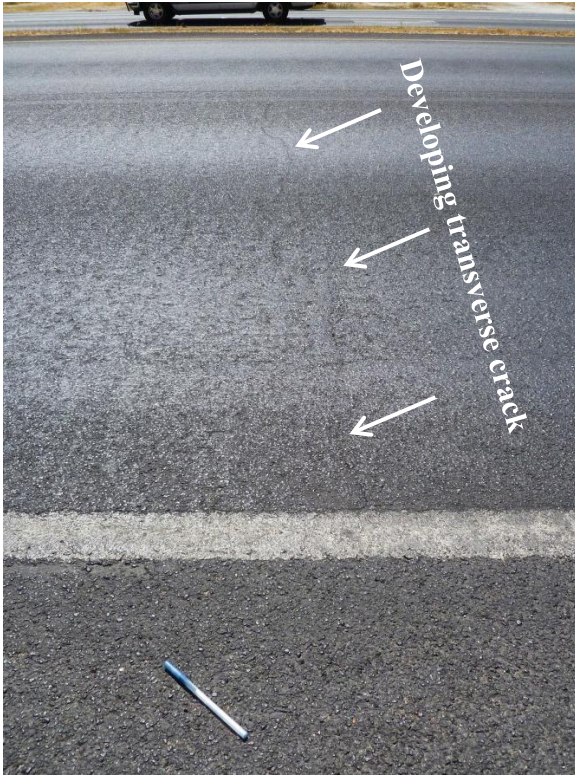
(a) Developing Transverse Crack in NB MicroTekk Flex

(b) Fatigue Cracking in EB MicroTekk

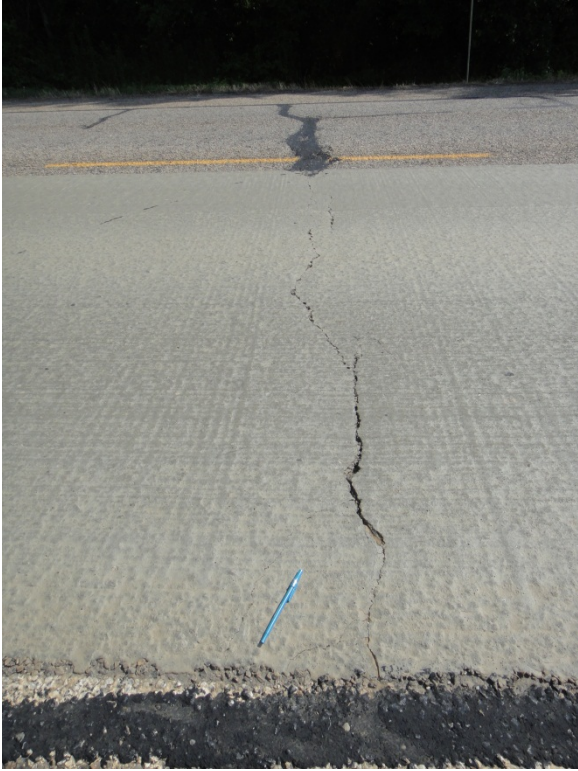
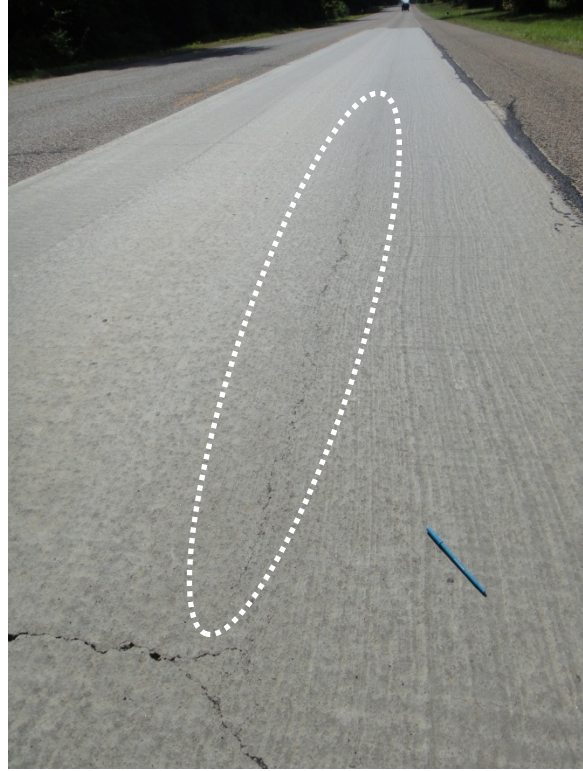
(a) Transverse Cracking

(b) Longitudinal Cracking

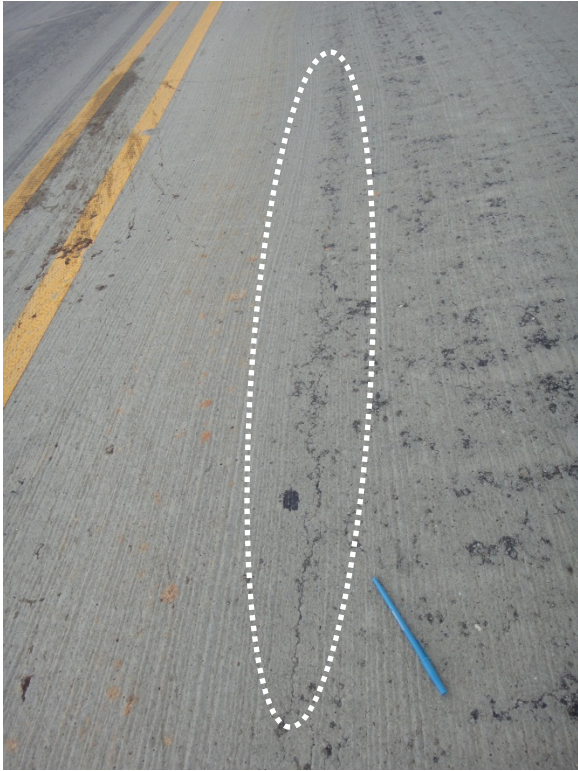
(a) Longitudinal Cracking

(b) Fine Fatigue Cracking

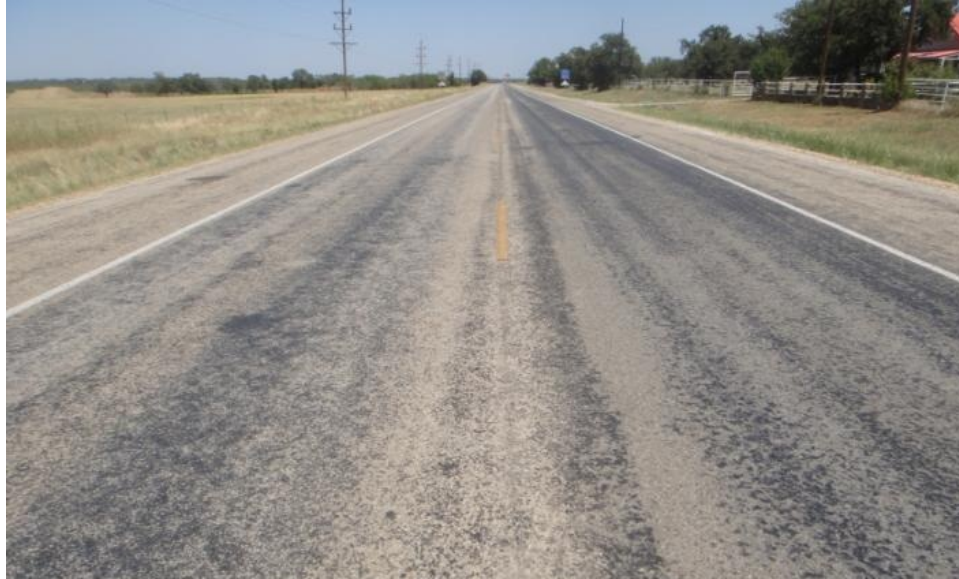
**Figure D.29. Flushing Surface Treatment (Brownwood-Fine PFC).**

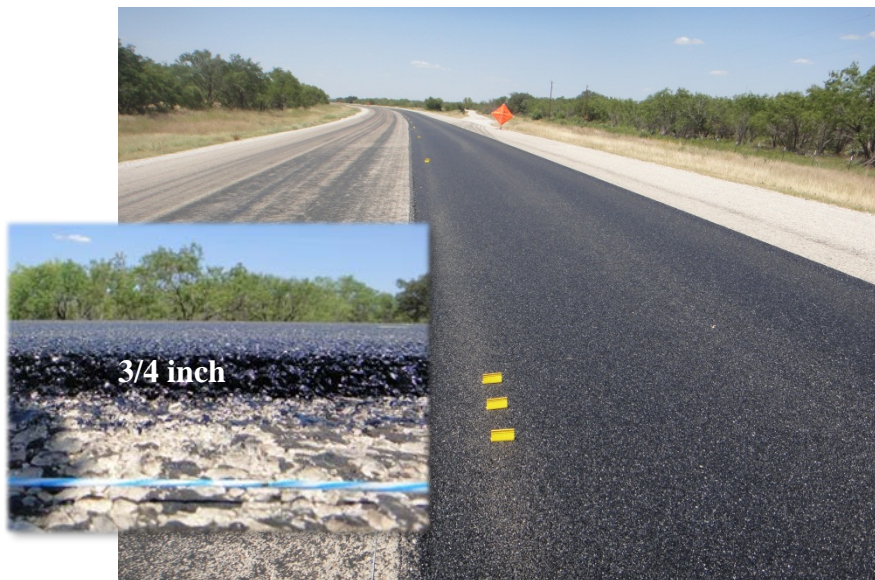
**Figure D.31. Project and Lift Thickness (Brownwood-Fine PFC).**
