1. Report No. FHWA/TX-15/0-6828-1	2. Government Accession No.	3. Recipient's Catalog No.	
4. Title and Subtitle INVESTIGATION OF NEW VEHICLE DETECTORS FOR HIGH-SPEED SIGNALIZED INTERSECTIONS		5. Report Date September 2015	6. Performing Organization Code

9. Performing Organization Name and Address Texas A&M Transportation Institute College Station, Texas 77843-3135		11. Contract or Grant No. Project 0-6828

INVESTIGATION OF NEW VEHICLE DETECTORS FOR HIGH-SPEED SIGNALIZED INTERSECTIONS

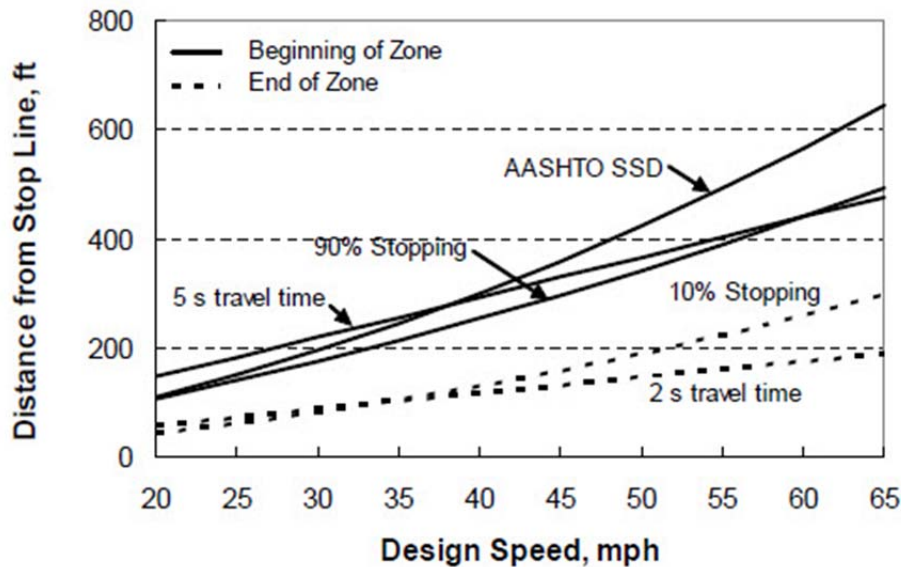
Figure 2. Comparison of Dilemma Zone Boundaries (11).

In the second approach, researchers characterize the dilemma zone based on the drivers' probabilistic nature in their decisions whether to stop or to proceed at the onset of yellow indication. These are also referred to as Type II dilemma zones, indecision zones, and option zones. The Type II dilemma zone boundary can be defined either in terms of distance or travel time to the stop bar. Zegeer (8) defined the beginning of the zone as the distance beyond which 90 percent of all drivers would stop if presented with a yellow indication and the end of the zone as the distance within which only 10 percent of all drivers would stop. This range is equivalent to the travel time to the stop bar of 4.5–5.0 s to 2.0–2.5 s (9). Bonneson et al. (10) suggested that the beginning of the dilemma zone is 5.0–6.0 s upstream, and the end is about 3.0 s upstream. Figure 2 provides a comparison of dilemma boundaries as defined by the observed distance, observed travel time, and safe stopping distance criteria.

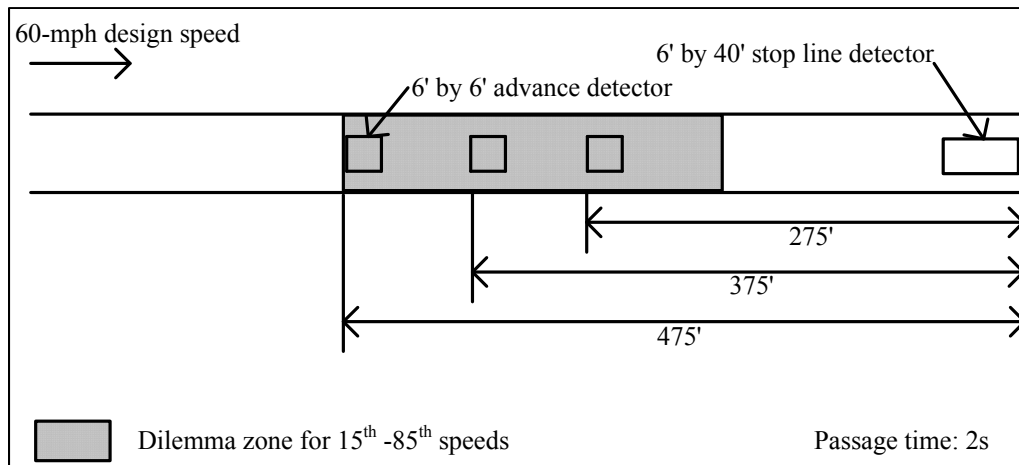
Figure 3. Multiple Advance Detector System (I3).

The layout for such a system, based on 60 mph design speed, is shown in Figure 3. Some of the suggested layouts and settings for detection design are shown in Table 1, and more details can be found in the Traffic Signal Operation Handbook (13).

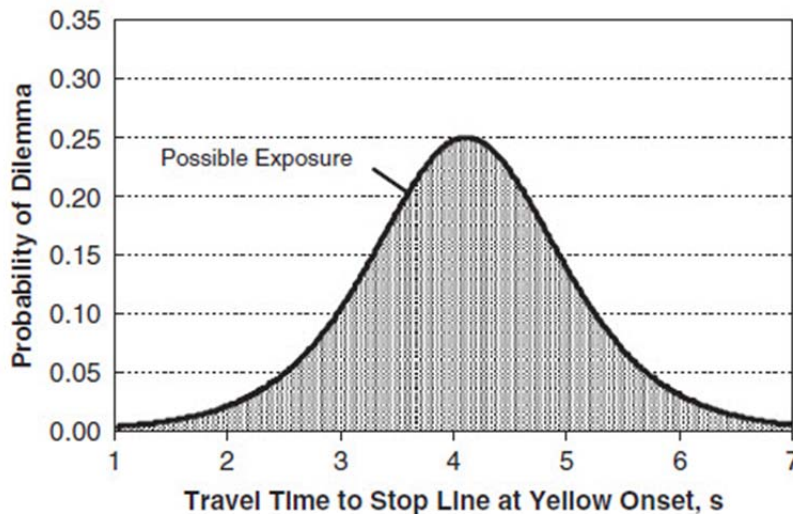
Figure 5. Probability of Dilemma (19).

Detection coverage is an indication of the extent to which the detection design will protect a vehicle when it is in its decision zone. The detection coverage is computed based on the probability of dilemma, which is shown in Figure 5. The probability of a dilemma is at its maximum when the probabilities of stopping and going are both equal to 0.5.

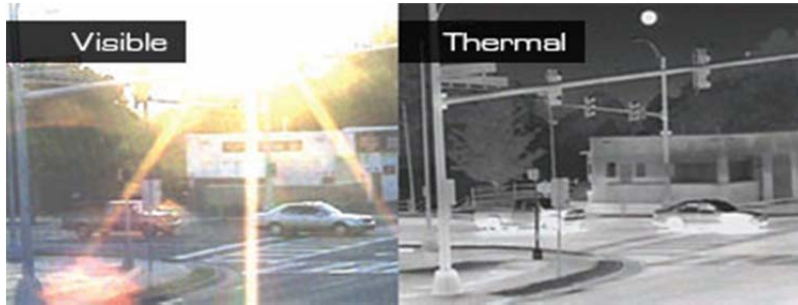
Figure 8. Image Showing the Effects of Sun Glare (21).

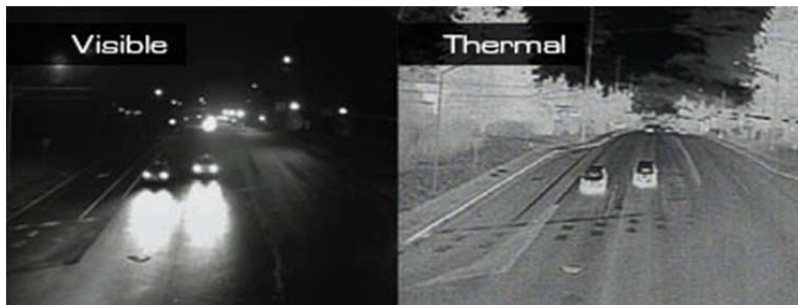
Figure 9. Image Showing the Effects of Headlights (21).

Headlights present a challenge when using visible light cameras during low light conditions causing advance detection of the headlight bloom before the vehicle actually arrives. Besides triggering detections at the wrong time, headlight detection can cause false calls and missed calls. Figure 9 shows the side-by-side images.

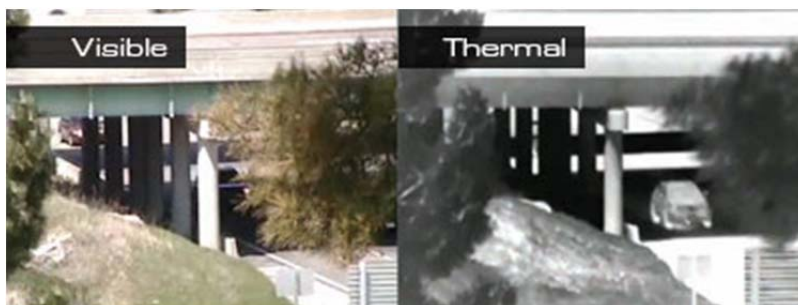
Figure 10. Image Showing the Effects of Shadows (21).

Problems caused by shadows include missed detections and false detections. Video cameras can miss vehicles, pedestrians, cyclists, and even animals if they are in shadows. False detections sometimes occur when shadows cast from vehicles occupying adjacent lanes cross an unoccupied lane. Thermal sensors are usually better able to distinguish the desired objects due to their ability to sense heat, not light (see Figure 10).

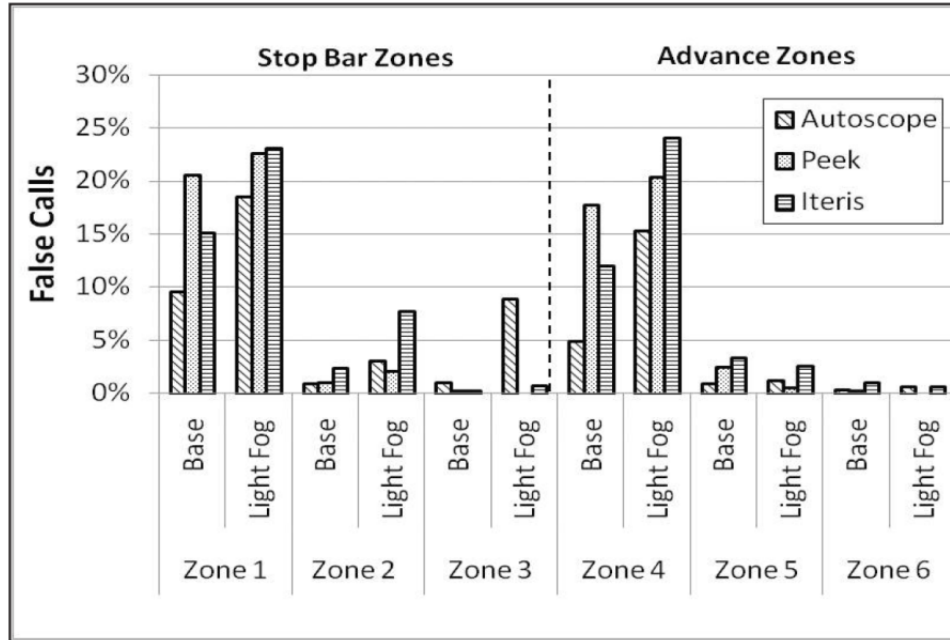
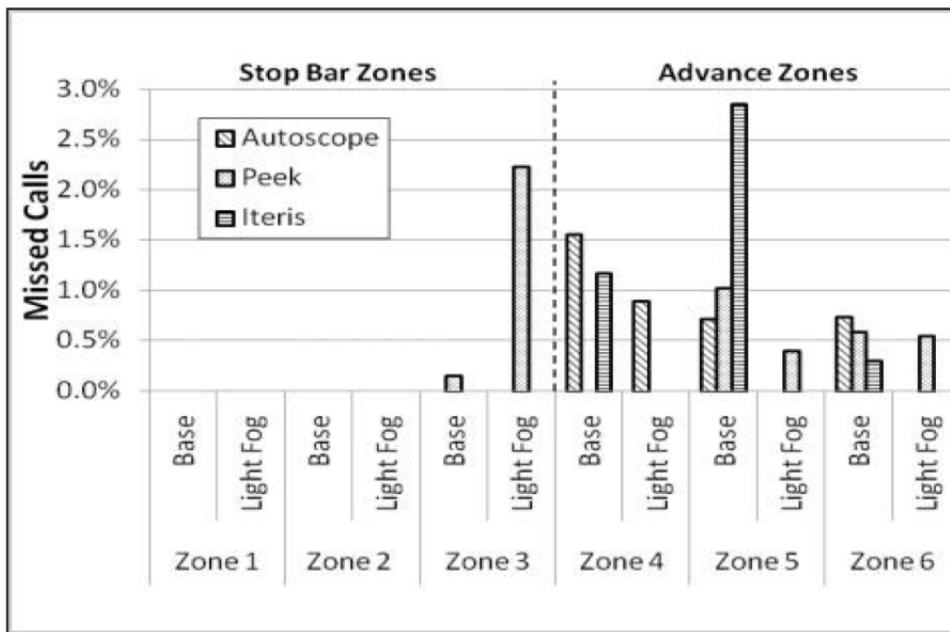
Figure 16. False and Missed Call Rates for Light Fog Conditions (38).

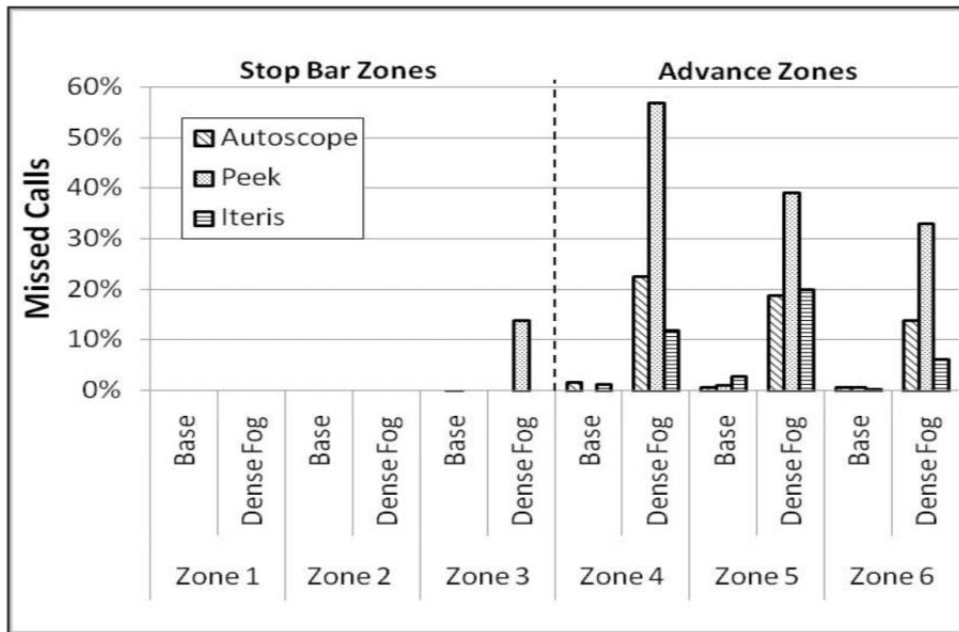
Figure 17. False and Missed Call Rates for Dense Fog Conditions (38).

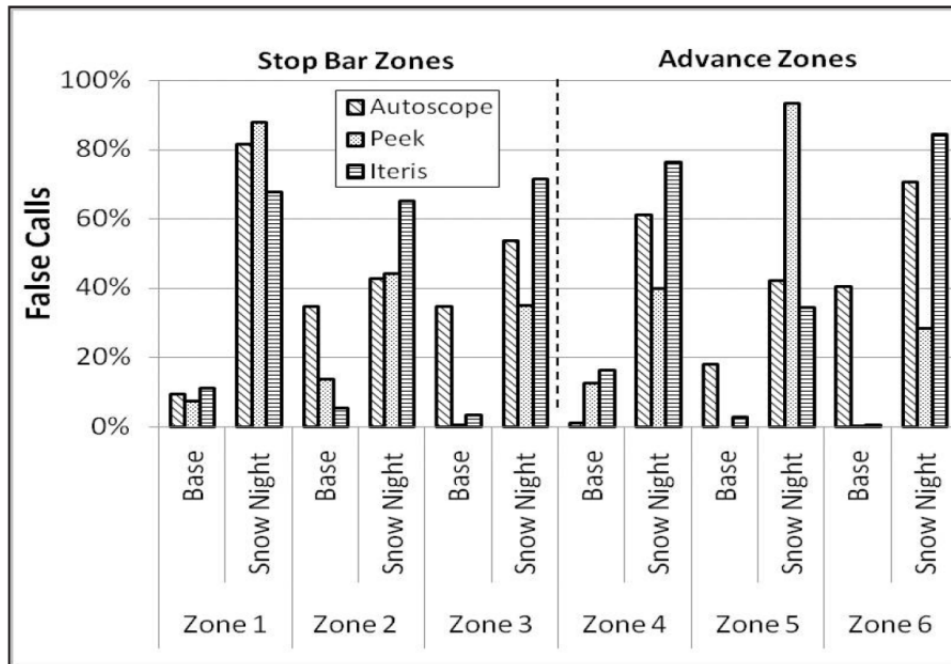
Figure 21. False Call Rates for Nighttime Snow Conditions (38).

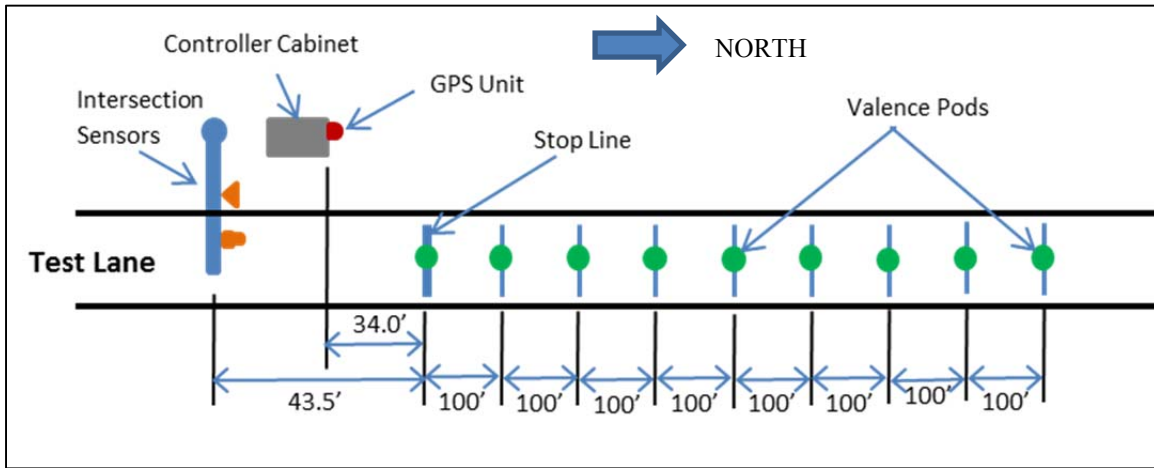
Figure 26. Plan View of Runway 35C and Cabinet Placement.

Figure 26 represents a plan view of runway 35C and the position of the nine wireless Pods used for this project. One Pod is positioned at the stop line, and the other eight Pods are positioned along the test lane at 100-ft intervals. The flow of traffic in this figure is from right to left (southbound). The Riverside tests included the noted range tests as well as detection characteristics of each detection system.

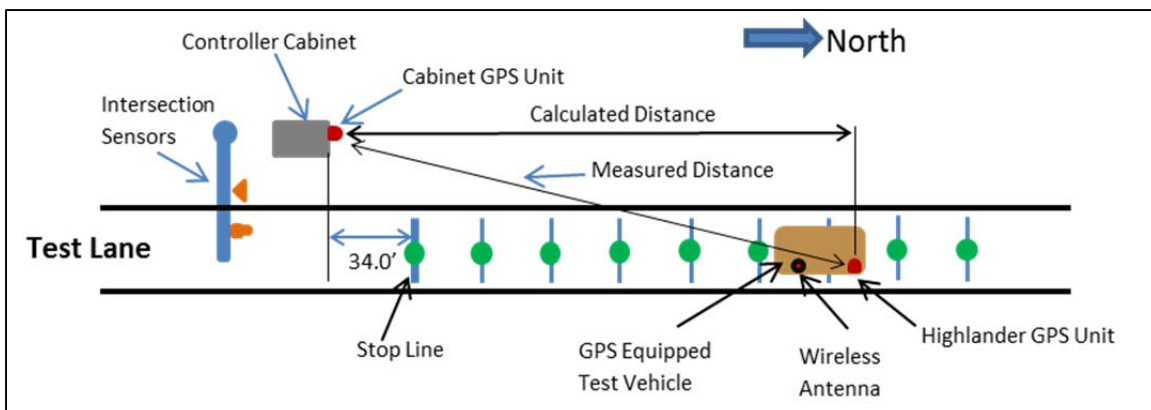
Figure 28. Longitudinal Dimensions Used for GPS.

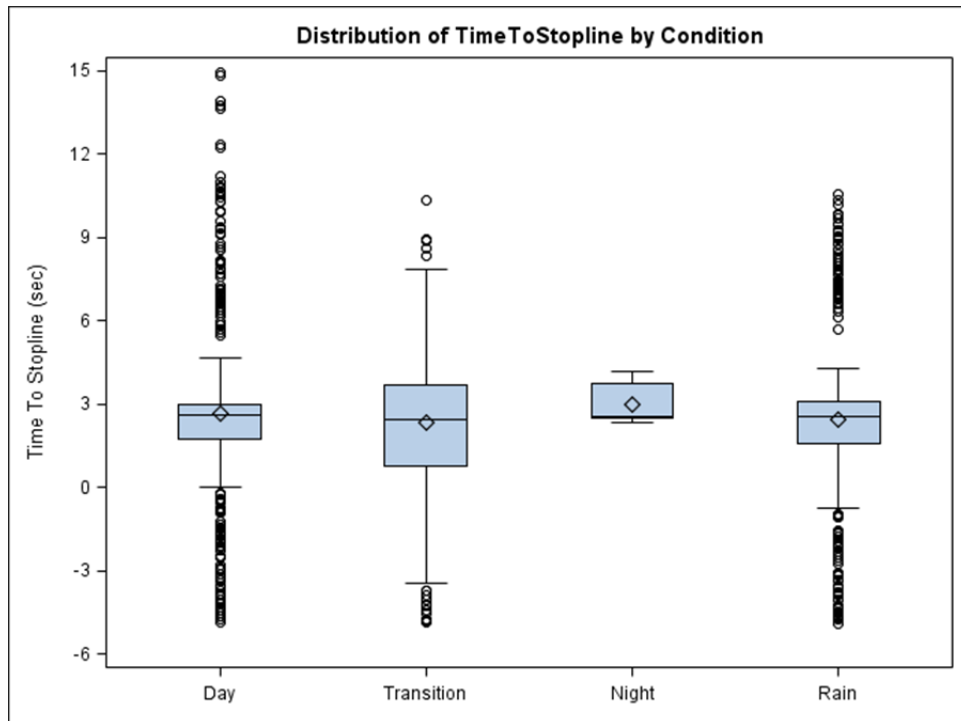
Figure 44. Box Plots of the Time to Stop Line when the Aldis (SB 46) Turned Off.

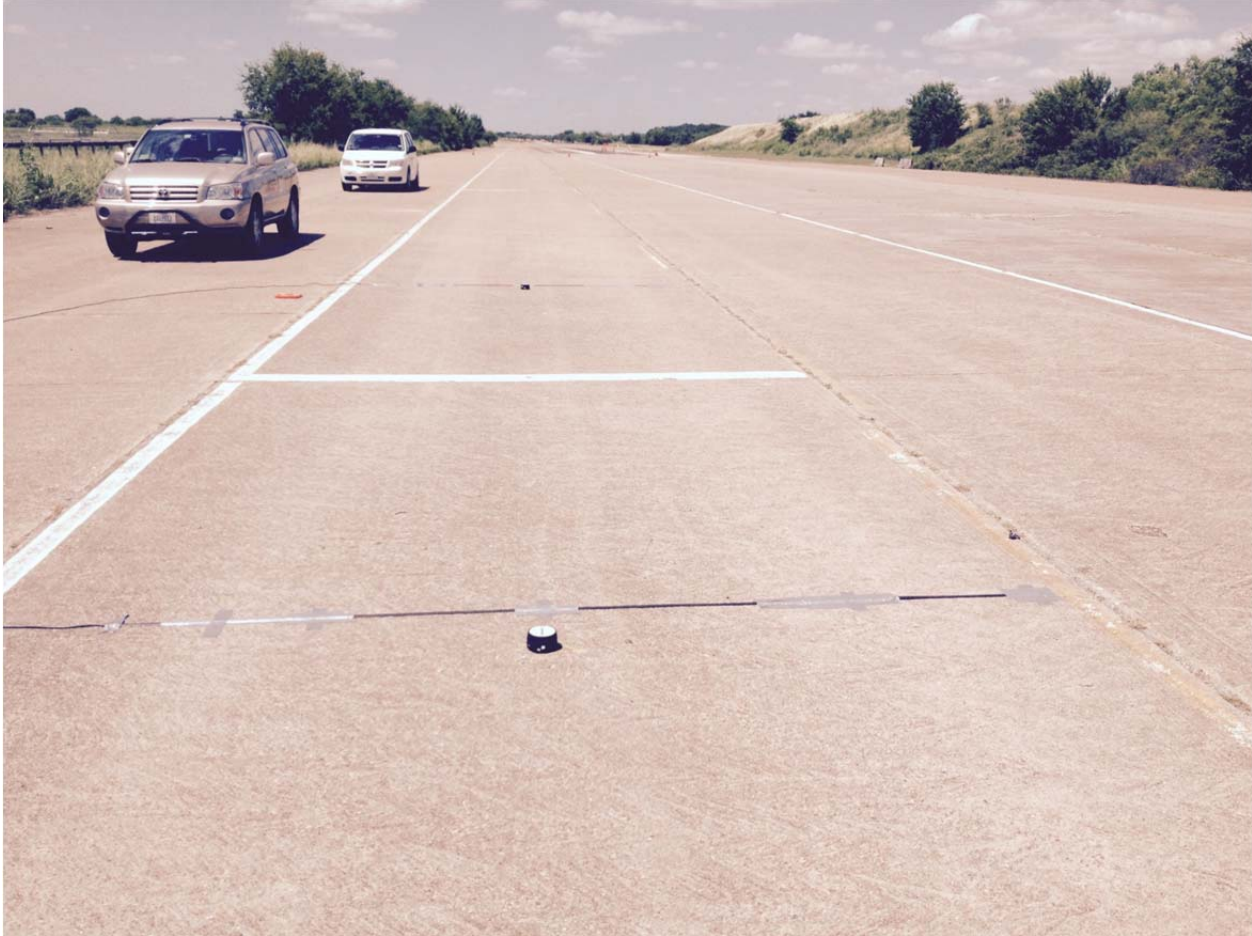
Figure 54. Photo of Magnetometers and Tapeswitches as Tested at Riverside.

The TTI research team developed software using LabView to read axle hits with the tapeswitches and store them on a field laptop computer beside the runway at Riverside. Each vehicle passage triggered either two or three hits as each axle passed over the tapeswitches. Passenger cars and pickups caused two detections and the Class 8 truck-tractor caused three detections. The front and rear vehicle overhangs were important measurements in associating the wheel hits with the actual front and rear of each vehicle. Table 48 summarizes the pertinent vehicle dimensions for this experiment.

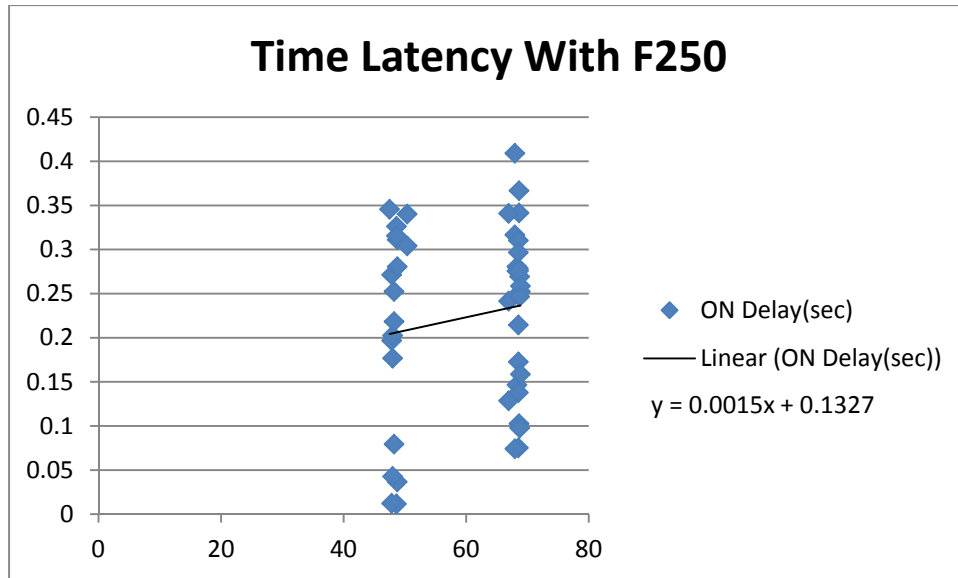
Figure 63. Time Latency (sec) versus Speed (mph) for Ford F-250.

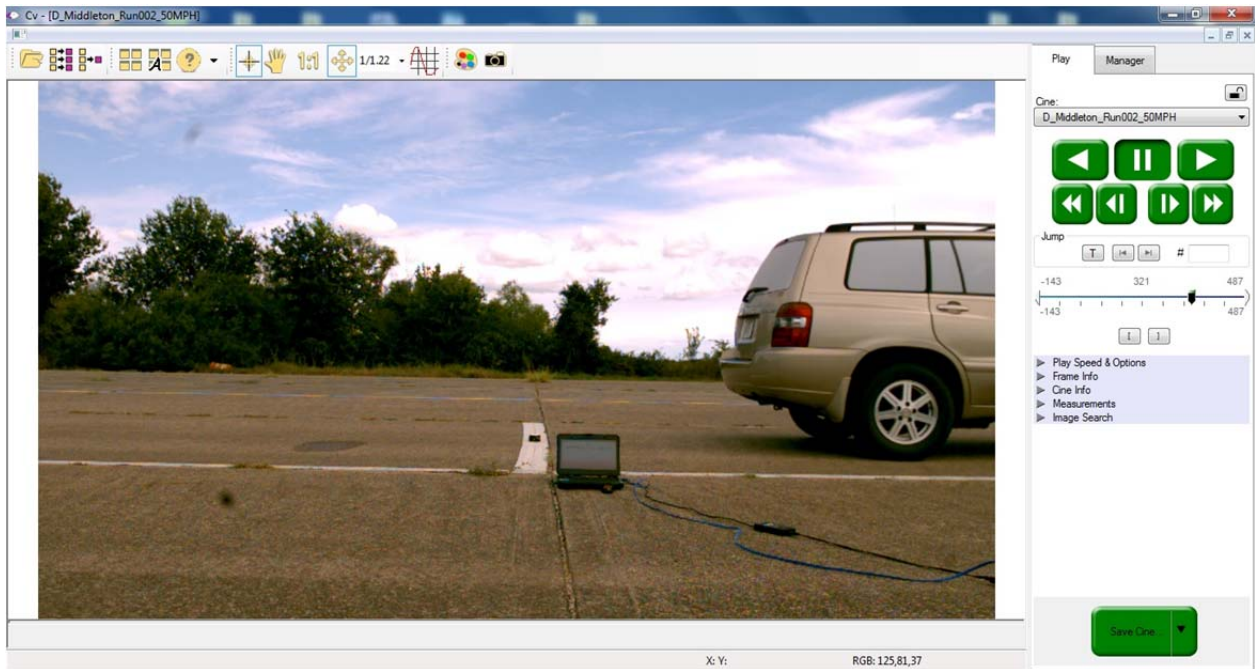
Figure 69. Photo Showing Laptop Monitor Turning White to Indicate Pod Activating.
