Expanding FDR Technologies in Maintenance Operations: Technical Report

Technical Report 0-6880-R1

TEXAS A&M TRANSPORTATION INSTITUTE
COLLEGE STATION, TEXAS

Report 0-6880-R1
Project 0-6880
Project Title: Expanding FDR Technologies in Maintenance Operations

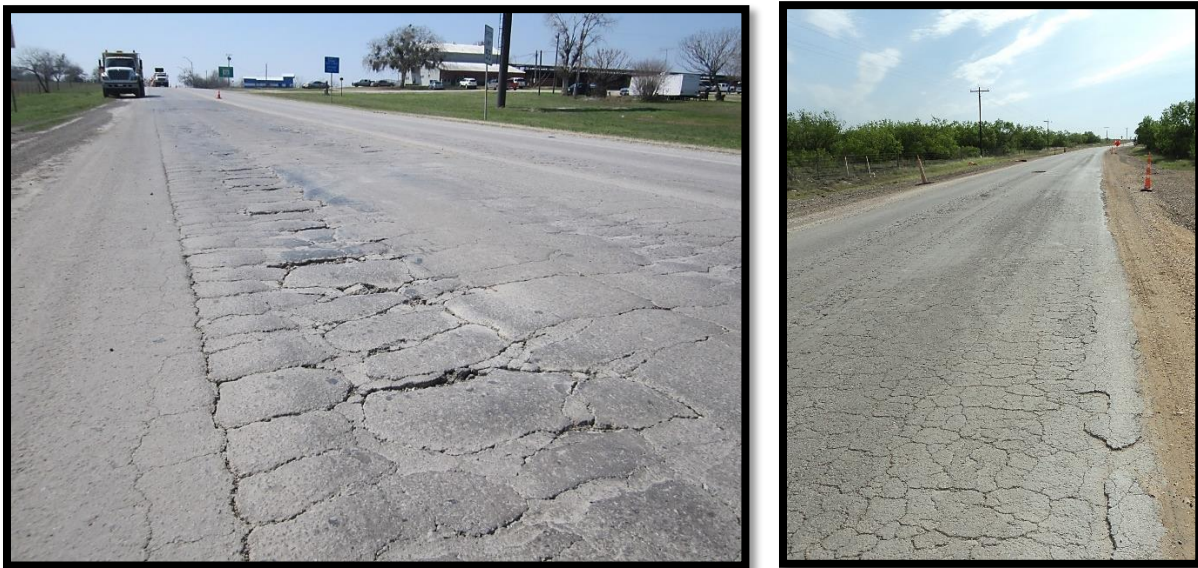
Figure 1. Energy-Sector Pavements in Need of Rehab.

With the Eagle Ford Shale boom, TxDOT faced the need to rehabilitate many miles of pavement in energy-sector areas of the state. Figure 1 shows typical distressed pavements. In these operational environments, one major project requirement was that no matter the rehab treatment, the roadway must be opened to energy-sector traffic at the end of each working day.

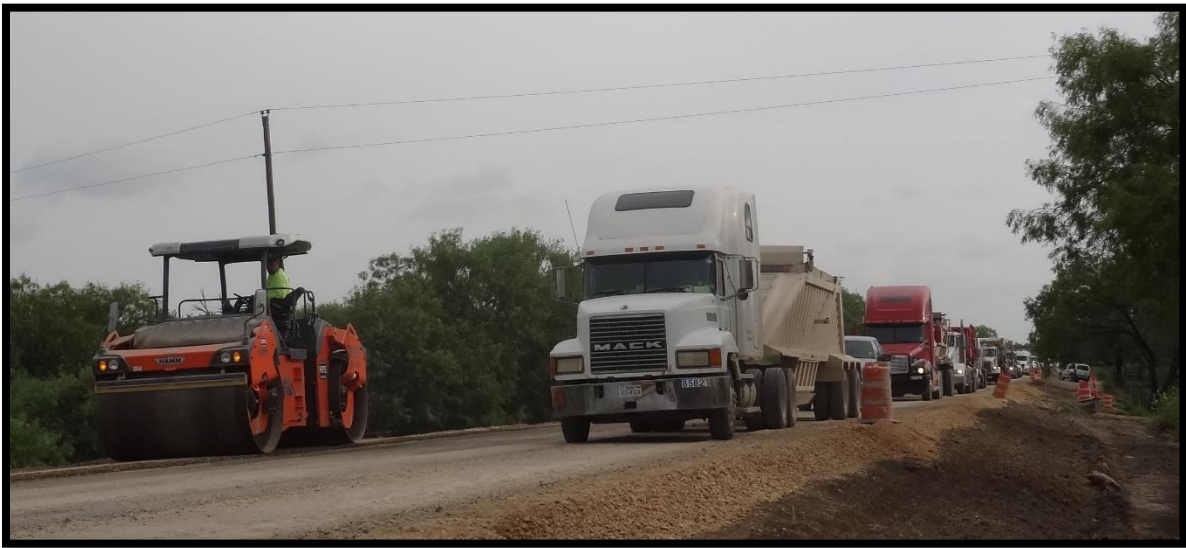
Figure 2. Energy-Sector Traffic within 2 Hours of Treatment on FM 99.

Based on the need to rapidly renew energy-sector damaged pavements and subject them to same-day energy-sector traffic, TxDOT's Corpus Christi District performed a pilot using foamed asphalt treatment on FM 99 in June 2014. Figure 2 shows that traffic was turned within 2 hours of working and treating a half section. The district reported good performance of the FDR mix

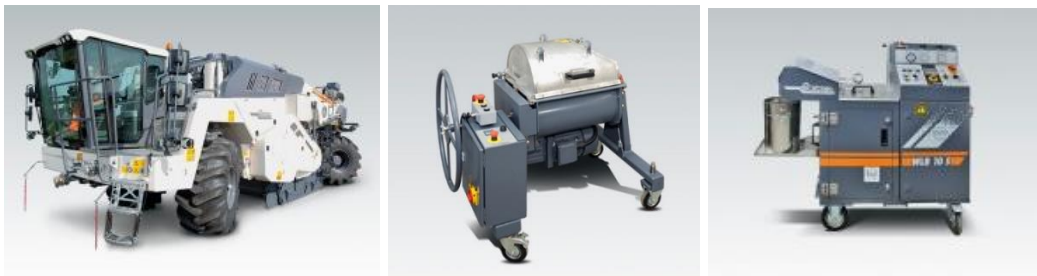
Figure 3. Recommended Field and Supporting Lab Equipment.

Based on the full feature set and tie-in between field equipment and supporting laboratory testing capabilities, Figure 3 shows the recommended field and supporting lab equipment for developing and placing test sections in this project.

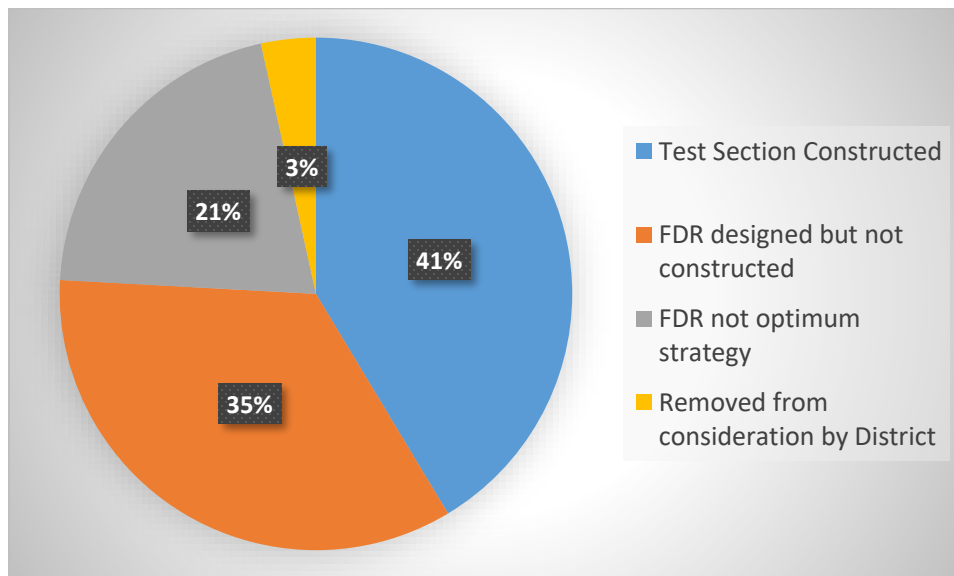
Figure 4. Key Outcomes from FDR Section Development.

Figure 4 summarizes the outcomes of test section development. In total, 10 districts placed test sections across 12 different pavements. The remainder of the nominated sections were either good candidates for FDR but not constructed for various reasons or sections where FDR did not provide the optimum rehabilitation strategy; in one case a section was removed from consideration by the district after initial collection of NDT. Figure 4 illustrates that FDR with asphalt-based treatments could provide a viable pavement rehabilitation solution for about 75 percent of nominated candidates. Given the cost and effort to set up and deliver a project, it is critical to properly conduct the upfront testing to eliminate the projects that are not good candidates.

Note: Total number of sections = 29.

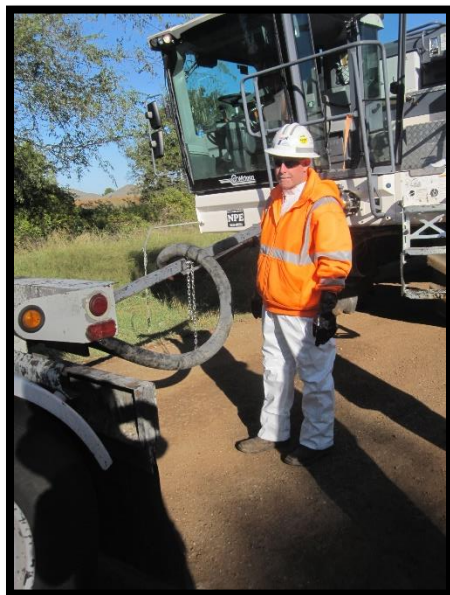
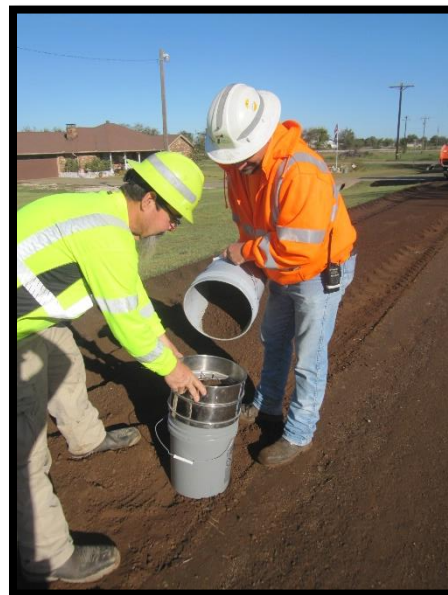
Figure 5. Equipment Operation and Processing Startup Support.

During test section placement, researchers worked with TxDOT districts to provide equipment and process startup support including performing essential equipment operations (Figure 5[a]); setting a processing speed to attain proper pulverization (Figure 5[b]); and sequencing the FDR process including treatment, proper compaction, and finishing (Figure 6). For short test sections requiring only a few days of production, researchers stayed on site throughout the duration of treatment. For longer test sections, after training TxDOT staff, researchers provided remote support as needed.

(a) Equipment operations

(b) Setting processing speed

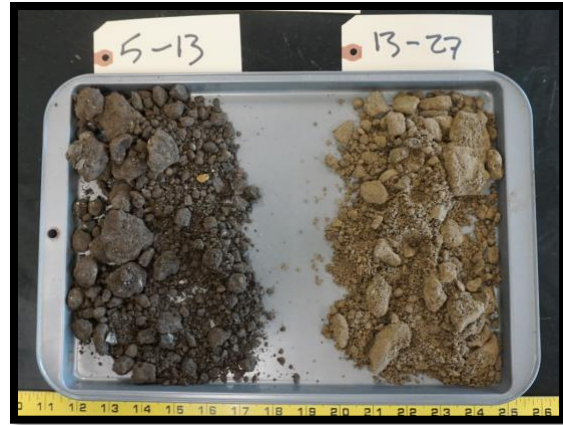
Figure 7. Example Materials That Used Lime Pretreatment.

Due to marginal quality of existing site materials, FM 99 in the San Antonio District and the IH 27 frontage road (FR) in the Lubbock District also used a lime pretreatment. Using the lime pretreatment provided a means of dropping the PI of the existing material, thus making the site material more compatible with asphalt treatments. Increasing the RAP percentage, such as occurred on FM 3080 and on a section of FM 2150, also generally makes materials more compatible with asphalt-based treatments.

Base PI = 20; clay subgrade

Base PI = 11; sandy subgrade

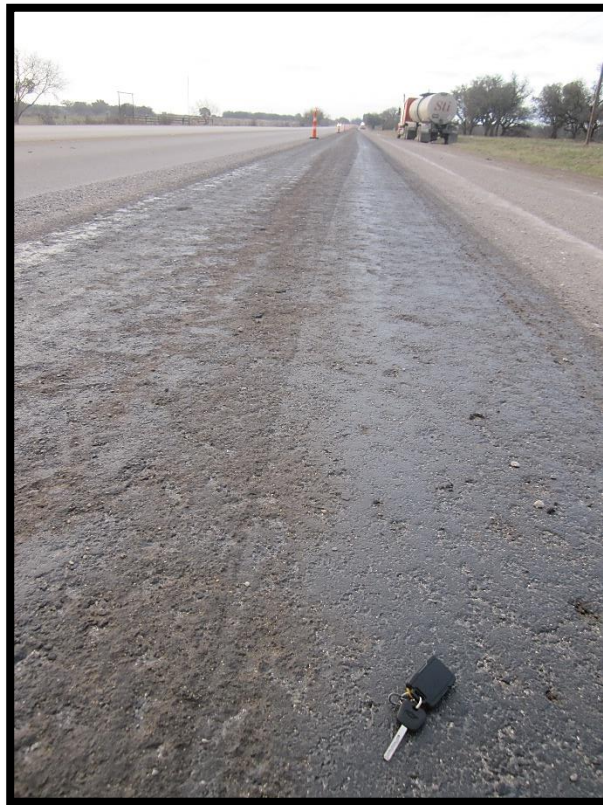
Figure 8. Treated, Finished Section after Fog Seal.

- The FDR layer is not intended to be an unsurfaced road. A light fog seal should be applied daily, particularly if daily trafficking is required. Figure 8 shows a treated, finished section after applying the fog seal. A seal coat or next course should be applied within 14 calendar days of compaction. Ideally, a seal should be placed at the end of each week of FDR treatment. The duration of acceptable time to run traffic without a seal coat in part depends on traffic counts.

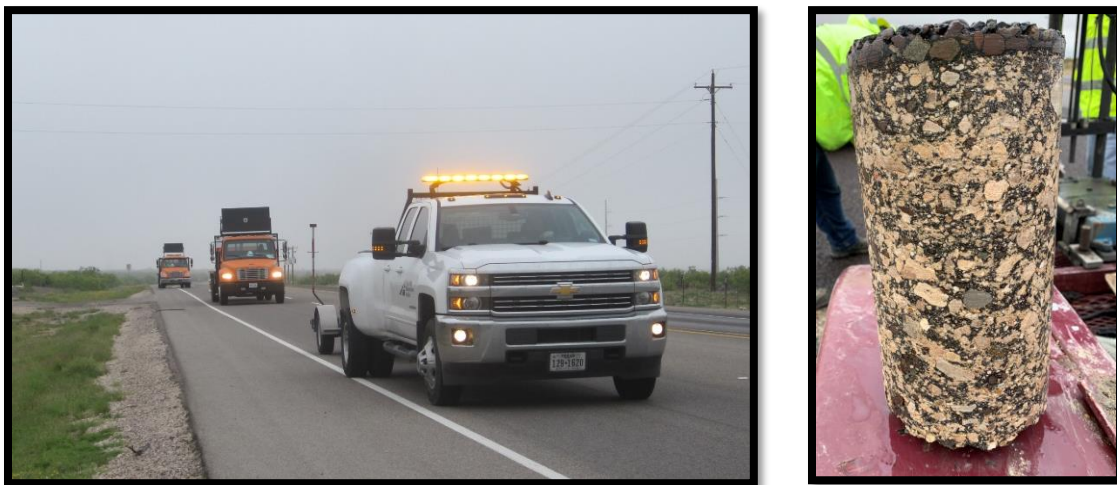
Figure 9. FWD Collection and Core from FDR Layer.

Researchers visited each test section over time, visually examining the pavement condition and documenting distresses. They also used NDT, primarily the FWD, to quantify the pavement's structural response. In some cases, researchers collected cores as a means of ground-truthing the condition of the treated layer. Figure 9 shows the typical FWD collection in progress and a core collected from one of the test sections.

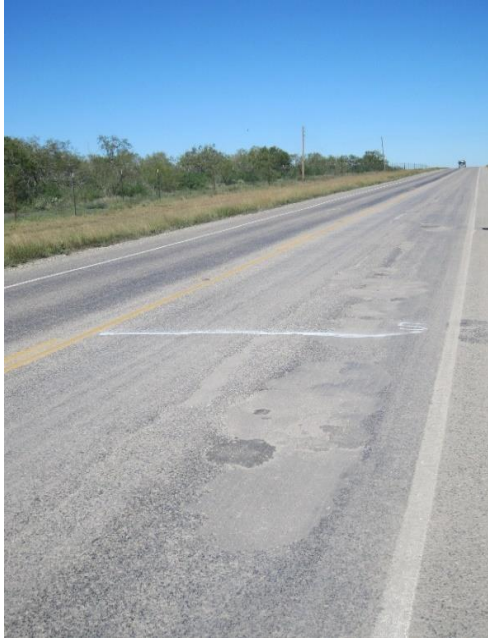
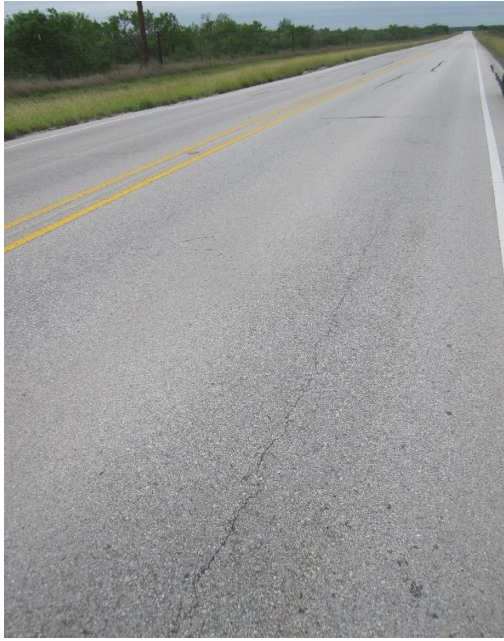
Section	FM 99 (SAT)			
Constructed	April–May 2016			
Pavement Structure	1.5" HMA + 10" foamed asphalt			
Treatment	2.5% lime pretreat (slurry) + 2.5% foamed asphalt

Dec. 2015 before FDR		May 2021 after FDR		
Summary of Structural Analysis	Aug. 2016	Dec. 2016	May 2018	May 2021
AVG normalized deflection (mils)	9.6	7.1	9.8	9.7
AVG FDR layer modulus (ksi)	520	938	626	547
Percent of section with effective stabilization	96	100	98	91
AVG subgrade modulus (ksi)	19.9	20.8	17.4	16.6
<i>Note: 1.5" HMA overlay placed between Aug. and Dec. 2016</i>				
Comments				
This section shows some shrinkage cracking, some longitudinal cracking, and some localized fatigue cracking. Transverse and block cracking is likely due to shrinkage from the lime reaction over time. Some longitudinal cracking is not in the wheel path and thus likely not load associated. Some longitudinal cracking is in the wheel path and thus likely load related. At some locations, wheel path cracking also has 1/8 to 1/2" rut depth. Especially near the county line, localized significant distress has recurred.

Lessons Learned				
The lime pretreatment allowed attainment of a mix design with poor site materials.

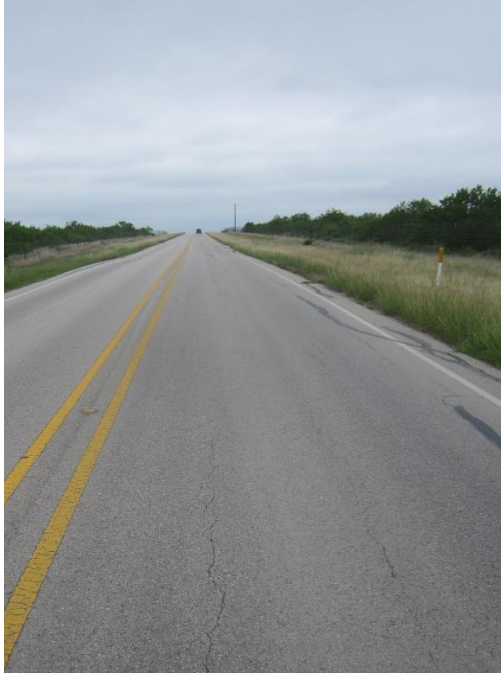
Section	FM 99 (SAT)		
Constructed	April–May 2016		
Pavement Structure	1.5" HMA + 10" emulsion		
Treatment	2.5% lime pretreat (slurry) + 4% emulsion + cement

May 2021 after FDR			
Summary of Structural Analysis	Aug. 2016	Dec. 2016	May 2018
AVG normalized deflection (mils)	28.1	13.9	23
AVG FDR layer modulus (ksi)	103	325	163
Percent of section with effective stabilization	23	71	43
AVG subgrade modulus (ksi)	10.8	16	11.8
<i>Note: 1.5" HMA overlay placed between Aug. and Dec. 2016</i>			
Comments			
<p>The emulsion section is only in the southbound direction from 1.17 to 2.2 mi south of the county line. During construction, TxDOT elected to mix in cement a few days after mixing emulsion. This section shows some localized longitudinal and fatigue cracking. Some longitudinal cracking is not in the wheel path and likely not load related. Some cracking is in the wheel path, which is likely load related; some wheel path cracking also exhibits rutting. The FDR layer modulus does not appear stable over time. This section also seems to have poorer subgrade compared to the entire project extents.</p>

Lessons Learned			
<p>The emulsion treatment was mixed with site material already exceeding optimum moisture content. This urgency for productivity conflicted with best practices and likely contributed to the high deflections and slow rate of gain in modulus of the FDR layer.</p>

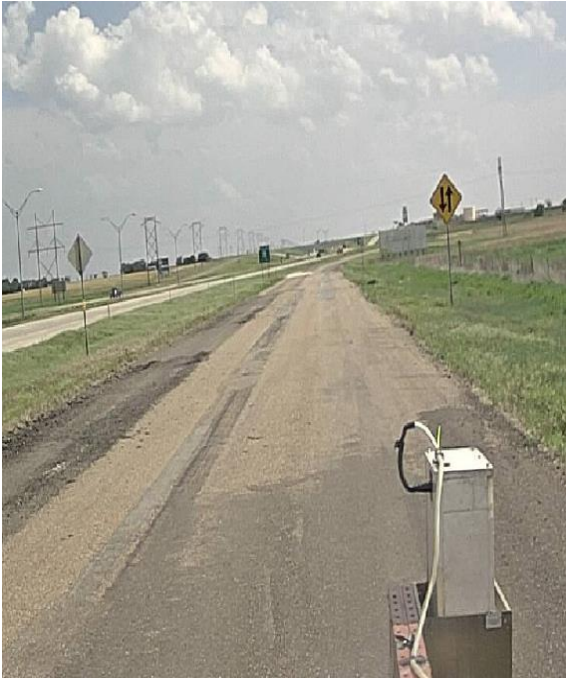
Section	IH 27 FR (LBB)
Constructed	August 2016
Pavement Structure	Sealcoat + 8" foamed asphalt
Treatment	4% lime pretreat (slurry) + 3% foamed asphalt

Summary of Structural Analysis	Aug. 2016	Jan. 2017	March 2018	June 2021
AVG normalized deflection (mils)	18.9	11.4	9.2	9.8
AVG FDR layer modulus (ksi)	127	397	699	846
Percent of section with effective stabilization	44	97	94	97
AVG subgrade modulus (ksi)	18.4	20.9	21.3	19.5

Comments
 The seal coat peeled and extensive raveling occurred in the first year, particularly in the southbound direction. A forensic investigation revealed the treated material was solid but raveled severely with the loss of the surface treatment protection. Blade on material was used to address the raveling. Transverse, relatively evenly spaced cracking exists, along with block cracking. Combined with increasing base modulus over time, this observation suggests long-term pozzolanic reactions are dominant in this section. Longitudinal cracking is also present in some locations.

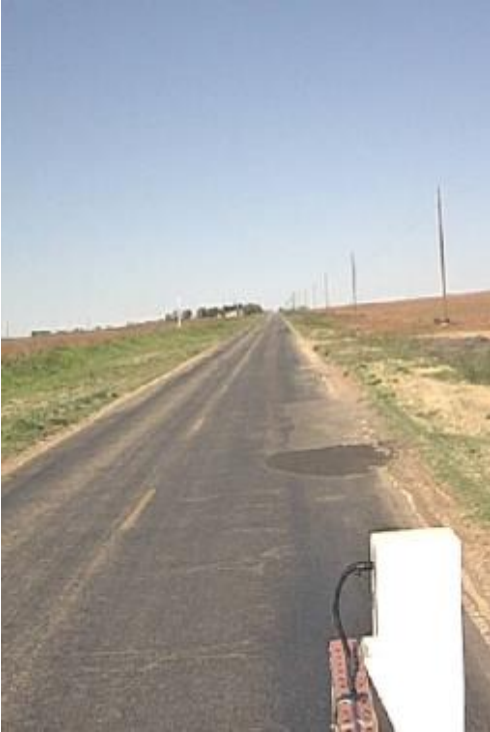
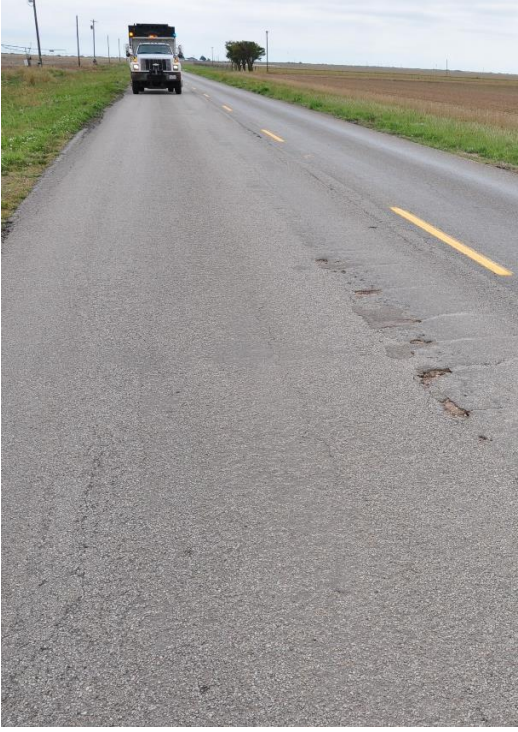
Section	FM 2150 (LBB)—0.85 to 2.4 mi W of RM 312
Constructed	August 2016
Pavement Structure	Sealcoat + 8" foamed asphalt
Treatment	1.5% cement + 2.4% foamed asphalt

Summary of Structural Analysis	Aug. 2016	Jan. 2017	March 2018	June 2021
AVG normalized deflection (mils)	17.0	18.0	20.7	24.2
AVG FDR layer modulus (ksi)	116	254	259	161.8
Percent of section with effective stabilization	19	58	50	41
AVG subgrade modulus (ksi)	10.2	12.5	11.0	13.5

Comments
 This project was segmented due to different materials and lab results obtained during the planning stage. This section treated 100% in-situ materials. Some edge failures exist, along with some locations of fatigue and block cracking in the inside wheel path. The structural analysis data suggest that effective stabilization throughout the section was never fully achieved. The structural data also suggest that somewhere between about 2 and 5 years in service, the structural capacity of the base layer may have started to decline. This observation and the most recent (June 2021) results may in part be influenced by potential impacts of the 2021 winter storm on the pavement.

Lessons Learned
 This material exhibited a very high dry strength in the lab, but only 28% retained strength. Treating only a half section of the road may partially have contributed to the distresses observed in the inside wheel path. This pavement serves the outbound loads from an aggregate pit; if at all possible, establishing more pavement width could help reduce the risk of edge failures.

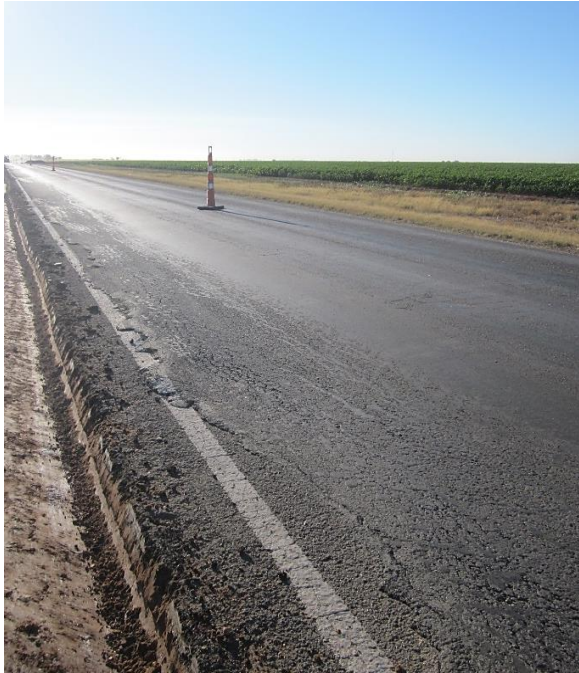
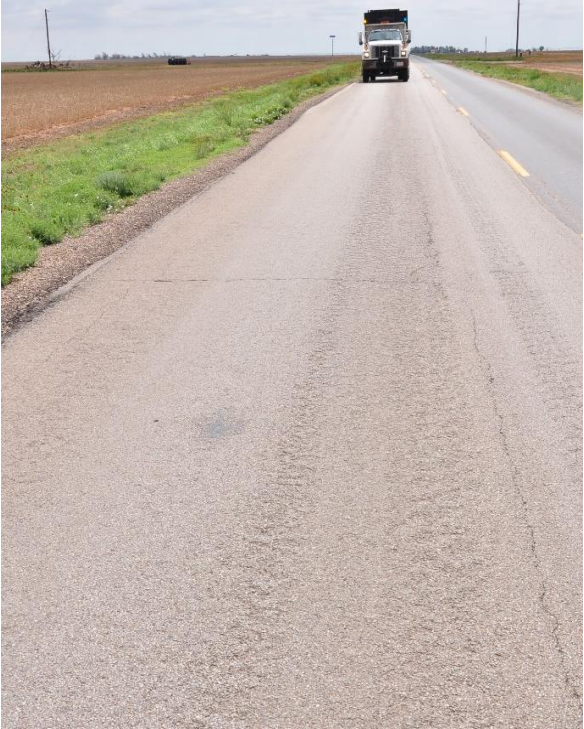
Section	FM 2150 (LBB)—2.4 mi W of RM 312 to RM 308			
Constructed	August 2016			
Pavement Structure	Sealcoat + 8" foamed asphalt			
Treatment	Add 2" RAP + 2.5% cement + 2.4% foamed asphalt

August 2016 before FDR		June 2021 after FDR		
Summary of Structural Analysis	Aug. 2016	Jan. 2017	March 2018	June 2021
AVG normalized deflection (mils)	22.2	12.7	16.1	18.8
AVG FDR layer modulus (ksi)	94	512	440	420
Percent of section with effective stabilization	12	94	90	68
AVG subgrade modulus (ksi)	15.8	13.8	11.2	10.8
Comments				
<p>This section added 2" RAP prior to treatment and used a higher cement content due to low moisture-conditioned strengths observed in the lab when only treating existing site materials. This section clearly shows failure mechanisms of a cement-treated base, indicating the higher cement content largely overshadowed the asphalt treatment, with block cracking, some raveling of material in locations at the intersection of the transverse and longitudinal cracks, and localized areas of tightly spaced block cracks in the wheel path.</p>

Lessons Learned				
<p>With dual stabilizer applications, when increasing the cement rates, evaluation should be made as to whether the asphalt treatment is worth the time, effort, and additional cost. While it is unknown what would be the condition of this section if only treated with cement, the site condition indicates essentially that a cement-treated base was constructed.</p>

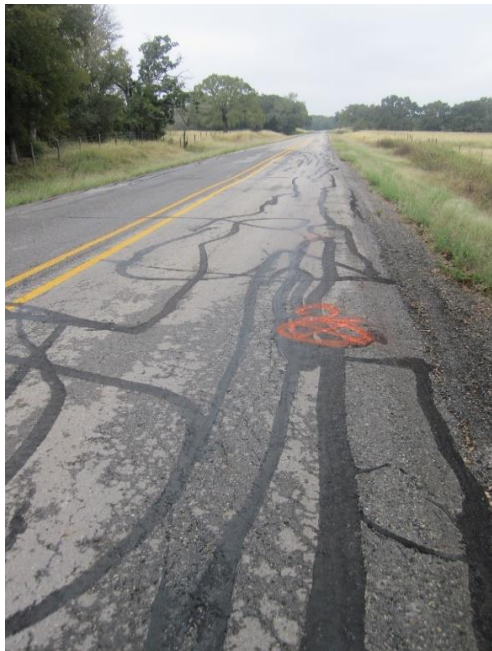
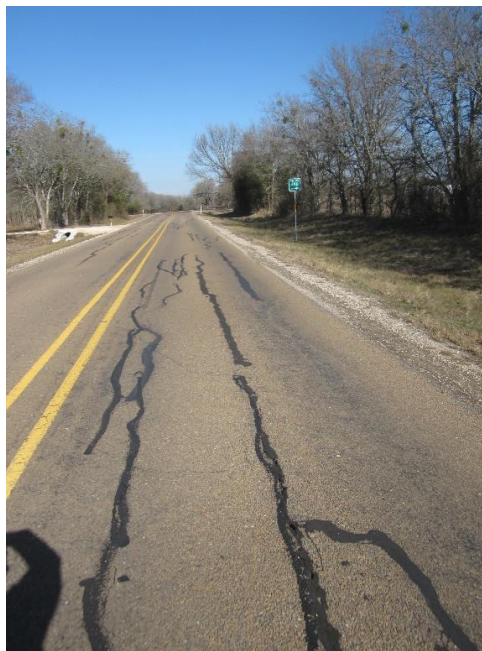
Section	Spur 619 (AUS)
Constructed	March 2017
Pavement Structure	Sealcoat + 8.5" foamed asphalt
Treatment	1.5% cement + 2.4% foamed asphalt

Summary of Structural Analysis	May 2017	May 2018	Dec. 2020
AVG normalized deflection (mils)	18.4	21.3	17.4
AVG FDR layer modulus (ksi)	324	288	294
Percent of section with effective stabilization	92	79	68
AVG subgrade modulus (ksi)	11.5	11.2	14.2

Comments
 This section was constructed largely for the district to gain experience with new technologies in a low-risk environment. The existing pavement had significant edge and longitudinal cracking in localized areas, which has recurred over time. The photos show some of the poorest condition locations from the project extents. Some of the cracks have faulted. Localized rutting also exists, generally 1/4–3/4". This pavement does not meet Texas triaxial thickness requirements, which at least partially contributes to the observed rutting. While the average FDR layer modulus is relatively stable, the variability is increasing, as evidenced from the decline over time in percent of section with effective stabilization.

Lessons Learned
 In the context of gaining experience in a low-risk setting, this project was a success. In the context of addressing the pavement distress, this project demonstrated that for pavements with edge or longitudinal cracking due to poor subgrades as the primary distress, FDR can improve conditions temporarily but is not addressing the real root cause, and caution and clear expectations up front should be set during future project selections.

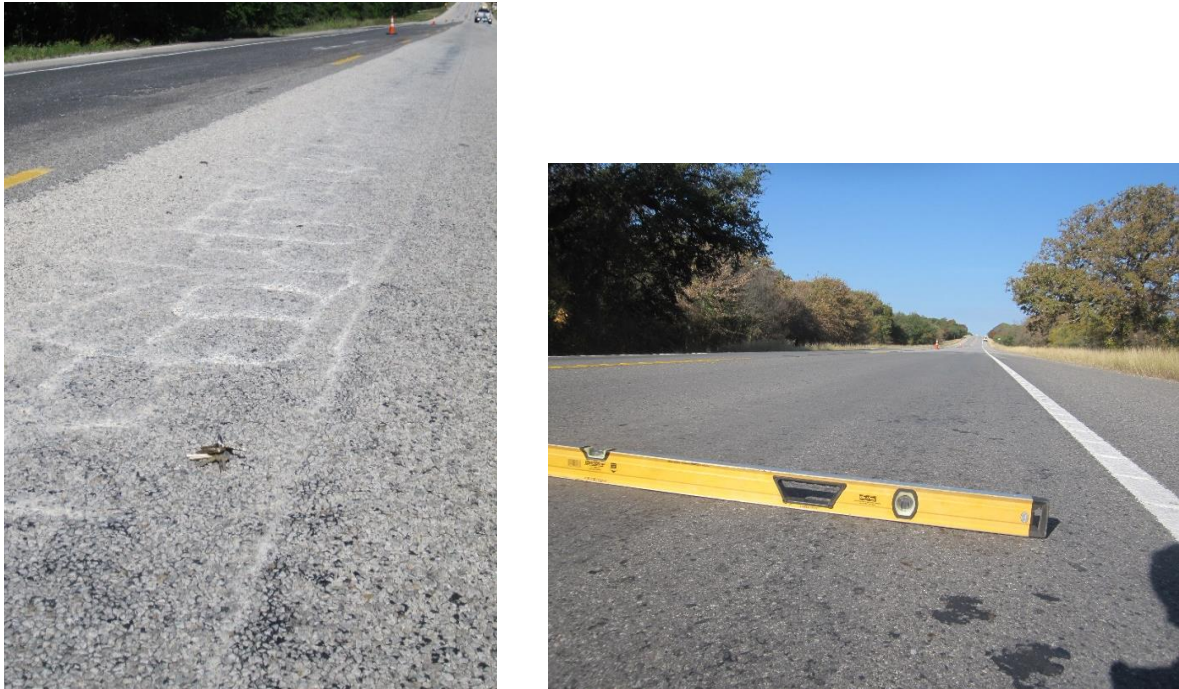
Section	SH 6 (BWD)		
Constructed	August 2017		
Pavement Structure	Sealcoat + 12" foamed asphalt		
Treatment	1.5% cement + 2.4% foamed asphalt

May 2017 before FDR		Nov. 2020 after FDR
Summary of Structural Analysis	Oct. 2017	March 2018	Nov. 2020
AVG normalized deflection (mils)	5.0	4.7	5.5
AVG FDR layer modulus (ksi)	1199	1103	1355
Percent of section with effective stabilization	100	100	100
AVG subgrade modulus (ksi)	25.3	25.8	24.4
Comments			
<p>Prior to FDR, this section showed areas of severe rutting and significant fatigue cracking. After FDR, some shrinkage occurred, likely due to the cement rate. Some edge and longitudinal cracking also developed over time. A forensic analysis revealed these longitudinal cracks generally were not in the wheel paths and coincided with localized areas of low (~ 7–10 ksi) subgrade modulus, meaning the cracks are likely subgrade induced. A short 300' section at the north end was mixed with only cement, and shrinkage cracking was more prevalent in that section. Two short locations of failures (fatigue cracking and rutting) exist, one of which may coincide with transition from foam to cement treatment.</p>

Lessons Learned			
<p>The foamed asphalt treatment provided a high modulus base with less shrinkage cracking compared to only mixing cement. The very high modulus of the base on this project means future efforts should analyze mixture design methods and develop techniques to optimize the mixture design for materials and site conditions. This mix, if anything, is probably overstabilized.</p>

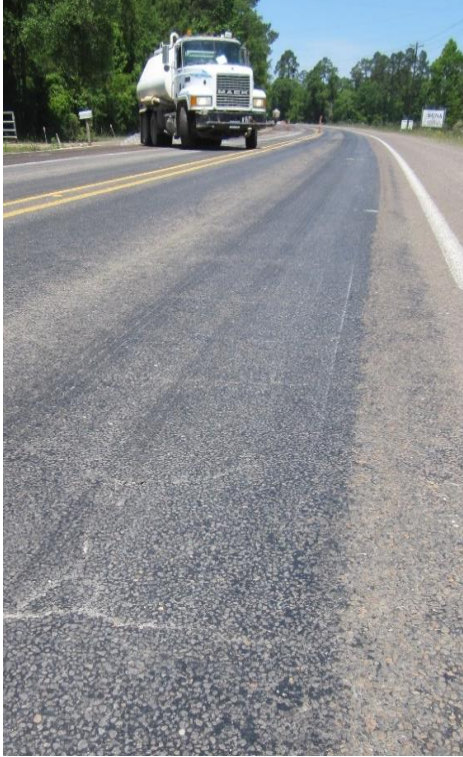
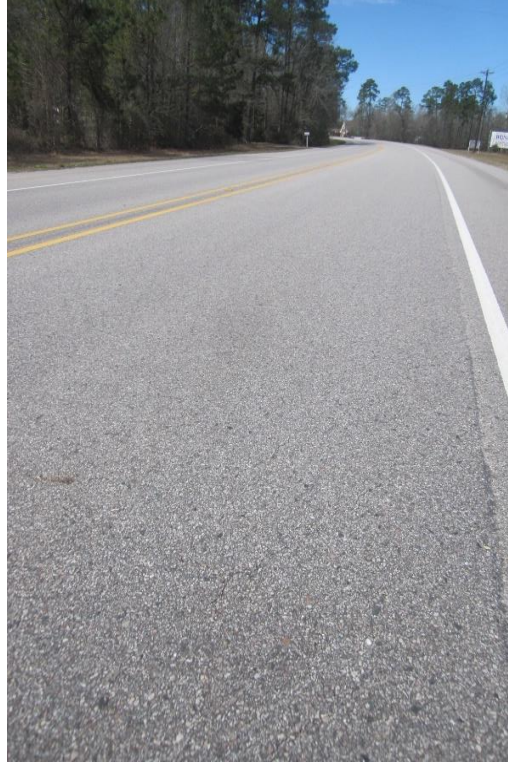
Section	SH 62 (BMT)
Constructed	May 2018
Pavement Structure	2.5" surface (underseal + HMA) + 7.5" foamed asphalt
Treatment	Add 2" RAP + 1% cement + 2.5% foamed asphalt

Summary of Structural Analysis	Jan. 2019	March 2021
AVG normalized deflection (mils)	8.4	11.3
AVG FDR layer modulus (ksi)	768	532
Percent of section with effective stabilization	100	96
AVG subgrade modulus (ksi)	14.4	15.6

This sectioned addressed localized distresses prior to placement of a seal and new overlay. Cement and RAP mixed in advance were placed on the roadway prior to FDR to provide more thickness of better material. Following FDR, some transverse cracks and longitudinal cracks were observed in the hot mix. The longitudinal cracks do potentially appear load related based on proximity to wheel path. Given the FWD results, properties of the hot mix may be a more likely contributor rather than potential lack of support from the base.

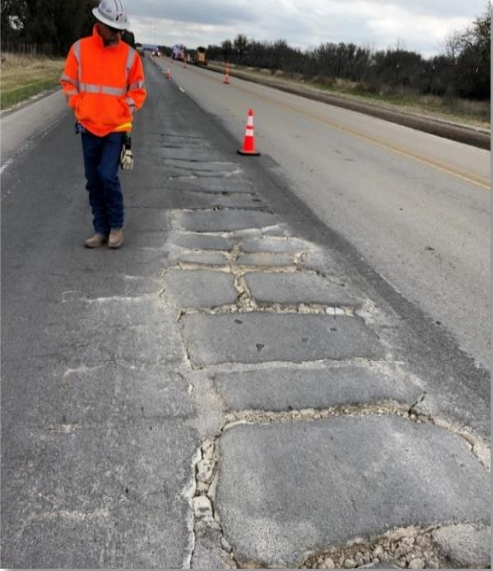
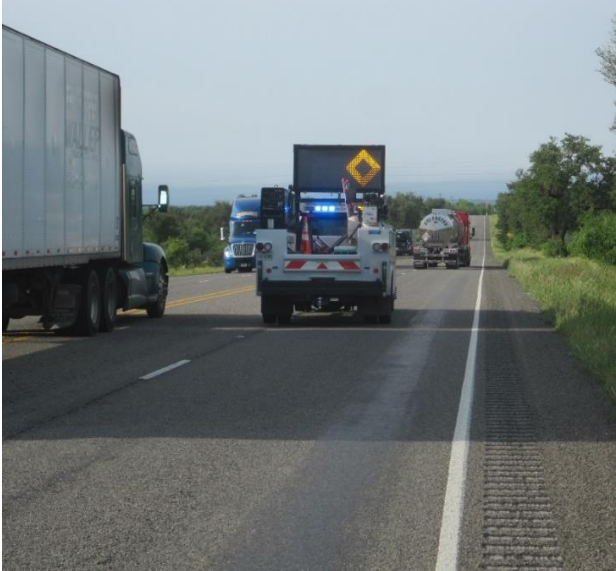
Section	US 83 (SJT)
Constructed	March 2019
Pavement Structure	A-R seal + seal coat + 10" emulsion treatment
Treatment	1% cement + 4.8% emulsion

Summary of Structural Analysis	April 2019		May 2021	
	P5_SB	P6_NB	P5_SB	P6_NB
AVG normalized deflection (mils)	23.2	15.4	17.5	13.5
AVG FDR layer modulus (ksi)	101	230	148	234
Percent of section with effective stabilization	29	68	45	70
AVG subgrade modulus (ksi)	12.2	13.6	15.0	16.4

This section consisted of multiple locations in passing lanes to restore failures in a Super 2 widening prior to placement of a full-width asphalt rubber seal. Results show for passing lane 5 (P5), which was poorer material, less desirable structural results compared to passing lane 6 (P6), which had better material. P5 materials did not meet lab requirements during testing, and the structural results show the field also did not meet general design assumptions. Thus far, the sections are holding up well to intense traffic, with some locations of depressions visible at the inside ~ 6" of the FDR cut. Given the very poor prior condition, and the fact that the materials treated had already been treated with cement at least once and rapidly failed, results thus far are positive from this section.

This section represented another excellent leveraging of state resources to prep specific sections of a larger corridor for future contract work. The nature of the original failures suggests future projects should try to avoid non-uniform widening. The viability of treating materials that have already been reworked multiple times also potentially expands the scope of the asphalt-based FDR toolkit.

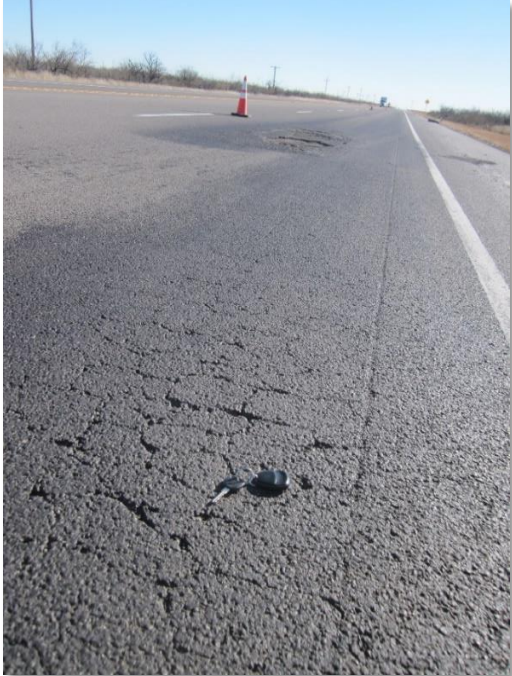
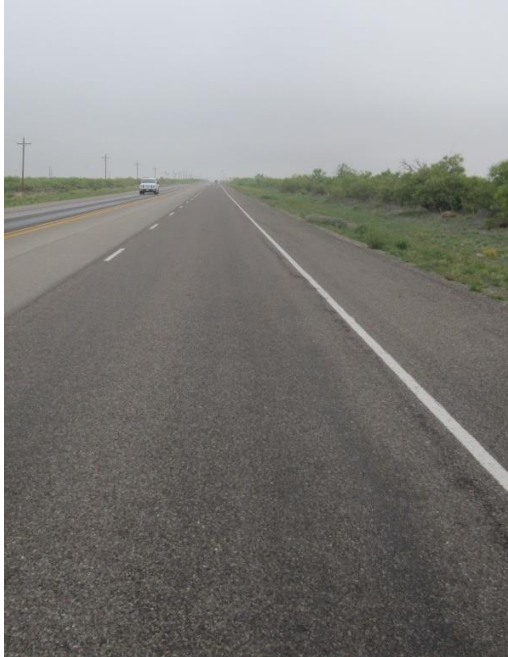
Section	SH 176 (ODA)	
Constructed	April 2019	
Pavement Structure	2CST + 10" foamed asphalt + 8" granular subbase	
Treatment	1% cement + 3.2% foamed asphalt	
<div style="display: flex; justify-content: space-around;"> <div style="text-align: center;">

<p>May 2021 after FDR</p> </div> </div>		
Summary of Structural Analysis	May 2019	May 2021
AVG normalized deflection (mils)	6.8	5.6
AVG FDR layer modulus (ksi)	341	449
Percent of section with effective stabilization	96	100
AVG subgrade modulus (ksi)	39	48
Comments		
<p>This pavement failed prematurely after a construction project due to a low-strength, moisture-susceptible flex base. The short foamed asphalt test section served as a demonstration of one potential strategy to rapidly strengthen the pavement and place energy-sector traffic on the road the same day. There is some localized rutting, ~ 1/4", and at the time of the May 2021 survey, focused FWD drops where this distress was observed did not reveal any unusual or concerning base, subbase, or subgrade modulus values.</p>

Lessons Learned		
<p>Construction projects should use extreme caution when using Item 247 Grade 4 with no strength requirements. Foamed asphalt provides a viable option for a long-term solution to strengthen this pavement. The material from this project did not exceed the 120 psi unconfined compressive strength, yet thus far, field performance has raised no concerns. Review of requirements for FDR mix design may be a topic to consider in the future. For in-house operations, the district reported this 1/2 mi long, 20' wide section cost \$168,000, which puts a strain on the district's ability to fund these type of activities.</p>

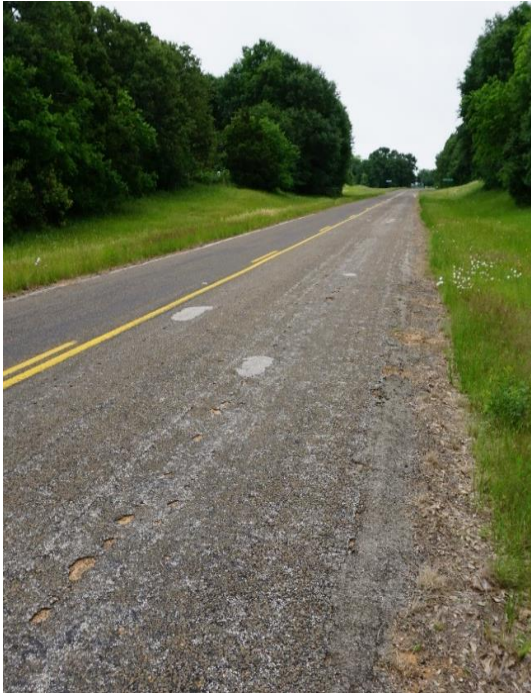
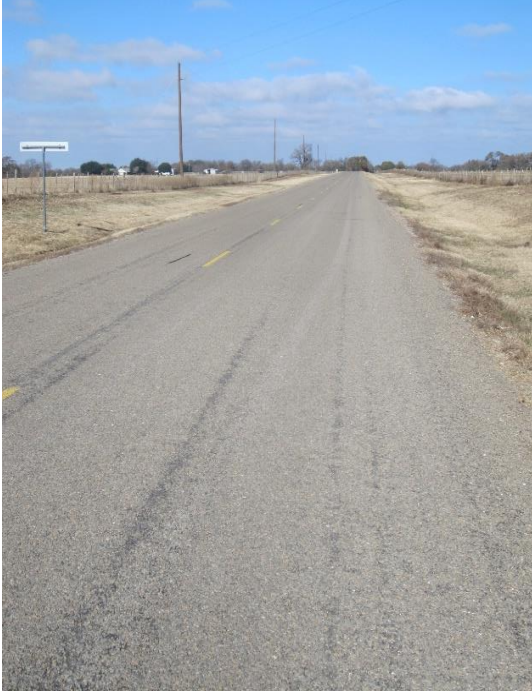
Section	FM 2159 (BRY)
Constructed	July 2019
Pavement Structure	Seal coat + 8" emulsion treatment
Treatment	Add 4" RAP + 1% cement + 4.5% emulsion

Summary of Structural Analysis	Sept. 2019	May 2021
AVG normalized deflection (mils)	10.6	7.4
AVG FDR layer modulus (ksi)	606	936
Percent of section with effective stabilization	97	100
AVG subgrade modulus (ksi)	21.4	26.0

Comments
 Adding the RAP prior to treating allowed for working with marginal site materials from a thin existing pavement. Some localized transverse and longitudinal cracks were noted; however, the overall results thus far are very good, and the structural data suggest the FDR layer is very stiff, well exceeding the typical design assumption value.

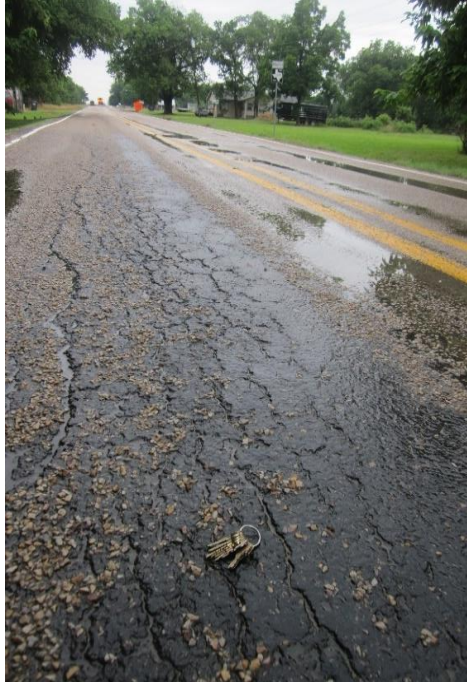
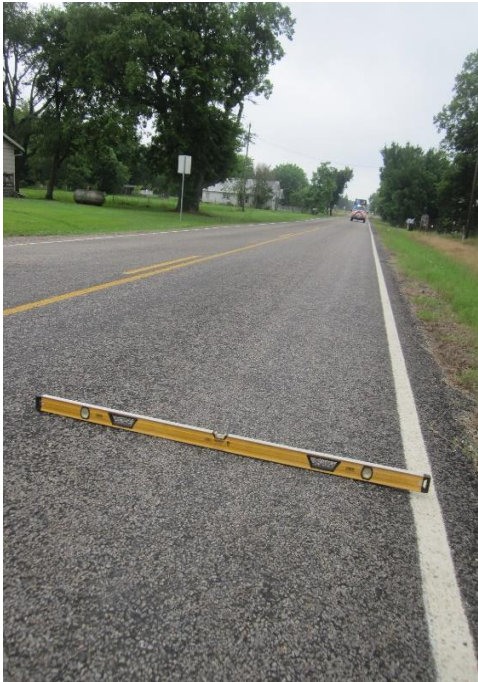
Section	FM 1335 (PAR)		
Constructed	July 2019		
Pavement Structure	Seal coat + 10" emulsion treatment		
Treatment	Add 2" new base + 1% cement + 4% emulsion		
<div style="display: flex; justify-content: space-around;"> <div style="text-align: center;">

<p>June 2021 after FDR</p> </div> </div>			
Summary of Structural Analysis		Sept. 2019	May 2021
AVG normalized deflection (mils)		19.0	18.8
AVG FDR layer modulus (ksi)		324	307
Percent of section with effective stabilization		79	74
AVG subgrade modulus (ksi)		11.1	12.2
Comments			
<p>This section serves a cotton gin and, prior to FDR, showed significant cracking and rutting. The FDR strategy did thicken the total pavement structure, although due to constraints, it still did not meet Texas triaxial required thickness for the poor subgrade. While some rutting, typically 1/4–1/2" has occurred, edge cracking thus far has not recurred, and in the context of the industry traffic and design decisions made, this section has shown good performance to date.</p>

Lessons Learned			
<p>The existing material moisture content was such that either aeration may have been required or construction delayed. It was decided to monitor moisture and delay construction. Particularly in wetter and more humid portions of the state, special care must be taken to not mix emulsion if materials are too wet, especially if same-day industry traffic is required.</p>

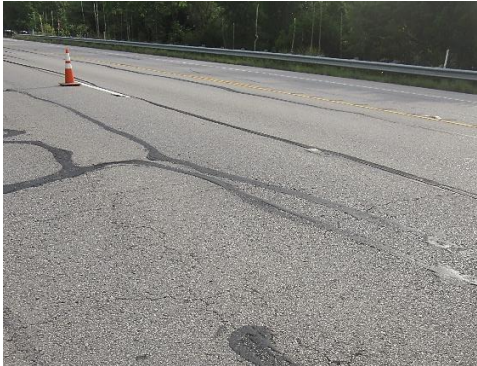
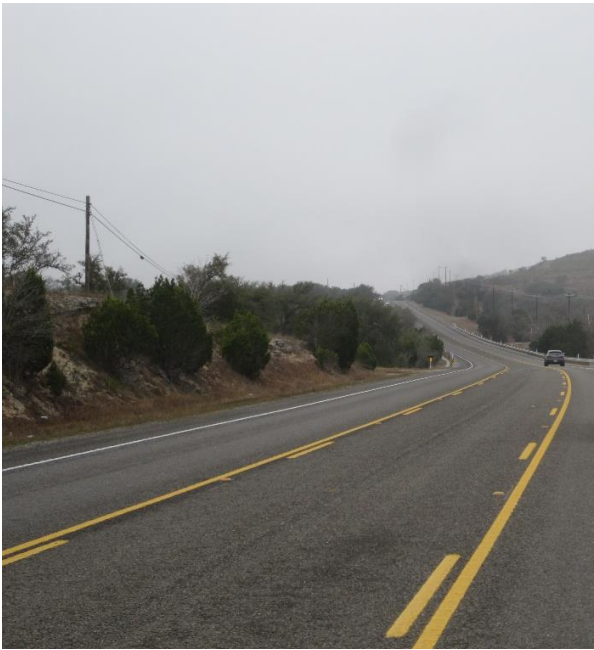
Section	US 281 (AUS)	
Constructed	July–August 2019	
Pavement Structure	4" HMA + 8" foamed asphalt	
Treatment	1% cement + 2.4% foamed asphalt

May 2019 before FDR	February 2021 after FDR
Summary of Structural Analysis		Feb. 2021
AVG normalized deflection (mils)		7.1
AVG FDR layer modulus (ksi)		319
Percent of section with effective stabilization		44
AVG subgrade modulus (ksi)		41
Comments	<p>This section showed significant cracking and rutting prior to FDR; localized partial-depth patches had been tried with limited success. After treatment, while the average FDR layer modulus was good, the variability was extremely high, with a coefficient of variation of over 100%. The low percentage measured with effective stabilization reflects this variability but also reflects complications processing the FWD data due to shallow depth to bedrock. In this situation, the normalized deflection is likely a better indicator of overall effectiveness of the pavement rehabilitation. The FWD data show that 87% of the project extents do not exceed the 10.4 mil anticipated deflection from design assumptions.</p>

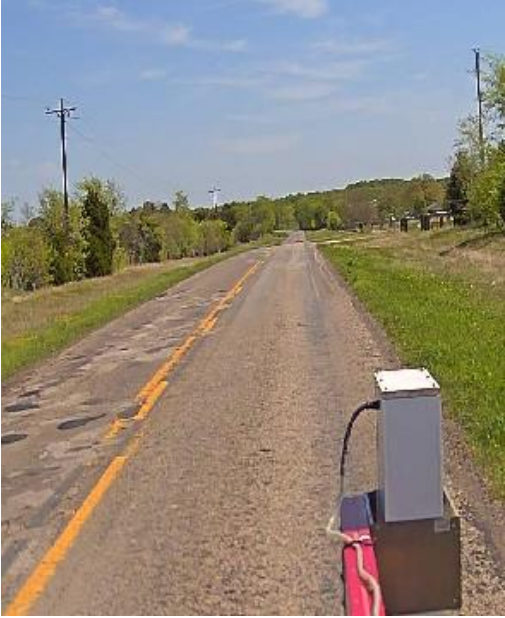
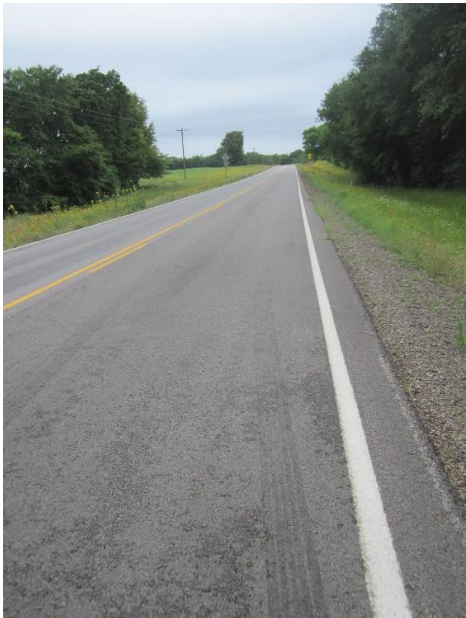
Section	FM 3080 (TYL)	
Constructed	July 2019	
Pavement Structure	1.5-2" HMA + 8" emulsion	
Treatment	Add 3" RAP, pretreat 8" with 3% lime, mix 4% emulsion	
<div style="display: flex; justify-content: space-around;"> <div style="text-align: center;">

<p>June 2021 after FDR</p> </div> </div>		
Summary of Structural Analysis	Dec. 2019	June 2021
AVG normalized deflection (mils)	19.0	17.1
AVG FDR layer modulus (ksi)	273	403
Percent of section with effective stabilization	87	80
AVG subgrade modulus (ksi)	13.2	13.7
Comments		
<p>Compared to the 56 mil average deflection prior to construction, FDR offered dramatic improvement on this section. Following FDR, the seal coat did not bond well, and most of the section received an overlay. At the most recent site visit, some localized edge cracking was noted in low-lying areas, and there is evidence of some shrinkage cracking, likely due to ongoing reactions from the lime. The average FDR layer modulus is good, although the increase in the average modulus value over time coinciding with a decrease in the percent of effective stabilization suggests increasing variability of field conditions.</p>

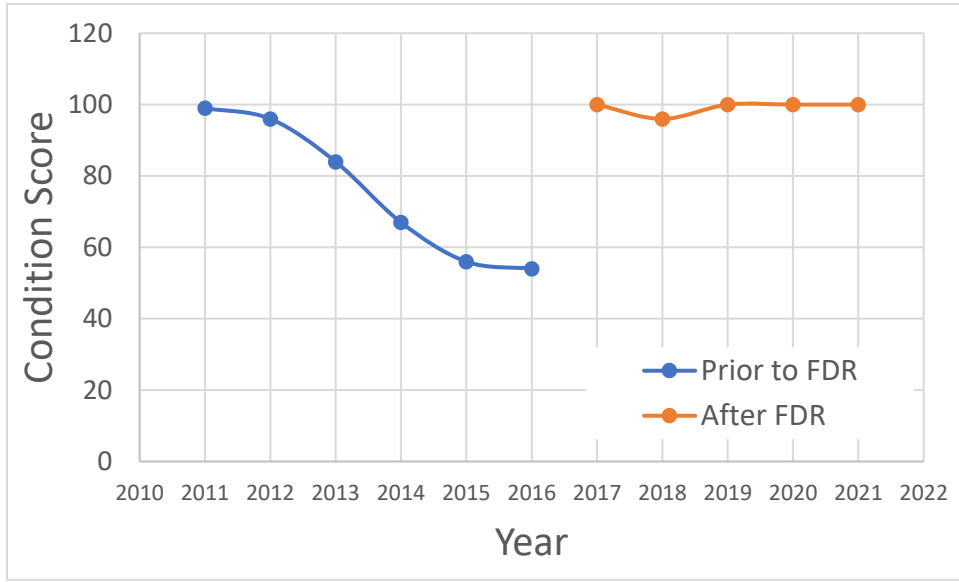
Figure 24. Pavement Condition over Time on FM 99 Test Section.

The test section on FM 99 in the San Antonio District represents the oldest and one of the longest test sections in this project. Figure 24 shows the overall condition score of the extents

represented by the FM 99 test section, from several years prior to FDR to the present. The results clearly show poor condition prior to FDR, and to date, the results show the pavement condition remaining excellent over the 5 years since FDR. Evaluation of the underlying data in these scores shows that prior to FDR, low ride scores and rutting were the main drivers of the deteriorating condition scores. After FDR, the data show longitudinal cracking has occurred, but to date, rutting is minimal and ride scores are good.

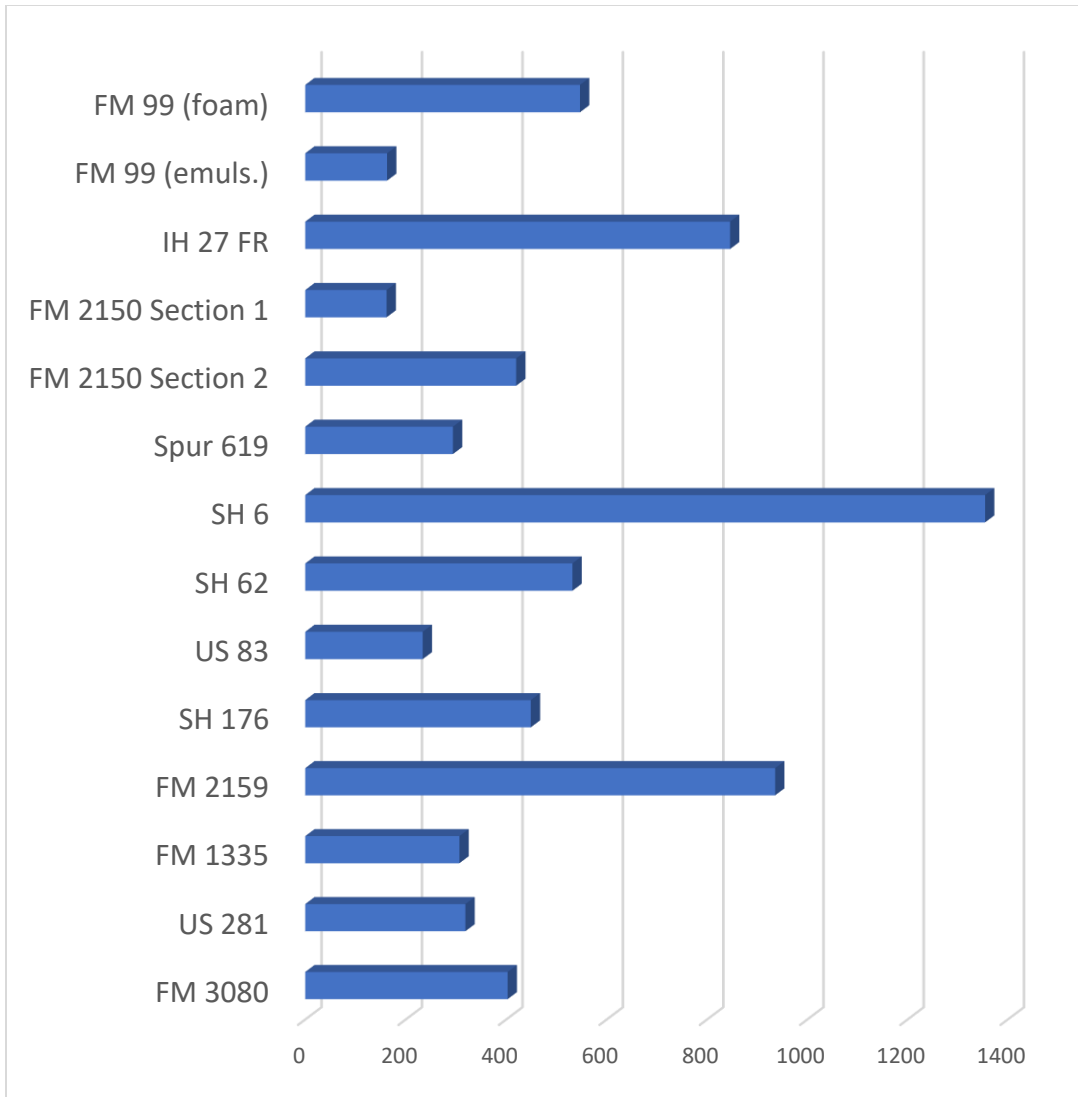
Figure 25. Summary Modulus of FDR Sections.

Figure 25 shows the results of the field FDR layer modulus for each section at the most recent performance monitoring time. The results show that, with two exceptions, the average FDR layer in service exceeded the 200 ksi design modulus. In fact, in some cases, the data suggest that materials may be over-stabilized. This topic of potential over-stabilization and how to optimize the mixture design may be an area for future research.
