Expanding FDR Technologies in Maintenance Operations: Technical Report

Technical Report 0-6880-R1

TEXAS A&M TRANSPORTATION INSTITUTE
COLLEGE STATION, TEXAS

Report 0-6880-R1
Project 0-6880
Project Title: Expanding FDR Technologies in Maintenance Operations

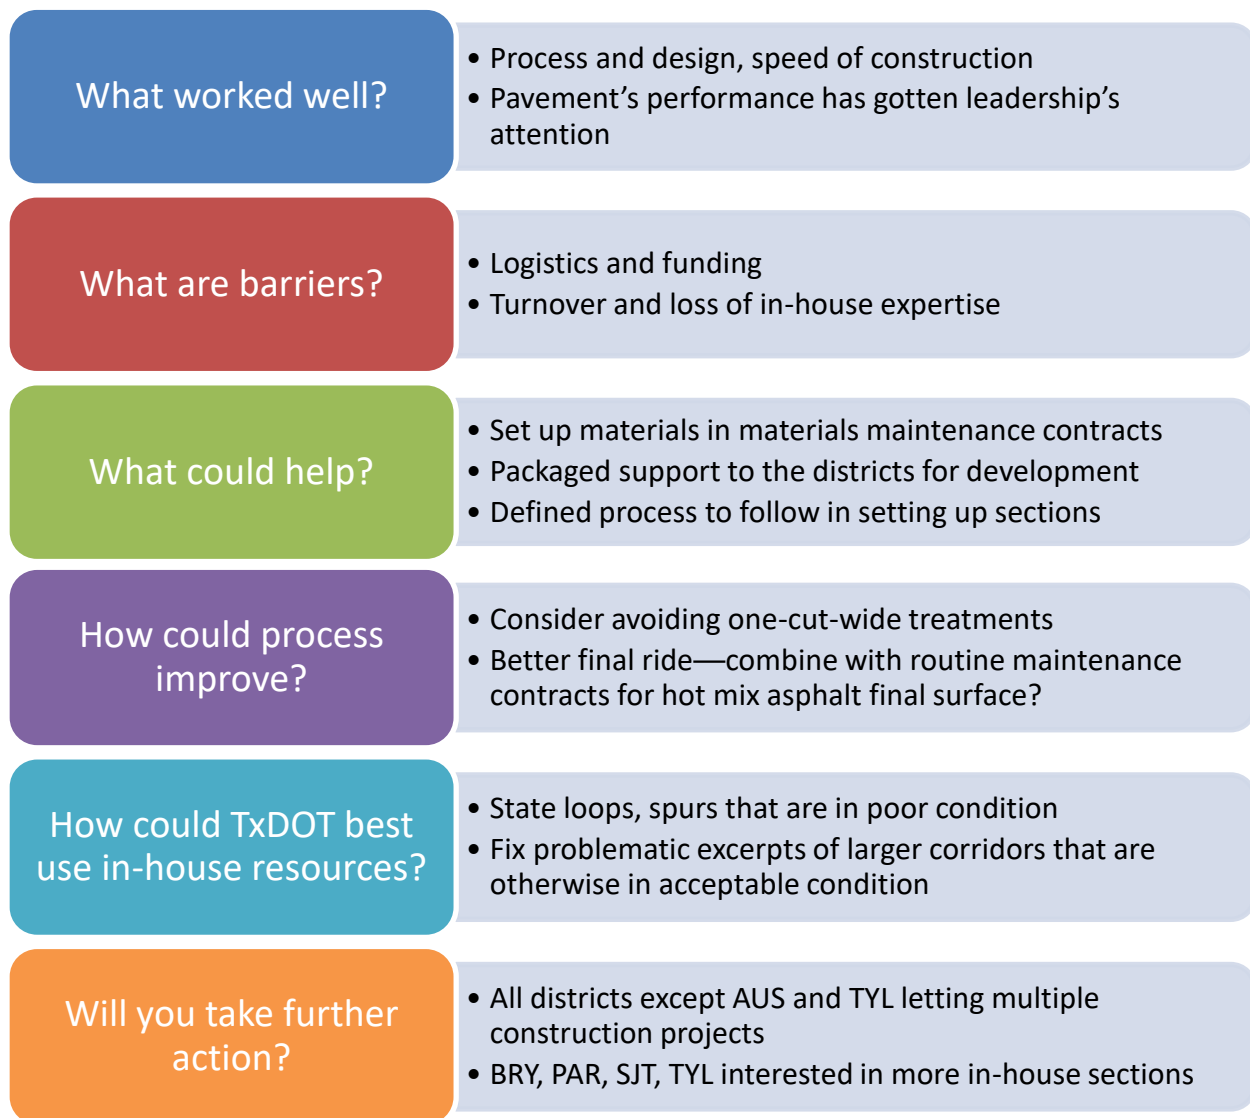
Figure 26. Summary of Stakeholder Feedback.

For areas of improvement, materials' cost and staff turnover/loss of expertise remain top concerns. Additionally, some districts expressed desire for a defined process to set up projects, or for turnkey assistance to analyze and help plan and develop a candidate section.
