Evaluation of Audible Lane Departure Warning Treatments for Seal Coat Road Surfaces

Technical Report 0-6888-R1

TEXAS A&M TRANSPORTATION INSTITUTE
COLLEGE STATION, TEXAS

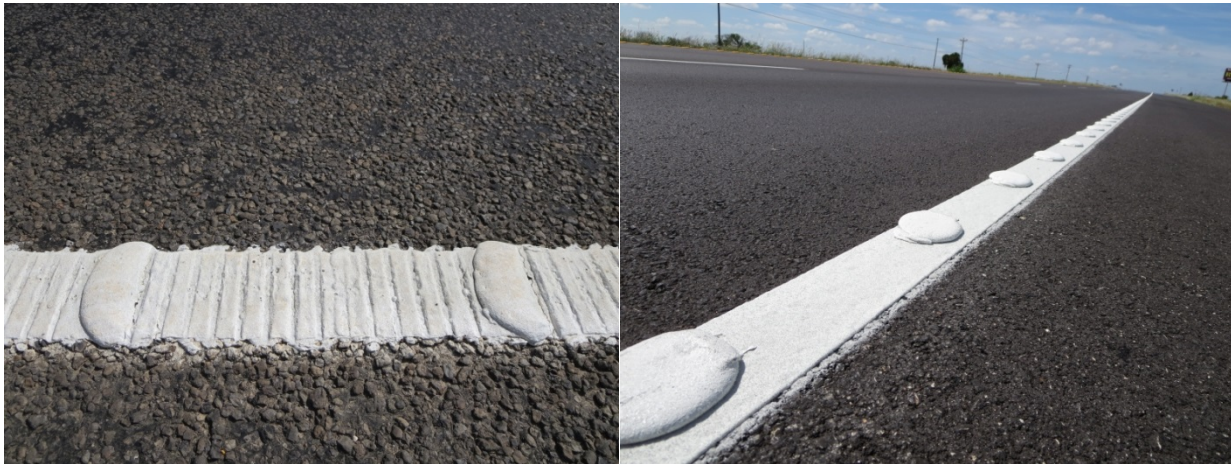
Figure 1. Inverted Profile Marking (Audible) and Profile Edge Line Markings.

The second most common treatment behind rumble strips is audible pavement markings. Audible pavement markings refer to any pavement marking designed with the intent to provide audible and tactile feedback that the driver is driving on the line. The most common audible pavement marking is a profiled pavement marking. Another form of pavement marking is inverted profile markings with or without an audible bump. The standard inverted profile marking produces a hum when driven over. The inverted profile marking with audible bump produces a more pronounced noise. Figure 1 provides an example of an inverted profile marking with audible bump (left image) and a profile pavement marking (right image).

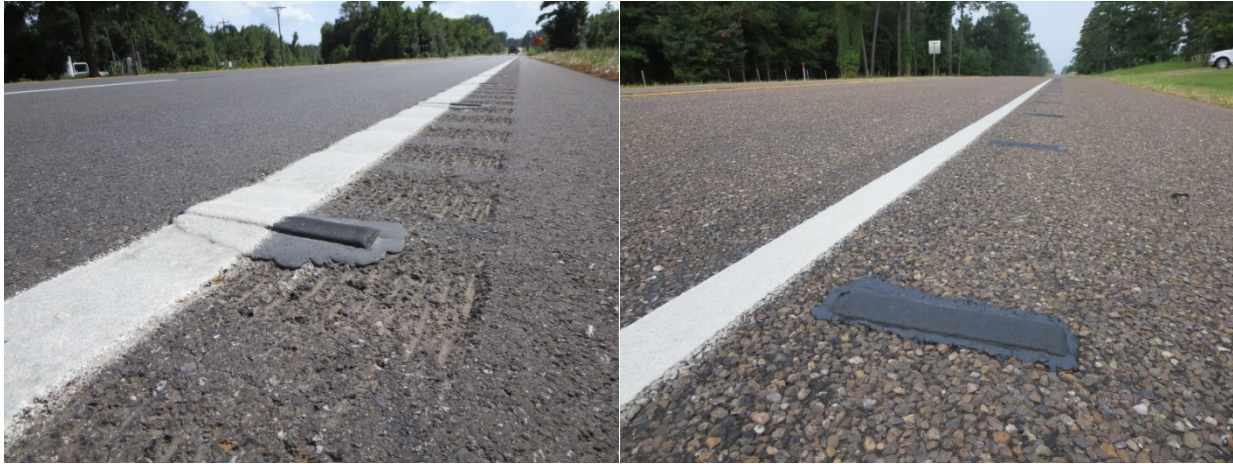
Figure 2. Rumble Bars on Edge Line and Shoulder.

In addition to pavement markings, other forms of on the road audible lane departure warning treatments are being used. Rumble bars, also referred to as preformed thermoplastic strips, or preformed raised rumble strips are used as a replacement for milled rumble strips. These preformed products are affixed to the roadway with the intent that they will perform similarly to rumble strips. Non-reflective raised traffic buttons in white, yellow, and black have also been used in a similar fashion. Figure 2 provides images of two different rumble bar installations. The left image in Figure 2 has the rumble bar installed in conjunction with rumble stripes. A rumble stripe is a rumble strip that has been placed along a marking location and then striped with a pavement marking. The right image in Figure 2 has the rumble bar installed on the shoulder.

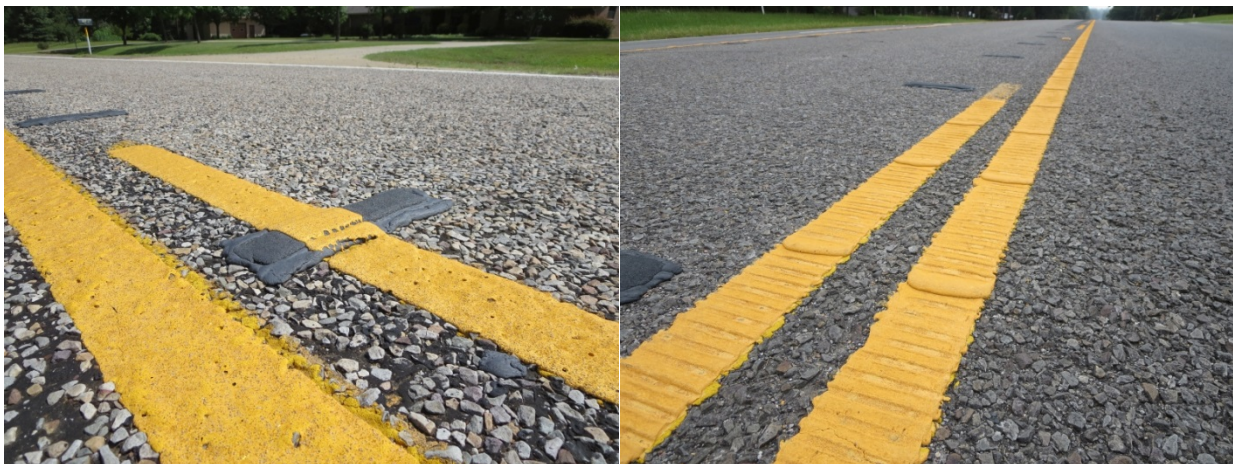
Figure 3. Rumble Bars and Audible Markings on Centerlines.

Figure 3 provides images of two different rumble bar setups along a centerline. The right image in Figure 3 has the rumble bars and inverted profile marking with audible bump.

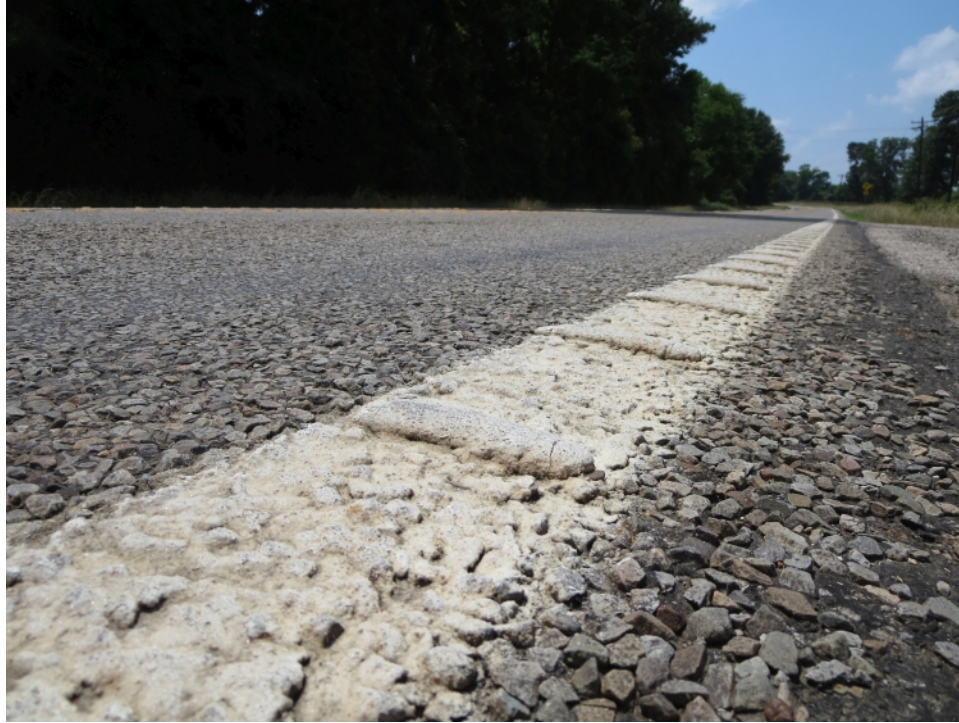
Figure 7. FM 1971 Edge Line Profile Audible Marking.

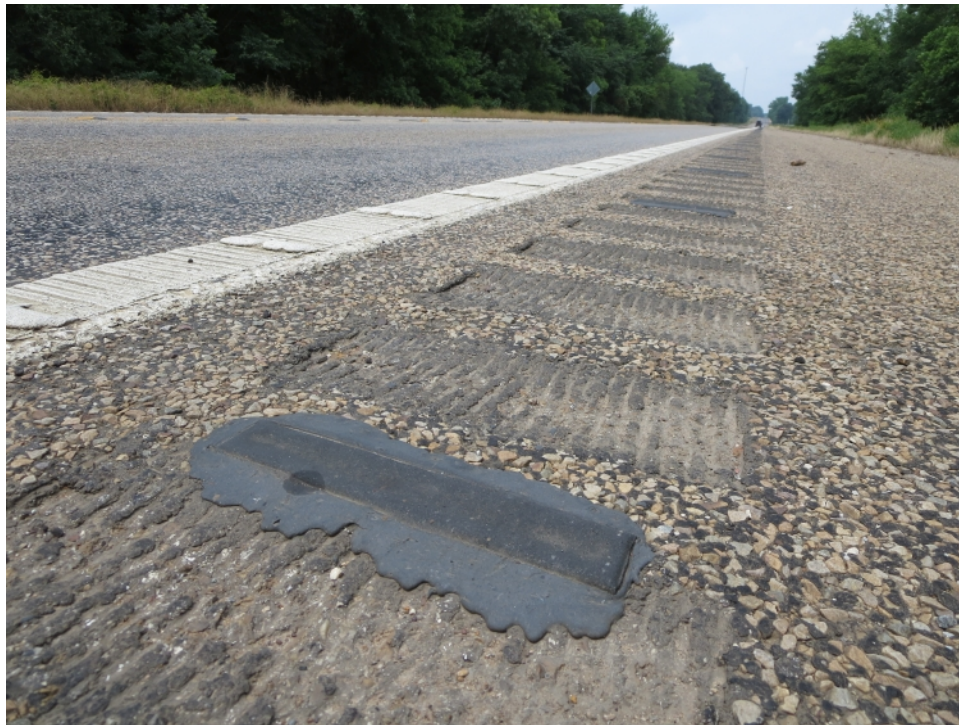
Figure 8. US 79 Edge Line Inverted Profile Marking with Audible, Milled Rumble Strips, and Rumble Bars.

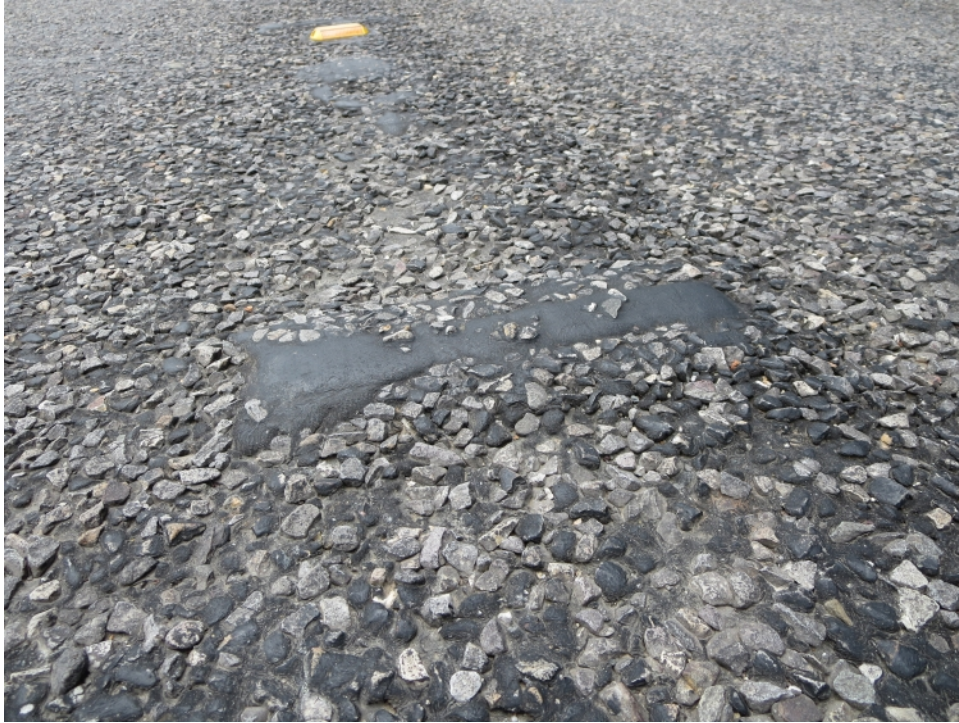
Figure 9. SH 155a Center Line Rumble Bars with One Seal Coat.

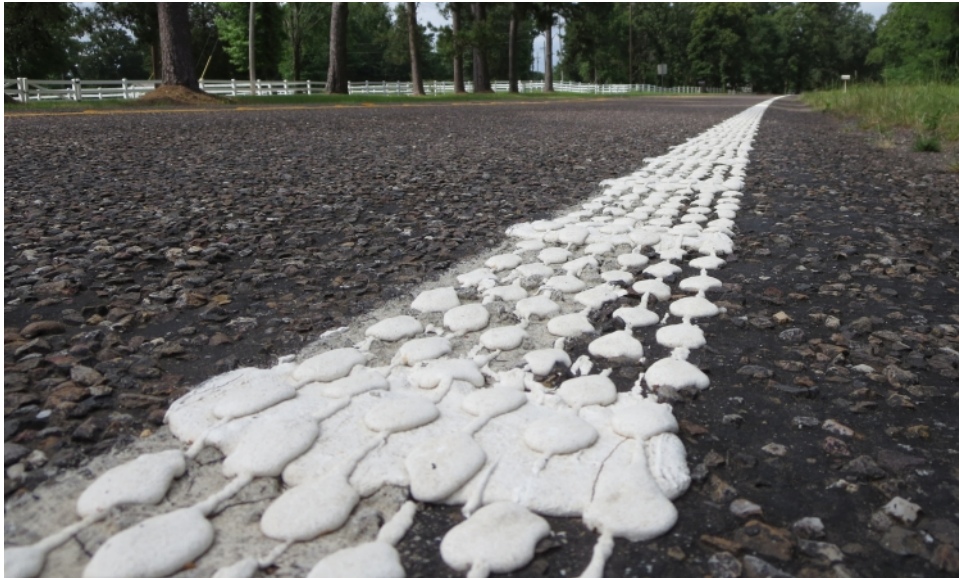
Figure 10. SH 43 Edge Line Profile Audible Marking with Dot Line.

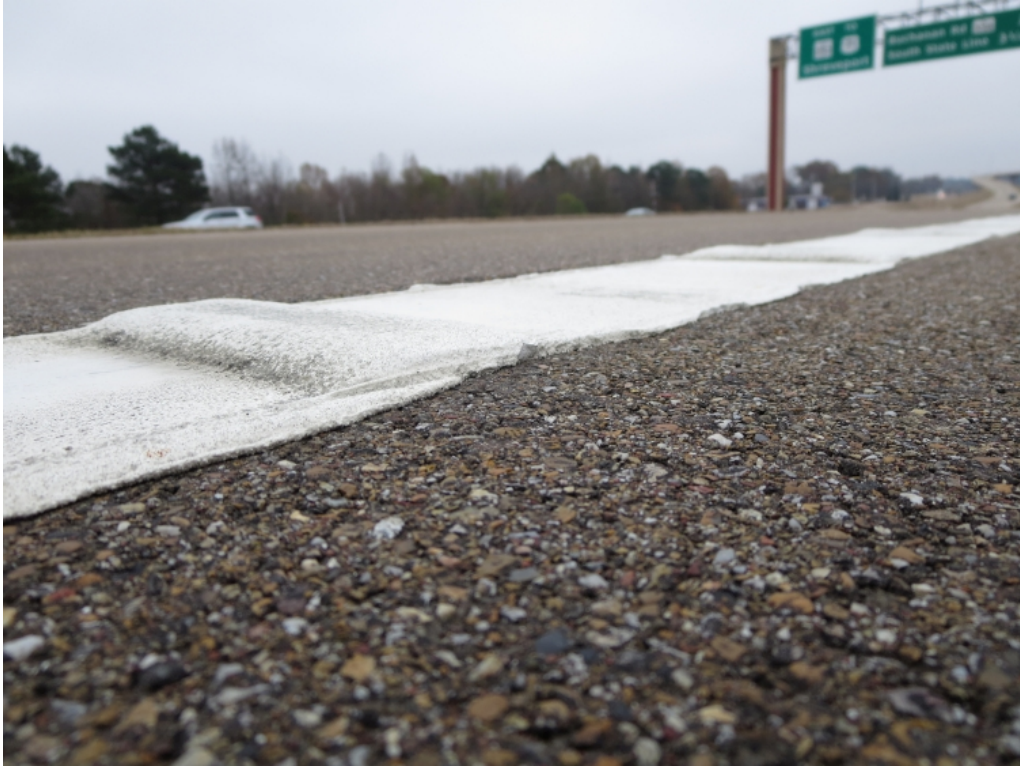
Figure 11. I-369 Edge Line Profile Audible Marking.

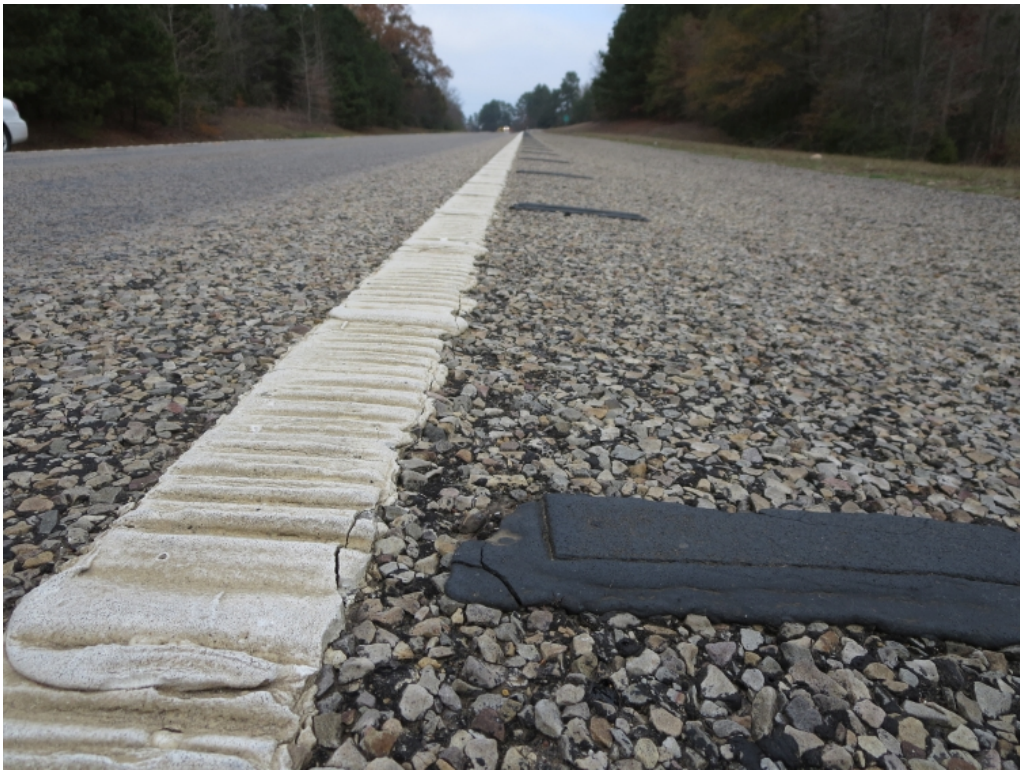
Figure 12. SH 8 Edge Line Inverted Profile Marking with Audible, and Shoulder Rumble Bars.

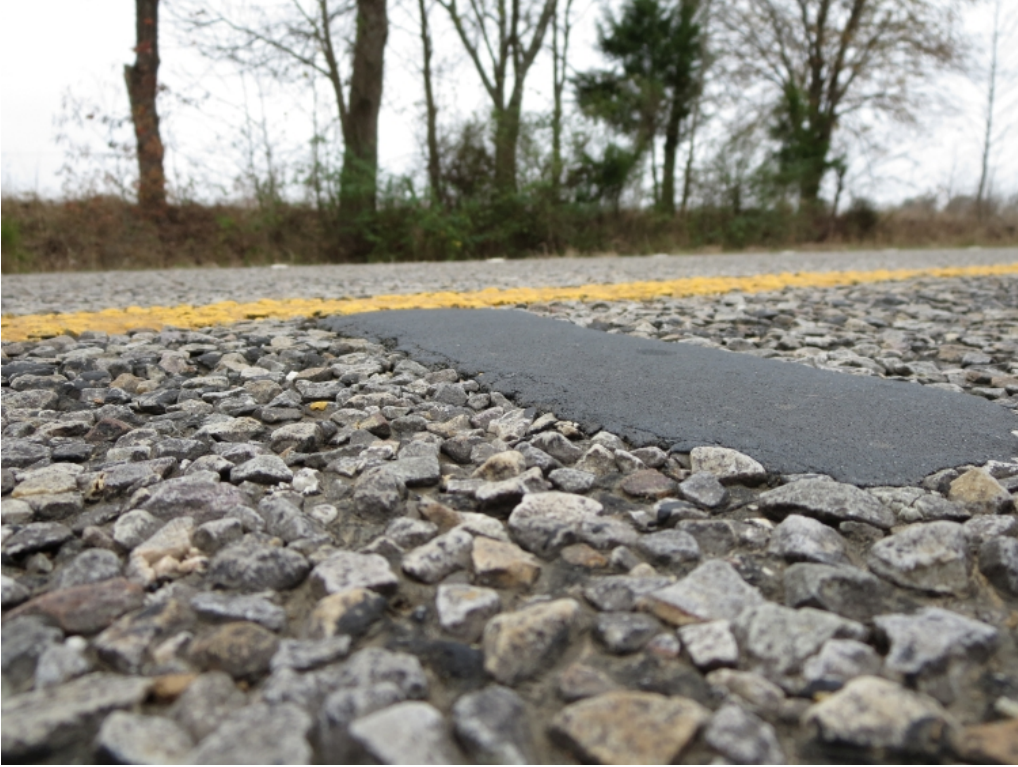
Figure 13. FM 2088 Center Line Rumble Bars (Bars Are Somewhat Flattened Out).

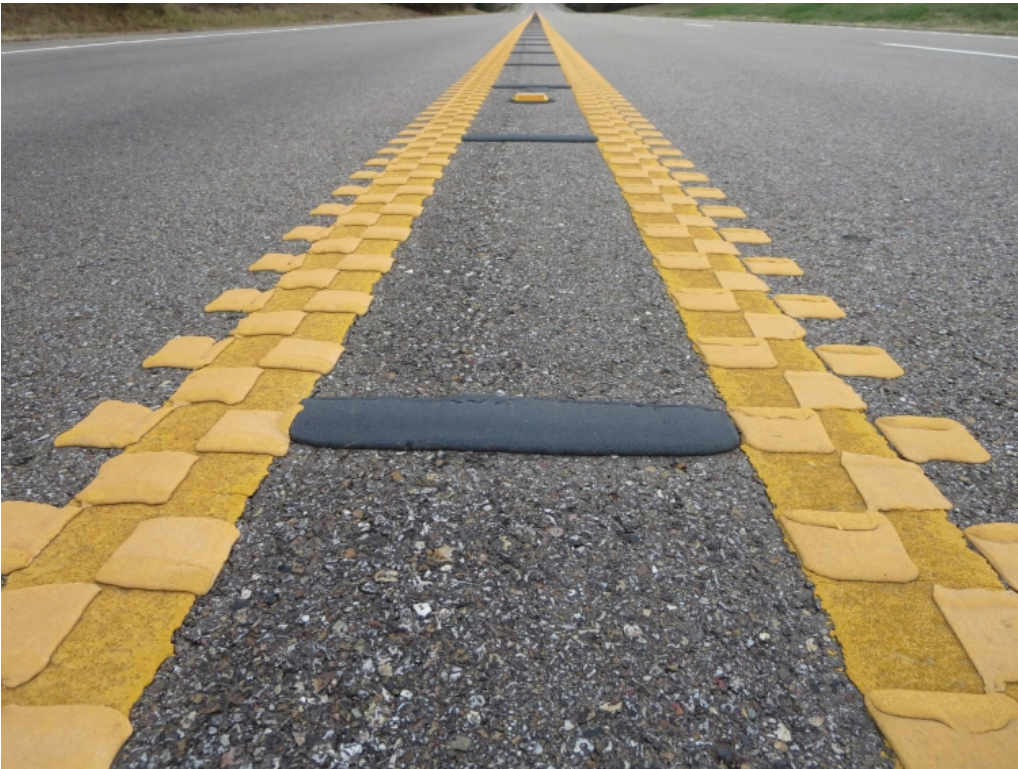
Figure 14. US 259 Checkerboard Pattern Audible Marking with Rumble Bars.

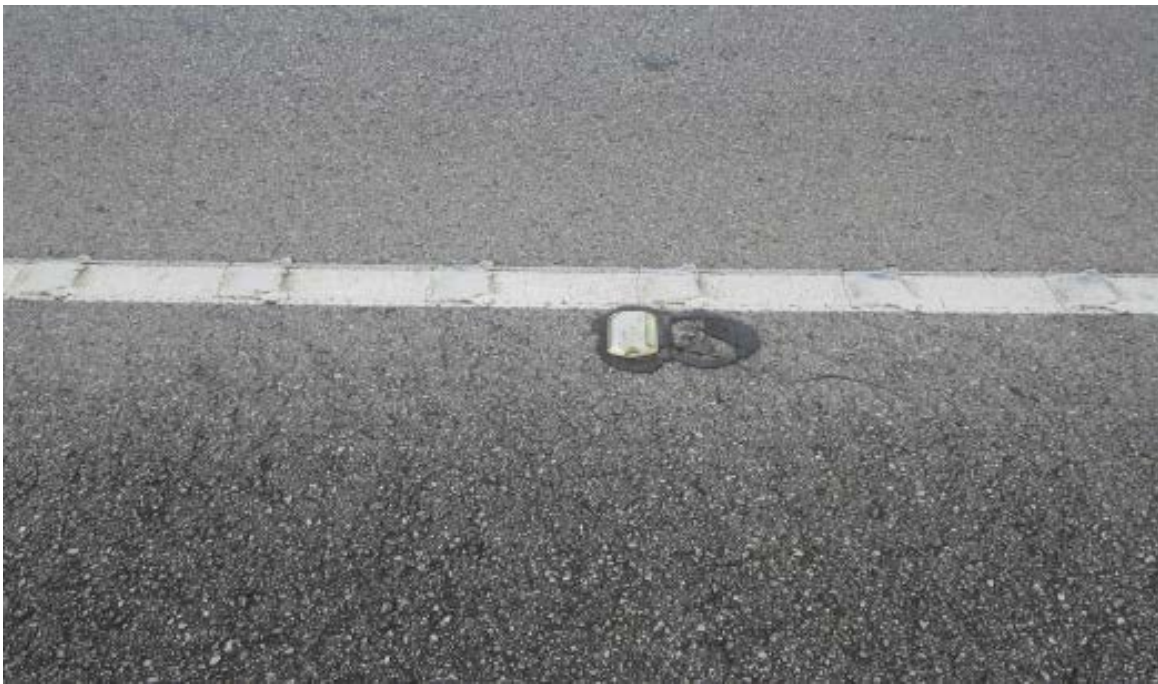
Figure 15. Aged Profile Pavement Marking near Bastrop.

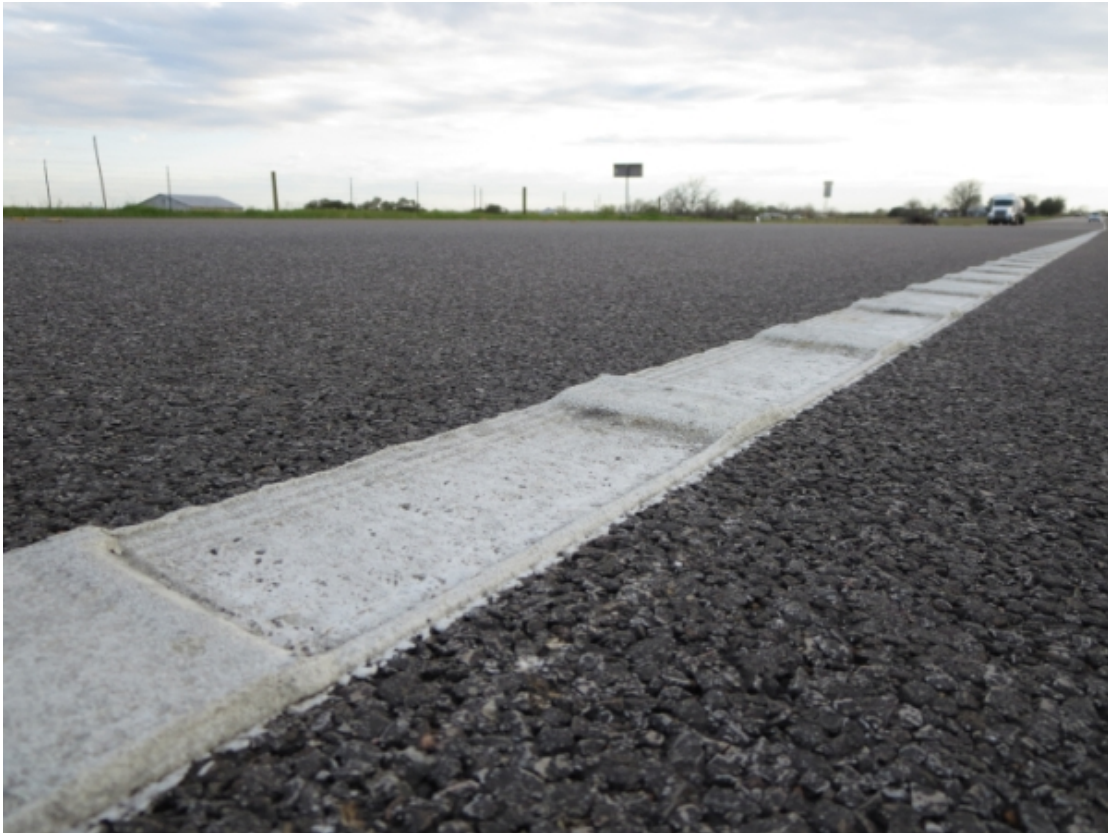
Figure 16. New Profile Pavement Marking near Lincoln.

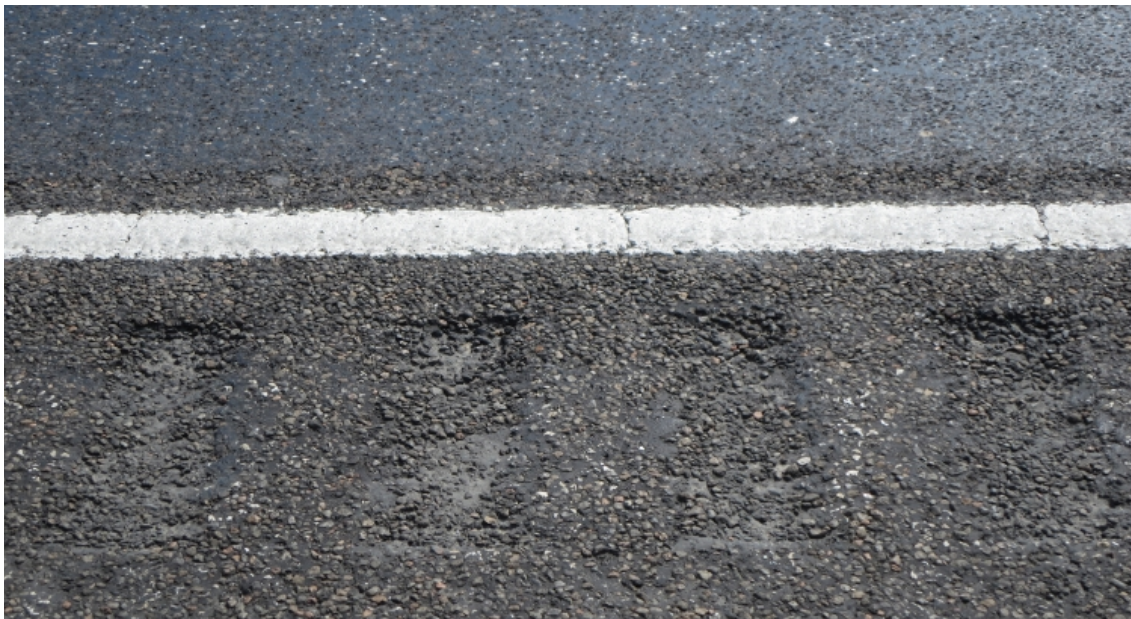
Figure 17. Seal Coat over Milled Rumble Strip near Bryan.

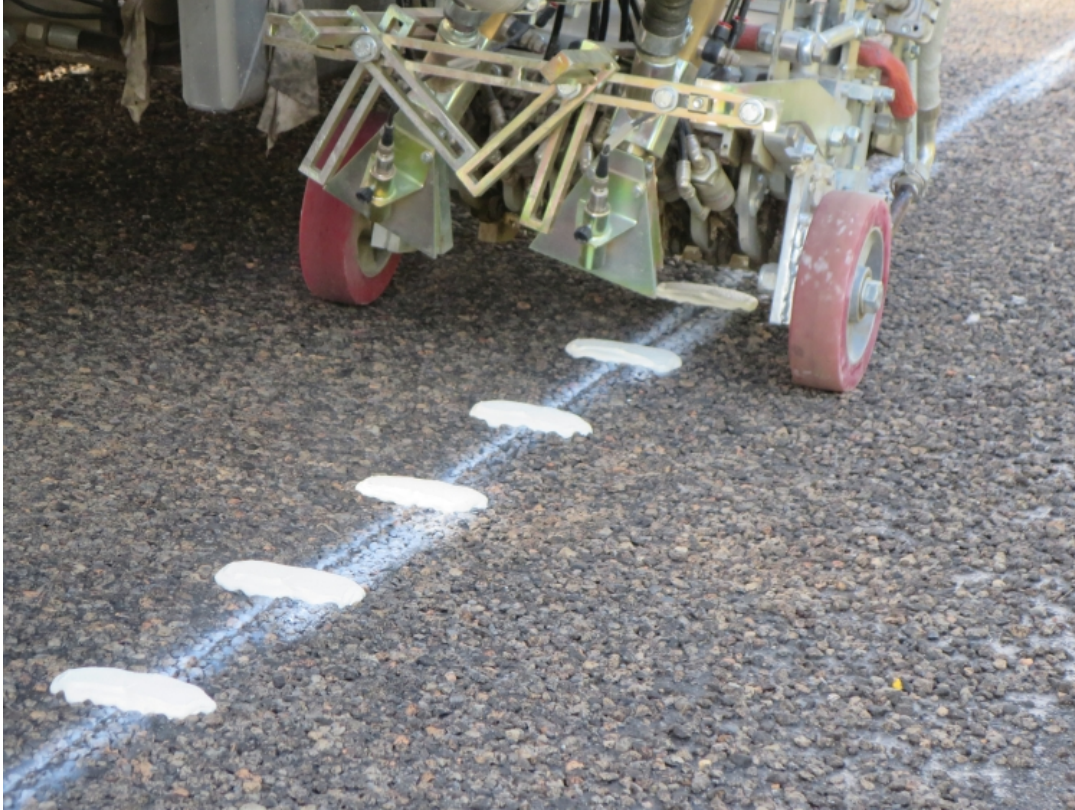
Figure 18. Profile Bump Installation.

typical levels and allow the research team to compare the different designs of the treatments. Figure 18 provides an image of the installation of the profiled bumps. The striping equipment was preprogrammed with the specific designs of each treatment. The spacing, length, and width of the bumps were all computer controlled.

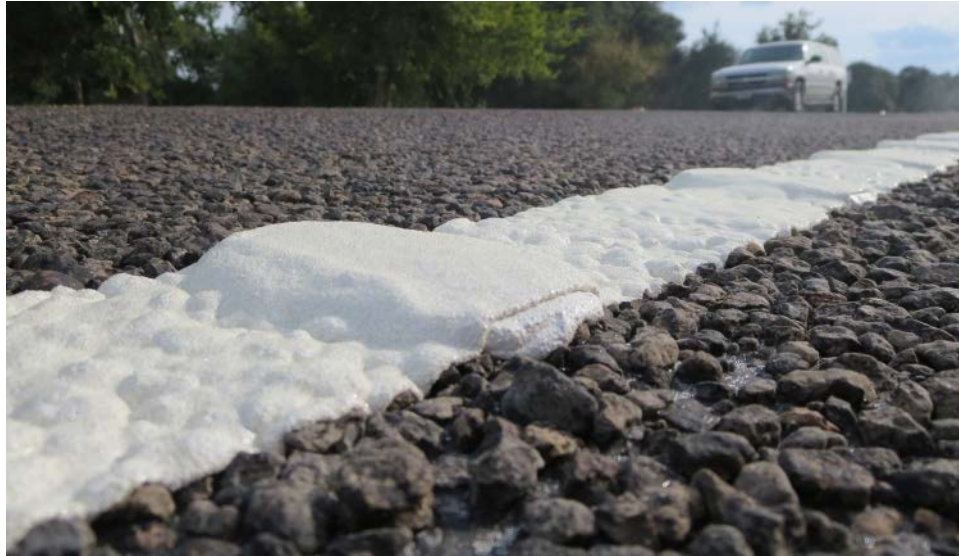
Figure 21. New Profiled Marking with Solid Line over Bump (WB1).

After the bumps were placed, the long lines were placed over the top. Test areas heading westbound received an extruded solid line with a high refractive index drop on glass bead. This bead type typically results in higher retroreflectivity levels. Test areas heading eastbound received a dot line with standard drop on glass beads. The dot line is anticipated to provide better

wet weather visibility due to its structure. When looking directly down on the marking or at short distances ahead, the gaps in the marking are visible. When looking farther down the road at typical driver viewing distances, the marking appears to be a solid line. Figure 21 shows the standard 12-in. spacing profiled bumps covered with the solid extruded line immediately after application. Figure 22 shows test area three eastbound where only the dot marking was applied. Figure 23 shows a test area with a combination of the dot marking and profiled bumps.

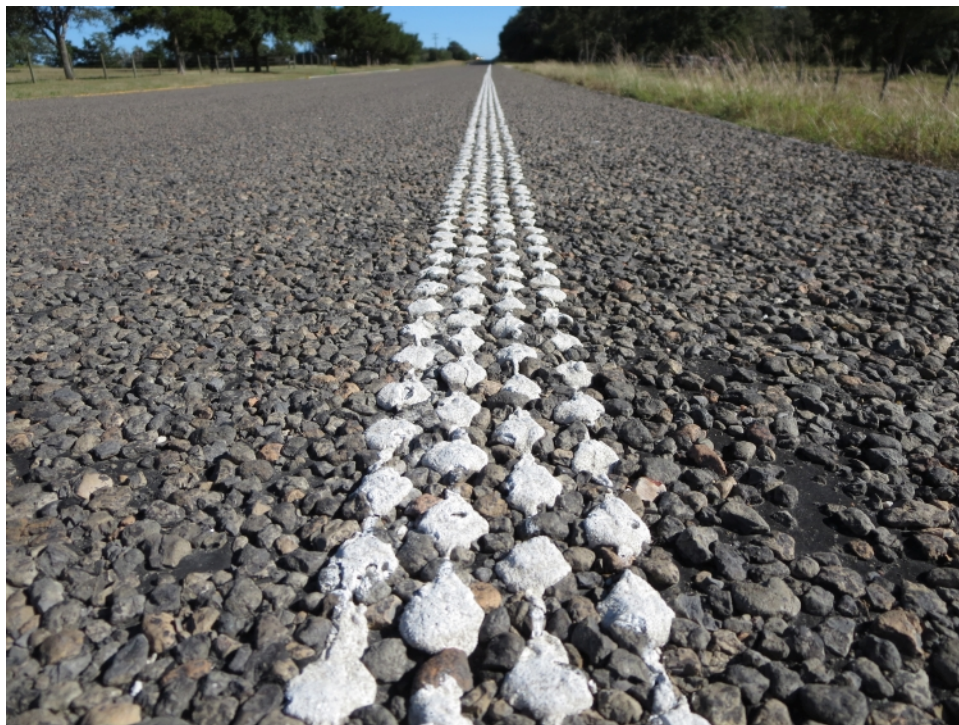
Figure 22. Dot Marking Only (EB3).

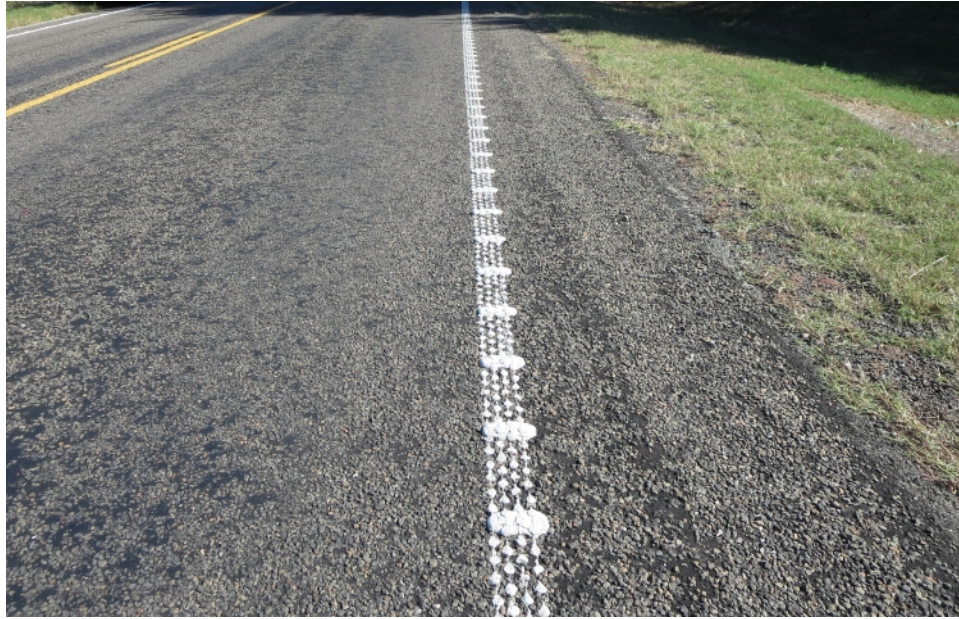
Figure 23. Profiled Bumps with Dot Marking (Standard Spacing, EB1).

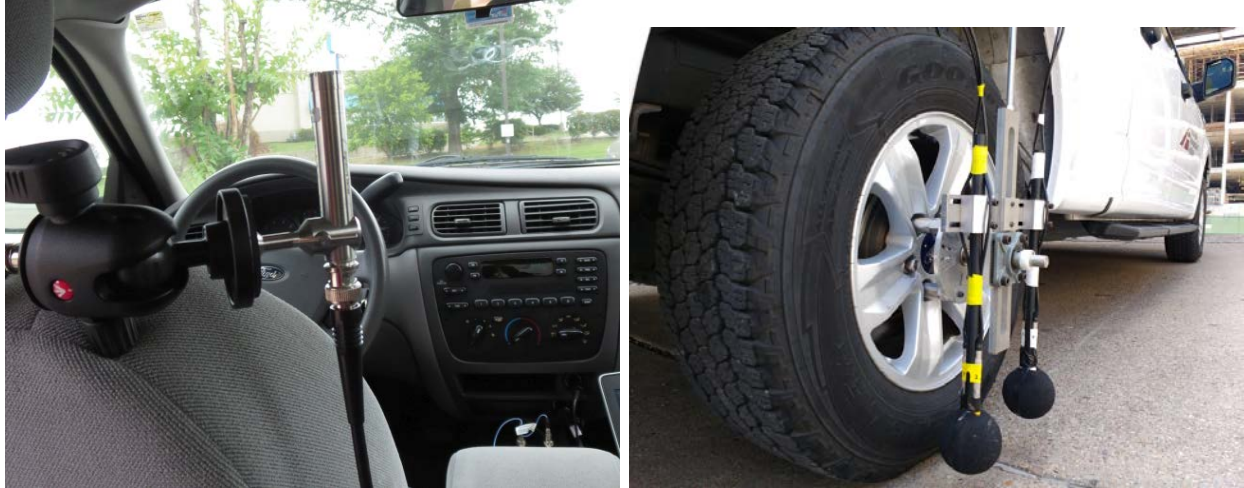
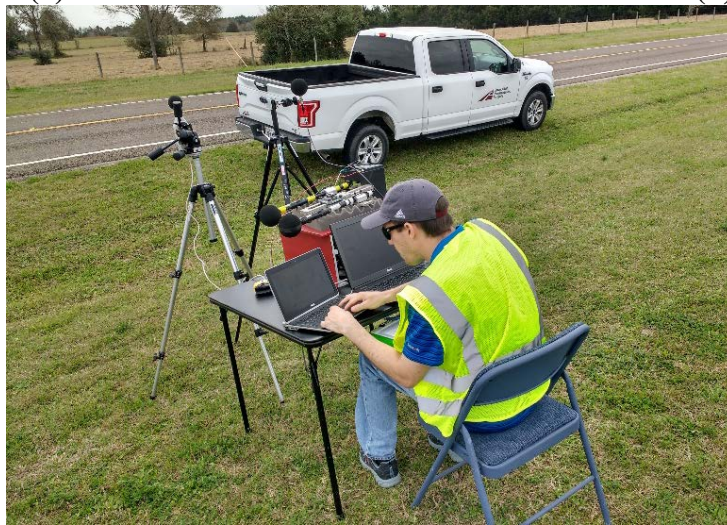
Figure 24. Noise Measurement Equipment: (a) Interior Microphone, (b) OBSI System (Only Leading Edge Enabled), and (c) Wayside Noise System.

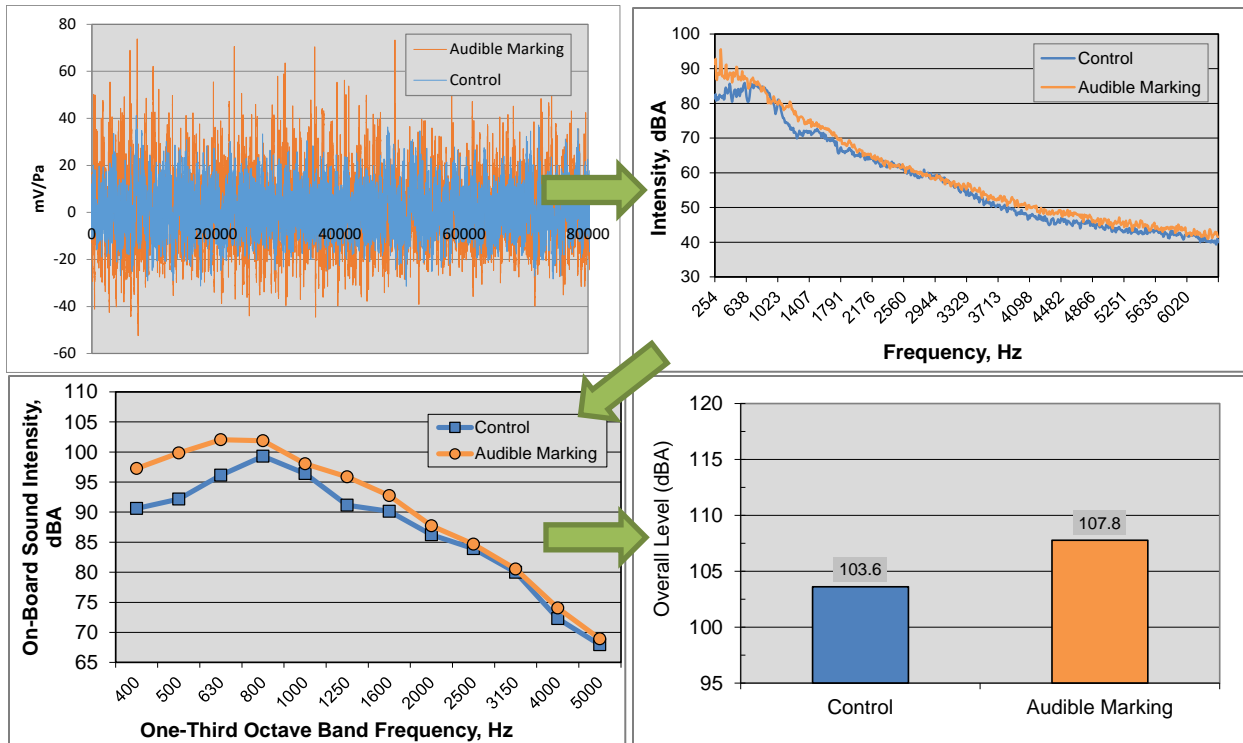
Figure 25. Progression of Noise Data Processing.
(Raw Data >> Narrow Band >> 1/3 Octave Band >> A-Weighted Noise Level)

The raw signals were processed with fast-Fourier transform (FFT) analysis, then the narrow-band and 1/3-octave band sound intensity was calculated. The overall a-weighted noise level, dBA, was then calculated (Figure 25).

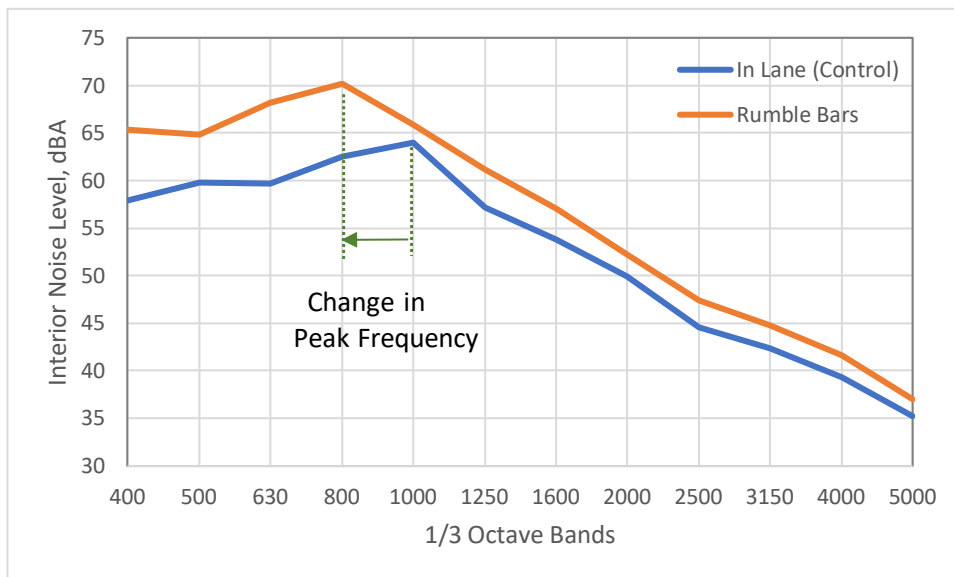
Figure 26. Calculation for Change in Peak Frequency.

Treatment performance was characterized by 1) the overall a-weighted noise level, 2) the overall change in noise level from the control (ambient noise while driving in the travel lane), and 3) the change in the peak frequency (Figure 26). The change in frequency is an important aspect of alerting drivers.

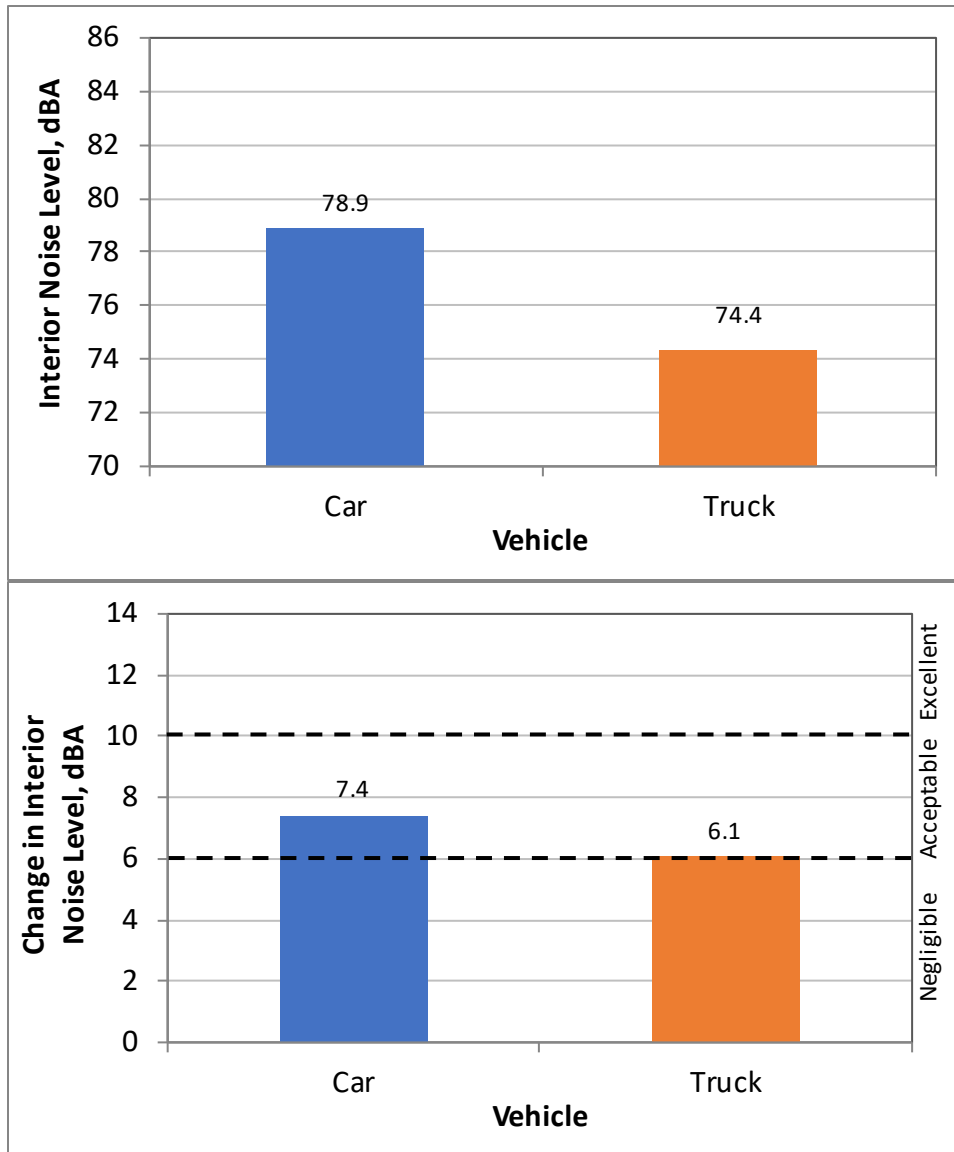
Figure 28. Statistical Effect of Vehicle Type: (a) Interior Noise Level and (b) Change in Interior Noise Level.

Based on the statistical analysis, both speed and vehicle type affect the interior noise level and the change in noise level. To analyze the effect of speed, only data where tests were done at both 55 and 70 mph were included. Data for both the car and the truck were averaged together. In the vehicle analysis, all locations were used and the data from different test speeds were averaged together. Figure 27 shows the overall effect of speed on noise level and change in noise level. The research team considered changes in noise level of less than 6 dBA as being negligible (i.e., not a great enough change to be easily noticeable to the driver). Anything greater than 10 dBA was considered excellent. Overall, faster speeds result in an increased noise level. Also, faster speeds results in a smaller change in noise from the ambient condition. While this difference in noise level change is statistically significant, the practical significance is negligible. Figure 28 indicates that the truck had lower interior noise than the car and less change in noise. Because of the wide variation among all vehicles in terms of body design, suspension, tires, and wear, this trend may not translate to every car and every truck but is the case for the two test vehicles. The data clearly show that different vehicle types can result in different levels of noise generation.

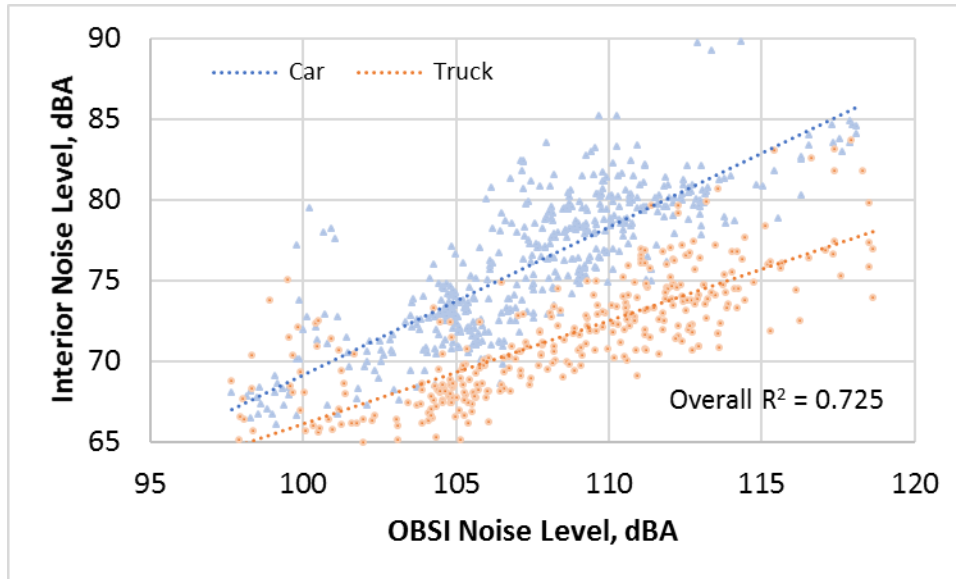
Figure 34. OBSI Noise Level vs Interior Noise Level.

The correlation of exterior noise (OBSI) and interior noise is given in the following correlation equation and illustrated in Figure 34. The effect of vehicle type was significant, so the car data have an additional shift factor in the equation. If any other vehicle were considered, a new shift factor would be required. The feasibility of predicting interior noise from the OBSI is moderate. For a given measured OBSI value, the predicted value is within ± 10 dBA with 95 percent confidence, which is too wide a range to use as a decision-making tool.

$$dBA_{Interior} = dBA_{OBSI} * 0.769 + 5.235 * IsCar - 11.849 \quad \text{Correlation Equation}$$

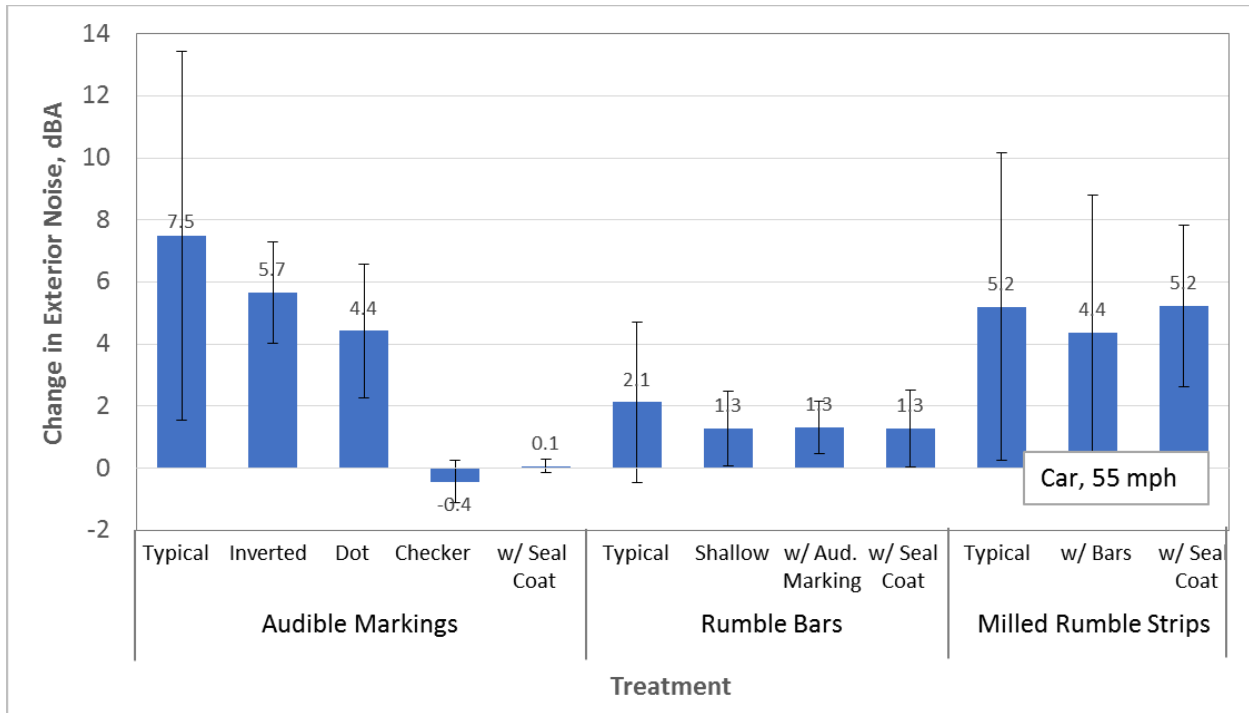
Figure 35. Change in Exterior Noise.

One concern with audible lane departure warning systems is the problem with noise pollution. The occasional vehicle driving on the treatment can cause annoyance to nearby residences, especially when the change in noise is large. Figure 35 shows the exterior noise change for the car on different treatment types as measured by the OBSI system. The loudest treatment is the typical audible lane marking, with an average noise increase of about 8 dBA. Next are two other audible marking designs and the milled rumble strips. The rumble bar designs have less than half the decibel increase as the audible markings or milled rumble strips. When considering which treatments have both high interior performance and low exterior noise generation, the milled rumble strips and rumble bars+audible markings did very well.

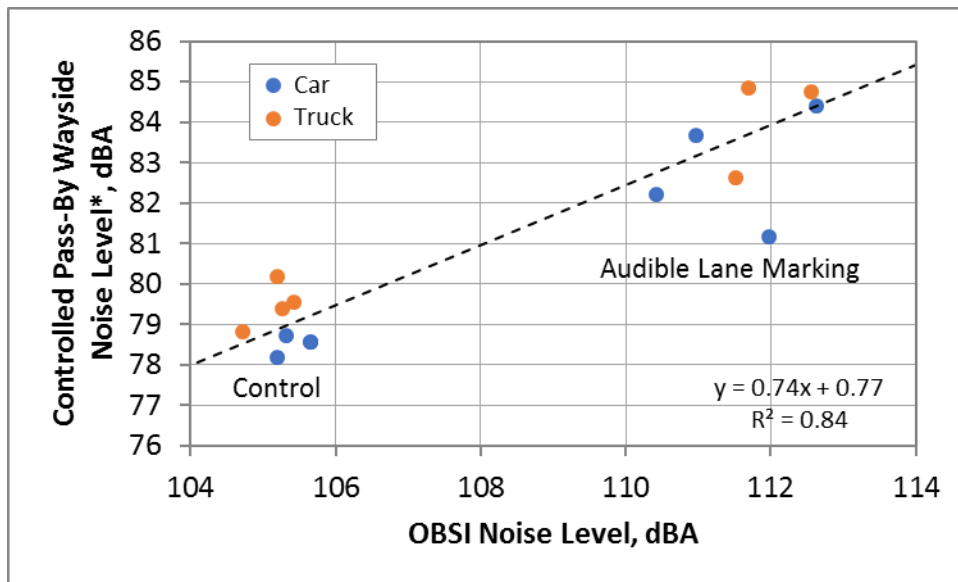
Figure 36. OBSI Noise Level vs. Wayside Noise Level.

Figure 36 shows a comparison of OBSI noise to wayside noise. The regression has an R^2 value of 0.84. The noise level at the source (OBSI) is in the range of 105 to 112 dBA and at an offset of 25 ft (distance to wayside measurement location); the noise level is reduced to between 78 and 85 dBA. The wayside noise level increased by approximately 5 dBA when on the treatment compared to the ambient noise when just driving in the lane (control).

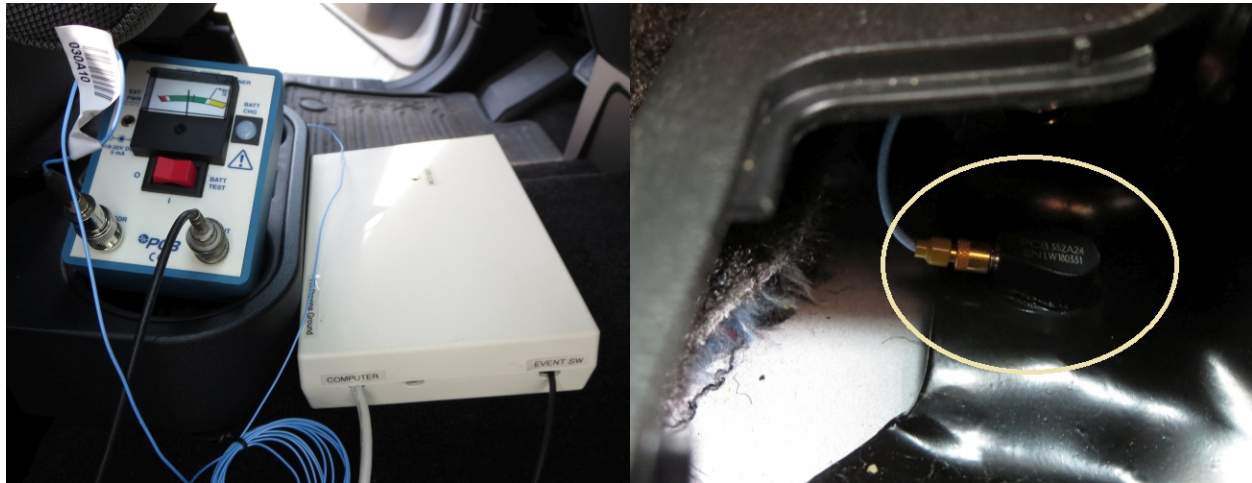
Figure 37. Vibration Data Collection Setup.

was selected because the treatments need to be able to transmit the vibration to the driver and through the seat is a major source of the vibration transmission. The base mounting point is also a solid mounting point where the vibration can be effectively monitored. Figure 37 shows the accelerometer mounted to the driver's seat frame, the power source for the accelerometer, and the data acquisition system that was used to transfer the data to the laptop computer.

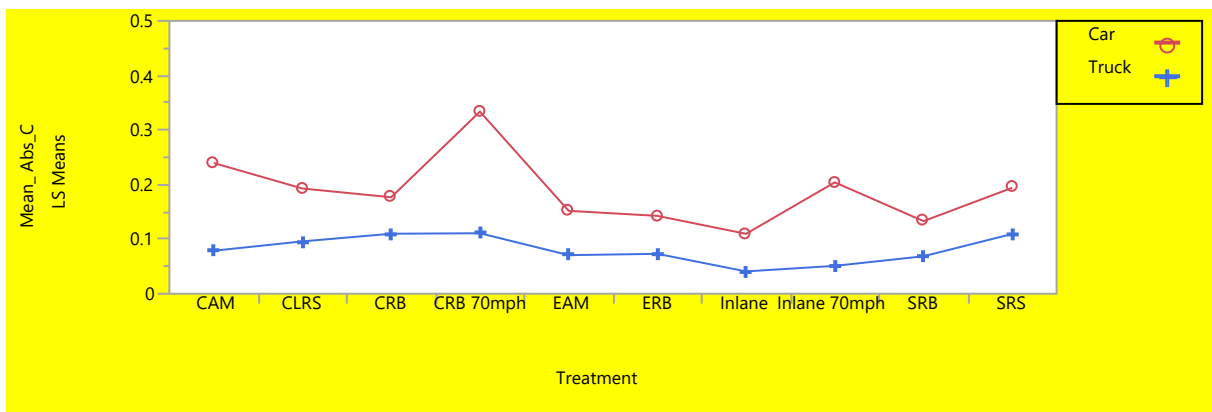
Figure 39. Atlanta District Trip 2 Vibration Summary.

Figure 39 and Figure 40 display the predicted mean absolute vibration values from the second Atlanta District trip and the test sections on SH 21. Both data sets show a significant difference between the truck and car results, with the car producing higher vibration levels. The center line rumble bar at 70 mph was one of the top performers, but the same treatment at 55 mph was a middle of the pack performer. This treatment shows the impact of speed greatly increased the performance, whereas other test areas do not show as large of an impact from speed. This is likely due to the specific design of the treatment such as its spacing and how it interacts with the vehicle wheelbase, speed, and suspension components. The results also show that centerline treatments result in higher vibration levels than shoulder or edge line treatments. This is likely due to the accelerometer being mounted to the outside rail of the driver’s seat, which is on the same side of the vehicle as the centerline treatments.

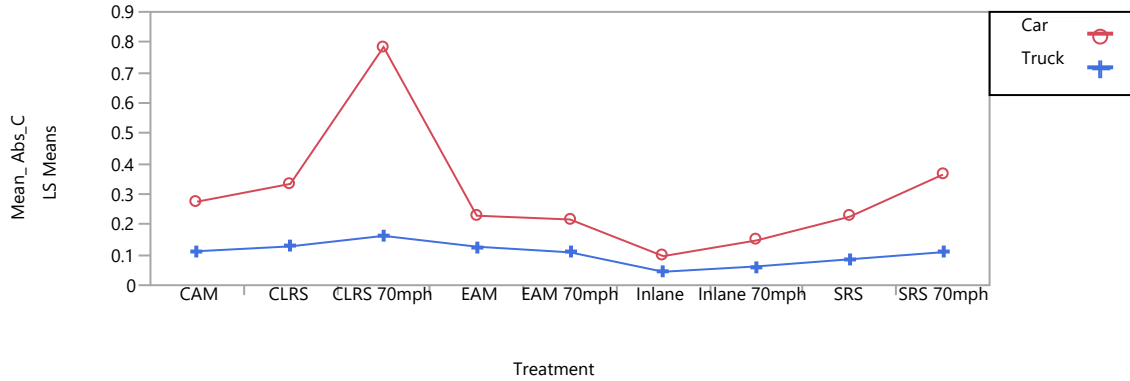
Figure 40. SH 21 Vibration Summary.
