Evaluation of Audible Lane Departure Warning Treatments for Seal Coat Road Surfaces

Technical Report 0-6888-R1

TEXAS A&M TRANSPORTATION INSTITUTE
COLLEGE STATION, TEXAS

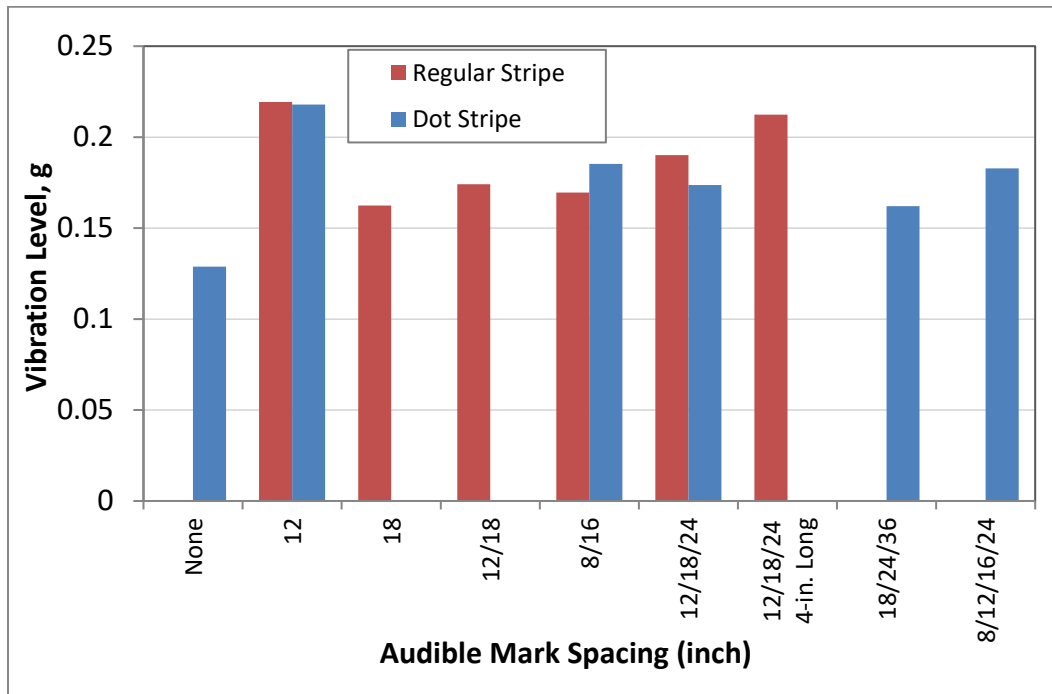
Figure 41. Brenham Vibration Level, Car 2016.

The Brenham test area allowed researchers to determine the impact of variable spacing on vibration levels. Data were collected soon after the treatments were installed and then a year later to determine if there was any loss in performance. The change in vibration level from a control run where the test vehicle stayed in the center of the lane to test run when the vehicle was on the treatment was also calculated. Figure 41 and Figure 42 provide the first-year vibration levels and changes in vibration levels for the car. The regular stripe indicates the westbound tests where the bumps were topped with a standard flat line marking. The dot stripe indicates the eastbound tests where the bumps were topped with a dot patterned structured marking. The results are similar to the noise results. The 12-in. spacing of the treatment and the variable spacing with the 4-in. long bump were the top performers.

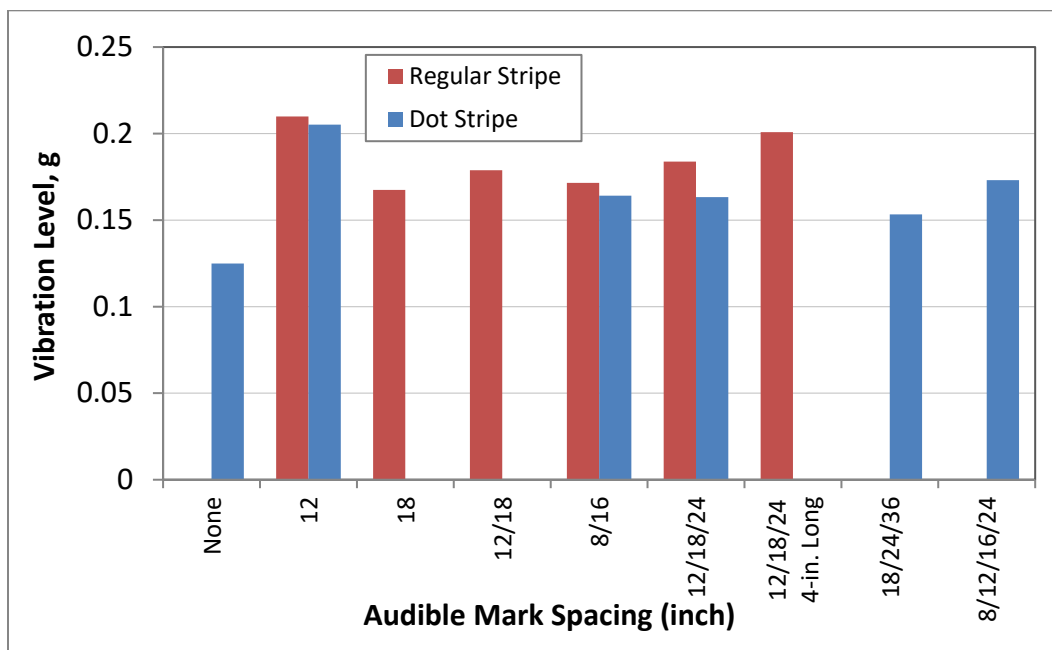
Figure 44. Brenham Vibration Level, Car 2017.

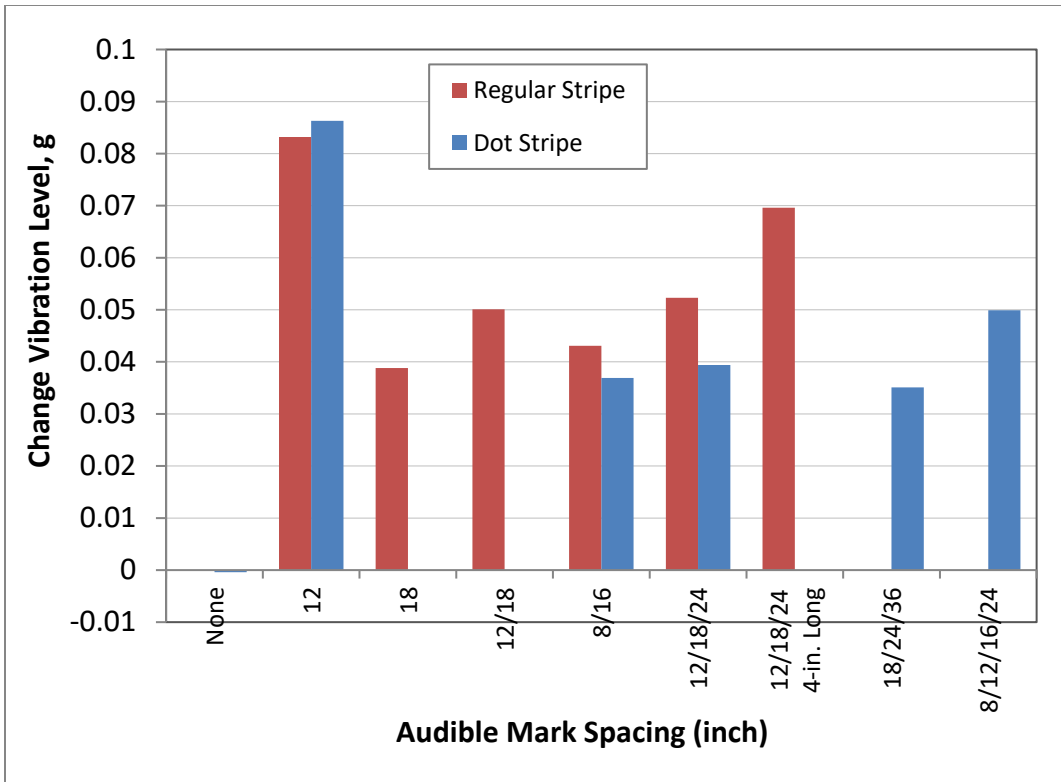
Figure 45. Brenham Change in Vibration Level, Car 2017.

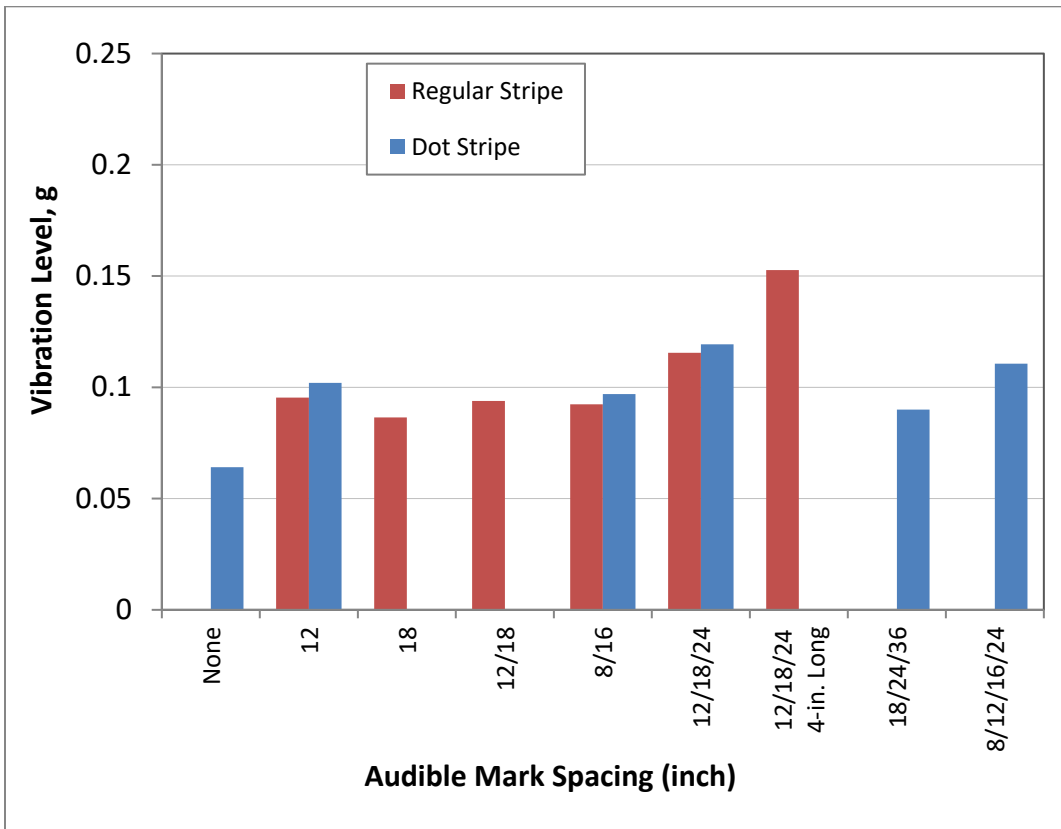
Figure 46. Brenham Vibration Level, Truck 2017.

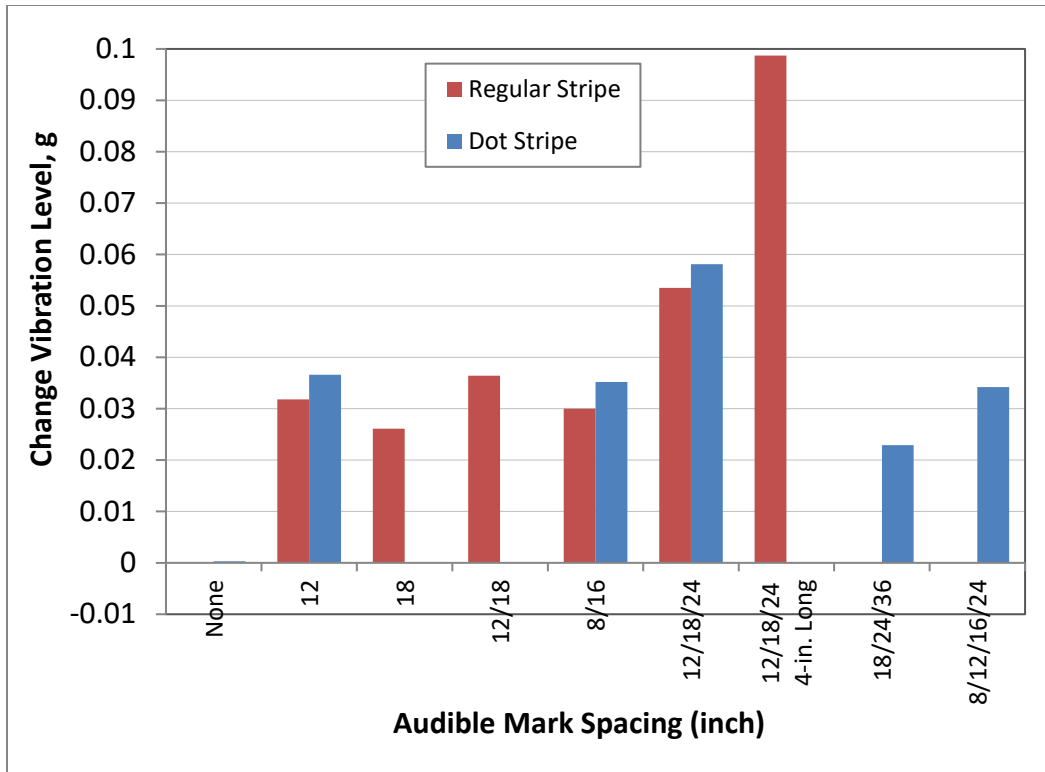
Figure 47. Brenham Change in Vibration Level, Truck 2017.

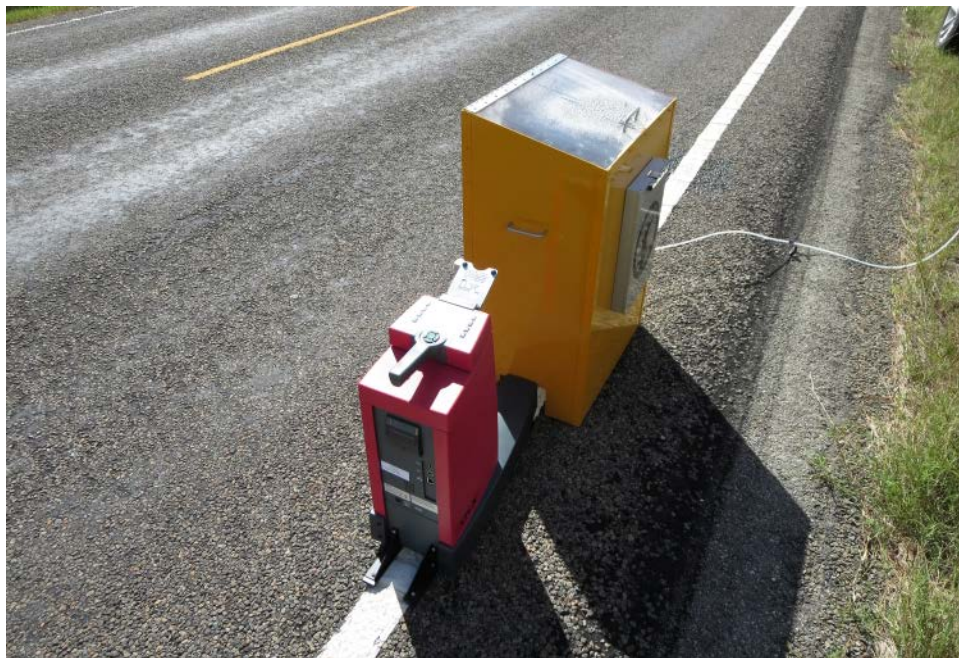
Figure 48. Continuous Wetting Test Setup on Profiled Marking.

The research team took continuous wetting retroreflectivity measurements at some of the test areas in addition to the previously mentioned dry retroreflectivity measurements. The research team conducted measurements using the ASTM E2832 standard test method for evaluating pavement marking retroreflectivity in a continuous wetting condition. This test method requires a calibrated wetting device and an external beam handheld retroreflectometer. Prior to conducting the continuous wetting measurements, the research team collected dry retroreflectivity readings with the handheld device in the same location. Readings were spaced over the length of several intervals of the profiled spacing and averaged to provide a more accurate value. Figure 48 provides an image of the continuous wetting box and retroreflectometer while taking measurements on a profiled marking. Figure 49 shows the wetted marking after taking measurements.

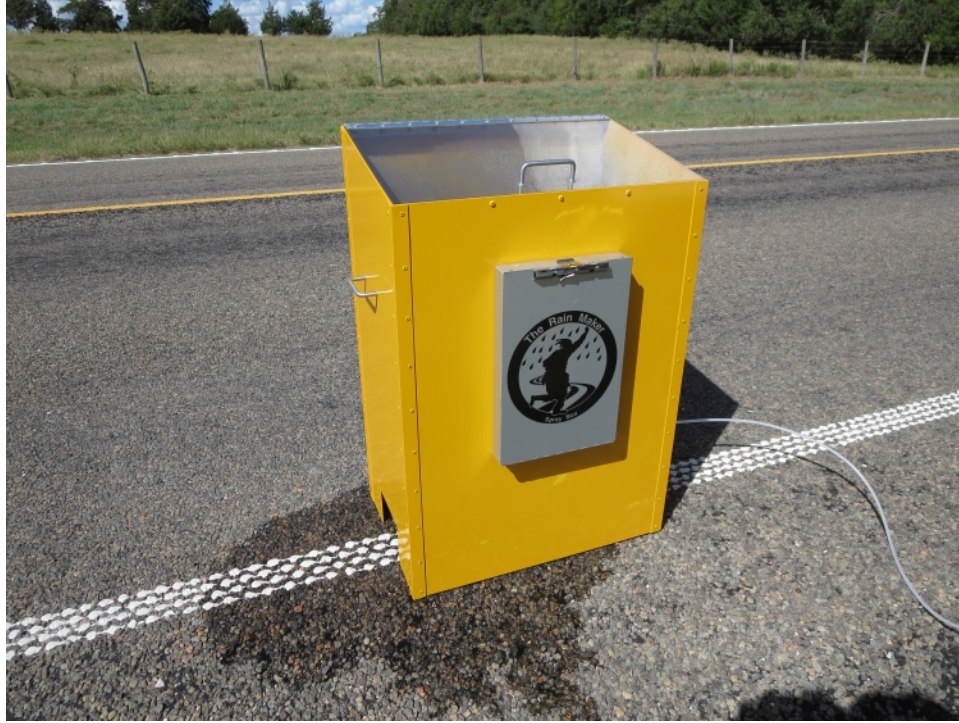
Figure 49. Continuous Wetting Setup after Test.

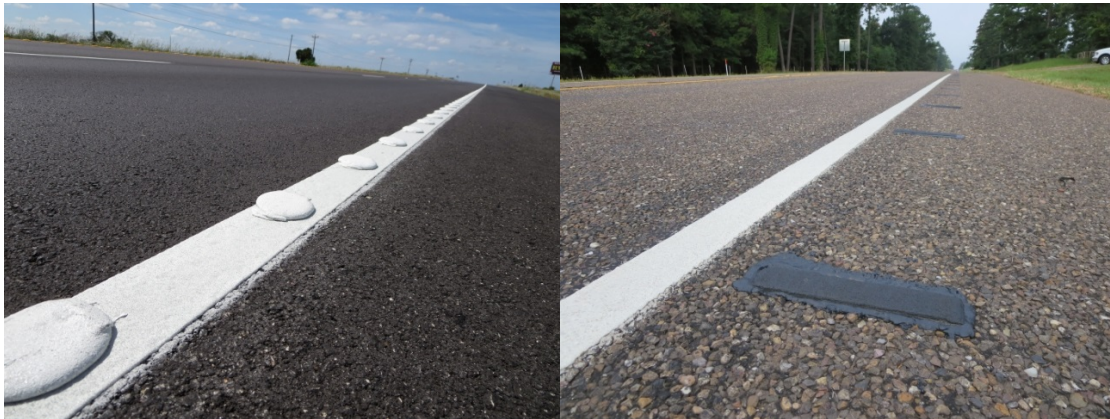
Profile pavement markings (left), rumble bars (right).

For this research project the focus is on audible pavement marking systems such as profile pavement markings and on preformed thermoplastic strips also referred to as rumble bars. These systems are the focus of the research because they can be used in areas where milled rumble strips cannot be used, i.e. many seal coat road surfaces. The research is not focusing on milled rumble strips. Please see the images below for examples of the ALDWS that are the focus of this research.
