DEVELOPMENT AND *MASH* TL-4 EVALUATION OF TxDOT RUBBER MOUNTED SINGLE SLOPE BARRIER

Test Report 0-6895-R1

Cooperative Research Program

TEXAS A&M TRANSPORTATION INSTITUTE

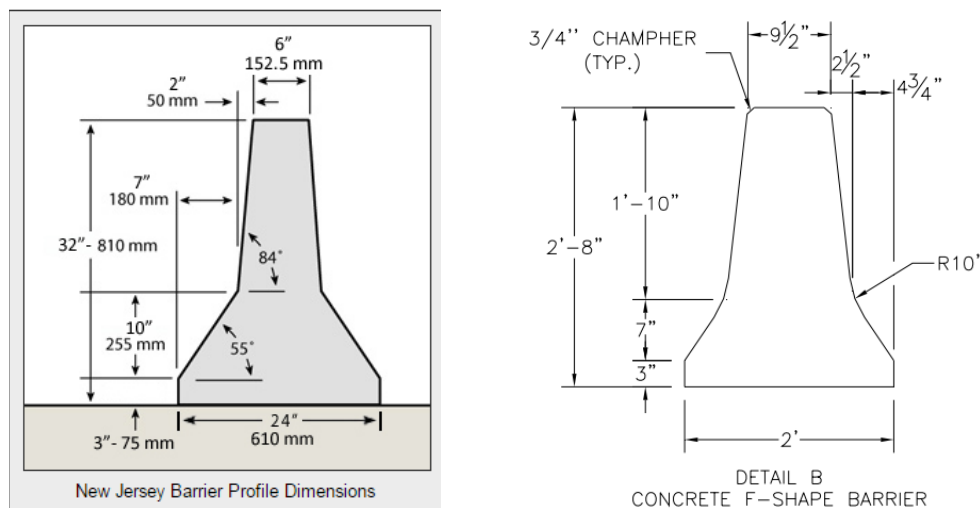
Figure 2.1. Common New Jersey Shape (Left) and F-Shape (Right) Concrete Barriers.

Concrete barriers provide positive rigid protection to errant roadway vehicles from hazards. Concrete barriers have different shapes and could be temporary or permanent in terms of installation. The barrier's performance upon impact depends on the vehicle type, impact speed, impact angle, and other variables (8). The concrete safety shape barrier is commonly known as the Jersey or New Jersey barrier and has a staged profile. This profile starts with a 3-inch vertical surface, then a slanted surface of 55° off horizontal level that goes vertically for 10 inches. Then, there is another slope break of 84° off horizontal level that goes vertically for 19 inches (8). The New Jersey profile has a height of 32 inches, and is shown in the left side of Figure 2.1. Another multistage concrete barrier, known as the F-Shape profile, is proven to exhibit an enhanced crash safety performance over the New Jersey profile. The F-Shape profile starts with a 3-inch vertical surface, then a slanted surface of 55° off horizontal level that goes vertically for 7 inches. Then, there is another slope break of 84° off horizontal level that goes vertically for 22 inches (8). The F-Shape profile has a height of 32 inches, and is shown in the right side of Figure 2.1.

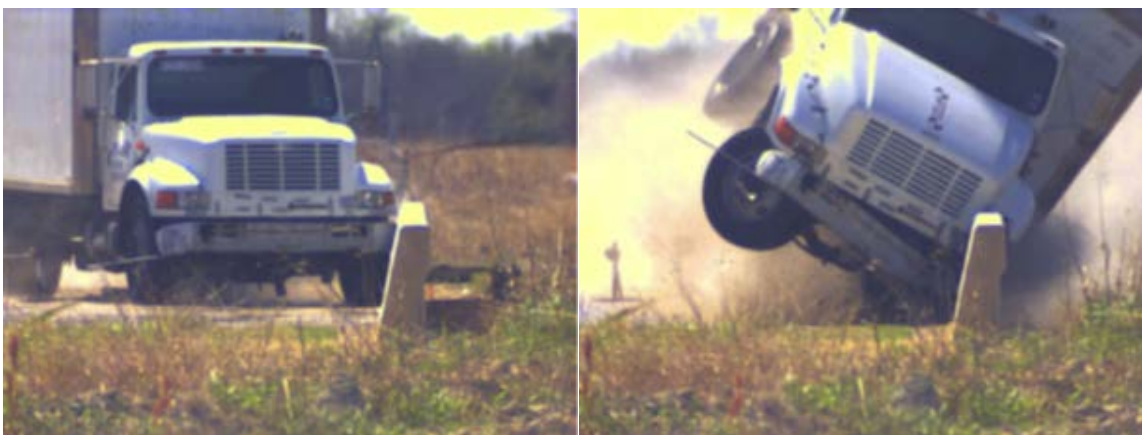
Figure 2.3. Sequences Showing SUT Impacting a 36-inch Tall Texas SSTR.

No notable occupant compartment deformation from the test was noted, but the impact to the vehicle itself was significant. Damages included a left front tire blow-out and bumper deformity. Other damages included the left frame rail, front axle, front U-bolts and springs, front tire rod, steering rod, left rear U-bolts and springs, and drive shaft. All of these were deformed as a result of the test. This test was considered a success per *MASH* evaluation criteria.

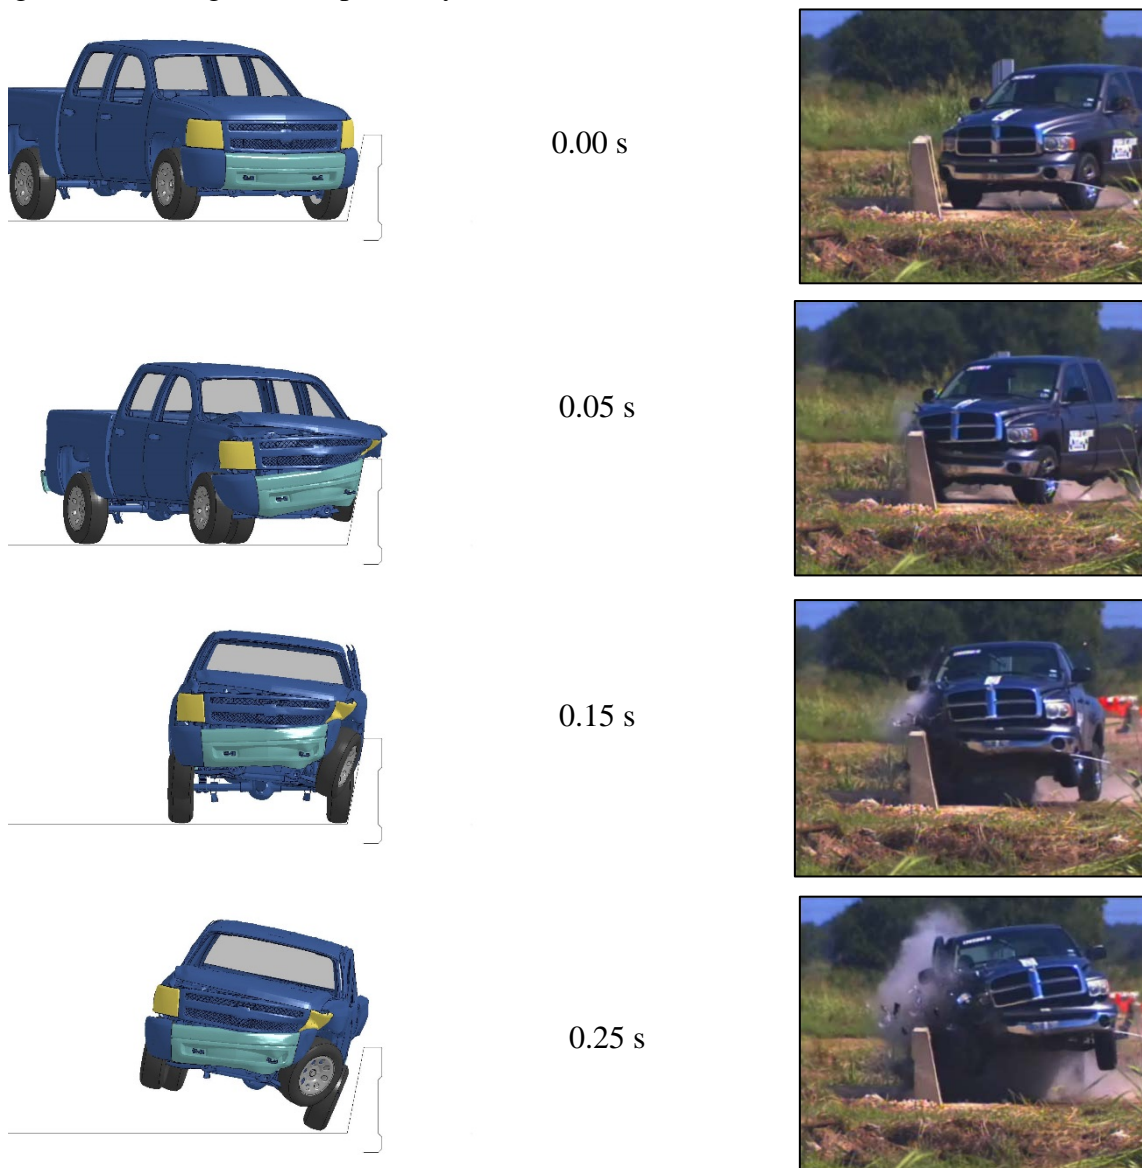
Figure 2.6. Sequential Comparison of Pan Form Test (Right) and Simulation (Left) under MASH Test 3-11 Impact Conditions.

Comparison of the results from the Pan Form Retrofit test and the finite element simulation point to a reasonable correlation. Figure 2.6 presents a photographic comparison of the simulation and the crash test. Table 2.1 shows the occupant risk values for the simulation. The X-acceleration, Y-acceleration, and the angular displacements for the crash test are shown in Figures 2.7 through 2.9, respectively.

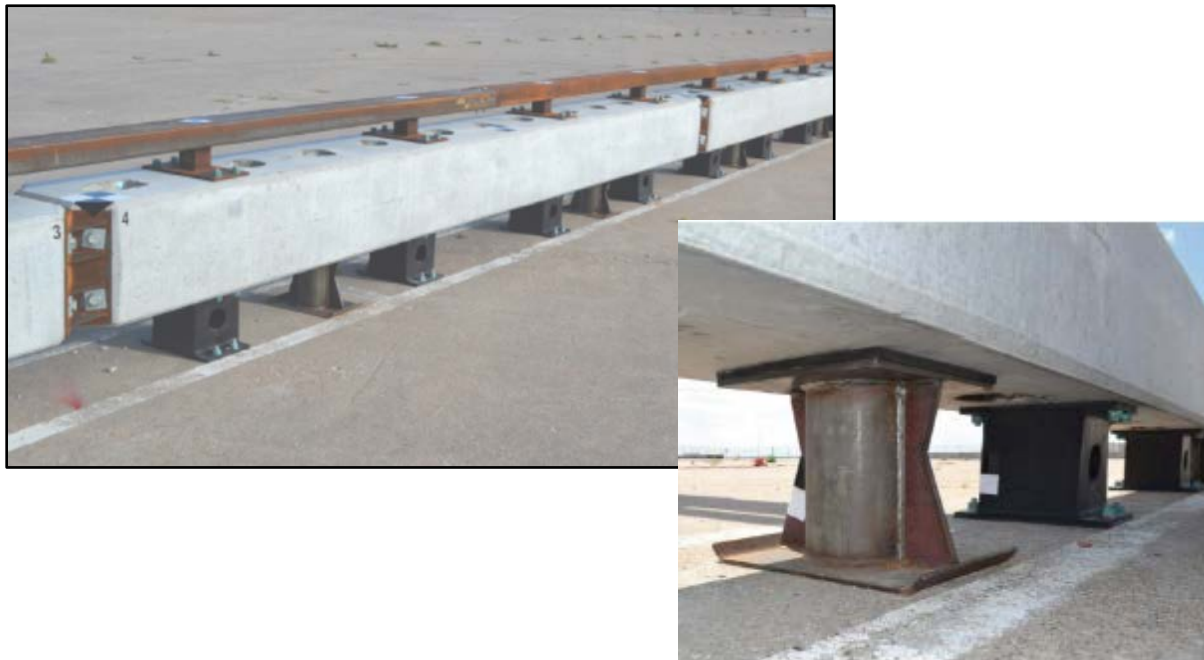
Figure 2.22. Concrete Beam Barrier with Alternating Steel and Rubber Post from MwRSF.

Researchers at the Midwest Roadside Safety Facility (MwRSF) developed a concrete barrier that employs precast concrete sections, steel rail on top, positively attached rubber footings, and sliding steel footings (12). Figure 2.22 shows this hybrid system. The rigid concrete barrier was designed to be a high containment longitudinal barrier. Elastomer (rubber) support posts, or shear fenders, were used to absorb energy by restoring their pre-crash position. This selection was based on restorability, resistance, flexibility, moldability, and successful performance in several safety tests. The shear fenders measured 11⁵/₈ inches × 10 inches × 15³/₄ inches and were attached to the concrete beam. They were also meant to extend the time of vehicle impact, thus reducing the force imparted to the vehicle.

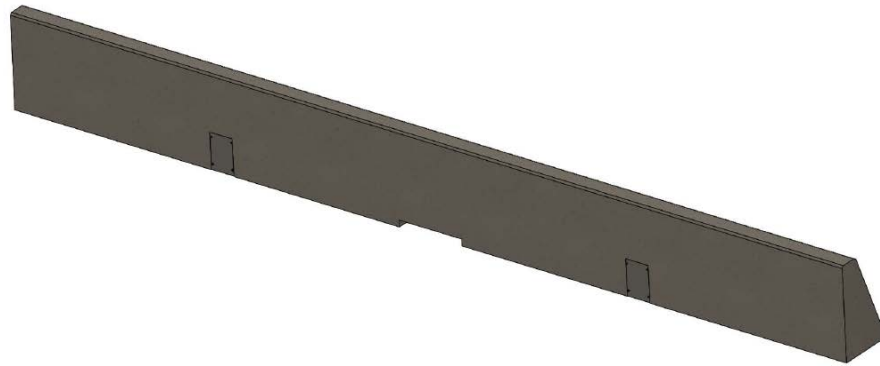
Researchers developed a concept for slip form concrete barrier with rubber fenders placed inside using steel enclosure. The concept is shown in Figure 2.23 for the Texas SSTR.

Figure 2.23. Single Slope Barrier with Two Rubber Fenders.

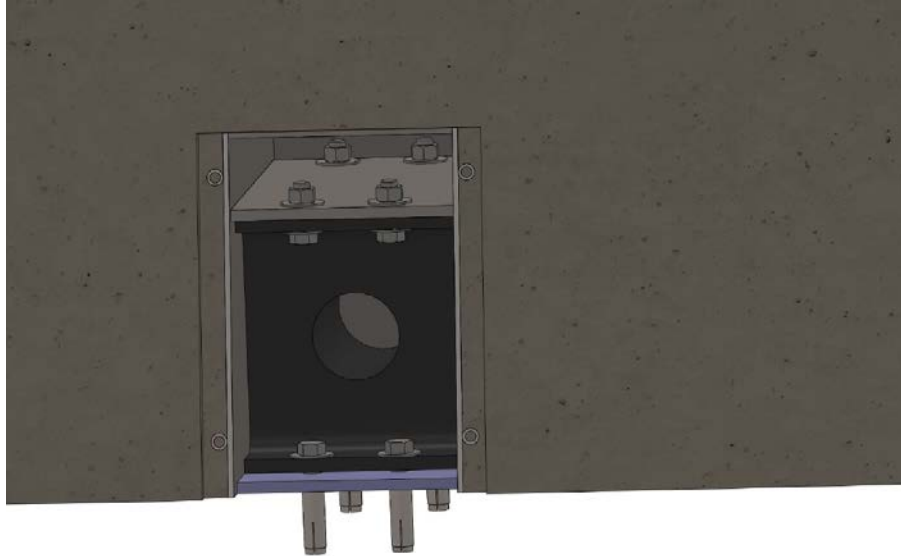
The steel enclosure allows for the slip form process and provides protection for the rubber fender during impact. Figure 2.24 shows a close-up view of this enclosure. The steel door is made transparent to show the inside of the enclosure.

Figure 2.24. Close-up Details of Single Rubber Fender Inserted within the Concrete Barrier.

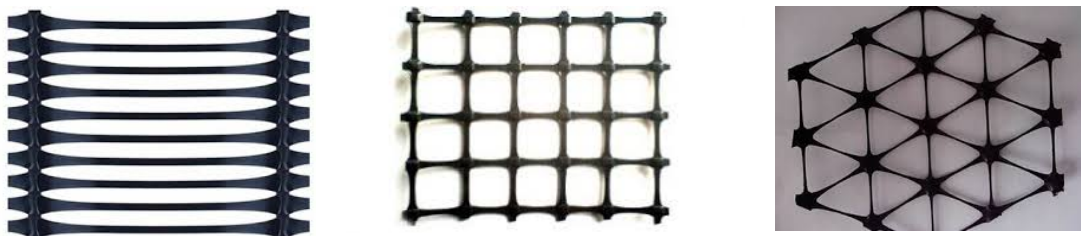
Figure 3.1. Images for Uniaxial, Biaxial, and Triaxial Geogrid.

Geogrid is a polymer mesh that is often used in geotechnical engineering applications as a ground stabilization technique to reinforce soils (13). Geogrids are commonly made from high density polypropylene and are classified as uniaxial, biaxial, and triaxial, depending on the opening area (see Figure 3.1).

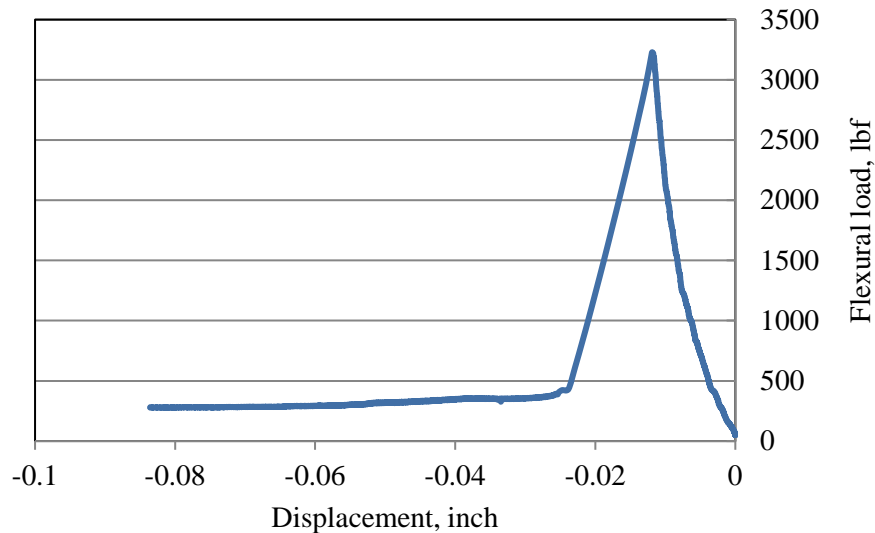
Figure 3.4. Load-Deflection Curve for Gnet.25 Sample.

As per ASTM C1609, flexural toughness was determined by calculating the area under the flexural testing load-deflection curve up to 0.08 inch deflection. Figure 3.4 shows a sample load-deflection curve **Error! Reference source not found.** The area under the curve was automatically calculated by the flexural testing device software. However, the machine was unable to capture the load-deflection data for the samples that exhibited brittle and abrupt failure, and provided incorrect toughness values. For these mentioned cases, the trapezoid method was incorporated to manually calculate the toughness value from the load-deflection curve.

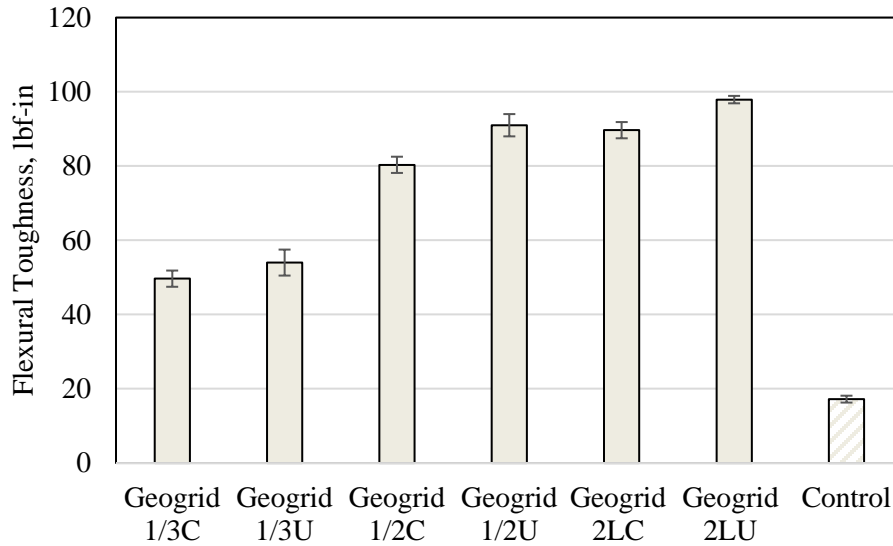
Figure 3.6. 28 Days-Flexural Toughness Results for Geogrid Samples.

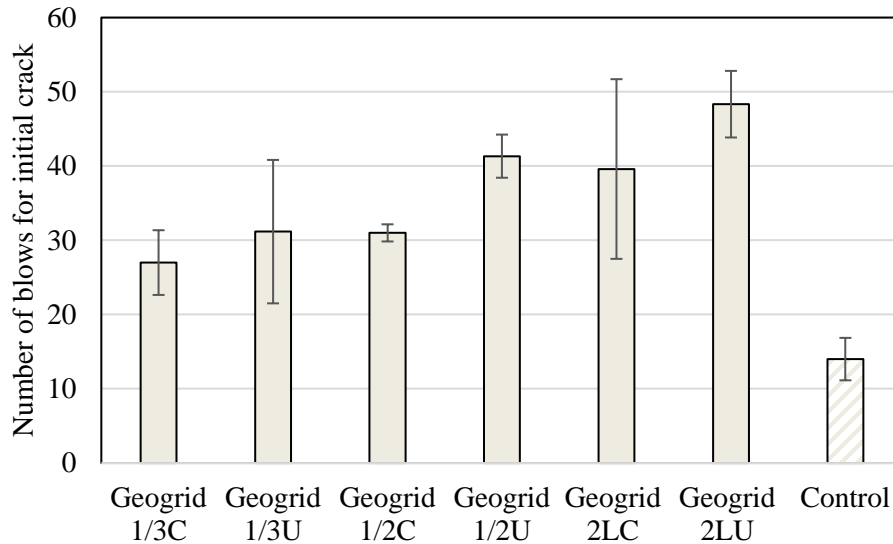
Figure 3.8. Number of Blows to Initial Crack Data Comparison for Geogrid Samples and Control.

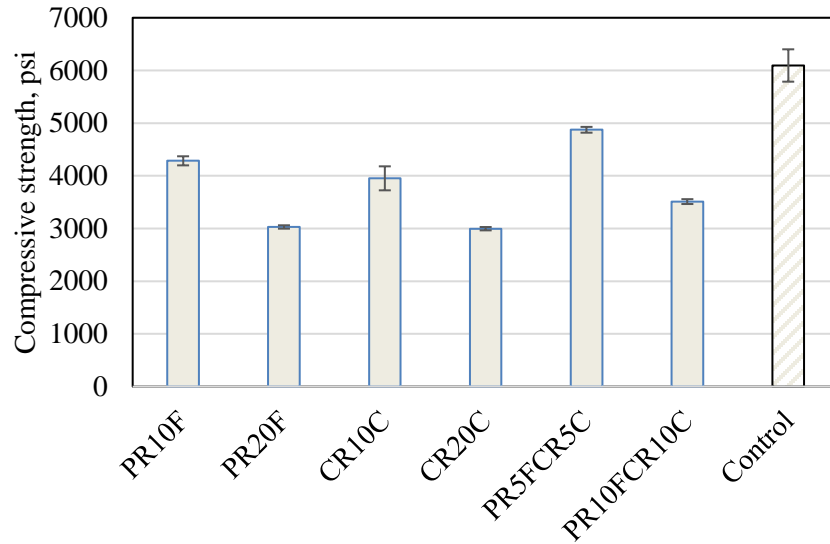
Figure 3.9. Initial Screening 28-Days Compressive Strength Test Results for Rubber Series.

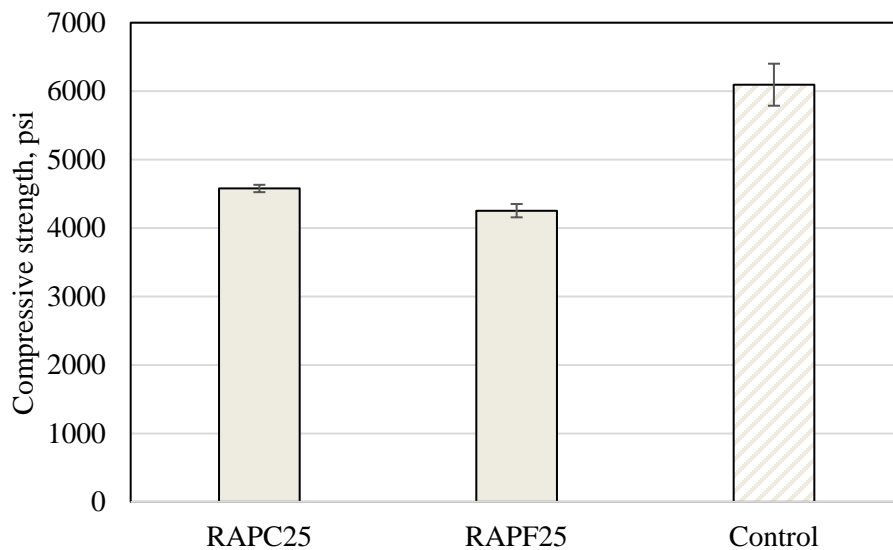
Figure 3.13. Initial Screening 28-Days Compressive Strength of RAP Series.

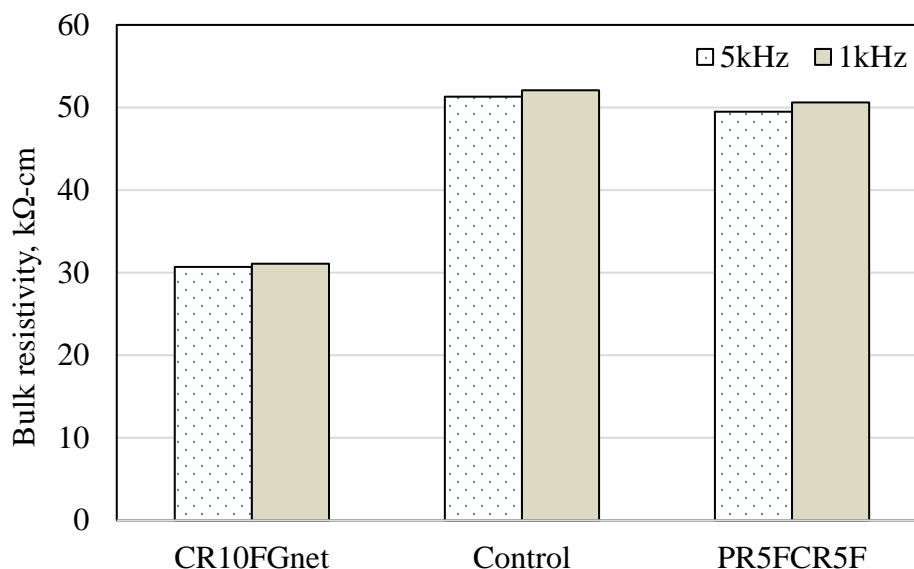
Figure 3.18. Bulk Resistivity Test Results for Cores Collected from Barriers Tested in Bogie Impact Field Test.

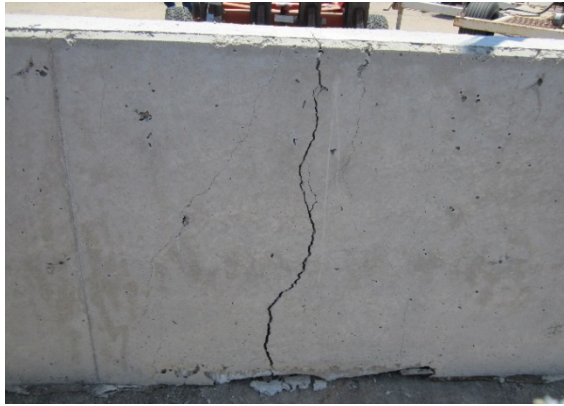
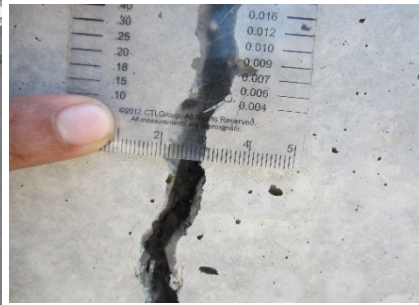
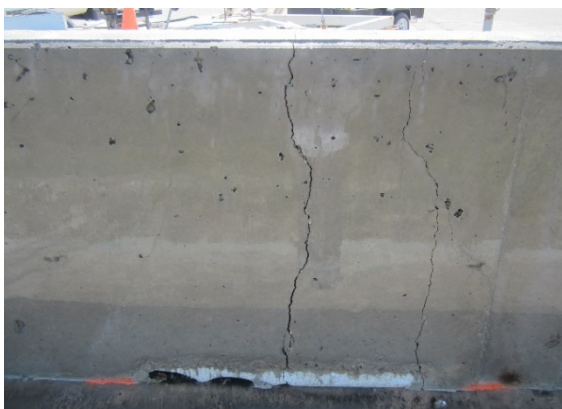
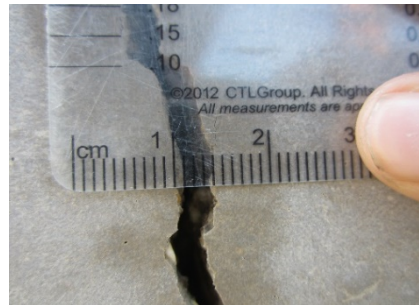
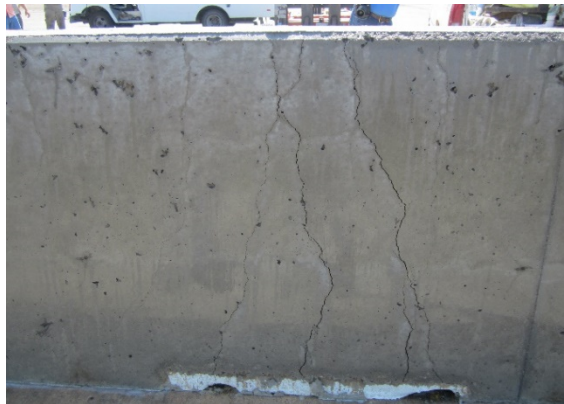
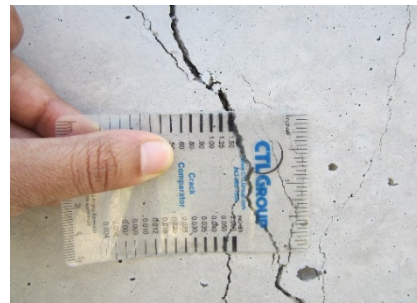
(a) CR10FGnet crack pattern

(b) CR10FGnet maximum crack width measurement

(c) Control mixture crack pattern

(d) Control maximum crack width measurement

(e) PR5FCR5F crack pattern

(f) PR5FCR5F maximum crack width measurement

- c) Figure 3.19 shows images of the crash barriers taken after field bogie test was performed to analyze crack pattern and crack opening. The crack pattern of the CR10FGnet mixture showed a zipper effect on the mixture. Impact loading induced zipper-like effect after initiation of the crack. Therefore, a single straight-line crack formation was observed. PR5FCR5F blend performed well in arresting the crack propagation; thus, thin width cracks with a branched pattern was observed for this mixture. Maximum crack opening for the control was smaller than CR10FGnet, but larger than PR5FCR5F mixture.

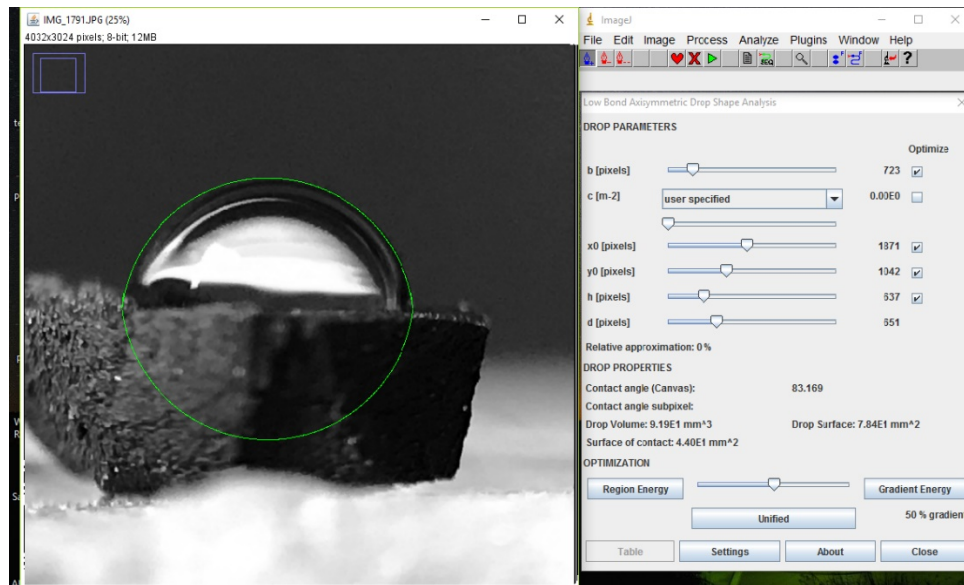
Figure 3.20. Drop Analysis on Surface of Rubber using ImageJ Plugin.

Two sets of 2-inch mortar cube samples were cast, one containing treated rubber particles and the other containing untreated particles. Compressive strength testing was performed at 7 and 28 days as an indirect way to assess change in bond properties. Additionally, the change in contact angle of the water on the surface of the rubber was assessed. The contact angle technique was incorporated to determine the wettability of rubber. Images of 0.5µL water droplets on the surface the surface of rubber was captured, and the ImageJ software plugin was utilized to analyze and determine the wetting angle of rubber before and after treatment (see Figure 3.20). A decrease in the angle of contact between the rubber and water indicates an increase in hydrophilicity.

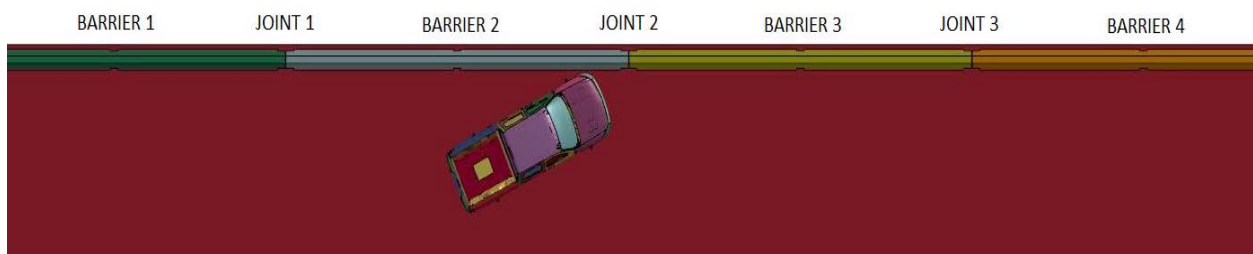
For these simulations, the PVC pipe used in the expansion joint was enlarged to 1.5 times the size of the standard expansion joint (which is 1¼inch pipe), and the friction between the expansion dowel and the PVC was reduced to 0.01. Based on the results from all four runs, there was no major snagging that takes place at the joint between the barriers and the truck appears to be successfully redirected after impact. Figures 4.1 and 4.2 show the barrier set-up with the joints and barriers labeled.

Figure 4.1. Four – 40-ft Segments Configuration.

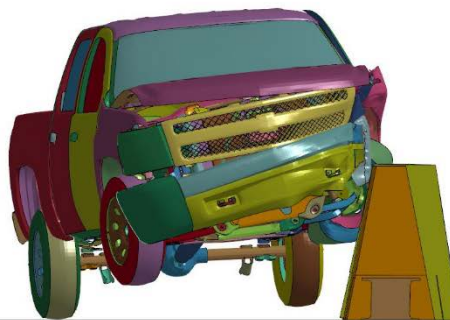
Figure 4.20. Vehicle Interaction with Barrier (Four 40-ft Segments – Three Rubber Fenders).

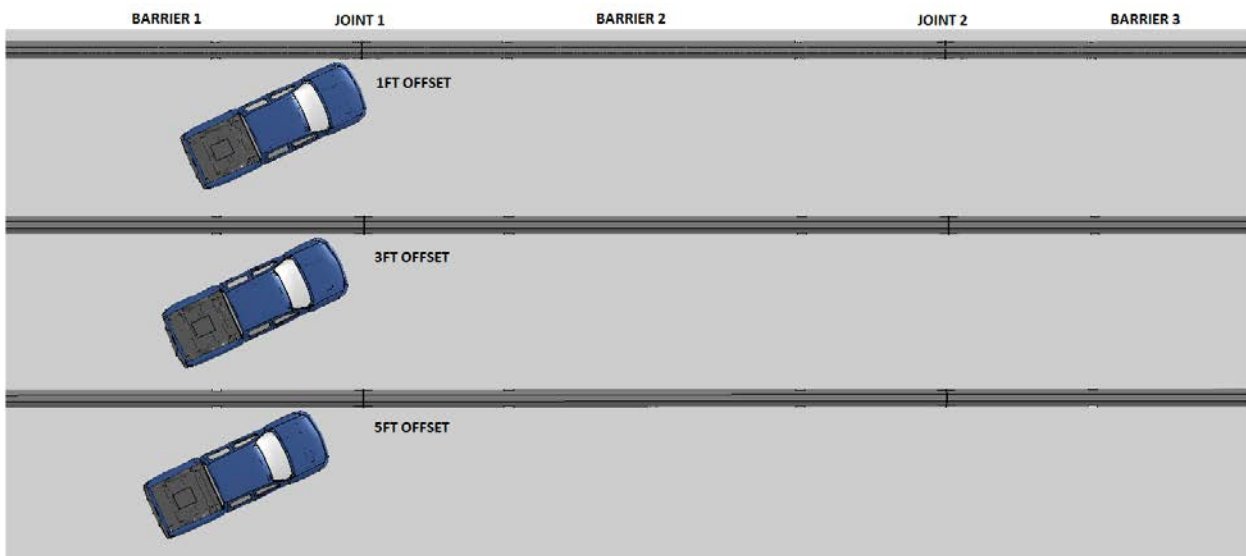
Figure 4.63. Plan View of Impact Configurations.

Three different simulation configurations were used to determine the critical impact point. All three simulations impact barrier number one and are each offset a predetermined distance (1, 3, or 5 ft) upstream of joint number one. Figures 4.63 and 4.64 show all three configurations from a plan and elevation view.

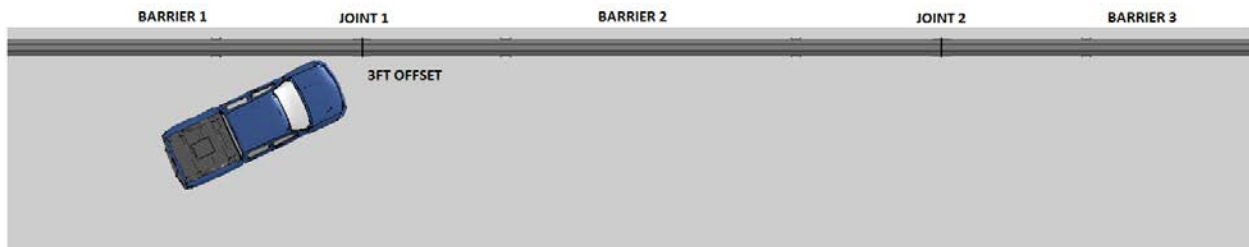
The second simulation impacts barrier number one at a distance of 3 ft upstream of the joint. For this simulation all barriers are 60 ft long and each barrier has two rubber fenders. The rubber fenders are mounted a distance of 15 ft from the joints. Figures 4.73 and 4.74 show the 3-ft offset configuration in more detail.

Figure 4.73. Plan View of Impact Configuration with 3-ft Offset.

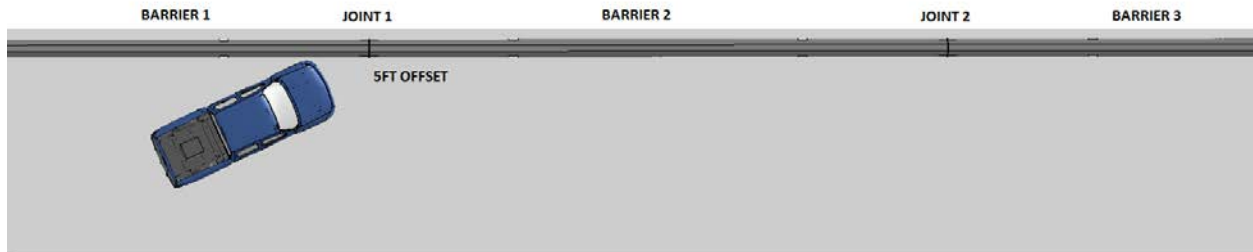
The third simulation impacts barrier number one a distance of 5 ft upstream of the joint. For this simulation, all barriers are 60 ft long and each barrier has two rubber fenders. The rubber fenders are mounted a distance of 15 ft from the joints. Figure 4.81 and Figure 4.82 show the 5-ft offset configuration in more detail.

Figure 4.81. Plan View of Impact Configurations with 5-ft Offset.

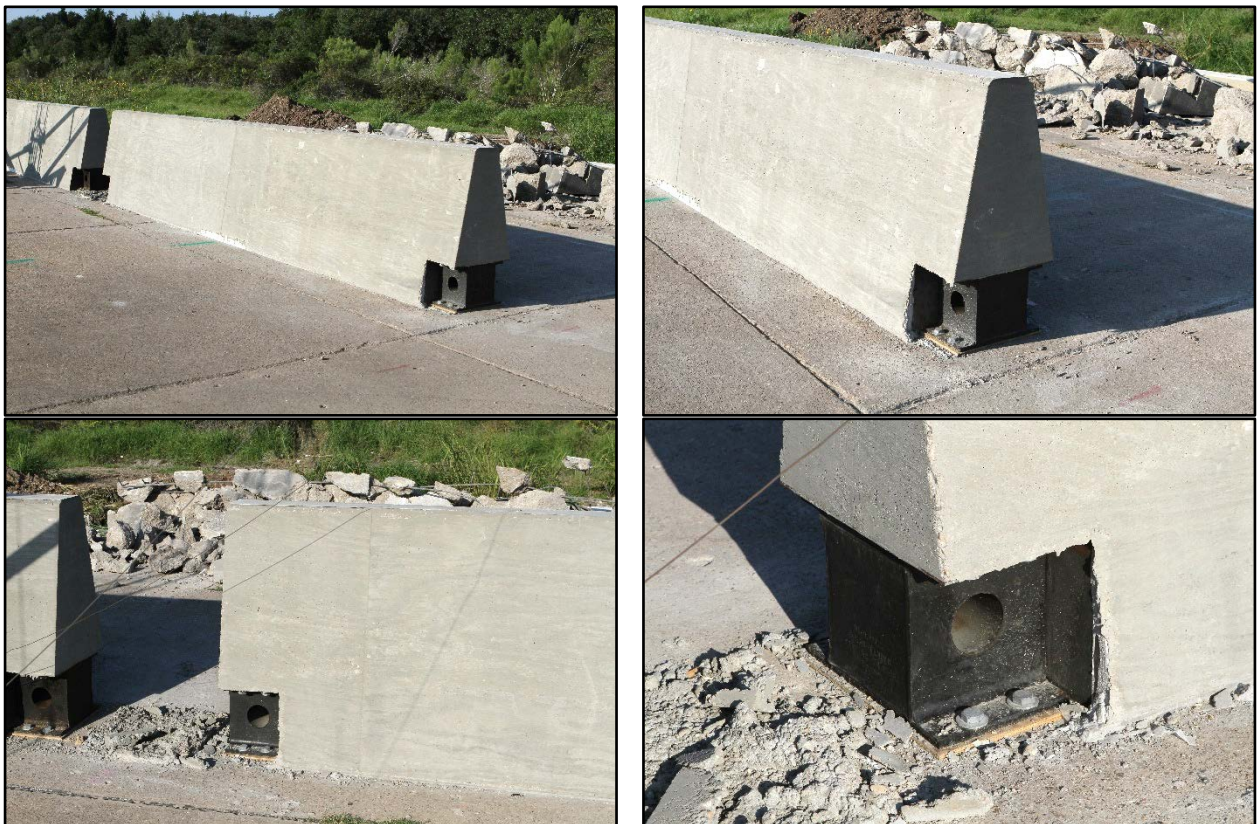
Internal steel reinforcement was comprised of 23 #4 V bars ($\frac{1}{2}$ -inch diameter) longitudinally spaced at 12-inches, except for 2 shortened #4 bars at 6-inch and 4-inch spacing at each end to further reinforce the box and allow for 2-inches of concrete cover. These 23 V bars were also inclusive of 3 shorter V bars located over the drainage relief. A large and a small U bar on each end provided additional reinforcement at the boxes. Ten #5 longitudinal bars ($\frac{5}{8}$ -inch diameter), five on each side, were vertically spaced on 8-inch centers. Refer to Appendix B.1, Sheets 2, 3, and 4 of 6 for reinforcement details. See Figure 5.1 for the completed installation.

Figure 5.1. Single-Slope Median Barrier with Shear Fender Anchor Plate before Test No. 468957-B4.

Other than the two shear fenders and their bolting, there were no additional bolts, pins, or adhesives that secured the barriers to the concrete apron. Each barrier was cast on plastic film on top of the clean runway apron. To facilitate ease of construction, the shear fenders were positioned within the formwork, secured to the apron, and bolted to the installed anchor plates prior to concrete placement.

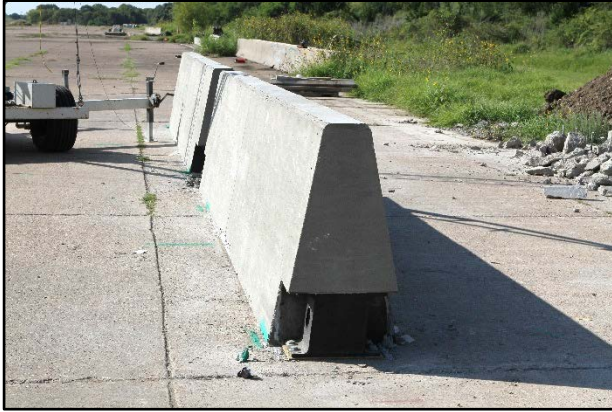
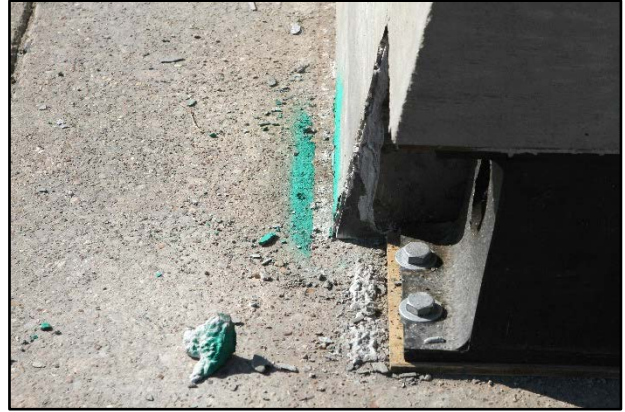
Figure 5.3. Right Traffic Side of Barrier after Test No. 468957-B4.

Maximum deflection of the barrier was 22.3 inches and maximum permanent deflection was 1¼ inches. Three vertical cracks (one at centerline and two 12 inches to each side of centerline) were noted on the field side. Figures 5.3 through 5.7 show damage to the barrier.

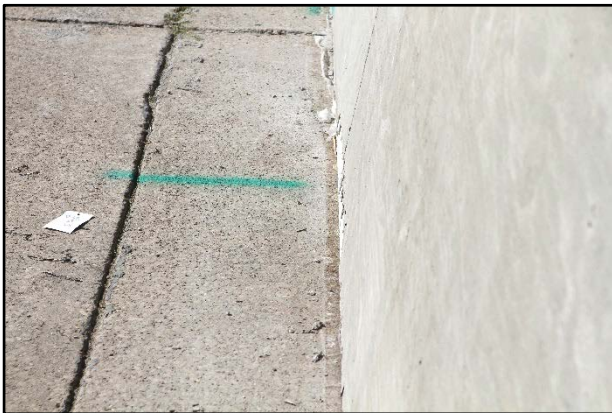
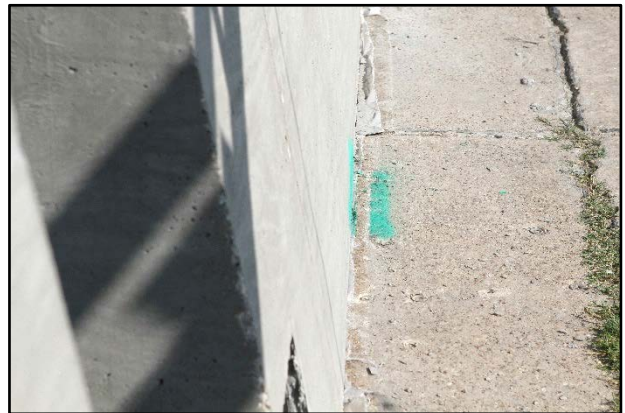
Figure 5.4. Center and Left Traffic Side of Barrier after Test No. 468957-B4.

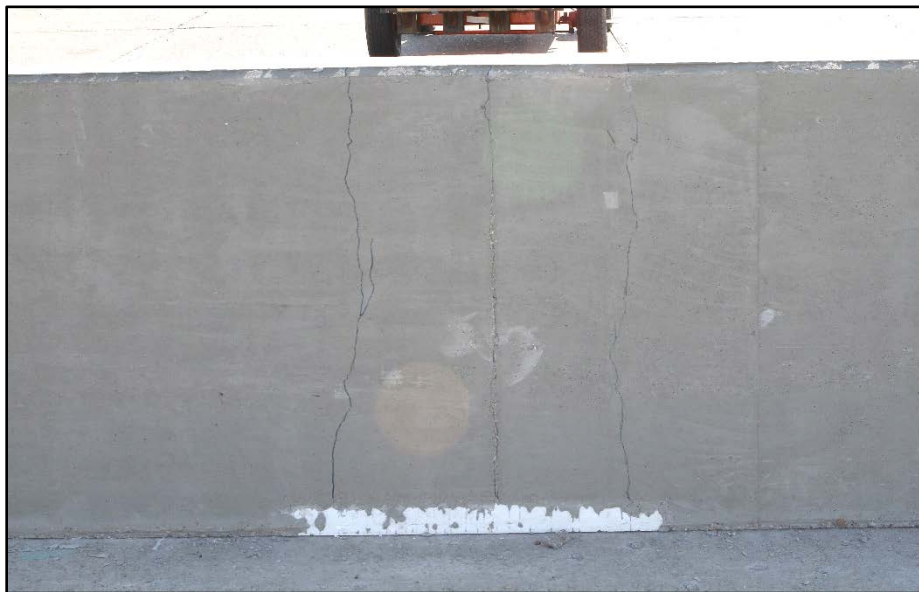
Figure 5.7. Field Side-Center of Barrier after Test No. 468957-B4.

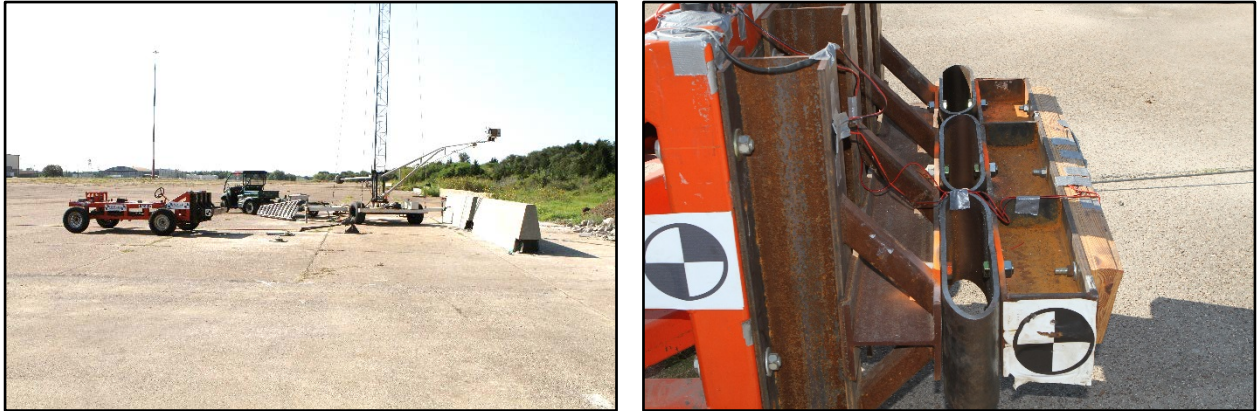
Figure 5.8 shows damage to the bogie vehicle. The pipe shapes crushed 8.9 inches. The vehicle rebounded 24 ft from the traffic face of the barrier.

Figure 5.8. Bogie Vehicle after Test No. 468957-B4.

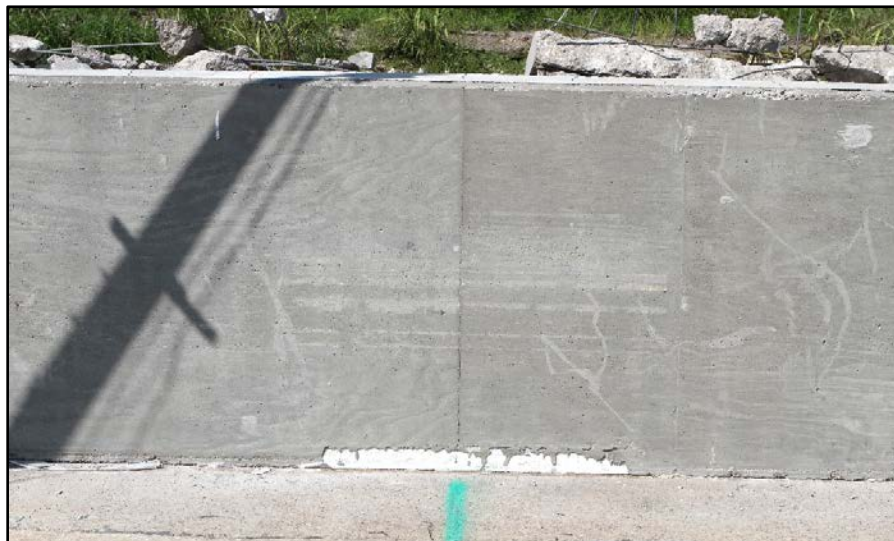
Figure 5.11. Impact Side of Barrier after Test No. 468957-B5.

Maximum deflection of the barrier was 29.3 inches and maximum permanent deflection was 0.5 inch. The barrier had been used for the previous test, and there were two additional cracks 24 inches to both sides of the centerline. Figures 5.11 and 5.12 show damage to the barrier.

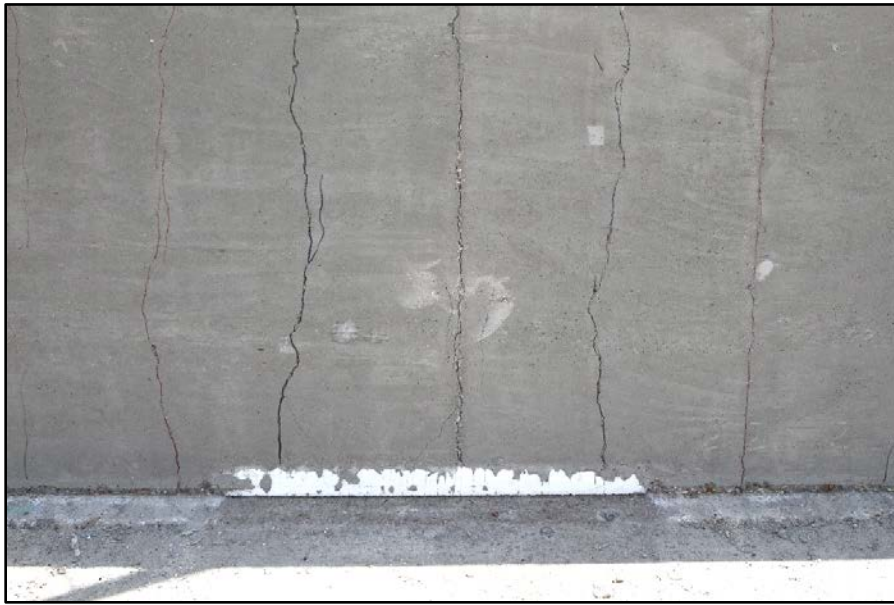
Figure 5.12. Field Side-Center of Barrier after Test No. 468957-B5.

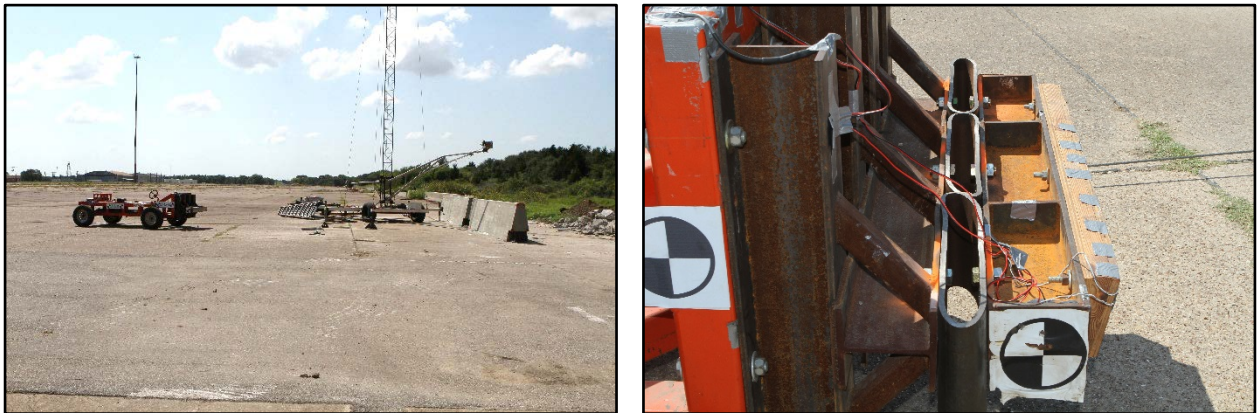
Figure 5.13. Bogie Vehicle after Test No. 468957-B5.

The pipes had been replaced from the previous test. Figure 5.13 shows damage to the bogie vehicle. Maximum crush of the pipe shapes in the nose was 10 inches. The vehicle rebounded 30 ft from the traffic face of the barrier.

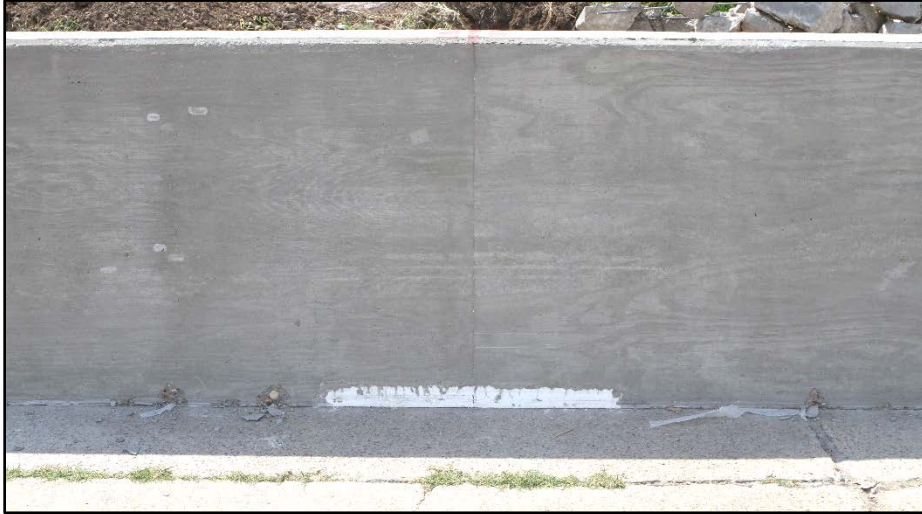
Figure 5.16. Impact Side of Barrier after Test No. 468957-B6.

Maximum deflection of the barrier was 21.0 inches, and there was no measureable maximum permanent deflection. On the field side of the barrier, three cracks radiated from the base of the barrier. Figures 5.16 and 5.17 show damage to the barrier.

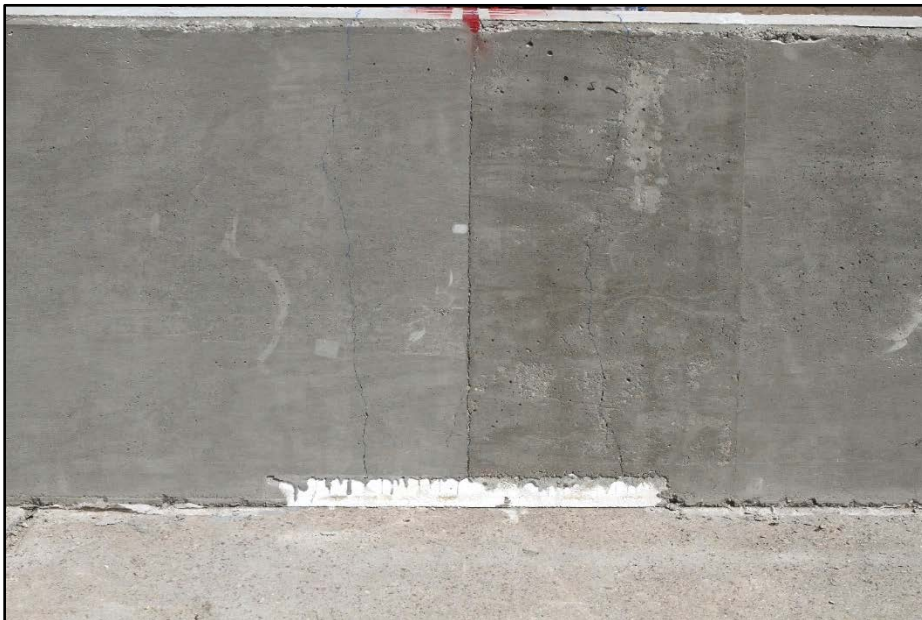
Figure 5.17. Field Side of Barrier after Test No. 468957-B6.

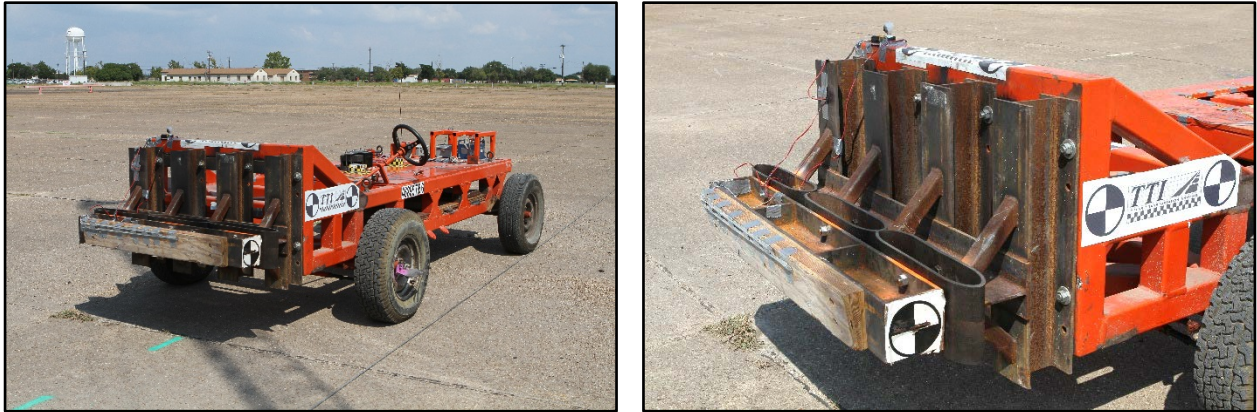
Figure 5.18. Bogie Vehicle after Test No. 468957-B6.

The pipe shapes had been replaced from the previous test. Figure 5.18 shows damage to the bogie vehicle. Maximum crush of the pipe shapes in the nose was 7 inches. The vehicle rebounded 26 ft from the traffic face of the barrier.

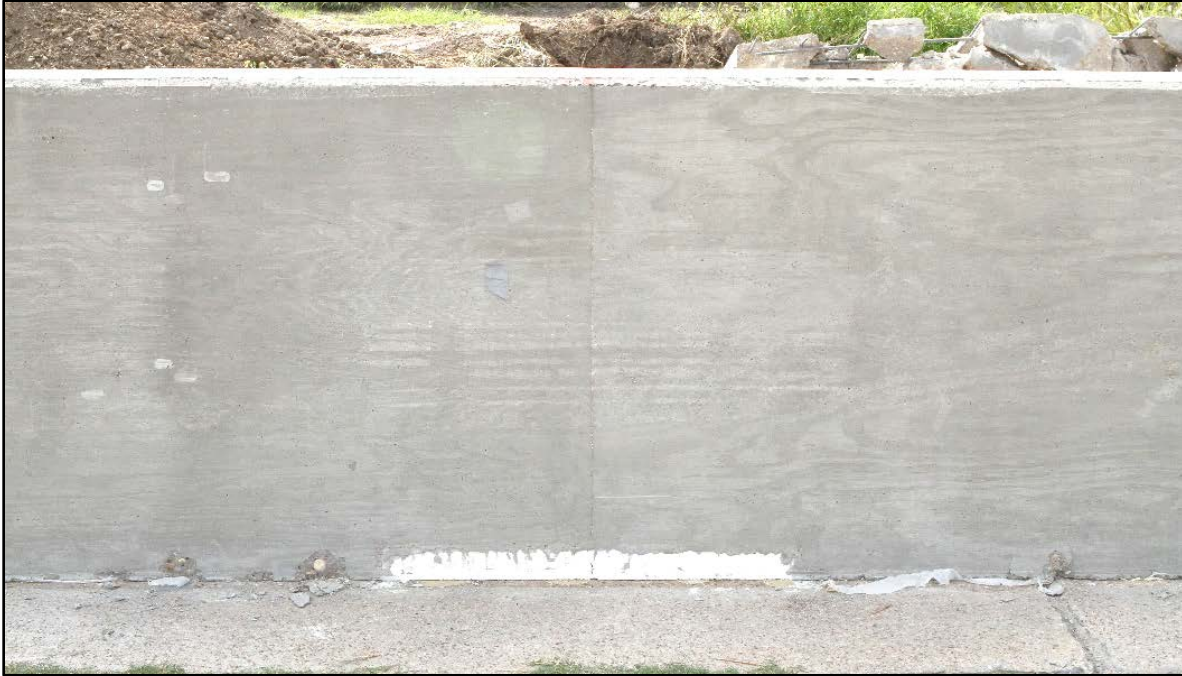
Figure 5.21. Impact Side of Barrier after Test No. 468957-B7.

Maximum deflection of the barrier was 30.5 inches, and maximum permanent deflection was 0.75 inch. The barrier used in Test No. 468957-B6 was used on this test. On the field side of the barrier, four additional cracks (two on each side) were noted to both sides of the center of the barrier. Figures 5.21 and 5.22 show damage to the barrier. Figure 4.23 shows a crack near the center of the block on the impact side.

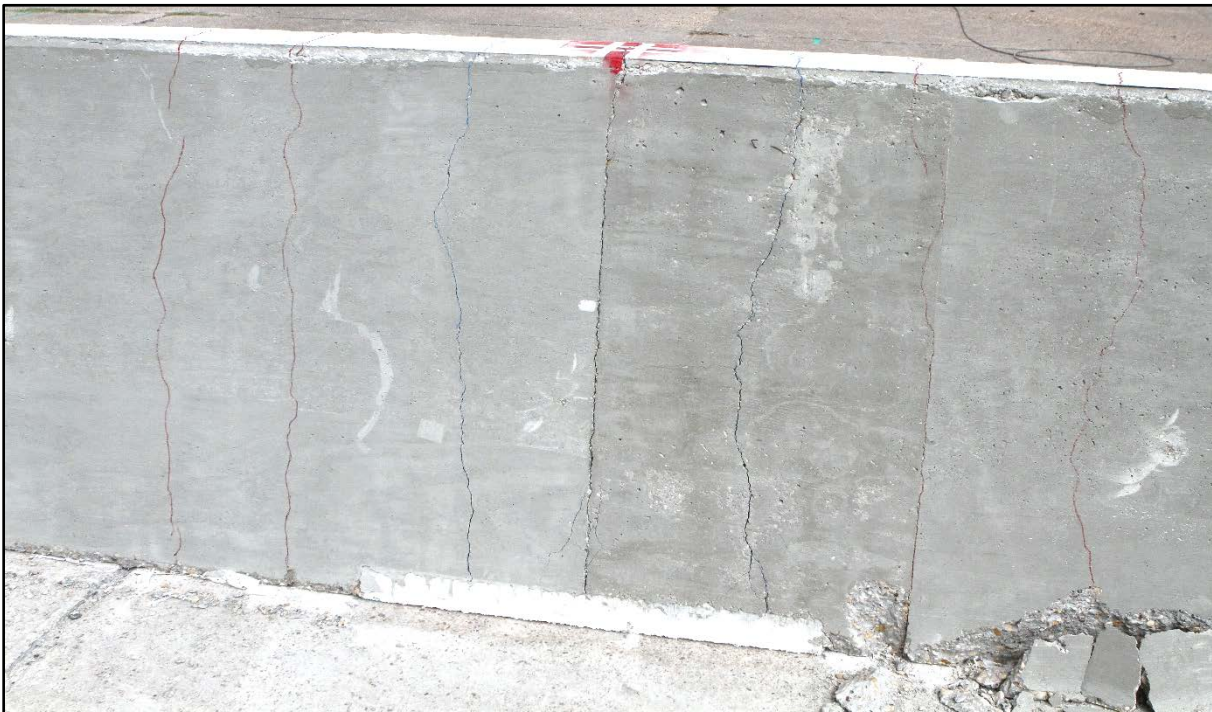
Figure 5.22. Field Side of Barrier after Test No. 468957-B7.

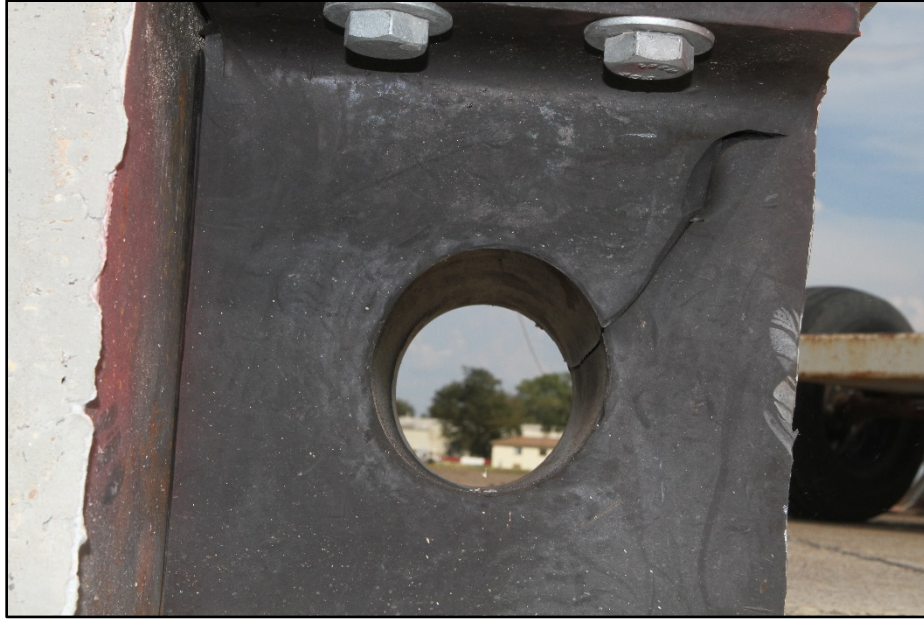
Figure 5.23. Crack in Block after Test No. 468957-B7.
