DEVELOPMENT AND *MASH* TL-4 EVALUATION OF TxDOT RUBBER MOUNTED SINGLE SLOPE BARRIER

Test Report 0-6895-R1

Cooperative Research Program

TEXAS A&M TRANSPORTATION INSTITUTE

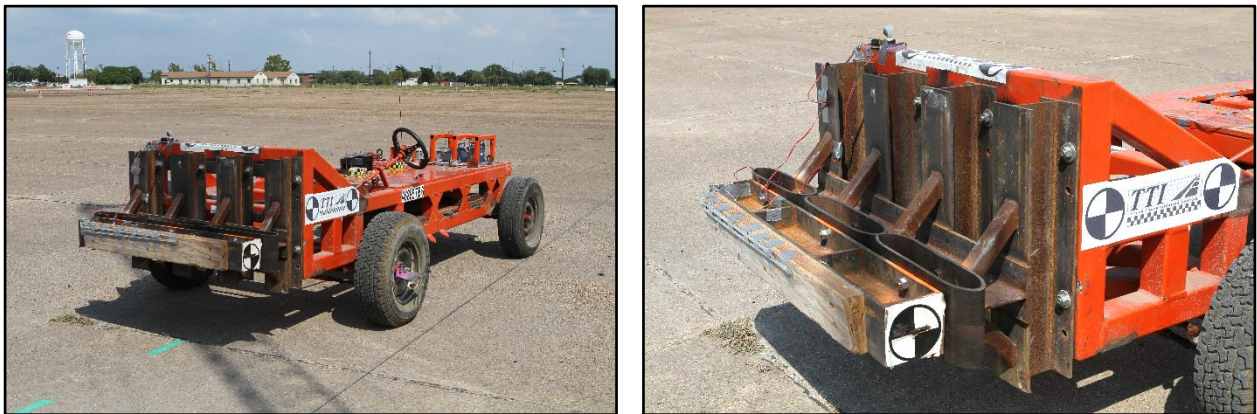
Figure 5.24. Bogie Vehicle after Test No. 468957-B7.

The pipe shapes had been replaced from the previous test. Figure 5.24 shows damage to the bogie vehicle. Maximum crush of the pipe shapes in the nose was 10 inches. The vehicle rebounded 26 ft from the traffic face of the barrier.

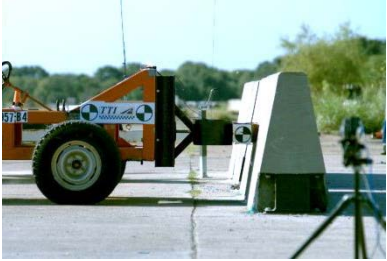
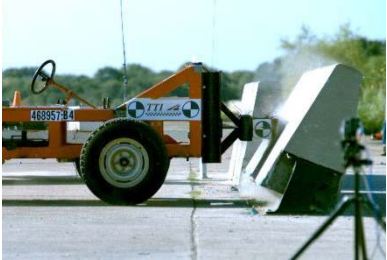
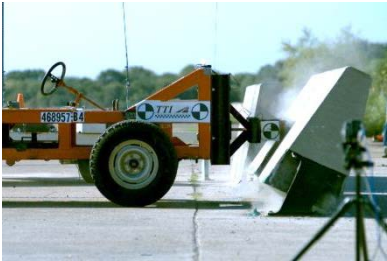
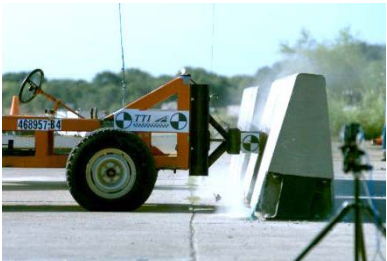
Table 5.1. Summary of Results for Test No. 468957-B4.

<p>0.000 s</p>	<p>General Information Test AgencyTexas A&M Transportation Institute Test No.468957-B4 Date2016-09-20</p> <p>Test Article Type.....Median Barrier with Shear Fender Name TxDOT Single-Slope Traffic Railing (SSTR) Installation Dimensions 42 inches tall x 20 ft long</p> <p>Soil Type Placed on Concrete Apron</p> <p>Test Vehicle Type.....Bogie Test Inertia Mass 4960 lb</p> <p>Impact Conditions Speed 18.3 mi/h Angle..... 90°</p> <p>Occupant Risk Values Longitudinal Occupant Impact Velocity..... 24.6 ft/s Longitudinal Ridedown Acceleration 4.3 g Longitudinal Average 50-ms Acceleration -14.2 g</p> <p>Dynamic Deflection22.3 inches Permanent Deflection 1.25 inch</p> <p>Vehicle Nose Crush8.9 inches Vehicle Rebound 24 ft</p> <p>Maximum Impact Force 10-ms Moving Average107 kips 50-ms Moving Average70 kips</p>

Tables 5.1 through 5.4 summarize the pertinent information from these four bogie tests.

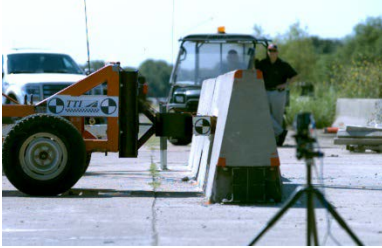
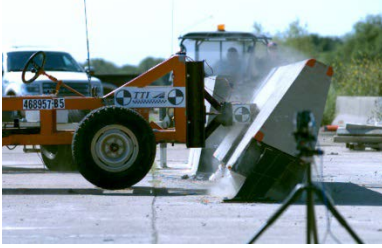
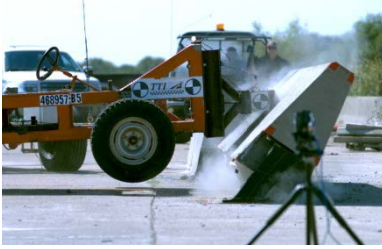
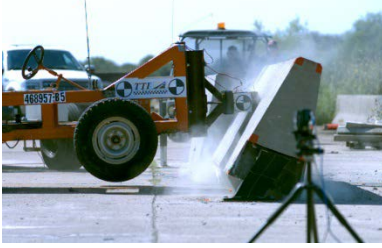
Table 5.2. Summary of Results for Test No. 468957-B5.

<p>0.600 s</p>	<p>Impact Conditions Speed 22.3 mi/h Angle..... 90°</p> <p>Occupant Risk Values Longitudinal Occupant Impact Velocity..... 25.9 ft/s Longitudinal Ridedown Acceleration 5.9 g Longitudinal Average 50-ms Acceleration -15.9 g</p> <p>Dynamic Deflection29.3 inches Permanent Deflection 0.5 inch</p> <p>Vehicle Nose Crush10.0 inches Vehicle Rebound 30 ft</p> <p>Maximum Impact Force 10-ms Moving Average194 kips 50-ms Moving Average79 kips</p>

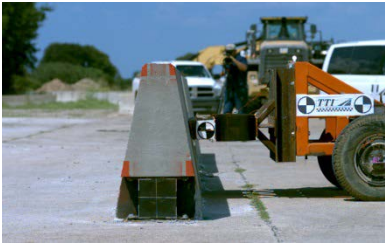
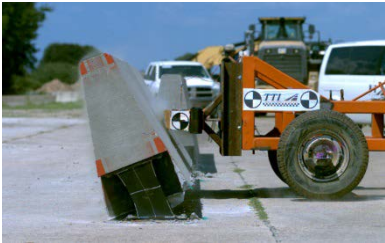
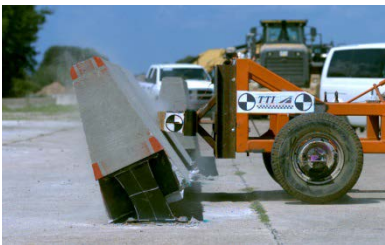
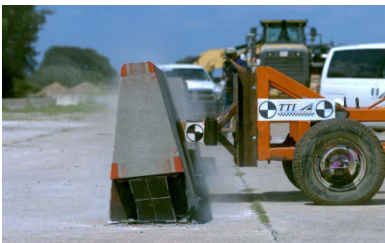
Table 5.3. Summary of Results for Test No. 468957-B6.

<p>Impact Conditions Speed 18.5 mi/h Angle..... 90°</p> <p>Occupant Risk Values Longitudinal Occupant Impact Velocity..... 26.6 ft/s Longitudinal Ridedown Acceleration 3.9 g Longitudinal Average 50-ms Acceleration -13.8 g</p> <p>Dynamic Deflection21.0 inches Permanent Deflection 0.5 inch</p> <p>Vehicle Nose Crush7 inches Vehicle Rebound26 ft</p> <p>Maximum Impact Force 10-ms Moving Average113 kips 50-ms Moving Average68 kips</p>

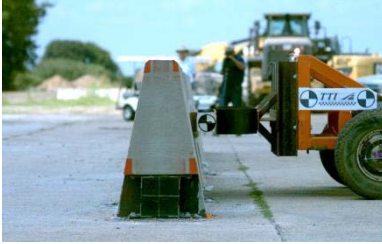
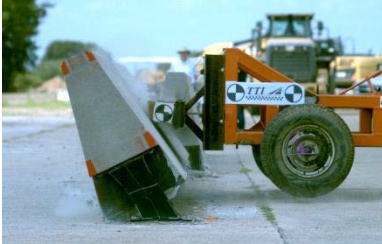
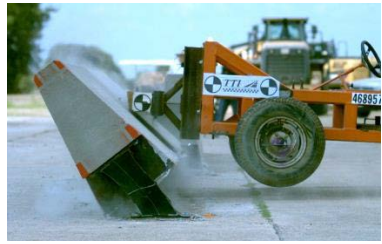
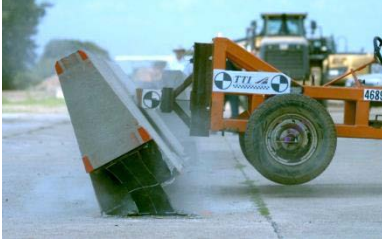
Table 5.4. Summary of Results for Test No. 468957-B7.

<p>0.040 s</p>	<p>Impact Conditions Speed 22.1 mi/h Angle 90°</p> <p>Occupant Risk Values Longitudinal Occupant Impact Velocity 25.6 ft/s Longitudinal Ridedown Acceleration 4.6 g Longitudinal Average 50-ms Acceleration -15.7 g</p>

<p>0.060 s</p>	<p>Dynamic Deflection 30.5 inches Permanent Deflection 0.75 inch</p> <p>Vehicle Nose Crush 10 inches Vehicle Rebound 26 ft</p> <p>Maximum Impact Force 10-ms Moving Average 184 kips 50-ms Moving Average 78 kips</p>

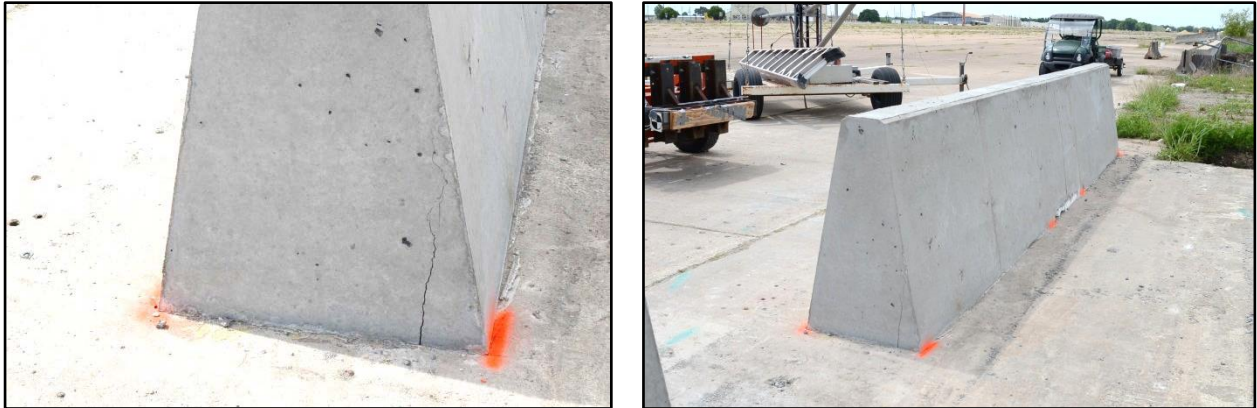
Figure 5.29. Right End and Field Side of Barrier after Test No. 468957-B8.

Maximum deflection of the barrier was 2.14 inches and maximum permanent deflection was 0.88 inch. Multiple vertical cracks radiated 3.5 ft to both sides of impact on the traffic side. Cracks on the field side were noted at center and 15 inches to the right of the crack at center. A crack was also noted in the ends on the field side corners of the barrier, as shown in Figures 5.29 and 5.30. Figures 5.29 through 5.33 show damage to the barrier.

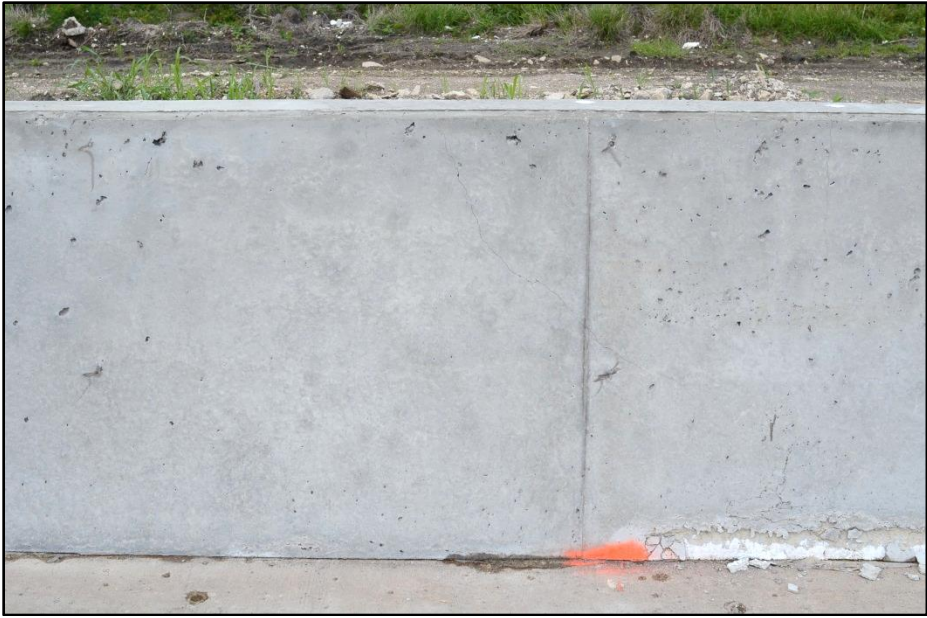
Figure 5.31. Traffic Face of Barrier after Test No. 468957-B8.

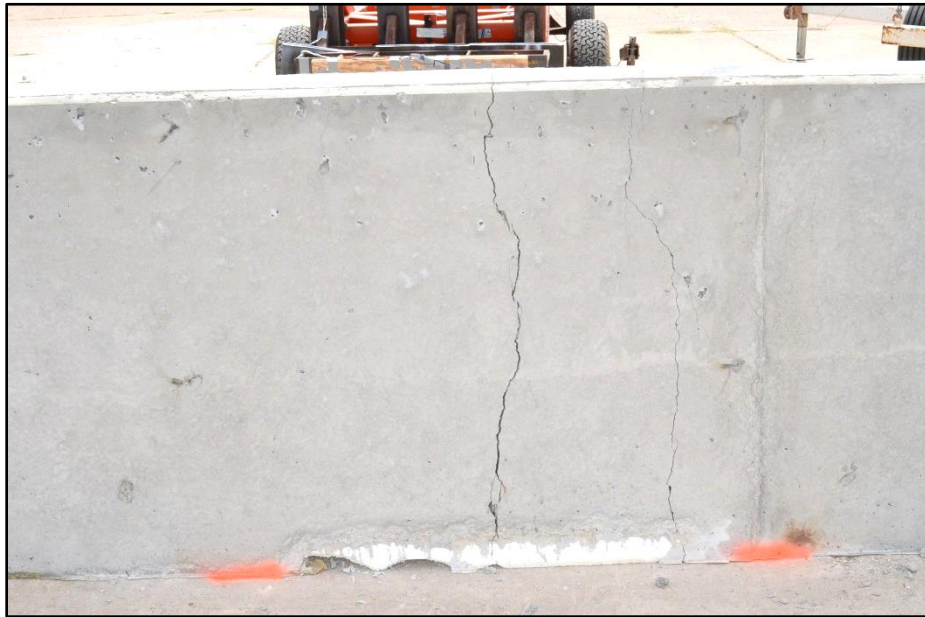
Figure 5.33. Field Side-Center of Barrier after Test No. 468957-B8.

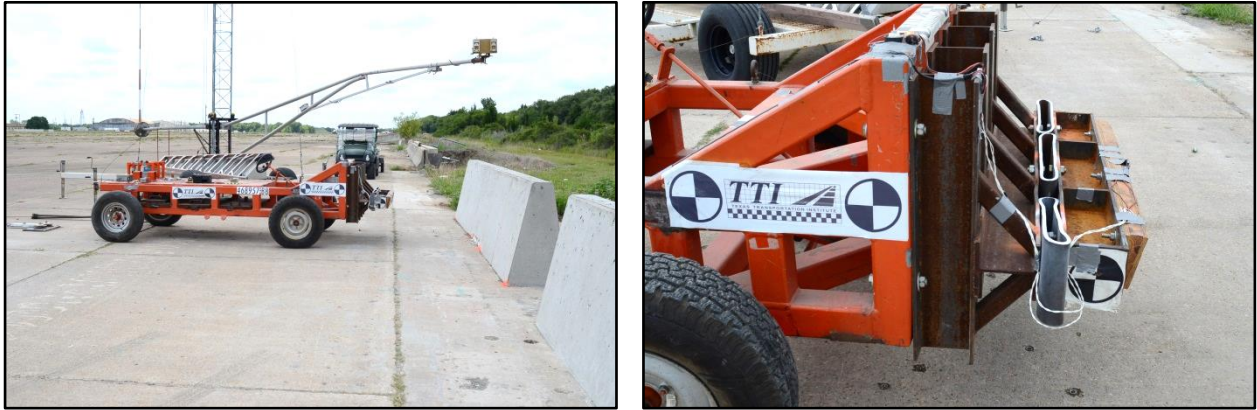
Figure 5.34 shows damage to the bogie vehicle. The pipe shapes crushed 10.8 inches. The vehicle rebounded 4.3 ft from the traffic face of the barrier.

Figure 5.34. Bogie Vehicle after Test No. 468957-B8.

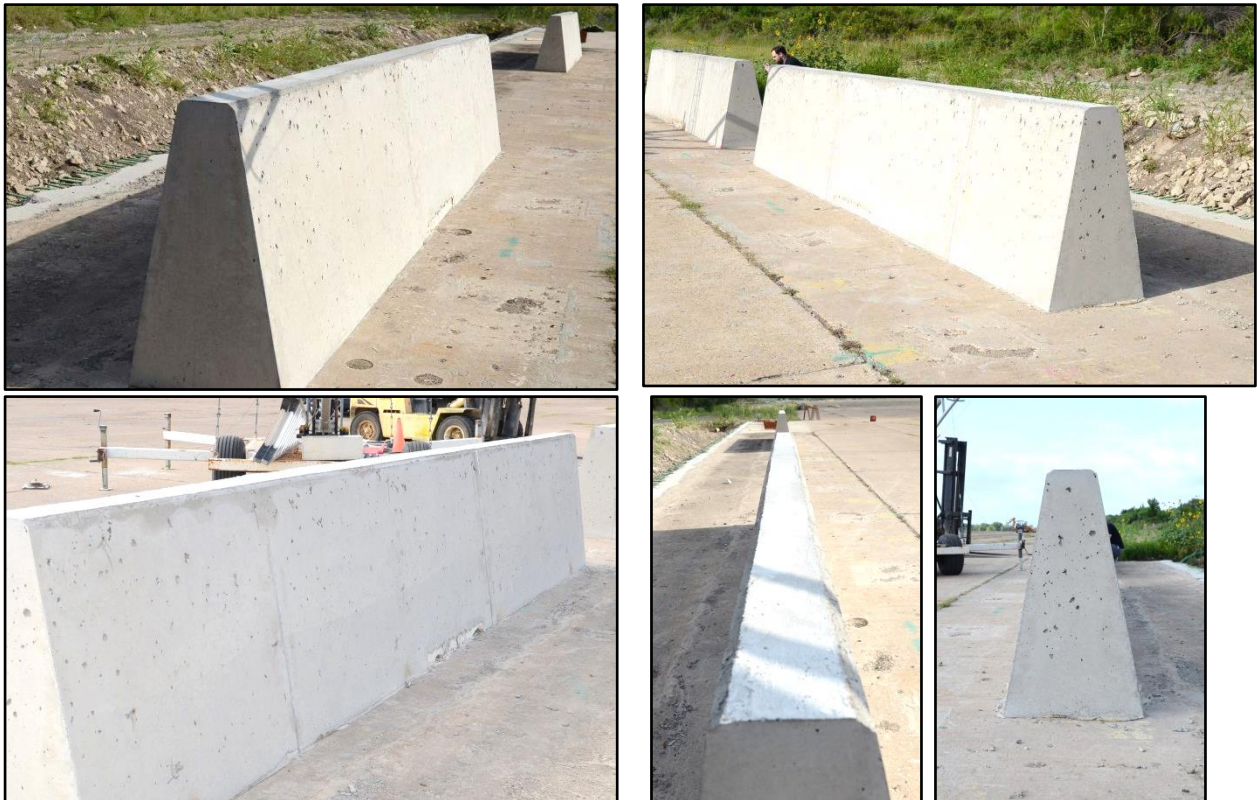
Figure 5.37. PR5FCR5F Mix Concrete Barrier before Test No. 468957-B9.

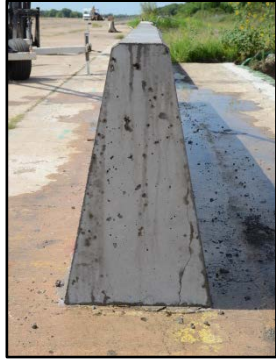
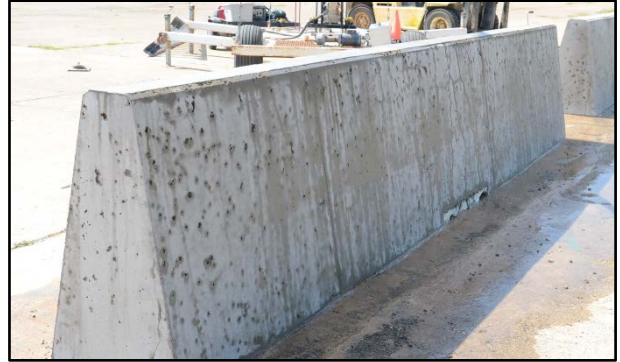
Maximum deflection of the barrier was 2.58 inches and maximum permanent deflection was 0.62 inch. Multiple vertical cracks radiated from the top over an area of 5.5 ft at impact on the field side. Cracks on the traffic side were noted at center and each end. Figures 5.38 through 5.42 show damage to the barrier.

Figure 5.38. Right End and Field Side of Barrier after Test No. 468957-B9.

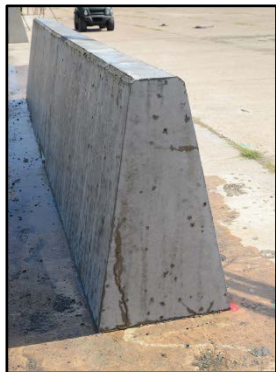
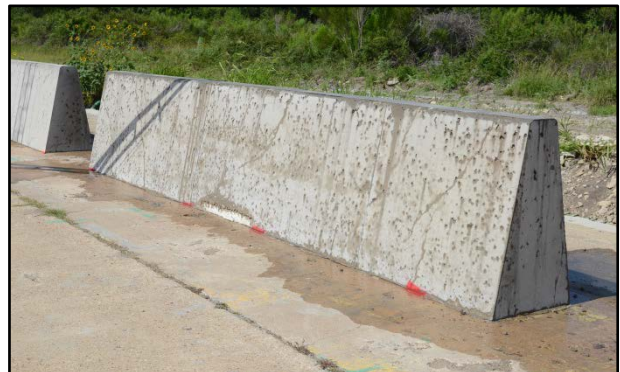
Figure 5.39. Left End and Traffic Side of Barrier after Test No. 468957-B9.

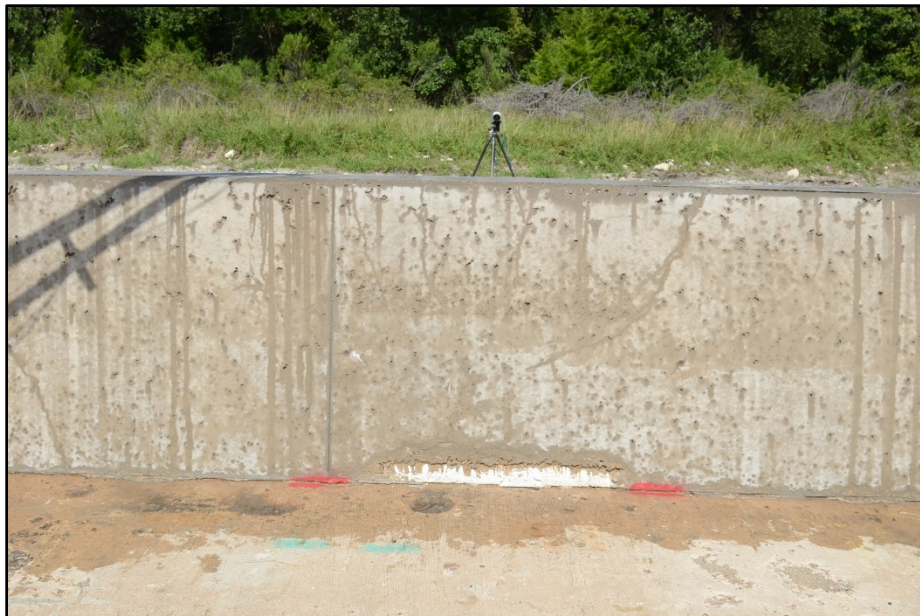
Figure 5.40. Traffic Face of Barrier after Test No. 468957-B9.

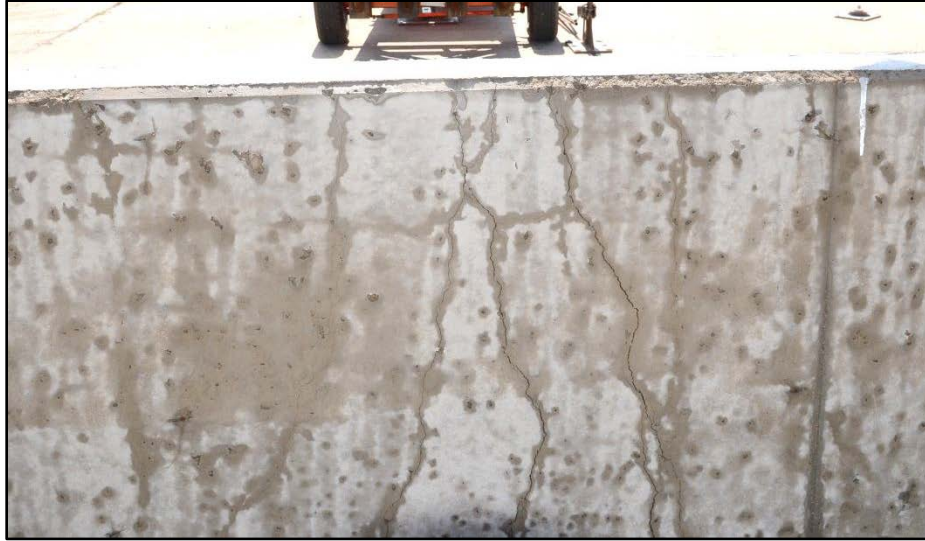
Figure 5.41. Top Field Side of Barrier after Test No. 468957-B9.

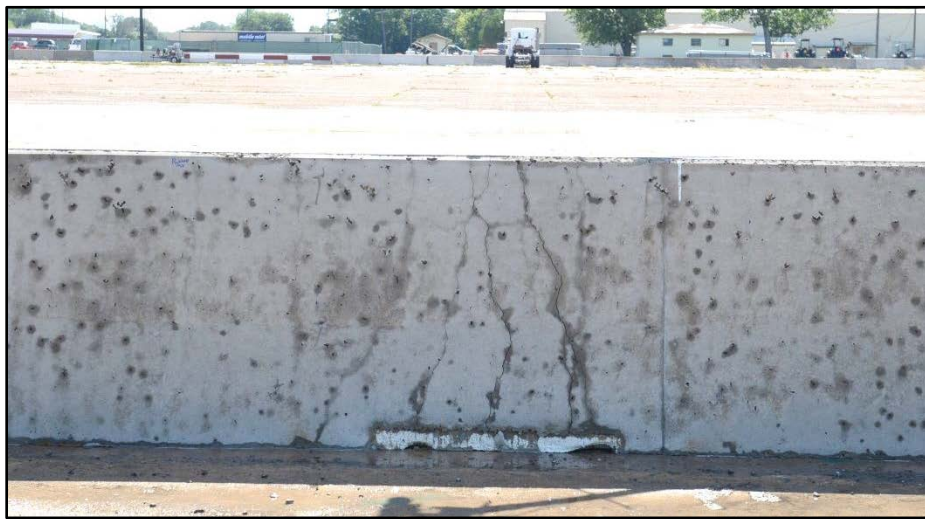
Figure 5.42. Field Side-Center of Barrier after Test No. 468957-B9.

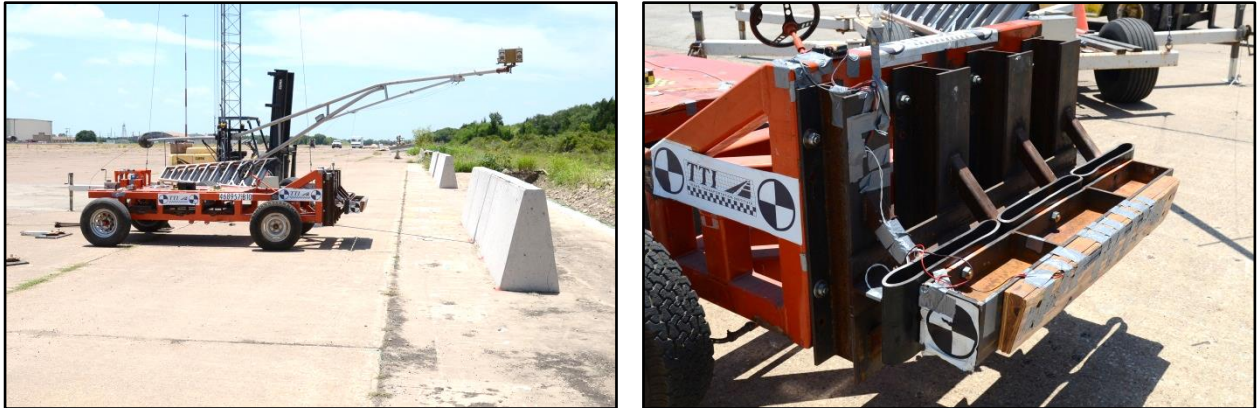
Figure 4.52. Bogie Vehicle after Test No. 468957-B10.

Figure 5.52 shows damage to the bogie vehicle. The pipe shapes crushed 10.5 inches. The vehicle rebounded 6.0 ft from the traffic face of the barrier.

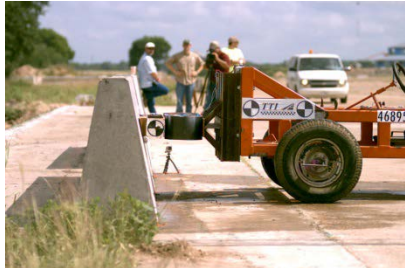
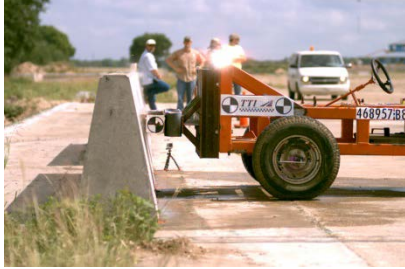
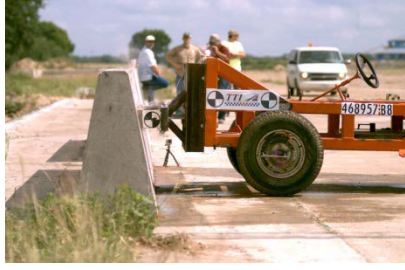
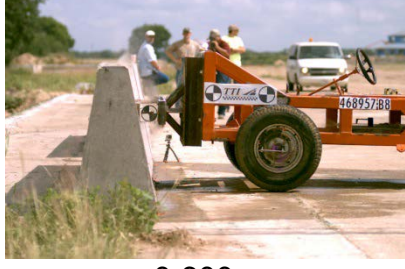
Table 5.8. Summary of Results for Test No. 468957-B8.

<p>0.000 s</p>	<p>General Information Test AgencyTexas A&M Transportation Institute Test No.468957-B8 Date2017-05-31</p> <p>Test Article Type.....Median Barrier with Class C Concrete Name TxDOT Single-Slope Traffic Railing (SSTR) Installation Dimensions 42 inches tall x 20 ft long</p>

<p>0.200 s</p>	<p>Soil Type Pinned to Concrete Apron</p> <p>Test Vehicle Type.....Bogie Test Inertia Mass..... 4960 lb</p> <p>Impact Conditions Speed 22.5 mi/h Angle..... 90°</p>

<p>0.400 s</p>	<p>Occupant Risk Values Longitudinal Occupant Impact Velocity..... 36.1 ft/s Longitudinal Ridedown Acceleration..... 0.6 g Longitudinal Average 50-ms Acceleration -18.3 g</p> <p>Dynamic Deflection2.14 inches Permanent Deflection 0.88 inch</p>

<p>0.600 s</p>	<p>Vehicle Nose Crush10.8 inches Vehicle Rebound 4.3 ft</p> <p>Maximum Impact Force 10-ms Moving Average228 kips 50-ms Moving Average92 kips</p>

Tables 5.8 through 5.10 summarize the pertinent information from these four bogie tests.

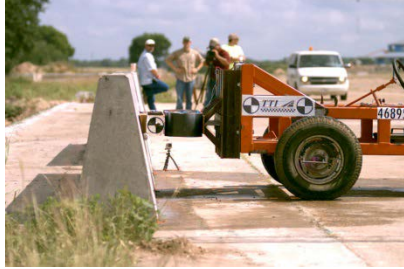
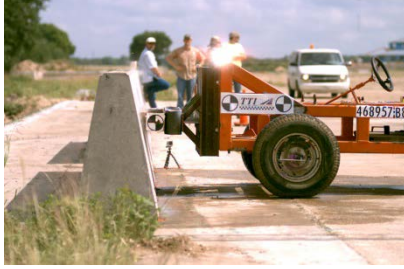
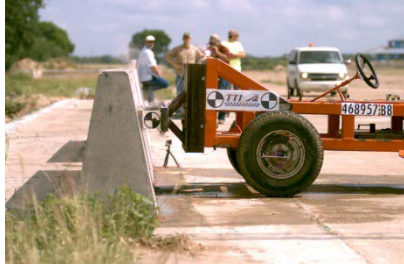
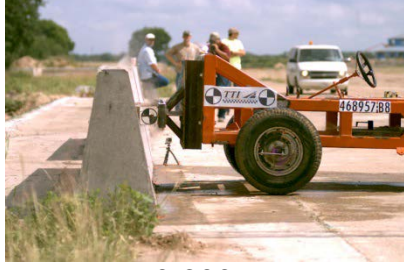
Table 5.9. Summary of Results for Test No. 468957-B9.

<p>0.000 s</p>	<p>General Information Test Agency Texas A&M Transportation Institute Test No. 468957-B9 Date 2017-06-23</p> <p>Test Article Type Median Barrier with PR5FCR5F Concrete Name TxDOT Single-Slope Traffic Railing (SSTR) Installation Dimensions 42 inches tall x 20 ft long</p>

<p>0.200 s</p>	<p>Soil Type Pinned to Concrete Apron</p> <p>Test Vehicle Type Bogie Test Inertia Mass 4960 lb</p> <p>Impact Conditions Speed 21.9 mi/h Angle 90°</p>

<p>0.400 s</p>	<p>Occupant Risk Values Longitudinal Occupant Impact Velocity 34.8 ft/s Longitudinal Ridedown Acceleration 0.8 g Longitudinal Average 50-ms Acceleration -18.5 g</p> <p>Dynamic Deflection 2.58 inches Permanent Deflection 0.62 inch</p>

<p>0.600 s</p>	<p>Vehicle Nose Crush 10.25 inches Vehicle Rebound 18.5 ft</p> <p>Maximum Impact Force 10-ms Moving Average 223 kips 50-ms Moving Average 91 kips</p>

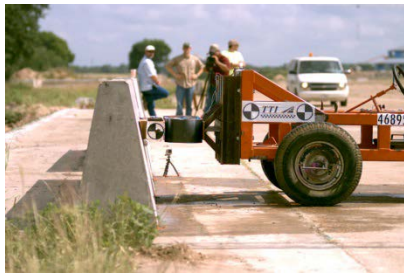
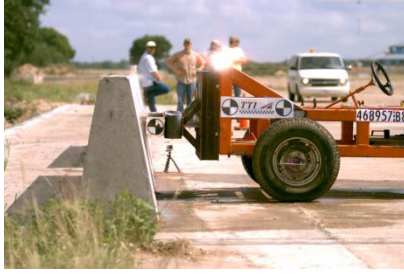
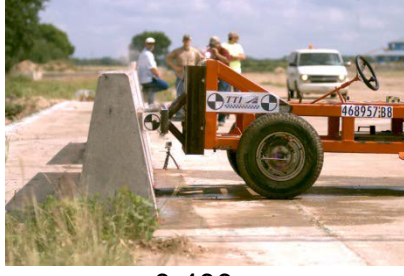
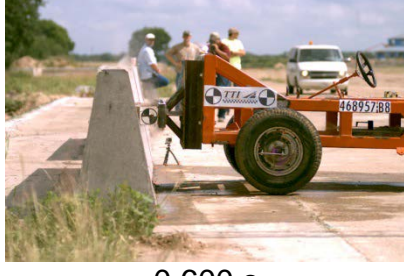
Table 5.10. Summary of Results for Test No. 468957-B10.

<p>0.000 s</p>	<p>General Information Test Agency Texas A&M Transportation Institute Test No. 468957-B10 Date 2017-06-23</p> <p>Test Article Type Median Barrier with CR10F-Gnet Mix Concrete Name TxDOT Single-Slope Traffic Railing (SSTR) Installation Dimensions 42 inches tall x 20 ft long</p>

<p>0.200 s</p>	<p>Soil Type Pinned to Concrete Apron</p> <p>Test Vehicle Type Bogie Test Inertia Mass 4960 lb</p> <p>Impact Conditions Speed 21.8 mi/h Angle 90°</p>

<p>0.400 s</p>	<p>Occupant Risk Values Longitudinal Occupant Impact Velocity 36.1 ft/s Longitudinal Ridedown Acceleration 0.7 g Longitudinal Average 50-ms Acceleration -17.2 g</p> <p>Dynamic Deflection 2.31 inches Permanent Deflection 0.88 inch</p>

<p>0.600 s</p>	<p>Vehicle Nose Crush 10.5 inches Vehicle Rebound 6.0 ft</p> <p>Maximum Impact Force 10-ms Moving Average 229 kips 50-ms Moving Average 85 kips</p>

- c) ***The barrier mixture containing only the rubber particles displayed smaller, more distributed cracks than the control barrier, which indicates that the rubber performed well in arresting the crack propagation and that the toughness of the concrete was improved through the rubber inclusions.***

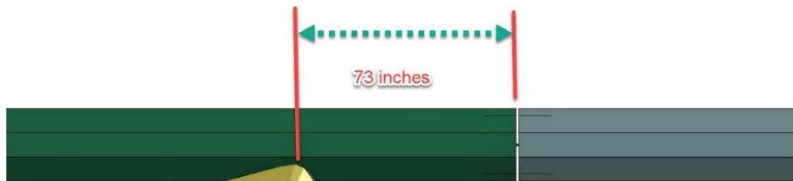
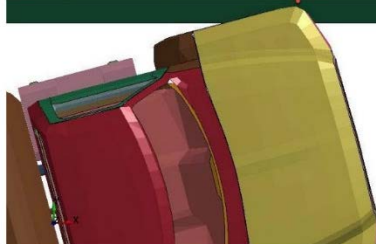
Figure 7.3. Target CIP for MASH Test 4-12 (Test No. 468958-1) on the TxDOT Rubber Mounted Single Slope Barrier.

CIP: SUT (4-12) @ 73 inches upstream of joint # 2 (middle joint of the installation)

Middle joint of the installation (joint #2)

Table 6.1 shows the test conditions and evaluation criteria for *MASH* Test Level 4 (TL-4). The target CIPs selected for the tests were determined according to the information provided in *MASH* Section 2.2.1 and Section 2.3 and FEA, and are shown in Figures 7.1 through 7.3.

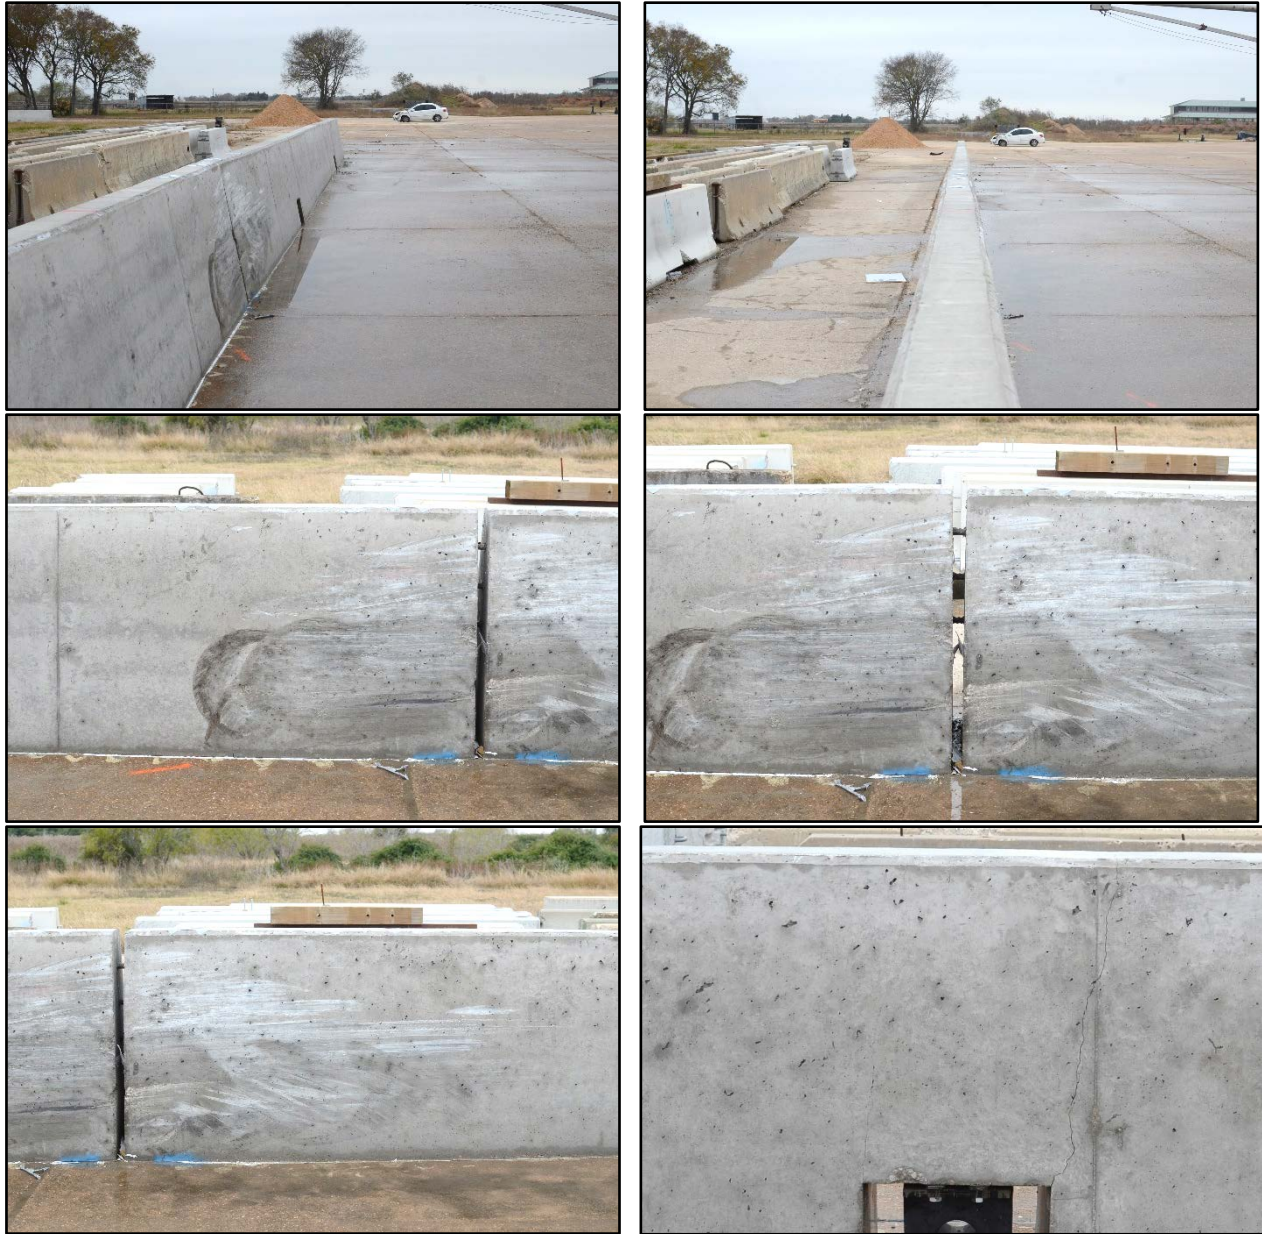
Figure 9.3. TxDOT Rubber Mounted Single Slope Barrier after Test No. 468958-3.

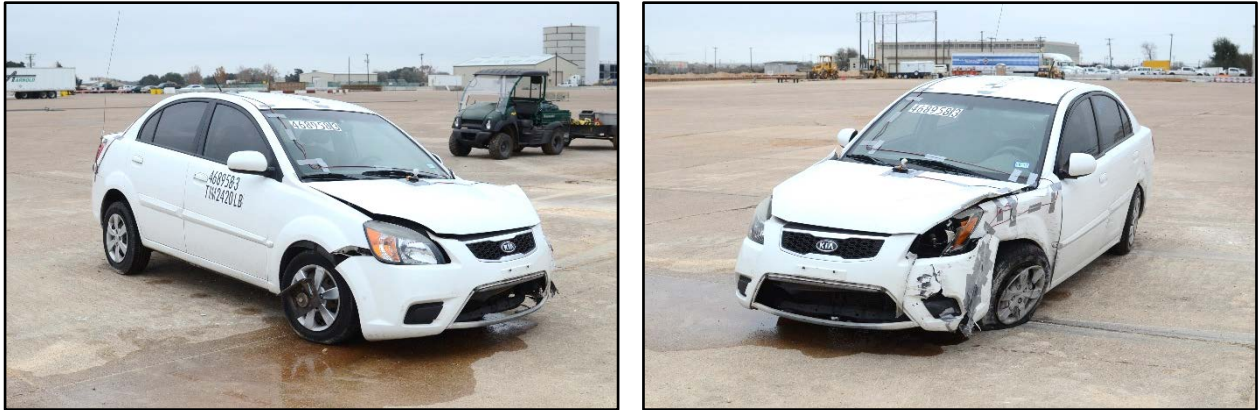
Figure 9.4. Test Vehicle after Test No. 468958-3.

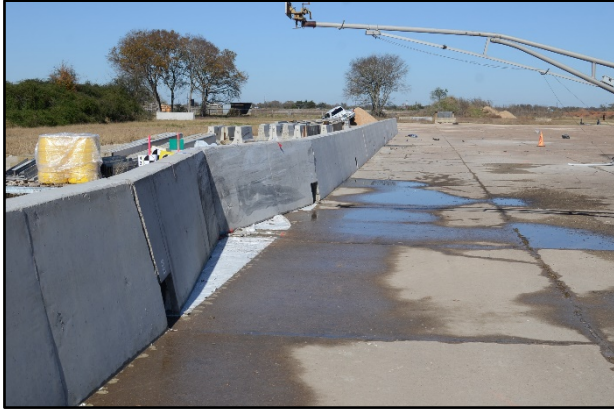
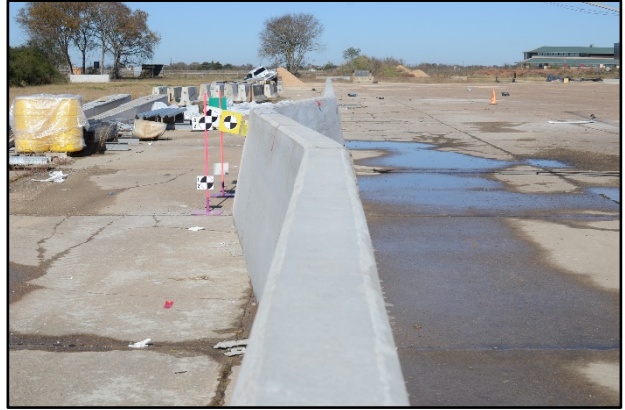
Figure 10.3. TxDOT Rubber Mounted Single Slope Barrier after Test No. 468958-2.

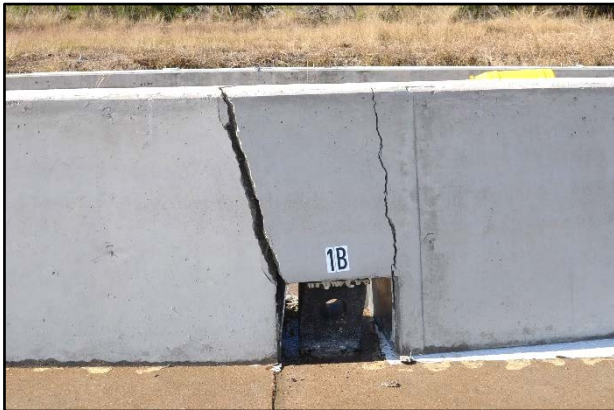
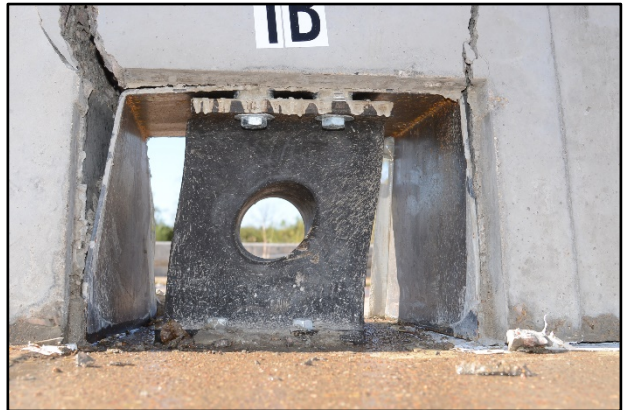
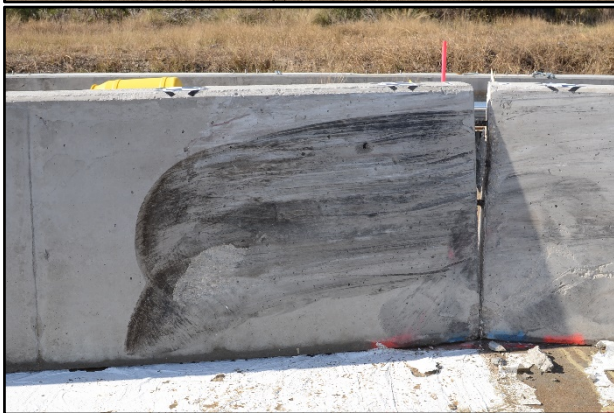
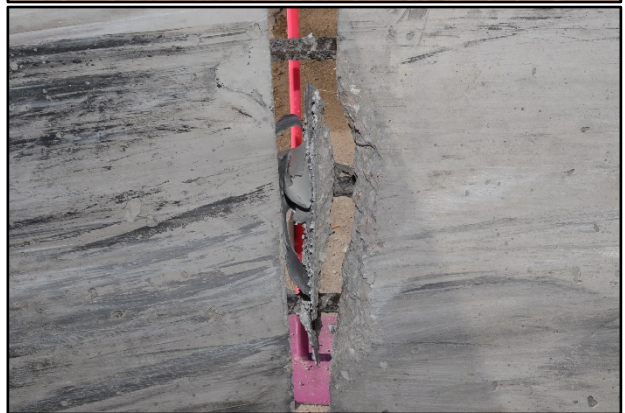
Figure 10.4. Damage to Barrier #1 after Test No. 468958-2.

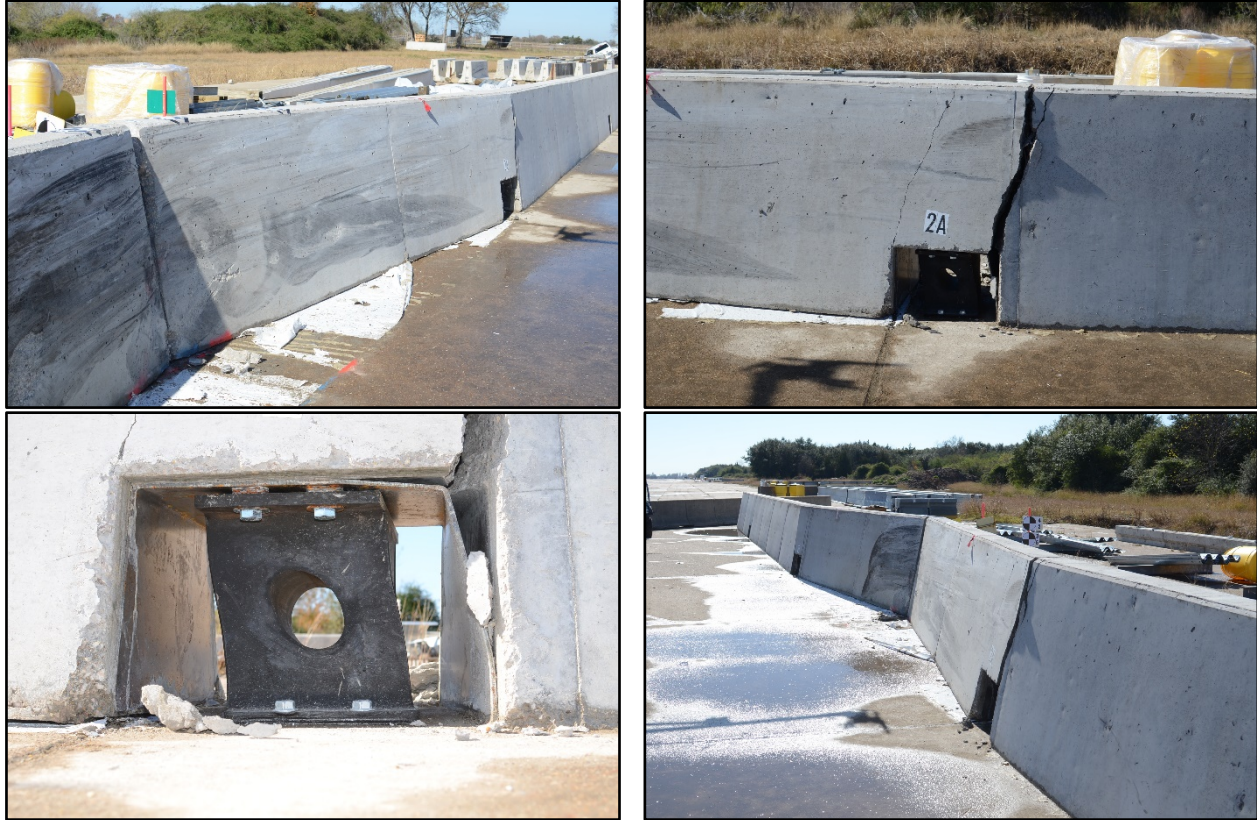
Figure 10.5. Damage to Barrier #2 after Test No. 468958-2.

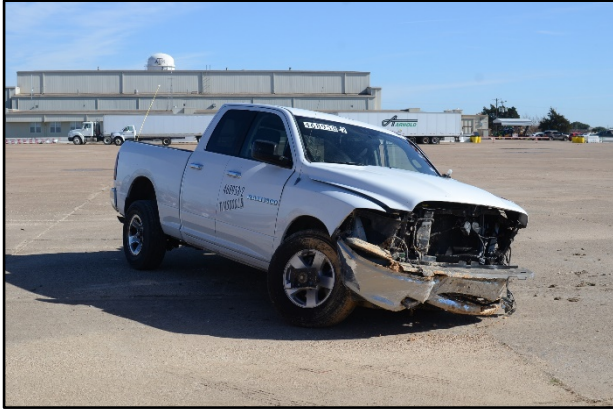
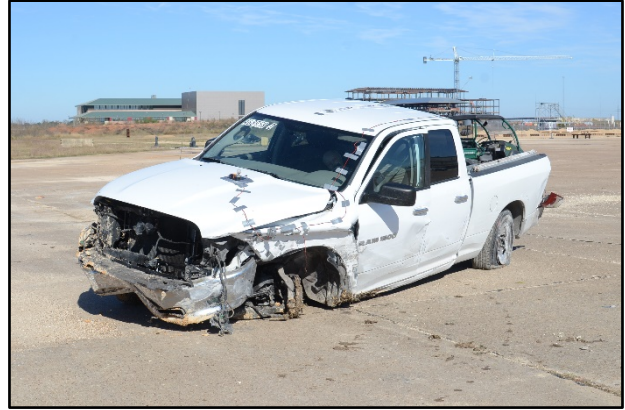
Figure 10.6. Test Vehicle after Test No. 468958-2.

Figure 10.6 shows the damage the vehicle sustained. The front bumper, grill, hood, radiator and support, left front fender, left front tire and rim, left front upper and lower A-arms, left front outer tie rod end, left front and rear doors, left exterior bed, left rear tire and rim, tail gate, and rear bumper were damaged. Maximum exterior crush to the vehicle was 8.0 inches in the side plane at the left front corner at bumper height. No occupant compartment deformation or intrusion was noted. Figure 10.7 shows the interior of the vehicle. Tables H.3 and H.4 in Appendix H.1 provide exterior crush and occupant compartment measurements.

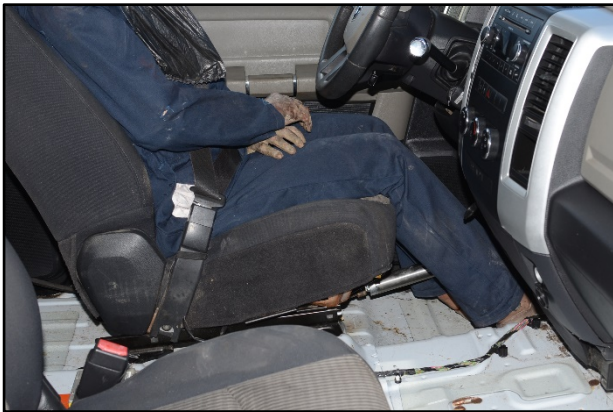
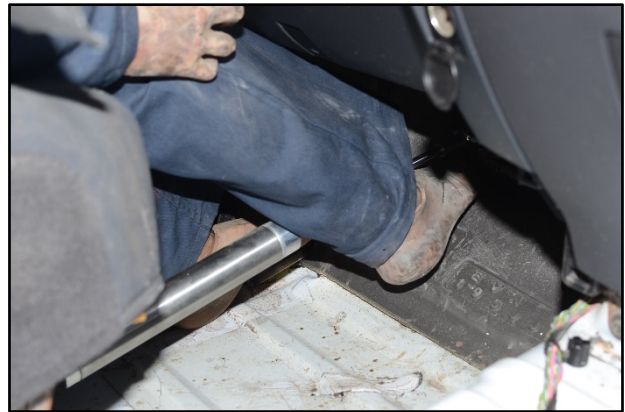
Figure 10.7. Interior of Test Vehicle for Test No. 568958-2.

Before Test

After Test

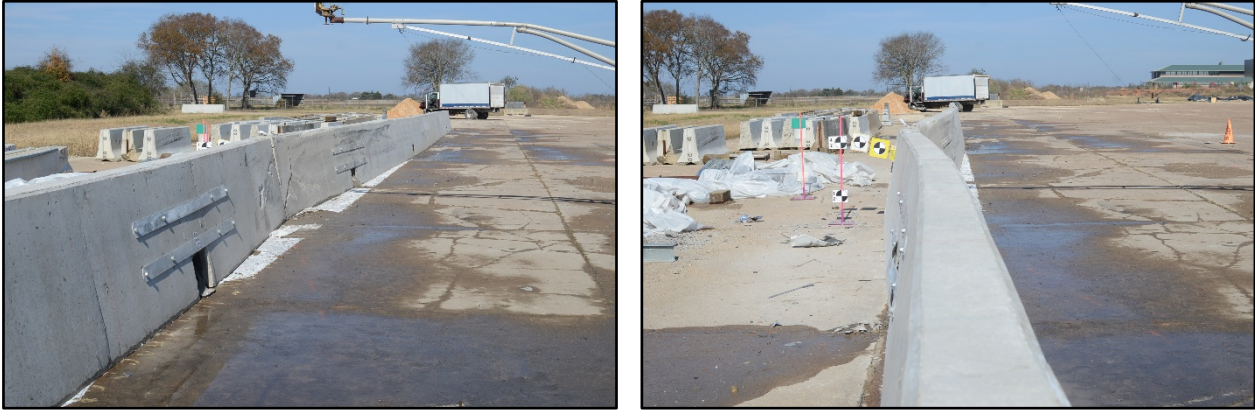
Figure 11.3. TxDOT Rubber Mounted Single Slope Barrier/Test Vehicle after Test No. 468958-3.

Figures 11.3 through 11.6 show the damage the barrier sustained. Numerous vertical cracks were noted on barriers #2 and #3. Working width was 74.3 inches at the field side toe of

the barrier. Maximum dynamic deflection during the test was 39.9 inches, and maximum permanent deformation was 21.0 inches.

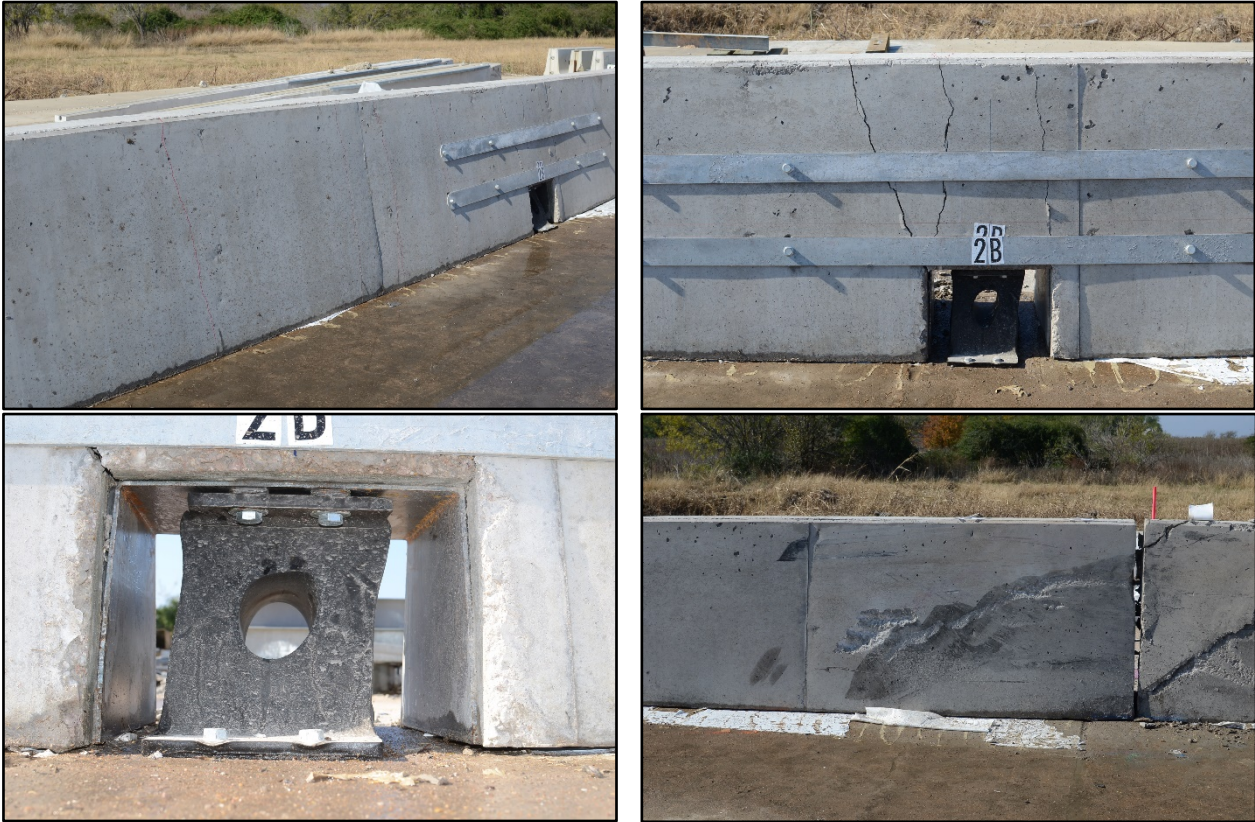
Figure 11.4. Damage to Barrier #2 after Test No. 468958-3.

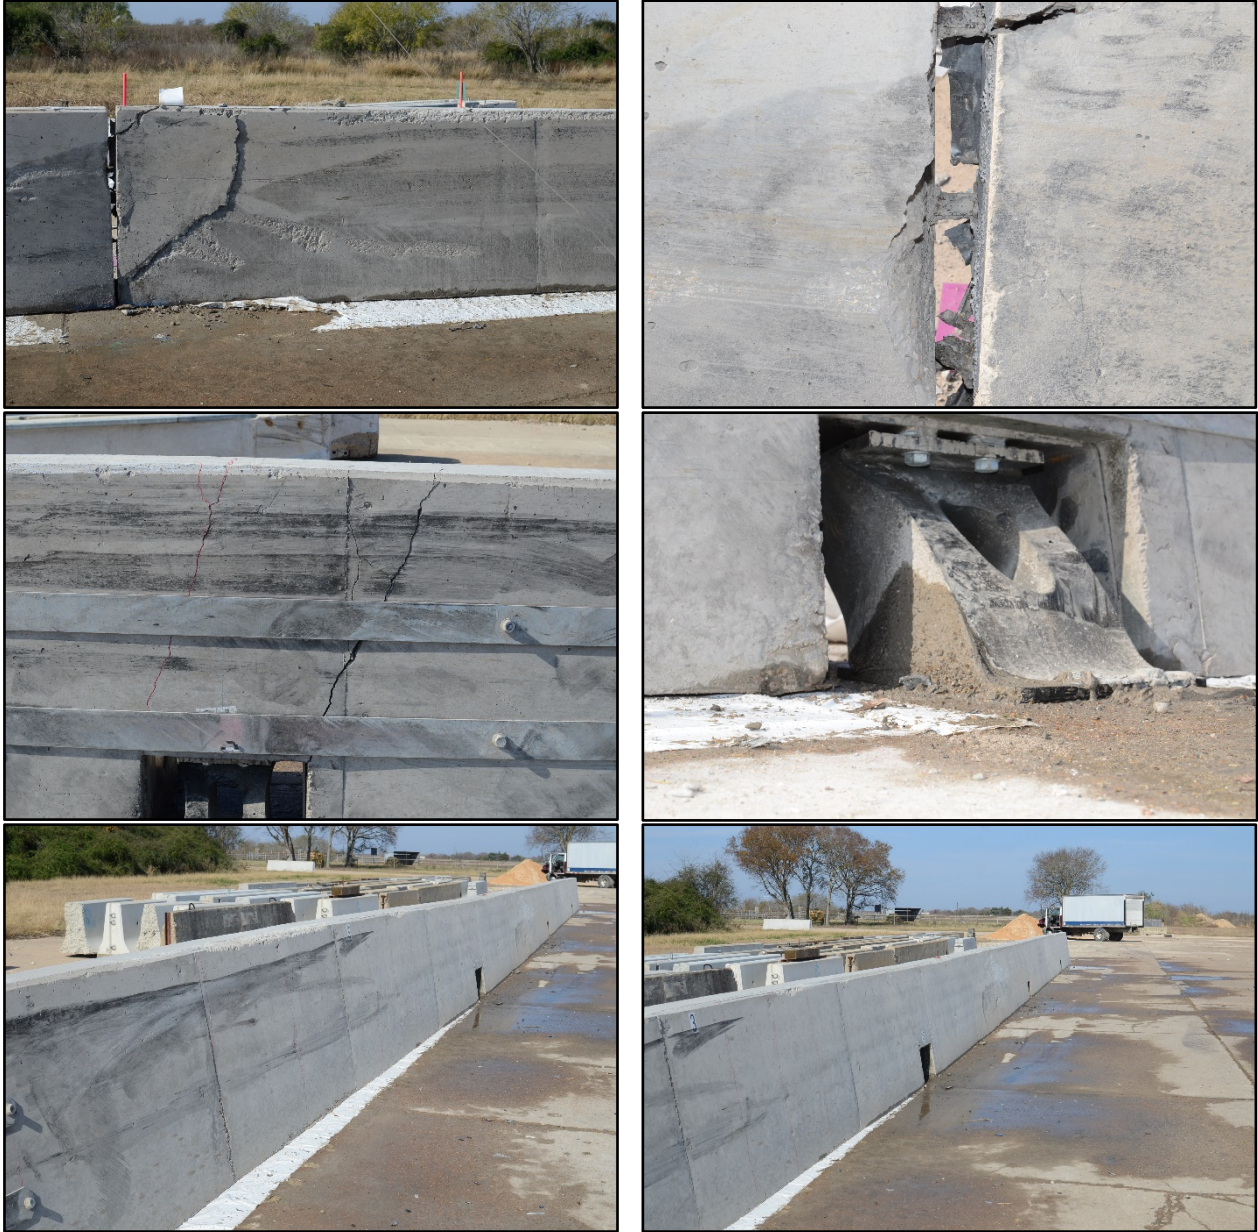
Figure 11.5. Damage to Barrier #3 after Test No. 468958-3.

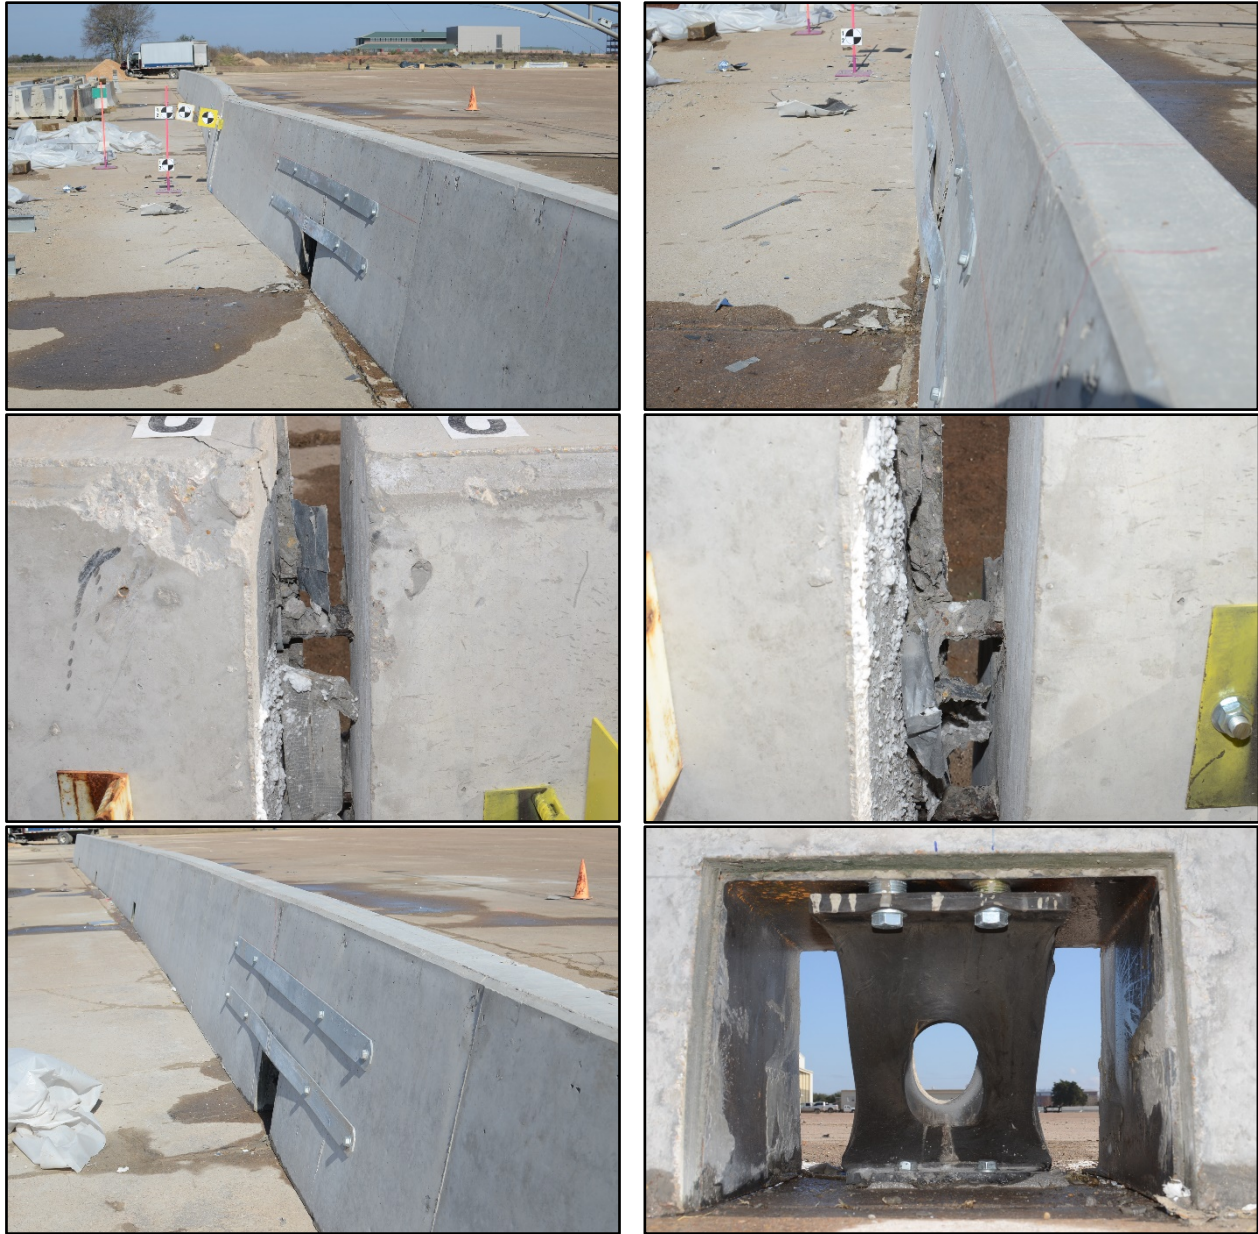
Figure 11.6. Damage to Field Side of Barrier after Test No. 468958-3.
