DEVELOPMENT AND *MASH* TL-4 EVALUATION OF TxDOT RUBBER MOUNTED SINGLE SLOPE BARRIER

Test Report 0-6895-R1

Cooperative Research Program

TEXAS A&M TRANSPORTATION INSTITUTE

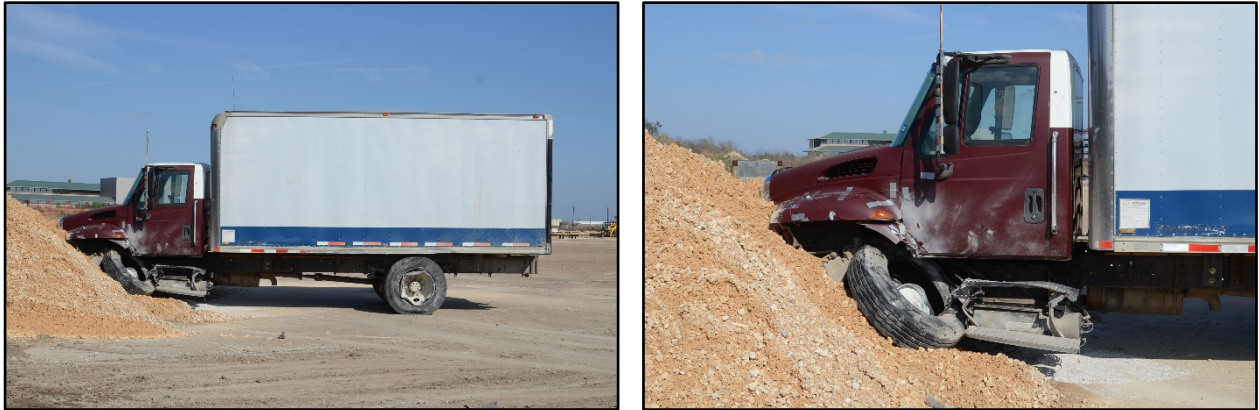
Figure 11.7. Test Vehicle after Test No. 468958-3.

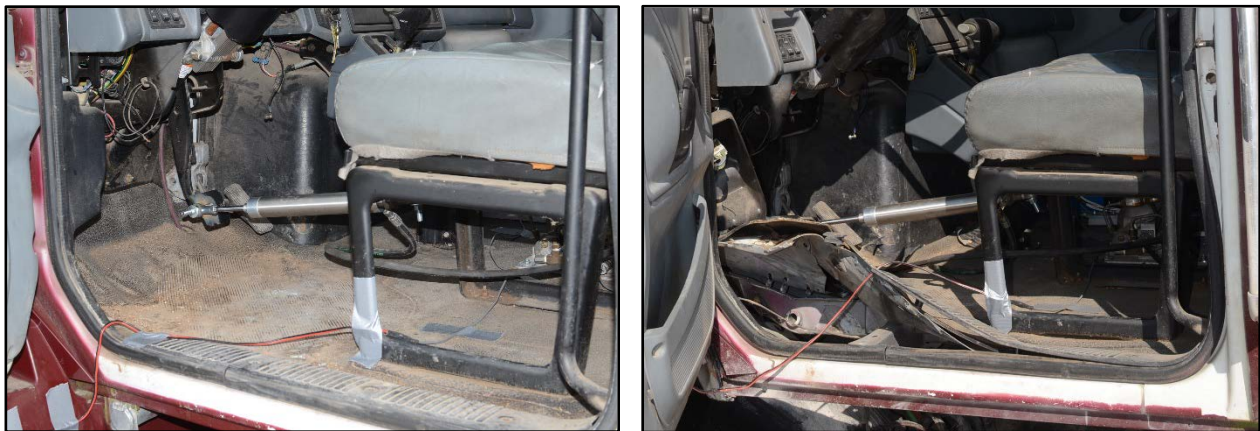
Figure 11.7 shows the damage that the vehicle had sustained. The front bumper, hood, grill, left front tire and rim, left front axle, left side of box, left rear tire and rim, and floor pan were damaged. Maximum exterior crush to the vehicle was 18.0 inches in the front plane at the left front corner at bumper height. Maximum occupant compartment deformation was 8.0 inches in the left side of the floor pan where the seam adjacent to the door frame was pushed upward. Figure 11.8 shows the interior of the vehicle.

Before Test

After Test

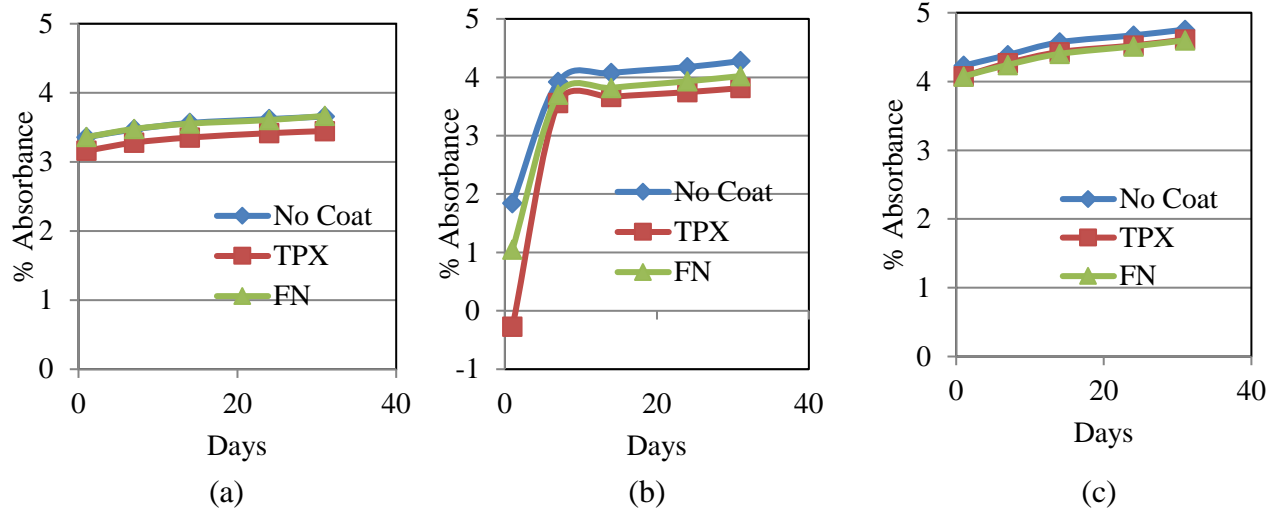
Figure 12.1. Plots for Percent Absorbance at Discrete Time Intervals in Days for Samples (a) Control, (b) PR5FCR5F, and (c) CR10FGnet.

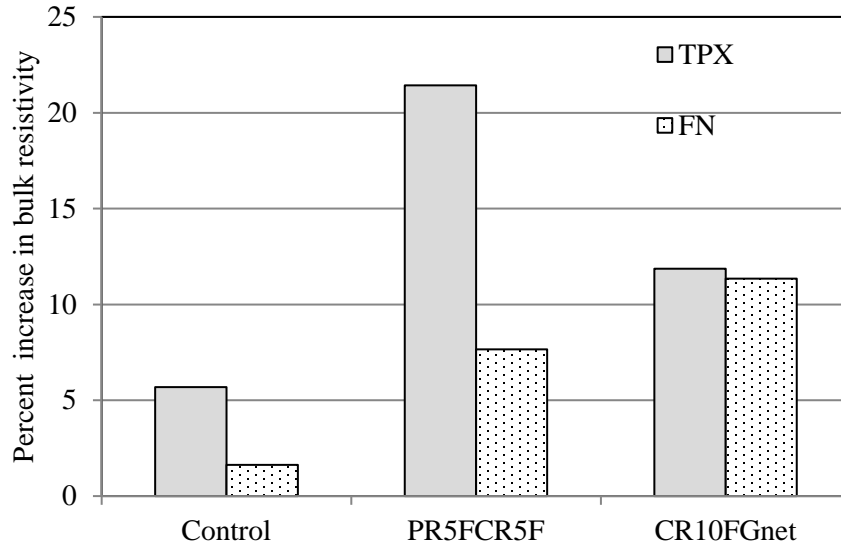
Figure 12.2. Change in Percent Bulk Resistivity of Coated Samples Compared to No-Coat Samples at Day 31.

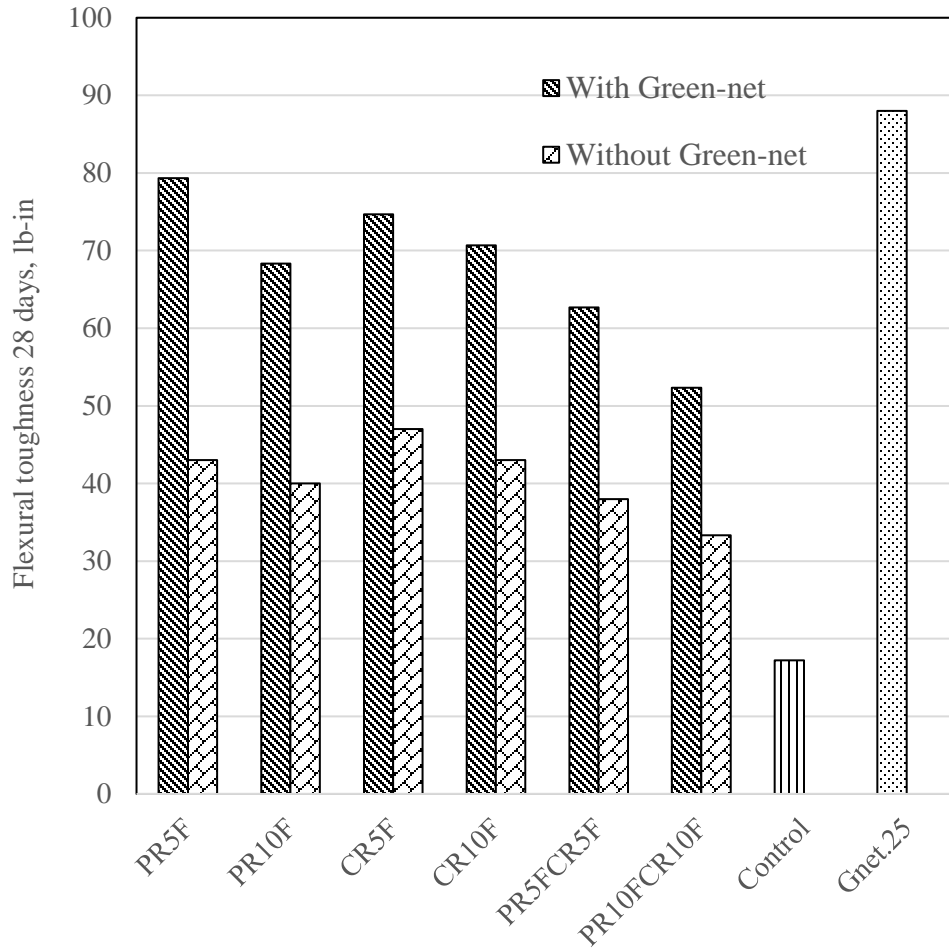
Figure A.3. Flexural Toughness Comparison between Rubberized Concrete Mixtures with and without Green-Net Fiber.

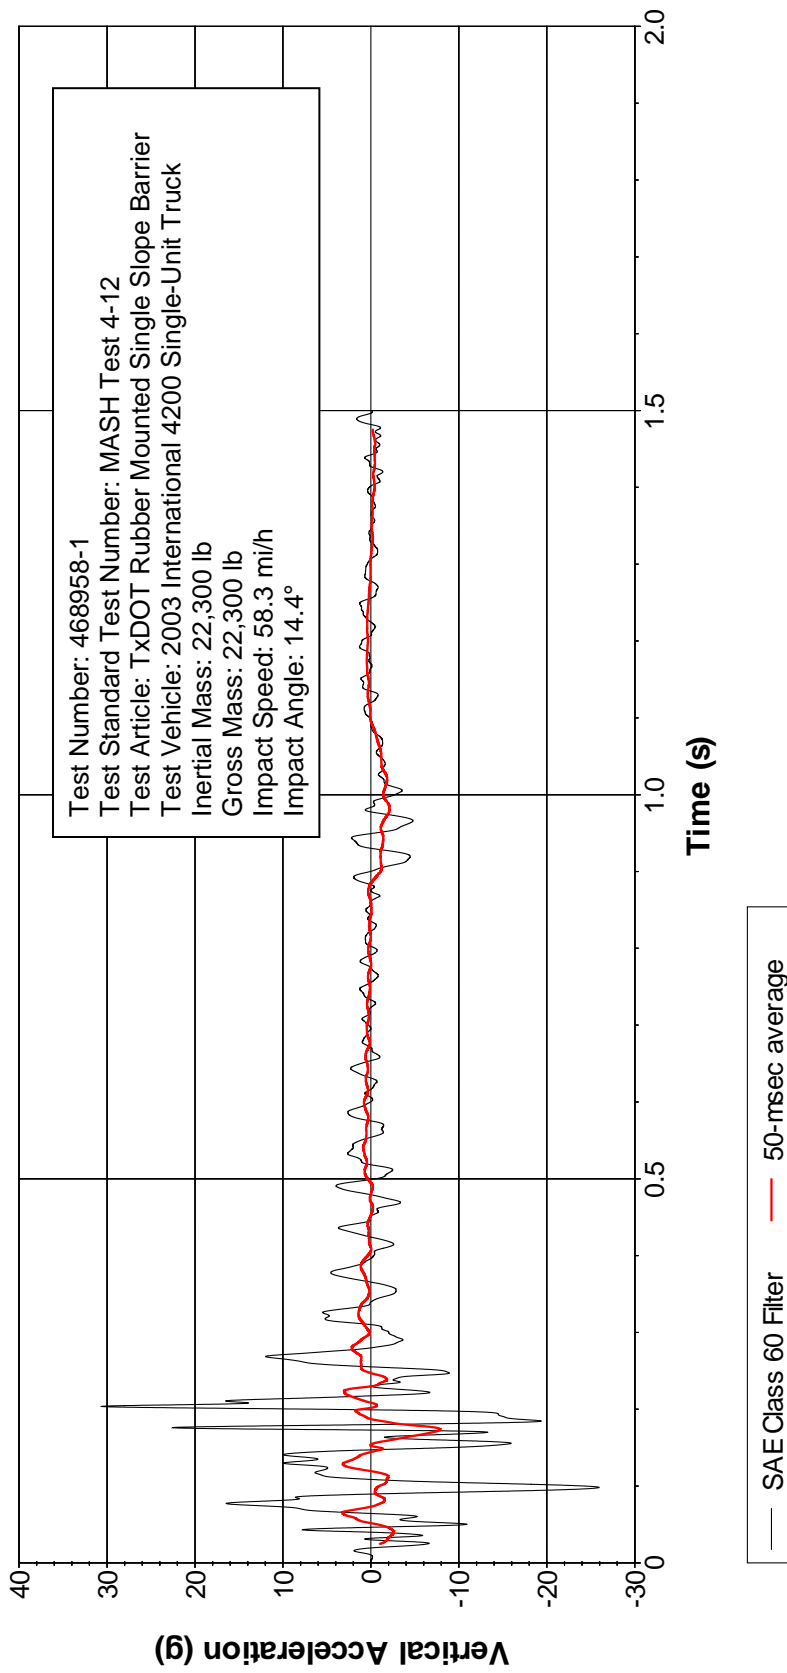
Figure I.8. Vehicle Vertical Accelerometer Trace for Test No. 468958-1 (Accelerometer Located Rear of Center of Gravity).
