Developing a Surface Drainage Rating for Inclusion in TxDOT's Asset Management System: Technical Report

Technical Report 0-6896-R1

TEXAS A&M TRANSPORTATION INSTITUTE
COLLEGE STATION, TEXAS

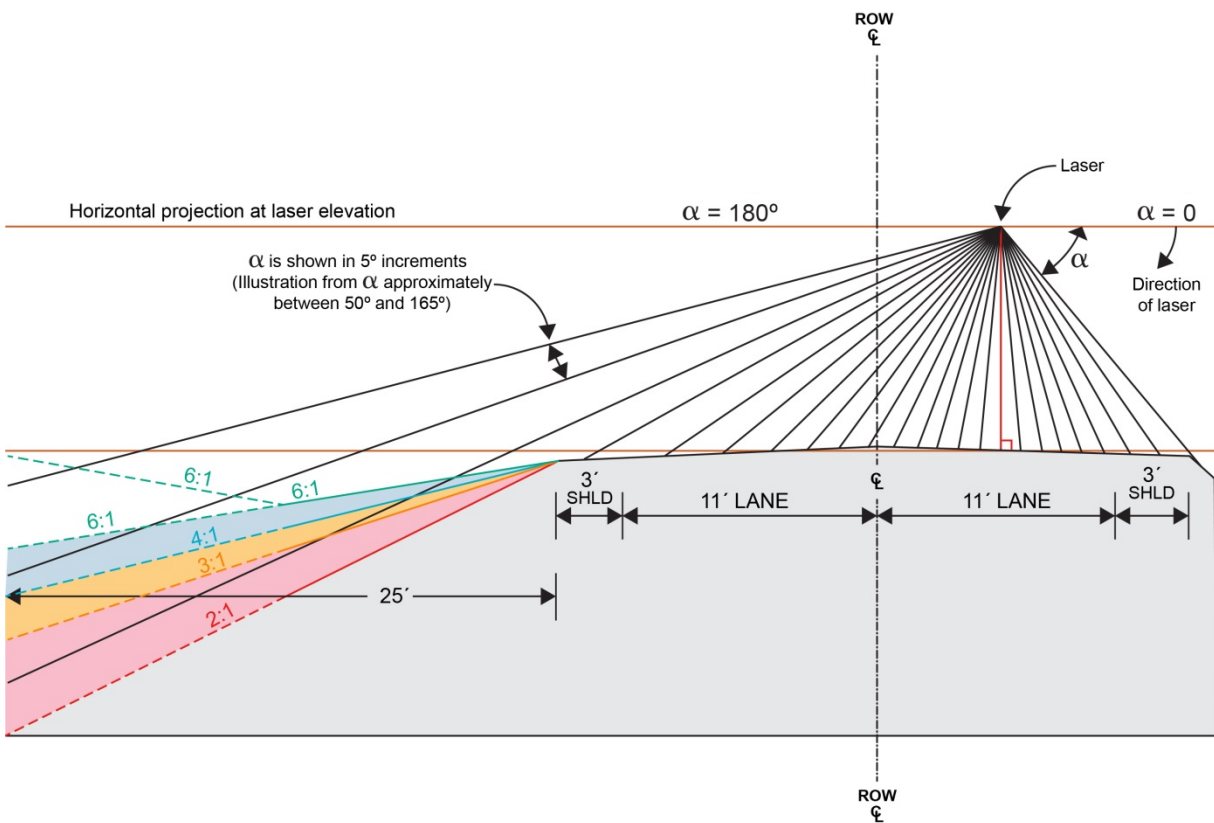
Figure 8. Transverse Laser Geometry.

The α value represents the angular resolution. Angular resolution is defined as the angular movement in the laser between measurements (44). In this study, the angular resolution is 0.6667° . The angular resolution increment spacing does not change, so more data points are collected in close proximity to the laser source. This can be seen in Figure 8, which includes laser lines on approximately 5° increments.

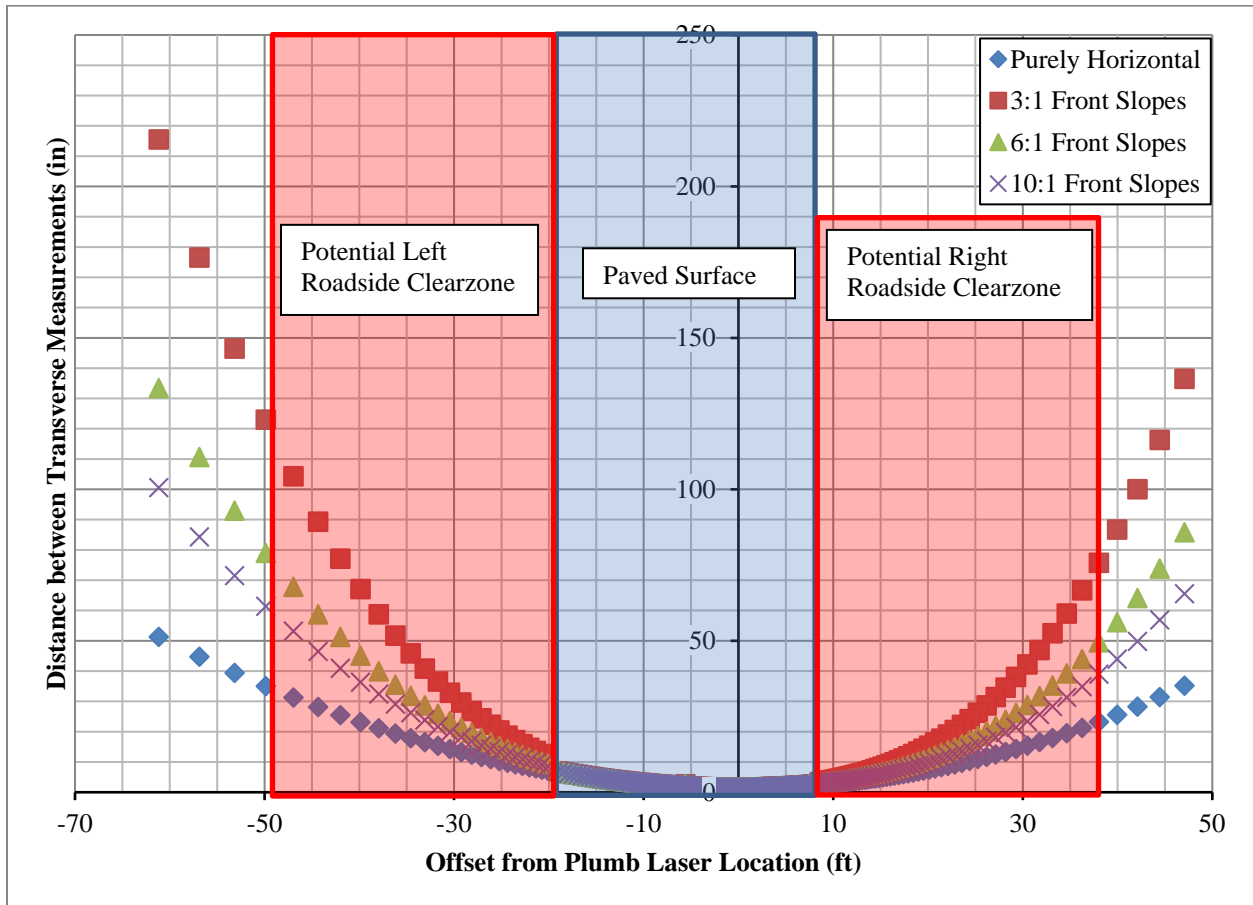
Figure 12. Transverse Spacing for a Two-Lane Roadway.

laser, measurements become farther apart. Figure 12 displays the spacing across a typical two-lane roadway with varying front slopes.

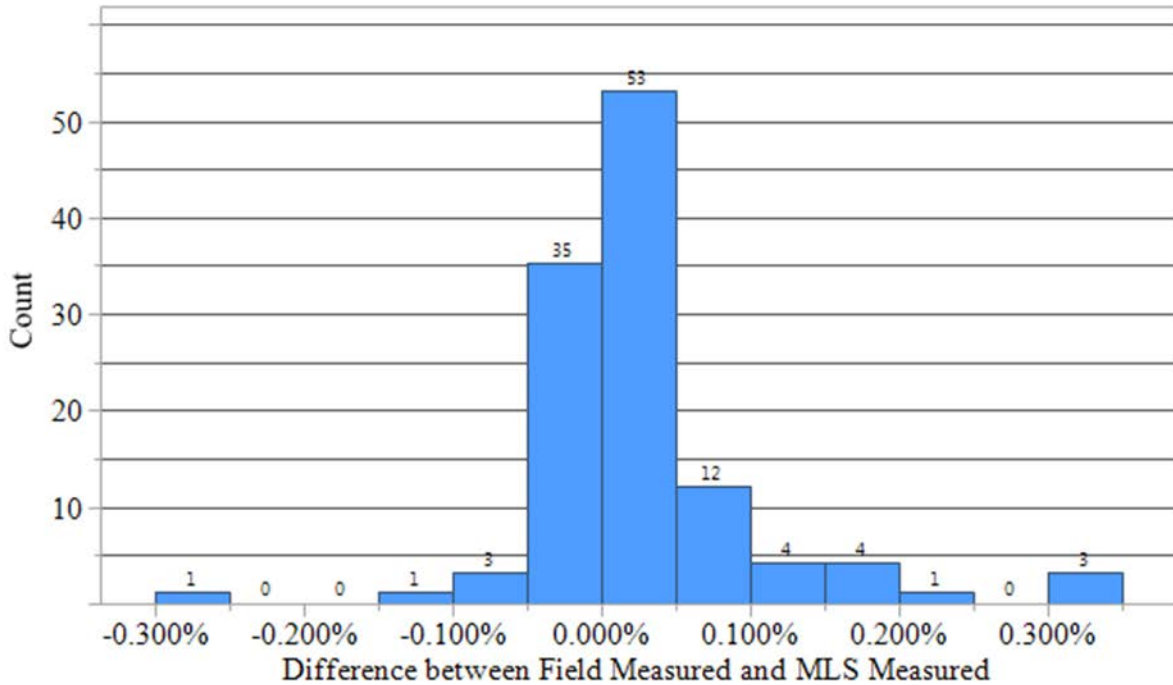
Figure 15. Histogram of Data Collection Lane Cross-Slope Accuracy.

precise location of the survey point is only as accurate as the survey equipment used, both a 1-ft (0.3048 m) longitudinal and transverse window are used for accuracy comparison. Three repeat runs and 39 cross-sections were used for comparison. The histogram in Figure 15 consolidates the 39 cross-sections from each of the three repeat runs. The population count in Figure 15 is 117 with 103 cross-sections, or 88 percent of cross-sections, within an accuracy of ± 0.1 percent. Approximately 92 percent of all cross-slopes are within ± 0.15 percent, and more than 95 percent of cross-sections are within ± 0.2 percent.

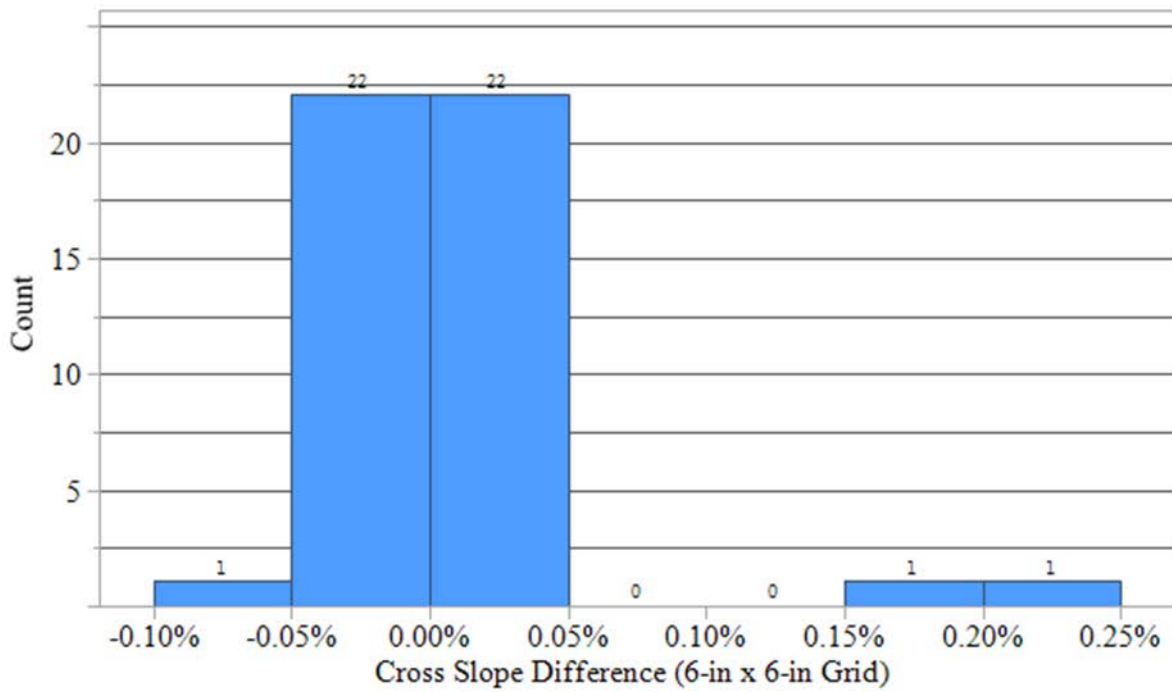
Figure 17. Histogram of Adjacent Lane Cross-Slope Accuracy Comparison Using a 6-in. x 6-in. Grid.

The expansion of the accuracy analysis includes the lane adjacent to the data collection lane. This analysis was also performed on New Main. Two processing methods were used to evaluate the accuracy of the processed data. The first method created 6-in. (0.1524 m) \times 6-in. (0.1524 m) grids for processing, and the other method increased the size of the grid to 1-ft (0.3048 m) \times 1-ft (0.3048 m) grids. For each method, a 2-ft (0.6096 m) window around the discretely surveyed location was used, and the LiDAR processed the cross-section most similar to the surveyed cross-section for accuracy comparison. Figure 17 displays the results of comparing 47 ground truth cross-sections with MLS-generated cross-sections using processed data on 6-in. (0.1524 m) \times 6-in. (0.1524 m) grids. With this grid size, the cross-section within a 2-ft (0.3096 m) window of the surveyed cross-section that is most similar is very nearly identical to the surveyed cross-section. Increasing the grid size to 1 ft (0.3048 m) \times 1 ft (0.3048 m) slightly increased the difference, as shown in Figure 18. Using 1-ft (0.3048 m) \times 1-ft (0.3048 m) spacing, 70 percent of cross-sections were within 0.10 percent of the surveyed measurements, while 96 percent were within 0.20 percent of the surveyed measurements.

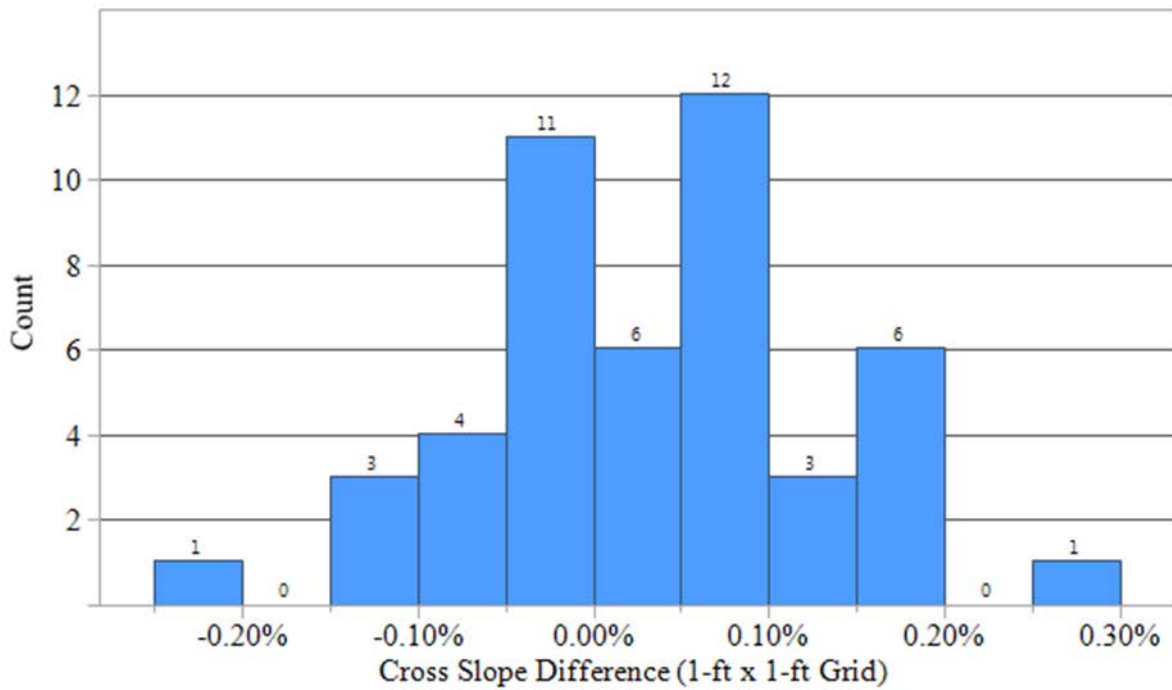
Figure 18. Histogram of Adjacent Lane Cross-Slope Accuracy Comparison Using 1-ft x 1-ft Grids.

LiDAR measurements in the lane adjacent to the data collection are often within 0.10 percent of the actual cross-slope using 1-ft (0.3048 m) × 1-ft (0.3048 m) grids. For this reason, the accuracy of a particular location measured traveling in one direction is compared with its accuracy while traveling in the other direction. In more practical terms, if a measurement occurs at STA 1+00, the cross-slope of the eastbound lane at this point should be the same regardless of whether or not the eastbound lane was the data collection lane or if the data were collected in the adjacent lane. This comparison was performed on 33 cross-sections generated on SH 30. MLS measurements occurred in both the eastbound and westbound directions. When the data collection lane was the eastbound lane, cross-sections processed in the data collection lane were compared with cross-sections at the same location processed from the adjacent lane when data collection occurred in the westbound lane. The same methodology was used for cross-sections generated for the westbound lane. Figure 19 shows that approximately 50 percent of the time the difference between a specific cross-slope when measured in the data collection lane as opposed to the adjacent lane is within 0.10 percent, and 73 percent of the time it is within 0.20 percent.

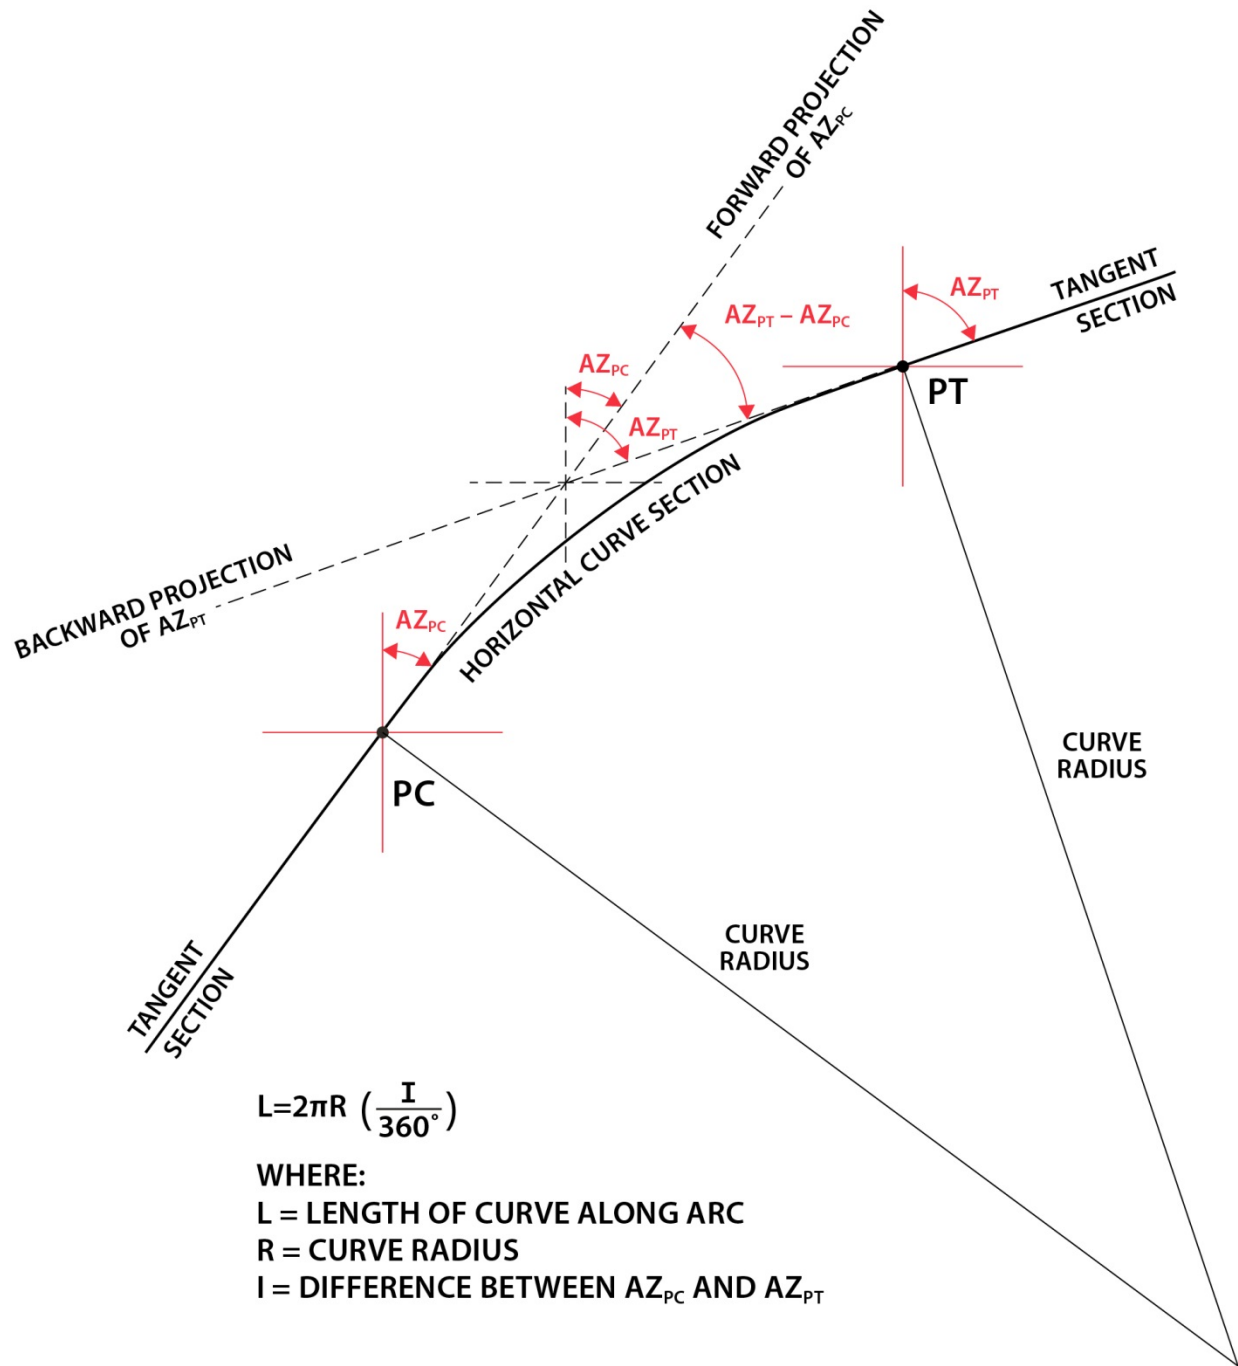
Figure 29. Horizontal Curve Geometry.

given speed, the allowable azimuth difference, I, is calculated. Speeds and minimum radii are shown in Table 20, along with calculated azimuth difference within the data collection section.

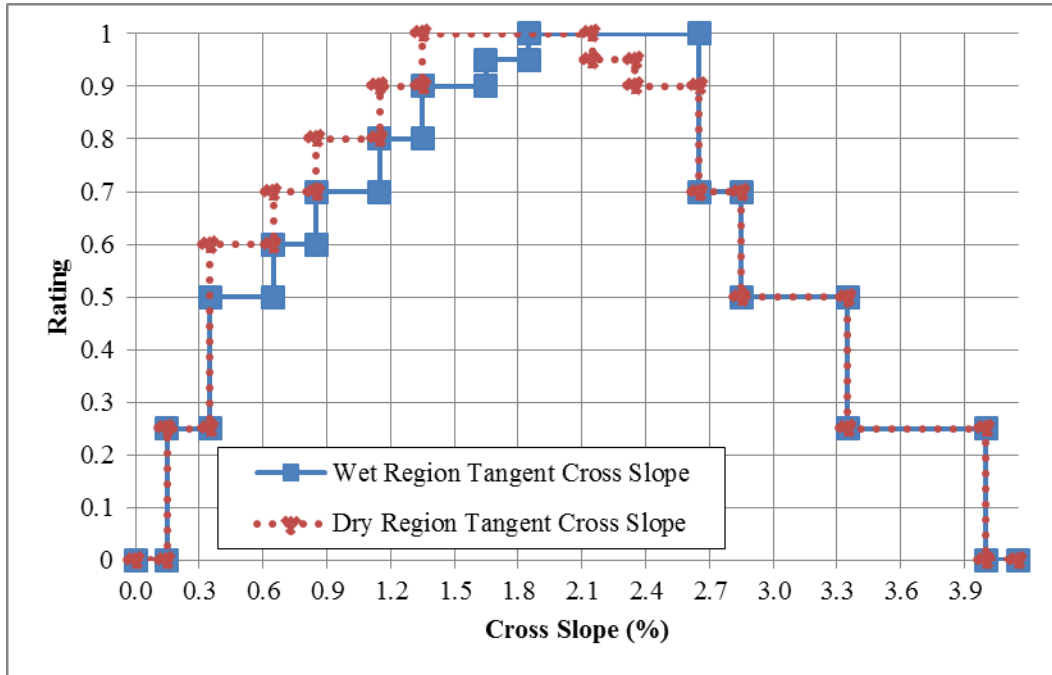
Figure 30. Tangent Rating Curves.

Researchers use 1-ft \times 1-ft grids for cross-slope analysis. For a 0.1-mile data collection section, up to 528 cross-sections are available. However, rarely will 100 percent of cross-sections be analyzed. Some cross-sections are lost due to physical obstructions, while others are removed from analysis because of noisy data. Within the study, a 50 percent threshold was set. To analyze the pavement within a data collection section, 264 cross-sections must be available for analysis, otherwise the section is classified as out of shape. Using recommended design cross-slopes and accounting for measurement error in the equipment, the rating curves in Figure 30 were used to rate each cross-section that meets the highpoint criteria. Researchers developed stepwise curves for both wet and dry regions. Stepwise curves are required because of the error window that must be accounted for when making deductions. For example, because equipment accuracy is ± 0.15 percent, within a wet region a cross-slope can be measured between 1.85 percent and 2.65 percent and receive no deduction because it lies between 2 percent and 2.5 percent

±0.15 percent. The stepwise curves allow drier climates to maintain flatter cross-slopes. Despite the fact that this is not as beneficial for drainage, the curves are built to comply with design requirements that were established with safety and drainage in mind.

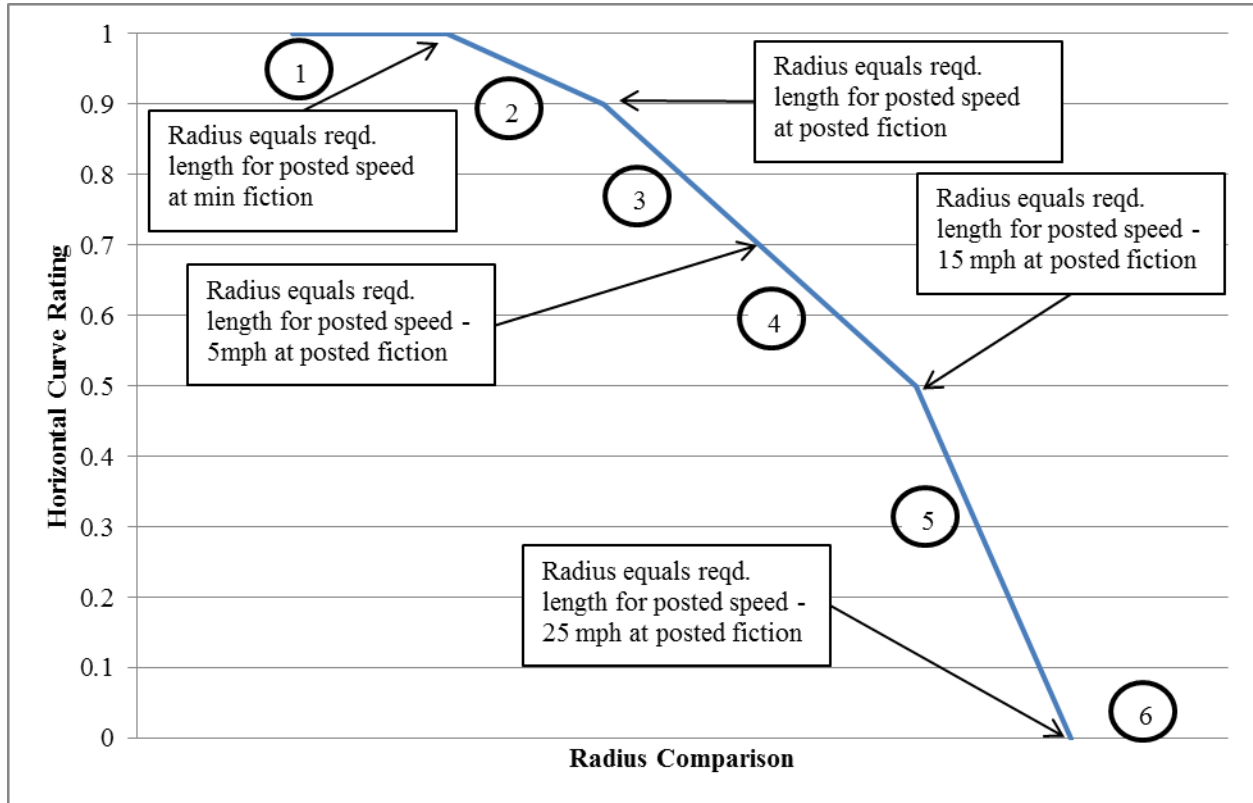
Figure 31. Horizontal Curve Rating Curve.

- Zone 1: No signs required, curve is very gentle and can easily be navigated at the posted speed limit.
- Zone 2: No signs required, curve can be navigated at the posted speed limit.
- Zone 3: Both a curve sign and advisory speed plaque for 5 mph lower than the posted speed limit are recommended.
- Zone 4: A curve sign, an advisory speed plaque for 15 mph lower than the posted speed limit, and chevrons are required.

- Zone 5: A curve sign, an advisory speed plaque for 25 mph lower than the posted speed limit, and chevrons are required.
- Zone 6: These curves should be avoided and represent locations where TxDOT might consider alignment changes.

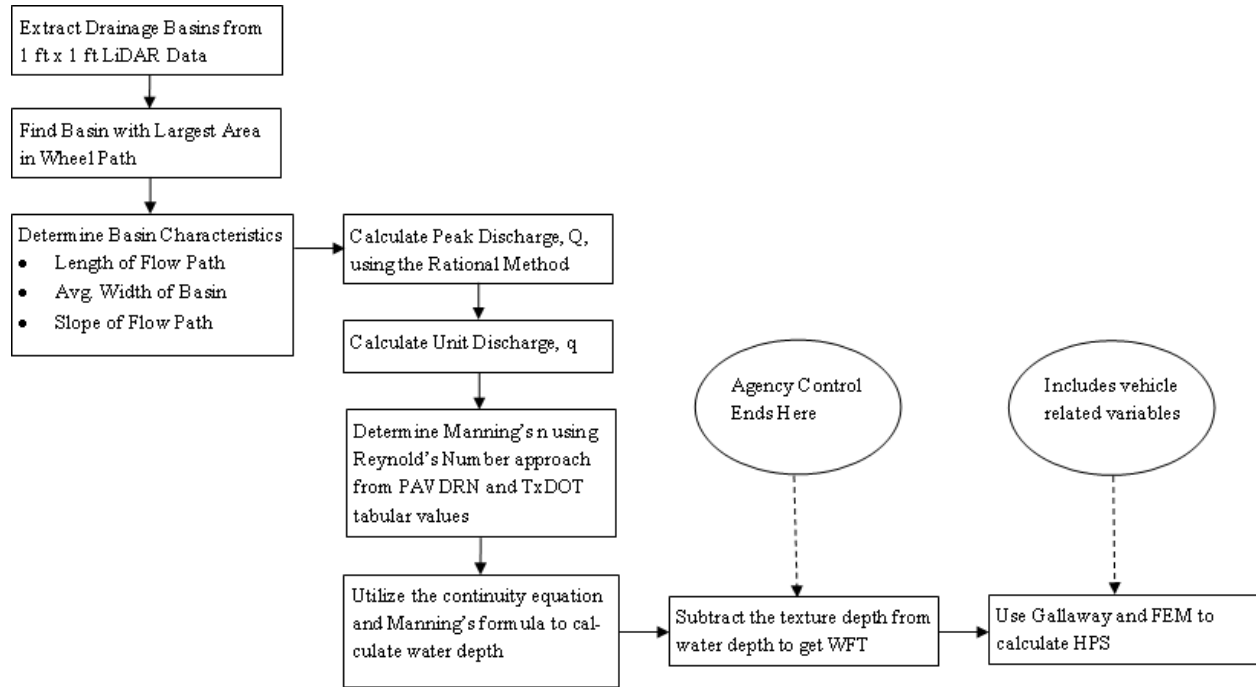
Figure 33. Hydroplaning Calculation Flow Chart.

calculation developed during PAVDRN model work. The PAVDRN model work relies on the Reynold's number calculation (31). Figure 33 is a flow chart of the HPS analysis. Figure 33 is followed by the equations used to calculate water depth on the surface.

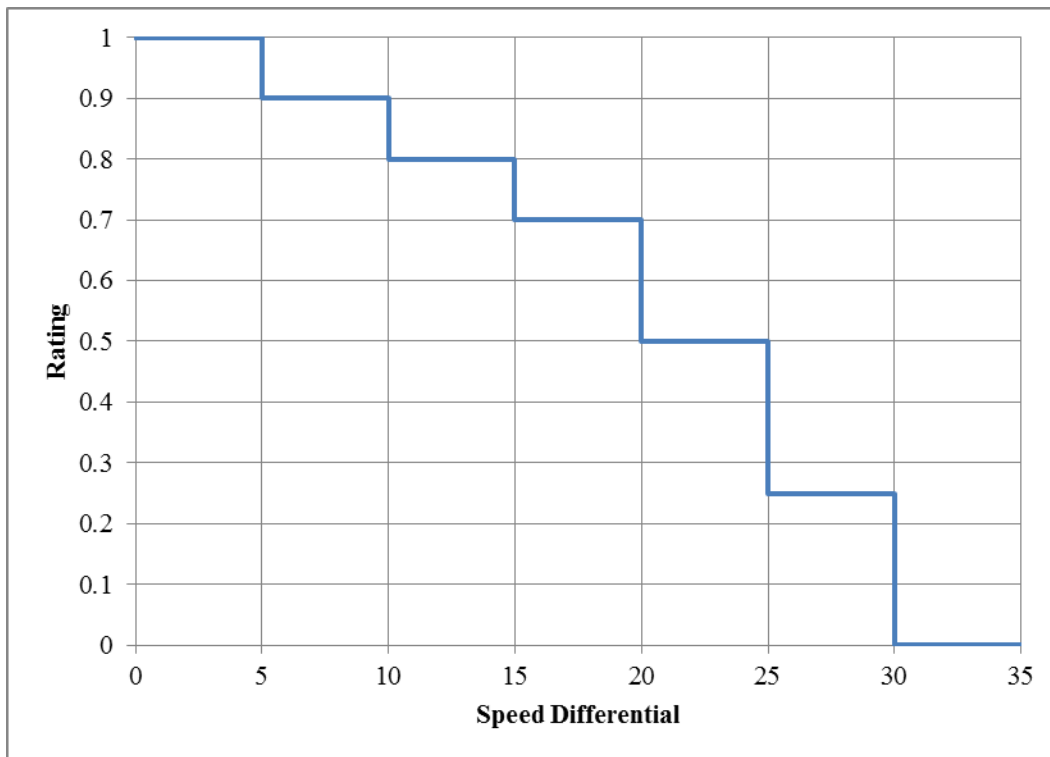
Figure 34. HPS Deduction Curve.

Researchers developed a deductions scheme for hydroplaning potential by comparing the calculated HPSs to the posted speed limit. Previous work has found that during rain events, motorists will slow below the speed limit by 3 mph to 6 mph, but the primary cause of slowing is visibility, not hydroplaning risk (32). In other words, motorists expect the roadway to function in a way that hydroplaning is not likely. The 50-year, 15-minute storm event used in the calculations would generate enough rain that visibility would be impacted, so prudent motorists will likely reduce their speed by approximately 5 mph. This threshold is used to develop a tiered deduction curve, as shown in Figure 34.

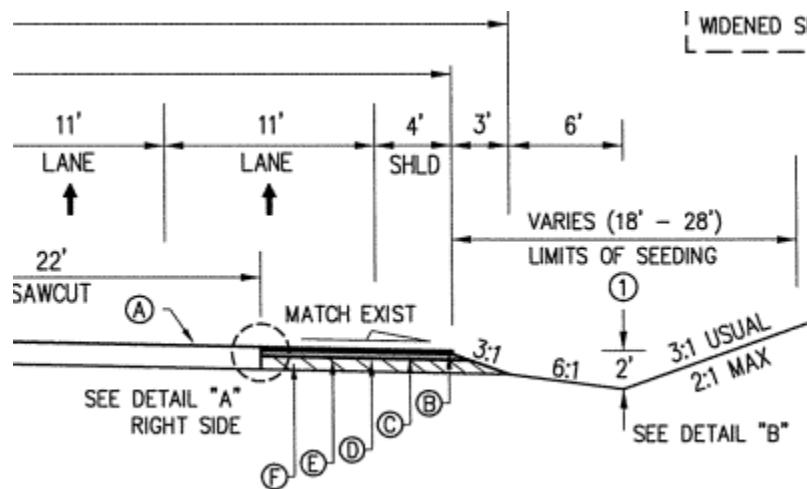
Figure 36. Ditch Depth Shown in Proposed Typical Section.

The depth to the bottom of the pavement structure is critical, and mobile LiDAR provides surface measurements. Depth of pavement structure varies from roadway to roadway. For example, in Figure 36 the pavement structure includes a seal coat, 2 in. of TY D HMA, 4 in. of TY B HMA, and 8 in. of flex base for a total depth of 14 in. plus a seal-coated surface.

Based on field feedback and information similar to that shown in Figure 36, researchers discovered that the minimum desired ditch depth ranged from between 1 ft and 2 ft below the bottom of the pavement structure, or approximately 2 ft to 3 ft from the pavement surface. To provide some latitude for grass growth on the roadside, researchers selected 3.5 ft as the depth to receive a perfect rating. Ideally, enough ROW exists that deep ditches exist far from the EOP, producing water surface flows significantly below the pavement structure while maintaining safe front slopes. This feature creates the balancing mechanism between ditch depth and front slope steepness. Researchers do not consider ditch offset in the rating because doing so would double count its effect with the combination of ditch depth and front slope steepness. A maximum ditch depth is not required within the rating because a too-deep ditch depth creates too steep of a front slope and will be reflected in the rating. The rating uses the curve in Figure 37.

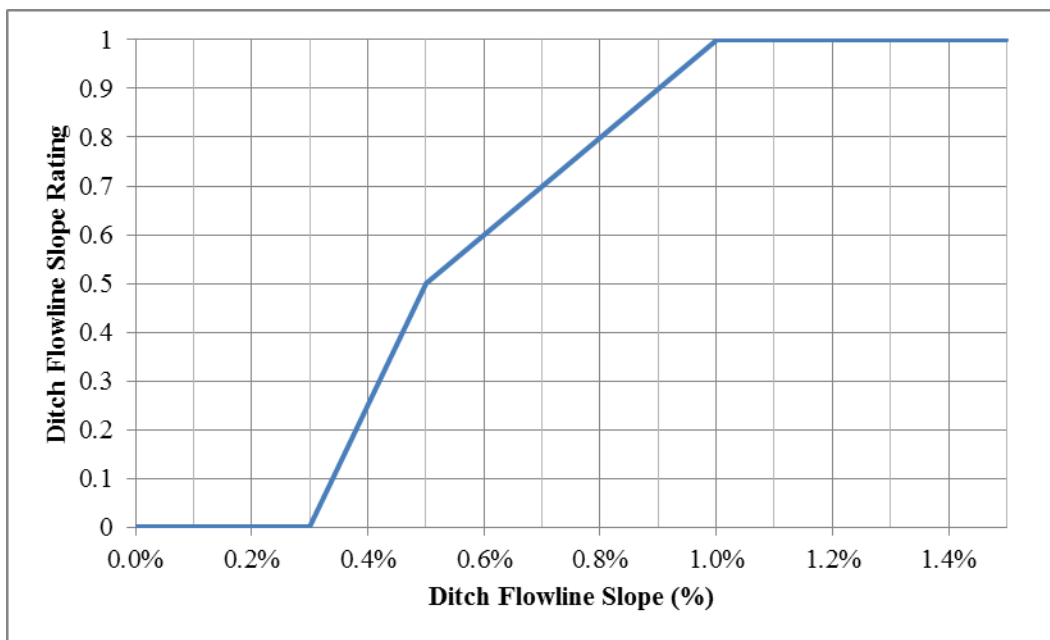
Figure 41. Ditch Flowline Slope Stepwise Rating Curve.

For pavement preservation, sedimentation causes more concern because silting in the flowline raises the water elevation and creates potential for water within pavement structural layers. Initially, researchers implemented a stepwise function that included punitive measures for slopes that were too flat and too steep. This method was overly punitive for slope approaching cross-culverts or flowlines at the toe of slope in front slope only sections. Additionally, the challenge of distinguishing between surface types along the ROW can lead to steep slopes being penalized when in reality erosion measures such as riprap are in place. While different material types can be distinguished at the project level, doing so at the network level becomes difficult. Therefore, the final rating for flowline slope focuses on providing information on ditches that are steep enough, rather than trying to identify slopes that might be too steep. Researchers selected a 1 percent fall as the threshold to receive a perfect rating. Anything steeper than that also receives a perfect rating, while flatter flowlines follow the deduction curve in Figure 41.

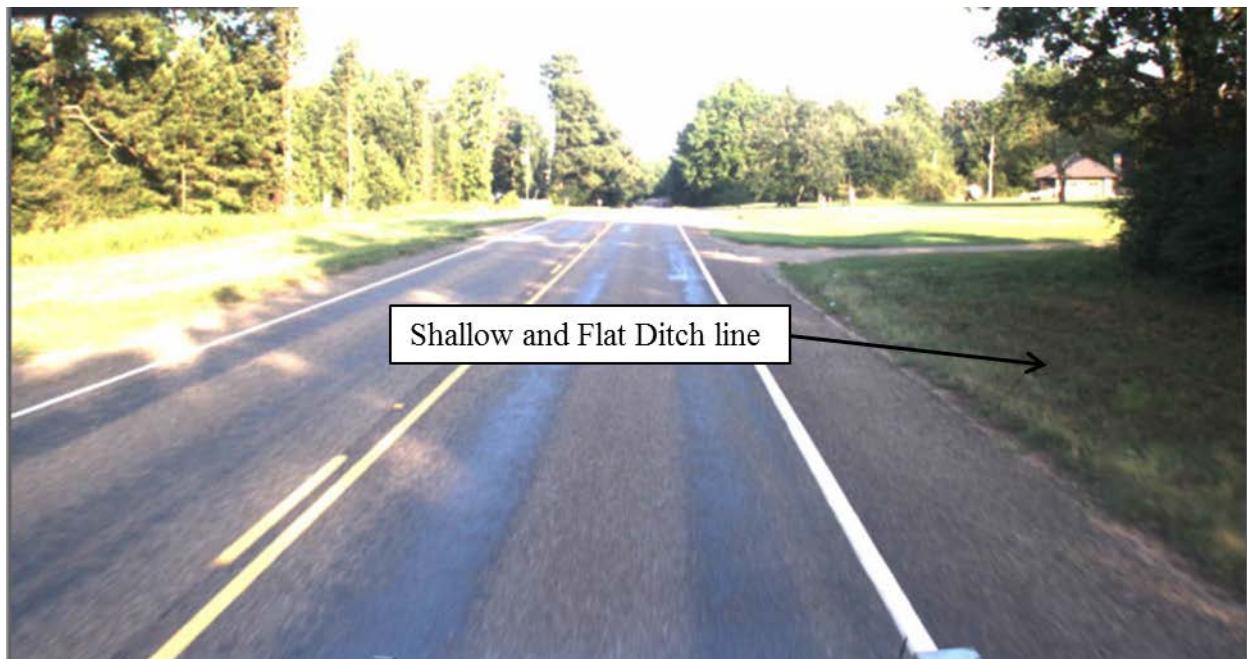
Figure 42. Section 26 on FM 31.

Table 24 indicates that many of the sections along FM 31 are defined as out of shape. Because of this result, the rating for many of the sections is driven down into the 70s and below. Section 26, at 75 percent, received the lowest roadside drainage rating. The low roadside rating stems from a shallow and flat ditch. Figure 42 is a screenshot from the mobile LiDAR post-processing software, Road Doctor, displaying the shallow and flat ditch in Section 26. Figure 43 represents a digital rendering of the right roadside of Section 26 along FM 31. Researchers created this rendering using the proof of concept code used to apply the network-level rating to large data sets. With a shallow and flat ditch, the expectation would be that the front slope portion of the roadside rating would be high. For Section 26, the front slope receives a 0.99, indicating a steepness slightly steeper than 6H:1V (for front slope rating, see Figure 35)

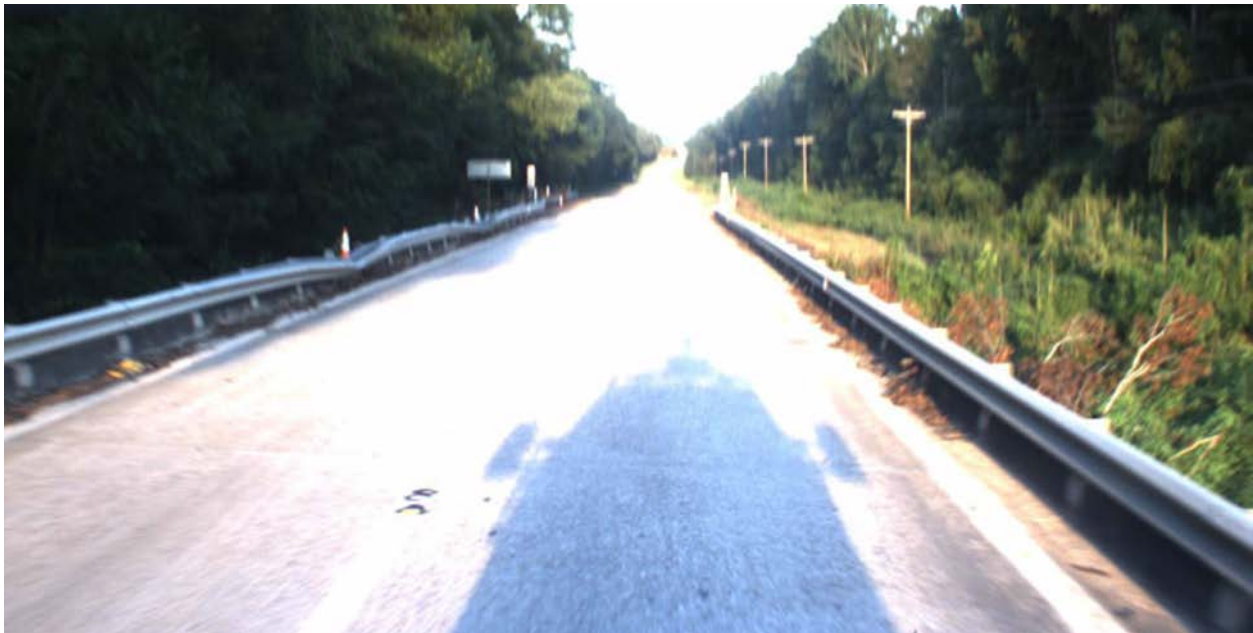
Figure 52. Section 14 on FM 1186.

In reality, Section 14 falls within a guardrail section protecting a large drainage structure. Researchers chose this section as an example of a potential flaw in network-level ratings. When vast amounts of information need to be processed with little manual intervention, special scenarios might be missed. Presently, this causes little trouble because it allows managers or engineers to investigate the reasonableness of the rating. With video files stored with the LiDAR data, this can be done without a field visit. Figure 52 displays Section 14 and clearly shows the guardrail. A reasonable question is, “How did the rating still provide a rating of 74 percent when there is a vertical drop-off beyond the guardrail?” The vegetation growing in the channel provided a target surface for the laser, and the elevation difference between the roadway surface and the vegetation was such that it appeared a slope was present.

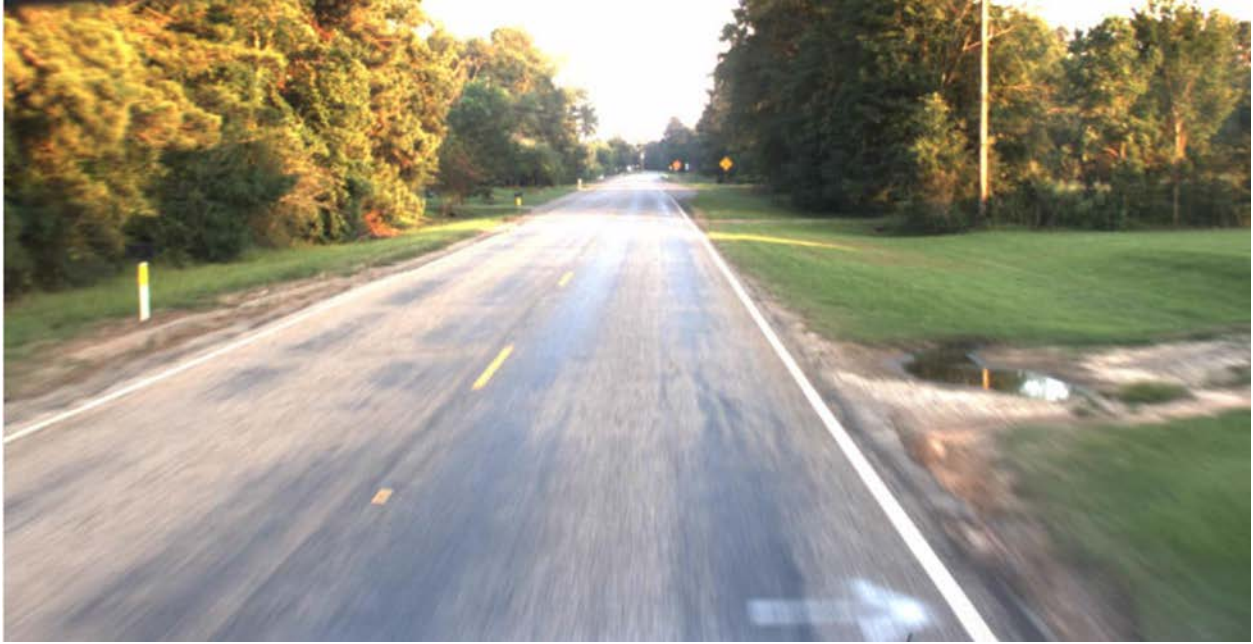
Figure 53. Section 64 on FM 1186.

Figure 53 shows Section 64 along FM 1186. Within Figure 53, the shallow and flat ditch along the right side of the roadway is apparent. The lack of shoulder width speaks to the width rating of 0.70. In fact, the right traveled way width in this section averages 12.04 ft, just wide enough to maintain a passing rating.

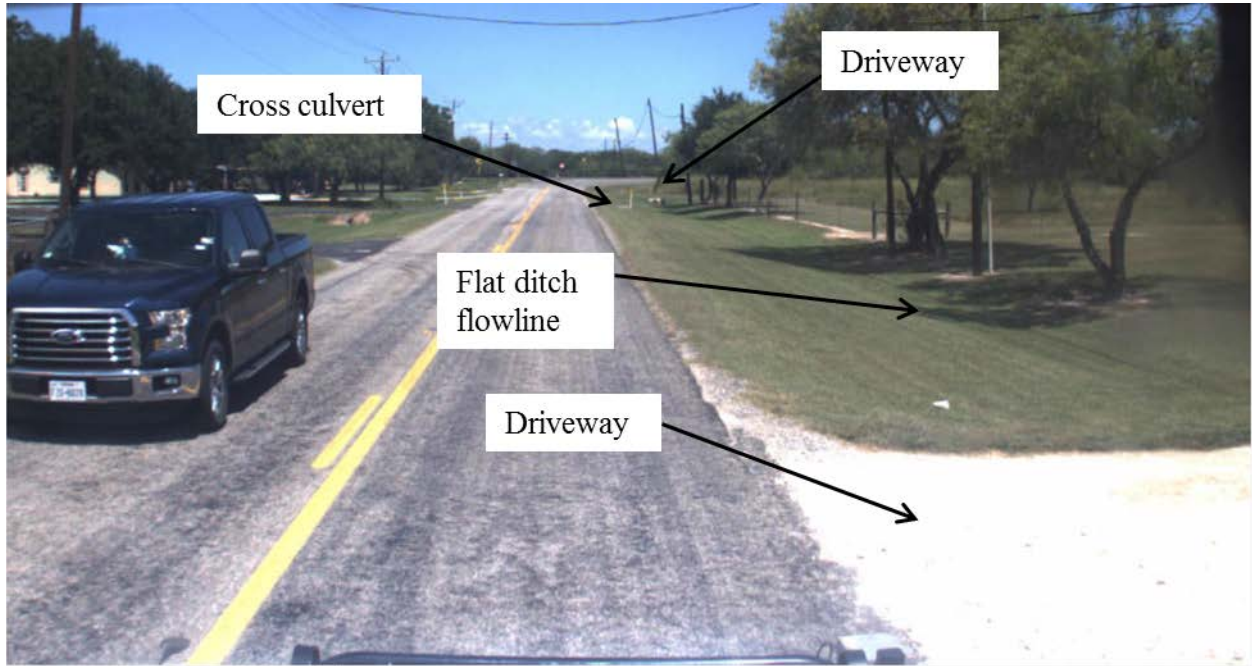
Figure 57. Section 10 along FM 136.

cross-culvert, but the ditch flowline approaching that point is flat enough to present a sedimentation or potential ponding issue. The ditch flowline slope in this area is approximately 0.6 percent. Figure 59 represents the digital rendering of the paved surface. The spike in Figure 59 represents the laser measuring the passing truck, seen in Figure 57.

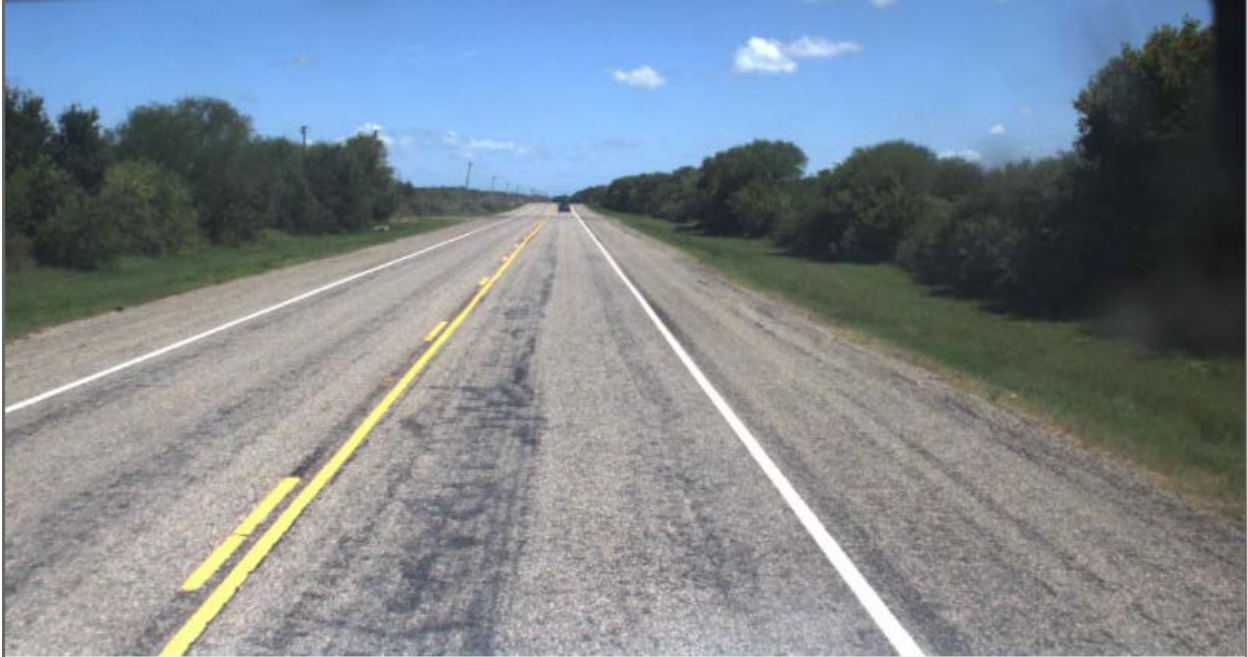
Figure 60. Section 33 along FM 2678 in the Corpus Christi District.

Section 33 on FM 2678 in the Corpus Christi district represents a tangent section with an overall rating of 86. This section has a roadside rating of 1.0 and a paved surface rating of 0.72. The paved surface rating is impacted by reductions in width, cross-slope, and hydroplaning potential ratings. This section is chosen as an example because in reality the width rating should equal 1.0, increasing the overall rating to 0.90. The width rating fails because the algorithm classifies the EOP too close to the edgeline stripe. Seal-coated roadways can create this issue at the network level. FM 2678 consists of a seal-coated surface where the precoated rock has begun to display the aggregate surface below the precoat, as shown in Figure 60. The EOP algorithm looks for reflectivity changes to determine the offset to the pavement's edge, and the exposed aggregate face can trick the algorithm into believing it has reached the EOP. Overall, the algorithm is highly effective at finding the EOP. Width transitions and the effectiveness in capturing these transitions has been previously discussed with FM 31 in the Atlanta District and FM 2661 in the Tyler District. Across 260 seal-coated sections on FM 2661, FM 31, and FM 2678, the algorithm accurately measures the width 234 times, while in only 26 it finds a narrower width than actual field conditions.

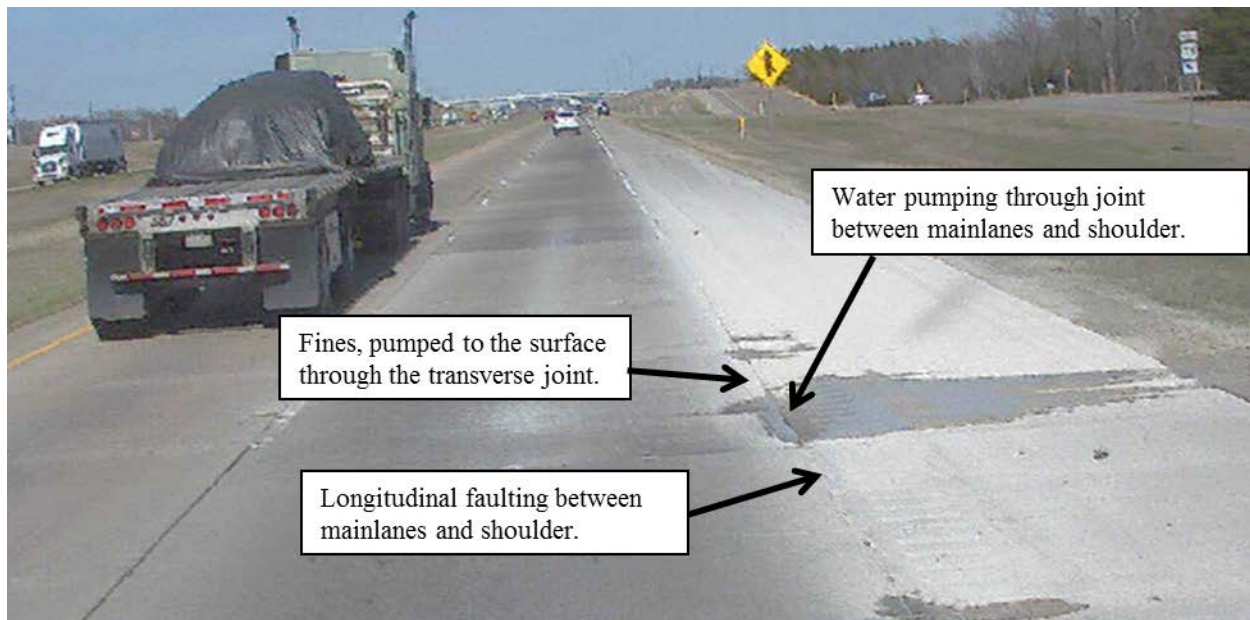
Figure 71. Water Pumping through Pavement and Shoulder Faulting at Project Site.

A project level evaluation occurred on US 75 on the north side of Sherman, Texas, within the Paris District. This case study evaluated a 700 m (0.4 mi) segment of US 75 in northern Texas that has persistent drainage related failures and distresses. Annual maintenance costs for this section exceed \$500,000, with many treatments lasting less than one year. The primary culprit appears to be water under and within the pavement structure. When water becomes entrapped within the pavement structure, the strength of unbound layers and subgrade soils is greatly reduced. Pumping begins to occur that can lead to faulting, cracking, and shoulder deterioration. Loading a pavement with wet sublayers results in moving the fines out of those layers, leading to a loss of support (58). Figure 71 shows an example of this type of pumping and faulting from the case study area.

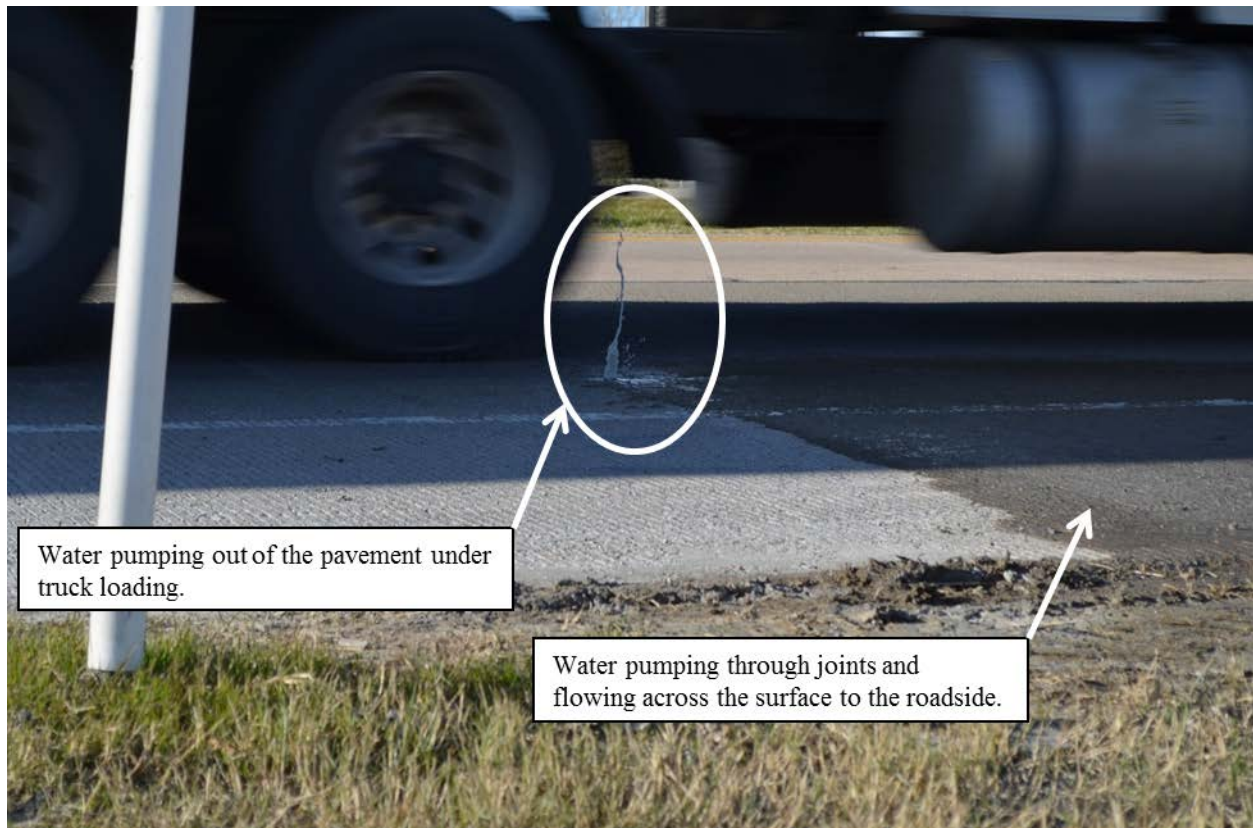
Figure 72. Water Pumping during Truck Traffic Loading.

An internal TxDOT report from 2012 noted poor drainage at multiple locations along the corridor. The report indicated that long after rain events, water can be seen standing in ditches, and there is clear evidence of water pumping through pavement joints (59). Site visits conducted in 2016 verified these observations. Figure 72 shows the site with water pumping through the joints and literally squirting up as a truck passes over the pavement.

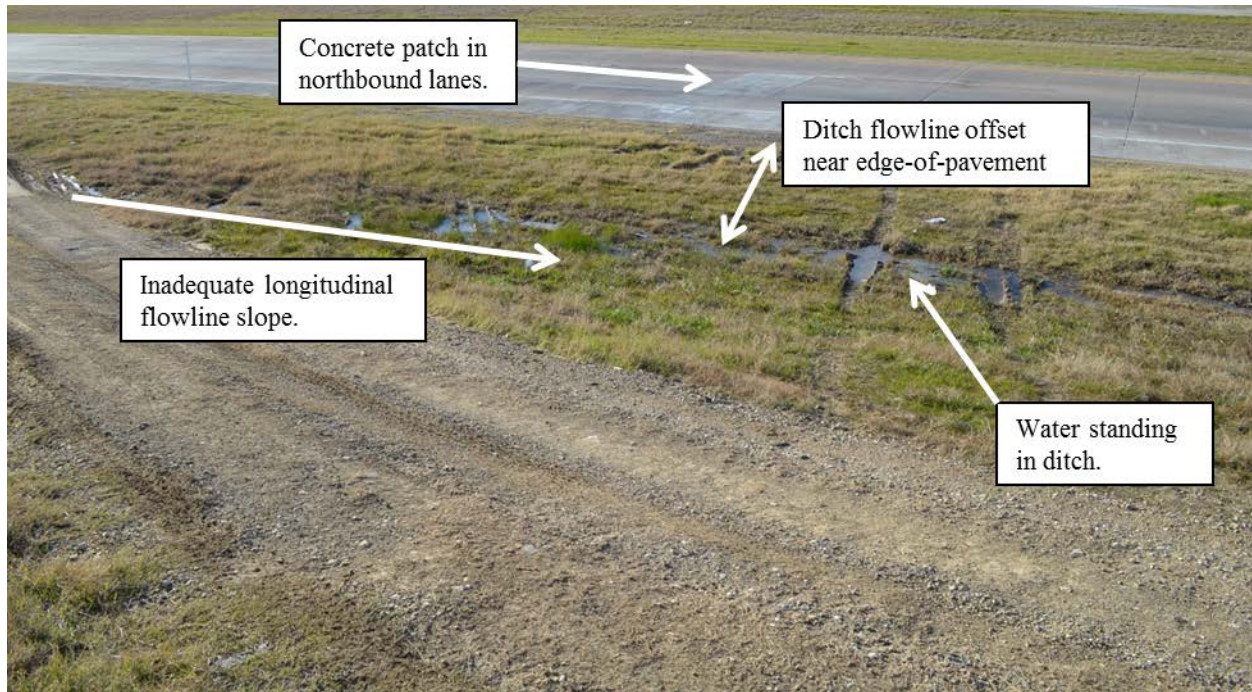
Figure 73. Flat and Shallow Ditch along US 75.

over a week after the last rain event. At this location, the frontage road rises above the mainlanes, creating a front slope off of the frontage road that drives the ditch flowline toward the mainlanes. This presents a significant challenge within the project level analysis.

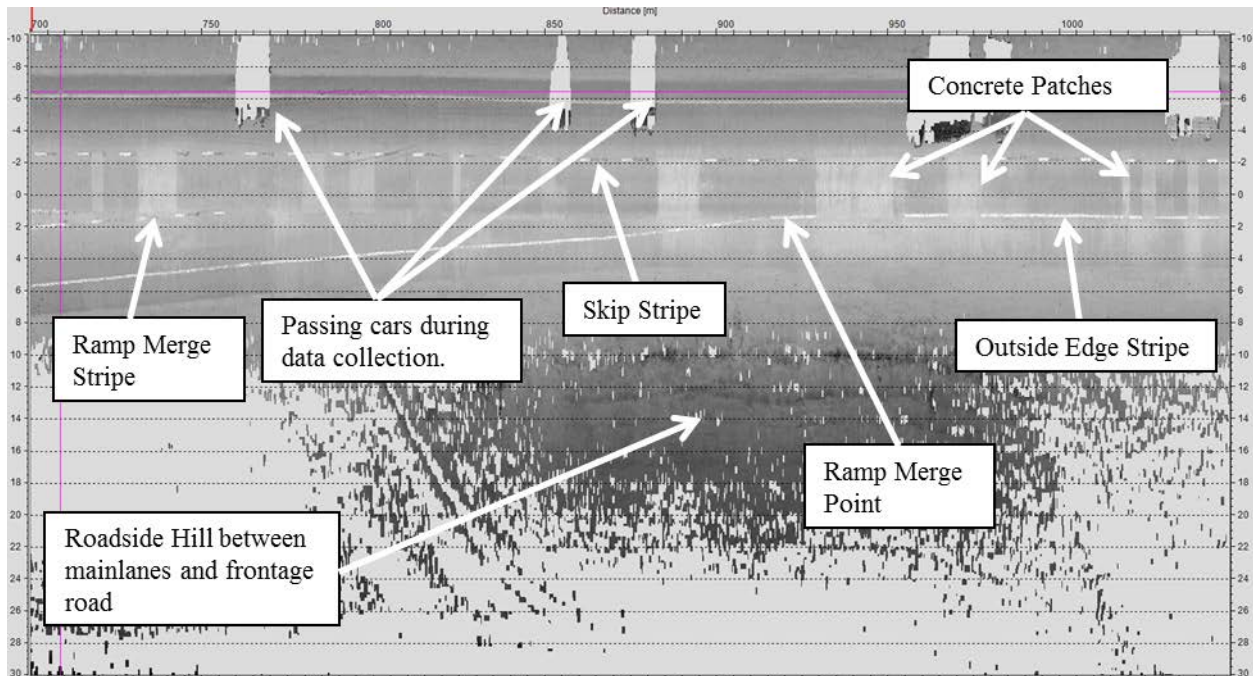
Figure 75. Project Plan View Displayed with Reflection Data.

During data processing, the data grid was built on 2-ft transverse and longitudinal increments. Additionally, raw reflection data were used to determine the location of lane striping and the EOP. Figure 75 displays the area of interest using LiDAR reflection data.
