Developing a Surface Drainage Rating for Inclusion in TxDOT's Asset Management System: Technical Report

Technical Report 0-6896-R1

TEXAS A&M TRANSPORTATION INSTITUTE
COLLEGE STATION, TEXAS

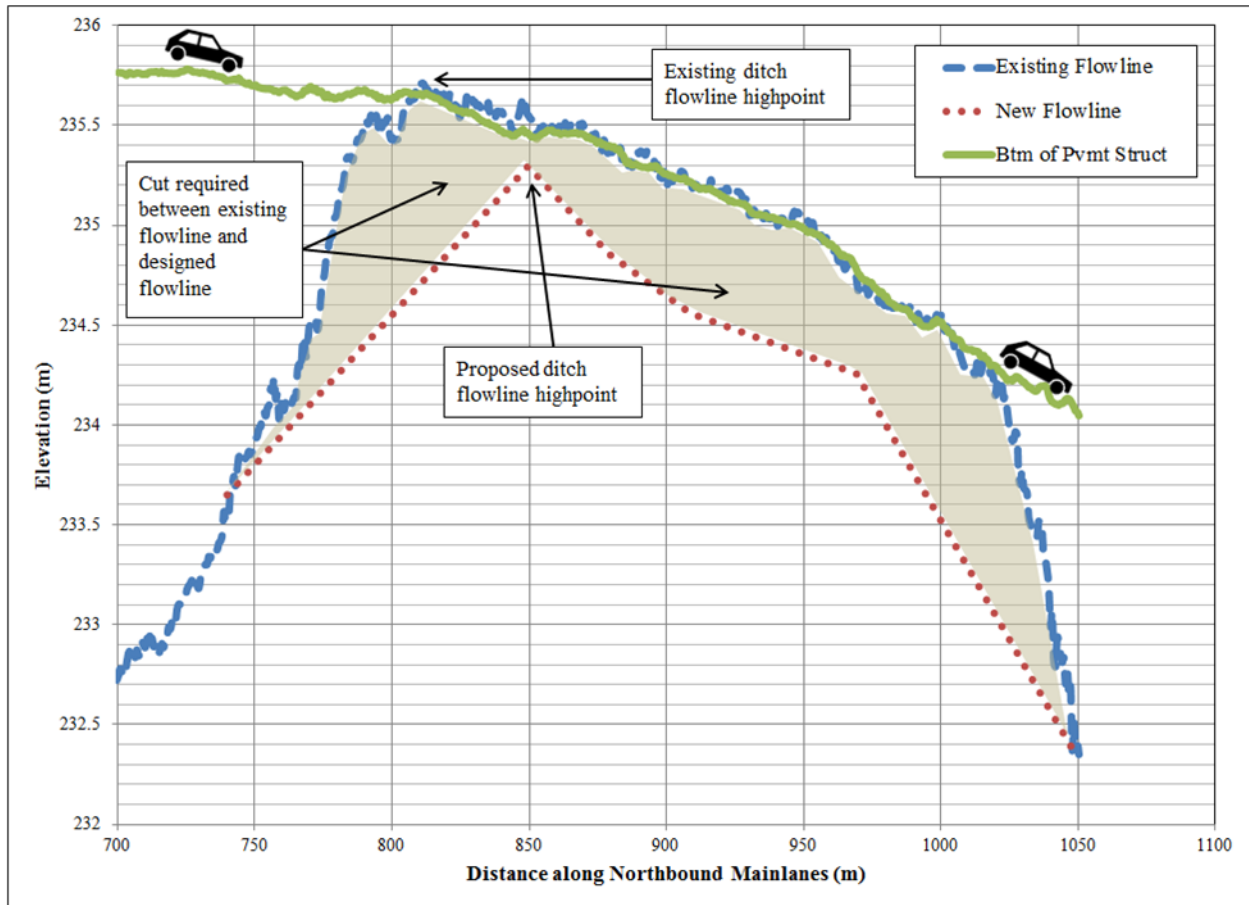
Figure 76. Existing and Proposed Elevations.

To visualize the problem and potential solution, Figure 76 displays the current bottom of pavement structure elevation compared with the existing ditch flowline elevation and the proposed ditch flowline elevation. These elevations were generated from LiDAR-collected data. The longitudinal reference in Figure 76 matches that in Figure 75 and travels parallel to the northbound mainlane centerline. Existing conditions are built upon LiDAR data, which collects a measurement each time it encounters a target object. This can make the data look noisy, but it provides significantly more information to develop a preliminary design than traditional techniques.

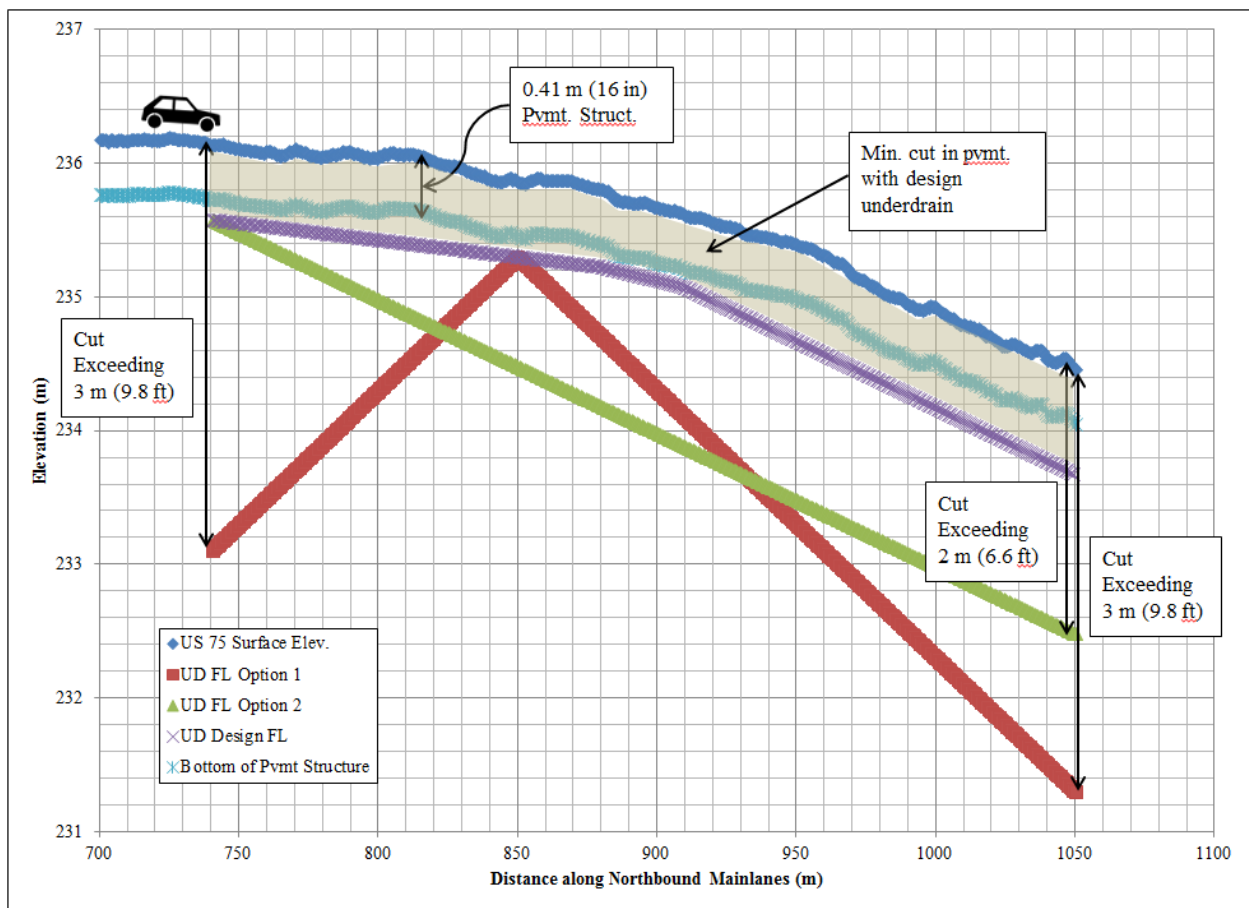
Figure 78. Longitudinal Underdrain Path Options.

Option 1 in Figure 78 sets the underdrain highpoint at the ditch flowline highpoint and provides 2 percent fall in each direction. With this option, by the 1050 m mark, the cut below the pavement surface exceeds 3 m (9.8 ft). Option 2 moves the underdrain highpoint to the 740-m location and places the flowline at the minimum cut of 0.56 m. One percent fall is provided to the north to 1050 m. Even with a flatter flowline slope, the cut at 1050 m exceeds 2 m (6.6 ft). Using the LiDAR data for design, it is clear that the longitudinal underdrain must be placed with a very flat flowline slope. Through multiple iterations, a design was provided placing the underdrain highpoint at 740 m with the minimum cut of 0.56 m. The design underdrain passes through the 850-m mark with a flowline elevation equal to the new roadside ditch flowline elevation. This flat spot is overcome by designing lateral underdrain lines to have adequate fall on each side of the flat spot.

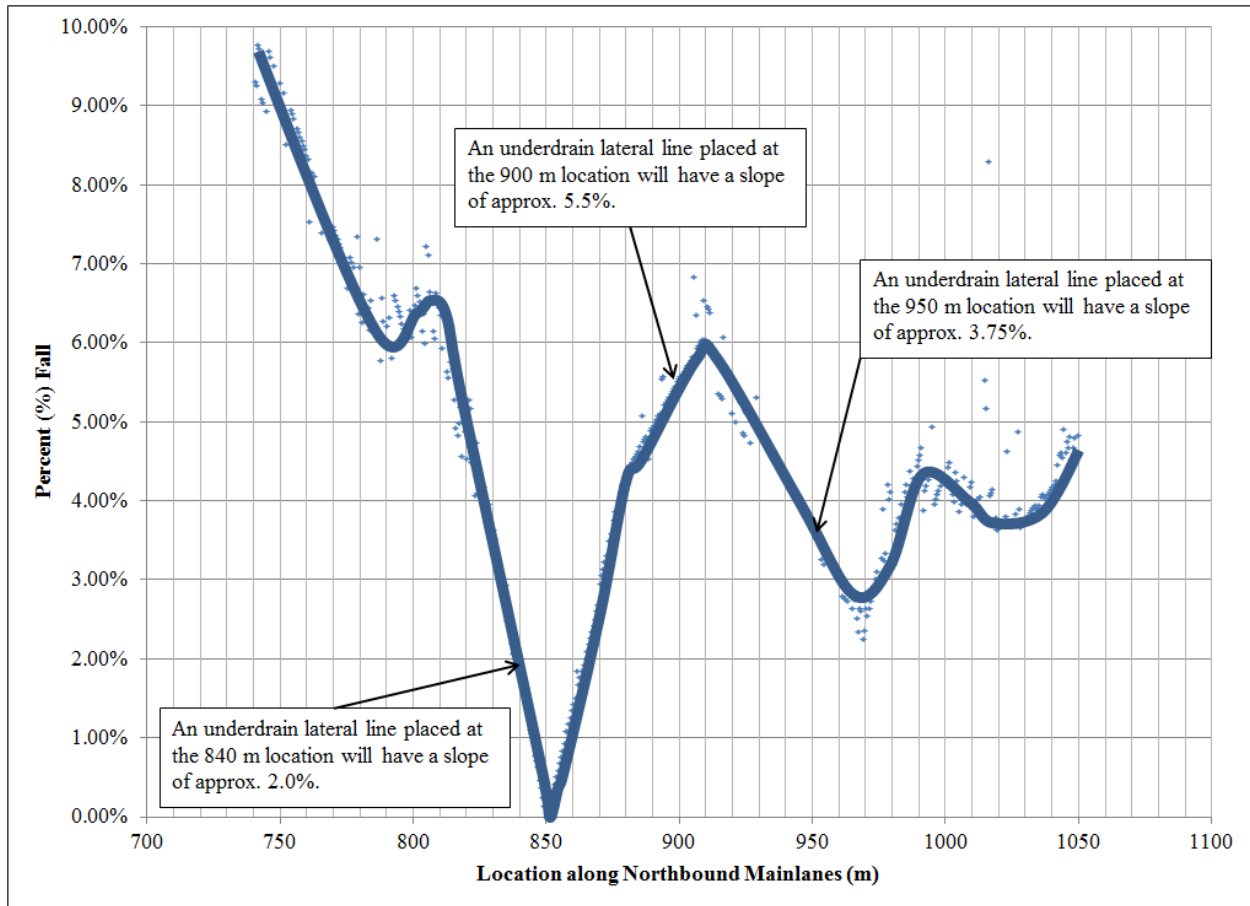
Figure 79. Potential Lateral Underdrain Pipe Slopes.

Additionally, lateral spacing should be close enough to allow for periodic clean-out of the longitudinal pipe. Figure 79 allows engineers to adjust lateral spacing with an understanding of how steep the flowlines can become. The flat spot is clearly visible at 850 m, but within 10 m (33 ft) on either side, lateral lines can be placed with 2 percent fall. The longitudinal underdrain at this location has 0.25 percent fall to the north. The initial underdrain design provided to TxDOT recommends placing lateral lines at 30 m (100 ft) spacings to ensure water is efficiently moved out from under the pavement with lateral lines.
