Allowable Limit Contraction and Abutment Scour at Bridges: Technical Report

Technical Report 0-6935-R1

TEXAS A&M TRANSPORTATION INSTITUTE
COLLEGE STATION, TEXAS

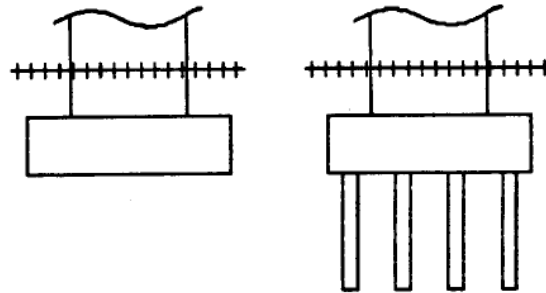
Figure 1. Scour Depth above Foundation Top.
(FHWA, 1995)

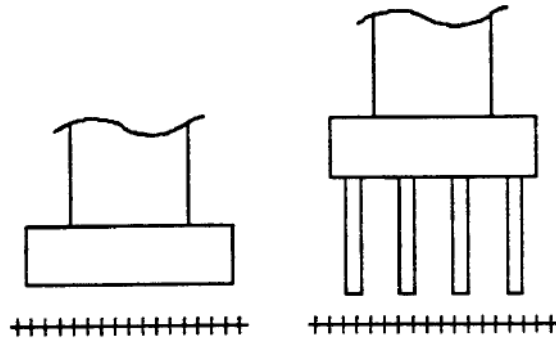
Figure 3. Scour Depth below Foundation Bottom.
(FHWA, 1995)

3	Bridge is scour critical. Bridge foundations are found to be unstable for the assessed scour, which may be either within the depth of the foundation (Figure 2) or below the foundation bottom (Figure 3; the crossed line in Figure 3 refers to the estimated scour depth).
2	Bridge is scour critical. Field review reveals excessive scour making the bridge foundations unstable and urging for immediate corrective measures.
1	Bridge is scour critical. Field observation indicates that the bridge foundation or abutment is near failure. Bridge is closed to traffic.
0	Bridge is scour critical. Bridge failure has occurred. Bridge is closed to traffic.

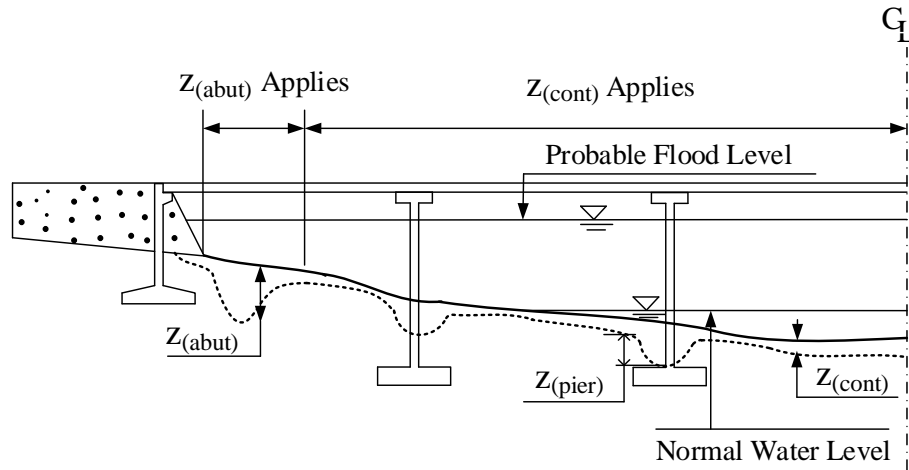
scour is caused by the presence of obstructions in the watercourse at the bridge section. Two types of local scour exist: pier scour and abutment scour. Figure 4 presents the contraction, pier, and abutment scour components. This figure indicates that abutment scour already includes contraction scour, but that pier scour and contraction scour are cumulative.

Figure 4. Scour Components.

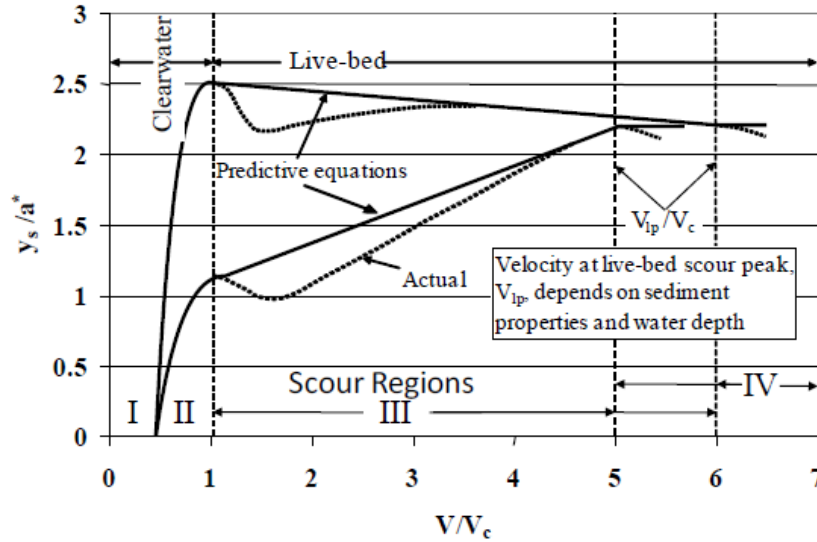
Figure 5. FDOT Scour Analysis Methodology.
(FHWA, 2012)

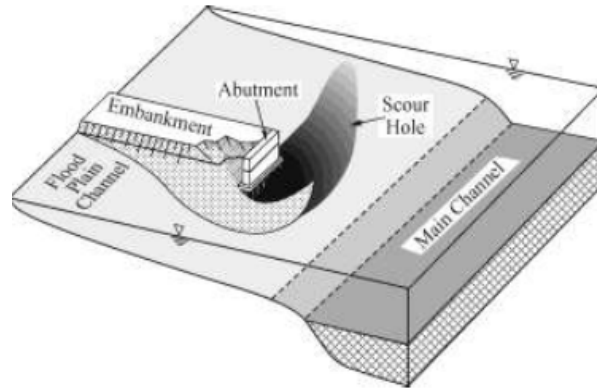
where y_{max} is the maximum flow depth including abutment scour, α_B is the amplification factor for condition B, y_c is the flow depth after clear water contraction scour, y_s is the abutment scour depth, and y_0 is the flow depth before scour.

Figure 7. Abutment Scour Condition B.

2. Condition B (Figure 7).

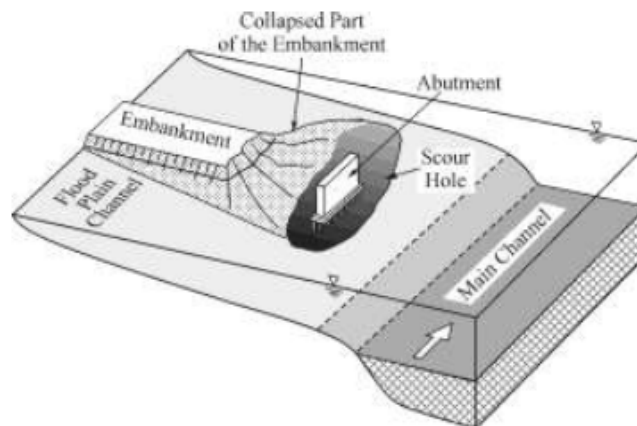
- The abutment approach embankment is breached.
- Local scour depth at the exposed abutment column is estimated similarly to pier scour.

Figure 8. Abutment Scour Condition C.

3. Condition C (Figure 8).

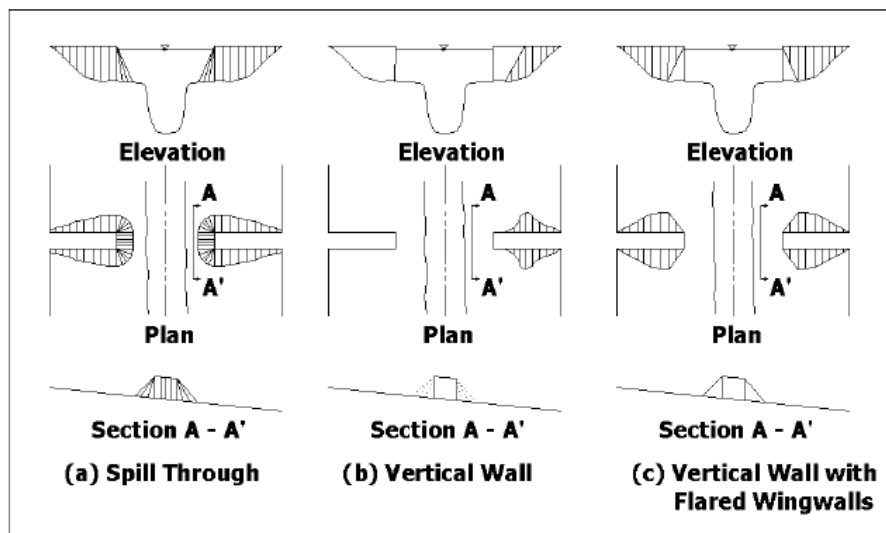
Two types of bridge abutments are commonly used in the United States. These are spill-through abutments and vertical wall abutments with or without wing walls (Figure 9).

Figure 9. Abutment Types.
(FHWA, 2012)

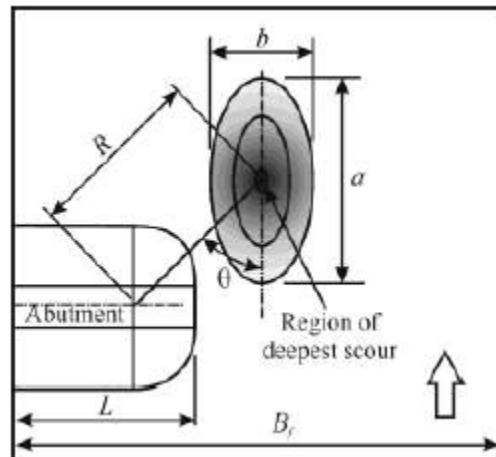
where Y_f is the flow depth in the floodplain.

Figure 11. Scour Radial Distance.

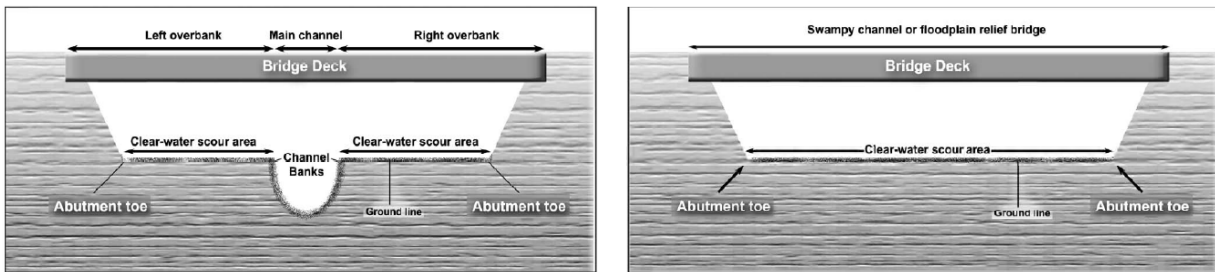
Measurements of abutment and contraction scour are collected by the USGS and the South Carolina Department of Transportation at 146 bridge sites in the Coastal Plain and Piedmont of South Carolina. Bridge sites in the Coastal Plain and Piedmont sites consist of either low flow main channels with set-back abutments in the floodplain or shallow swampy channel on the floodplain (Figure 13). In total, 209 abutment scour measurements and 76 contraction scour measurements were collected during this field study. These observations are used to verify the applicability of scour prediction equations and to develop an improved method to predict scour in South Carolina.

Figure 13. Common Configuration of Abutments at Coastal Plain Bridge Sites in South Carolina.

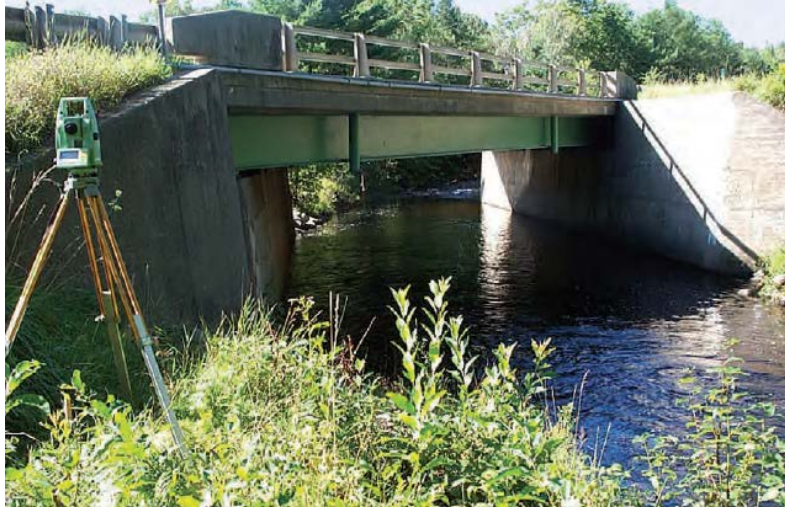
Abutment scour is measured at 50 bridge sites in Maine by the USGS in cooperation with Maine DOT to evaluate 5 abutment scour prediction methods: Froehlich/Hire method, Sturm method, Maryland method, Melville method, and the envelope curves approach. The abutments at the study sites are vertical wall abutments with wing walls and are mainly located near the main channel (Figure 14). The abutment scour holes are surveyed with a total station theodolite or measured from the surveyed water surface elevation. The measured scour depths represent the maximum historical scour depths and are not related to any particular flood event. The reference surface for measuring the abutment scour is the concurrent streambed surface outside the abutment scour zone. Therefore, the measured scour depths do not include contraction scour, which is assumed to cover all the bridge section.

Figure 14. Typical Abutment Configuration and Location at the Studied Bridge Sites in Maine.

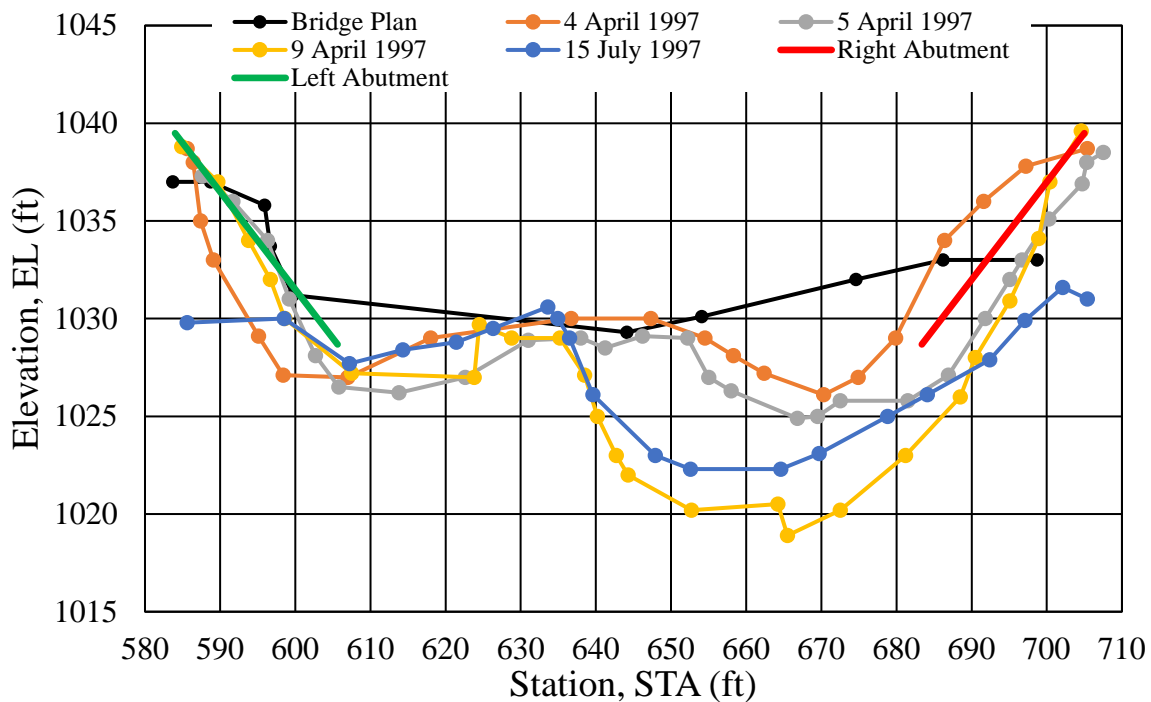
This case is retrieved from the NBSD. Supporting files for this case (Site ID 73) consist of a plot of the bridge plan, photos taken during the flood and various channel cross-sections measurements. The bridge is in a rural/agricultural area in Swift County, Minnesota. The bridge channel was surveyed on three days during a flood in April 1997 and then after the flood in July 1997. During the flooding event, scour progressed near the right abutment (Figure 15). During the visit on 9 April 1997, a slope failure of the right abutment (looking downstream) was observed.

Figure 15. Channel Profiles for CR 22 over Pomme de Terre River.

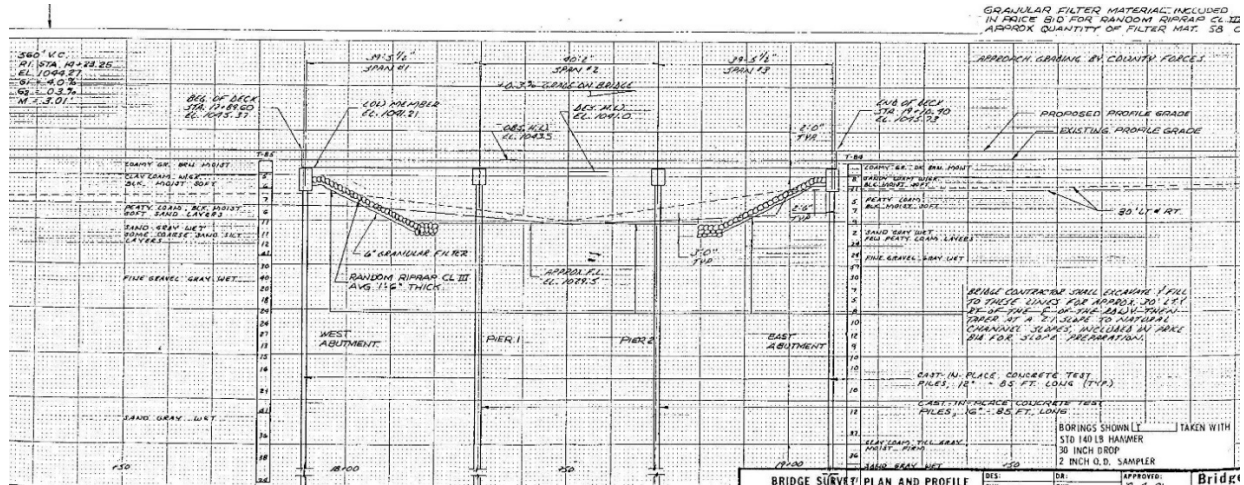
While no information is given about the embankment soil, the channel bed soil is classified as silty sand SM. The boring logs in Figure 16 indicate that the channel bed is mostly sand with few peaty loam layers. Soil samples collected from the upstream bridge face are comprised of non-cohesive fine sand and silt. Standard Penetration Test N results at the bottom of the abutment, reported on the boring logs (Figure 16), are used to estimate the channel bed friction angle ϕ'_c , which is found to be 30°.

Figure 16. Profile Plot of CR 22 over Pomme de Terre River from Bridge Plan.

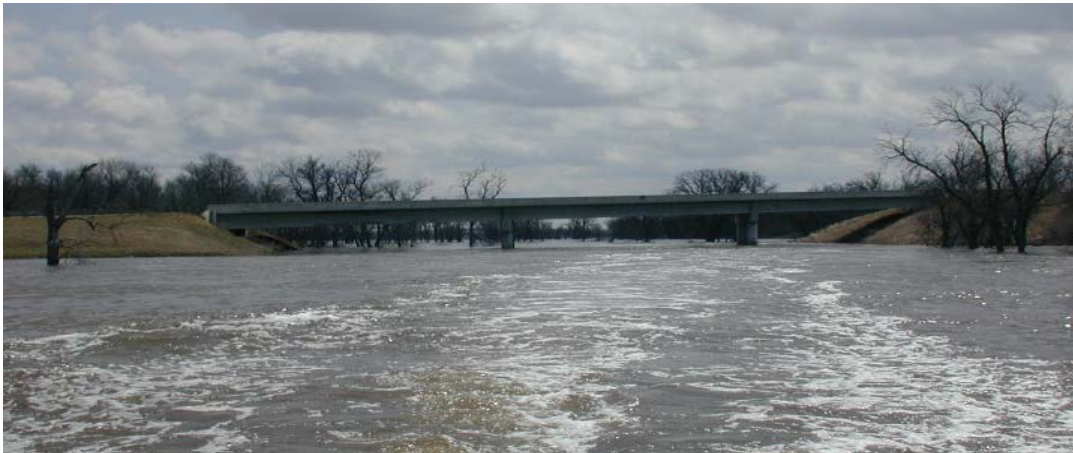
Figure 17. SR 37 over James River during the Flood—Looking Downstream.

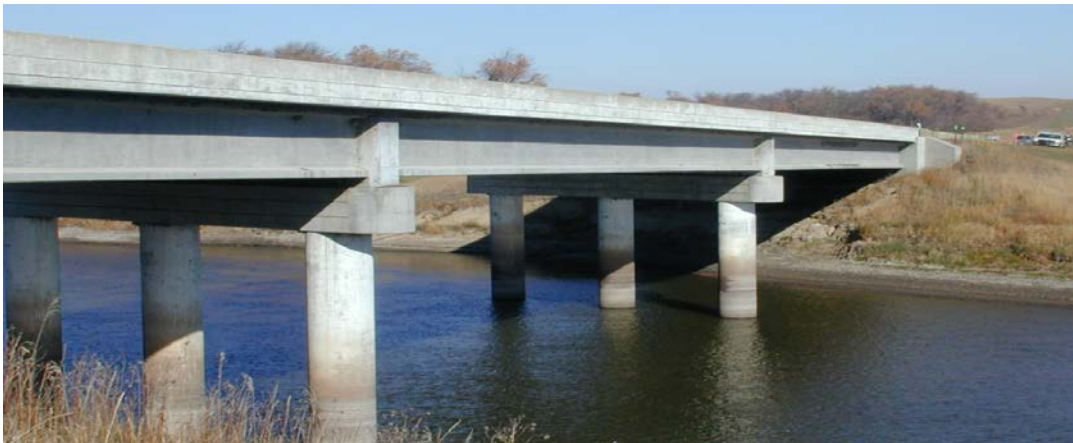
Figure 18. SR 37 over James River after the Flood—Looking at the Left Abutment from the Downstream.

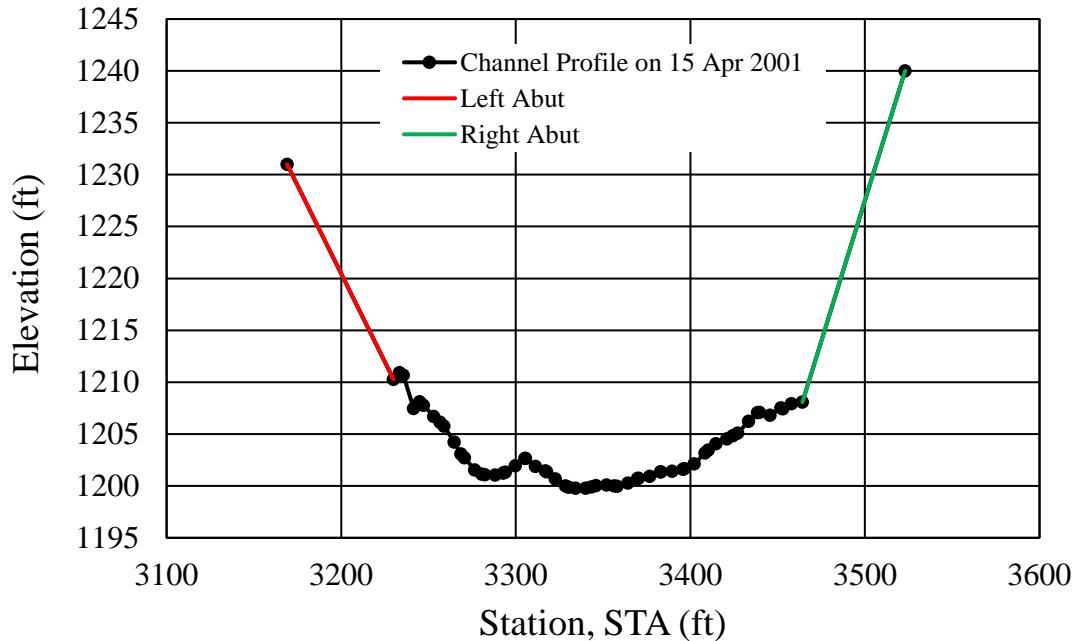
(Figure 19). The left abutment experienced some scour but remained stable (Figure 20) while no scour occurred at the right abutment.

Figure 19. Channel Profile for SR 37 over James River.

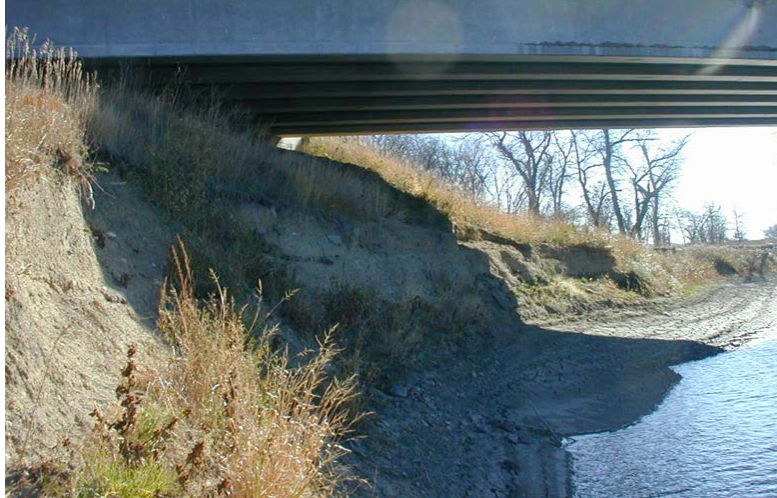
Water surface elevations were measured during the flood using a wire-weight gage located on the upstream bridge face. These elevations are found to cover 81 percent of the abutment total height at the left abutment ($WL_{\text{Left}}= 81$ percent) and 57 percent at the right abutment ($WL_{\text{Right}}= 57$ percent).

Figure 20. Scour at the Left Abutment of SR 37 over James River during the Flood.

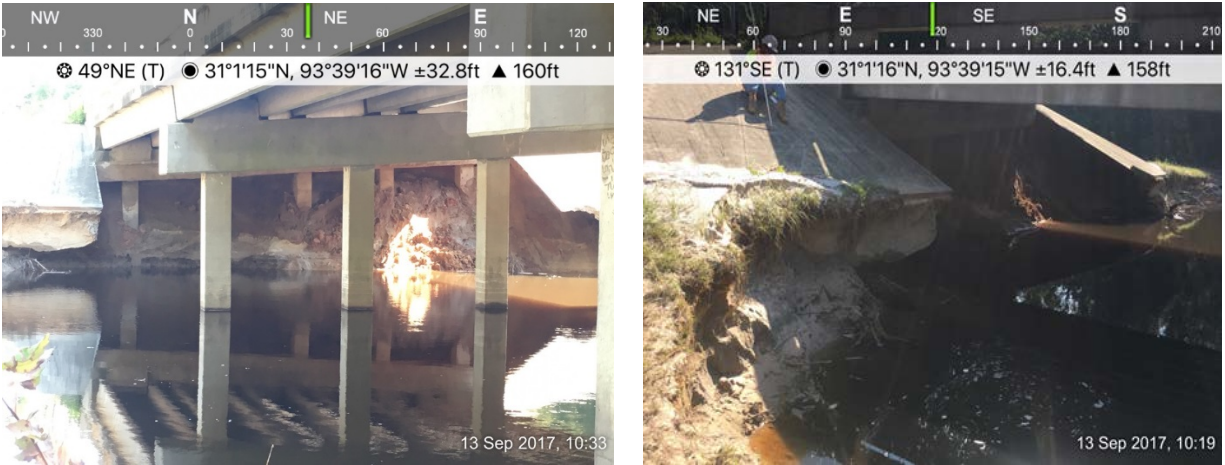
FM 692 over McGraw Creek is in Newton County, Texas. The bridge has been closed to traffic due to damage sustained during Hurricane Harvey (August–September 2017). The information needed to analyze the case is provided by the TxDOT office in Austin. The flooding caused significant scour in the bridge channel and caused the failure of the left abutment (Figure 21).

Figure 21. Left Abutment Failure at FM 692 over McGraw Creek.

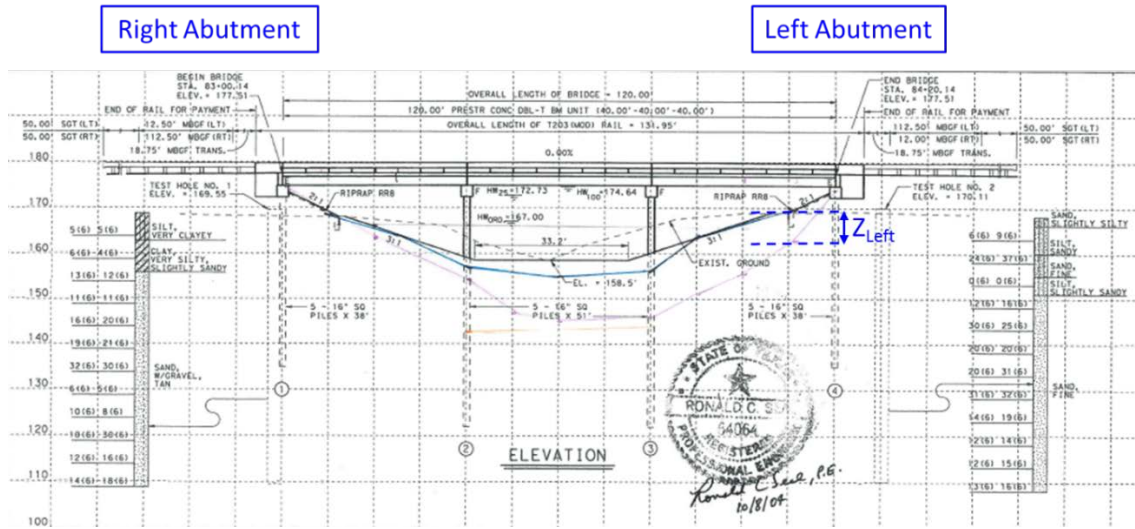
The borehole logs indicate that the bed soil is slightly silty sand at the left abutment and very clayey silt at the right abutment. The borehole logs also show the results of TCP test. The TCP blow counts, N_{TCP} , at the bottom of the left and right embankments are 15 and 10, respectively. The undrained shear strength S_u values are calculated using N_{TCP} values and the linear relationship S_u (tsf) = $N_{TCP}/40$ (TxDOT, 2018). It follows that the undrained shear strength of the channel bed soil at the left abutment is $S_{uLeft} = 750$ psf and at the right abutment is $S_{uRight} = 500$ psf. No information is given on the soil type of the embankments nor on the water elevation at the time of the failure.

Figure 22. Bridge Layout of FM 692 over McGraw Creek Showing the Channel Profiles before and after Harvey.

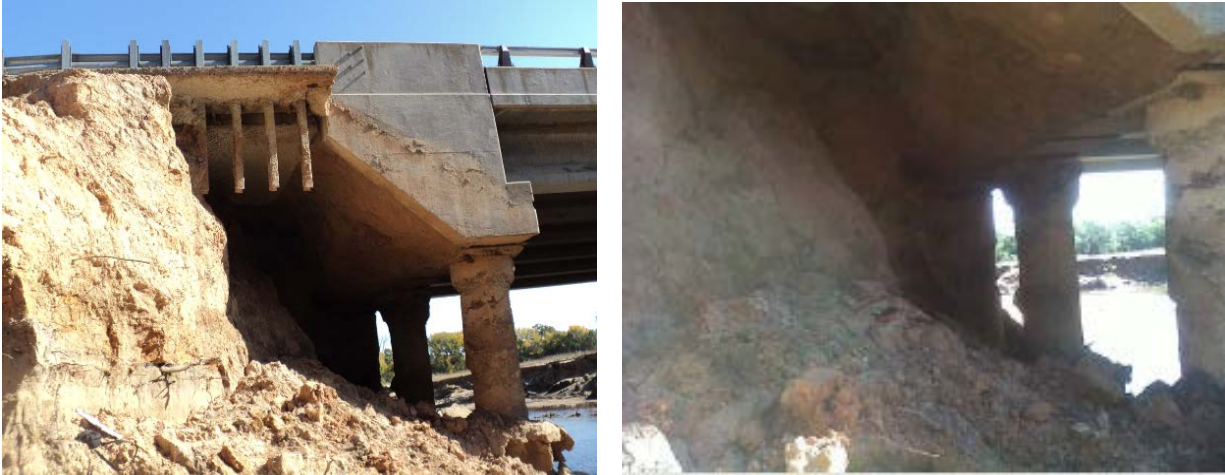
FM 937 over Montgomery Creek is a single span bridge located in Limestone County, Texas. The bridge was closed to traffic in October 2013 due to the Halloween flash flood event. Figure 23 shows the slope stability failure of the left abutment embankment. The slope of the right embankment did not fail, but the concrete riprap was damaged (Figure 24).

Figure 23. Left Abutment Failure at FM 937 over Montgomery Creek.

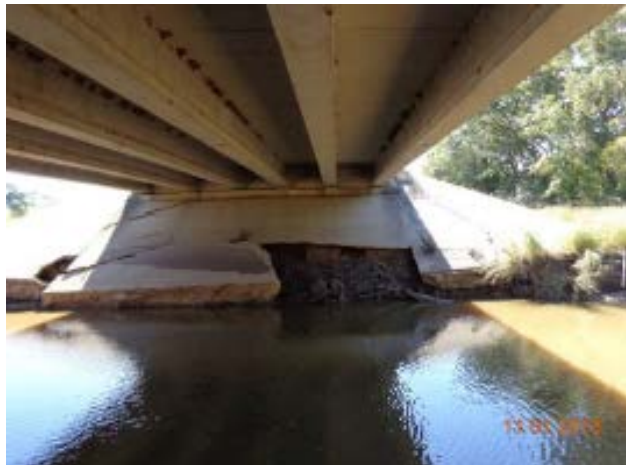
Figure 24. Damaged Concrete Riprap at the Right Abutment of FM 937 over Montgomery Creek.

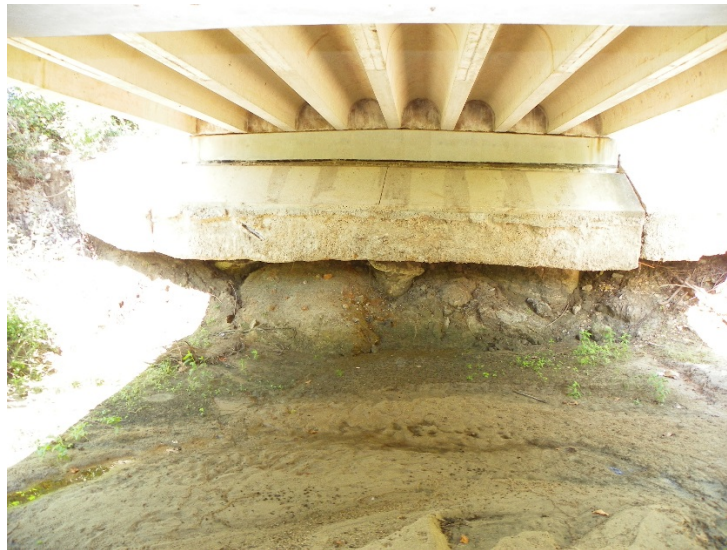
CR 309 over Rocky Creek is in Washington County, Texas. On 19 April 2016, the bridge was closed to traffic due to Tax Day Flooding. While the concrete riprap remained in place and the abutment embankment did not fail, the soil composing the left embankment was scoured out and washed away (Figure 25). As a result, the abutment drilled shafts were exposed and a large void was formed under the concrete riprap (Figure 26).

Figure 25. Scour at the Left Abutment of CR 309 over Rocky Creek.

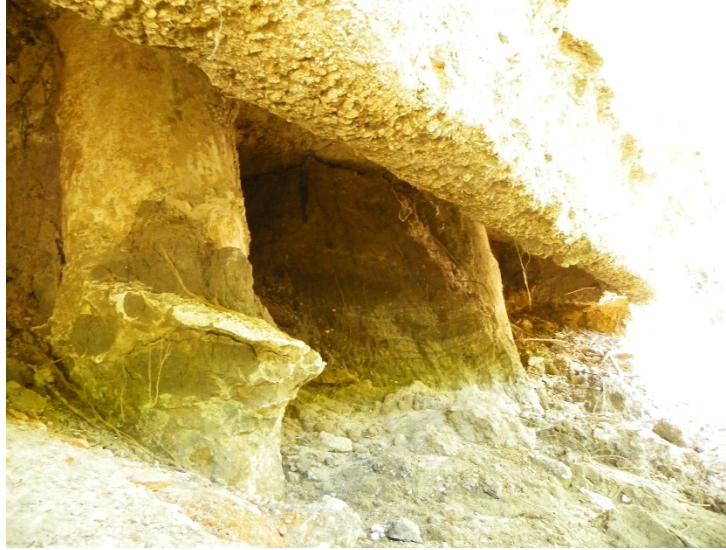
Figure 26. Voids under the Left Abutment Concrete Riprap of CR 309 over Rocky Creek.

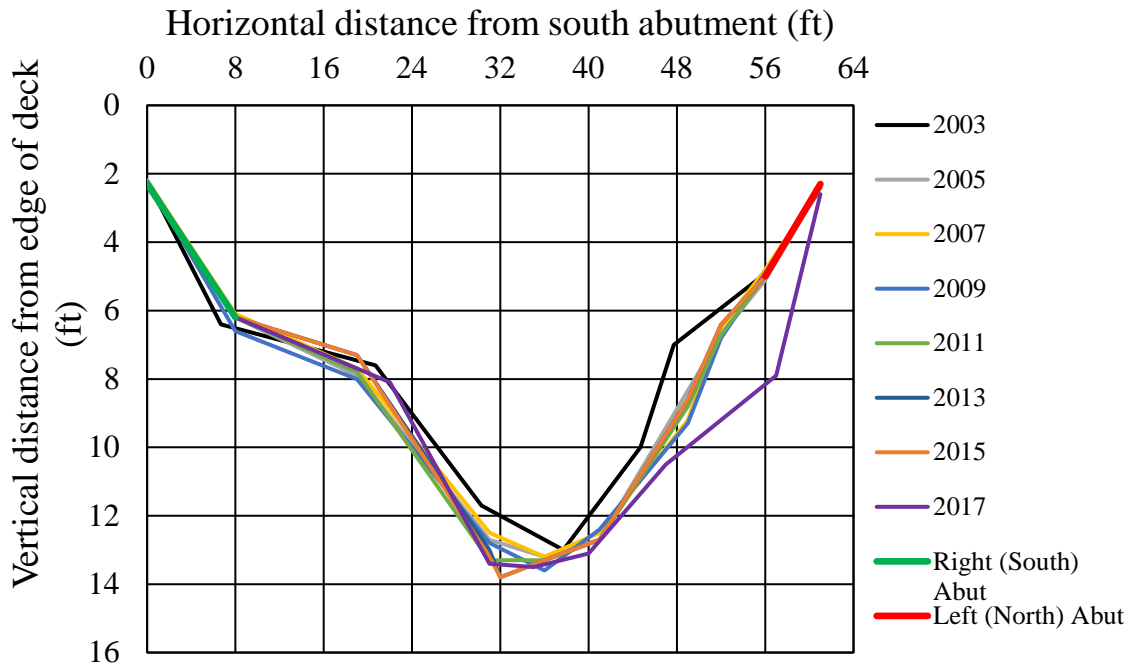
The borehole logs presented on the bridge layout plan indicate that the channel soil directly under the abutment embankment is tan sandy clay. TCP blow counts, N_{TCP} , are reported on the borehole logs. The N_{TCP} values at the bottom of the left and right embankments are 9 and 13, respectively. The linear relationship between the undrained shear strength S_u and N_{TCP} for low plasticity clay (CL) soils, S_u (tsf) = $N_{TCP}/30$ (TxDOT, 2018) is used to estimate the undrained shear strengths of the channel bed at the left and right abutments. Table 9 presents these geotechnical parameters, in addition to the geometry and scour parameters.

Figure 27. Channel Profiles at CR 309 over Rocky Creek from 2003 to 2017.

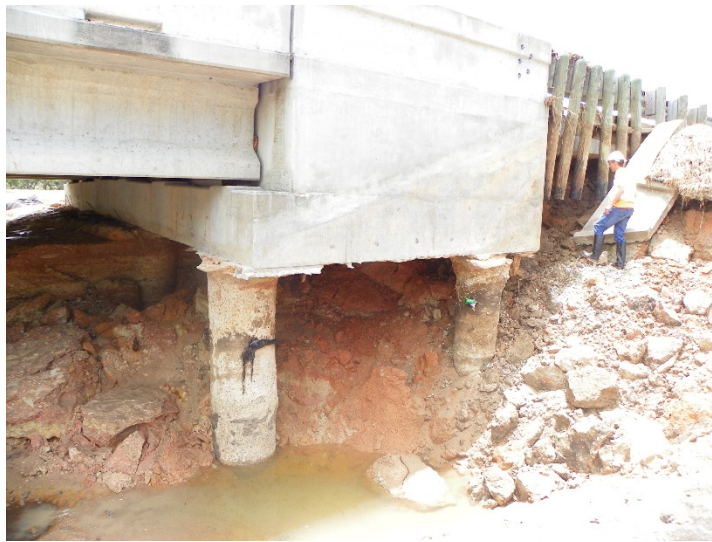
SH 105 over Rocky Creek is also located in Washington County, Texas. The bridge was closed to traffic in April 2017 due to Tax Day Flooding. Large scour holes formed during the flooding and caused the failure of the right abutment (Figure 28). Pictures from the inspection of the bridge site after the flood showed that the right abutment, where the failure occurred, was not protected against scour while the left abutment was protected by a gabion mattress.

Figure 28. Right Abutment Failure at SH 105 over Rocky Creek.

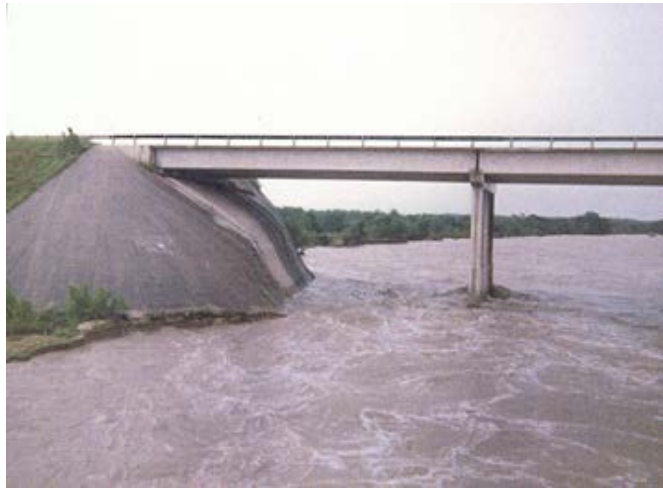
Figure 29. Right Abutment Failure at US 90 over Nueces River.

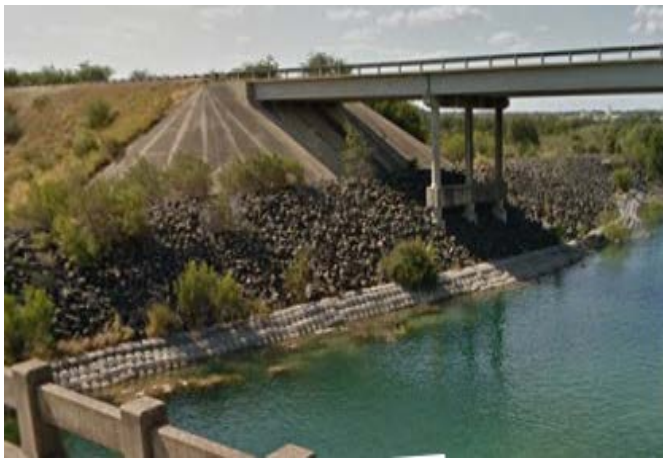
promptly repaired, and stone riprap was placed at the end of the embankment to prevent future failure due to scour (Figure 30).

Figure 30. Right Abutment Repair at US 90 over Nueces River.

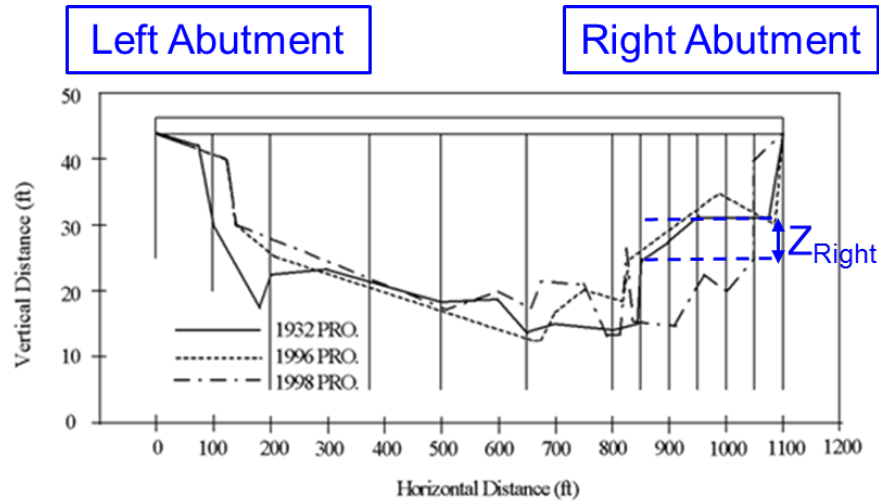
The 1998 cross-section profile of Nueces River at US 90 shows how the right (west) abutment slope became vertical after the embankment failure due to scour at the abutment (Figure 31). This profile indicates that the total abutment height is around $H= 14$ ft, and the abutment slope angle is $\beta= 26.6^\circ$. The scour depth at the right abutment is calculated as the vertical distance between the embankment toe and the bottom of the scour hole (Figure 31) and is found to be $Z_{\text{Right}}= 7$ ft. The channel bed is comprised of gravel and the embankment soil type is unknown. Table 11 presents the parameters of this case.

Figure 31. Channel Profiles at US 90 over Nueces River.

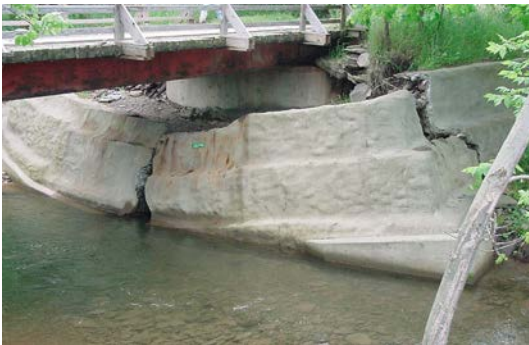
Figure 32. Abutment Foundation Failure by Vertical Loading.

- **Failure mode 1:** Abutment foundation failure by vertical loading (Figure 32).
- **Failure mode 2:** Abutment foundation failure by horizontal loading (Figure 33).
- **Failure mode 3:** Slope stability failure of the abutment embankment (Figure 34).
- **Failure mode 4:** Lateral channel migration and erosion of the embankment soil (Figure 35).

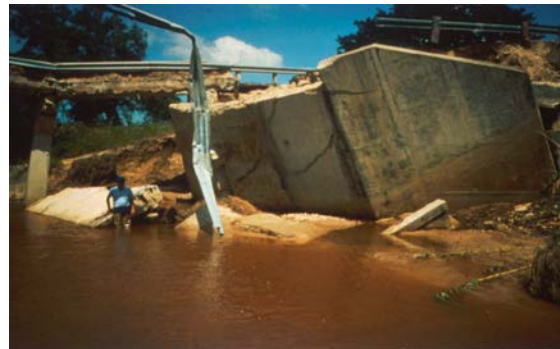
Figure 33. Abutment Foundation Failure by Horizontal Loading.

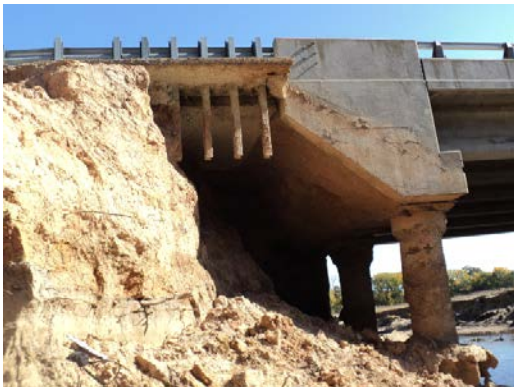
Figure 34. Slope Stability Failure of the Abutment Embankment.

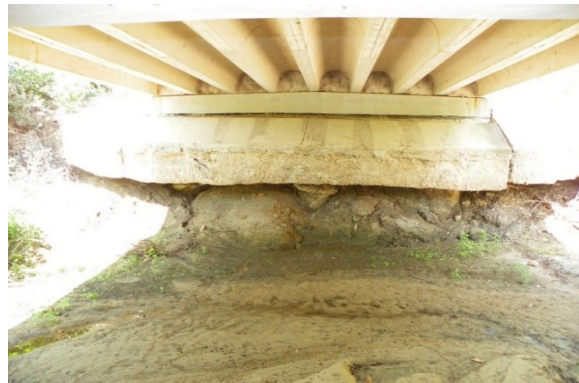
Figure 35. Erosion of the Embankment Soil.

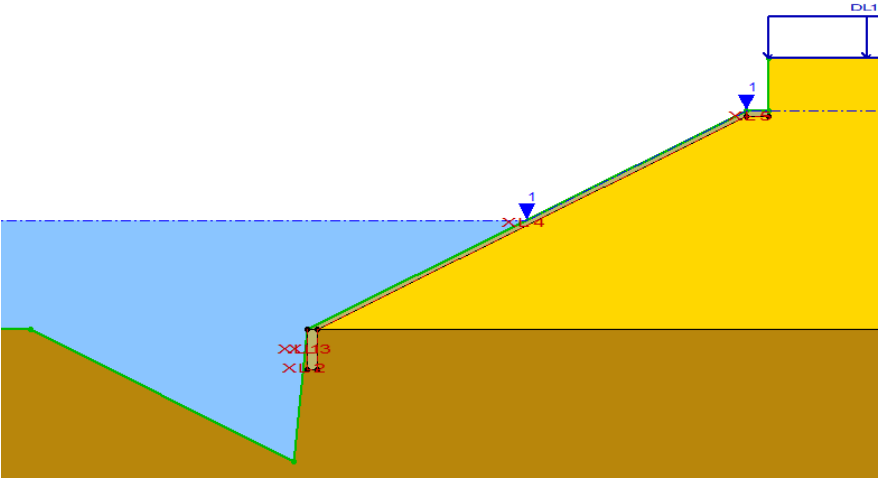
failure surface is prevented from intersecting the concrete layer using exclude lines (Figure 36). In this way, the presence of the concrete protection layer does not enhance geotechnical stability. On the other hand, this layer helps simulating realistic deep-seated slip surfaces going beyond the abutment cap and prevents shallow raveling failures.

Figure 36. XCLUDE Lines around the Concrete Protection.

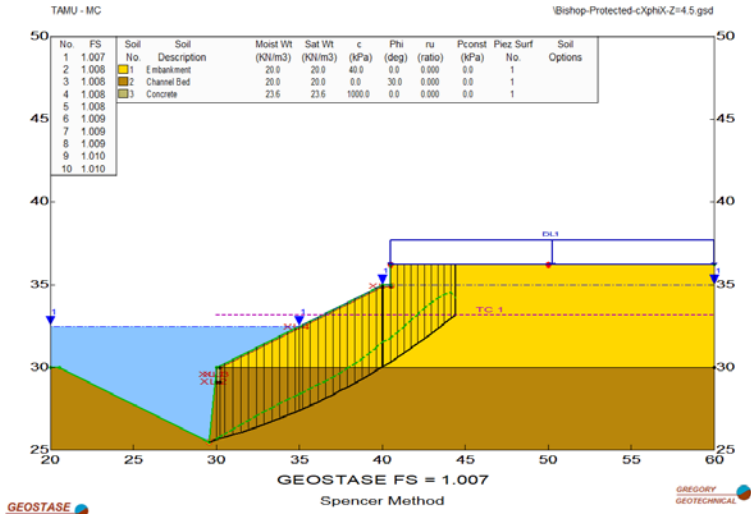
$$z_c = \frac{2c'}{\gamma \tan(45^\circ - \frac{\phi'}{2})} \tag{Eq. 5-1}$$

Figure 37. Tension Crack Used to Suppress the Tension in a Medium Stiff Embankment.

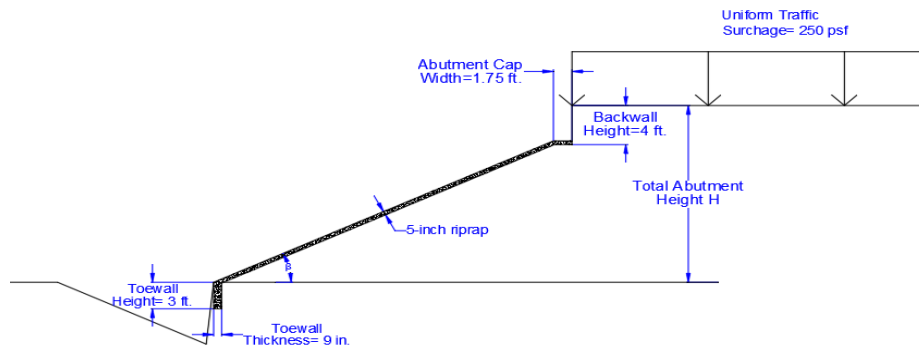
Figure 38 illustrates the abutment cross-section used in the slope stability analyses. The abutment embankment is protected by concrete riprap of type RR8 including a 5-inch thick facing and a 3-ft deep toe-wall. The abutment slope is set to 2H:1V, which gives a slope angle β of 26.6°. This is representative of a typical slope of riprap in Texas. The abutment cap and back-wall dimensions are those corresponding to TxDOT pre-stressed concrete I girder, Tx34 or Tx40, typically used with a 28 ft roadway. A slope height of 16.4 ft (5 m) is first considered. To cover the range of possible embankment heights, the stability analyses are repeated with a smaller slope height of 6.5 ft (2 m) and a larger slope height of 24.5 ft (7.5 m). Adding the back-wall height of 4 ft results in three total height H values of 10.5 ft, 20.4 ft, and 28.5 ft. A uniform traffic surcharge of 250 psf is placed on the approach roadway.

Figure 38. Abutment Model.

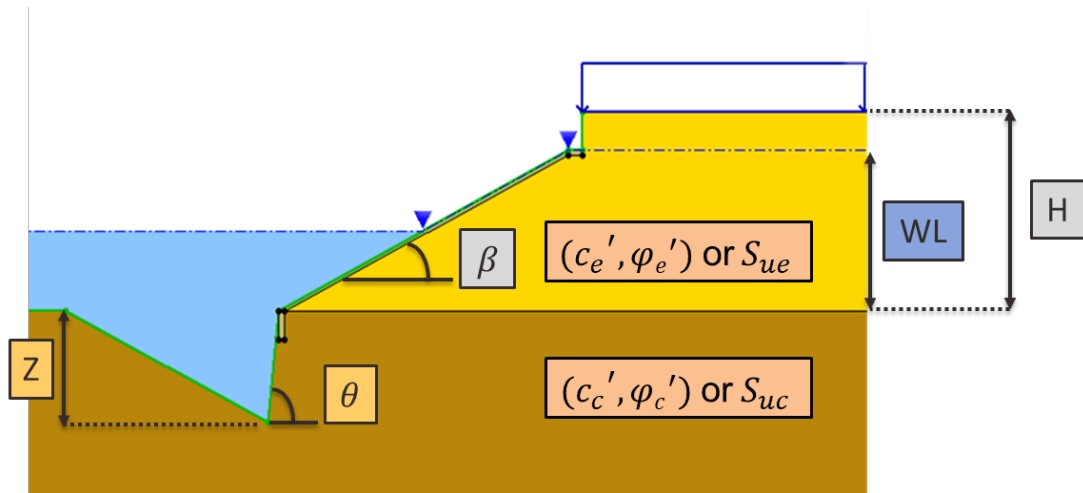
The abutment model variables can be divided into four categories (Figure 39).

Figure 39. Abutment Model Variables.

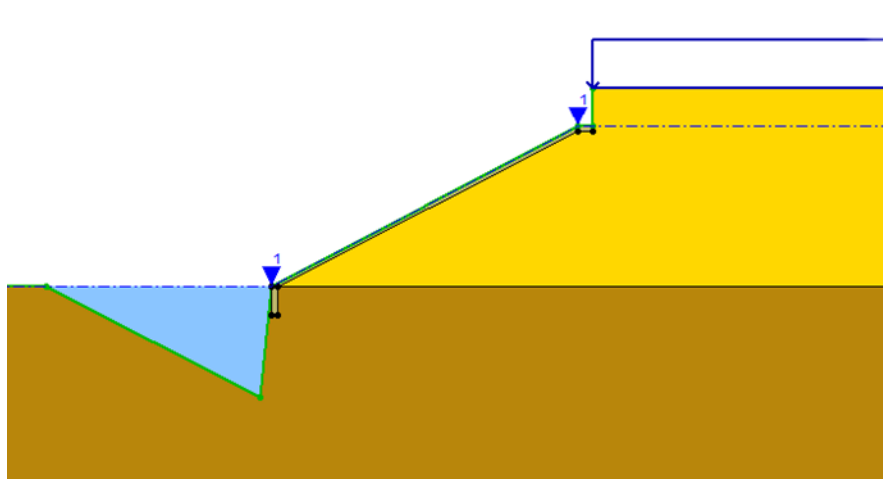
condition would be dry, the slope stability of the abutment embankment should be analyzed using a long-term effective analysis. It has been proven that the effective analysis of dry conditions results in a higher FS against slope stability than that of the rapid drawdown condition. Although the dry condition (no water) and other steady state conditions with WL=100 percent and WL=50 percent were simulated, the determination of the failure scour depth Z_{Fail} at or near the abutment is based on the rapid drawdown condition.

Figure 40. Complete Rapid Drawdown.

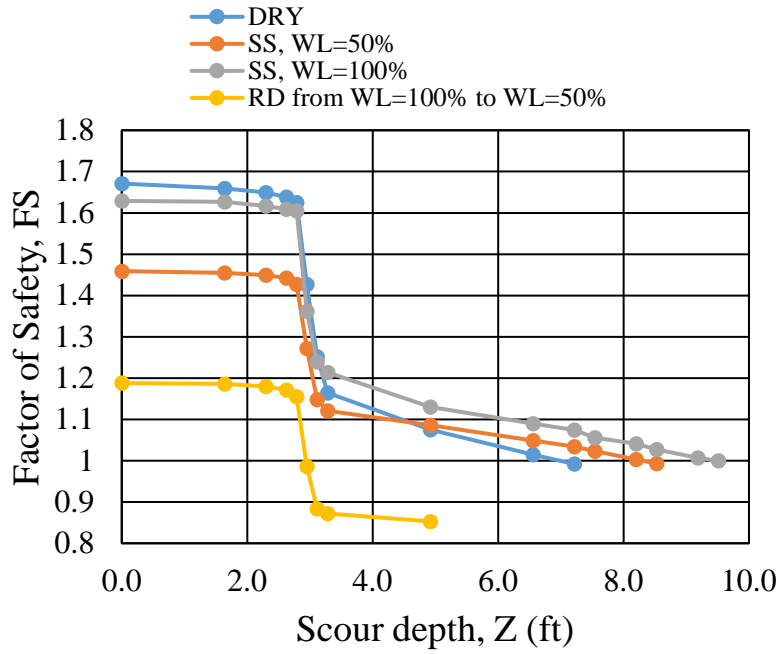
seen in Figure 41 and Table 16, rapid drawdown is the most critical water condition and is therefore used to determine the failure scour depth Z_{Fail} .

Figure 41. FS vs. Z Using Effective Stress Analysis.

Water Condition	DRY	SS, WL=50%	SS, WL=100%	RD from WL=100% to WL=50%
Failure Scour Depth, Z_{Fail} (ft)	7.0	8.3	9.5	2.9
Z_{Fail}/H	0.34	0.40	0.46	0.14

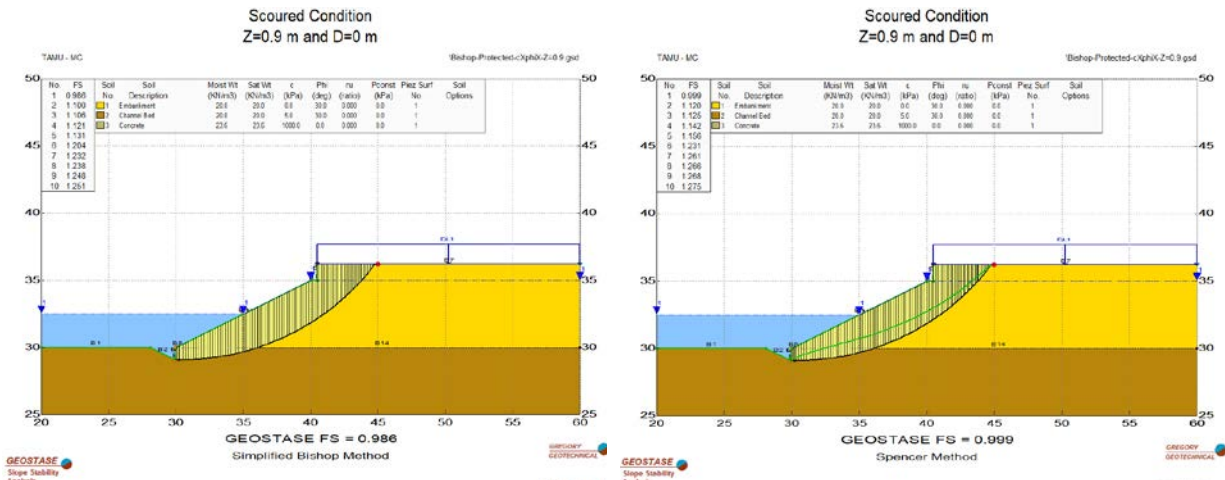
(a) Simplified Bishop Method

Figure 42. Failure Surface Location at Z Equal to the Toe-Wall Depth.

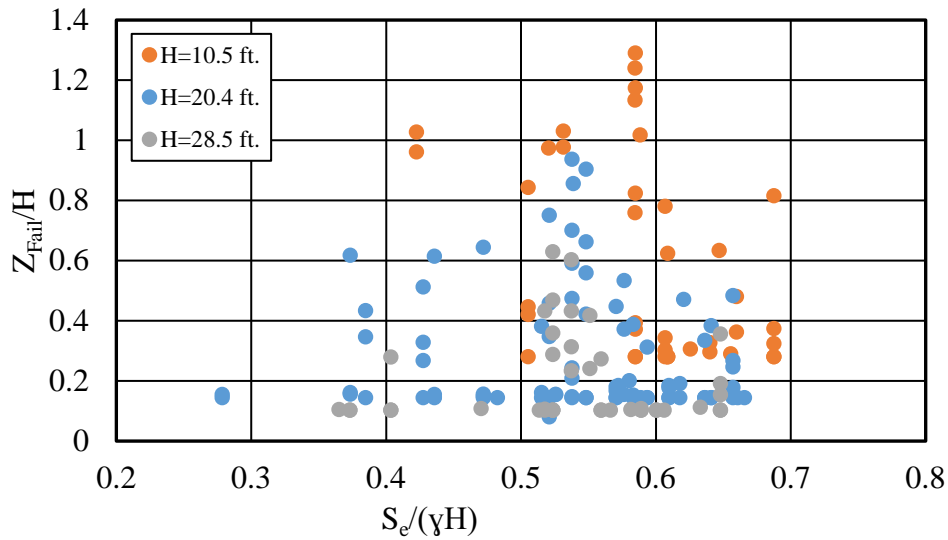
At first, S was taken to be the bulk shear strength of the embankment S_e with $S_e = c'_e + \gamma H \tan \phi'_e$, which results in $\frac{S_e}{\gamma H} = \frac{c'_e}{\gamma H} + \tan \phi'_e$. Figure 44 shows that no correlation exists between Z_{Fail}/H and $S_e/\gamma H$. It was thought that including the channel bed shear strength parameters in the expression of S would improve the relationship between Z_{Fail}/H and $S/\gamma H$. Consequently, S_e was replaced by S_{avg} with $S_{avg} = c'_{avg} + \gamma H (\tan \phi')_{avg}$ where $c'_{avg} = \frac{c'_e + c'_c}{2}$ and $(\tan \phi')_{avg} = \frac{\tan \phi'_e + \tan \phi'_c}{2}$. However, no correlation is observed between Z_{Fail}/H and $S_{avg}/\gamma H$ neither (Figure 45).

Figure 44. Z_{Fail}/H vs. $S_e/\gamma H$.

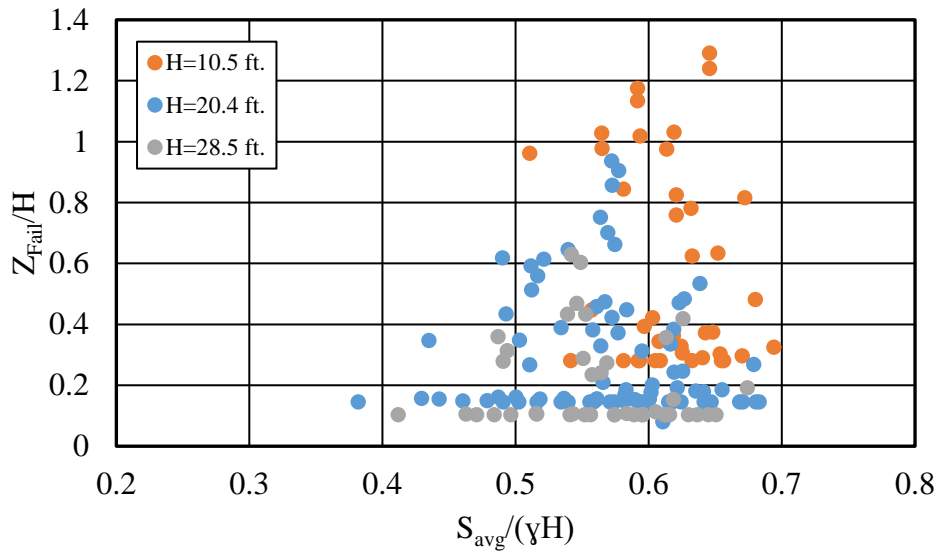
Figure 45. Z_{Fail}/H vs. $S_{avg}/\gamma H$.

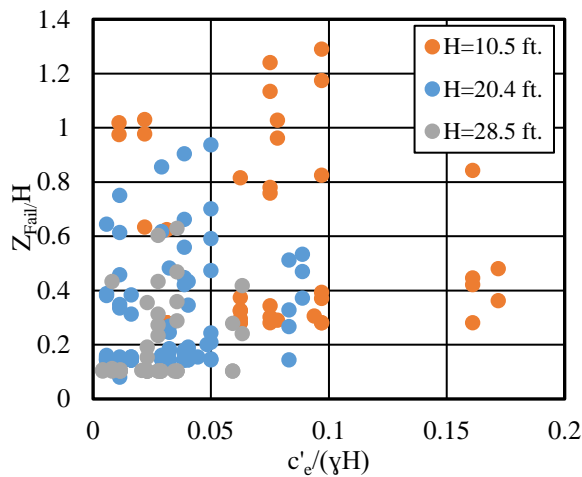
Given the importance of the traditional stability number $N=c'/\gamma H$ in slope stability analyses, Z_{Fail}/H results are plotted against $c'/\gamma H$, $c'/\gamma H$, and $c'_{avg}/\gamma H$ in Figure 46, Figure 47, and Figure 48, respectively. A general trend of increasing Z_{Fail}/H with increasing $c'_{avg}/\gamma H$ can be observed despite the scatter in the data points for $c'_{avg}/\gamma H < 1$. This scatter is due to the variation of the embankment and channel bed effective friction angles, not captured in the independent variable $c'_{avg}/\gamma H$.

Figure 46. Z_{Fail}/H vs. $c'/\gamma H$.

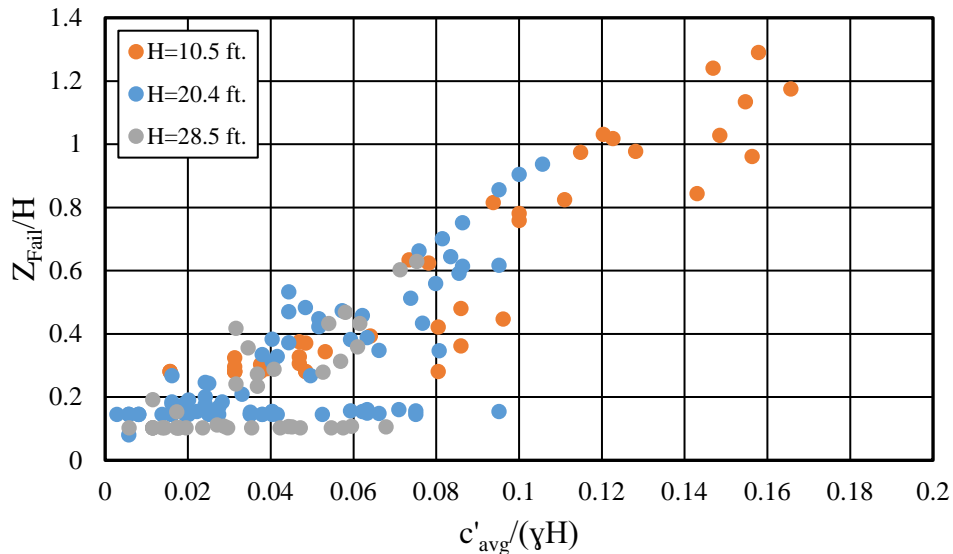
Figure 48. Z_{Fail}/H vs. $c'_{avg}/\gamma H$.

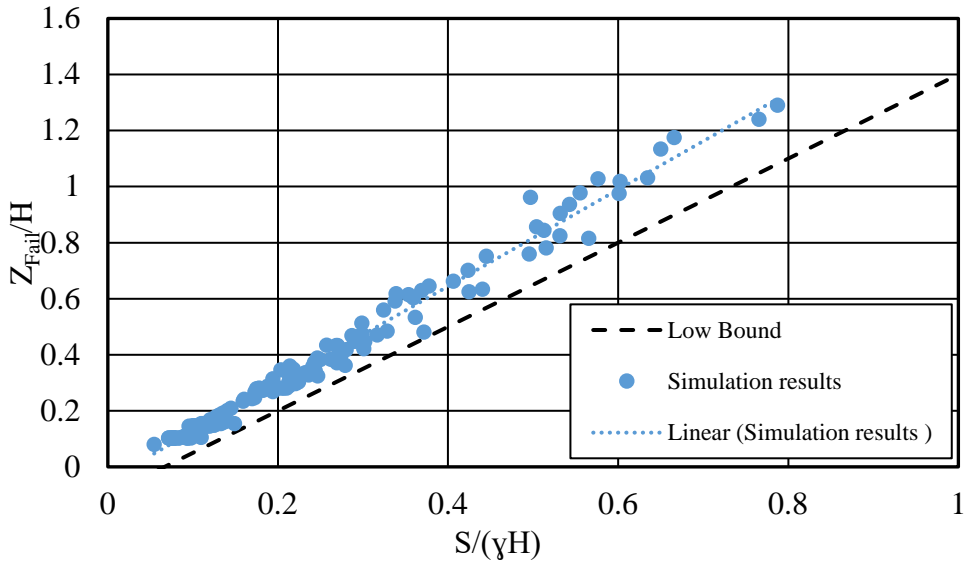
$$\frac{Z_{Fail}}{H} = 1.55 \frac{S}{\gamma H} - 0.1 \quad (\text{Eq. 5-4})$$

Figure 50. Z_{Fail}/H vs. $S/\gamma H$.
