Allowable Limit Contraction and Abutment Scour at Bridges: Technical Report

Technical Report 0-6935-R1

TEXAS A&M TRANSPORTATION INSTITUTE
COLLEGE STATION, TEXAS

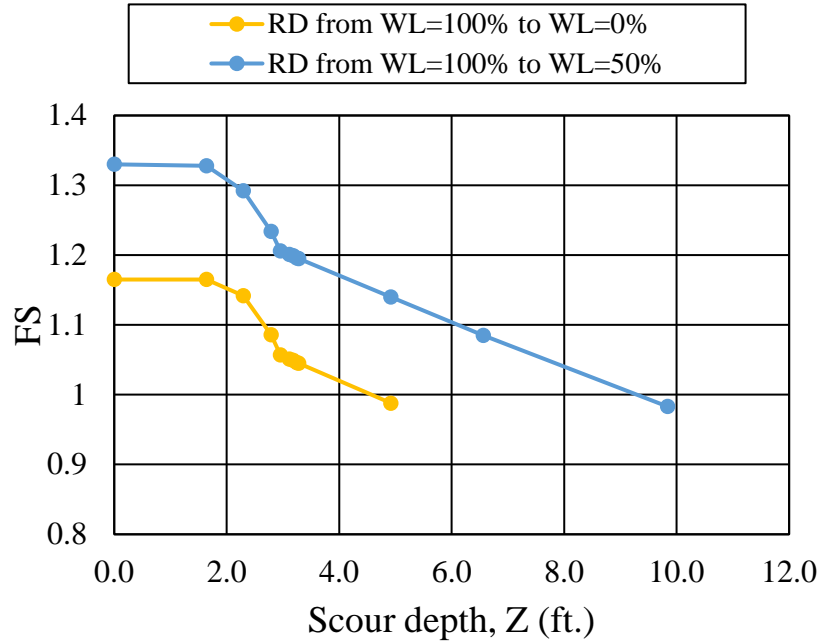
To avoid assuming the pore water pressure distribution in the embankment and channel bed after sudden drawdown, the slope stability analysis is performed using a range of undrained shear strength values with the three abutment heights. This total stress analysis allowed the simulation of both complete and half rapid drawdown conditions. Figure 51 shows the relationship between FS against slope stability and Z for a single combination of input parameters where $H=20.4$ ft, $S_{uc}= 418$ psf, and $S_{uc}= 627$ psf. Similarly to the results of the effective stress analysis, the FS decreases as Z increases and the relationship becomes linear for Z greater than the riprap toe wall height (3 ft). As expected, the data points corresponding to the complete rapid drawdown condition are always below those corresponding to the half rapid drawdown condition (Figure 51). The failure scour depth Z_{Fail} associated with $FS=1$ is determined for each of the two rapid drawdown conditions by linear interpolation (Table 19).

Figure 51. FS vs. Z Using Total Stress Analysis.

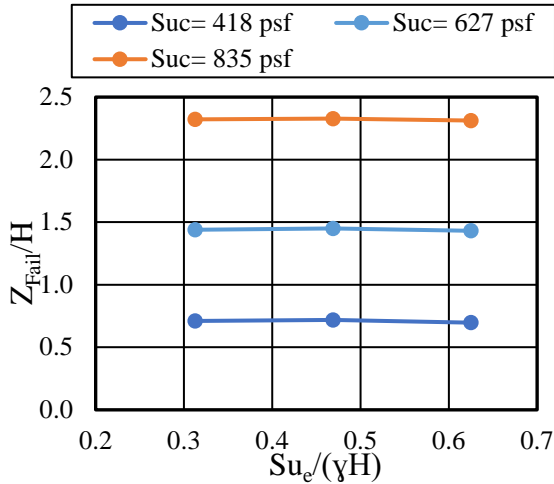
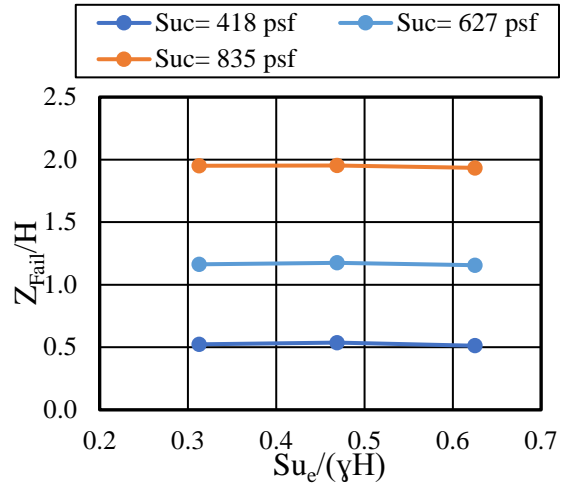
(a) Rapid Drawdown from WL=100% to WL=50%

Figure 52. Z_{Fail}/H vs. $Su_e/\gamma H$ with $H=10.5$ ft.

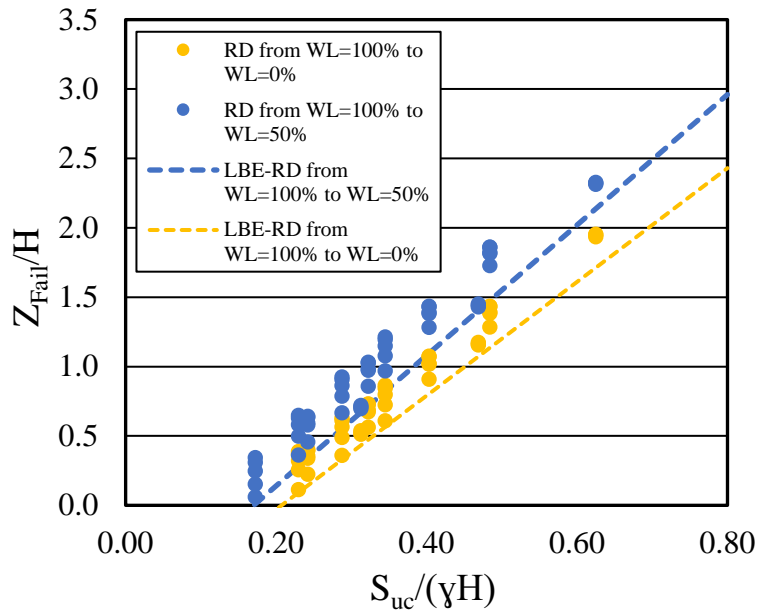
Figure 55. Z_{Fail}/H vs. $S_{uc}/\gamma H$.

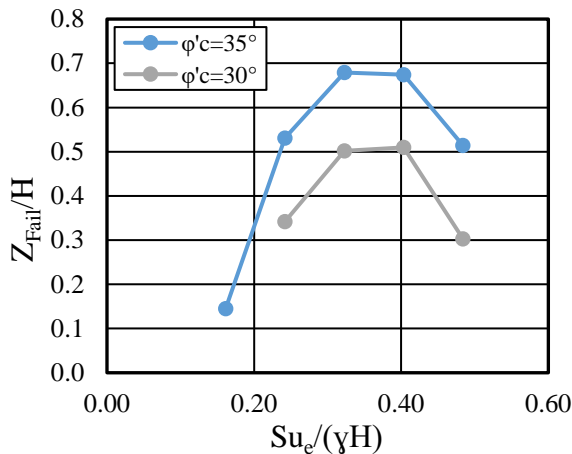
Figure 56. Z_{Fail}/H vs. $S_{ue}/\gamma H$ for Rapid Drawdown to Half Slope Height with $H=20.4$ ft.

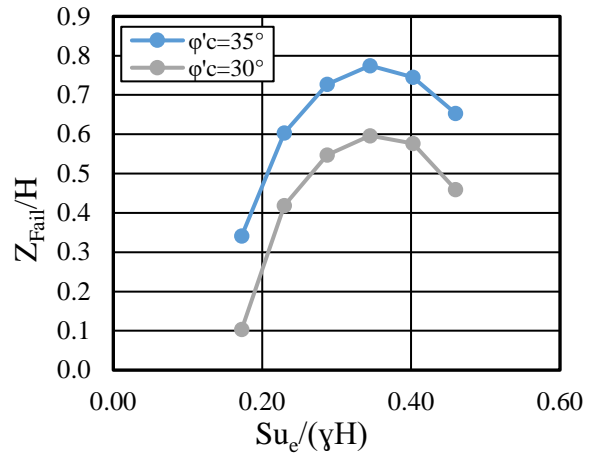
Figure 57. Z_{Fail}/H vs. $S_{ue}/\gamma H$ for Rapid Drawdown to Half Slope Height with $H=28.5$ ft.

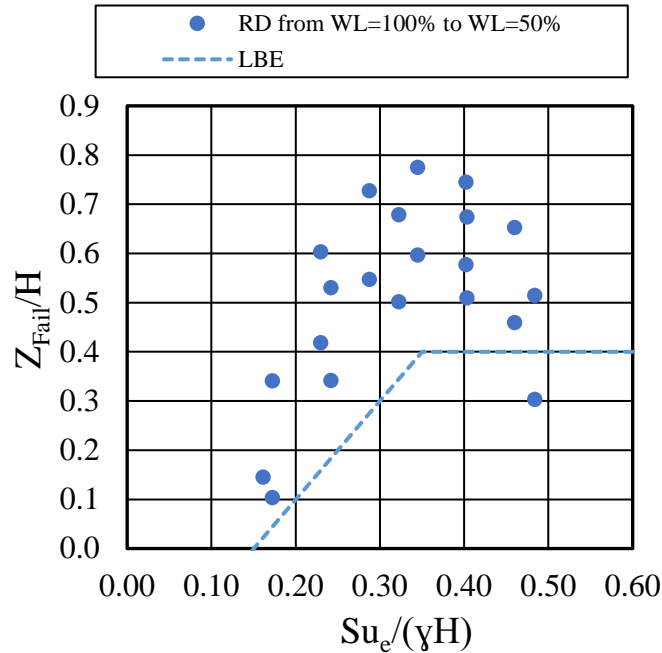
Figure 58. Z_{Fail}/H vs. $S_{ue}/\gamma H$ for Rapid Drawdown to Half Slope Height.

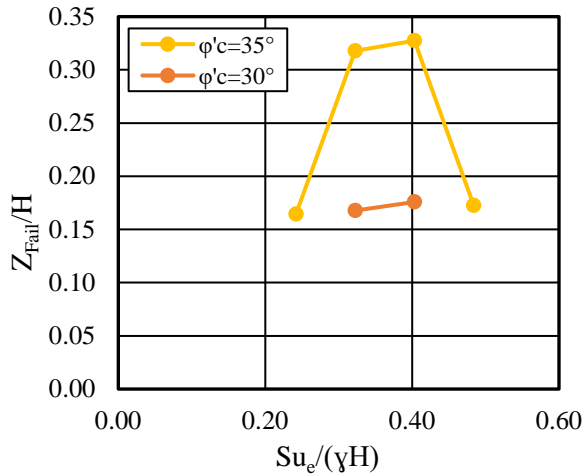
Figure 59. Z_{Fail}/H vs. $S_{ue}/\gamma H$ for Complete Rapid Drawdown with $H=20.4$ ft.

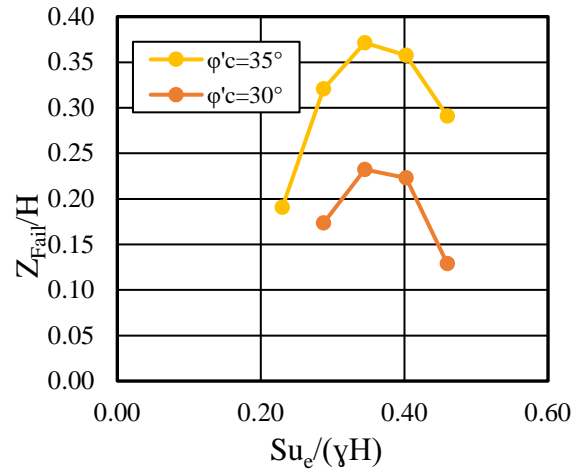
Figure 60. Z_{Fail}/H vs. $S_{ue}/\gamma H$ for Complete Rapid Drawdown with $H=28.5$ ft.

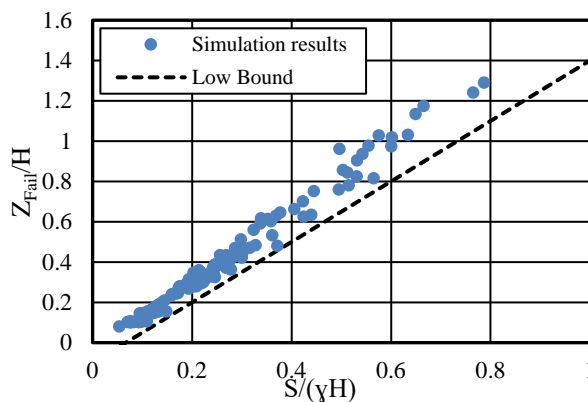
Figure 61. Effective Stress Analysis Results.

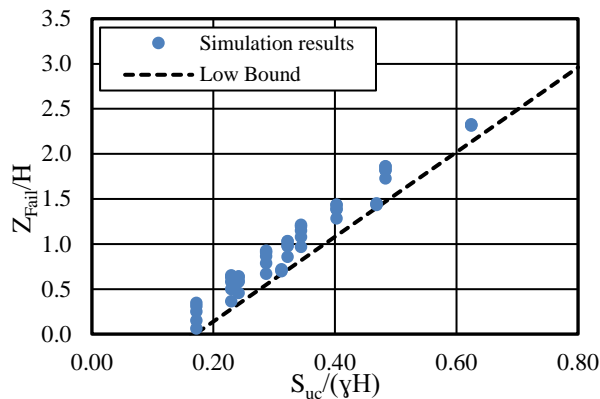
Figure 62. Total Stress Analysis Results.

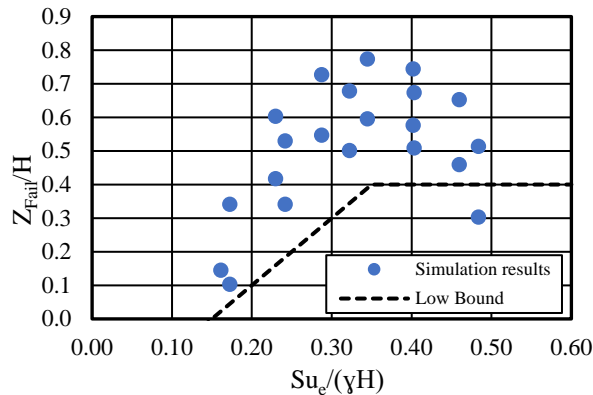
Figure 63. Total Stress Analysis Results with Cohesionless Channel Bed.
