MASH TL-3 EVALUATION OF GUARDRAIL TO RIGID BARRIER TRANSITION ATTACHED TO BRIDGE OR CULVERT STRUCTURE

Test Report 0-6954-R1

TEXAS A&M TRANSPORTATION INSTITUTE

TEXAS DEPARTMENT OF TRANSPORTATION

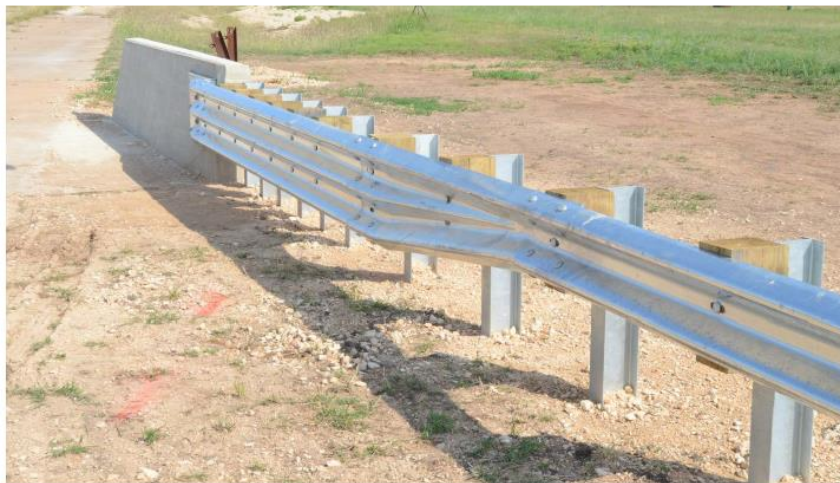
Figure 2.8. Thrie Beam Transition without Curb.

Three design changes were proposed by researchers to possibly improve the performance of the system. A short curb may be placed at the end of the parapet under the rail to help prevent wheel snagging. The steel blockout at the end of the parapet could be increased in depth to offset the rail to decrease the amount of snagging. Also, the posts in the nested section of the guardrail could be strengthened by using a larger size post and increasing the embedment depth to overall stiffen the transition and ultimately reduce the dynamic deflections. Some previous studies suggest that excessive deflection in the transition region can induce vehicle instability, but if the system becomes too stiff the upstream end of the transition section may need to be redesigned and evaluated. Figure 2.8 shows a photograph of the installation.

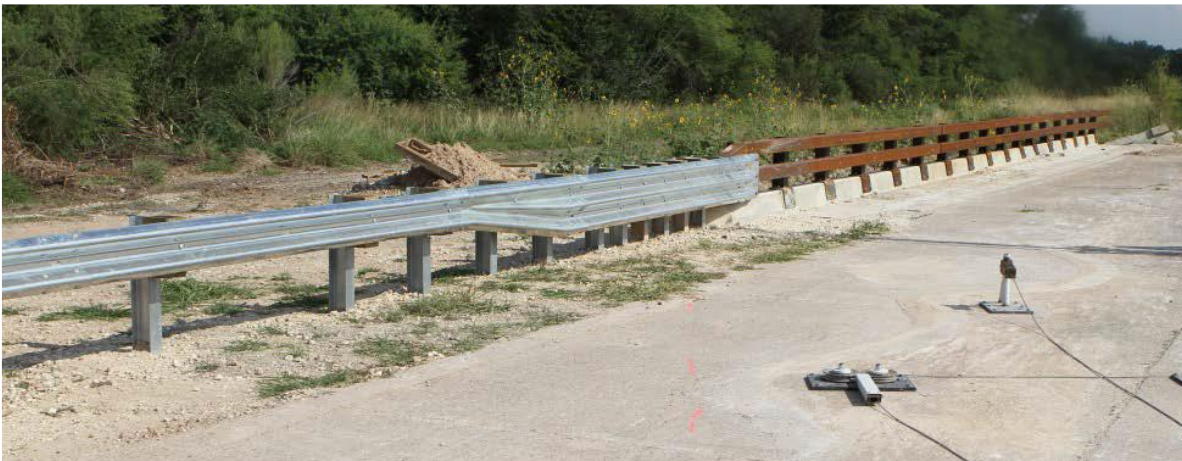
Figure 2.9. T131RC Bridge Rail Transition Impact View.

The TxDOT T131RC Bridge Rail Transition consists of two nested 12 gauge thrie beam sections supported by six W6×8.5 posts spaced at 37 ½ inches on centers. The nested thrie beams connect to a 10 gauge asymmetric transition piece on the upstream end. The nested thrie beam transition was connected to a 10 gauge end shoe on the downstream end. This end shoe was anchored to the end of the T131RC Bridge Rail. The height from the finished grade to the top of the W-beam guardrail and transition was 31 inches.

The TxDOT T131RC Bridge Rail Transition contained and redirected both the 1100C vehicle and the 2270P vehicle. Overall, all *MASH* TL-3 requirements were met, therefore the TxDOT T131RC Bridge Rail Transition performed acceptably as a *MASH* TL-3 transition. Figures 2.9 through 2.11 show photographs of the test installation.

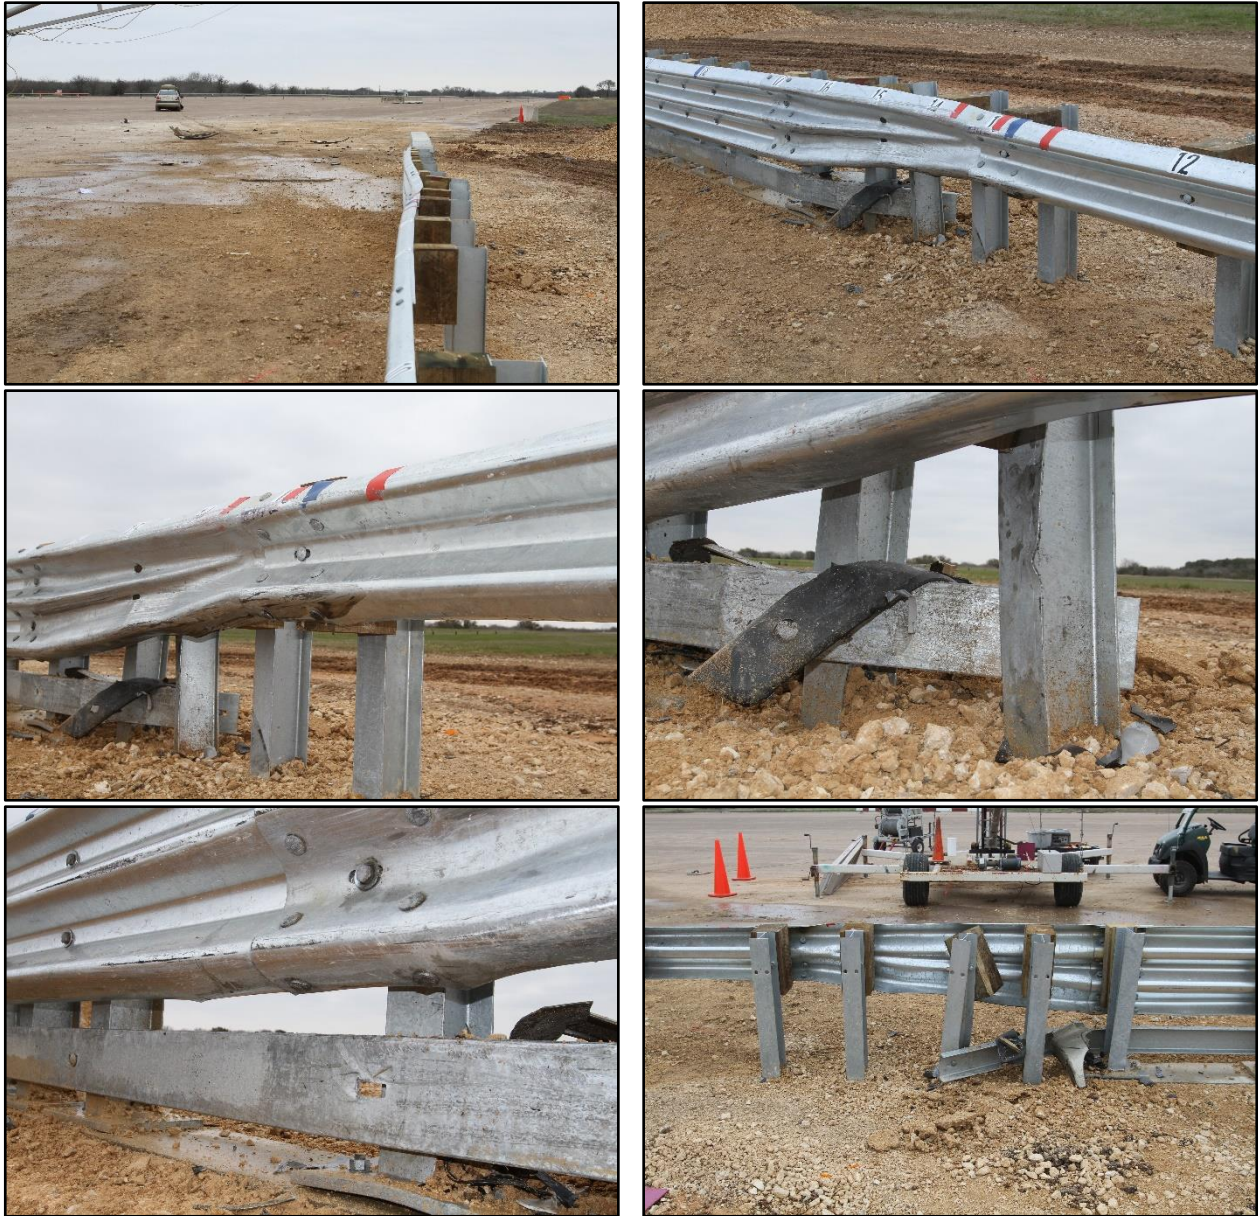
Figure 7.5. Upstream Transition after Test No. 469549-01-1.

Figure 7.5 shows the damage to the upstream transition. The soil was disturbed around posts 12 through 16, the guardrail was released from post 15, and the rub rail was released from post 17. Post 15 showed evidence of significant contact with the vehicle, and it was leaning back and downstream approximately 10 inches. The base plate of post 17 was buckled. Working width was 26.2 inches, and height of working width was 31.0 inches. Maximum dynamic deflection during the test was 7.1 inches, and maximum permanent deformation was 3.4 inches (at post 15).

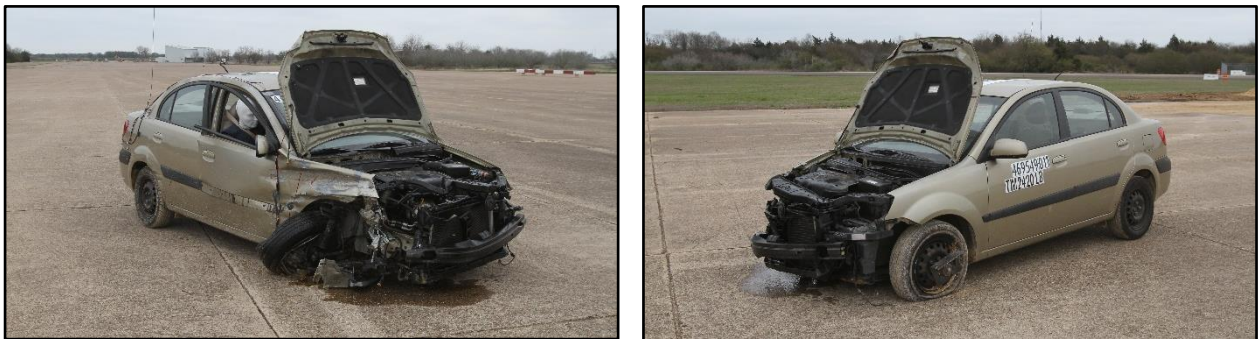
Figure 7.6. Test Vehicle after Test No. 469549-01-1.

Figure 7.6 shows the damage sustained by the vehicle. The front bumper, hood, radiator and support, right front fender, right front tire and rim, right front strut and tower, right front lower A-arm, right outer CV joint, right front door and glass, right rear door, right rear quarter panel, and right front floor pan were damaged. Maximum exterior crush to the vehicle was 10.0 inches in the side plane at the right front corner at bumper height. Maximum occupant compartment deformation was 1.25 inches in the kick panel across the floor pan. Figure 7.7 shows the interior of the vehicle. Tables D.2 and D.3 in Appendix D1 provide exterior crush and occupant compartment measurements.

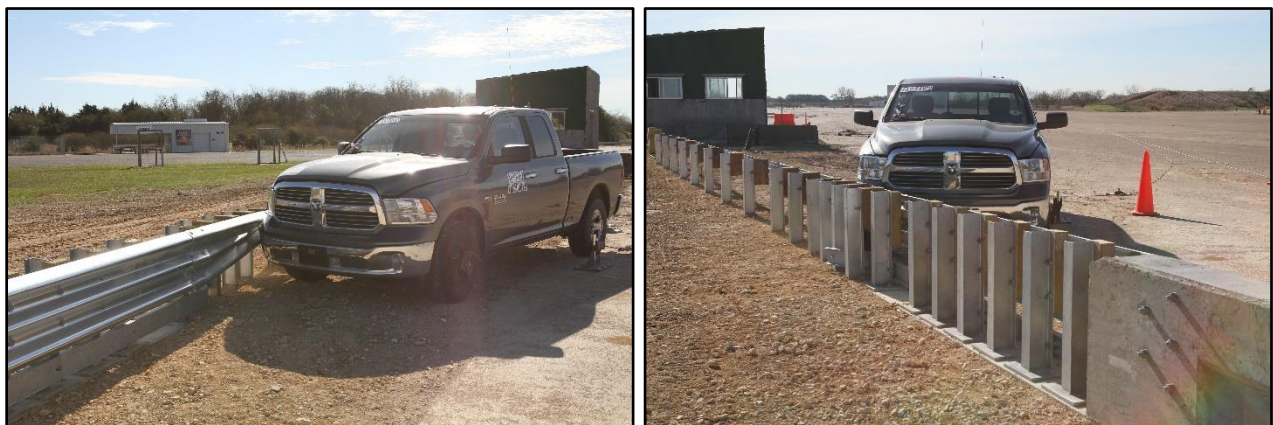
Figure 7.9. Upstream Transition/Test Vehicle Geometrics for Test No. 469549-01-2.

Figures 7.9 and 7.10 show the 2013 RAM 1500 pickup truck used for the crash test. The vehicle's test inertia weight was 5034 lb, and its gross static weight was 5034 lb. The height to the lower edge of the vehicle bumper was 11.75 inches, and height to the upper edge of the bumper was 27.0 inches. The height to the vehicle's center of gravity was 29.0 inches. Tables E.1 and E.2 in Appendix E1 give additional dimensions and information on the vehicle. The vehicle was directed into the installation using the cable reverse tow and guidance system, and was released to be freewheeling and unrestrained just prior to impact.

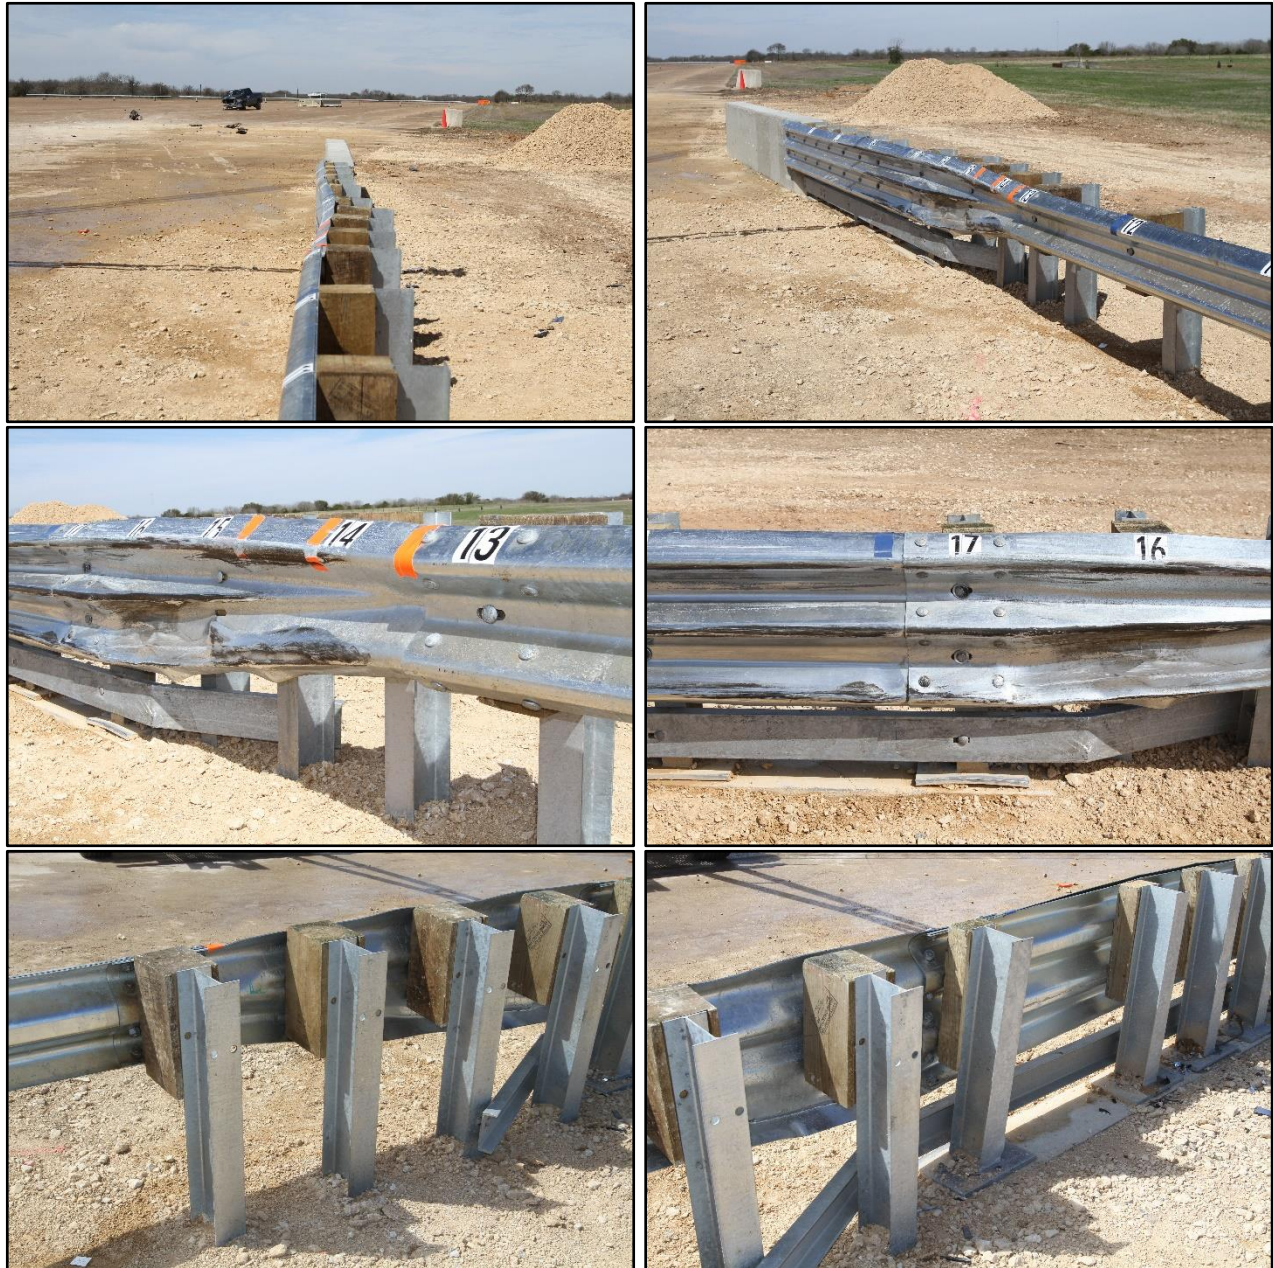
Figure 7.11. Upstream Transition after Test No. 469549-01-2.

Figure 7.11 shows the damage to the transition. The soil was disturbed around posts 13 through 15. The base plate of post 17 was deformed. The concrete wing wall was cracked at post 17, and between posts 17 and 18. Working width was 22.7 inches, and height of working width

was 50.5 inches. Maximum dynamic deflection during the test was 6.3 inches, and maximum permanent deformation was 2.75 inches at post 16.

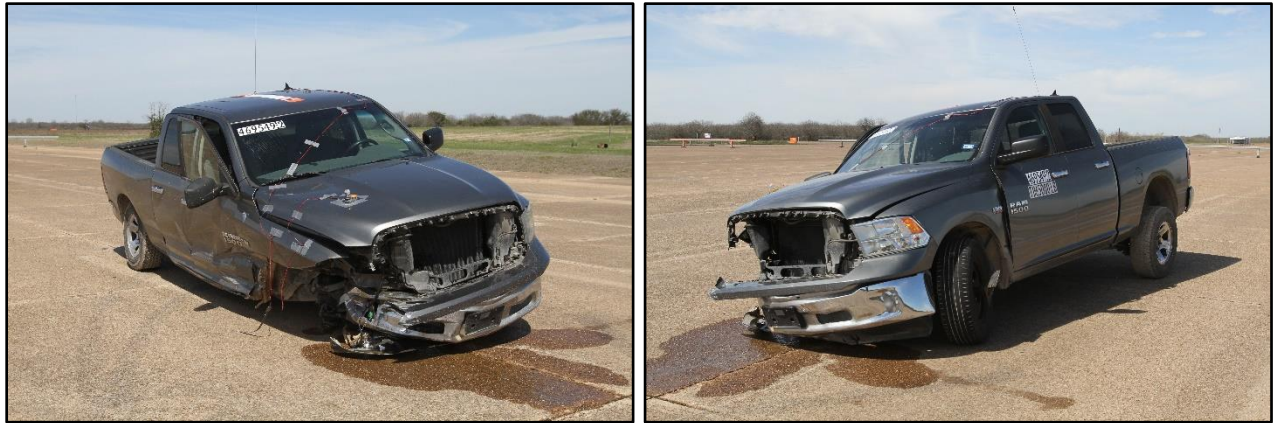
Figure 7.12. Test Vehicle after Test No. 469549-01-2.

Figure 7.12 shows the damage sustained by the vehicle. The front bumper, radiator and support, grill, right front fender, right front upper and lower A-arms, right front tire and rim, right front door and window glass, right rear door, right rear cab corner, right rear exterior bed, right rear rim, and rear bumper were damaged. The right front wheel (with tire) was completely

removed. Maximum exterior crush to the vehicle was 15.0 inches in the front plane at the right front corner at bumper height. Maximum occupant compartment deformation was 2.0 inches in the in the right firewall area and 4.0 inches in the right front kick panel. Figure 7.13 shows the interior of the vehicle. Tables E.3 and E.4 in Appendix E1 provide exterior crush and occupant compartment measurements.

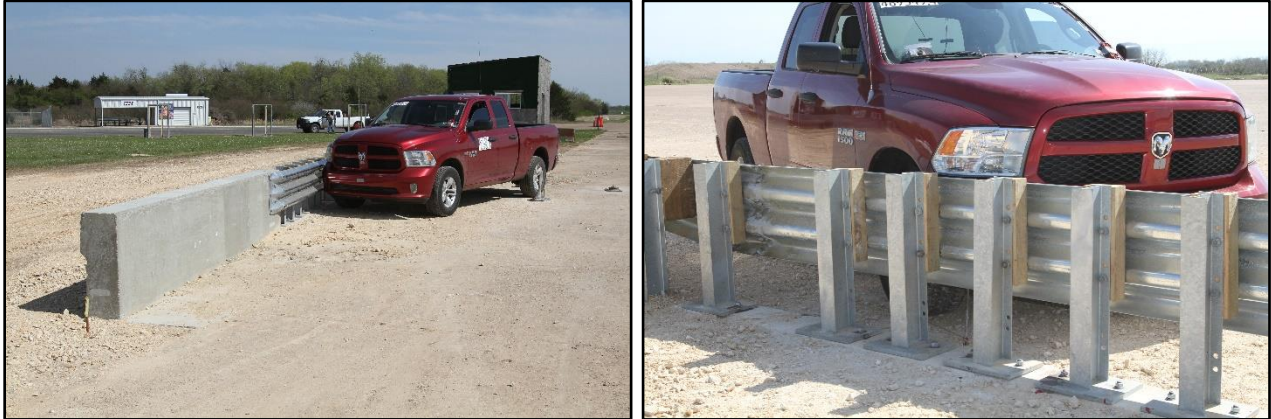
Figure 8.1. Downstream Transition/Test Vehicle Geometrics for Test No. 469549-01-4.

Figures 8.1 and 8.2 show the 2013 RAM 1500 pickup truck used for the crash test. The vehicle's test inertia weight was 5052 lb, and its gross static weight was 5052 lb. The height to the lower edge of the vehicle bumper was 11.75 inches, and height to the upper edge of the

bumper was 27.0 inches. The height to the vehicle's center of gravity was 28.25 inches. Tables F.1 and F.2 in Appendix F1 give additional dimensions and information on the vehicle. The vehicle was directed into the installation using the cable reverse tow and guidance system, and was released to be freewheeling and unrestrained just prior to impact.

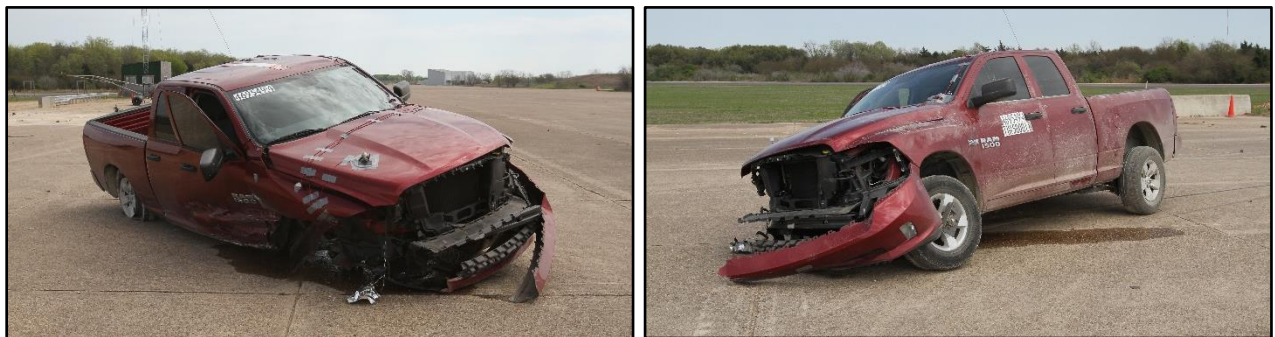
Figure 8.4. Test Vehicle after Test No. 469549-01-4.

Figure 8.4 shows the damage sustained by the vehicle. The front bumper, radiator and support, grill, right front fender, right upper and lower A-arms, right front tire and rim, right frame rail, right front and rear doors, right cab corner, right rear exterior bed, and right rear tire and rim were damaged. The right front wheel (with tire) was completely removed. The windshield had stress cracks radiating from the right side A-pillar. Maximum exterior crush to the vehicle was 17.0 inches in the front plane at the right front corner at bumper height. Maximum occupant compartment deformation was 6.0 inches in the right side firewall and kickpanel. Figure 8.5 shows the interior of the vehicle. Tables F.3 and F.4 in Appendix F1 provide exterior crush and occupant compartment measurements.
